Nanisivik Mine

RECLAMATION ACTIVITIES

QUARTERLY REPORT (3rd quarter 2007)

(PER Water License NWBNAN0208)

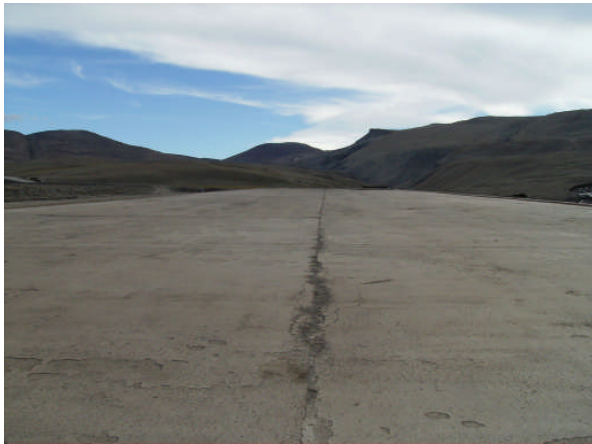
Clean con shed floor

Final cleaning of the Concrete slab was completed in early July, prior to placement of a half metre thick aesthetic cover of shale. The cover material was then graded and compacted for use as a freight staging area by the Canadian Coast Guard. Excavation of contaminated soil adjacent to the concentrate shed foundation and along the former conveyor way was completed during the quarter. Excavation of Hydrocarbon contaminated soil from the former lunch shack (refuge station) continued. This area turned out to be much larger than anticipated. The main excavation was completed, but further hydrocarbon contaminated soil remains to be excavated near the former fuel pump house in 2008.

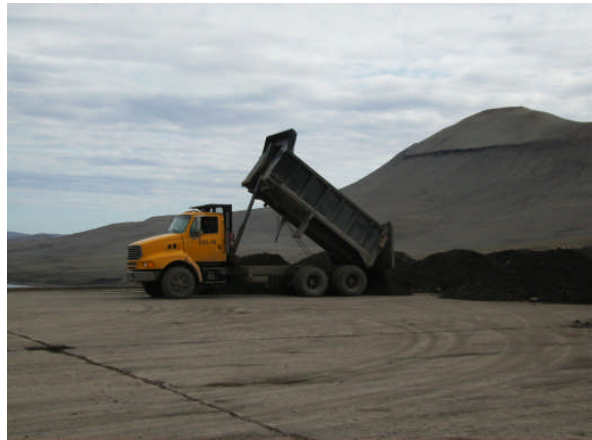
Placing Shale on Con Shed floor

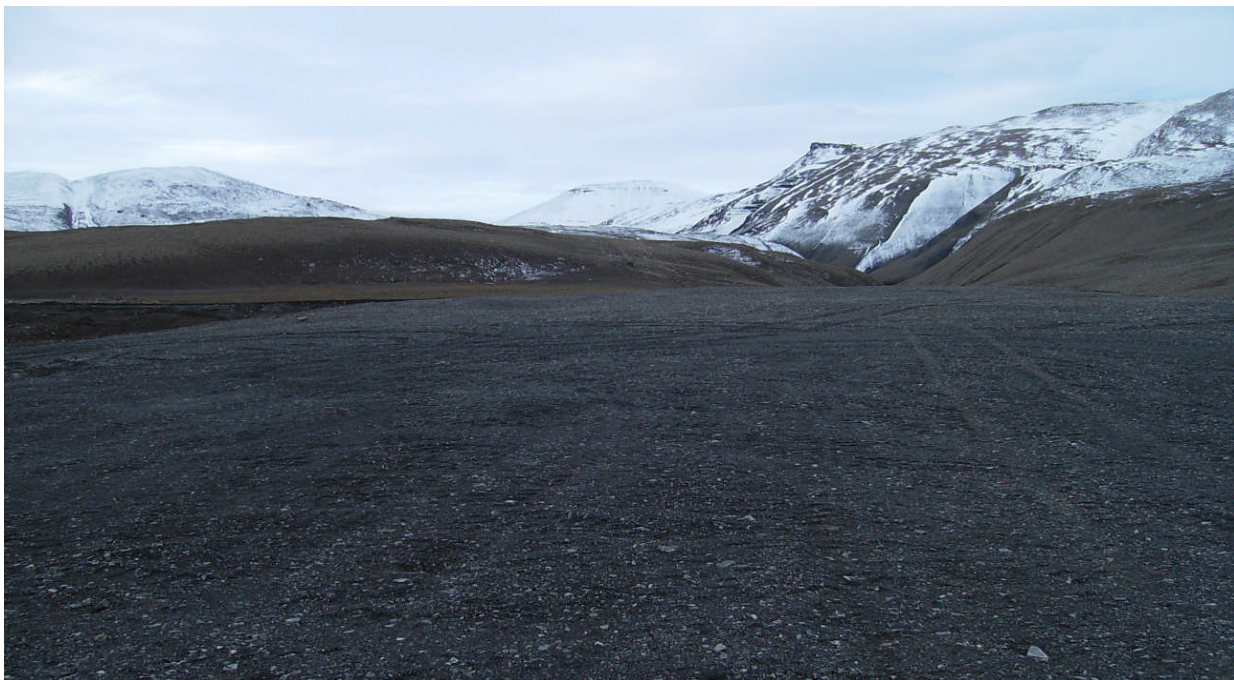
Con Shed Floor with Final Shale Cover in Place

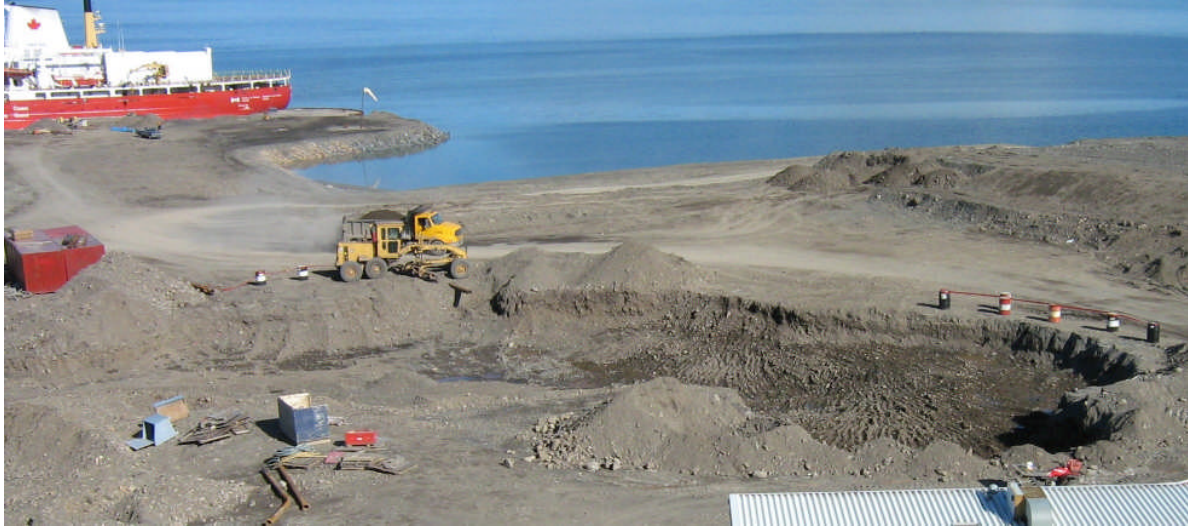
Hydrocarbon Excavation near former refuge station

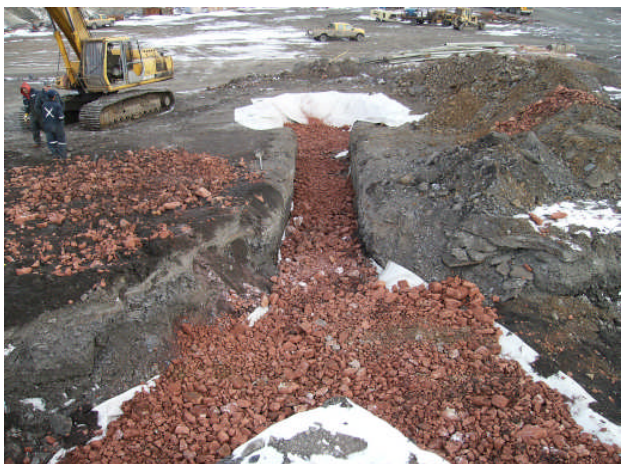
Seepage conduit and sump under construction

The placement of metal contaminated soil on the mill foundation continued during the 3rd quarter. Hydrocarbon contaminated soil in front of the powerhouse and shop was excavated down to bedrock. The foundation footing was originally poured right on top of bedrock. Further investigation below the floor was not possible, however, some liquid was noted to be seeping from below the footing onto the bedrock. We dealt with this, by first removing the liquid and then establishing a conduit between the foundation and a sump outside the eventual thermal cover. Sand berms were built and lined with a geothermal liner that extended approximately 16 metres from the corner of the foundation. Course rock was placed prior to the area being back filled. We will now be able to monitor and control future seepage if any. A layer of shale was placed over the entire foundation by the end of the quarter.

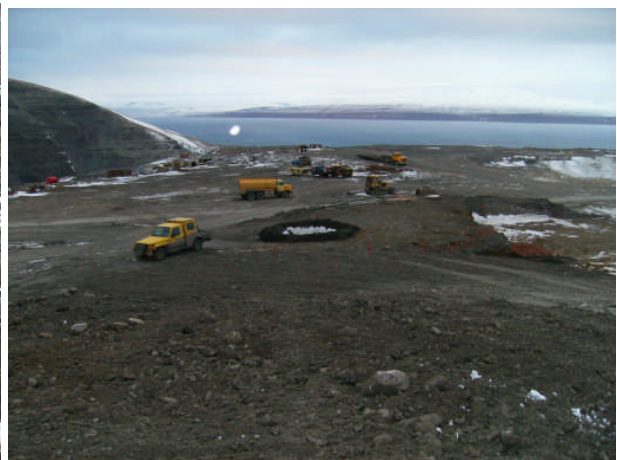
Completed Sump

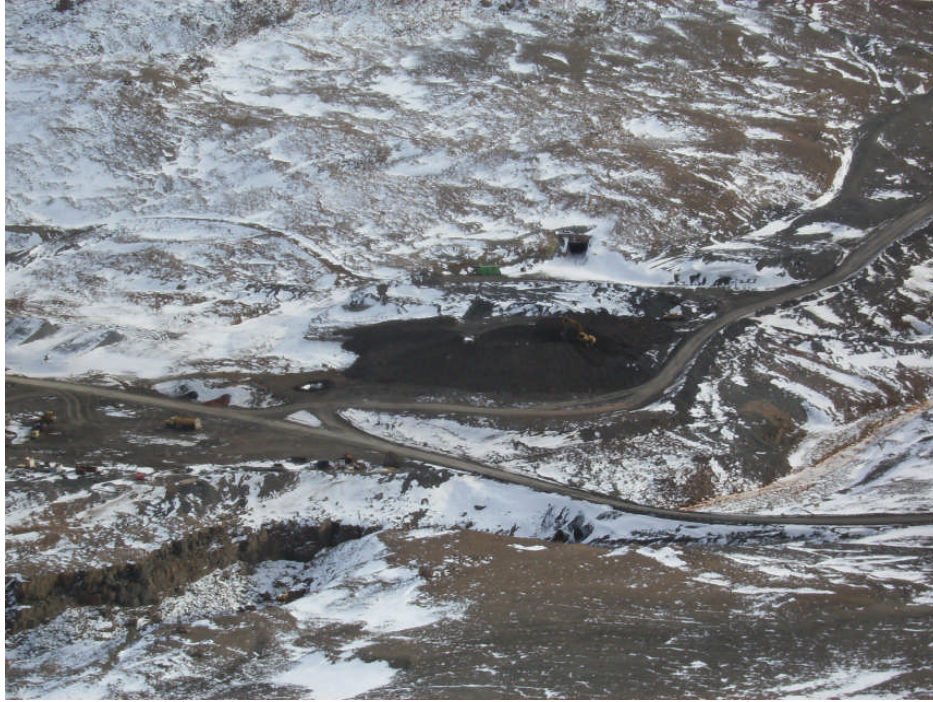
Shale Placement on Industrial Complex Foundation

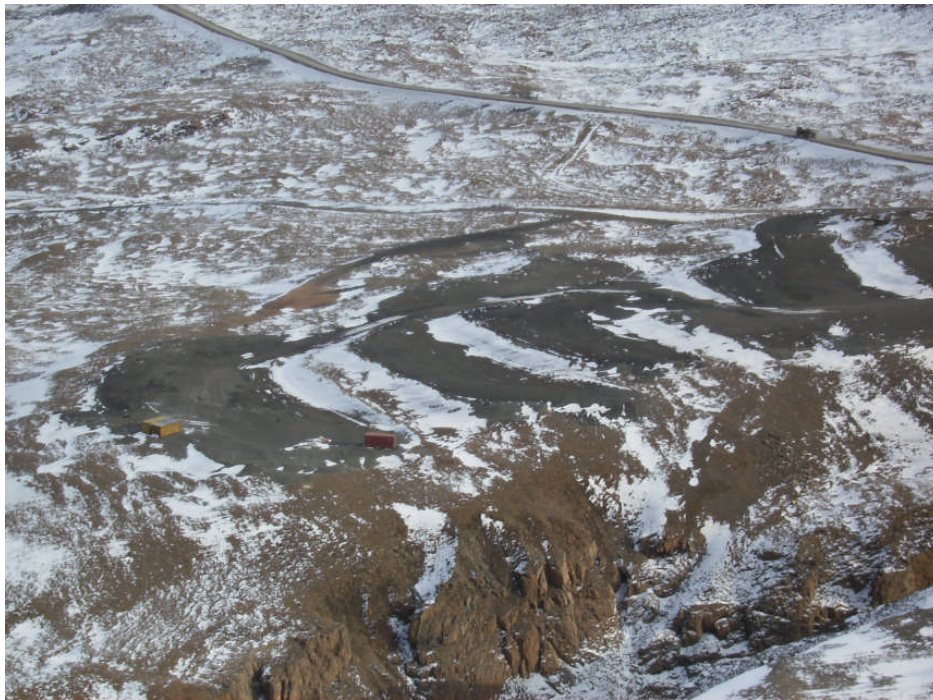
View of empty warehouse yard from adjacent hill top

Cleanup in the warehouse yard continued throughout the quarter. Much of the inventory was transferred to Zinifex (formerly Wolfden Resources). They have been crating and preparing infrastructure, spare parts and supplies; to ship to their new project near Bathurst Inlet (High Lake). Other material designated as scrap was hauled underground.

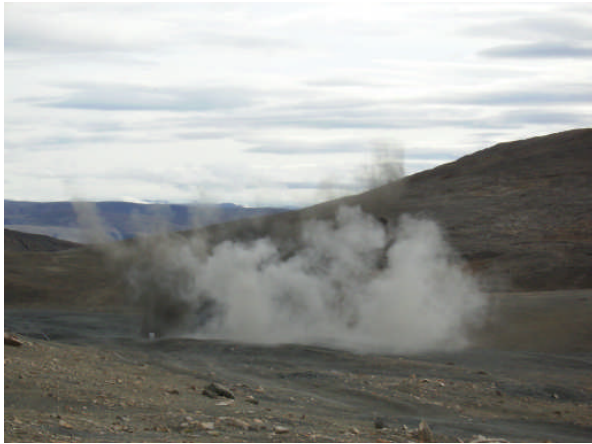
Explosives disposal

The remaining explosives on site were disposed of during the quarter. The non-electric caps were bundled together in clusters of approximately 100 inside a short piece of heavy plastic pipe and then detonated using an electric cap and detonating cord. The remnants of the caps were generally fused together after each explosion so that they could easily be picked up and disposed of in the mine.

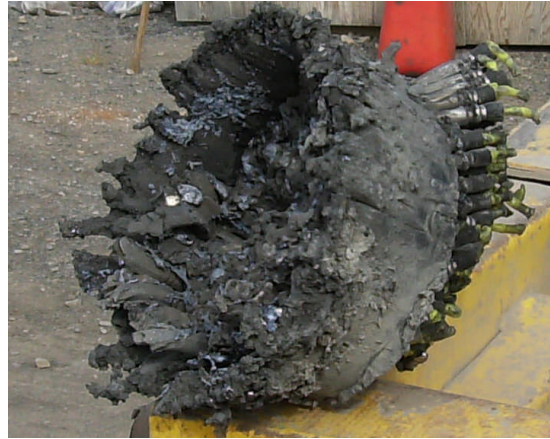
Cluster of detonated caps fused together

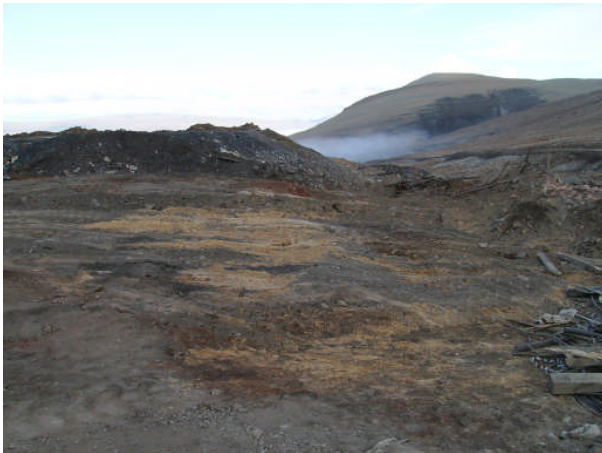
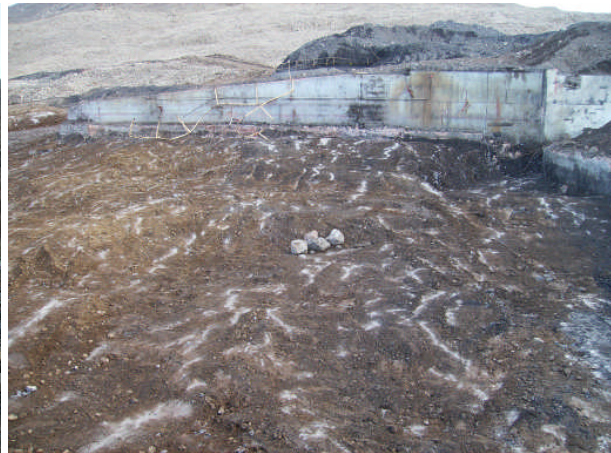
North Yard

Excavation of metal and hydrocarbon-contaminated soil continued during the 3rd quarter. This area proved to contain more contaminated soil than originally anticipated. The fuel day tanks were removed as well as the dispensing station and the storage buildings. The coarse material that was used to build the original pad allowed the contamination to penetrate fairly deep, resulting in us having to excavate to bedrock over a large area. This area will be completed in 2008.

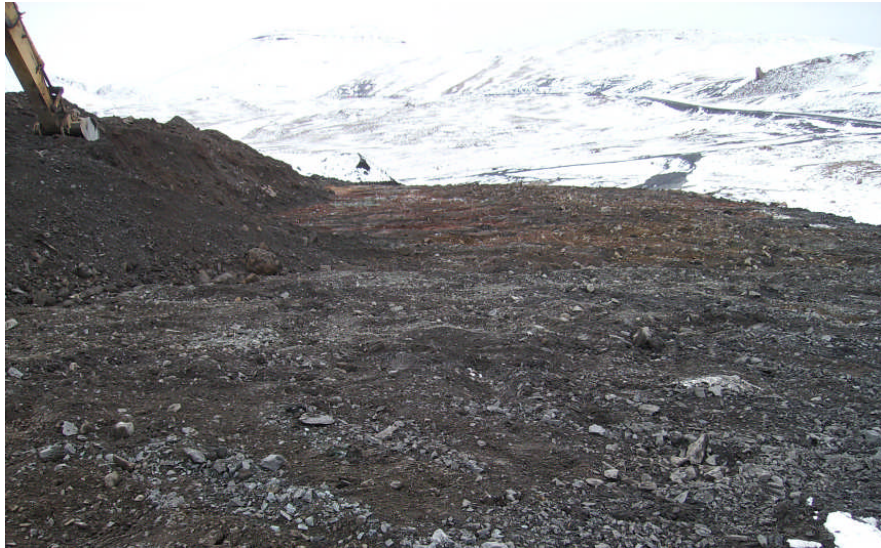
West Yard Excavation

Metal contaminated soil from the west yard as well as metal & HC co-contaminated soil from the calcium tank area was removed during the quarter. The metal soil was pushed into the foundation and the co-contaminated soil was hauled underground.

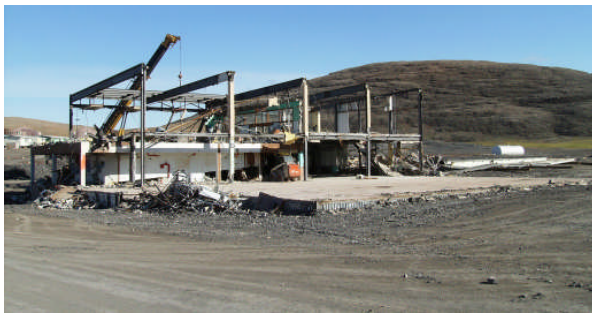
Rec Center Demolition

The remaining infrastructure was removed during the 3rd quarter. The pad for the arena was also removed and hauled underground during the quarter.

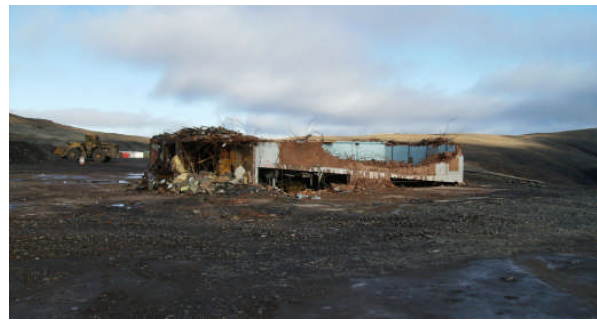
Swimming Pool Removal

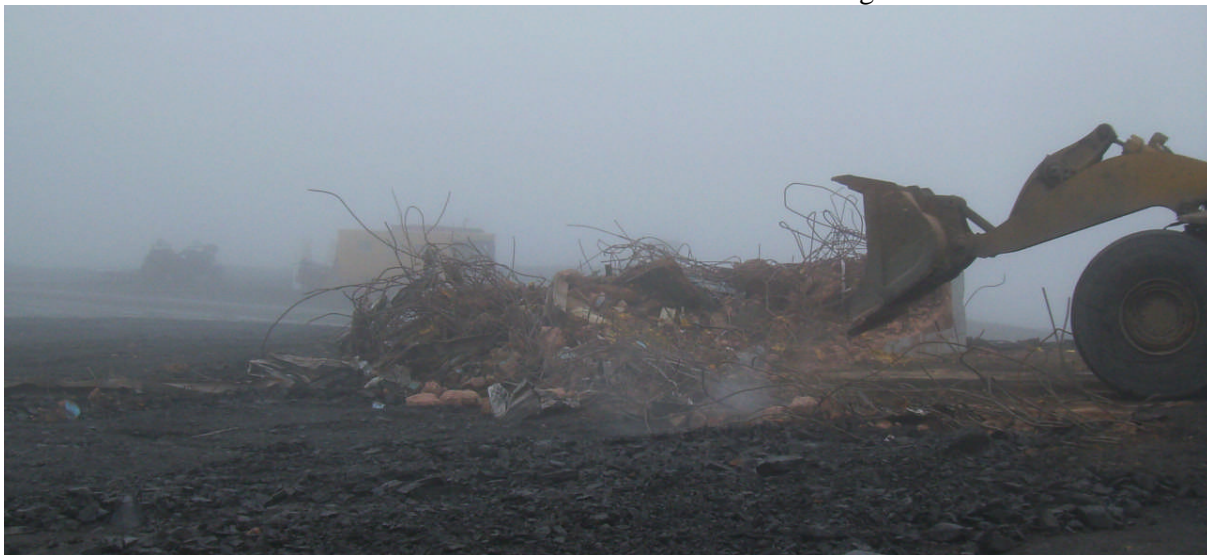
Rec Center Demolition nearing completion
