## **BREAKWATER RESOURCES LTD.**

### **HYDRAULIC STRUCTURES AS-BUILT REPORT**

### **NANISIVIK MINE, NU**

### **FINAL REPORT**

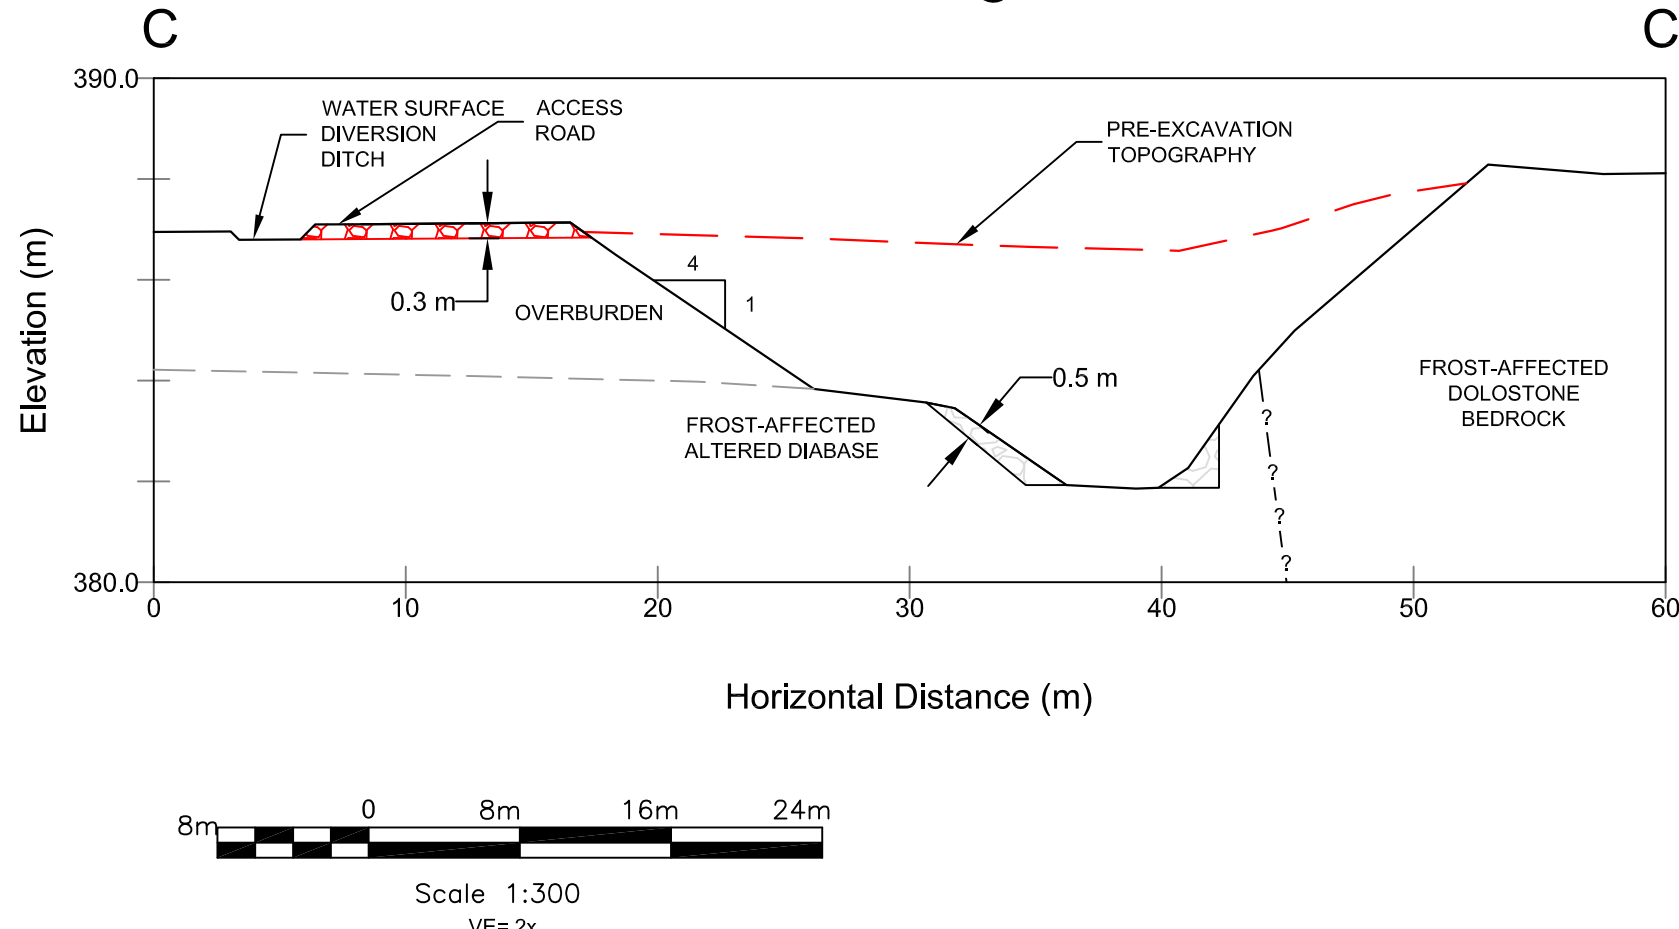
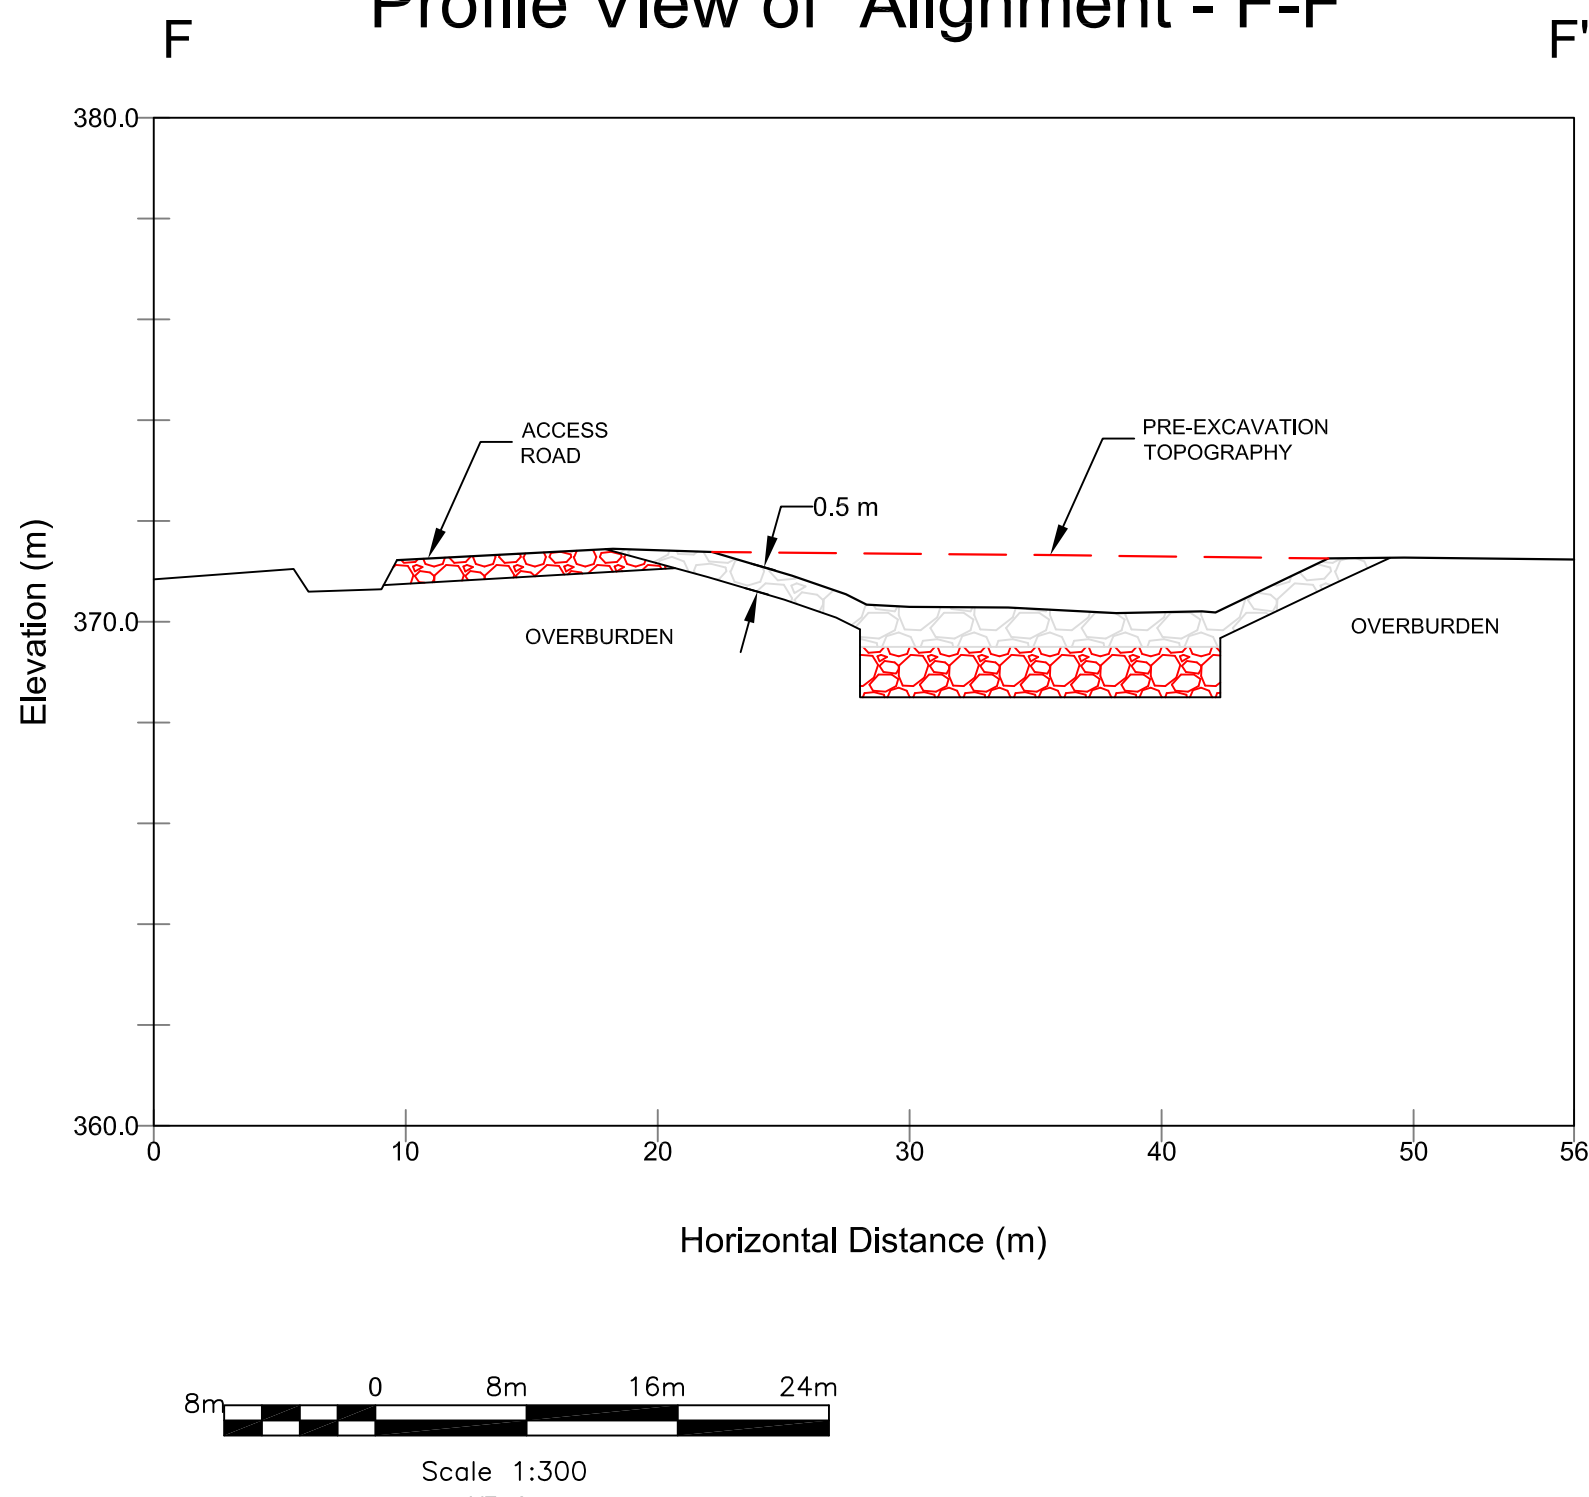
PROJECT:	NANISIVIK MINE RECLAMATION HYDRAULIC STRUCTURES AS-BUILT REPORT		
TITLE:	WEST TWIN DIKE SPILLWAY SECTION VIEWS 1		
CLIENT:	PROJECT No.:	FIGURE No.:	REV.:
BREAKWATER RESOURCES LTD.	0255-012-05	4	0

- PRE-EXCAVATION TOPOGRAPHY ALONG CENTERLINE OF SPILLWAY EXCAVATION.
- TYPE 1 RIP RAP  $D_{50} = 300\text{mm}$
- TYPE 2 RIP RAP  $D_{50} = 100\text{mm}$

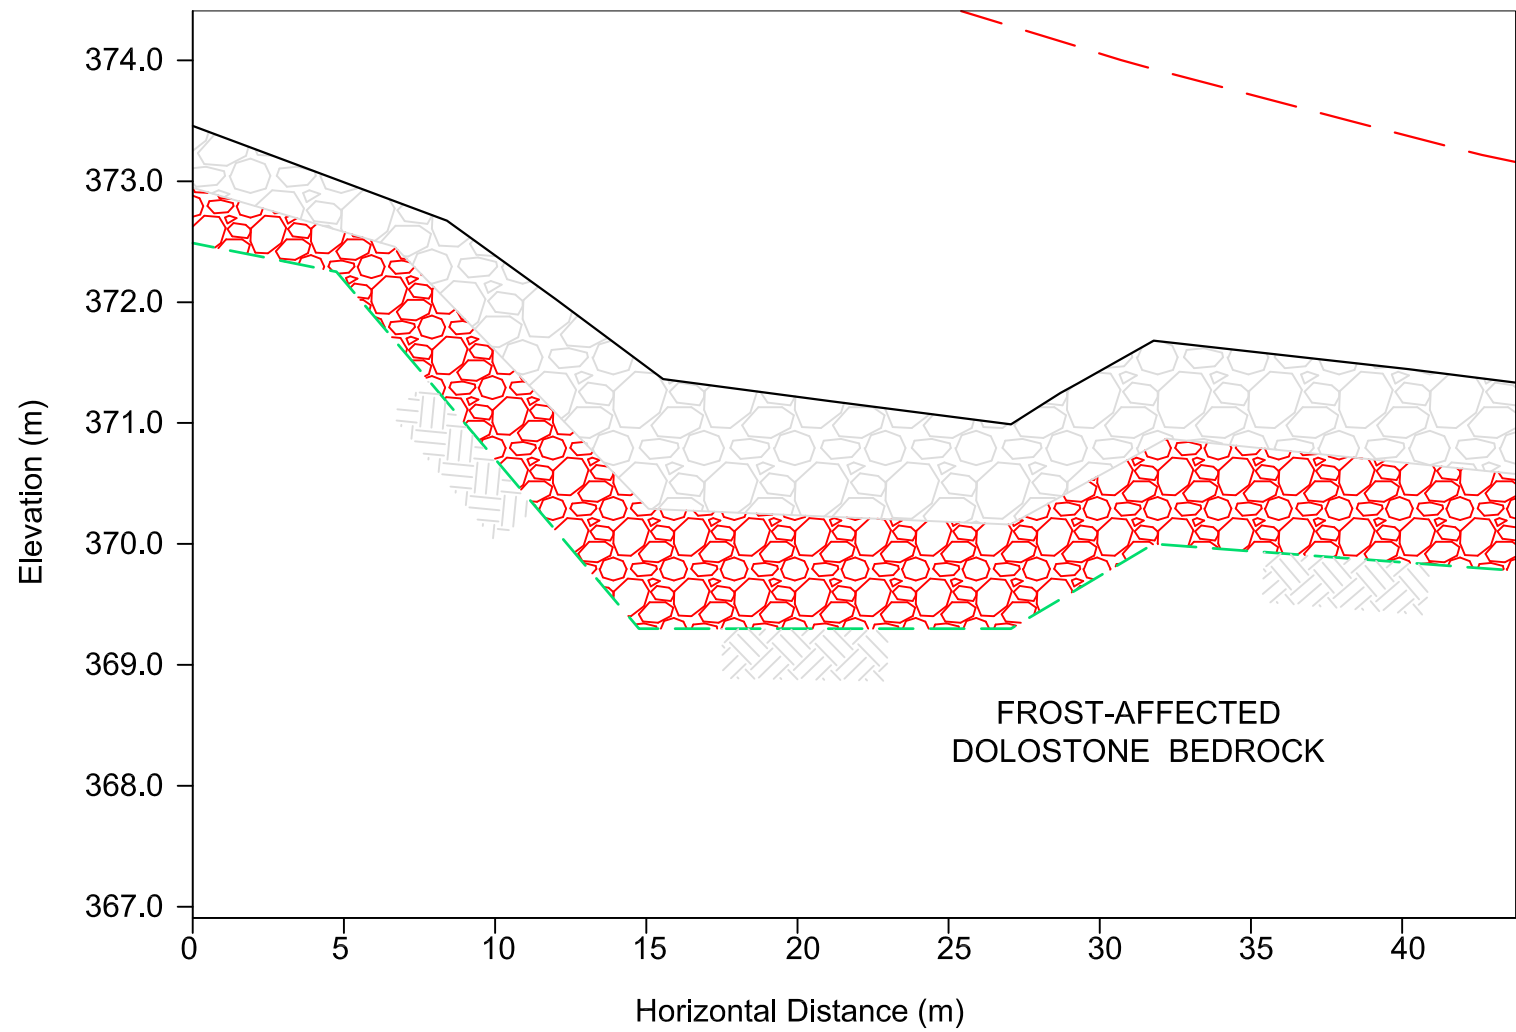
DETAIL 2  
BACKFILL DETAILS THROUGH PLUNGE POOL

The plunge pool was constructed at the transition between the chute and outlet sections of the spillway. The base of the plunge pool was founded in frost-affected dolostone bedrock. Additional riprap was applied to the base and side slopes of the plunge pool area to provide additional erosion protection during high flow events.

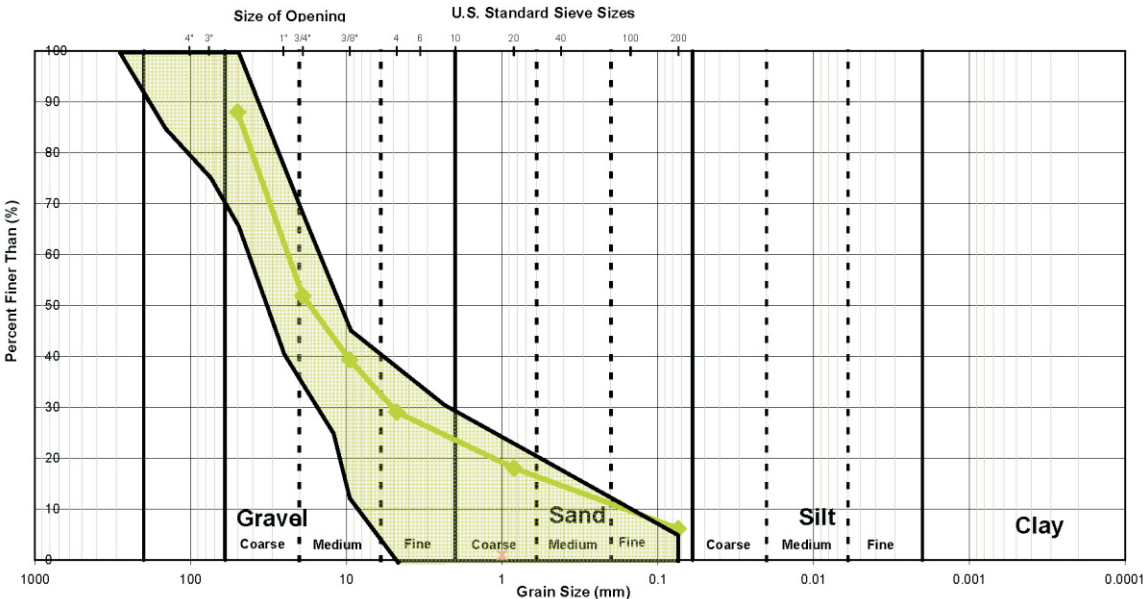
Note: Shaded areas denote design specifications (Golder 2005b).

The materials were subsequently excavated using the 385ME excavator and transported to various stockpiles, depending on the material type. Overburden was mostly transported to the Mt. Fuji shale quarry and stockpiled in the base of the quarry (see Photo 3). This material was used to reclaim the quarry by grading the floor to prevent ponding. The frost-affected rock, denoted by its smaller size and red stained surface colour (see Photo 5), was transported to a stockpile adjacent to the spillway outlet area for later use as Type 2 riprap. The competent rock material, denoted by its larger particle size and lack of soil staining, was transported to a separate stockpile adjacent to the spillway outlet for later use as Type 1 riprap (see Photo 6). Grain size distribution analyses undertaken on both materials confirmed these materials were appropriate for use as riprap. The results of these analyses are provided on Figure 6.

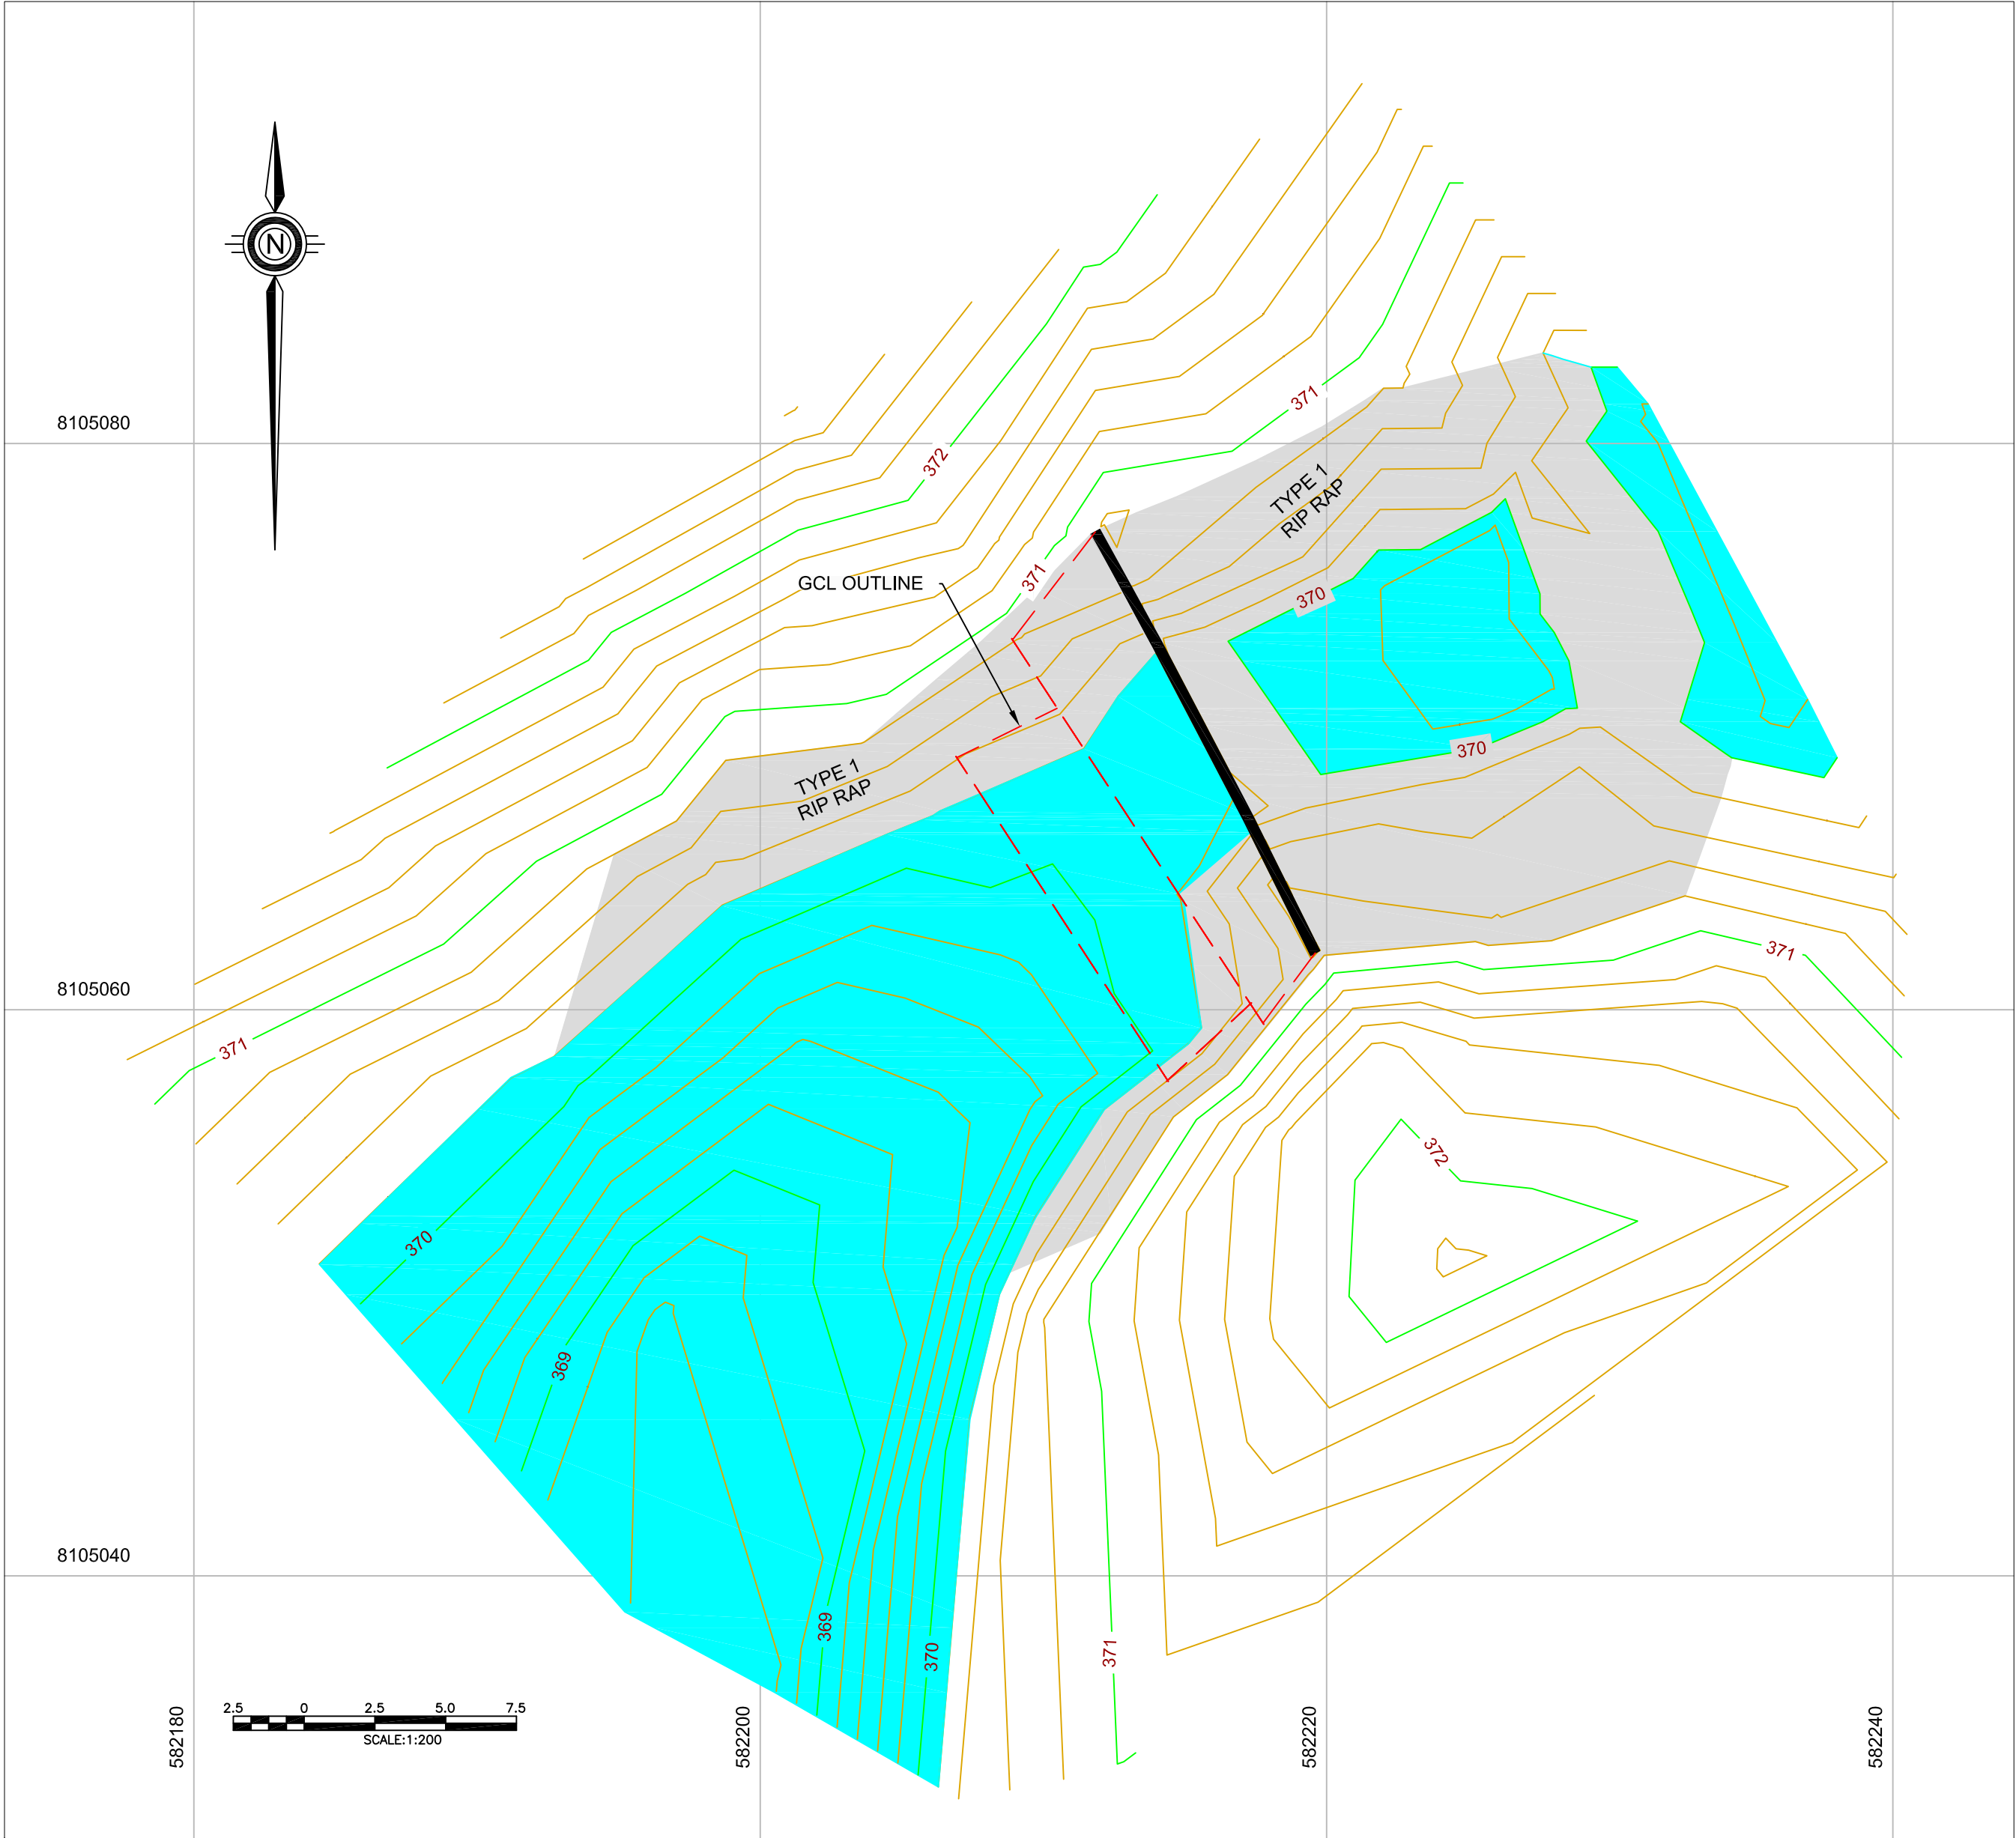
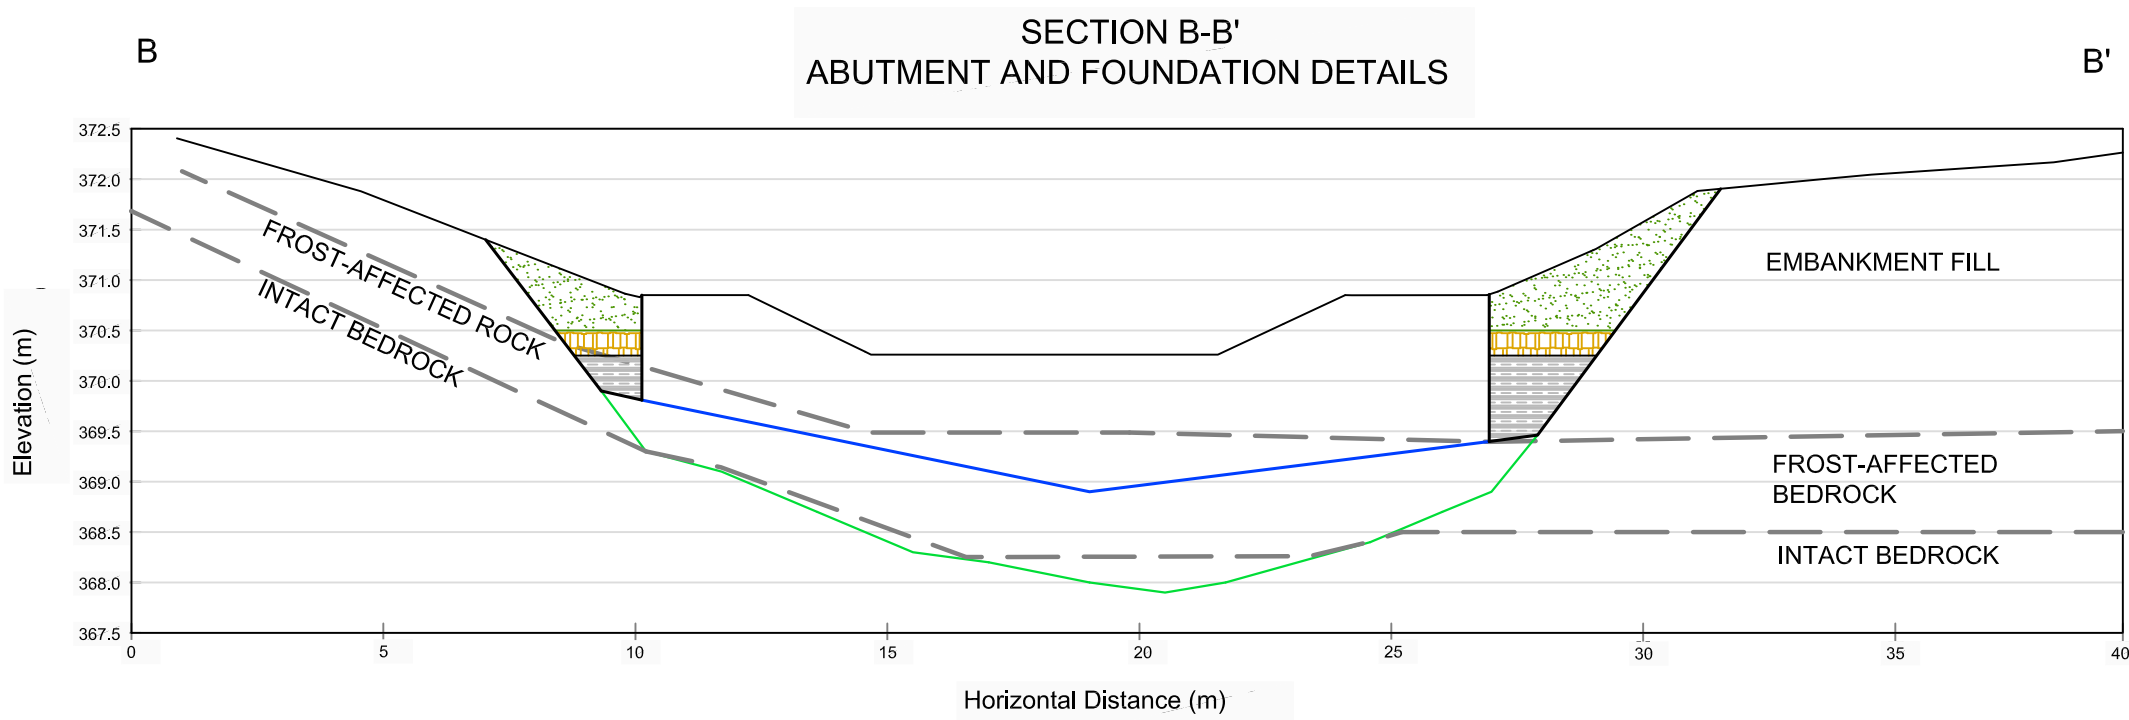
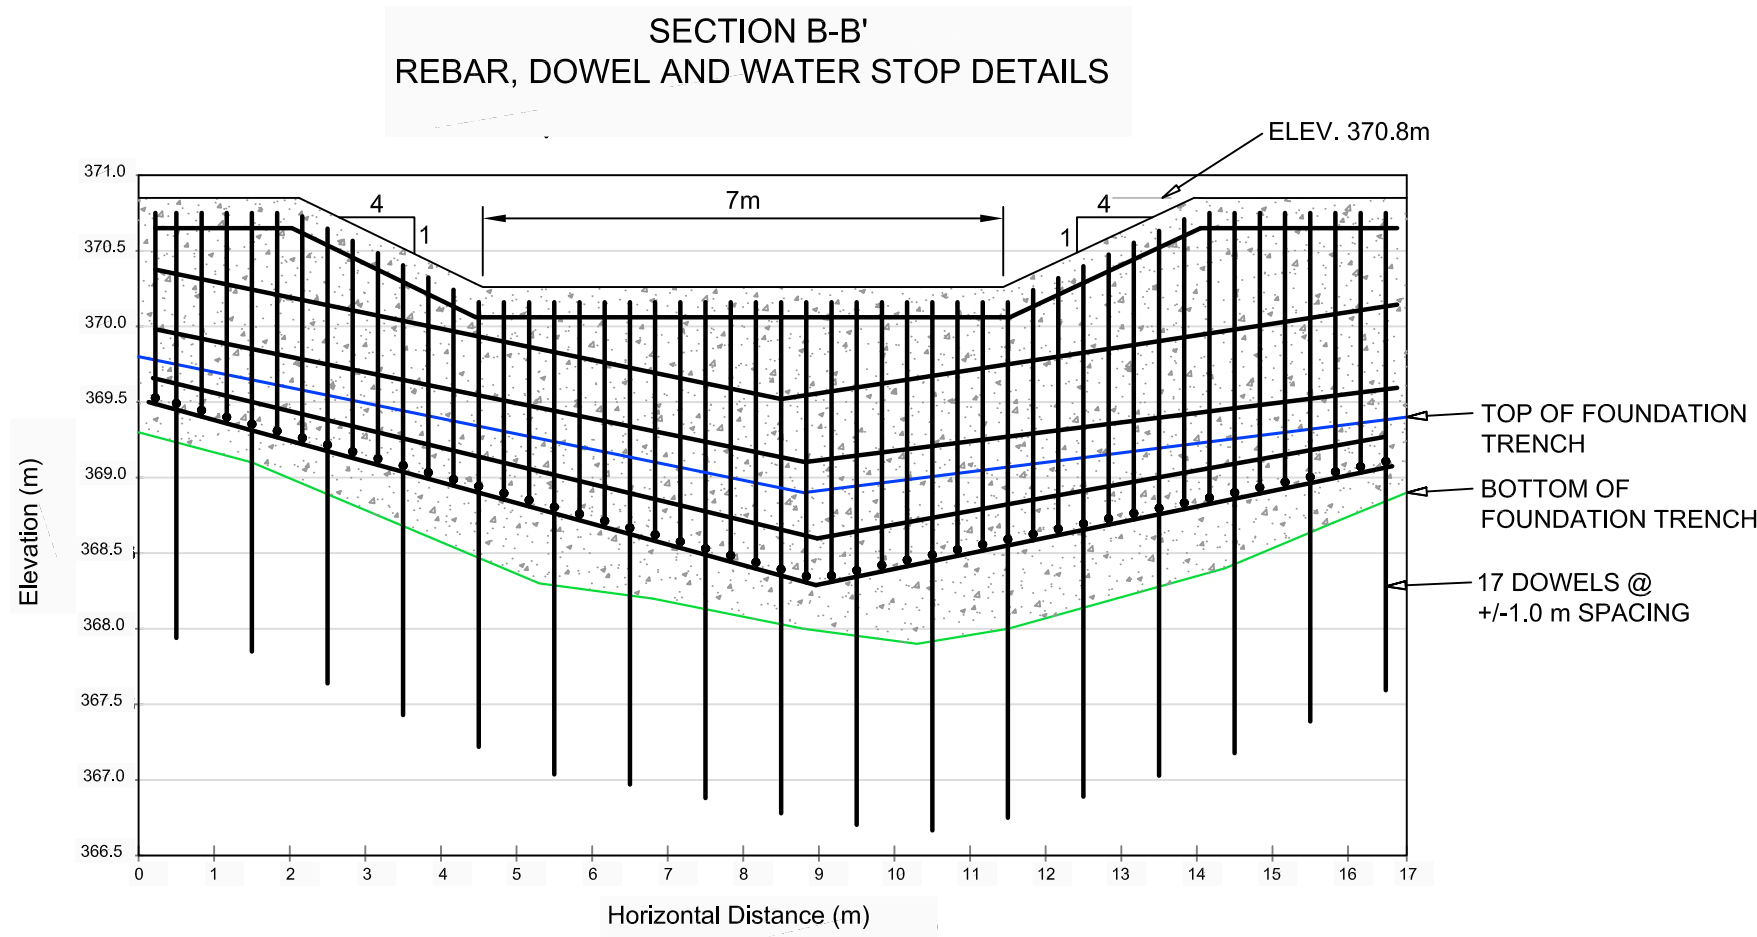
PLAN VIEW - WEST TWIN OUTLET CHANNEL

- A steel reinforced, concrete foundation trench was to be constructed to limit seepage through the foundation of the overflow weir.
- A 0.3 m wide, steel reinforced, concrete cut-off wall was to be constructed to provide a fixed, non-erodible invert and prevent seepage through the riprap and bedding zones at the sides of the channel. The invert elevation of the central portion of the wall was to be 370.2 m.

- The bedrock foundation beneath the trench was to be grouted to further reduce seepage under the wall.
- The wall was to extend 5 m laterally into the adjacent embankment fill and into the natural ground abutment to increase the length of the seepage path around the wall.

Select photos of the reclamation process including pre-reclamation conditions and weir construction are illustrated on the photos included in Appendix II. The as-built details of the West Twin Outlet Channel are provided on Figure 7. The following sections provide details regarding the construction schedule, construction materials, construction methodologies and the as-built survey information.

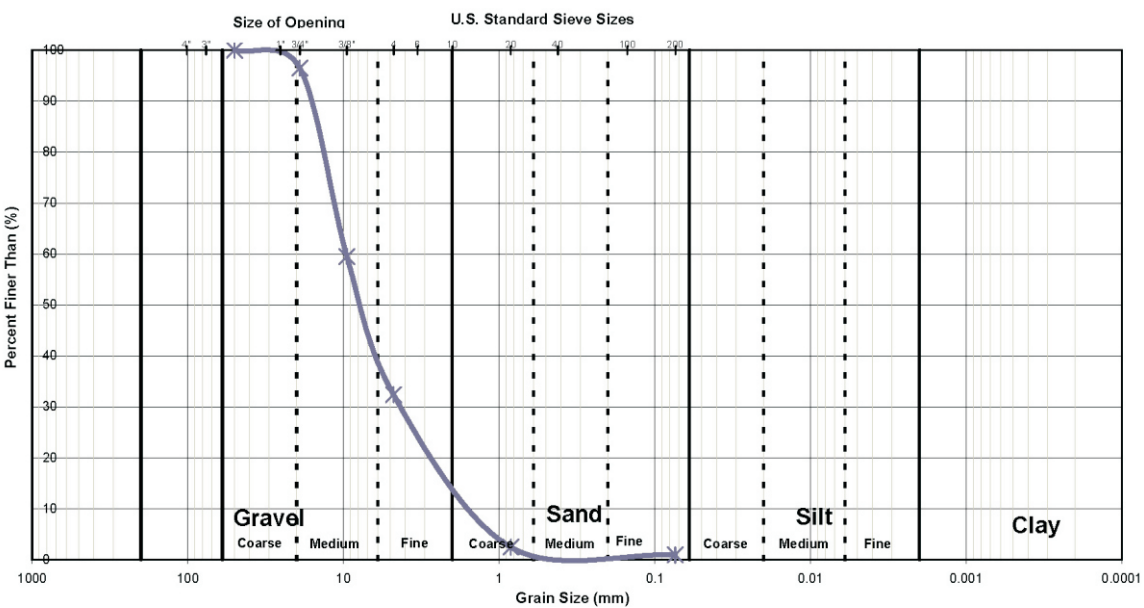
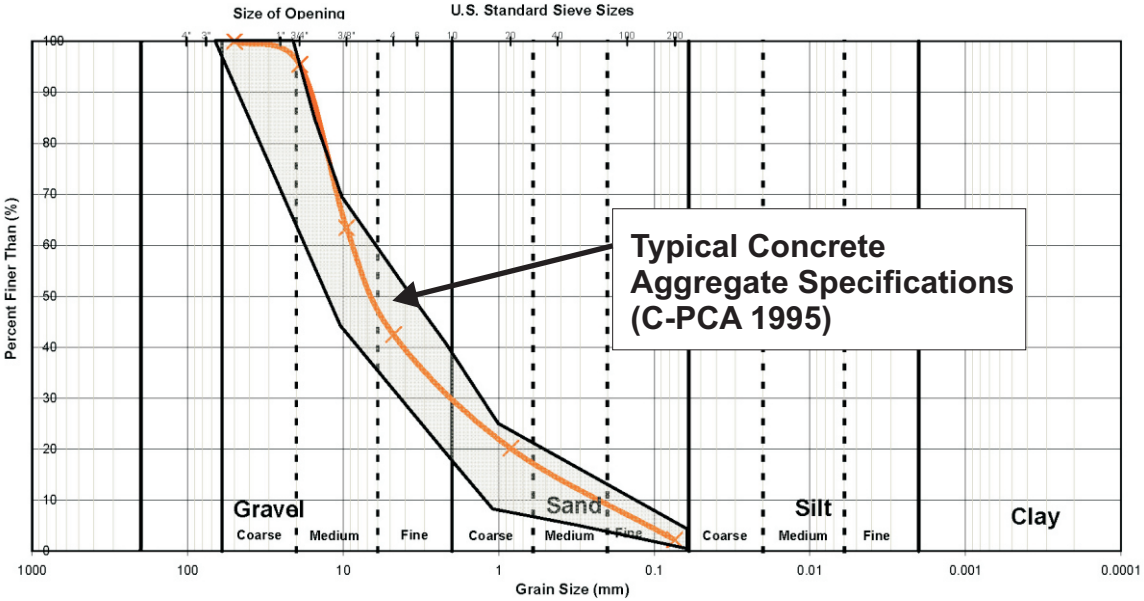
Measured grain size distribution curves for each aggregate type are provided on Figure 8. As can be seen, the combined grain size distribution meets typical concrete aggregate grain size specifications, as documented in CPCA (1995). It should be noted that the DMS reject material was used as coarse aggregate due to its appropriate grain size distribution and availability. No mineralogical information was available on this material. However, it was noted by mine staff that the DMS reject material was typically composed of dolostone.

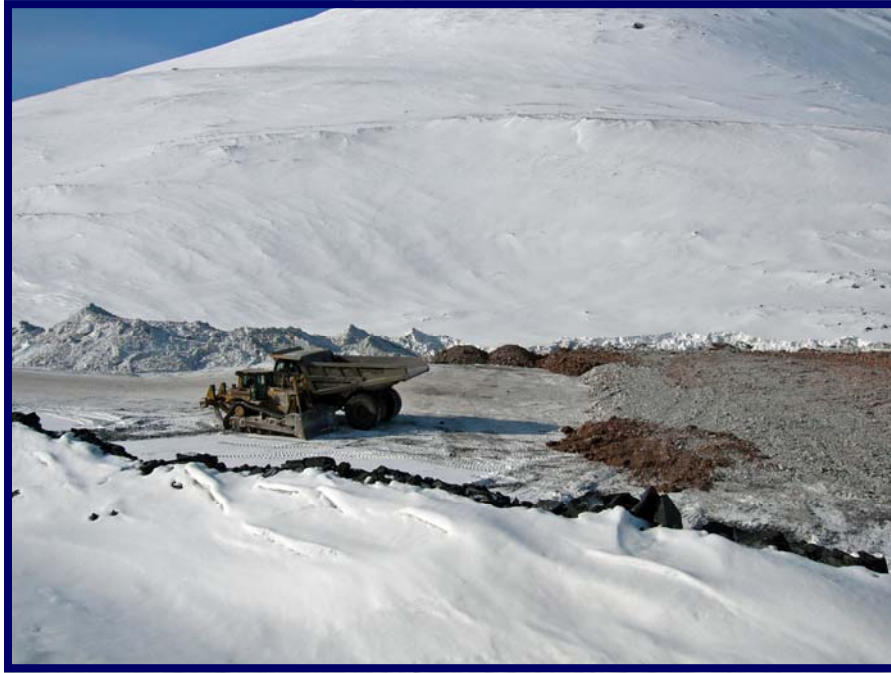
Photo 2 May 14, 2005  
Blast at spillway.

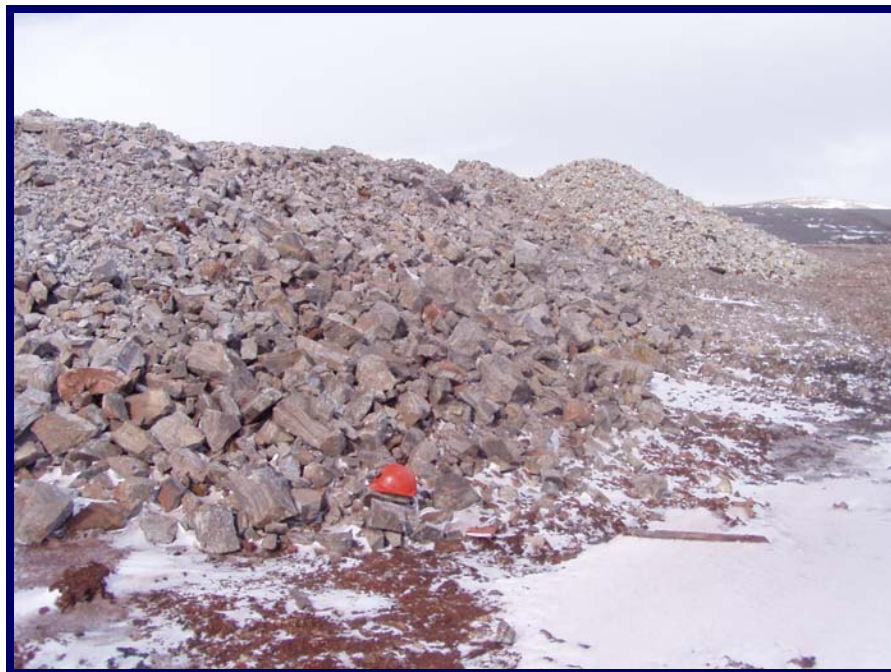
Photo 5 May 20, 2005  
Stockpile of Type 2 riprap.  
Note field book for scale.  
Also note red staining on surface of rock.

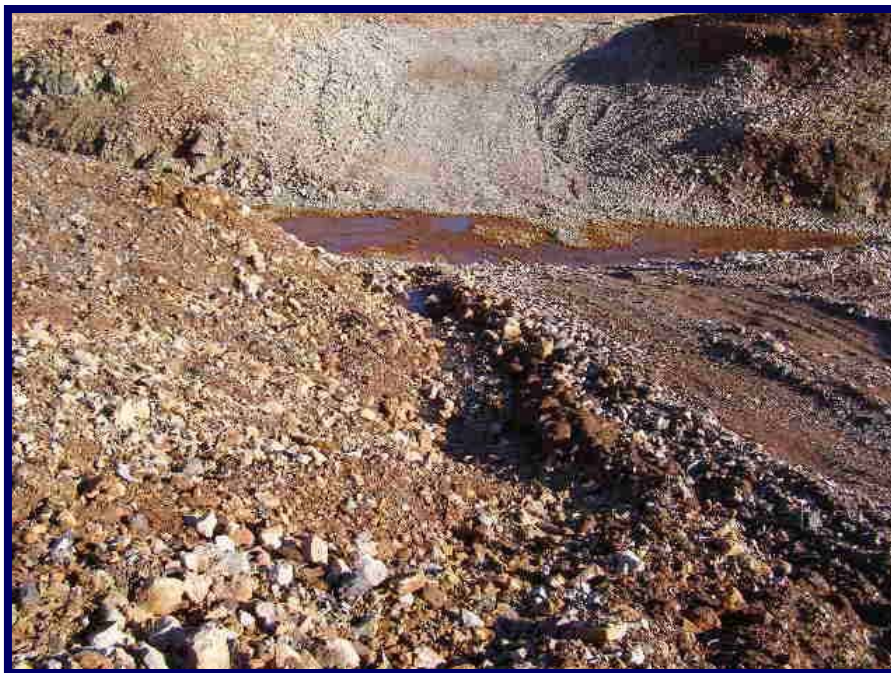
Photo 13 May 18, 2005  
Access ramp between inlet and chute portions of spillway.

An access ramp was constructed on both sides of the spillway excavation, approximately 200 m from the inlet (see Photo 13). The ramp was excavated primarily in dolostone bedrock on the left side of the spillway and a mixture of overburden, frost-affected bedrock and competent bedrock on the right side of the spillway. The ramp was sloped at an angle of approximately 4(H):1(V) and a 0.3 m thick layer of armour rock was applied to the surface of the access ramp, on both sides of the channel, to improve trafficability.

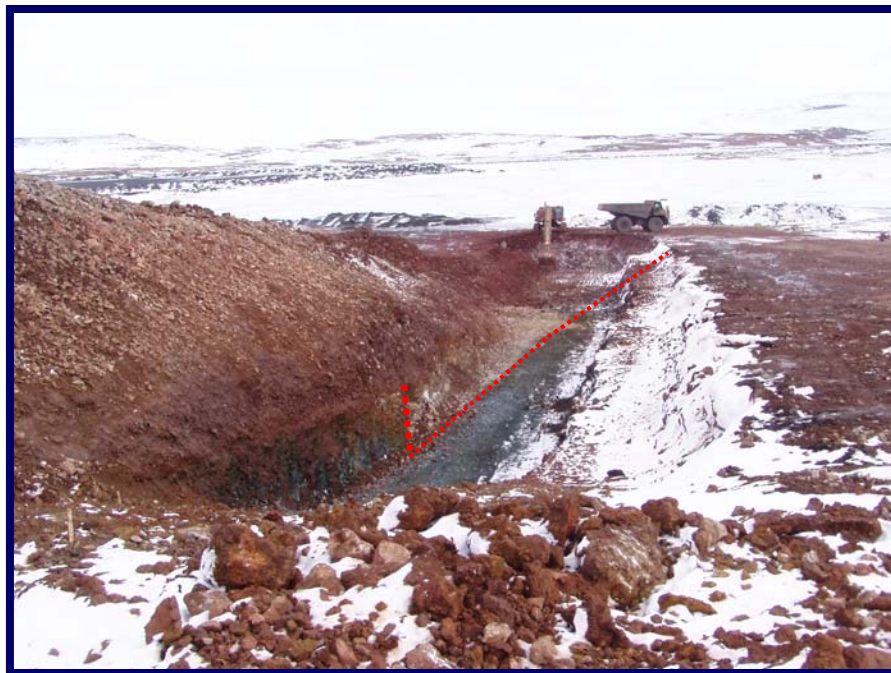
Photo 15 May 18, 2005  
Initial excavation of lower portion of spillway chute.  
Note exposed diabase (dark green colour) in sidewall.

The excavation of the inlet portion of the spillway is photographically documented on Photos 15 through 26. Excavation of the spillway chute started at the plunge pool and proceeded towards the access ramp. As the excavation proceeded, it was observed that a diabase dike was encountered through the majority of the sidewalls of the excavation (see Photos 15 and 16). The quality of the diabase material was observed to range from slightly weathered, to being locally altered to ice-rich clay. As the excavation reached approximately Station 290 (290 m from the inlet at the Surface Cell), it was apparent that the quality of the rock encountered in the side walls of the excavation was sufficiently poor that the stability of the excavation, as originally designed, could not practically be maintained in the long term (see Photos 17 and 18). As such, the design grades were altered to limit the exposure of diabase in the side walls and provide a stable slope configuration. The revised grades were achieved by backfilling the excavation with rockfill (Type 1 and Type 2 riprap) such that the remaining exposure of diabase rock in the side walls was limited in height to a maximum of approximately 1 m. During backfilling, approximately 1 m of Type 2 riprap was placed on the bottom of the excavation. Type 1 riprap was then placed in the excavation to the revised grade elevation. The average thickness of backfill through the chute section was approximately 2 m, with a maximum fill thickness of 3.5 m. The remnant exposed side walls were treated as frost affected bedrock and were armoured with Type 1 riprap.

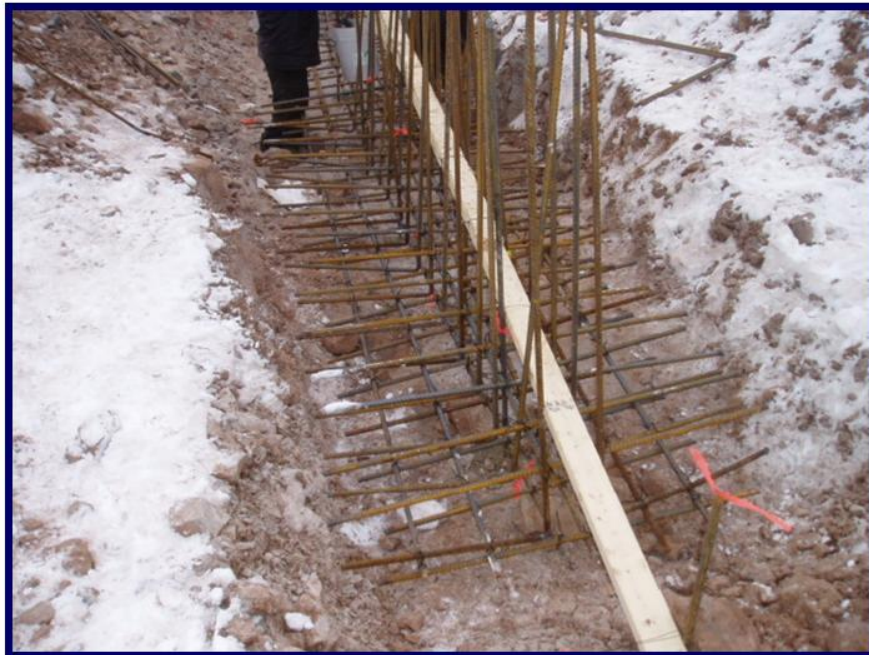
Photo 5 - September 12, 2005  
Grouting of the dowels into competent bedrock in foundation trench.

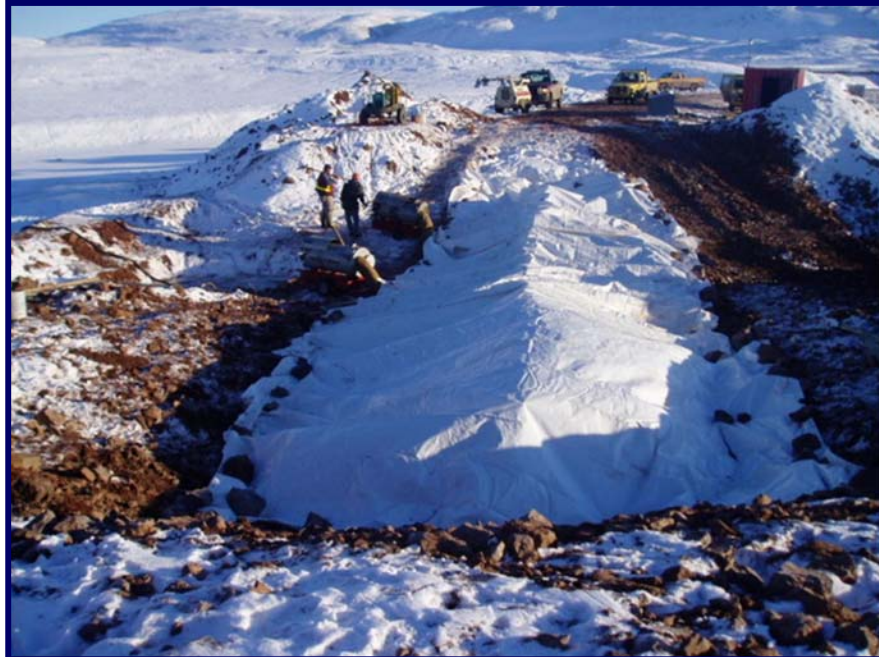
Photo 15 - September 20, 2005  
Completed concrete pour in foundation trench.  
Note the water stop placed into the foundation.

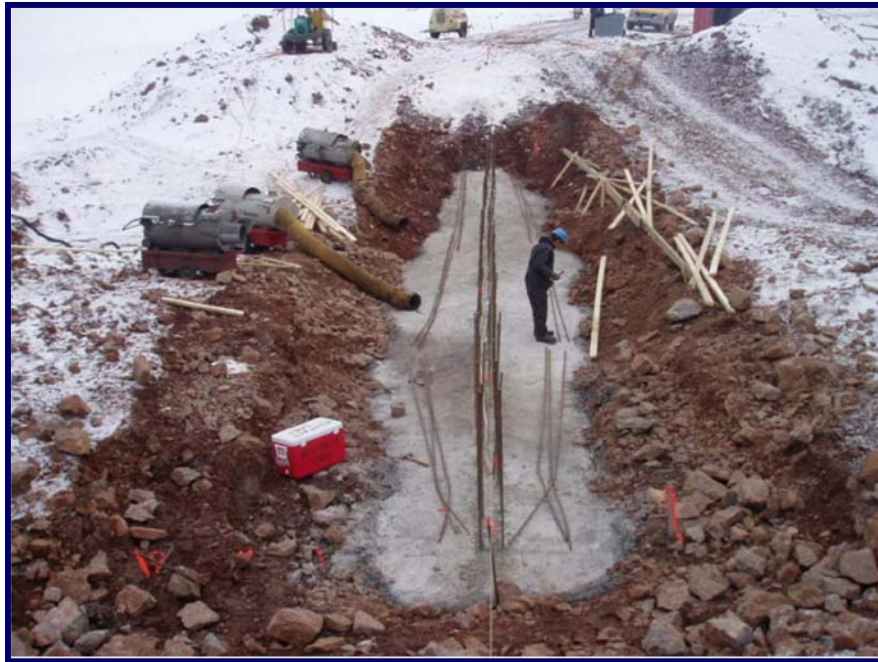
Photo 16 - September 20, 2005  
Tarps and heaters used to allow the concrete to cure after the concrete pour in foundation trench.

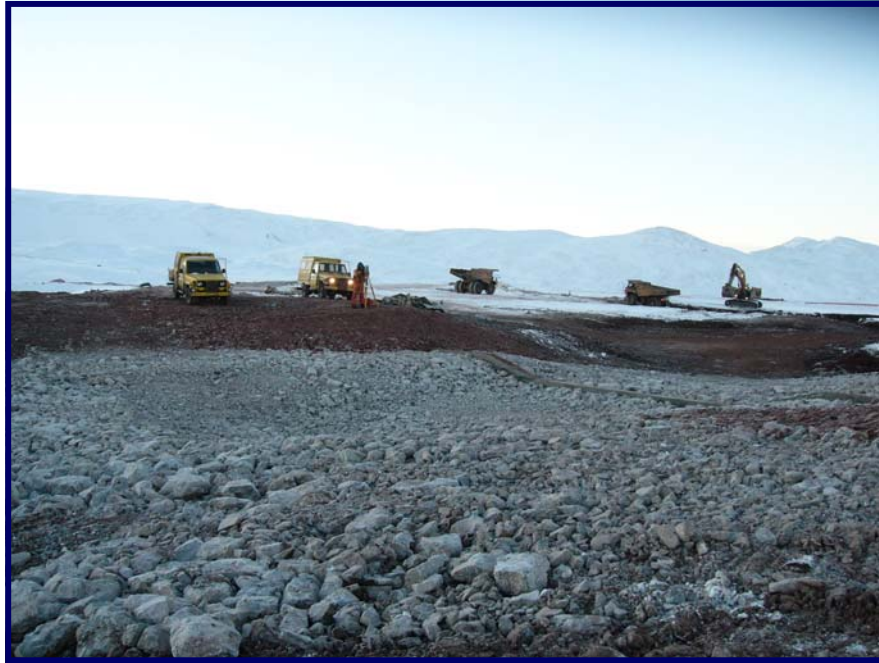
Photo 34 - October 8, 2005  
Shows a view of the armoured West Twin Outlet Channel, including the downstream plunge pool.

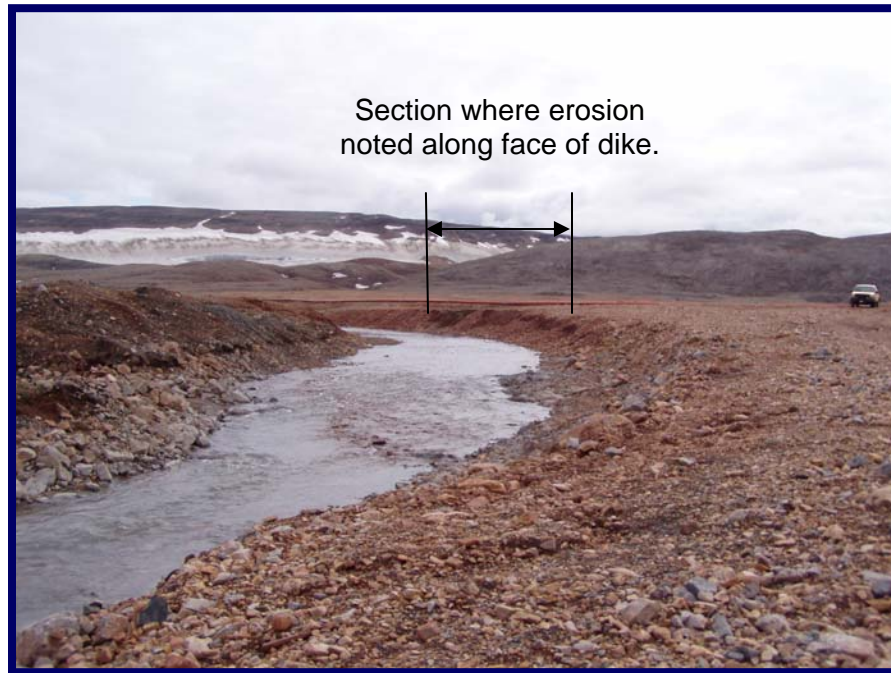
Photo 2 - July 2004  
East Twin Diversion Channel prior to reclamation.  
Close up view of area of erosion on face of dike.

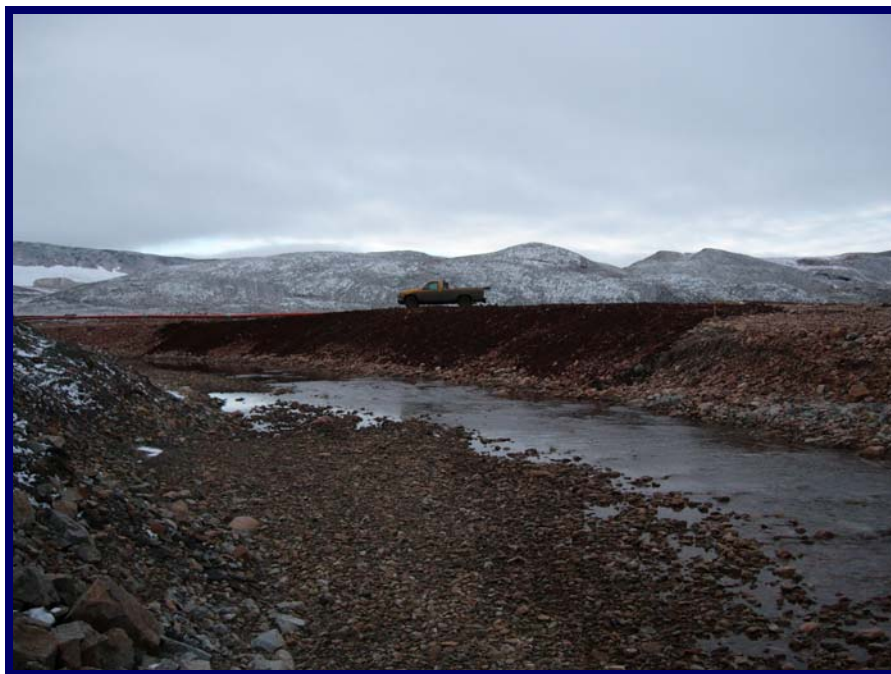
Photo 3 - July 2004  
View looking upstream.  
Note area of erosion on dike.

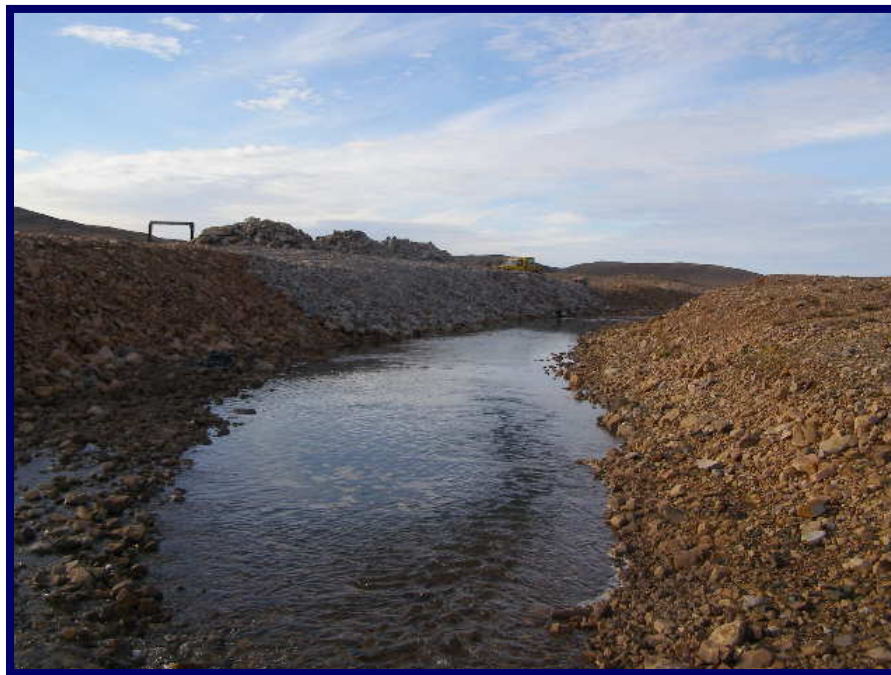
Photo 5 - August 2006  
View looking upstream.  
Armoured section of diversion dike.  
Note grain size distribution of rockfill.
