# Breakwater Resources Ltd.

## Nanisivik Reclamation Update

October 15, 2007

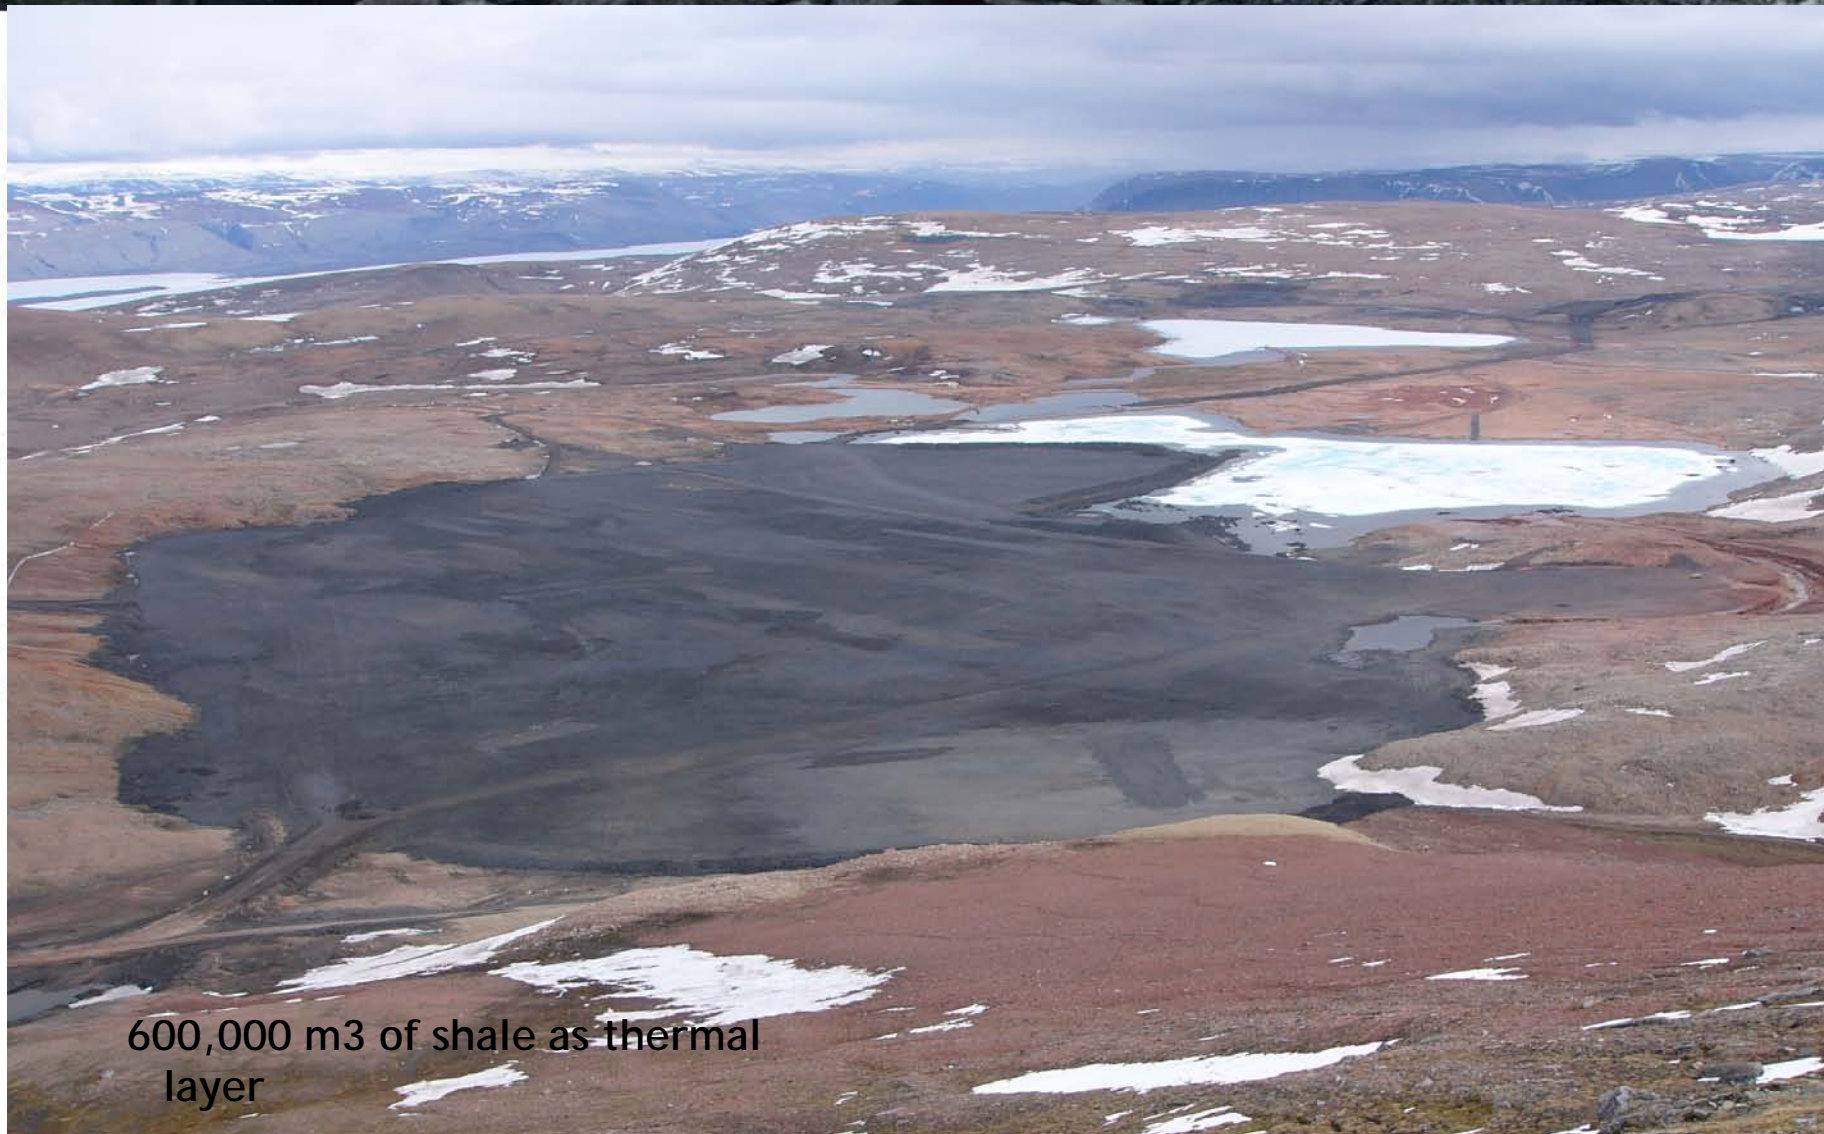
600,000 m<sup>3</sup> of shale as thermal  
layer

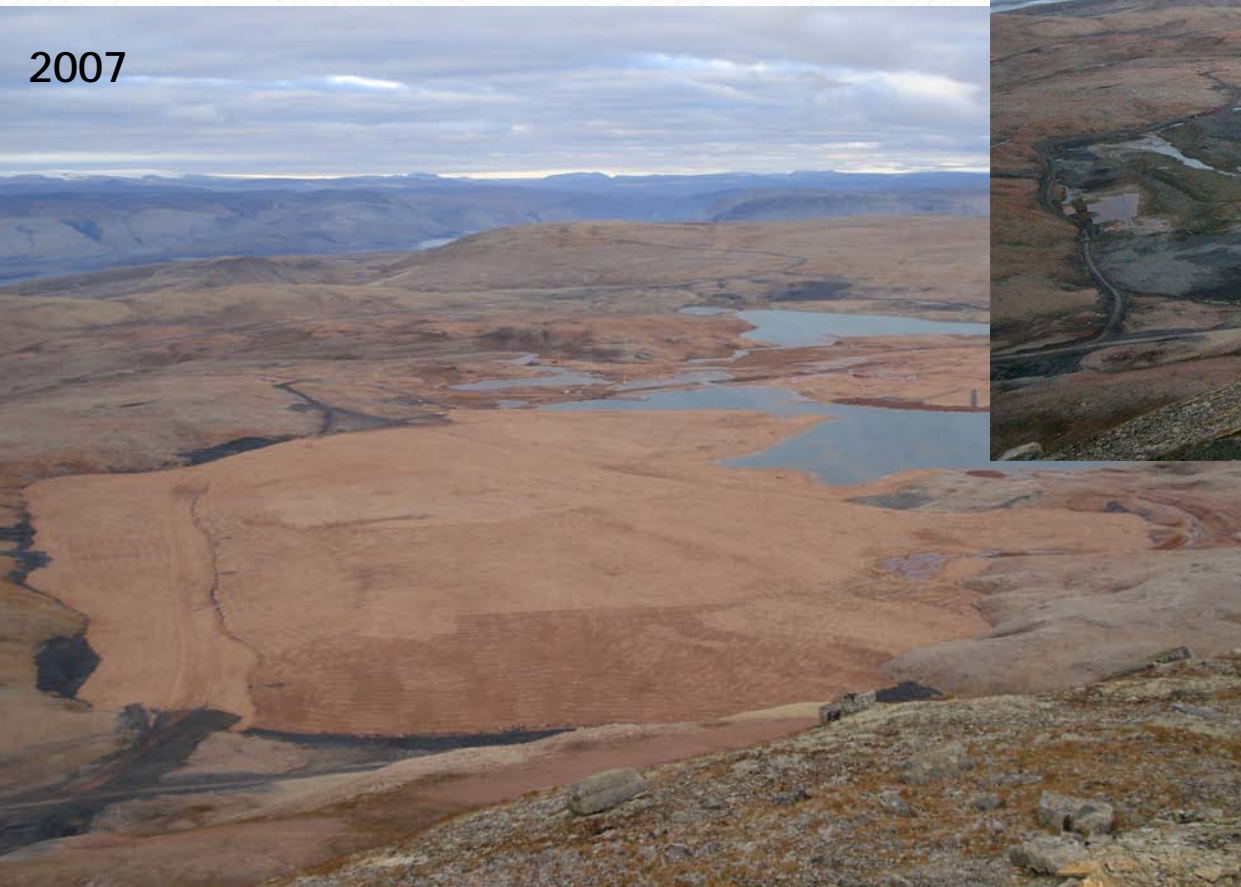
2007

125,000 m<sup>3</sup> of armour

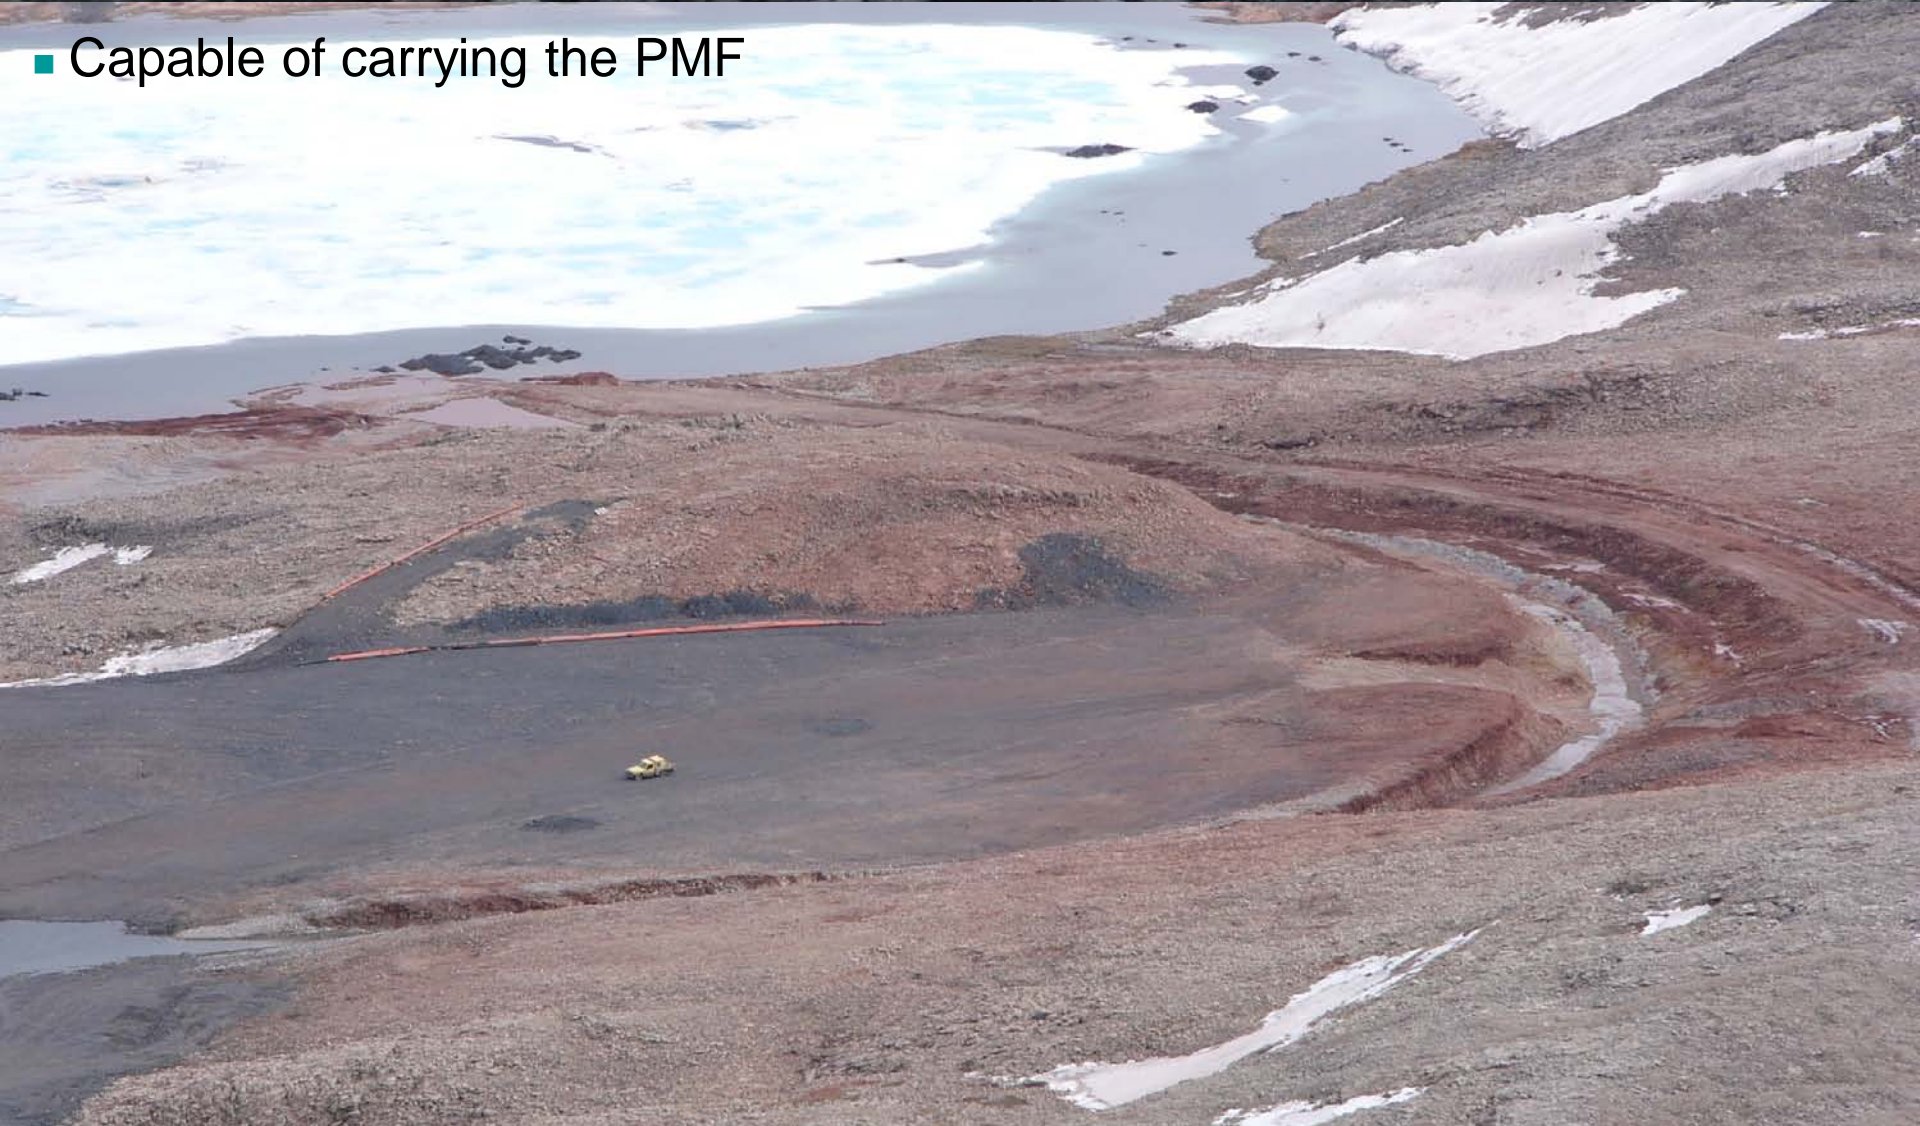
■ Capable of carrying the PMF

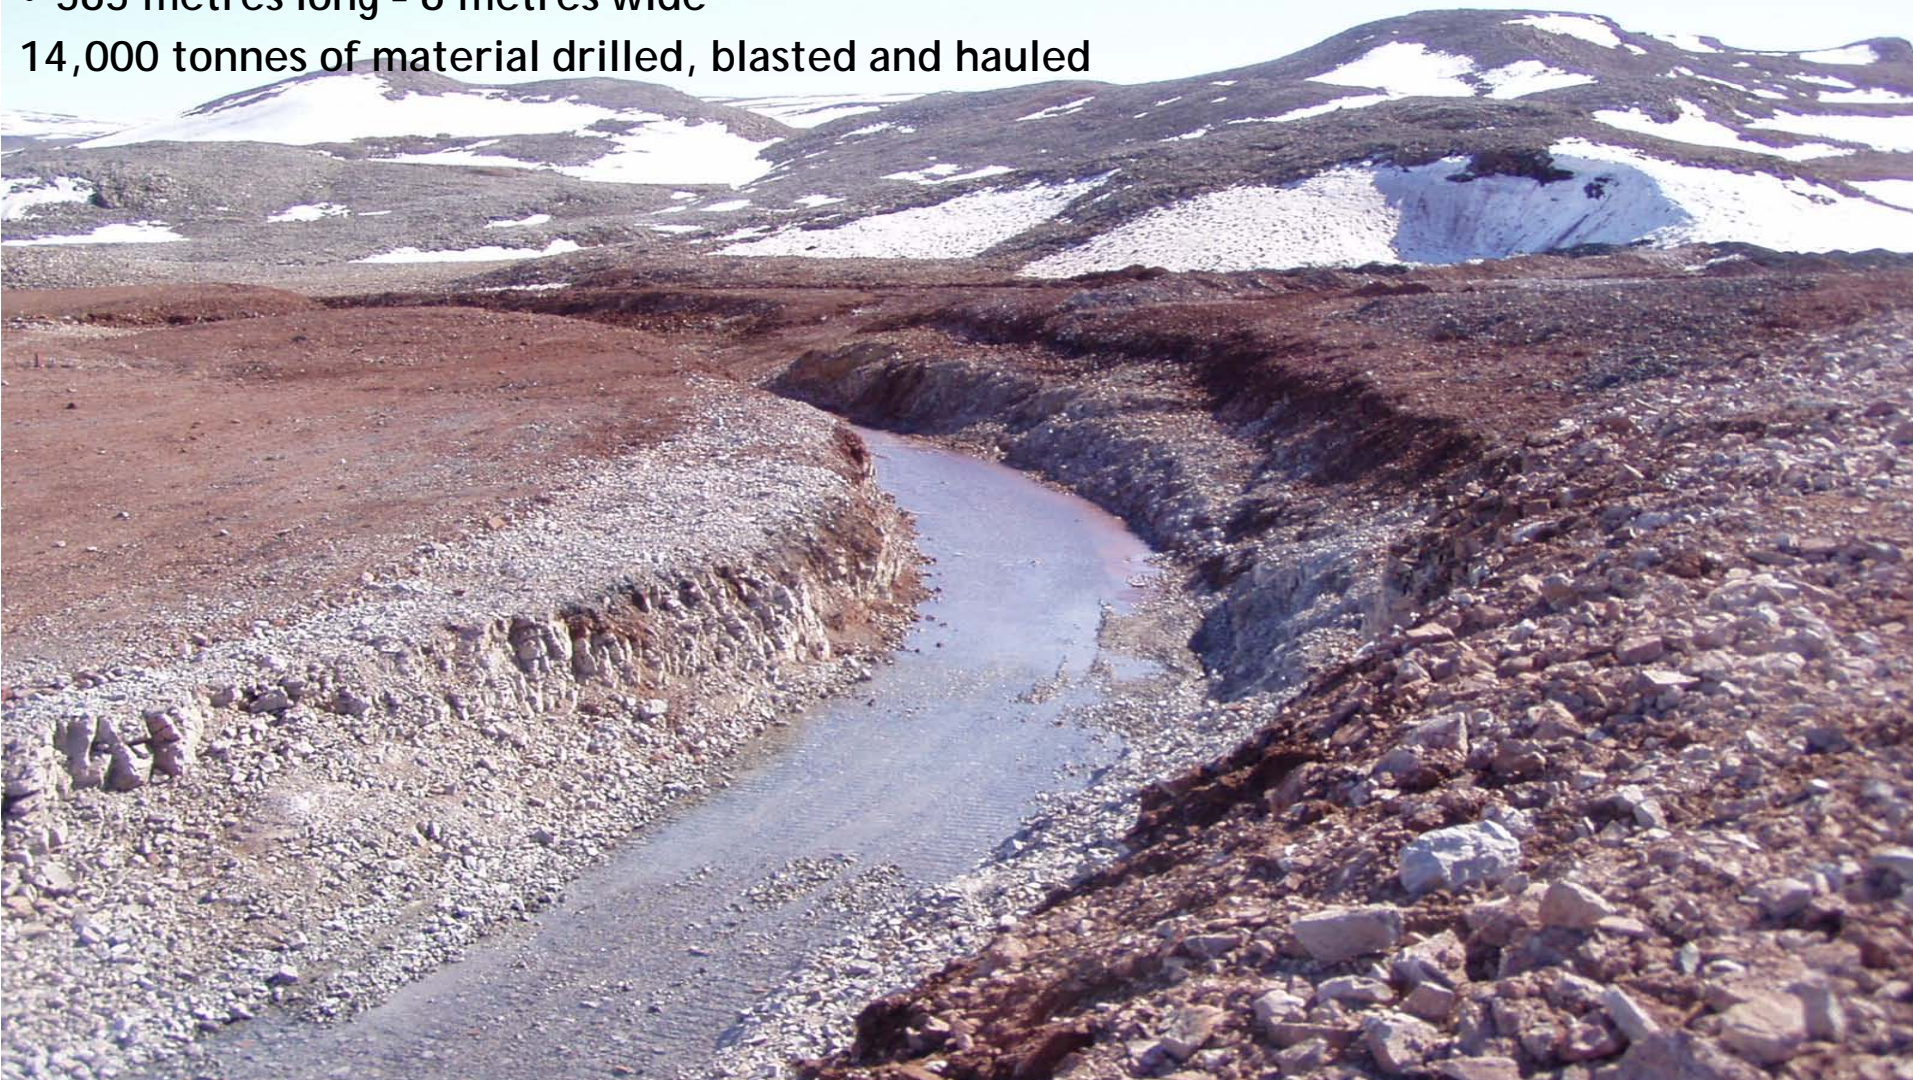
- 565 metres long - 6 metres wide  
14,000 tonnes of material drilled, blasted and hauled

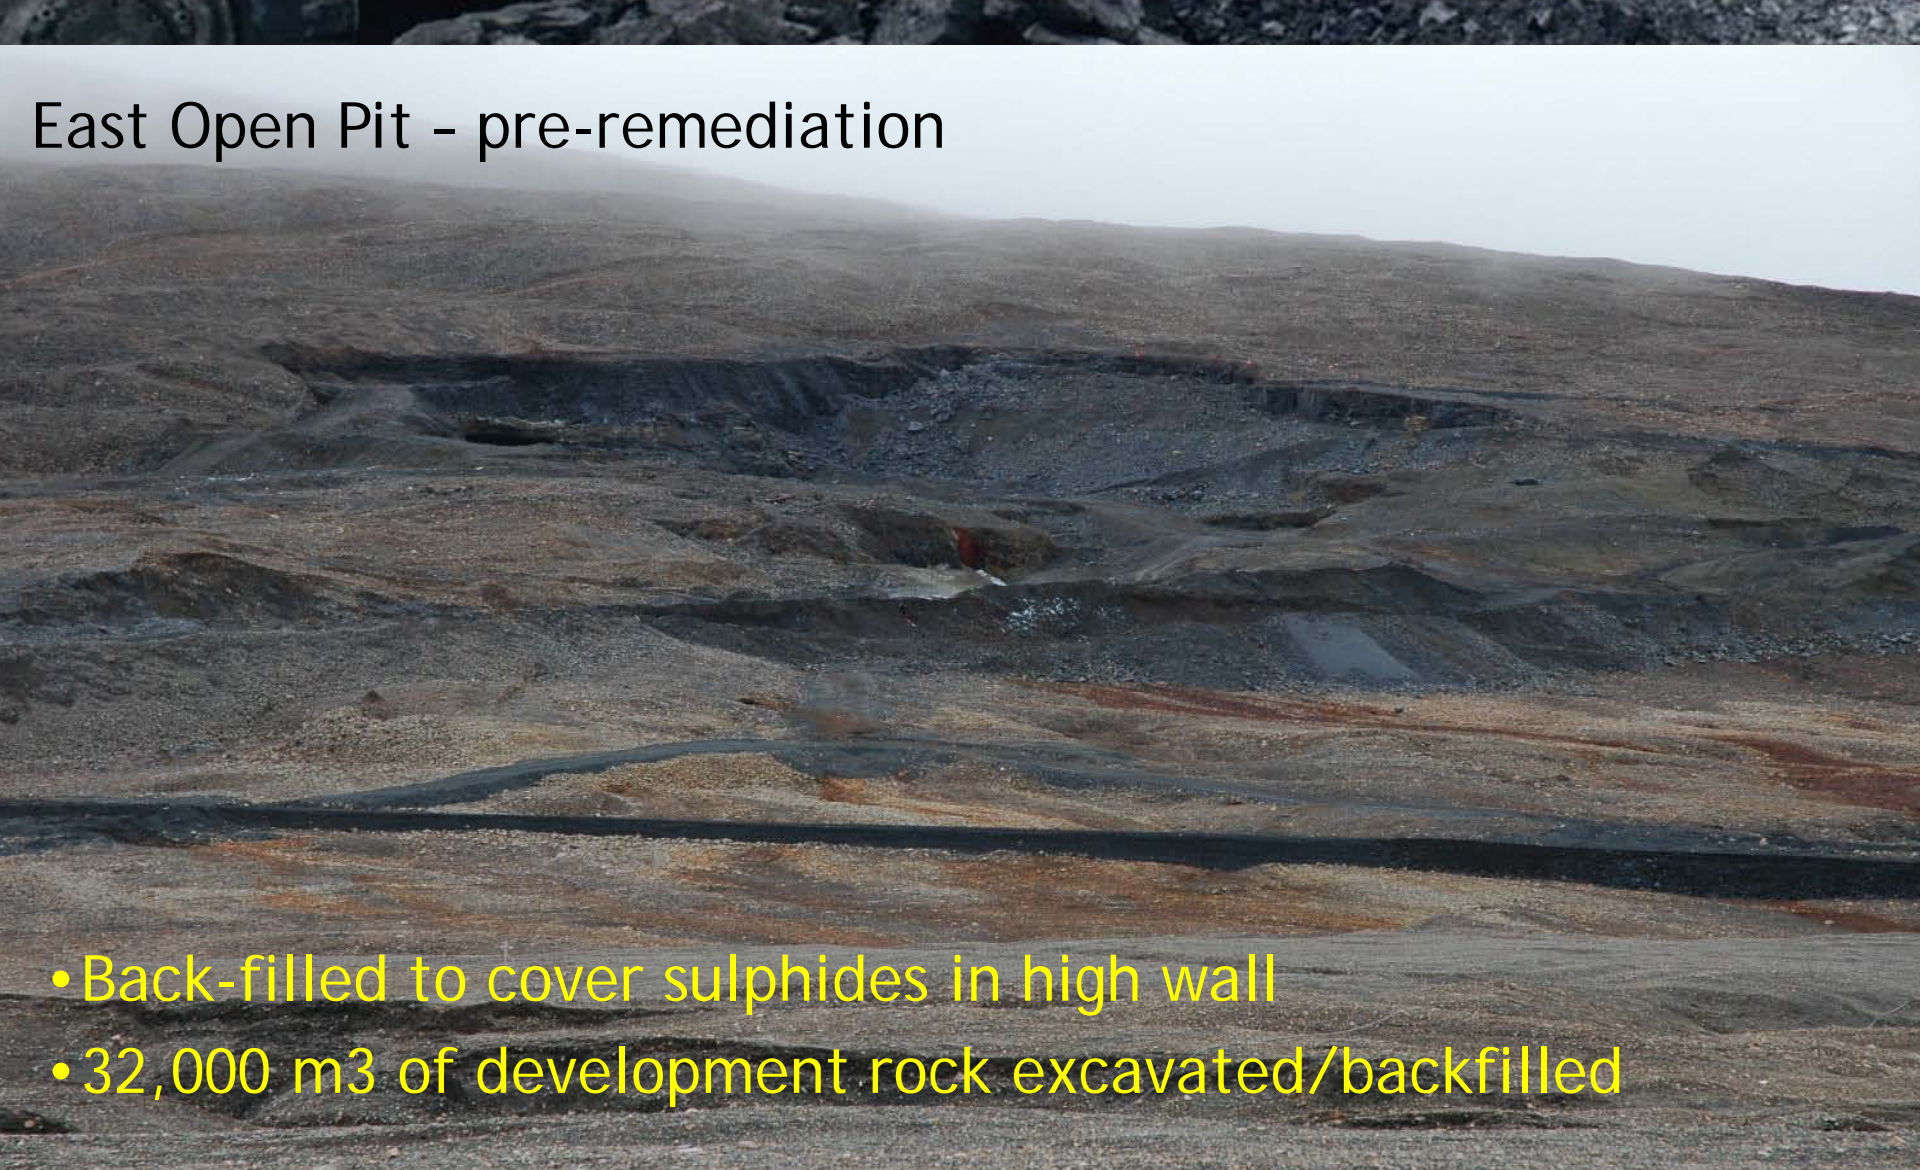
## East Open Pit - pre-remediation

- Back-filled to cover sulphides in high wall
- 32,000 m<sup>3</sup> of development rock excavated/backfilled

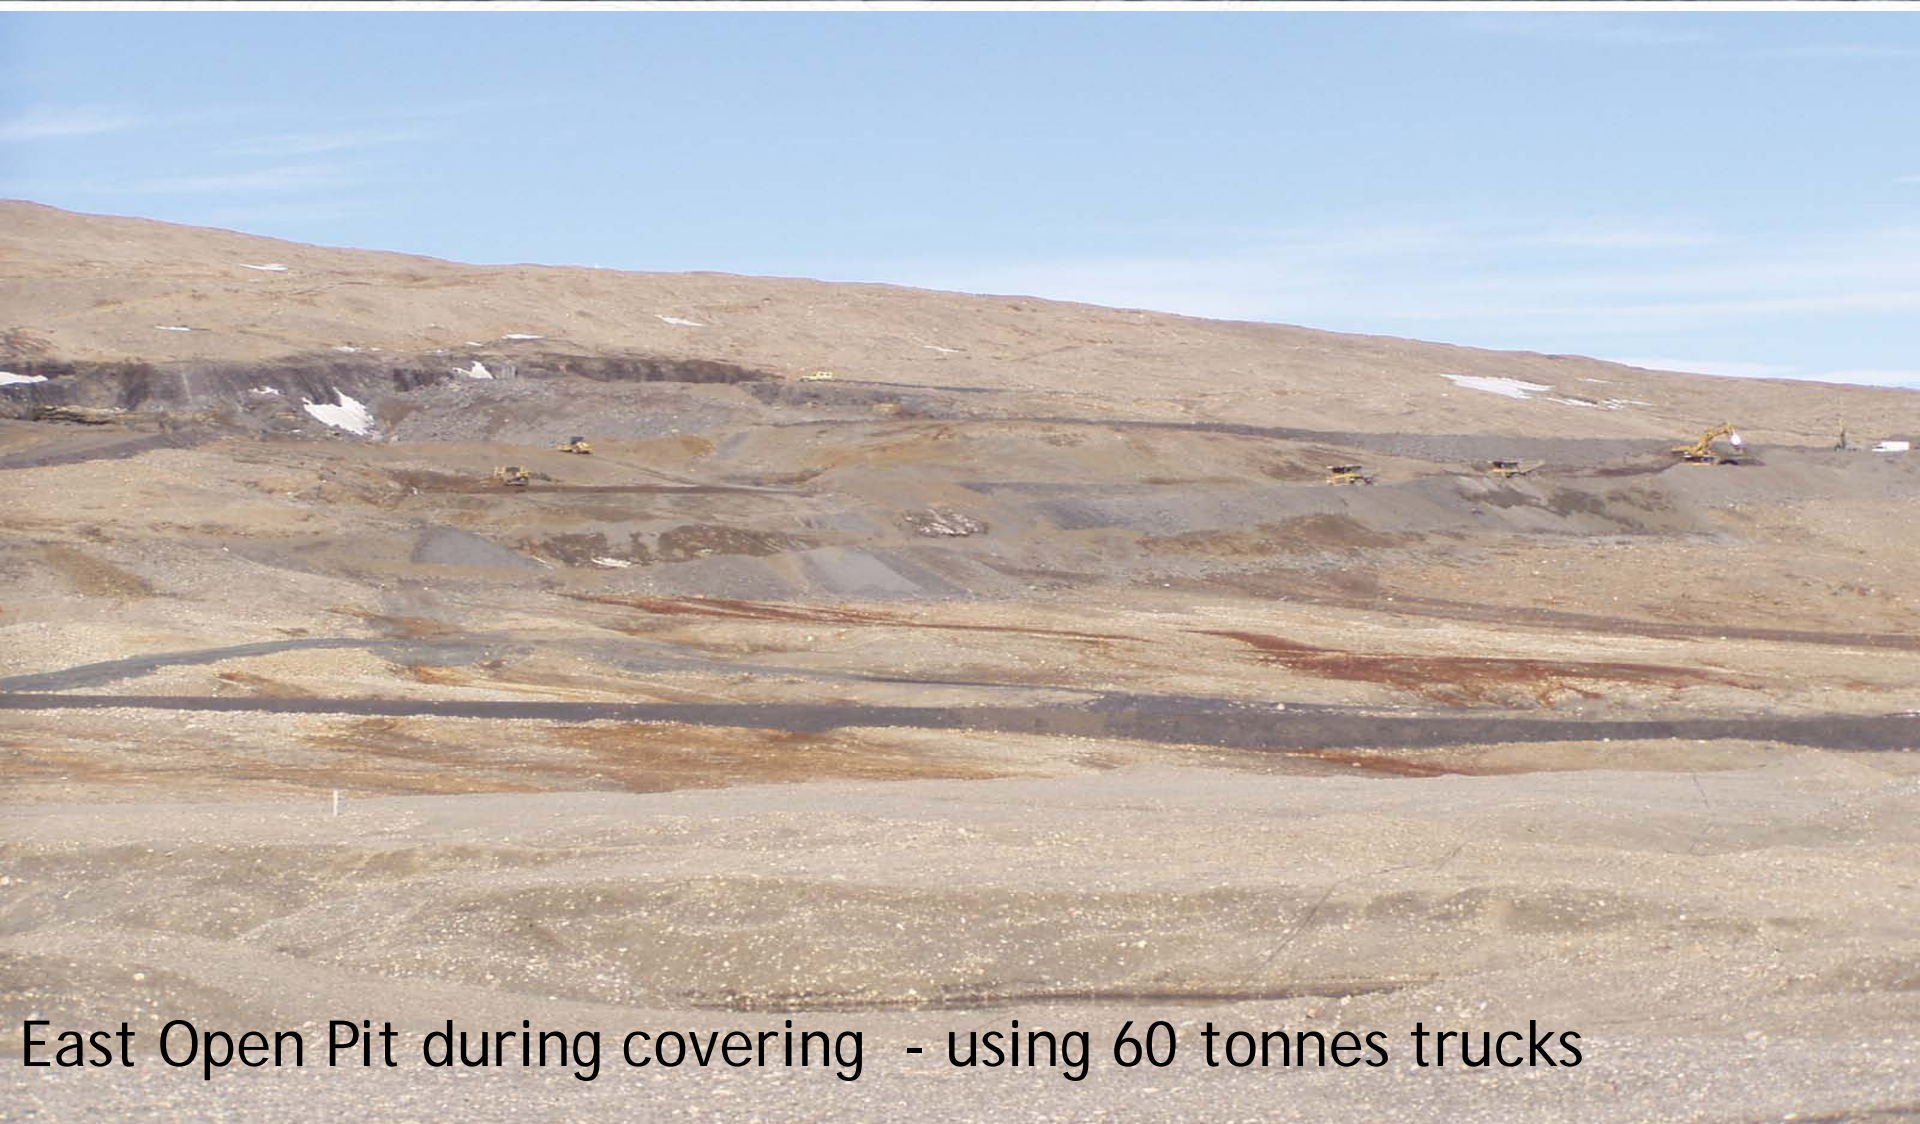
East Open Pit during covering - using 60 tonnes trucks

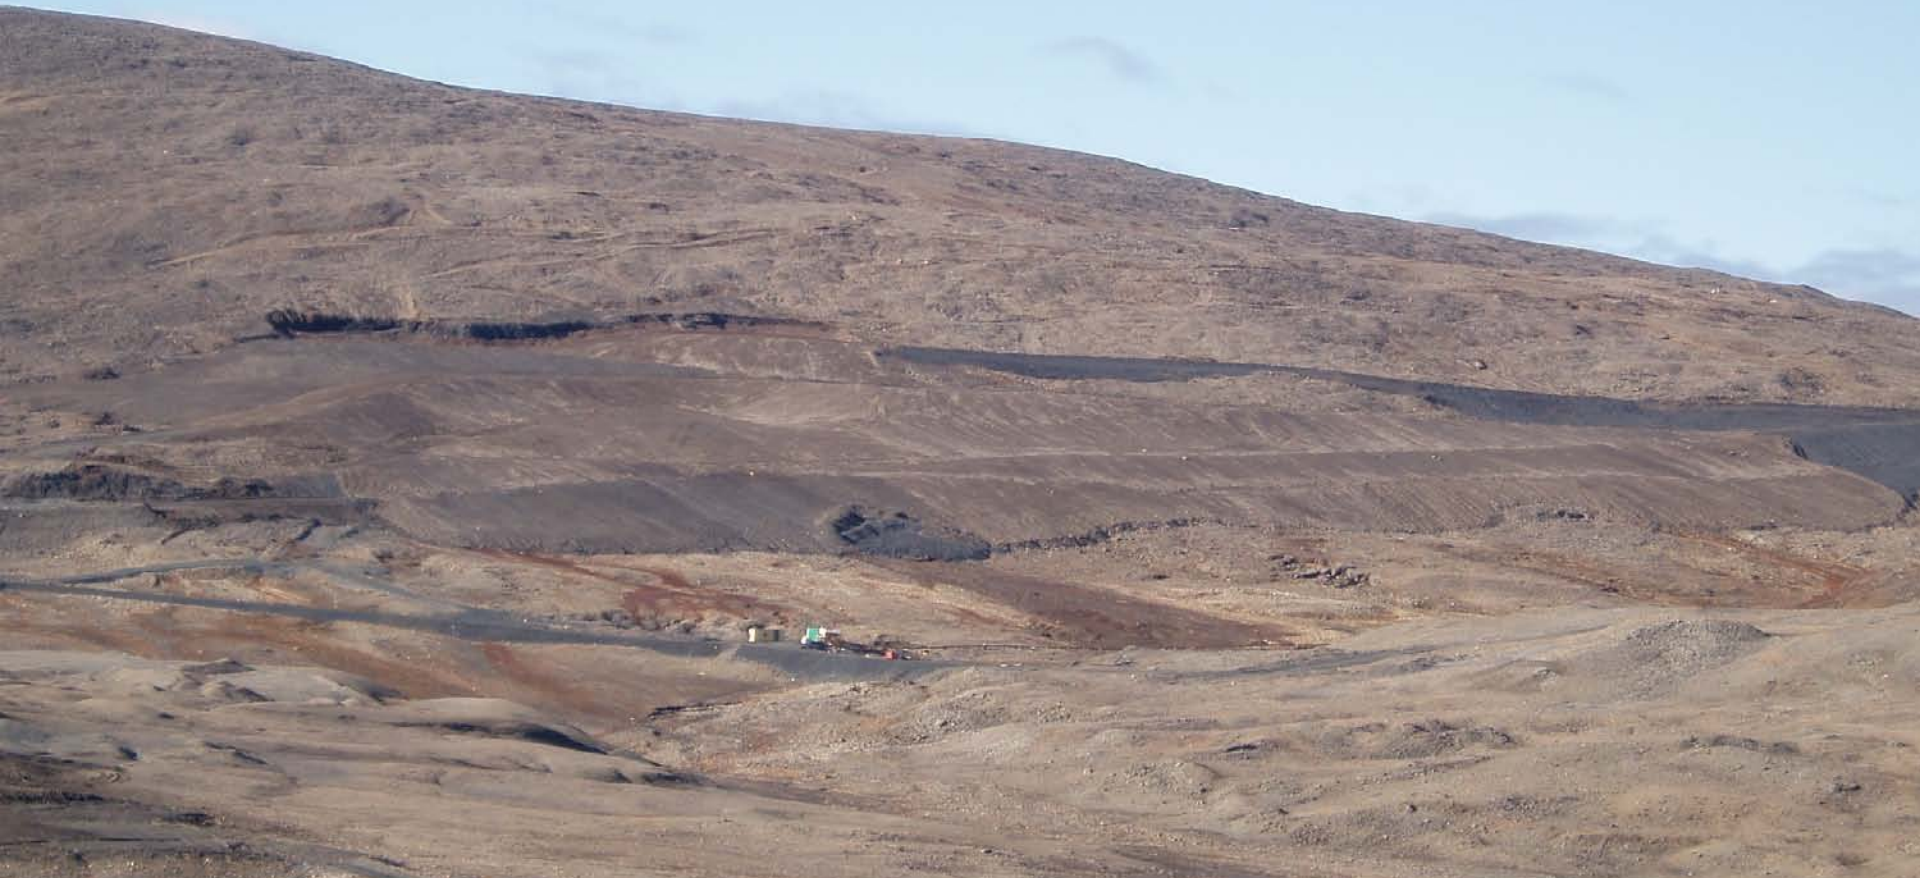
## East Open Pit complete

- 100,000 m<sup>3</sup> of shale and 30,000 m<sup>3</sup> armour for geothermal cover

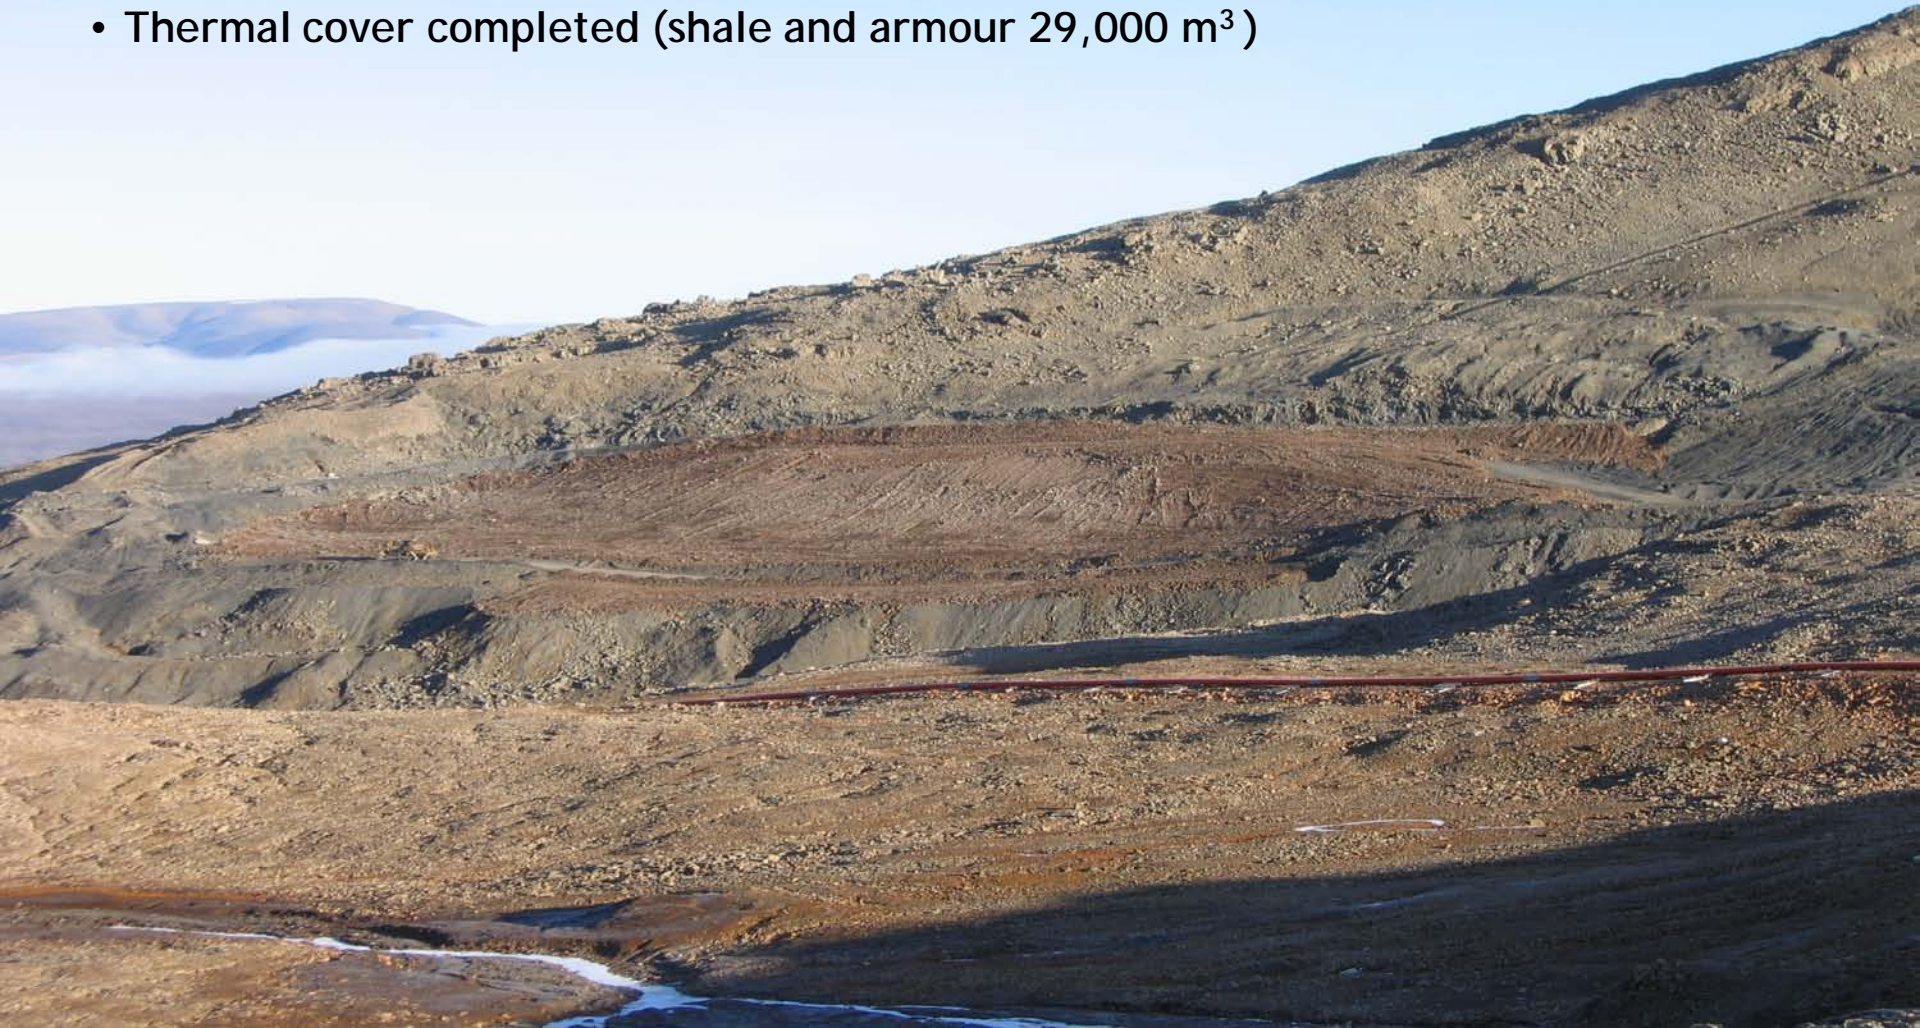
- Thermal cover completed (shale and armour 29,000 m<sup>3</sup>)

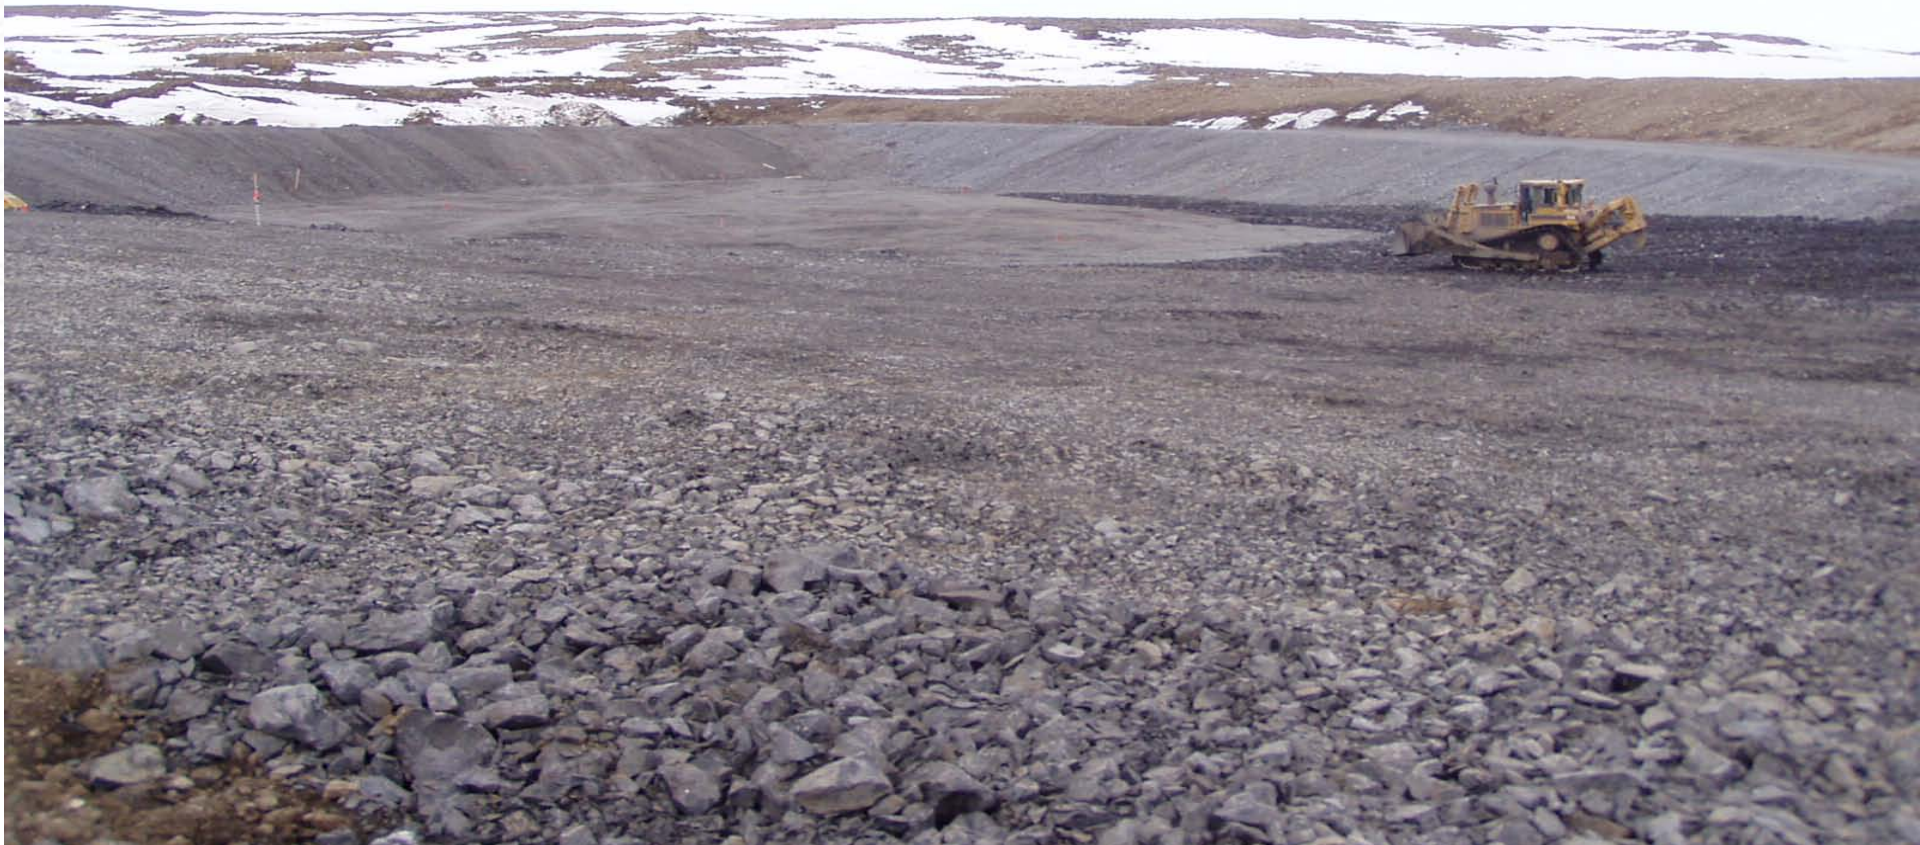
## Oceanview - 45,000 m<sup>3</sup> shale and armour

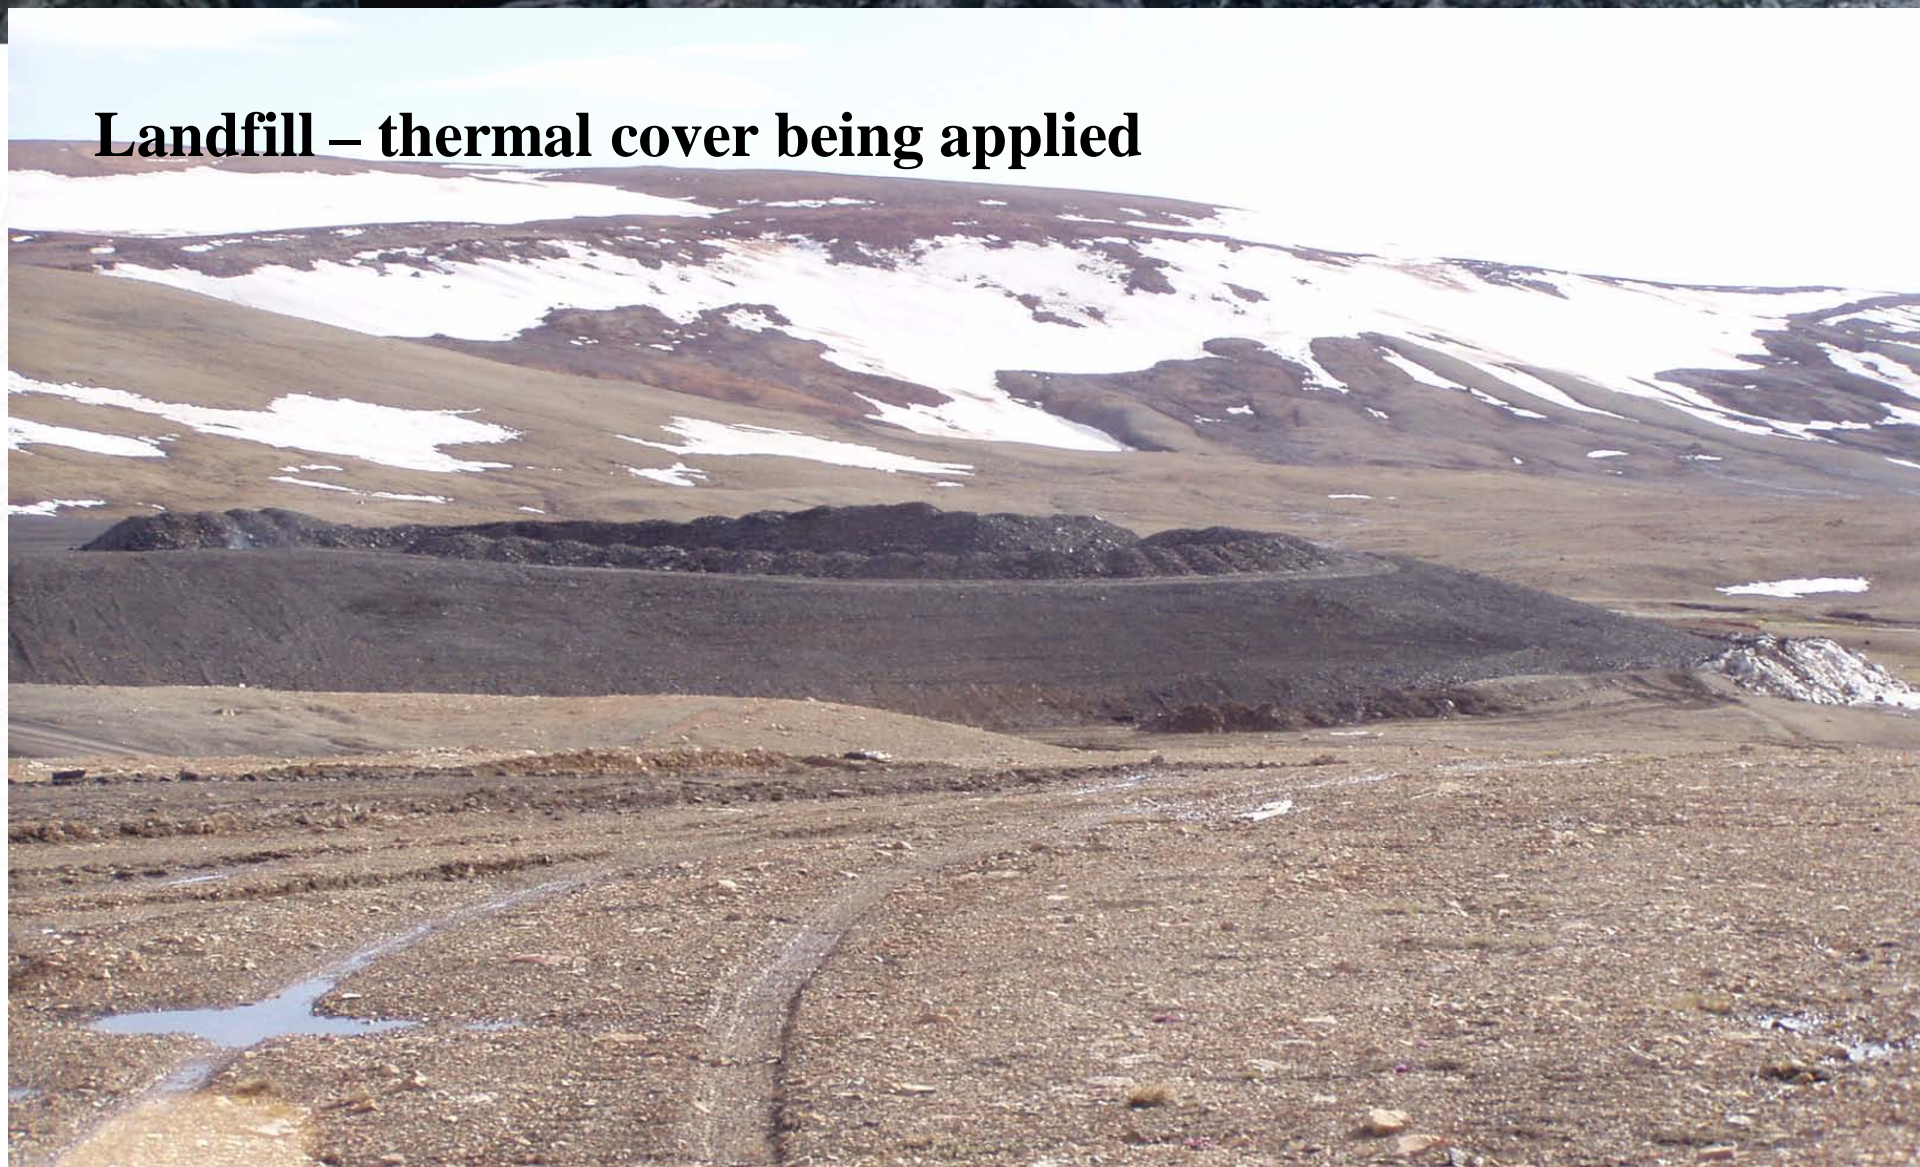
## Landfill – thermal cover being applied

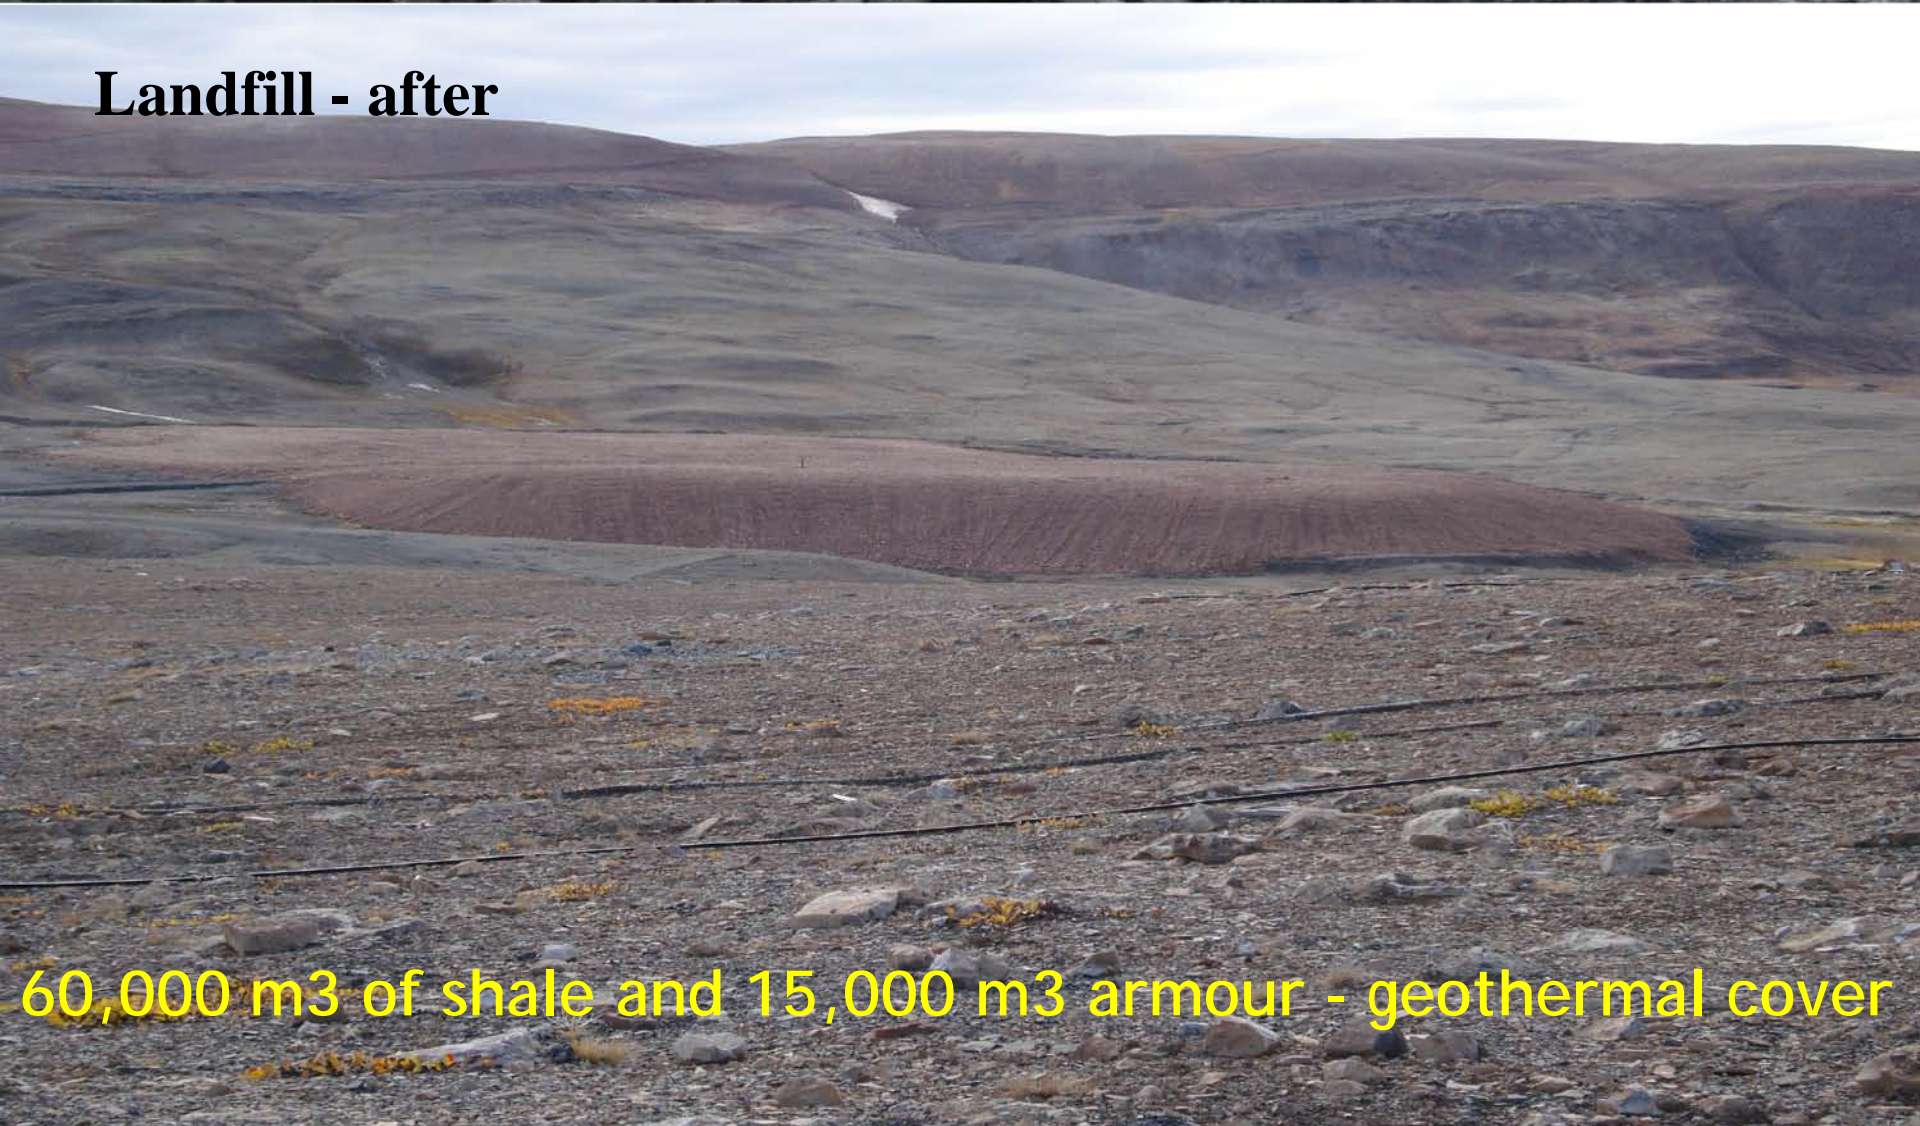
## Landfill - after

60,000 m<sup>3</sup> of shale and 15,000 m<sup>3</sup> armour - geothermal cover

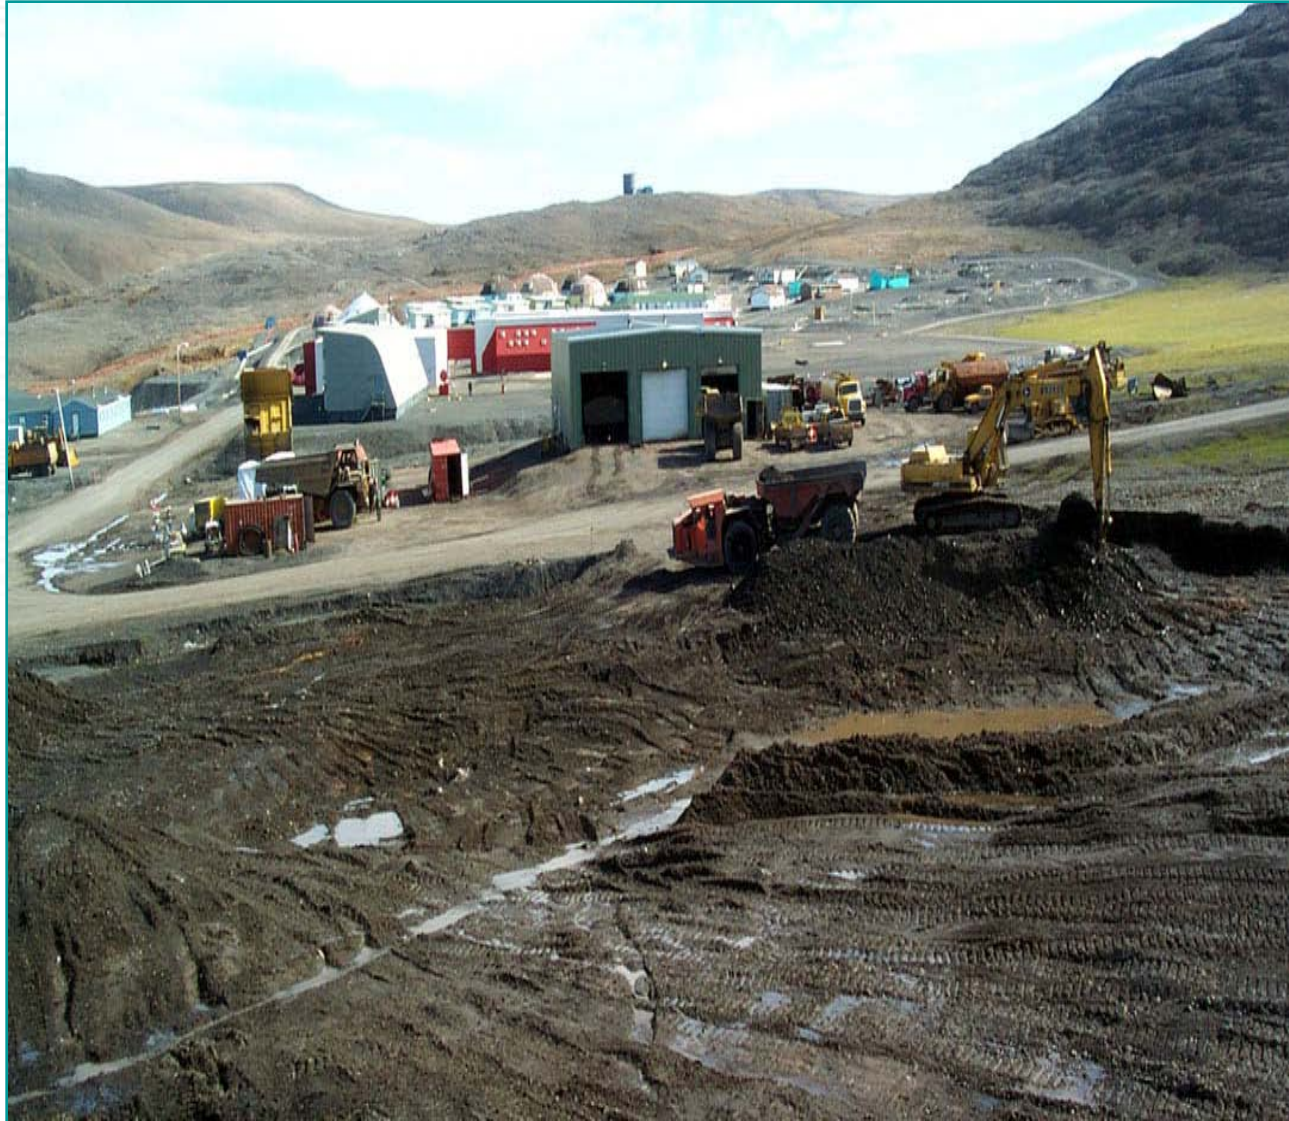
## Contaminated Soil Targets

- HHERA determined no risk from metals but company committed to cleaning up "hotspots"
- Hydrocarbon soils were cleaned to CCME
- Soil volumes range between 1,000 and 36,000 m<sup>3</sup>
- Total estimated volume of 170,000 m<sup>3</sup>
