# Breakwater Resources Ltd.

## Nanisivik Reclamation Update

October 15, 2007

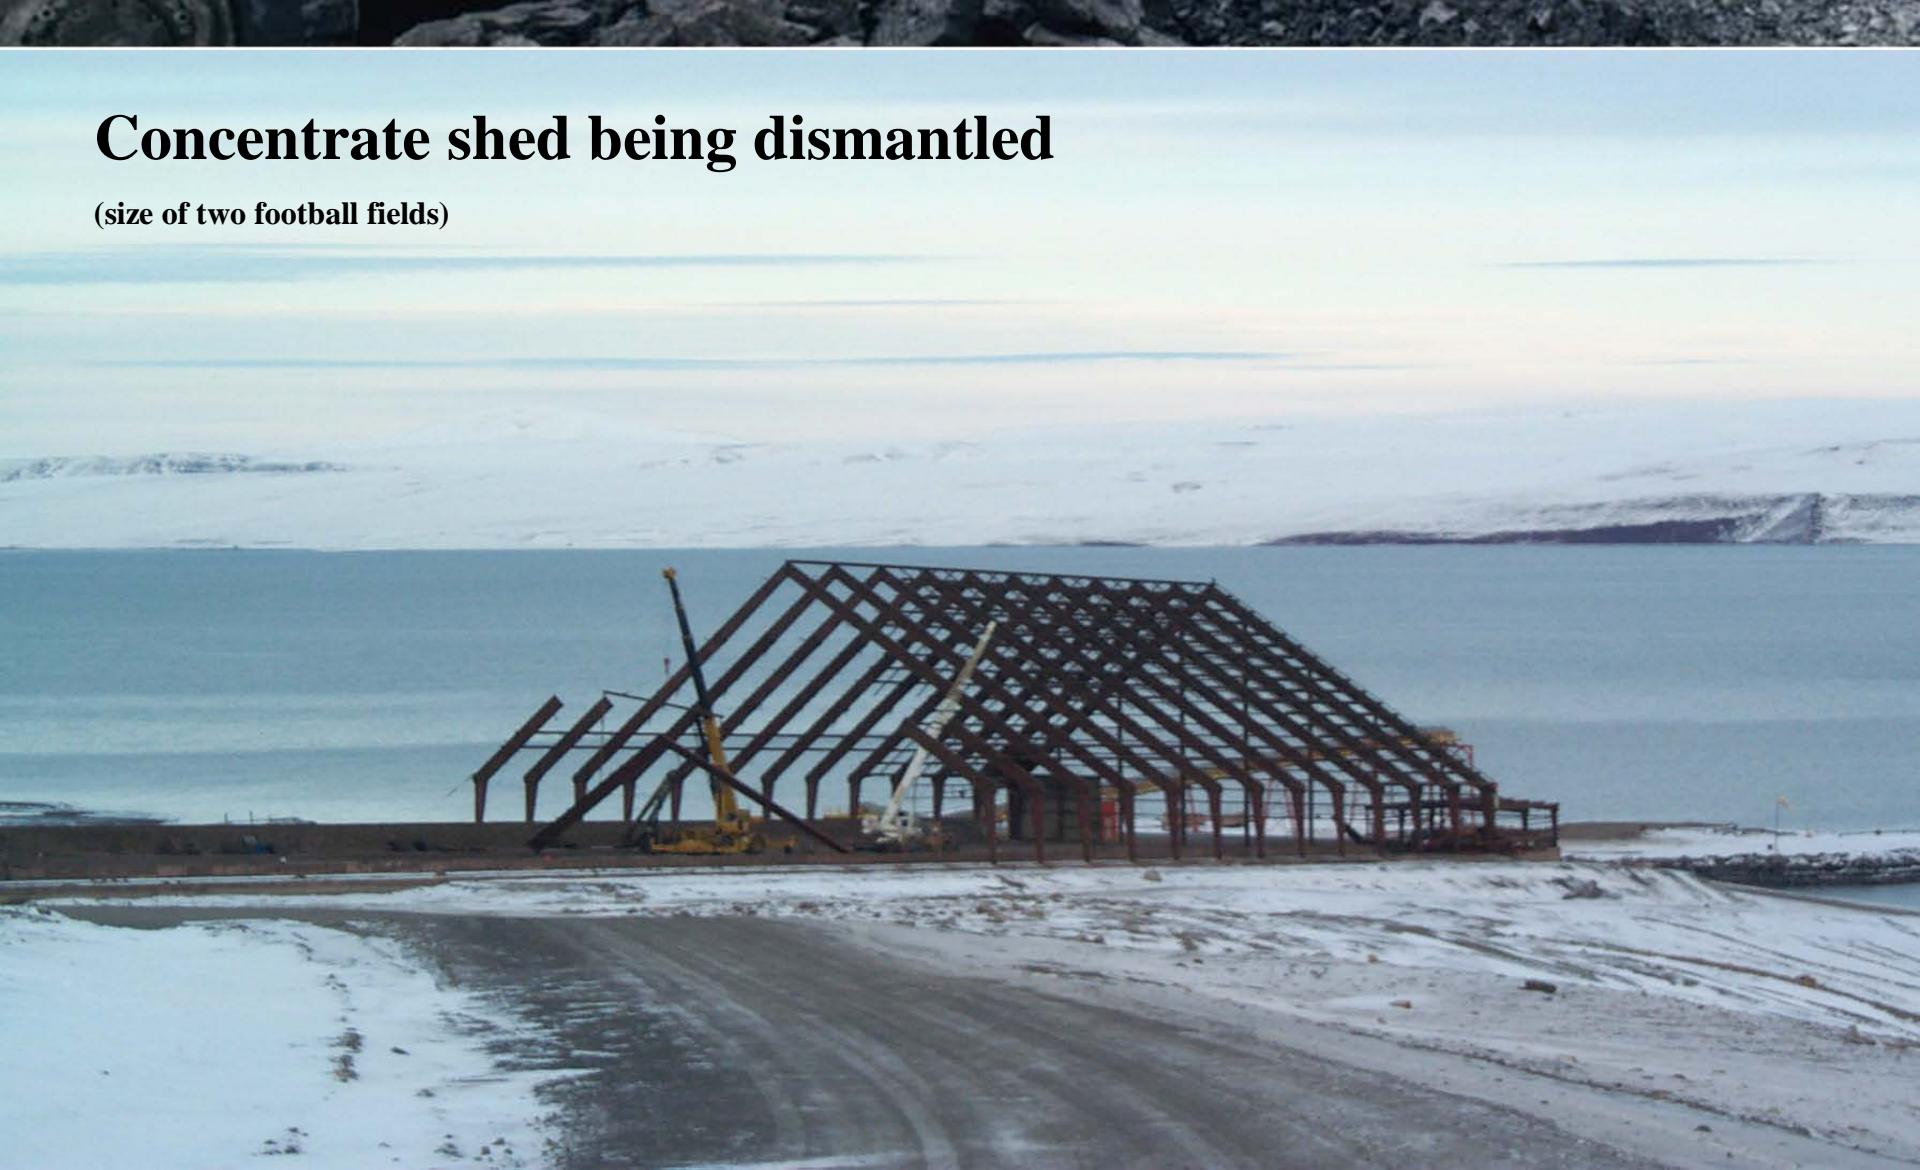
# Concentrate shed being dismantled

(size of two football fields)

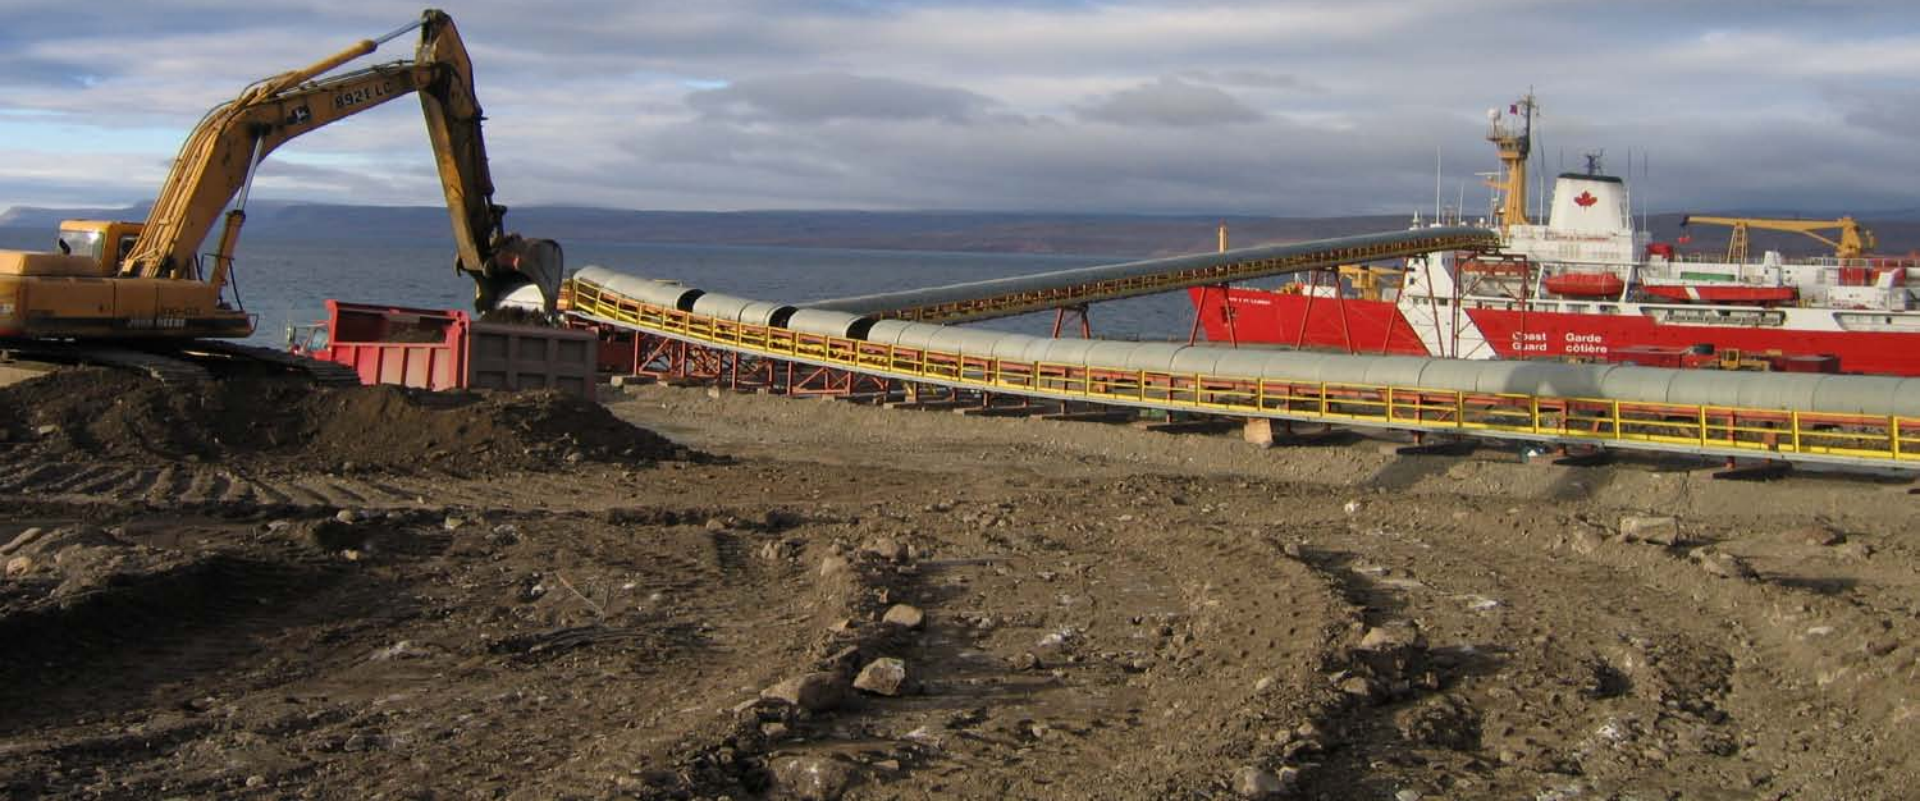
## Dock Site

- Total contaminated soil removal +50,000 m<sup>3</sup>

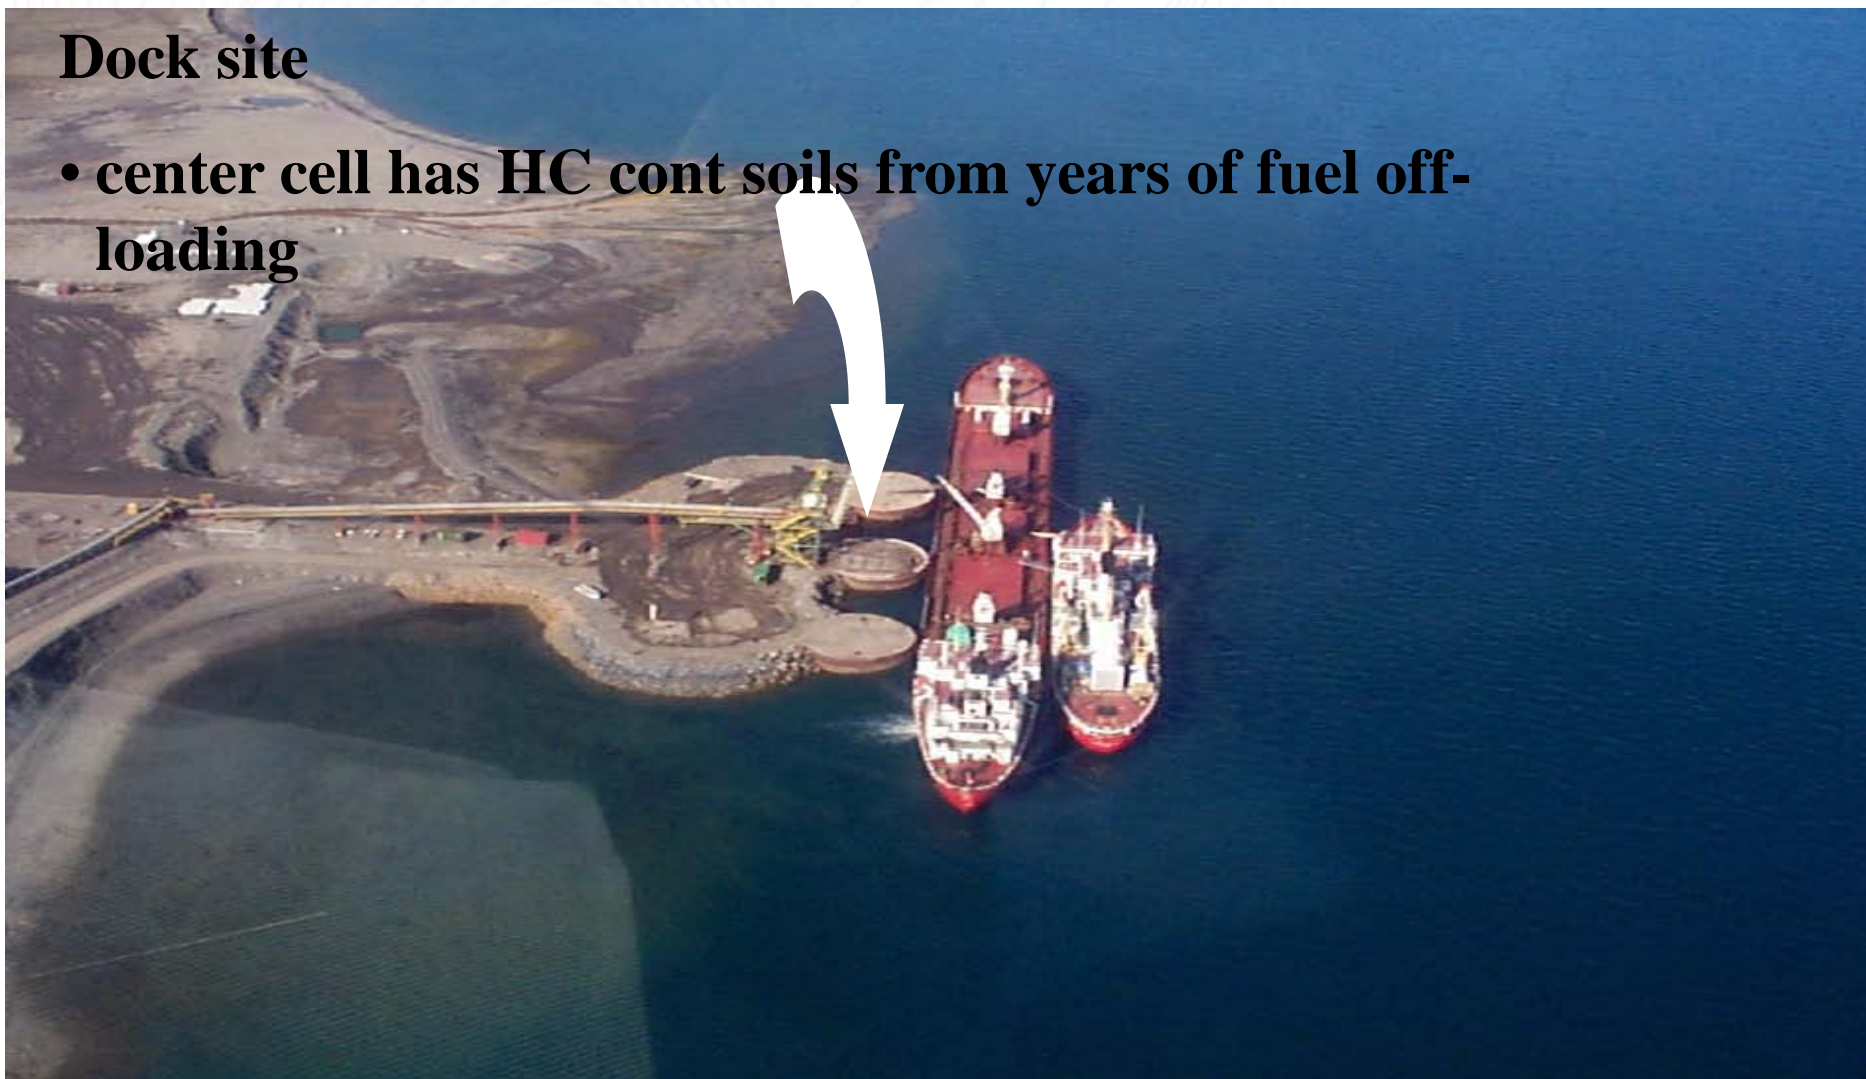
## Dock site

- center cell has HC cont soils from years of fuel off-loading

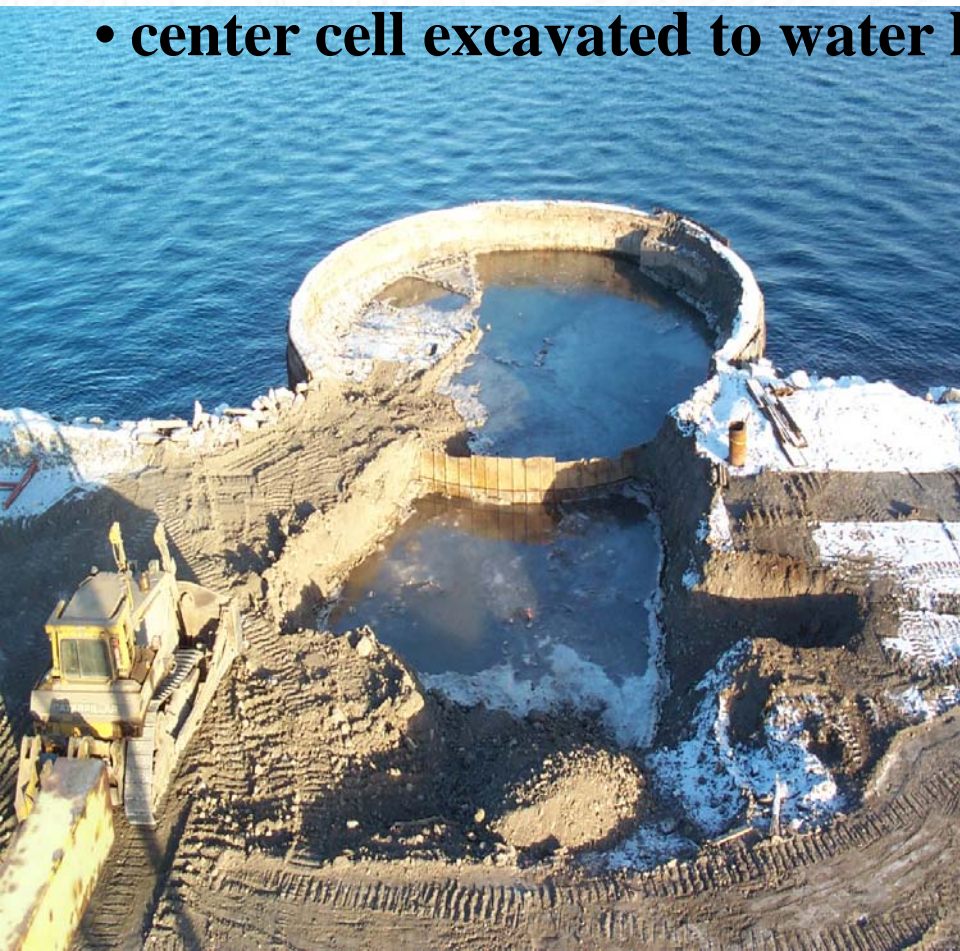
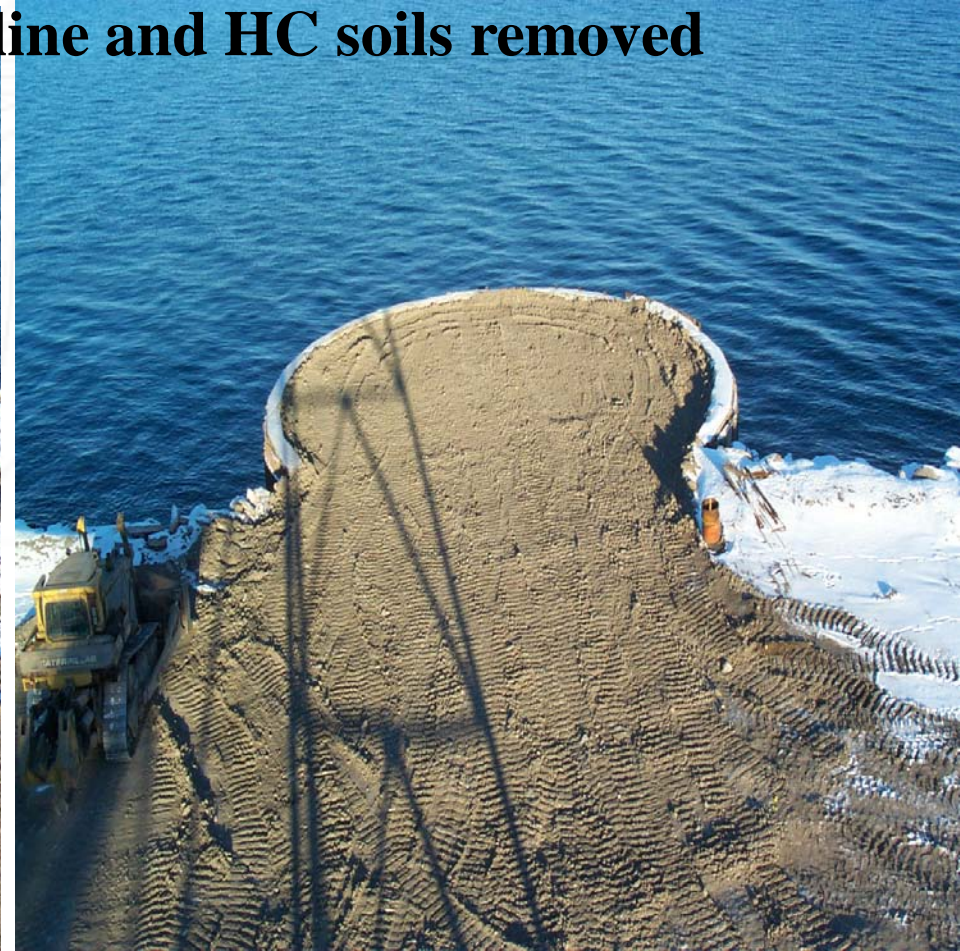
## Dock site

- center cell excavated to water line and HC soils removed

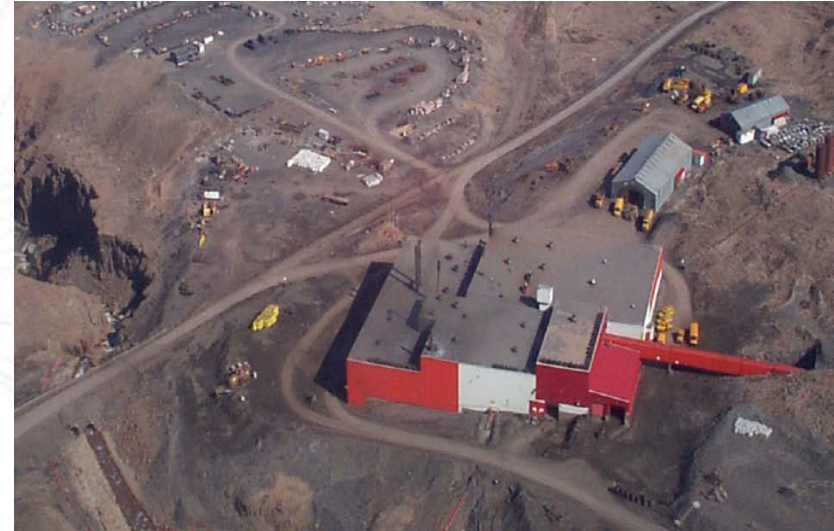
## Industrial complex

- Assets purchased by Wolfden
- Equipment/inventory salvage
- PCBs shipped
- Nuclear density gauges shipped
- Non-hazmats disposed underground
- Infrastructure dismantled
- ~ 75,000 m<sup>3</sup> of contaminated soil (metals, HC) excavated
- Foundation backfilled - thermal cover
- Residual soils in 2008

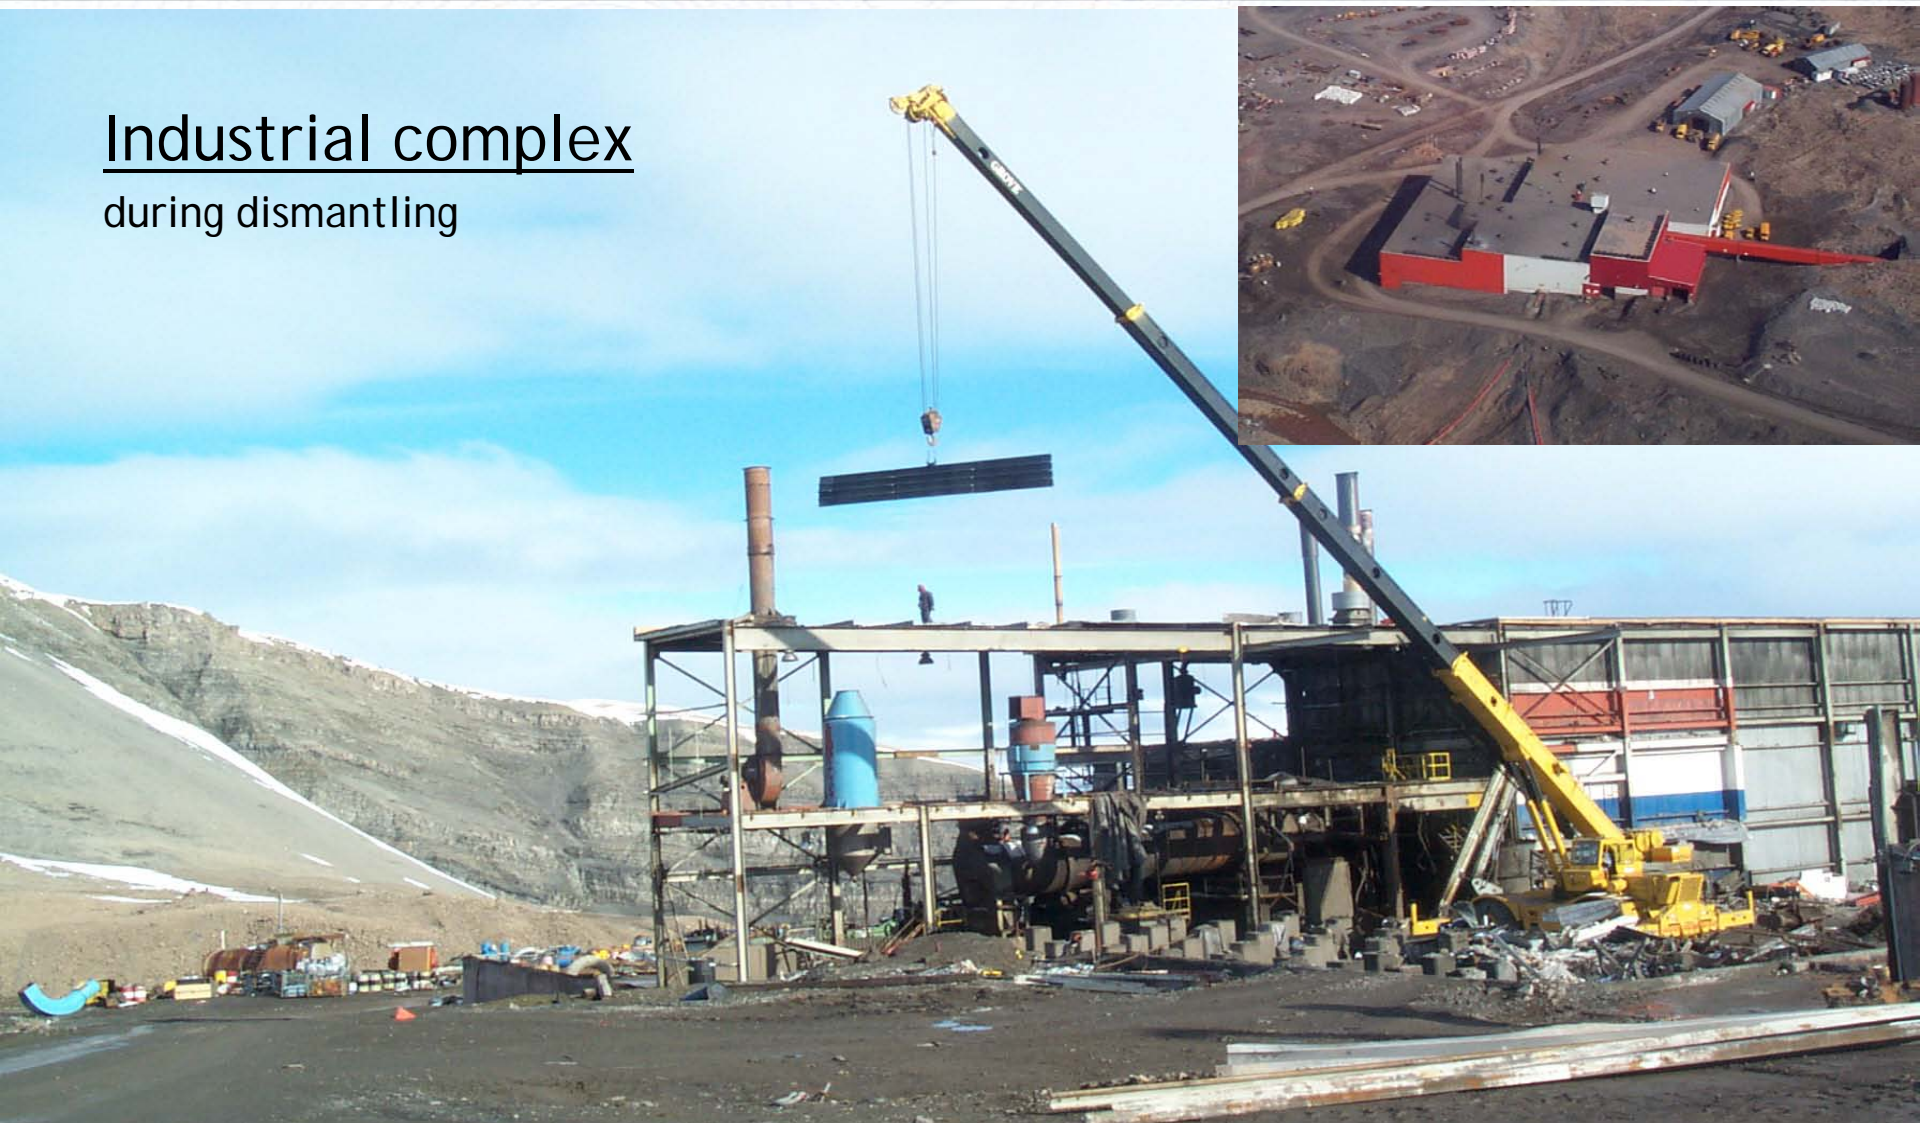
# Industrial complex during dismantling

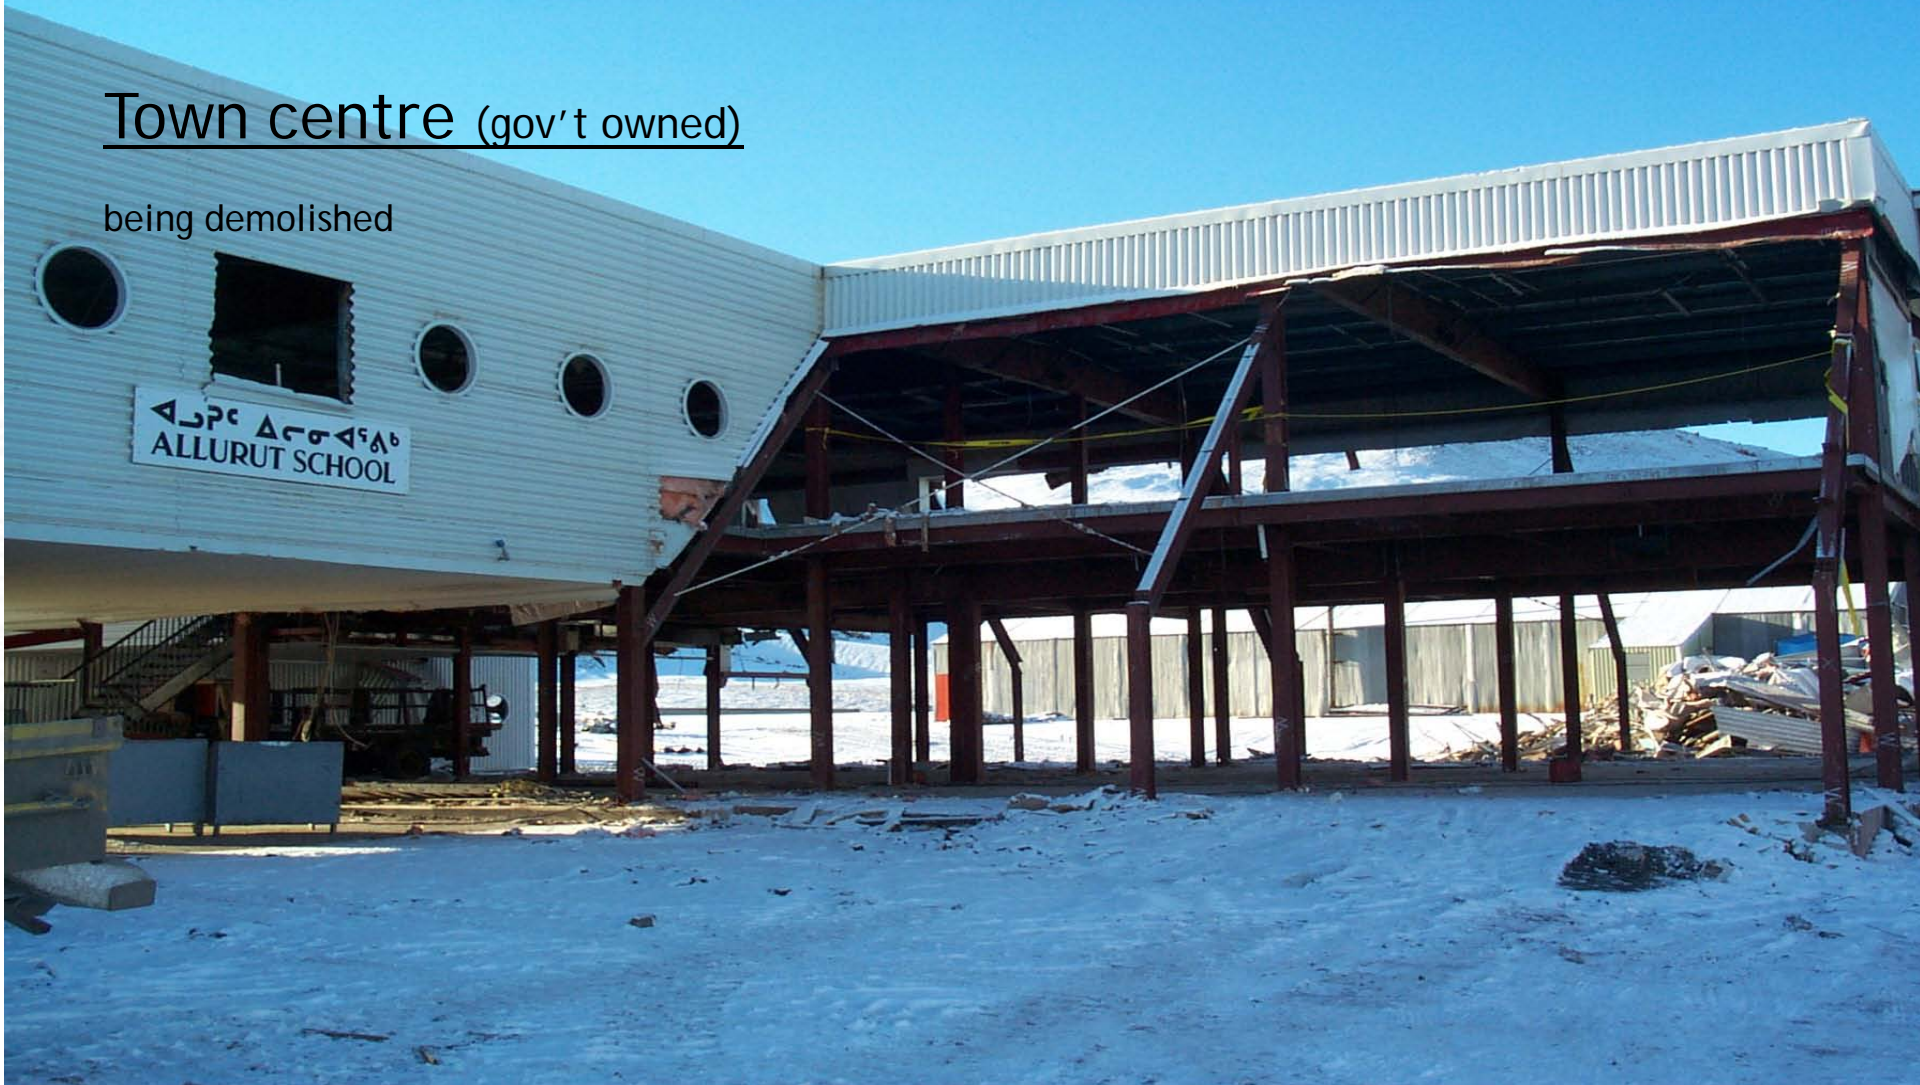
## Town centre (gov't owned)

being demolished

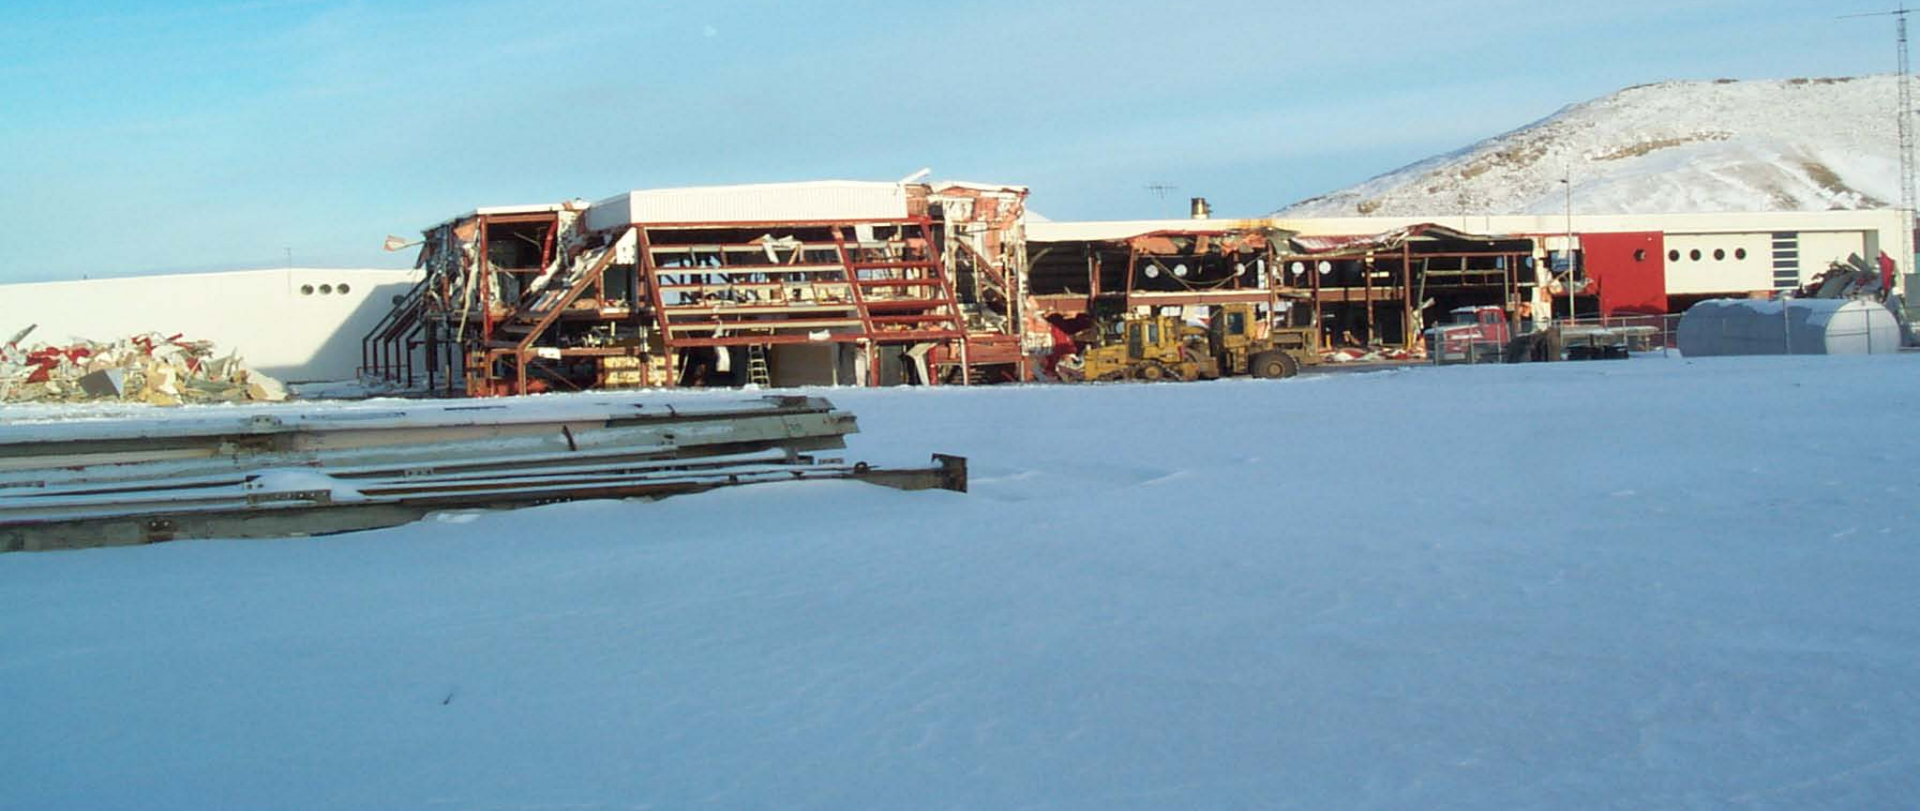
## Town centre (gov't owned)

being demolished

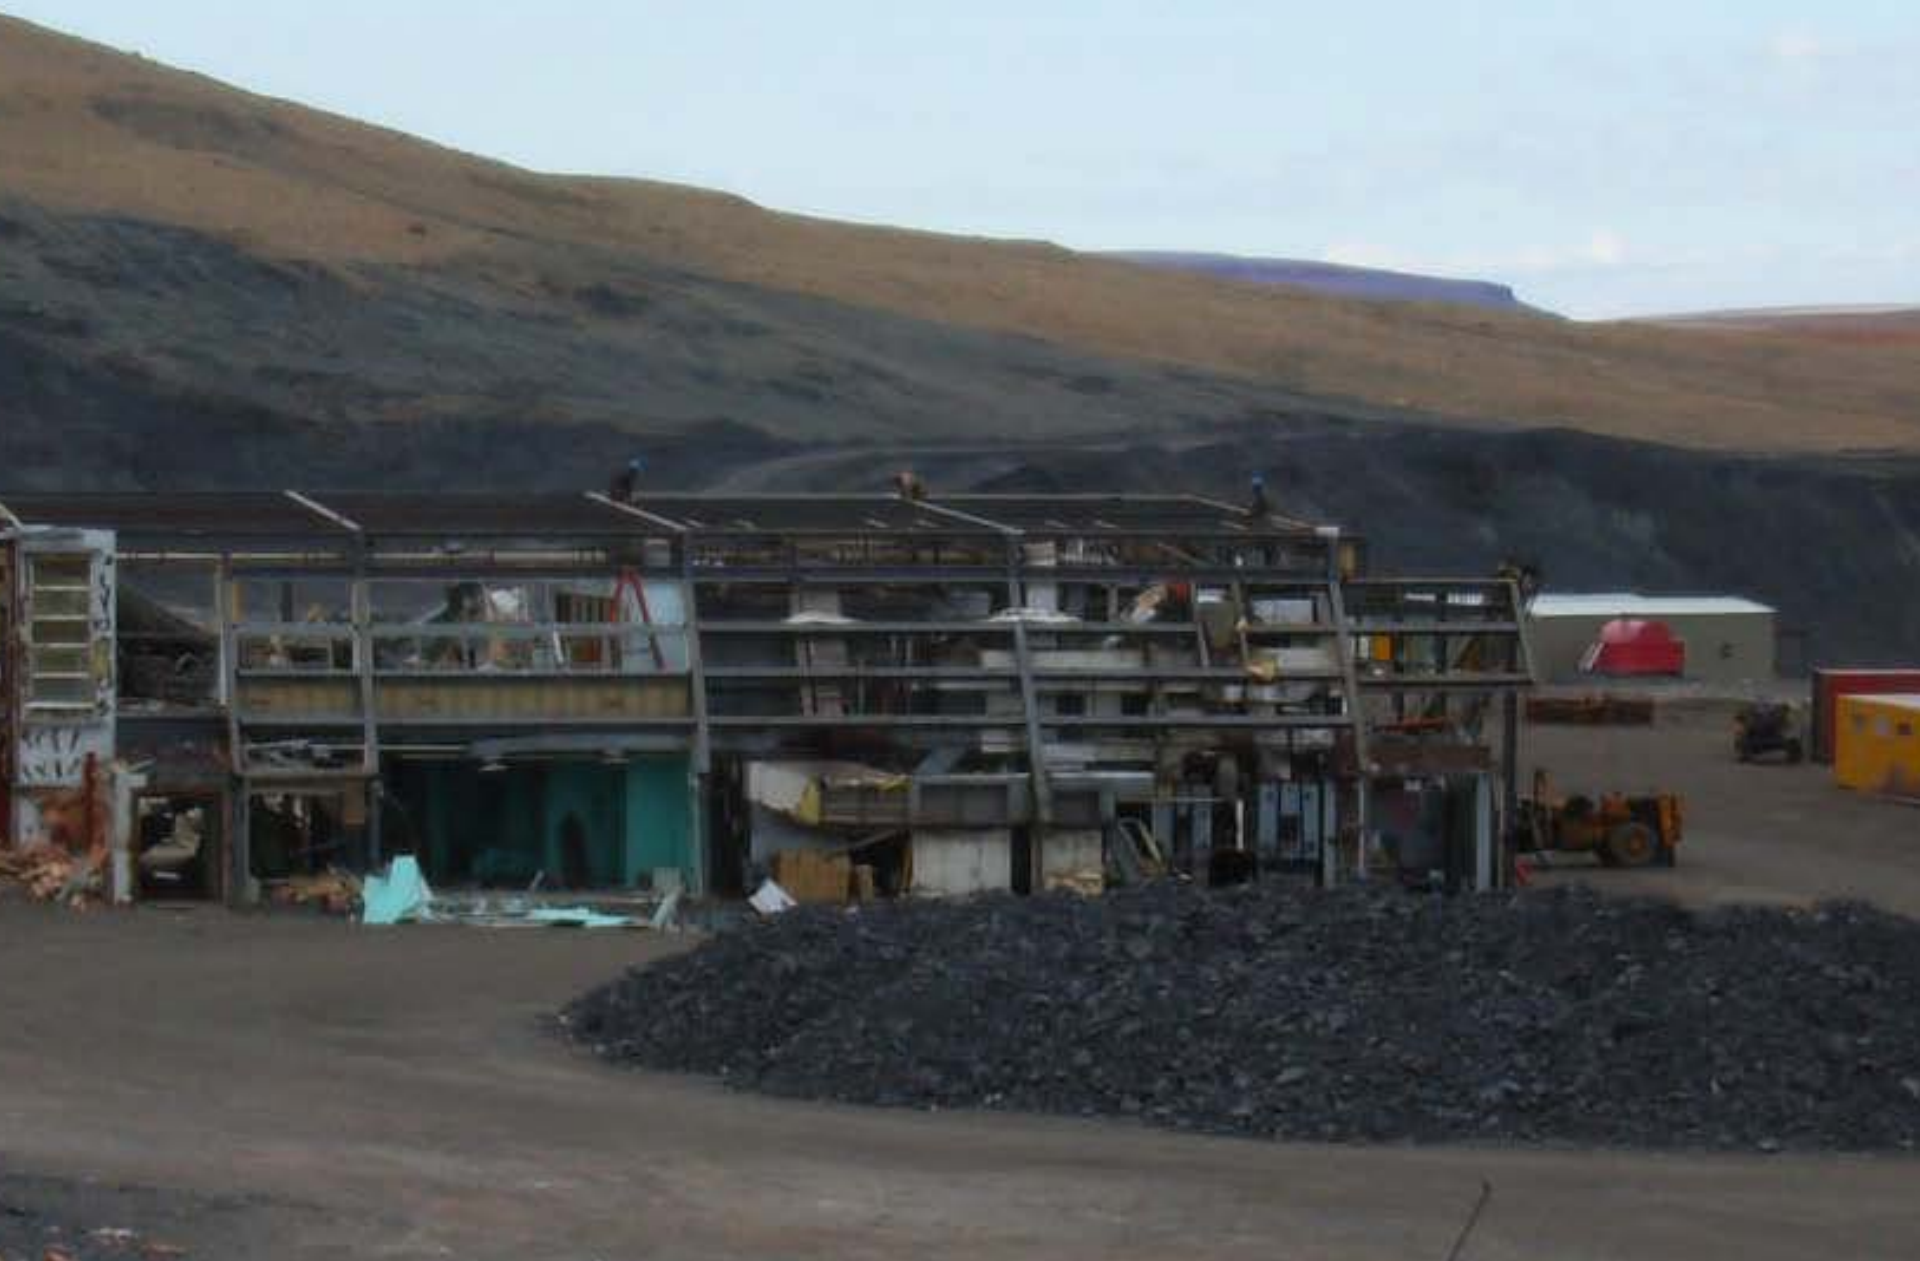
# Gymnasium/pool complex

ing demolished
