- PHOTOGRAPHS -

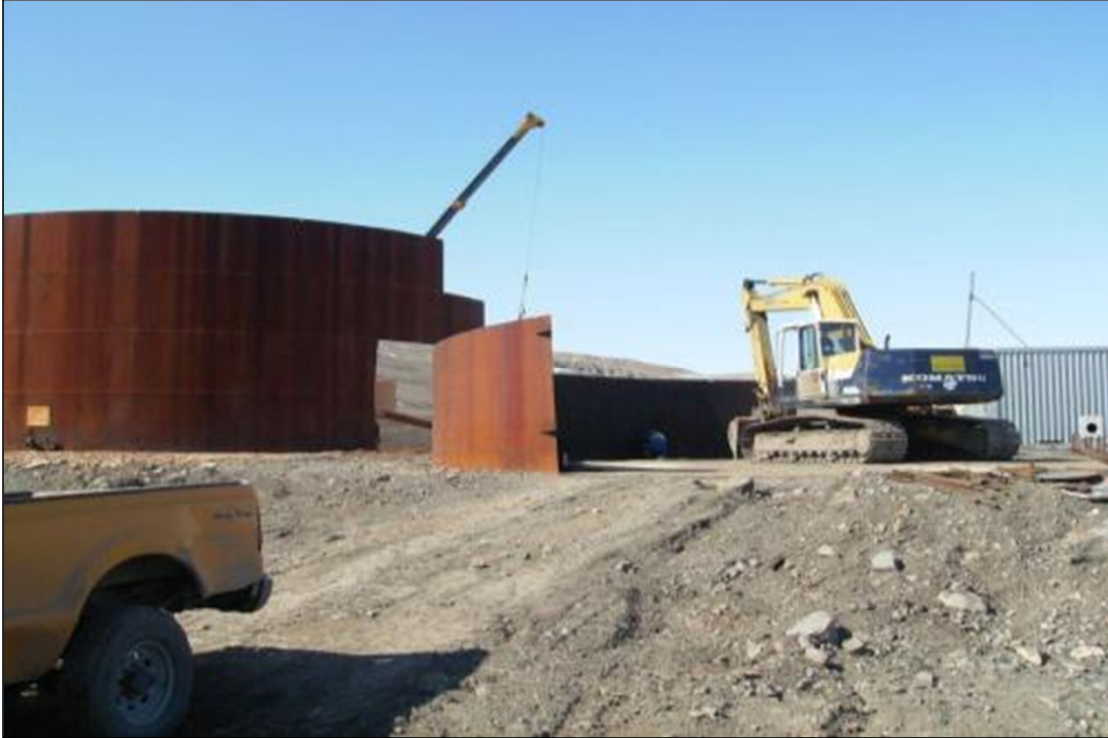
PHOTOGRAPH 1

June 20, 2011. Tank Farm demolition in progress. Tank decommissioning commenced the week of May 30, 2011. By June 10, 2011 all small vertical tanks and pipelines were removed.

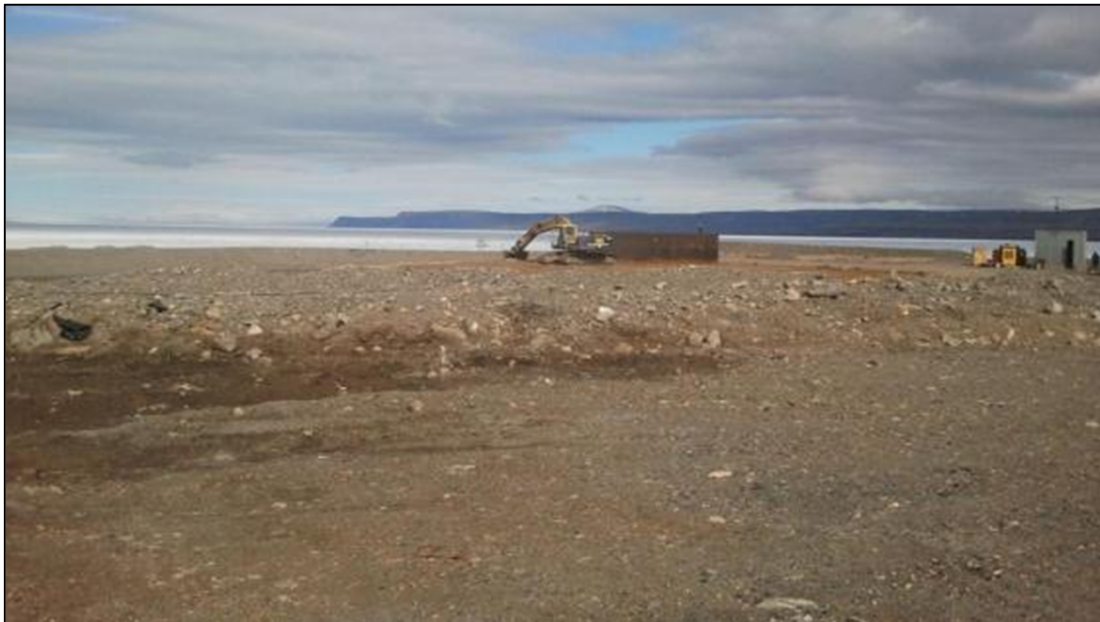
PHOTOGRAPH 2

Tank Farm demolition progress as of June 23, 2011. Future site of the Lower Treatment area in the foreground adjacent to former tank farm south berm.

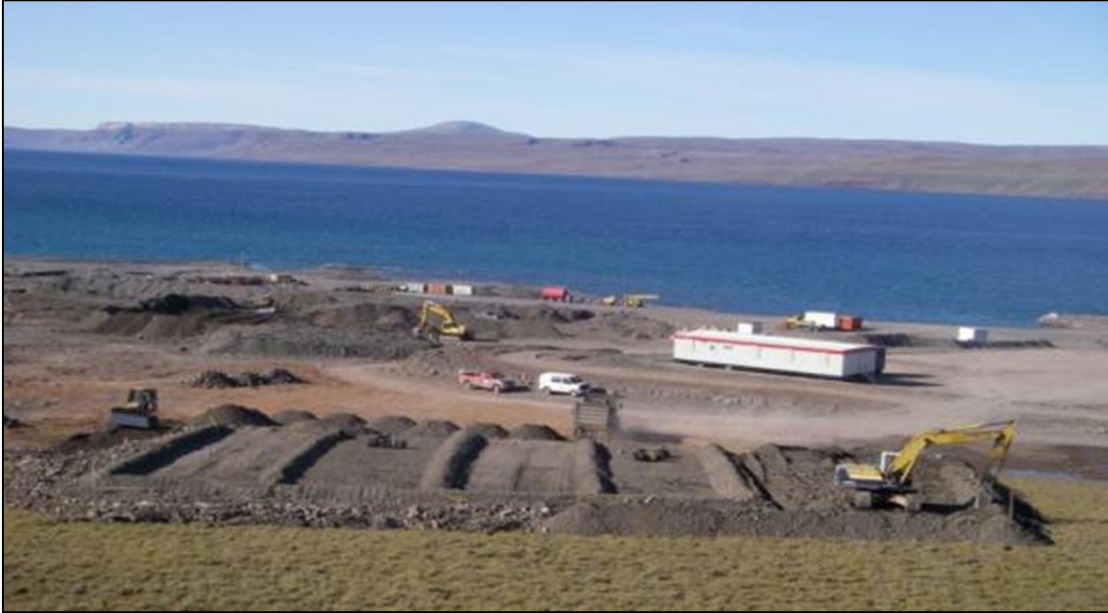
PHOTOGRAPH 3

August 16, 2011. Upper Treatment Area (UTA) in foreground. Its diversion berm and ditch are under construction. The excavator at the centre of the photo is situated between the former tank farm and the Lower Treatment Area (LTA).

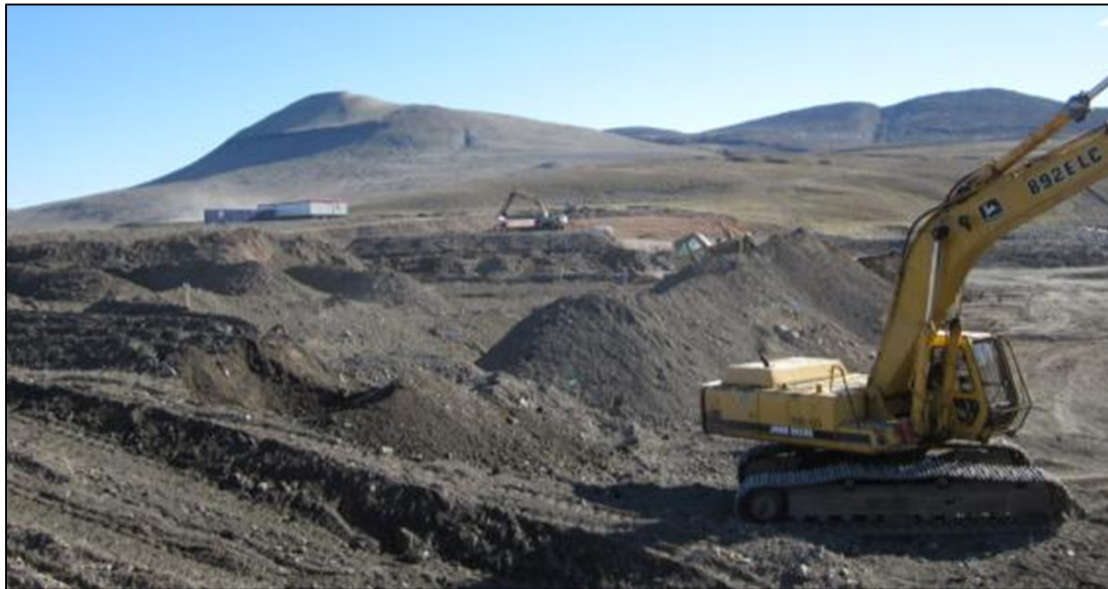
PHOTOGRAPH 4

August 16, 2011. The excavator in the foreground sits in what was the tank farm secondary containment area. The bulldozer is pushing clean soil into the secondary containment area.

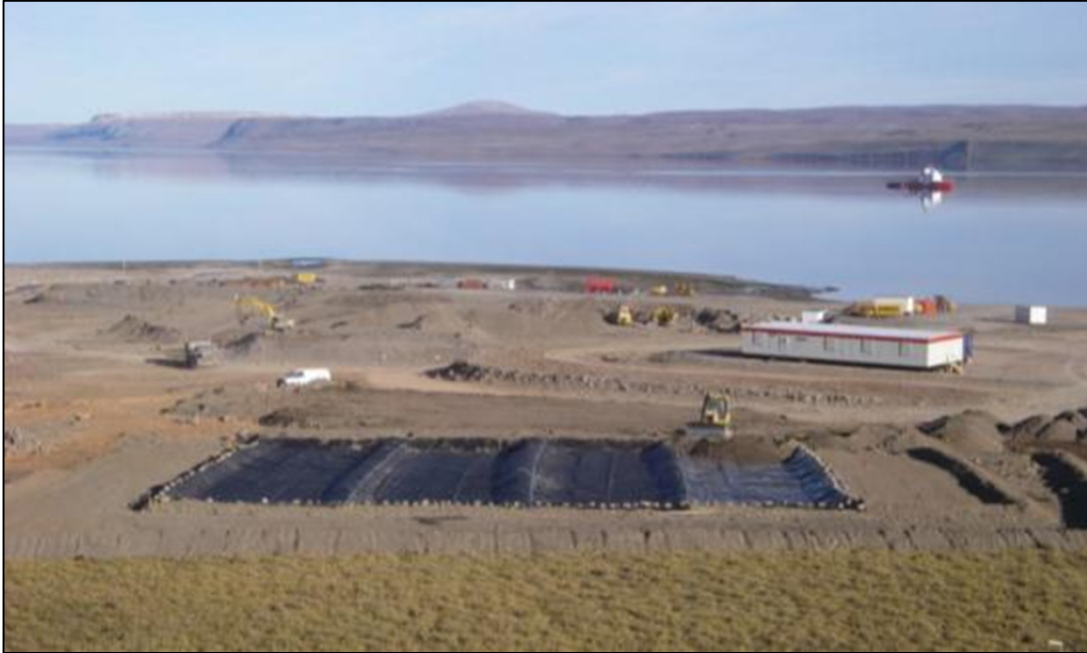
PHOTOGRAPH 5

August 19, 2011. The liners have been installed at the UTA. Part of the soil previously placed in the LTA is being relocated here. The soil stockpiled at the right of the photo will be used to expand the UTA and construct additional surface water diversion berms.

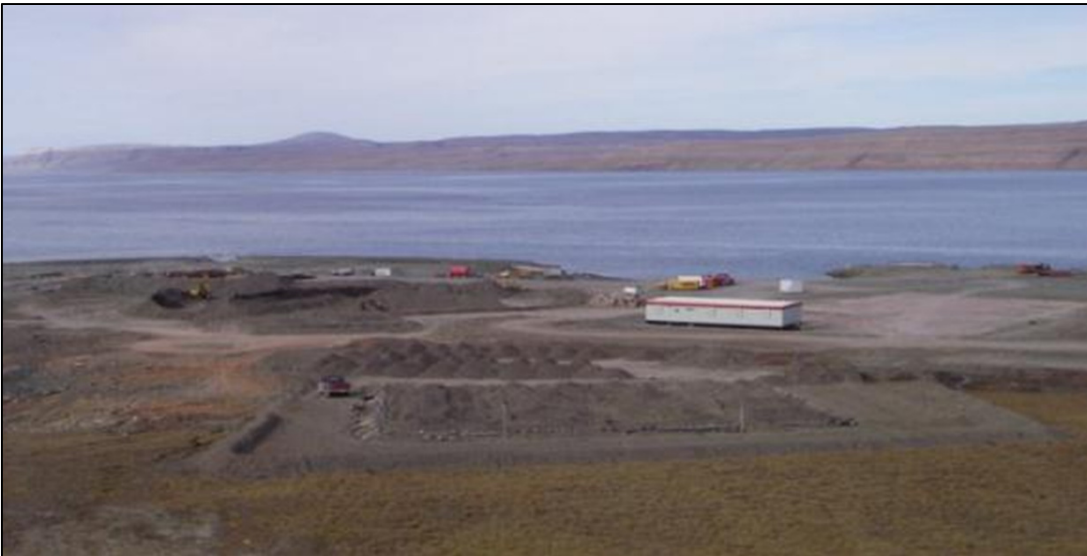
PHOTOGRAPH 6

August 22, 2011. Four cells in the UTA has been filled with 1.5 m of contaminated soil. Clean soil has been stockpiled between the access road and the UTA in preparation for the expansion of the UTA. The foundation for a fifth treatment cell is complete.

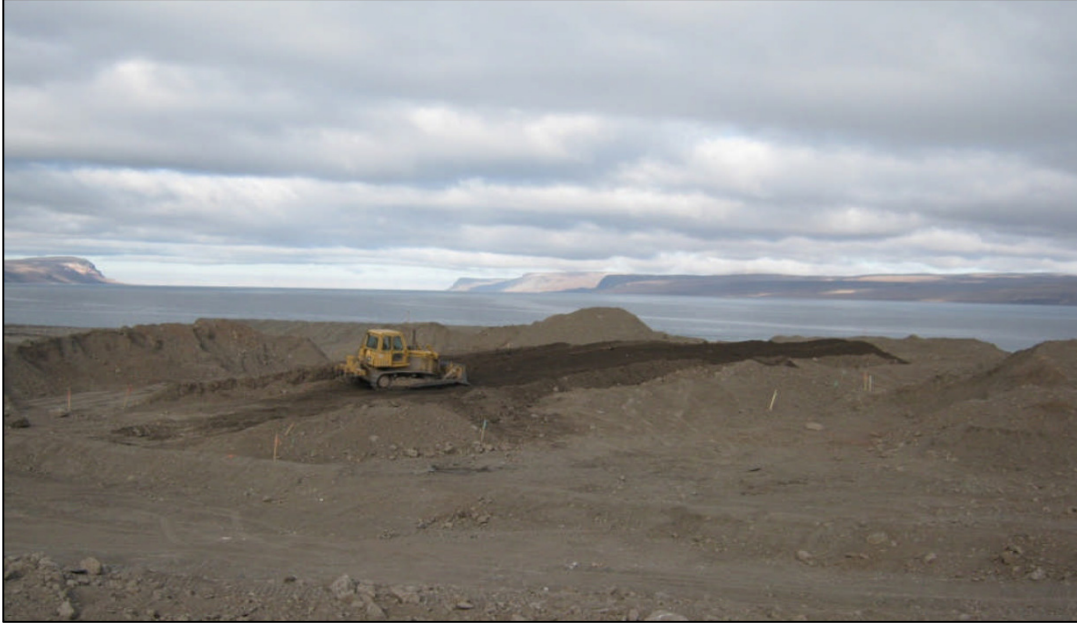
PHOTOGRAPH 7

September 1, 2011. Soil contaminated with volatile hydrocarbons is being aerated as it is pushed into windrows in a lined area of the former tank farm. The soil beneath the tanks here was not contaminated. Approximately 0.5 m of clean material overlies the liner to protect it.

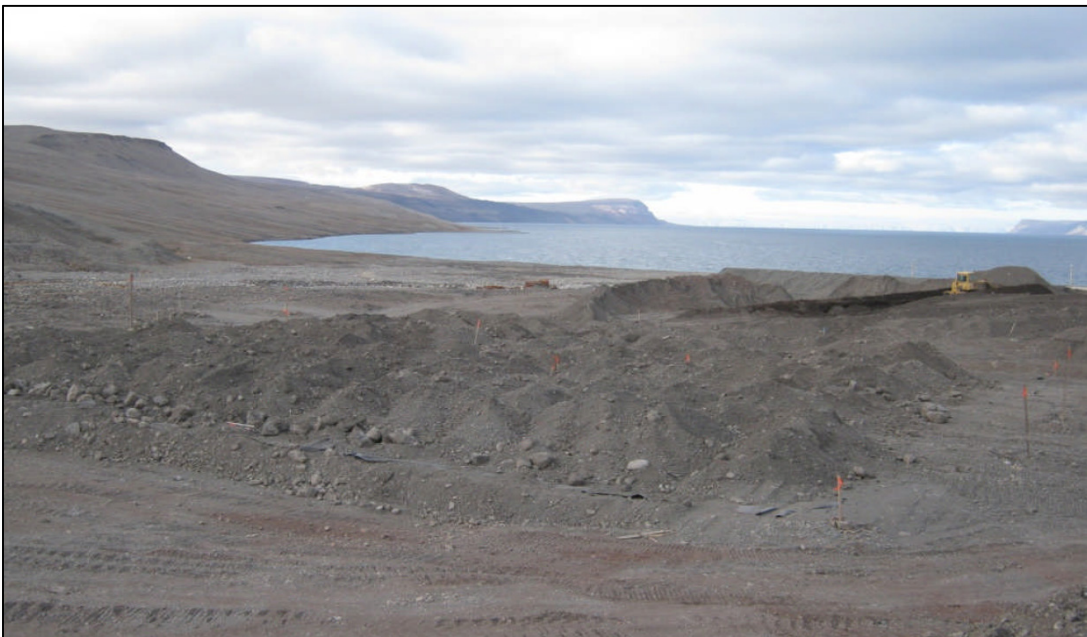
PHOTOGRAPH 8

September 1, 2011. The soil in the LTA has been aerated by the excavator.

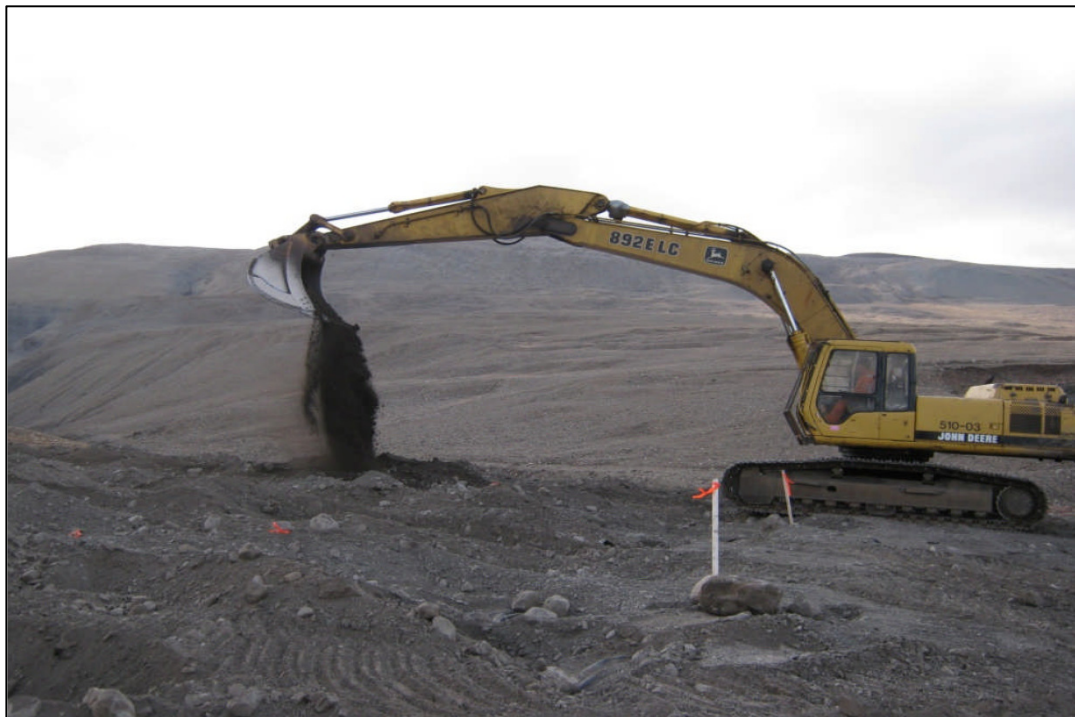
PHOTOGRAPH 9

September 1, 2011. Soil in the UTA is being aerated. Aeration in the LTA, UTA and within the footprint of the former tank farm continued until mid September when winter conditions arrived.

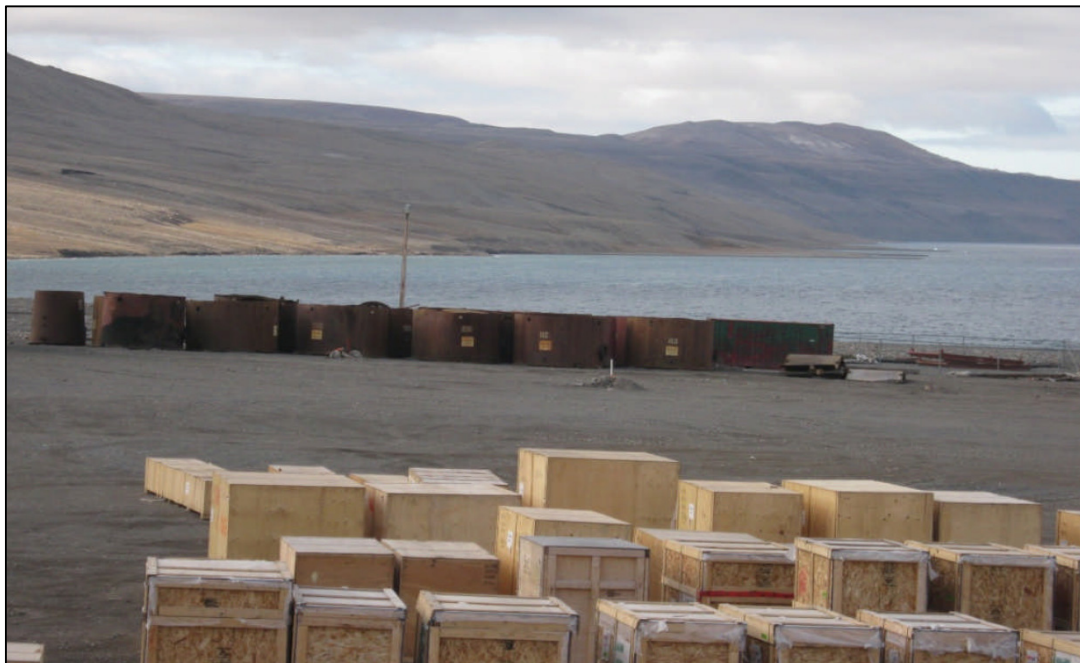
PHOTOGRAPH 10

September 1, 2011. The steel tanks in the background are filled with demolition debris and await shipment off-site. Cargo from a recent sealift destined for other communities is in the foreground.
