Nanisivik Mine Contaminated Soil Remediation 2012 Progress Report

CanZinco Ltd.

SRK Consulting (Canada) Inc.
1CB002.002
March 2013

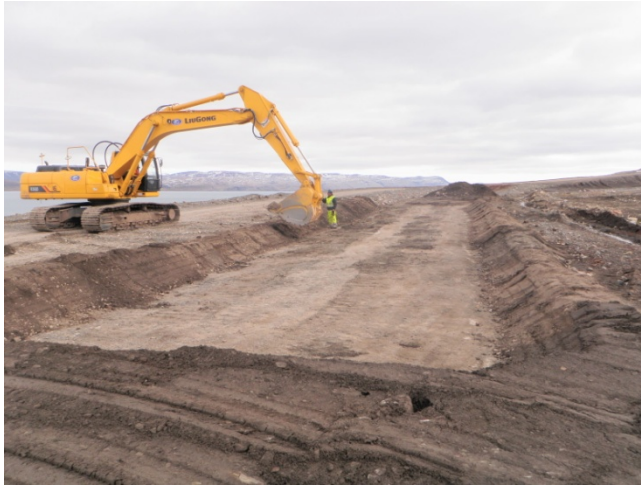
Photo 1: Berm construction for UTA-9
(August 20, 2012)

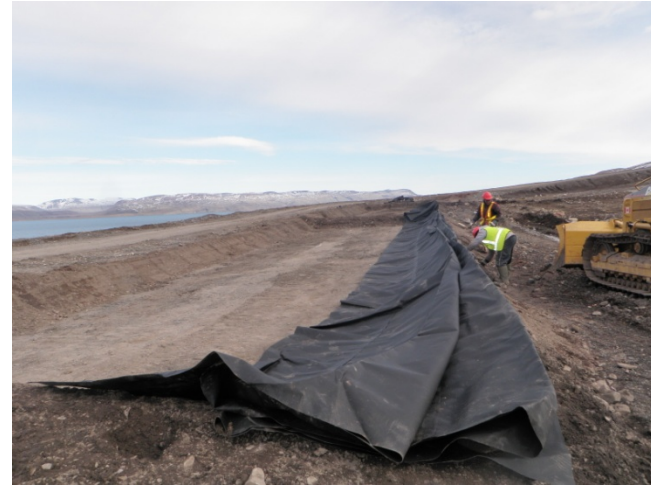
Photo 2: RLLDPE liner placement in UTA-9
(August 20, 2012)

The base of the treatment cells were constructed of coarse grained sand and gravel. The base and berms of each soil treatment cell were covered with 36 mil Reinforced Linear Low Density Polyethylene geomembrane liner; prefabricated to 10 by 30 m dimensions. The conceptual plan estimated that each cell would hold 400 to 500 m³ of contaminated soil (Stantec, 2010); however the as-built soil volume in each cell is closer to 200 m³. The reduction in volume is attributed to the lower height of the biopiles (1.5 m as opposed to the 2.0 m proposed); necessary to effectively remediate the soil. The construction of water sumps within the lined treatment cells also reduced the total volume of soil contained in each cell.

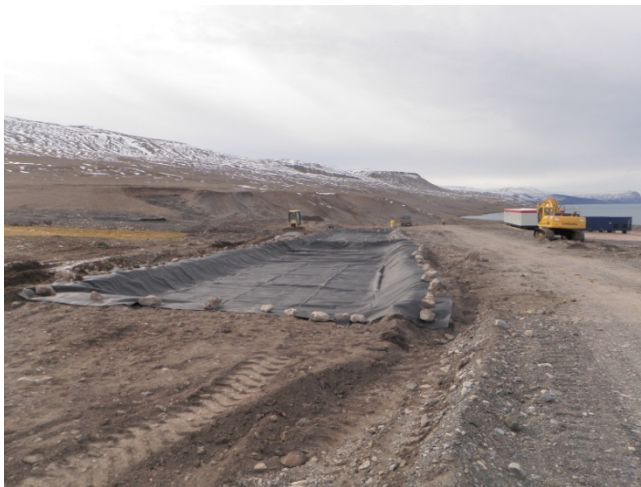
Photo 3: Liner placed and secured in UTA-10
(August 20, 2012)

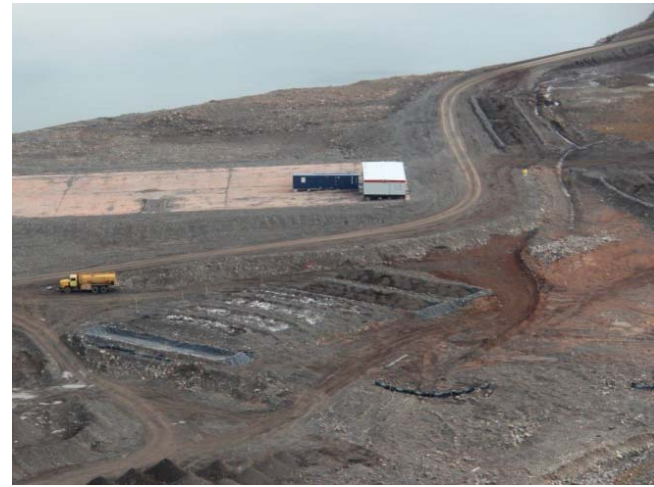
Photo 4: Aerial view of LTA and drainage diversion
berm and silt fencing (August 30, 2012)
(photo courtesy of Canadian Coast Guard)

Mitigation measures undertaken during the 2012 construction included stormwater retention ponds, water diversion ditches and silt fencing (Appendix A: Photo 4).

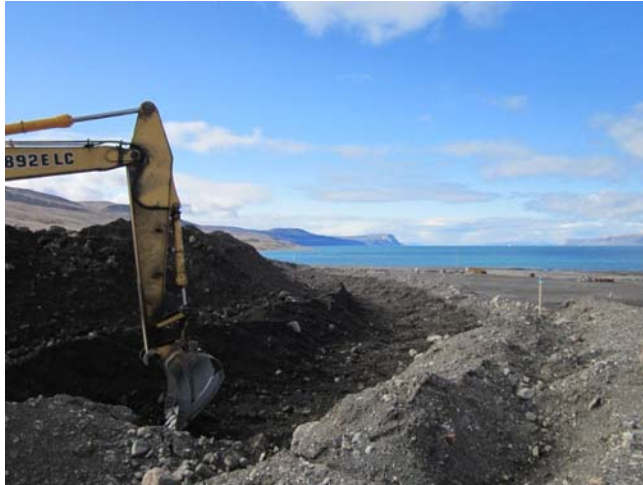
Photo 5: Excavation of Area 1 with exterior berm being maintained (August 12, 2012)

Soil excavation at the Site in 2012 focused on soil that had been backfilled into areas 1 and 3 in 2011 (Appendix A: Photo 5). The soil was consolidated into a stockpile in Area 1.

No excavation of the berm was undertaken in 2012 in order to maintain an elevated permafrost horizon along its down gradient length. The elevated zone of permafrost is intended to act as a subsurface barricade to inhibit the migration of contaminated groundwater.

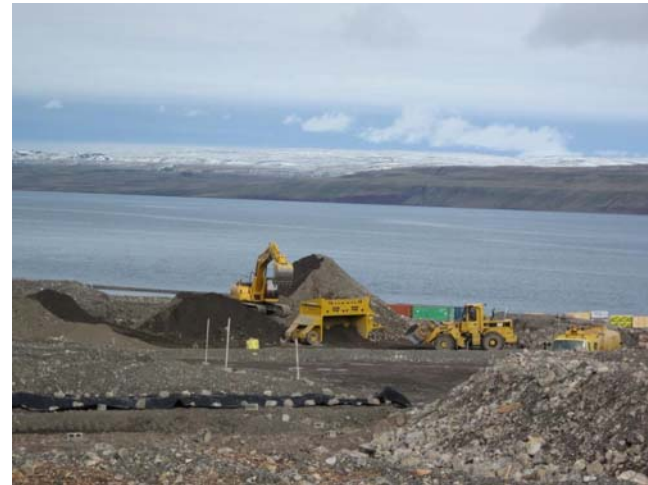
Photo 6: Screening of oversized rock from stockpile in Area 1 (August 18, 2012)

The screening process to remove rocks larger than 10 cm reduced the volume of soil requiring treatment by approximately 15%. The process effectively promoted the volatilization of PHC components and it homogenized the PHC soil quality. Removal of the large rocks from the soil loaded into the treatment cells also reduced the risk of damage to the liner. The ease at which the soil passed through the screener suggests that a smaller screen grid could be used and thereby increase the volume of rocks removed.

Due to the wet conditions during screening in 2012 aggregates of soil remained on the surface of the oversized rock. The oversized rock is to be processed through the screener a second time when a dry weather opportunity presents itself.

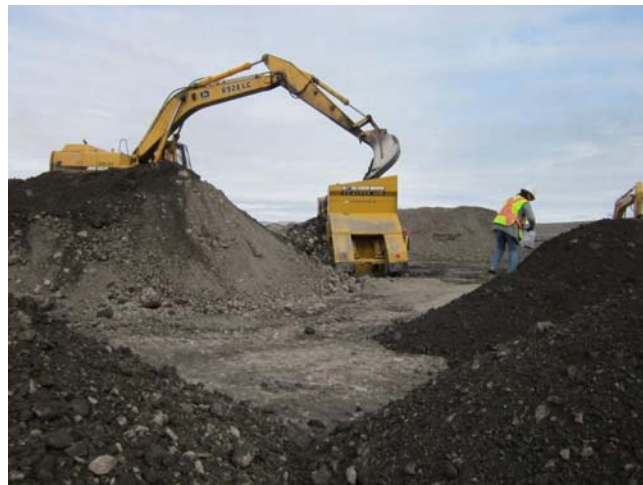
Photo 7: Collecting sample of soil from in-situ area following screening of oversized rock (August 22, 2012)

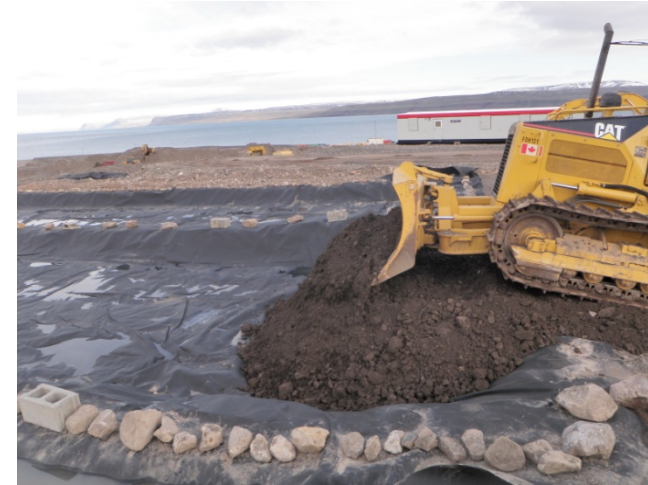
Photo 8: Bulldozer pushes screened low level PHC contaminated soil into UTA-7 to create base layer (August 20, 2012)

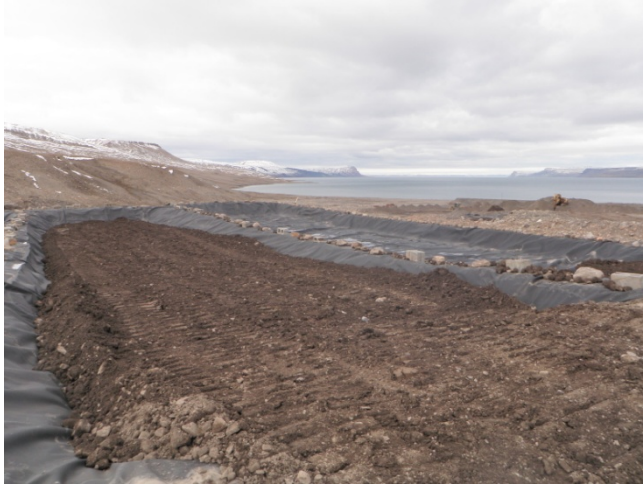
Photo 9: Base and ramp completed in UTA-7
(August 20, 2012)

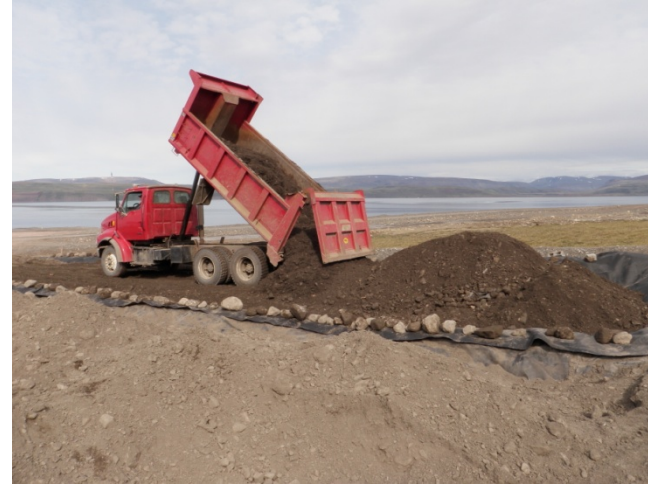
Photo 10: Loading contaminated soil into
UTA-5; material hauled from Area 1 (July 16, 2012)

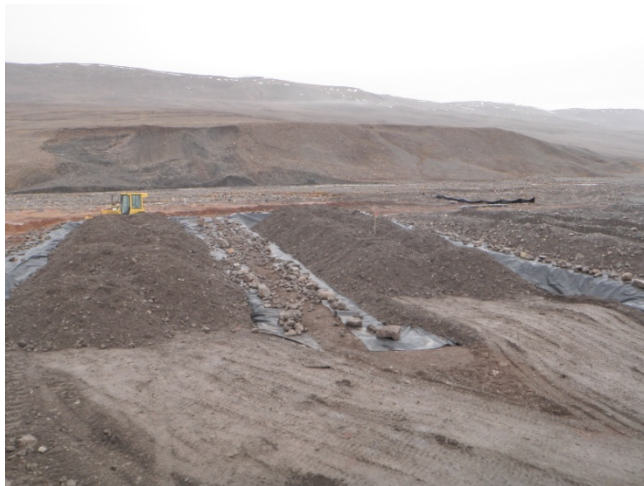
Photo 11: Screened contaminated soil loaded in LTA-5 and
LTA-6 (August 24, 2012)

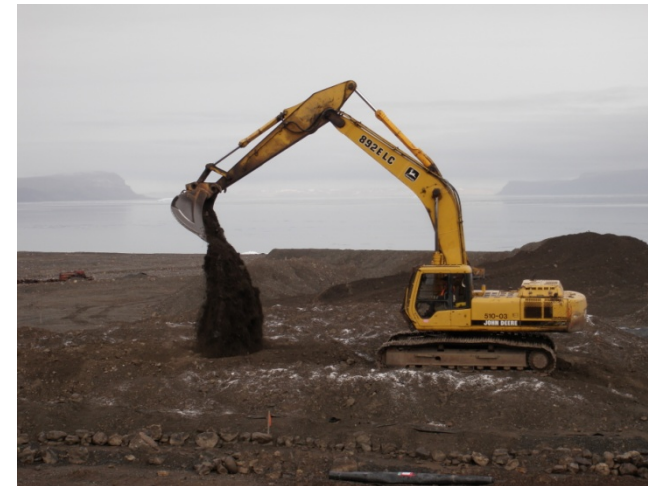
Photo 12: Fertilizer being mixed into the soil
at LTA (July 14, 2012)

The nutrients needed for accelerating bioremediation are added to the soil in appropriate levels for the microbial cells to replicate and survive. Research studies on remediation of hydrocarbon contaminated soils in the Arctic have shown success applying a Carbon:Nitrogen:Phosphorus (C:N:P) nutrient amendment ratio of 100:7.5:0.5 (Paudyn et.al. 2008). Nitrogen and phosphorus are the nutrients most often limiting microbial degradation in cold region soils. Nitrogen and phosphorus were added to the constructed biopiles in the form of granular agricultural fertilizers Urea and diammonium phosphate (DAP). For every one bag of DAP applied, between six and eight bags of Urea were applied depending on the PHC concentration in the biopile. Additional supplies were received on the 2012 sealift and nutrients were added to the remaining biopiles and the stockpile of screened PHC contaminated soil within the former tank farm footprint later in August 2012.

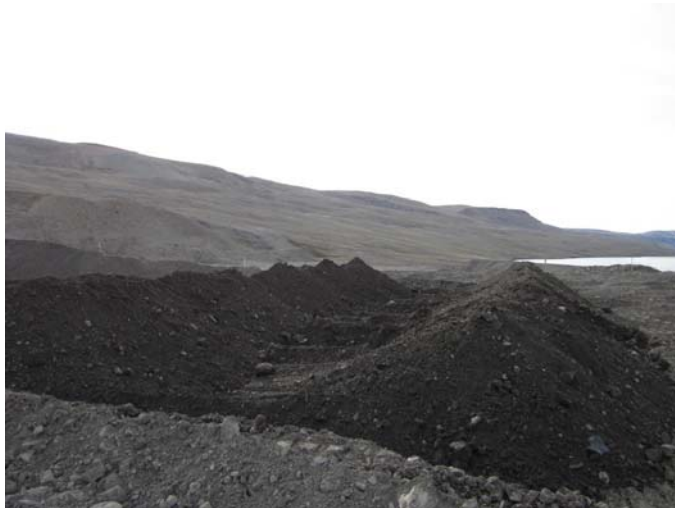
Photo 13: Windrows within in-situ treatment area

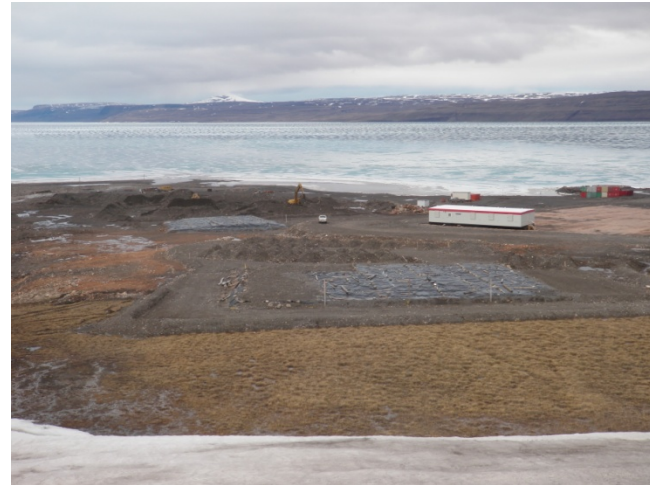
Photo 14: UTA and LTA prior to cover removal
(June 19, 2012)

At the end of the 2011 field season, the biopile treatment cells were covered in accordance with the original 2010 remediation program proposed for the Site (Stantec 2010). Insufficient supplies were available to cover all of the biopiles. Cells UTA-1 and part of UTA-2 remained uncovered during the 2011/2012 winter season (Appendix A: Photo 14). In June 2012, field observations indicated that the soil within the uncovered biopiles did not show evidence of washout or erosion. Water was not observed to be pooling and the moisture content of the soil was observed to be within the ideal range for bioremediation. Surface soil samples were collected from both the uncovered and covered biopiles and submitted for laboratory analyses of PHC F1-F4.

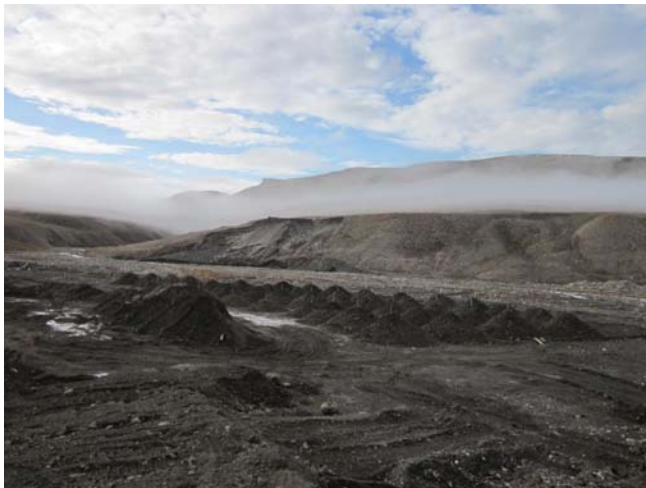
Photo 15: Stockpiles of soil in former secondary containment area pending laboratory confirmation that they meet the SQROs (August 26, 2012)

Given the homogeneity achieved with the screening process, a maximum stockpile size for soil that appears to meet the SQROs of 250 m³ is recommended.

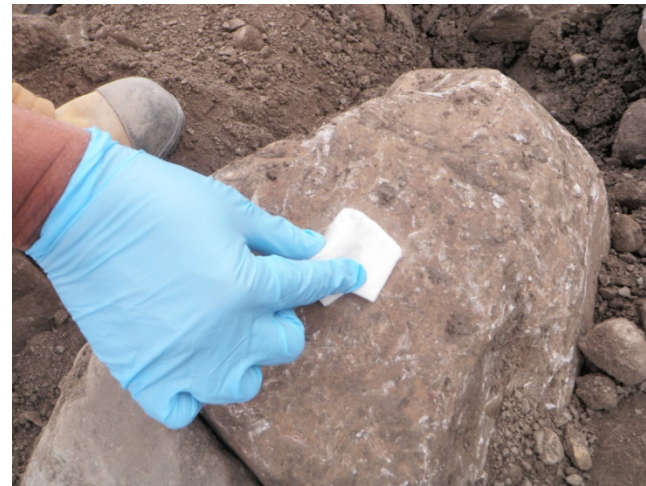
Photo 16: Collecting a swab sample from the surface of a rock that had been screened (August 30, 2012)
