CONSTRUCTION SUMMARY REPORT
NANISIVIK MINE SITE

November 2012

Project Number: Y-B9977

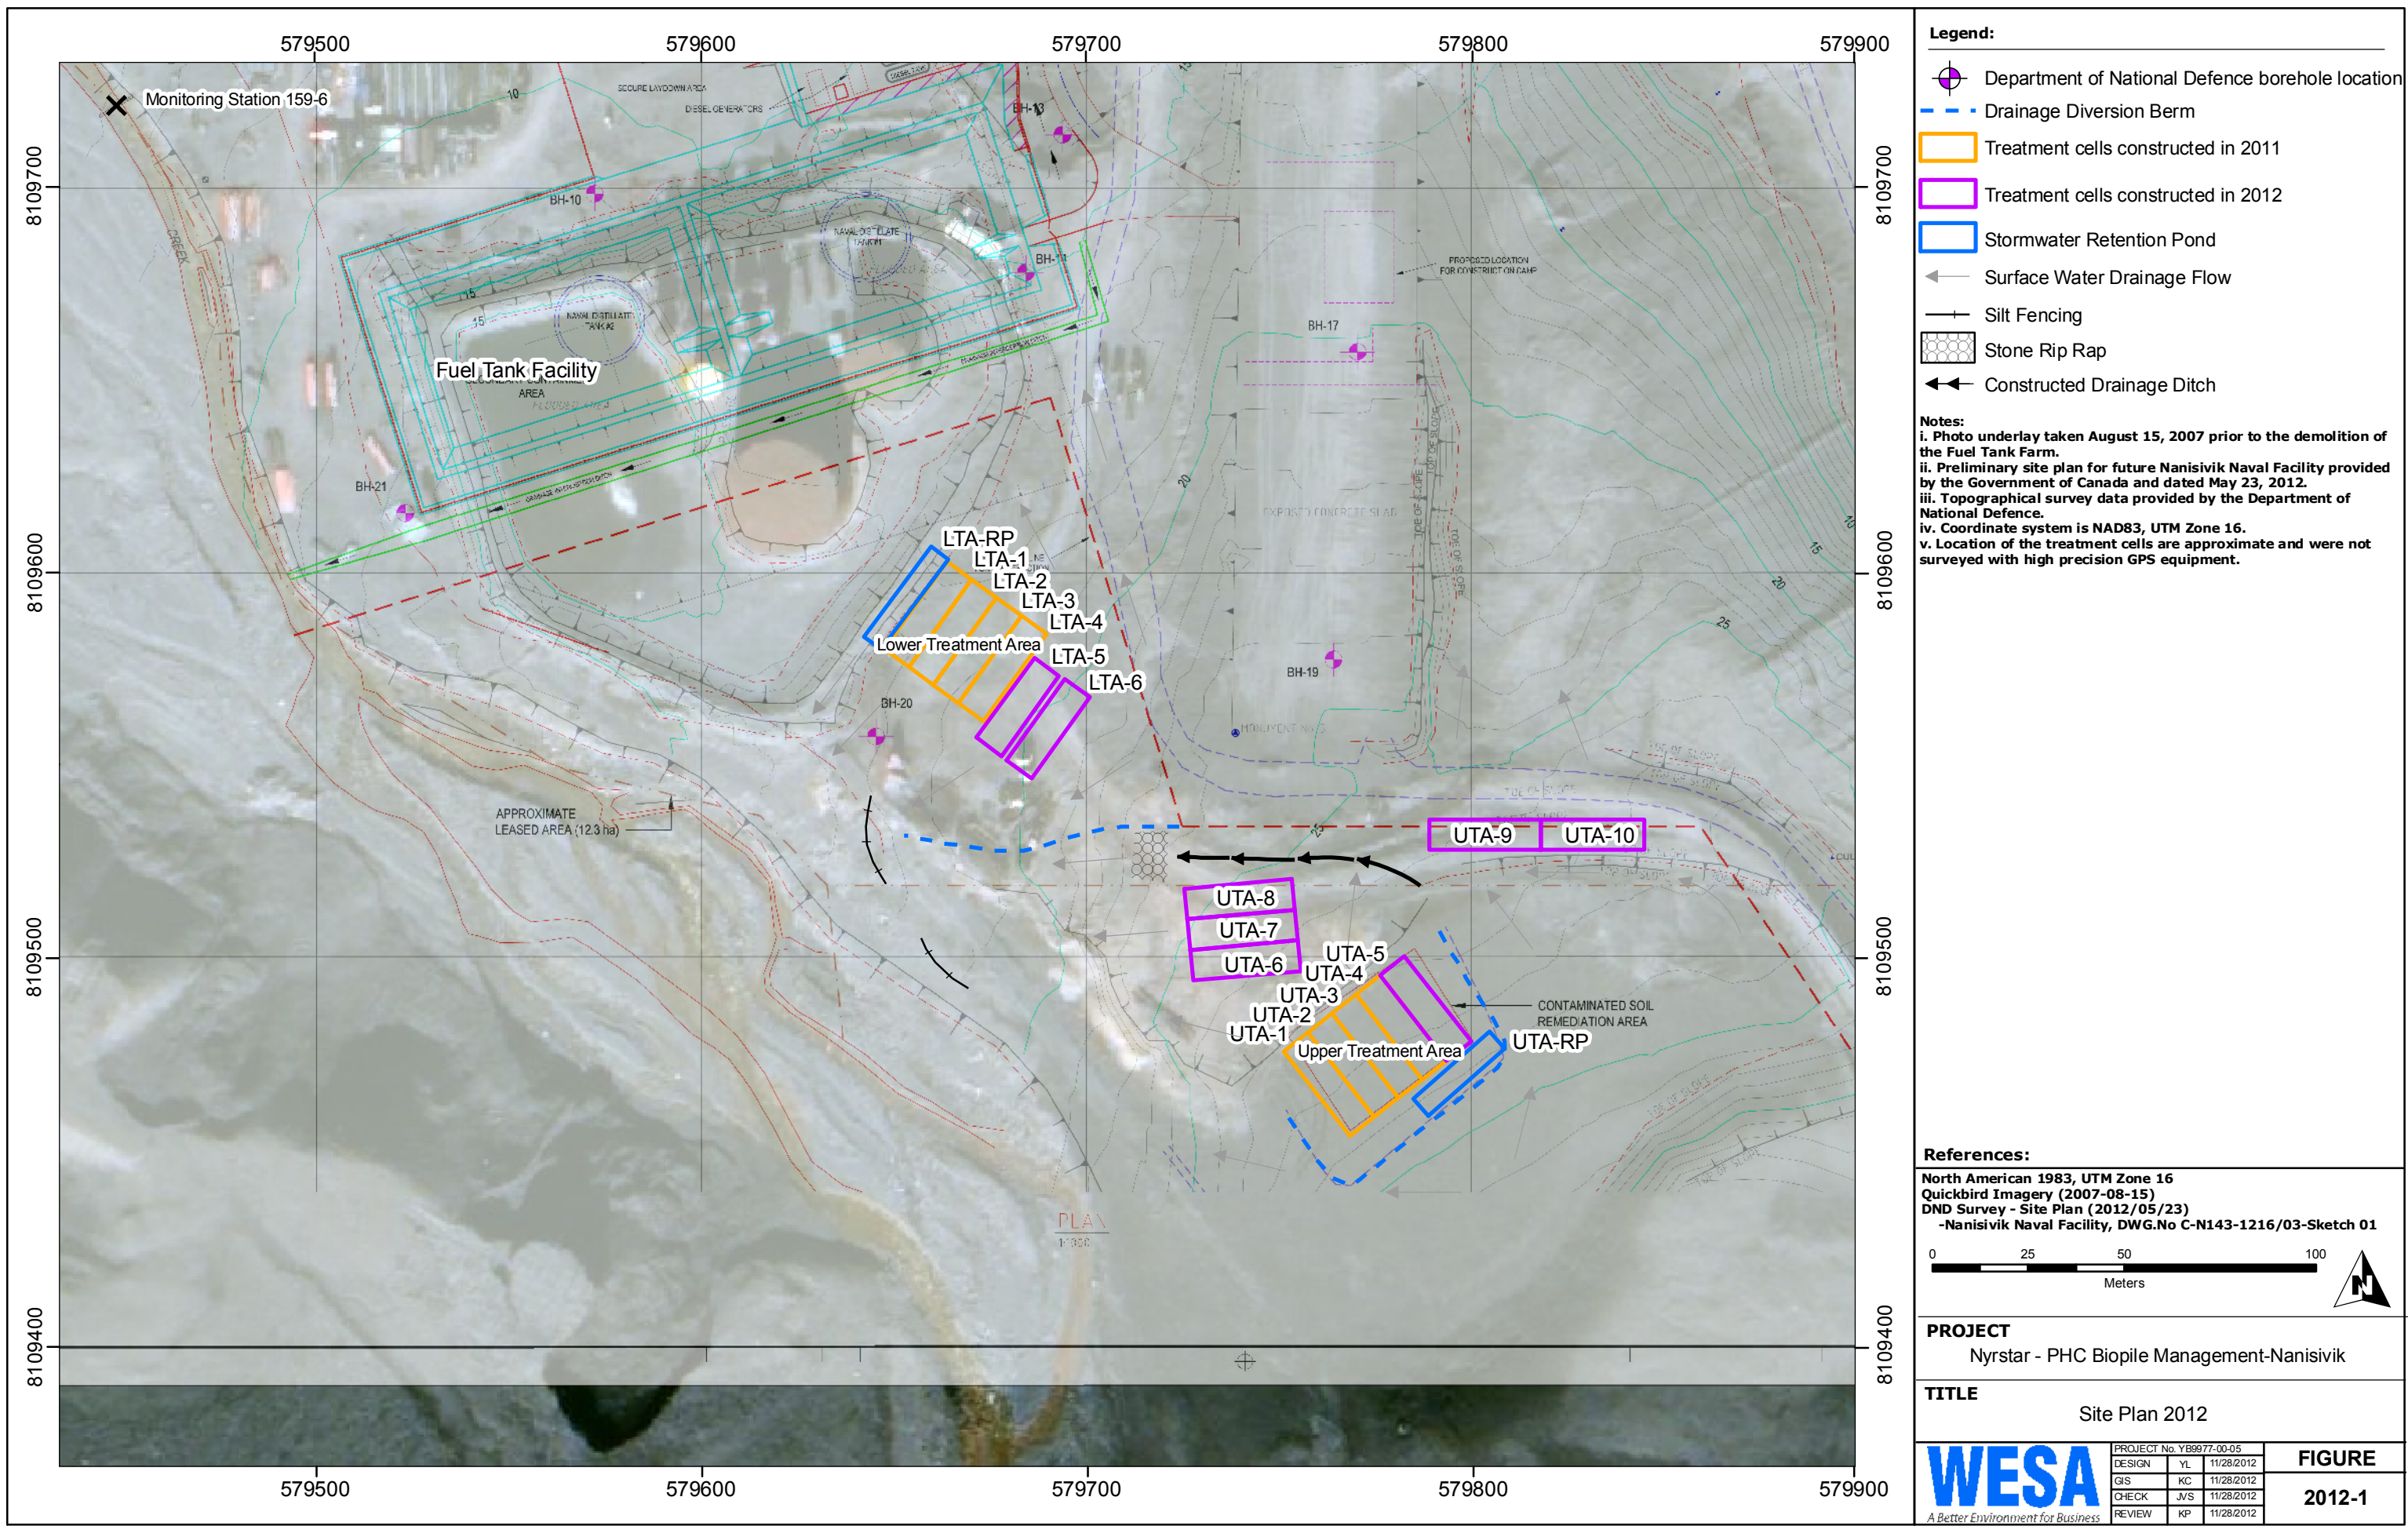
Two treatment areas for hydrocarbon contaminated soil have been established at the Nanisivik Site: a Lower Treatment Area (LTA) located immediately to the south of the former tank farm; and an Upper Treatment Area (UTA) located approximately 150 metres to the south of the former tank farm area (Figure 1).

Two stormwater retention ponds were constructed: one at the UTA and one at the LTA. Pond locations are shown in Figure 1. Dimensions of the LTA pond are approximately 28.5m long by 4.6m wide by 0.5m deep; having capacity for approximately 52,000 litres. Dimensions of the UTA pond are approximately 23.5m long by 4.0m wide by 0.5m deep; having capacity for approximately 41,000 litres. Both ponds are lined with High Density Polyethylene (HDPE) geomembrane liner. As-built drawings of the stormwater retention ponds are presented as Figures 4 and 5. Construction photos are included in Appendix A.

Initially, a drainage ditch was excavated around the southern and eastern perimeter of the UTA. This ditch was subsequently filled in with boulders (August 2011) to prevent glaciation in the spring. To effectively direct water away from the UTA, a diversion berm was constructed outside of the ditch (Figure 1). The drainage diversion berm was constructed to a height of approximately

In 2011, an existing roadside drainage ditch was extended between the UTA and the access road (Figure 1) for the purposes of directing surface runoff away from the UTA and the access road. The V-cut drainage ditch was constructed with a gradual slope along the old access road; terminating at the corner of the road. Rip rap of coarse rock was placed at the crest of the down-gradient slope at the corner of the road to slow the drainage of runoff and protect the slope from potential soil erosion.

The stormwater diversion berm to direct water away from LTA was extended further west in 2012 (Figure 1). The berm was constructed to a height of approximately 0.3m. The ground surface to the north of the diversion berm was also graded to direct water away from LTA.

Silt fencing was installed at two locations down-gradient of the new diversion berm to restrict suspended solids from entering the creek. It was observed that surface water drainage infiltrated the ground before reaching the two silt fences. Drainage structure locations are illustrated in Figure 1. Construction photos are included in Appendix A.

Monitoring of Total Suspended Solids (TSS) was conducted by CanZinco bi-weekly within 100 m down-gradient of the area disturbed during construction. Results for 2011 and 2012 are reported in the annual water quality reports submitted to the Water Board. 2011 and 2012 TSS results at station 159-6 (Figure 1) ranged from 23 mg/L to below the detection limit of 2 mg/L (Stantec

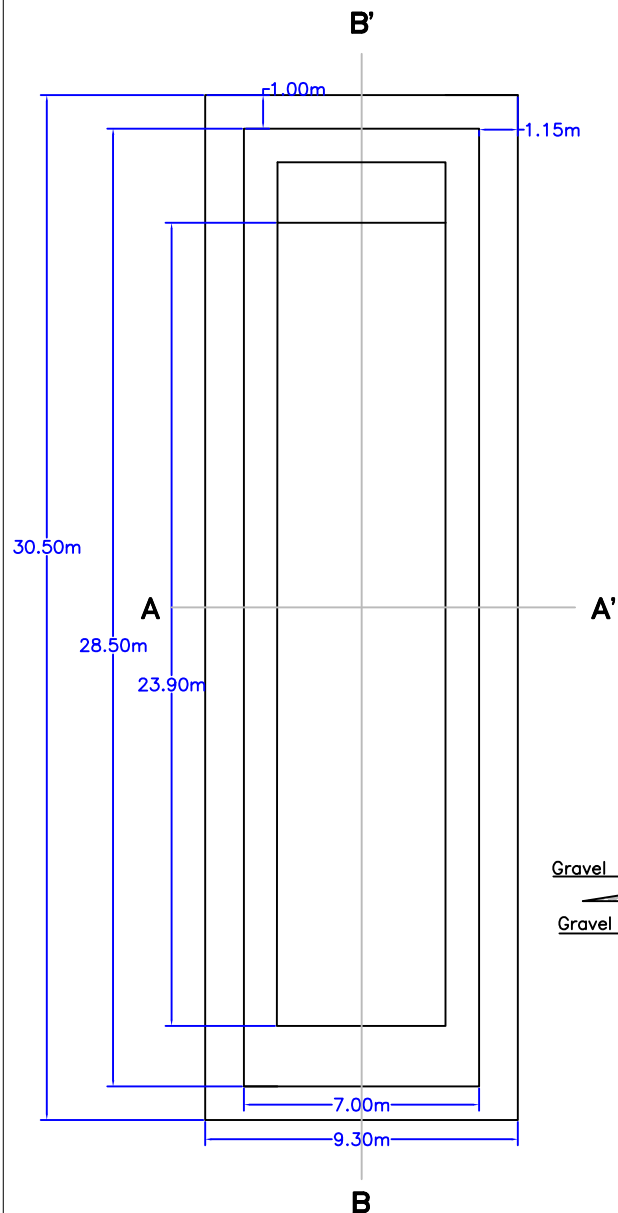
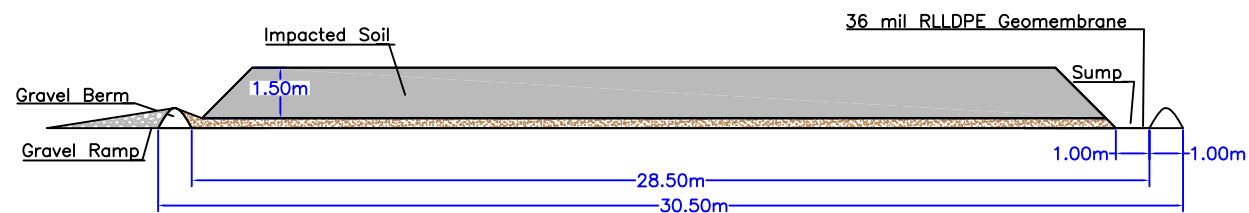
FIGURE: 2

CROSS SECTION A-A'

CROSS SECTION B-B'

BIOPILE TREATMENT CELL

Treatment cell as-built construction dimensions and details are illustrated in Figures 2 and 3, respectively.

The soil treatment cells were constructed in accordance with the original design (Stantec, 2010) as approved by the Water Board (Nunavut Water Board, 2010). As-built drawings of the constructed treatment cell are presented as Figure 2.

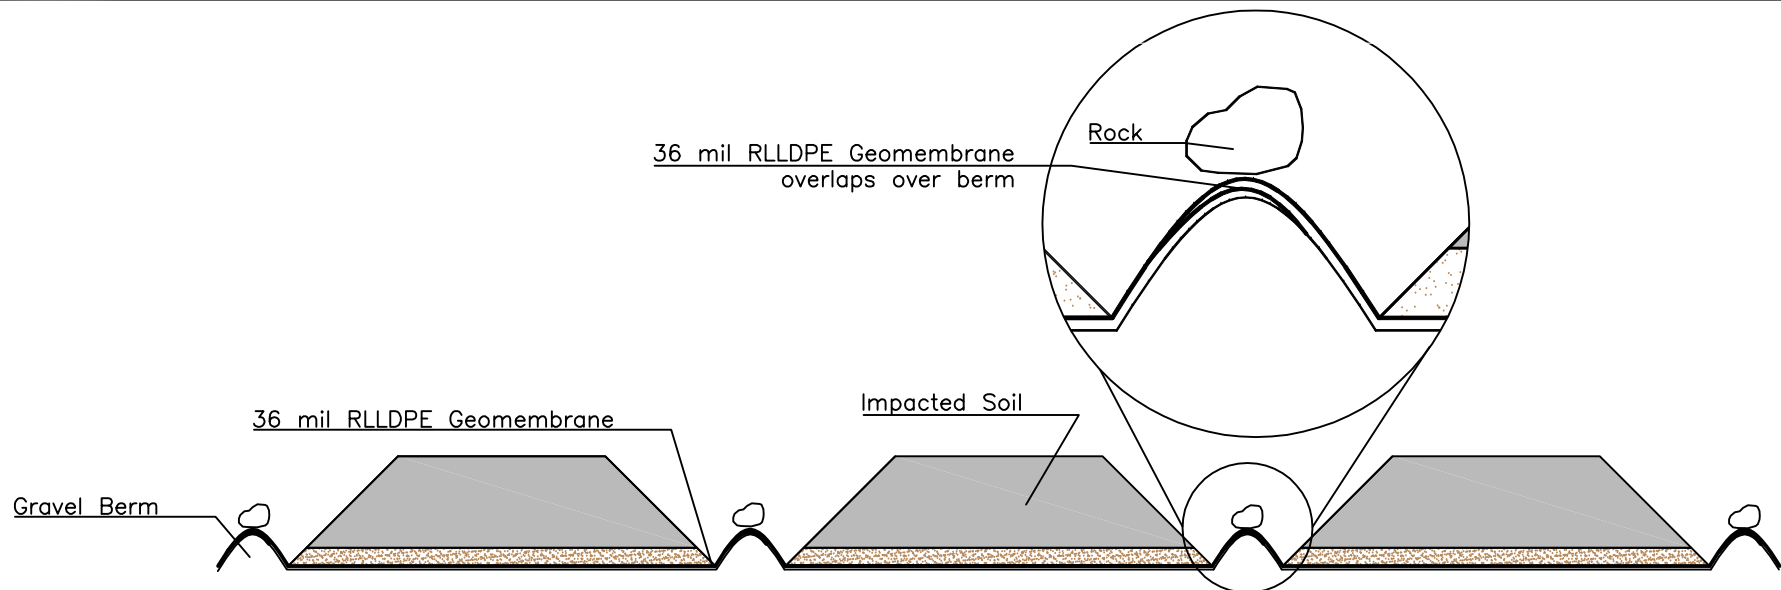
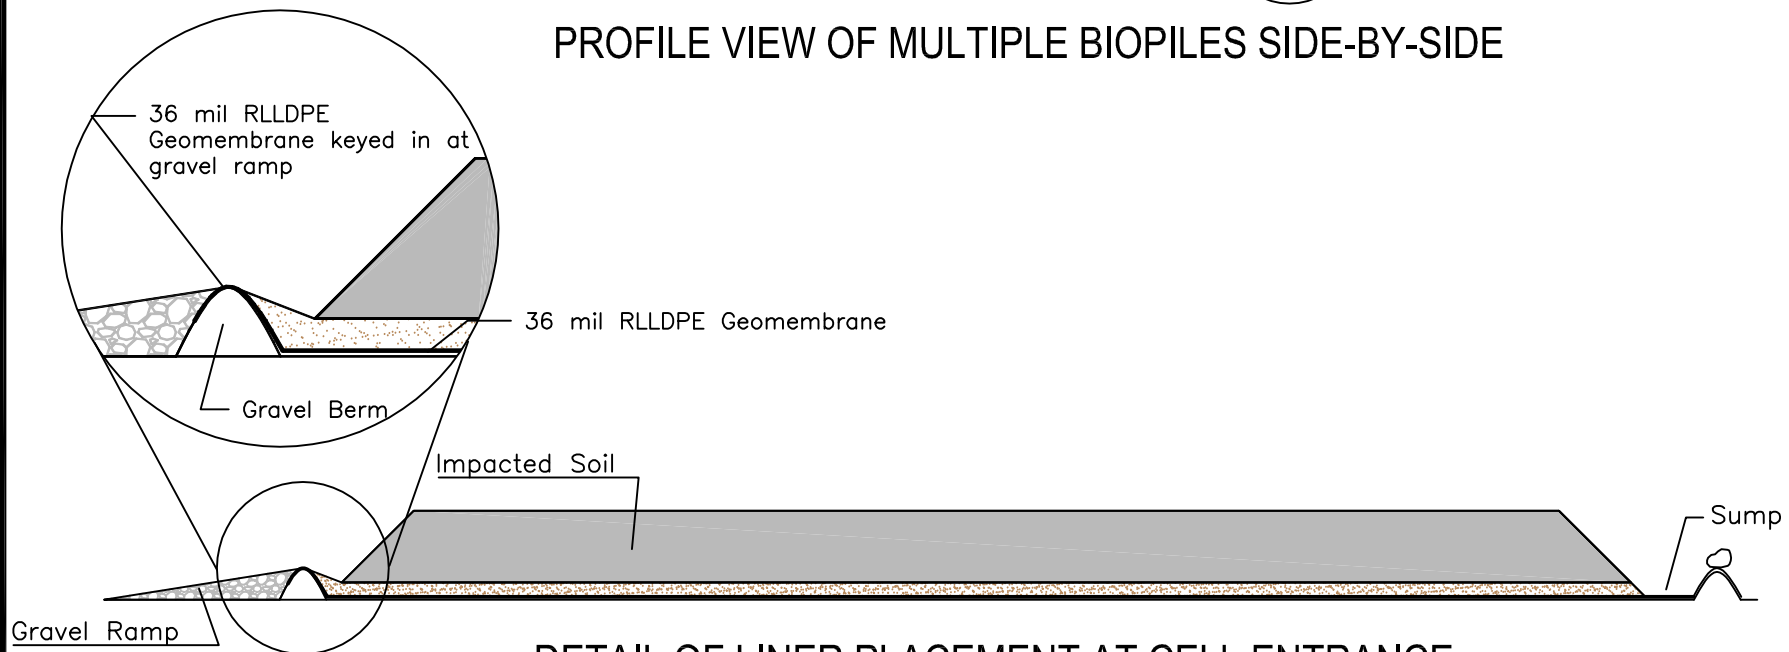
FIGURE: 3

PROFILE VIEW OF MULTIPLE BIOPILES SIDE-BY-SIDE

DETAIL OF LINER PLACEMENT AT CELL ENTRANCE

BIOPILE TREATMENT CELL DETAILS

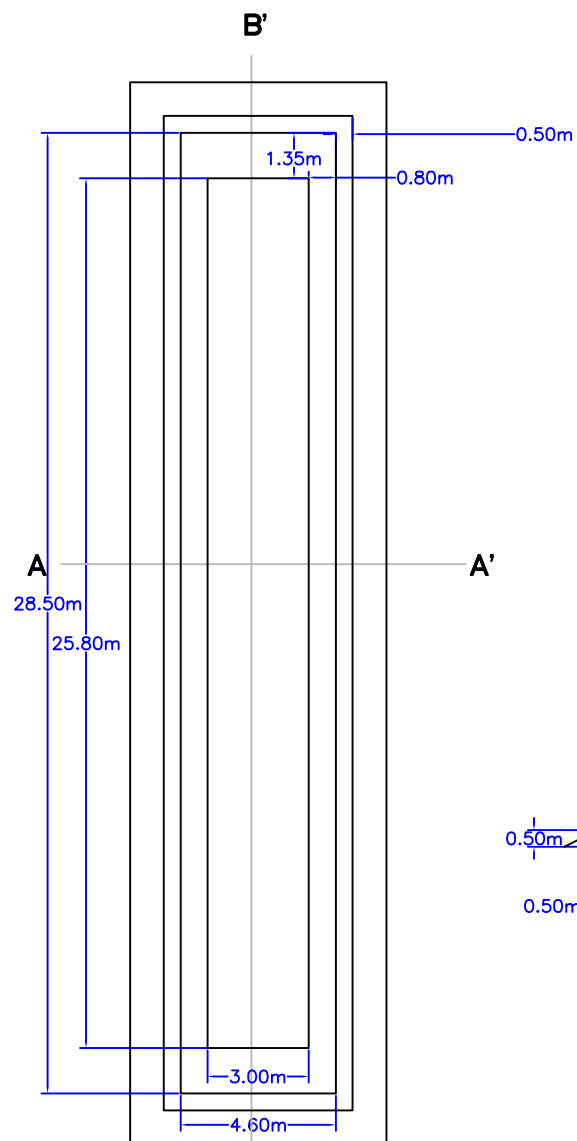
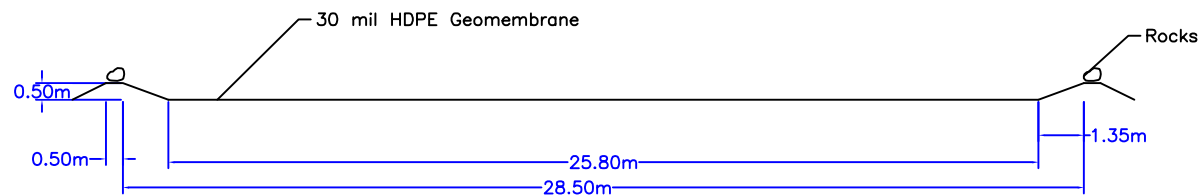
FIGURE: 4

CROSS SECTION A-A'

CROSS SECTION B-B'

LOWER TREATMENT AREA
STORMWATER RETENTION POND

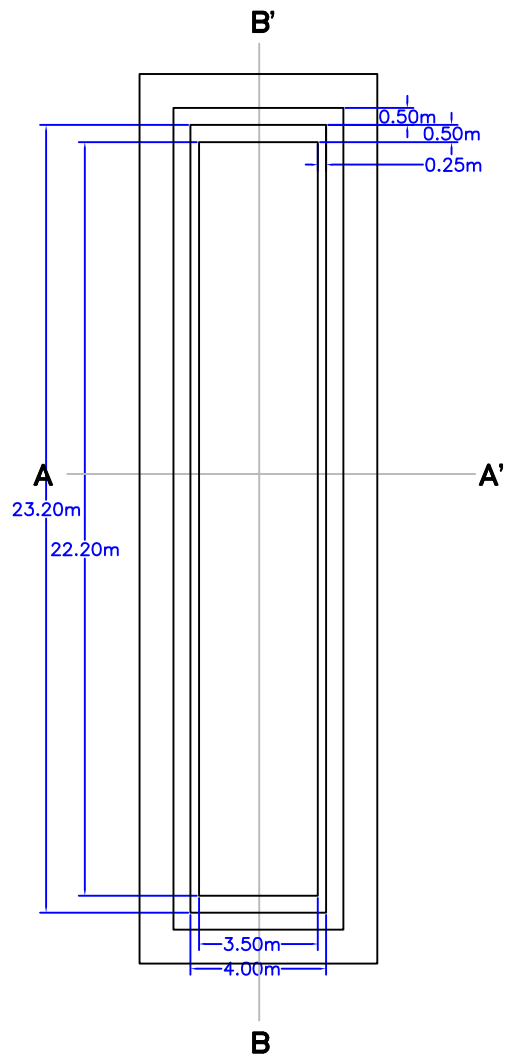
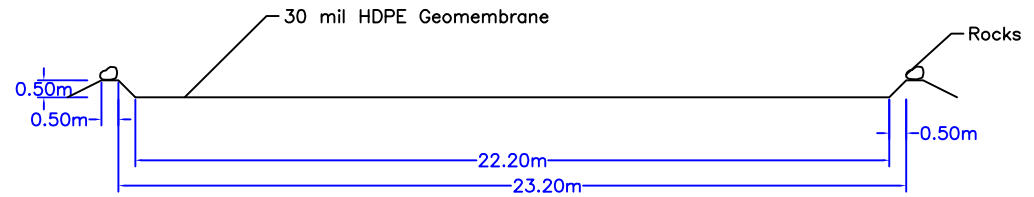
FIGURE: 5

CROSS SECTION A-A'

CROSS SECTION B-B'

UPPER TREATMENT AREA
STORMWATER RETENTION POND

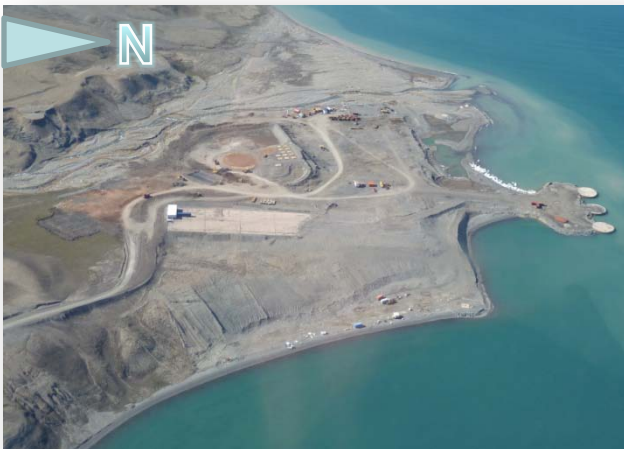
Photo 3: Aerial view of Nanisivik dock site on July 18, 2011. Construction of UTA and LTA in progress.

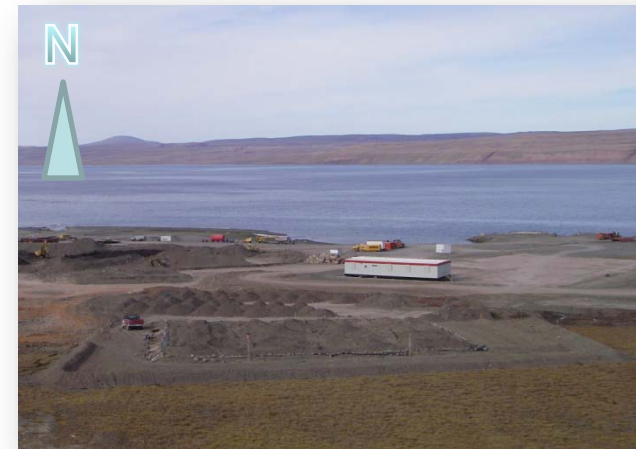
Photo 4: Site overview on August 24, 2011. UTA with water diversion berm in foreground and construction of cells 6, 7, and 8 in progress.

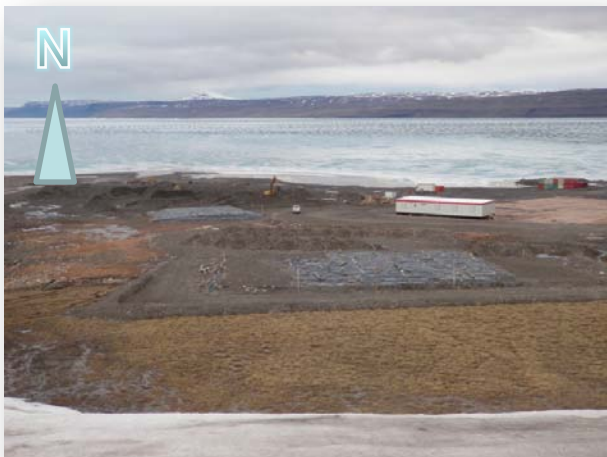
Photo 5: UTA on June 19, 2012 prior to the removal of the cover on cells 2, 3 and 4.

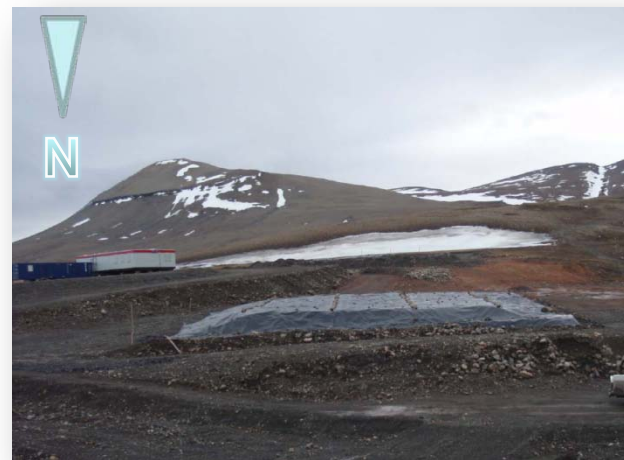
Photo 6: LTA on June 19, 2012 prior to the removal of the cover on treatment cells

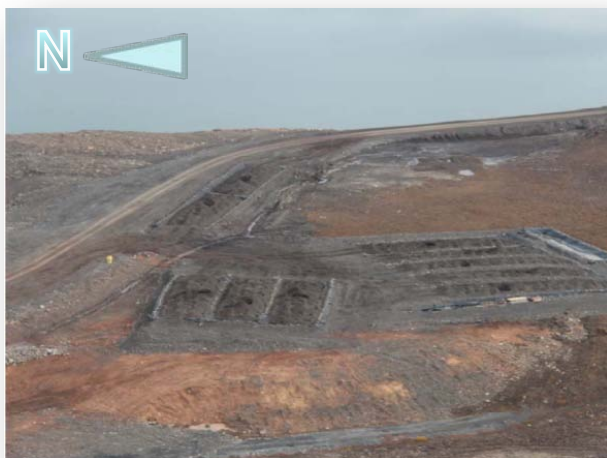
Photo 7: Aerial view of UTA on August 30, 2012. Treatment cells and water diversion structures are fully constructed.

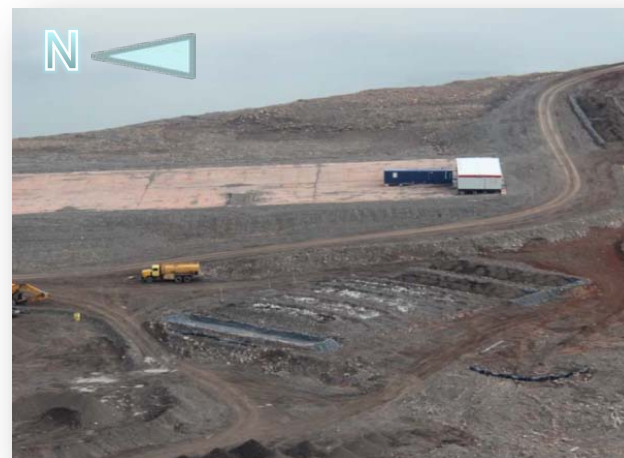
Photo 8: Aerial view of LTA on August 30, 2012. Treatment cells and water diversion structures are fully constructed.
