# Nanisivik Mine Contaminated Soil Remediation 2015 Progress Report

CanZinco Mines Ltd.

SRK Consulting (Canada) Inc.  
1CB002.002  
March 2016

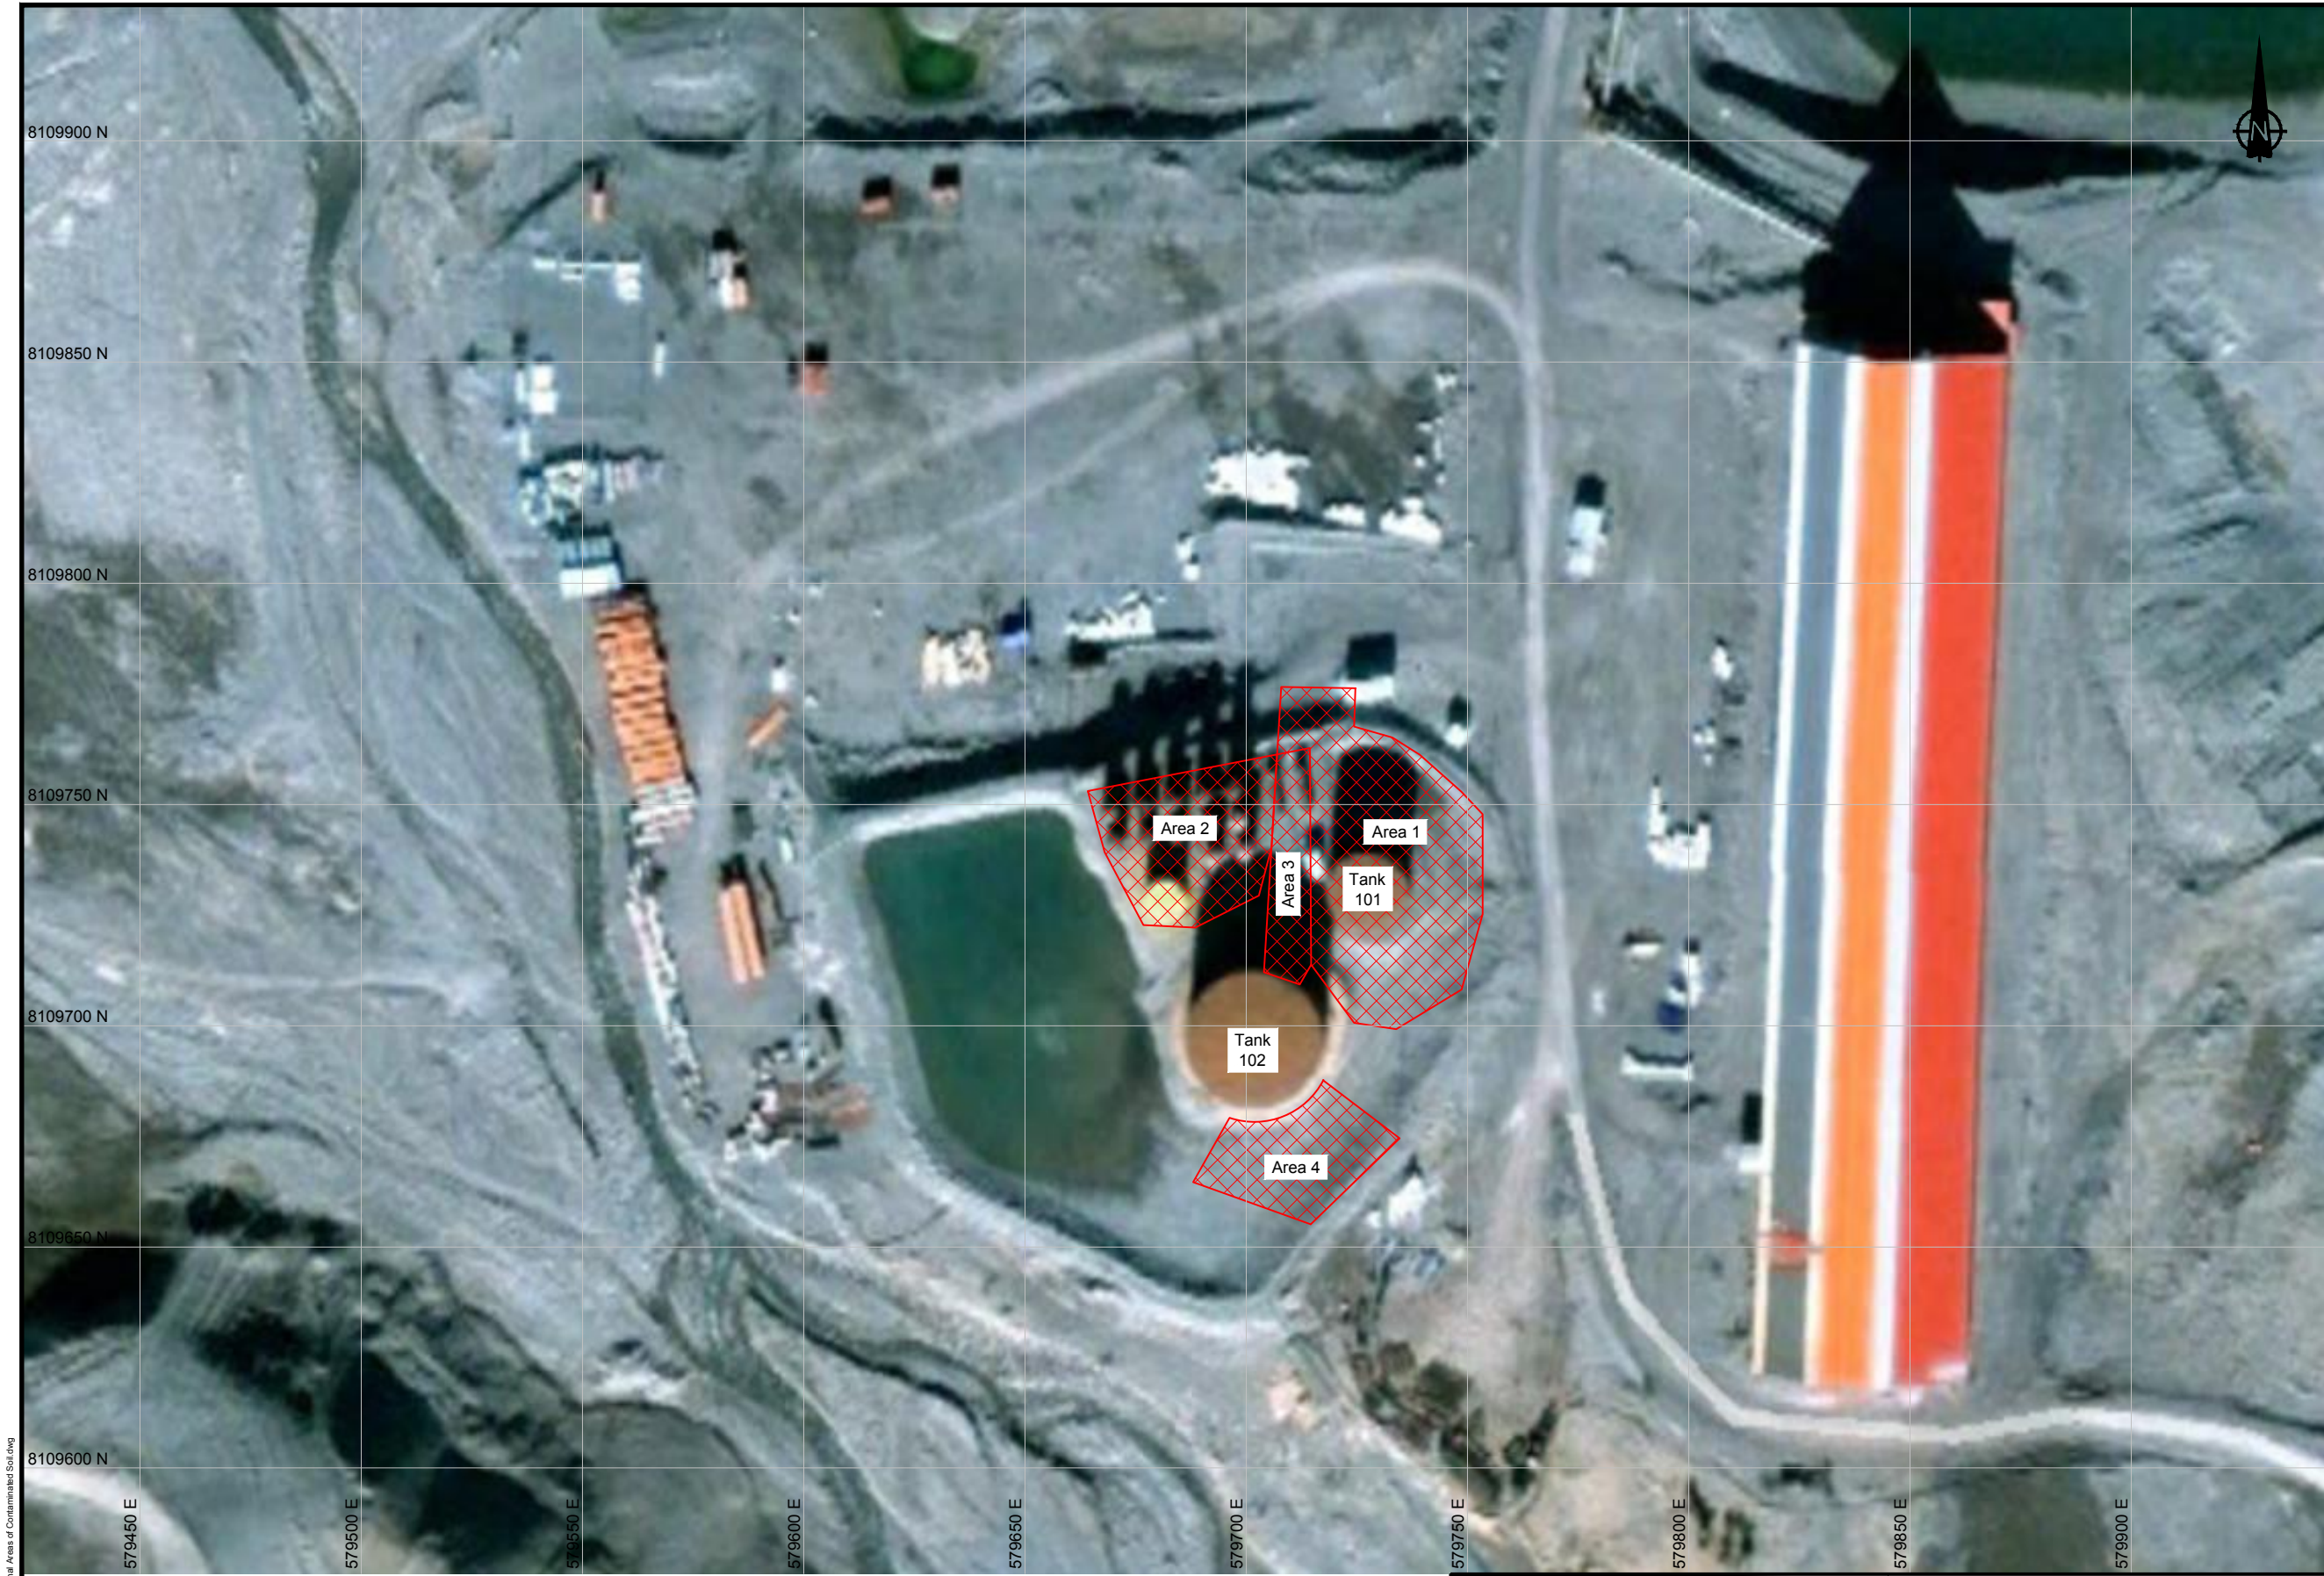
DATE: February 2015	APPROVED: SM	FIGURE: 1
------------------------	-----------------	--------------

Original Areas of  
Contaminated Soil

Delineation of the PHC contaminated soil was conducted to refine the estimated quantity of contaminated soil requiring treatment. Four areas of contamination were identified (Figure 1). As reported in the 2011 Annual Report, the quantities of soil requiring treatment were determined to be approximately 17,000 m<sup>3</sup> (Nyrstar 2012).

Preliminary boundaries of the areas to be remediated were identified by a series of test pits excavated within the footprint of the bulk fuel storage facility in 2011. Results of the field screening measurements and analytical analysis indicated four areas of PHC contamination as shown on Figure 1. These four areas have been the focus of remedial efforts at the Site.

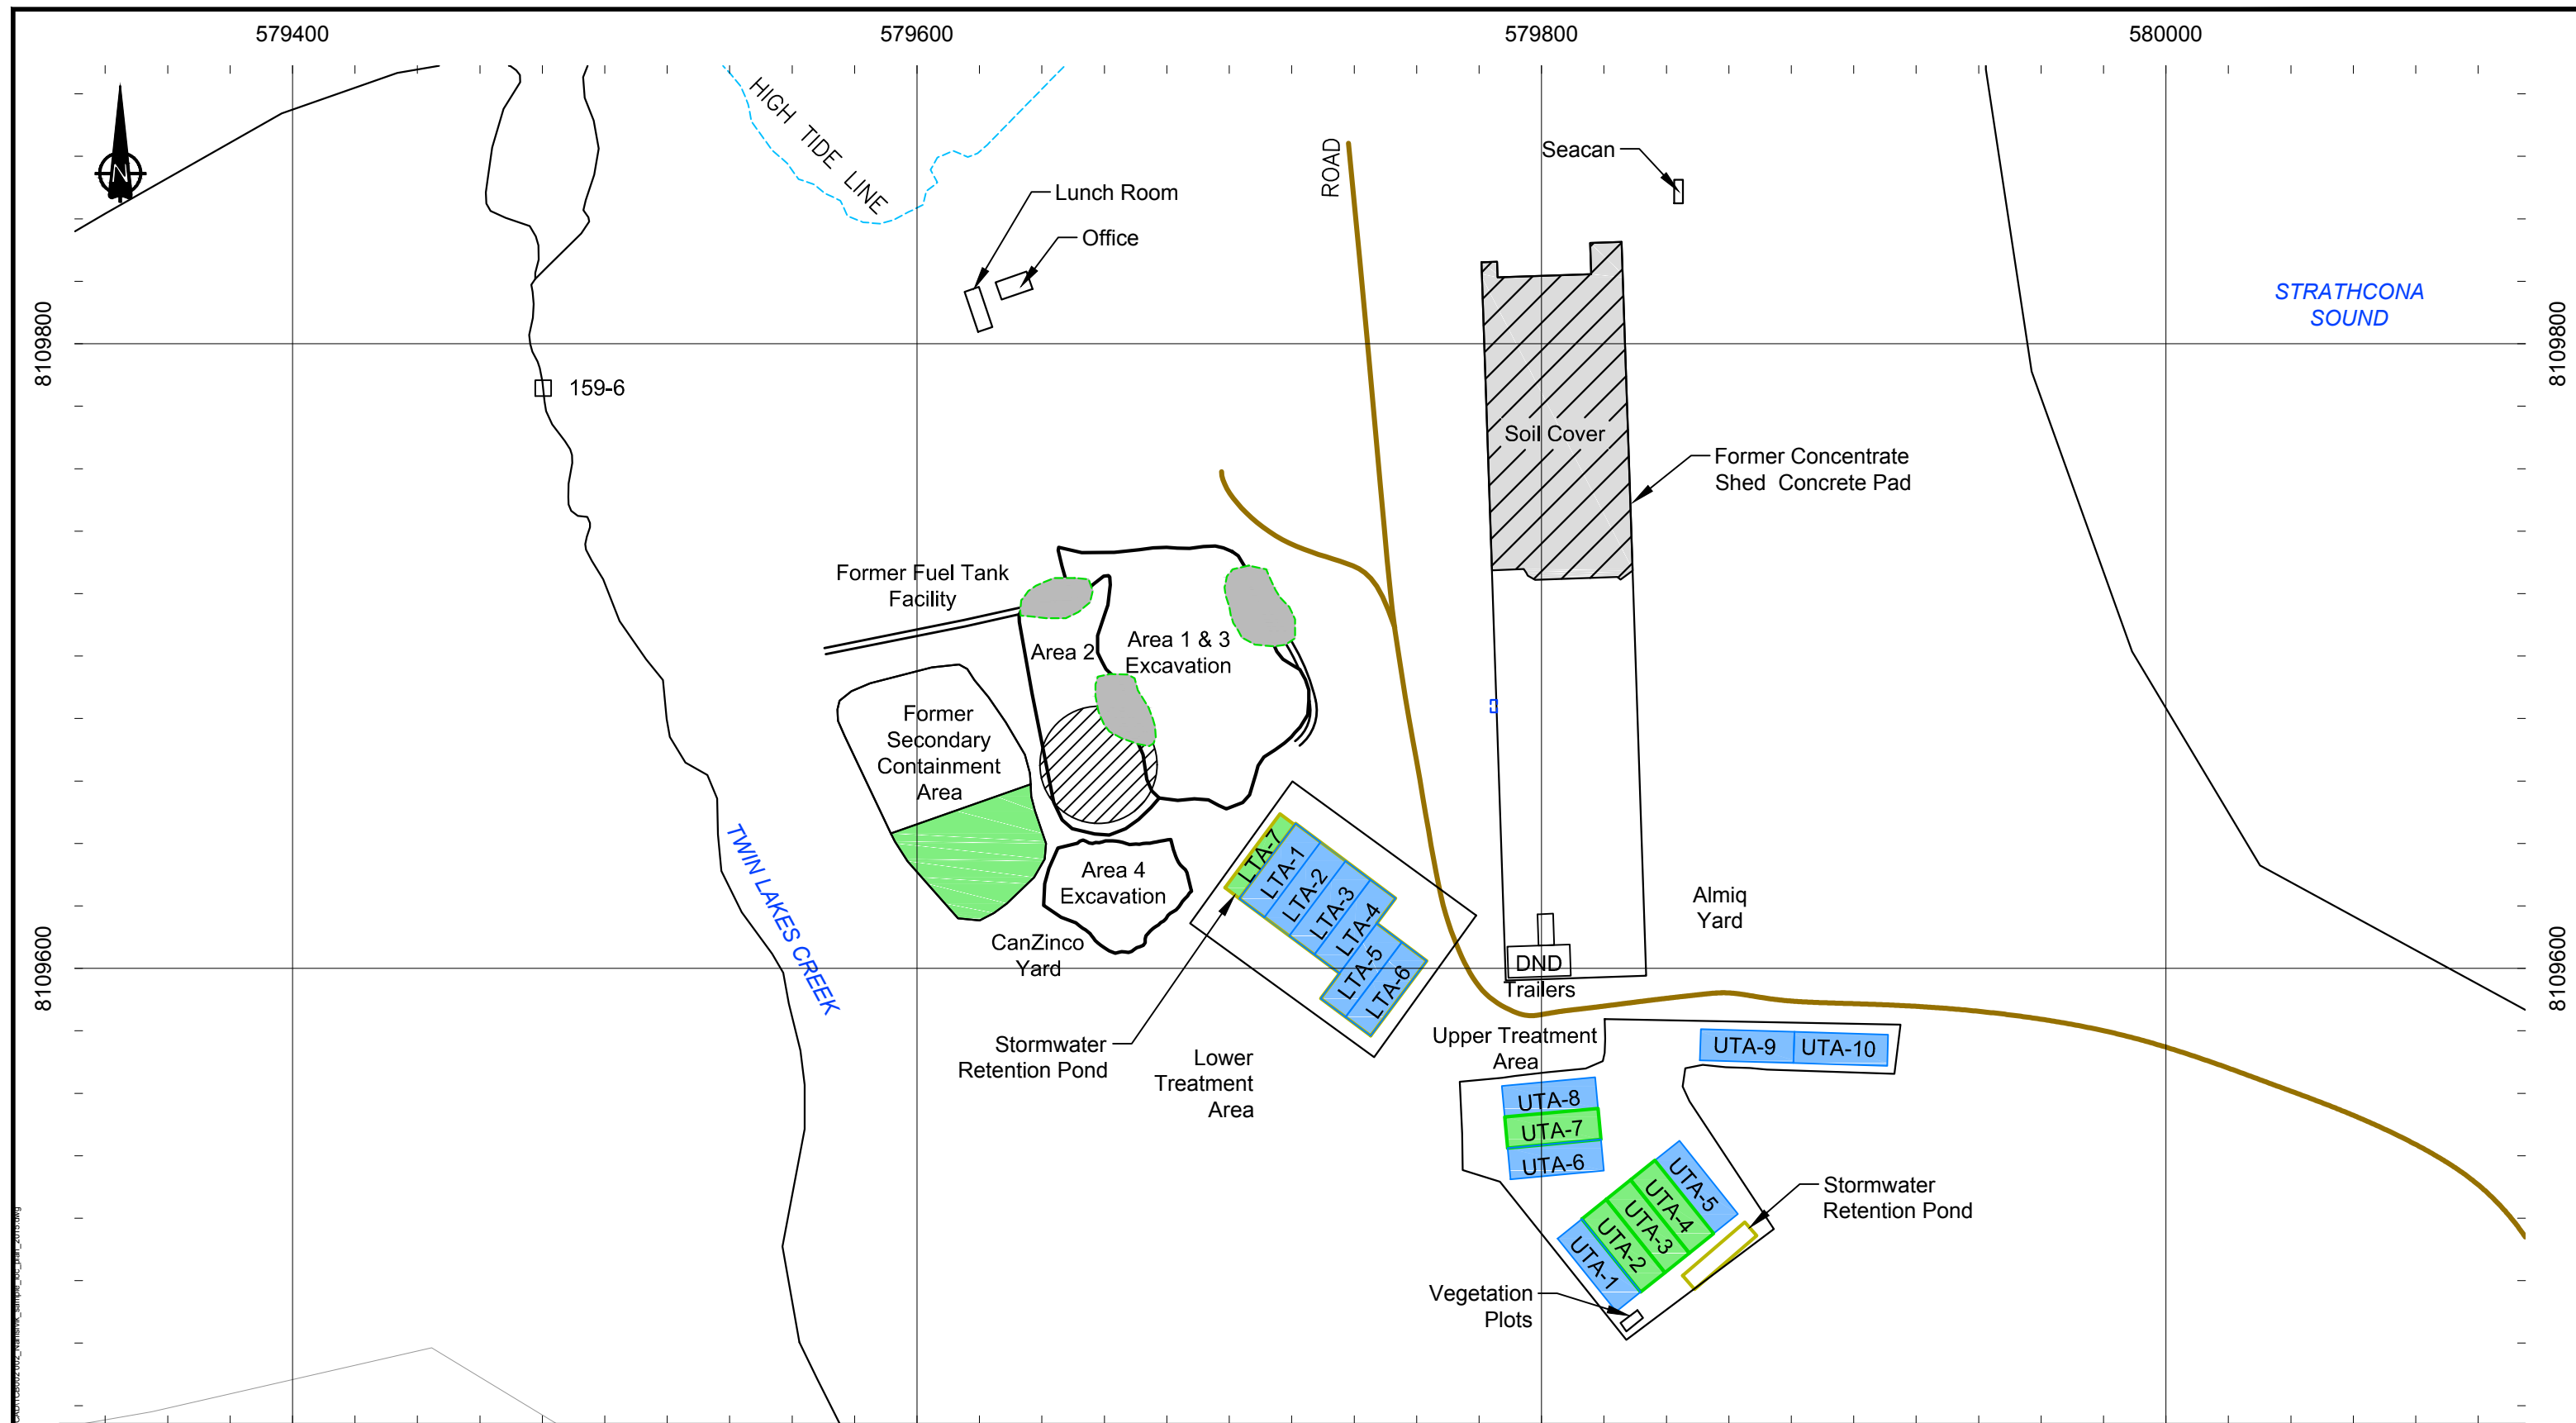
DATE: Jan. 2016	APPROVED: AL	FIGURE: 2
--------------------	-----------------	--------------

**General Site Arrangement**

In 2015, soil was stockpiled in two locations (Figure 2) based on PHC concentrations as follows:

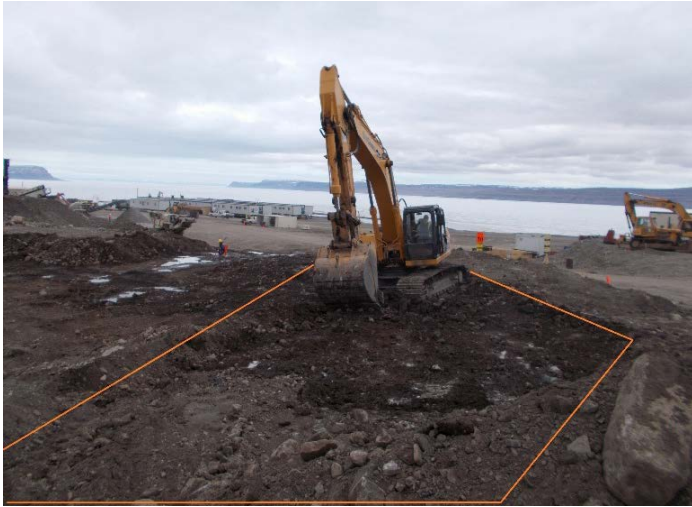
**Photo 1:** Final excavation of Area 1 outlined in orange. Facing north.

Area 1. Remnants of contaminated soil were excavated from the northeast wall of the area. (Appendix A: Photo 1).

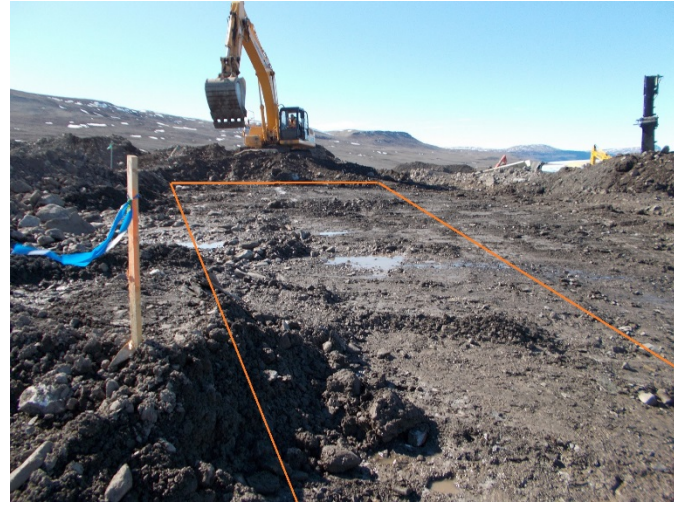
**Photo 2:** Final excavation of Area 2 north berm outlined in orange. Facing west.

Area 2. Remnants of contaminated soil in the north berm of the area were removed. (Appendix A: Photo 2). The liner that had remained at the base of the in-situ treatment area in the floor of Area 2 was removed and stored beside the LTA pending disposal in the CanZinco landfill. (Appendix A: Photo 3).

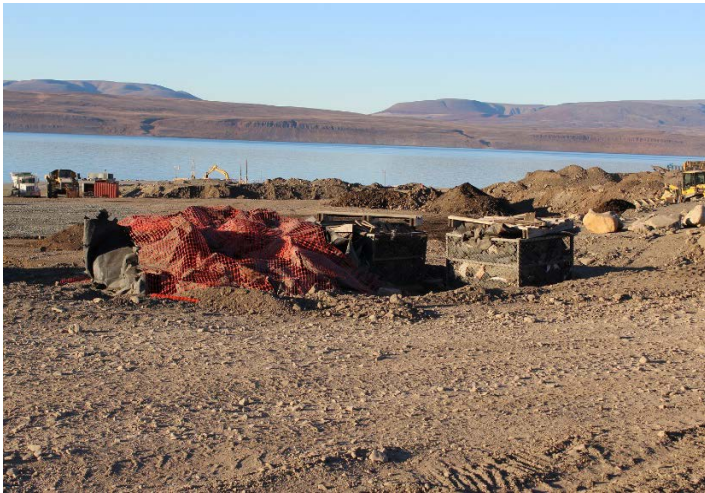
**Photo 3:** Waste liner secured for winter between LTA and DND construction zone. Facing north.

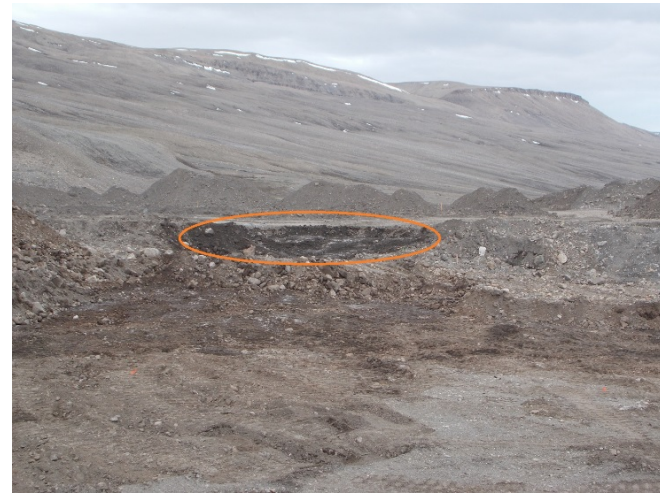
**Photo 4:** Final excavation of Area 3 west wall and Area 2 floor outlined in orange. Facing west.

Area 3. Remnants of contaminated soil were removed from the west wall and a portion of the adjacent floor of Area 2. (Appendix A: Photo 4).

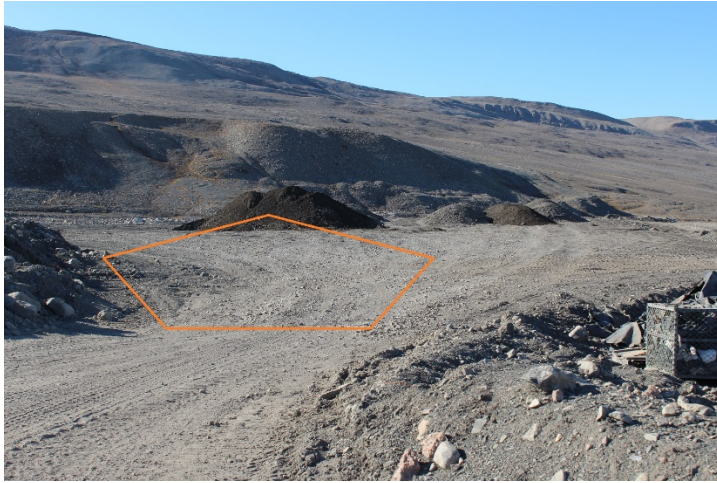
**Photo 5:** CanZinco Yard showing location of Area 4 excavation backfilled and regraded in orange. Facing west.

Area 4. The excavation of contaminated soil in Area 4 was completed in 2014. In 2015, remediated soil was placed in the excavation and the area leveled off. (Appendix A: Photo 5).

**CanZinco Yard:** Stockpiles of soil that has been remediated to meet the SQROs has been placed in the former secondary containment area since 2012. In 2015, the southern half of the former secondary containment area along with the footprint of Area 4 was utilized for remediated soil. This area is outside of the DND construction zone and is referred to as the CanZinco Yard. (Appendix A: Photo 5).

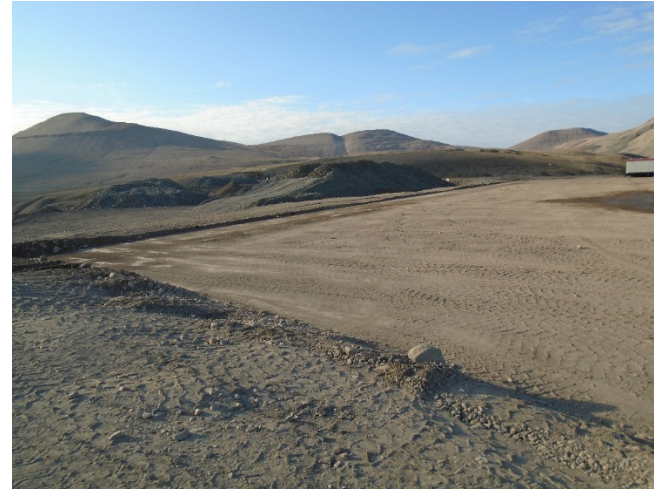
**Photo 6:** East side concrete pad following evacuation by CanZinco in July. Facing southeast.

**Concrete Pad:** The pad was used until late July to store soil based on the terms of an agreement made with the surface lease holder. Stockpiles which did not meet the SQROs at the end of the 2014 field season (Pad 3-2, Pad 4-1, Pad 4-2) were consolidated before being subdivided into smaller stockpiles and sampled. Based on the analytical results the stockpiles of soil were relocated to the CanZinco Yard, or to the UTA and LTA if further treatment was required. Stockpiles of soil that lacked analytical results were relocated to the LTA at the end of July and the pad vacated by CanZinco. (Appendix A: photos 6 and 7).

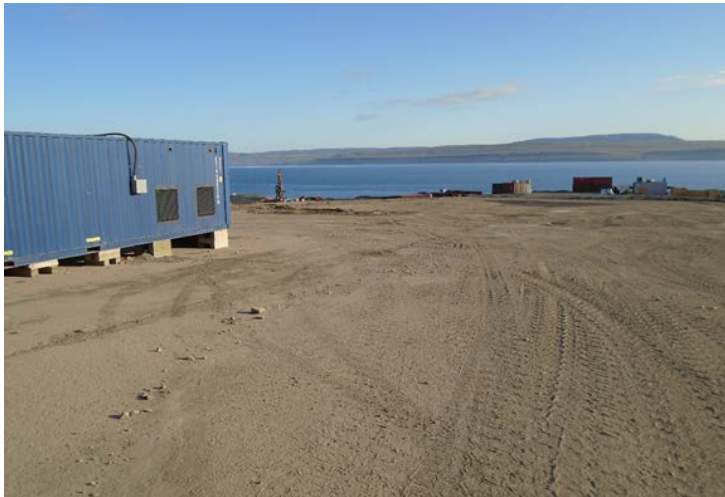
**Photo 7:** West side of the pad adjacent to the DND trailers following evacuation by CanZinco in July. Facing north.

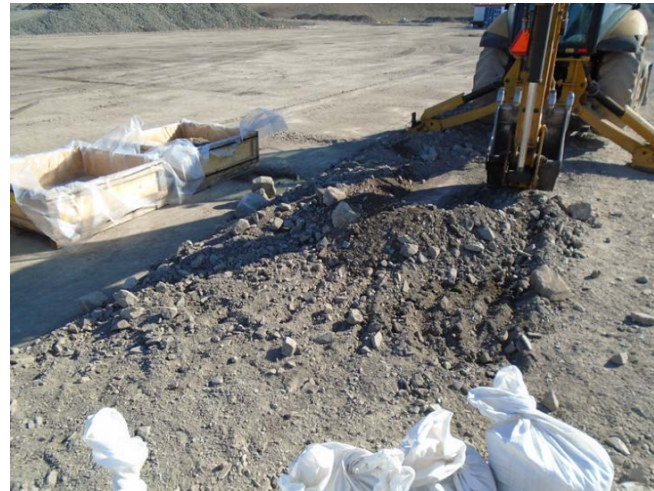
**Photo 8:** Lead and zinc concentrate contaminated soil was shoveled into bags and then a backhoe used to scrape the underlying soil. The bags and soil were deposited in the wood boxes. Facing southeast.

During the removal of the crates from the pad approximately 10 kg of lead concentrate impacted soil was spilled from one of the crates onto soil adjacent to the west side of the pad. The area of the spill was excavated and remediation confirmation samples collected at the end of July. The spill was reported to the NWT/NU Spill Report Line. Additional excavation occurred in August because one sample result from the base of the excavation exceeded the SQROs. The area was then resampled. The recovered material was placed in sturdier lined crates. (Appendix A: photos 8 and 9). Ex-situ samples were collected to characterize the soil in each new crate.

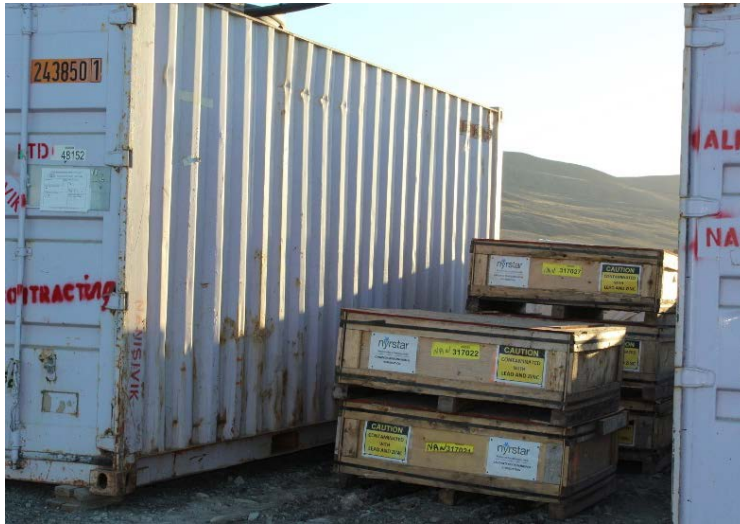
**Photo 9:** Boxes of waste lead and zinc concentrate contaminated soil pending shipment off-site for disposal.

All crates are clearly marked as hazardous waste and as the property of CanZinco Mines Ltd. (Appendix A: Photo 9).

Lead concentration results showed that storage boxes 3, 4 and 5 must be shipped off site for disposal as hazardous waste. The contents of the remaining boxes and the soil placed in the LTA stormwater retention pond meet the SQROs and can be disposed of on site.

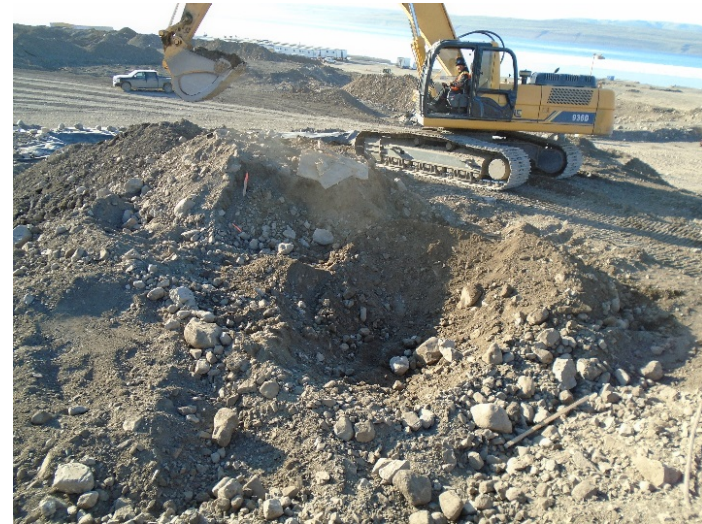
**Photo 10:** Excavation of waste concentrate contaminated soil from LTA2 and LTA3. Facing northwest.

A second crate was deposited directly into the LTA (biopiles LTA2-4 and LTA3-5). The remnants of the crate's contents and soil adjacent to it was excavated and the recovered material placed in the west half of the LTA stormwater retention pond. (Appendix A: photos 10 and 11).

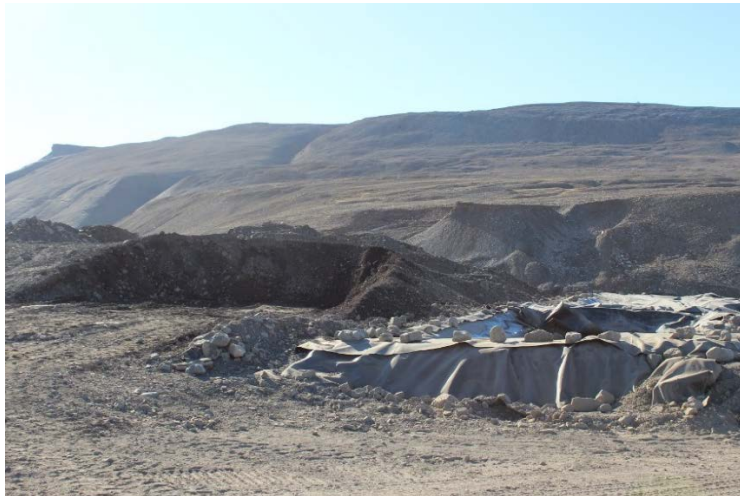
**Photo 11:** Soil recovered from LTA2 and LTA3 is placed in LTA stormwater retention pond and covered. Facing west.

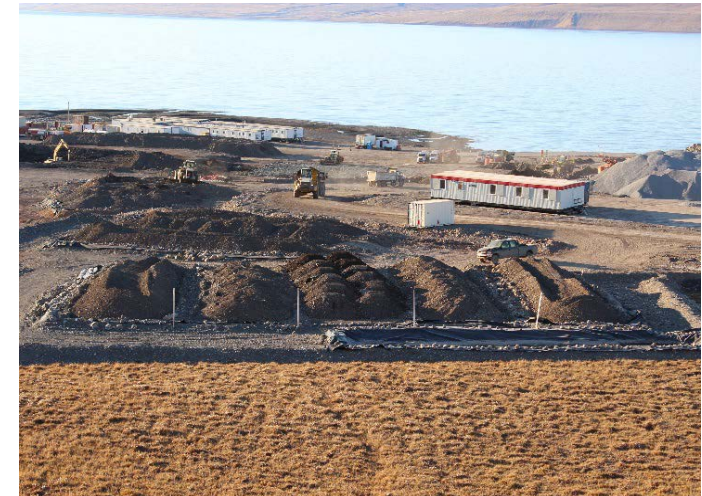
**Photo 12:** Treatment cells containing PHC contaminated soils. Facing north.

The UTA and LTA treatment facilities are a series of geosynthetic lined cells where biopiles of PHC contaminated soil are managed. (Appendix A: Photo 12). Normally, the biopiles are constructed to a height of 1.5 m and each cell stores approximately 220 m<sup>3</sup> of contaminated soil. The height of the biopiles in cells LTA2 thru LTA6 at the end of the season exceeded 1.5 m in order to accommodate all of the soil that either exceeded the SQROs or lacked laboratory analytical results characterizing its quality at the time the pad was vacated.
