Nanisivik Mine Contaminated Soil Remediation 2016 Progress Report

SRK Consulting (Canada) Inc.
1CB002.002
February 2017

This report provides a summary of contaminated soil remediation completed at the former Nanisivik bulk fuel storage facility in 2016.

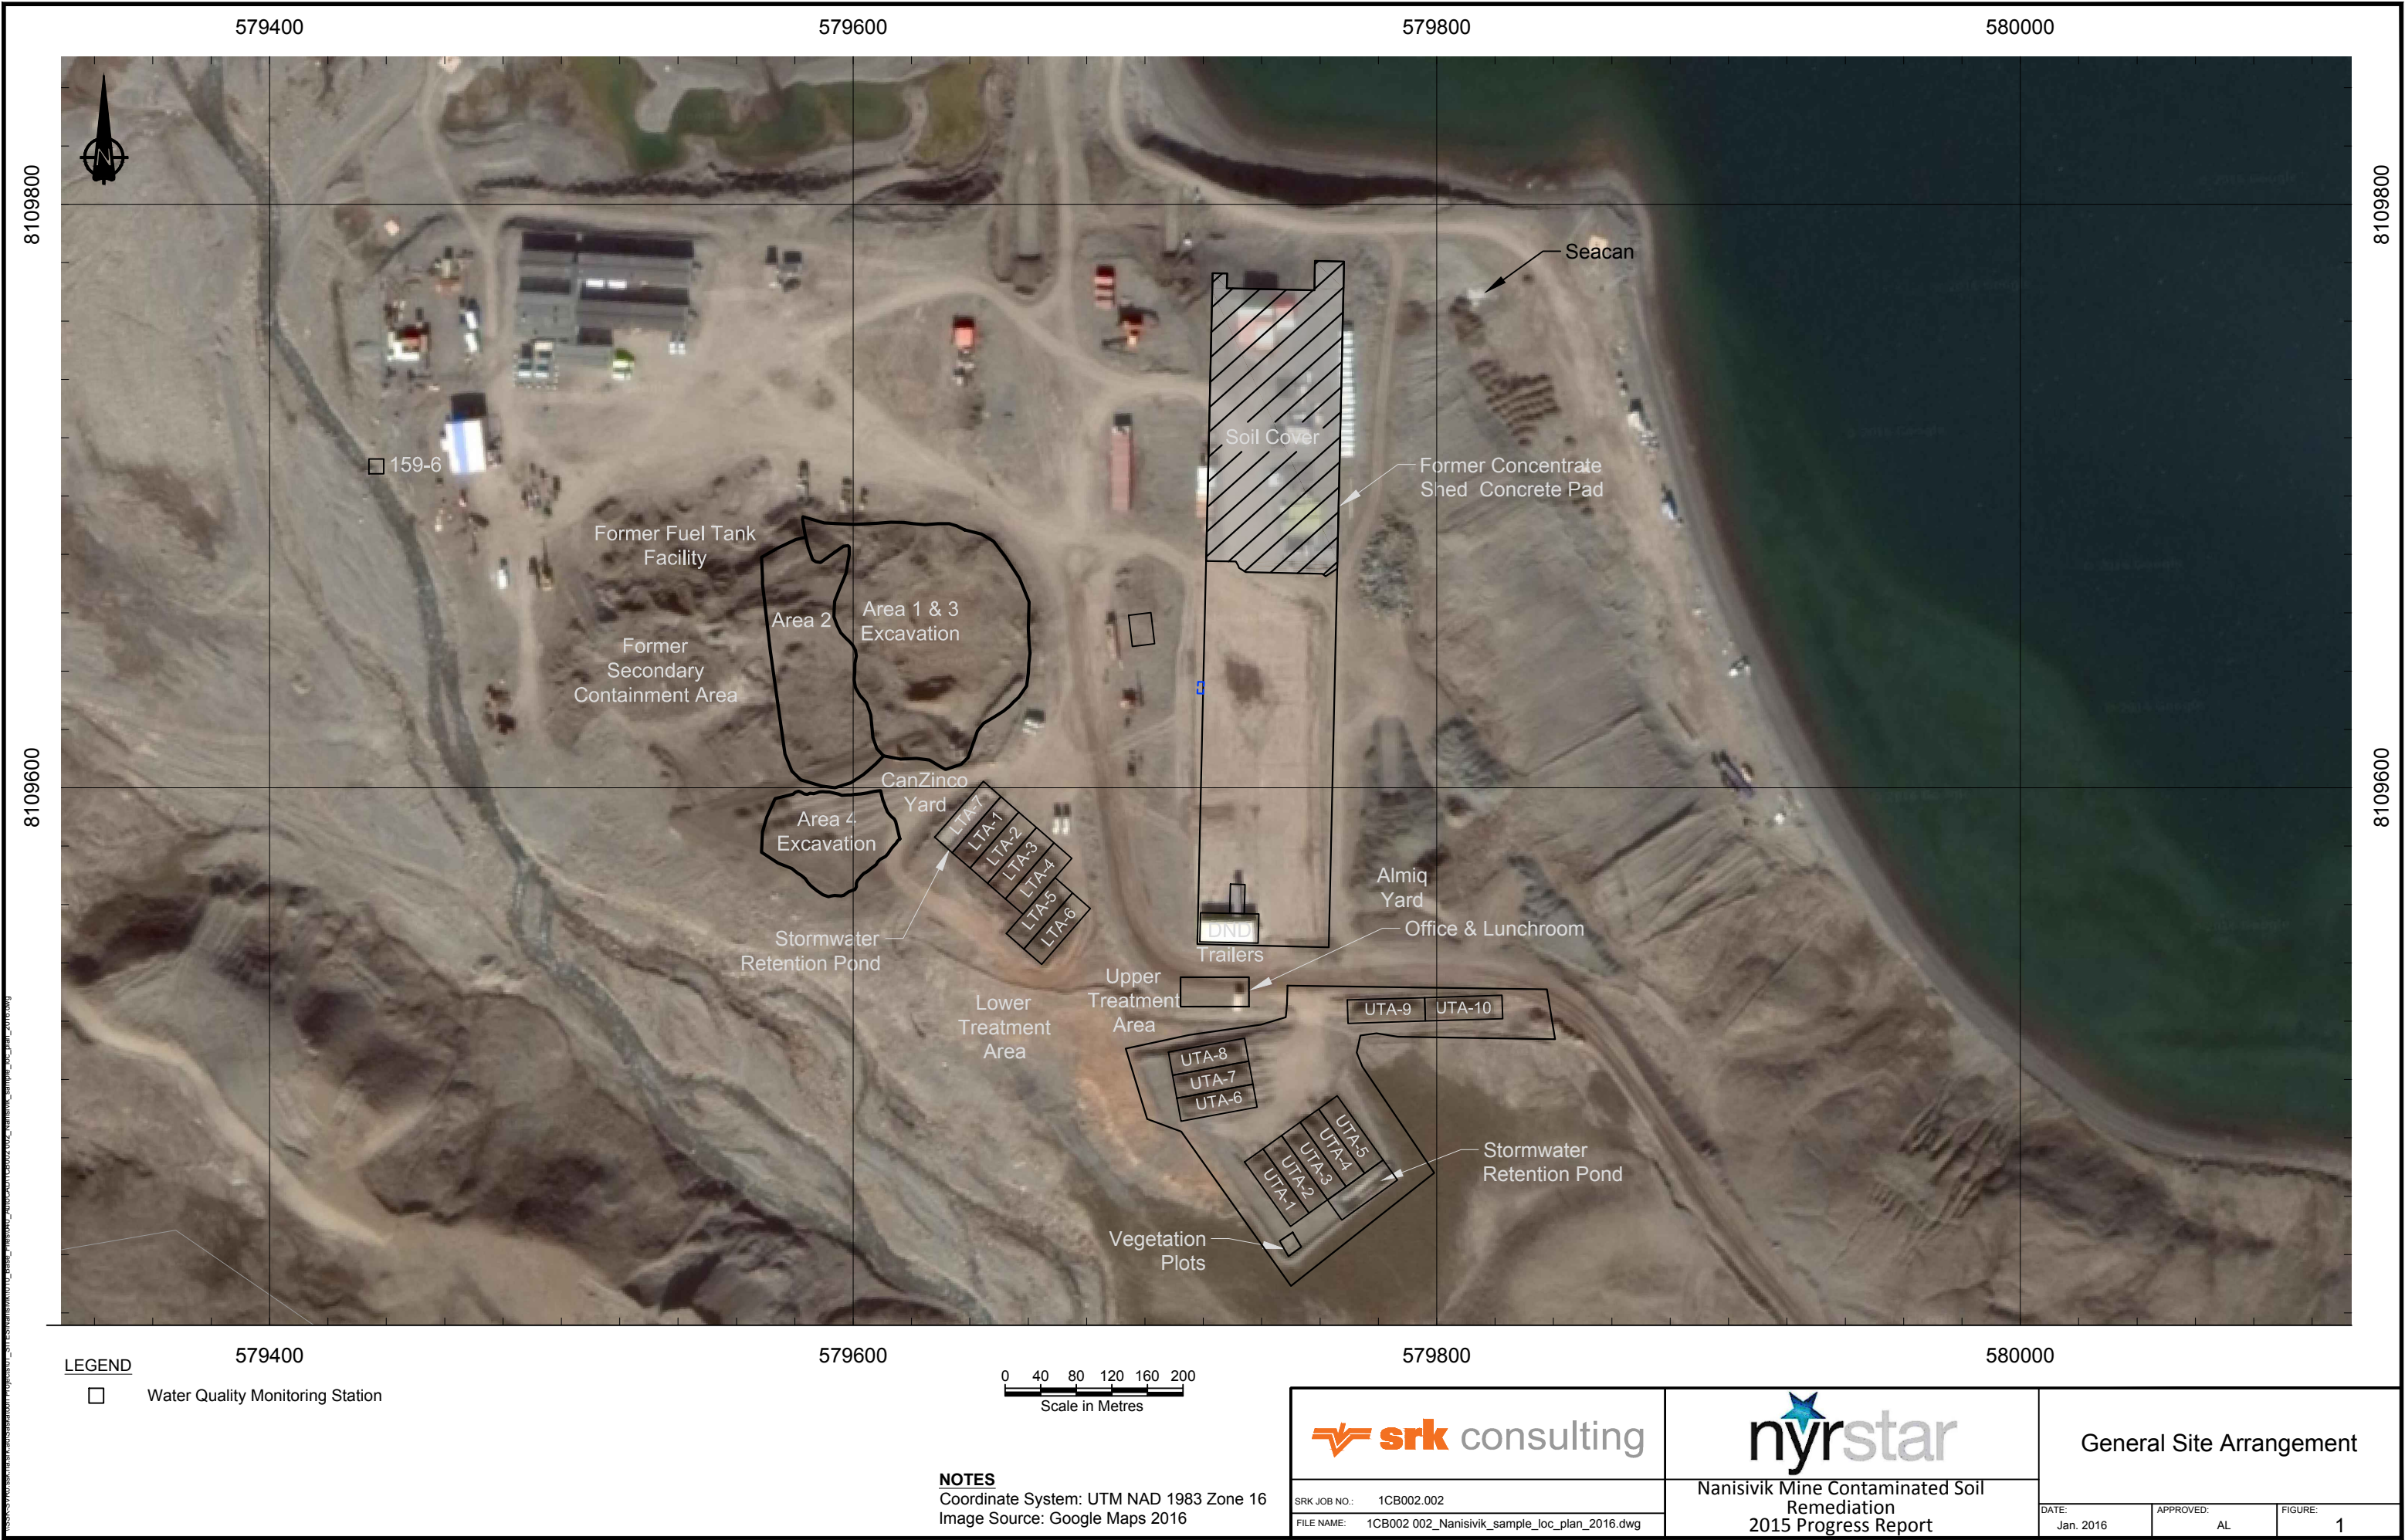
General Site Arrangement		
		Nanisivik Mine Contaminated Soil Remediation 2015 Progress Report		
SRK JOB NO.: 1CB002.002	FILE NAME: 1CB002_002_Nanisivik_sample_loc_plan_2016.dwg	DATE: Jan. 2016	APPROVED: AL	FIGURE: 1

Figure 1: General Site Arrangement

Delineation of the PHC contaminated soil was conducted to refine the estimated quantity of contaminated soil requiring treatment. Four areas of contamination were identified (Figure 1).

The UTA and LTA treatment facilities are a series of geosynthetic lined cells where biopiles of PHC contaminated soil are managed (Figure 1). The biopiles of PHC contaminated soil are treated through two principal mechanisms: volatilization and bioremediation. Volatilization occurs when the soil is aerated. In the bioremediation process, microorganisms are responsible for the degradation of the PHC in the soil. Nutrients are added and moisture content managed to enhance the microbial performance.

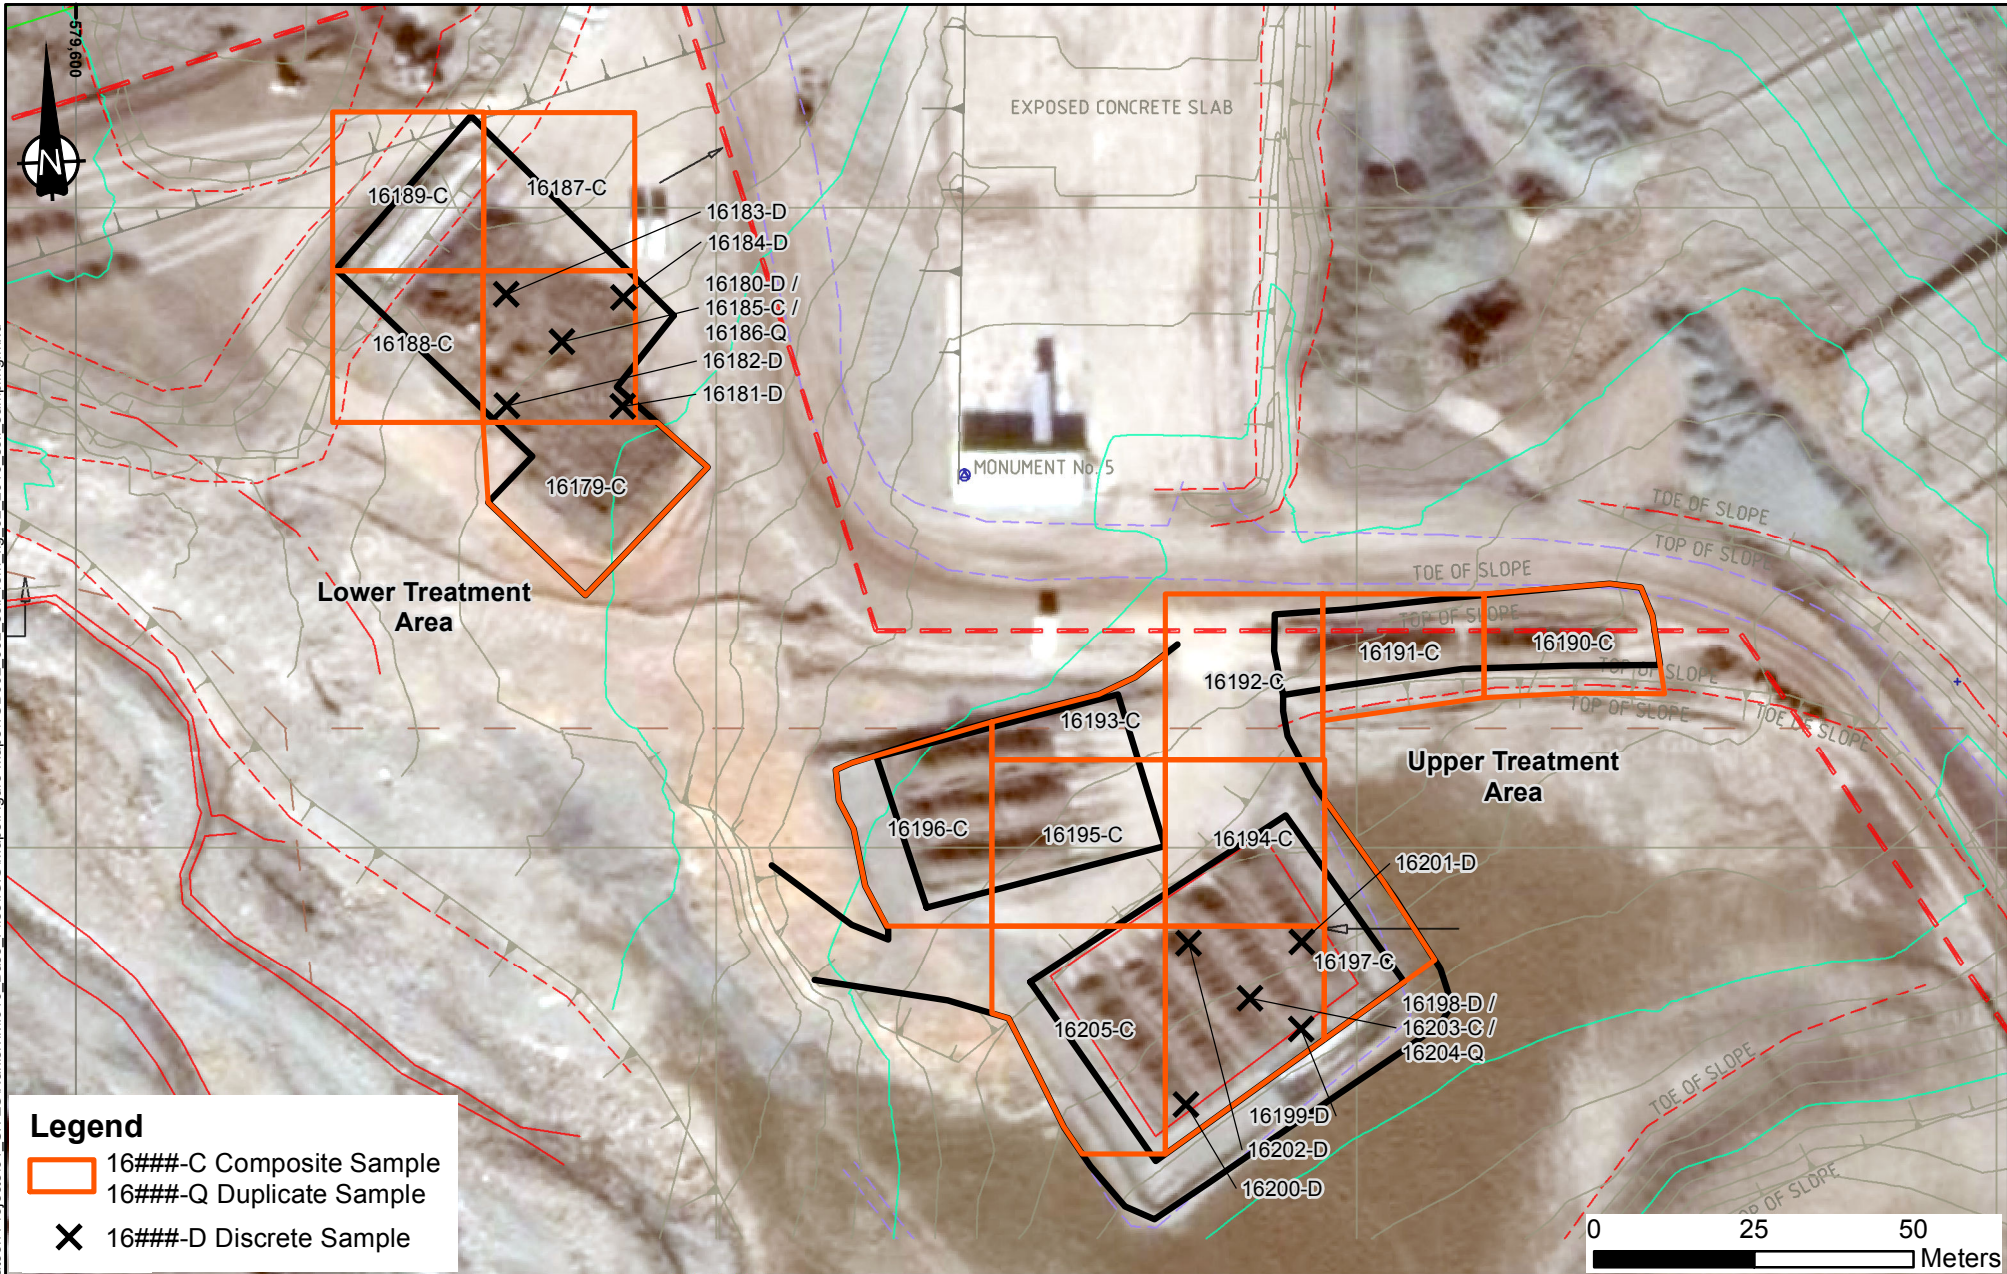
Figure 2: Decommissioning Confirmation Soil Samples

The sample locations are shown on figure 2 and the results are compared to the SQROs in tables 1 and 2 (back of report). QA/QC sample results are provided in table 3 (back of report). The samples identified with the ending "C" represent composite samples. Samples ending in "D" represent discrete grab samples. Samples ending in "Q" represent field duplicates.

Results for 23 treatment facility closure confirmation soil samples are summarized in Table 4 (back of report) and illustrated on Figure 2. All samples collected adhered to the in situ remediation confirmatory soil sampling procedure. Table 6-1 below indicates the areas where and the type of sample collected.

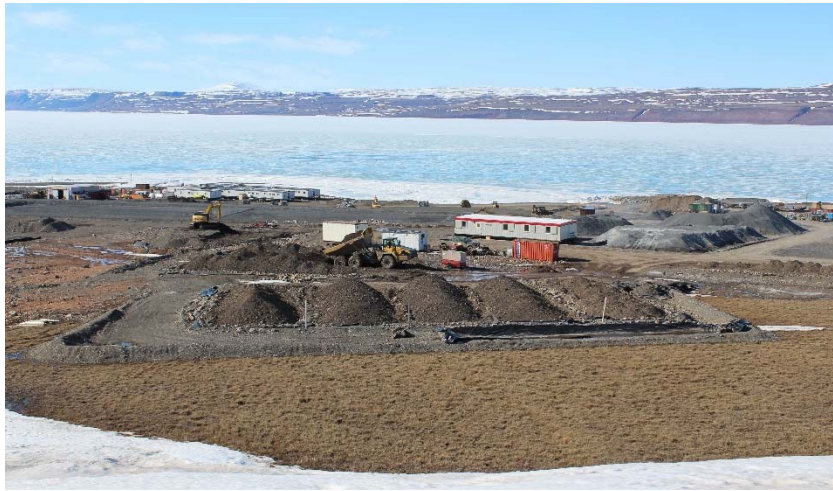
Photo 1: Some soil was relocated from the LTA to the UTA in early June. Facing north.

The four biopiles that met the SQROs at the end of the 2015 season were offloaded on June 10. On June 11, approximately 600 m³ of soil from cells LTA2 thru LTA6 were relocated to the empty cells and biopiles, with a height of 1.5 m, re-established in the LTA¹ (Appendix A: Photos 1 and 2). An estimated 3,000 m³ of soil required treatment in 2016.

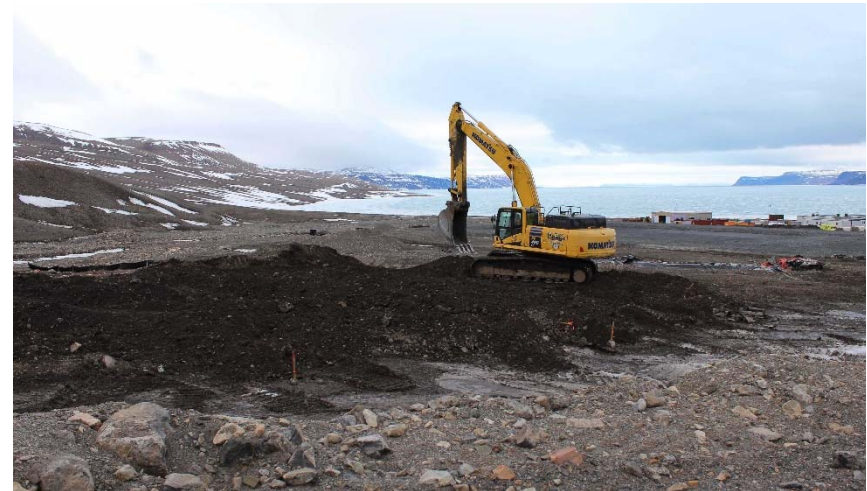
Photo 2: Biopiles with a height of approximately 1.5 m were re-established in the LTA in early June. Facing north.

¹ In order to accommodate all of the soil that lacked ex situ sample results when the pad was vacated in 2015, the height of the biopiles in LTA2 thru LTA6 in exceeded 1.5 m and the typical volume of 220 m³(SRK 2016).

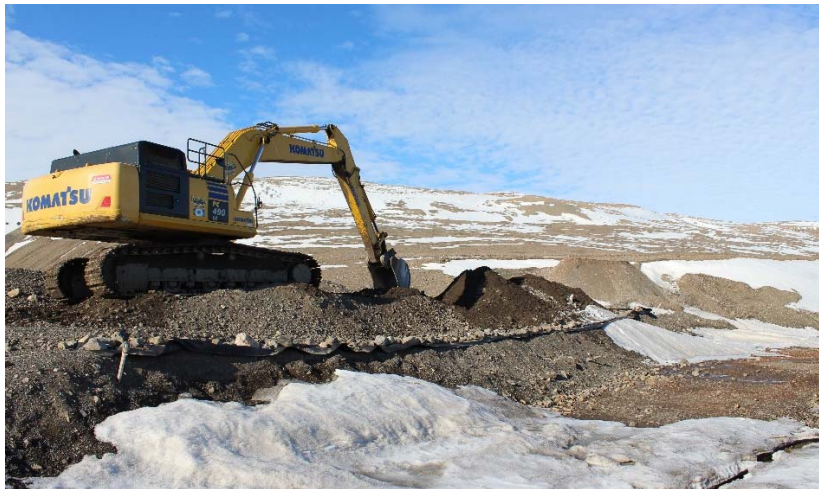
Photo 3: The soil in the UTA is being aerated in early June. Facing west.

The biopiles in the UTA and LTA were turned and aerated as listed in Table 5-1 using an excavator (Appendix A: Photo 3). Each full bucket was lifted to the vertical extent of the bucket

arm and then let to fall from elevation to achieve an air exchange. The bottom 0.3 to 0.5 m of the biopiles was frozen and therefore not aerated.

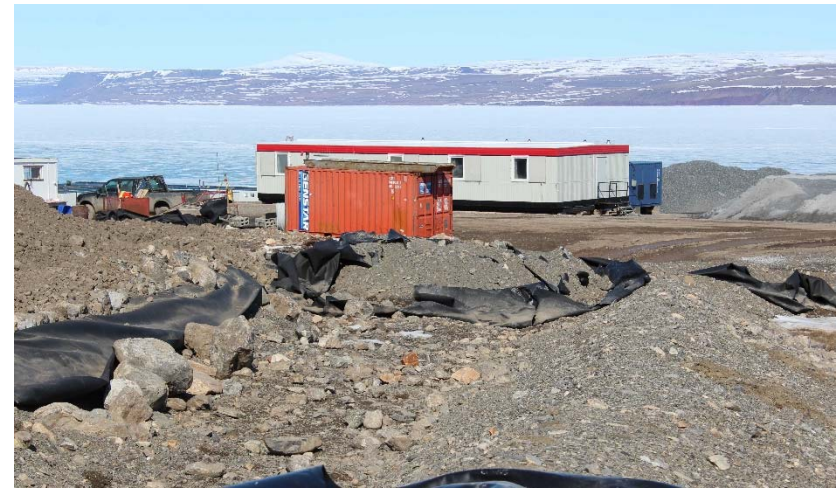
Photo 4: A stockpile of PHC contaminated soil was observed to have been placed to the east of treatment cell UTA5 on June 8, 2016. Facing north.

A stockpile of approximately 50 m³ PHC contaminated soil that did not originate from CanZinco's activities was observed to have been placed to the east of treatment cell UTA5 when SRK arrived on site on June 8, 2016 (Appendix A, Photo 4). A liner appeared to be in place below the stockpile. The stockpile and liner were removed by DND's contractors before SRK returned to site on August 22 (Appendix A, Photo 5).

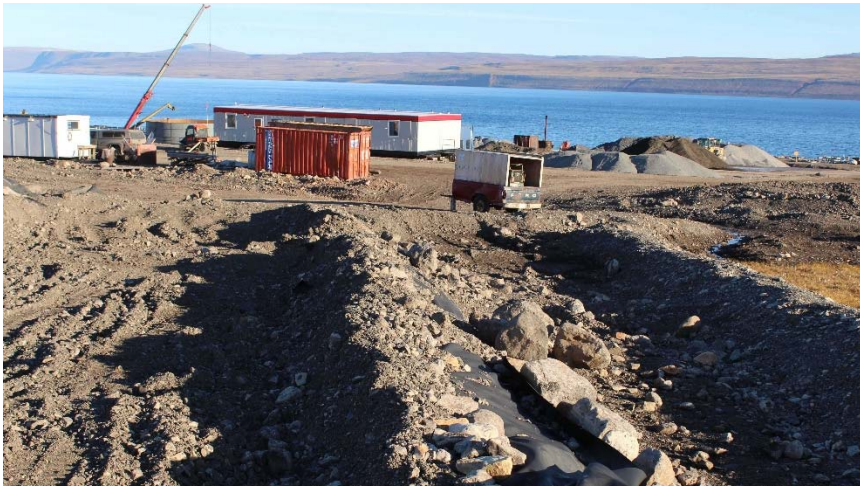
Photo 5: The stockpile and liner was removed by DND's contractors before August 22. Facing north.

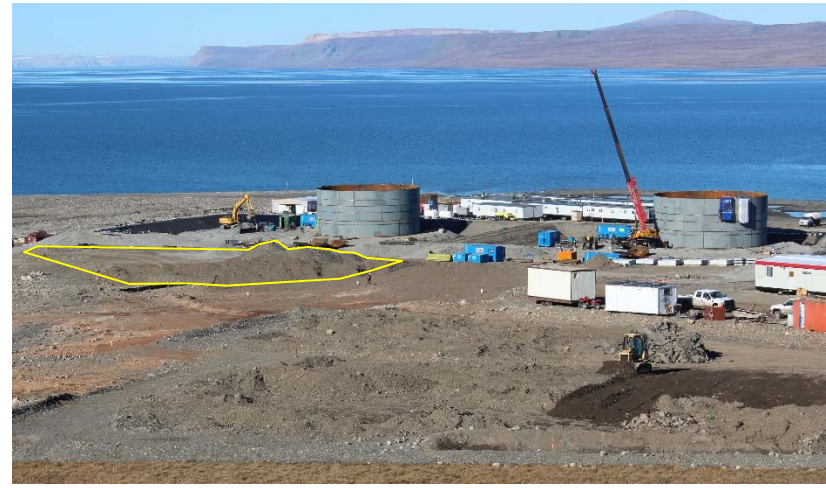
Photo 6: The stockpile of remediated soil is outlined in yellow. Closure samples were collected from the base of the LTA after the liner was removed. Facing north.

relocated to a laydown yard built by DND's contractor on the east side of the concrete pad. The soil removed from the cells between June 29 and August 26 (~3,000 m³) was relocated to a stockpile in the southern part of the former secondary containment area, the CanZinco Yard. DND's contractor was observed to be using soil from the stockpile for the construction of the new fueling facility during SRK's August visit. No records of the volume utilized by DND in 2016 were provided. A stockpile of remediated soil remained on the CanZinco Yard at the end of the season (Appendix A: Photo 6).

Decommissioning of the treatment cells commenced August 24 and involved the removal of the liner. Upwards of 0.3 m of remediated soil remained above the liner and an excavator, bulldozer and a skid steer loader were used along with manual labour to remove the liner from the overlying soil (Appendix A: Photo 7). The liner was consolidated into a single stockpile at the LTA and contained under snow fence (Appendix A: Photo 8) on August 29. The remediated soil was left on the footprint of the treatment facilities and used to contour the area occupied by the treatment facilities to inhibit the ponding of surface water. Following decommissioning, closure confirmatory samples were collected from the base of the decommissioned facilities (Appendix A: Photo 6).

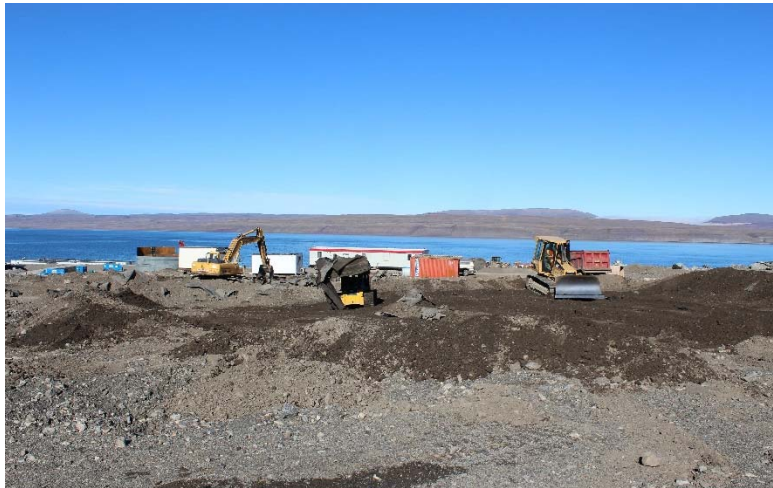
Photo 7: Heavy equipment is used to expose the liner for removal. Facing north.

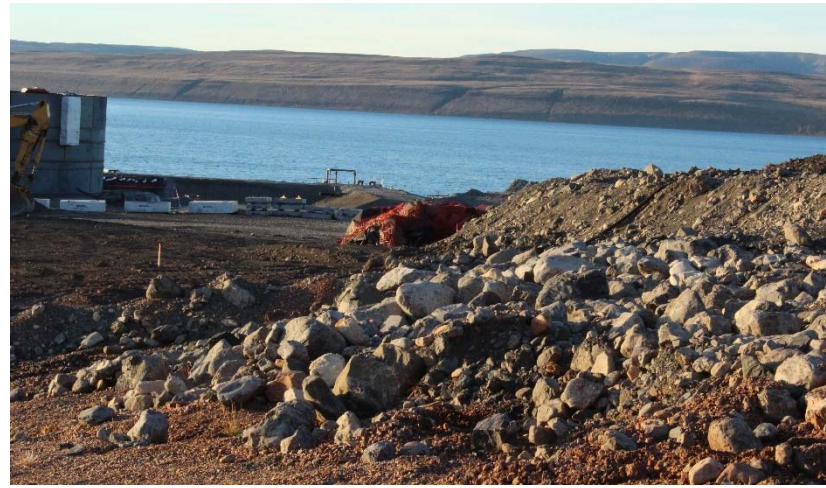
Photo 8: The liner was consolidated into a single stockpile at the LTA and covered with orange snow fencing to secure it in place over the winter. Facing north.

- The waste liner stockpiled at the LTA is to be transferred to the CanZinco landfill. To prevent inadvertent use of the CanZinco landfill site by others all waste liner is to be disposed of in the landfill within one field season and the landfill closed. The landfill is to be operated in accordance with the Landfill Operations and Maintenance Manual (Nyrstar 2015b) and covered in accordance with the NWB reviewed and accepted closure plan described in the Nanisivik Mine Non-Hazardous Waste Landfill (SRK 2014d) memorandum.
