NANISIVIK MINE, NUNAVUT

**2020 UPDATE TO GEOTECHNICAL
INSTRUMENTATION CONTINGENCY PLAN**

PROJECT NO.: 0255030

DATE: March 13, 2020

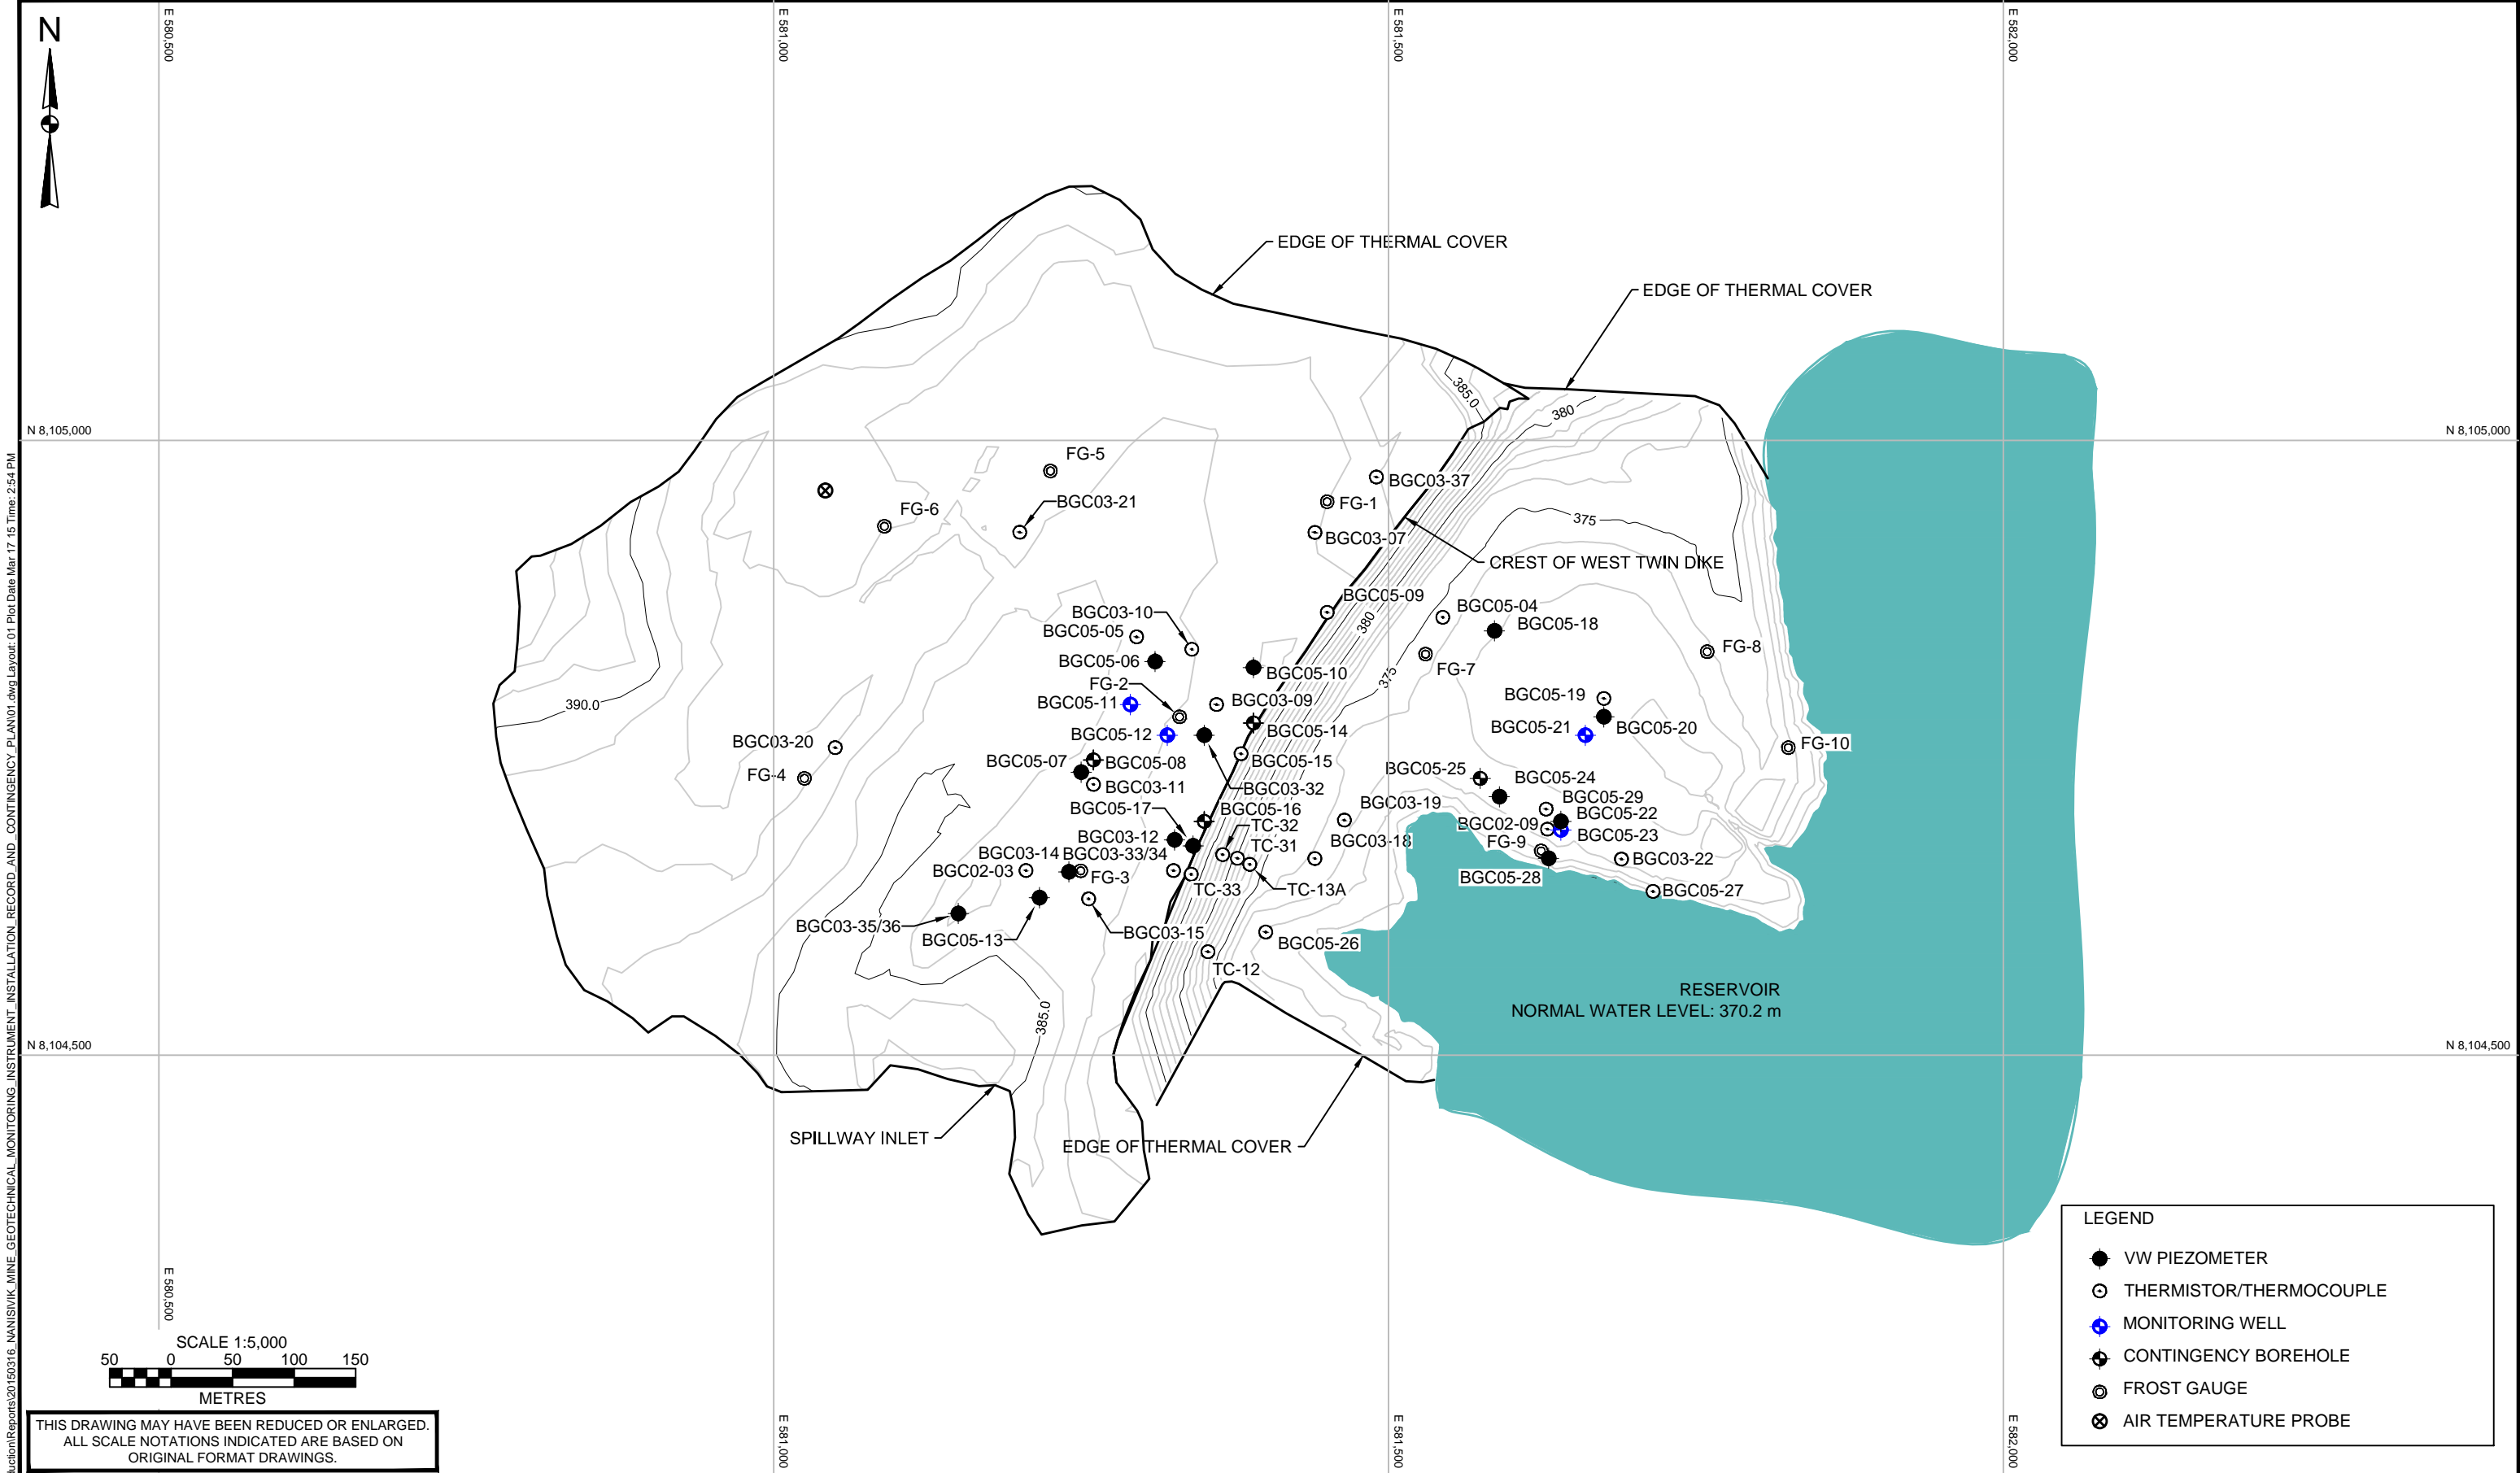
PROJECT: NANISIVIK MINE, NUNAVUT: 2020 UPDATE TO GEOTECHNICAL INSTRUMENTATION CONTINGENCY PLAN	
TITLE: EAST OPEN PIT WASTE ROCK COVER: GEOTECHNICAL MONITORING INSTRUMENT LOCATIONS	
PROJECT No.: 0255-030	DWG No.: 02

- LEGEND
- ⊙ THERMISTOR
 - ⊙ FROST GAUGE
