**NANISIVIK MINE, NUNAVUT**

**2020 WATER QUALITY MONITORING**

PROJECT NO.: 0255032

DATE: March 24, 2021

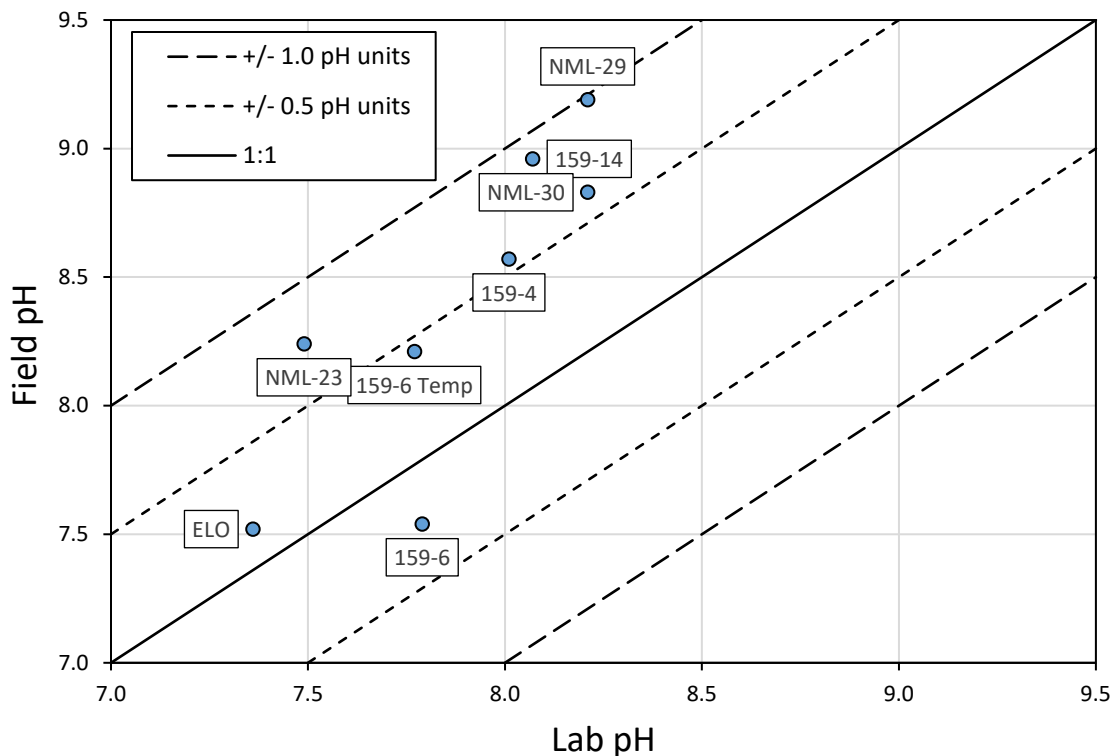
**Figure 4-1. Comparison of field versus laboratory pH.**

Figure 4-1 shows that most samples (i.e., 7 of 8) contain higher field pH measurements relative to values recorded by the laboratory. The five samples that do not meet the pH DQO have pH values within the typical range observed at the site (Appendix C). Hence, field measured pH values are considered to be representative of site conditions at the time of sampling.

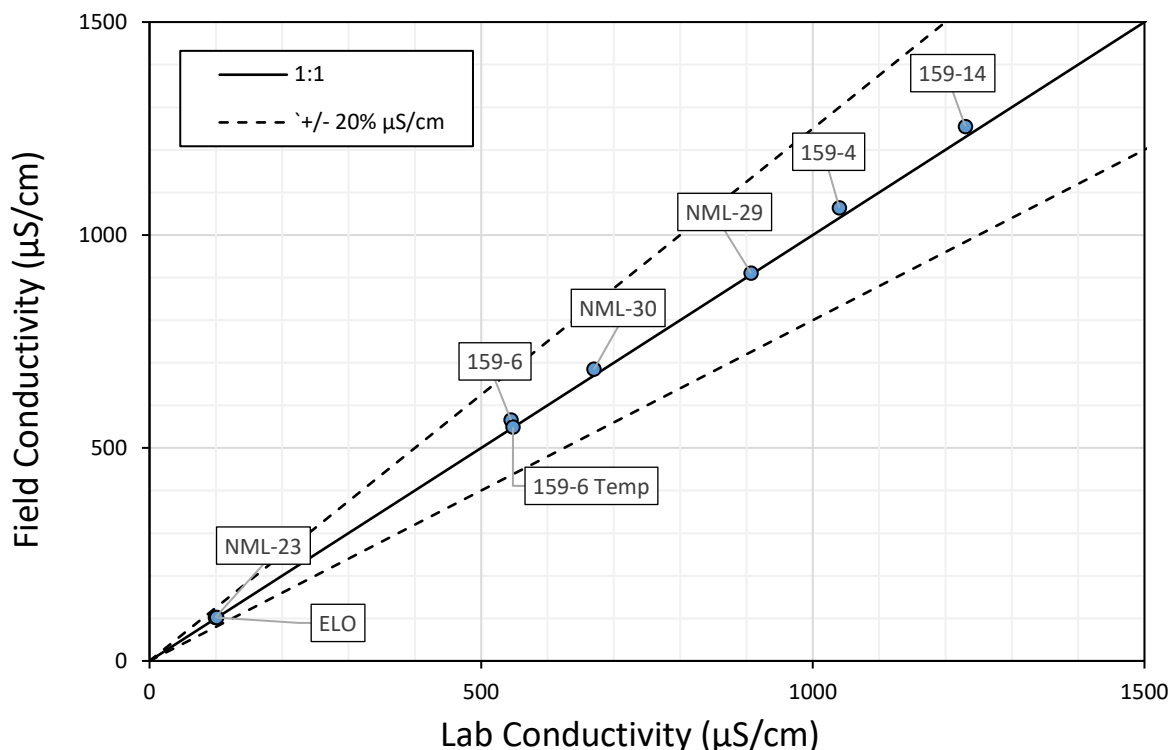
Field conductivity values were temperature-corrected to 25°C to allow for a comparison to laboratory-measured conductivity values. The field versus laboratory measured specific conductance values are shown in Figure 4-2, which are comparable and meet the DQO (of RPD < 20%) for all samples collected.

**Figure 4-2. Comparison of field versus laboratory conductivity.**

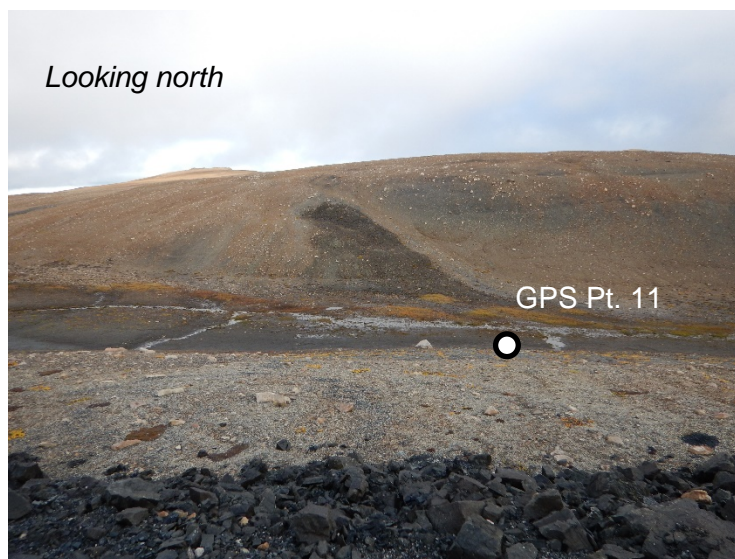
**Figure 4-3. Photograph showing localized seepage, upstream of Station NML-29, near GPS Pt. 11.**

Based on these observations, the sulphate Action Level exceedances at NML-29 are likely associated with seepage and (potentially) thawing conditions from the north side of the drainage channel, or an area(s) other than the Landfill that discharge to the drainage channel (along which NML-29 is located).

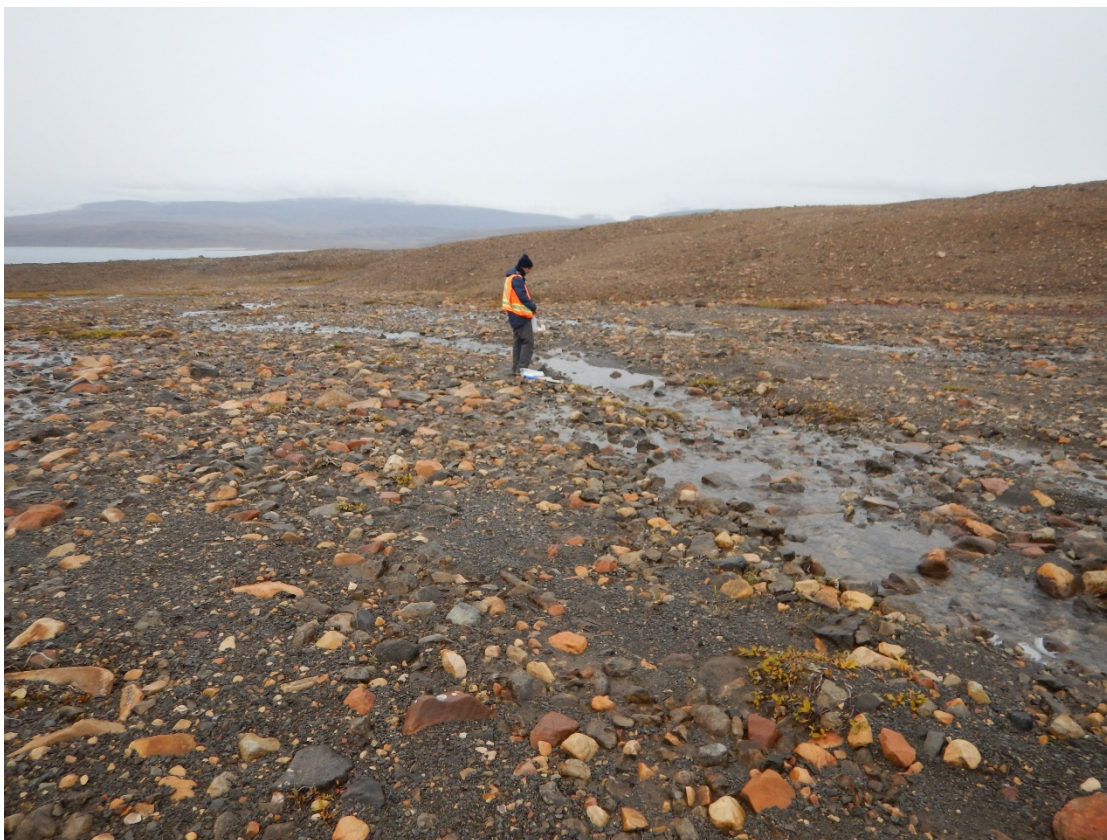
Station ID	159-14
Latitude	73.047278 N
Longitude	-84.418062 W
Sample Date	August 21, 2020
Temperature (°C)	6.9
Conductivity (uS/cm) <sup>1</sup>	797.1
pH (pH units)	8.96
Total Dissolved Solids (mg/L)	790
Visible Hydrocarbons?	No
Flow condition <sup>2</sup>	Flowing

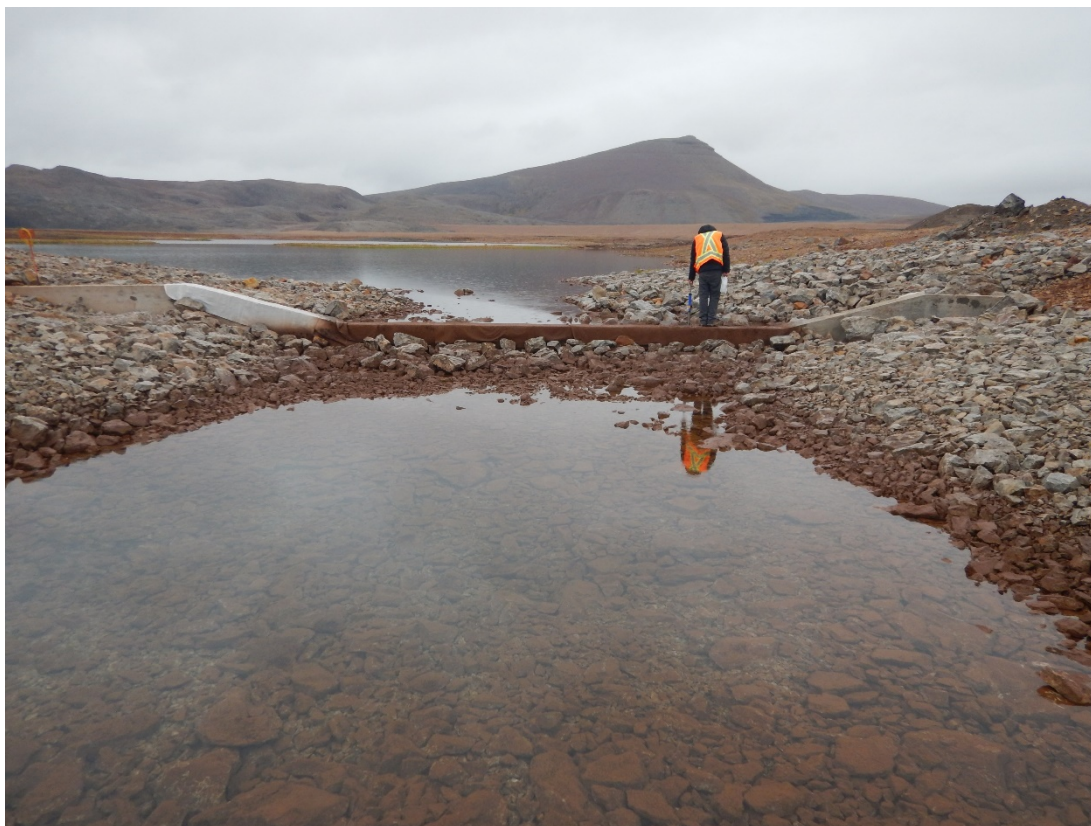
Station ID	159-4
Latitude	73.025644 N
Longitude	-84.477130 W
Sample Date	August 21, 2020
Temperature (°C)	6.7
Conductivity (uS/cm) <sup>1</sup>	671.8
pH (pH units)	8.57
Total Dissolved Solids (mg/L)	670
Visible Hydrocarbons?	No
Flow condition <sup>2</sup>	Stagnant

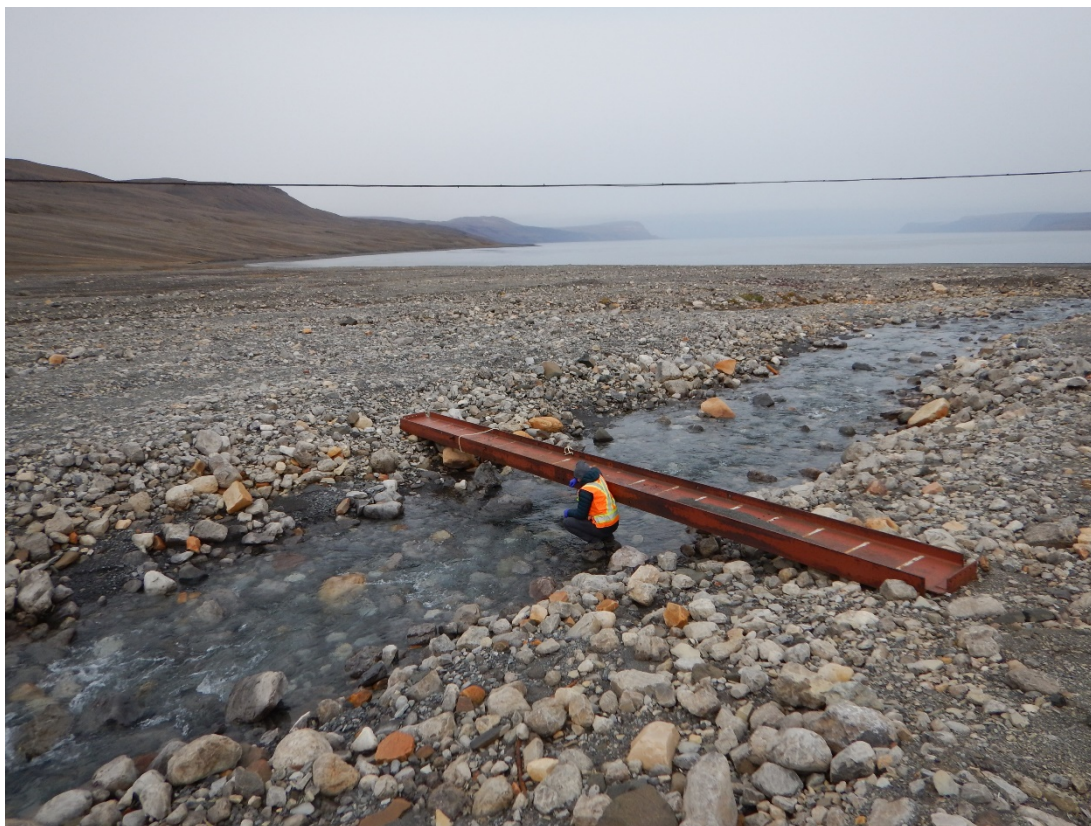
Station ID	159-6
Latitude	73.069603 N
Longitude	-84.557824 W
Sample Date	August 21, 2020
Temperature (°C)	6.0
Conductivity (uS/cm) <sup>1</sup>	349.5
pH (pH units)	7.54
Total Dissolved Solids (mg/L)	400
Visible Hydrocarbons?	No
Flow condition <sup>2</sup>	Flowing

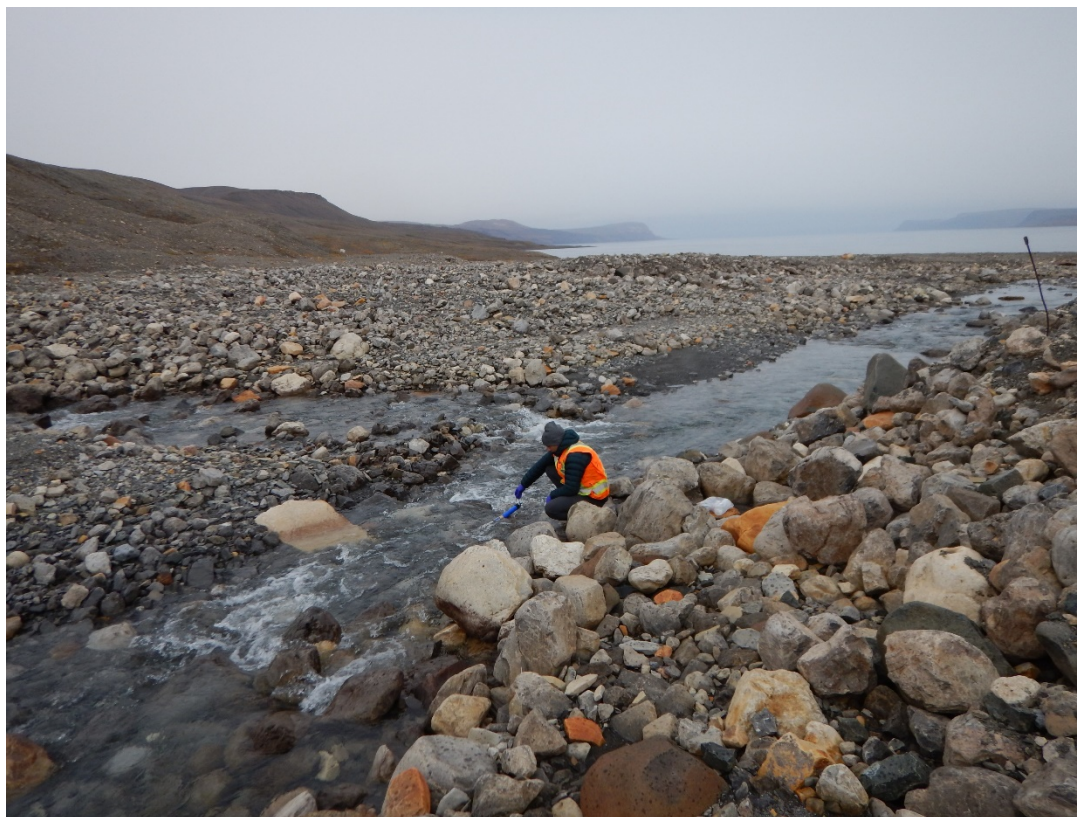
Station ID	159-6 Temp
Latitude	73.069141 N
Longitude	-84.556367 W
Sample Date	August 21, 2020
Temperature (°C)	5.3
Conductivity (uS/cm) <sup>1</sup>	331.9
pH (pH units)	8.21
Total Dissolved Solids (mg/L)	350
Visible Hydrocarbons?	No
Flow condition <sup>2</sup>	Flowing

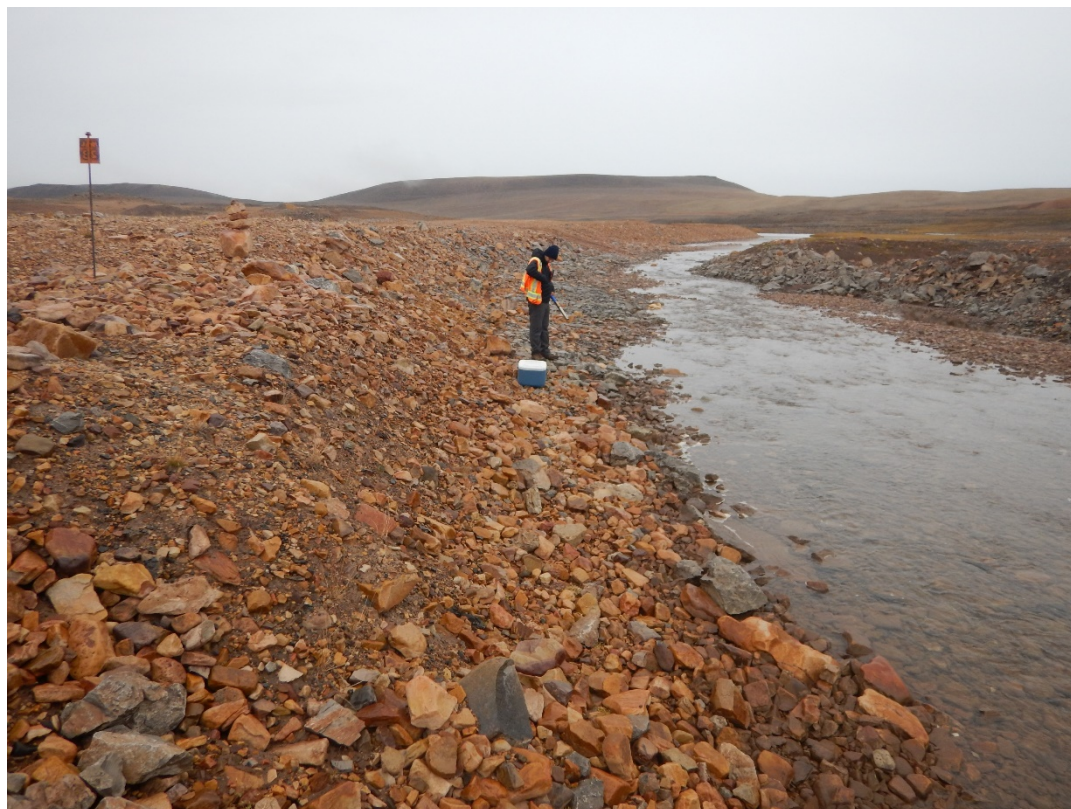
Station ID	NML-23
Latitude	73.022970 N
Longitude	-84.472946 W
Sample Date	August 21, 2020
Temperature (°C)	7.4
Conductivity (uS/cm) <sup>1</sup>	65.6
pH (pH units)	8.24
Total Dissolved Solids (mg/L)	60
Visible Hydrocarbons?	No
Flow condition <sup>2</sup>	Flowing

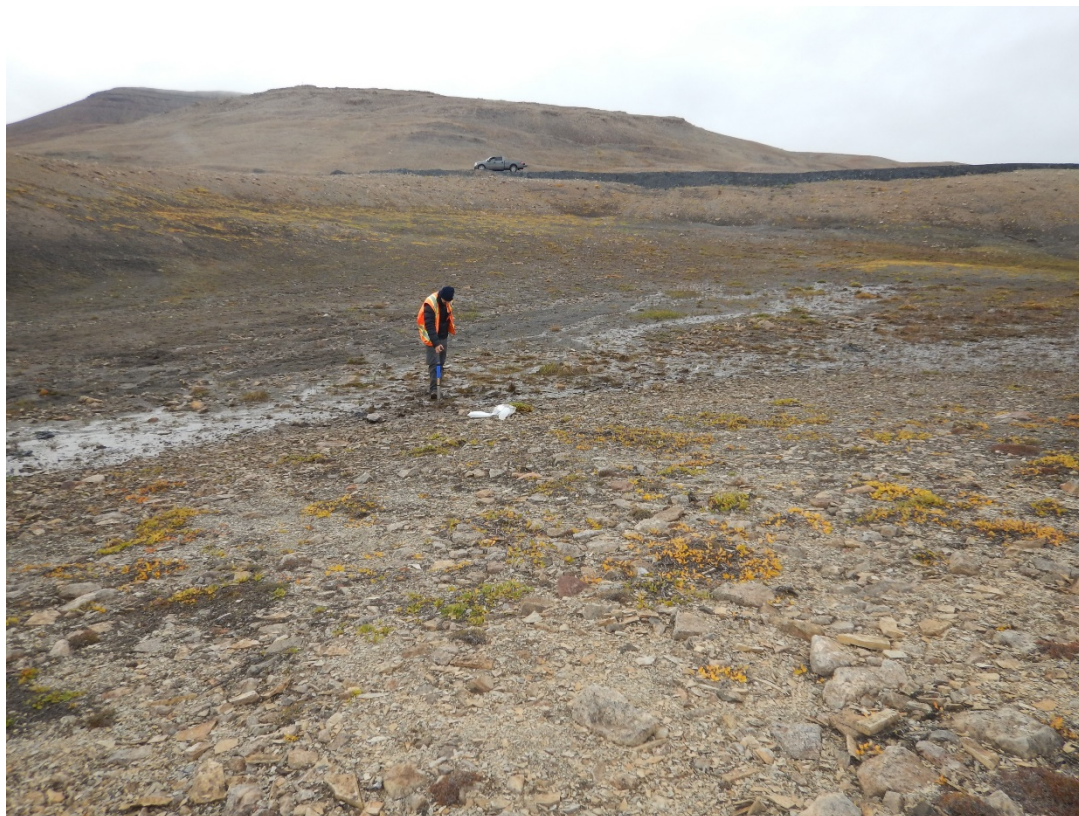
Station ID	NML-29
Latitude	73.038523 N
Longitude	-84.555158 W
Sample Date	August 21, 2020
Temperature (°C)	6.8
Conductivity (uS/cm) <sup>1</sup>	576.4
pH (pH units)	9.19
Total Dissolved Solids (mg/L)	430
Visible Hydrocarbons?	No
Flow condition <sup>2</sup>	Stagnant

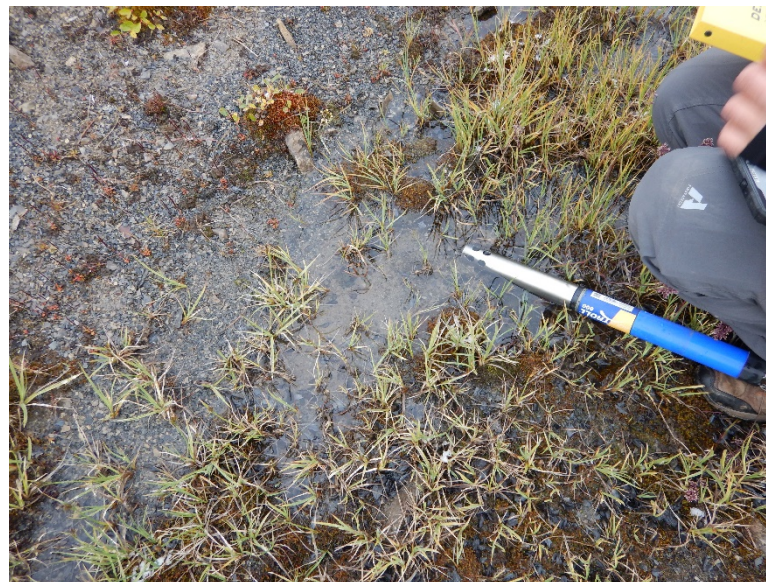
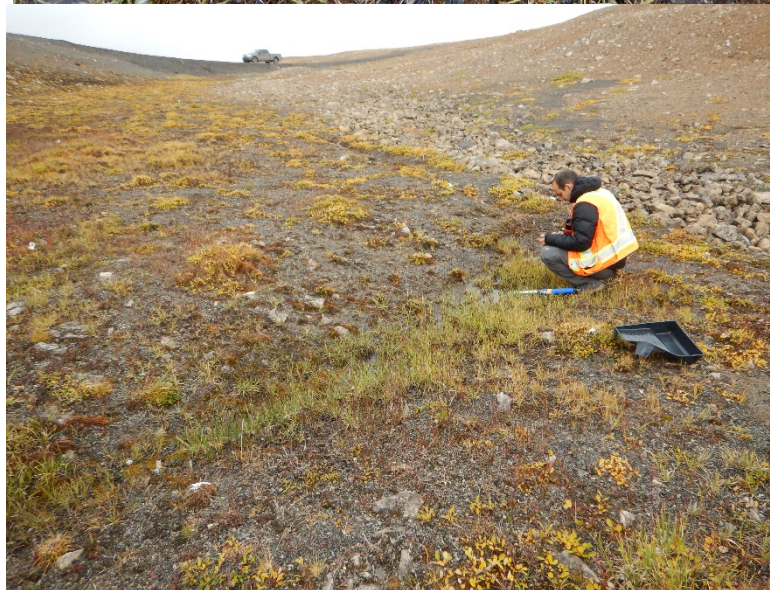
GPS Point	7
Latitude	73.03857 N
Longitude	-84.56250 W
Temperature (°C)	3.97
Conductivity (uS/cm) <sup>1</sup>	627
pH (pH units)	7.63
Total Dissolved Solids (mg/L)	680
Flow conditions <sup>2</sup>	Clear, stagnant water

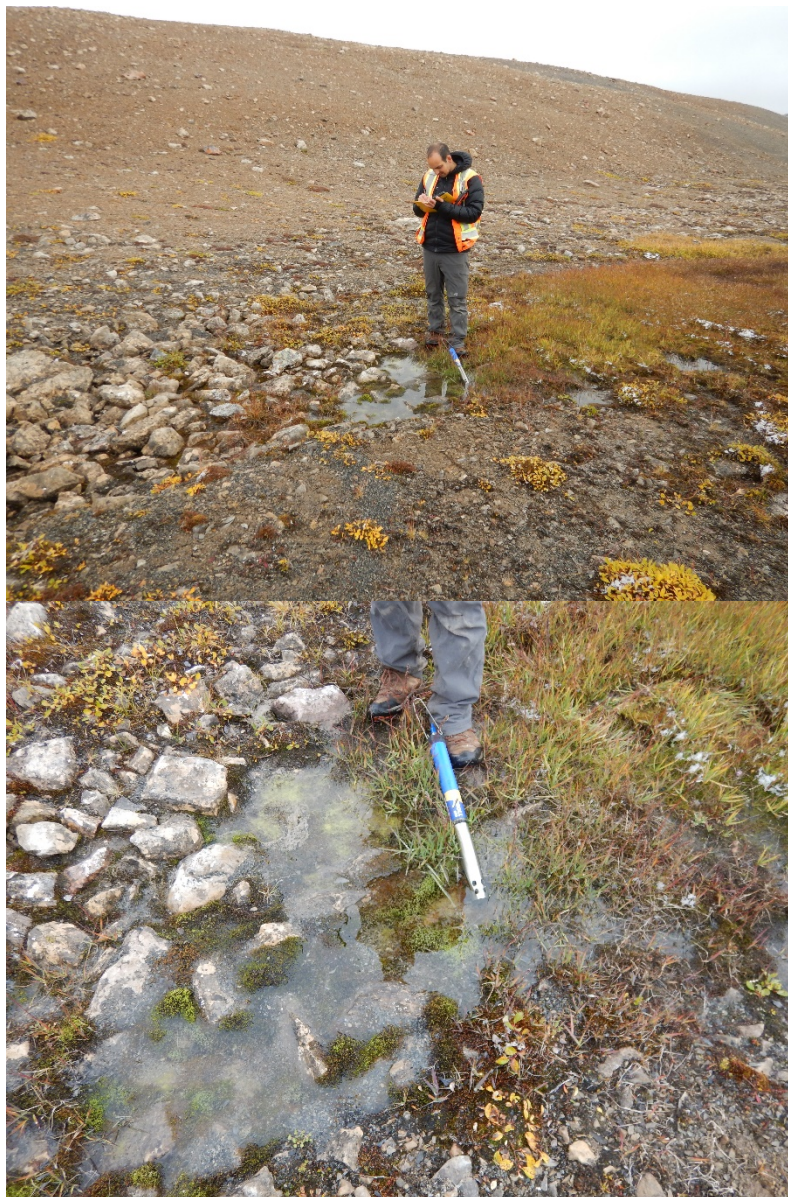
GPS Point	8
Latitude	73.03866
Longitude	-84.56136 W
Temperature (°C)	3.17
Conductivity (uS/cm) <sup>1</sup>	443.84
pH (pH units)	7.98
Total Dissolved Solids (mg/L)	490
Flow conditions <sup>2</sup>	Clear, stagnant water

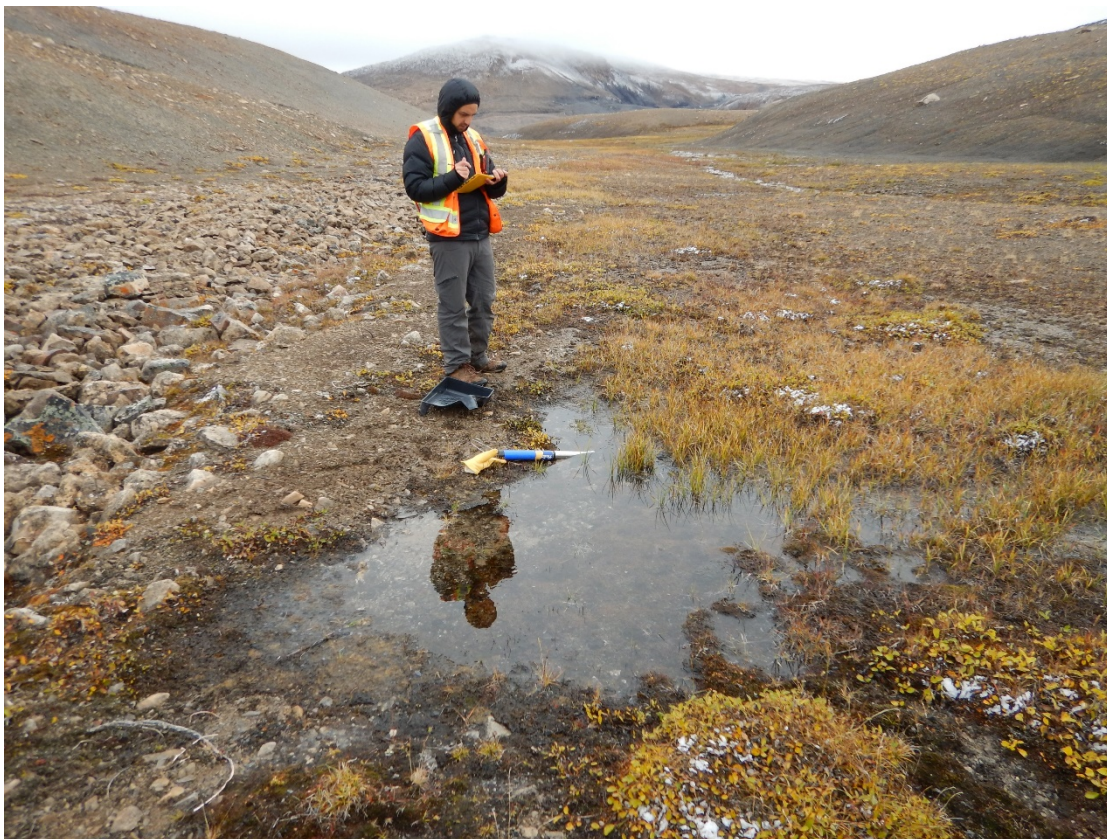
GPS Point	9
Latitude	73.03851 N
Longitude	-84.56070 W
Temperature (°C)	3.06
Conductivity (uS/cm) <sup>1</sup>	447.11
pH (pH units)	8.07
Total Dissolved Solids (mg/L)	500
Flow conditions <sup>2</sup>	Clear, stagnant water

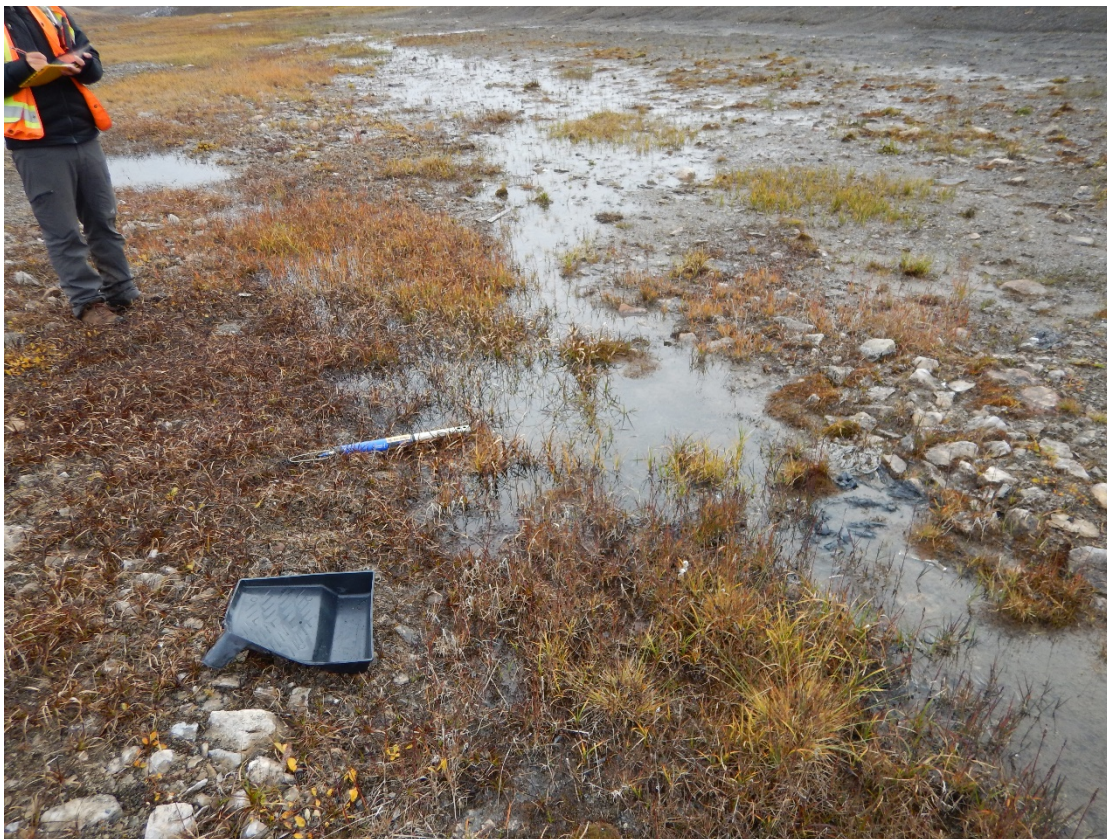
GPS Point	10
Latitude	73.03844 N
Longitude	-84.55933 W
Temperature (°C)	3.22
Conductivity (uS/cm) <sup>1</sup>	489.81
pH (pH units)	7.94
Total Dissolved Solids (mg/L)	550
Flow conditions <sup>2</sup>	Clear, stagnant water

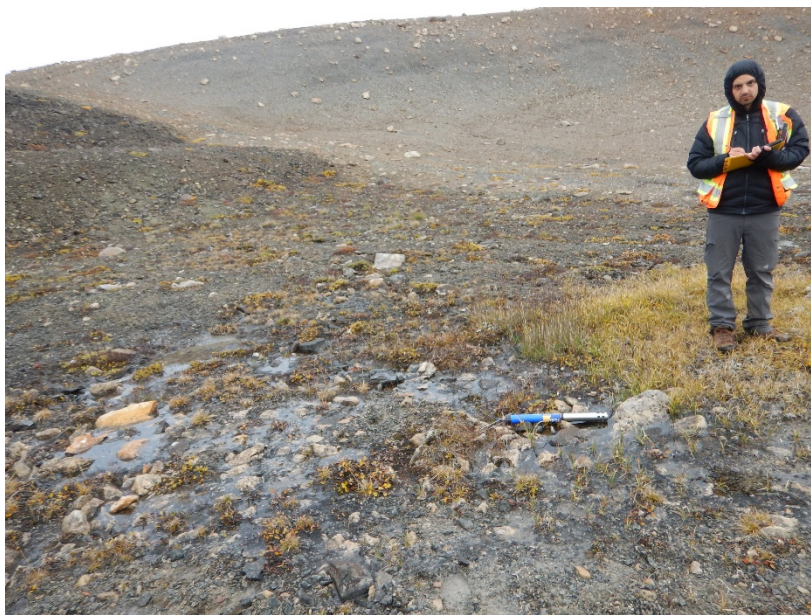
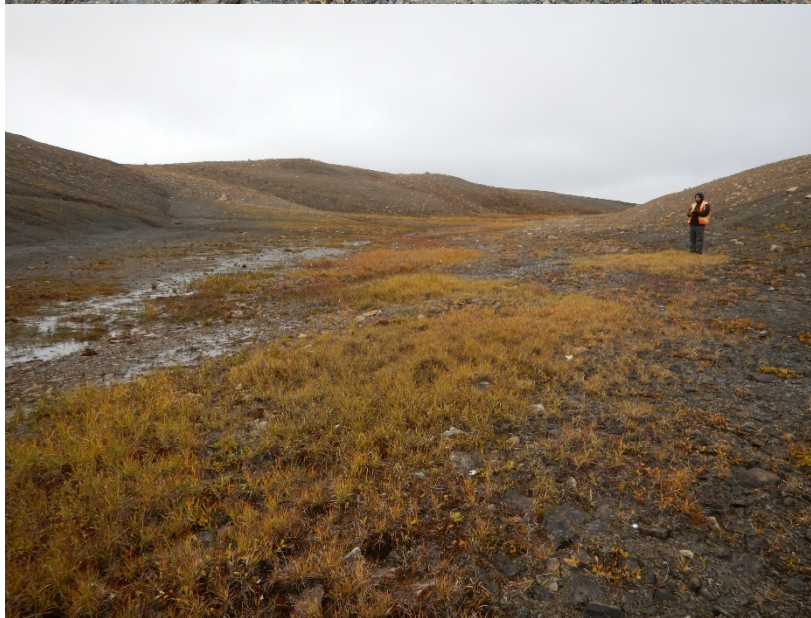
GPS Point	11
Latitude	73.03862 N
Longitude	-84.55893 W
Temperature (°C)	2.66
Conductivity (uS/cm) <sup>1</sup>	668.68
pH (pH units)	7.96
Total Dissolved Solids (mg/L)	750
Flow conditions <sup>2</sup>	Clear, stagnant, north side drainage, minor flow from north side dam slope towards confluence with south side of landfill

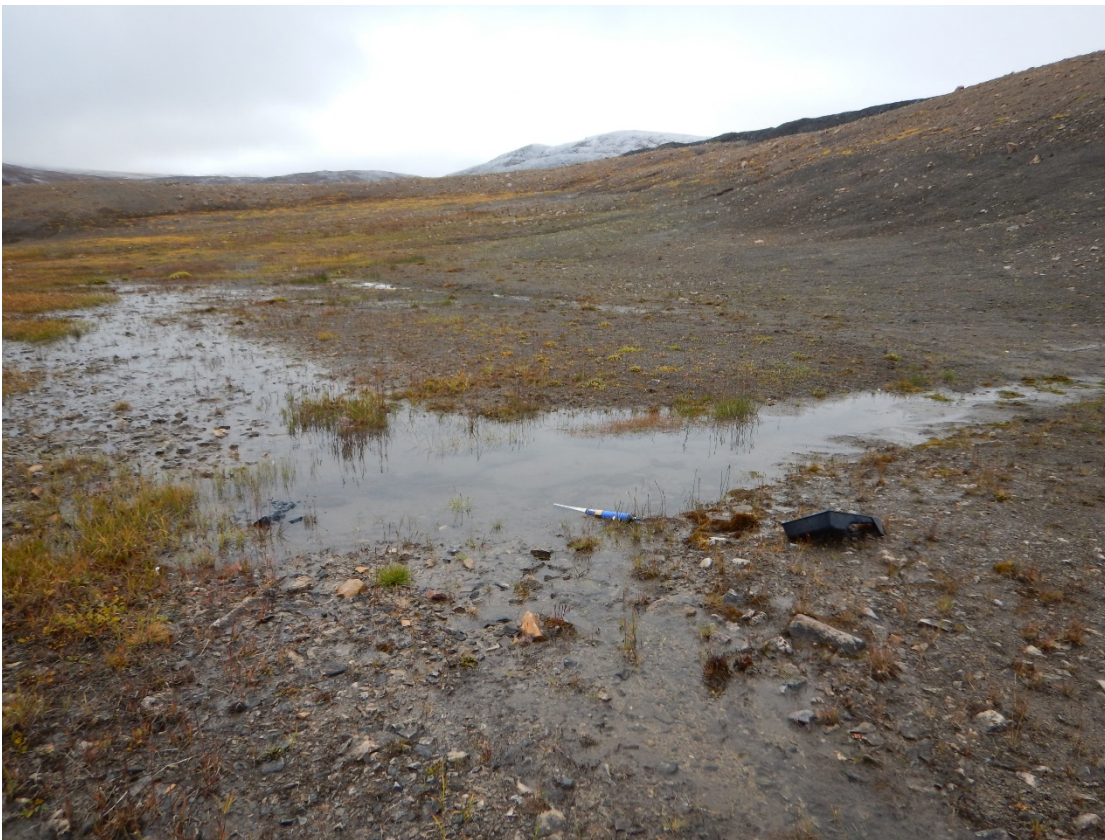
GPS Point	12
Latitude	73.03868 N
Longitude	-84.55748 W
Temperature (°C)	2.74
Conductivity (uS/cm) <sup>1</sup>	497.7
pH (pH units)	8.25
Total Dissolved Solids (mg/L)	530
Flow conditions <sup>2</sup>	Clear, flowing water

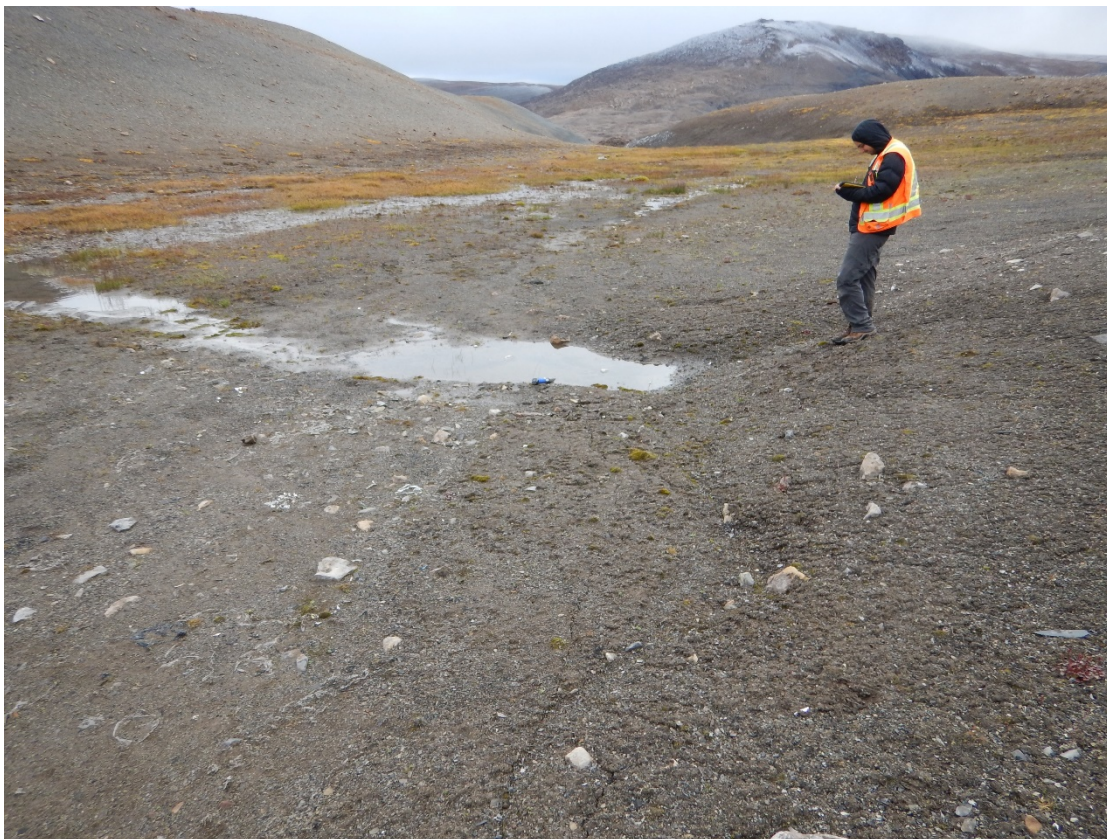
GPS Point	13
Latitude	73.03856 N
Longitude	-84.55752 W
Temperature (°C)	2.41
Conductivity (uS/cm) <sup>1</sup>	758.48
pH (pH units)	8.38
Total Dissolved Solids (mg/L)	870
Flow conditions <sup>2</sup>	Clear, stagnant water. Garbage debris in water.

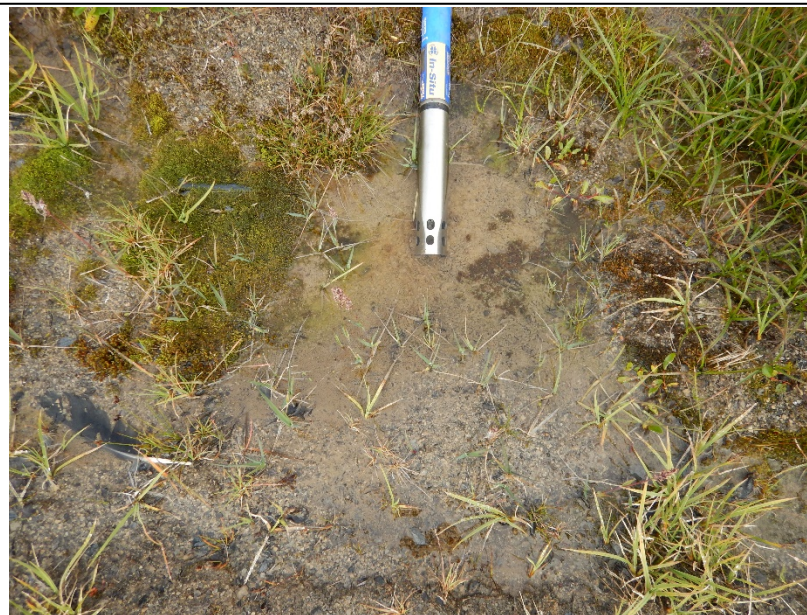
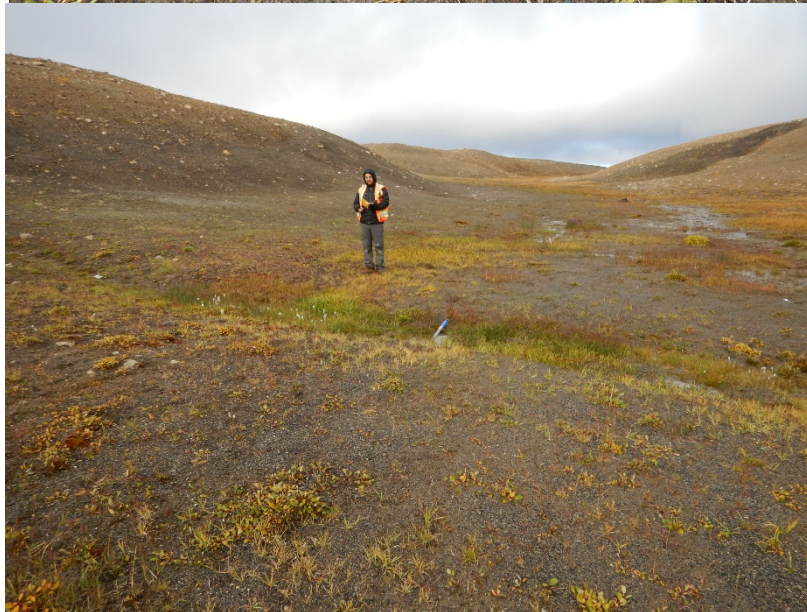
GPS Point	14
Latitude	73.03858 N
Longitude	-85.55608 W
Temperature (°C)	2.67
Conductivity (uS/cm) <sup>1</sup>	678.04
pH (pH units)	8.3
Total Dissolved Solids (mg/L)	700
Flow conditions <sup>2</sup>	Clear, stagnant water.
