CANZINCO MINES LTD

NANISIVIK MINE, NUNAVUT

2021 WATER QUALITY MONITORING

PROJECT NO.: 0255033

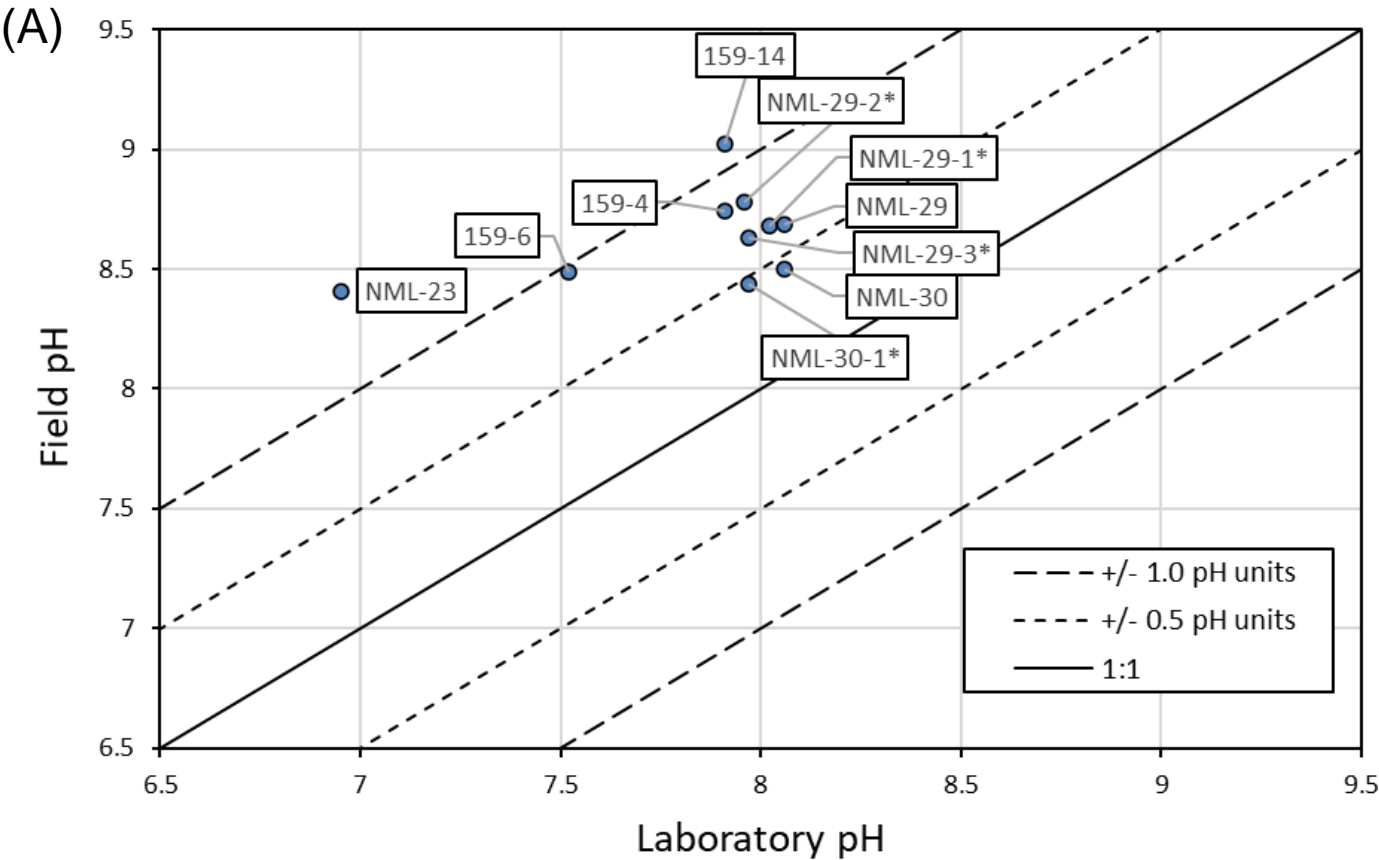
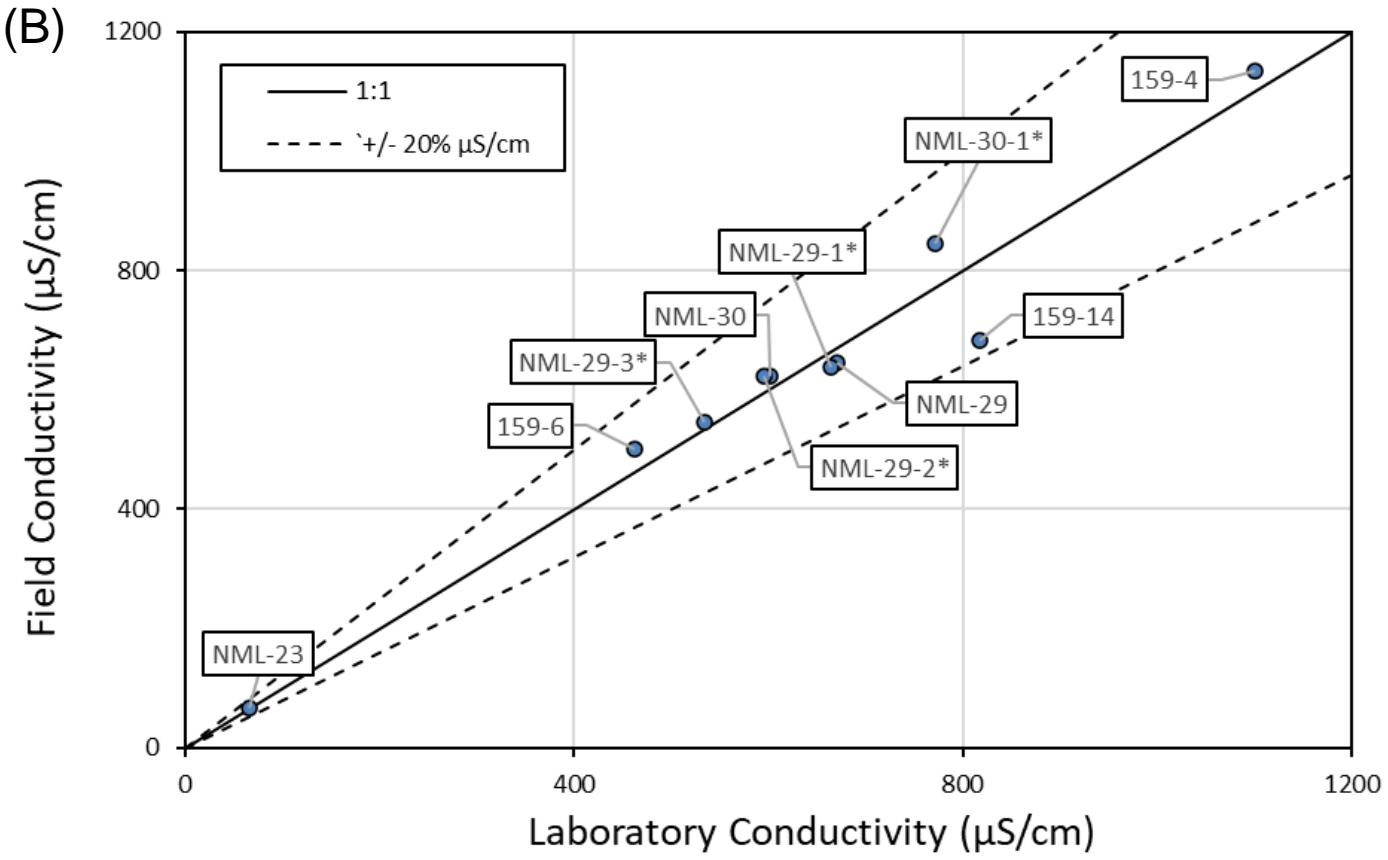
The results of the comparison of field versus laboratory pH values are shown in Figure 4-1A. Two (of 10) samples meet the pH DQO of +/-0.5 units, whereas six samples range between 0.5 pH unit and 1.0 pH unit difference and two samples (Stations 159-14 and NML-23) have a field to laboratory pH discrepancy greater than 1.0 pH units.

The field versus laboratory measured specific conductance values are shown in Figure 4-1B. All samples meet the DQO of RPD less than or equal to 20% hence, the field measured specific conductance is considered to be representative of site conditions at the time of sampling.

All samples contain higher field pH measurements relative to values recorded in the laboratory, which has been noted in previous years (e.g., BGC, March 24, 2021). The field procedures conducted to measure pH were in agreement with standard practice and daily sensor calibration results met the manufacturer's requirements (i.e., pH slope was within -66 to -50 mV/pH and pH 7 offset was ± 30 mV)⁵.

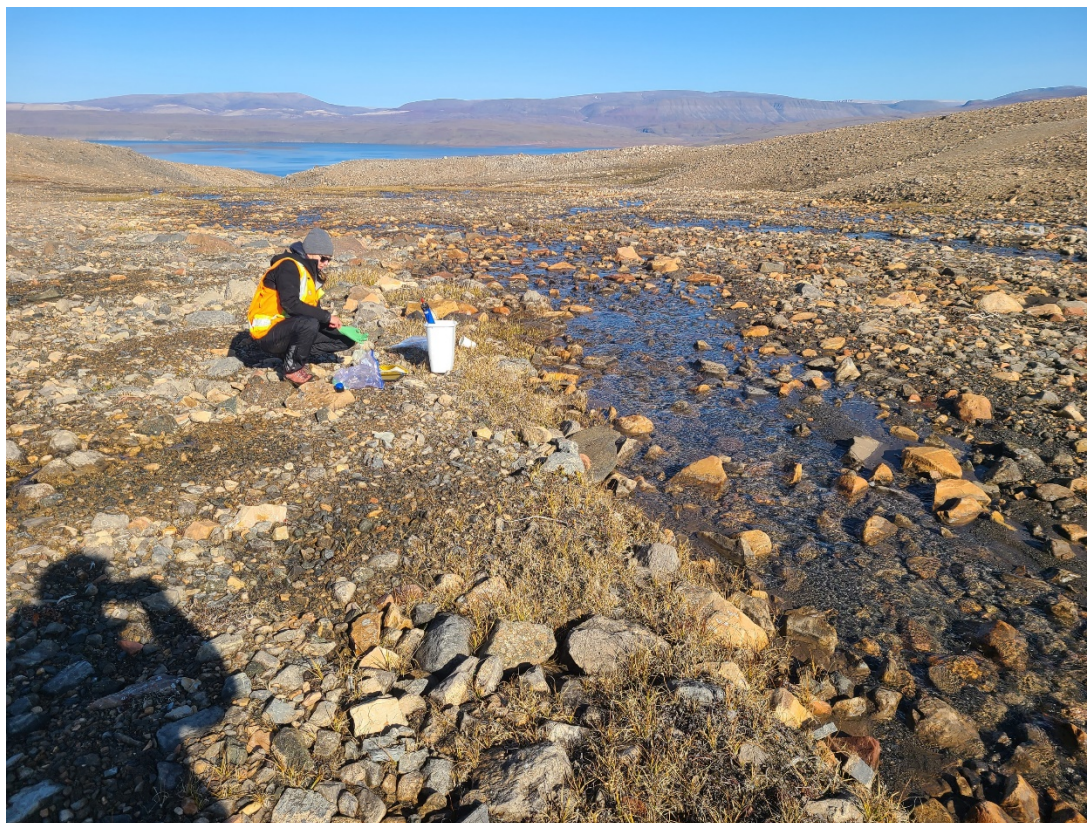
Station:	159-14
Latitude:	73.047278 N
Longitude:	-84.418062 W
Date Sampled:	August 22, 2021
Field Temperature (°C):	6.53
Conductivity (µS/cm) ¹ :	682
Field pH:	9.02
Field Total Dissolved Solids (ppt):	0.44
Flow Condition ² :	Flowing
Visible Hydrocarbons?	No

View looking North

No Action Level exceedances are reported at Station 159-14 in 2021. Measured chemical parameters at Station 159-14 do not present a visually interpreted increasing or decreasing trend in post-closure; however, an increasing trend in pH is observed, with highly alkaline values of approximately pH 9 noted since 2019 (Appendix C).

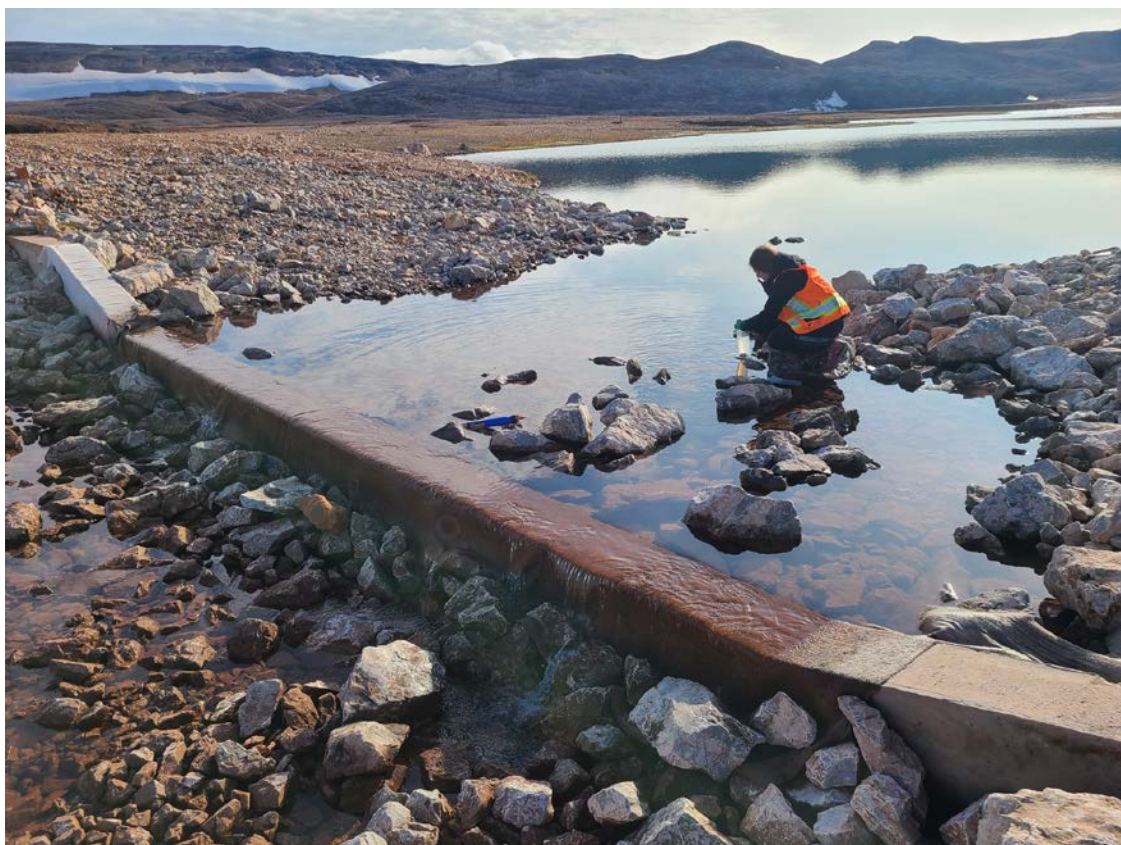
Station:	159-4
Latitude:	73.025644 N
Longitude:	-84.477130 W
Date Sampled:	August 20, 2021
Field Temperature (°C):	8.27
Conductivity (µS/cm) ¹ :	1135
Field pH:	8.74
Field Total Dissolved Solids (ppt):	0.74
Flow Condition ² :	Flowing
Visible Hydrocarbons?	No

View looking South

pH is within the authorized range of pH 6.0 to pH 9.5. A visible hydrocarbon sheen was not observed in 2021 sampling program at Station 159-4.

Sulphate is not included in the parameter list for Station 159-4, but is typically reviewed to assess the presence of acid rock drainage (ARD) conditions. Sulphate concentration at Station 159-4 is 500 mg/L and within the historical post-closure range observed at this station (i.e., 107 mg/L to 1,090 mg/L (2009 to present day); Appendix C). Additionally, concentrations of sulphate, as well as other metals (e.g., Cd, Pb, Zn), present a visually-interpreted decreasing trend with time from operations to post-closure periods, suggestive of improving conditions.

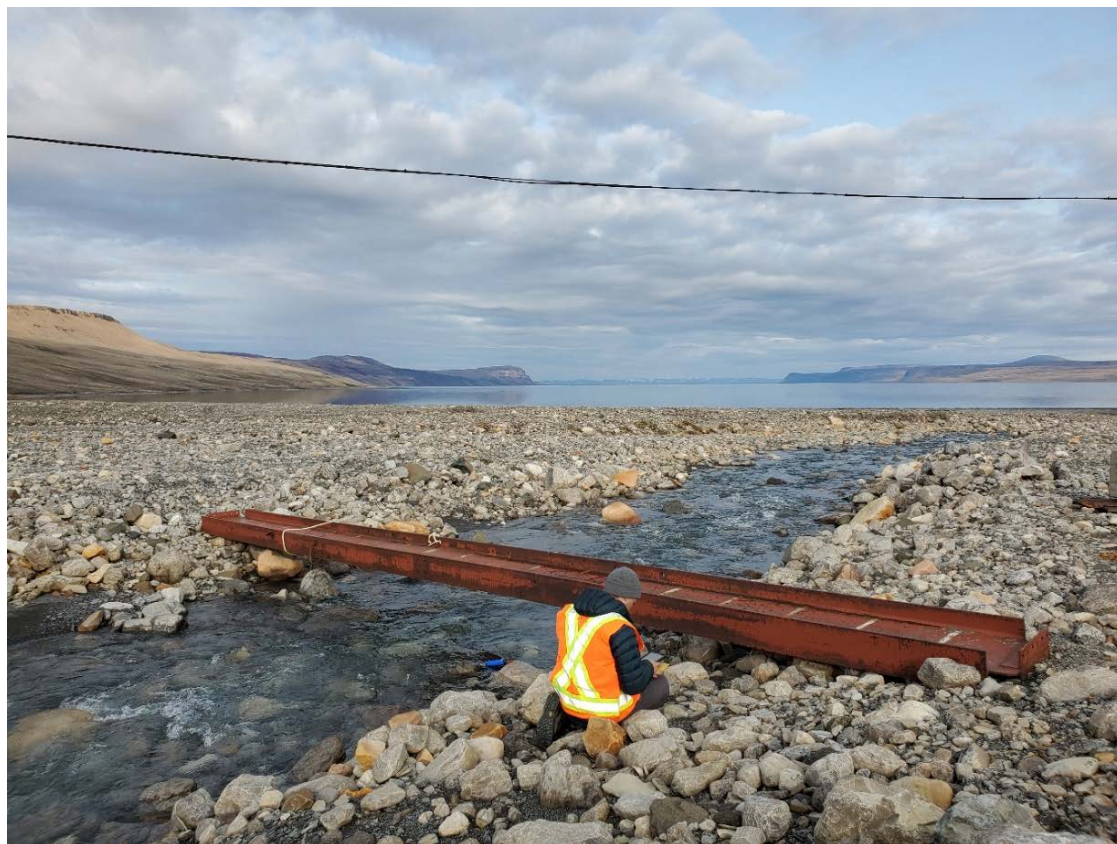
Station:	159-6
Latitude:	73.069603 N
Longitude:	-84.557824 W
Date Sampled:	August 21, 2021
Field Temperature (°C):	5.54
Conductivity (µS/cm) ¹ :	502
Field pH:	8.49
Field Total Dissolved Solids (ppt):	0.33
Flow Condition ² :	Flowing
Visible Hydrocarbons?	No

View looking North

visible sheen from petroleum hydrocarbons was not observed at these monitoring stations in the Twin Lakes Creek watershed and, for those station whereby samples were submitted for petroleum hydrocarbon analysis (i.e., NAN-2 parameter suite; 159-6), measured concentrations were below laboratory detection.

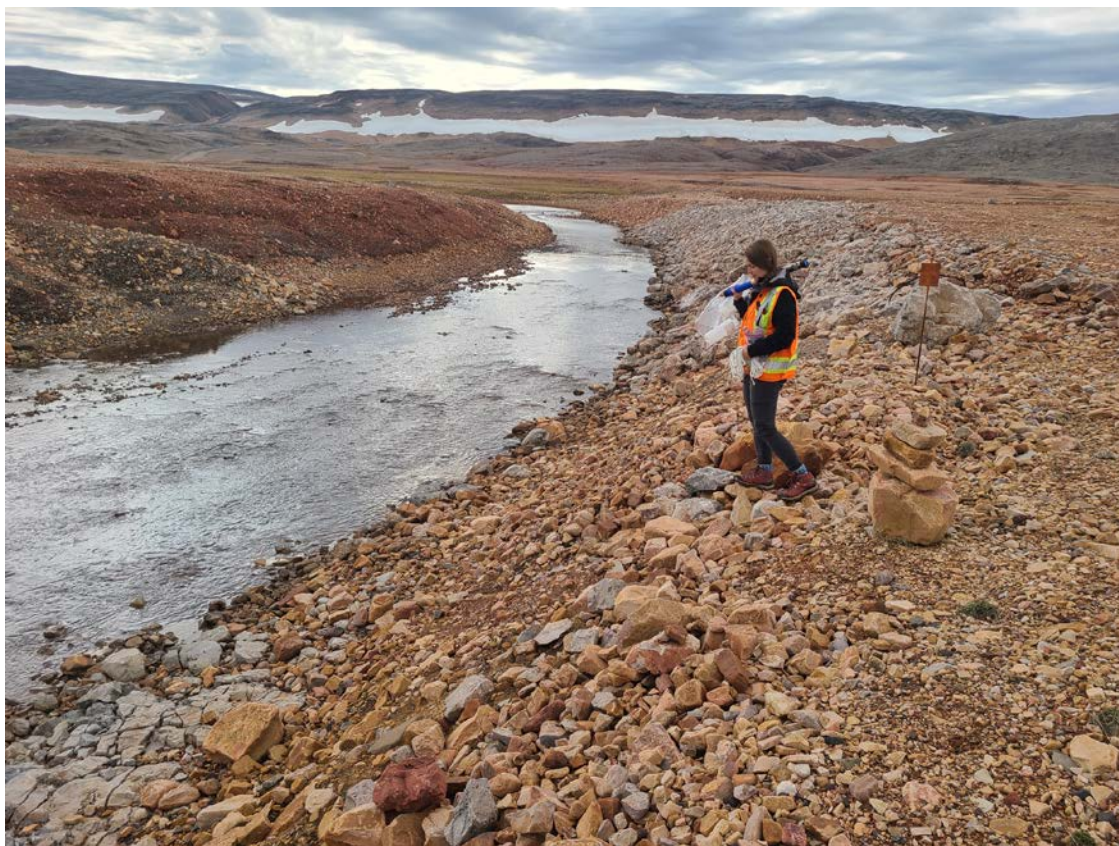
Station:	NML-23
Latitude:	73.022970 N
Longitude:	-84.472946 W
Date Sampled:	August 20, 2021
Field Temperature (°C):	7.4
Conductivity (µS/cm) ¹ :	66
Field pH:	8.41
Field Total Dissolved Solids (ppt):	0.04
Flow Condition ² :	Flowing
Visible Hydrocarbons?	No

View looking South

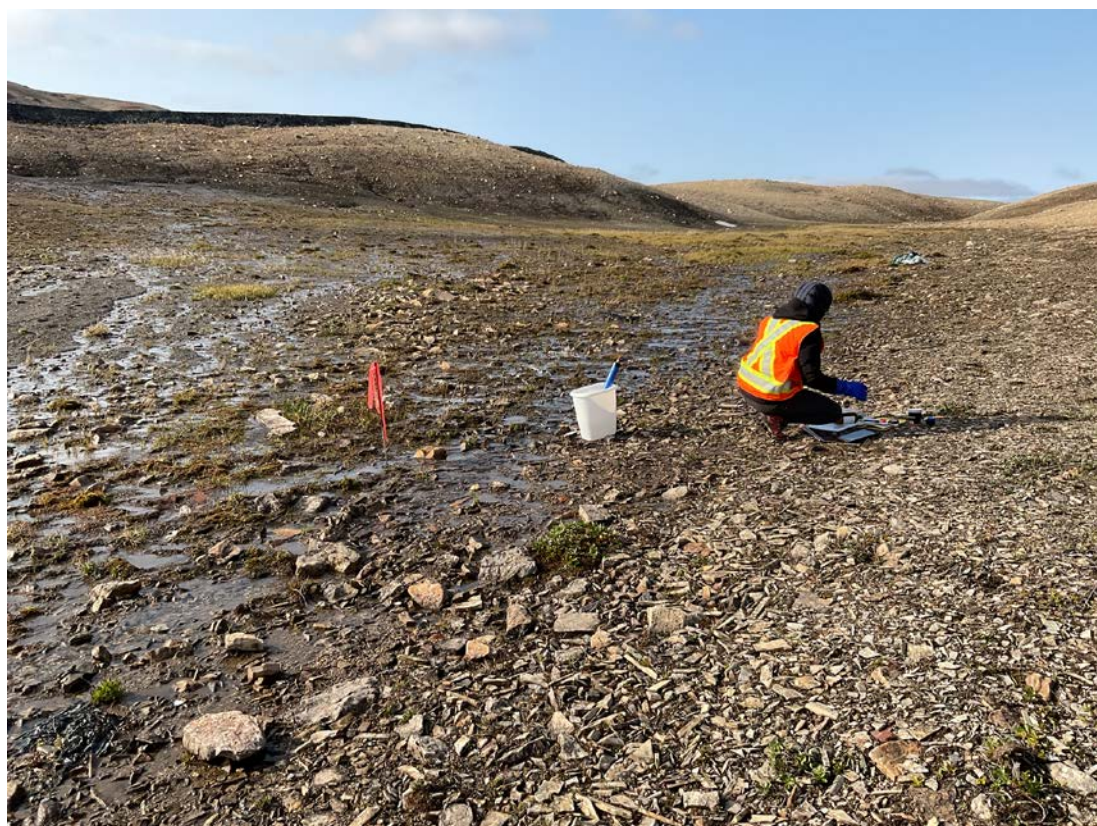
Station:	NML-29
Latitude:	73.038523 N
Longitude:	-84.555158 W
Date Sampled:	August 21, 2021
Field Temperature (°C):	5.66
Conductivity (µS/cm) ¹ :	645
Field pH:	8.69
Field Total Dissolved Solids (ppt):	0.42
Flow Condition ² :	Flowing
Visible Hydrocarbons?	No

View looking Southwest

As shown in Table 4-5, no Action Level exceedances are reported at Stations NML-29 and NML-30 in 2021; however, a sulphate exceedance was noted in 2020 at Station NML-29 (BGC, March 24, 2021), which triggered a site investigation to be conducted in 2021 to assess the

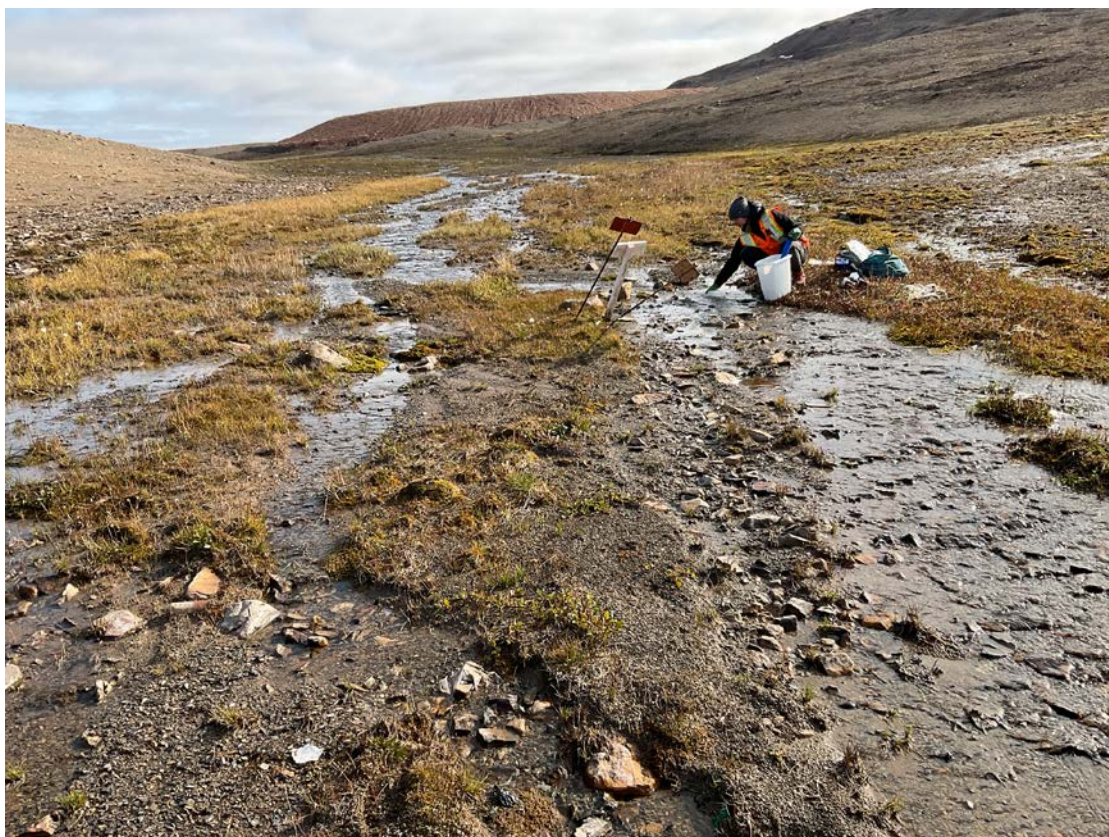
Station:	NML-30
Latitude:	73.038580 N
Longitude:	-84.574106 W
Date Sampled:	August 21, 2021
Field Temperature (°C):	7.18
Conductivity (µS/cm) ¹ :	623
Field pH:	8.50
Field Total Dissolved Solids (ppt):	0.40
Flow Condition ² :	Flowing
Visible Hydrocarbons?	No

View looking East

Therefore, seepage from the Landfill cover would be interpreted to migrate towards the west-flowing drainage and towards Station NML-30. No exceedances have been noted at NML-30 in 2020 (BGC, March 24, 2021) nor 2021 (Table 4-5).

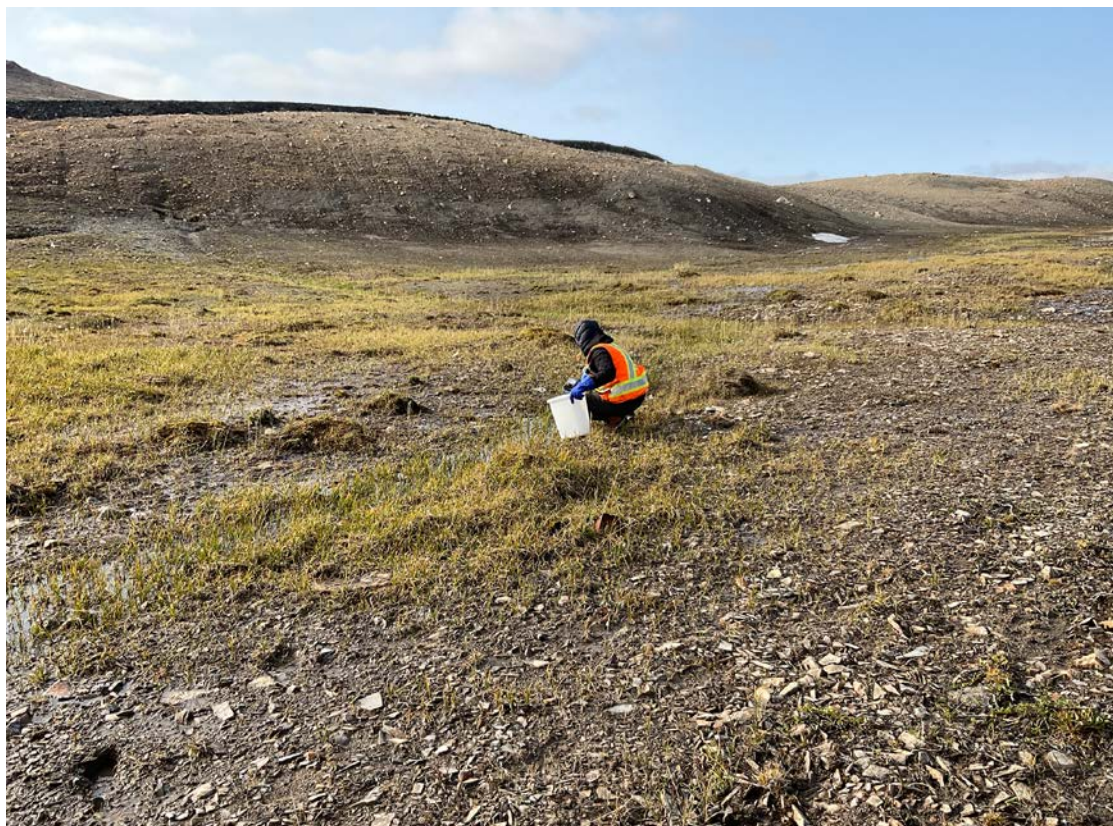
Station:	NML-29-1*
Latitude:	73.03872500
Longitude:	-84.5559361
Date Sampled:	August 21, 2021
Field Temperature (°C):	5.82
Conductivity (µS/cm) ¹ :	638
Field pH:	8.68
Field Total Dissolved Solids (ppt):	0.42
Flow Condition ² :	Flowing
Visible Hydrocarbons?	No

View looking South

Three (of four) site investigation samples were collected upstream of Station NML-29 and east of the roadway (i.e., NML-29-3*, NML-29-2*, and NML-29-1*, from upstream to downstream). In 2021, the same area of active seepage (interpreted to be associated with active layer thaw) was observed on a south-facing slope opposite the Landfill and approximately 150 m upstream of Station NML-29. A sample (NML-29-2*) was collected at this thaw seepage, along with one sample collected upstream (NML-29-3*) and one collected downstream and towards Station NML-29 (NML-29-1*). The data from these sites, along with Station NML-29, show increasing sulphate concentrations from upstream to downstream.

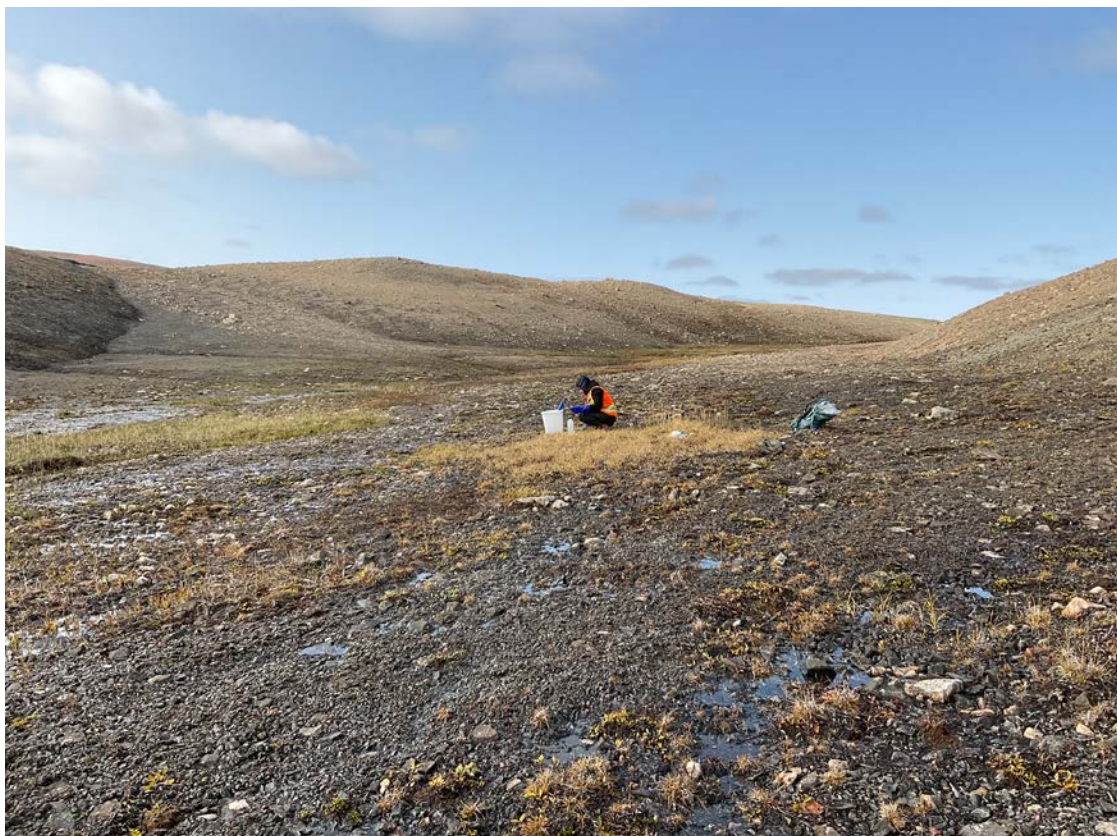
Station:	NML-29-2*
Latitude:	73.0386055
Longitude:	-84.558669
Date Sampled:	August 21, 2021
Field Temperature (°C):	4.74
Conductivity (µS/cm) ¹ :	623
Field pH:	8.78
Field Total Dissolved Solids (ppt):	0.40
Flow Condition ² :	Flowing
Visible Hydrocarbons?	No

View looking Southwest

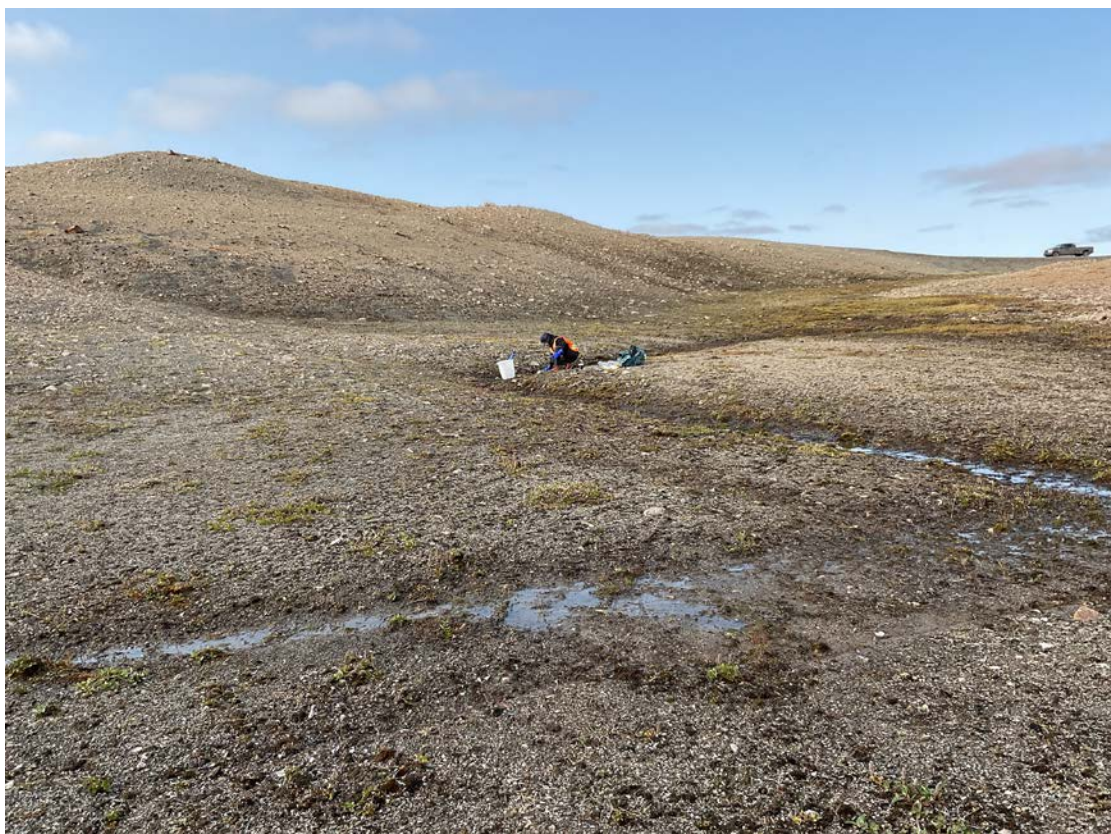
Station:	NML-29-3*
Latitude:	73.0384027
Longitude:	-84.560072
Date Sampled:	August 21, 2021
Field Temperature (°C):	5.51
Conductivity (μS/cm) ¹ :	546
Field pH:	8.63
Field Total Dissolved Solids (ppt):	0.35
Flow Condition ² :	Flowing
Visible Hydrocarbons?	No

View looking Southwest

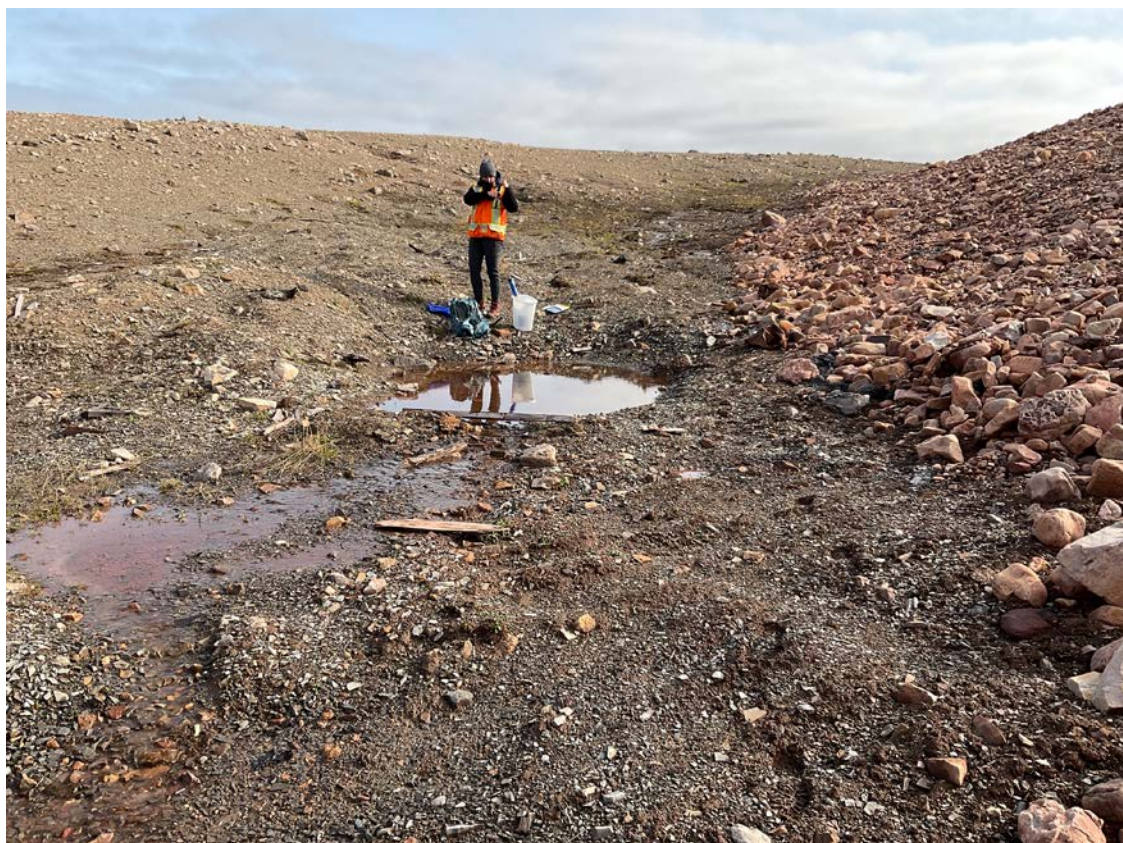
Station:	NML-30-1*
Latitude:	73.0382888
Longitude:	-84.565244
Date Sampled:	August 21, 2021
Field Temperature (°C):	4.64
Conductivity (µS/cm) ¹ :	846
Field pH:	8.44
Field Total Dissolved Solids (ppt):	0.55
Flow Condition ² :	Flowing
Visible Hydrocarbons?	No

View looking South

Station NML-30 is located to the west of the roadway and one investigation sample was collected along its west-flowing drainage (i.e., NML-30-1*; Figure 4-2). Minimal water was observed flowing adjacent the northeast edge of the Landfill, and between the edge of the toe and the topographic high (roadway). The observed flow at NML-30-1* is interpreted to be a combination of seepage from the Landfill, likely migrating along the top of the permafrost and within the active layer zone of the Landfill cover and seepage from the adjacent slope. Runoff from upslope of the Landfill is diverted by a berm (to the south of the Landfill; Figure 4-2) and directed to the west and then north towards Station NML-30.

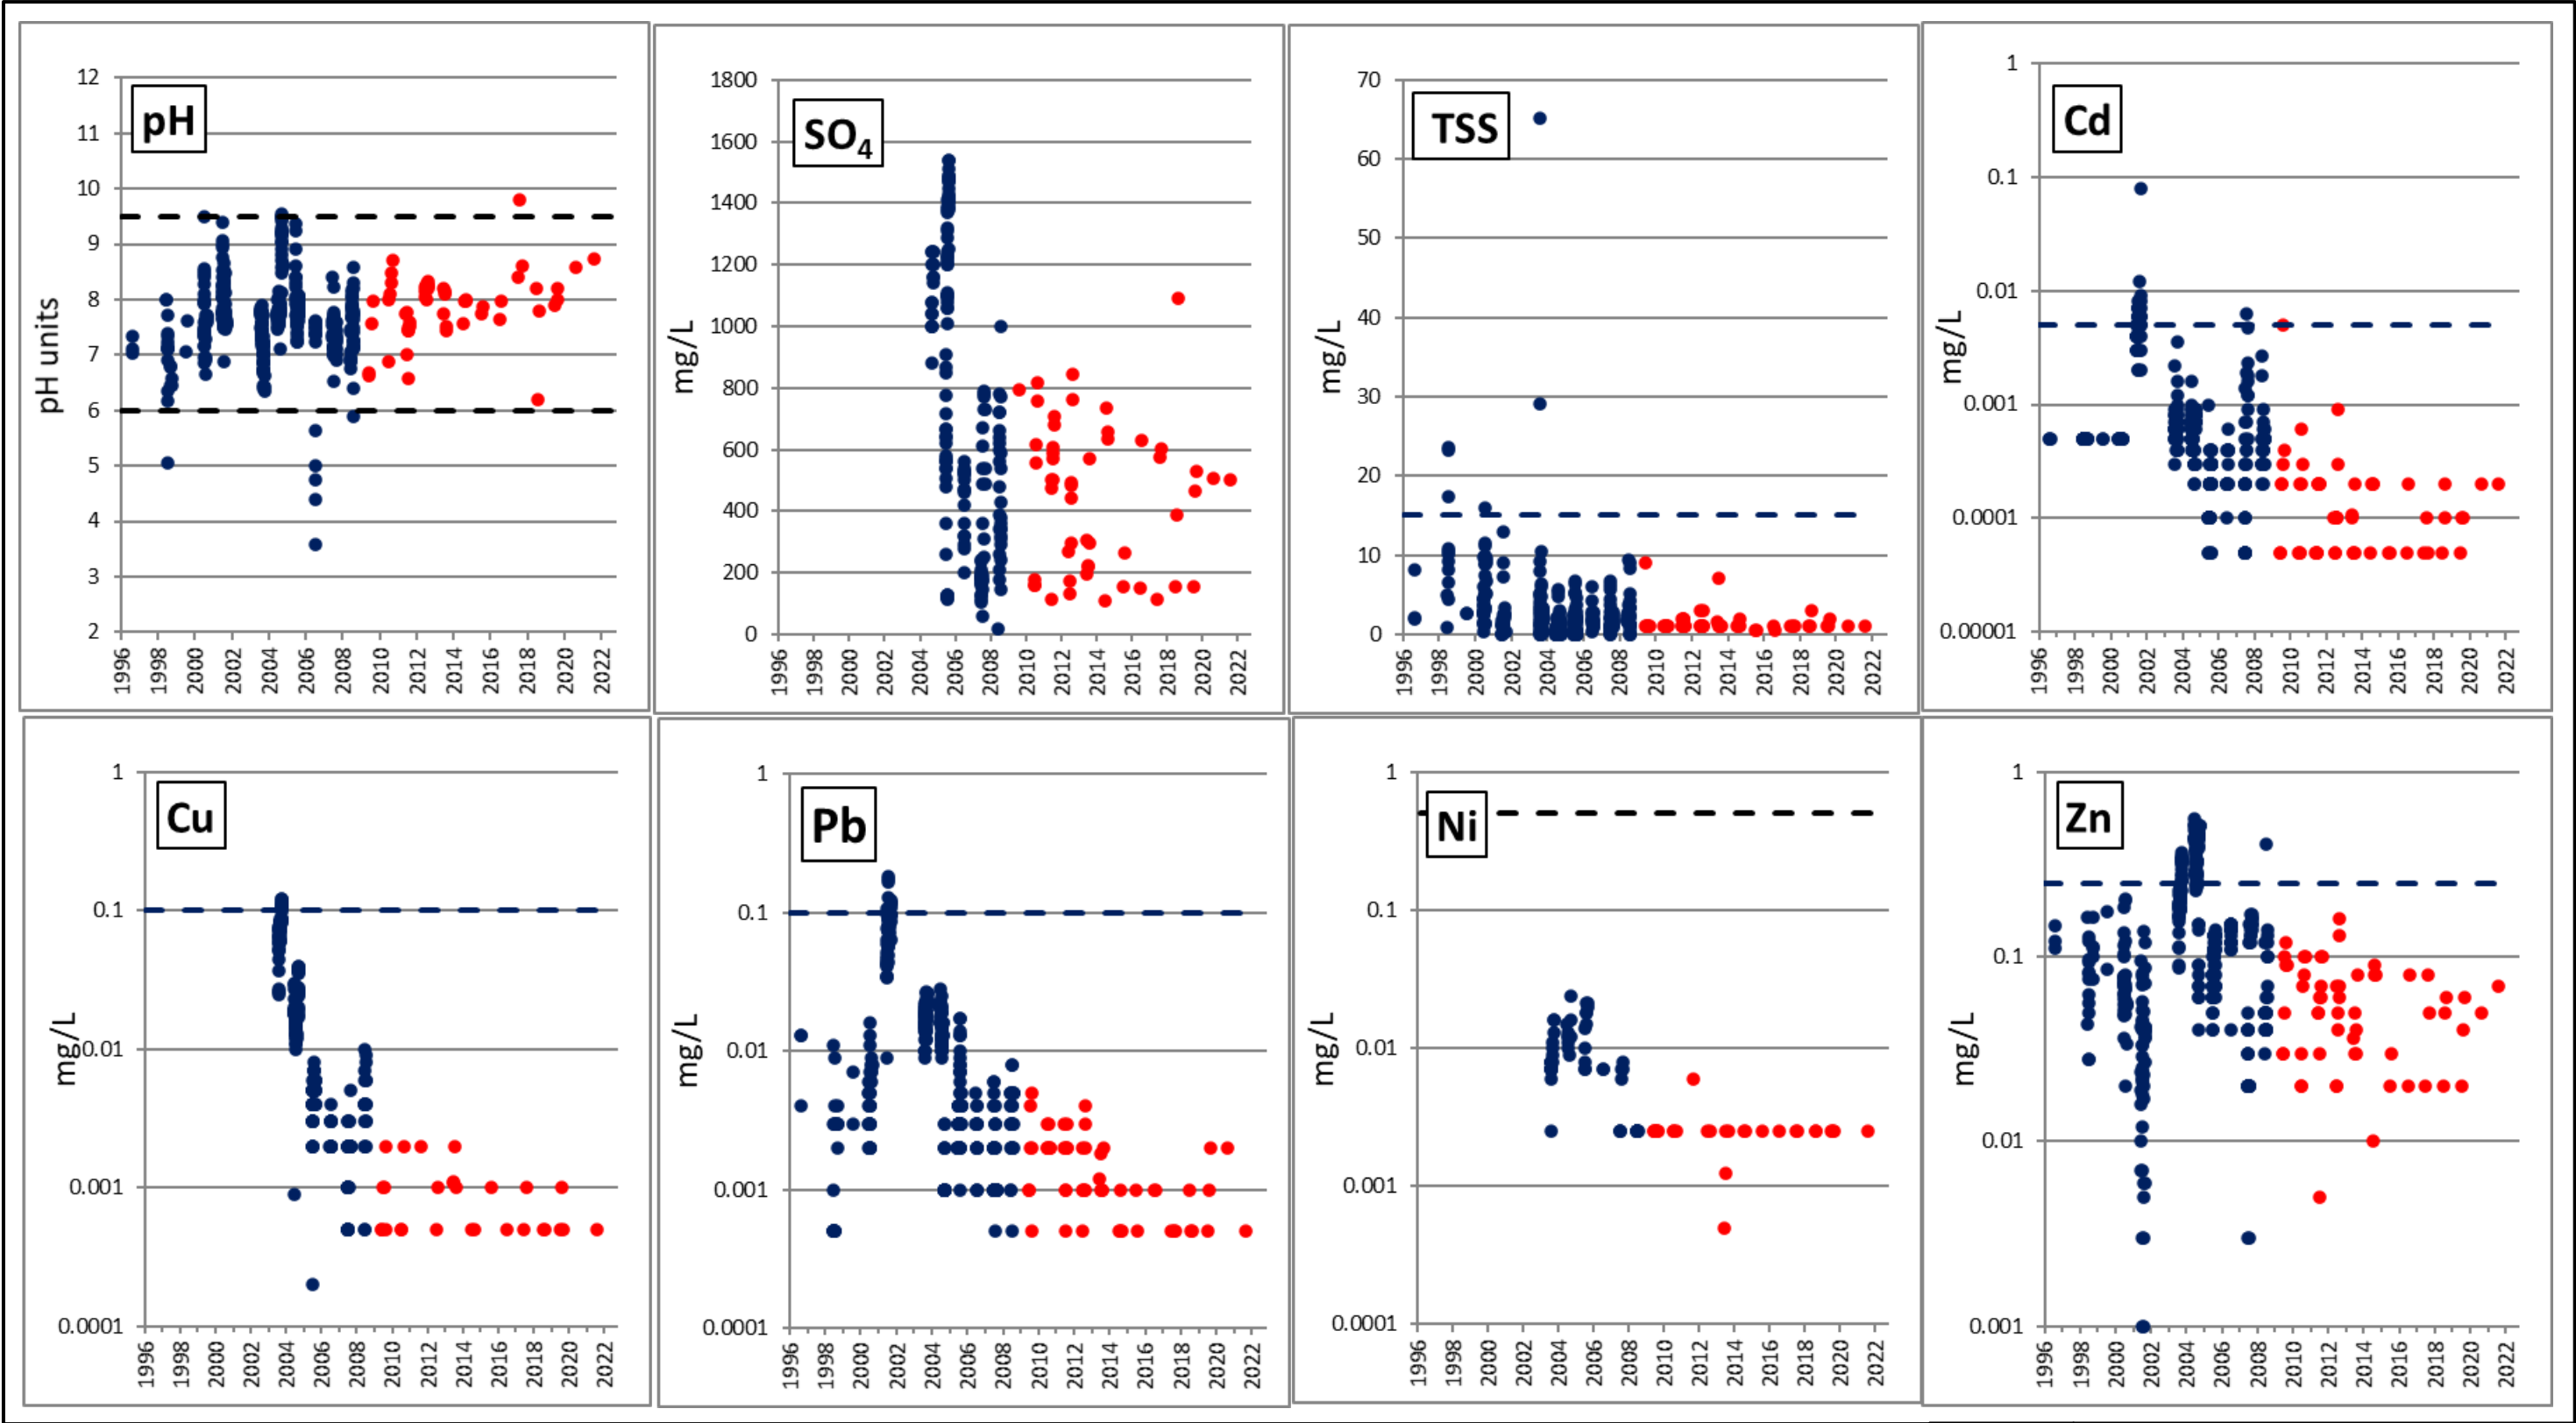
5. All results reported below the detection limit (DL) are presented as half the associated DL.			
PREPARED BY:	FIGURE TITLE		
CJ	Temporal trends at Station 159-4		
CHECKED BY:	CLIENT:		
BMA	CanZinco Mines Ltd.		
APPROVED BY:	SCALE:	PROJECT NO:	FIGURE NO:
SB	NTS	0255033	C-1

2. Blue dots represent samples collected prior to closure, on October 1, 2008 (Stantec, March 10, 2020); red dots represent samples collected in post-closure.

4. Data for total As not presented; however, values remain <0.003 mg/L (i.e., below the lab detection limit) and have not exceeded the MAC of 0.25 mg/L over its period of record (i.e., 2003 - 2021).

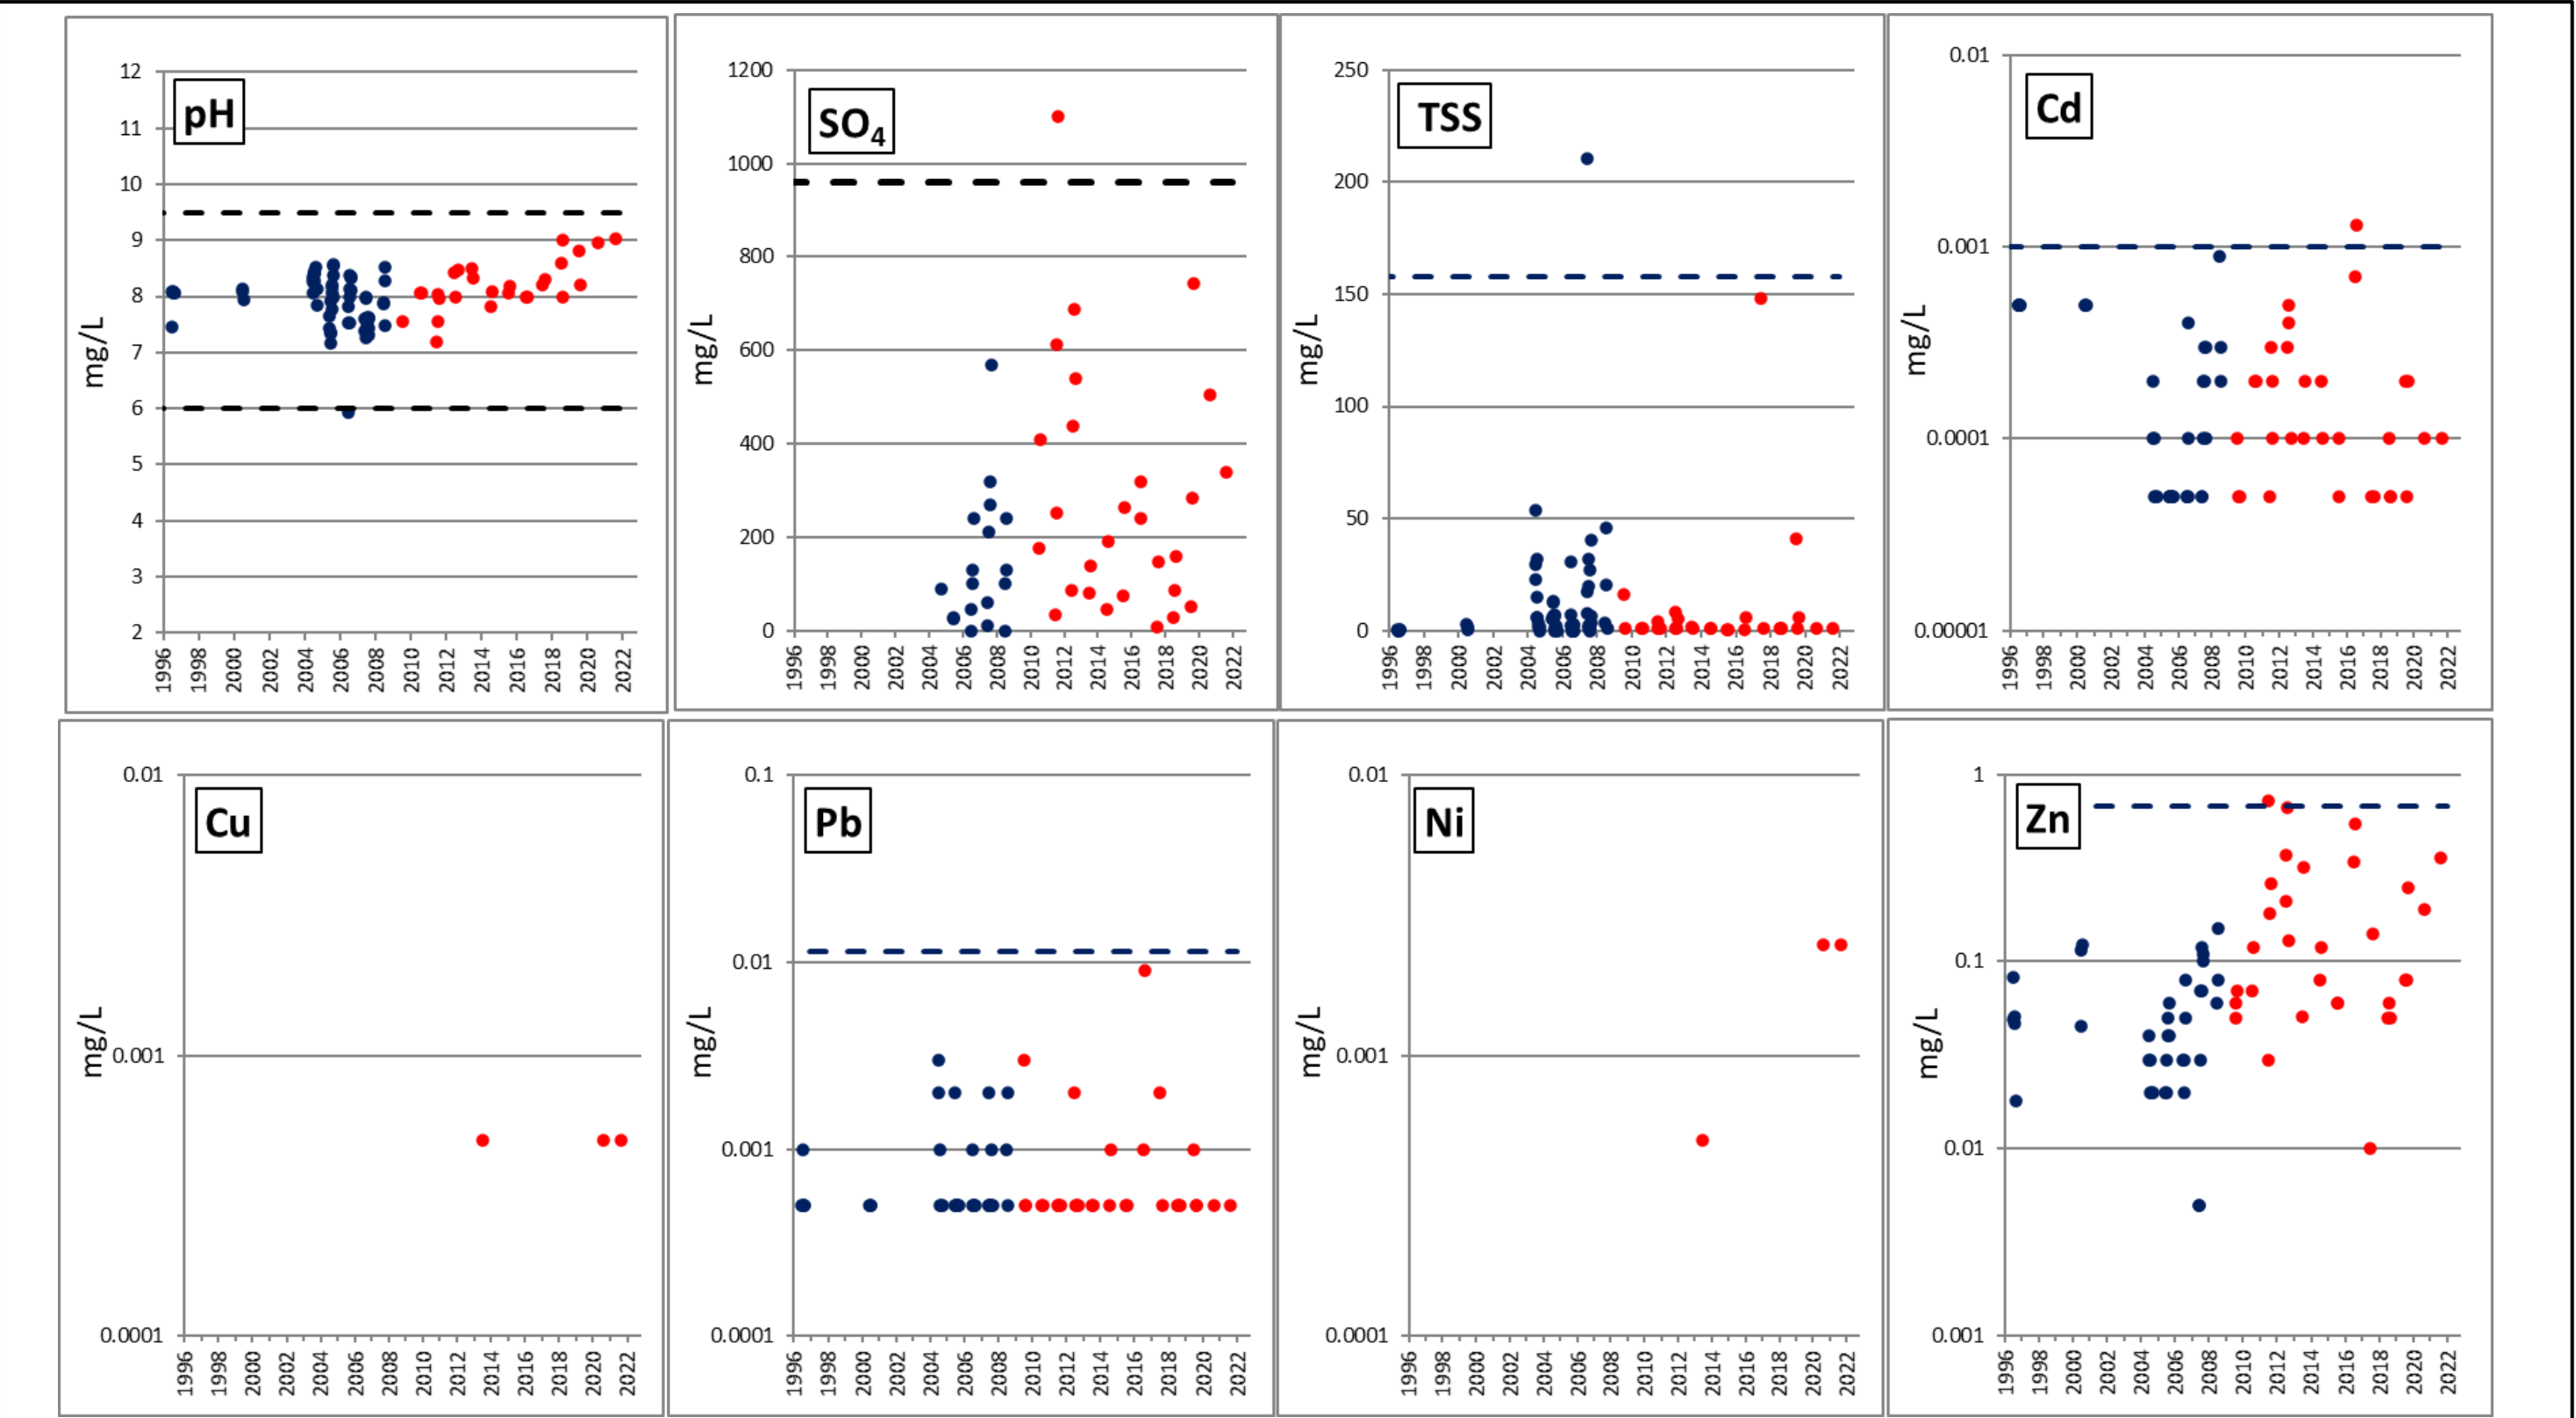
<div>CHECKED BY:</div> <div>BMA</div>	<div>CLIENT:</div> <div>CanZinco Mines Ltd.</div>
<div>APPROVED BY:</div> <div>SB</div>		<div>SCALE:</div> <div>NTS</div>	<div>PROJECT NO:</div> <div>0255033</div>	<div>FIGURE NO:</div> <div>C-3</div>

<div>NOTES</div> <div><div>1. This Figure should be read in conjunction with BGC's report titled "Nanisivik Mine, Nunavut - 2021 Water Quality Monitoring", and dated March 2022.</div><div>2. Blue dots represent samples collected prior to closure, on October 1, 2008 (Stantec, March 10, 2020); red dots represent samples collected in post-closure.</div><div>3. Dashed lines indicate the site-specific Action Levels for Station 159-6, as provided in the Mine's Contingency Plan for Water Quality Exceedances (Stantec, March 27a, 2020). However, pH guidance reflects the MAC range denoted in the Water Licence 1AR-NAN2030. For temporal plots where no dashed lines are present, no Action Levels are defined.</div><div>4. All results reported below the detection limit (DL) are presented as half the associated DL.</div></div>				<div>PREPARED BY:</div> <div>CJ</div>	<div>FIGURE TITLE</div> <div>Temporal trends at Station 159-14</div>
