CANZINCO MINES LTD

NANISIVIK MINE, NUNAVUT

2021 WATER QUALITY MONITORING

PROJECT NO.: 0255033

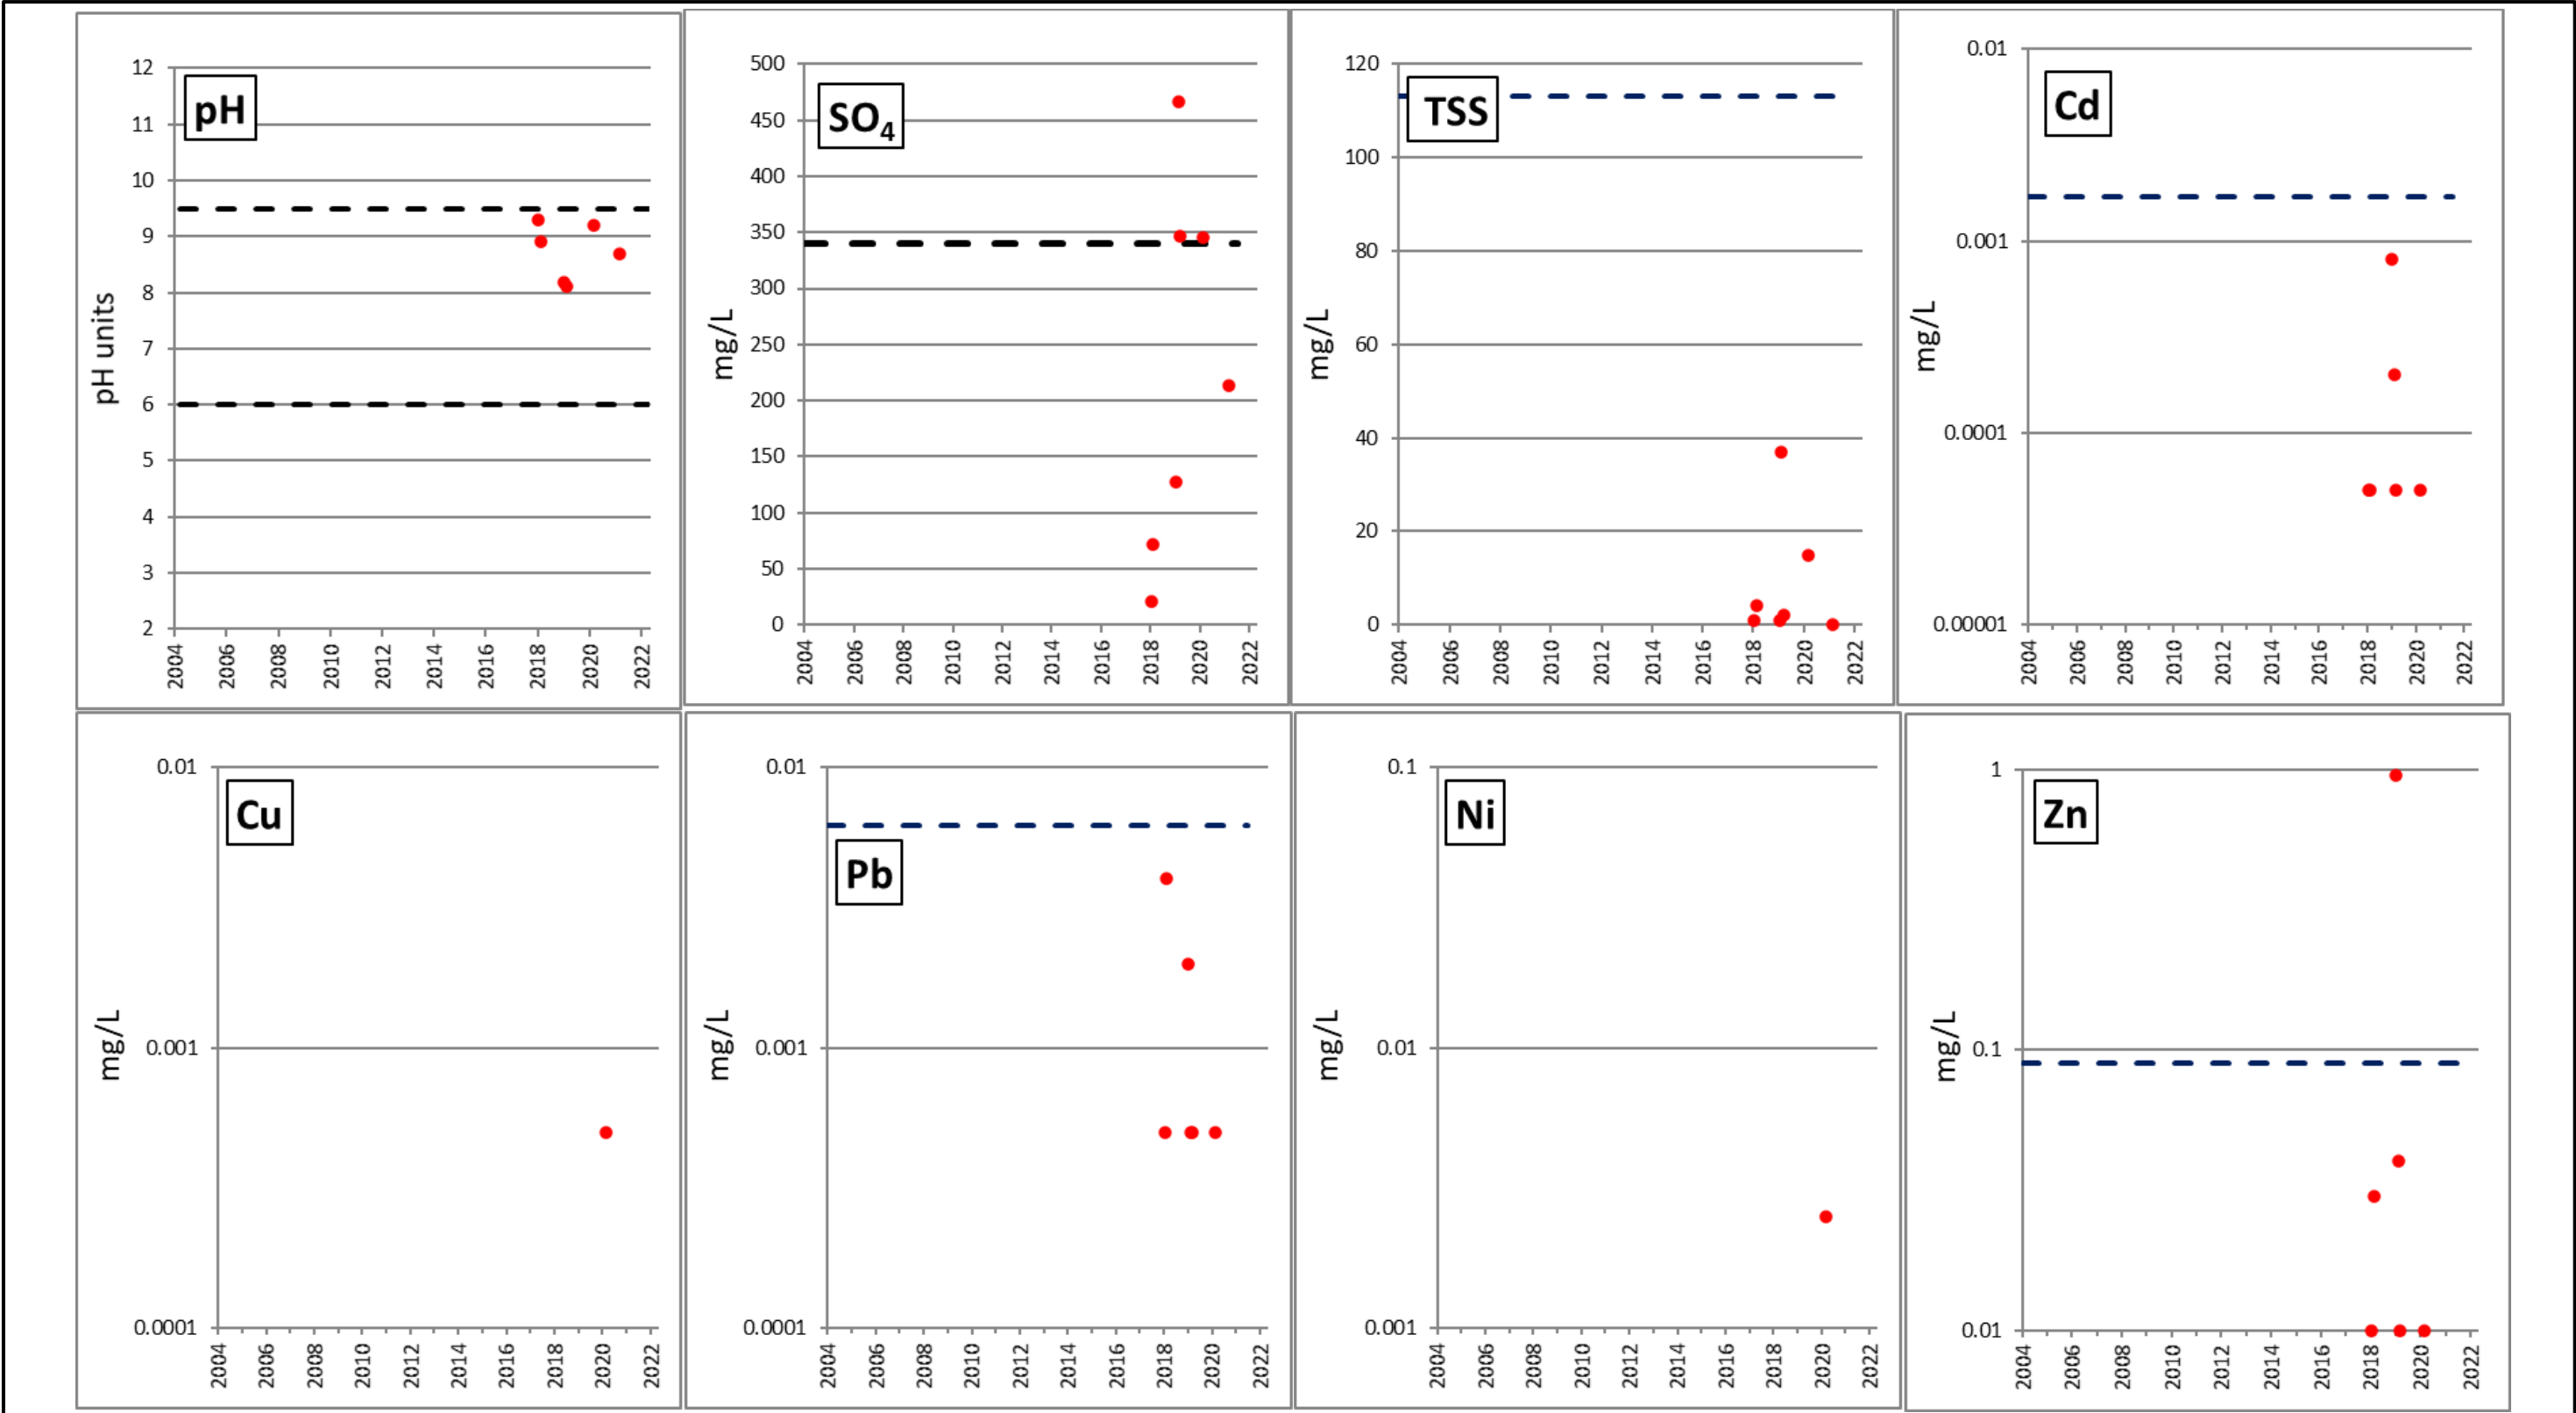
PREPARED BY:	FIGURE TITLE		
CJ	Temporal trends at Station NML-29		
CHECKED BY:	CLIENT:		
BMA	CanZinco Mines Ltd.		
APPROVED BY:	SCALE:	PROJECT NO:	FIGURE NO:
SB	NTS	0255033	C-5

5. Samples are inconsistently collected at NML-29 due to insufficient water for sampling.
