Nanisivik Mine
RECLAMATION ACTIVITIES
QUARTERLY REPORT (2nd quarter 2005)
(PER Water License NWBNAN0208)

SUBMITTED TO
The Nunavut Water Board

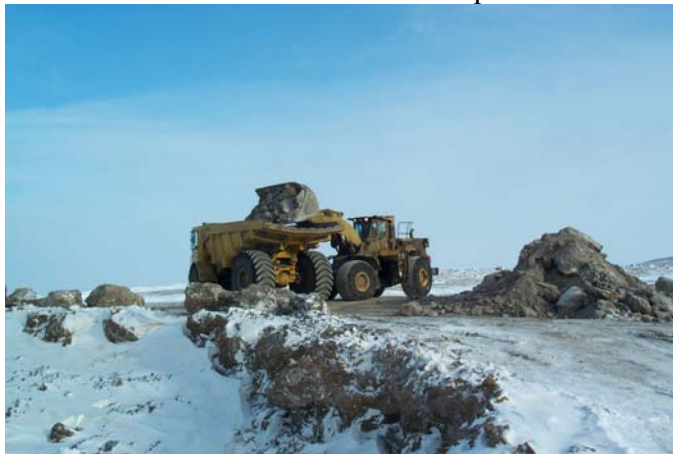
This Area was contaminated with hydrocarbons due to leaky fuel drums that were stored there some time in the earlier years of the operation. The area was drilled and blasted in early April. The contaminated material (1900 m³) was then hauled underground. A small area of contamination remains and will be excavated in the 3rd quarter.

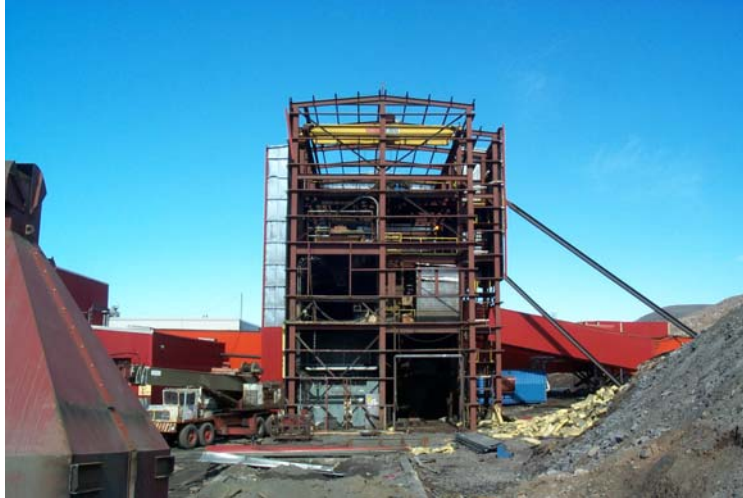
DMS Plant

Vendetti Construction, (the contractor for Wofliden Resources) continued dismantling the mill and related infrastructure. There is still some of the process equipment to remove from the

milling area and the powerhouse remains in operation for the time being. The contractor has been focusing on other areas of salvage during the warmer weather.

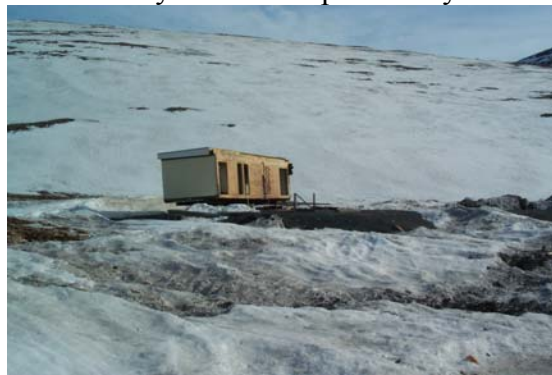
2nd half of House 1010 ready for transport

One House was removed during the quarter. This was a government house that was on a trailer. The unit was split in half and towed to Arctic Bay by Hamlet personnel for use as a storage unit. The Hamlet of Arctic Bay took all responsibility for cleaning the unit prior to use.

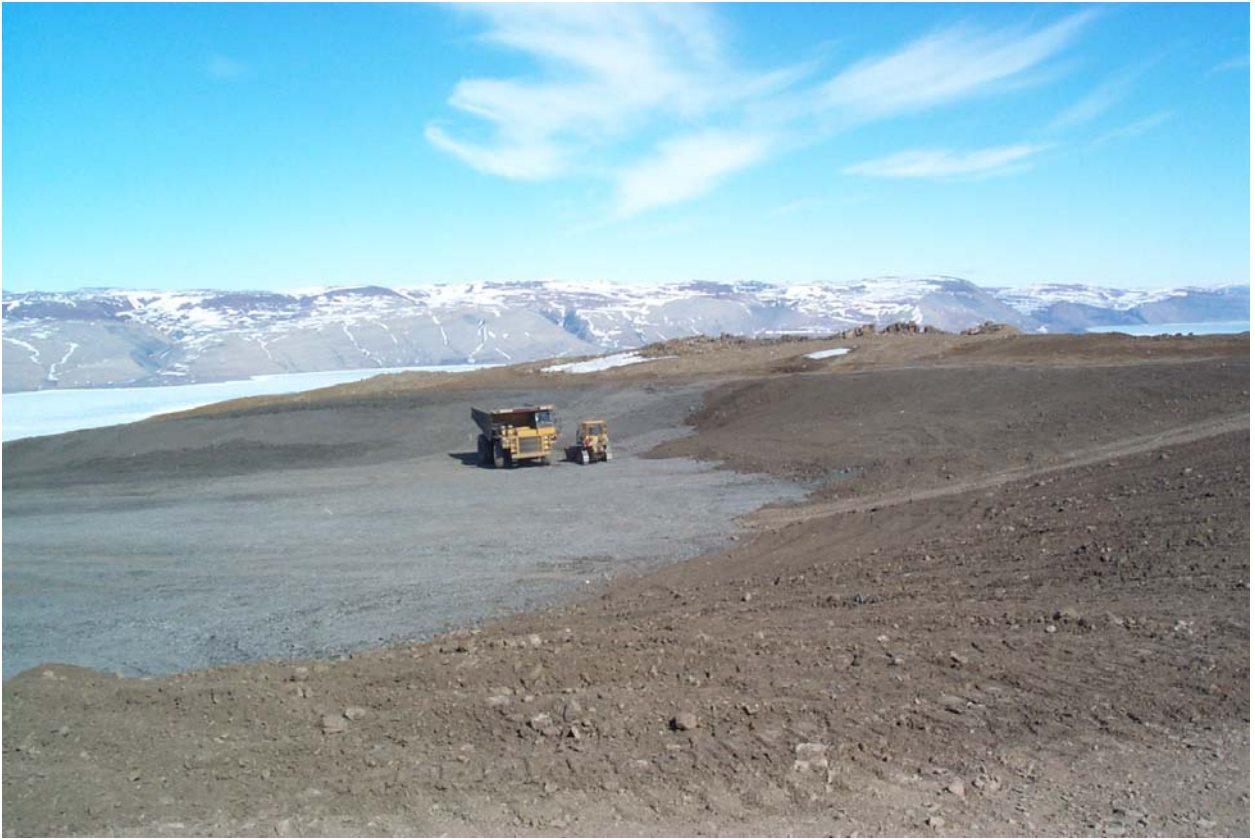
Sand and Gravel Cover in progress at the Ocean View Pit

The reclamation of the pit area and cover of the previously closed portal began in May. In total 8,449 m³ of sulphide waste rock was removed from the adjacent areas and the Oceanview haul road and placed as fill in the main pit and East Trench. 4833 m³ of shale was also placed as part of the final cover. Completion of the shale and gravel covers is planned for the next quarter.

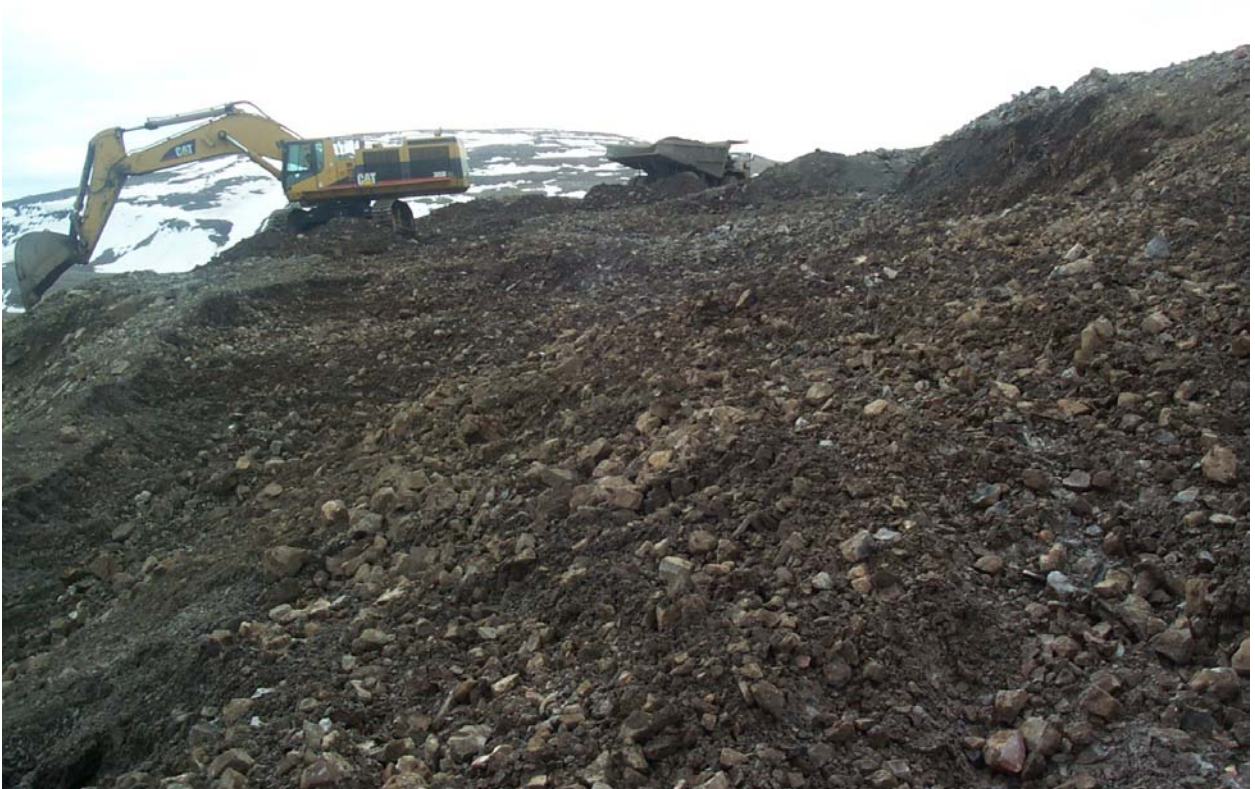
Excavating the East Pit waste rock pile down to original ground

The reclamation of this area was begun in June. In total 57,992 m³ of sulphide waste rock was removed from the adjacent and nearby areas (see chart below) and placed as sub-grade fill in the main pit and East Trench.

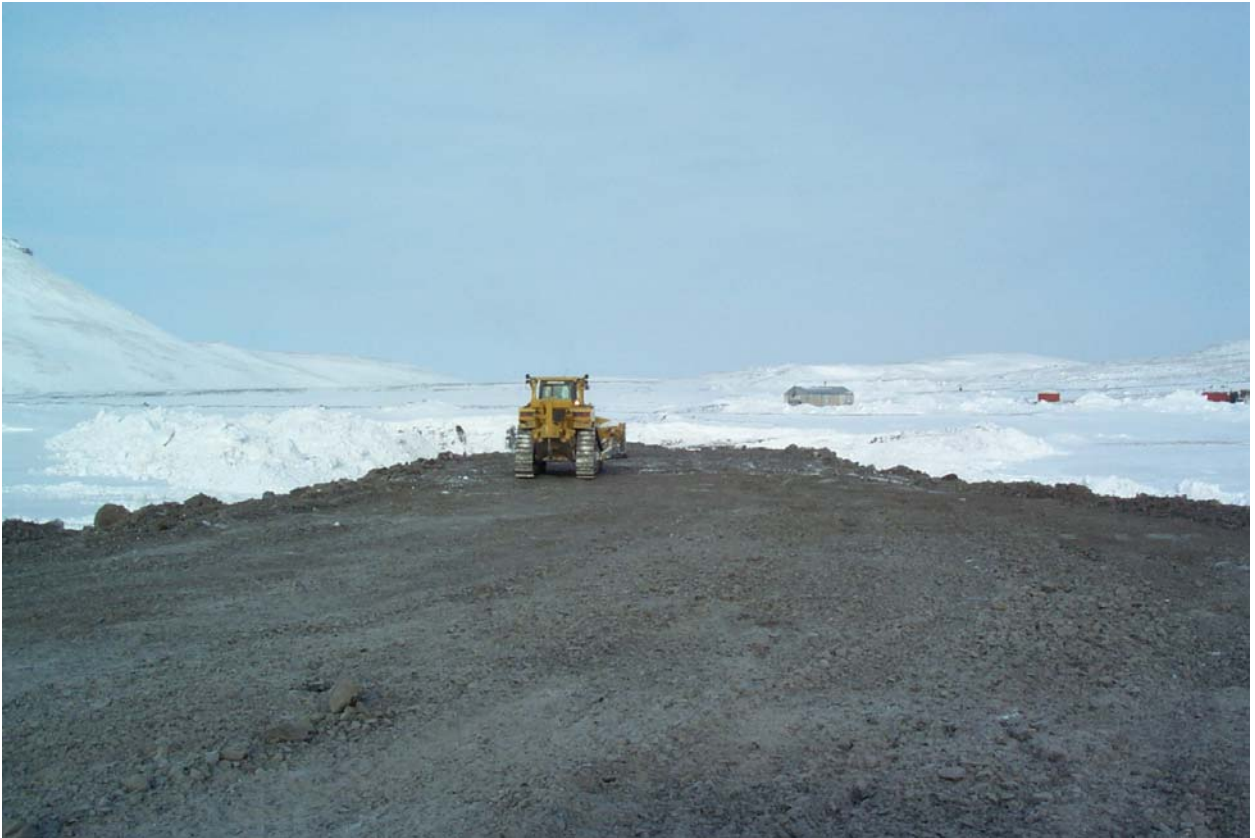
Haulage Road Construction from The East Twin Quarry to the West Twin Deposition Area

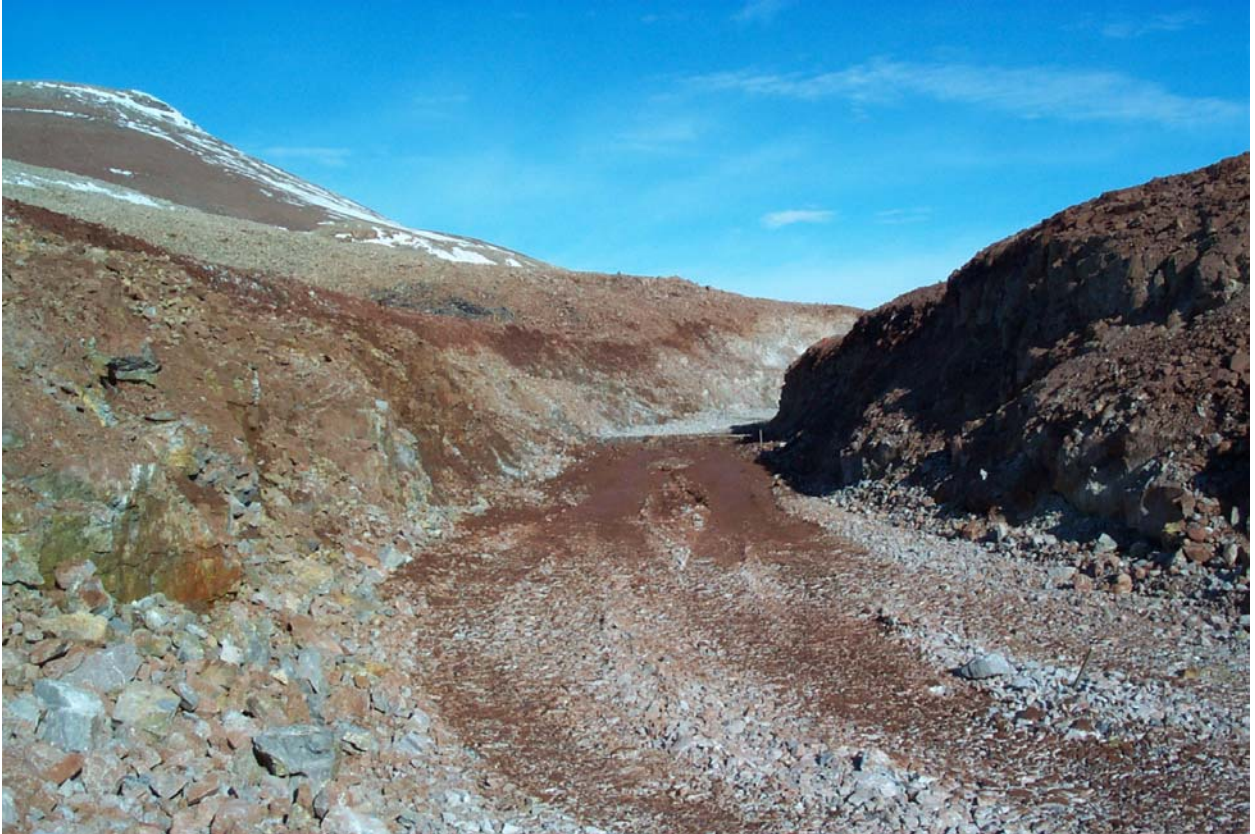
Newly Constructed Spillway from the Surface Cell to West Twin Reservoir

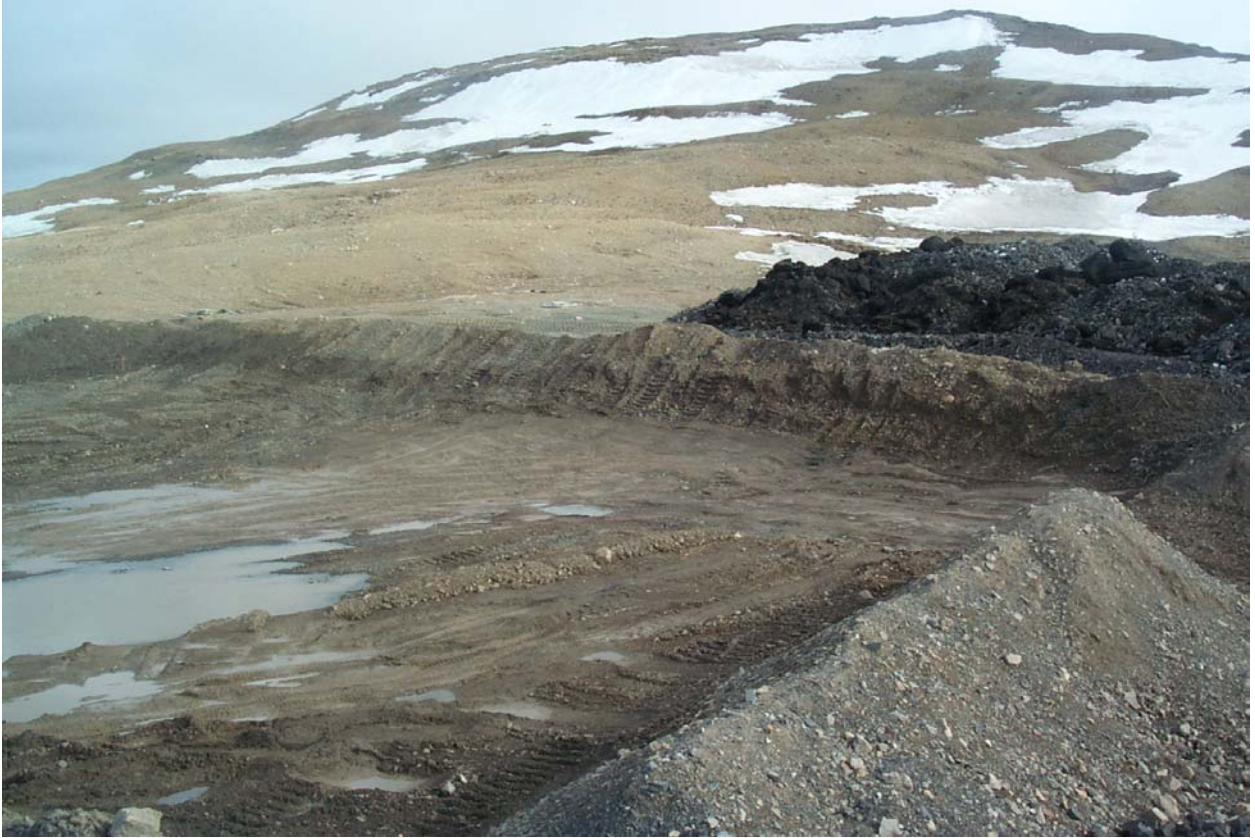
Landfarm excavated and ready for recontouring

The land farming process was incomplete, so the remaining contaminated material was ripped up and hauled underground. A total of 1500 cubic metres were removed.
