**Reclamation Activities Quarterly Report
(3rd Quarter 2005)
(PER Water License NWBNAN0208)**

Submitted to:
The Nunavut Water Board

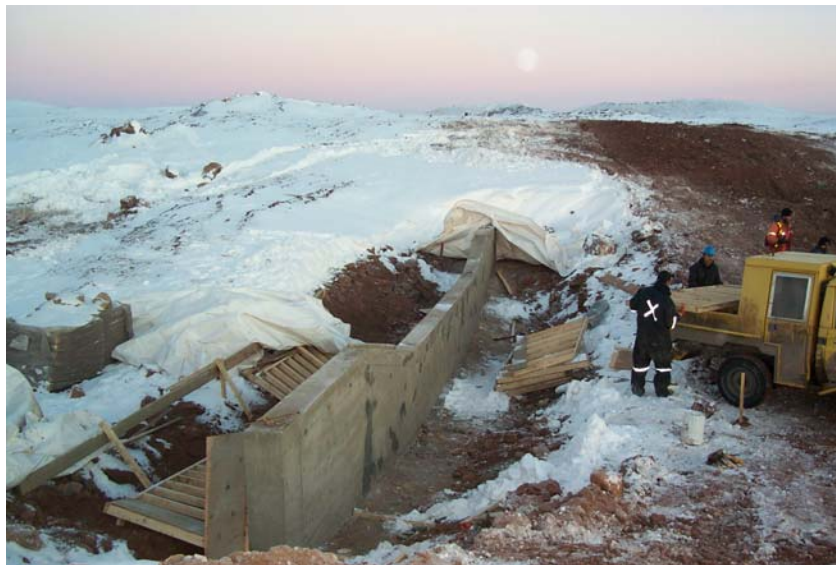
West Twin outlet structure: The excavation for the WTDA outlet structure was begun on September 9, with the foundation poured on Sept. 20 and the wall poured on September 29. The completion of the structure (final excavations and riprap fill) and the reinforcement of the West Twin diversion dike were scheduled for October.

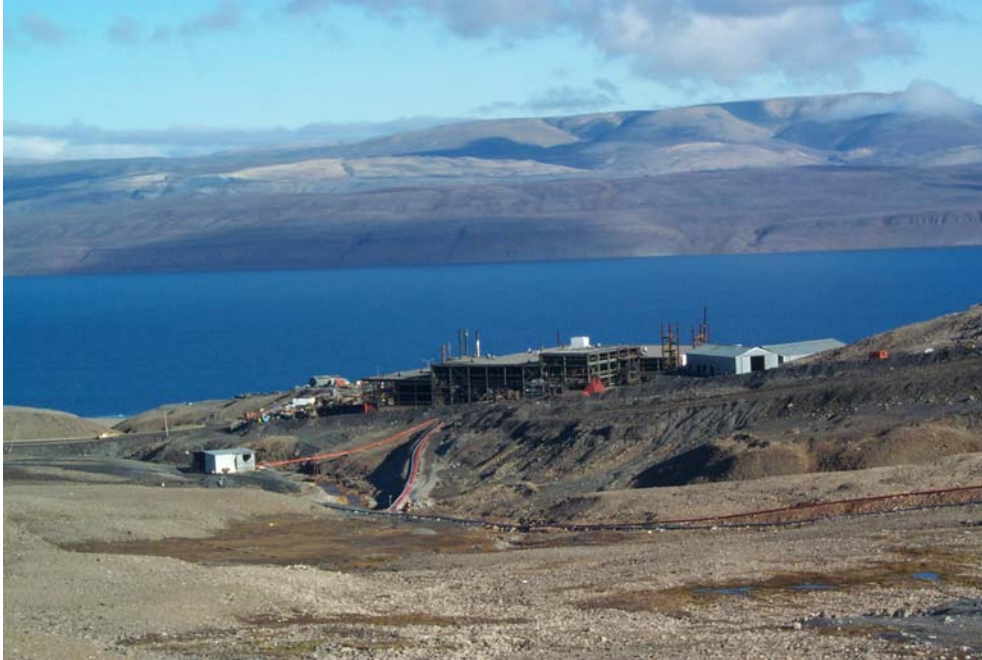
Vendetti Construction, (the contractor for Wolfden Resources) continued dismantling the mill and related infrastructure. Most of the exterior cladding and insulation has now been removed.

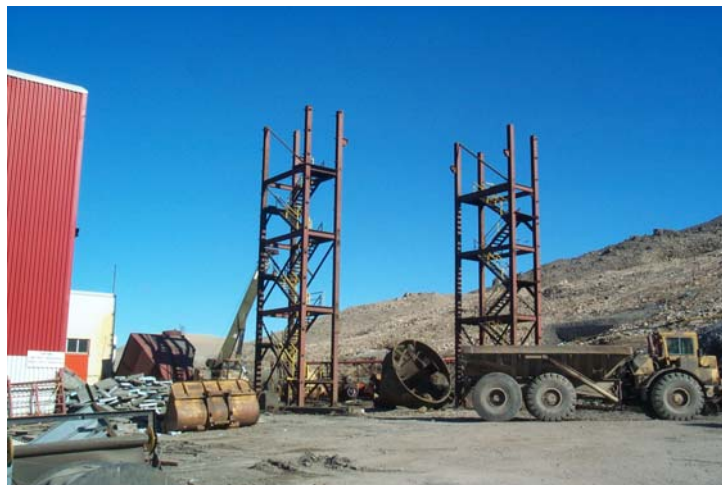
The DMS plant was dismantled except for the two stairwells which will be taken down next year.

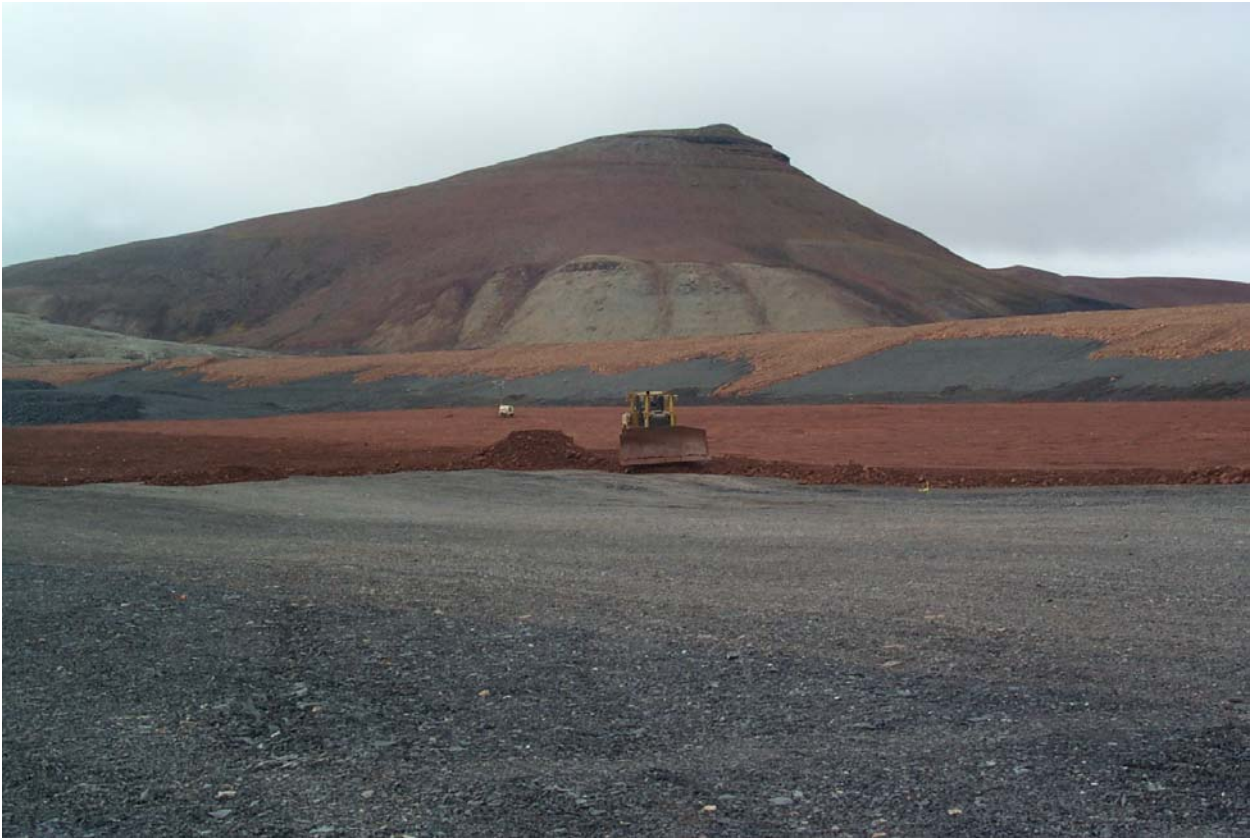
Sand and Gravel Cover in progress at the Test cell

Tailings ponds: The remaining shale cover on the “toe” areas of the test cell and surface cell were completed in August. The shale came from material that was hauled in the previous quarter and stockpiled on site.

The sand and gravel cover which was begun in a small way in the last quarter, proceeded to completion from August 23 to September 22. In that period *149,000m³ of material (from the East Twin sand & gravel borrow area) were placed, graded and compacted.

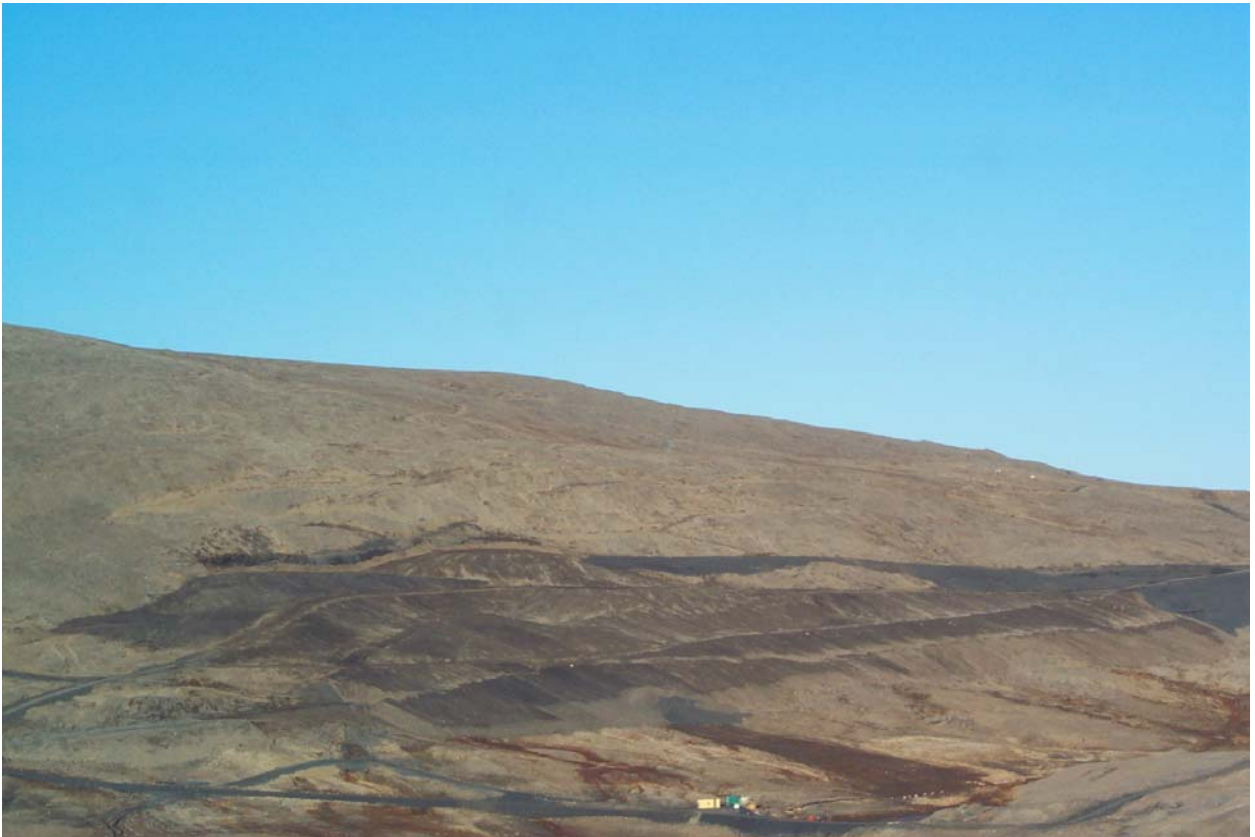
View of the reclaimed East Open Pit

In total *188,000m³ of shale was quarried from the Shale Hill borrow pit and placed to grade during this period. *37,000m³ of sand and gravel armouring (acquired from areas adjacent to the pit) was applied. The design cover for this area is now complete excepting for a minor touch up at the deflection berm located at the toe of the cover (to be completed in 2006).

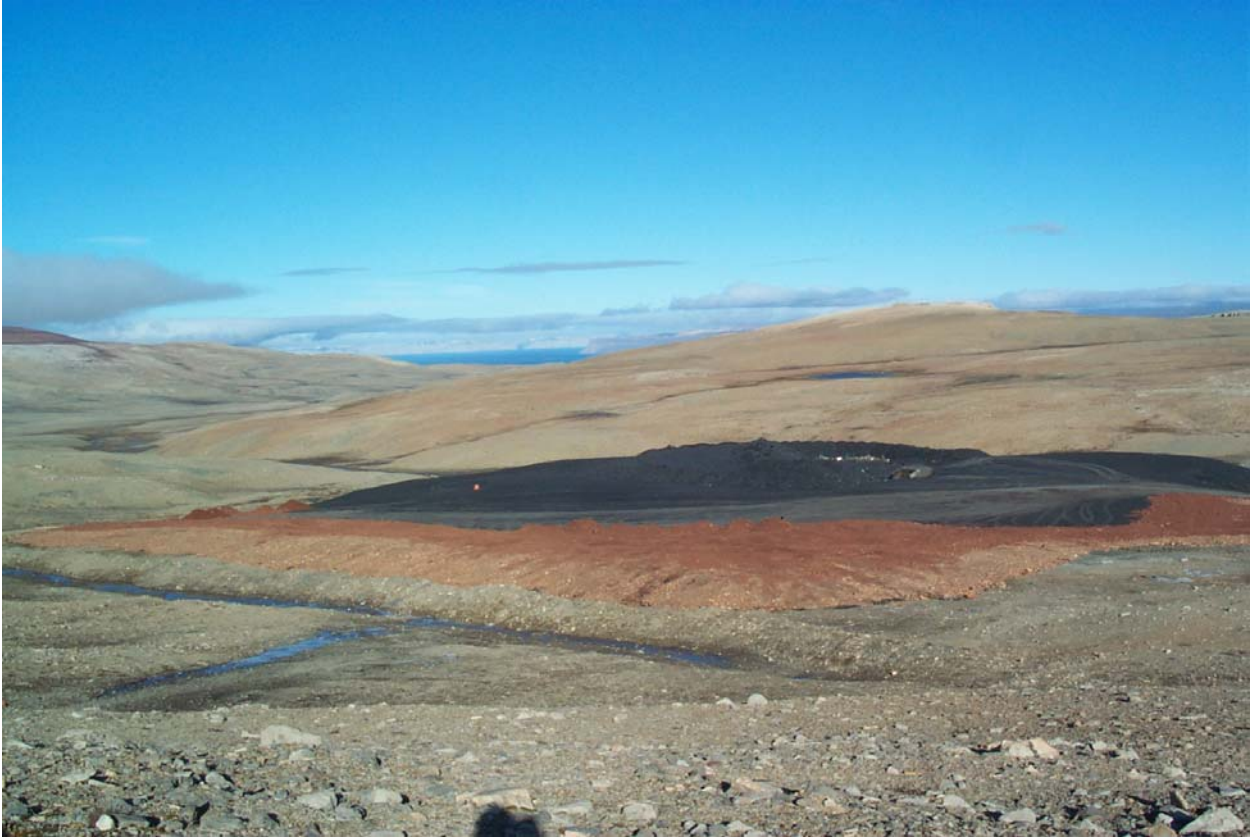
Sand and Gravel placement at the landfill site in progress

In total *1,000m³ of shale was quarried from the Landfill borrow pit and placed to grade during this period to complete the shale cover. *12,000m³ of sand and gravel armouring (acquired from the East Twin sand & gravel borrow area) was applied. The design cover for this area is now complete.

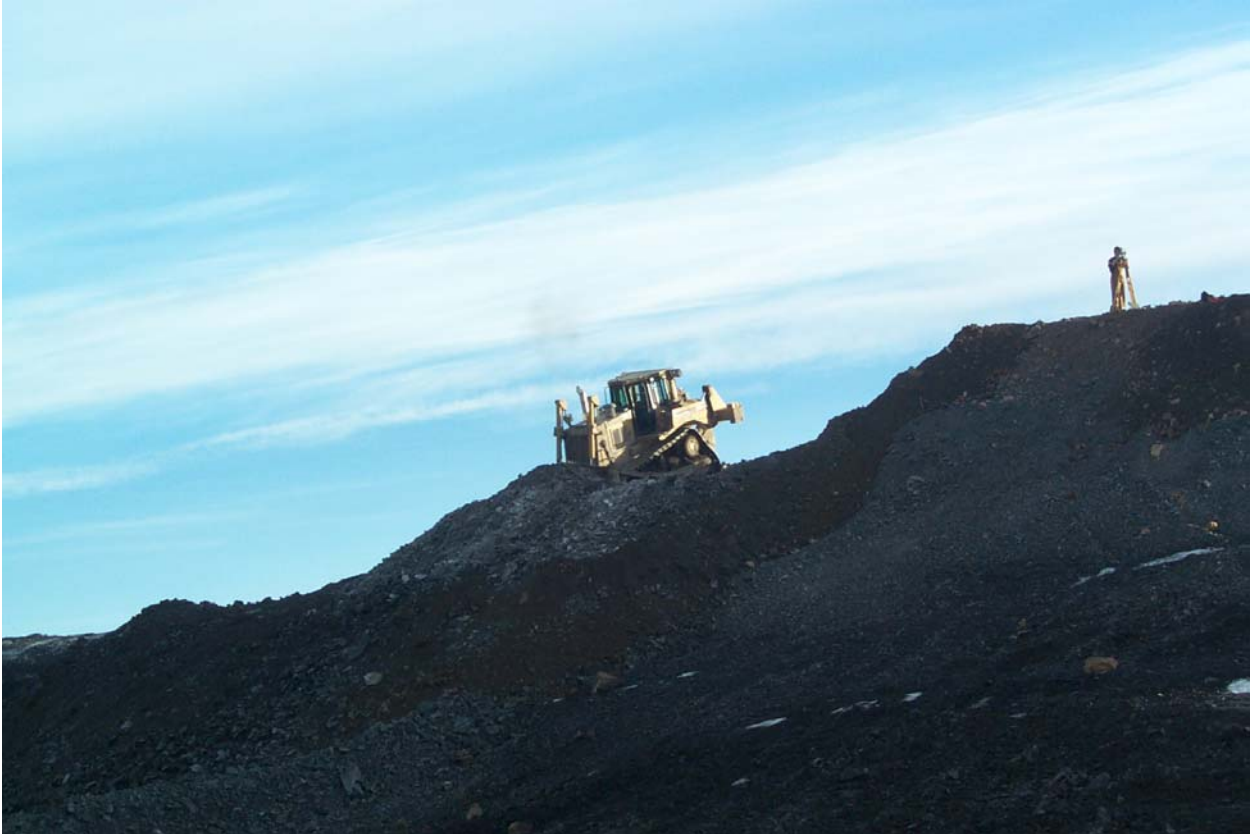
Final Sloping of the Shale Hill Quarry

Shale Hill pit: This pit was active during the quarter. The pit has been reclaimed.

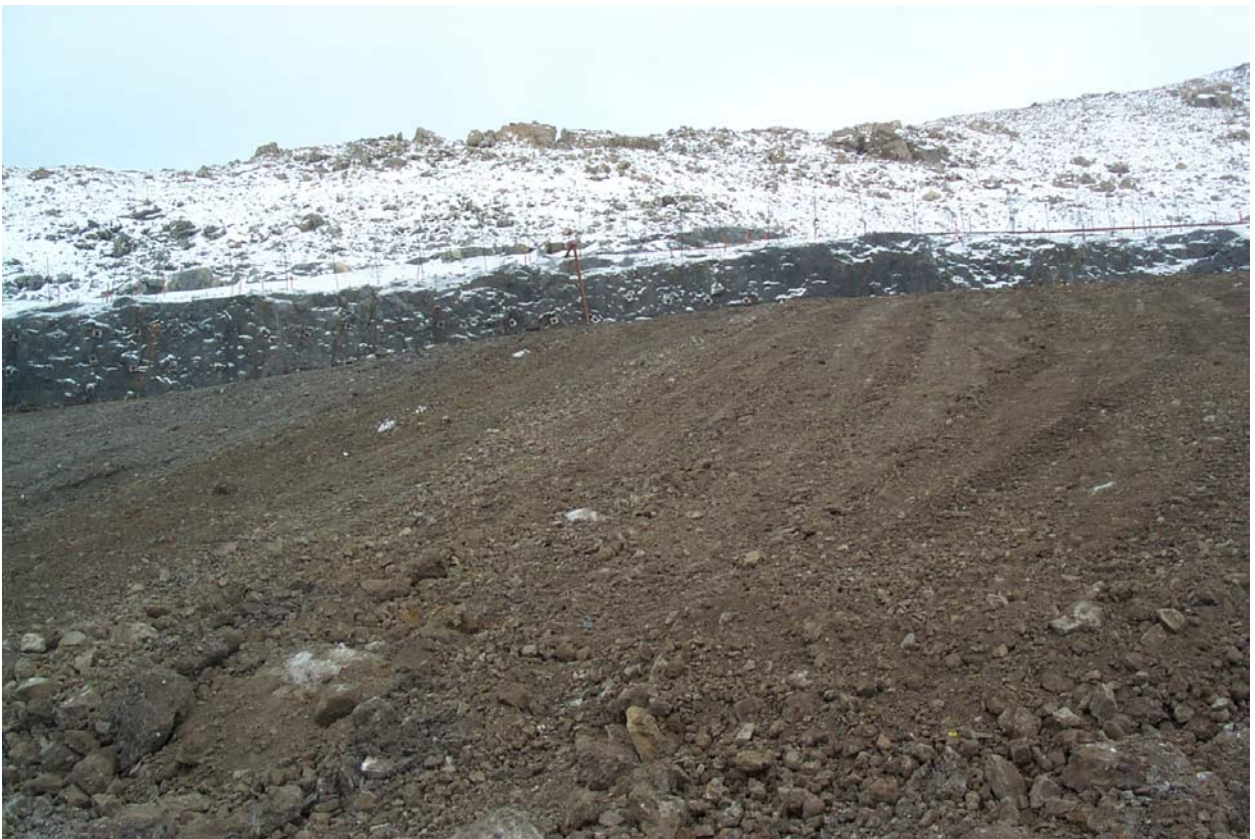
Waste Rock placed in the West Open Pit

Waste rock located along the roadway and slopes from 09S portal to the West open pit was removed and placed in the pit excavation. In total 24,000m³ of waste rock were removed by excavation up September 30, 2005. Portals 00 and 01 were closed as part of this operation. An additional 380 cubic metres of hydrocarbon contaminated soils from the day tank near oo portal were excavated and hauled underground. Some of the shale cover will be placed in the 4th quarter and the remainder (including the armour rock) is scheduled for 2006.
