Nanisivik Mine
RECLAMATION ACTIVITIES
QUARTERLY REPORT (2nd quarter 2007)

(PER Water License NWBNAN0208)

The information contained herein is submitted as the Quarterly Report covering the months of April through June 2007. The reclamation activities at Nanisivik during this period included the following:

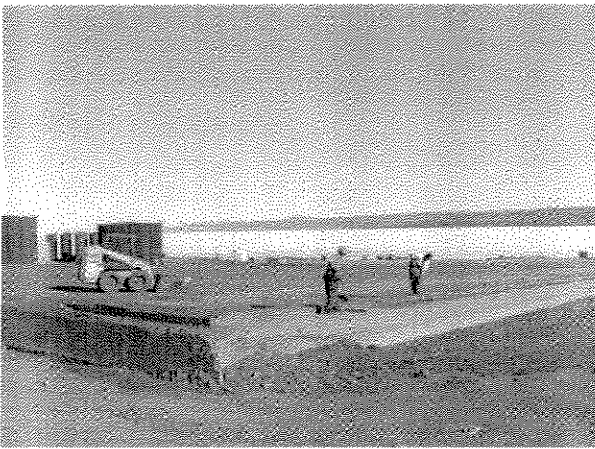
Sweeping operations on con shed floor

The remaining concrete pony walls were removed and hauled underground during the quarter. In addition to this, the slab was cleaned using a mechanical sweeper. Final cleaning of the joints and edges would be completed in the 3rd quarter. Excavation of contaminated soil adjacent to the concentrate shed foundation was well underway by the end of June. A grader was utilized for the large flat lay down area adjacent to the roadway, as metal contamination here was very shallow. Some areas however required additional excavation utilizing the flat lip bucket on the excavator. Excavation of Hydrocarbon contaminated soil from the former lunch shack (refuge station) also began during the quarter. Extensive sampling and on site testing was ongoing throughout the clean up process, enabling us to reasonably delineate the contaminated areas.

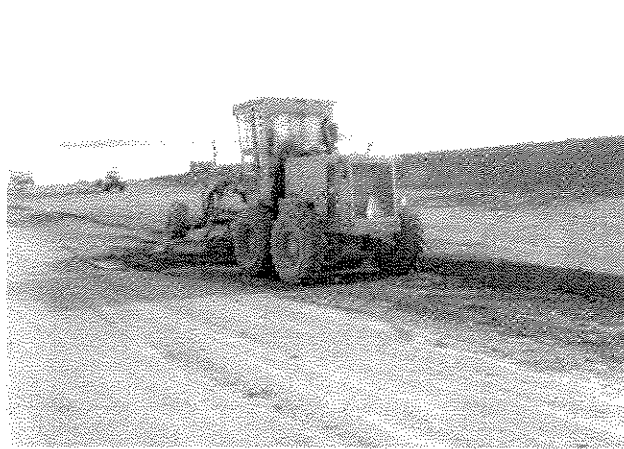
Scraping up metal contaminated soil
