**Decommissioning of Dock Facilities at Polaris Mine
Little Cornwallis Island, Nunavut**

**00282
March 2001**

Westmar

COMINCO LTD.

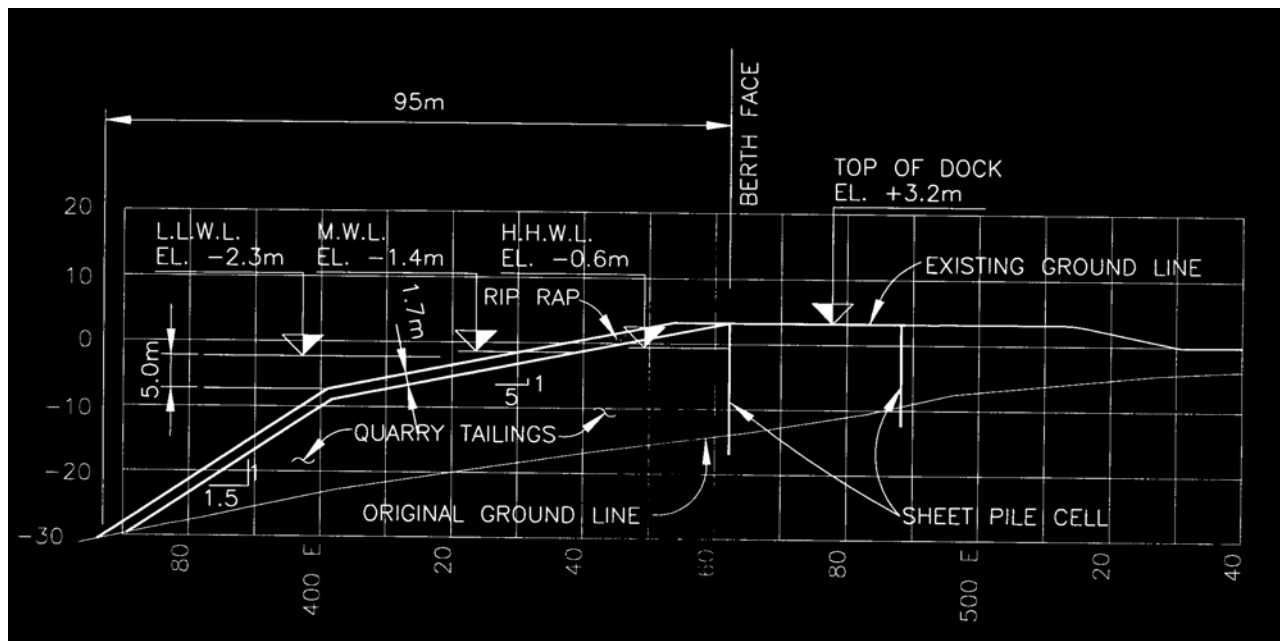
Figure 9: Cross-section through dock at Station 1400 N

showing Option 2, to encase dock in rock (Scale 1:1,000).

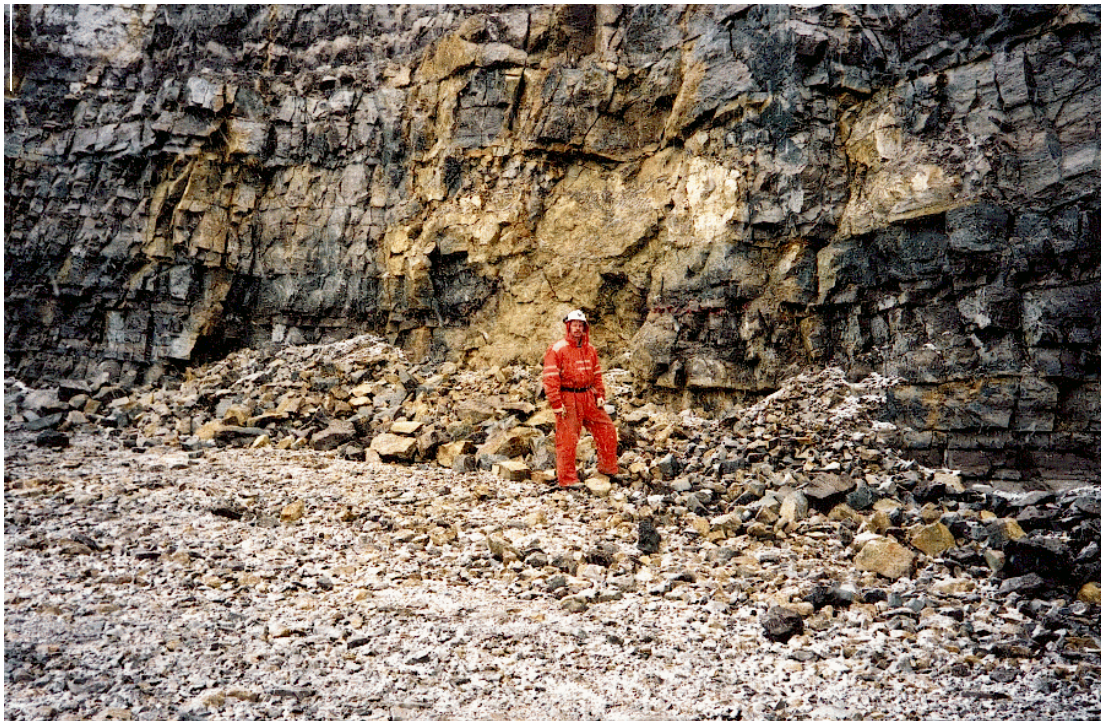
Photograph No. 1: Quarry face in Little Red Dog Quarry (August 17, 2000).

LRDQ is generally highly fractured, as can be seen in *Photograph No. 1* in *Appendix B*. The joint spacing in the quarry will limit the mean size to the range of 400 mm to 500 mm. This size of rock was achieved just south of the dock at Station 1300 N, as shown in *Photograph No. 13*.

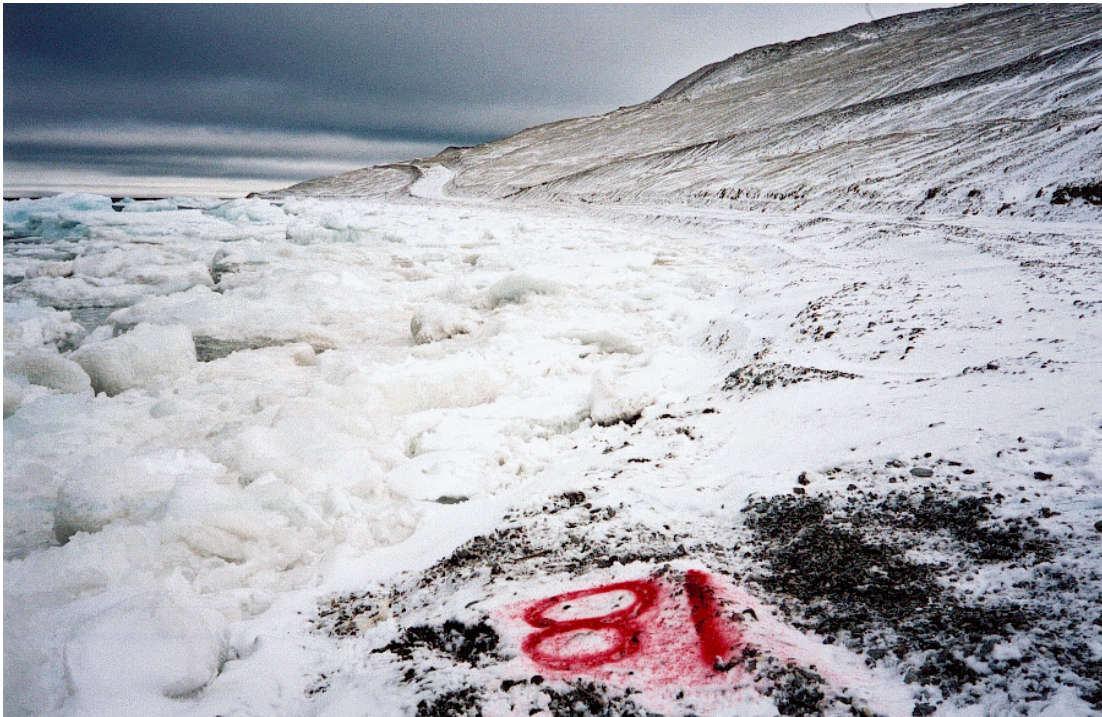
Photograph No. 5: View of shoreline looking north at Station 1800 N. The beach is natural at this location, and is comprised of gravel with a mean size of about 10 mm (August 19, 2000).

Station	Existing Shoreline and Dock	Shoreline After Decommissioning
1800 N	Natural beach gravel with a mean grain size of about 10 mm.	The natural beach will remain unchanged.
1700 N	The north end of the fill, with some pieces of rock up to 300 mm cubic size.	The bank will be trimmed landward from the mean water mark along a slope of about 17.5H:1V to high water, and then faired into the existing ground line over a total distance of about 25 m. Erosion and sedimentation is controlled by the flat slope and permafrost.
1600 N	Near the north end of the fill. The fill is not covered by riprap at this location, and has some pieces of rock up to 300 mm cubic size.	The bank will be trimmed landward from the mean water mark along a slope of about 17.5H:1V to high water, and then faired into the existing ground line over a total distance of about 45 m. Erosion and sedimentation is controlled by the flat slope and permafrost.

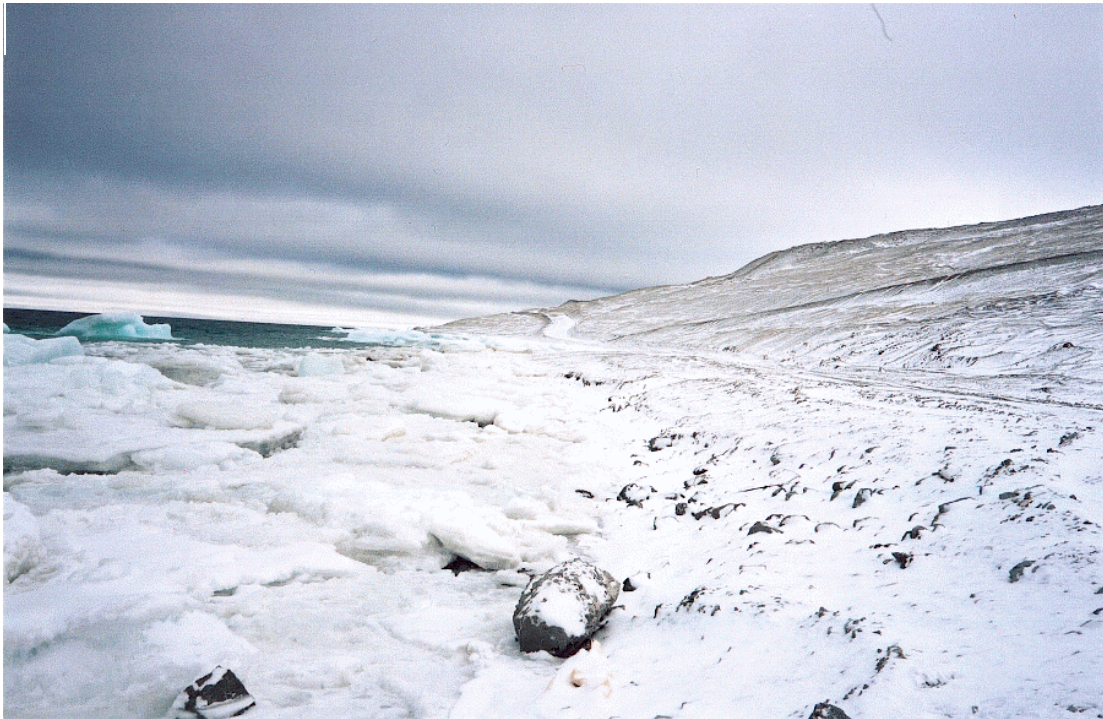
Photograph No. 6: View of shoreline looking north at Station 1700 N. The fill, which is tapering out at this station, is about a 300 mm minus material. (August 19, 2000).

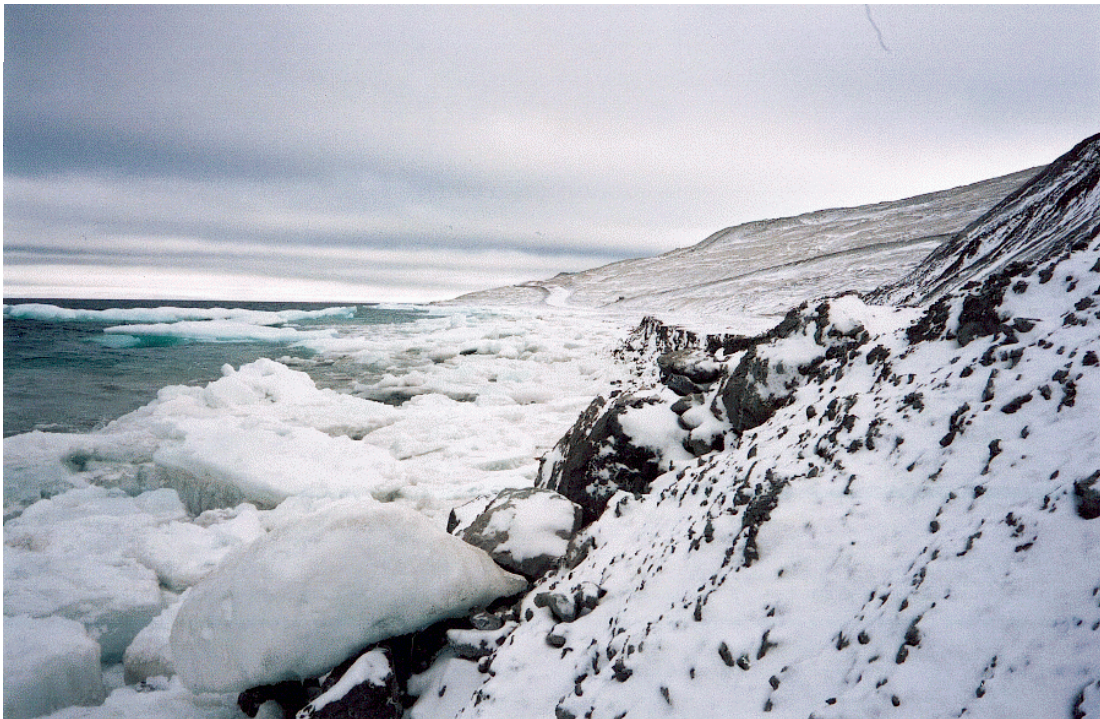
Photograph No. 8: View of shoreline looking north at Station 1600 N. The fill is about a 300 mm minus material, with a mean size of 25 mm. (August 19, 2000).

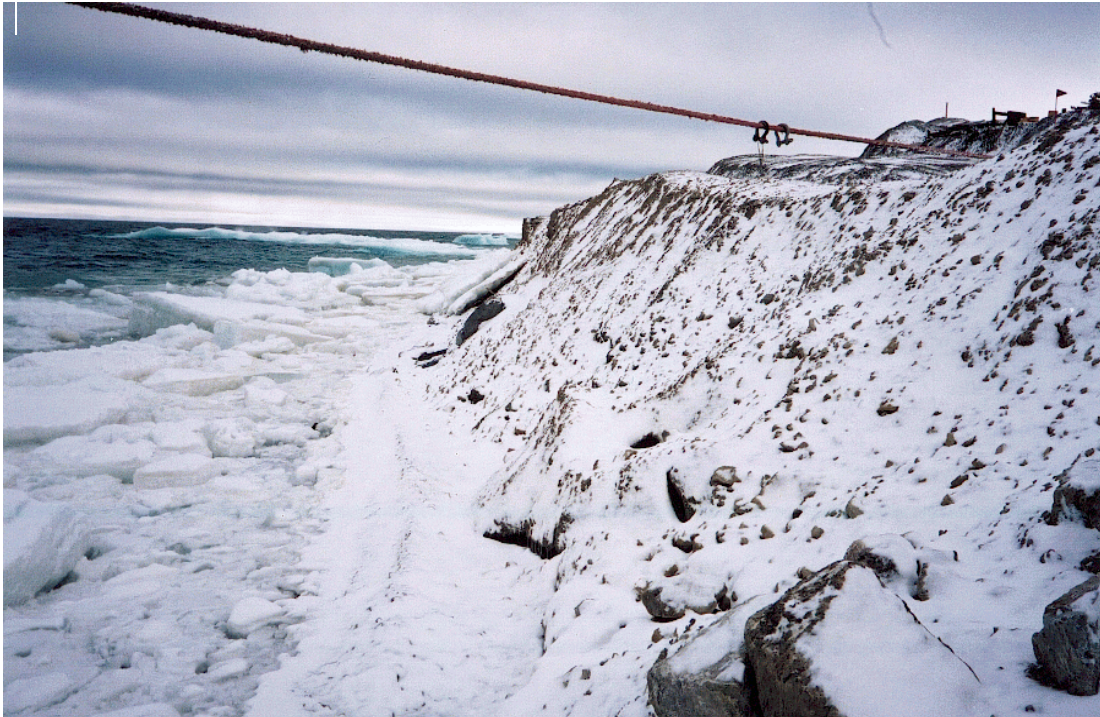
Photograph No. 10: View of shoreline looking north at Station 1500 N. The shoreline to the north of 1500 N is fill comprised of material with about 300 mm minus material. (August 19, 2000).

1500 N	The bank to the north of this location is not covered with riprap, while the bank between this location and the dock is covered with riprap with a mean size of about 300 mm cubic dimension.	The bank will be trimmed landward from the mean water mark along a slope of about 17.5H:1V to high water, and then faired into the existing ground line over a total distance of about 25 m. Erosion and sedimentation is controlled by the flat slope and permafrost.
1400 N	This section passes through the sheet pile cell dock and the Process Barge.	A plane sloping upward at 17.5H:1V from about 2 m below low water at the front of the dock, intersects the surface of the fill about 60 m west of the Process Barge. Erosion and sedimentation is controlled by the flat slope and permafrost.
1300 N	The bank at this location is covered with what is likely the largest possible size of riprap from Little Red Dog Quarry and observed on the shoreline, with a mean size of 400 mm to 500 mm.	The bank will be trimmed landward from the mean water mark along a slope of about 17.5H:1V, and faired to the existing ground line over a total distance of about 75 m. Erosion and sedimentation is controlled by the flat slope and permafrost.

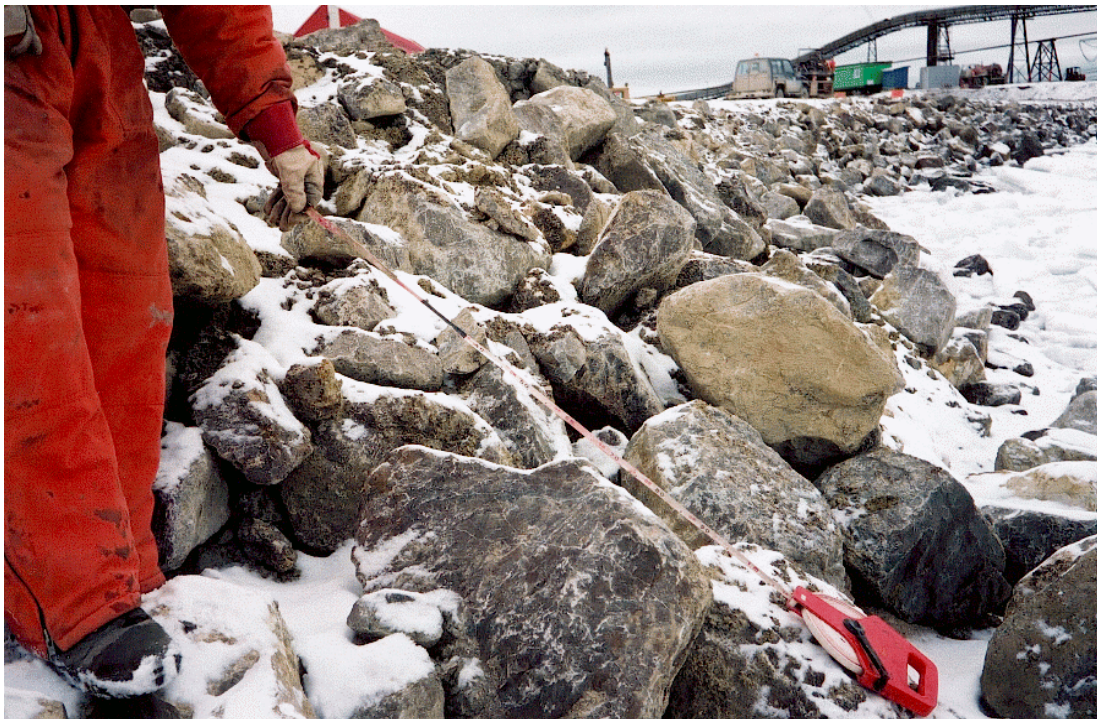
Photograph No. 11: View of shoreline looking south at Station 1500 N. The shoreline is covered

with rip rap to the south of Station 1500 N, with a mean size of about 300 mm (August 19, 2000).

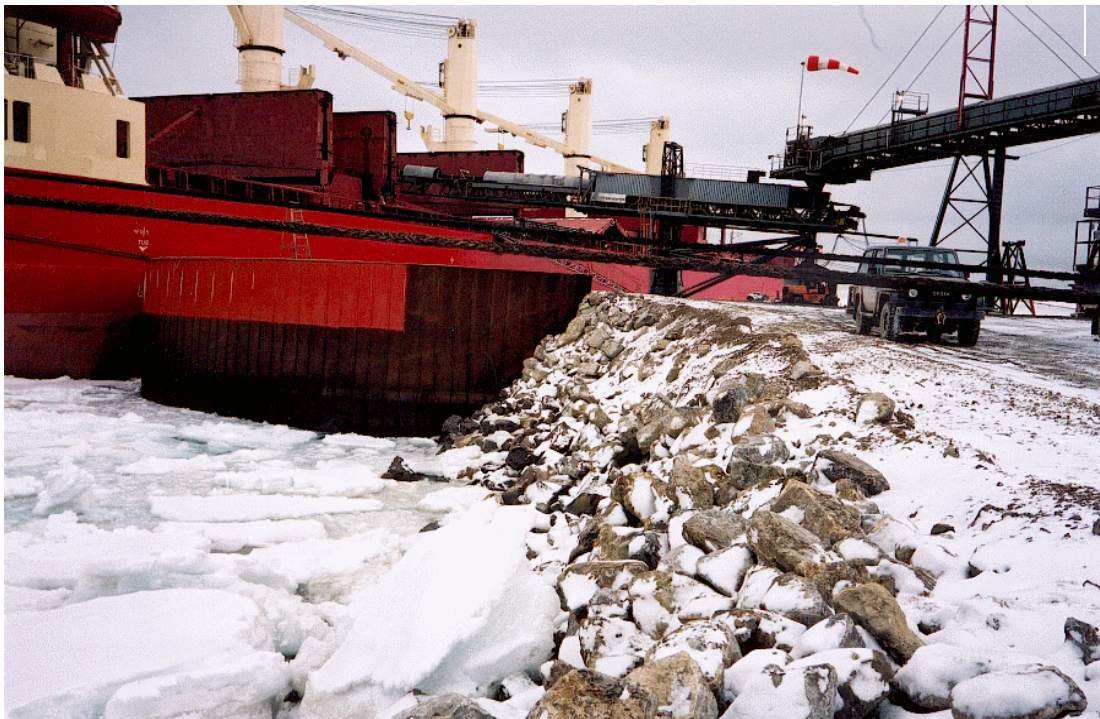
Photograph No. 12: View of shoreline looking north at Station 1300 N.
New riprap has been placed in this area in the last 2 years. (August 19, 2000).

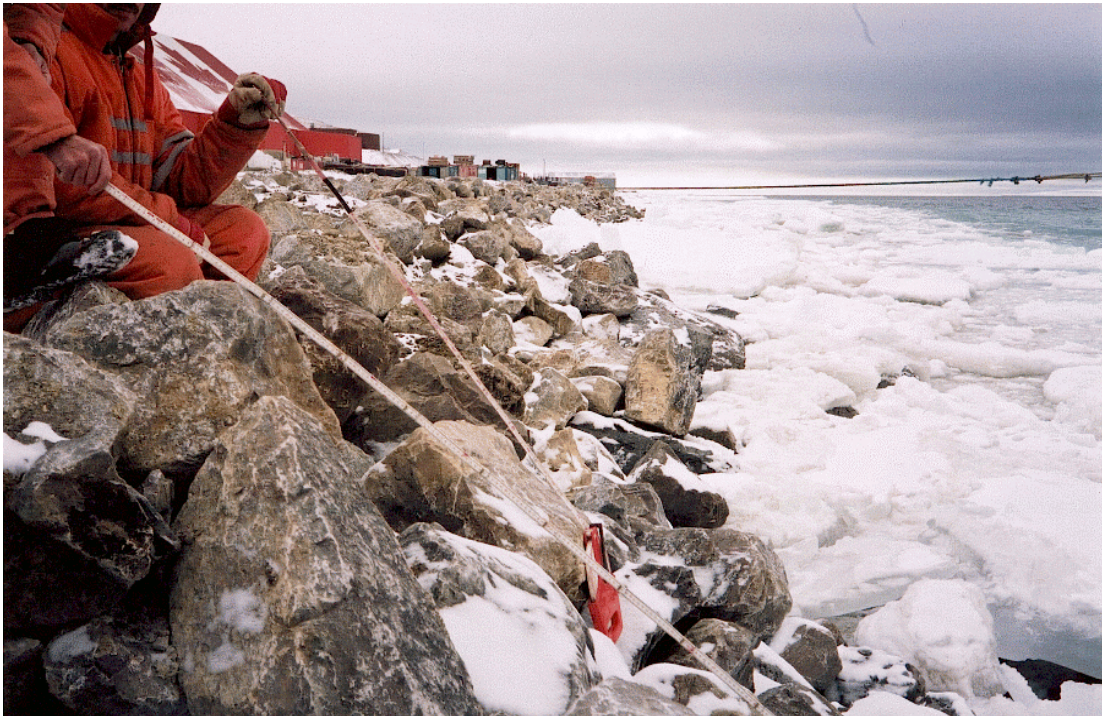
Photograph No. 13: View of shoreline looking south at Station 1300 N. This area has the largest size rock produced from the Little Red Dog Quarry and used as riprap, with a mean size in the range of about 400 mm to 500 mm. (August 19, 2000).

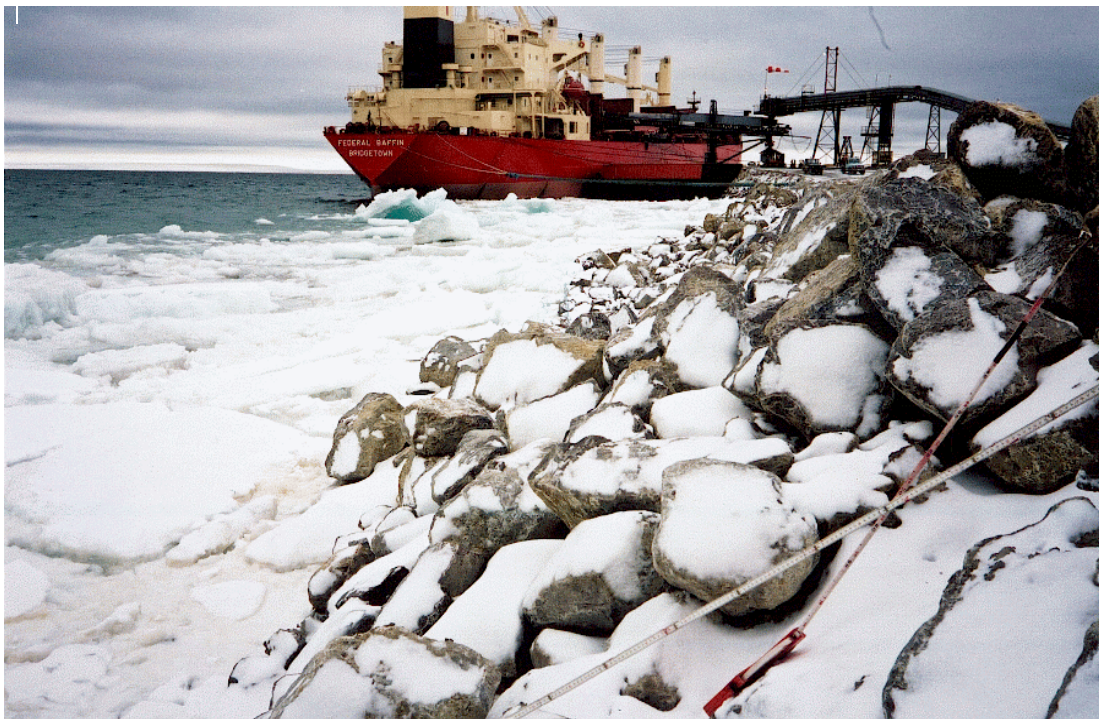
Photograph No. 14: View of shoreline looking north at Station 1200 N. New riprap has been placed between here and the dock in the last 2 years, and has a mean size of about 300 mm. (August 19, 2000).

1200 N	The bank between this location and the dock has been armoured with riprap in the last two years, while the shoreline south of this location has not and the gravel fill is generally unprotected from wave attack and is eroding.	The bank will be trimmed landward from the mean water mark along a slope of about 17.5H:1V to the existing ground line over a distance of about 35 m. Erosion and sedimentation is controlled by the flat slope and permafrost.

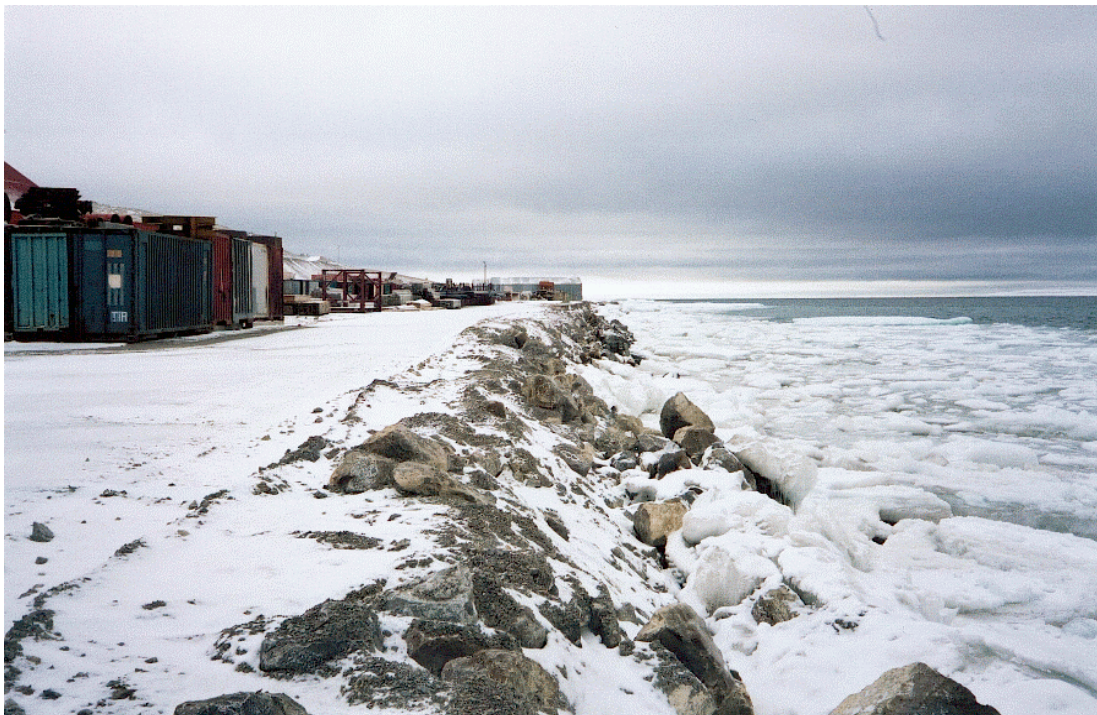
Photograph No. 15: View of shoreline looking south at Station 1200 N. It has been more than

two years since riprap has been placed south of Station 1200 N. (August 19, 2000).

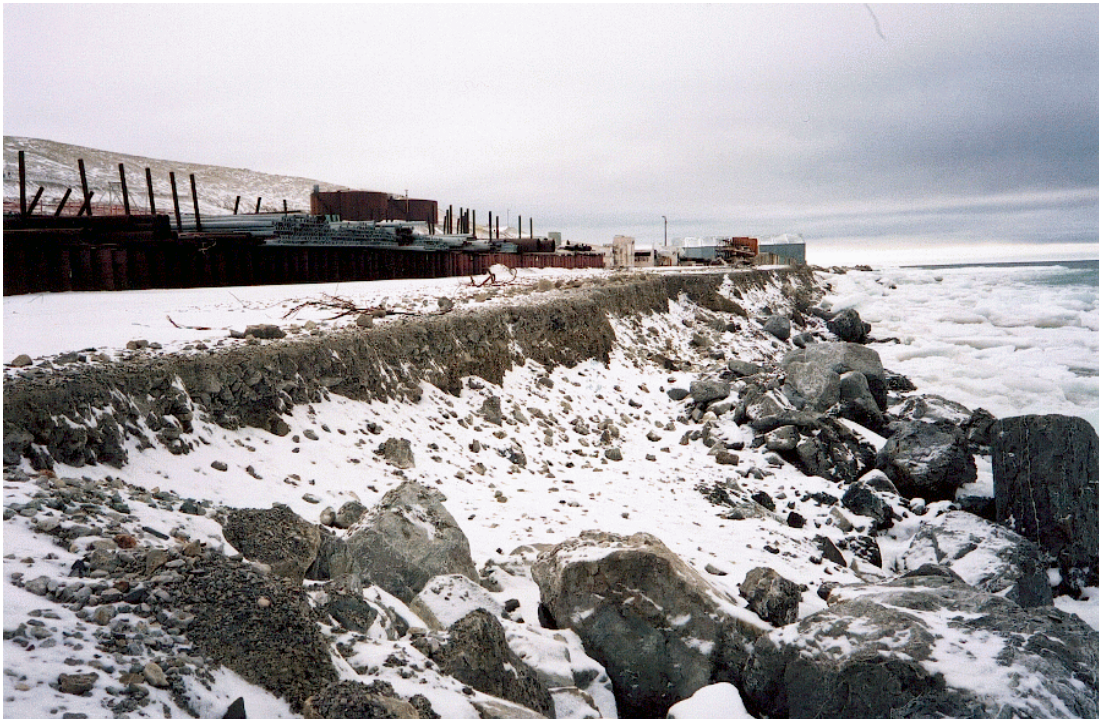
Photograph No. 17: View of shoreline looking south at Station 1100 N. The riprap is failing and the bank behind the riprap is eroding. Some larger pieces of mine rock are in the order of 900 mm cube size, and are deteriorating rapidly due to freeze/thaw cycles. (August 19, 2000).

Station	Existing Shoreline and Dock	Shoreline After Decommissioning
1100 N	The bank is exposed to wave action as much of the riprap has slipped down the bank.	The bank will be trimmed landward from the mean water mark along a slope of about 17.5H:1V to the existing ground line over a distance of about 35 m. Erosion and sedimentation is controlled by the flat slope and permafrost.
1000 N	Similar to Station 1100 N, the bank is exposed to wave action as much of the riprap has slipped down the bank.	The bank will be trimmed landward from the mean water mark along a slope of about 17.5H:1V to high water, and then faired into the existing ground line over a total distance of about 30 m. Erosion and sedimentation is controlled by the flat slope and permafrost.
900 N	This location is at the north end of the Temporary Dock, which was installed in 1980/81 to offload equipment at the site before the sheet pile cell dock was operational.	The bank will be trimmed landward from the mean water mark along a slope of about 17.5H:1V to high water, and then faired into the existing ground line over a total distance of about 30 m. Erosion and sedimentation is controlled by the flat slope and permafrost.

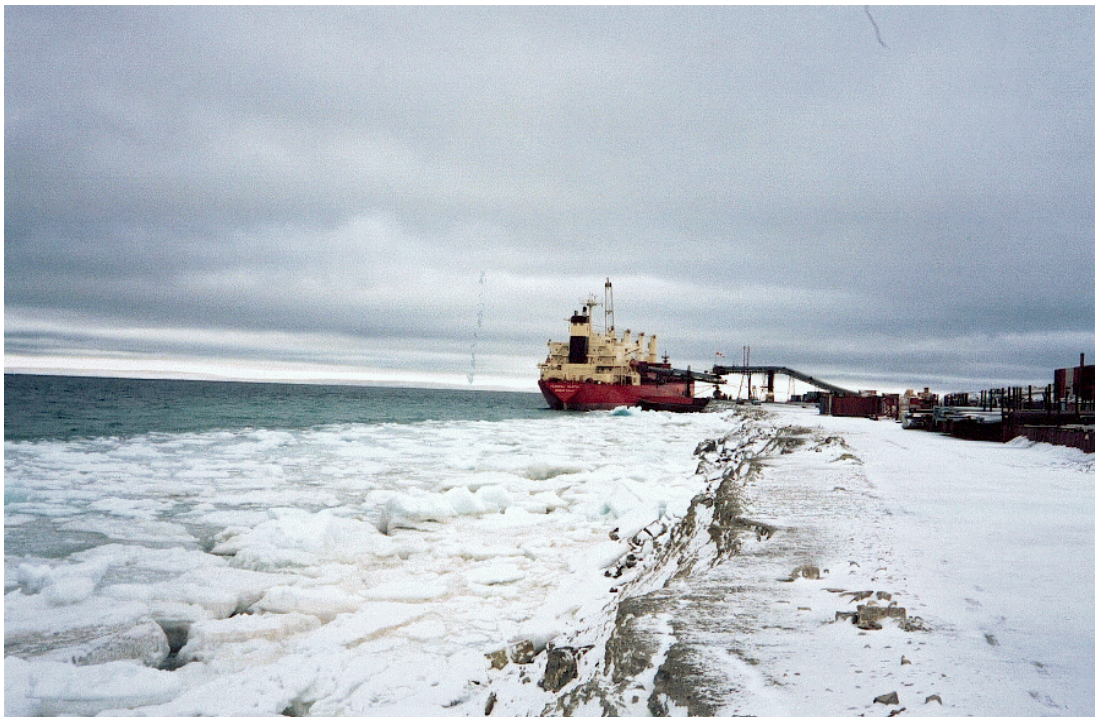
Photograph No. 18: View of shoreline looking north at Station 1000 N. Most of the riprap has slipped down the slope at this location. (August 19, 2000).

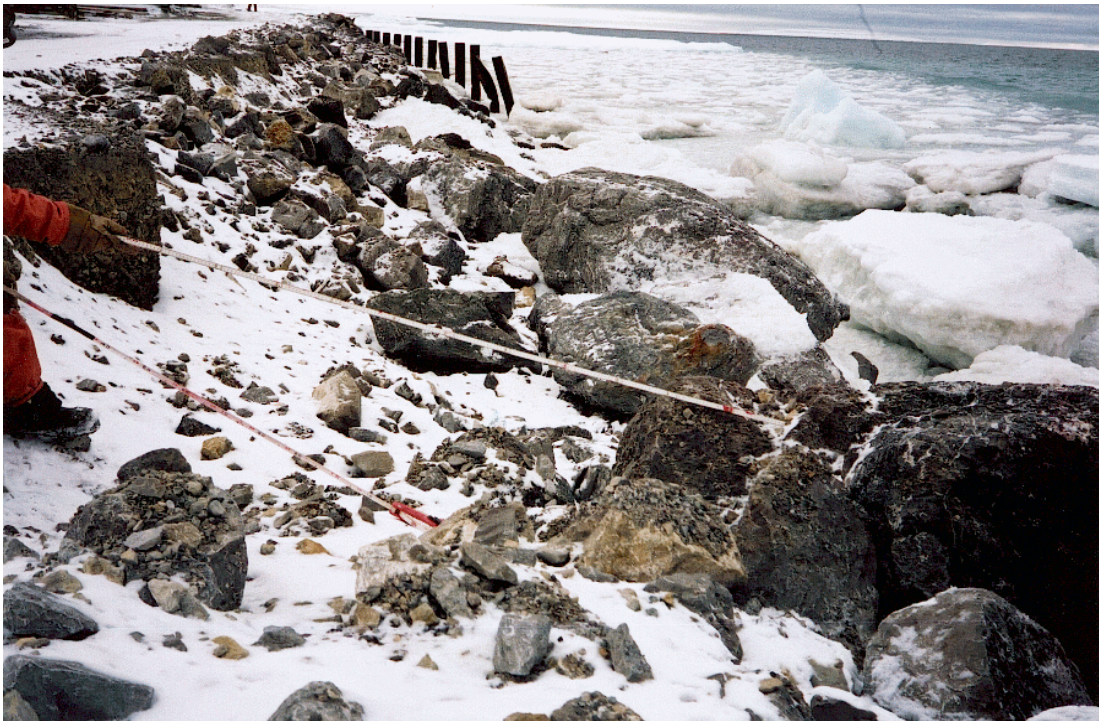
Photograph No. 21: View of shoreline looking south at Station 900 N. Note the H-Piles at the berth face of the temporary dock. (August 19, 2000).

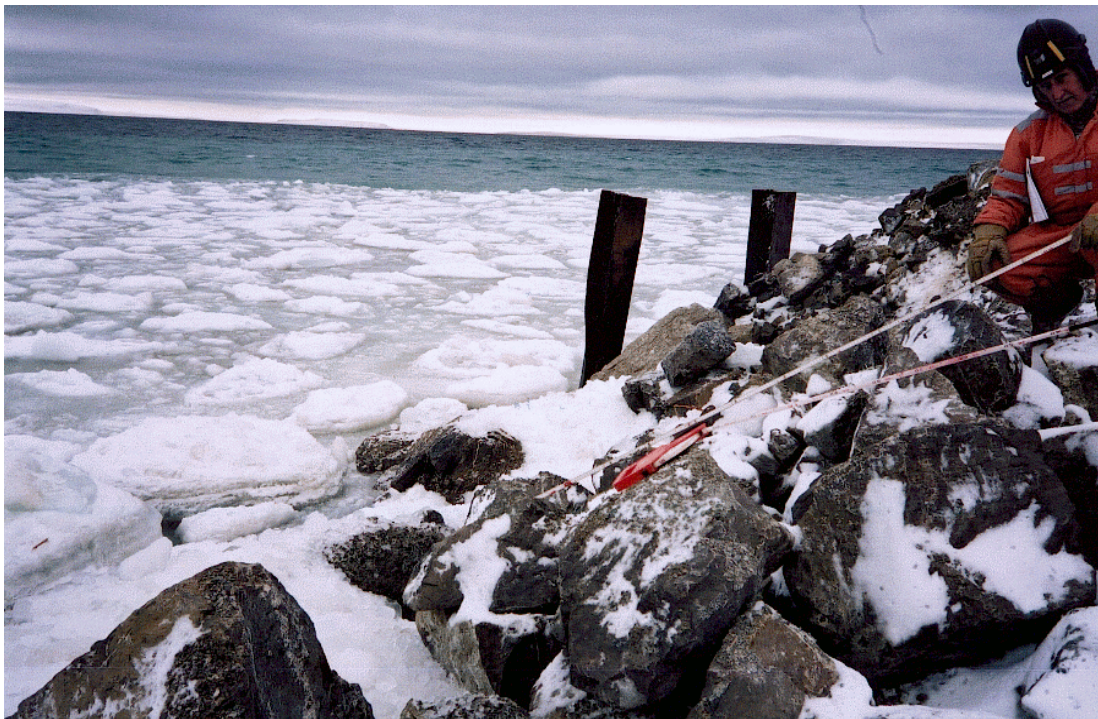
Photograph No. 22: View of shoreline looking north at Station 800 N. This is the southern extent of the riprap and is immediately south of the H-Piles at the temporary dock. (August 19, 2000).

800 N	This location is at the south end of the temporary dock. There is riprap immediately to the north of this location, and natural beach to the south of this location.	This section will have some minor trimming to fair in the shoreline. Erosion and sedimentation is controlled by the flat slope and permafrost.
700 N	Natural beach gravel with a mean grain size of about 10 mm, similar to Station 1800 N.	There is no excavation required at this location.

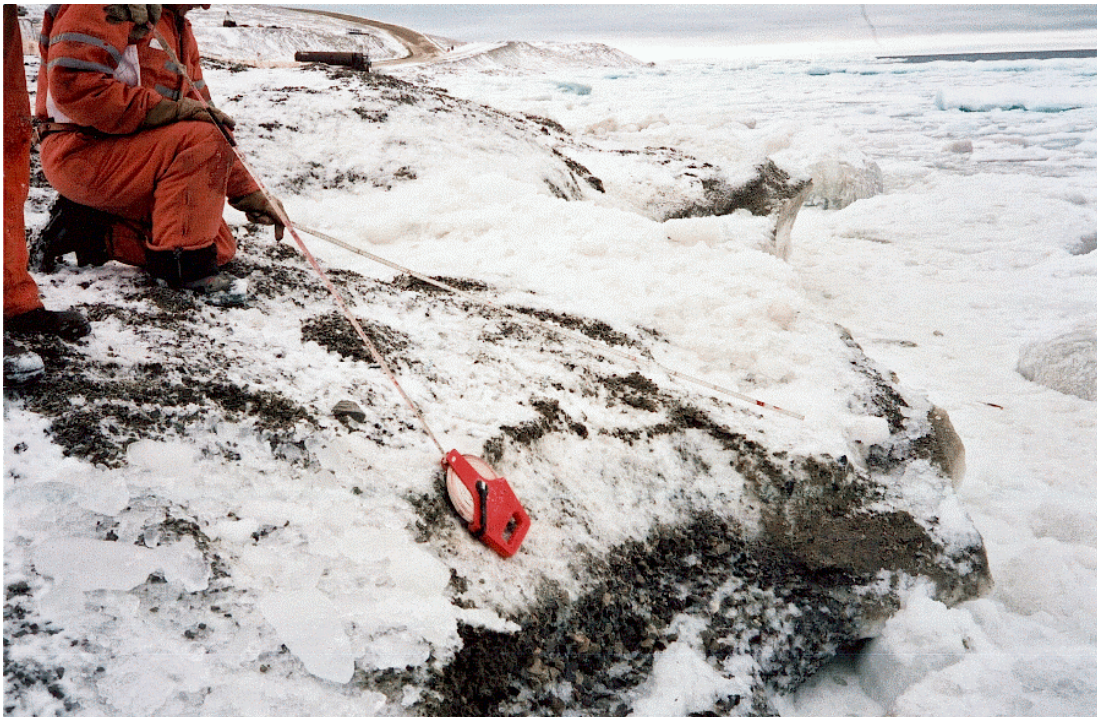
Photograph No. 23: View of shoreline looking south at Station 800 N.

The beach is natural material south of Station 800 N. (August 19, 2000).

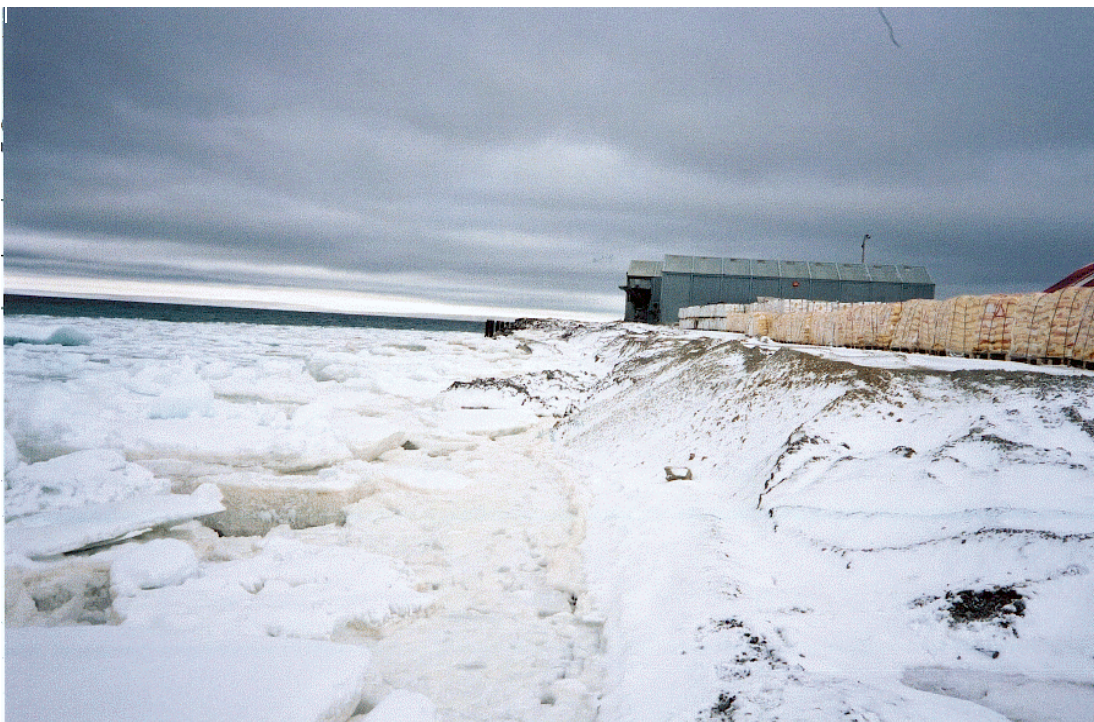
Photograph No. 24: View of shoreline looking north at Station 700 N. The beach is comprised of natural material at this location, with some regrading of the top of the bank to form a flat storage area. (August 19, 2000).
