APPENDIX 15

GEOTECHNICAL INSPECTION OF OPERATIONAL LANDFILL

**Subject: Landfill Cover 2003
Polaris, Nunavut**

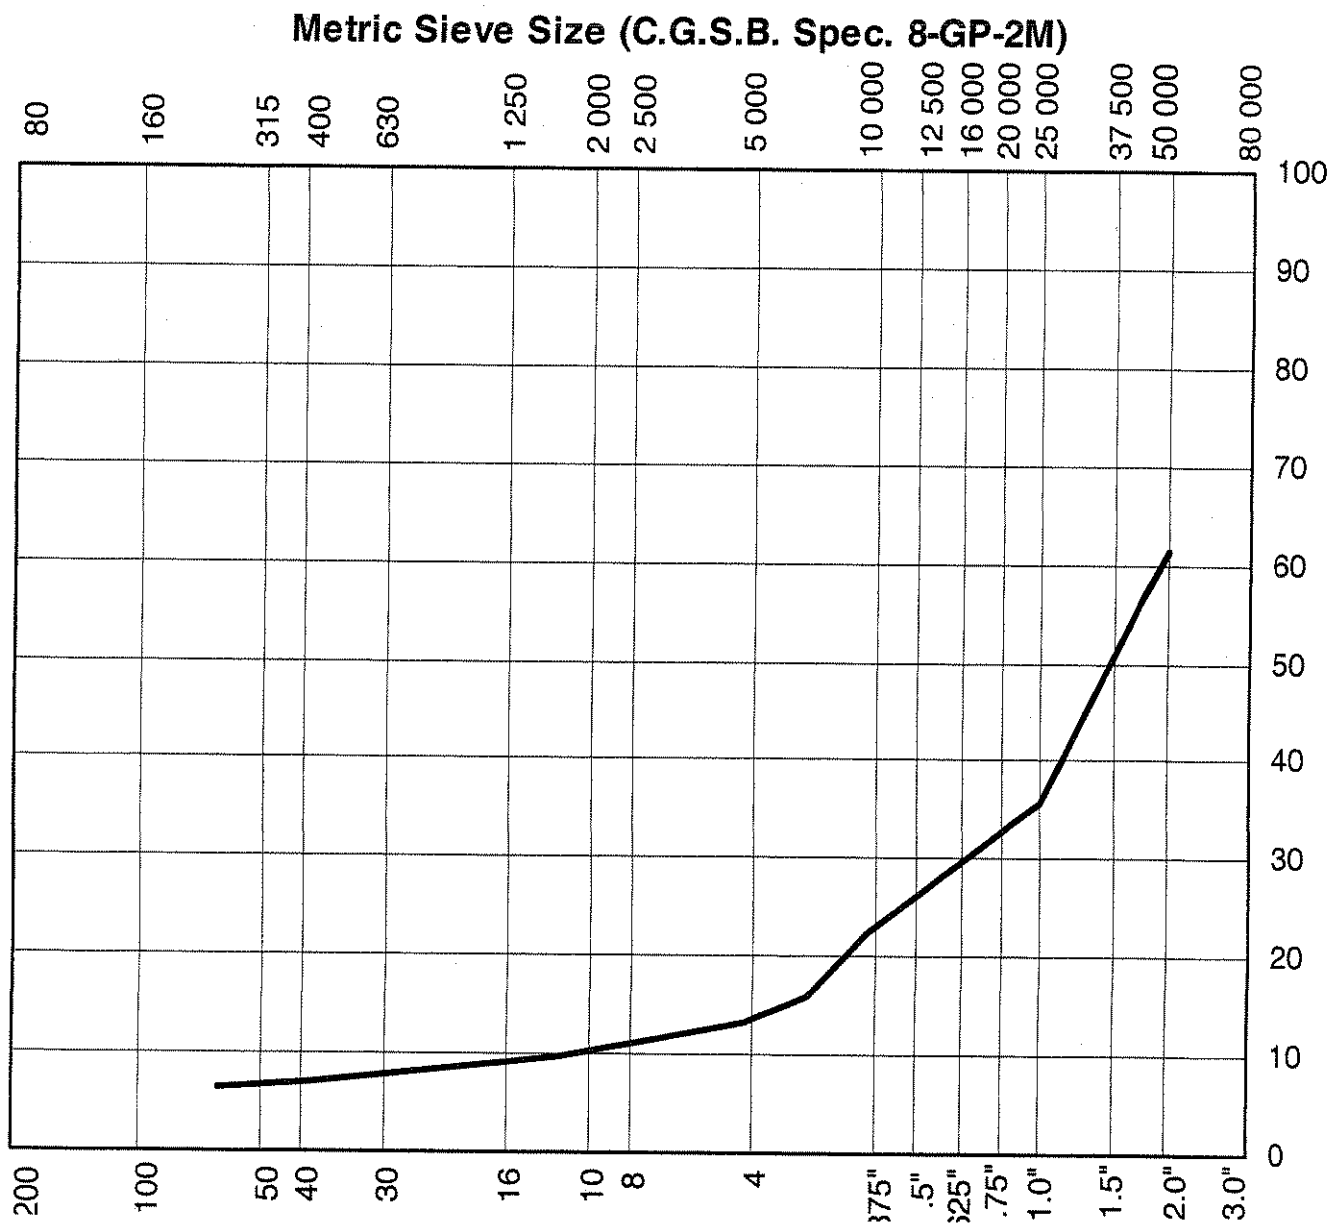
Plotted August 18th Results of Sieve Analysis by
TC for 200 mm minus Material- Only 80 mm
minus portion plotted

The results of two gradation analyses carried out by TC were provided to EBA (dated July 28 and August 18). Results of the gradation analyses are shown in Appendix B. Testing frequencies by TC are below that specified by GLL, however, the materials tested comply with the GLL gradation specification. TC reported that two or three other samples taken during cap placement remain to be tested.

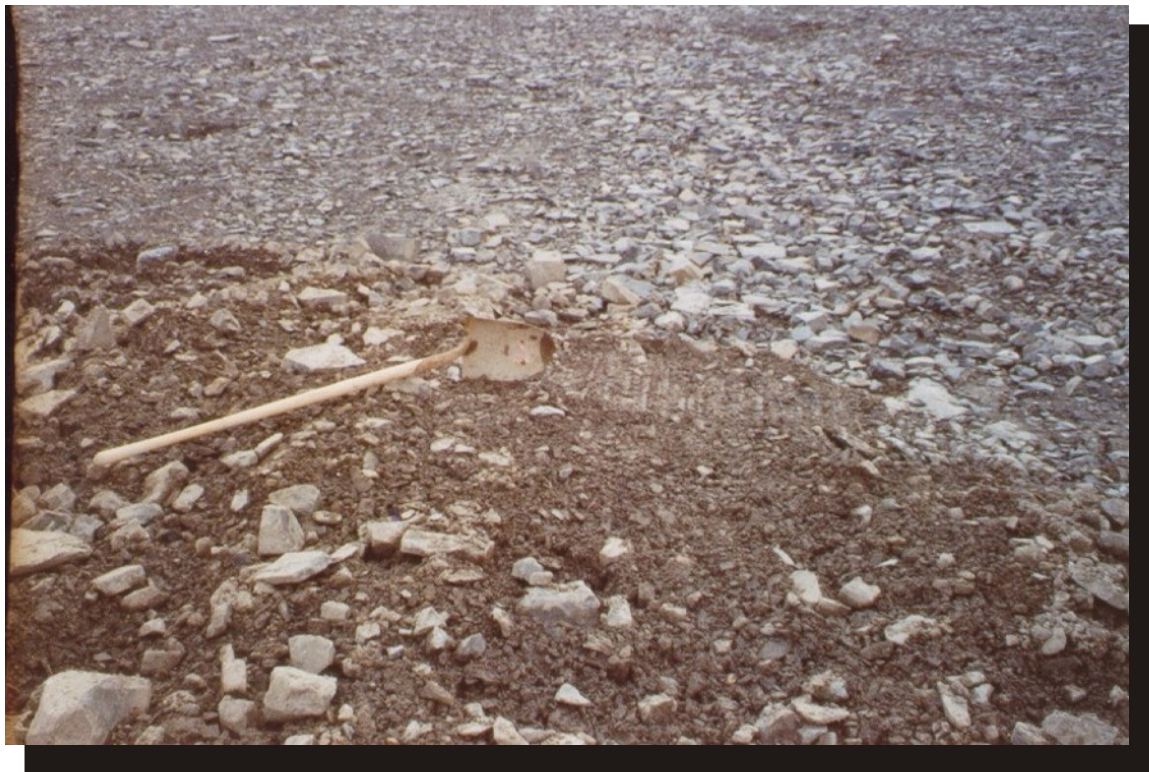
Photo 1

In general the shale fill appears clast supported, however, the fractions of sand and silt vary somewhat. Some areas showed substantial segregation at finished grade comprising entirely of gravel to cobble size angular materials that are very pervious (Photo 1). In other areas the matrix material is sand with some silt.

Typical segregated shale surface on landfill bench top.

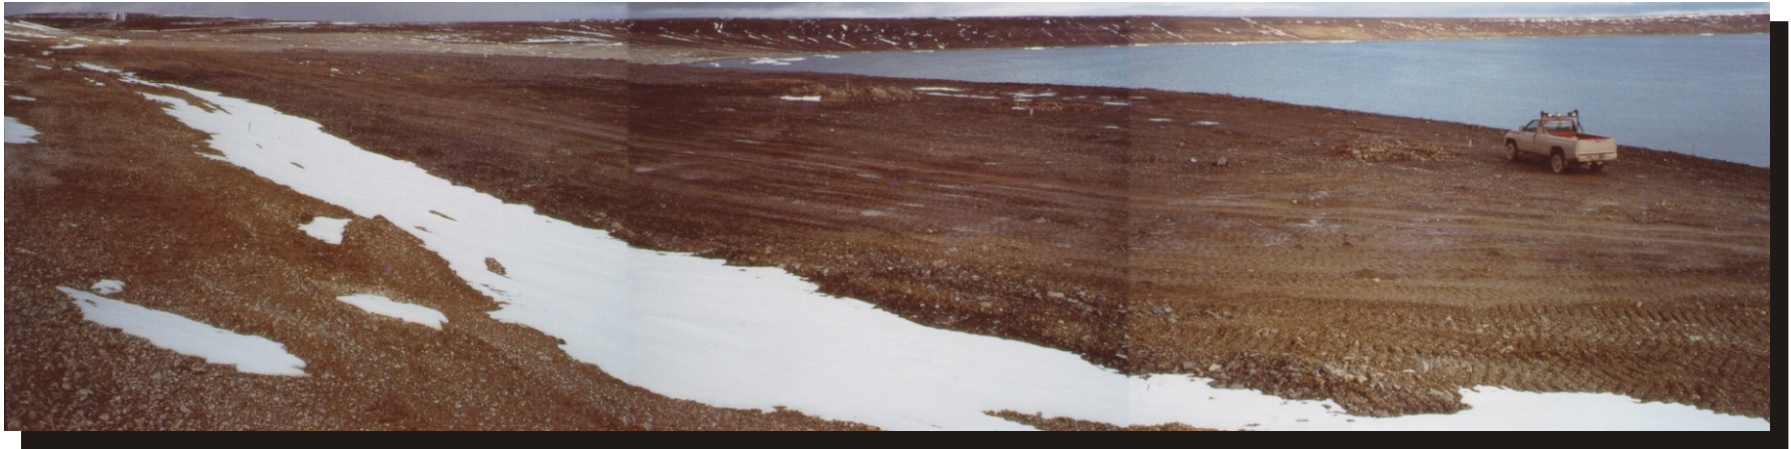
Photo 2
Panoramic view of top of landfill on August 19, 2003.

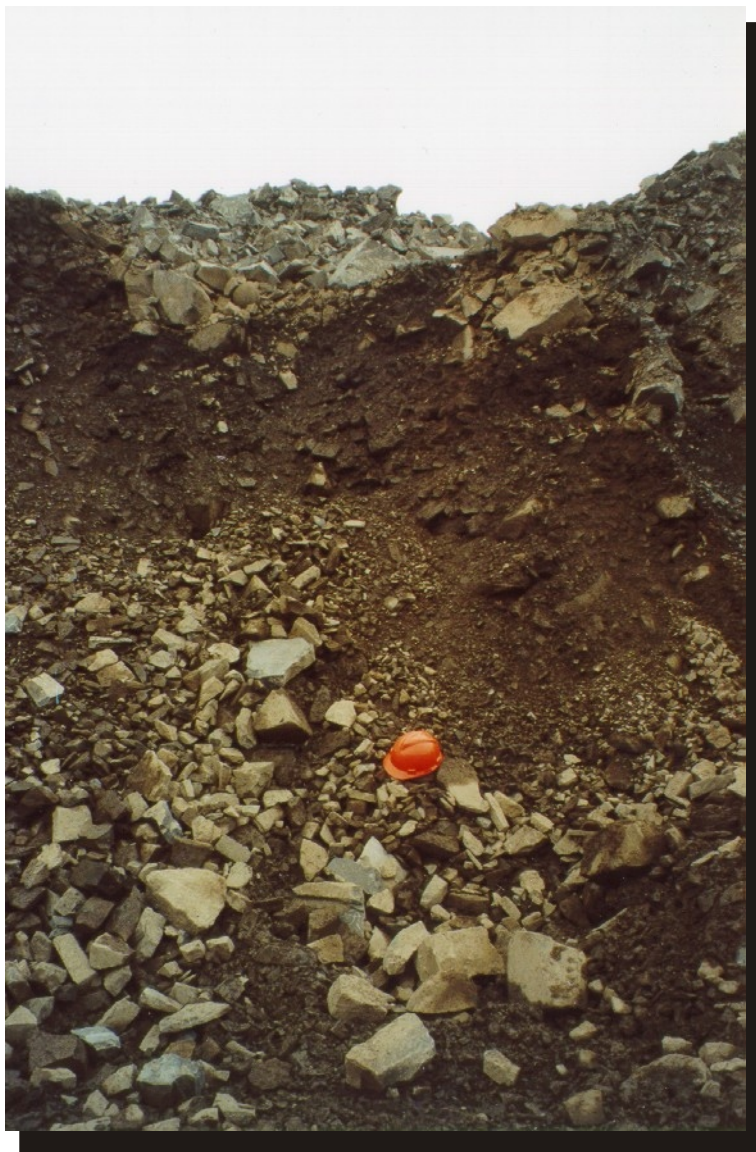
EBA observed that the imported shale cover consists of angular gravel, with sand, trace to some silt and with platy to blocky angular cobble size shale fragments. Gradation test results are described in Section 4.4. Photographs of the shale stockpile taken at the borrow source are also provided as Photos 3 and 4.

Photo 3
View of cut in shale stockpile at borrow pit.

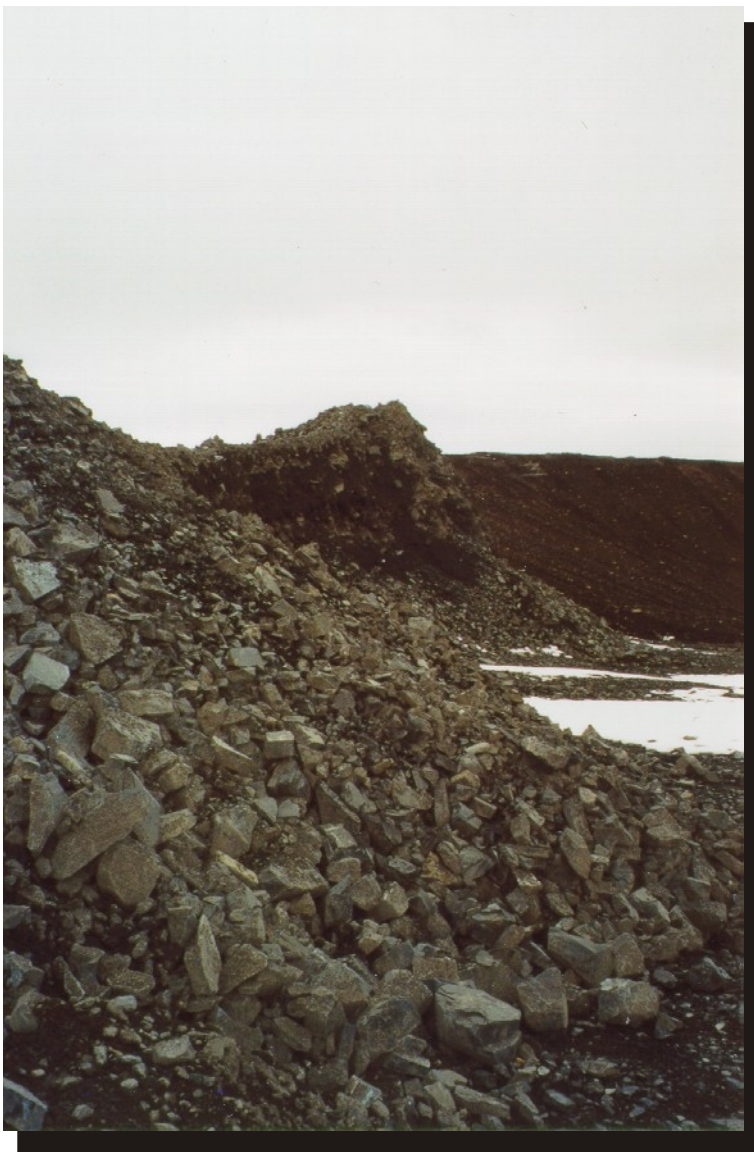
Photo 4
View of shale stockpile at borrow pit.

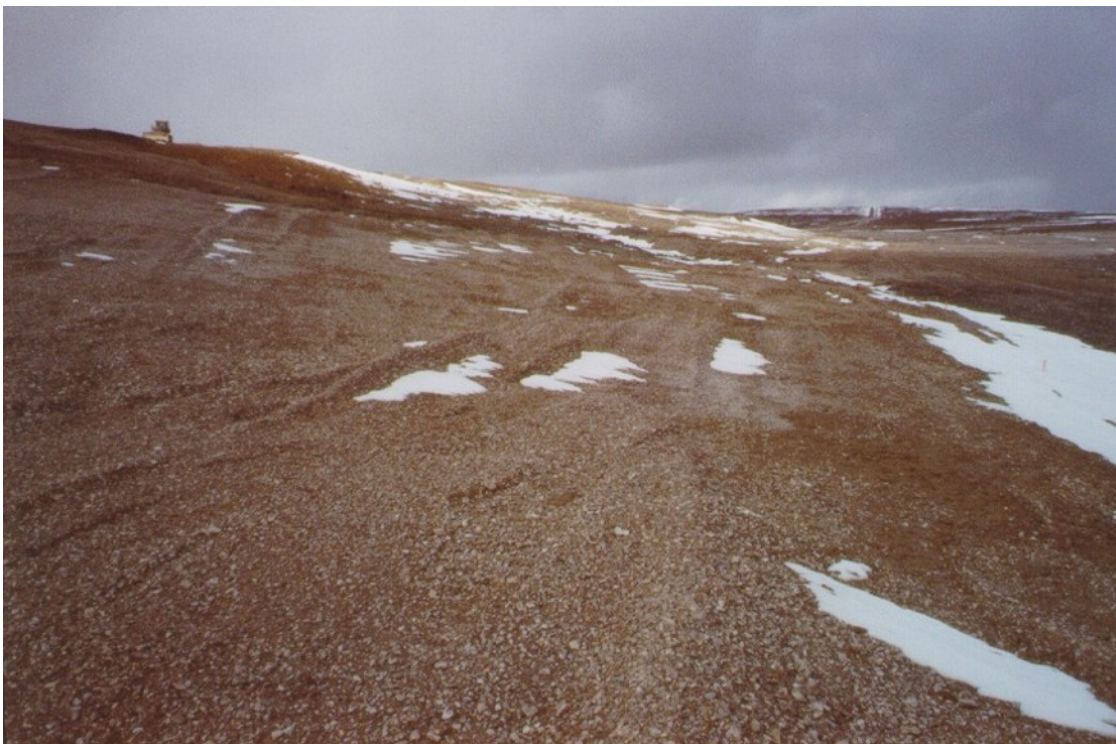
**Photo 5**

Native materials on the slopes immediately up-gradient of the landfill are brown sand and gravel with some silt (Photos 5, 6 and 7).

Graded slope in area of hydrocarbon remediation upslope of Operational Landfill on August 20, 2003. Soils are reworked locally derived soils.

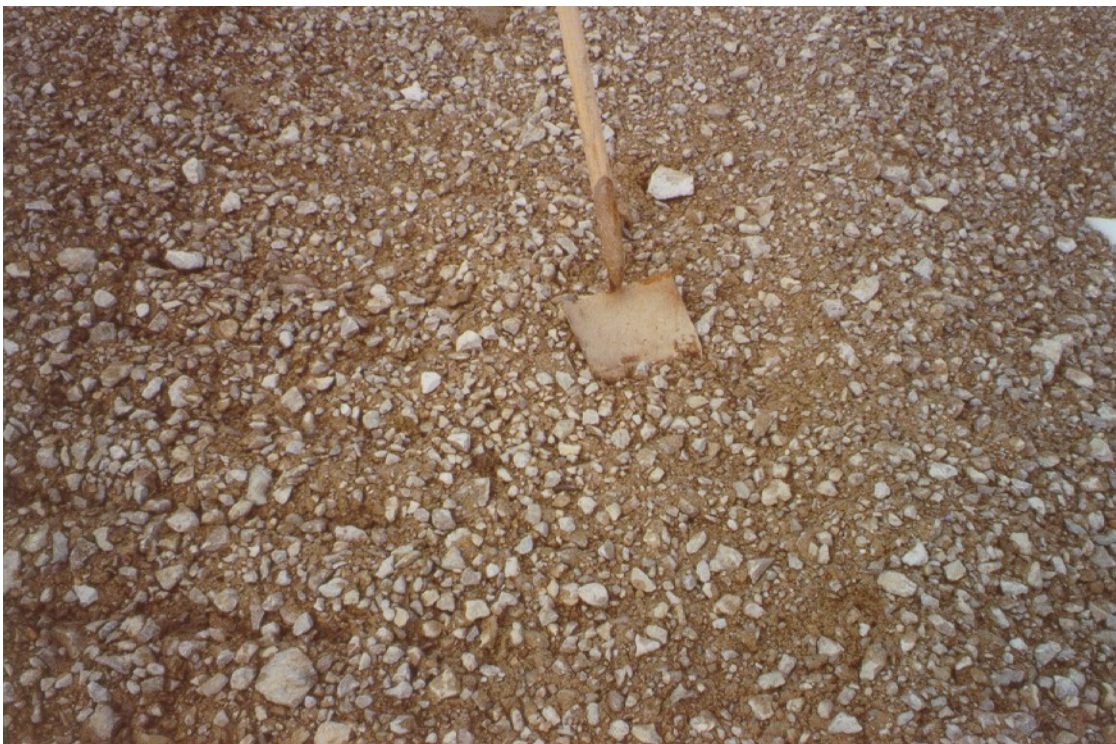
**Photo 6**

Locally derived soils upslope of Operational Landfill on August 20, 2003.

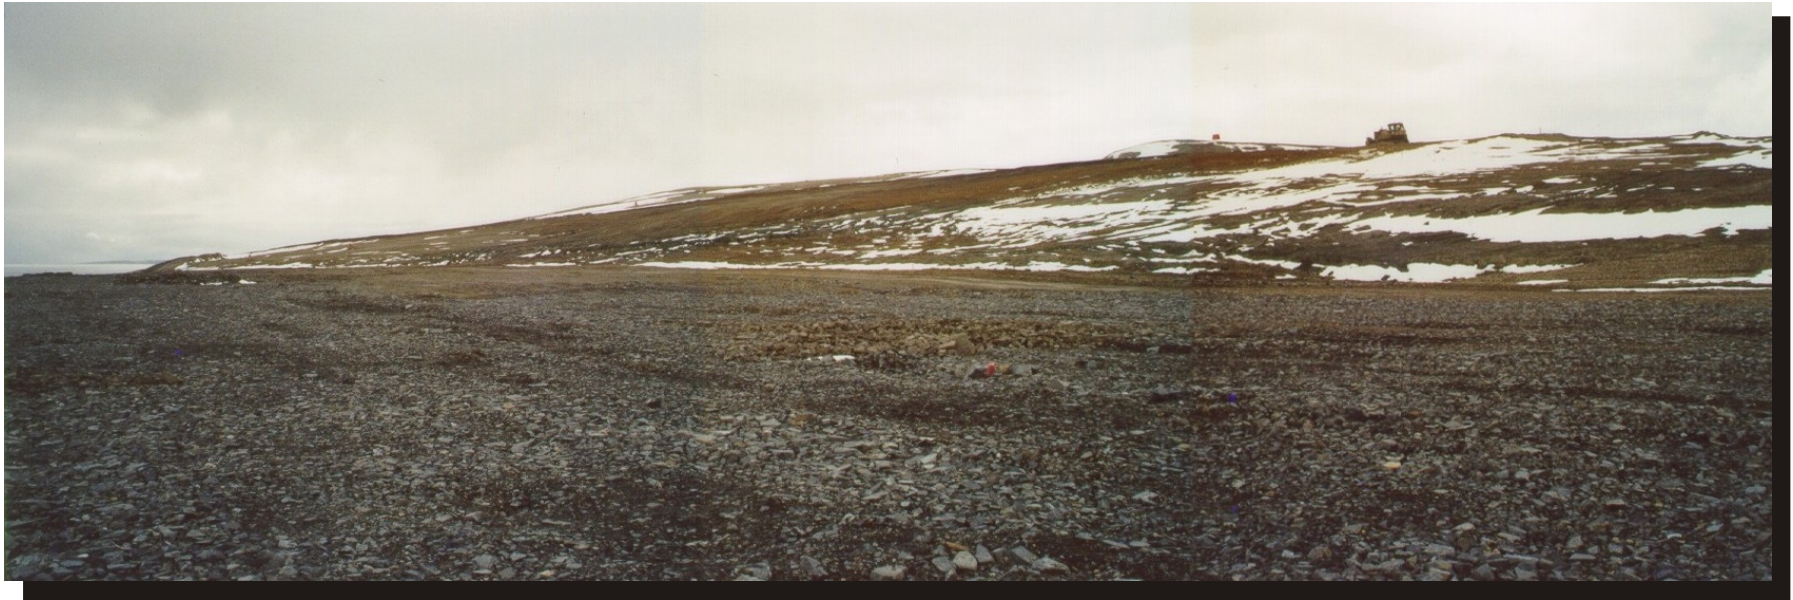
Panoramic view of slope above landfill, Looking west on August 19, 2003.

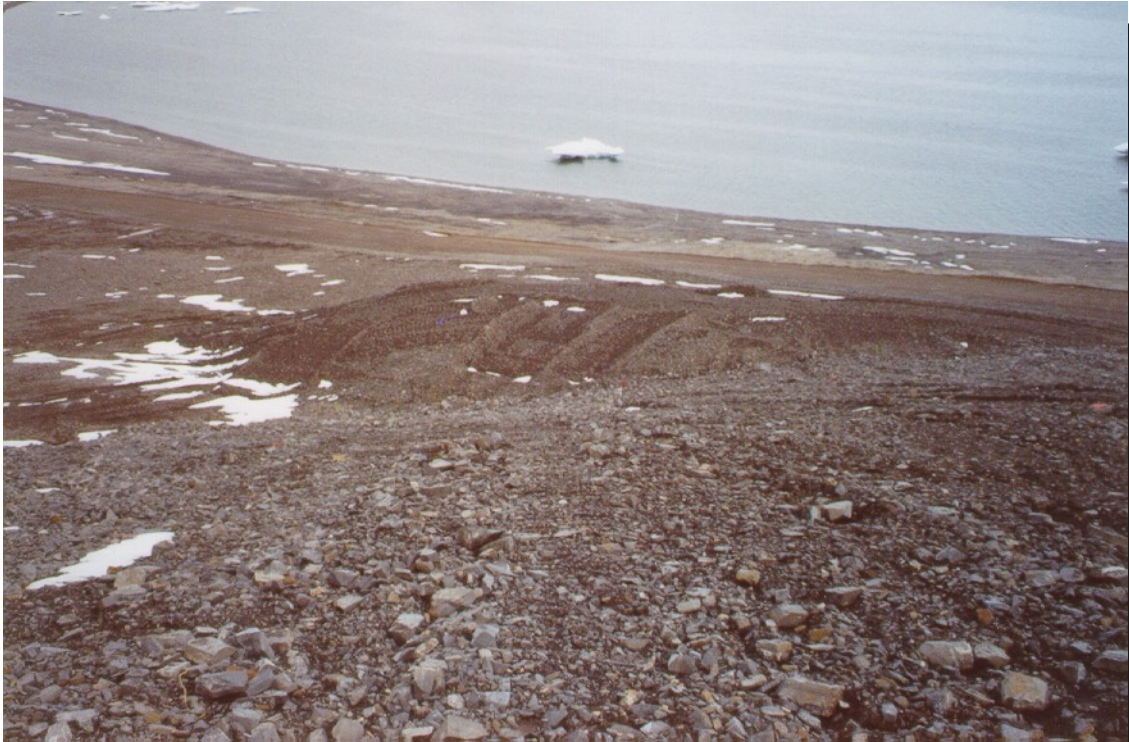
**Photo 8**

A remnant pile of stockpiled “beach” gravel remains at the toe of the landfill at the north east toe of the landfill (Photo 8).

Typical view of graded slope downslope of bench at northeast end of operational landfill on August 20, 2003.

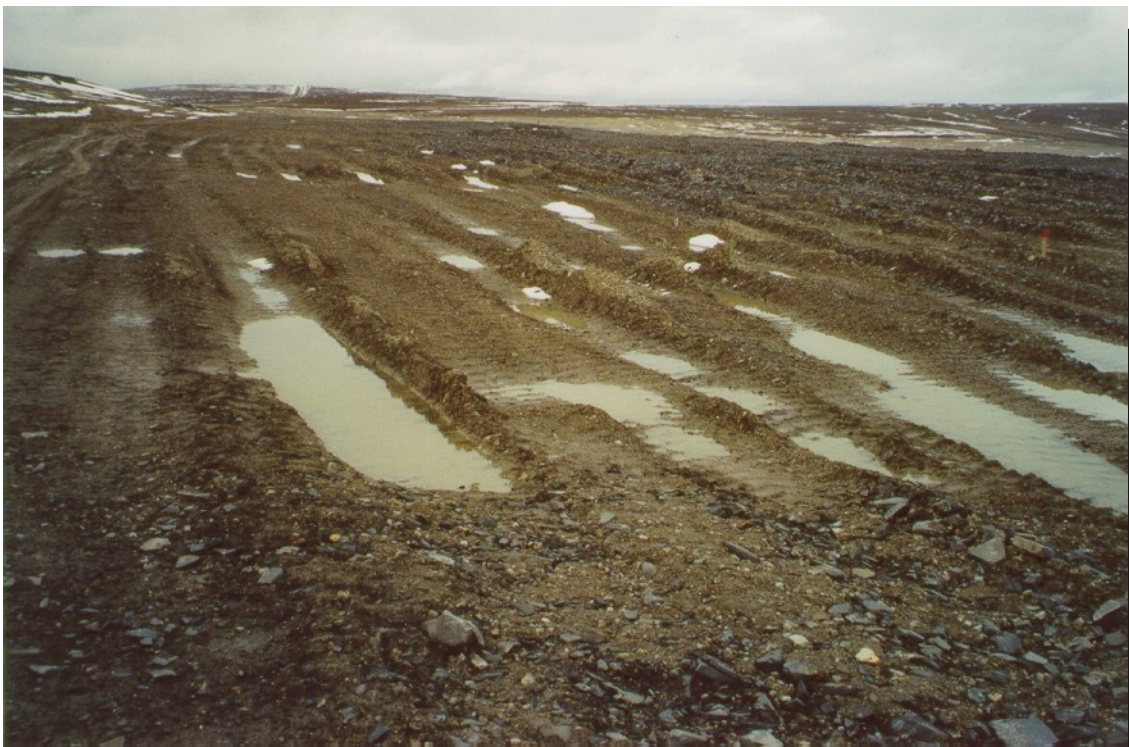
**Photo 9**

Rutting in of top of landfill bench downslope of June 2003 hydrocarbon remediation site on August 19, 2003.

- Visually monitor the landfill cover during spring runoff and heavy rainfall events for evidence of concentrated surface runoff, heavy seepage emerging from the landfill cover, or subsidence which could in any way interfere with the ability of the cover to adequately protect the landfill from erosion or shallow instability.
- For at least the first year keep a stockpile of limestone fill to facilitate remediation, if needed.
- Areas rutted under the weight of rubber tired vehicles should be graded to remove the ruts and to positively shed surface water before placement of the 0.6 m thick limestone cap.

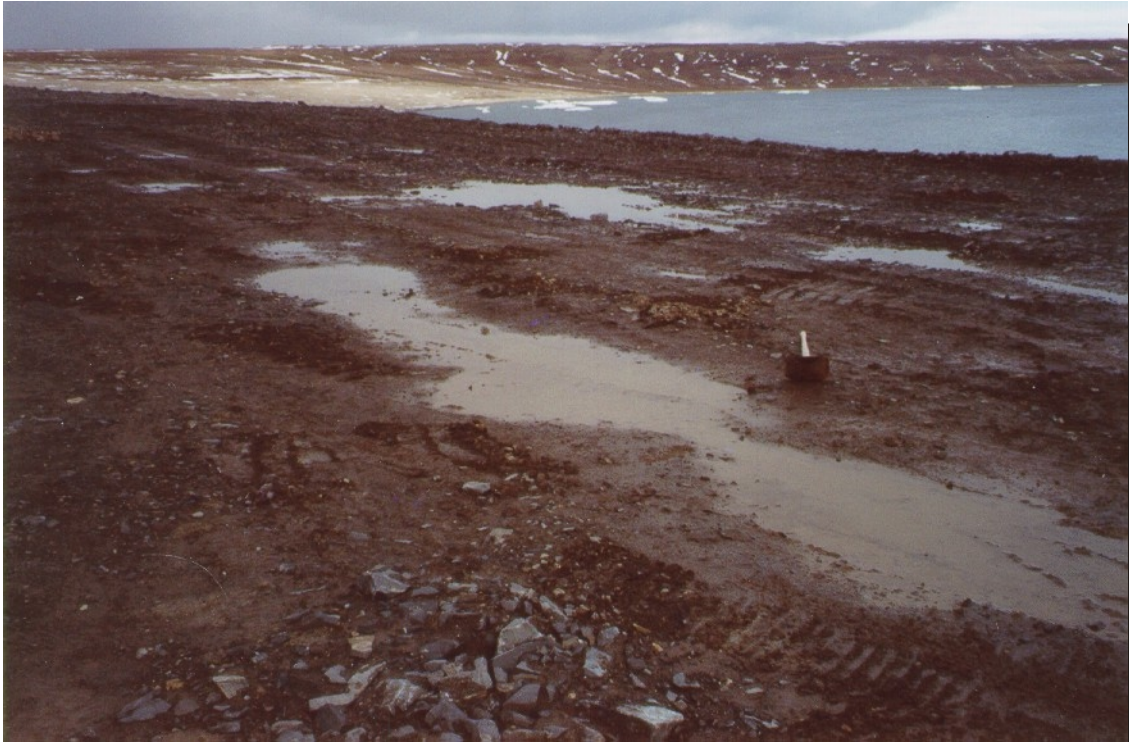
**Photo 10**

Some mixing of the shale fill with brown sand and gravel fill with silt occurred in on the top of the flat bench and in particular in an area of excavation and backfill that preceded the landfill capping (around June 2003, personal communication with John Knapp). The excavation and backfill was carried out in conjunction with the remediation of an old hydrocarbon spill located upslope of the landfill. A sketched plan showing the influenced area is provided in Appendix B. Some rutting of the fills on the top of the operational landfill coincident with the bottom of the remediated site is apparent. Rutting has occurred under the traffic of rubber tired vehicles and minor pooling of runoff (recent snowmelt) water was occurring in this area (Photos 9 and 10). TC has stated that the grades on the surface of the operational landfill, disturbed by rutting will be restored at the time the limestone cover materials are placed.

Ponded water on top of landfill at southwest end on August 20, 2003. Ponding occurs where reworked native materials are mixed with shale (below hydrocarbon clean-up) and where fines have been tracked onto the landfill from access roads.

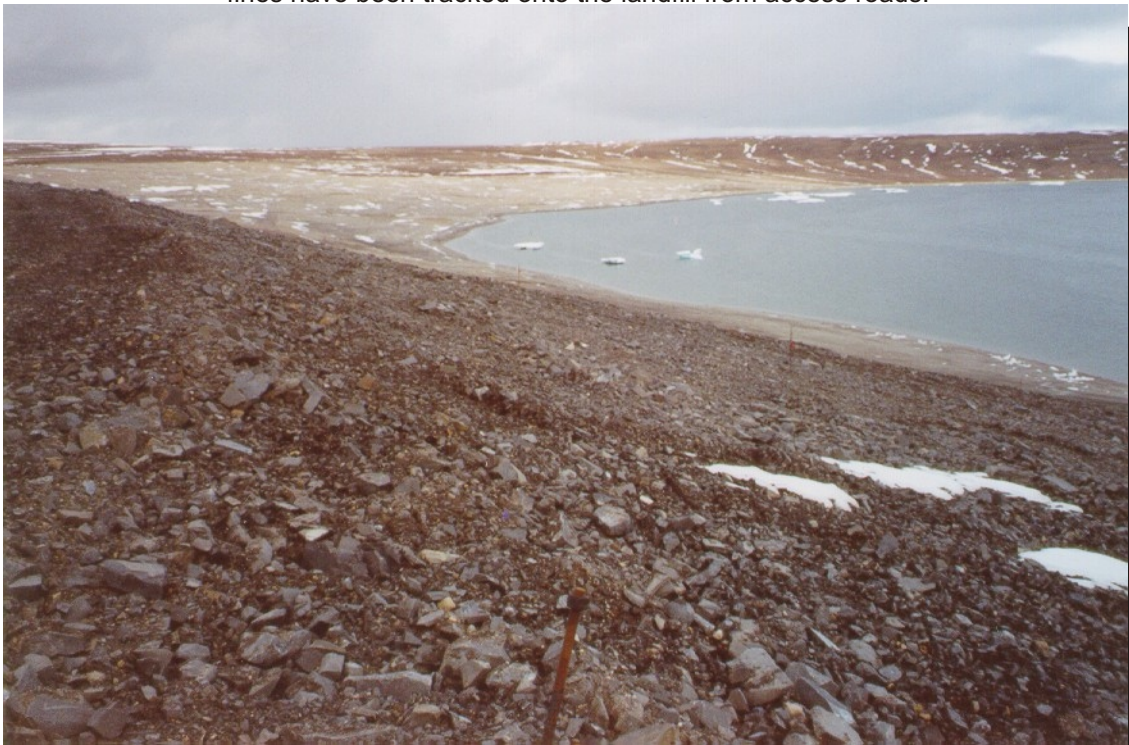
**Photo 11**

Typical view of graded slope downslope of bench at southwest end looking northeast on August 20, 2003.
