**POLARIS MINE**

**DECOMMISSIONING AND RECLAMATION ACTIVITIES**

**QUARTERLY REPORTING – 4th QUARTER 2003**

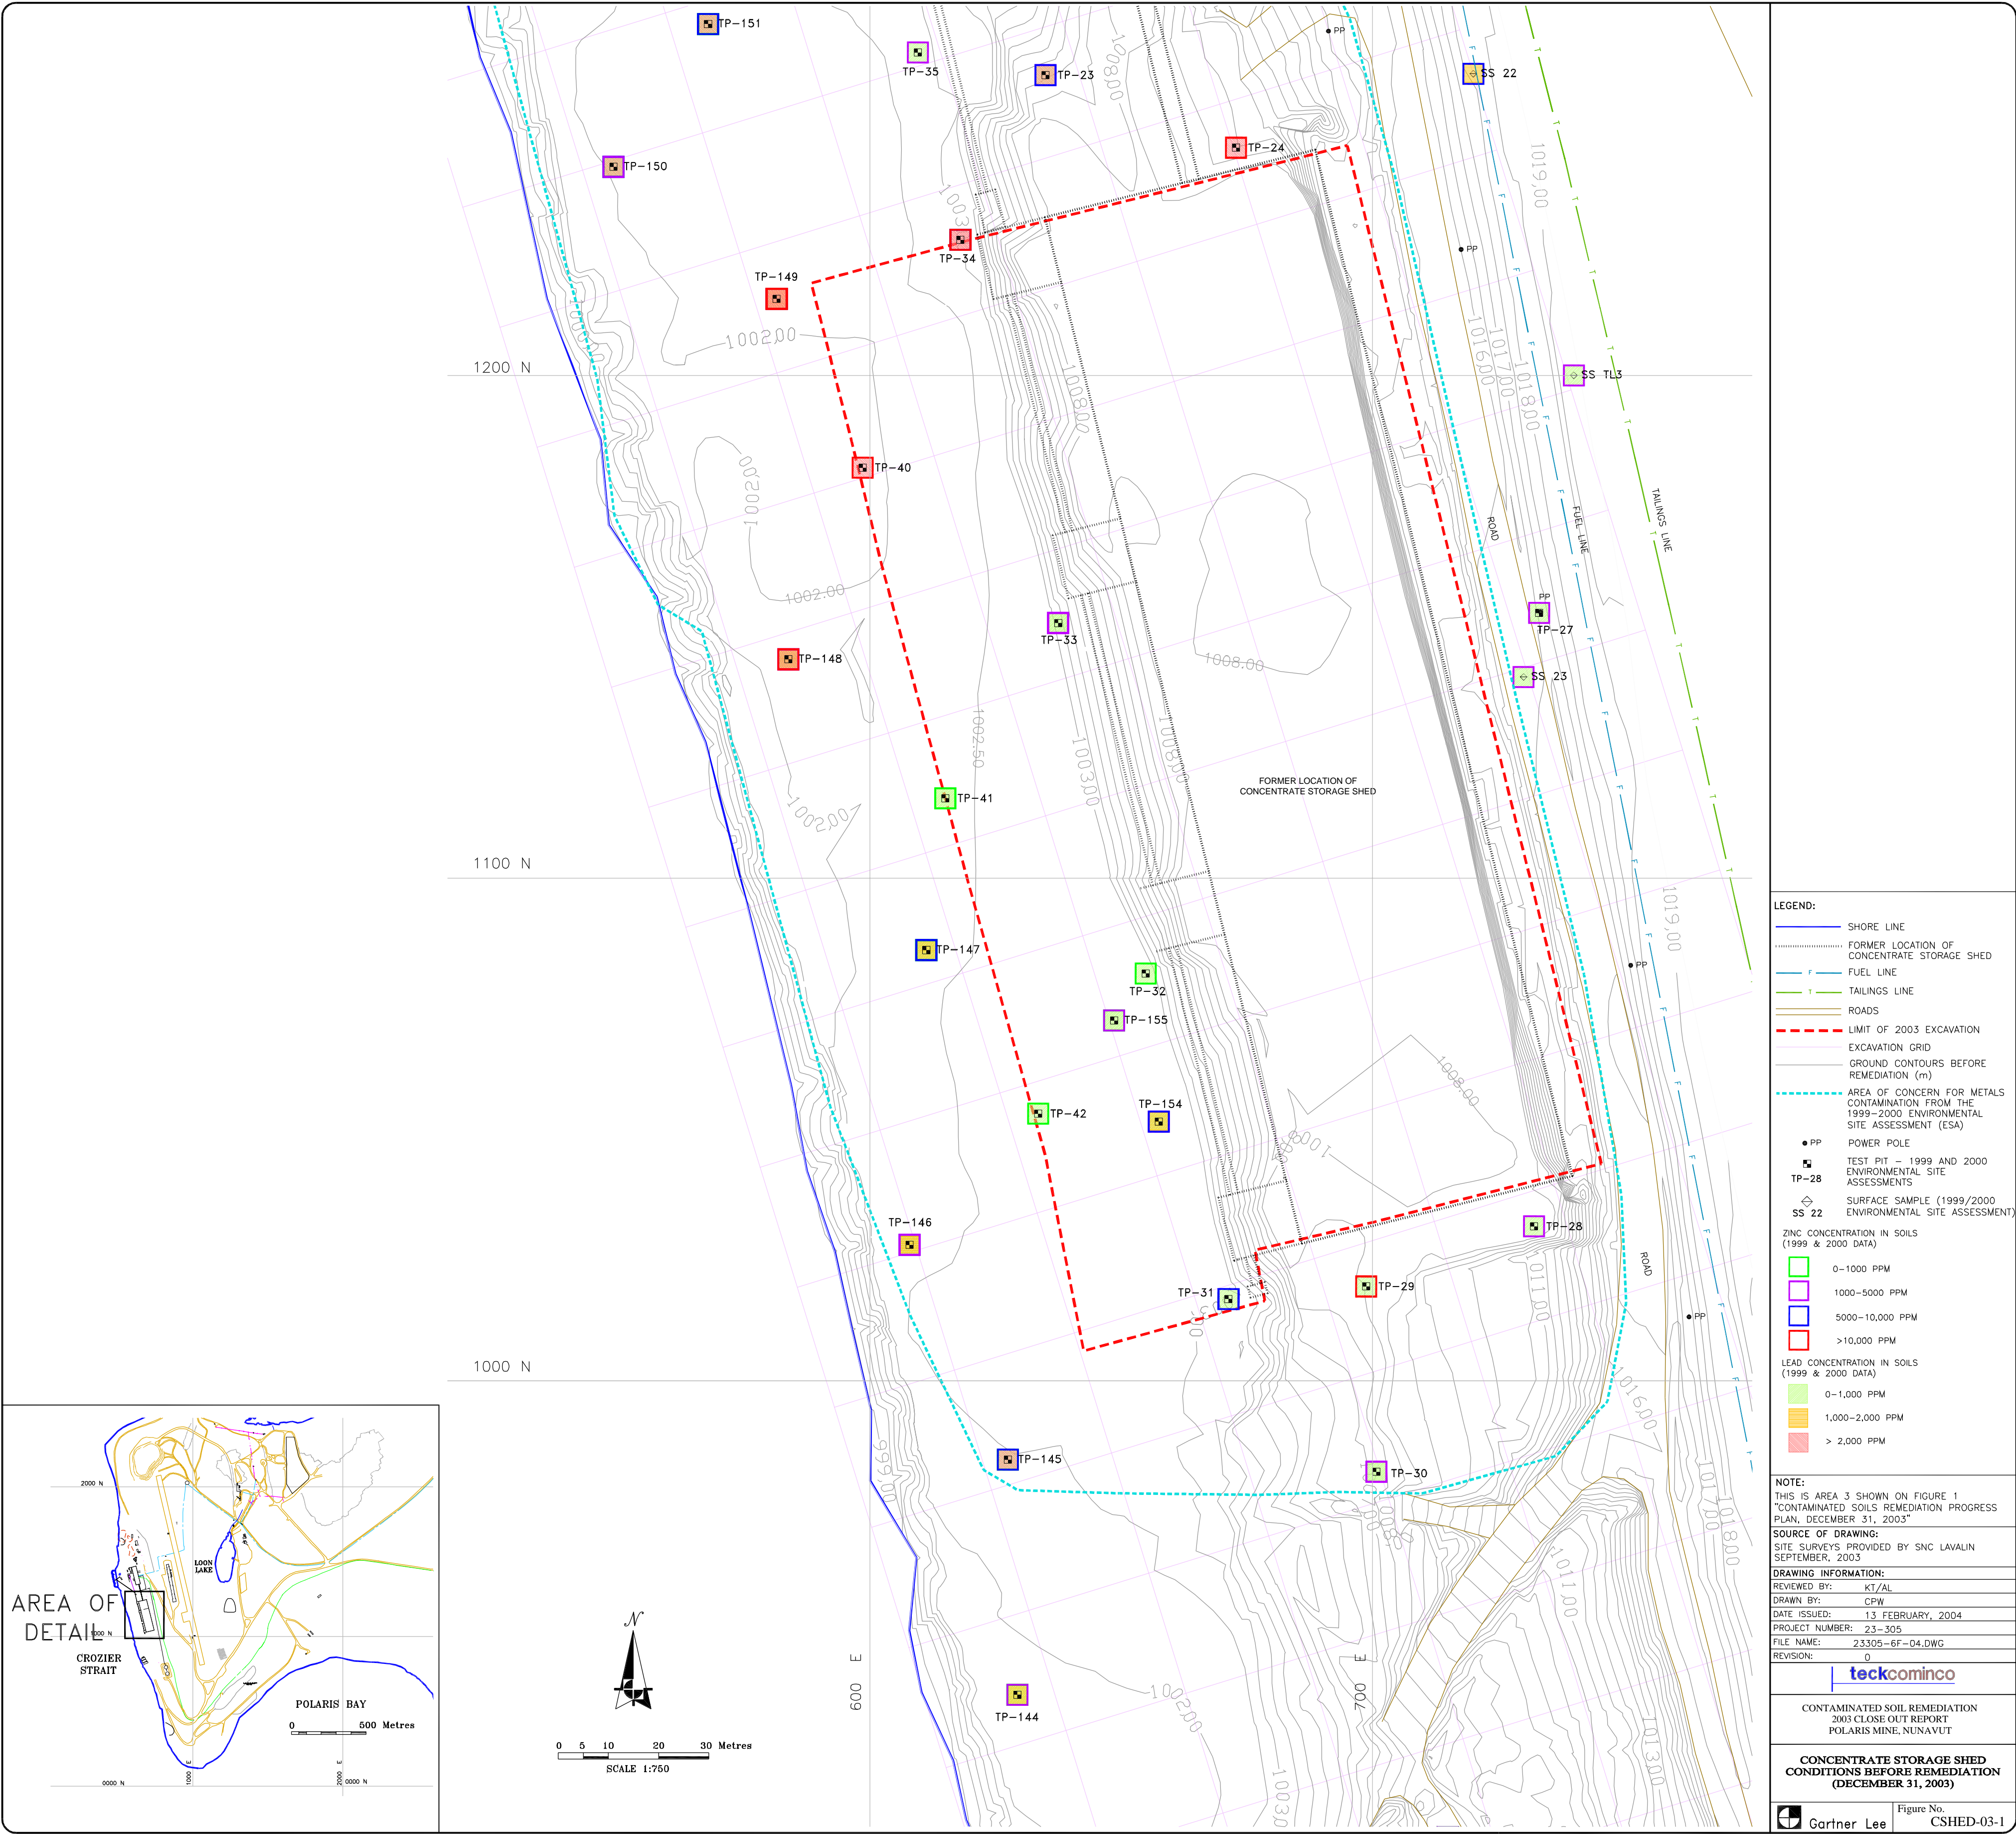
The soil remediation of the area west of the former concentrate storage shed, the western portion of the floor, and the east wall of the former shed, has been completed to meet the Polaris Mine remedial targets. This conclusion is based on confirmatory sampling, consistent with the approved site specific sampling procedures and protocols. However, where limestone bedrock was encountered along the eastern portion of the floor of the former shed, significant lead and zinc concentration dust was detected within the bedrock fractures. It was not proven practical to effectively remove the concentrate dust contained within these fractures with the equipment available. The Decommissioning and Reclamation Program being implemented at the Polaris Mine was developed to limit the exposure of lead and zinc to human and other ecological receptors. The plan included soil remediation. It did not include the excavation of bedrock.

In consultation with Teck Cominco Limited (TCL), a soil cover was used to for the mitigation of the residual concentrate dust within the bedrock fractures. The area of bedrock with residual

CONCENTRATE STORAGE SHED  
CONDITIONS AFTER REMEDIATION  
(DECEMBER 31, 2003)

The cover was placed to minimize potential human or ecological receptor contact with the floor of the excavation where contaminated soils were trapped in the fractured bedrock and could not be effectively removed.

In recognition of these issues, GLL recommended mitigation measures to limit human or ecological contact. Isolation under a durable cover of naturally occurring sand and gravel material that is available nearby was determined to be the most practical and effective. The cover constructed is composed of native gravels that were obtained near to the Operational Landfill area. This gravel has a suitable gradation to resist erosion from wind and surficial runoff. This natural material will also blend in with the natural surroundings and will contribute to enhancing the aesthetics of the resulting surface.

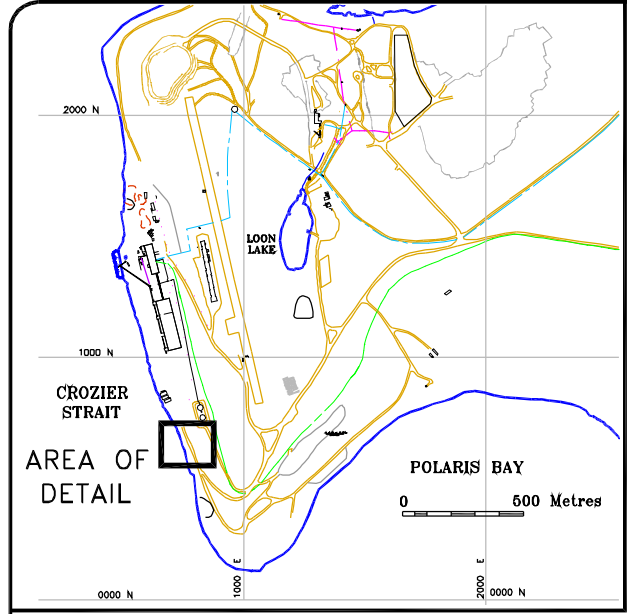
Gartner Lee
Figure No.	SPL02-24-1

**2002 FUEL SPILL  
CONDITIONS BEFORE REMEDIATION  
(DECEMBER 31, 2003)**

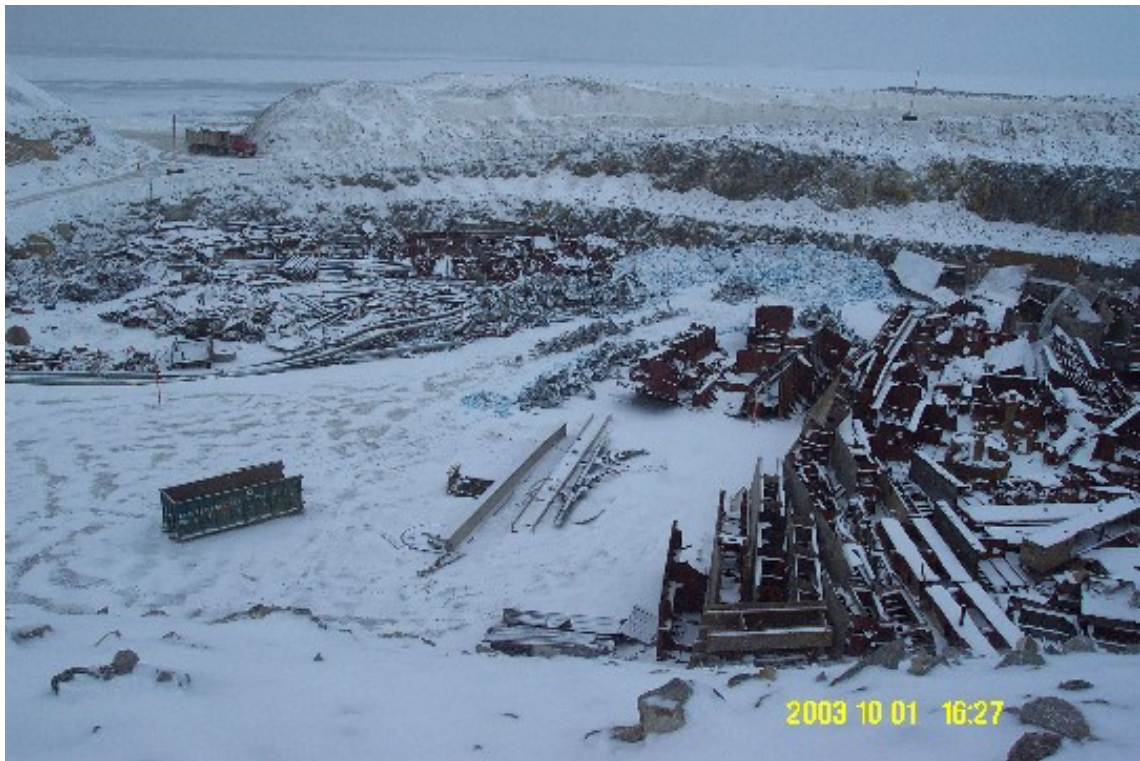
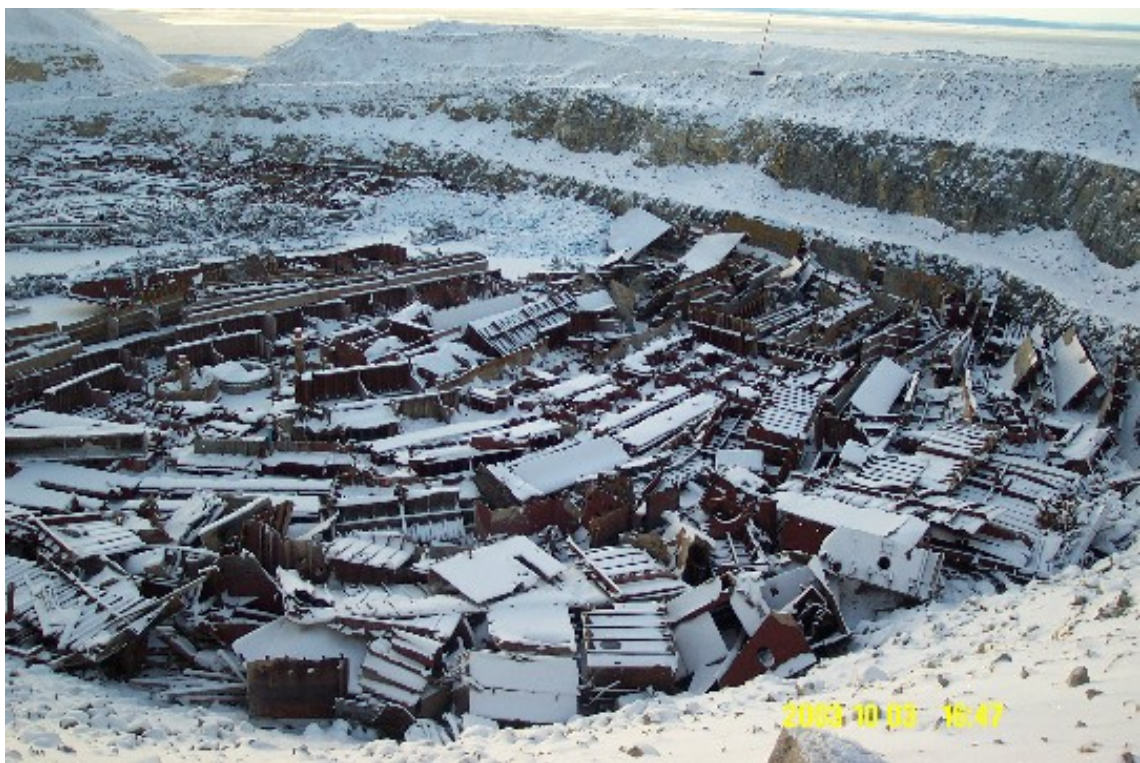
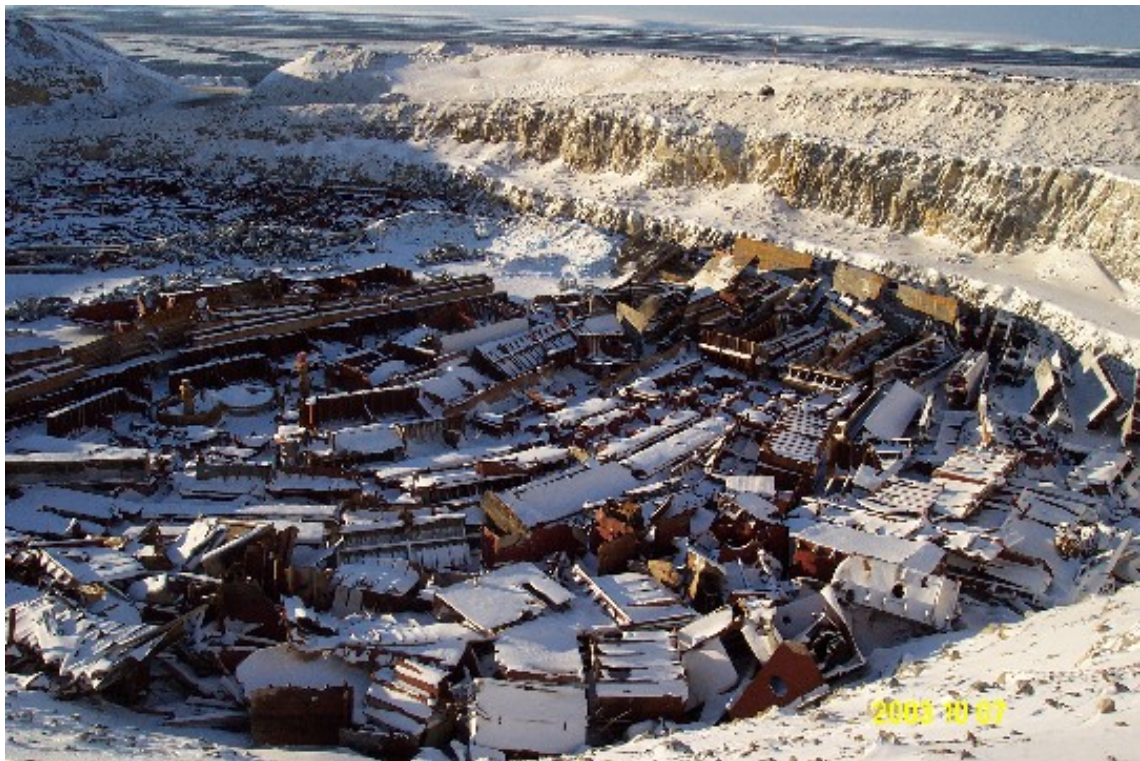
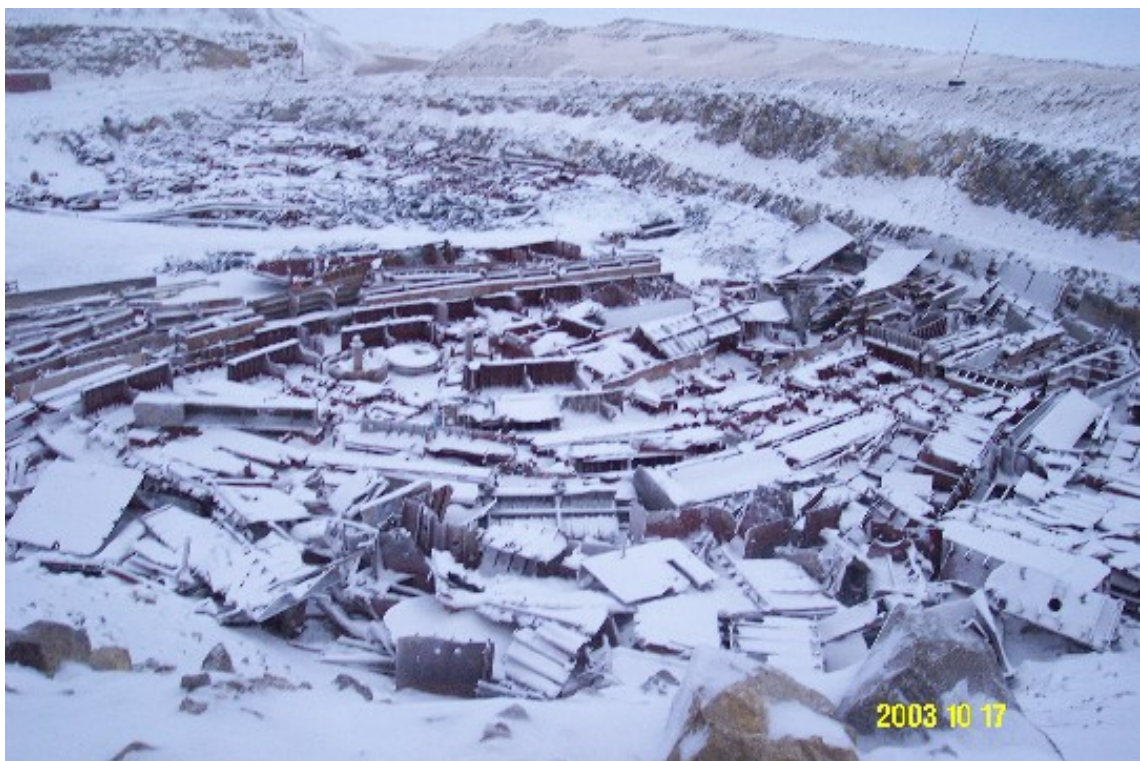
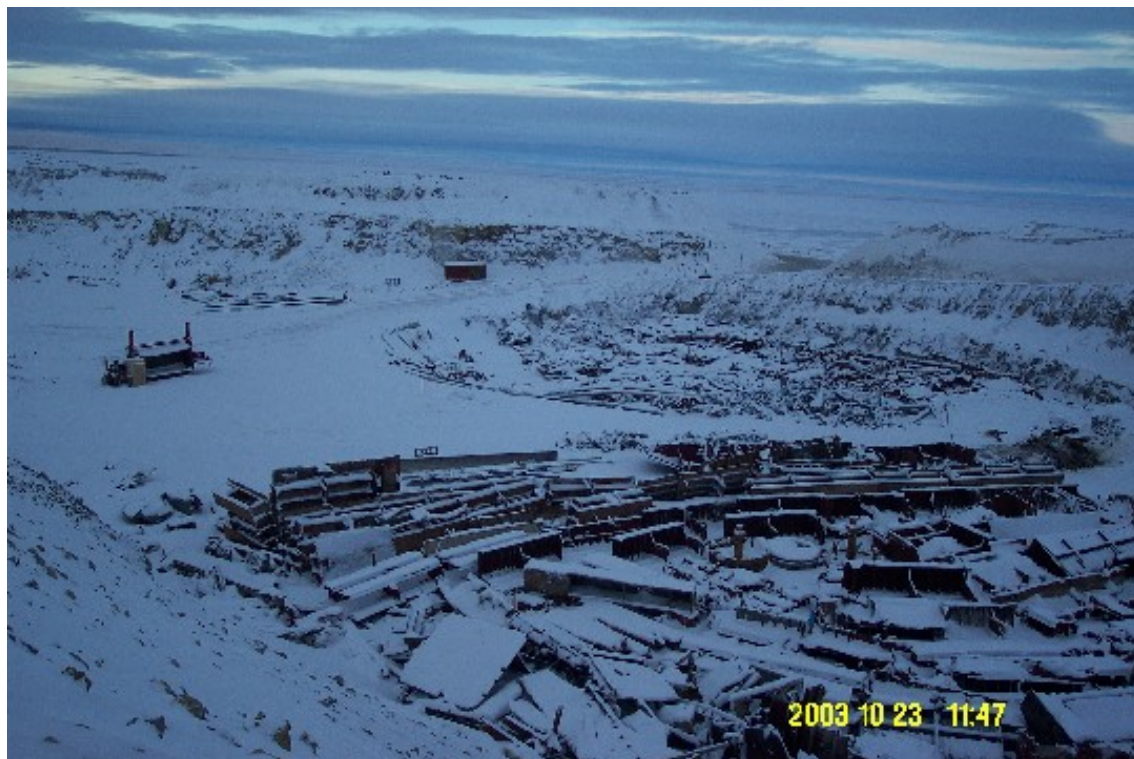
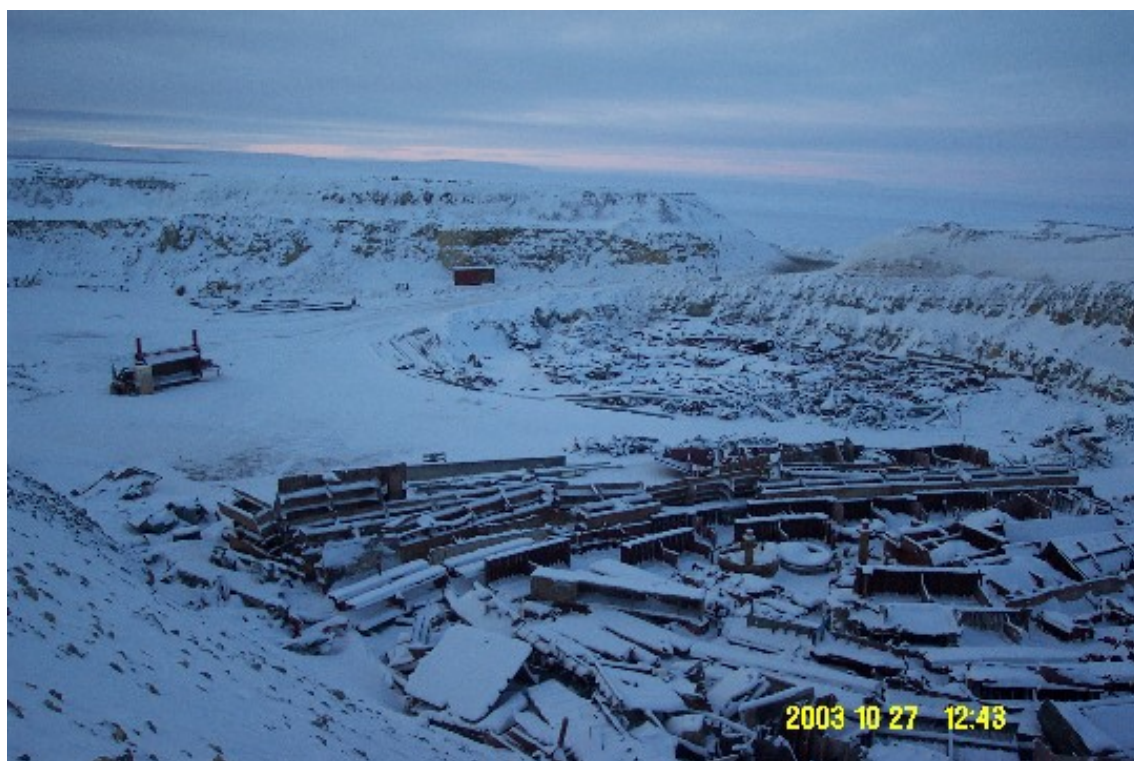
As specified in the Closure Plan, a photographic record of debris placement is being maintained. Attached to this appendix are pictures of typical debris being placed in LRDQL. As there was little debris placed into LRDQL during the quarter, fewer pictures were taken than in the previous two quarters. Lack of light prevented pictures from being taken in December.
