APPENDIX 11

RECORD of CONTAMINATED SOILS EXCAVATED AND DISPOSAL LOCATIONS IN THE MINE

APPENDIX 13

GARROW LAKE EROSION MONITORING

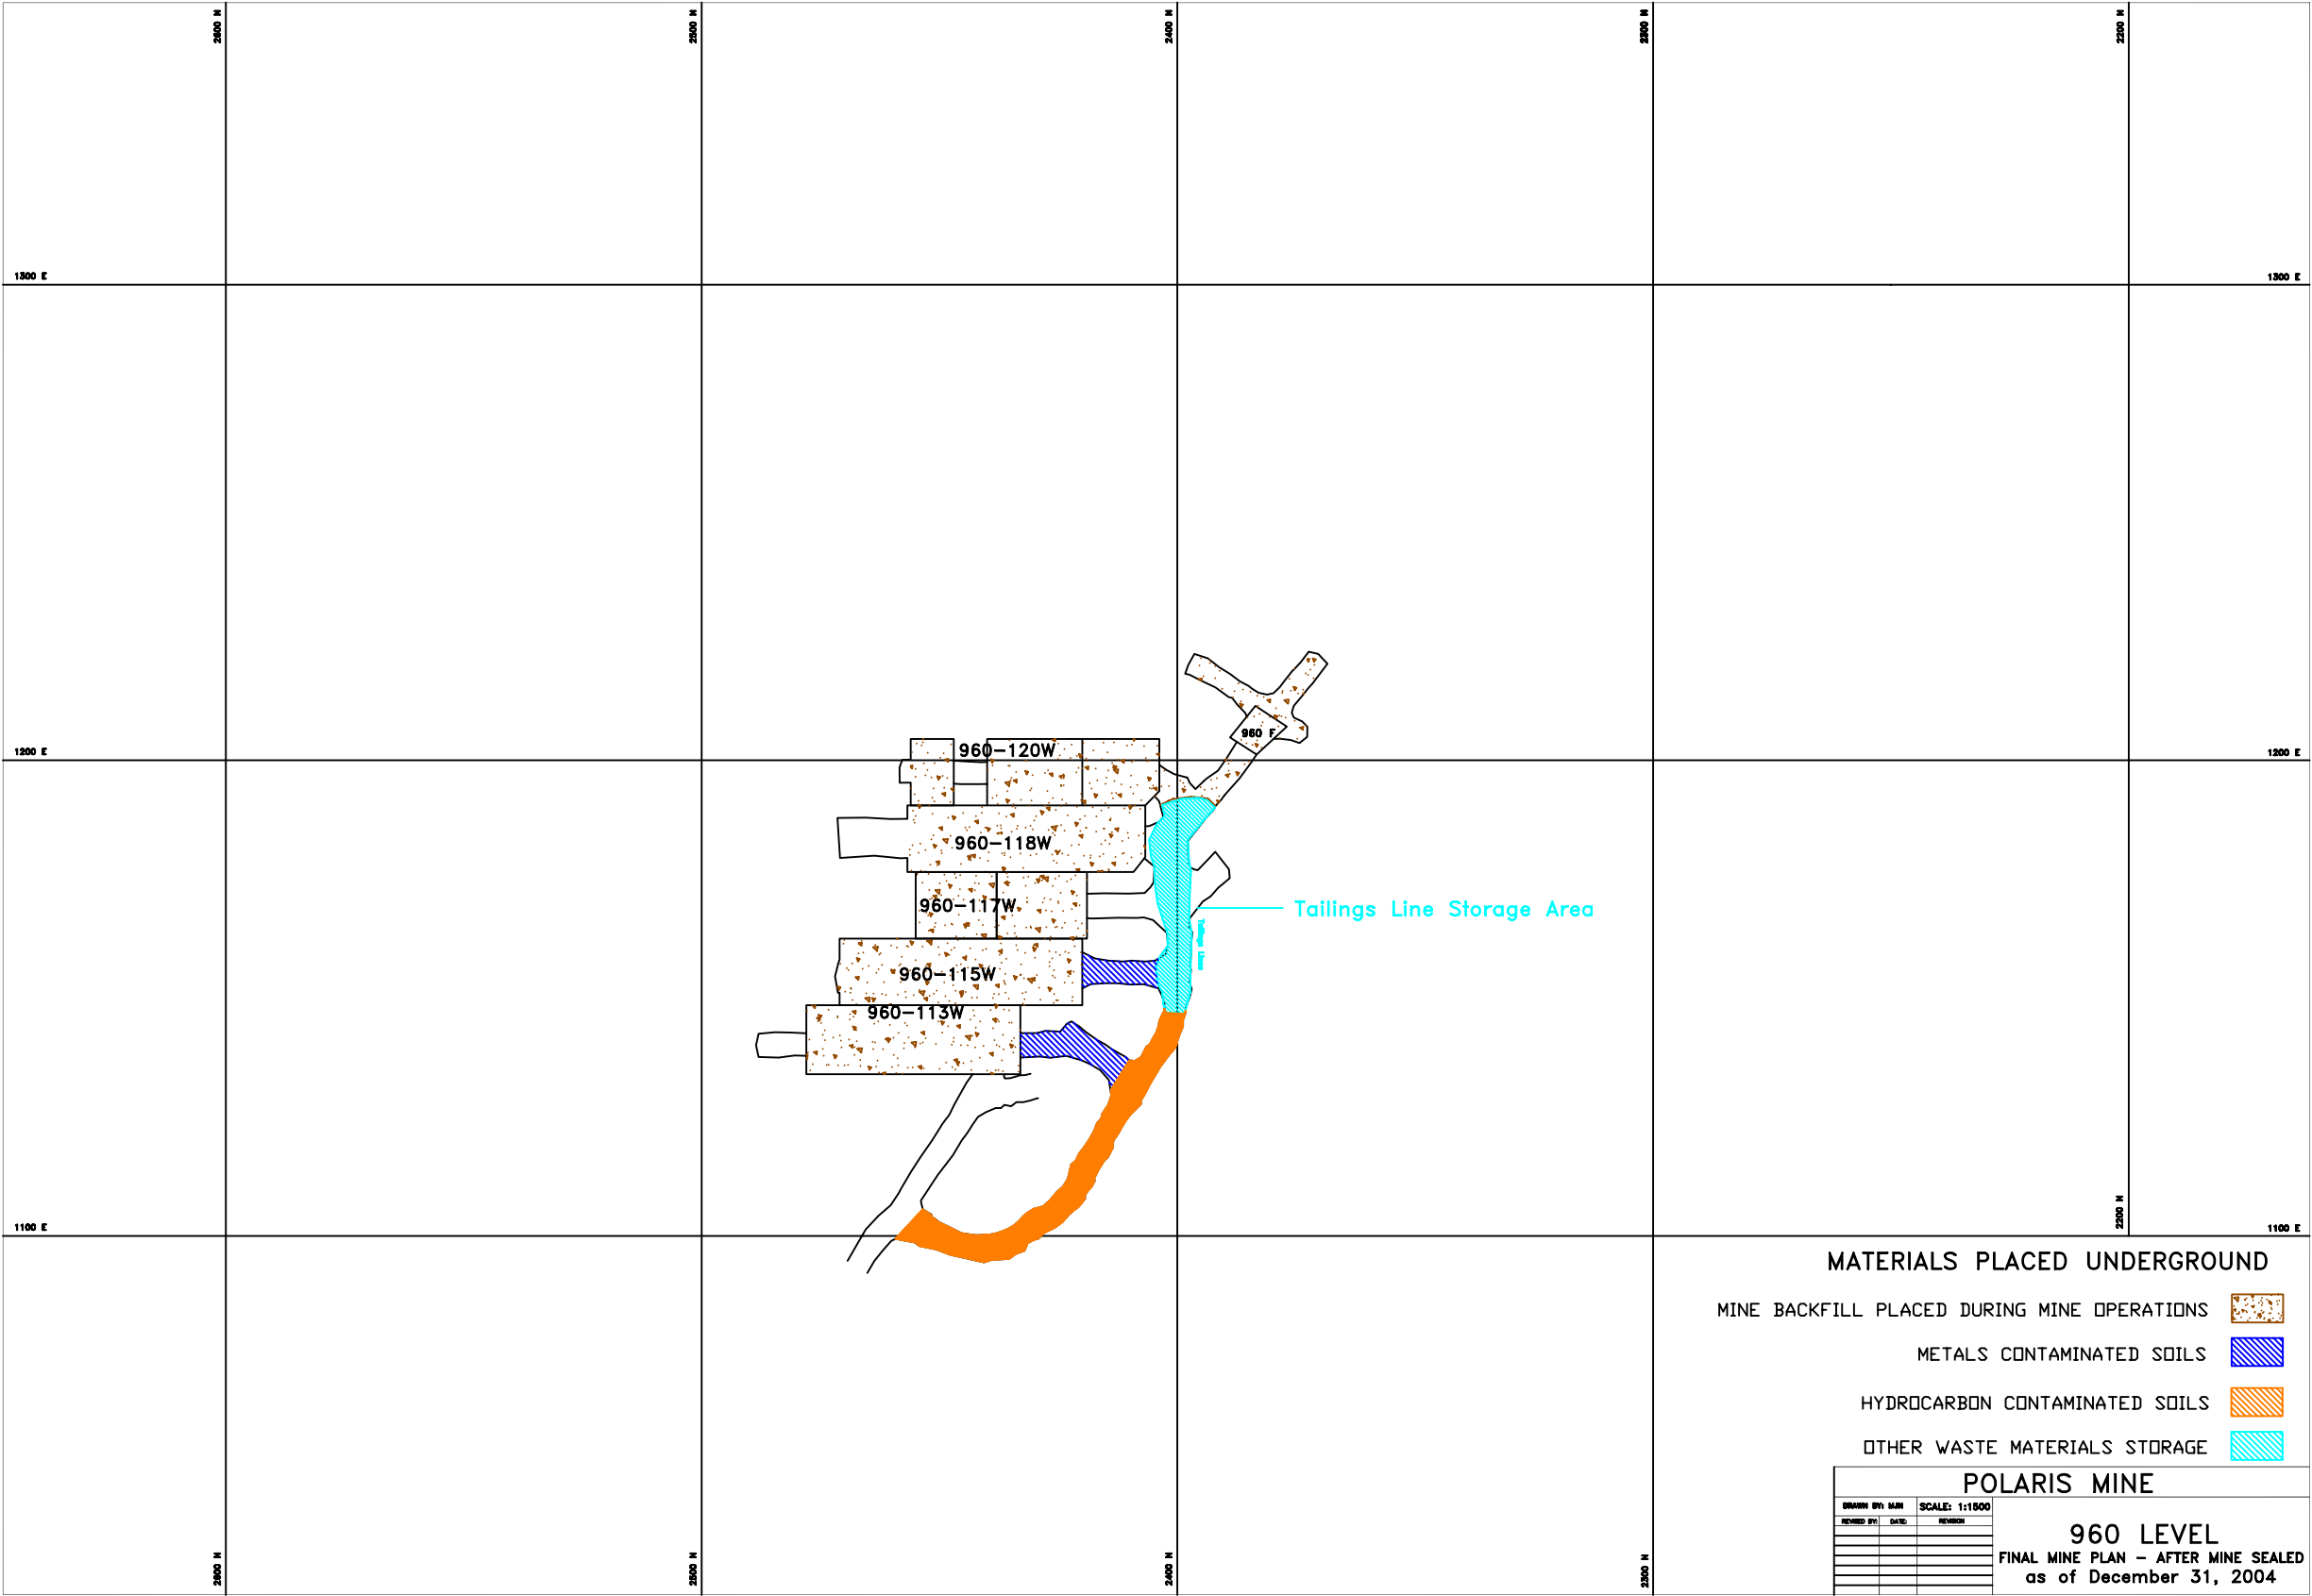
960 LEVEL

- MINE BACKFILL PLACED DURING MINE OPERATIONS
- METALS CONTAMINATED SOILS
- HYDROCARBON CONTAMINATED SOILS
- OTHER WASTE MATERIALS STORAGE

FINAL MINE PLAN – AFTER MINE SEALED
as of December 31, 2004

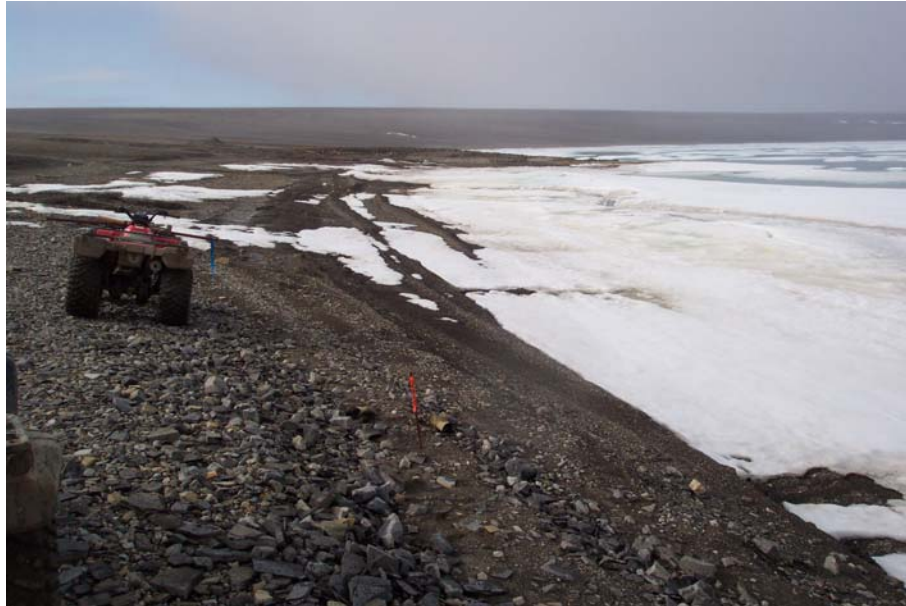
Erosion Pin Station # 8 – July 17, 2004

However, there is sufficient data to compare 2004 data to 2003 data. There is no sign of erosion at any of the locations being monitored.

Pin measurements indicate no significant movements occurred during either of 2003 or 2004.

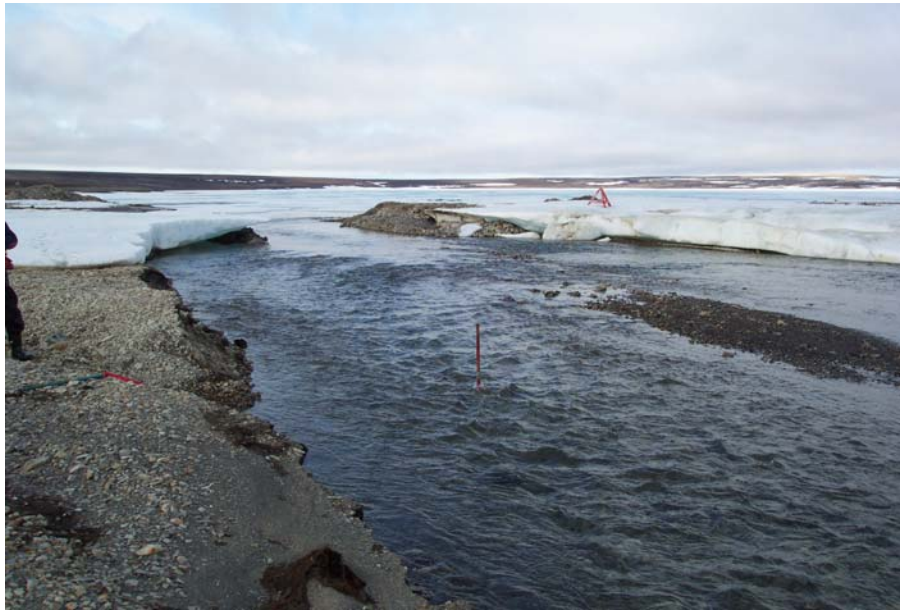
Station 12 – Near the outlet of Garrow Lake

Three rebar pins were placed into the creek channel to monitor for erosion of the creek bottom (see photographs below). One pin was placed near the outlet of Garrow Lake, one about midway between the lake and the ocean, and one near the outlet of the creek into the ocean.

On a weekly basis starting on July 16th, measurements were taken from the top of the pin to the creek bottom. Any erosion of the channel bottom at the location of the pin would be identified by the distance from the top of the pin to the creek bed. The measurements taken during the flow period seem to suggest that the bed of the creek was dynamic and in the case of two of the three monitoring stations, indicated some deposition of material in the stream bed.

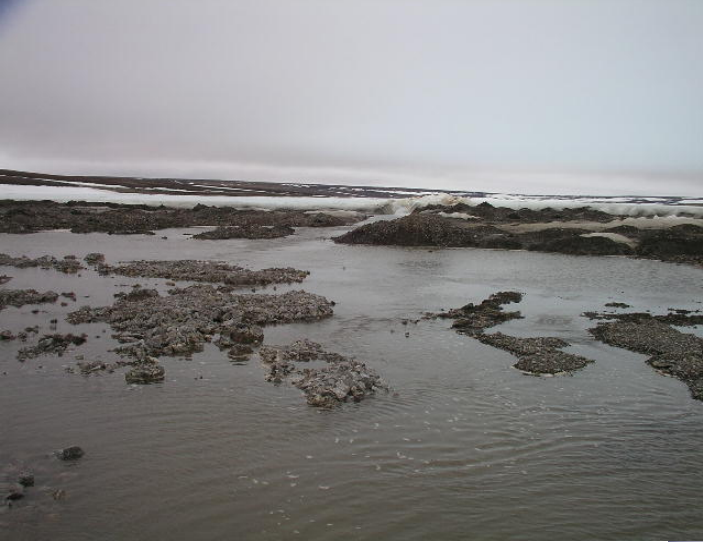
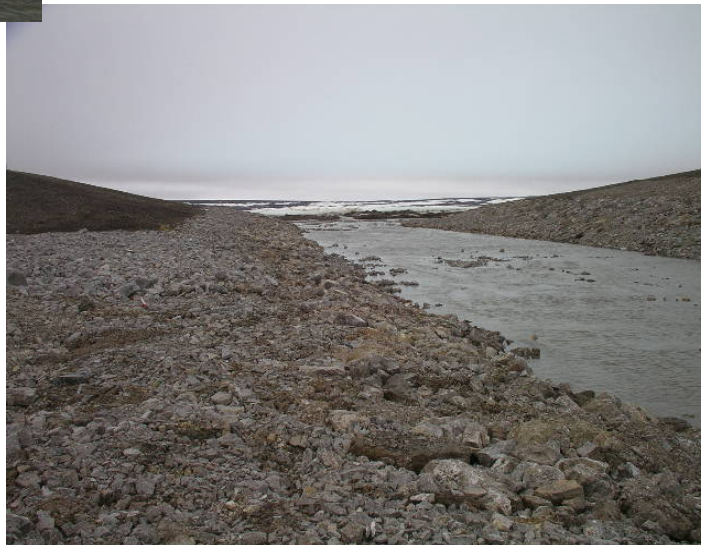
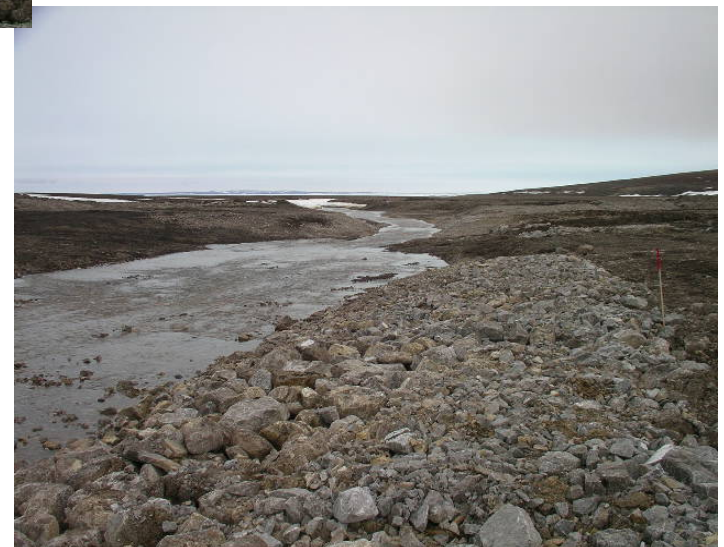
July 5 2004

The following photographs were generally taken from the same locations each time to provide a record of flow and creek channel changes that occurred over time during the 2004 discharge period. The requirement was to do this on a weekly basis but this was done on a more frequent basis through July when the flow was at its highest. It is evident from the photographs that some erosion of the channel occurred during the peak flows. The dam was decommissioned prior to spring melt and more water than anticipated was initially released as the ice on the lake and in the channel melted.

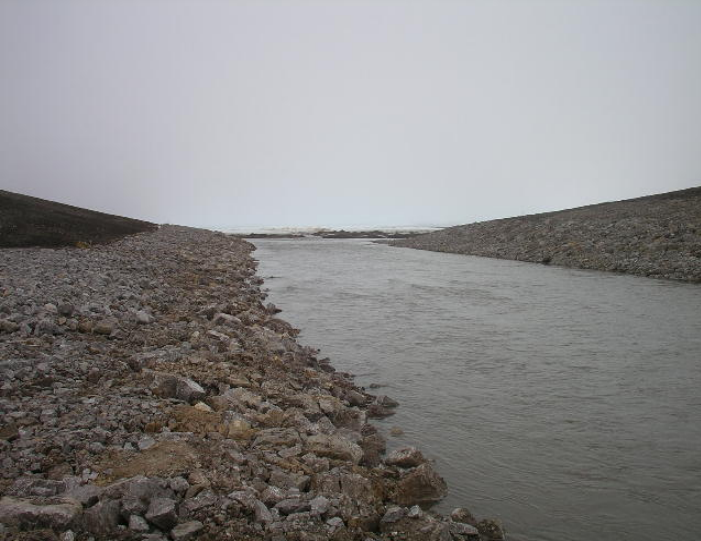
July 6 2004

On July 6th, 2004 the TSS results exceeded permit and MMER criteria. This was reported to Environment Canada. At the same time as the TSS sample was collected, samples were also collected for Total Metals and Acute Toxicity. The results indicated that the TSS was not caused by mobilization of tailings but rather from erosion of the creek channel. All metals concentrations in the water were compliant with the Water Licence and MMER criteria. Additionally, the Acute Toxicity testing for Rainbow Trout and *Daphnia magna* show there was no acute toxicity. All other TSS sampling events during the discharge season were compliant with the Water Licence and the MMER.

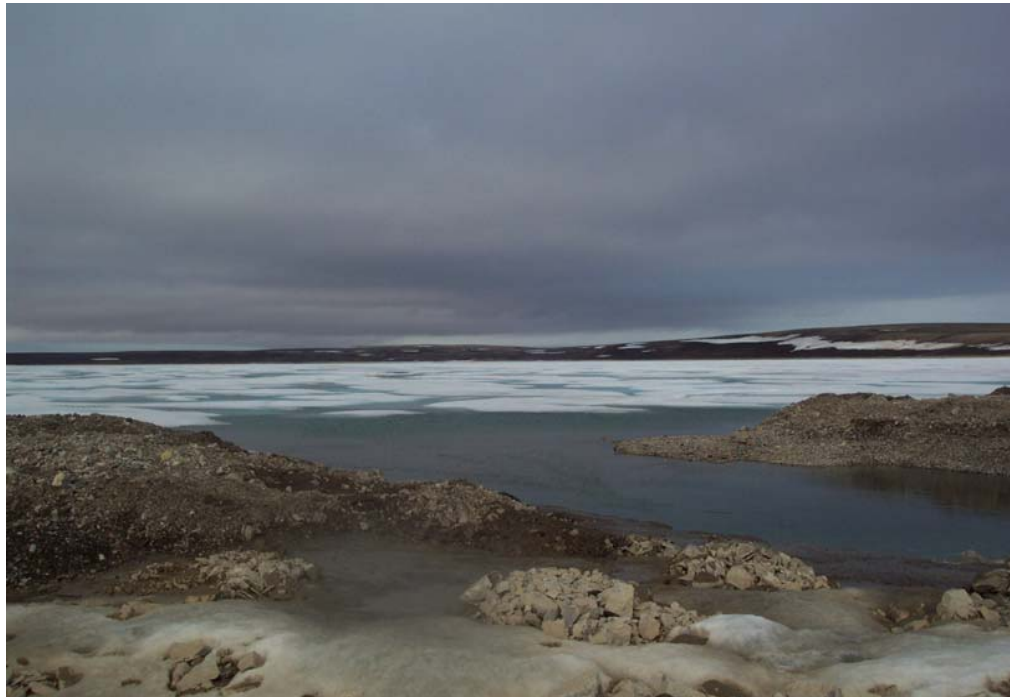
STATION 0 +00

The monitoring program also included the requirement to take a series of photographs along the complete length of Garrow Creek channel once flow for the season had been concluded. Due to weather conditions, the channel would have been under snow before all water had ceased flowing so the photography was done near the end of July when flow was low and before snow covered the landscape. A series of survey markers were set up every 100 metres along the length of the channel starting at Garrow Lake outflow origin through to where the creek discharges into the ocean. The following photographs are identified by the distance from the origin of the creek flow.
