**POLARIS MINE
POST-RECLAMATION MONITORING REPORT
3rd QUARTER 2006 FOR THE
NUNAVUT WATER BOARD
&
INDIAN AND NORTHERN AFFAIRS CANADA**

Re: Polaris Mine Water Licence NWB1POL0311 – 2006 3rd Quarter Water Licence Report

**Report on Post-closure Geotechnical Inspection for
Polaris Mine Site in 2006
Area 1 – Garrow Lake, Creek and Dam**

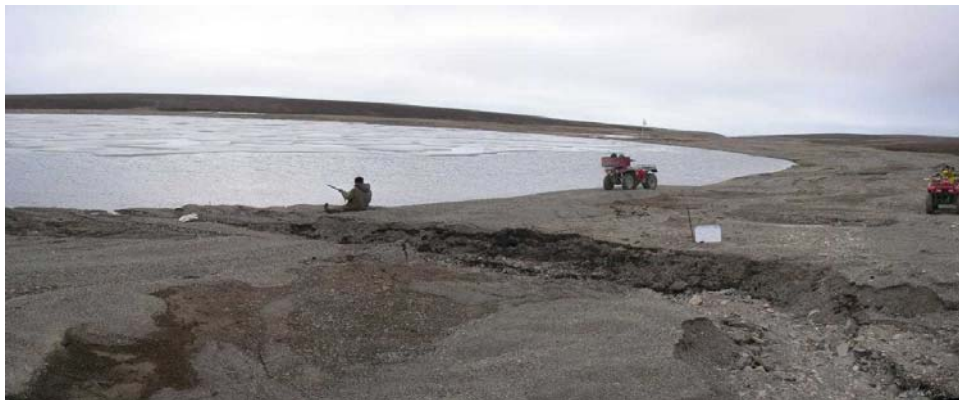
View south from south quadrant pin – Station 10. Note adjacent localised erosion by a small stream which appears to be self armouring. This is an old stream gradually re-establishing itself at a stable gradient through the accumulation of beach materials deposited while the lake was raised during operations. It is very localised and the side slopes are going to take some time to gradually flatten and stabilise.

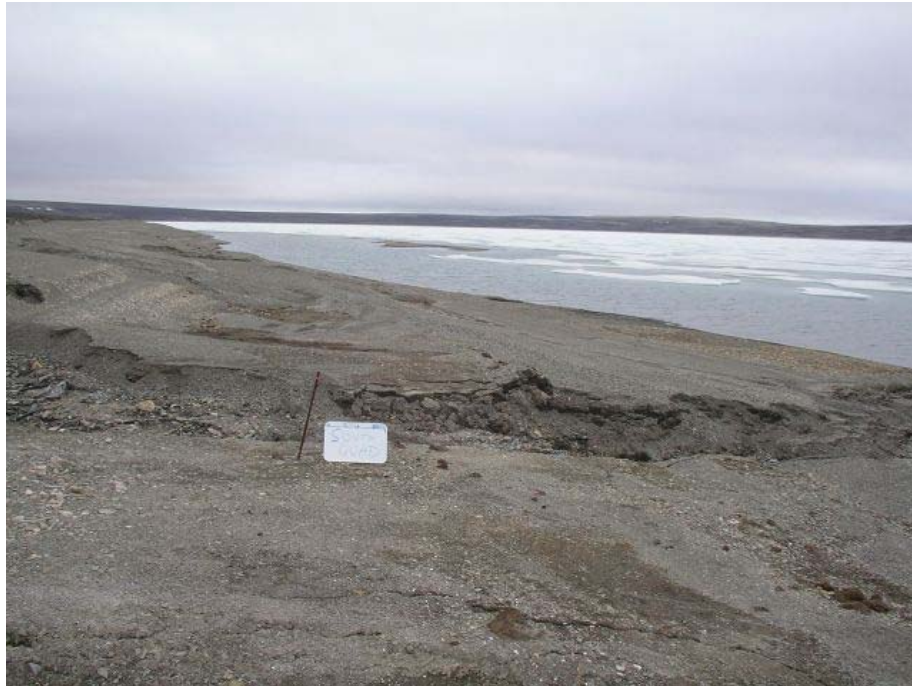
View north at south quadrant pin at Station 10. The overall nature of the beach terrain appears unchanged since previously inspected in 2005.

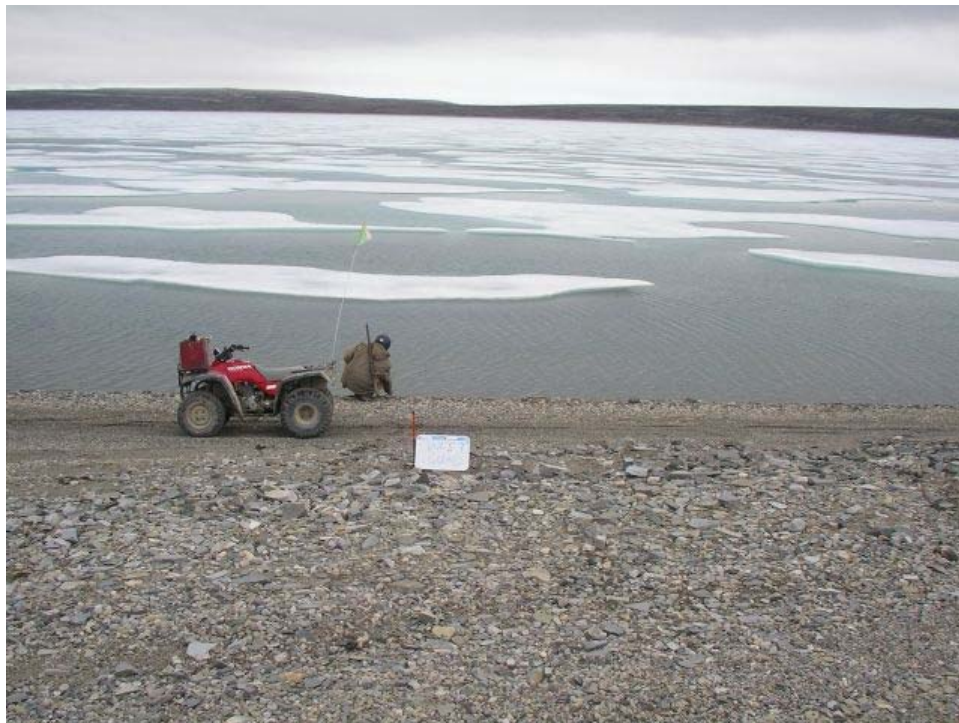
Shoreline viewed from erosion pin at West Quadrant Station 11 shows no apparent signs of change since inspected in 2005.

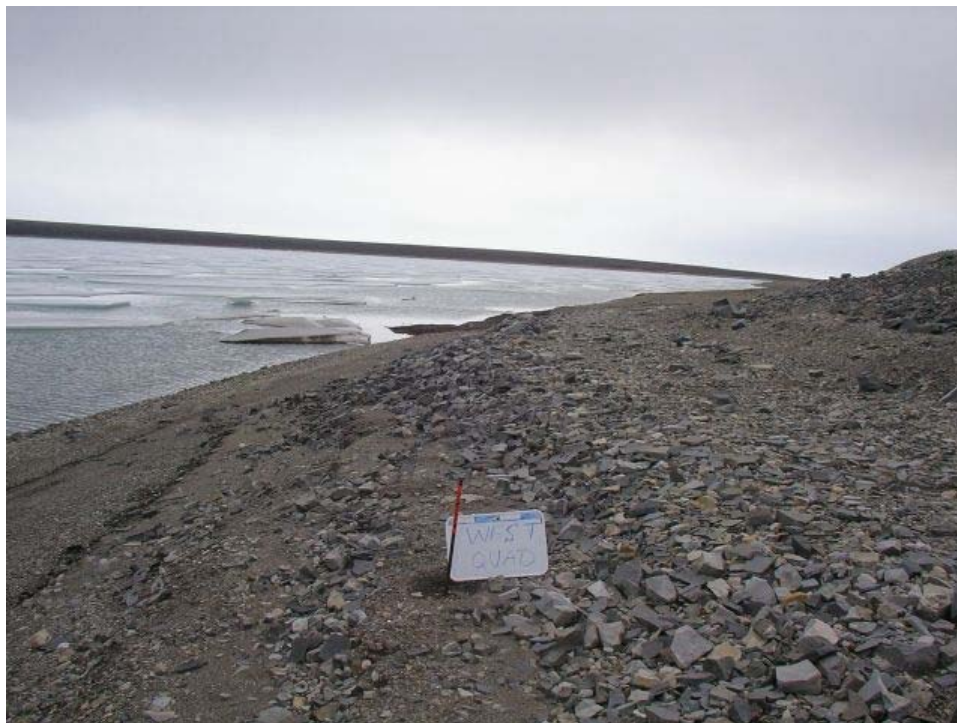
West Quadrant (Station 11) – view south, showing little change since last inspection in 2005.

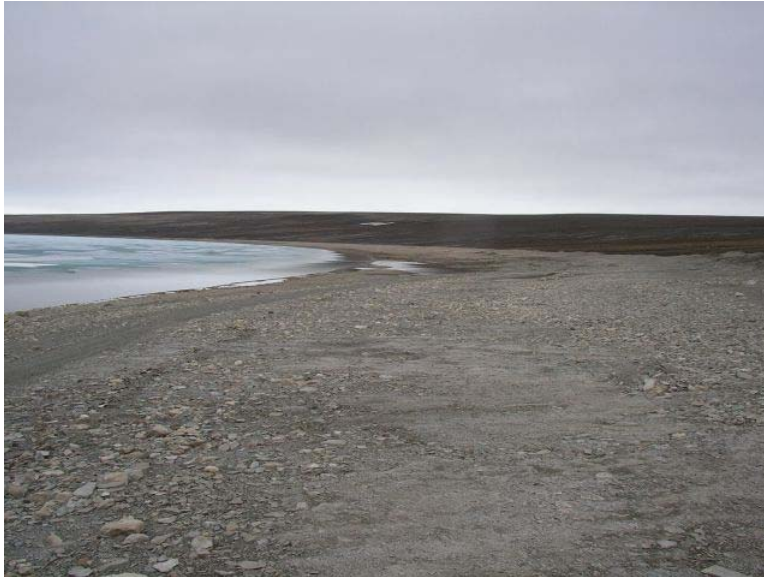
View west at North Quadrant Pin at Station 8 – sediments become more coarse and less subject to minor erosion proceeding north and east from the west quadrant. The situation remains unchanged since previous inspection in 2005.

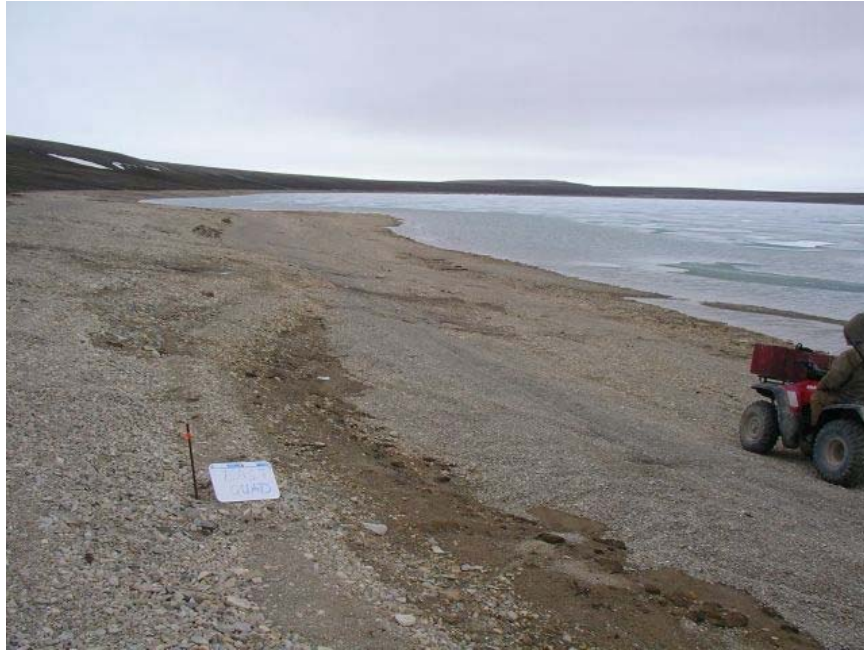
View south at East Quadrant Pin at Station 9 – sediments exposed are coarser than on west shore. No sign of widespread change since last inspection in 2005.

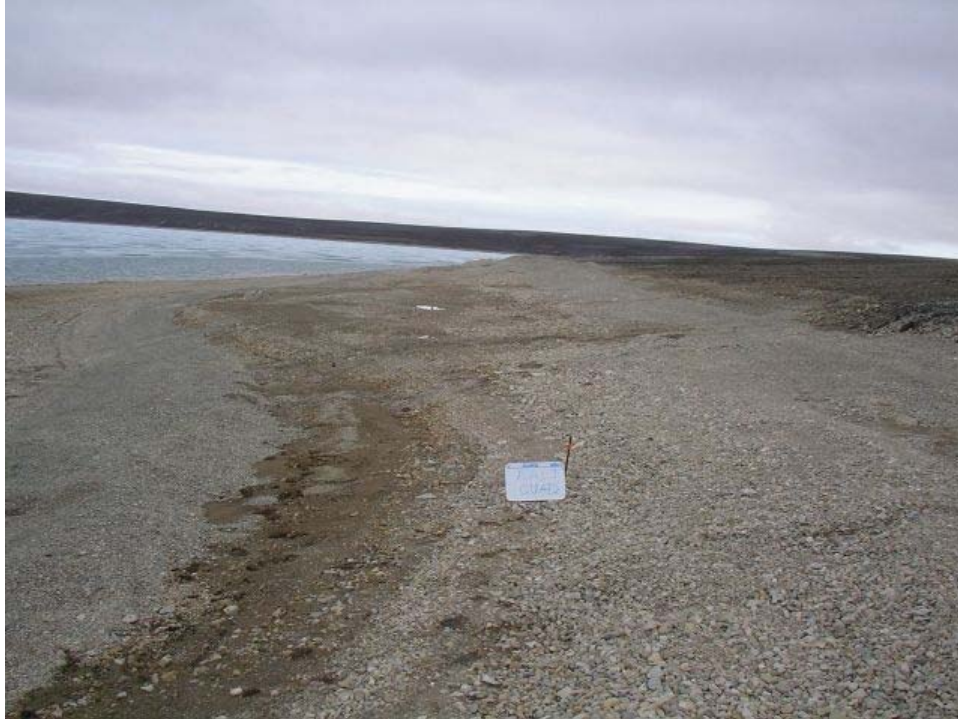
View north at East Quadrant Pin – Station 9. No evidence of significant change since previous inspection in 2005.

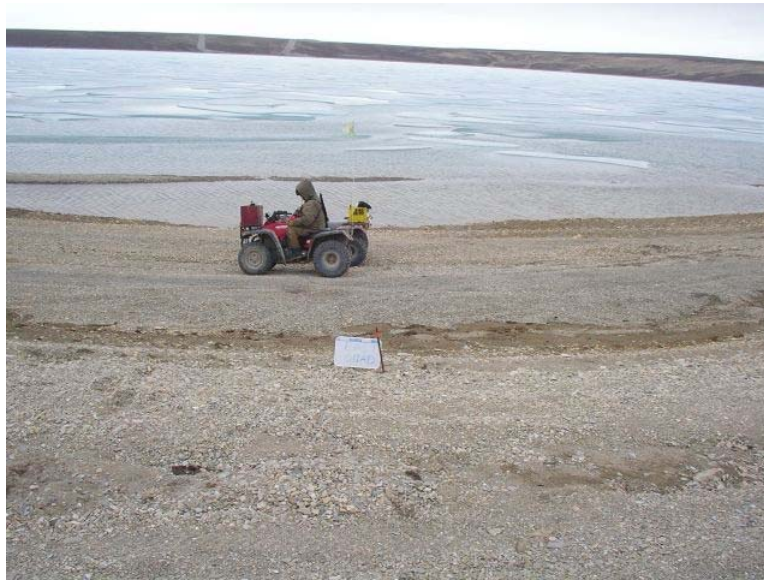
View from point south of East Quadrant (Station 9) where beach has become steeper proceeding southwards along eastern shore, with coarser angular rock fragments. Water level is slightly higher. Conditions are generally the same as observed in 2005.

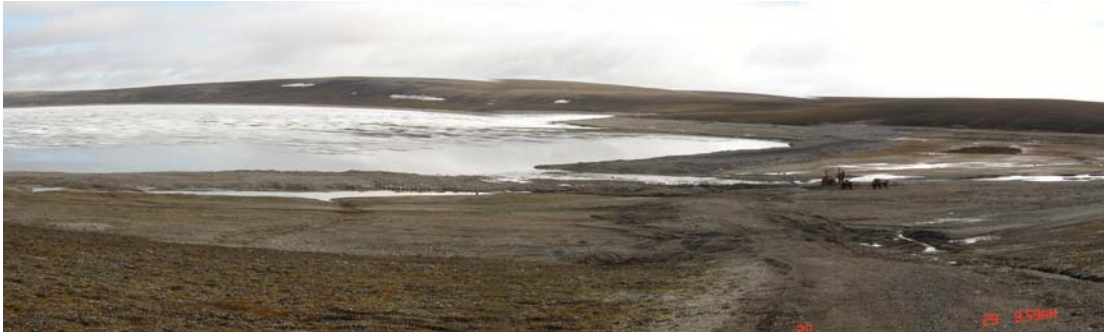
2005 – Panoramic view of Garrow Lake at left and wave break structure in the centre from waypoint GLWB1 on the access road on the western valley side slope.

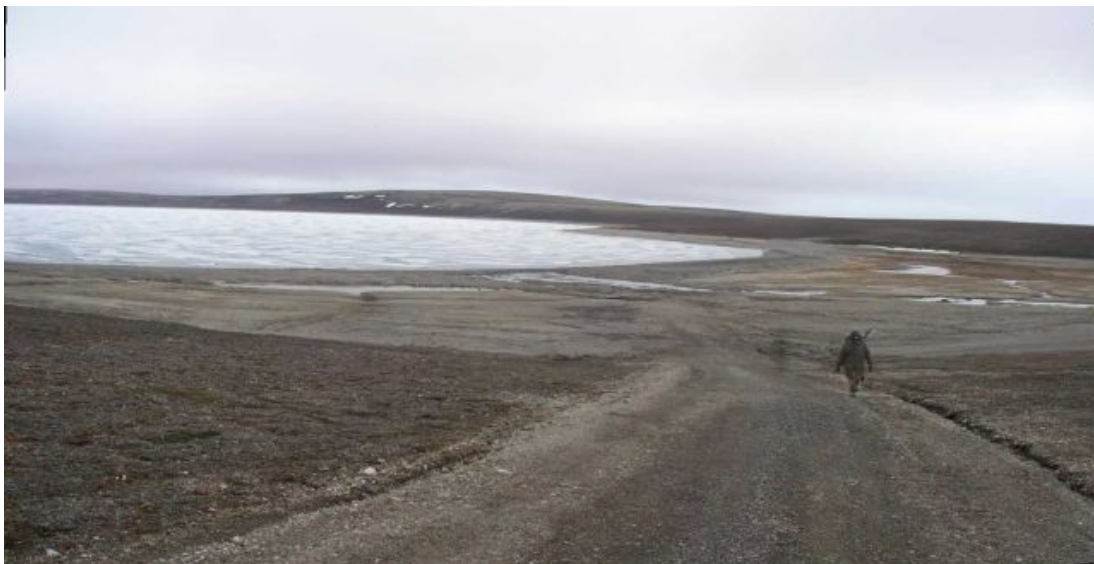
2006 – Panoramic view of Garrow Lake at left and wave break structure in the centre from waypoint GLWB1 on the access road on the western valley side slope. Note that outlet channel has filled in with a 0.4 m thick ridge of beach gravel. Otherwise no major changes have occurred since last inspection in 2005.

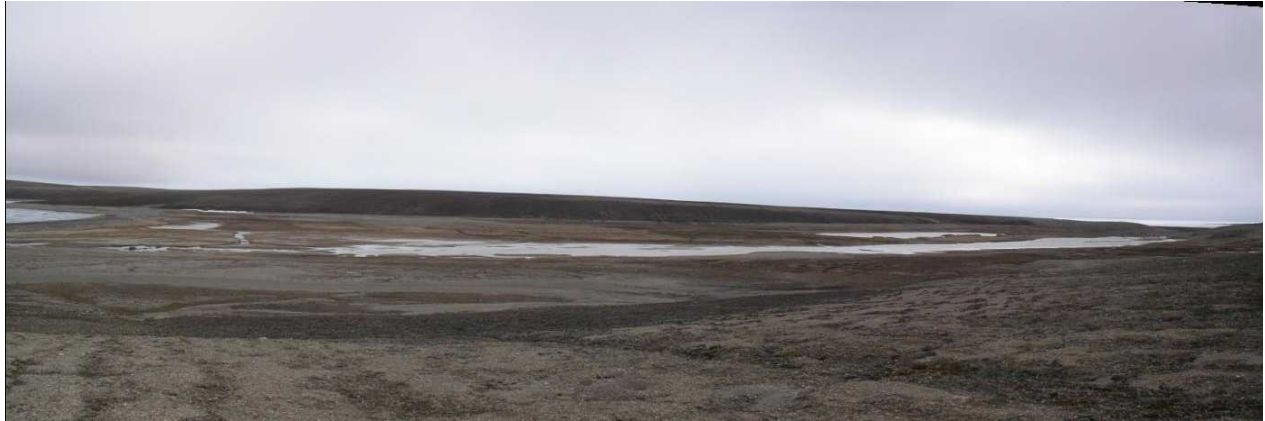
2006 – Wider panoramic view from waypoint GLWB1 of valley downstream of wave break structure. No changes observed.

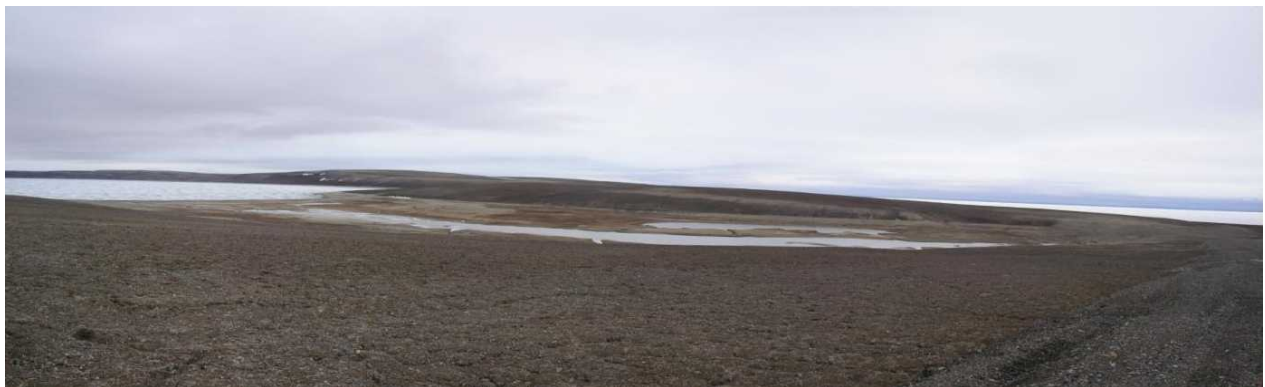
2006 – View from Garrow Dam access roadway, with dam at right and wave break structure at left.

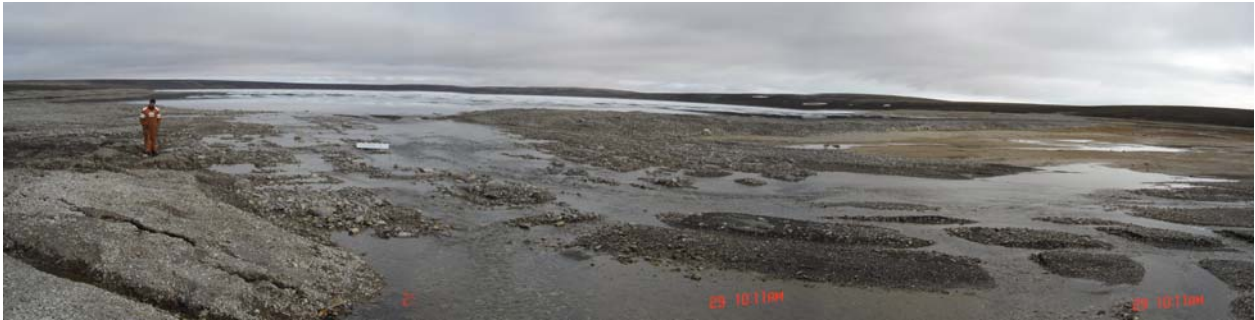
2005 – View north and east from waypoint GLWB2 looks upstream at outlet channel with wave break structure extending to the right. Material in channel is gravel sized and flow is only slightly turbid. Water quality sampling indicates that turbidity levels downstream at the main dam were low, evidenced by TSS measurements of 3 mg/l, at or below detection, on July 24 and July 31st 2005.

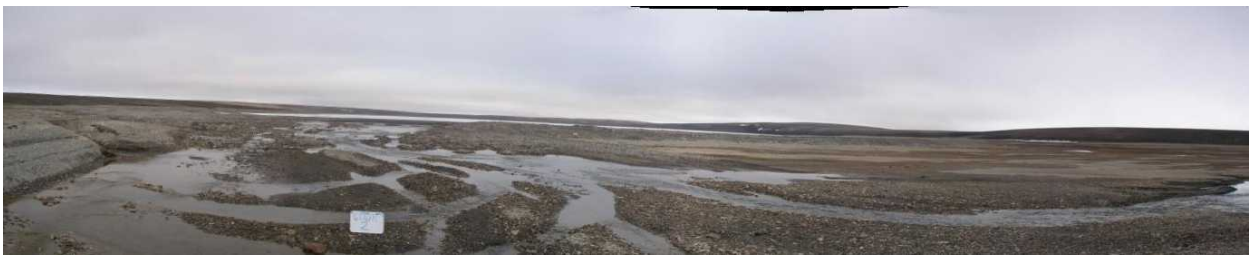
2006 – View north and east from waypoint GLWB2 looks upstream at outlet channel with wave break structure extending to the right.. Note where gravel berm has formed across channel outlet. Otherwise no changes observed. Water seeping through gravel is clear.

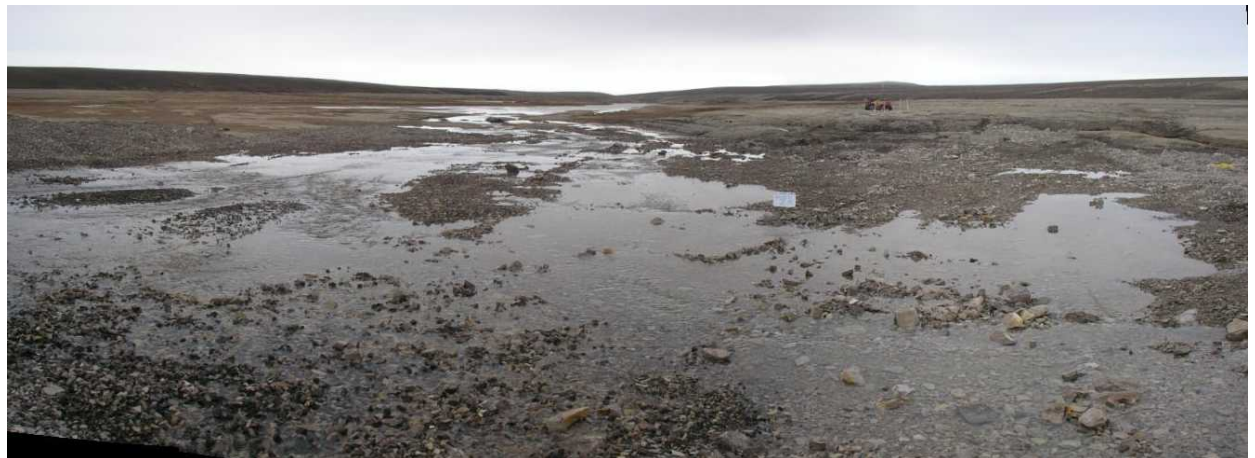
2006 – View from waypoint GLWB2a looks downstream from a point in the middle of the outlet channel. Conditions appear to be largely unchanged since previous inspection in 2005.

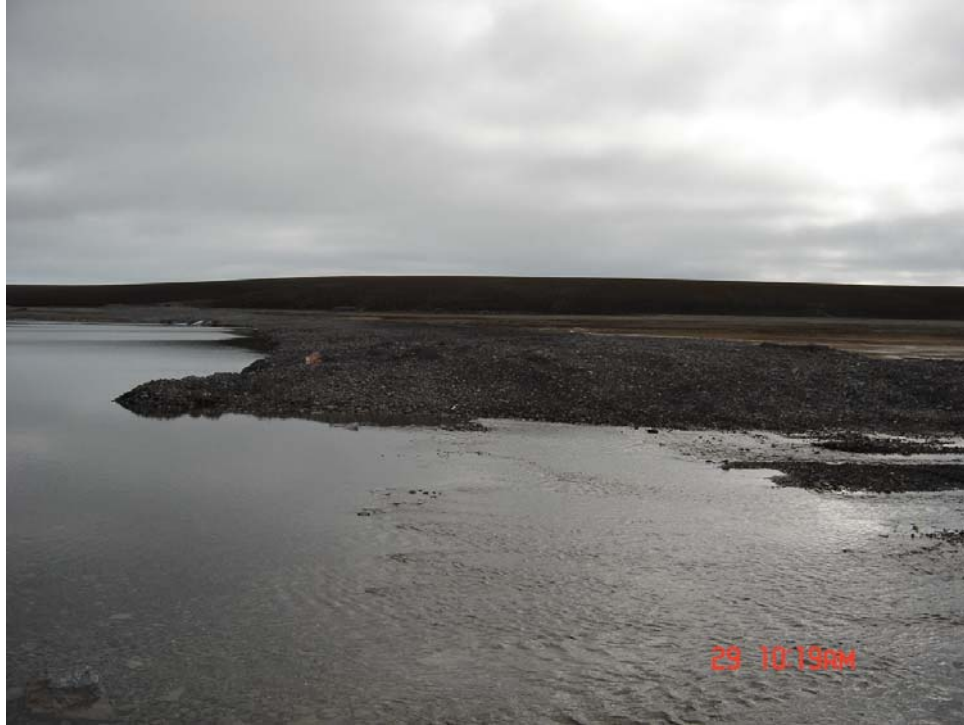
2005 – View from waypoint GLWB2a looks eastward across outlet channel illustrating uniform flow.

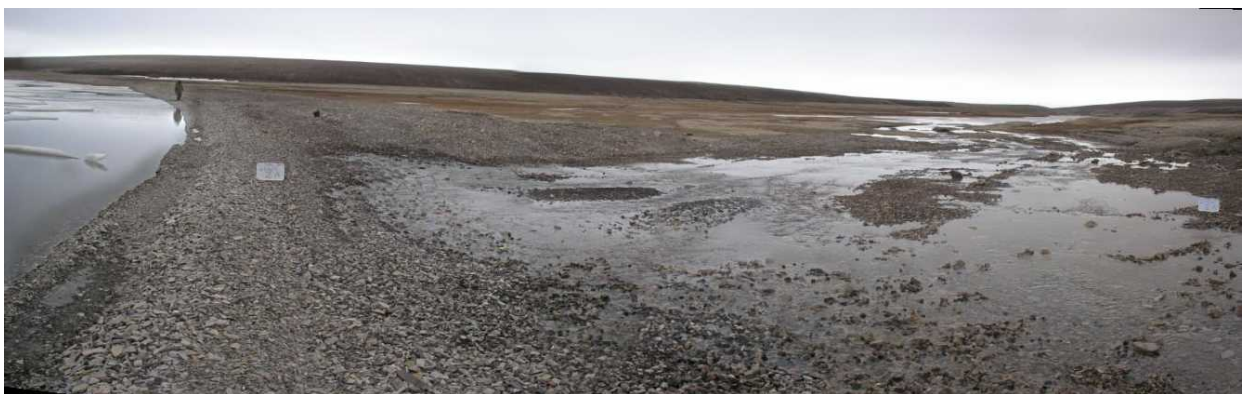
2006 – View from waypoint GLWB2a looks eastward across outlet channel shows where channel has been infilled by a ridge of beach gravel 3 to 4 m wide and approximately 0.4m thick. Seepage is flowing cleanly through the base of the gravel ridge. Ridge material is medium to coarse gravel.

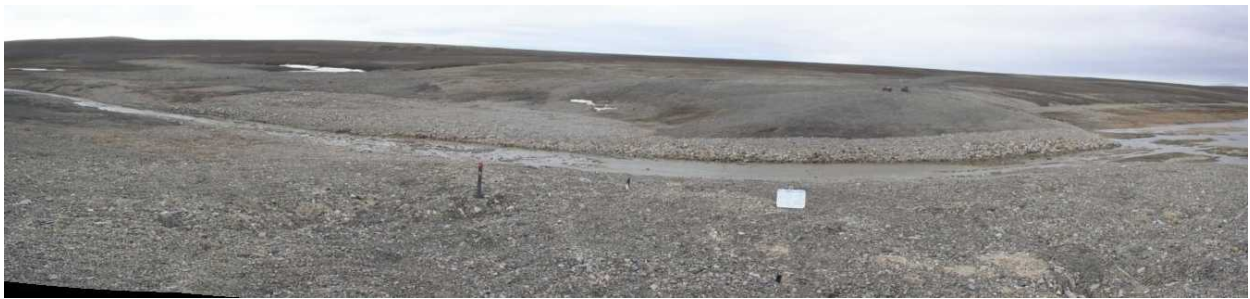
View of the west side of the dam breach from east abutment from waypoint GLD2, showing inlet at right, and rip-rapped channel which is generally in good condition. Opposite side slope, inclined at approximately 12 degrees, appears stable. Conditions are unchanged from the previous inspection in 2005.

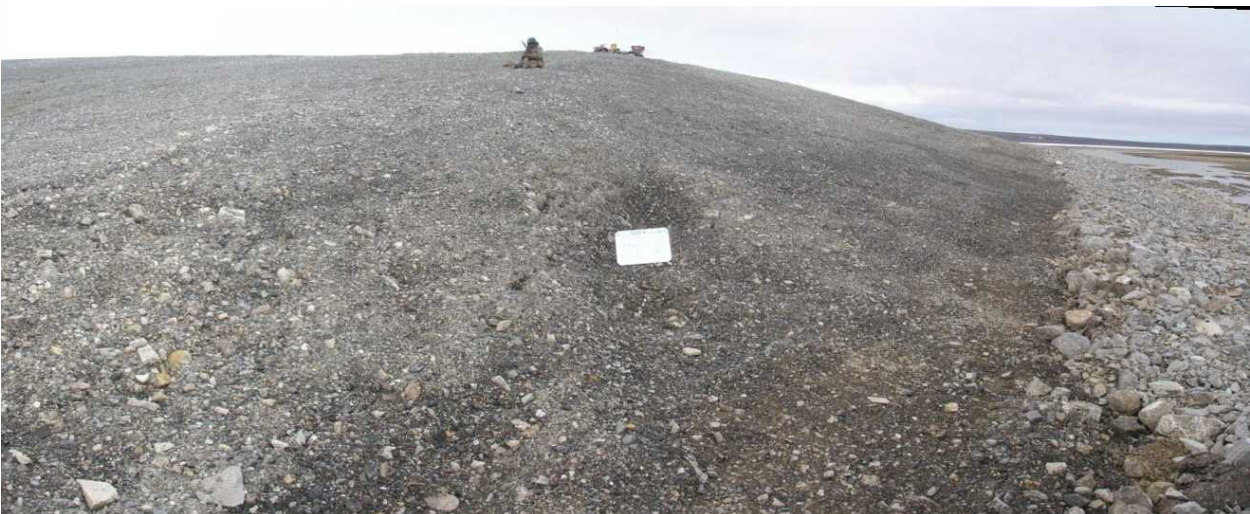
View of the south edge of the west side of the dam breach from east abutment from waypoint GLD 06 1A showing a minor crack and slight slumping that was also observed in 2005 and appears unchanged.

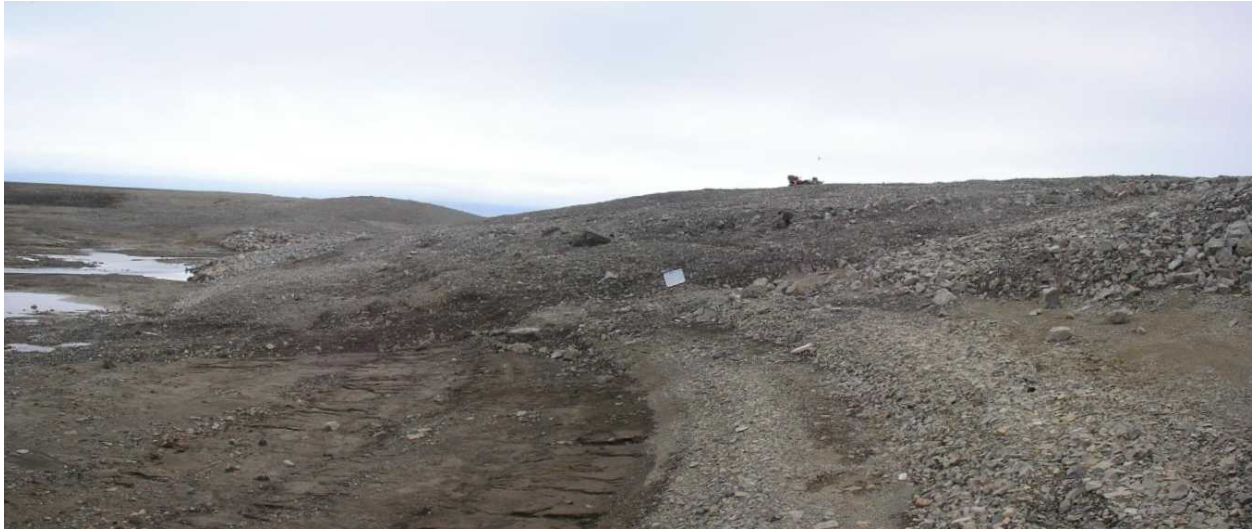
View of north flank of west side of dam from waypoint GLD 06 1B, where an area where material mixed with snow was dumped. This appears to be stable and relatively old and is located well away from the main rip-rapped channel. The area affected is about 20 m wide and occurs over the lower half of the overall slope. It should be observed in future inspections, but is not expected to be problematic.

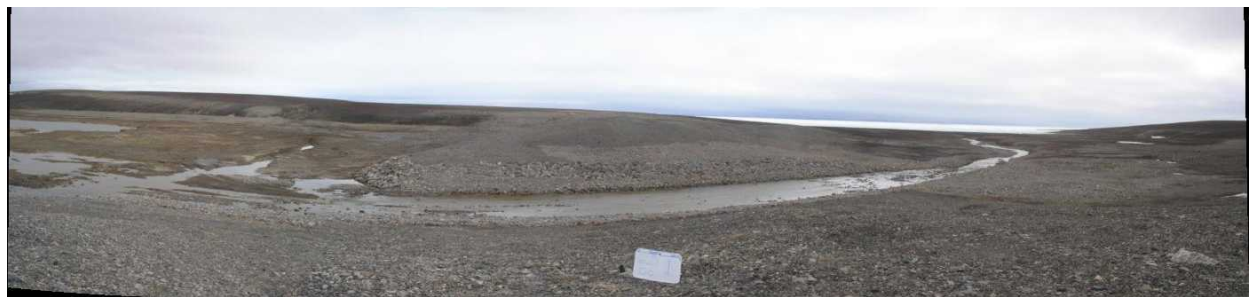
View of east side of dam breach from west abutment from waypoint GLD1. Both breach side slopes are inclined at approximately 12 degrees and are generally in good condition. There is no discernible change since the previous inspection in 2005.

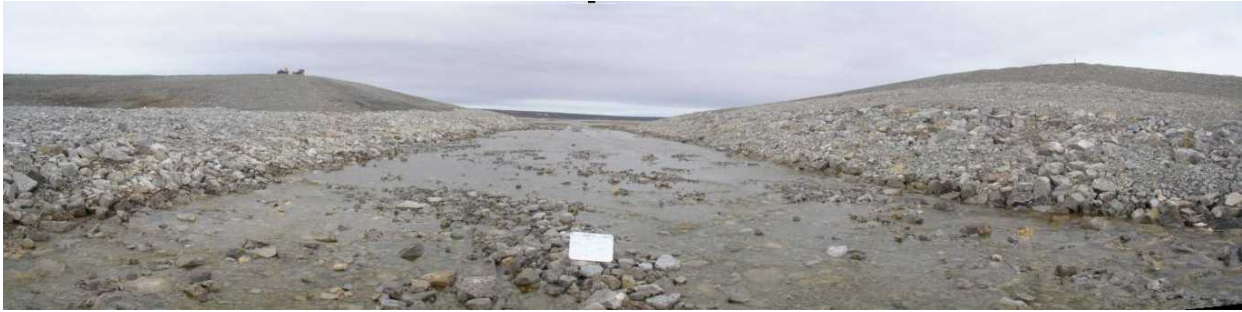
View northwards at waypoint GLD3, looking upstream along creek channel, showing rip-rap lining, which is in good condition. Flow is moderately uniform across channel, with high clarity. Conditions appear to be unchanged since previously inspected in 2005.

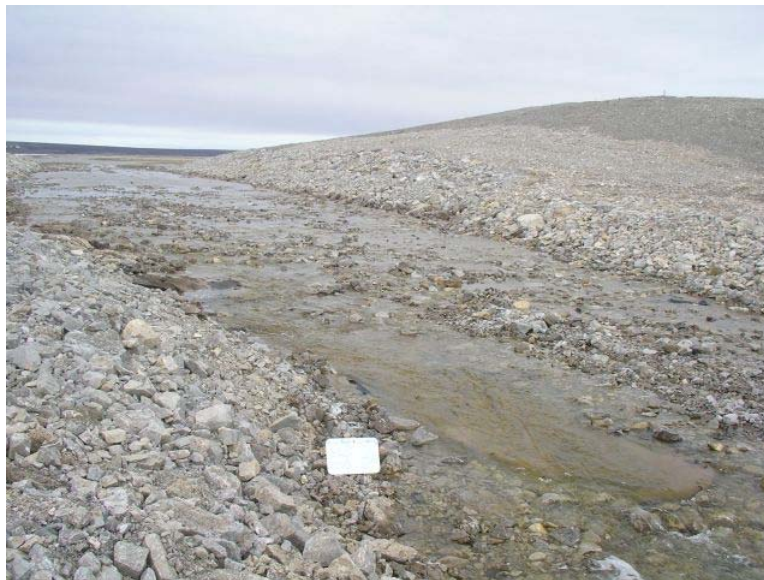
View from 30 m downstream of waypoint GLD3 at a point where channel gradient increases. Filter fabric underlying the rip-rap material was observed in 2005 to be exposed over a width of 3 to 4 m and over a length of about 10m. Conditions appear not to have changed significantly since then. The integrity of surrounding rip-rap does not appear to have been affected. Remedial action to replace rip-rap is recommended as a precaution in 2007.

- The remnants of the former decommissioned Garrow Lake dam are stable. There is a small area where geotextile is exposed and should be covered with rip-rap in 2007.
- The covers over the mine entrances are all stable with no concerns noted.
- Both landfill covers are in excellent condition and there were no concerns noted. The natural slope above the Operation Landfill has a drainage feature that ongoing monitoring is recommended.

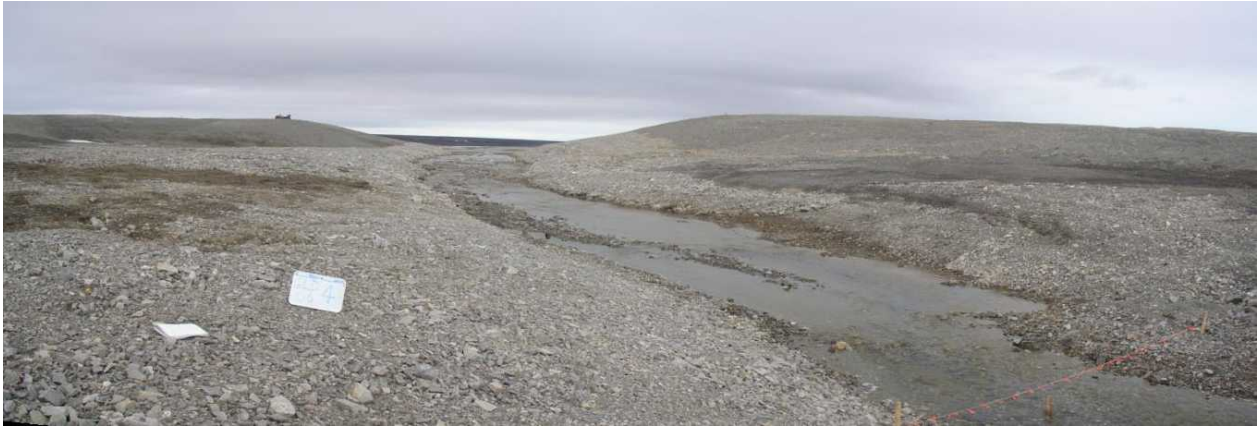
View looking upstream from waypoint GLD4 of overall breached dam and rip-rapped channel. No significant changes are discernible since the previous inspection in 2005.

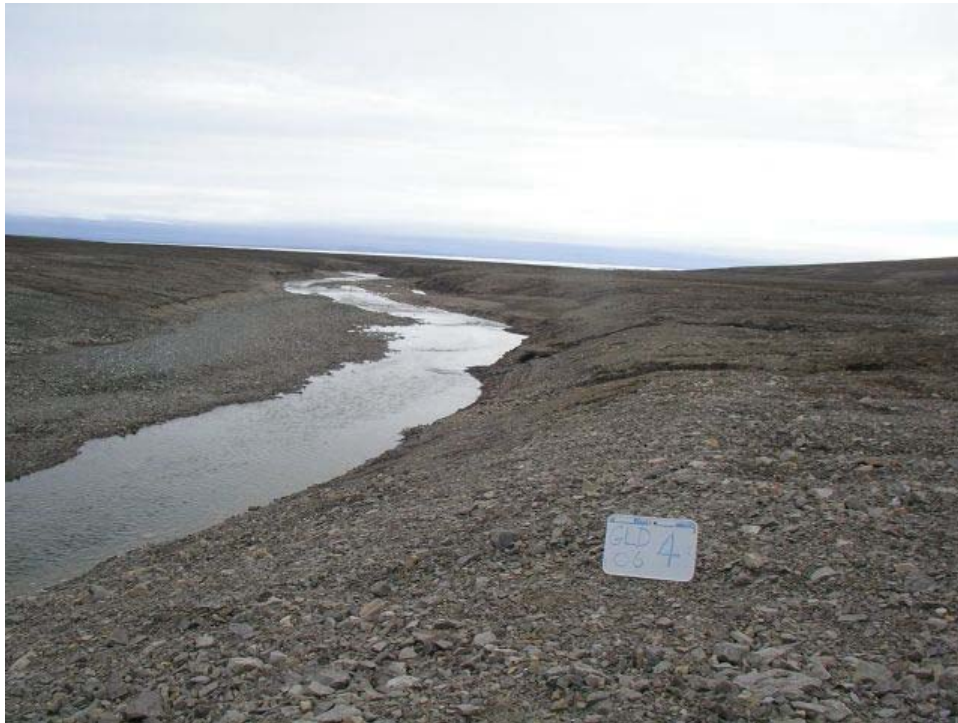
View looking downstream from waypoint GLD4 of lower end of outlet channel. Conditions are almost unchanged since the previous inspection in 2005.

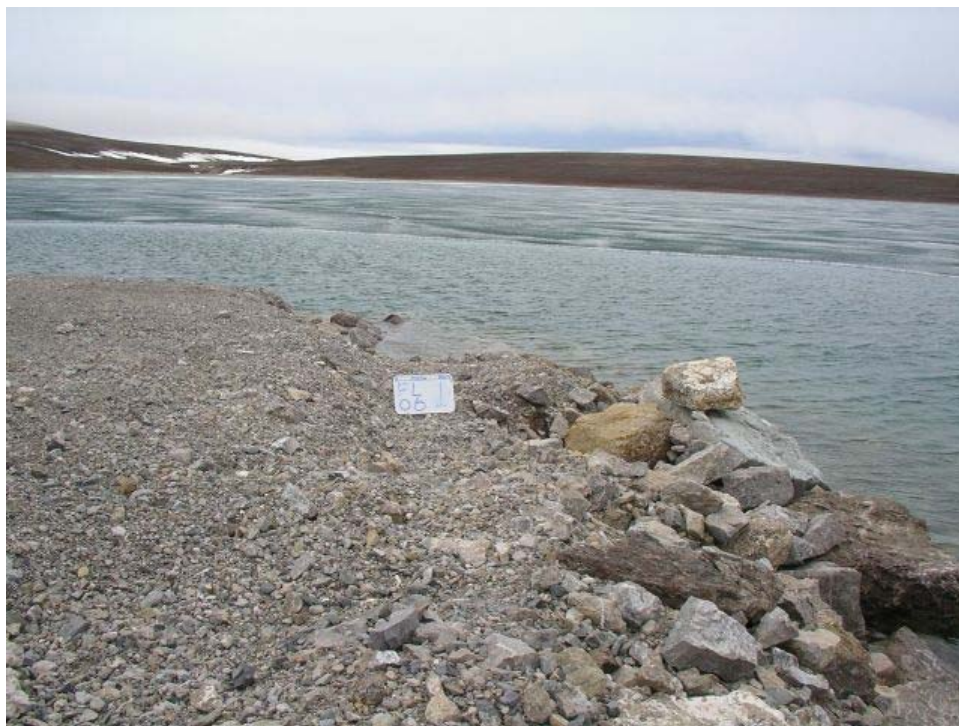
2006 – View from waypoint FL1 looking across end of causeway – note slight subsidence in foreground and significant erosion of finer material at far corner.

- Some minor erosion at the Frustration Lake jetty appears to have occurred due to either wave or ice action. In general the jetty remains stable.
- There was no observable erosion or foreshore instability concerns identified around the perimeter of Garrow Lake. Measurements of the four erosion pin stations around Garrow Lake were incorrectly done last year, so they were monitored this year. All four pins appear to be moving. There is a similar change in measurements at all four. This is likely due to frost jacking as visual observations do not suggest any erosion activity. This is the last year that the pins will be monitored. In future, monitoring of the perimeter of the lake will be by visual observations.

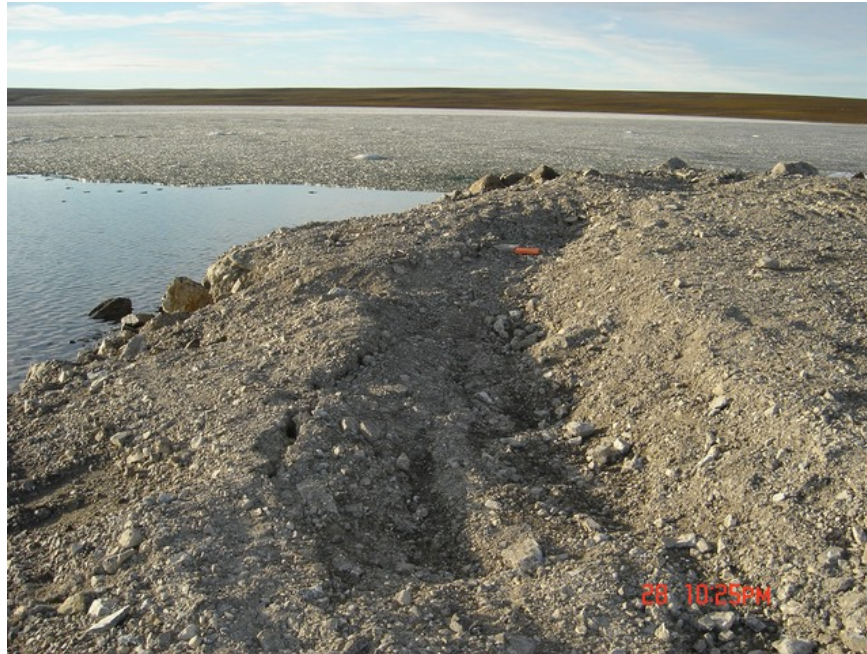
2005 – View from waypoint FL2 looking northeast across northern end of causeway.

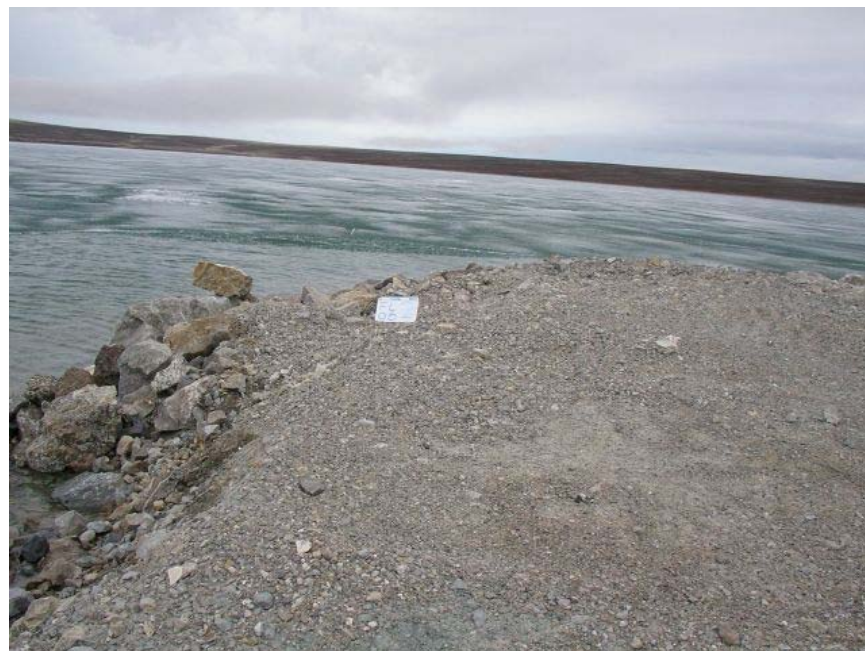
2006 – View from waypoint FL2 looking across northern end of causeway – previously observed subsidence in 2005 near sign remains unchanged, with vertical separation of about 0.3 m over a width of 2 m. As shown in photo from waypoint FL1, corner at lower left has been eroded exposing coarse rockfill. Surrounding fill across crest of causeway appears unaffected and stable.

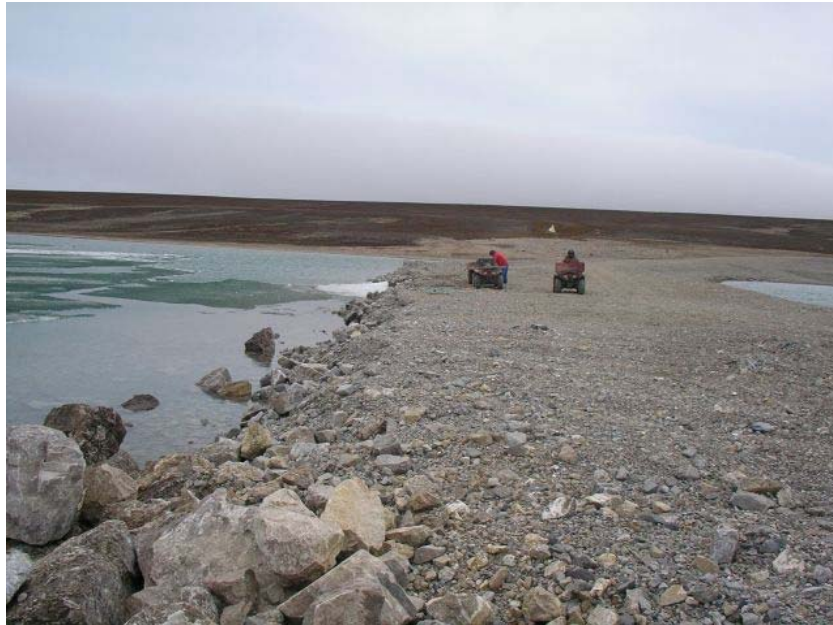
2006 – View from waypoint FL1 looking east towards shoreline. Conditions appear virtually unchanged since observed in 2005, with some minor loss of finer material exposing coarse rockfill.

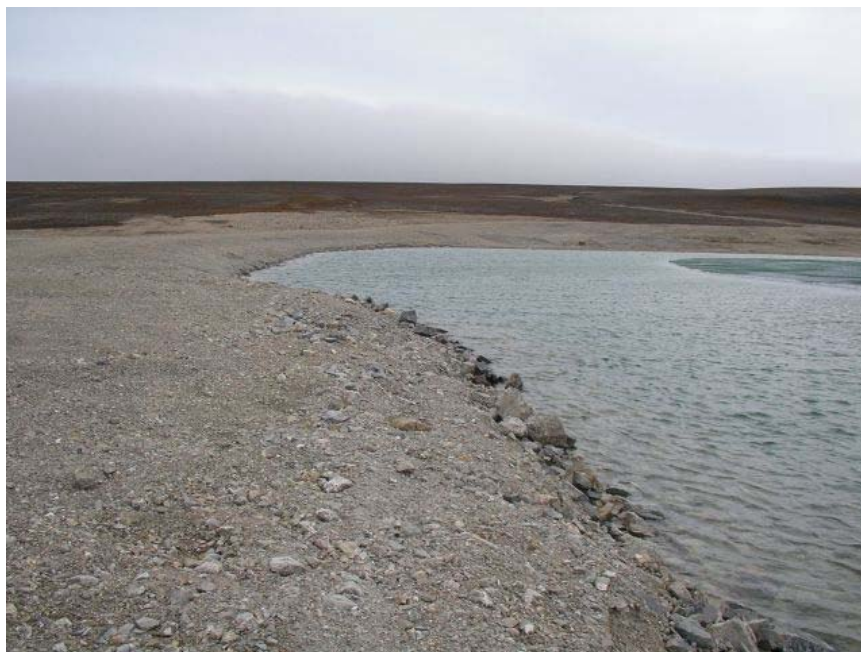
2006 – View from waypoint FL2 looking towards shoreline along west side of causeway. No sign of deformation observed along this side. Some loss of fines has occurred at waters edge, but no signs of major instability.

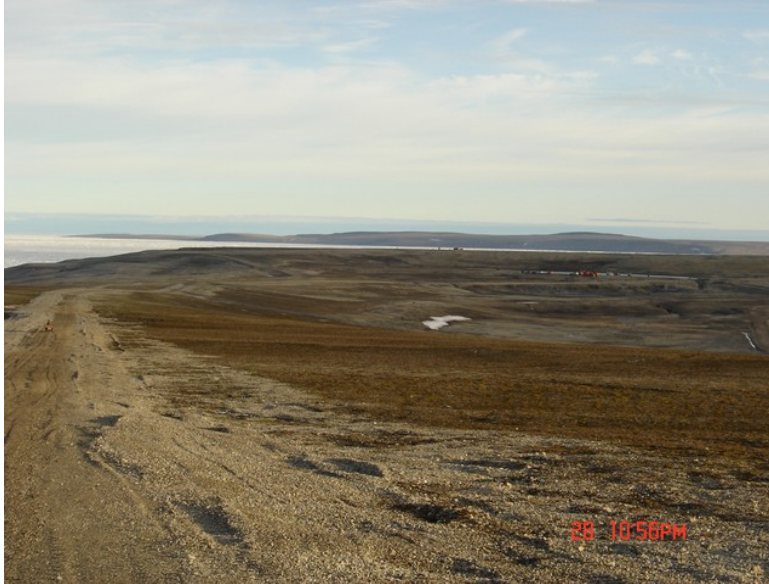
2005 – View of segment of road to Frustration Lake looking southwest towards mine site from the highest point of topography. Roadway and sideslope are in good condition, free of significant erosion features. No photo taken during 2006 inspection, as was misty, and no major changes observed .

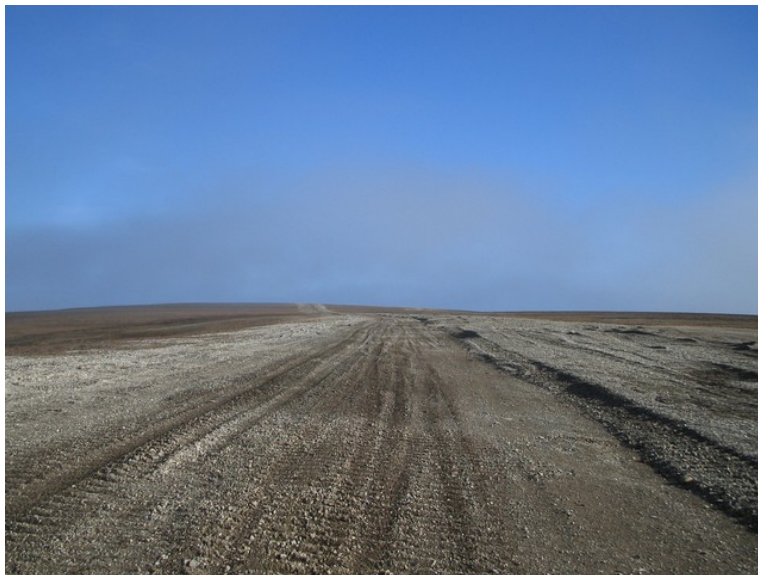
2005 – View to the southwest looking towards topographic high point showing approximately the middle one-third of the access road to Frustration Lake. This section is in good condition. No photo taken during 2006 inspection, as was misty, and no major changes observed .

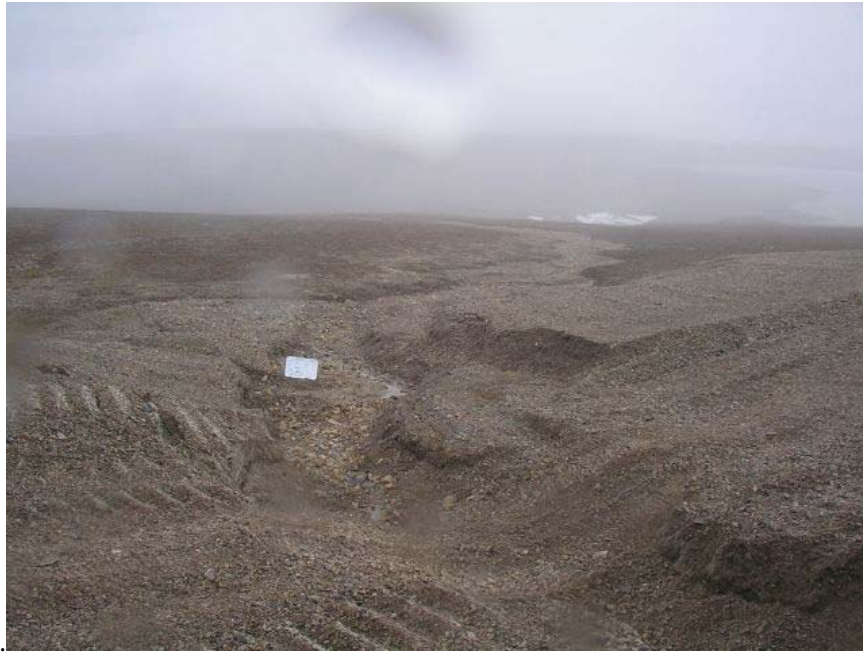
2006 – View downslope of waypoint FLR06 4, approximately 1.4 km from the intake causeway, which appears to be stable and self-armoring.

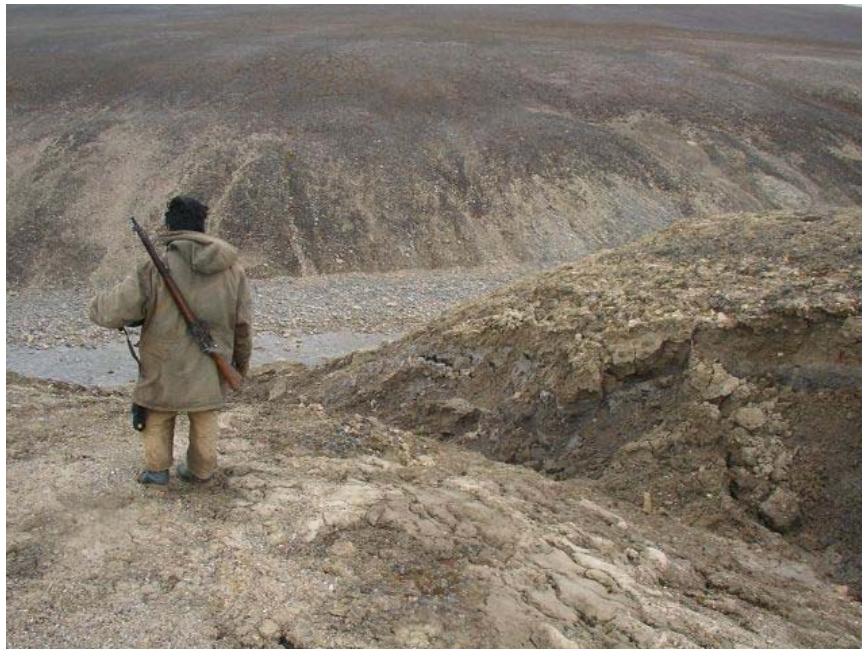
2006 – View of an active erosion gully downslope of the road, near to river bed, at waypoint FLR06 3, approximately 1.2 km from the causeway. Observation of the surrounding terrain suggests that other such gullies have formed and have eventually stabilised with the accumulation of coarse materials.

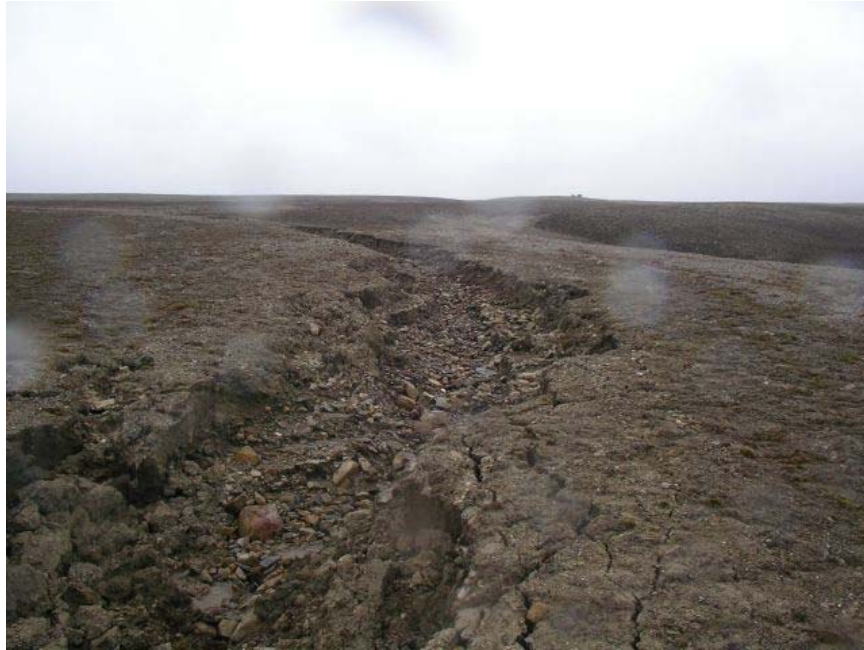
2006 – Erosion gully partway downslope of waypoint FLR06 3 appears to be self armouring.

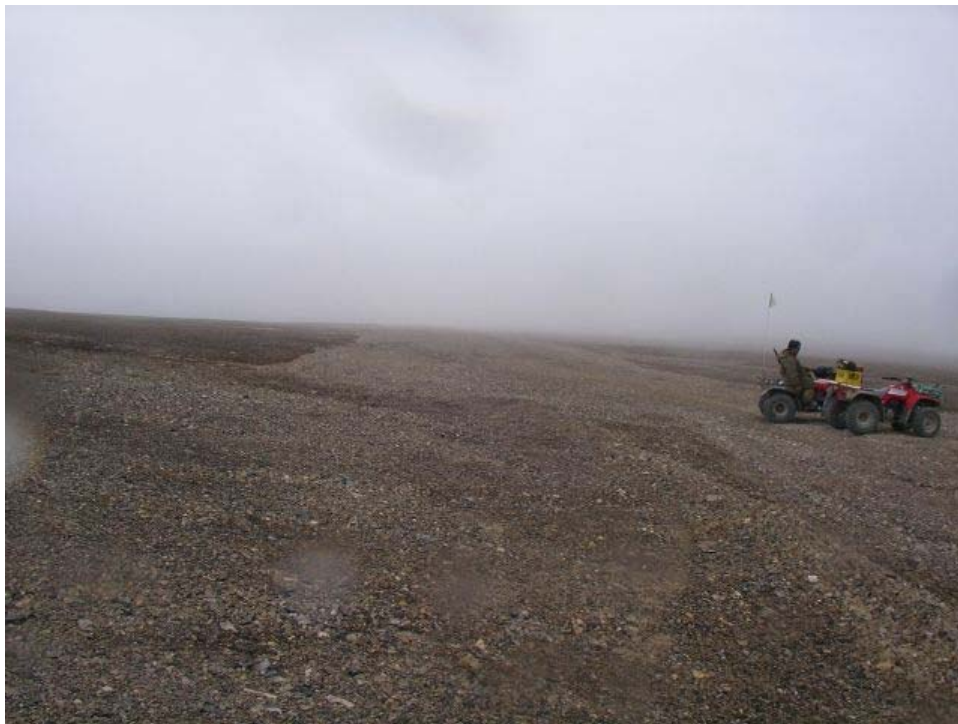
2006 – Views southwards at FLR06 3 looking up road which is in good condition.

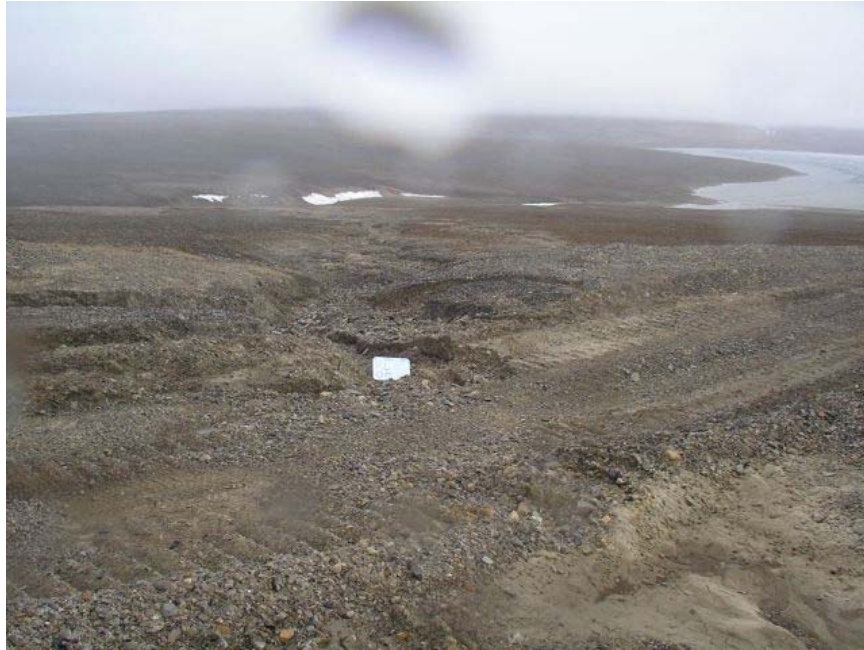
2006 – Closer view of minor erosion gully waypoint FLR06 3 approximately 1.2 km distant from causeway. There appears to be sufficient coarse fraction so that self-armouring is occurring. However, remedial drainage work carried out after this site inspection to dissipate concentration of runoff which is causing accelerated erosion downslope, as shown in preceding photographs.
