**POLARIS MINE
POST-RECLAMATION MONITORING REPORT
3rd QUARTER 2006 FOR THE
NUNAVUT WATER BOARD
&
INDIAN AND NORTHERN AFFAIRS CANADA**

Re: Polaris Mine Water Licence NWB1POL0311 – 2006 3rd Quarter Water Licence Report

**Report on Post-closure Geotechnical Inspection for
Polaris Mine Site in 2006
Area 1 – Garrow Lake, Creek and Dam**

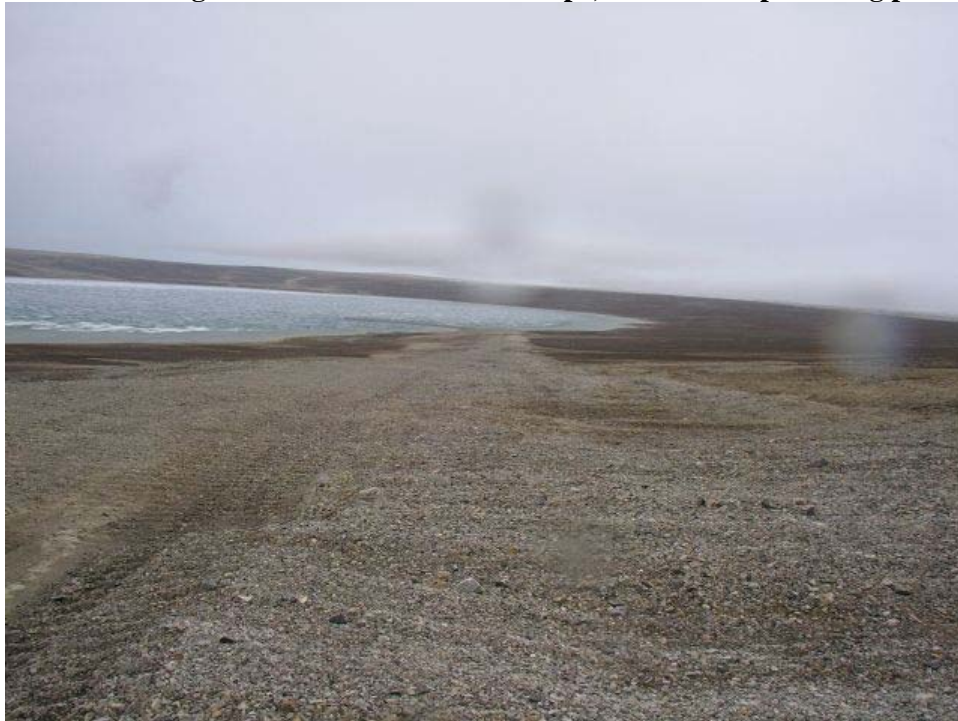
2006 – A drainage swale at waypoint FLR 06 2, approximately 900 m from the intake embankment. Overall condition of this segment of the access road remains good.

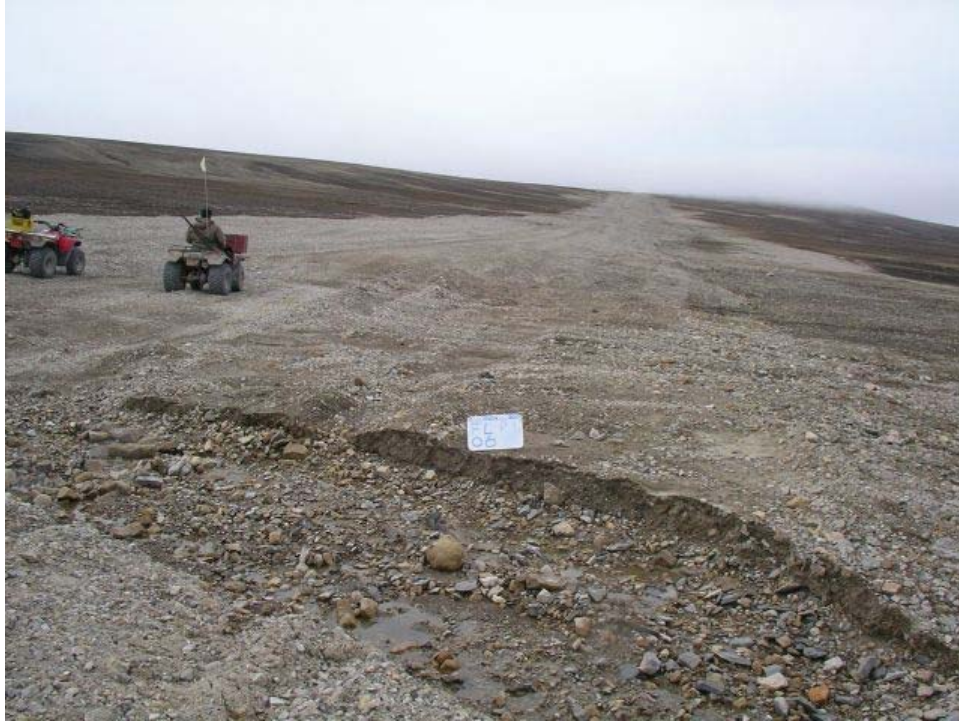
2006 – Access roadway at waypoint FLR 06 1 view to the southwest at about 200 m distance from intake causeway. Erosion is localised, shallow, and appears to be self armouring.

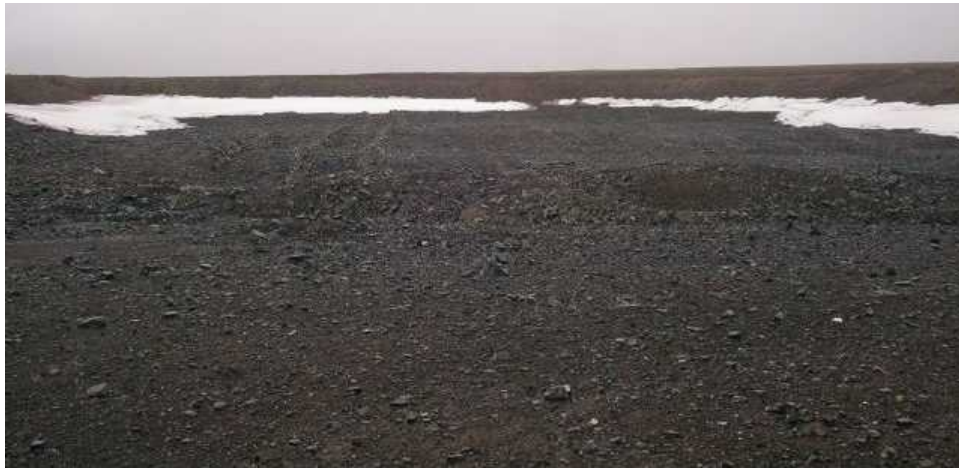
2006 – View looking east up slope into extension of New Quarry, from waypoint NQ1 PH1, shows stable side slopes with no discernible change from 2005.

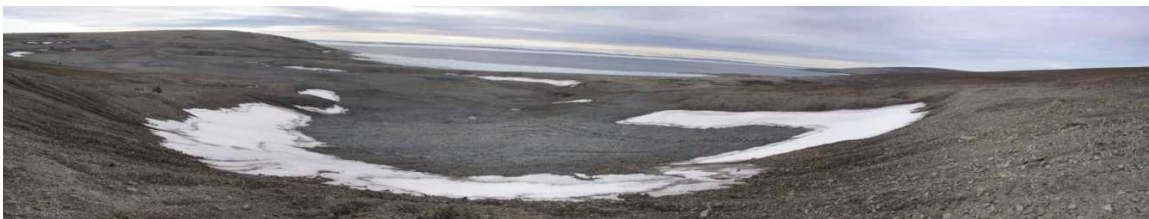
2006 – Panoramic view looking west down slope into extension of New Quarry, from waypoint NQ1 PH2, shows area of disturbed soil, which appears to be stable, with no discernible change since inspected in 2005.

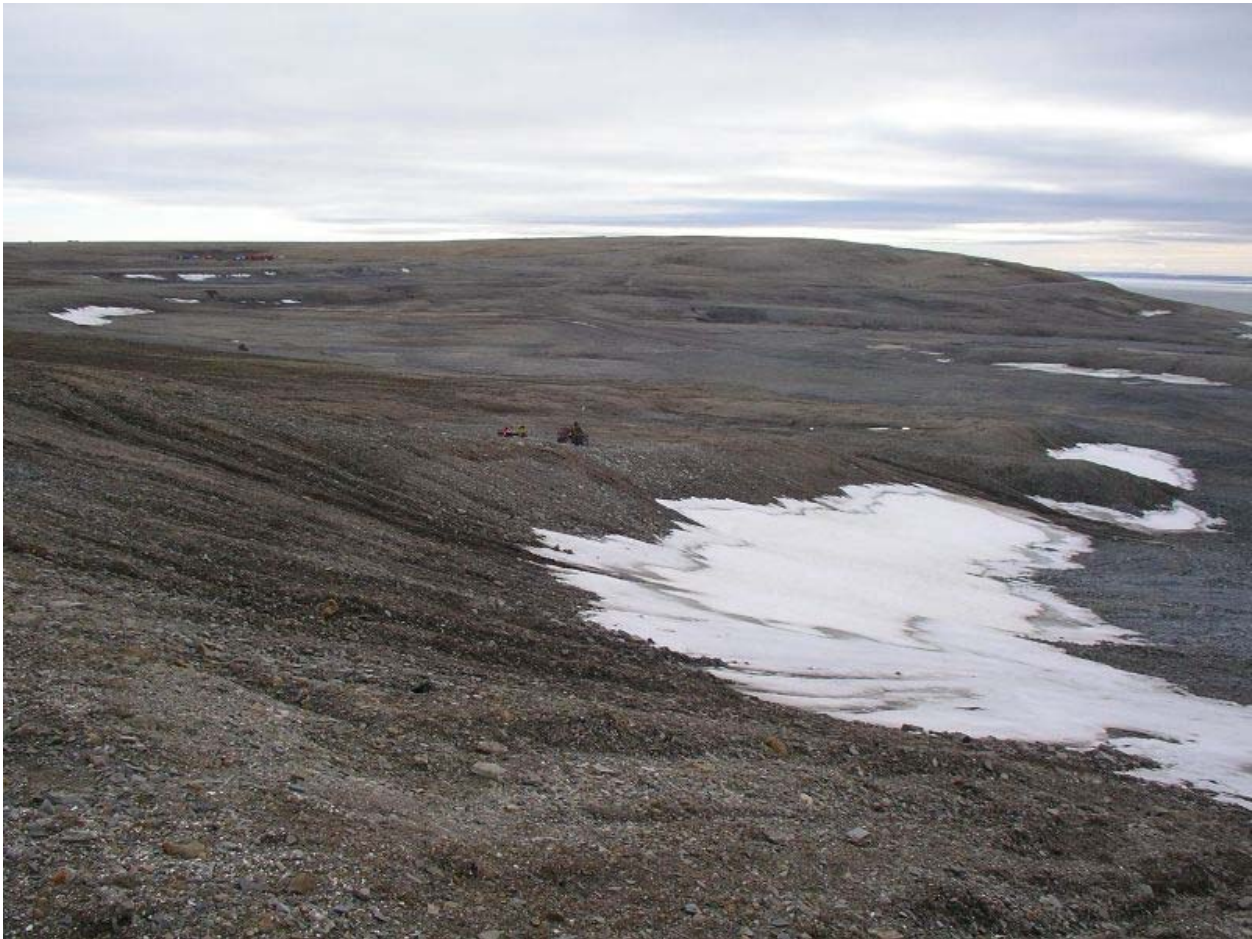
2006 – View looking down west sideslope of New Quarry Extension, where stripped organic surficial soil has been spread. Occasional cracks but no signs of mass movement presenting any hazard to humans or wildlife, with no significant change since last inspection in 2005.

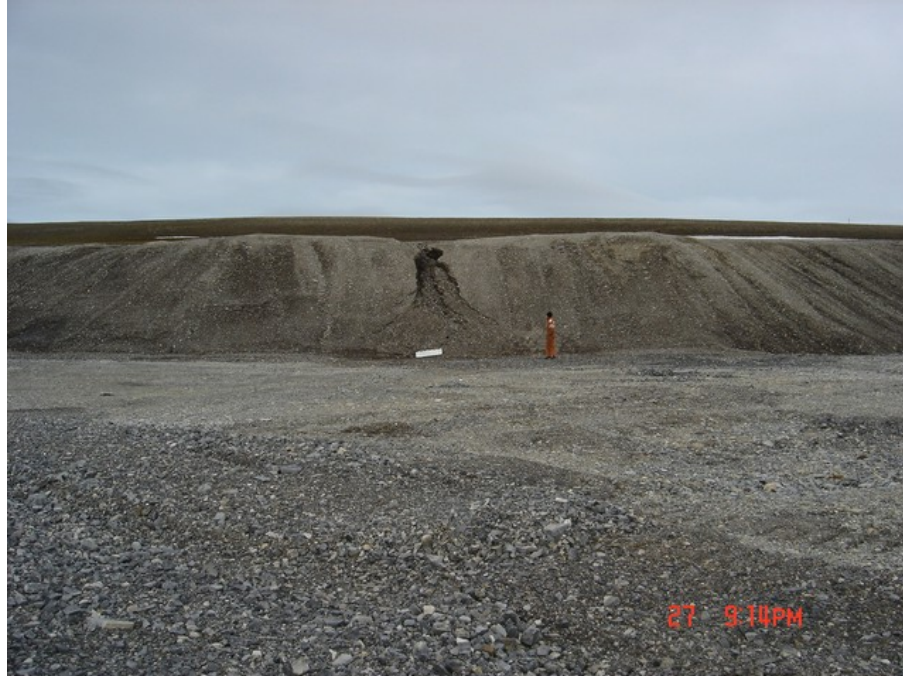
2005 – Isolated erosion gully at waypoint NQ2 PH1.

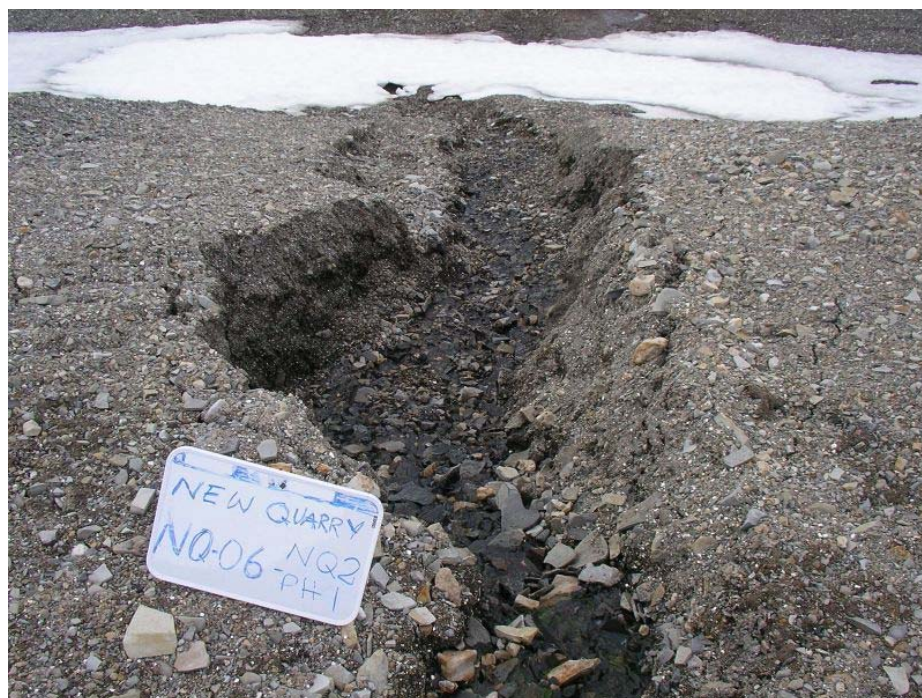
2006 – Close-up view of erosion gully at waypoint NQ2 PH1, showing relatively small width, and apparent tendency to be self-armouring, with no apparent changes from 2005.

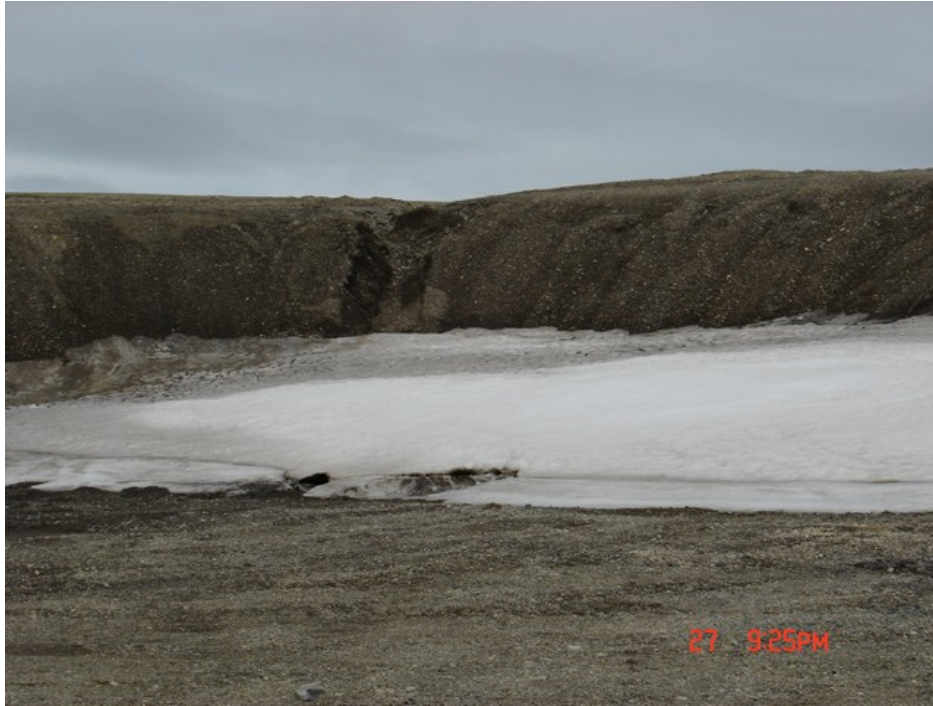
2005 – An isolated erosion gully at waypoint NQ3 PH1.

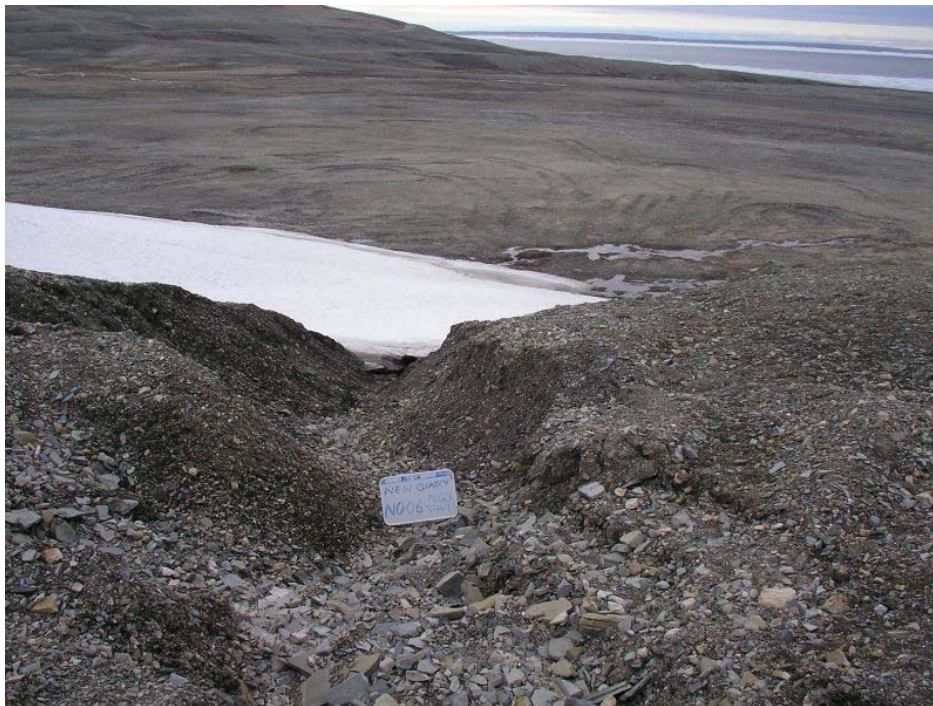
2006 – An isolated erosion gully at waypoint NQ3 PH1. Conditions appear to be unchanged since last inspected in 2005, with evident tendency to self-armour.

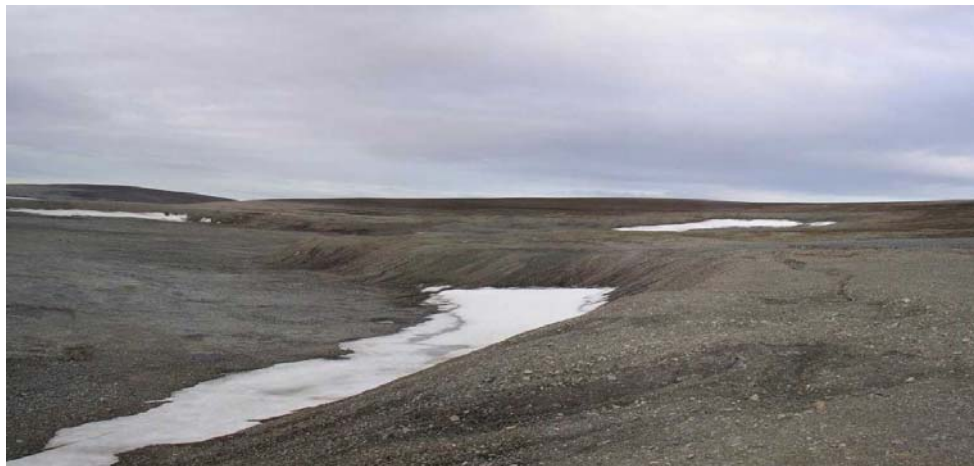
2006 – Area above waypoint NQ5 view looking northeast across area of disturbed surficial soil bordering edge of quarry side slope. Illustrates typical pattern of surficial deformation caused by seasonal thaw of disturbed surficial soils. This poses no threat to humans or wildlife, and no discernible changed observed since last inspected in 2005.

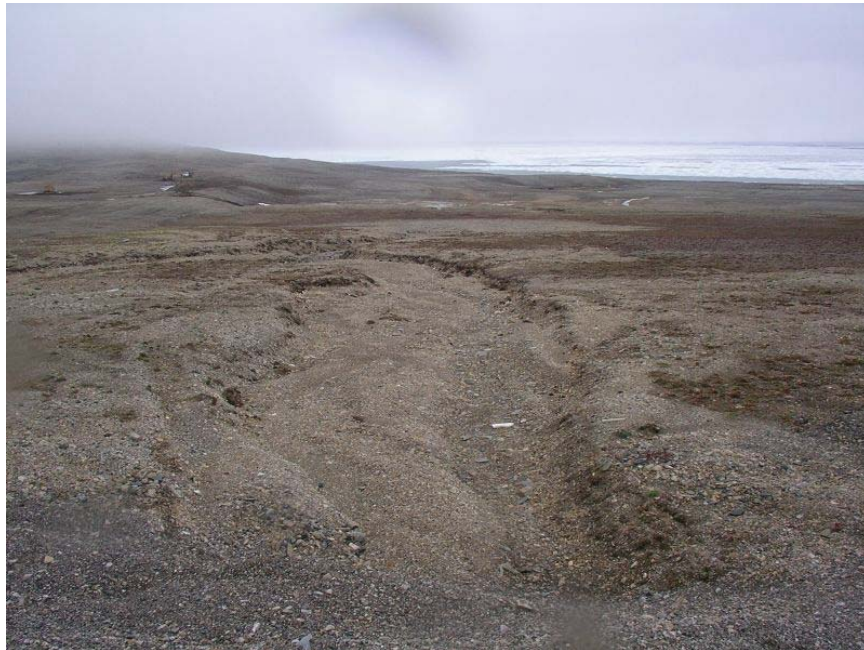
2006 – View to northwest at waypoint NQGTOP1 of a thaw/erosion gully on slope between road to Frustration Lake and the new Quarry area. This feature extends down to the top of the fan shown in photographs taken from waypoint NQ6 (see below). No discernible change since 2005 inspection.

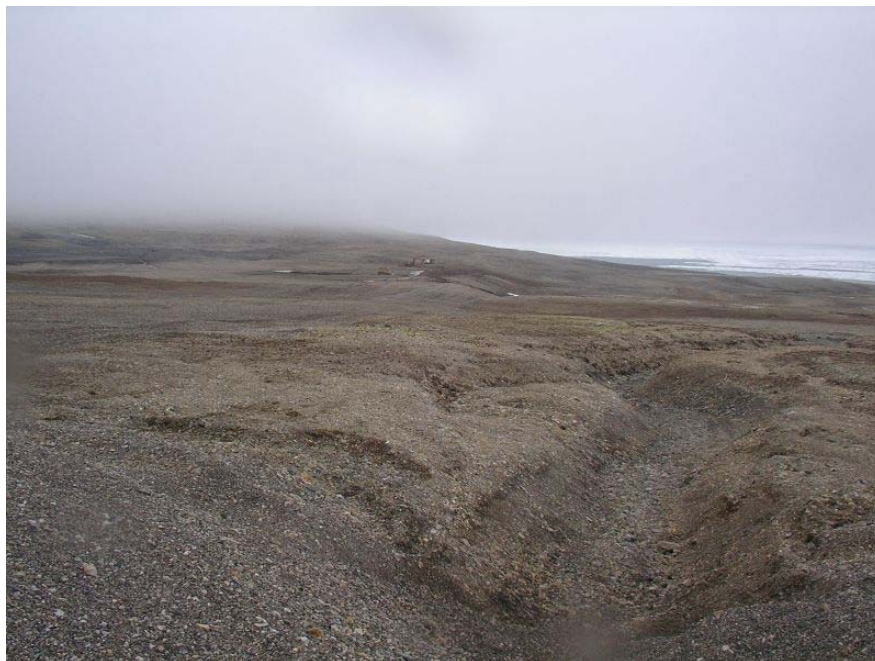
2006 – View to northwest from waypoint NQGTOP2 of second thaw/erosion gully adjacent and parallel to the one shown above at waypoint NQGTOP1. No discernible change since 2005 inspection.

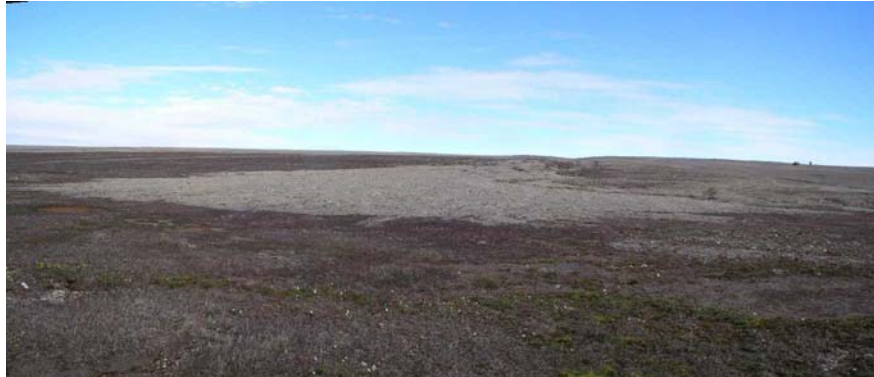
2006 – View at waypoint NQ 6 northeast across natural slopes to west of new Quarry area. Thawing and erosive processes have during the life of the project appear to have resulted in two parallel gullies and erosion of surficial weathered rock which has formed a fan as shown. No discernible change observed since last inspection in 2005.

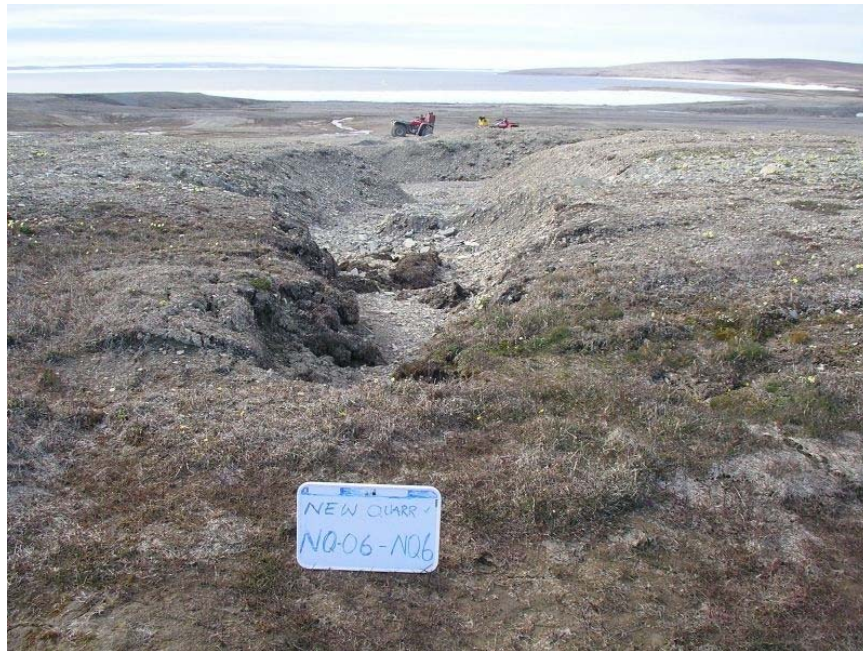
2006 – View northwest looking down gully at waypoint NQ6. This appears to be a slow erosive process, possibly as a result of intermittent storm runoff transporting coarse material from fan upslope, shown in photograph above. Although there has been no discernible change since inspected in 2005, this area should continue to be monitored. See measurements of gully size noted in following photographs at known GPS locations to facilitate future comparison of rate of erosion. Localised erosion control measures, likely best implemented by manual labour, to protect surrounding tundra, should be planned for implemented as soon as is practical in 2007.

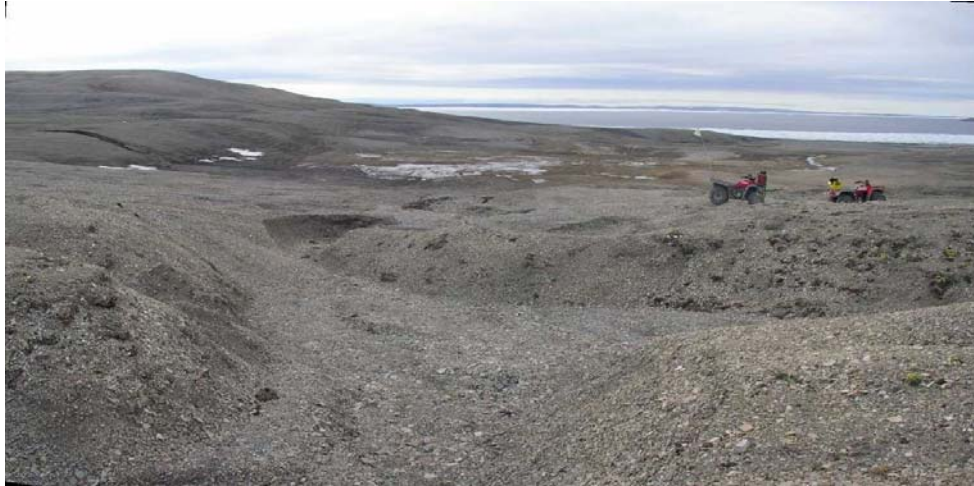
2006 – Photo shows gully through loosened materials around edge of new Quarry, down slope of waypoint NQ6. There is no discernible change since the last inspection in 2005.

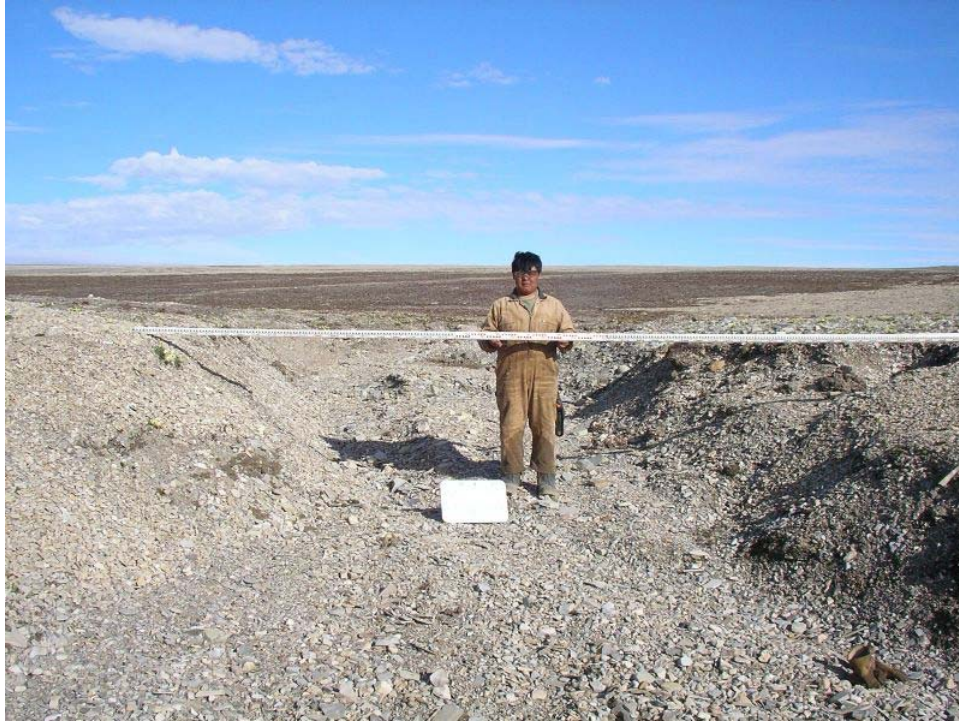
2006 – At waypoint NQG1B. The measured depth of the gully was 1.3 m, which within limits of accuracy, indicate no significant since inspected in 2005.

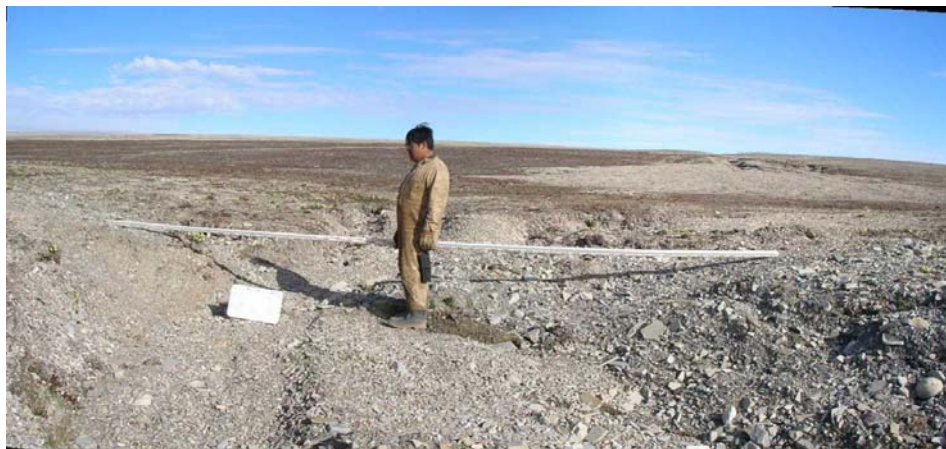
2006 – At waypoint NQG1C, the dimensions and physical characteristics of the gully remain the same as observed in 2005.

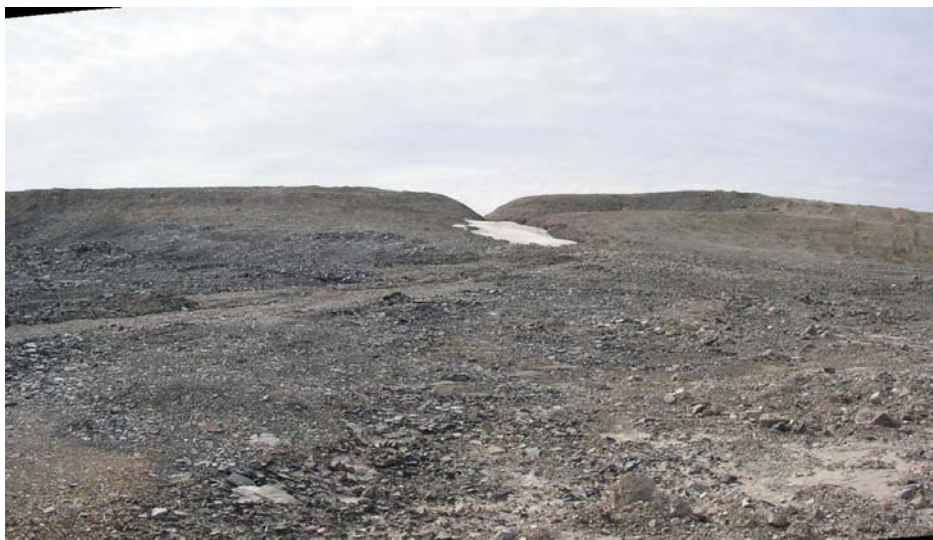
2006 – Photo looking west to where drainage from Loon Lake crosses through fill material around the perimeter of the New Quarry area. The overall nature of this drainage remains unchanged since last inspected in 2005.

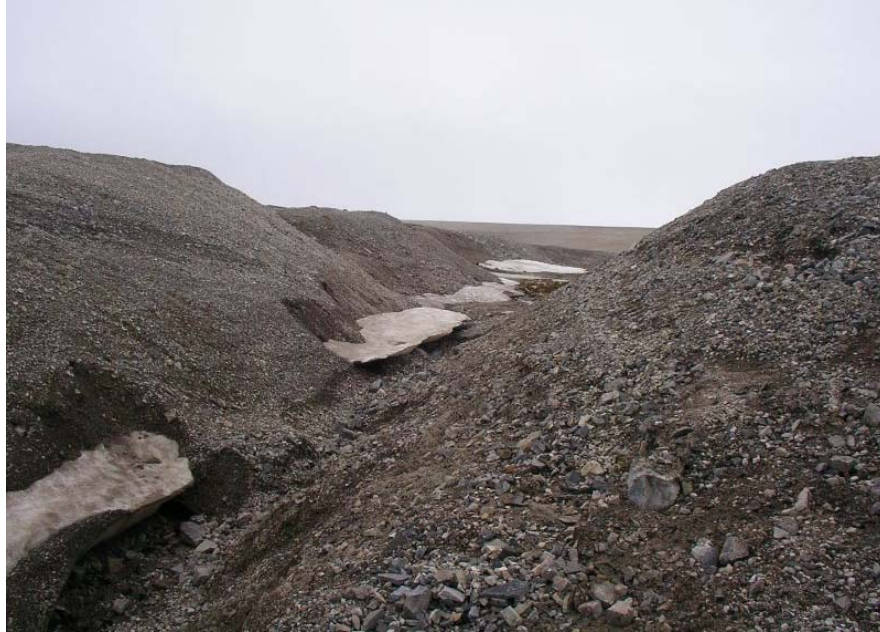
2006 – Photo looking upstream from waypoint NQG2, where there was an existing half-round culvert that was removed, subsequent to the 2006 site visit.

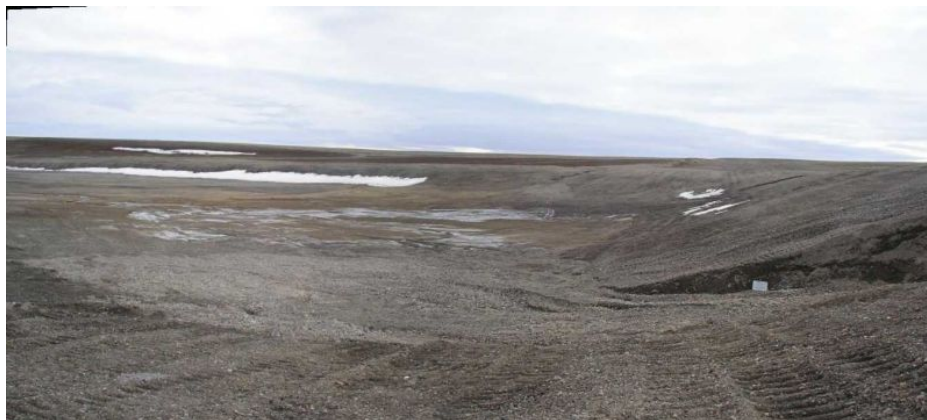
2006 – Debris fanning across floor of New Quarry from erosion gully where Loon Creek drains across a fill embankment. Little change was observed in the overall nature of this feature since inspected in 2005.

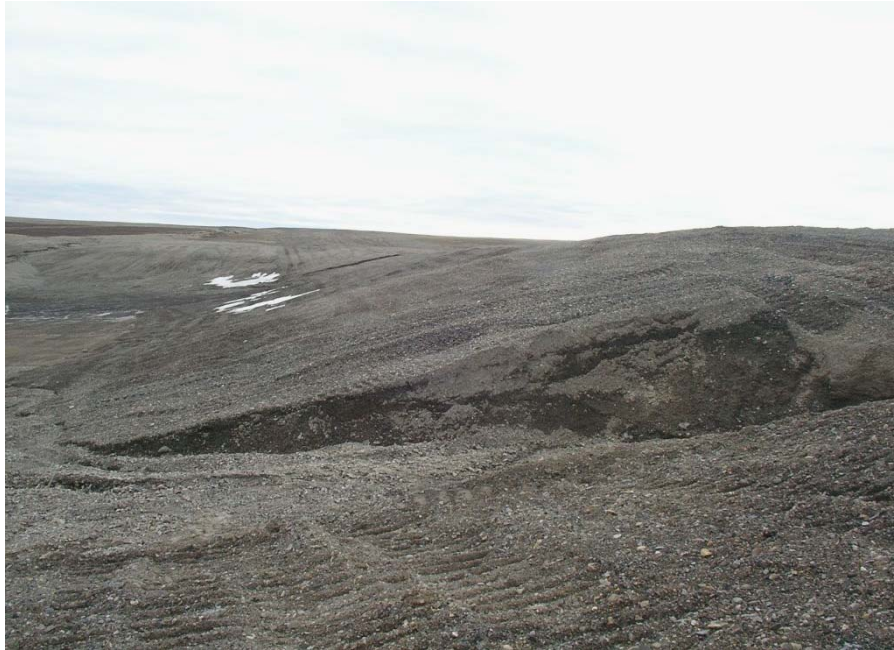
2006 – View adjacent and immediately to west of view shown above showing significant erosional down cutting of what appears to be quarry strippings of silty sand and gravels.

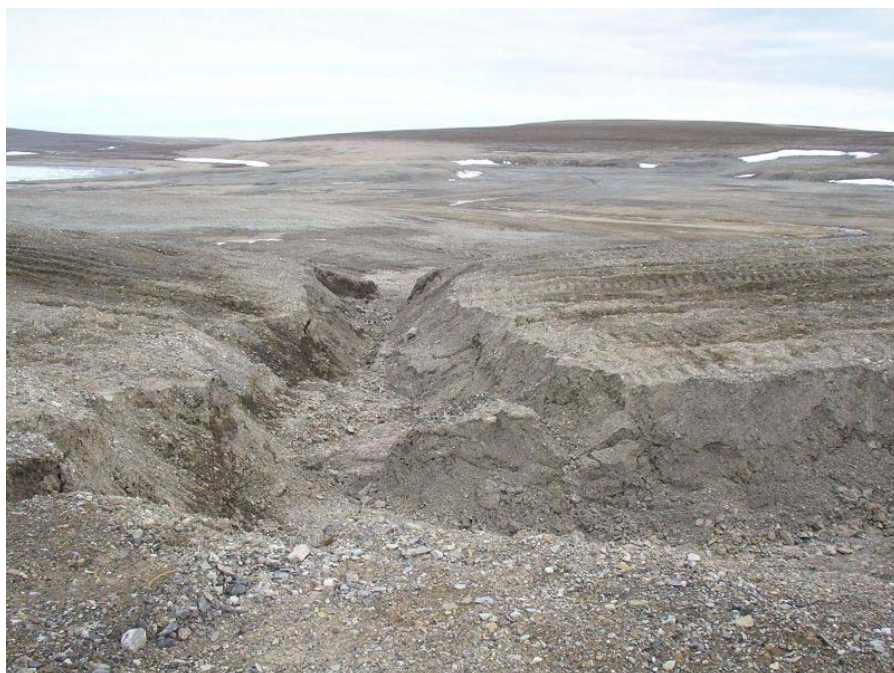
2006 – View upstream from waypoint NQ0603. Erosional down cutting of loose silty sand and gravel was expected, but it appears that obstruction by ice may have caused a second erosion gully to form, reducing flow in this one.

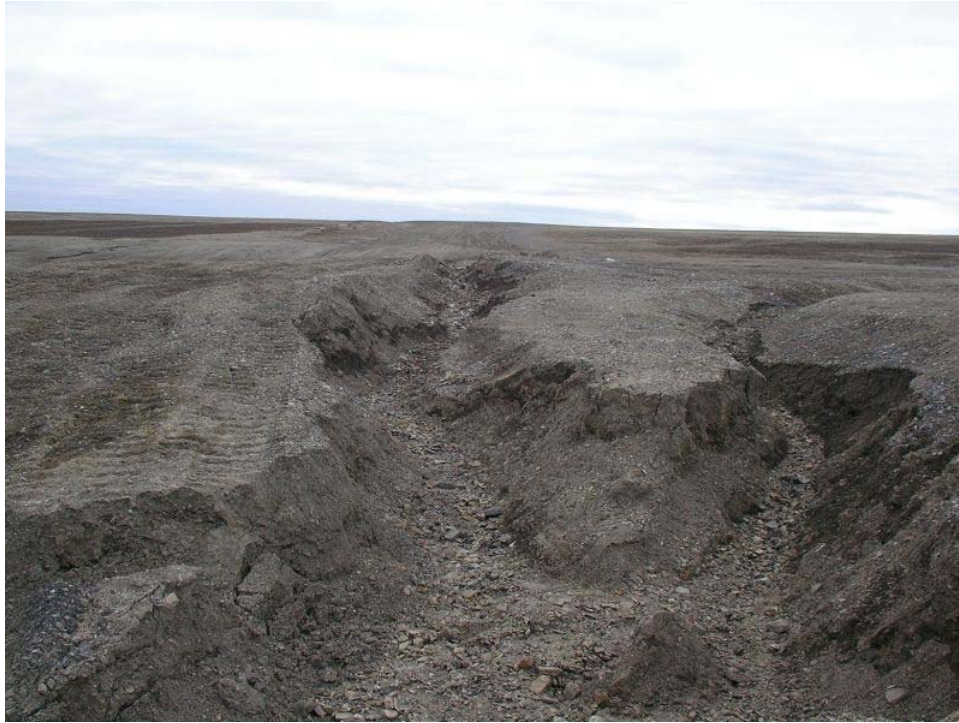
2006 – View further upstream, from waypoint NQ0604. Little change observed since 2005, but remedial measures warranted.

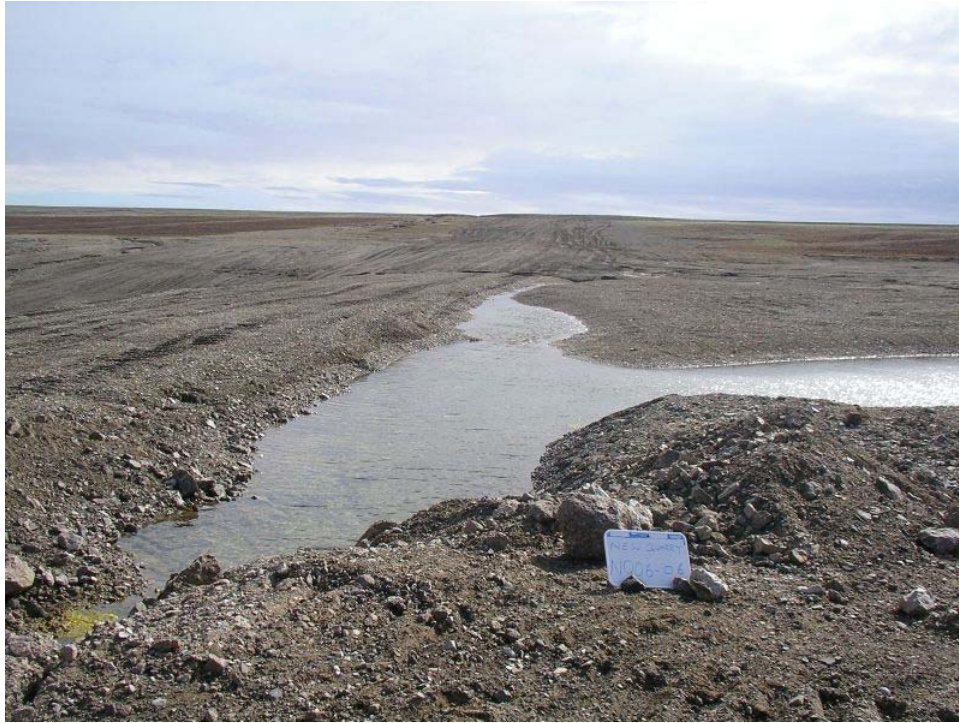
2006 – View at waypoint NQ0606, where drainage is ponding behind embankment fill slope. Conditions appear similar to those observed in 2005.

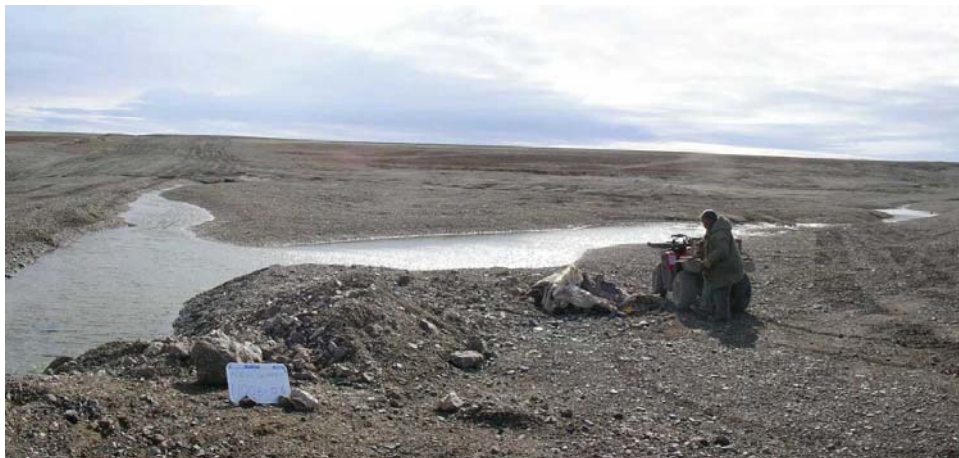
2006 – View at waypoint NQ0606 to the west shows drainage which has formed a meandering pond across the upper and western part of the New Quarry area.

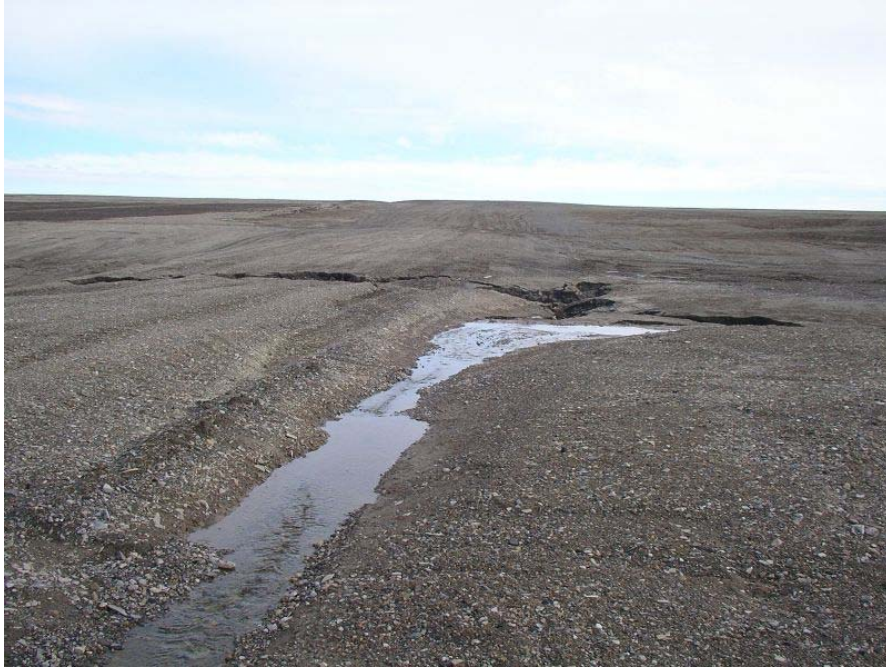
View looking southeast from waypoint NQ06 17 towards erosion gully newly formed in the spring of 2006.

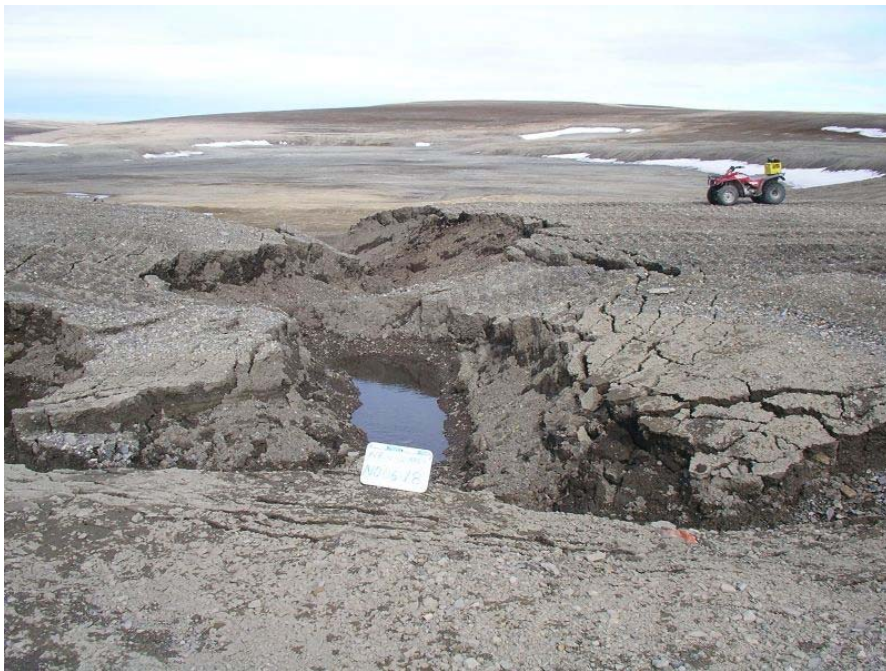
View north down second gully at waypoint NQ06 18.

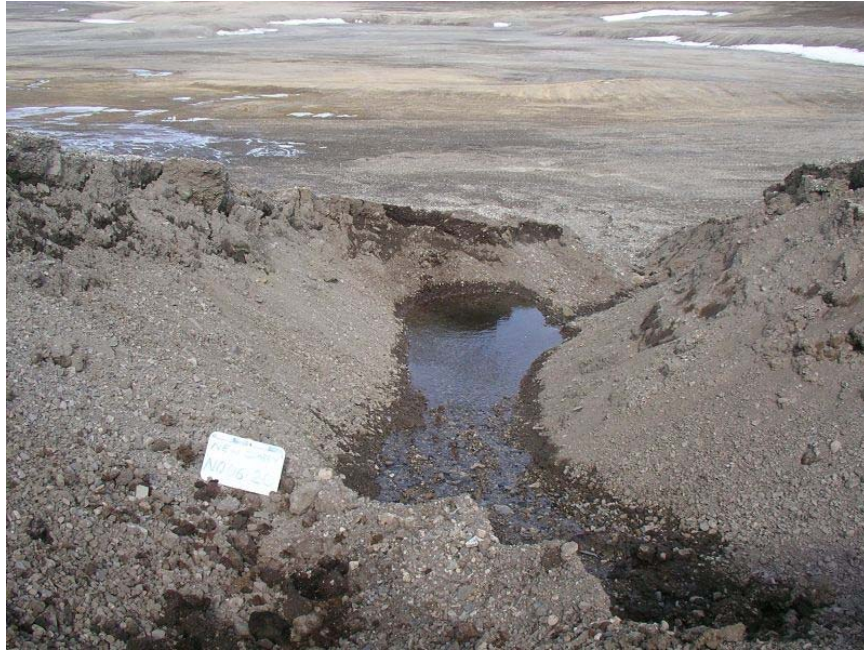
View from waypoint NQ06 20 in middle segment of second erosion gully showing silty sand and gravel, with some cobbles. The water is likely ponded above a frozen horizon.

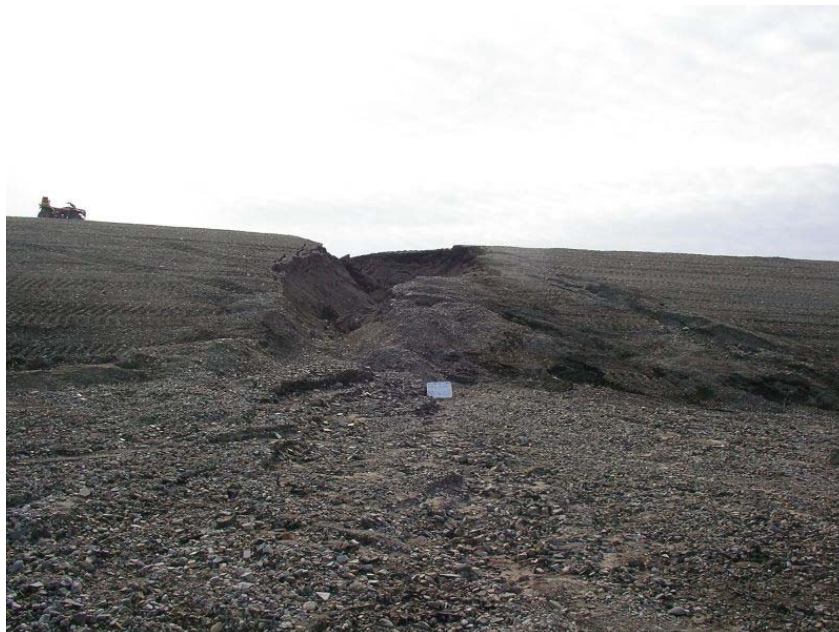
View from waypoint NQ06 21 looking southwest up into second erosion gully.

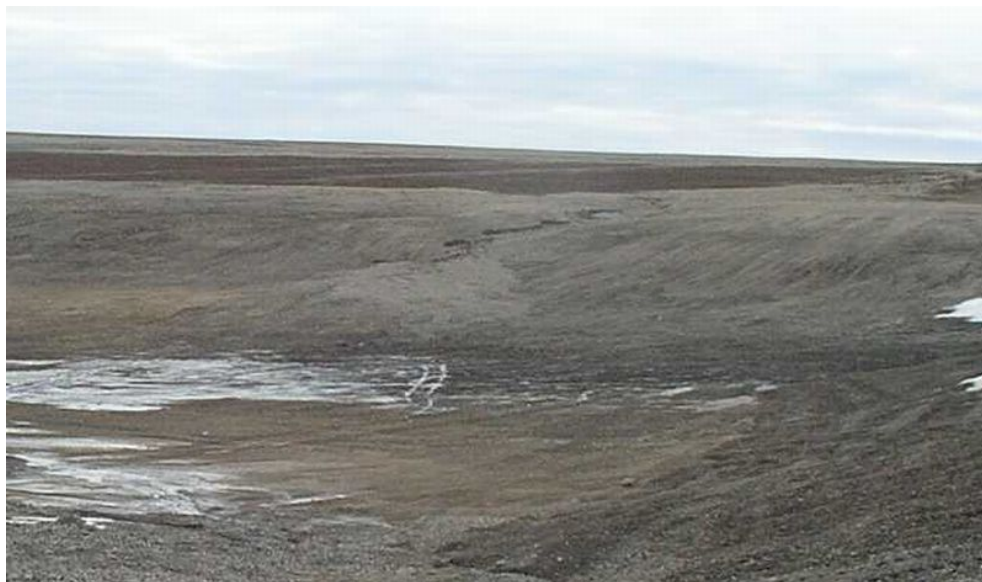
2006 – View eastwards from waypoint NQLOONCK of erosion gully at waypoint NQ6, where conditions remain unchanged since observed in 2005.

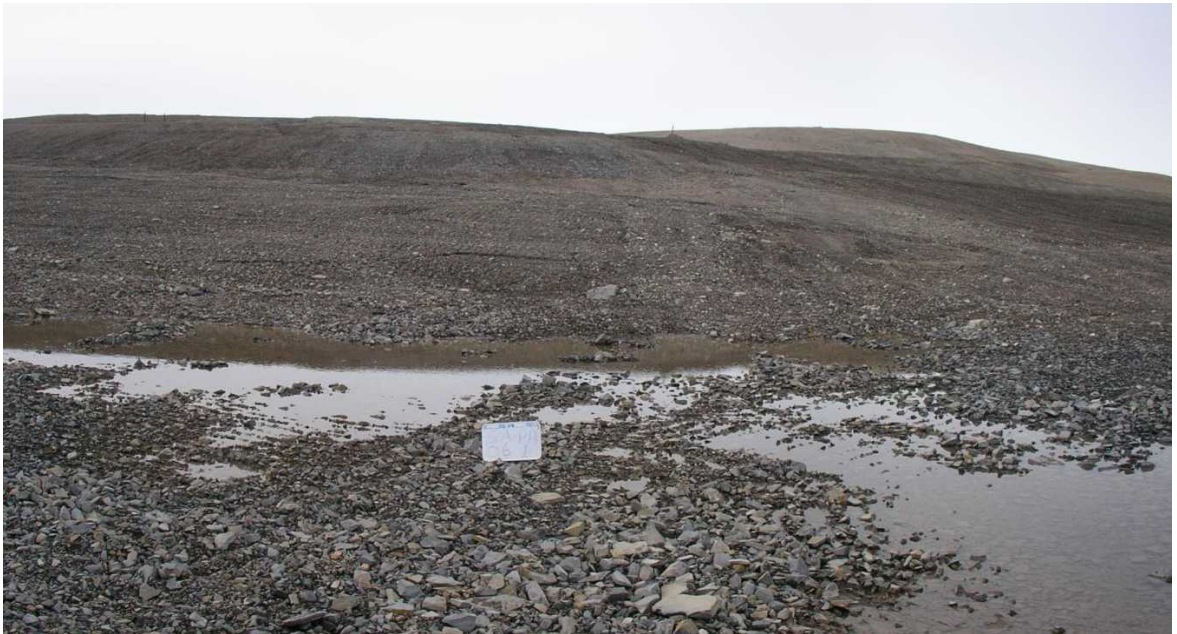
Photo of location SA1 at waypoint SA PH 1, with view looking west, shows no discernible change since inspected in 2005.

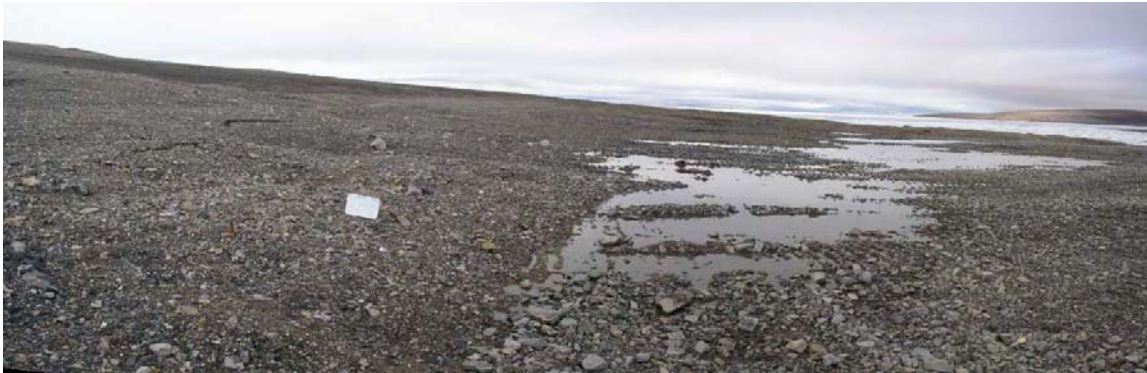
Photo of location SA1 from waypoint SA1 PH2, looking northwest, showing a crack, which is some 30 m in length, several cm in width, and no differential displacement. This terrain does not present a hazard to humans or wildlife, and appears unchanged since the 2005 inspection.

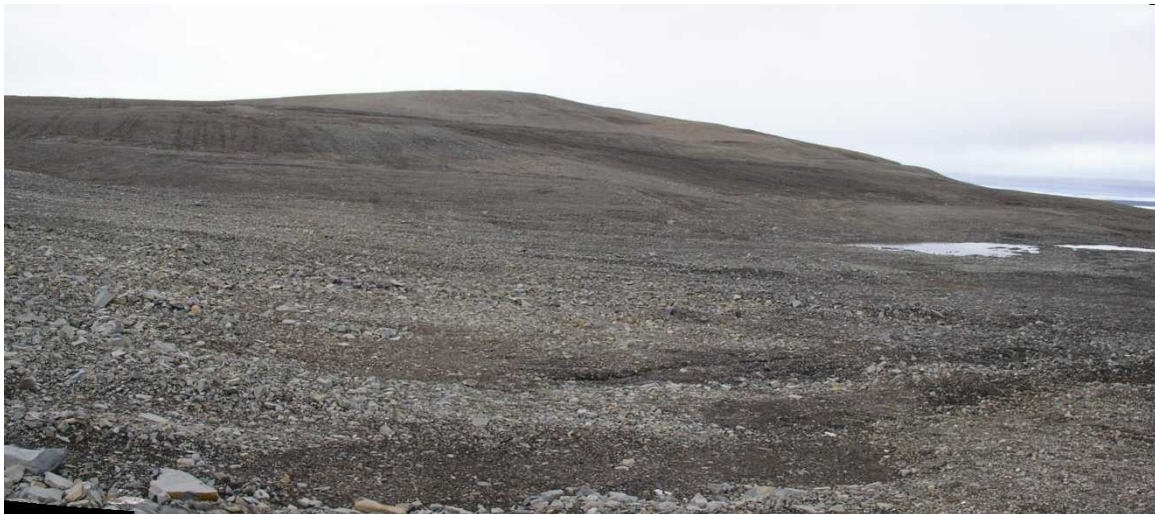
Subsidence Area from waypoint SA PH 3, atop a small road embankment on the eastern margin of the subsidence area, appears unchanged since 2005 inspection, apart from slightly more shallow water ponding.

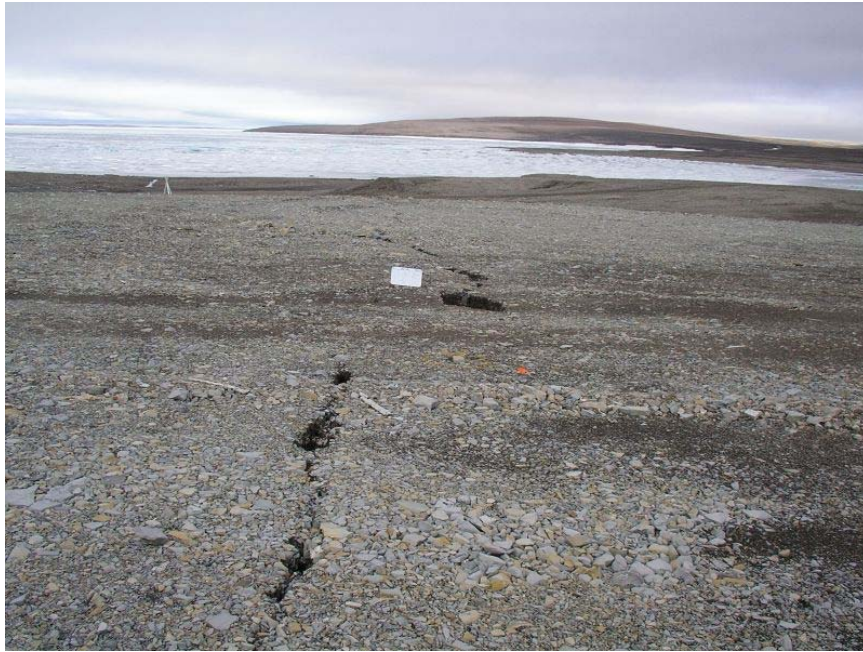
Crack observed at waypoint SA 06 1, and which was documented in previous years' surveys. There is negligible differential displacement across the crack, which is not continuous, has an open width of 2 to 6 cm, and a discernible depth of 5 to 20 cm. This is not considered to be hazardous.

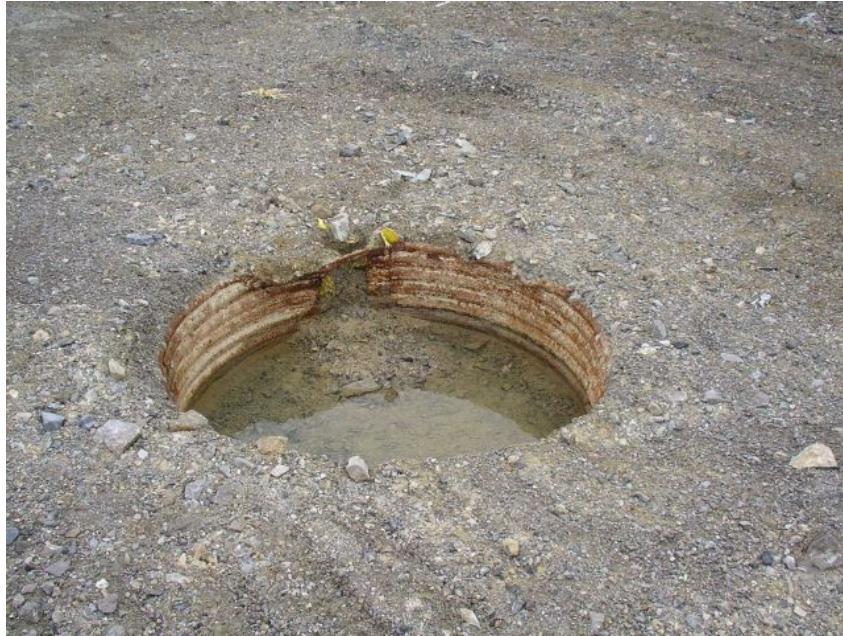
Remnant culvert pipe at the top of a raise bore hole at waypoint SA 06 RAISE 1 is approximately 1m in diameter and 20 cm deep. This is not considered to pose a significant hazard.

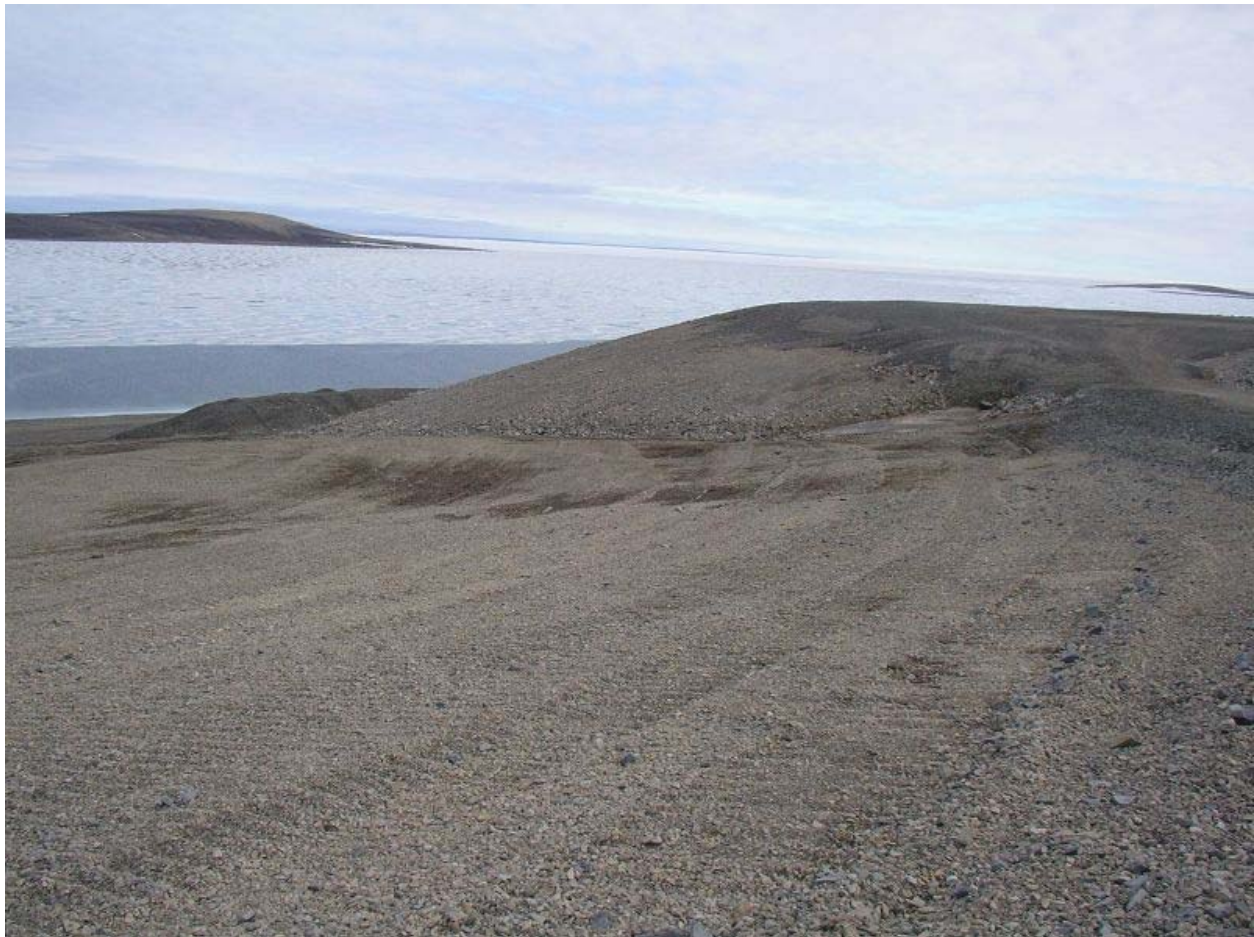
**View southwest from waypoint OLFPH2, showing the northeast end slope, which is
in good condition.**
