**POLARIS MINE
POST-RECLAMATION MONITORING REPORT
3rd QUARTER 2006 FOR THE
NUNAVUT WATER BOARD
&
INDIAN AND NORTHERN AFFAIRS CANADA**

Re: Polaris Mine Water Licence NWB1POL0311 – 2006 3rd Quarter Water Licence Report

**Report on Post-closure Geotechnical Inspection for
Polaris Mine Site in 2006
Area 1 – Garrow Lake, Creek and Dam**

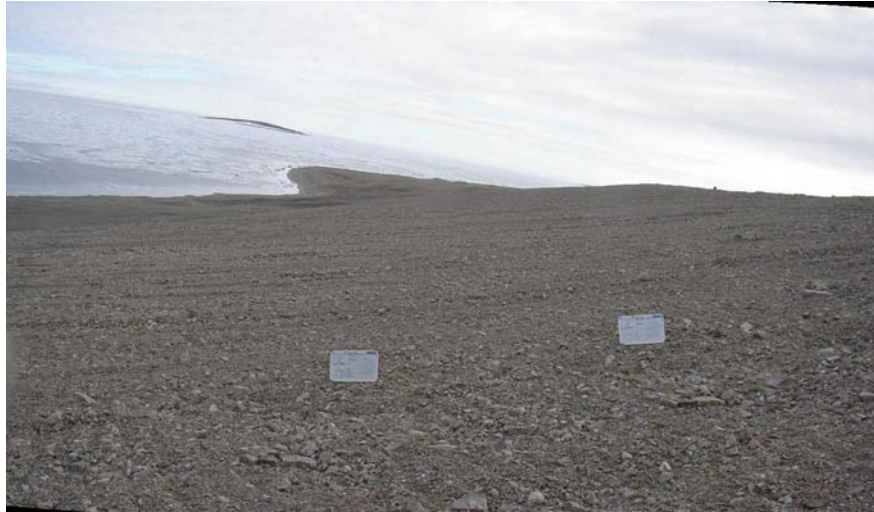
View southwest along main side slope of the Operational Landfill from waypoint OLF3, again showing slopes in good condition, free of any erosion or deformation, as previously observed in 2005.

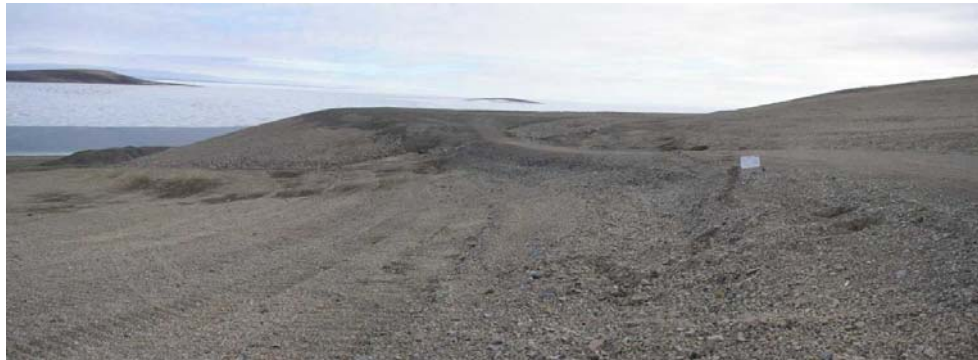
Minor almost imperceptible crack at edge of approach road to northeast end of the Operational Landfill, viewed from waypoint OLFPH 2, appears unchanged since 2005 inspection.. This is not associated with any other signs of settlement or instability in the slope above or below, and poses no hazard to humans or wildlife.

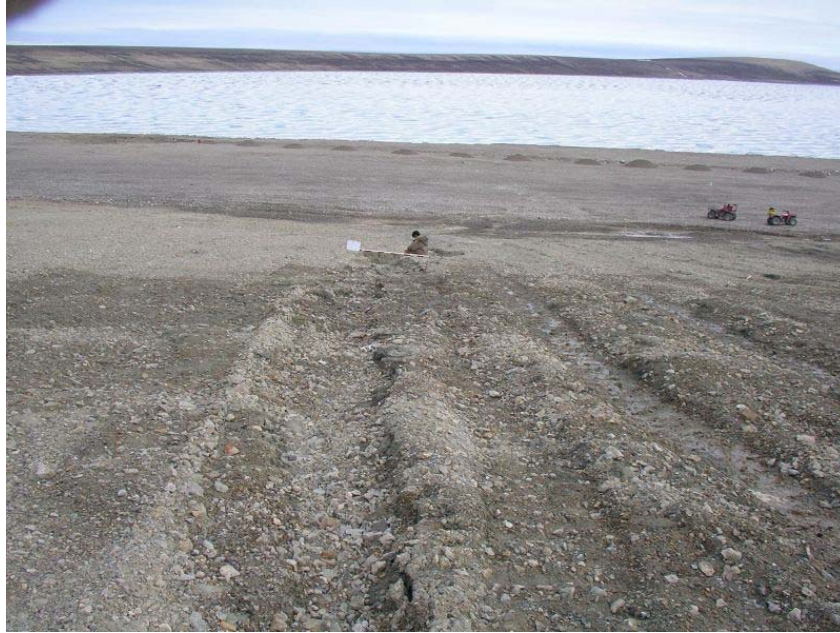
View down slope from waypoint LO SPR TOP. The degree of erosion is not serious and appears to be gradually self-armouring, and is virtually identical to observed conditions in 2005 .

operational landfill in this area appears stable and uniform. Annual monitoring of the slope above the landfill is recommended. The following photographs and measurements will facilitate future tracking of the erosion features and effects of seepage flow, if any, on the landfill.

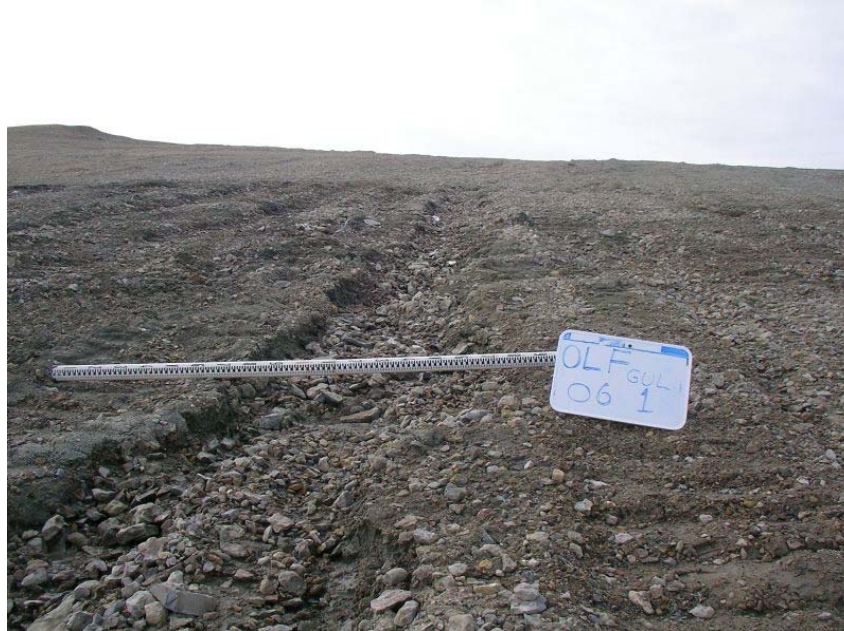
Erosion gully at waypoint OLF GUL1 has a depth of 20 cm and is identical to 2005 observations.

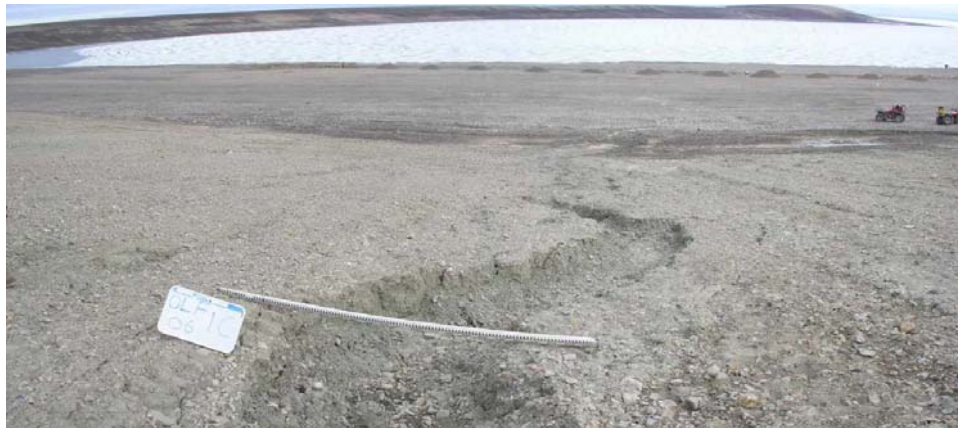
At waypoint OLF GUL2 looking downstream, again showing identical conditions to 2005 inspection.

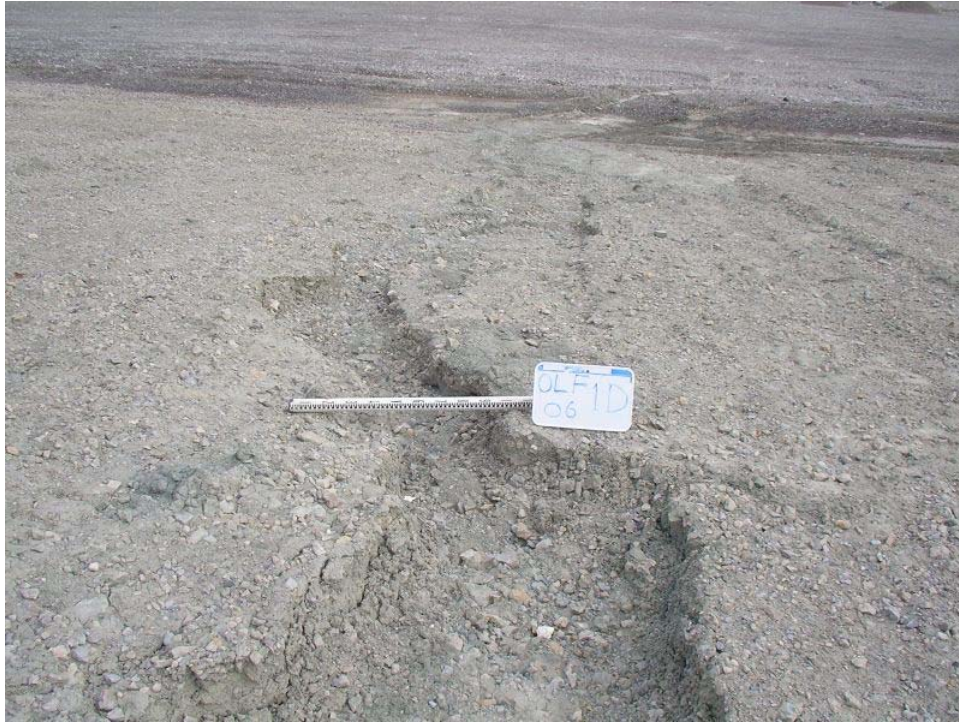
View downslope at waypoint OLF GUL3 - erosion gully is 32 cm deep, as previously measured in 2005.

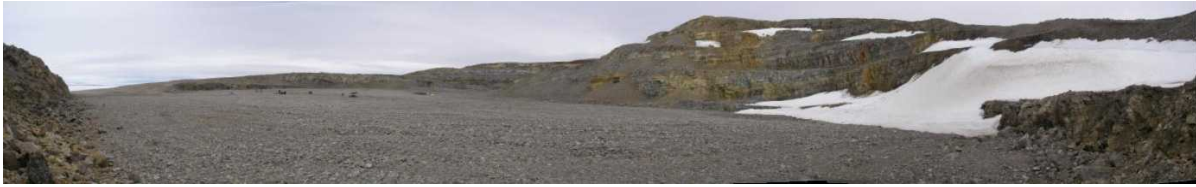
From waypoint LRD3 conditions appear identical to 2005 inspection .

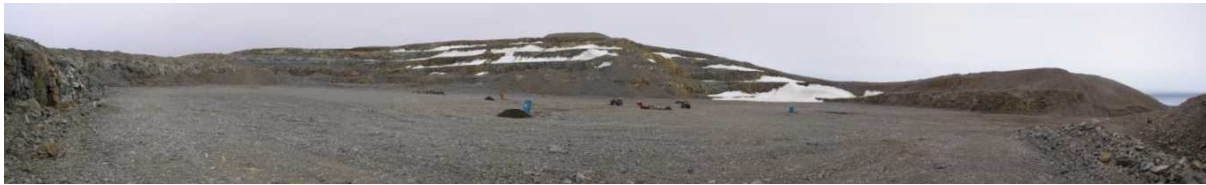
From waypoint LRD4 conditions appear identical to 2005 inspection.

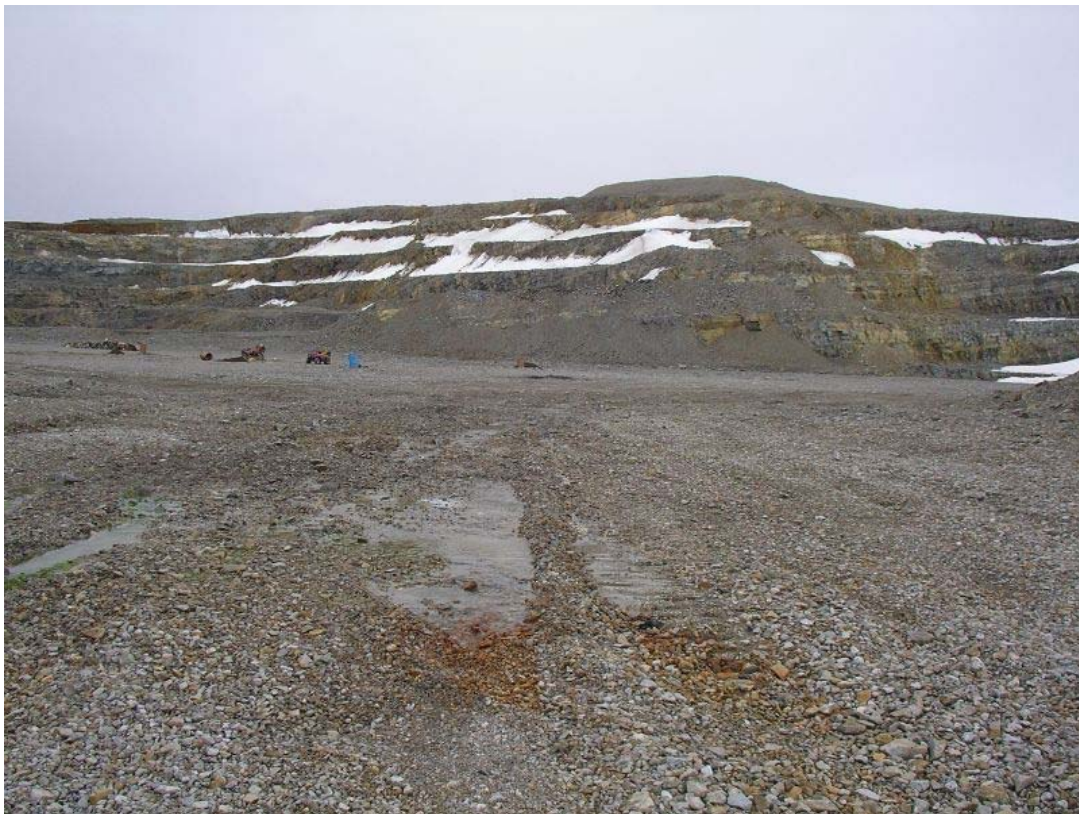
View approximately eastwards through the topographic “notch” in the perimeter of the LRD quarry, from waypoint LRD5, where seepage through surficial gravel and rockfill daylights over a distance of some 10 m before re-infiltrating. This flow was sampled and was estimated at 1 to 2 litres/sec, exhibiting little to no turbidity. No erosion or instability was observed in the slopes below the notch of the LRD quarry. Conditions appear unchanged since the 2005 inspection.

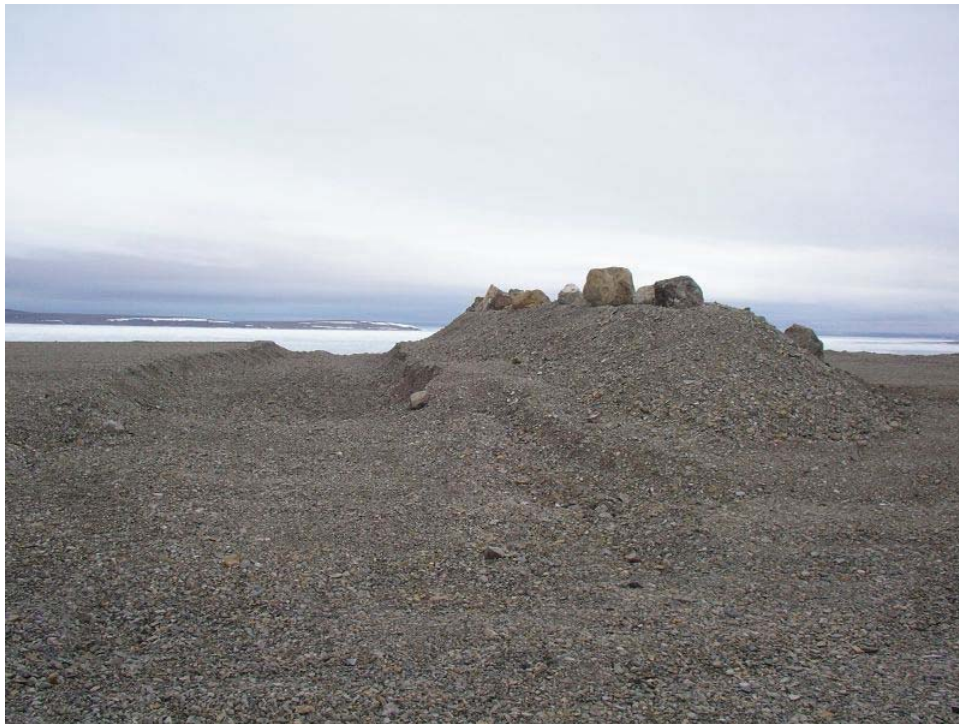
View of the terrain adjacent to the north end of the airstrip, and of the safety berm around the upper edge of the LRD quarry slopes. The berms are in good condition.

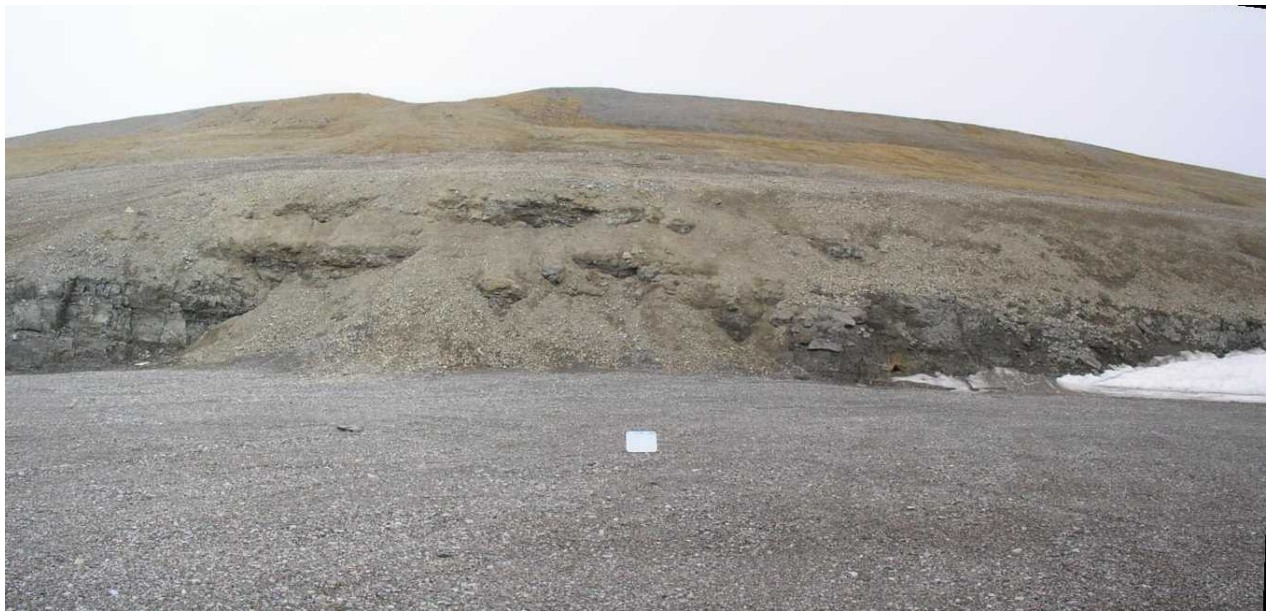
The following photographs document the good condition of the area above and surrounding the Conveyor Portal. No signs of instability or settlement were observed in both 2005 and 2006.

2006 – Conveyor Portal from waypoint CP1.

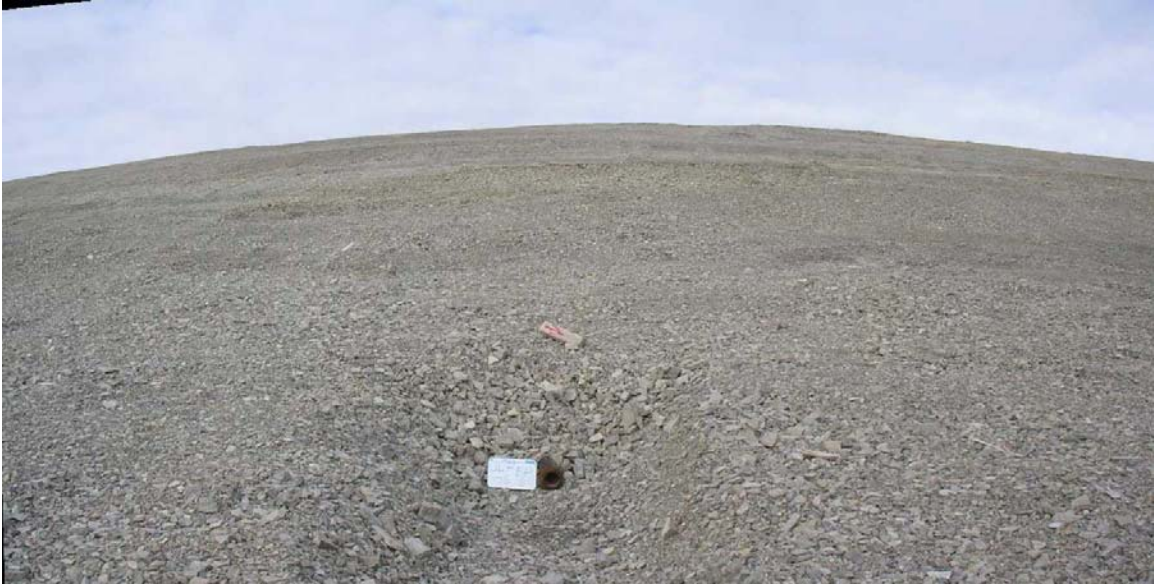
2006 – View from waypoint EP1, with no drainage or signs of discharge from vent pipe that extends to the back of the sealed drift and is in permafrost. Overall slope is approximately 10 degrees and covered in coarse gravel sized rockfill. No signs of instability or hazard to humans or wildlife.

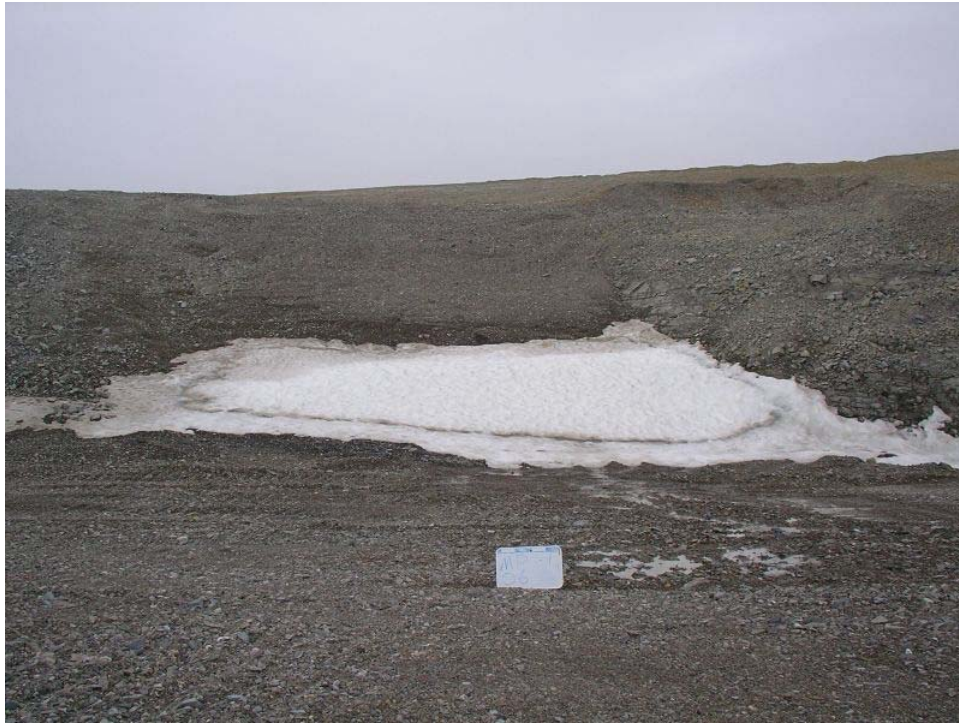
2006 – Main Portal from waypoint MP1; no signs of instability.

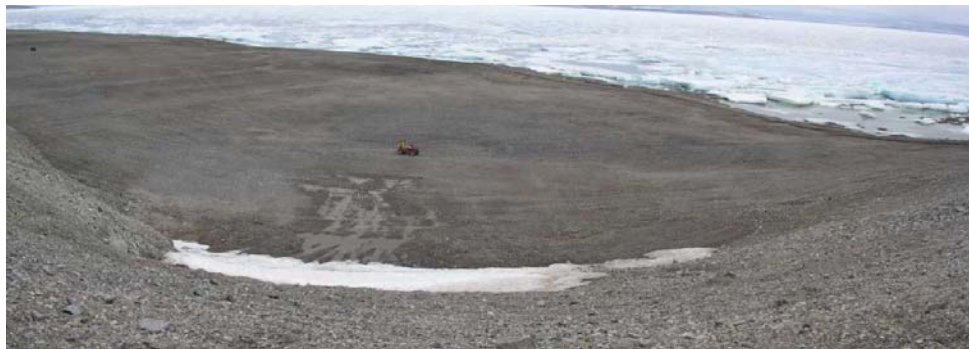
2006 – Slope above Main Portal area is inclined at about 26 degrees, locally steepening to 35 degrees. Minor slumping was observed, but not considered to present hazard to humans or wildlife.

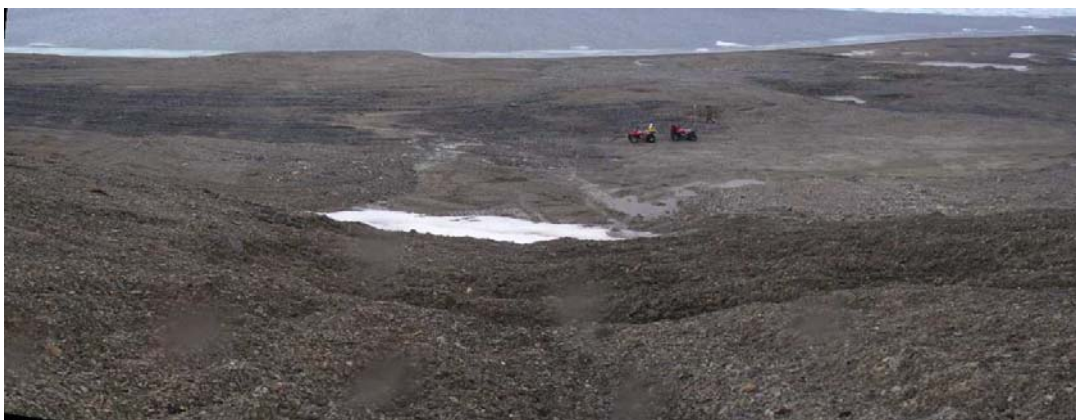
2006 – North Portal from slope above, which shows no sign of cracks or distress.

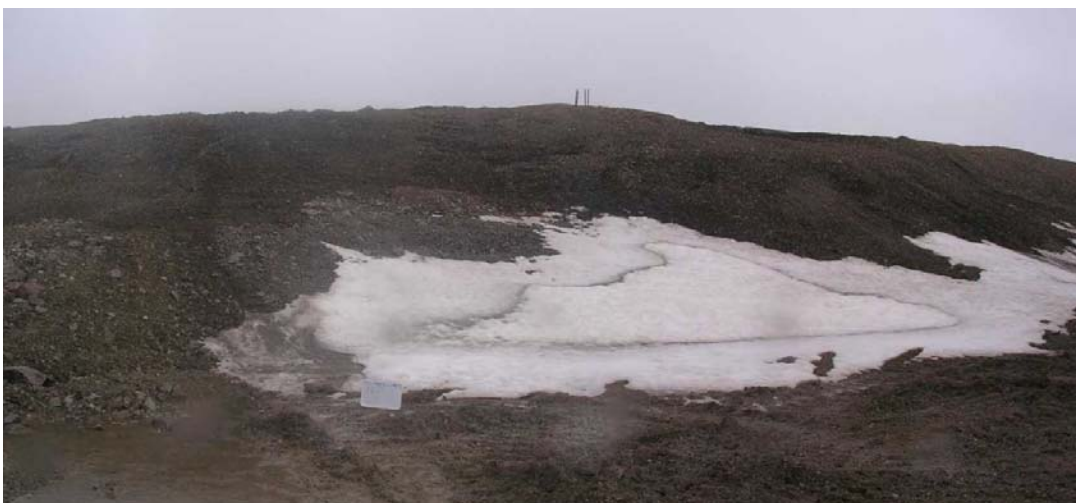
2006 – North Portal from waypoint NP1, where conditions appear unchanged where observable above the snow patch. This portal accessed a decline and was frozen prior to being backfilled.

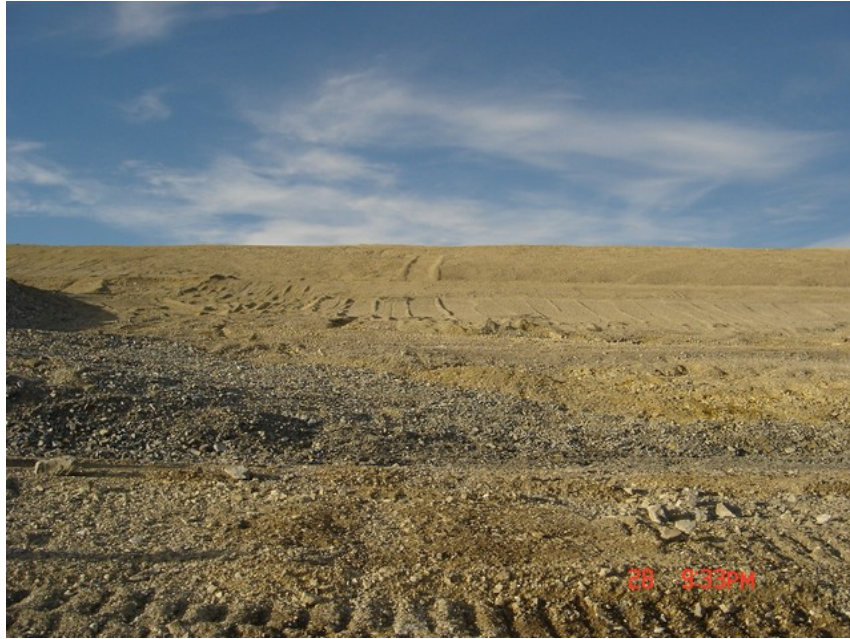
2005 – SL-11 North 8 367 300 - View to east. Conditions remain unchanged when inspected in 2006.

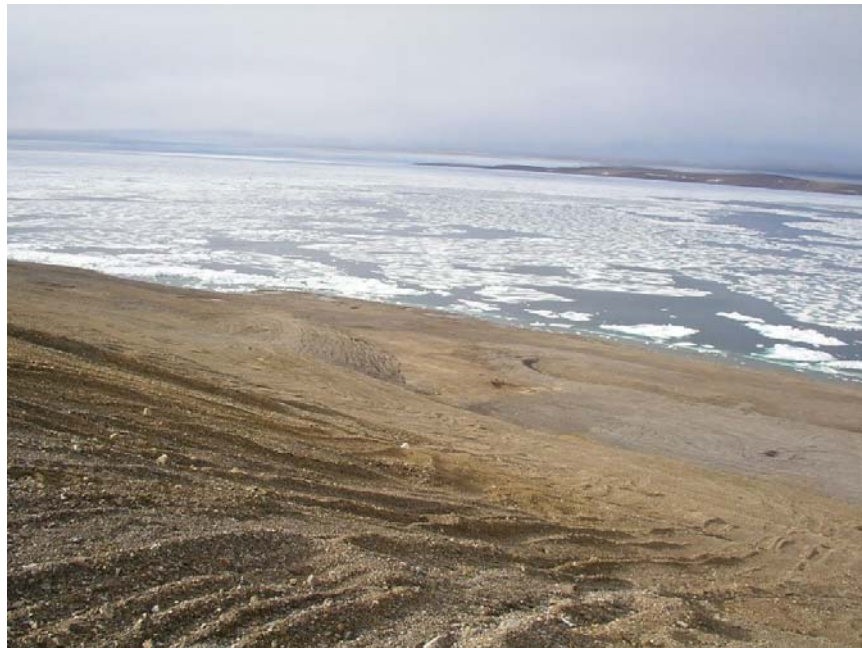
2006 – View of shoreline from waypoint JUL21PAN1 shows the shoreline in the vicinity of waypoints SL8 through SL10.

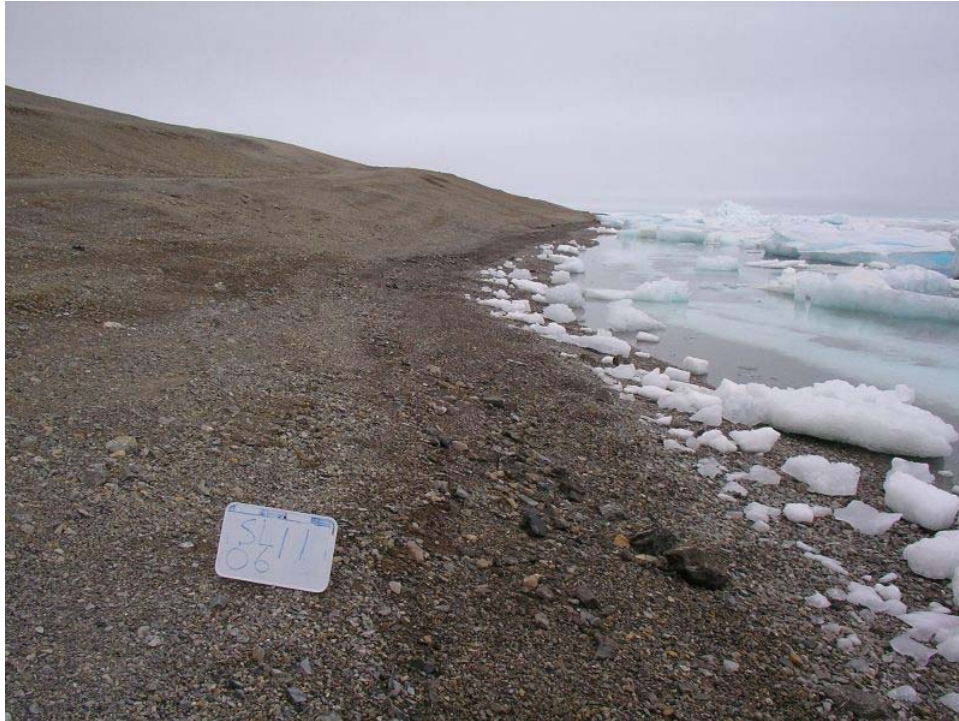
2006 – SL-11 North 8 367 300 view to south. Conditions appear to be unchanged since 2005 inspection.

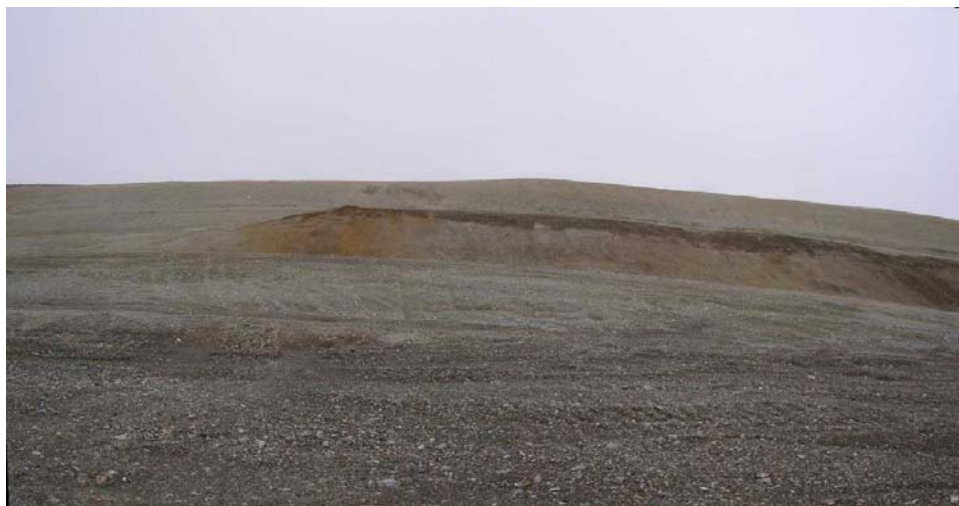
2006 – SL-10 North 8 367 400 view to east shows re-sloped tank farm embankment.

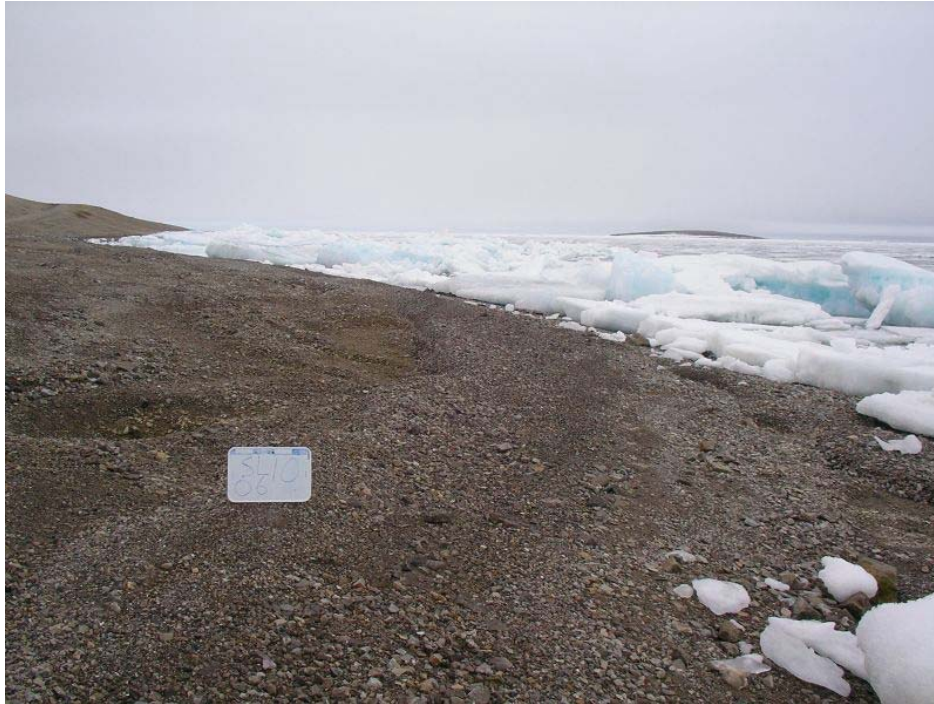
2006 – SL-10 North 8 367 400 view to south. Conditions appear to be unchanged since 2005 inspection.

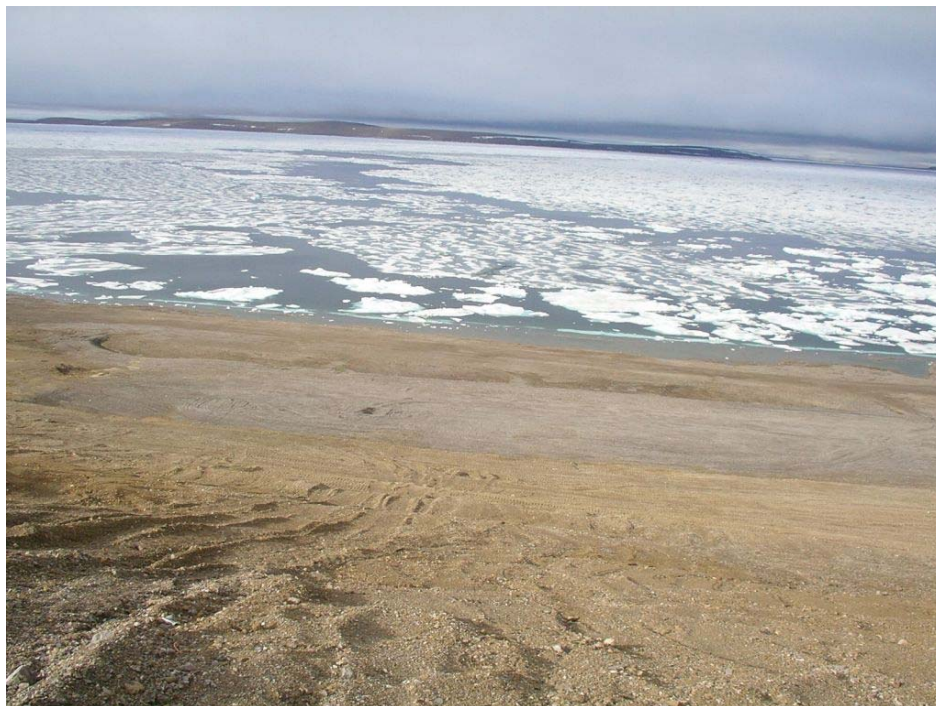
2006 – View of shoreline from waypoint JUL21PAN1 shows shoreline in vicinity of waypoints SL7 and SL8.

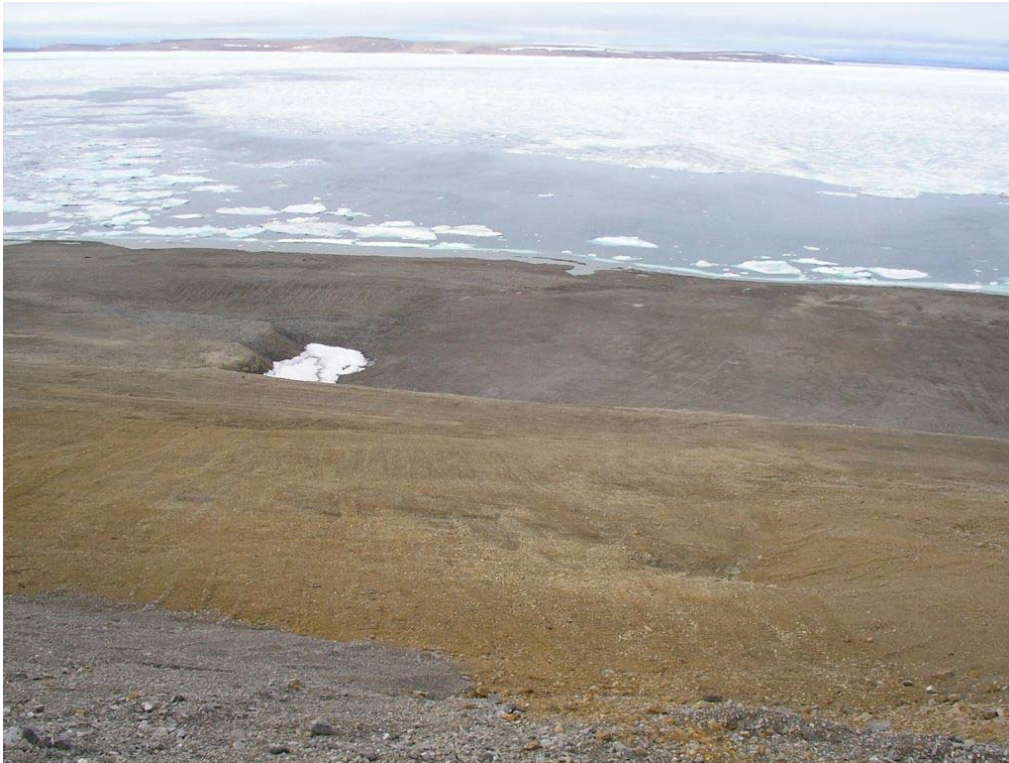
2006 – View of shoreline from waypoint JUL21PAN2 shows shoreline in vicinity of waypoints SL5 and SL6.

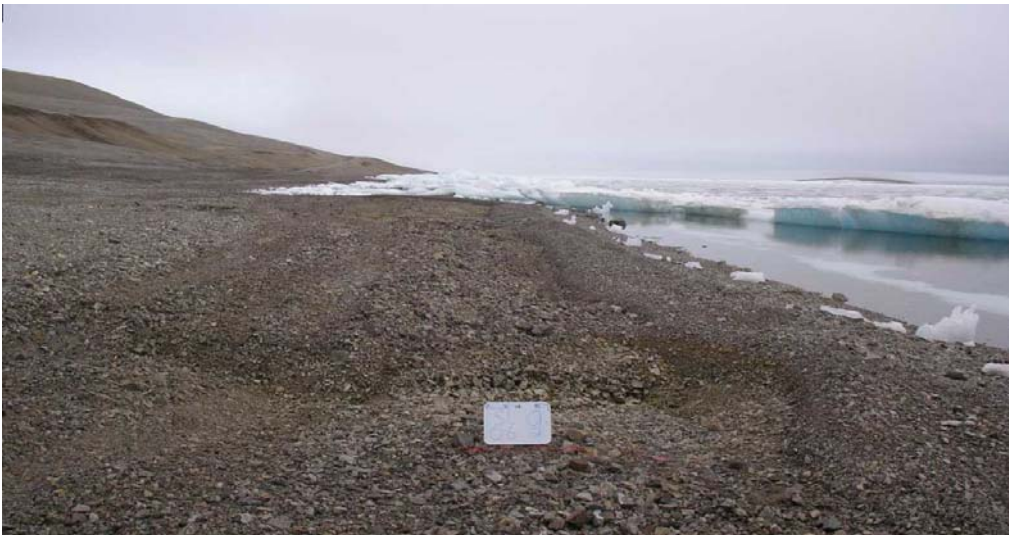
2006 – SL-9 North 8 367 500 view to south. Conditions appear to be largely unchanged.

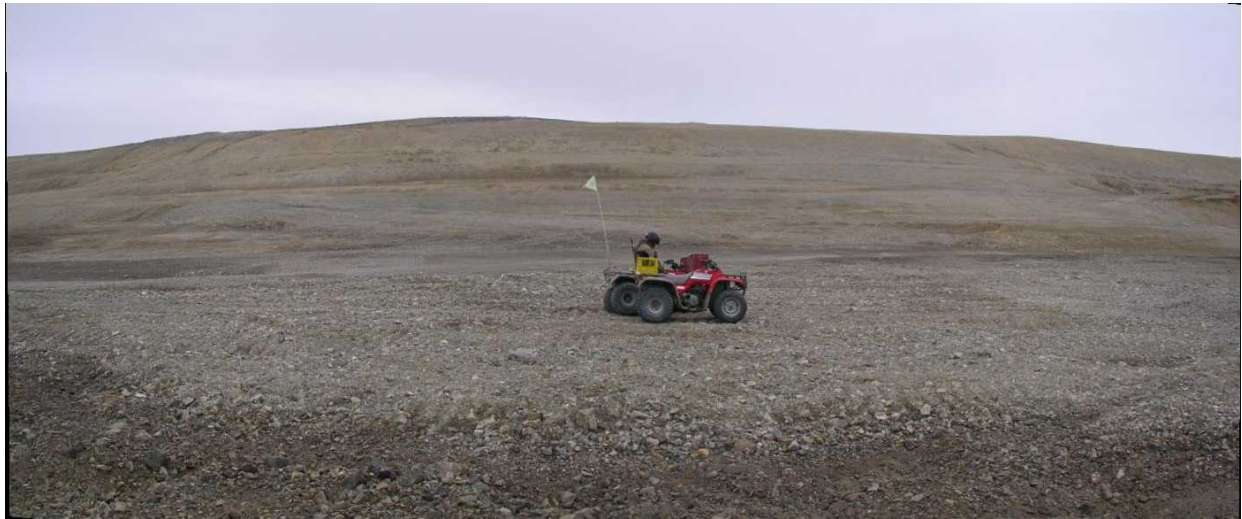
2006 – SL-9 North 8 367 500 view to east. Conditions appear to be largely unchanged.

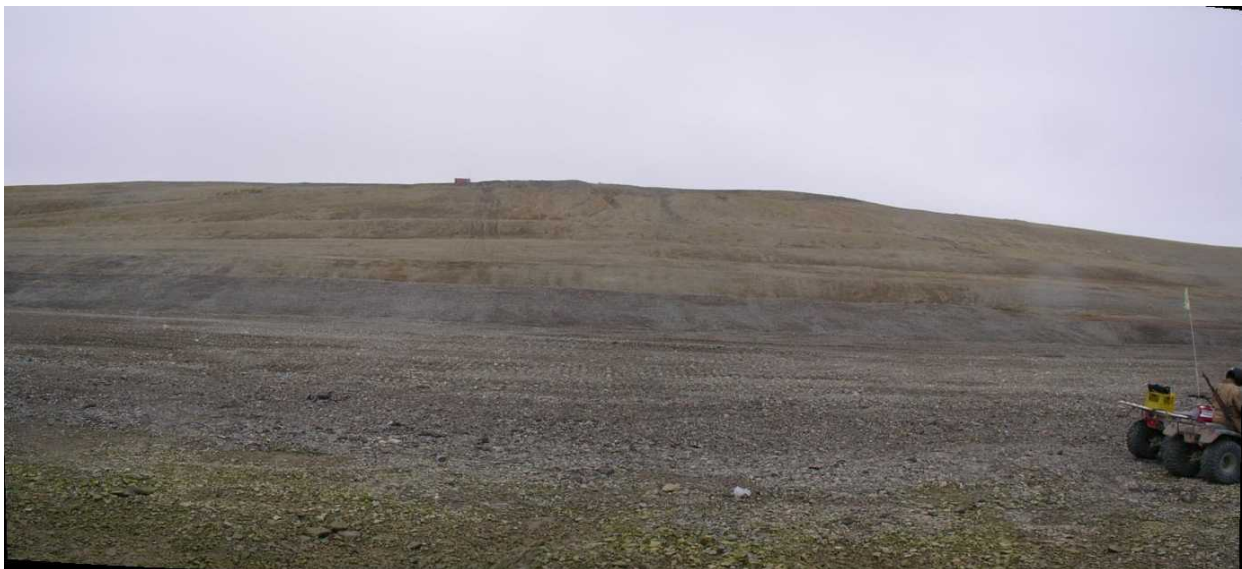
**2006 – SL-8 North 8 367 600 view to east. Conditions remain unchanged since inspected in 2005.
Note that more detailed inspection of gullies at top centre was conducted in 2006, and further
photographs and discussion are presented later in this appendix.**

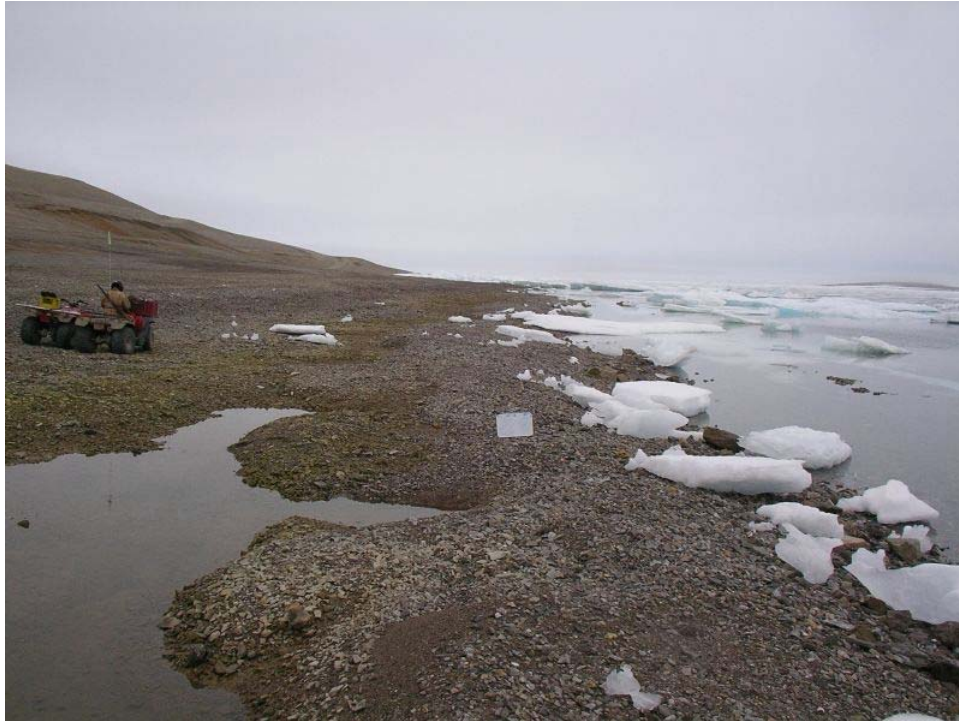
2006 – SL-8 North 8 367 600 view to south. Conditions are broadly unchanged since 2005; Note that beach gravel is accumulating as a low berm at the shore line, likely as a result of ice action.

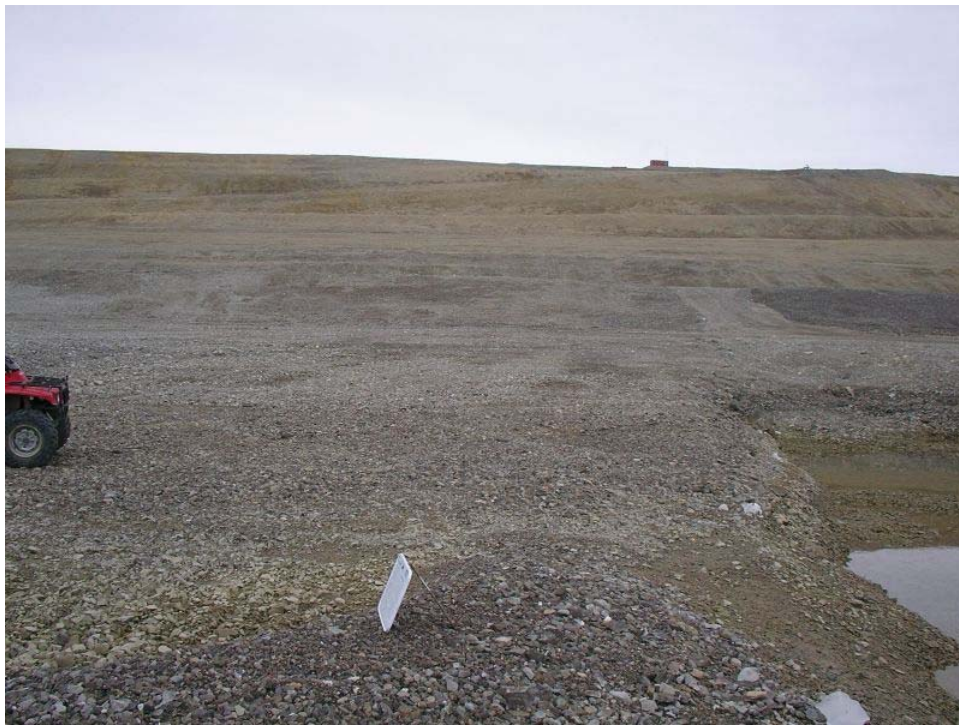
2006 – SL-7 North 8 367 700 view to east. Conditions are unchanged since the 2005 inspection.

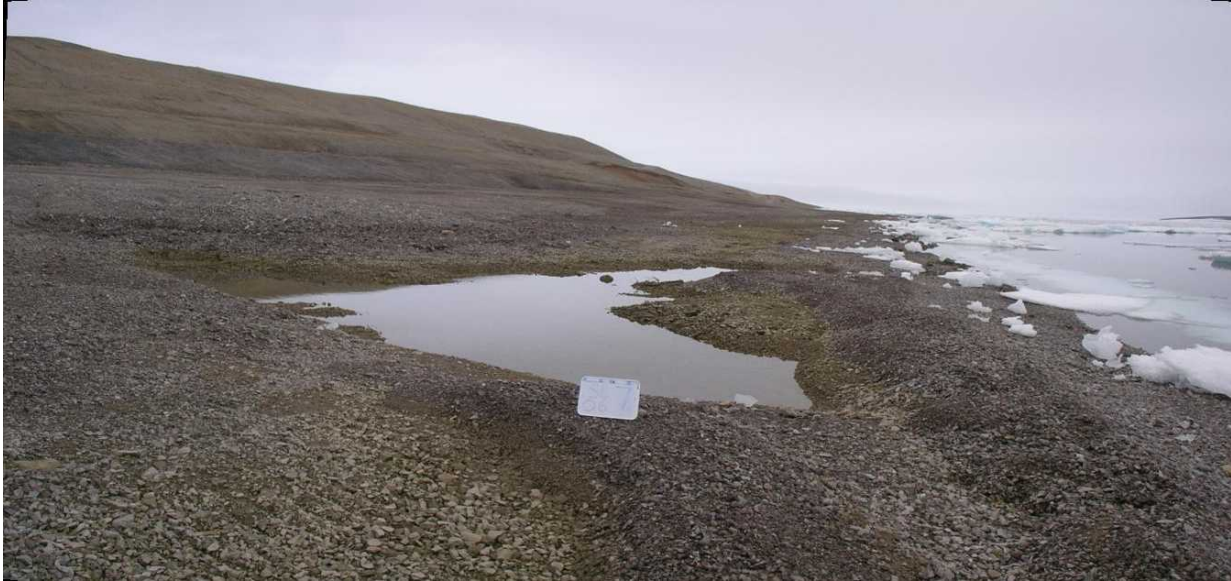
2006 – SL-7 North 8 367 700 view to south. Conditions are broadly unchanged since 2005; Note that beach gravel is accumulating as a low berm at the shore line, likely as a result of ice action.

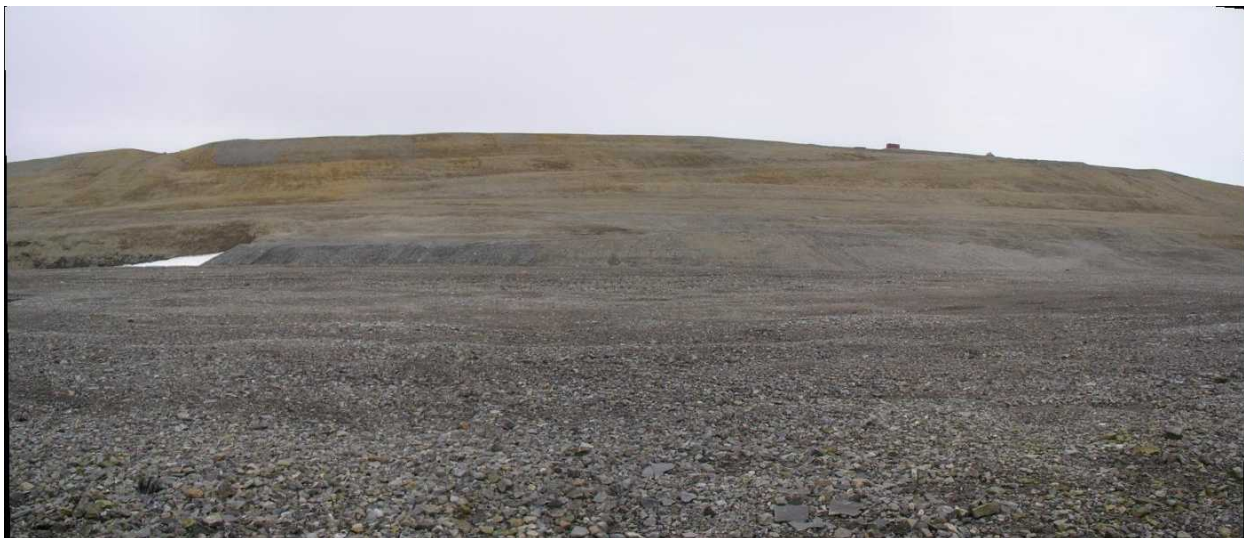
2006 – SL-6 North 8 367 800 view to east. Conditions appear unchanged since last inspection in 2005.

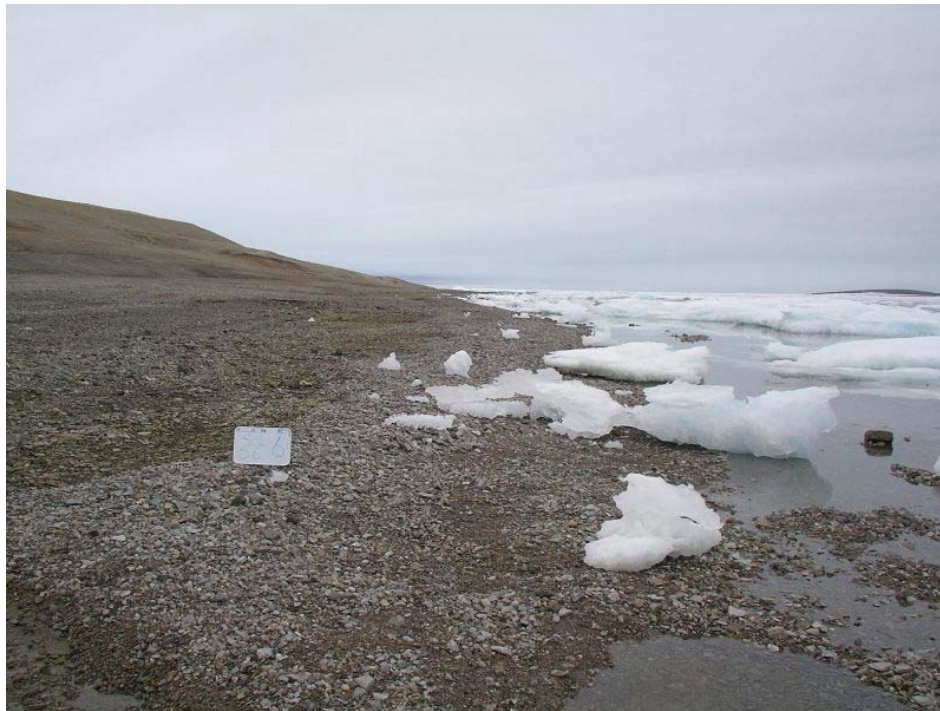
2006 – SL-6 North 8 367 800 view to south. Conditions appear unchanged since inspected in 2005.

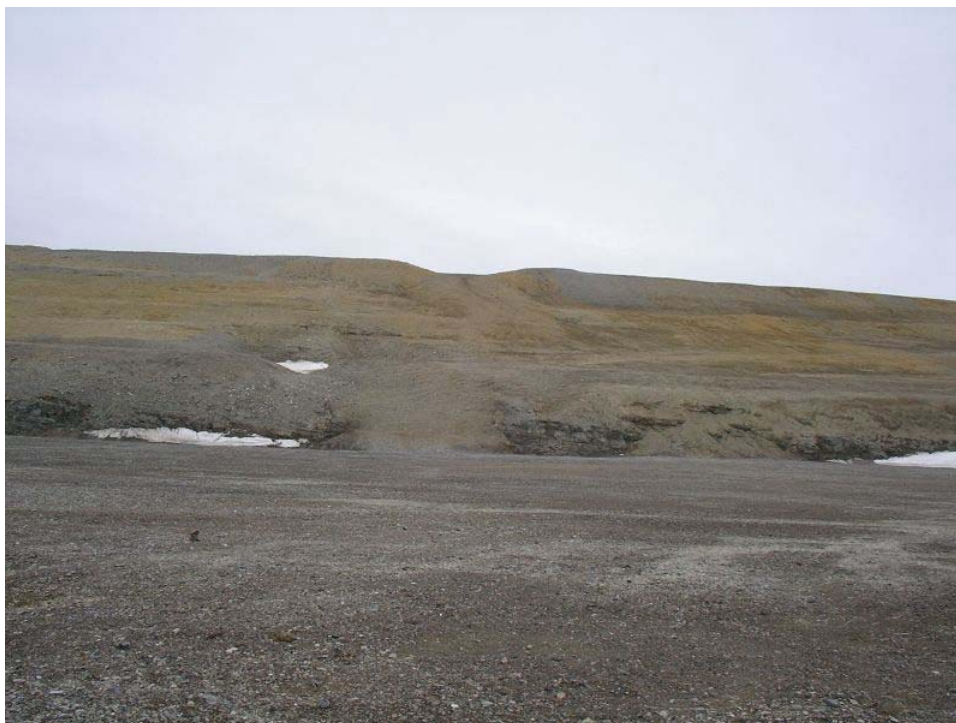
2006 – SL-5 North 8 367 900 view to east. Conditions are unchanged since inspected in 2005.

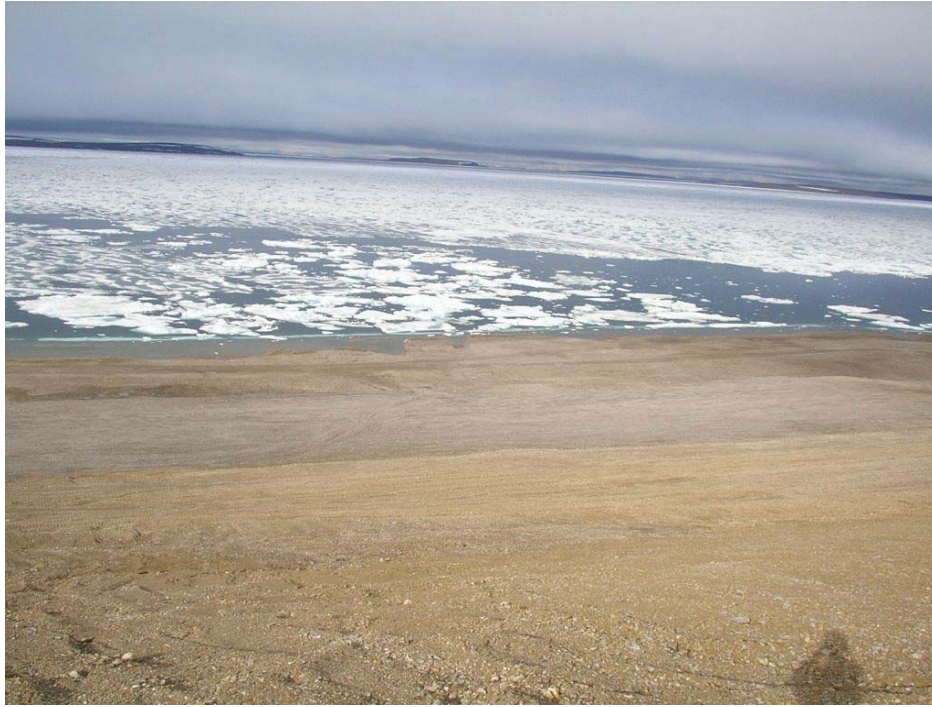
2006 – View of shoreline from waypoint JUL21PAN1 shows shoreline in vicinity of waypoints SL5 through SL7.

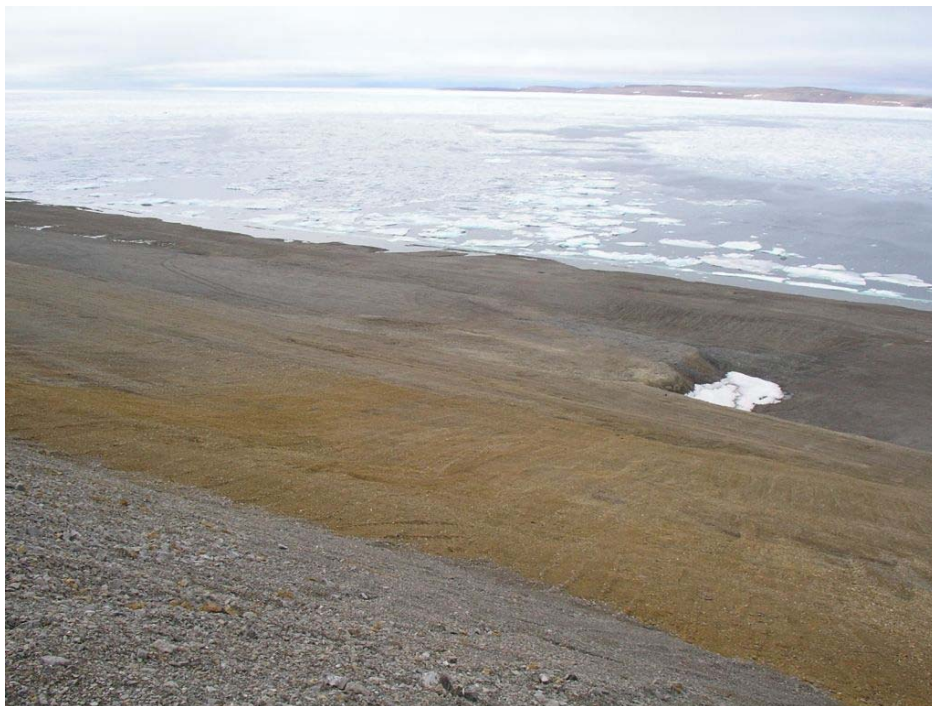
2006 – View of shoreline from waypoint JUL21PAN2 shows shoreline in vicinity of waypoints SL6 through SL8.

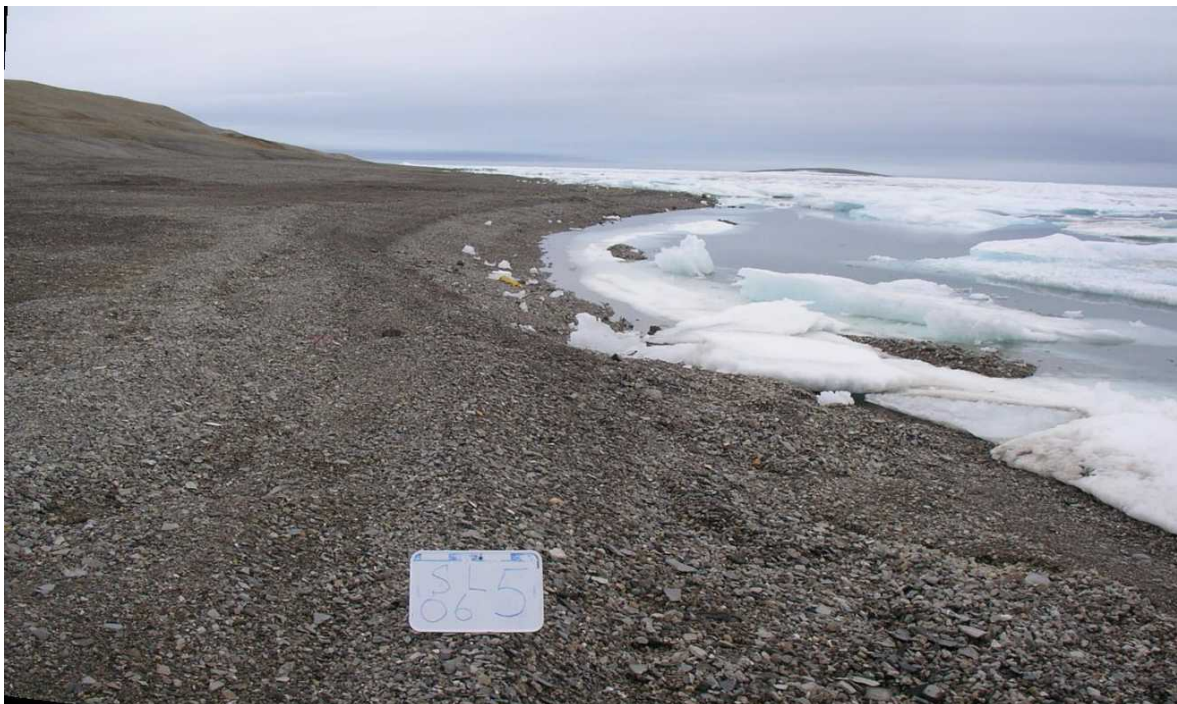
2006 – SL-5 North 8 367 900 view to south. Conditions are unchanged since 2005 inspection.

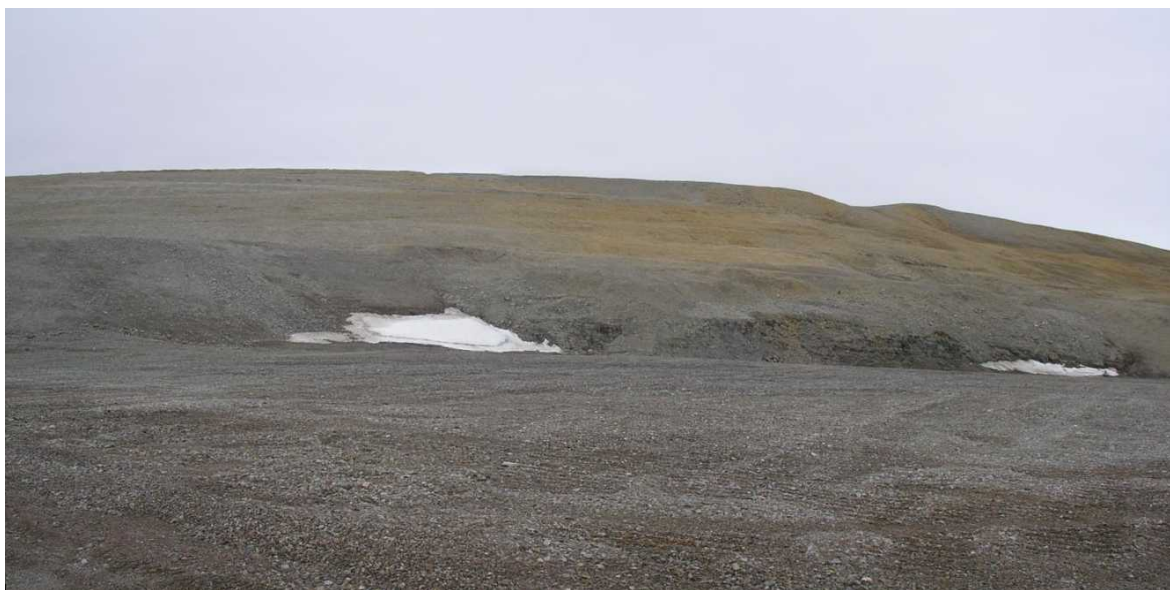
2006 – SL-4 North 8 368 000 view to east. Conditions are unchanged since 2005.
