**POLARIS MINE
POST-RECLAMATION MONITORING REPORT
3rd QUARTER 2006 FOR THE
NUNAVUT WATER BOARD
&
INDIAN AND NORTHERN AFFAIRS CANADA**

Re: Polaris Mine Water Licence NWB1POL0311 – 2006 3rd Quarter Water Licence Report

**Report on Post-closure Geotechnical Inspection for
Polaris Mine Site in 2006
Area 1 – Garrow Lake, Creek and Dam**

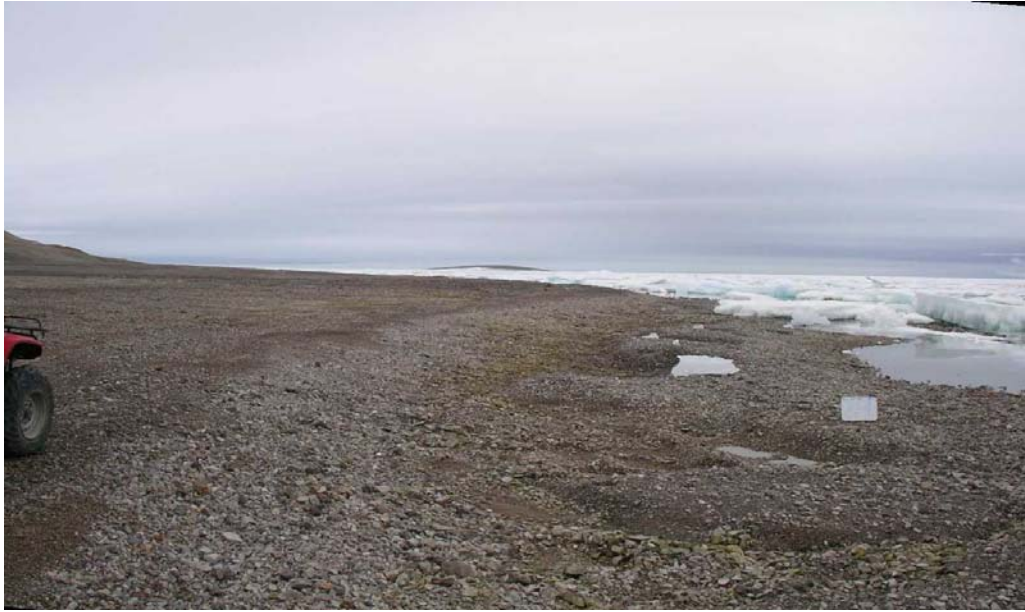
2006 – SL-4 North 8 368 000 view to south. Generally conditions appear unchanged although ice action has apparently re-arranged gravel berms slightly.

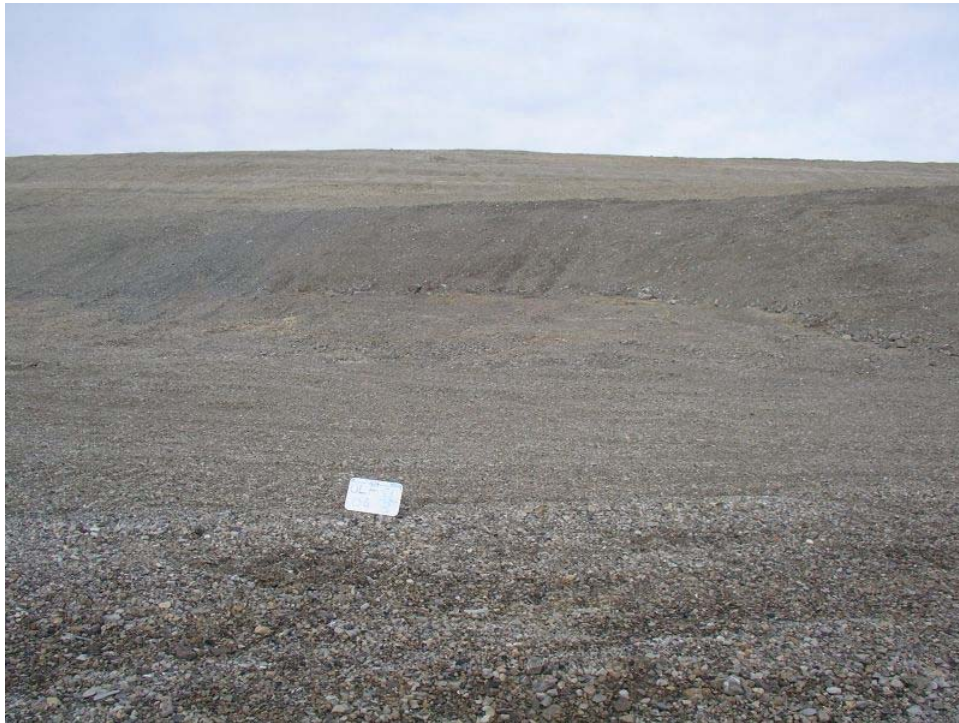
2006 – SL-3 North 8 368 100 view to east. Conditions appear similar to 2005.

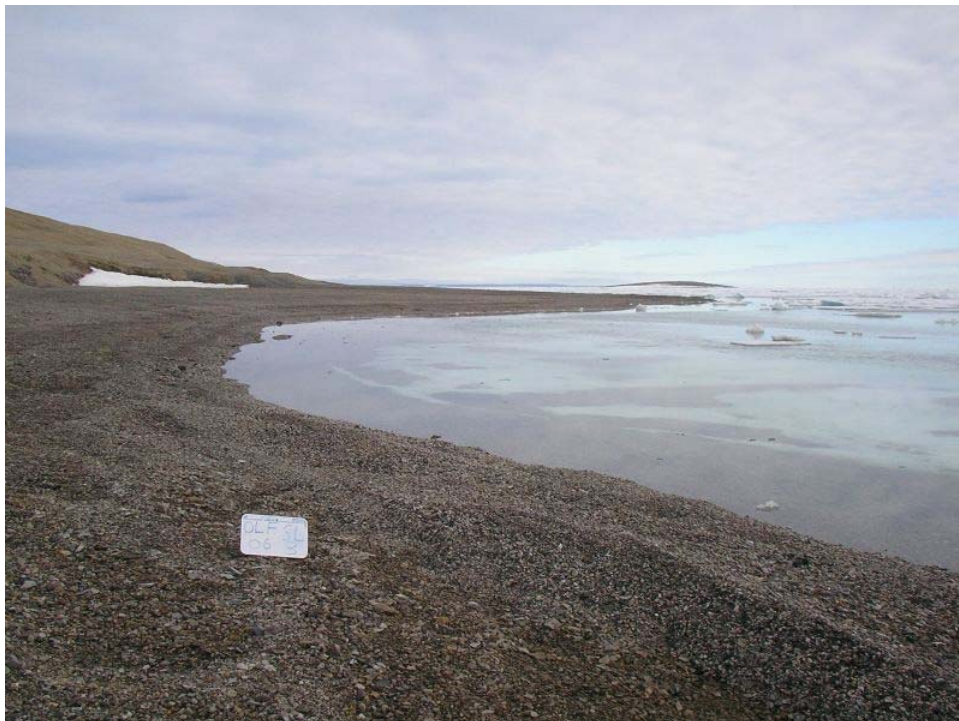
2006 – SL-3 North 8 368 100 view to south. Conditions appear unchanged since 2005.

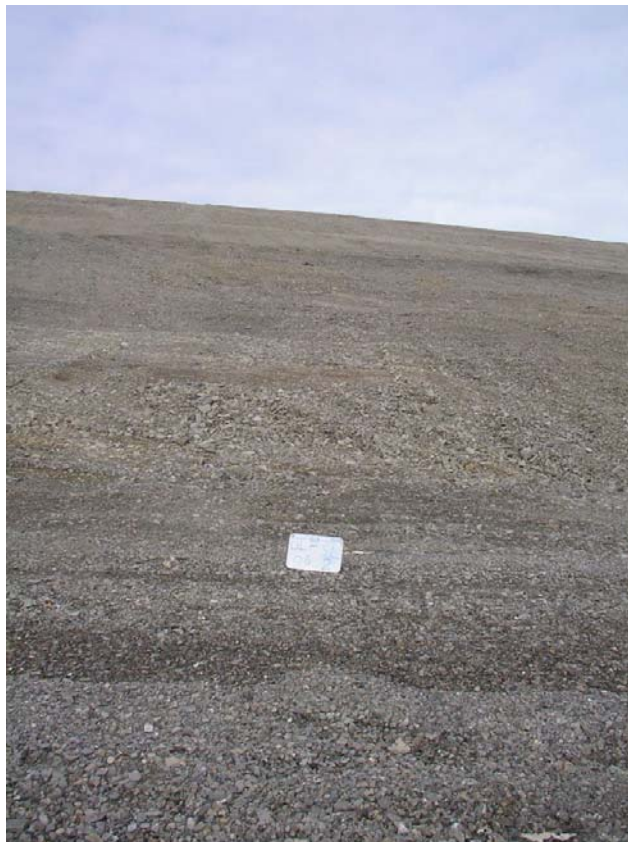
2006 – SL-2 North 8 368 200 view to east. Conditions are similar to observed in 2005.

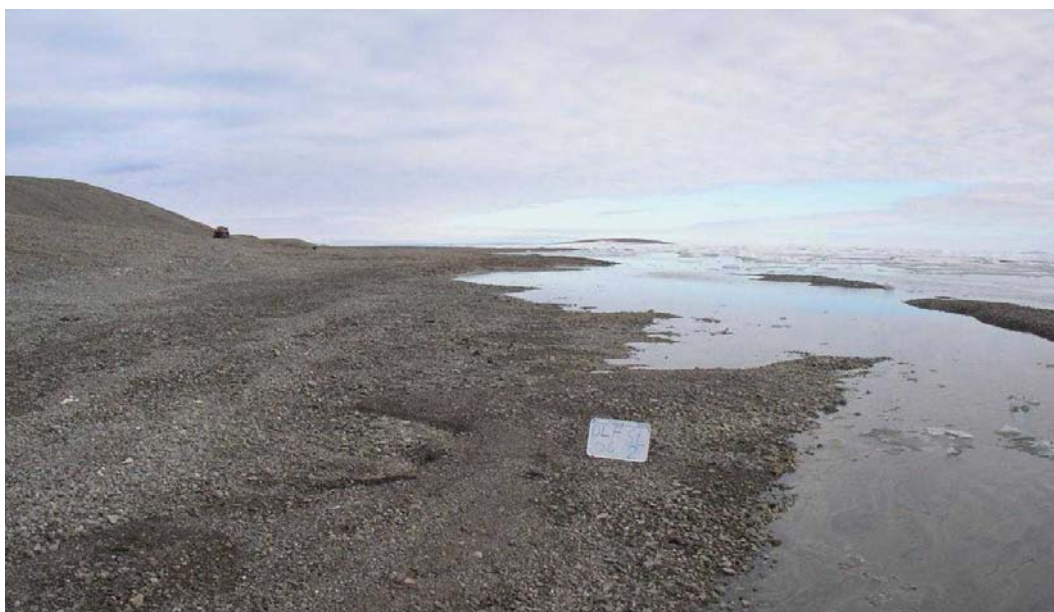
2006 – SL-2 North 8 368 200 view to south. Conditions appear to be generally similar to those observed in 2005.

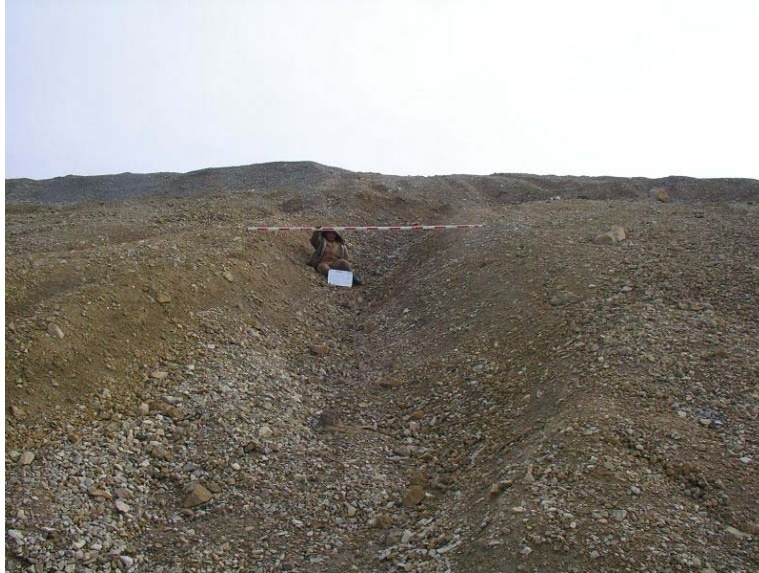
At waypoint GUL06 1, several localised erosion gullies were observed on the upper side-slopes above the western shoreline. These features appear unchanged from the 2005 inspection. The depth of the gully shown here is 1 m, and has a base width of 1 m. The gully is not fed by a significant drainage and appears to be a remnant from operations. Material in the gully is relatively coarsely sized and evidently self-armouring.

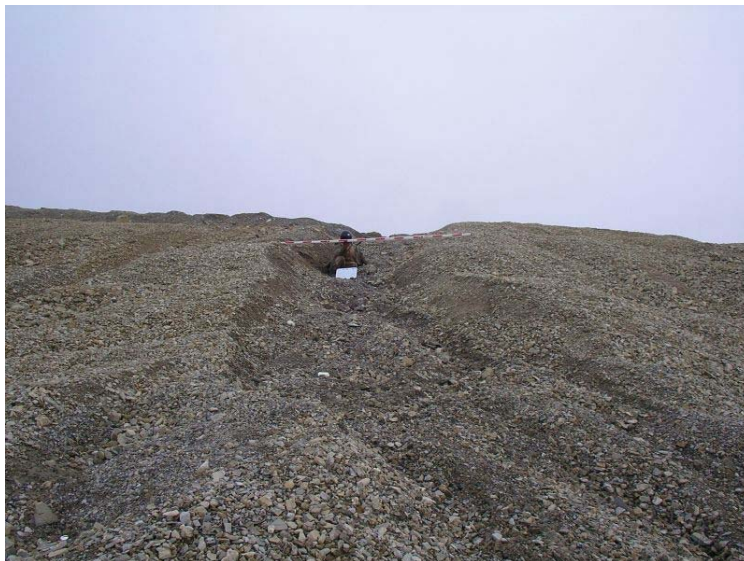
At waypoint GUL06 2, this shallow and isolated erosion gully appears to be unchanged from the 2005 inspection and is evidently self-armouring. The gully is 0.9 m deep and has a base width of about 2 m. Bedrock is exposed over part of this gully.

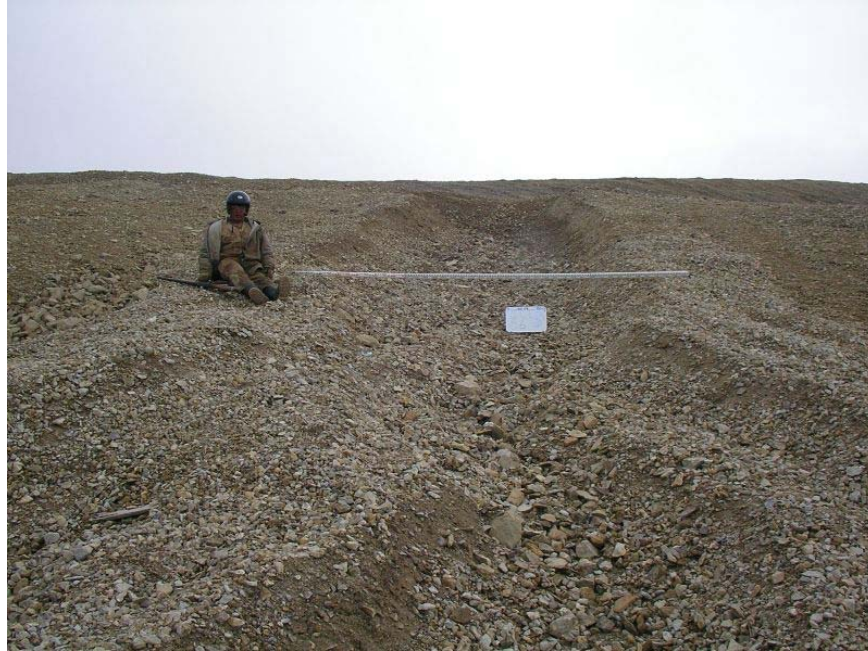
At waypoint GUL06 3, conditions in this localised shallow erosion gully appear stable and unchanged from 2005. The gully is blocked off at the top and is evidently self-armoured with coarse material.

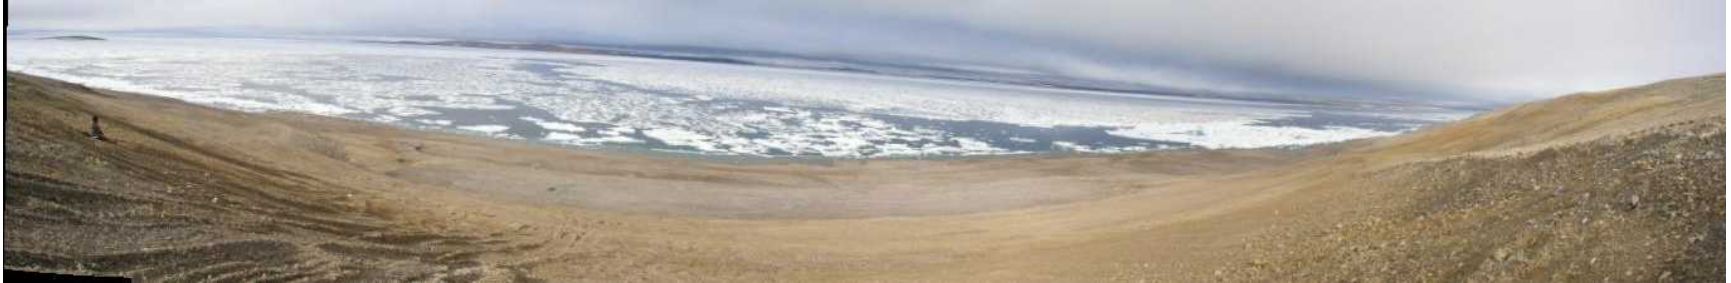
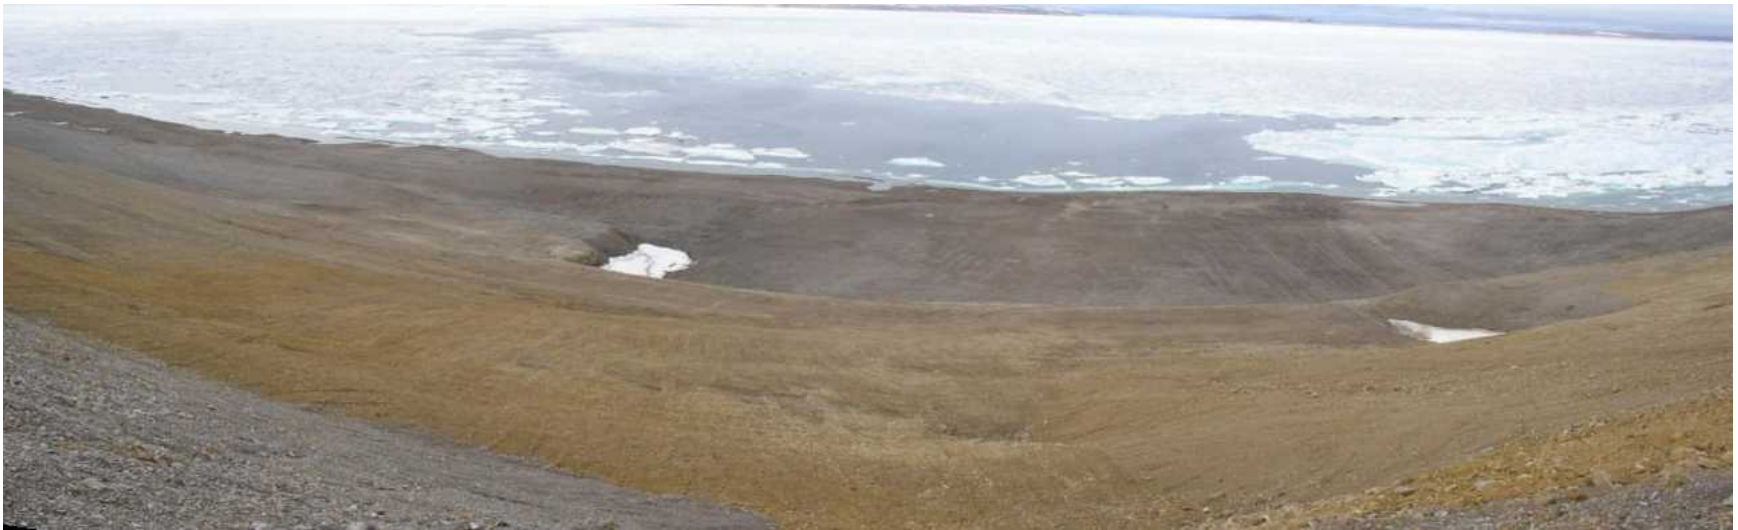
Panoramic views of the western shoreline from waypoint JUL21PAN1 taken in 2006.

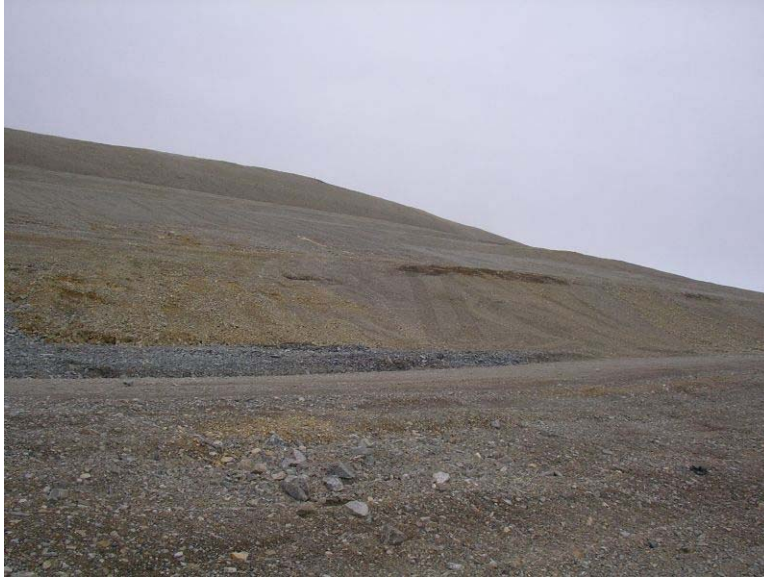
2006 view of the outside sides slope of the former incinerator pad that was re-sloped to address the regulators concern with the initially over steepened slopes. Average slopes of between 21 and 23 degrees were observed. The materials exposed are gravel and cobbles with some silty sand. The slopes appear in a stable condition with no seepage, settlement or cracking observed.

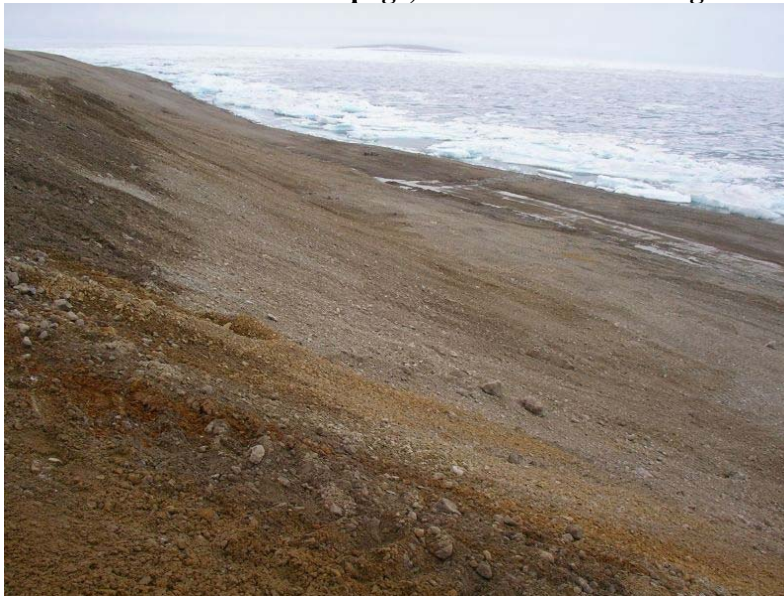
2006 Tank Farm Pad re-sloping – view from the north end looking south across a slope that has been flattened to slopes in the range of 20 to 23 degrees with horizontal. No signs of seepage were observed and the materials exposed are silty sands and gravels, with some cobbles. The slope appears stable with no signs of cracking or settlement.
