APPENDIX 7

TECK COMINCO RESPONSE TO JULY 2003 INAC SITE INSPECTION

Re: Polaris Mine Closure DIAND Inspection July 2 – 3, 2003

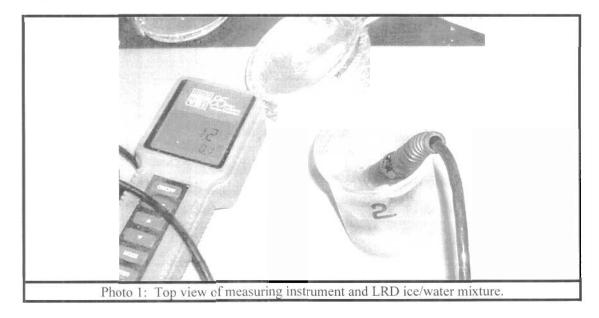
The samples were stored in 300mL beakers in the freezer until the samples were approximately 40% frozen. At this point the ice in the beaker was broken up and the instrument inserted in the ice/water mixture. The mixture was then stirred in order to maintain a constant temperature. When the readings became stable, temperature and salinity parameters were taken. The results from the experiment are as follows:

A photo to illustrate the process is located below.
