Project No.: PIN-4 (3.6)

RE: Final Report for Water Use License #NWB5BYR0308

PIN-4 BYRON BAY
DUE DILIGENCE CLEAN UP
MARCH, 2003

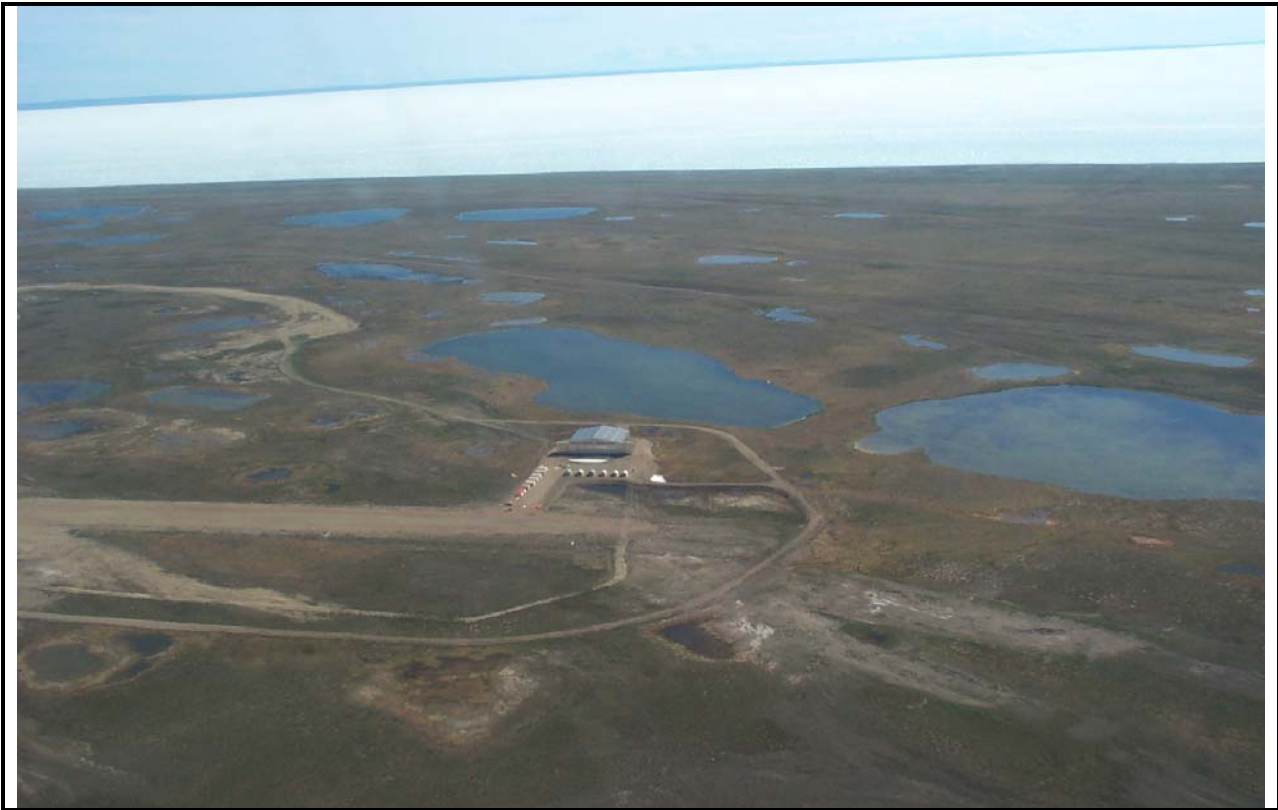
Photo 1: Aerial view of camp at the hangar.

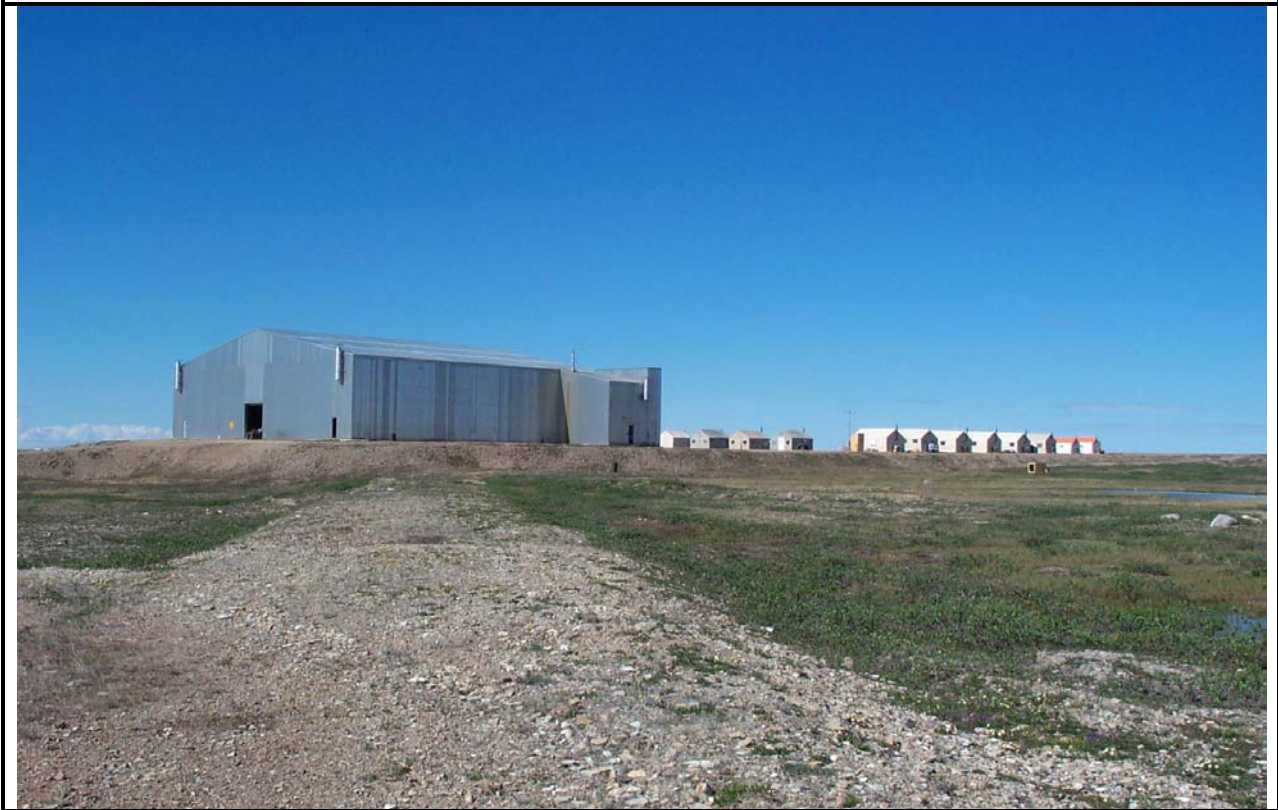
Photo 2: Site investigation camp.
