# **The Collection of Landfill Monitoring Data at the CAM-M Cambridge Bay Site – 2007 Report**

Prepared for  
**Defence Construction Canada**

Submitted by  
**Gartner Lee Limited**

**January, 2008**

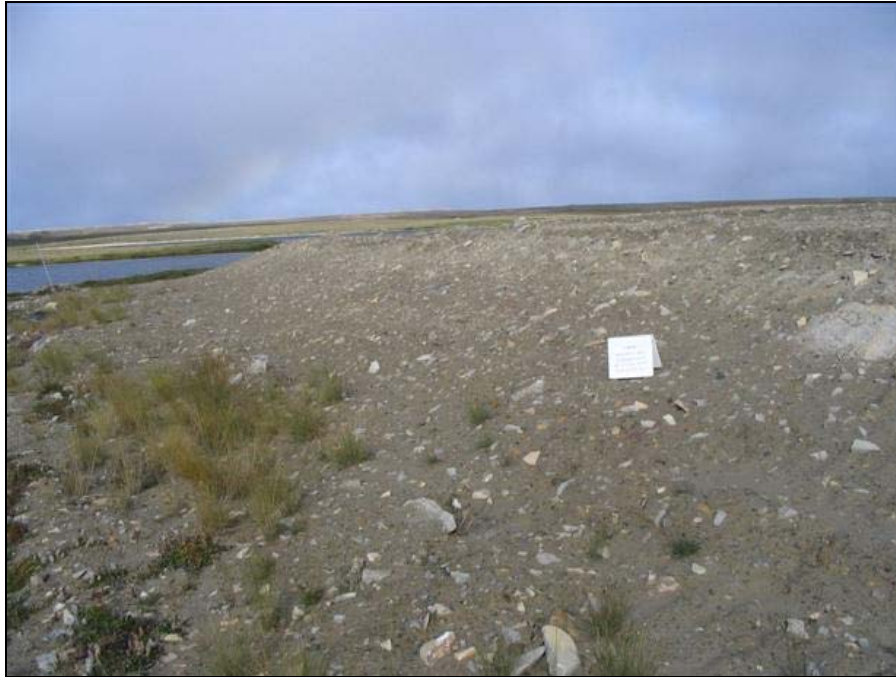
Photo MLFN-1A, Easting: 495755, Northing: 7667517, Direction: 300°  
Main Landfill North; south slope, west of road  
Scale: photo placard dimensions are 29.4 cm wide by 27.5 cm in height

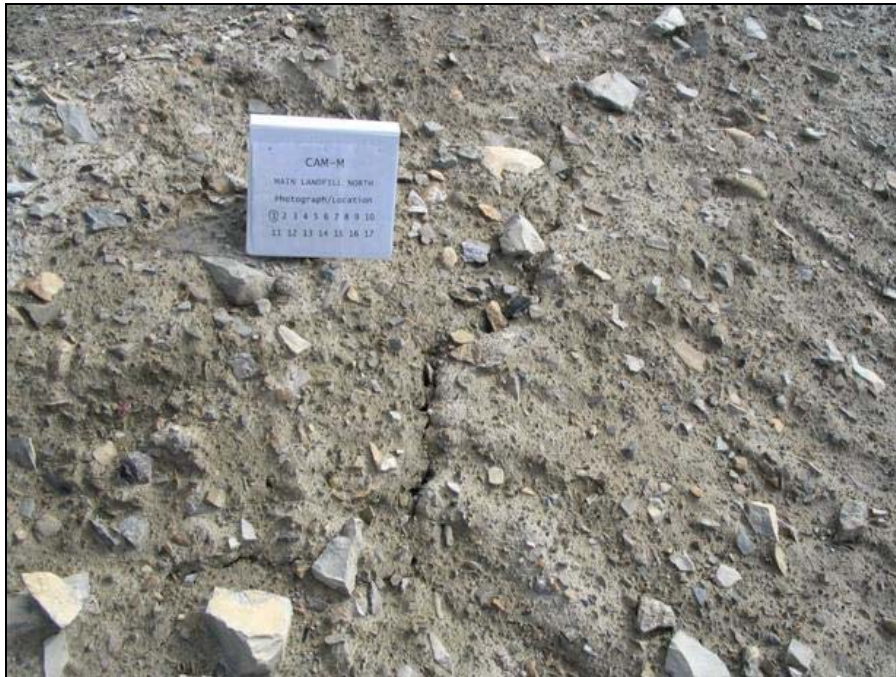
Photo MLFN-1B, Easting: 495755, Northing: 7667517, Direction: 110°  
Main Landfill North; 2.5 cm wide by 2.5 cm deep by 4 meters long crack on south slope  
Scale: photo placard dimensions are 29.4 cm wide by 27.5 cm in height

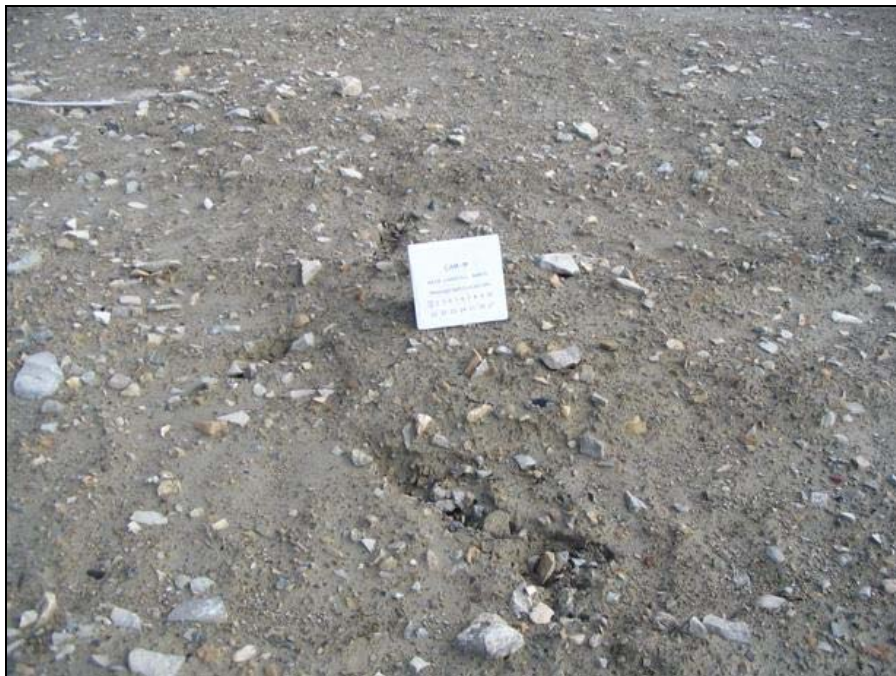
Photo MLFN-1C, Easting: 495755, Northing: 7667517, Direction: 20°

Main Landfill North; view of crack on crest that extends for 10 m

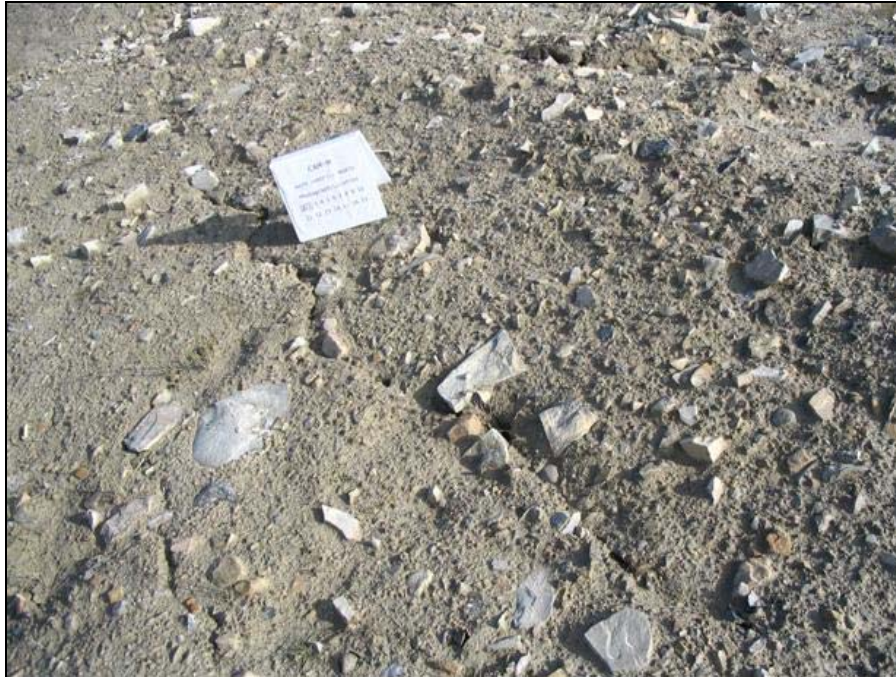
Photo MLFN-1D, Easting: 495755, Northing: 7667517, Direction: 20°

Main Landfill North; max crack width approximately 5 cm, max crack depth approximately 7.5 cm

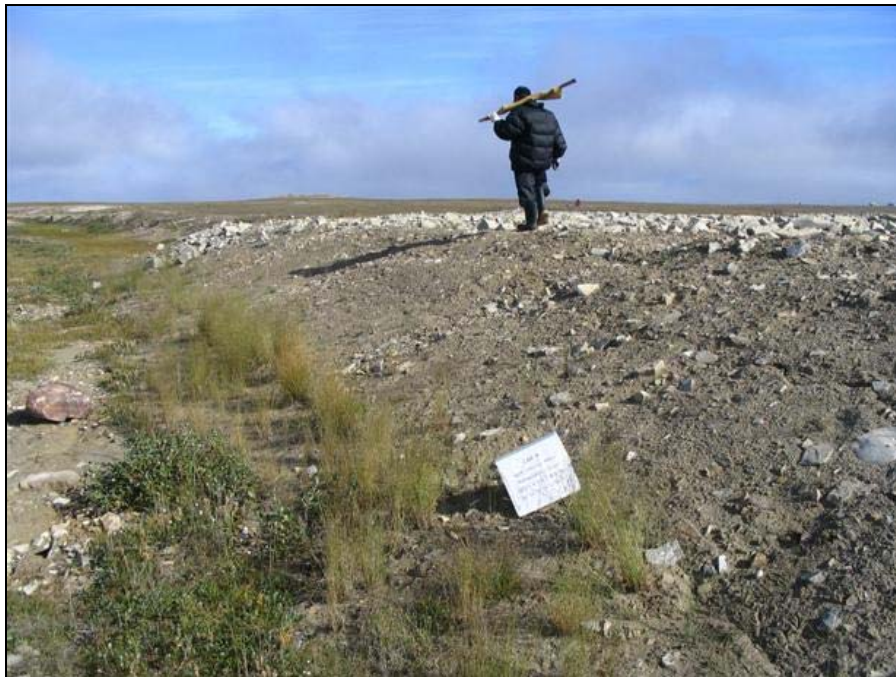
A total of five tension cracks were observed at the MLFN, including two previously observed cracks and three new cracks. A tension crack on the west slope (Photo location 2 on Figure A-1) appears to be unchanged since 2005 with no indications of recent movement or progressive instability. A new tension crack in the southwest corner of the landfill that extends 4 m along the south slope and 10 m onto the crest was observed in 2007 (Photos MLFN-1B, 1C and 1D in Appendix A2). A midslope tension crack (Photos MLFN-11A through 11G in Appendix A2) appears unchanged since the 2005 inspection with a maximum width of approximately 0.1 m, however a hairline tension crack was observed in 2007 along the crest above this midslope crack indicating potential slope instability. A 30 m long tension crack along the southeast crest (Photos MLFN-15A through 15D in Appendix A2) was also observed in 2007. The crack has a rounded scarp shape on the crest (Photo MLFN-15C) and it appears that the southeast crest of the landfill (near as-built Coordinate Point No. 108) may have slumped as much as 0.3 m (vertical) over several metres (horizontal) since completion of construction as a result of slope movement in this corner of the landfill (to be confirmed by survey). Tension cracks and adjacent slopes should be monitored during future inspections for increased size and movement, respectively.

Photo MLFN-2A, Easting: 495727, Northing: 7667665, Direction: 0°  
Main Landfill North; tension crack on slope  
Scale: photo placard dimensions are 29.4 cm wide by 27.5 cm in height

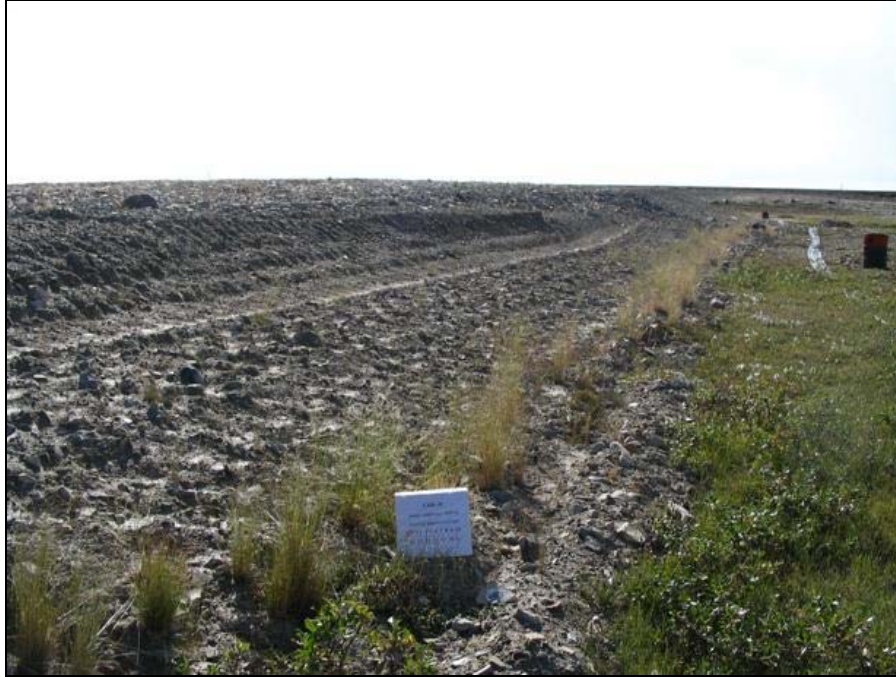
Photo MLFN-2C, Easting: 495727, Northing: 7667665, Direction: 180°  
Main Landfill North; view of slope facing south  
Scale: photo placard dimensions are 29.4 cm wide by 27.5 cm in height

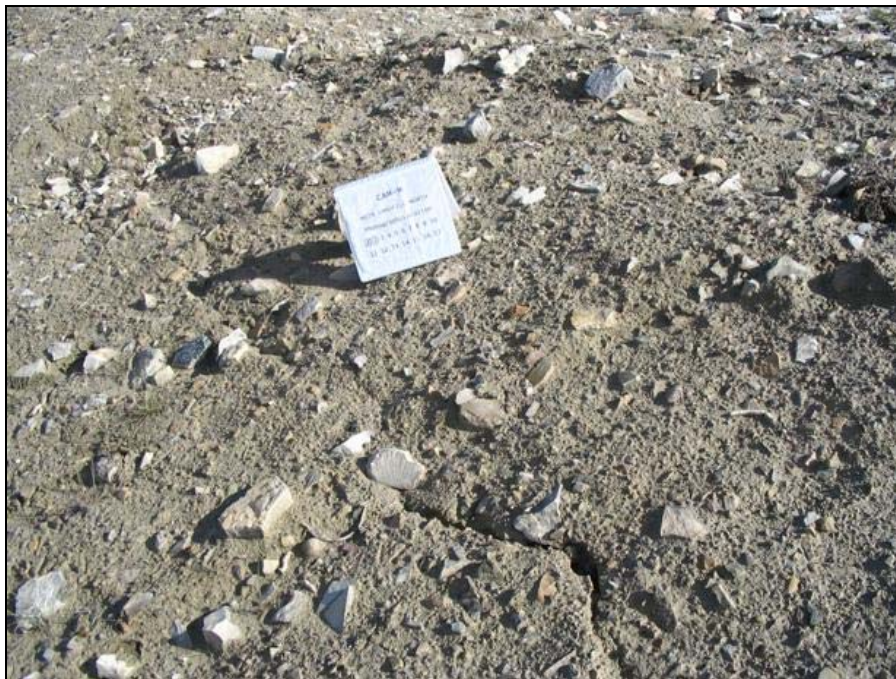
Photo MLFN-2D, Easting: 495755, Northing: 7667517, Direction: 45°  
Main Landfill North; close-up of crack  
Scale: photo placard dimensions are 29.4 cm wide by 27.5 cm in height

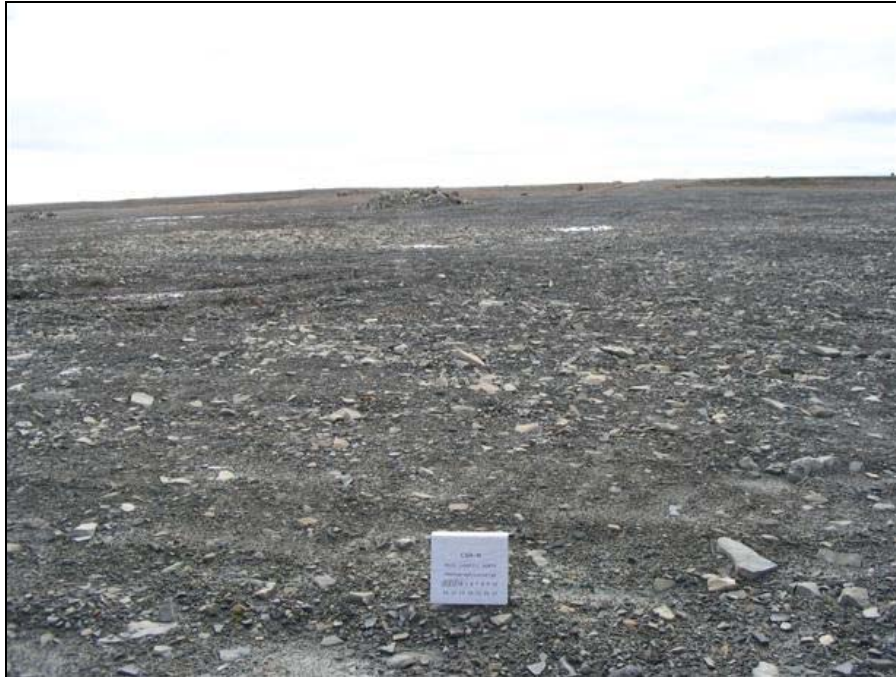
Photo MLFN-4A, Easting: 495814, Northing: 7667617, Direction: 180°  
Main Landfill North; Some undulations and ponded water at top of landfill  
Scale: photo placard dimensions are 29.4 cm wide by 27.5 cm in height

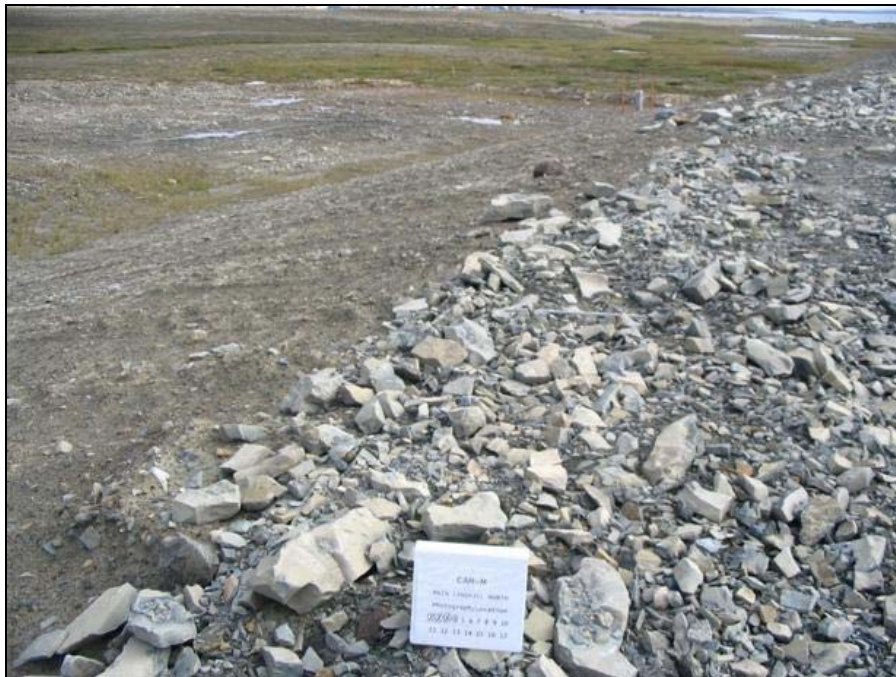
Photo MLFN-4B, Easting: 495814, Northing: 7667617, Direction: 90°  
Main Landfill North; north slope  
Scale: photo placard dimensions are 29.4 cm wide by 27.5 cm in height

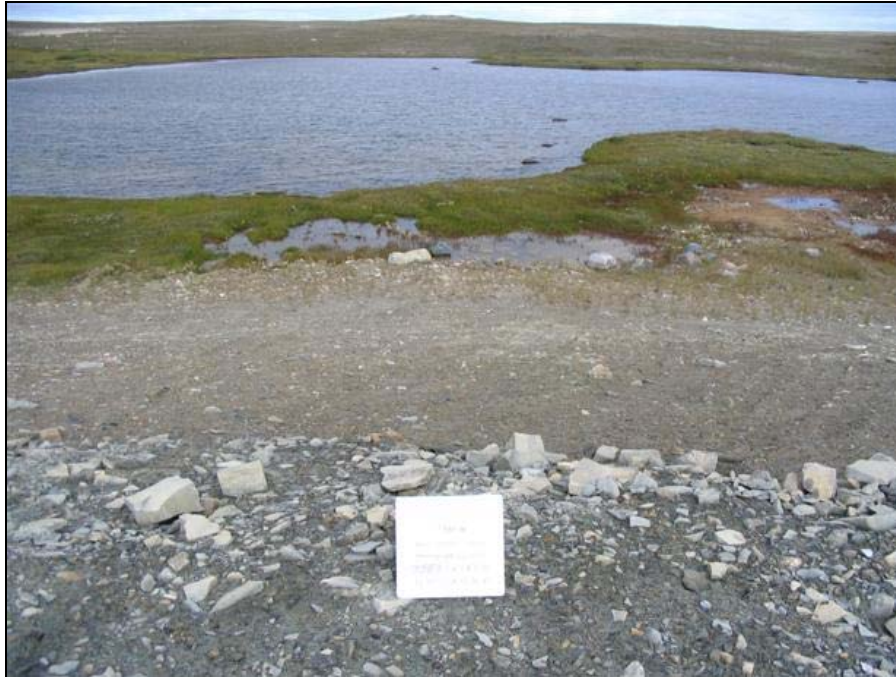
Photo MLFN-4C, Easting: 495814, Northing: 7667617, Direction: 0°  
Main Landfill North; downslope towards ponded water at toe  
Scale: photo placard dimensions are 29.4 cm wide by 27.5 cm in height

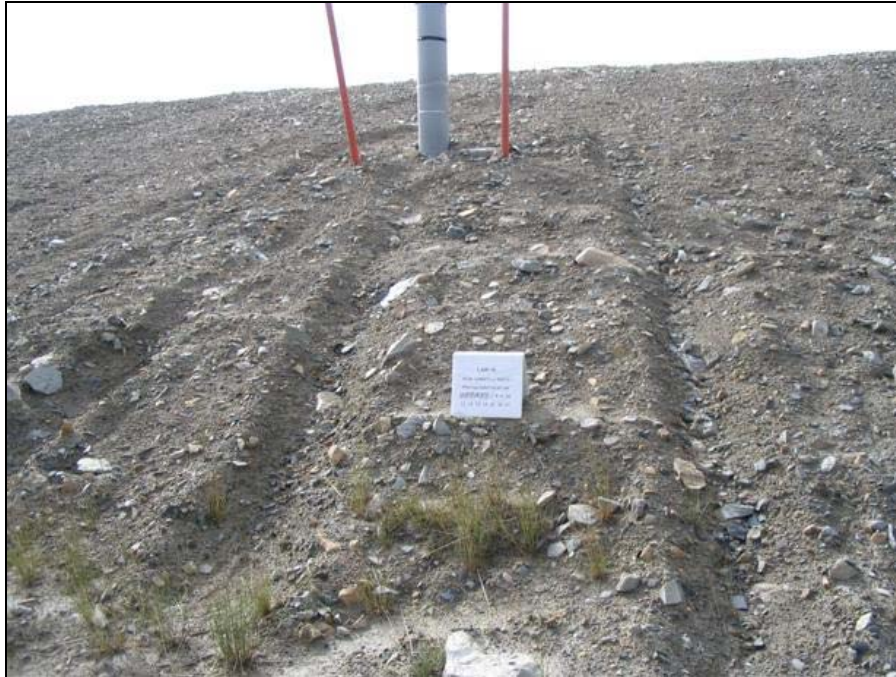
There are minor erosion gullies and rills on the north slope (Photo locations 6, 7, 8 and 9 on Figure A-1) that appear to be self-armouring and unchanged from previous inspections. These areas should be monitored for increased deepening of erosion gullies. The maximum erosion gully depth observed in 2007 is approximately 0.2 m.

Photo MLFN-6, Easting: 495814, Northing: 7667617, Direction: 225°  
Main Landfill North; Erosion gullies about 0.3 m wide and 0.2 m deep spaced approximately 2 – 3 m apart  
Scale: photo placard dimensions are 29.4 cm wide by 27.5 cm in height

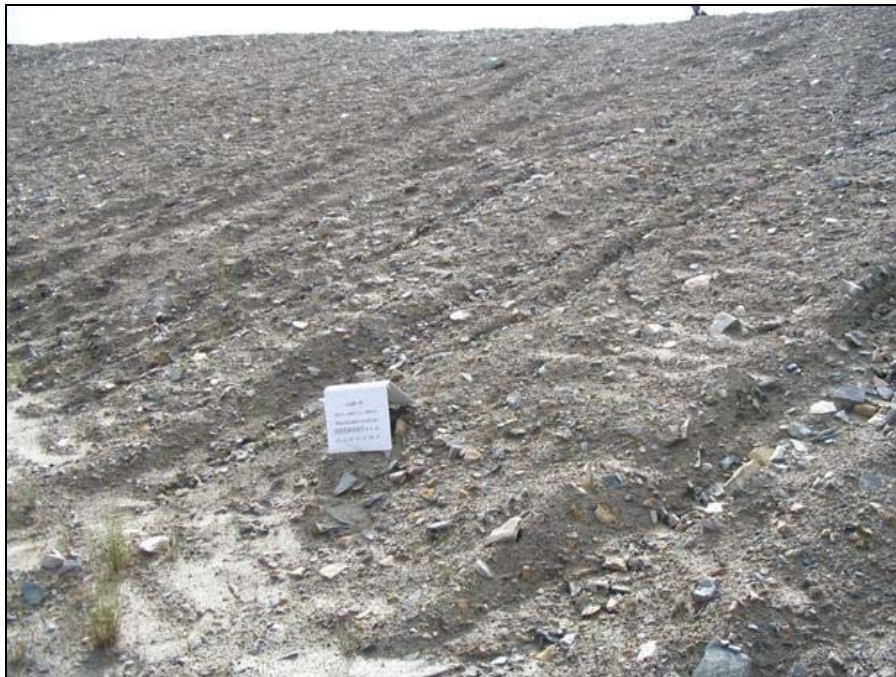
Photo MLFN-7A, Easting: 495874, Northing: 7667561, Direction: 110°  
Main Landfill North; looking across erosion gullies on slope  
Scale: photo placard dimensions are 29.4 cm wide by 27.5 cm in height

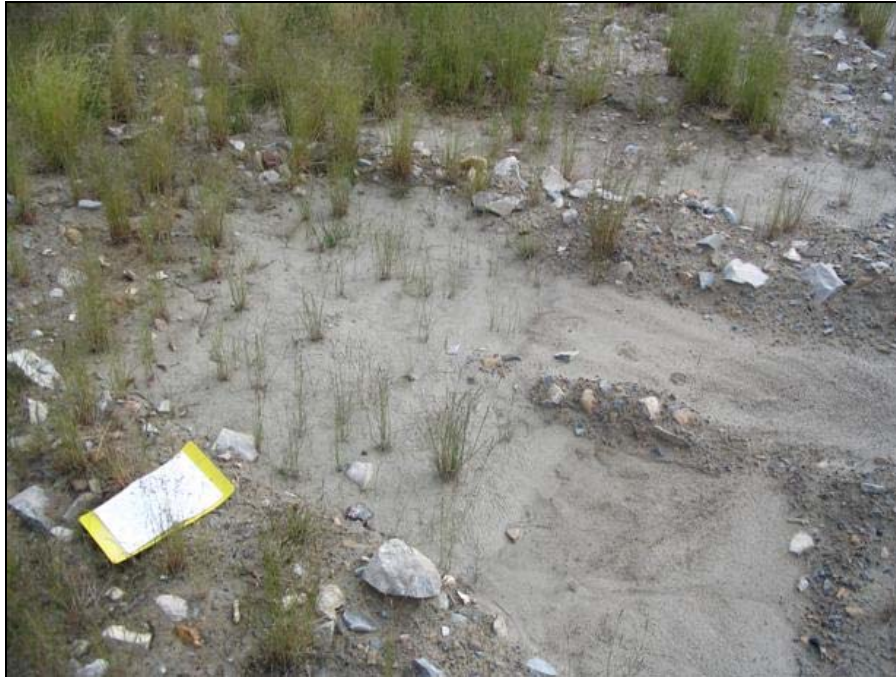
Photo MLFN-7B, Easting: 495874, Northing: 7667561, Direction: 110°  
Main Landfill North; view of fines covering vegetation at toe  
Scale: field book dimensions are 29.5 cm wide by 20.0 cm in height

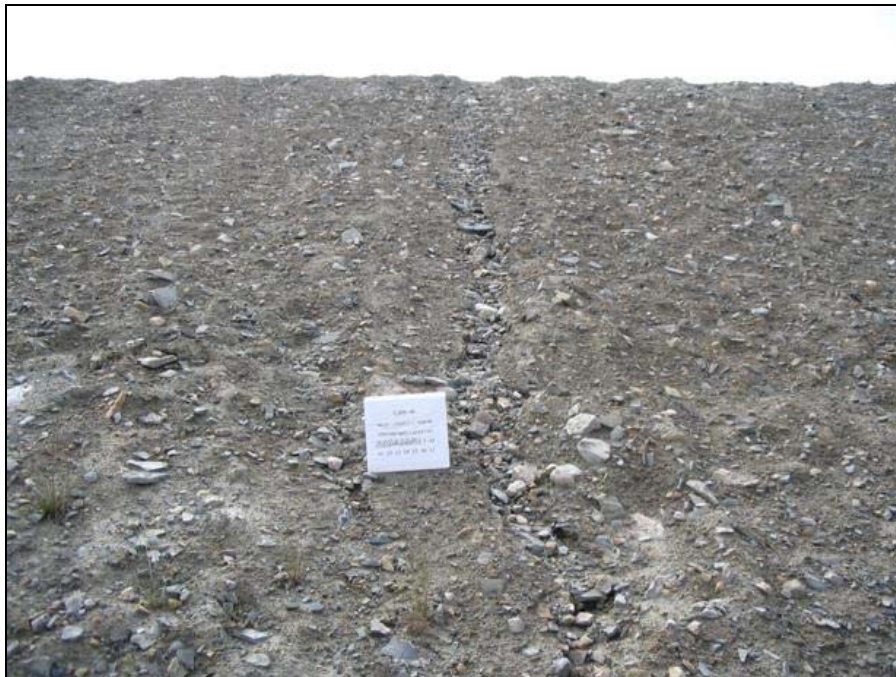
Photo MLFN-8, Easting: 495874, Northing: 7667564; Direction: 200°  
Main Landfill North; looking up erosion channel West of ITN2 about 0.3 m wide and 0.1 m deep  
Scale: photo placard dimensions are 29.4 cm wide by 27.5 cm in height

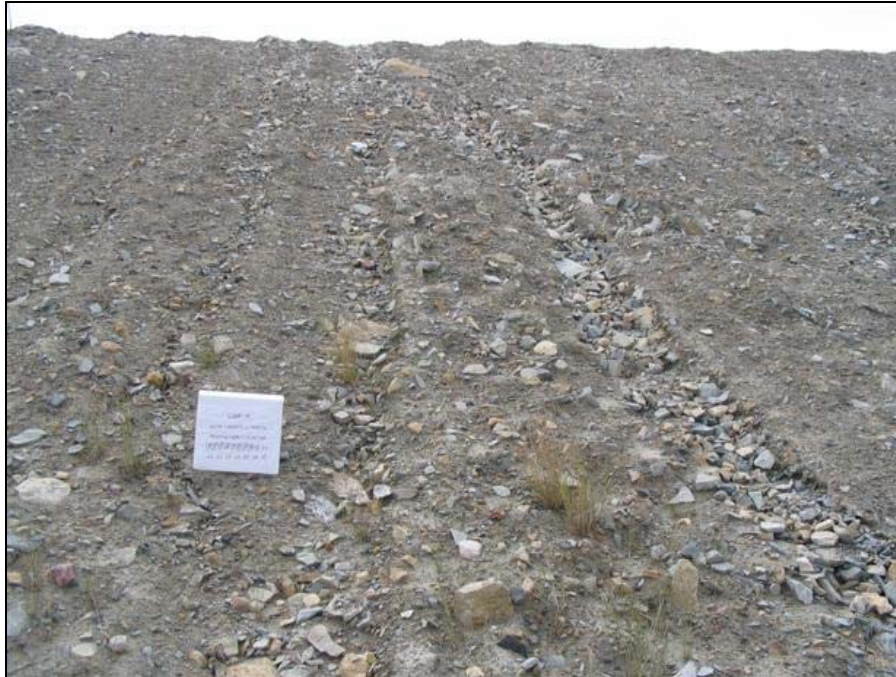
Photo MLFN-9, Easting: 495898, Northing: 7667542, Direction: 200°  
Main Landfill North; view of erosion gullies  
Scale: photo placard dimensions are 29.4 cm wide by 27.5 cm in height

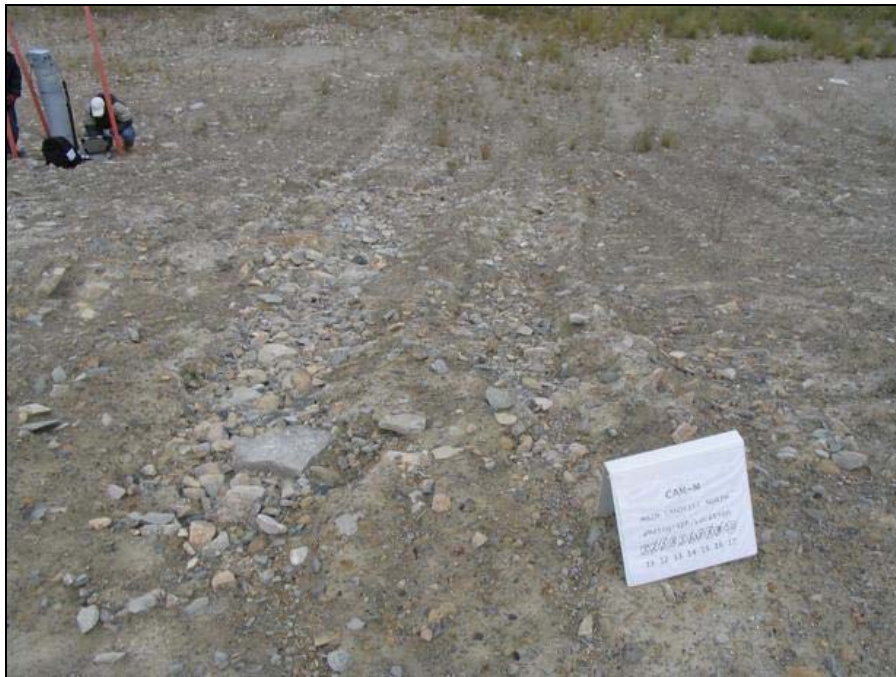
Photo MLFN-10A, Easting: 495895, Northing: 7667528, Direction: 20°  
Main Landfill North; looking down slope at erosion  
Scale: photo placard dimensions are 29.4 cm wide by 27.5 cm in height

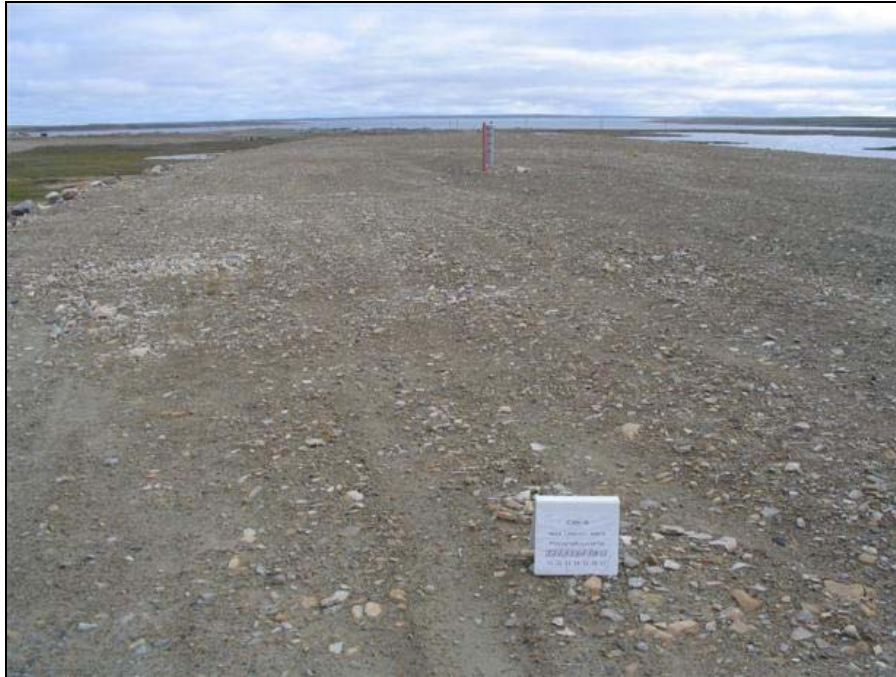
Photo MLFN-10B, Easting: 495895, Northing: 7667528, Direction: 110°  
Main Landfill North; facing east along crest  
Scale: photo placard dimensions are 29.4 cm wide by 27.5 cm in height

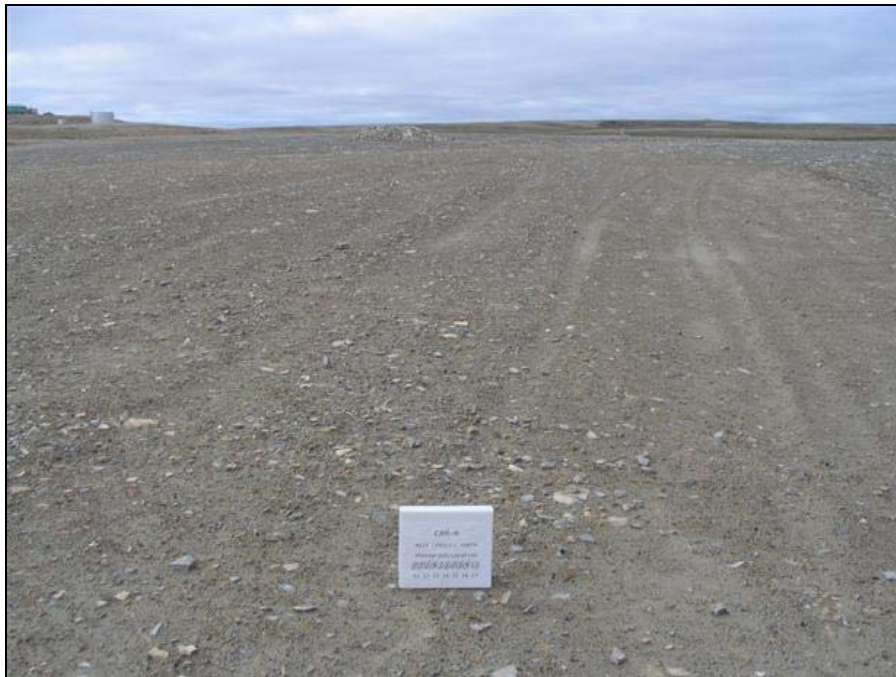
Photo MLFN-10C, Easting: 495895, Northing: 7667528, Direction: 300°  
Main Landfill North; facing west along crest  
Scale: photo placard dimensions are 29.4 cm wide by 27.5 cm in height

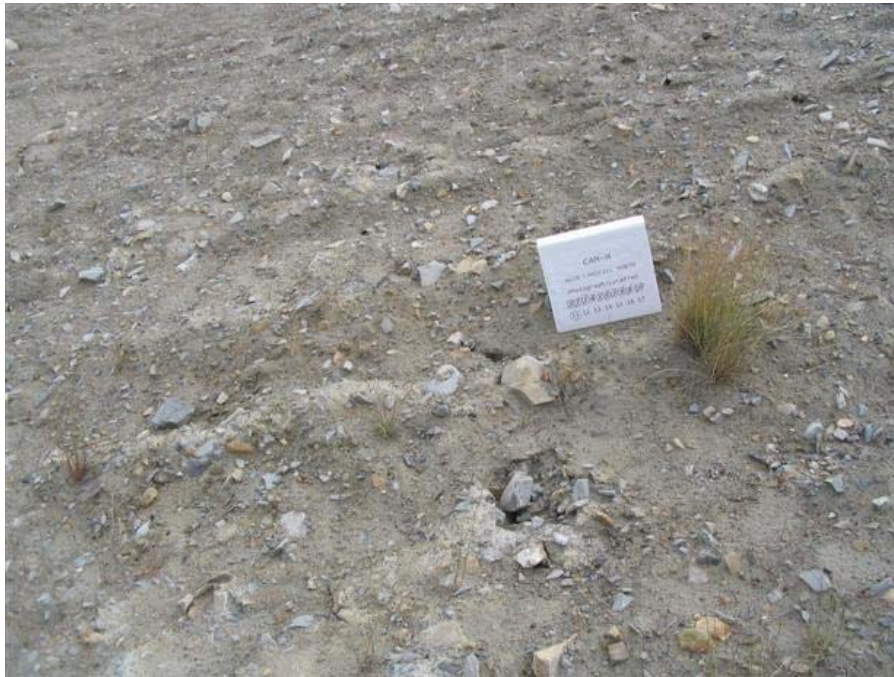
Photo MLFN-11A, Easting: 495916, Northing: 7667534  
Main Landfill North; west end of crack along toe of slope  
Scale: photo placard dimensions are 29.4 cm wide by 27.5 cm in height

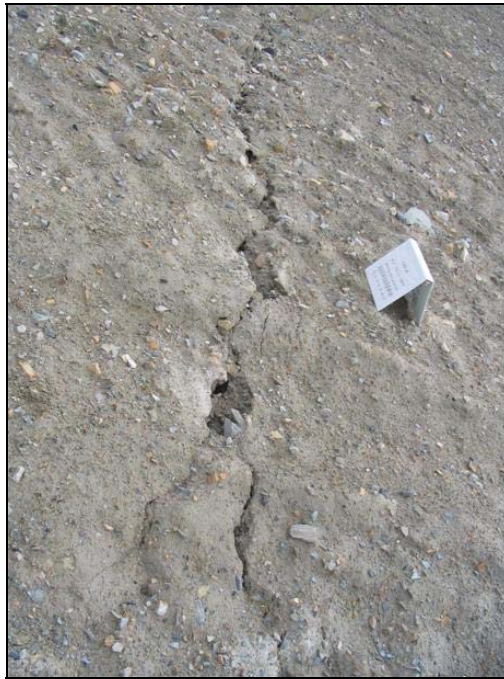
Photo MLFN-11B, Easting: 495916, Northing: 7667534  
Main Landfill North; crack max width 0.1 m, max depth 0.1 m  
Scale: photo placard dimensions are 29.4 cm wide by 27.5 cm in height

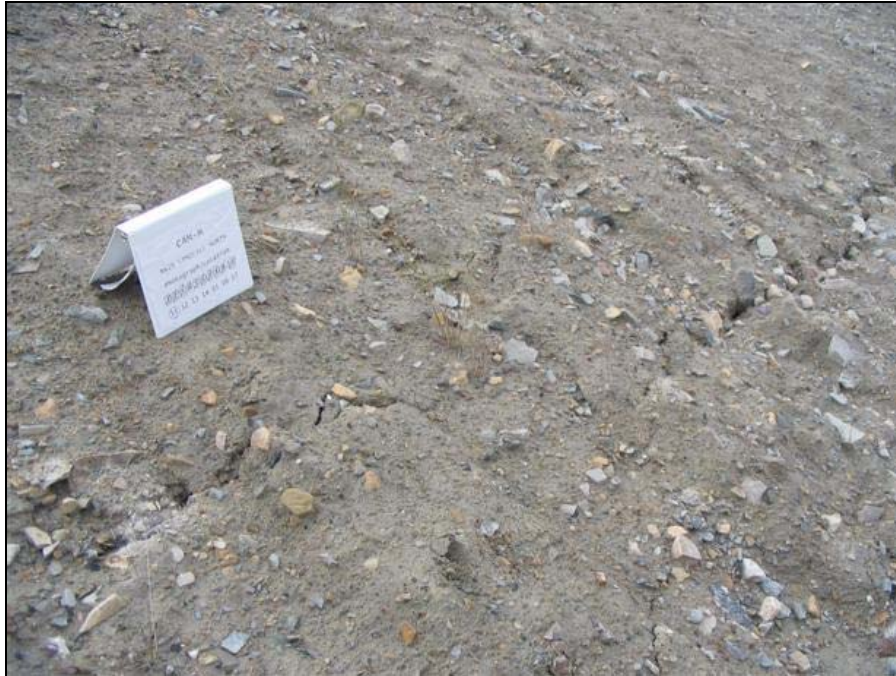
Photo MLFN-11C, Easting: 495916, Northing: 7667534  
Main Landfill North; crack along toe of slope  
Scale: photo placard dimensions are 29.4 cm wide by 27.5 cm in height

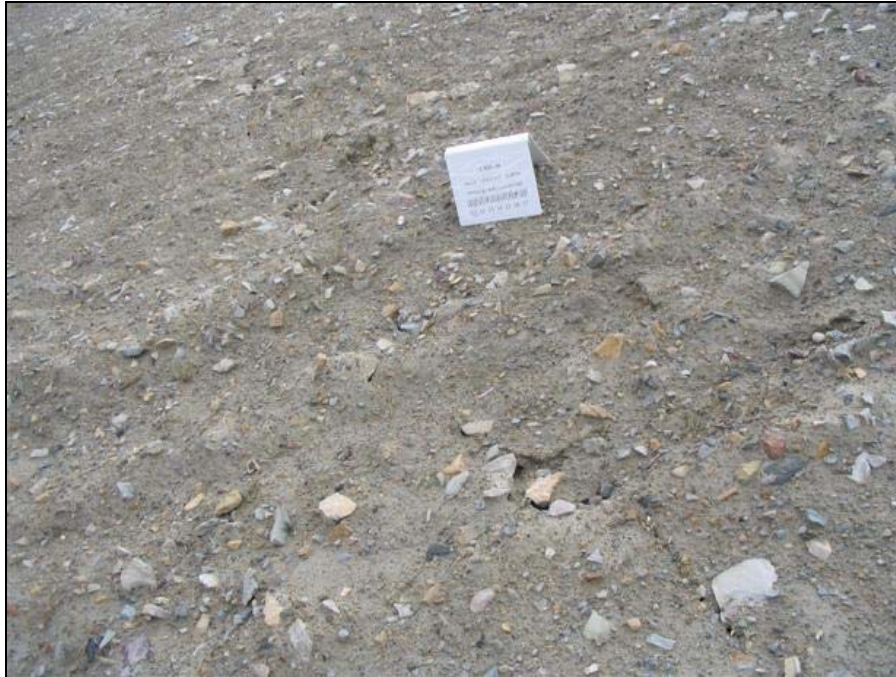
Photo MLFN-11D, Easting: 495916, Northing: 7667534  
Main Landfill North; crack along toe of slope  
Scale: photo placard dimensions are 29.4 cm wide by 27.5 cm in height

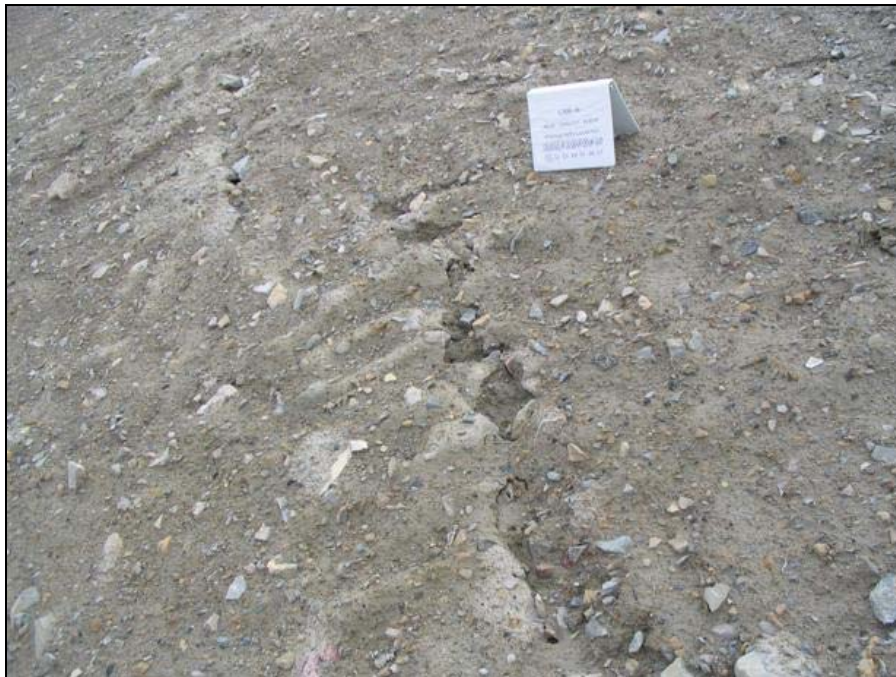
Photo MLFN-11E, Easting: 495916, Northing: 7667534  
Main Landfill North; crack along toe of slope  
Scale: photo placard dimensions are 29.4 cm wide by 27.5 cm in height

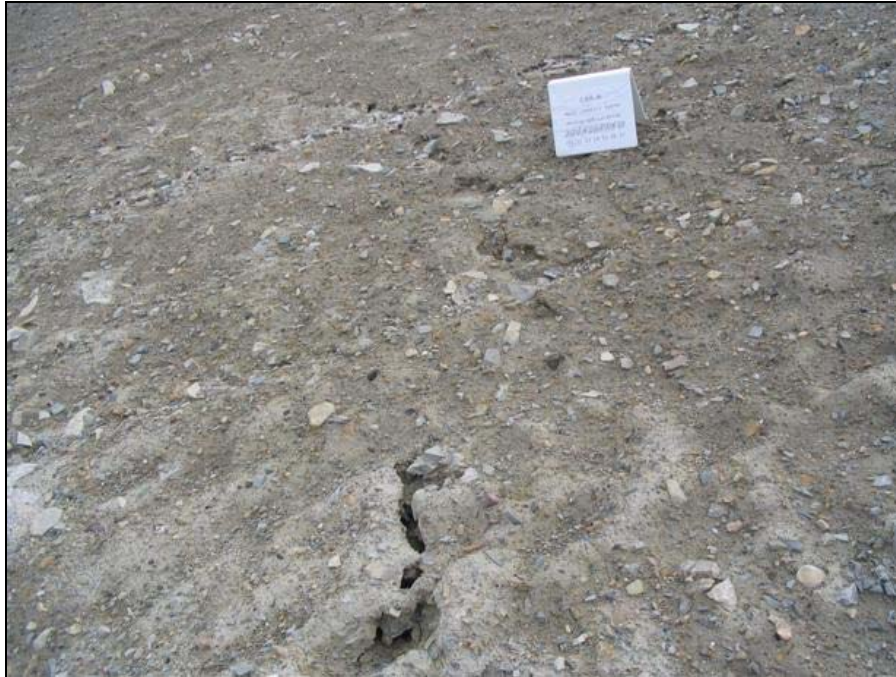
Photo MLFN-11F, Easting: 495916, Northing: 7667534  
Main Landfill North; crack along toe of slope  
Scale: photo placard dimensions are 29.4 cm wide by 27.5 cm in height

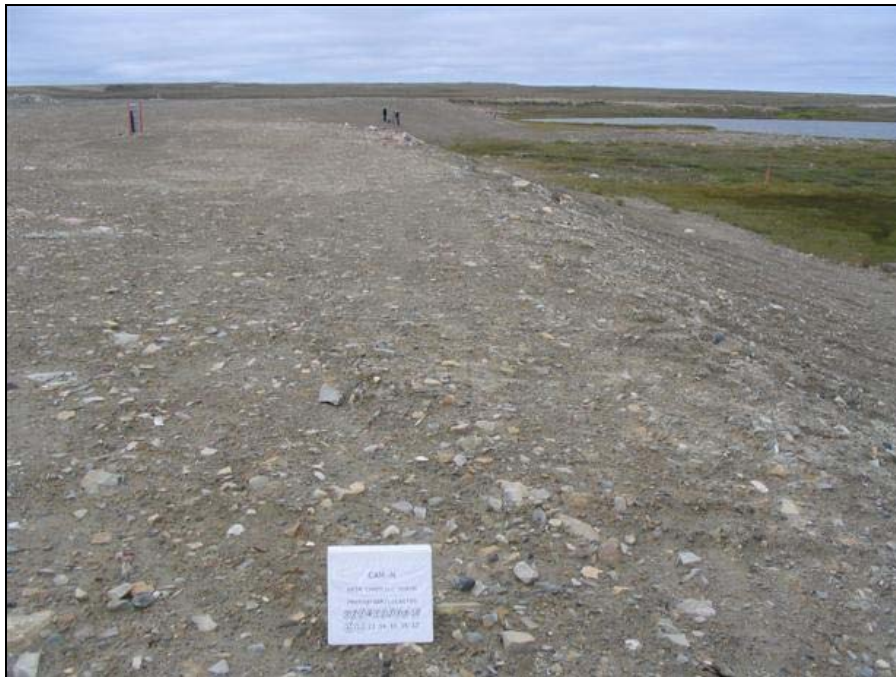
Photo MLFN-11G, Easting: 495916, Northing: 7667534  
Main Landfill North; east end of crack along toe of slope  
Scale: photo placard dimensions are 29.4 cm wide by 27.5 cm in height

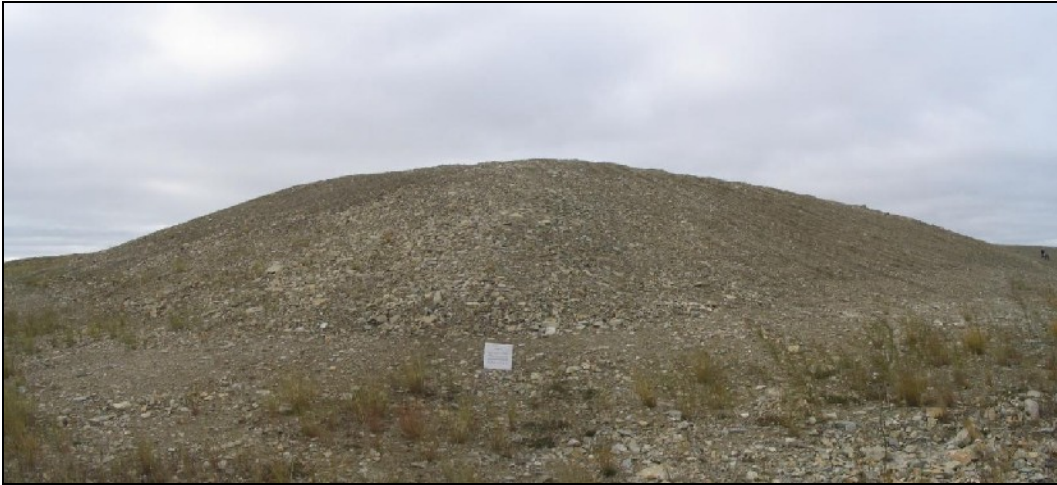
Photo MLFN-12, Easting: 495951, Northing: 7667491, Direction: 315°  
Main Landfill North; along crest above crack below, hairline crack along crest not visible in photo  
Scale: photo placard dimensions are 29.4 cm wide by 27.5 cm in height

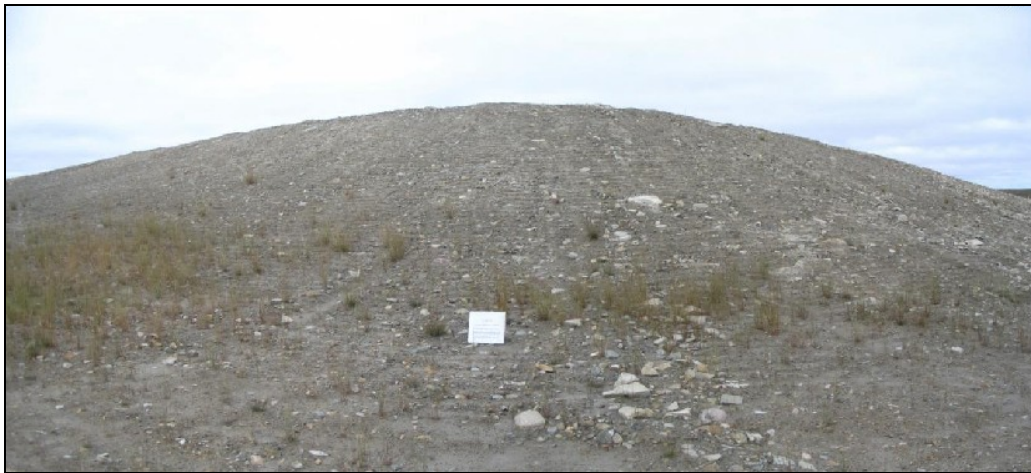
Photo MLFN-14, Easting: 495960, Northing: 7667457, Direction: 0°  
Main Landfill North; southeast corner slope  
Scale: photo placard dimensions are 29.4 cm wide by 27.5 cm in height

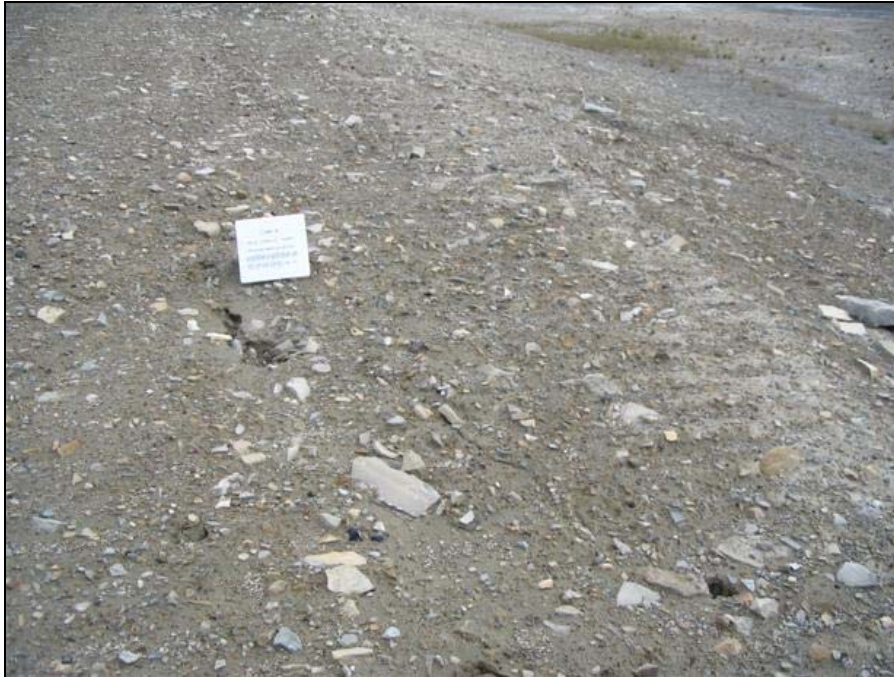
Photo MLFN-15A, Easting: 495927, Northing: 7667478, Direction: 110°  
Main Landfill North; tension crack along crest, west end  
Scale: photo placard dimensions are 29.4 cm wide by 27.5 cm in height

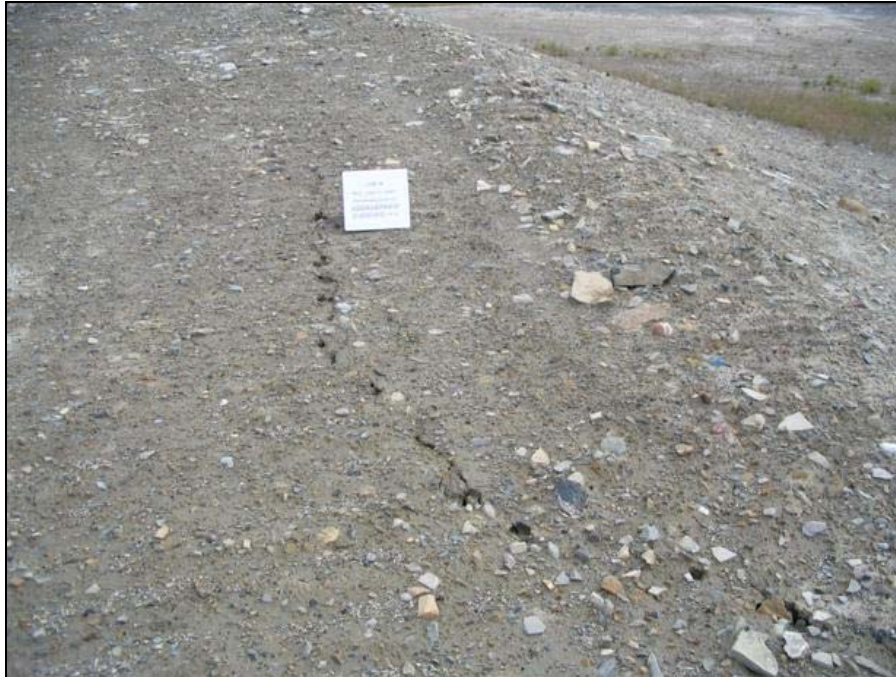
Photo MLFN-15B, Easting: 495927, Northing: 7667478, Direction: 110°  
Main Landfill North; tension crack along crest  
Scale: photo placard dimensions are 29.4 cm wide by 27.5 cm in height

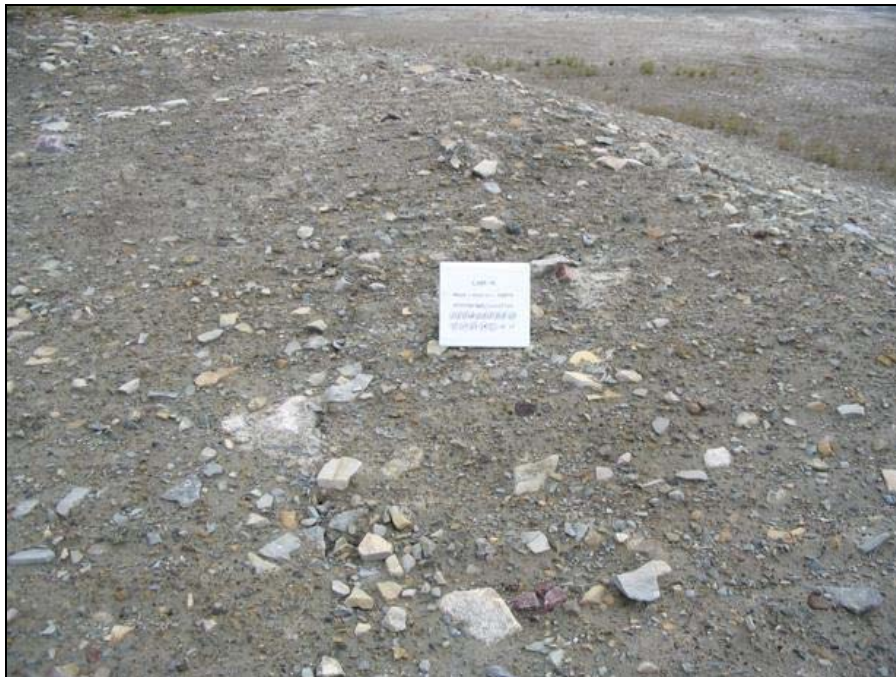
Photo MLFN-15C, Easting: 495927, Northing: 7667478, Direction: 110°  
Main Landfill North; tension crack along crest  
Scale: photo placard dimensions are 29.4 cm wide by 27.5 cm in height

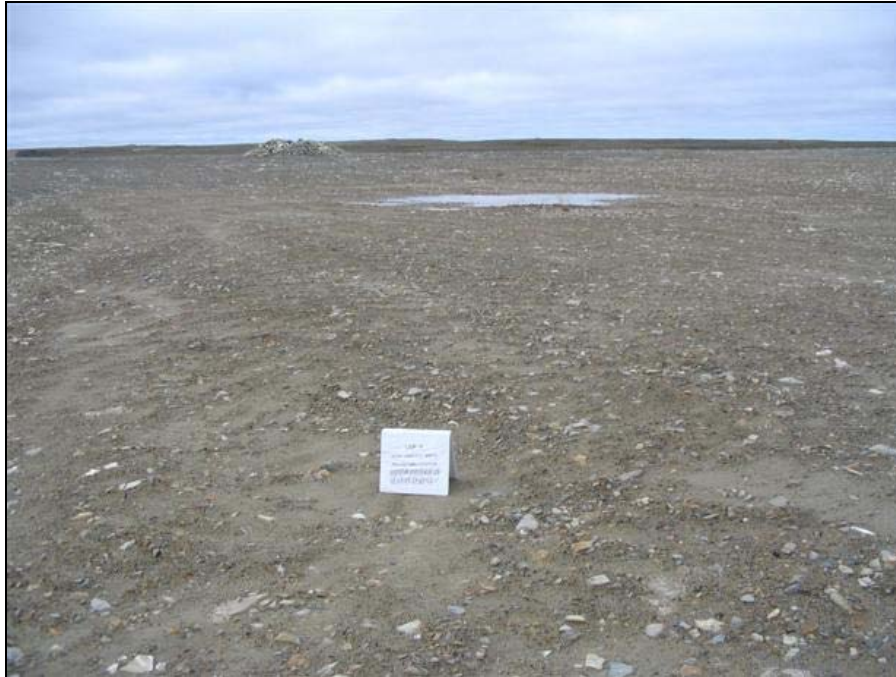
Photo MLFN-15D, Easting: 495927, Northing: 7667478, Direction: 110°  
Main Landfill North; tension crack along crest, east end  
Scale: photo placard dimensions are 29.4 cm wide by 27.5 cm in height

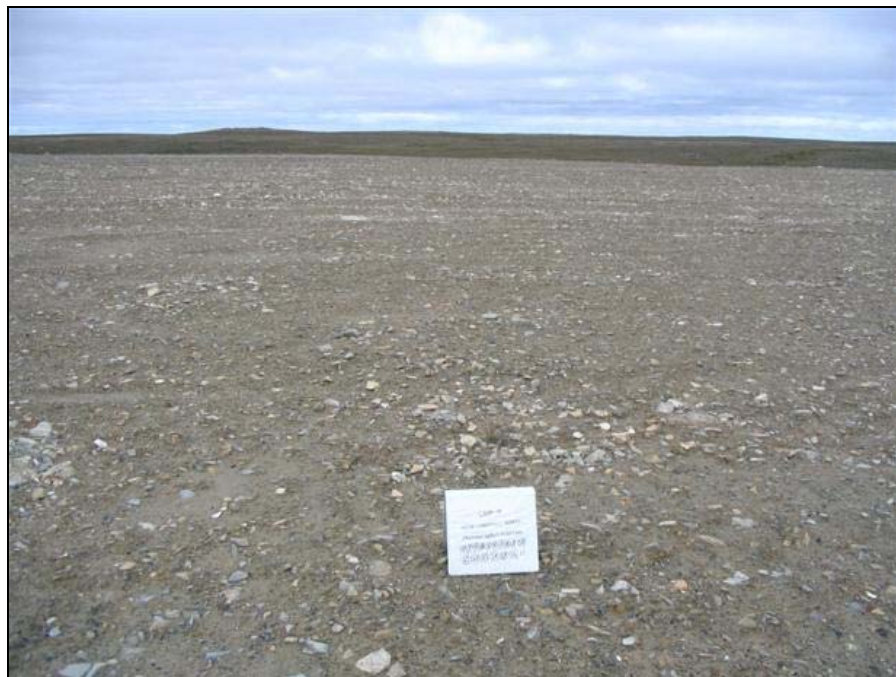
Photo MLFN-16B, Easting: 495866, Northing: 7667488, Direction: 0°  
Main Landfill North; south central facing north  
Scale: photo placard dimensions are 29.4 cm wide by 27.5 cm in height

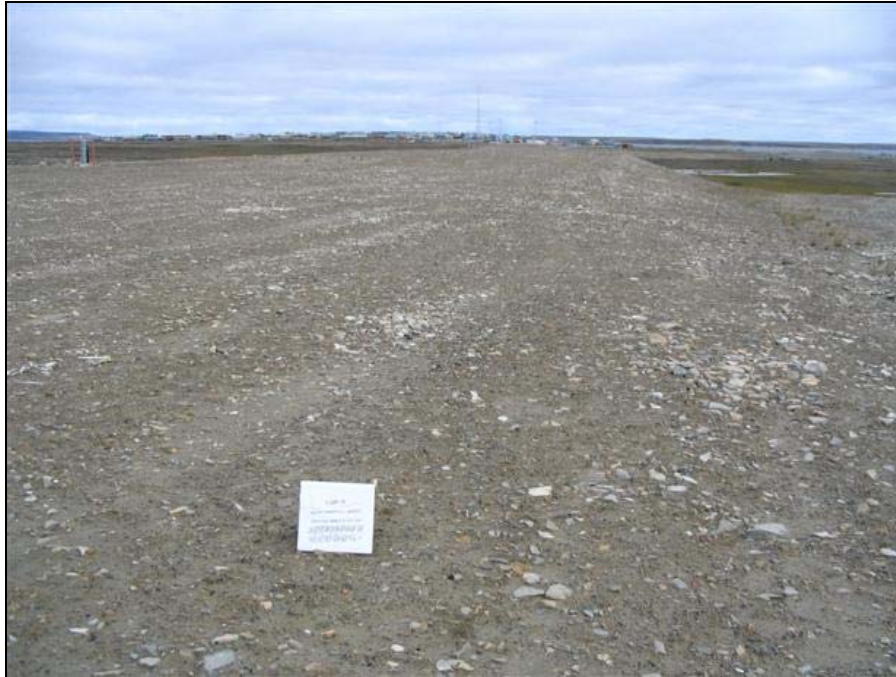
Photo MLFN-16C, Easting: 495866, Northing: 7667488, Direction: 90°  
Main Landfill North; south central facing east  
Scale: photo placard dimensions are 29.4 cm wide by 27.5 cm in height

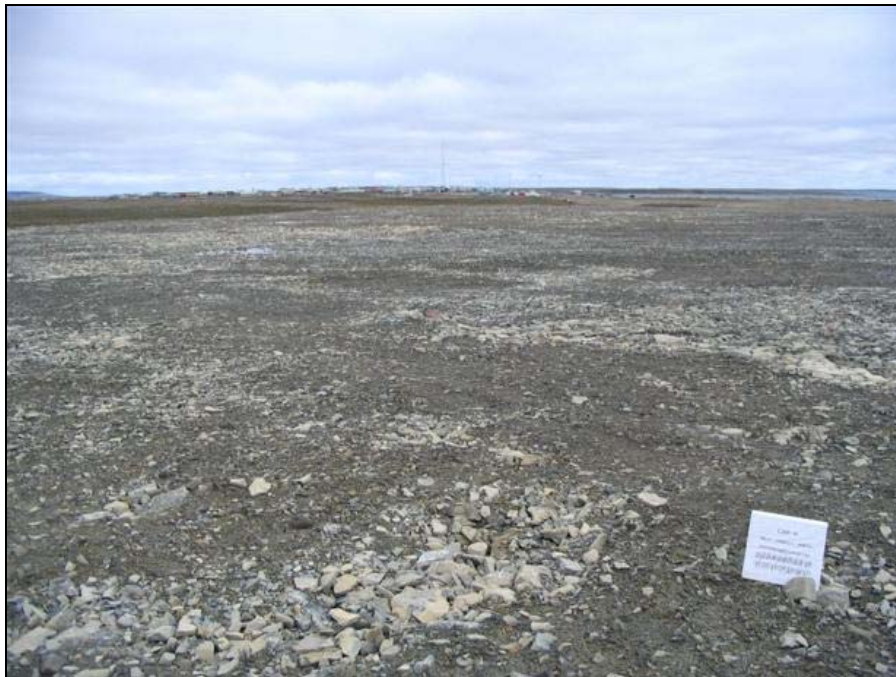
Photo MLFN-17A, Easting: 495768, Northing: 7667581, Direction: 90°  
Main Landfill North; east of road facing east  
Scale: photo placard dimensions are 29.4 cm wide by 27.5 cm in height

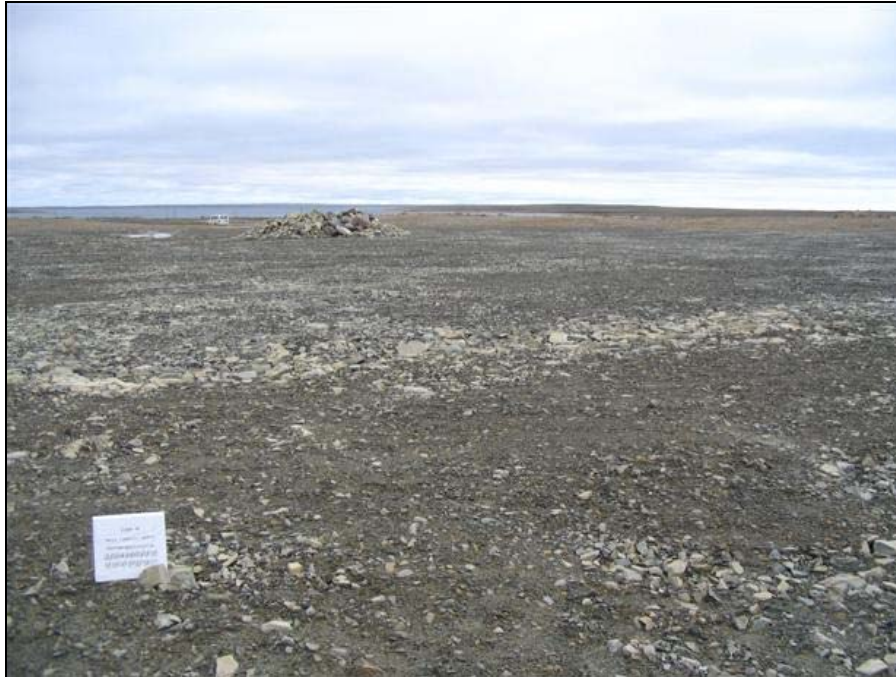
Photo MLFN-17B, Easting: 495768, Northing: 7667581, Direction: 140°  
Main Landfill North; east of road facing southeast  
Scale: photo placard dimensions are 29.4 cm wide by 27.5 cm in height
