# **The Collection of Landfill Monitoring Data at the CAM-M Cambridge Bay Site – 2007 Report**

Prepared for  
**Defence Construction Canada**

Submitted by  
**Gartner Lee Limited**

**January, 2008**

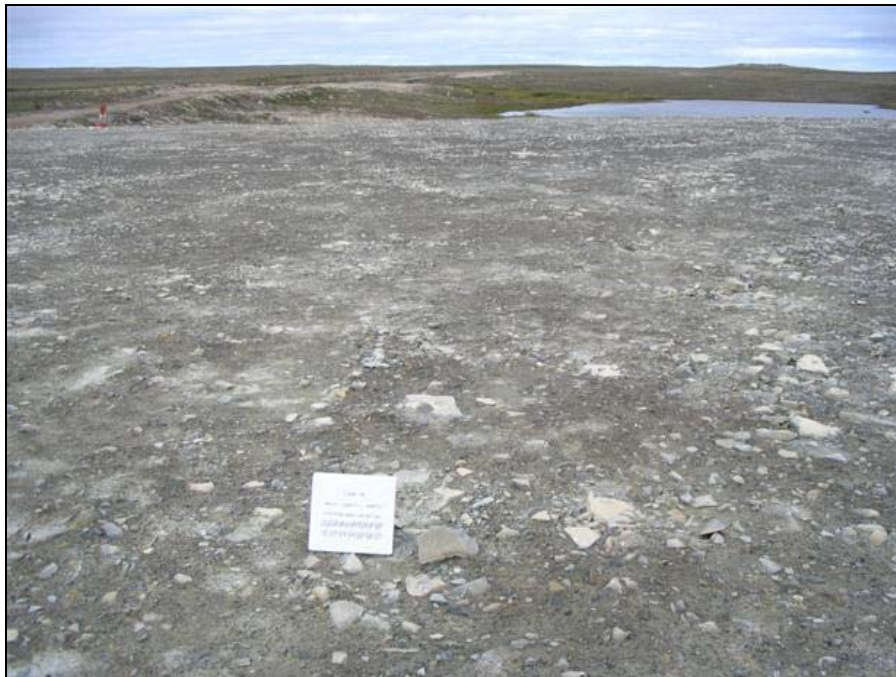
Photo MLFN-17C, Easting: 495768, Northing: 7667581, Direction: 0°  
Main Landfill North; east of road facing north  
Scale: photo placard dimensions are 29.4 cm wide by 27.5 cm in height

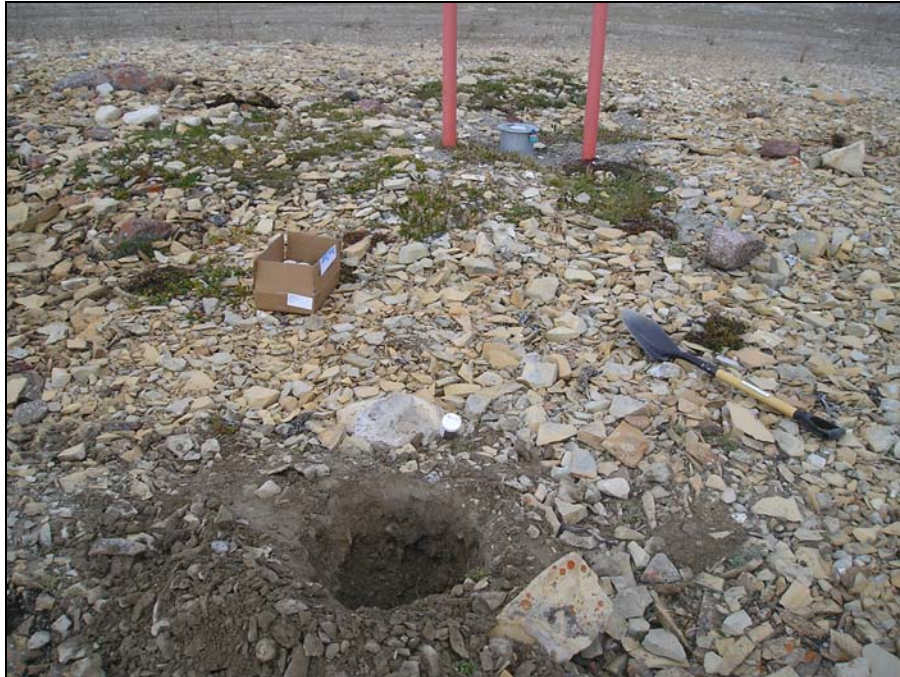
Test pit CM-MW-4. Samples CM-MW-4-1 and CM-MW-4-2 collected. Samples with identification numbers ending in "1" (ex. CM-MW-4-1) collected at 0-10cm and samples with identification numbers ending in "2" collected at 40-50cm.

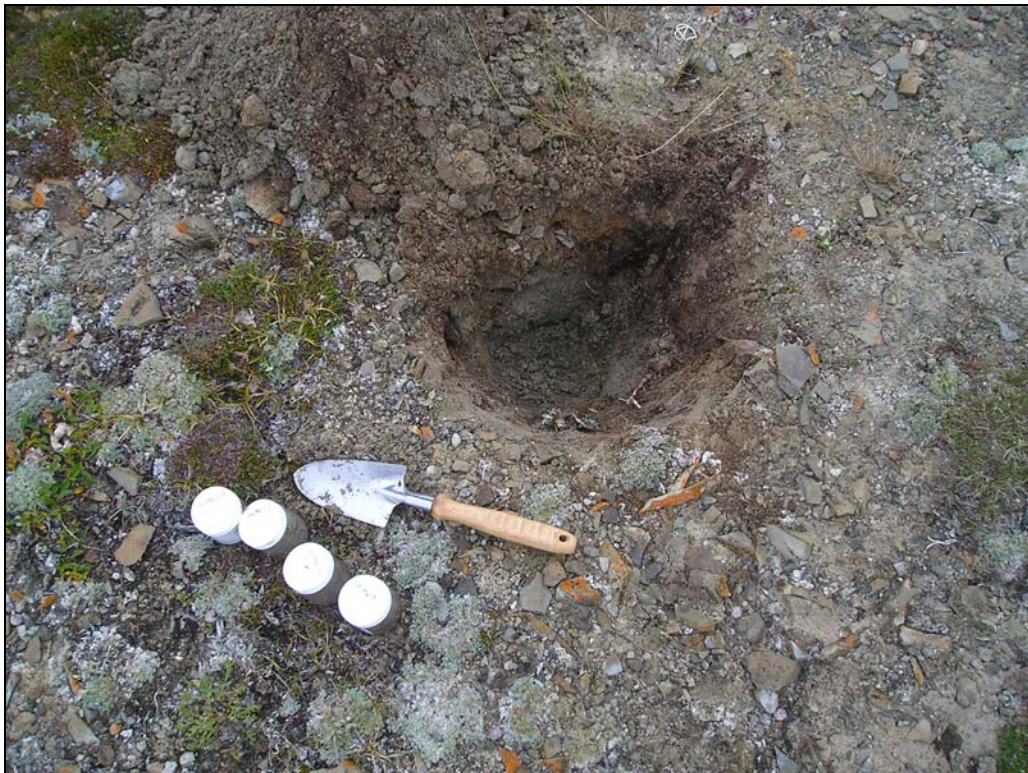
Test Pit CM-MW-5. Samples CM-MW-5-1 and CM-MW-5-2 collected.

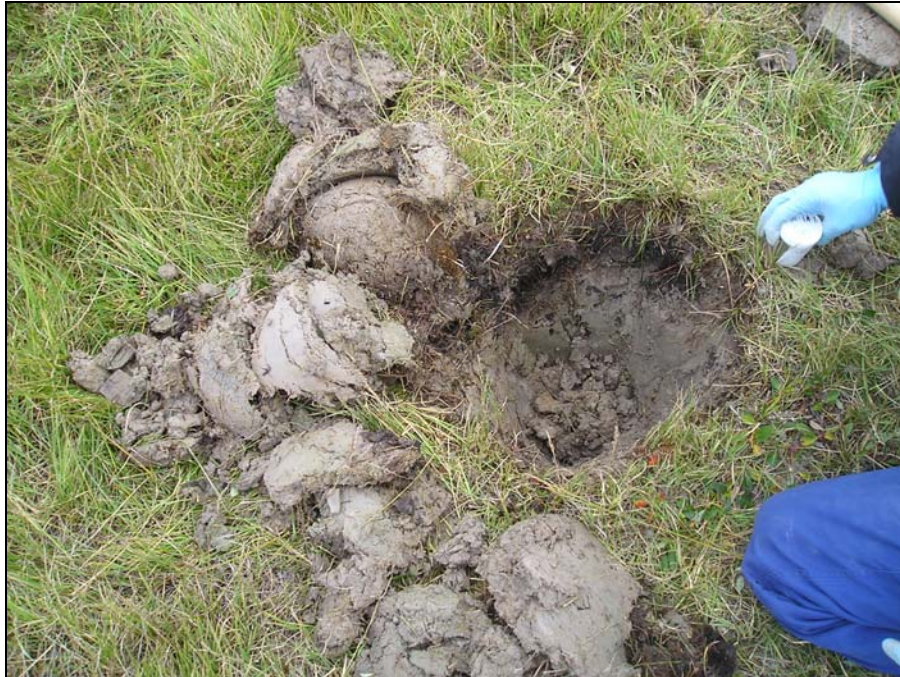
Test pit CM-MW-6A. Samples CM-MW-6A-1 and CM-MW-6A-2 collected.

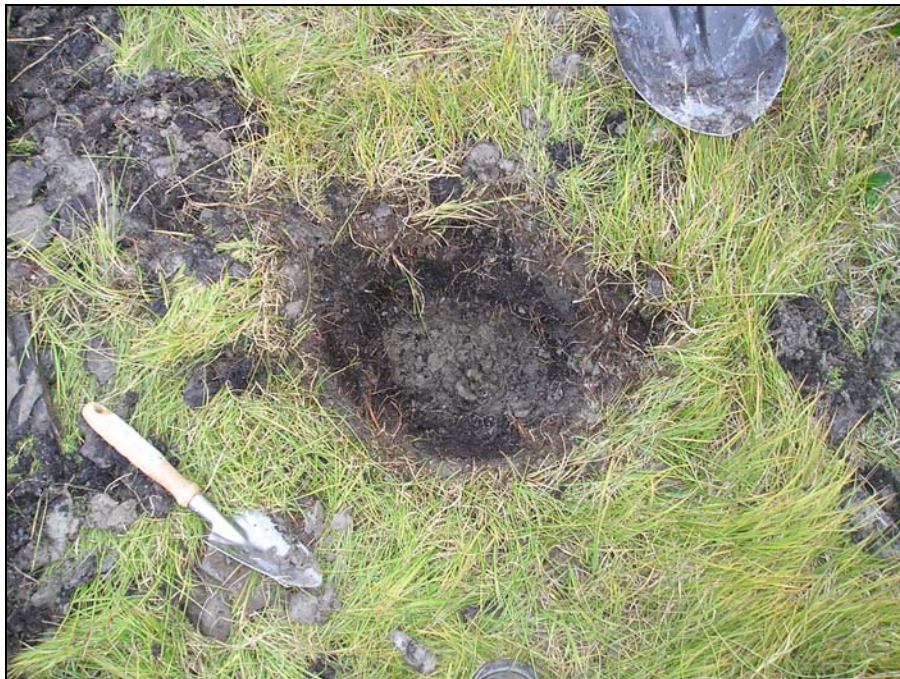
Total Petroleum Hydrocarbons (TPH) (C6-34) were detected in both the shallow and depth samples from sample location MW-6B, which was located North of MW-6. Samples CM-MW-6B-1 and CM-MW-6B-2 represent the shallow and depth samples respectively for this test pit. The concentrations should be evaluated in the context of the Landfill Monitoring plan, and should be compared to Defence Construction Canada's (DCC) internal Dew Line Clean Up standards. The highest concentrations of hydrocarbons were found in the F3 fraction (C16-34). No other soil samples at the Main Landfill – North contained detectable levels of TPH (>40mg/kg).

Test Pit CM-MW-6B. Samples CM-MW-6B-1 and CM-MW-6B-2 collected.

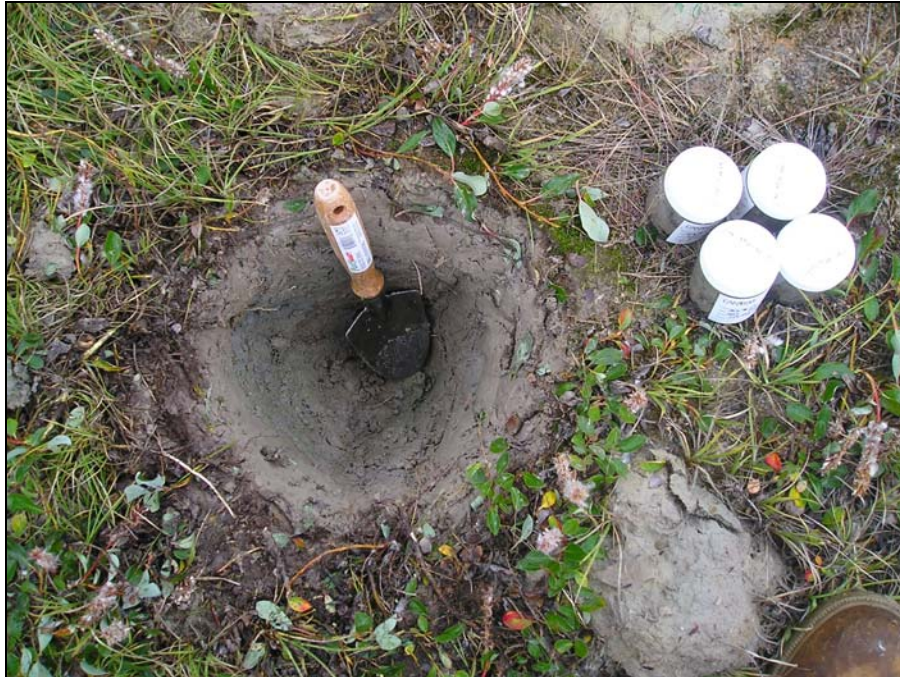
Test pit CM-MW-6C. Samples CM-MW-6C-1 and CM-MW-6C-2 collected.

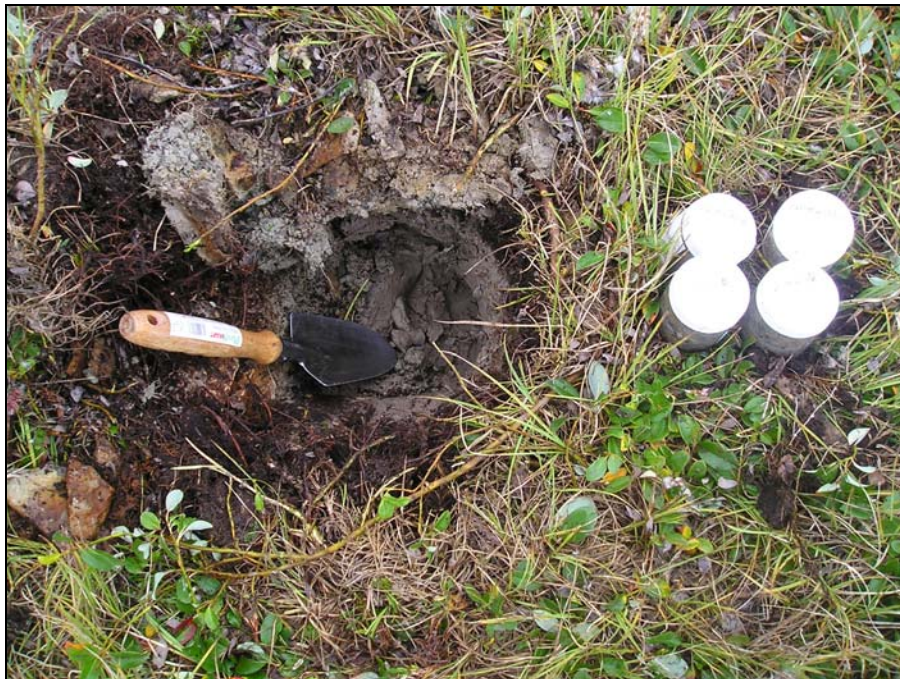
Test pit CM-MW-6D. Samples CM-MW-6D-1 and CM-MW-6D-2 collected.

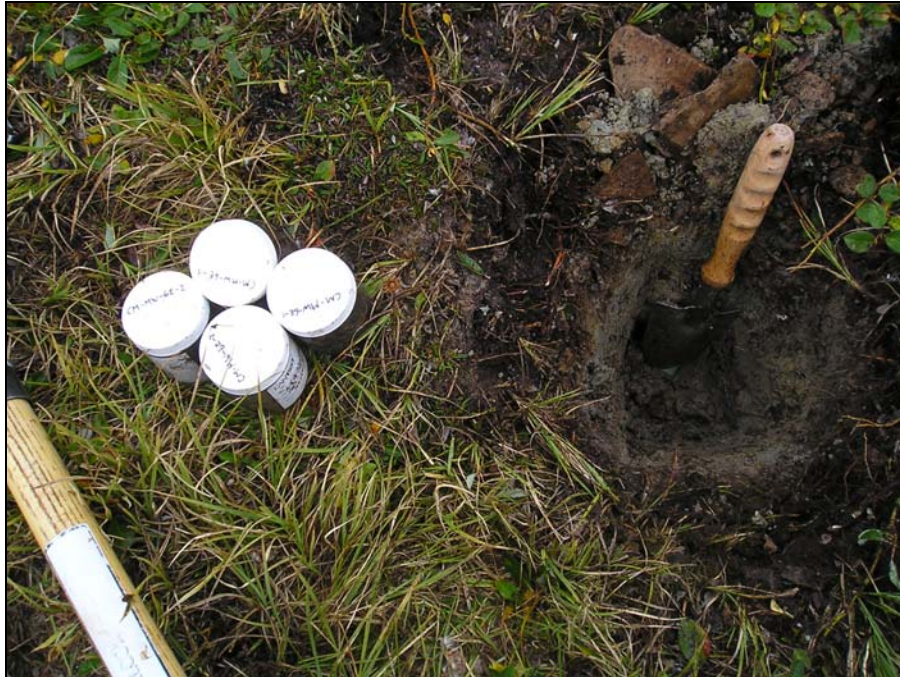
Test pit CM-MW-6E. Samples CM-MW-6E-1 and CM-MW-6E-2 collected.

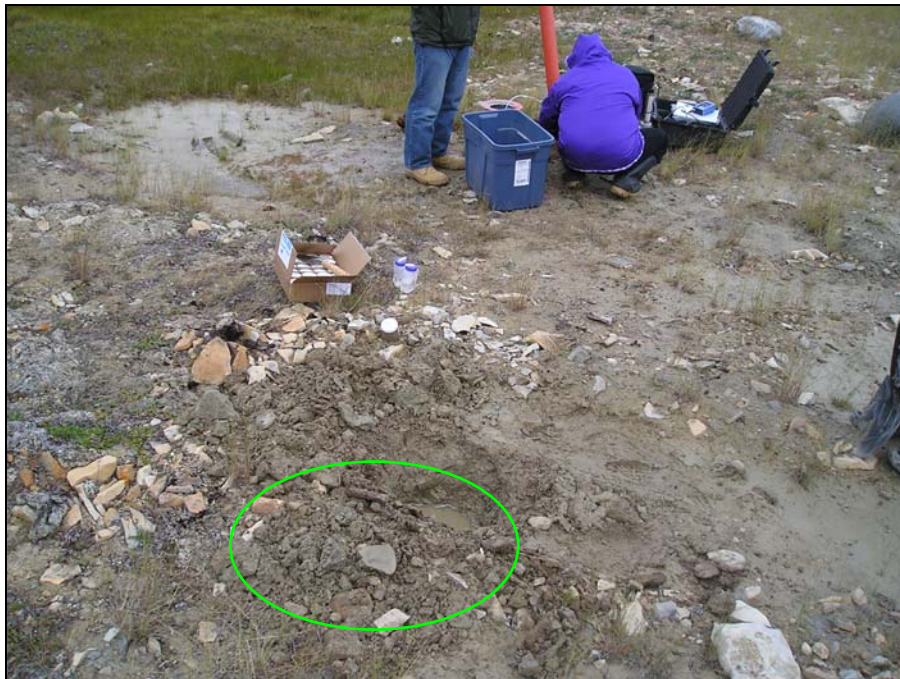
Test pit CM-MW-7. Samples CM-MW-7-1 and CM-MW-7-2 collected.

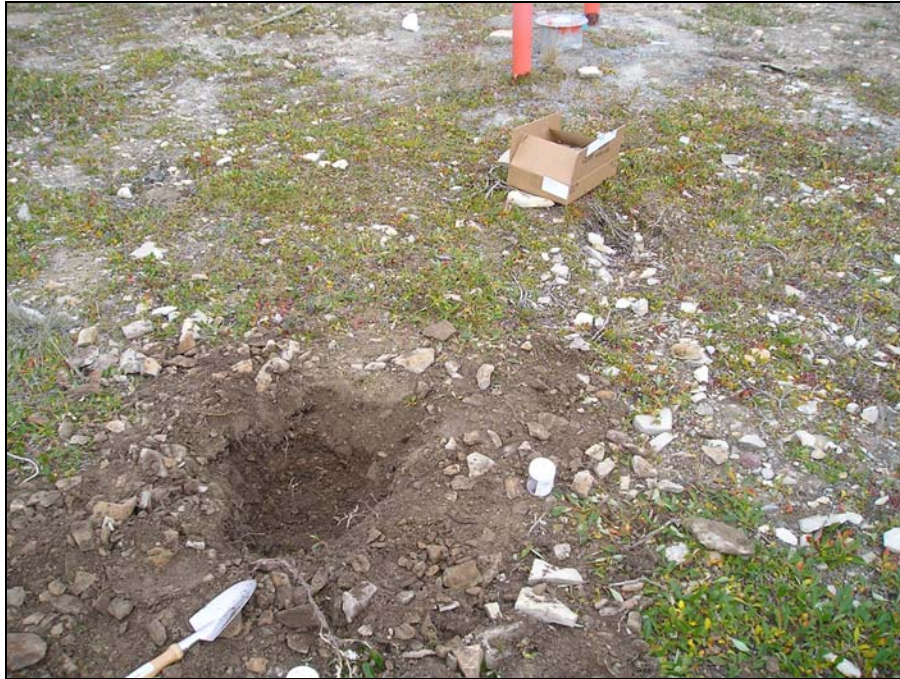
Test pit CM-MW-8 (Upgradient). Samples CM-MW-8-1 and CM-MW-8-2 collected.

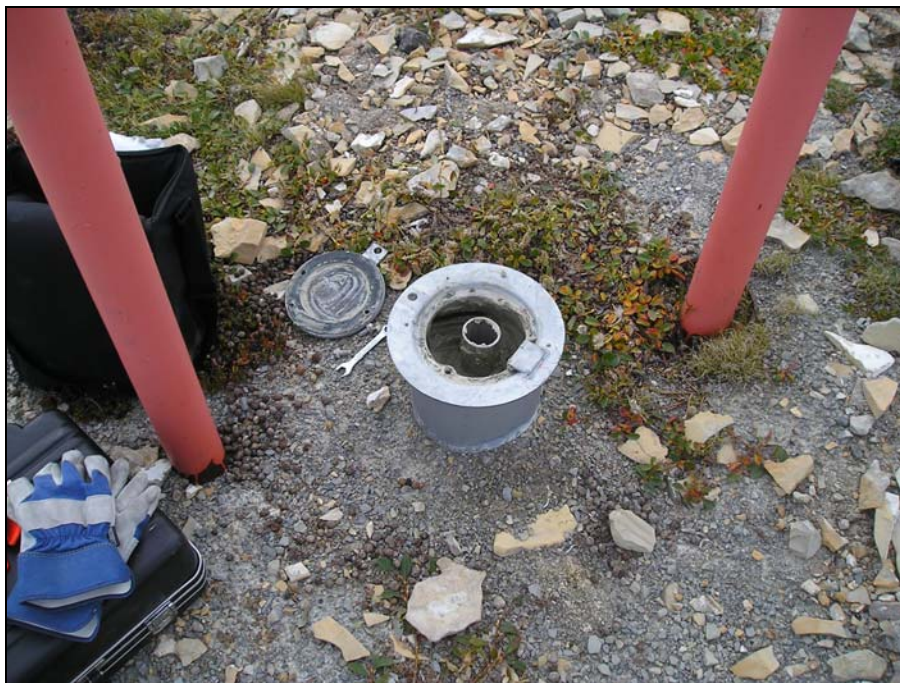
Monitoring well MW-4. No sample collected as well MW-4 was dry

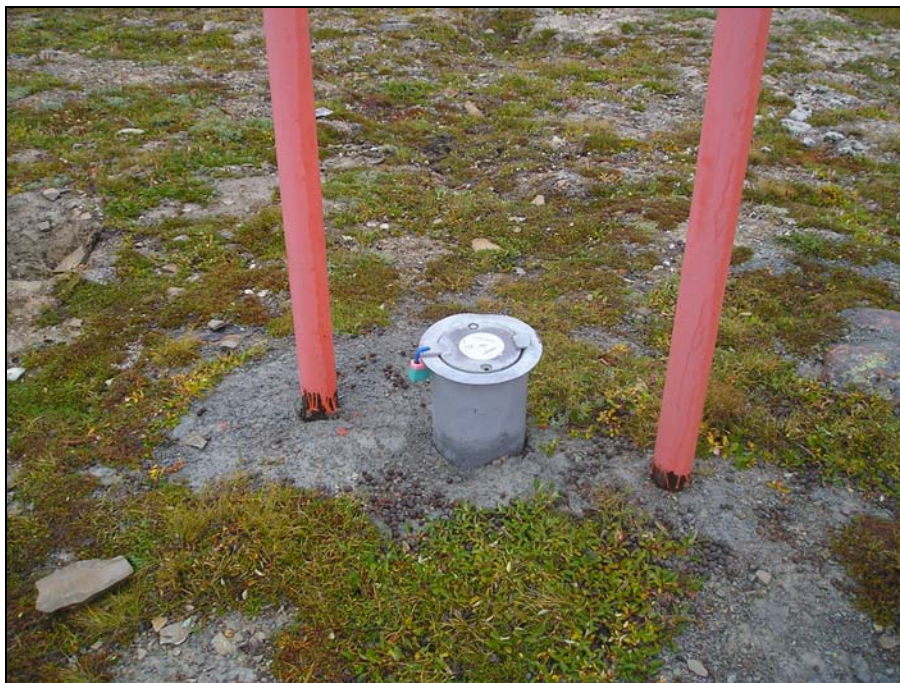
Monitoring well MW-5. Sample CM-MW-5 collected.

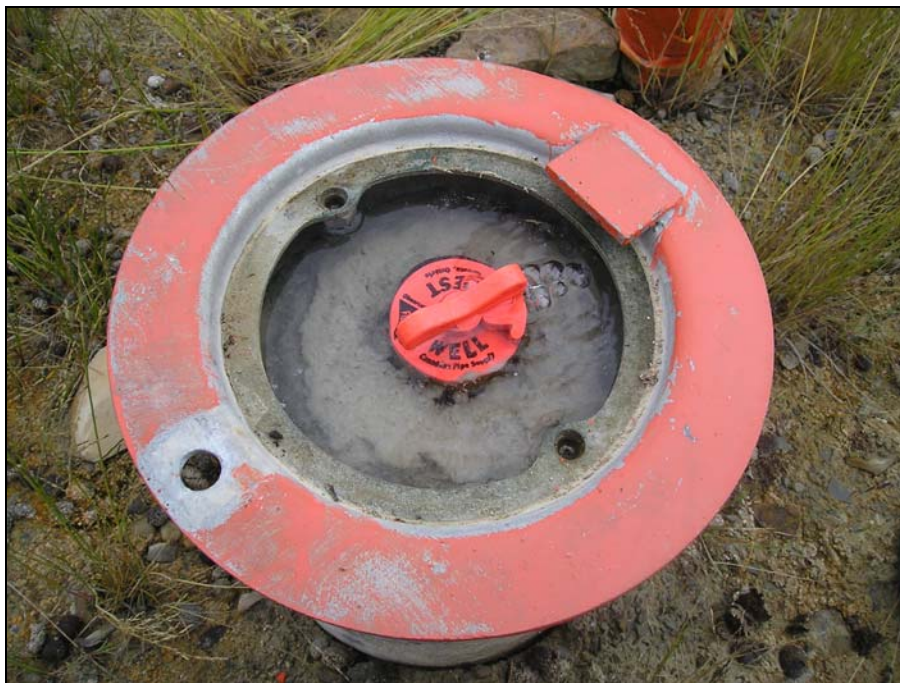
Monitoring well MW-7. Sample CM-MW-7 collected. Bentonite swollen to top of pipe (TOP) and standing water inside well casing over TOP.

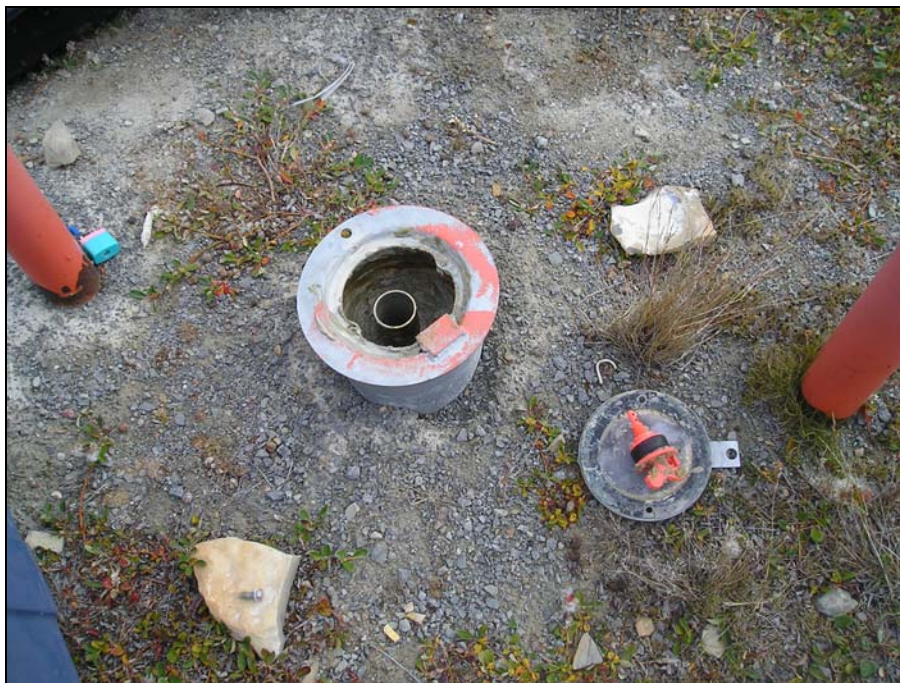
Monitoring well MW-8 (Upgradient). Sample CM-MW-8 collected.

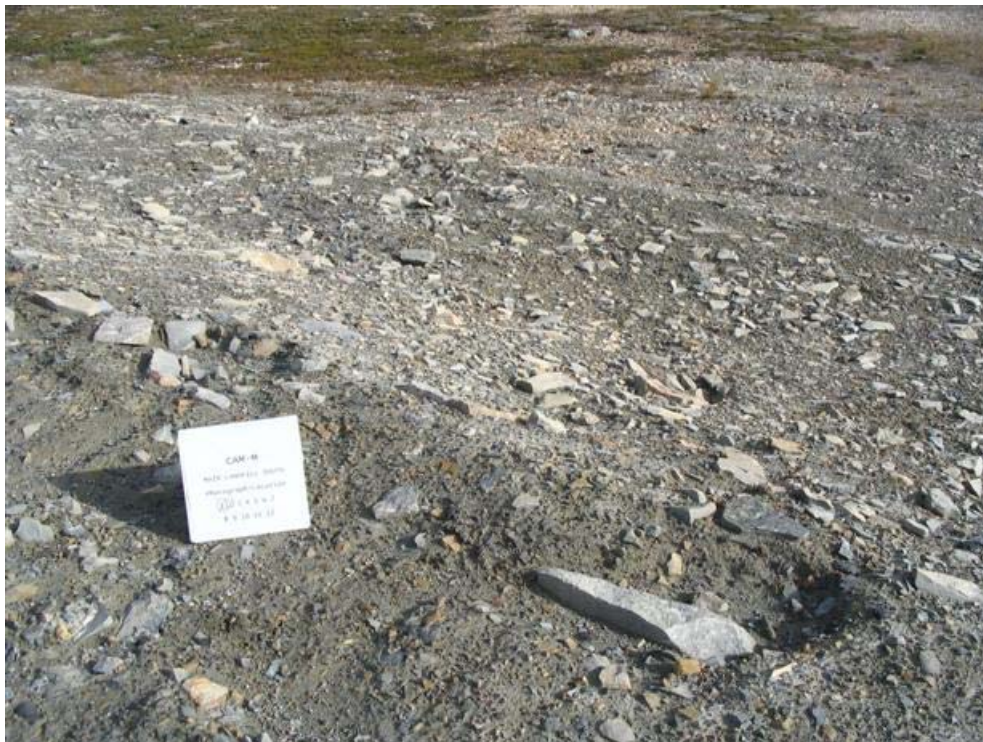
Photo MLFS-2B, Easting: 495807, Northing: 7667351, Direction: 45°  
Main Landfill South; close-up of north slope where self-armouring erosion has occurred

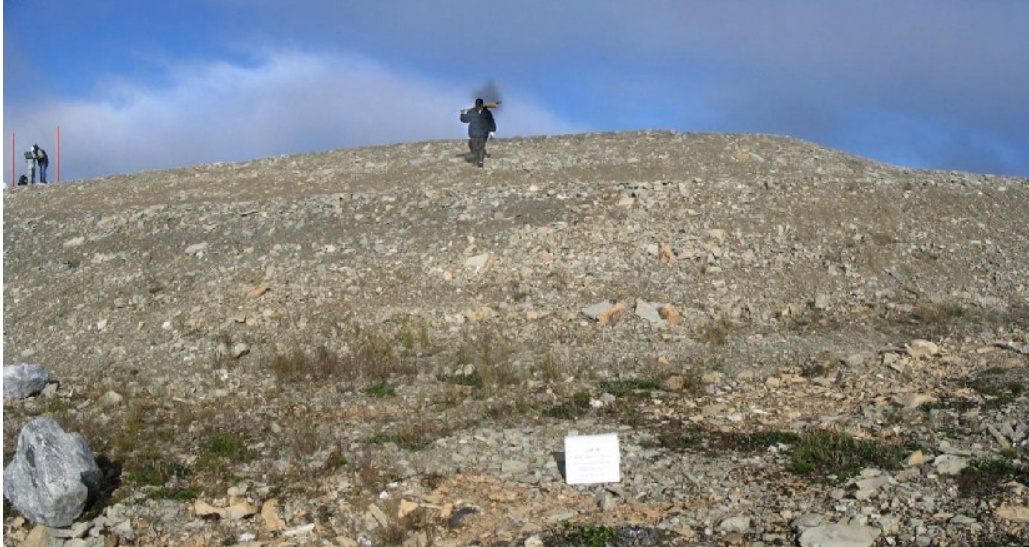
Some minor erosion gullies on the southwest slope appear to be self-armouring (Photos MLFS-6A, 7A and 10D in Appendix B2) and the eroded fines appear to have been accumulating on the midslope bench (Photos MLFS-6B and 6C in Appendix B2) and at the toe of the landfill (Photo MLFS-10E in Appendix B2). Some orange stained rock was observed at the northeast toe of the landfill (Photo MLFS-3 in Appendix B2).

Photo MLFS-3, Easting: 495821, Northing: 7667332, Direction: 300°  
Main Landfill South; facing slope from toe, some orange stained rock at toe.  
Scale: photo placard dimensions are 29.4 cm wide by 27.5 cm in height

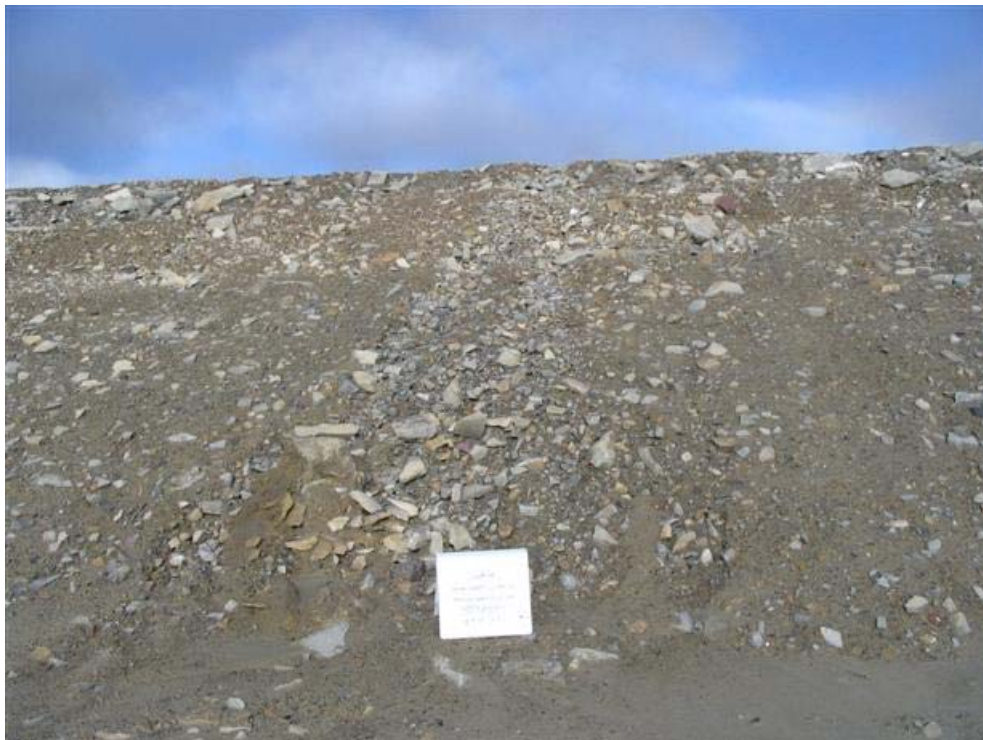
Photo MLFS-6A, Easting: 495764, Northing: 7667296, Direction: 315°  
Main Landfill South; view from bench looking up slope at fines that have washed onto bench  
Scale: photo placard dimensions are 29.4 cm wide by 27.5 cm in height

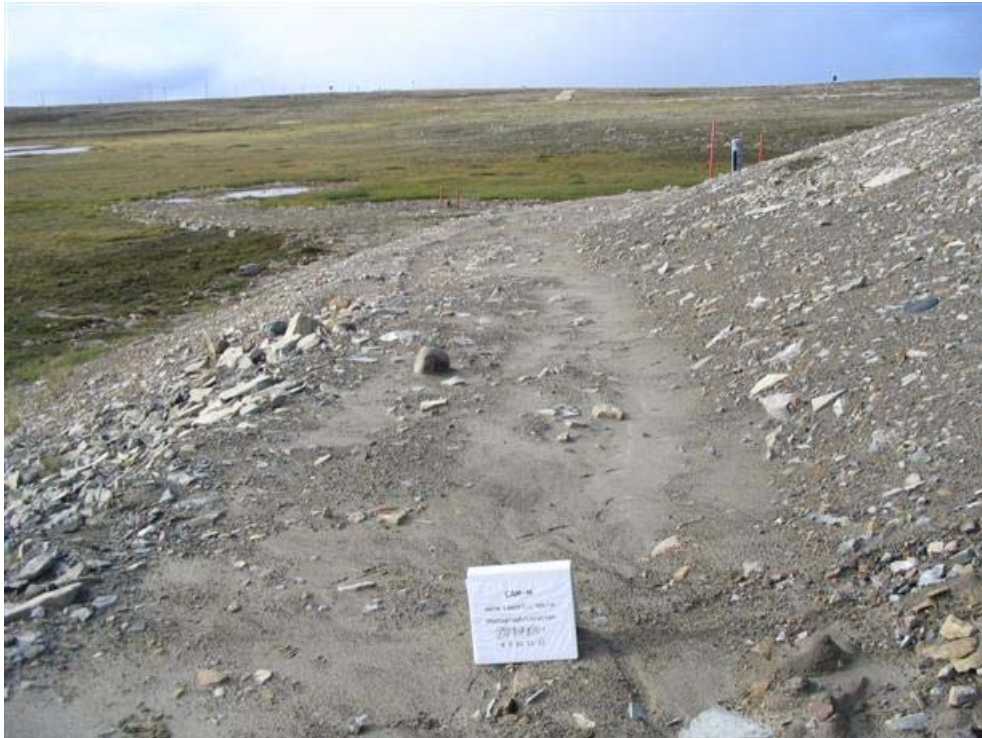
Photo MLFS-6B, Easting: 495764, Northing: 7667296, Direction: 225°  
Main Landfill South; view from bench facing south  
Scale: photo placard dimensions are 29.4 cm wide by 27.5 cm in height

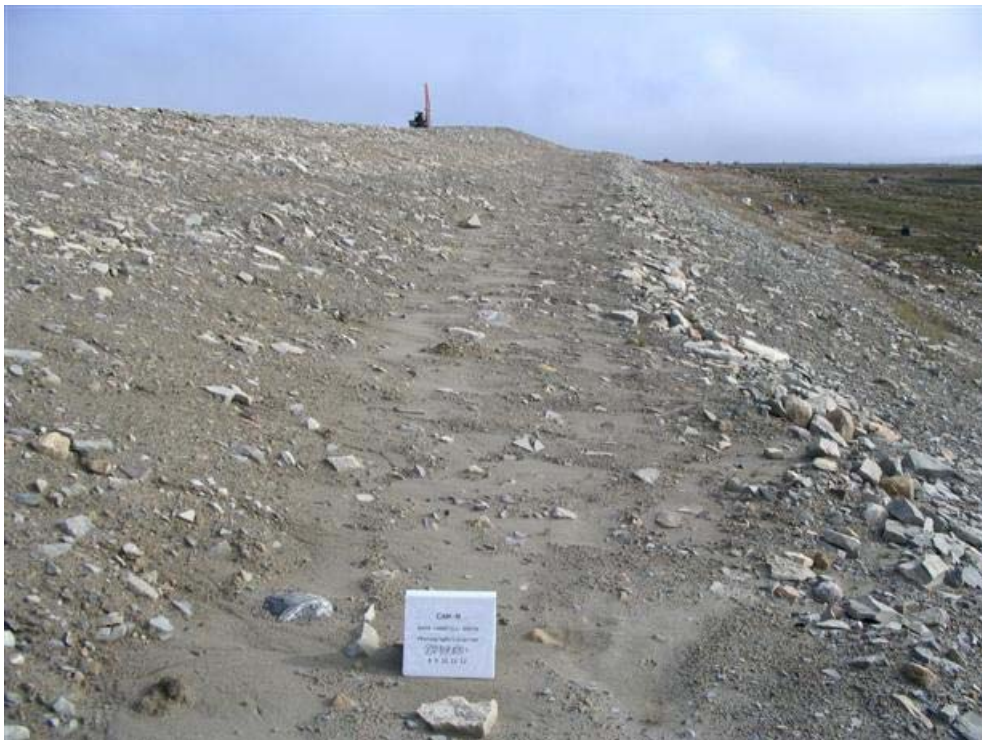
Photo MLFS-6C, Easting: 495764, Northing: 7667296, Direction: 45°  
Main Landfill South; view from bench facing north

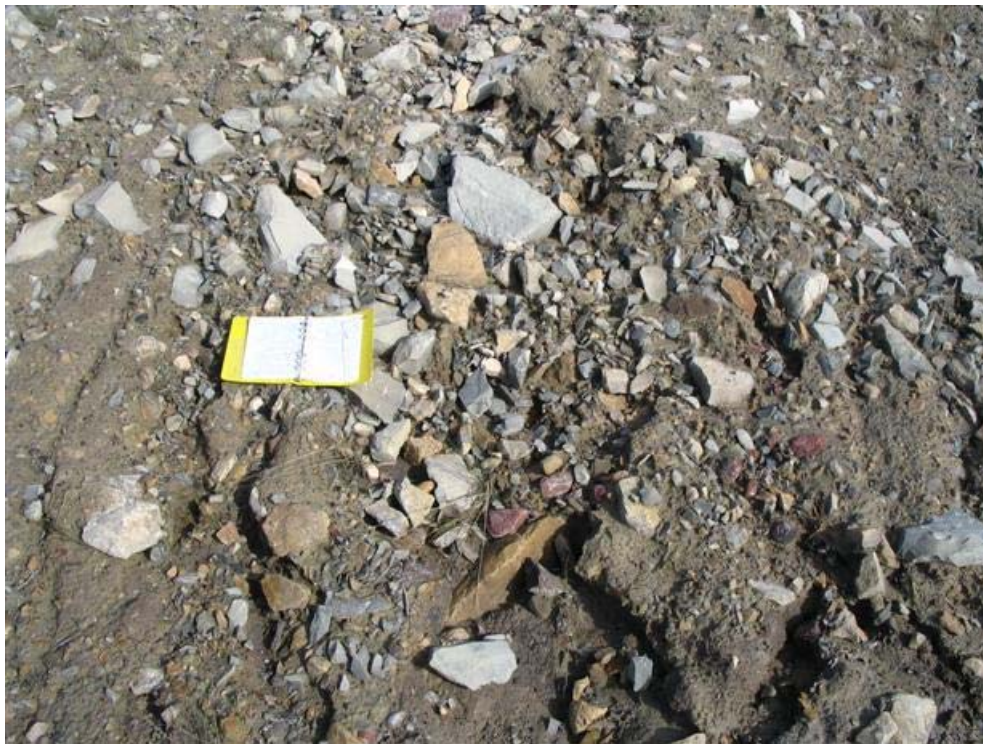
Photo MLFS-7D, Easting: 495751, Northing: 7667267, Direction: 340°  
Main Landfill South; close-up of erosion  
Scale: field book dimensions are 29.5 cm wide by 20.0 cm in height

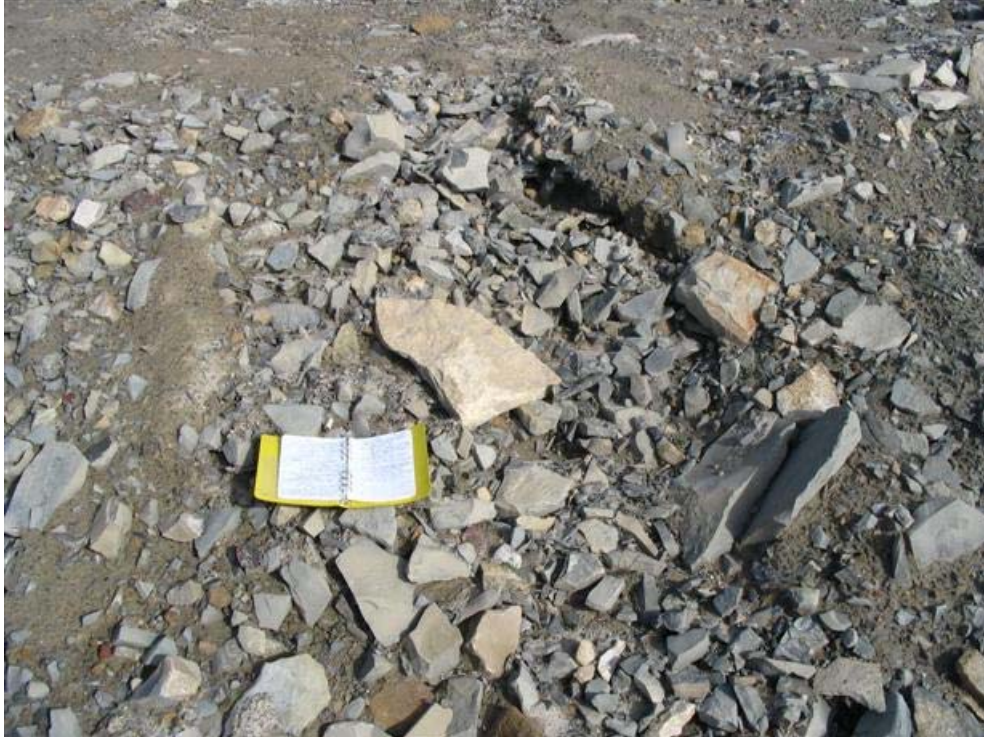
Photo MLFS-7E, Easting: 495751, Northing: 7667267, Direction: 340°  
Main Landfill South; close-up of erosion  
Scale: field book dimensions are 29.5 cm wide by 20.0 cm in height

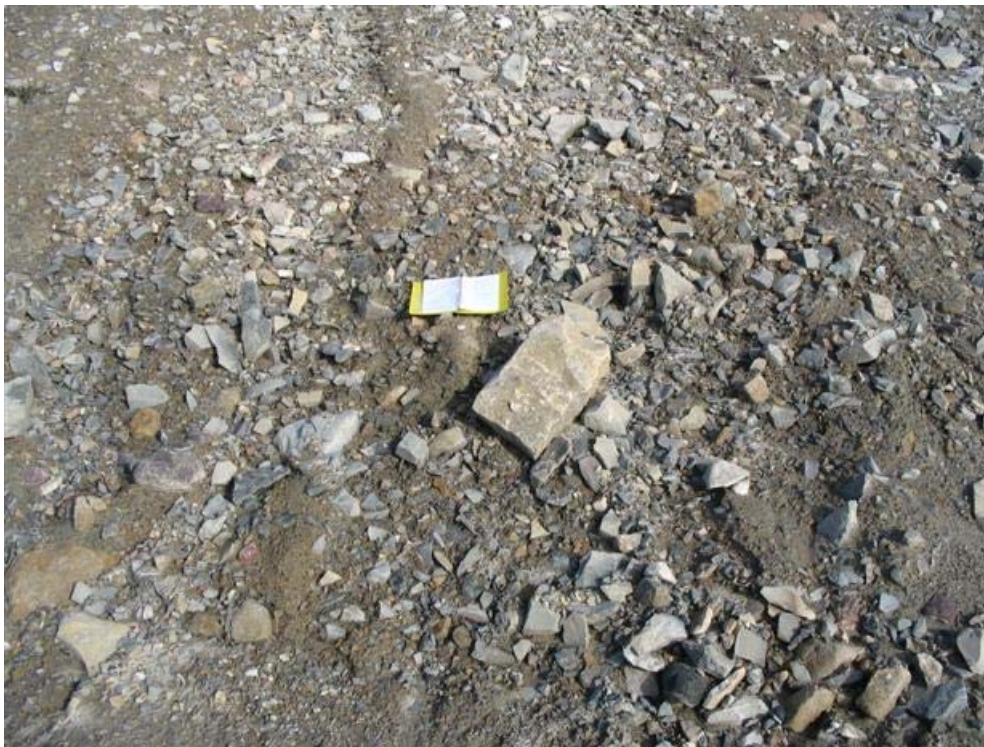
Photo MLFS-7F, Easting: 495751, Northing: 7667267, Direction: 340°  
Main Landfill South; close-up of erosion

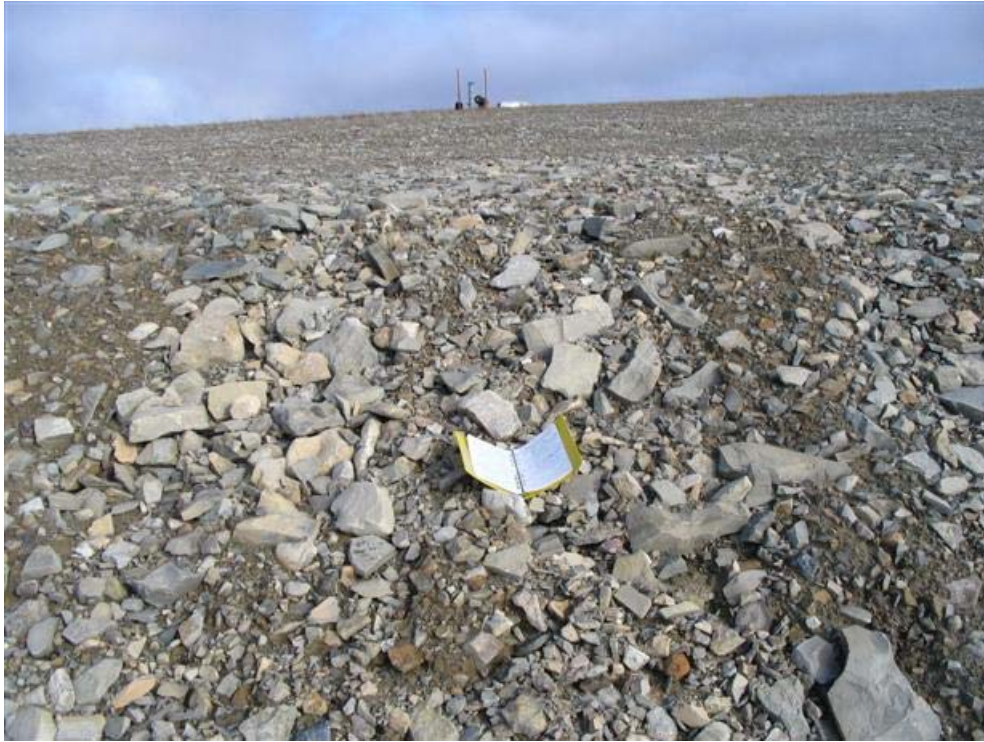
Photo MLFS-7G, Easting: 495751, Northing: 7667267, Direction: 340°  
Main Landfill South; close-up of erosion  
Scale: field book dimensions are 29.5 cm wide by 20.0 cm in height

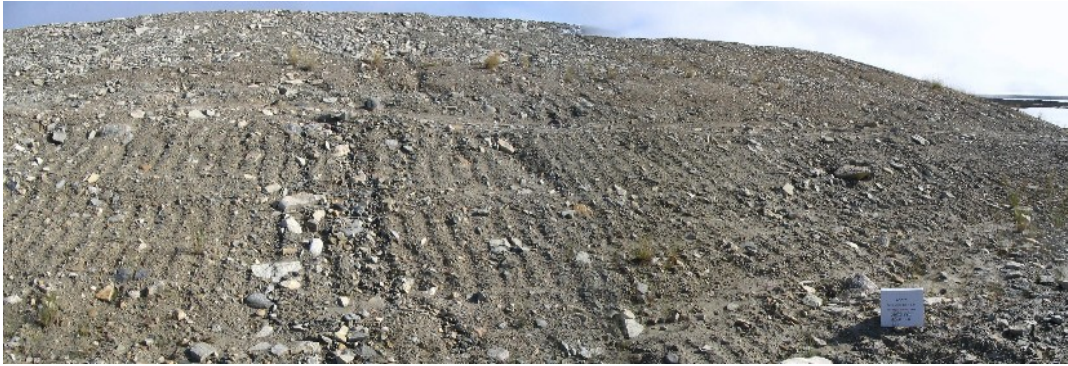
Photo MLFS-9, Easting: 495737, Northing: 7667296, Direction: 45°  
Main Landfill South; west slope with minor erosion  
Scale: photo placard dimensions are 29.4 cm wide by 27.5 cm in height

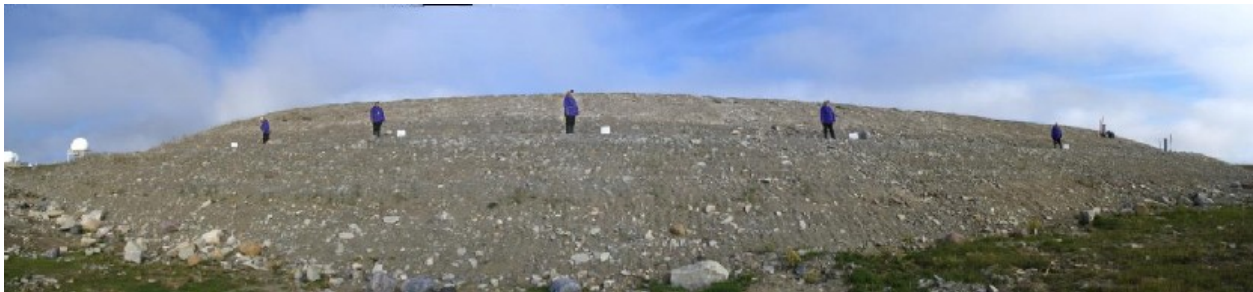
Photo MLFS-10A, Easting: 495657, Northing: 7667274, Direction: 340°  
Main Landfill South; minor erosion on south slope  
Scale: photo placard dimensions are 29.4 cm wide by 27.5 cm in height

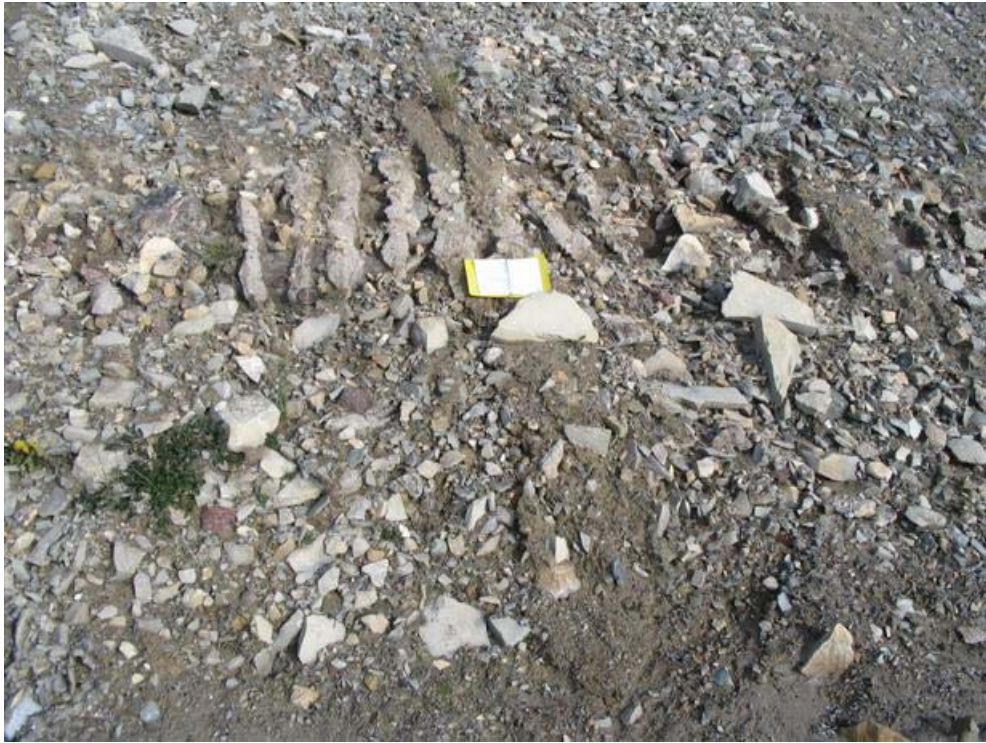
Photo MLFS-10B, Easting: 495657, Northing: 7667274, Direction: 340°  
Main Landfill South; close-up of erosion  
Scale: field book dimensions are 29.5 cm wide by 20.0 cm in height

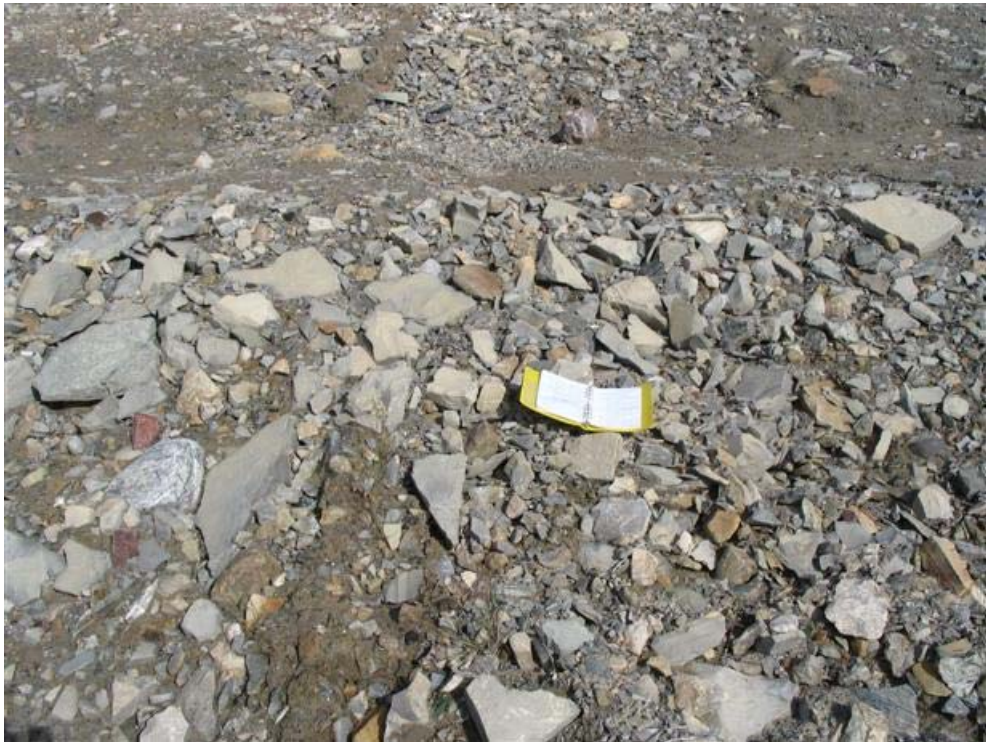
Photo MLFS-10C, Easting: 495657, Northing: 7667274, Direction: 340°  
Main Landfill South; close-up of erosion  
Scale: field book dimensions are 29.5 cm wide by 20.0 cm in height

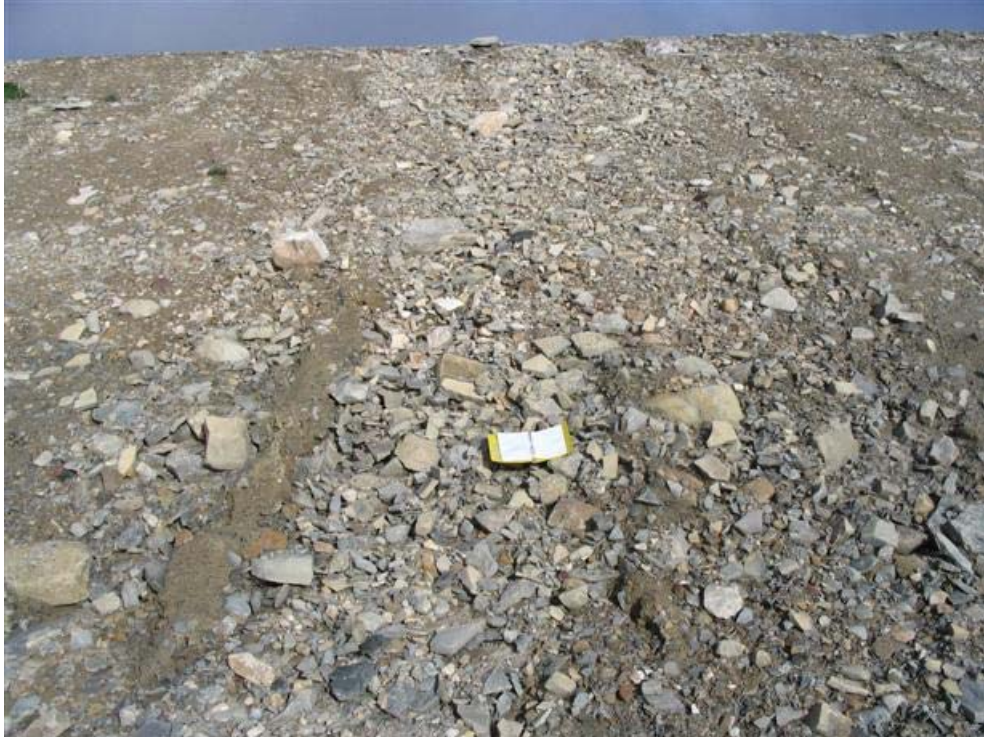
Photo MLFS-10D, Easting: 495657, Northing: 7667274, Direction: 340°  
Main Landfill South; close-up of erosion  
Scale: field book dimensions are 29.5 cm wide by 20.0 cm in height

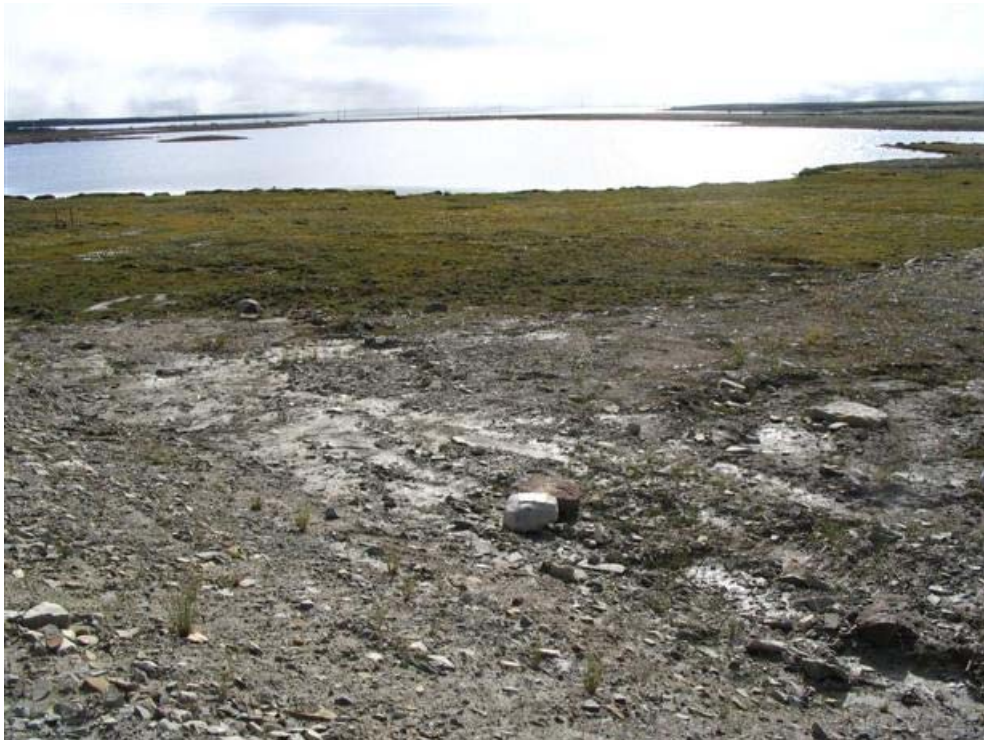
Photo MLFS-10E, Easting: 495657, Northing: 7667274, Direction: 90°  
Main Landfill South; eroded fines below ITS2 and VT5

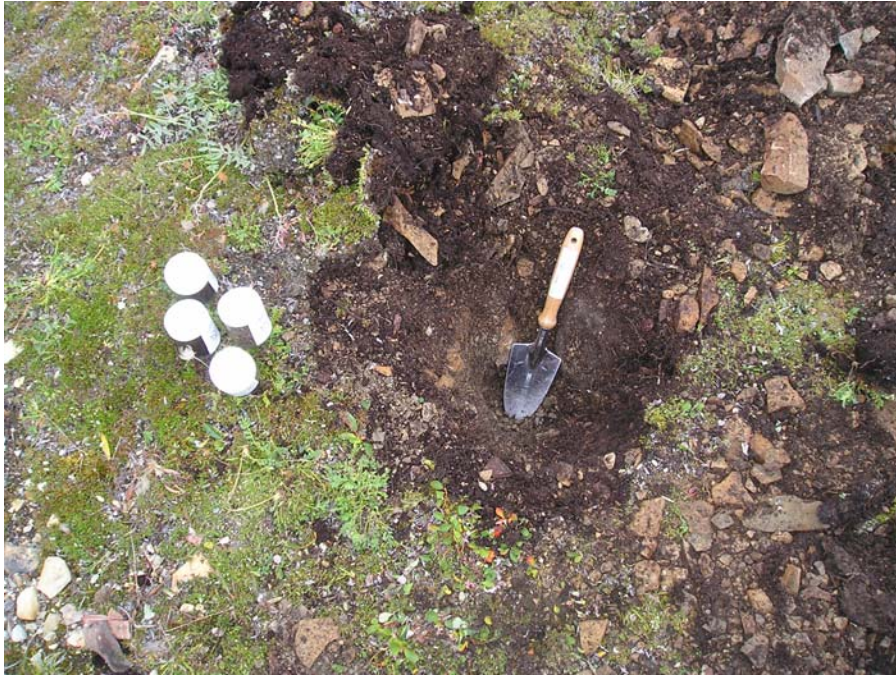
Low concentrations of Total Petroleum Hydrocarbons (TPH) (200mg/kg) were detected in the shallow sample from soil sample location MW-1. The concentrations noted are not considered to be significant, however these should be evaluated in the context of the Landfill Monitoring Plan.

Test pit CM-MW-1. Samples CM-MW-1-1 and CM-MW-1-2 collected. Samples with identification numbers ending in “1” (ex. CM-MW-1-1) collected at 0-10cm and samples with identification numbers ending in “2” collected at 40-50cm.

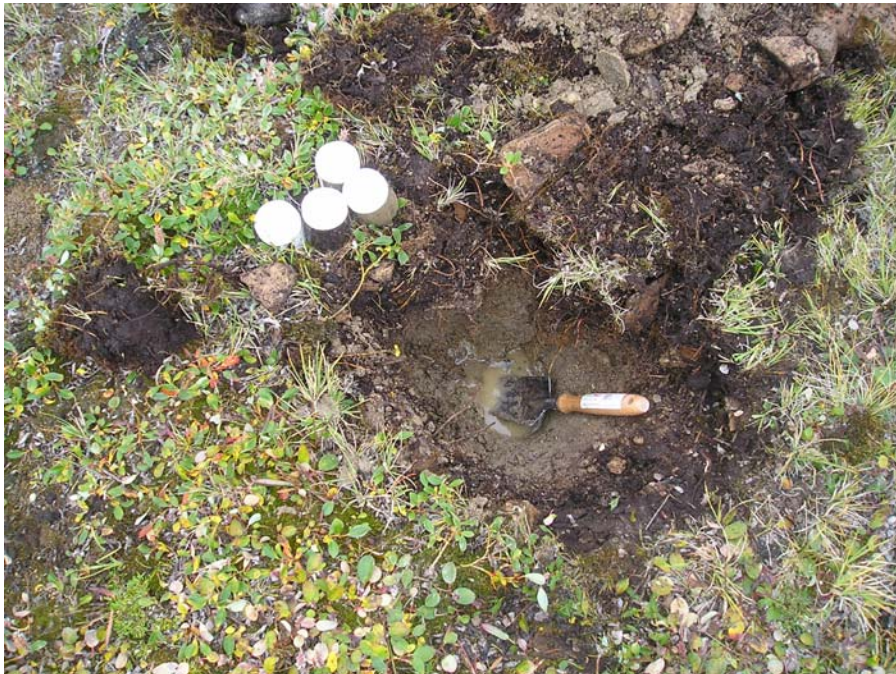
Test Pit CM-MW-2. Samples CM-MW-2-1 and CM-MW-2-2 collected.

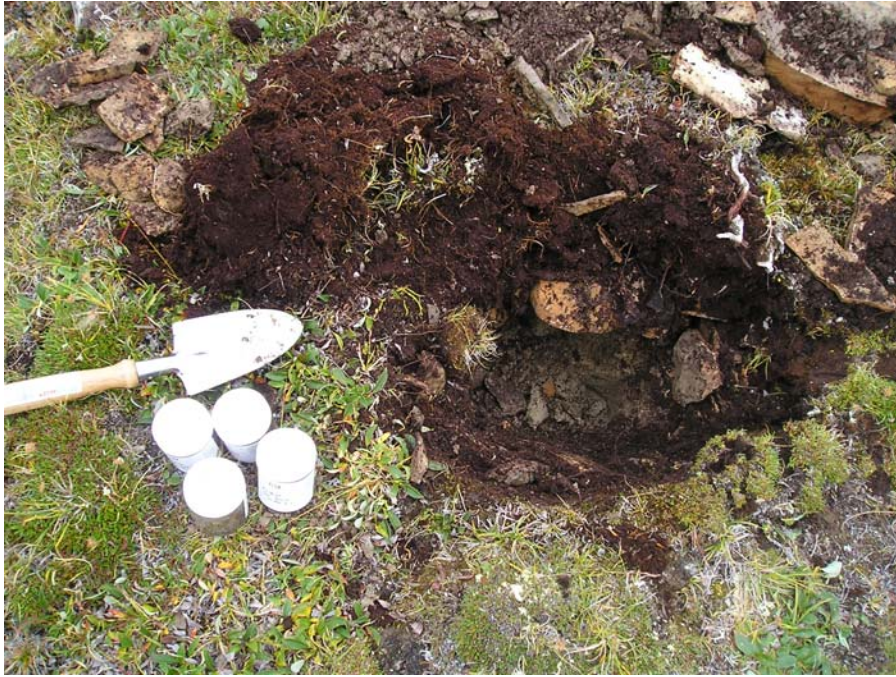
Test pit CM-MW-3. Samples CM-MW-3-1 and CM-MW-3-2 collected.

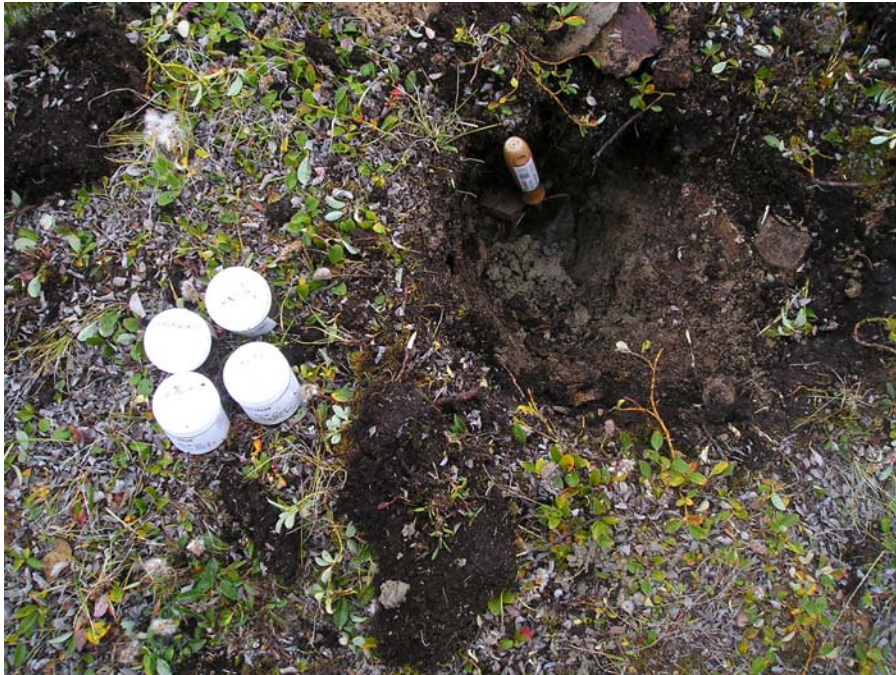
Test Pit CM-MW-9 (Upgradient). Samples CM-MW-9-1 and CM-MW-9-2 collected.
