# **The Collection of Landfill Monitoring Data at the CAM-M Cambridge Bay Site – 2007 Report**

Prepared for  
**Defence Construction Canada**

Submitted by  
**Gartner Lee Limited**

**January, 2008**

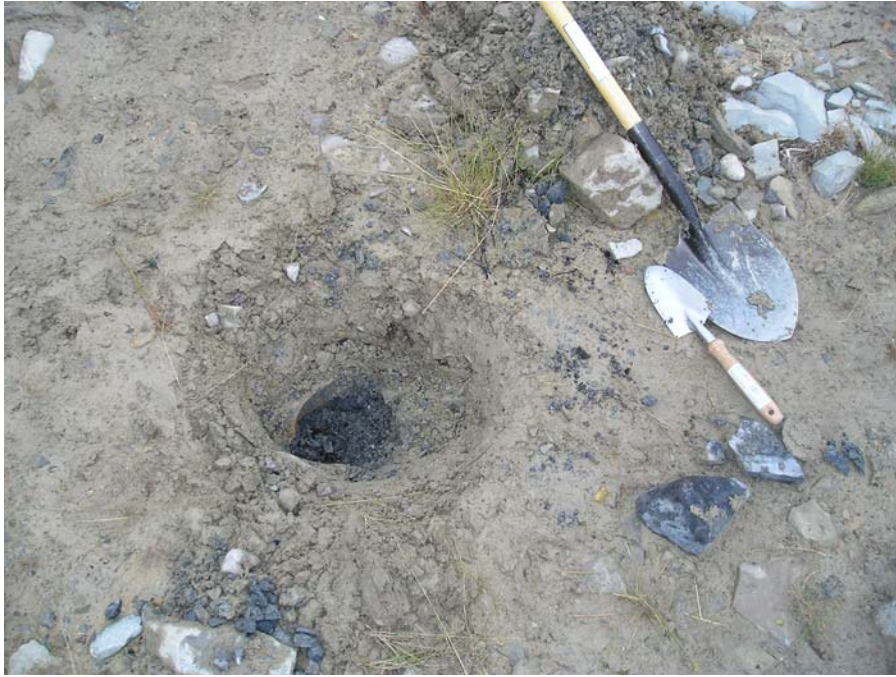
Test pit CM-MW-14. Samples CM-MW-14-1, CM-MW-14-2, CM-17-1 (Duplicate of CM-MW-14-1), CM-17-2 (Duplicate of CM-MW-14-2) collected.

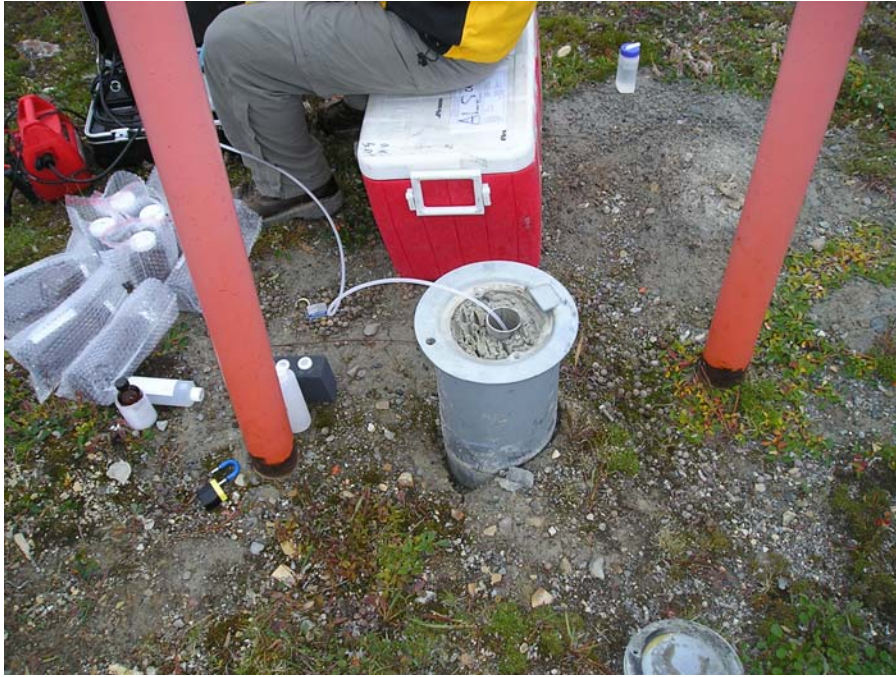
Monitoring well MW-1. Sample CM-MW-1 and CM-MW-16 (Duplicate) collected.

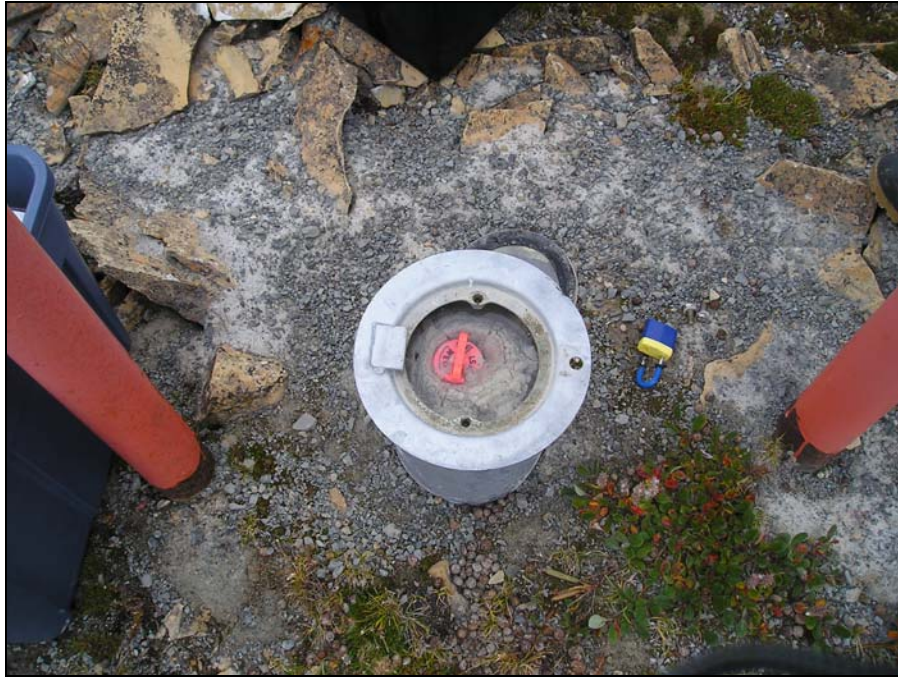
Monitoring well MW-2. Sample CM-MW-2 collected.

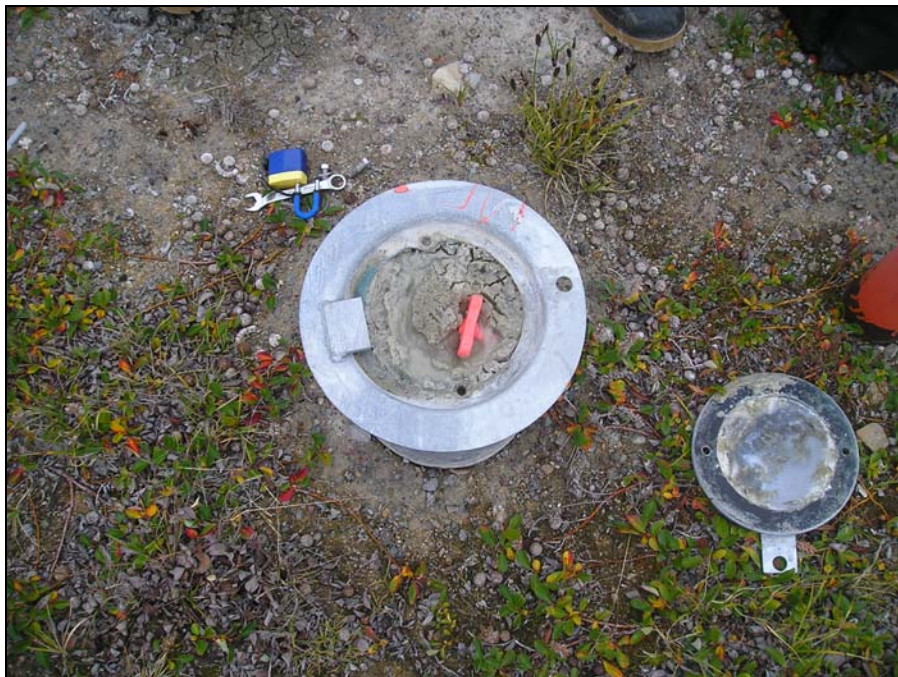
Monitoring well MW-3. Sample CM-MW-3 collected. Bentonite swollen to top of pipe (TOP) and standing water inside well casing over TOP.

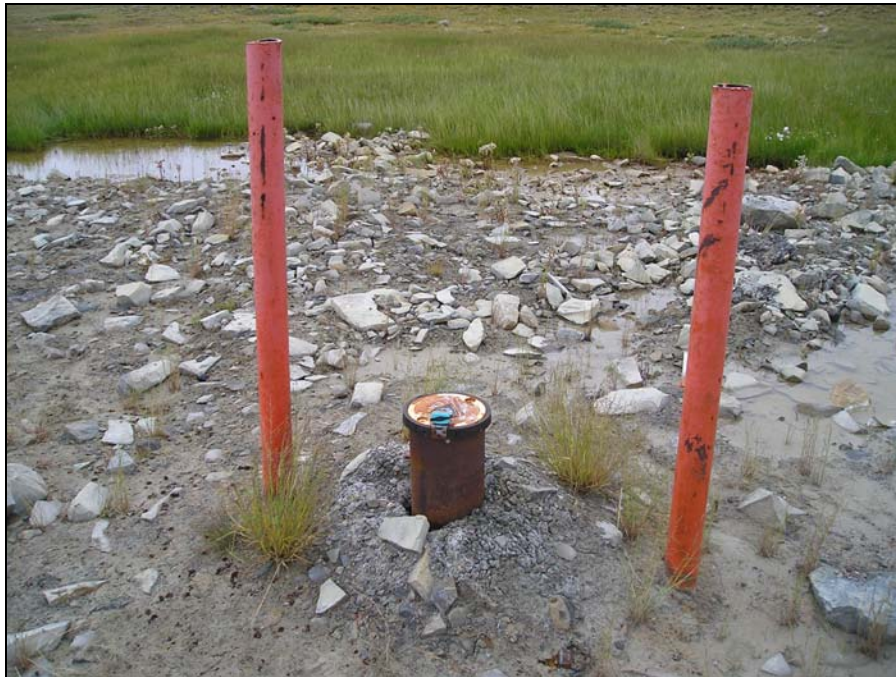
Monitoring well MW-9 (Upgradient). Sample CM-MW-9 collected. Bentonite swollen over TOP.

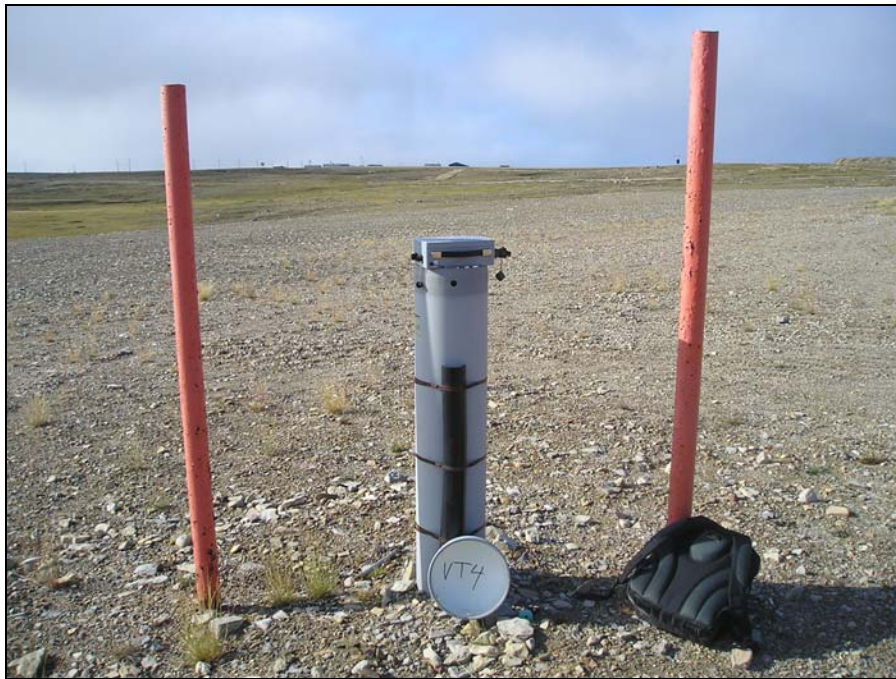
Monitoring well MW-14. Sample CM-MW-14 collected.

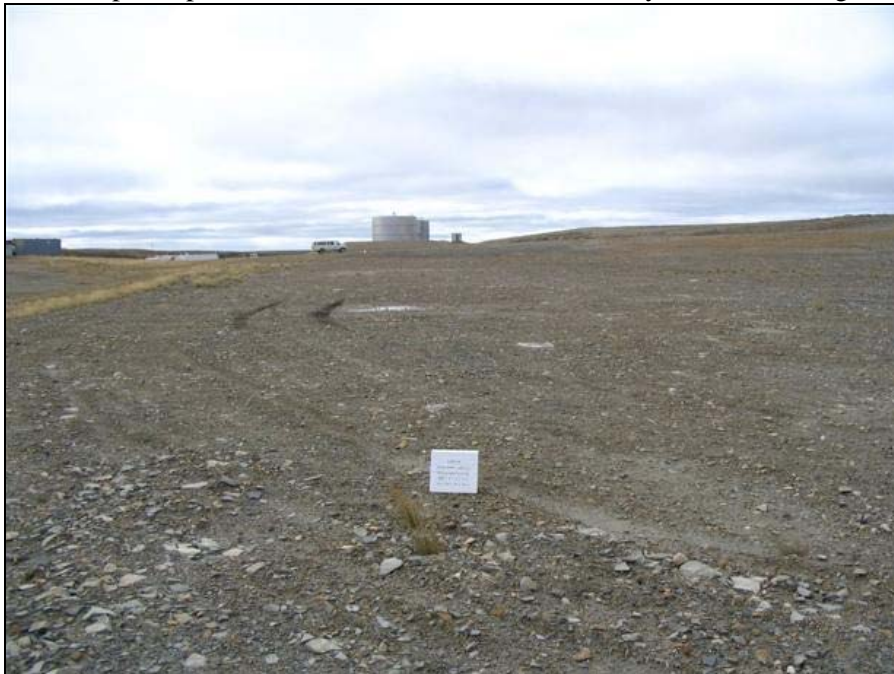
Photo SSLF-2, Easting: 496366, Northing: 7666015, Direction: 225°  
South Shore Landfill; minor depressions in landfill surface  
Scale: photo placard dimensions are 29.4 cm wide by 27.5 cm in height

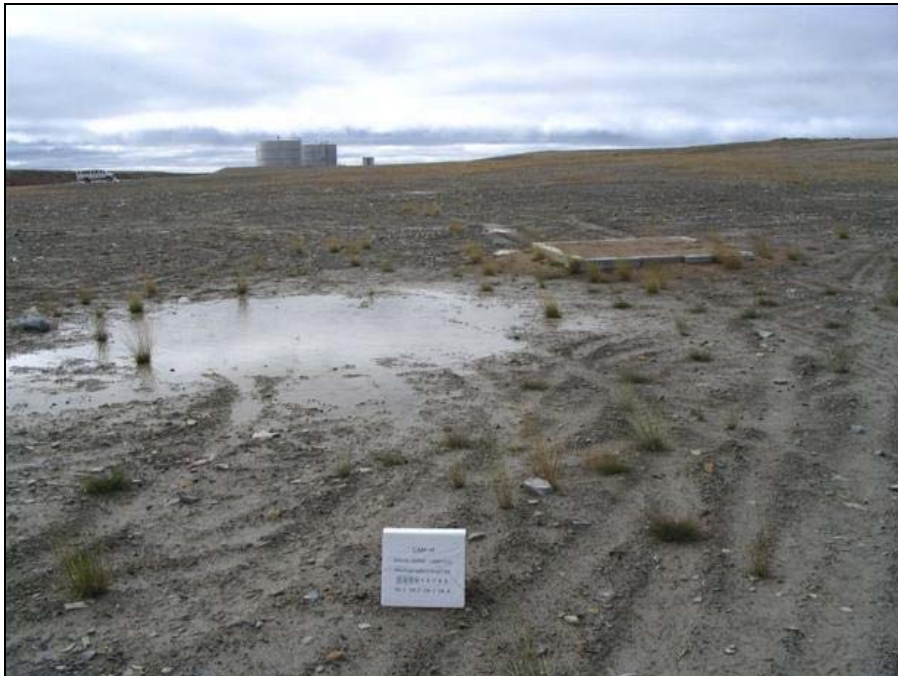
Photo SSLF-4, Easting: 496341, Northing: 7666056, Direction: 240°  
South Shore Landfill; view near golf tee of shallow depression with ponded water  
Scale: photo placard dimensions are 29.4 cm wide by 27.5 cm in height

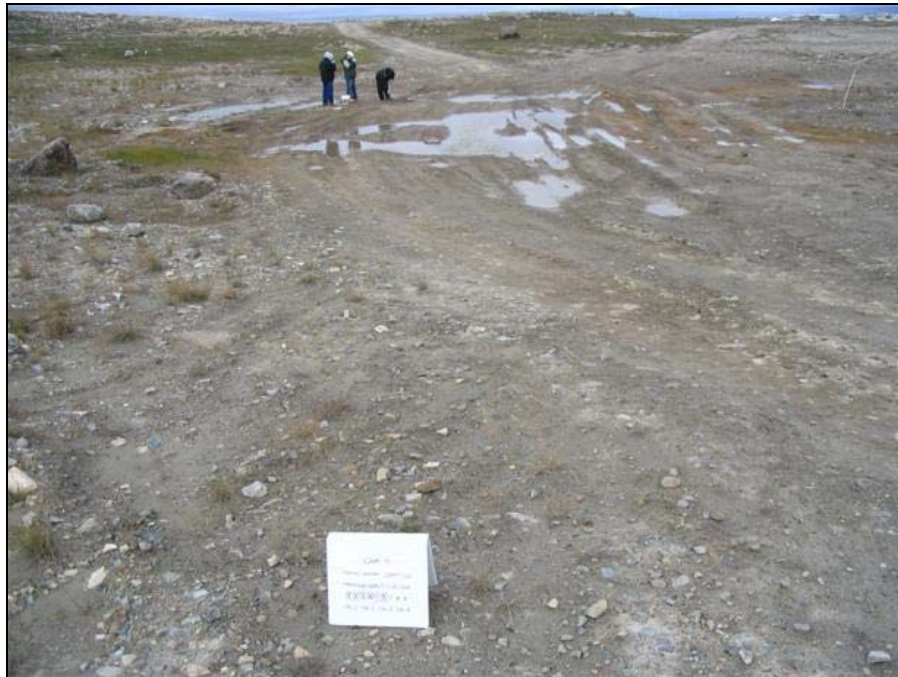
Photo SSLF-5C, Easting: 496386, Northing: 7666035, Direction: 340°  
South Shore Landfill; east central slope facing ponded water and seepage  
Scale: photo placard dimensions are 29.4 cm wide by 27.5 cm in height

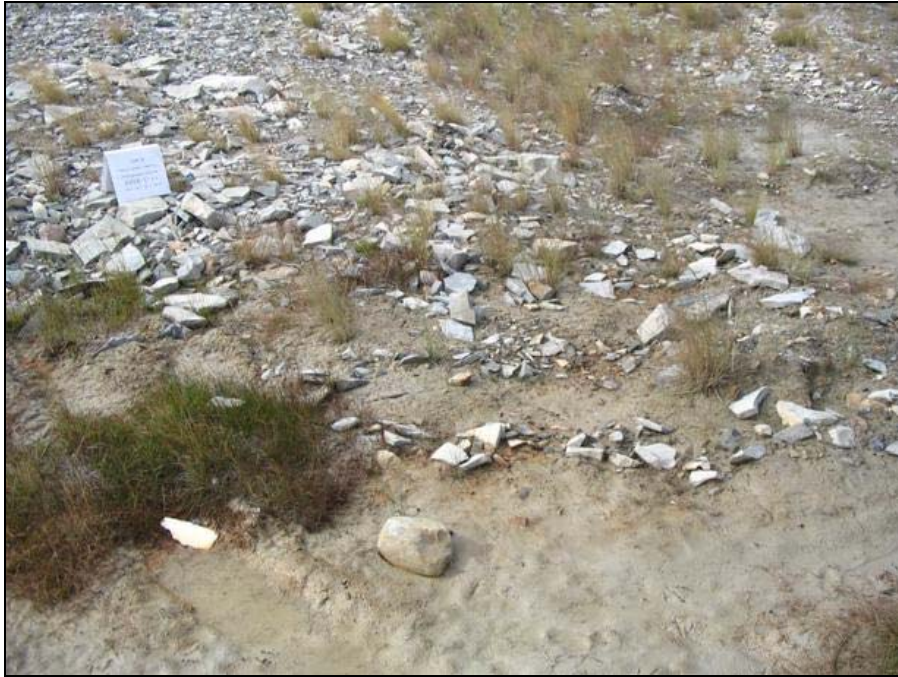
Photo SSLF-6B, Easting: 496383, Northing: 7666067, Direction: 340°

South Shore Landfill; northeast corner

~~SOUTH~~ <sup>NORTH</sup> EAST CORNER  
- SOME DRAINAGE STAINING SURFACES  
(CLOSEUP PHOTO 6B)

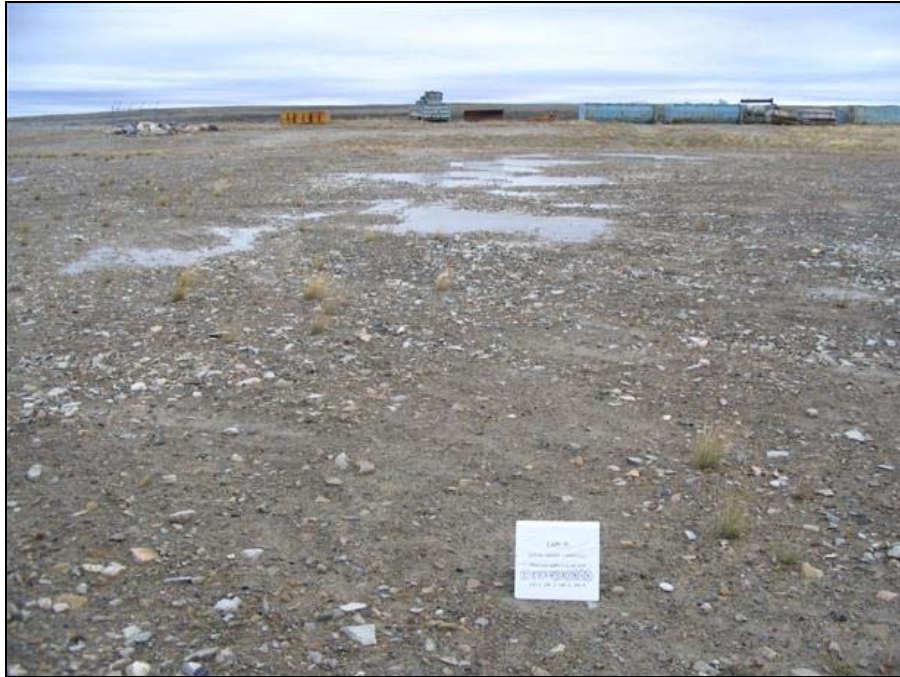
Shallow depressions with ponded water were observed on southcentral surface of the landfill cover (Photo SSLF-11A in Appendix C2). Minor seepage and orange staining were observed at the northeast toe near Photo Location 6 on Figure C-1 (Photos SSLF-5C and 6B). Previously observed exposed crushed metal drums and wire at the northeast toe are still present with no apparent change from previous inspection photographs.

Photo SSLF-11A, Easting: 496274, Northing: 7665993, Direction: 160°  
South Shore Landfill; facing south to ponded water depressions  
Scale: photo placard dimensions are 29.4 cm wide by 27.5 cm in height

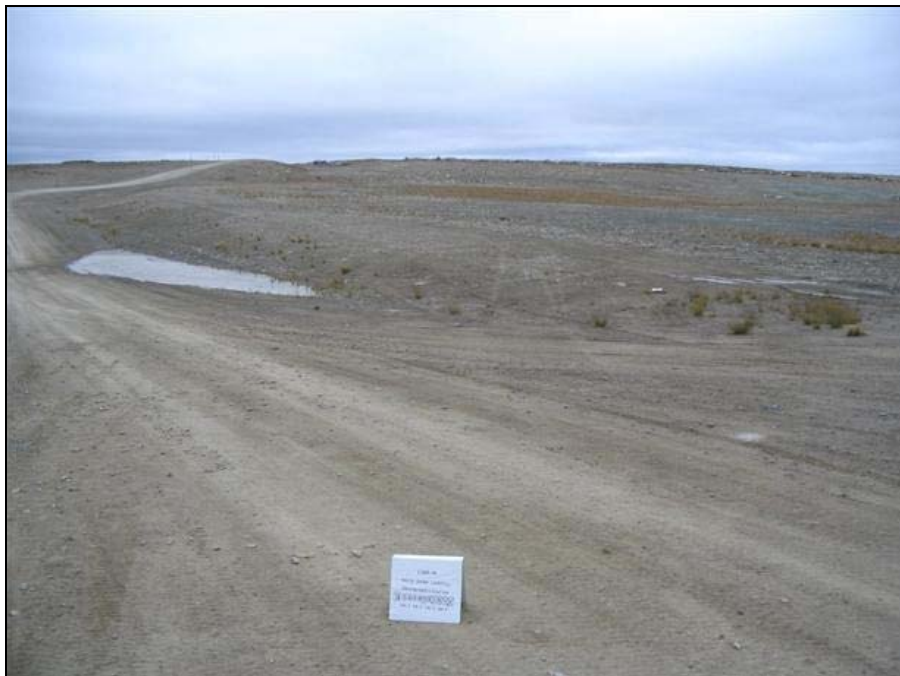
Photo SSLF-12, Easting: 496292, Northing: 7665877, Direction: 0°  
South Shore Landfill; southwest corner of landfill facing ditch with ponded water  
Scale: photo placard dimensions are 29.4 cm wide by 27.5 cm in height

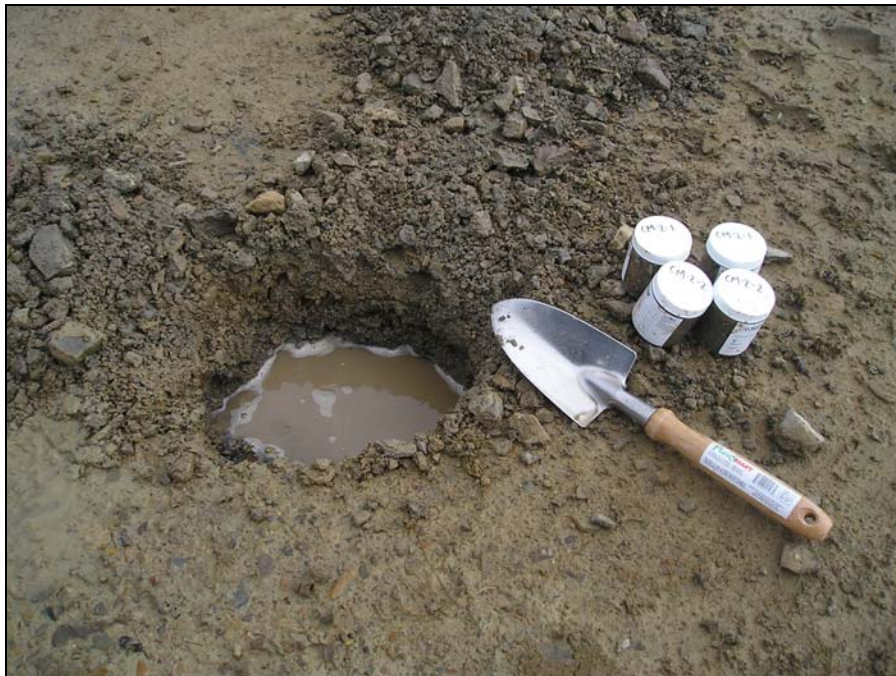
Test pit CM-2. Samples CM-2-1 and CM-2-2 collected. Water table reached at 20cm.

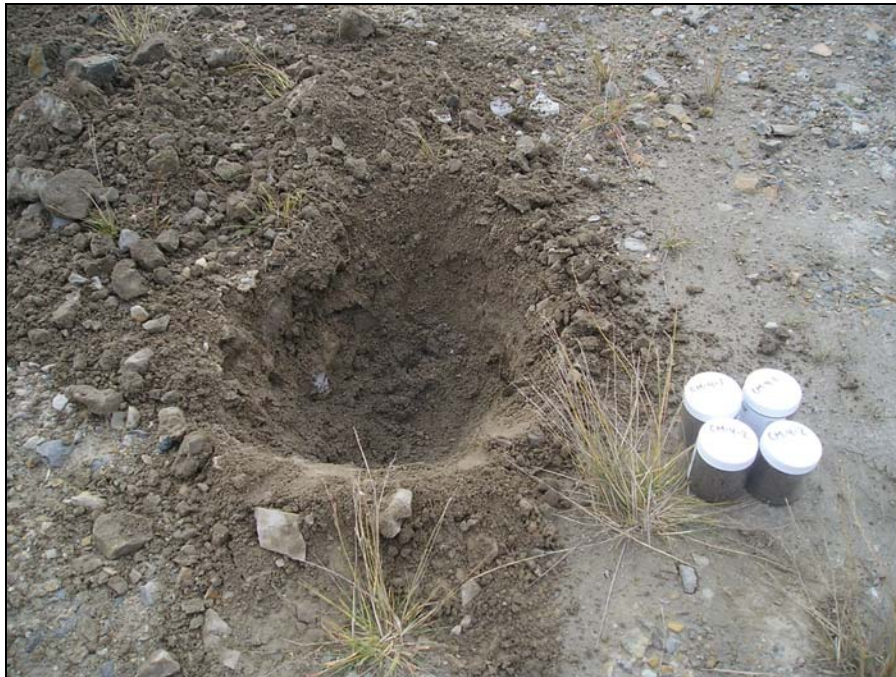
Low concentrations of Total Petroleum Hydrocarbons (TPH) (43mg/kg and 57mg/kg) were detected in both the shallow and deep samples respectively from soil sample location CM-4. The samples were re-analyzed to characterize the TPH CCME fractions F1-F3. All fractions were returned as non-detectable levels. Also, low concentrations of PCBs (0.04mg/kg) were detected in the shallow sample from soil sample location CM-4. The concentrations noted are low however they should be evaluated in the context of the Landfill Monitoring Plan

Test pit CM-4. Samples CM-4-1 and CM-4-2 collected.

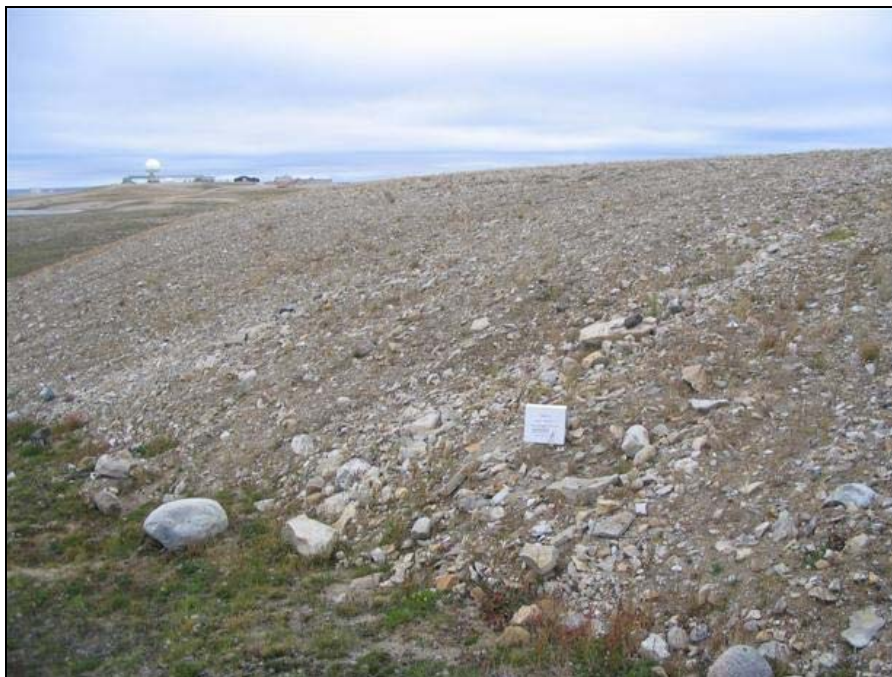
Photo WLF-6A, Easting: 494519, Northing: 7668166, Direction: 90°  
West Landfill; view facing east towards dew line station  
Scale: photo placard dimensions are 29.4 cm wide by 27.5 cm in height

There is some minor erosion on the east slope that appears to be self-armouring (Photos WLF-3, 5 and 6A in Appendix D2). There is an area of settlement at the north end of the landfill, east of Photo Location 8 on Figure D-1. The settlement area appears to be north of the constructed landfill cover indicating that the settlement may be related to thaw of ground ice north of the landfill. The settlement has resulted in the formation of tension cracks (Photos WLF-8A and 8B in Appendix D2) that encircle the north, west and south perimeter of the depression. The maximum width of the cracks is about 5 cm and maximum visible depth is about 20 cm. Photo WLF-9 (Appendix D2) illustrates the proximity of the depression relative to the landfill. Previously documented tension cracks up to 40 cm in width (Photos WLF-8 and 8A in 2005 Inspection Report) could not be located during the 2007 inspection and it is suspected that the area may have been repaired since 2005 (see light coloured gravel area at top of Photo WLF-10A in Appendix D2).

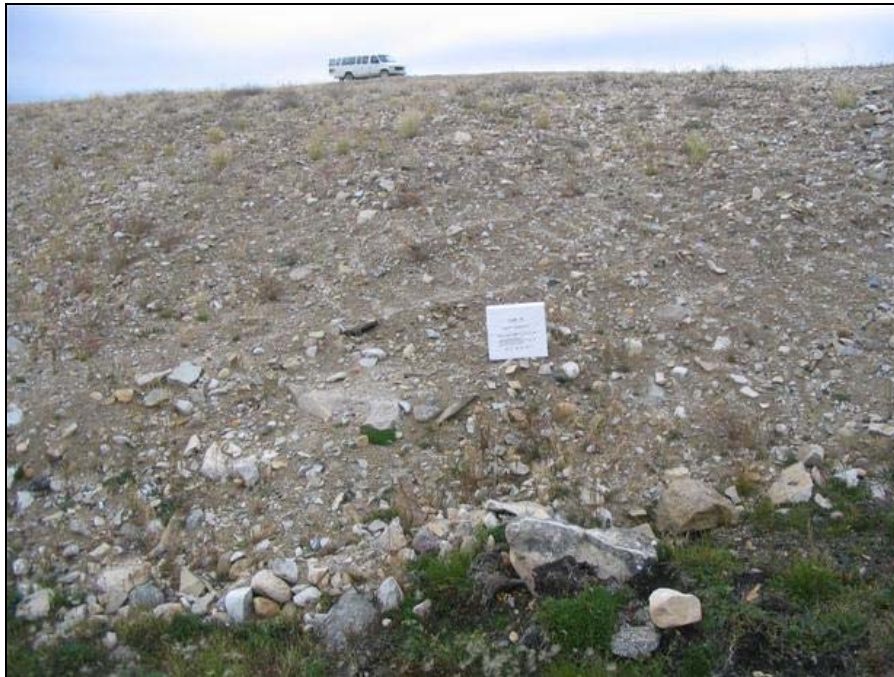
Photo WLF-6B, Easting: 494519, Northing: 7668166, Direction: 160°  
West Landfill; view facing south towards slope  
Scale: photo placard dimensions are 29.4 cm wide by 27.5 cm in height

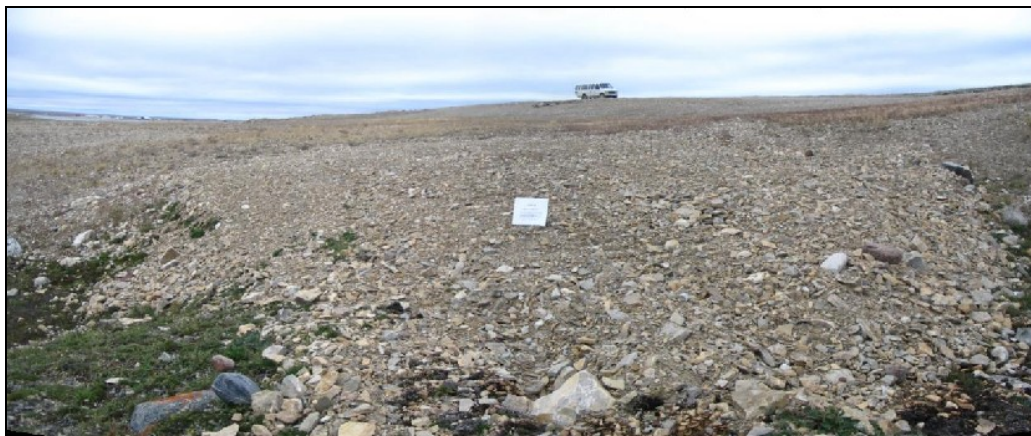
Photo WLF-7, Easting: 494507, Northing: 7668176, Direction: 130°  
West Landfill; view facing east towards western slope  
Scale: photo placard dimensions are 29.4 cm wide by 27.5 cm in height

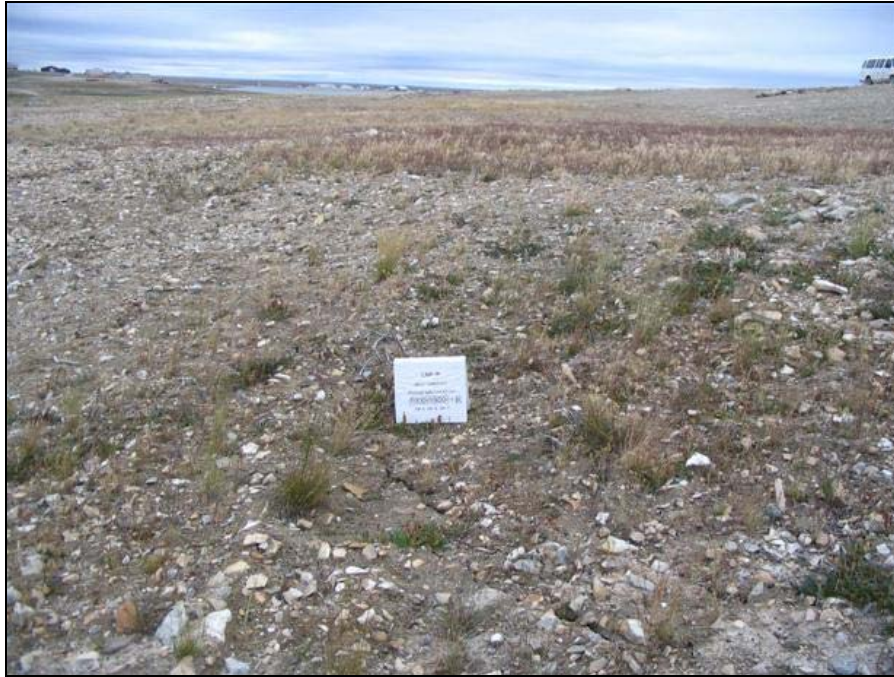
Photo WLF-8A, Easting: 494491, Northing: 7668172, Direction: 45°  
West Landfill; facing landfill from area of settlement west of landfill  
Scale: photo placard dimensions are 29.4 cm wide by 27.5 cm in height

- SOME TENSION CRACKS  
BUT NOT RELATED TO  
WASTE OR LANDFILL
- PHOTO 8A FACING LANDFILL  
TOWARDS DOW LINE  
STATION
- PHOTO 8B FACING AWAY  
FROM LANDFILL
- CRACK WIDTH MAX. 2 INCHES  
AND APPROX 6-8 INCHES  
DEEP

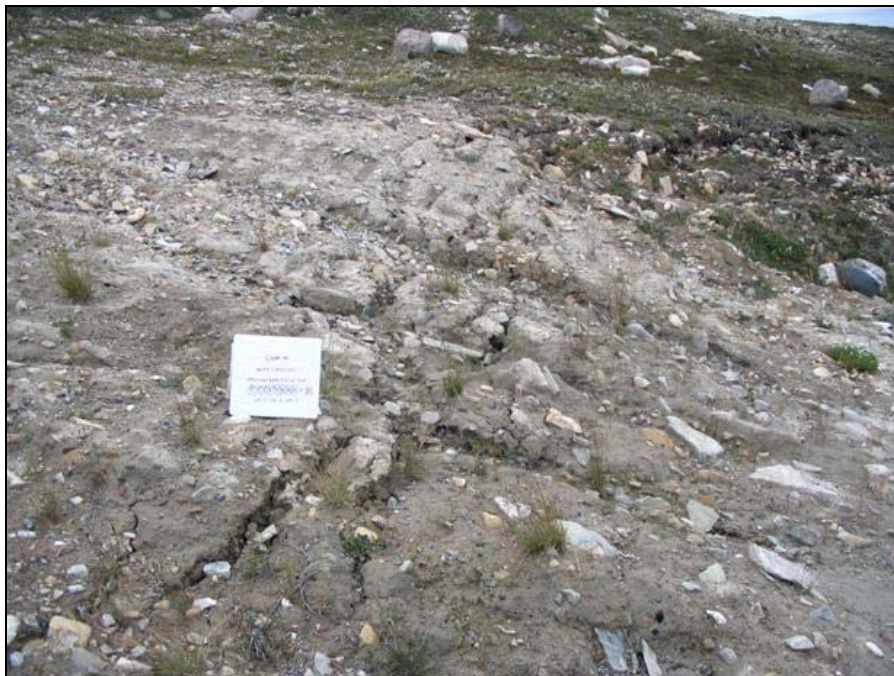
Photo WLF-8B, Easting: 494491, Northing: 7668172, Direction: 270°  
West Landfill; tension cracks above thaw settlement area, maximum width 5 cm, maximum  
observed depth about 20 cm.  
Scale: photo placard dimensions are 29.4 cm wide by 27.5 cm in height.

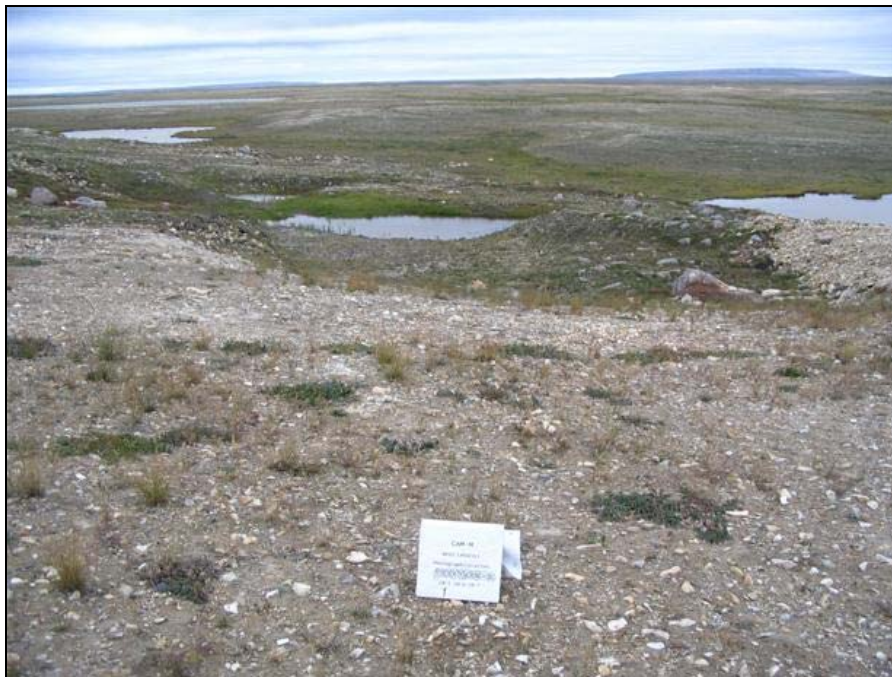
Photo WLF- 9B, Easting: 494479, Northing: 7668169  
West Landfill; facing northeast towards thaw settlement area  
Scale: photo placard dimensions are 29.4 cm wide by 27.5 cm in height

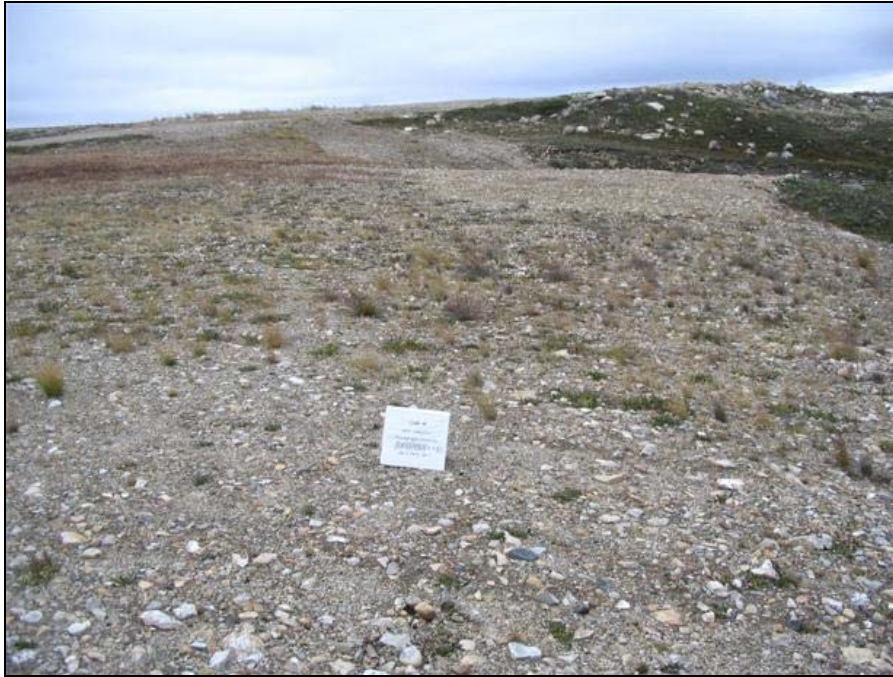
Photo WLF-10A, Easting: 494520, Northing: 7668142, Direction: 250°  
West Landfill; view facing northwest towards suspected regraded area  
Scale: photo placard dimensions are 29.4 cm wide by 27.5 cm in height

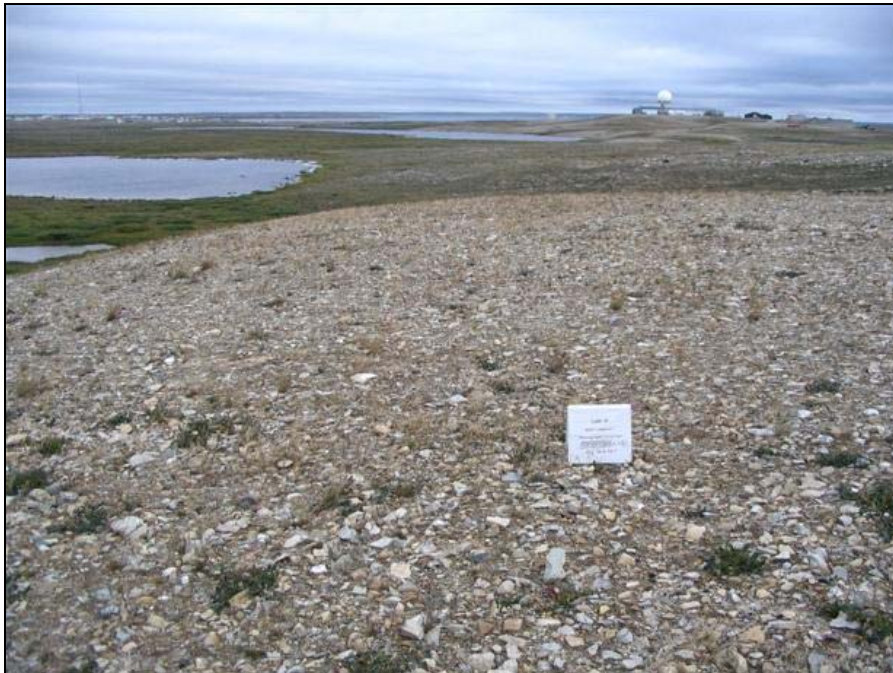
Photo WLF-10B, Easting: 494520, Northing: 7668142, Direction: 70°  
West Landfill; view facing southeast  
Scale: photo placard dimensions are 29.4 cm wide by 27.5 cm in height

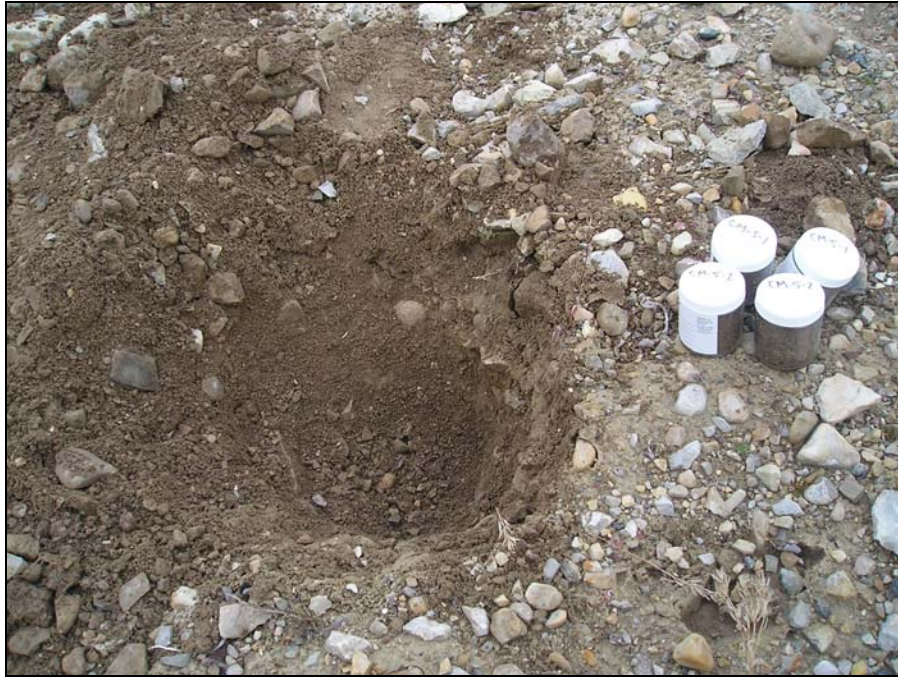
Test pit CM-5 (Upgradient). Samples CM-5-1 and CM-5-2 collected. Samples with identification numbers ending in “1” (ex. CM-5-1) collected at 0-10cm and samples with identification numbers ending in “2” collected at 40-50cm.

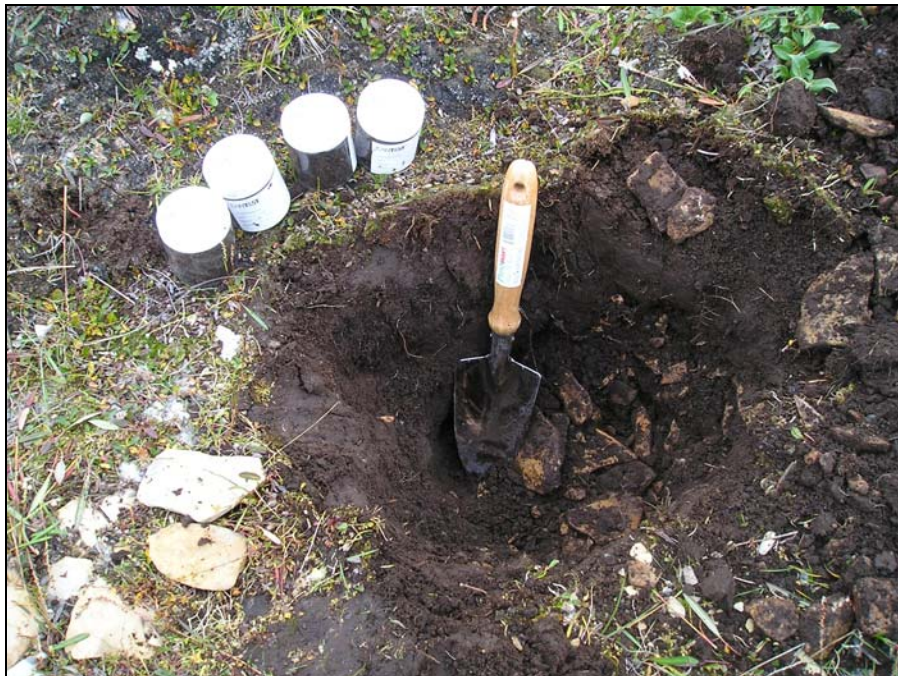
Test pit CM-6. Samples CM-6-1 and CM-6-2 collected.

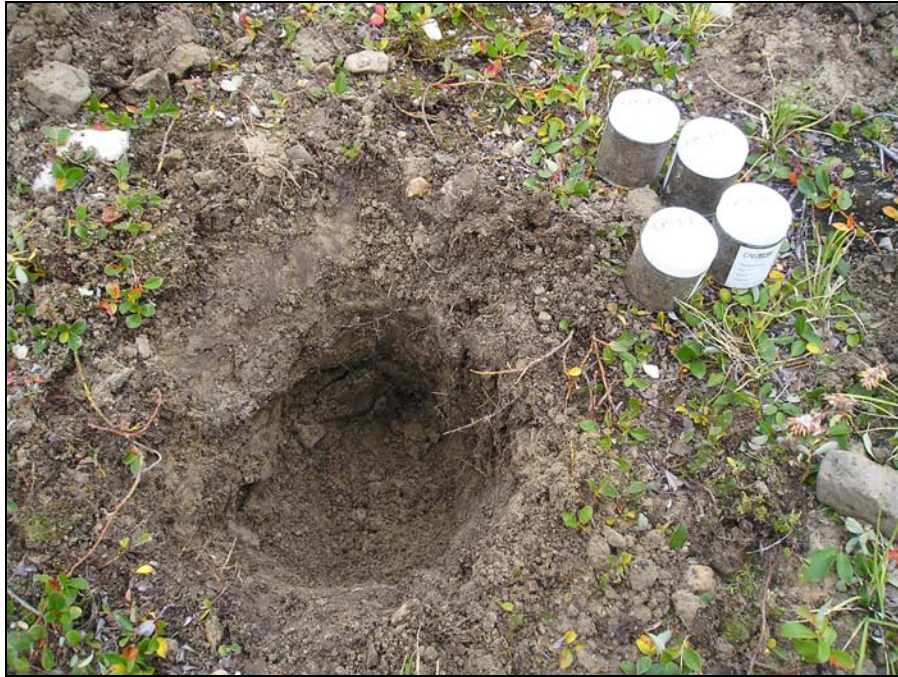
Test pit CM-7. Samples CM-7-1 and CM-7-2 collected.

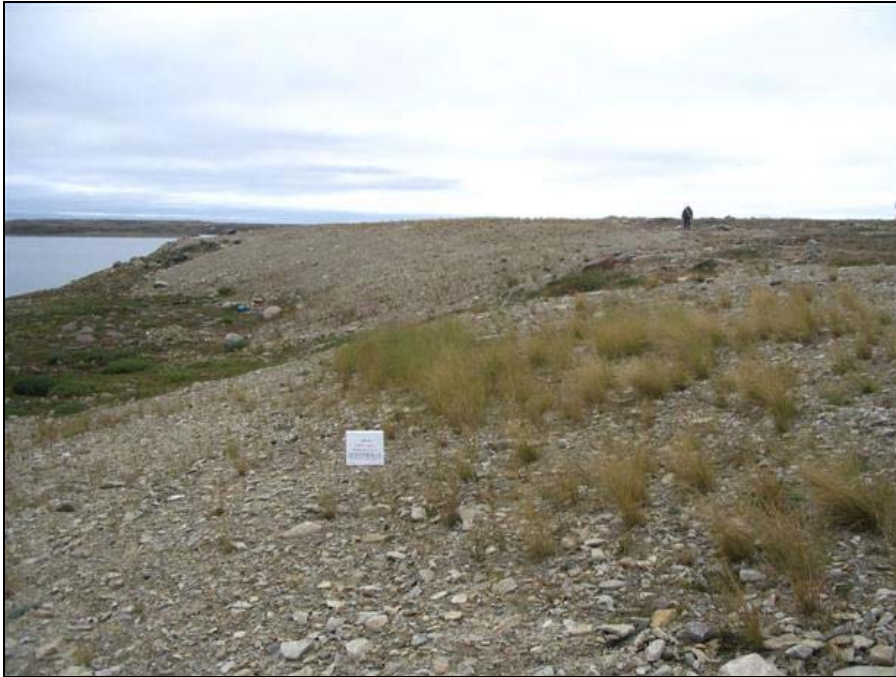
Photo ALF-4A, Easting: 493127, Northing: 7666785, Direction: 270°  
Airport Landfill; facing west to Area 8 slope  
Scale: photo placard dimensions are 29.4 cm wide by 27.5 cm in height

There is some minor erosion on the south slope of Area 8 that appears to be self-armouring (Photo WLF-4A in Appendix E2). Previously observed exposed crushed metal drums at the west end of Area 7 are still present (Photo ALF-5A) with no apparent change from previous inspection photographs.

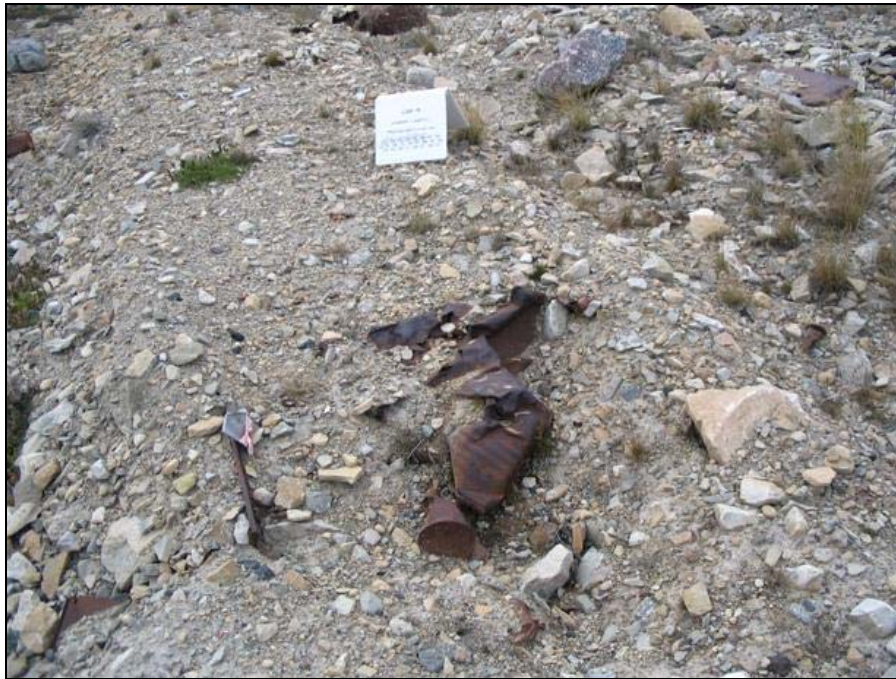
Photo ALF-5A, Easting: 492972, Northing: 7666752, Direction: 315°  
Airport Landfill; close-up of exposed metal drums  
Scale: photo placard dimensions are 29.4 cm wide by 27.5 cm in height

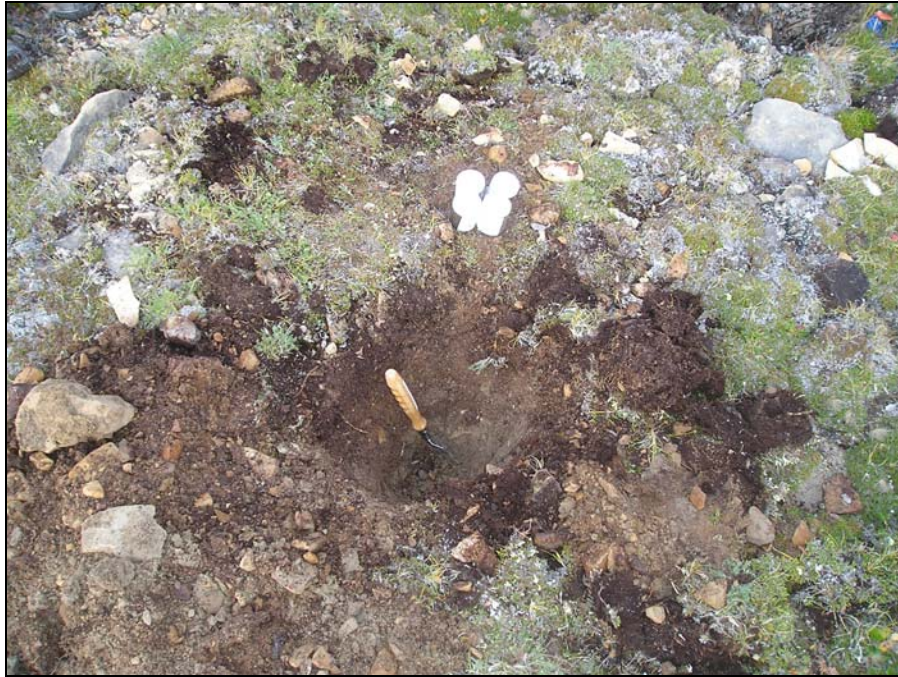
Test pit CM-8 (Upgradient). Samples CM-8-1 and CM-8-2 collected. Samples with identification numbers ending in “1” (ex. CM-8-1) collected at 0-10cm and samples with identification numbers ending in “2” collected at 40-50cm.

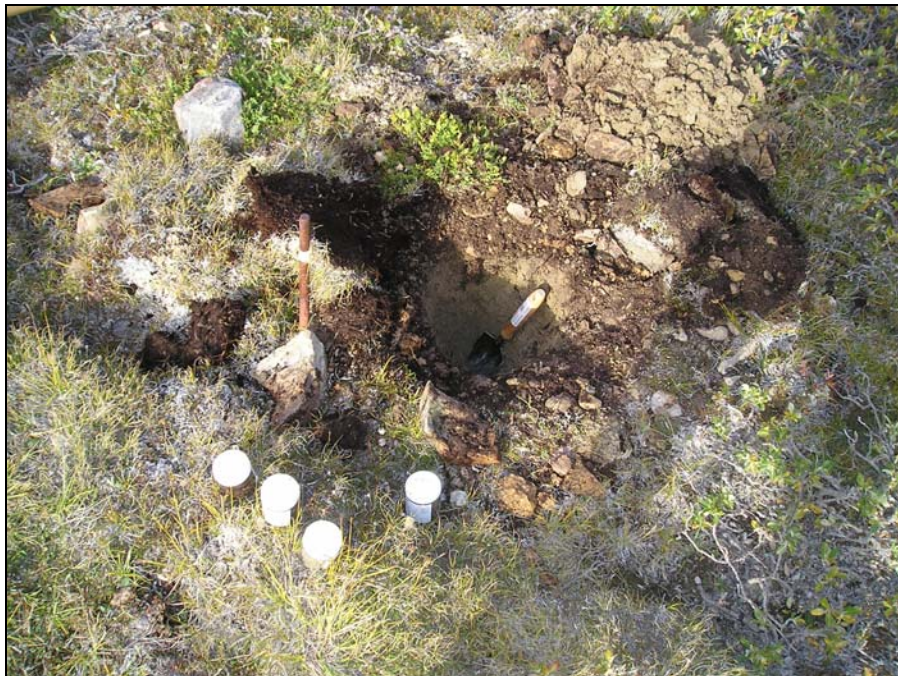
Test Pit CM-9 (Upgradient). Samples CM-9-1 and CM-9-2 collected.

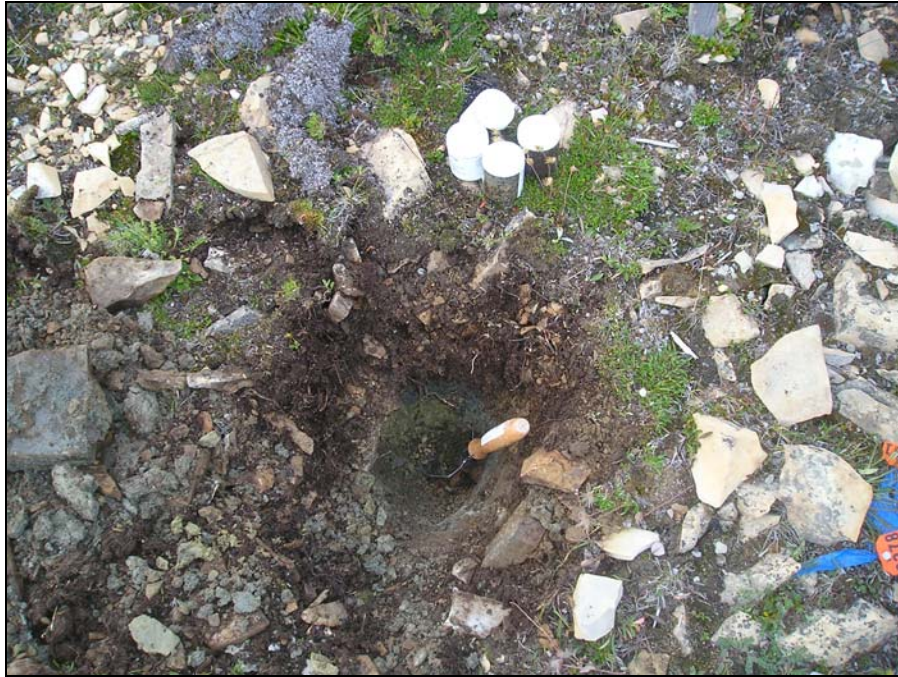
Test pit CM-10. Samples CM-10-1 and CM-10-2 collected.

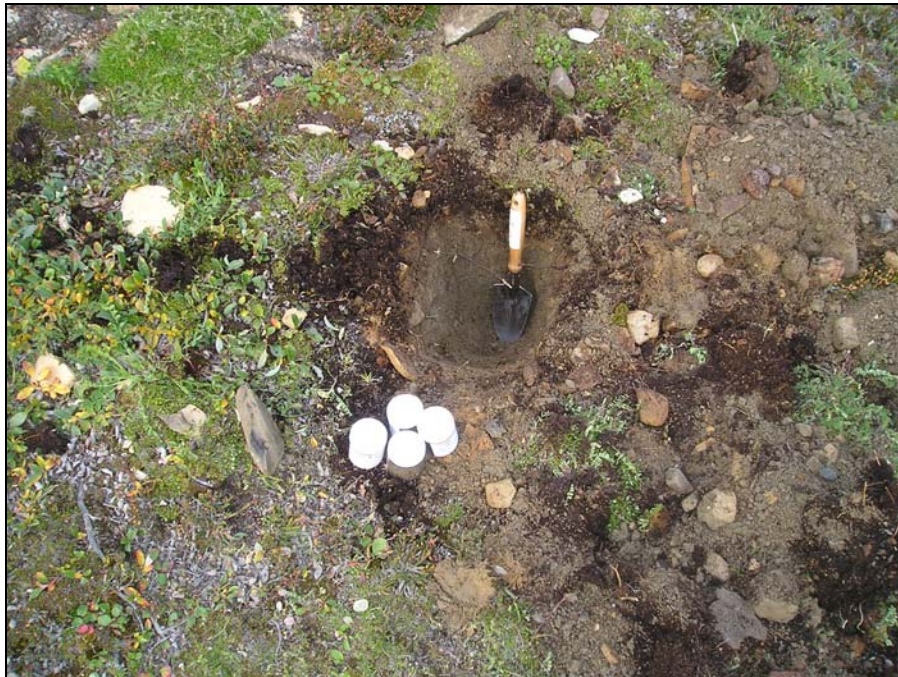
Test Pit CM-11. Samples CM-11-1 and CM-11-2 collected.

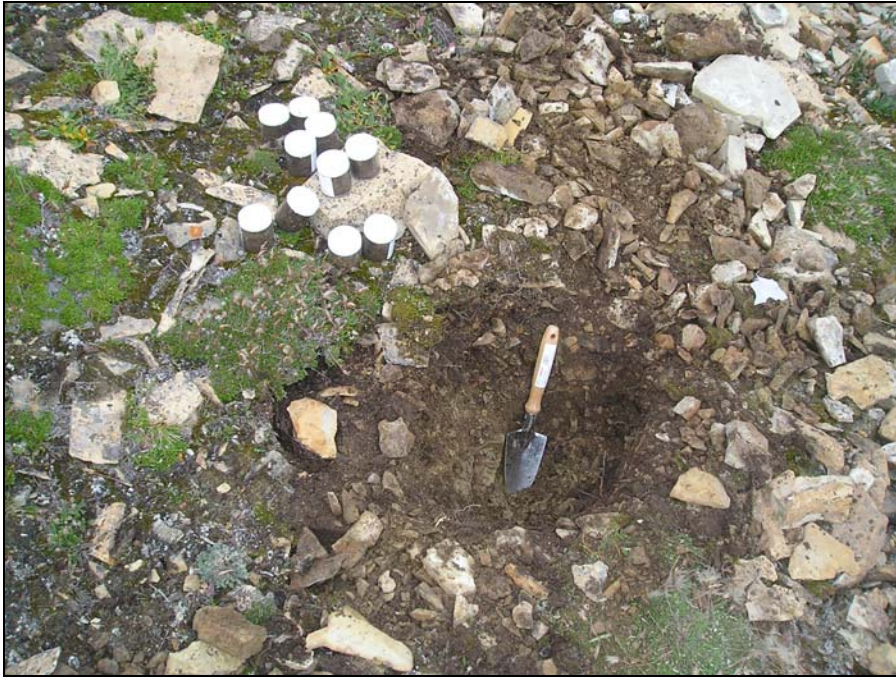
Test pit CM-12. Samples CM-12-1, CM-12-2, and CM-16-1 (Duplicate of CM-12-1) collected.

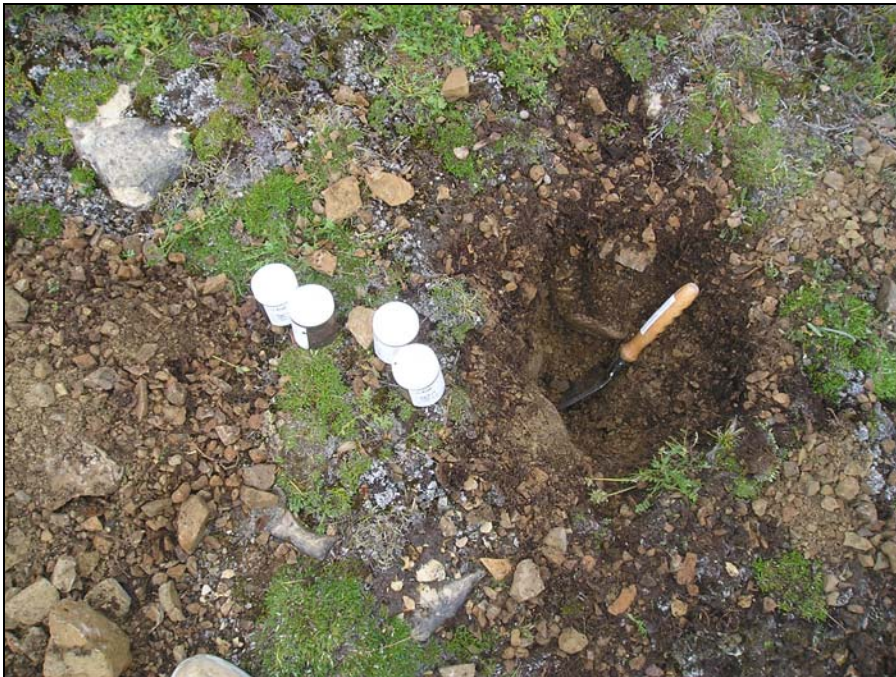
Test pit CM-13-1. Samples CM-13-1 and CM-13-2 collected.

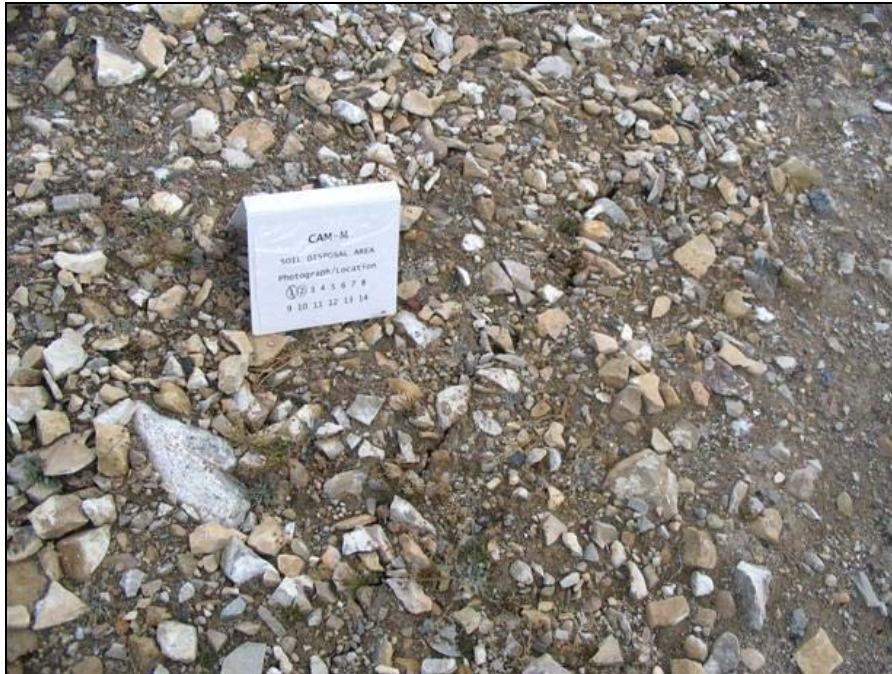
Photo SDA-2A, Easting: 494390, Northing: 7669207, Direction: 315°  
D.C.C. Tier II Soil Disposal Area; close-up of crack, max. width 1.5 cm  
Scale: photo placard dimensions are 29.4 cm wide by 27.5 cm in height
