# **The Collection of Landfill Monitoring Data at the CAM-M Cambridge Bay Site – 2007 Report**

Prepared for  
**Defence Construction Canada**

Submitted by  
**Gartner Lee Limited**

**January, 2008**

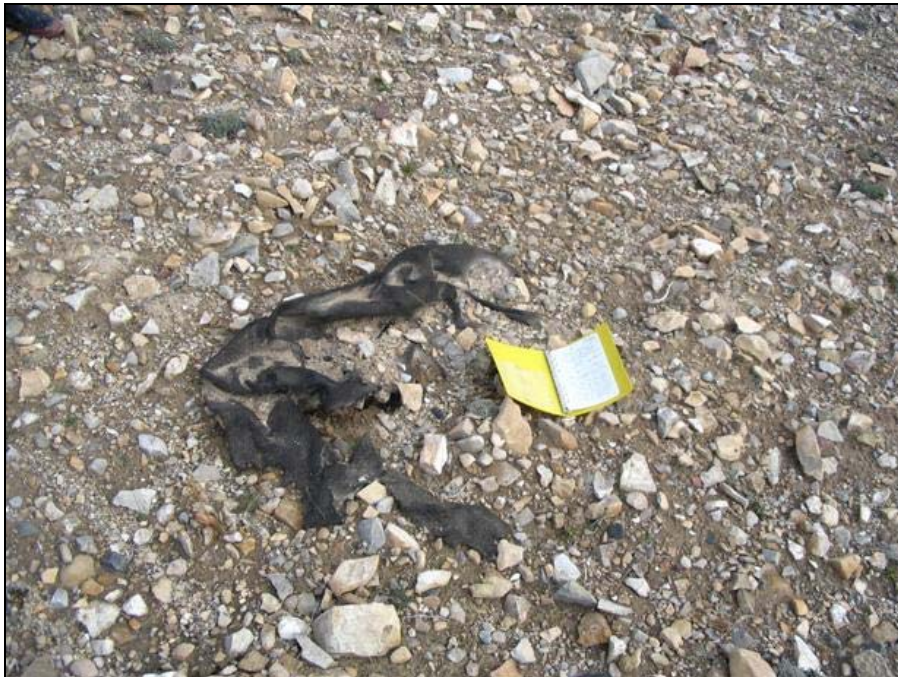
Photo SDA-2C, Easting: 494390, Northing: 7669207, Direction: 315°  
D.C.C. Tier II Soil Disposal Area; exposed geotextile

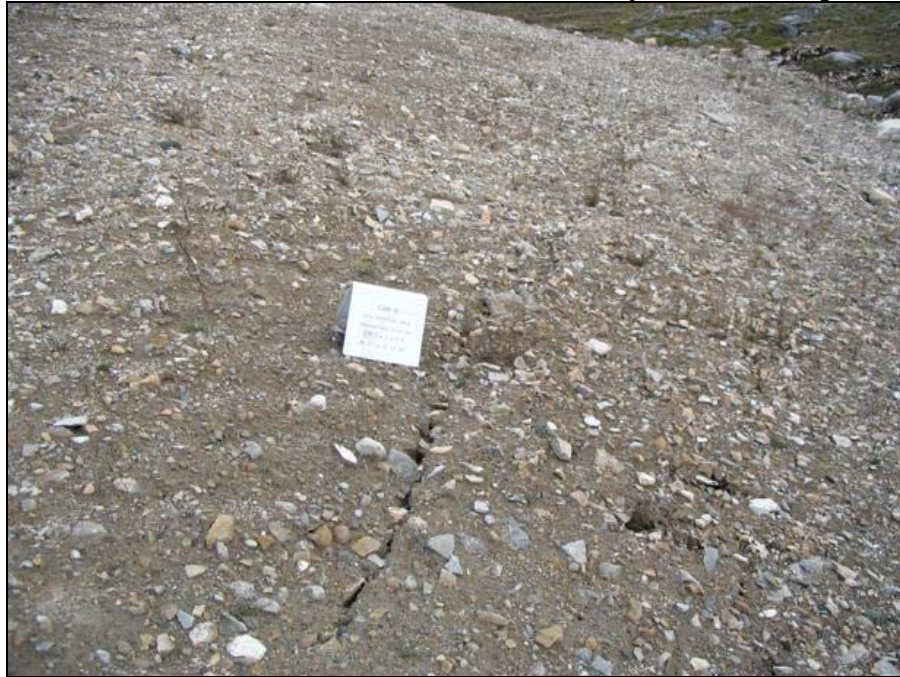
Photo SDA-3A, Easting: 494417, Northing: 7669235, Direction: 45°  
D.C.C. Tier II Soil Disposal Area; 40 m long crack, max. width 2.5 cm, max. depth 10 cm  
Scale: photo placard dimensions are 29.4 cm wide by 27.5 cm in height

Minor erosion rills on the northwest and northeast slopes appear to be self-armouring. A small 0.5 m diameter settlement depression was observed on the crest near Photo Location 8 on Figure F-1 (Photo SDA-8A in Appendix F2). A total of four tension cracks were observed at the SDA, including one previously observed crack and three new cracks. A previously observed tension crack on the northeast slope measures approximately 40 m in length from the northeast corner with a maximum width of about 2.5 cm (Photos SDA-3A, 3B and 4B in Appendix F2). A few parallel tension cracks have formed at the northeast end of this crack near the landfill toe (Photos SDA-4B in Appendix F2). A new tension crack on the southeast slope of the landfill measures approximately 20 m in length with a maximum width of about 1.5 cm (Photos SDA-2A and 2B in Appendix F2). A new 15 m long tension crack was observed in 2007 along the southeast crest with a maximum width of about 5 cm (Photos SDA-5C and 5D in Appendix F2). A hairline tension crack was observed in 2007 along the crest between Photo Locations 6 and 8. Tension cracks and adjacent slopes should be monitored during future inspections for increased size and movement, respectively.

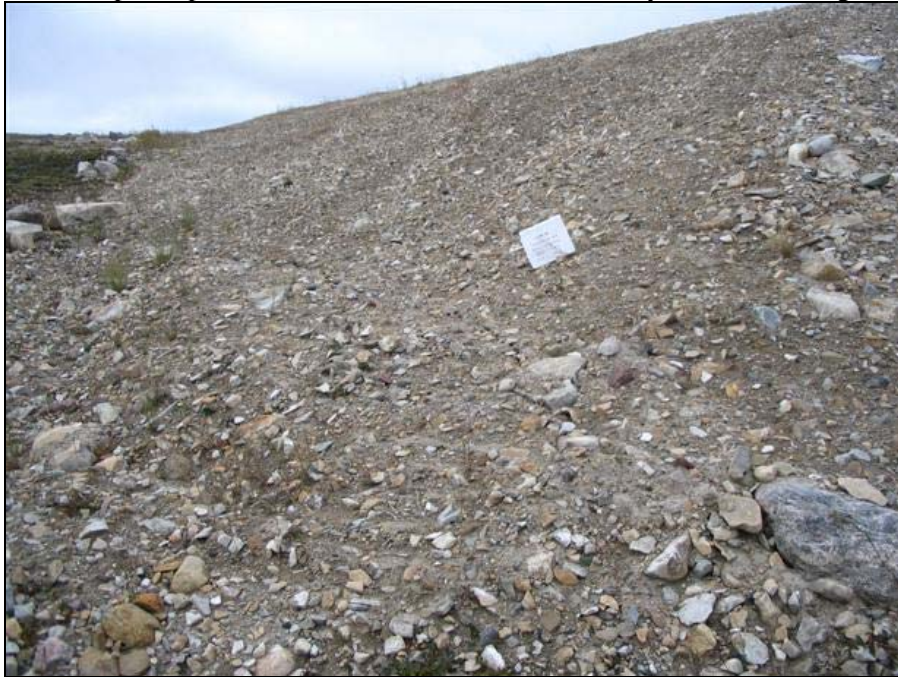
Photo SDA-3B, Easting: 494417, Northing: 7669235, Direction: 45°  
D.C.C. Tier II Soil Disposal Area; close-up of crack

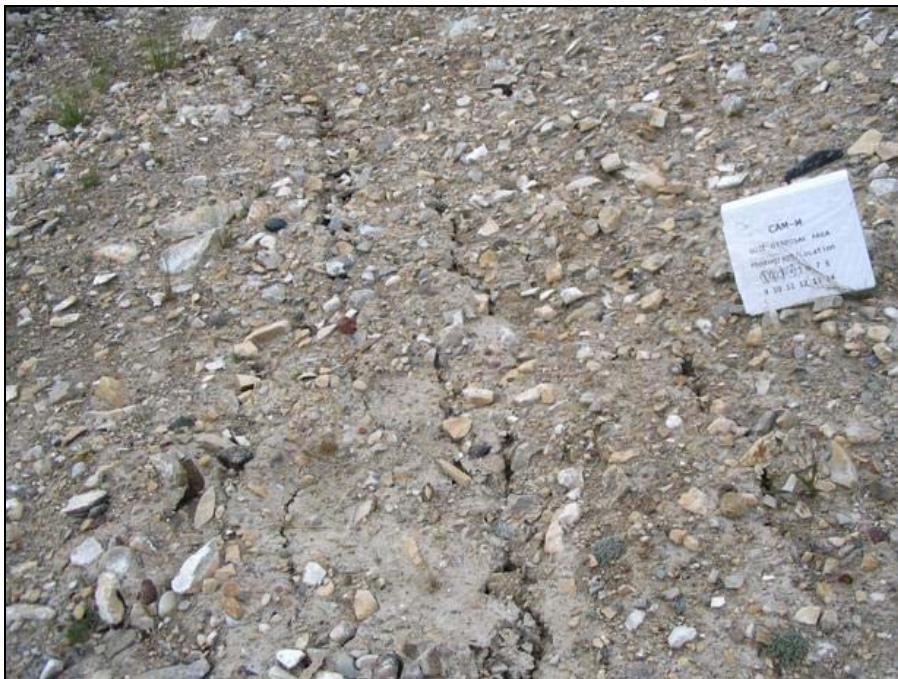
Photo SDA-4B, Easting: 494431, Northing: 7669256, Direction: 200°

D.C.C. Tier II Soil Disposal Area; close-up of cracking at toe  
Scale: photo placard dimensions are 29.4 cm wide by 27.5 cm in height

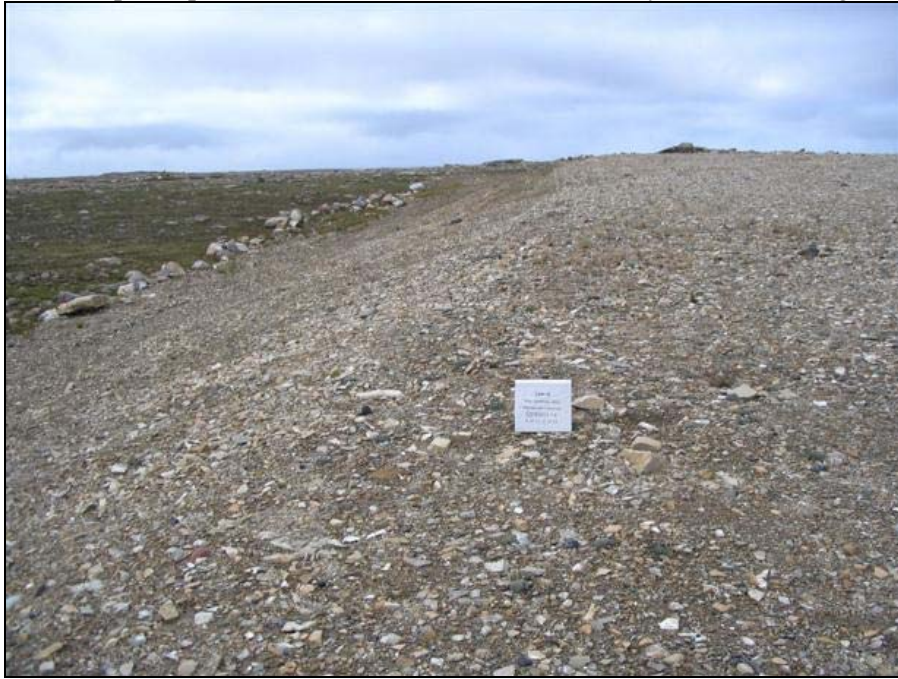
Photo SDA-5A, Easting: 494413, Northing: 7669256, Direction: 200°  
D.C.C. Tier II Soil Disposal Area; view facing south along east crest  
Scale: photo placard dimensions are 29.4 cm wide by 27.5 cm in height

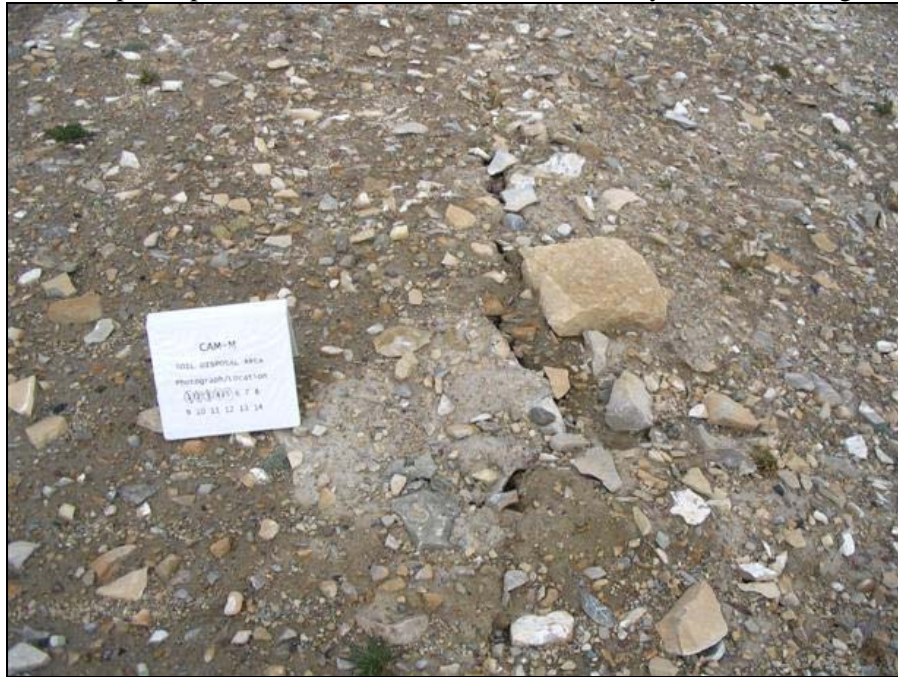
Photo SDA-5B, Easting: 494413, Northing: 7669256, Direction: 315°  
D.C.C. Tier II Soil Disposal Area; view facing west along north crest  
Scale: photo placard dimensions are 29.4 cm wide by 27.5 cm in height

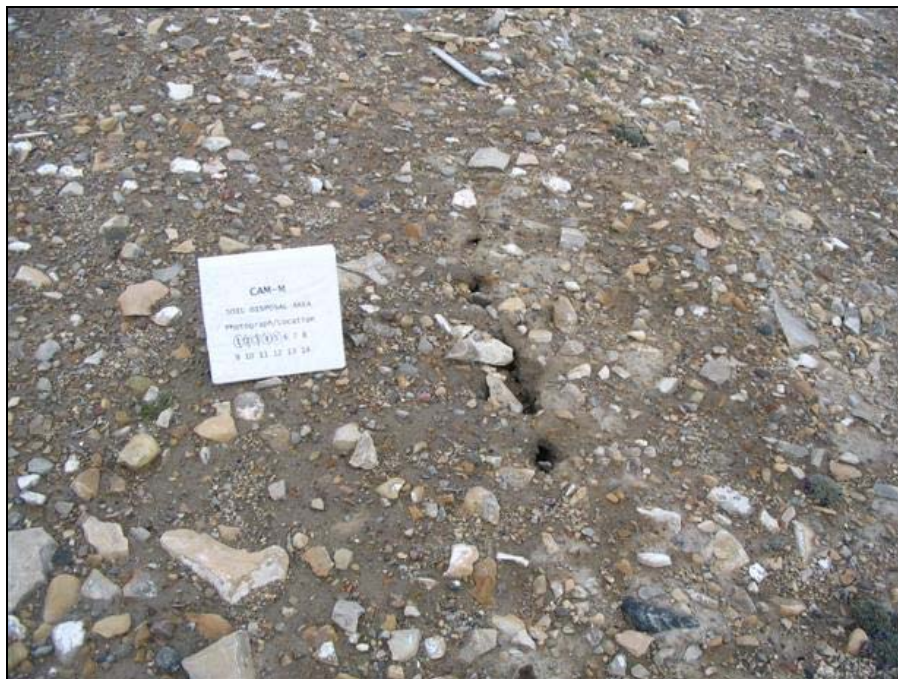
Photo SDA-5C, Easting: 494413, Northing: 7669256, Direction: 315°  
D.C.C. Tier II Soil Disposal Area; close up of tension crack along north crest  
Scale: photo placard dimensions are 29.4 cm wide by 27.5 cm in height

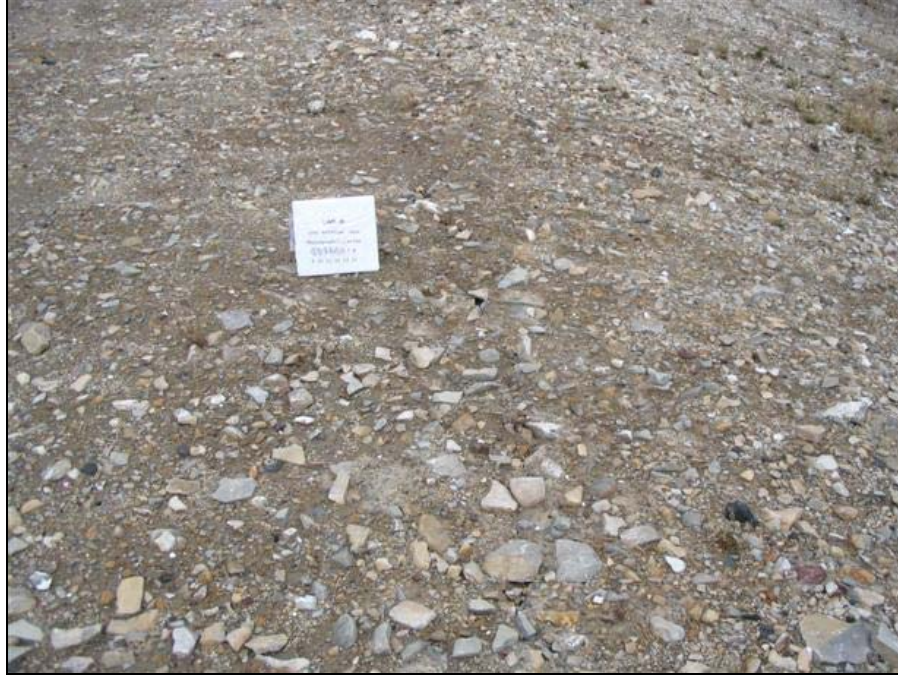
Photo SDA-5D, Easting: 494431, Northing: 7669256, Direction: 315°  
D.C.C. Tier II Soil Disposal Area; west end of crack, max. width 5 cm, max. depth 10 cm  
Scale: photo placard dimensions are 29.4 cm wide by 27.5 cm in height

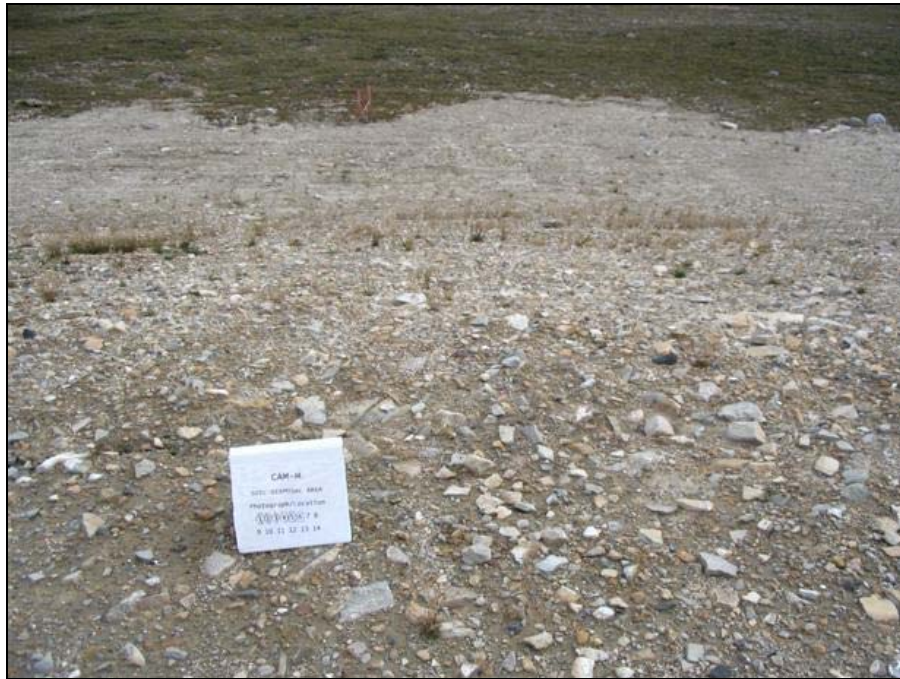
Photo SDA-6A, Easting: 494388, Northing: 7669274, Direction: 315°  
D.C.C. Tier II Soil Disposal Area; view facing west along crest  
Scale: photo placard dimensions are 29.4 cm wide by 27.5 cm in height

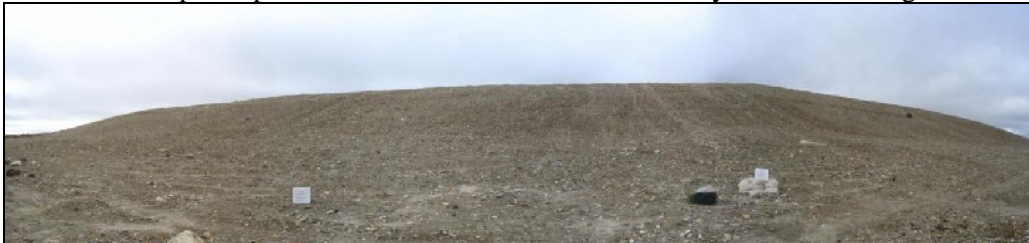
Photo SDA-6B, Easting: 494388, Northing: 7669274, Direction: 45°  
D.C.C. Tier II Soil Disposal Area; view facing north down slope  
Scale: photo placard dimensions are 29.4 cm wide by 27.5 cm in height

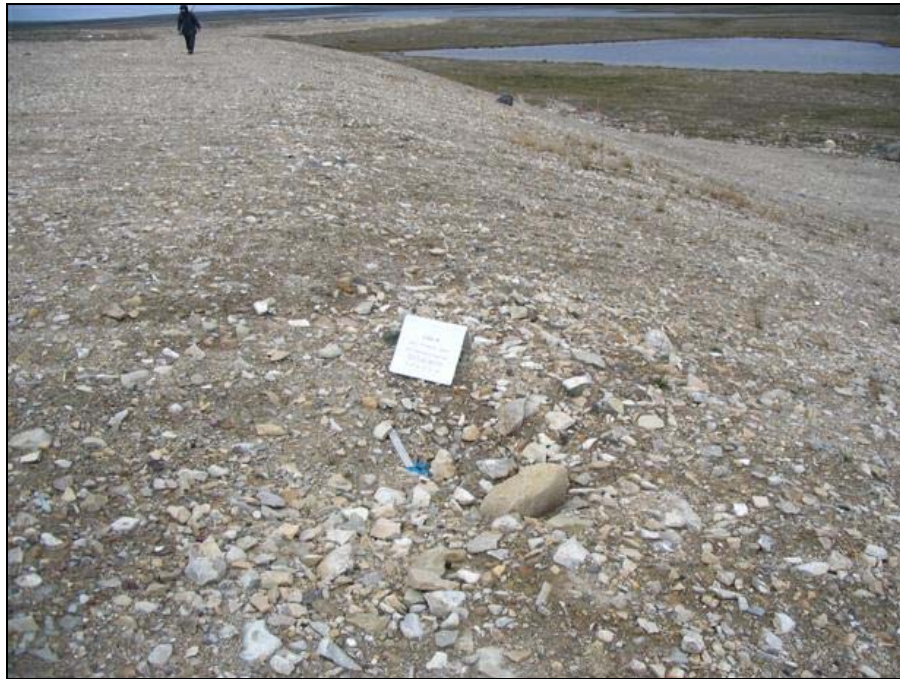
Photo SDA-7, Easting: 494388, Northing: 7669325, Direction: 225°  
D.C.C. Tier II Soil Disposal Area; view of north slope  
Scale: photo placard dimensions are 29.4 cm wide by 27.5 cm in height

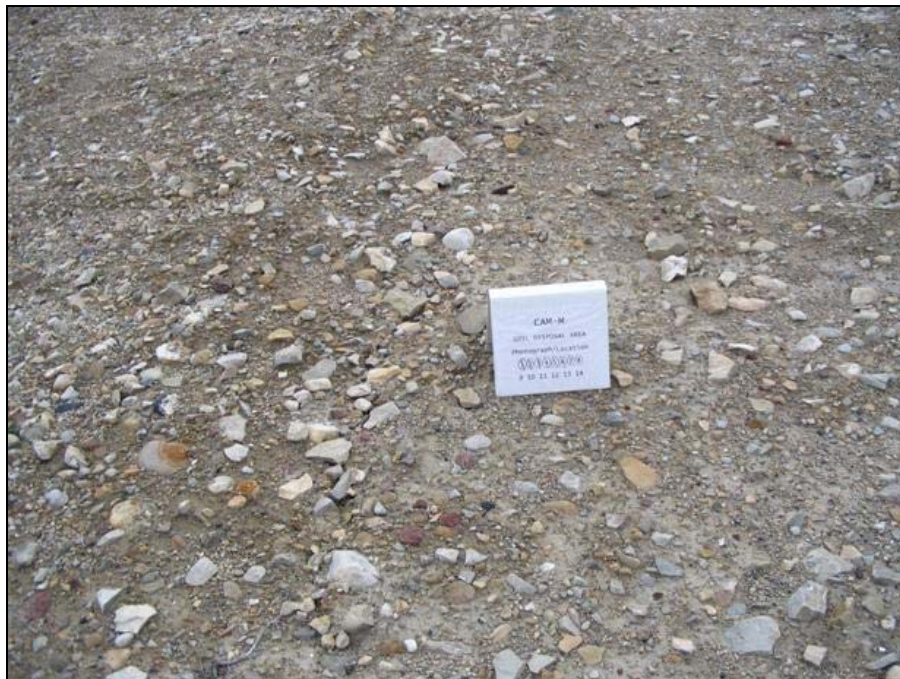
Photo SDA-8A, Easting: 494371, Northing: 7669282, Direction: 315°  
D.C.C. Tier II Soil Disposal Area; small settlement area at crest, 0.5 m diameter, 0.2 m deep  
Scale: photo placard dimensions are 29.4 cm wide by 27.5 cm in height

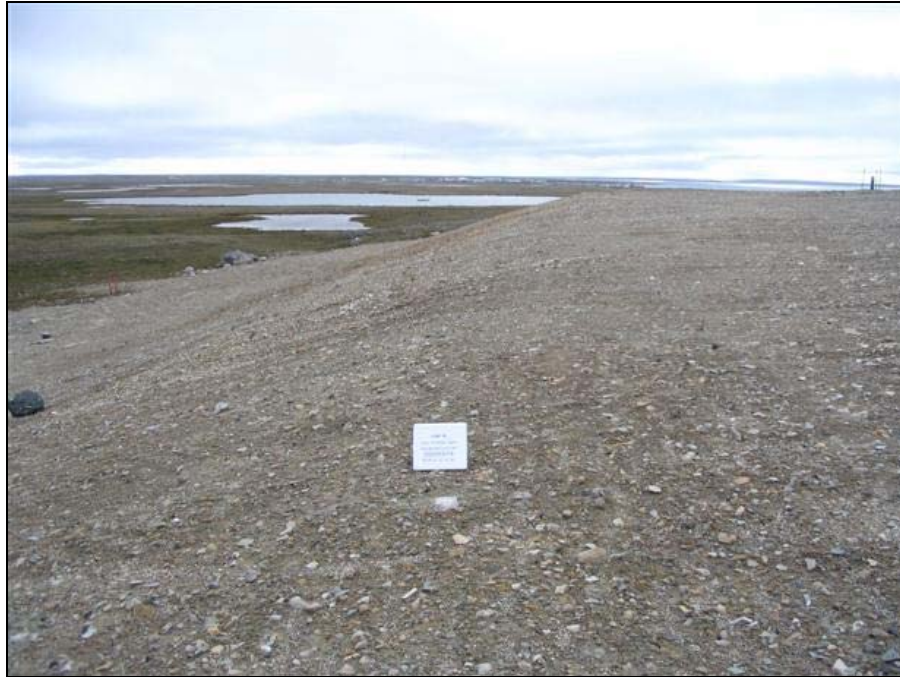
Photo SDA-8B, Easting: 494371, Northing: 7669282, Direction: 315°  
D.C.C. Tier II Soil Disposal Area; west of settlement area facing east  
Scale: photo placard dimensions are 29.4 cm wide by 27.5 cm in height

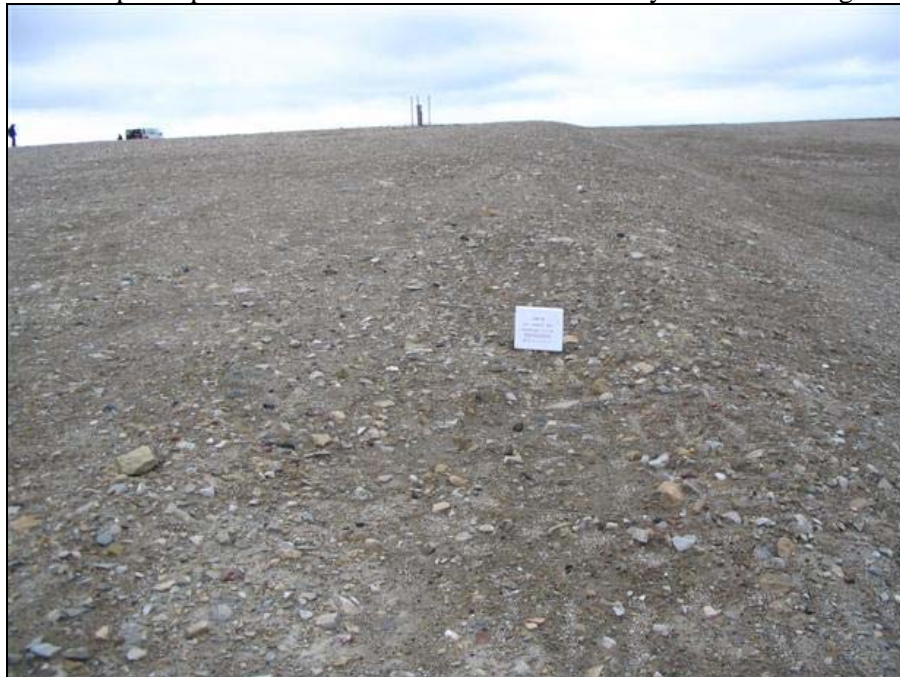
Photo SDA-9A, Easting: 494332, Northing: 7669312, Direction: 45°  
D.C.C. Tier II Soil Disposal Area; view facing northeast along west crest  
Scale: photo placard dimensions are 29.4 cm wide by 27.5 cm in height

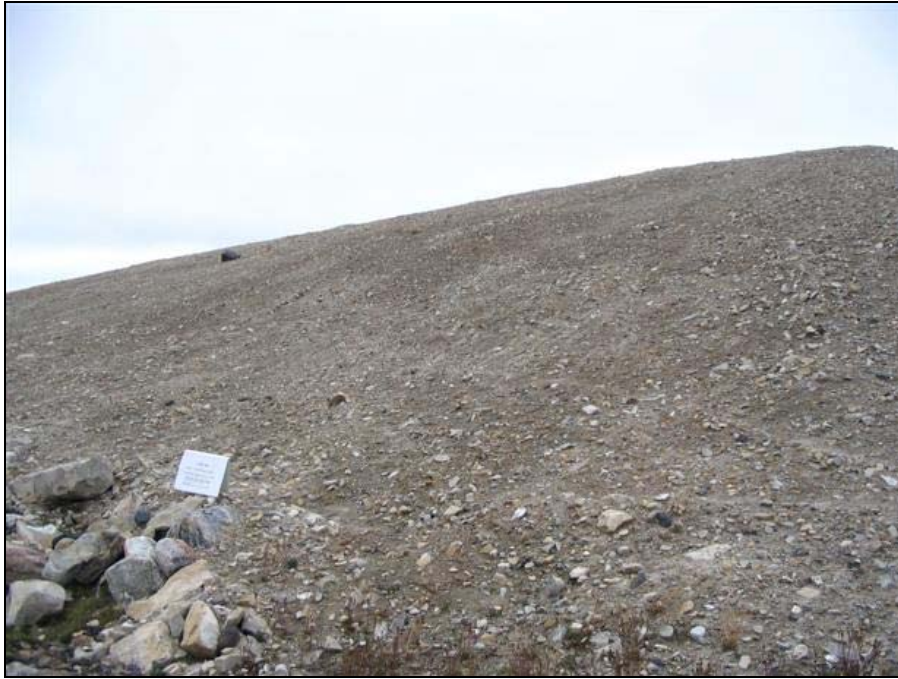
Photo SDA-9B, Easting: 494332, Northing: 7669312, Direction: 225°  
D.C.C. Tier II Soil Disposal Area; view facing southwest along west crest

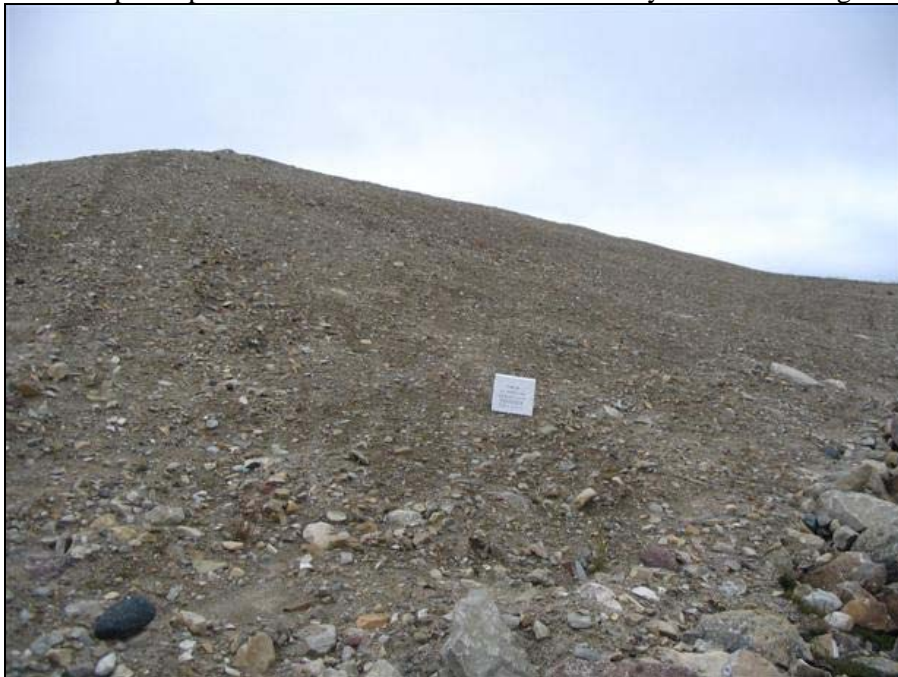
Photo SDA-10A, Easting: 494327, Northing: 7669340, Direction: 135°  
D.C.C. Tier II Soil Disposal Area; view facing east along north slope  
Scale: photo placard dimensions are 29.4 cm wide by 27.5 cm in height

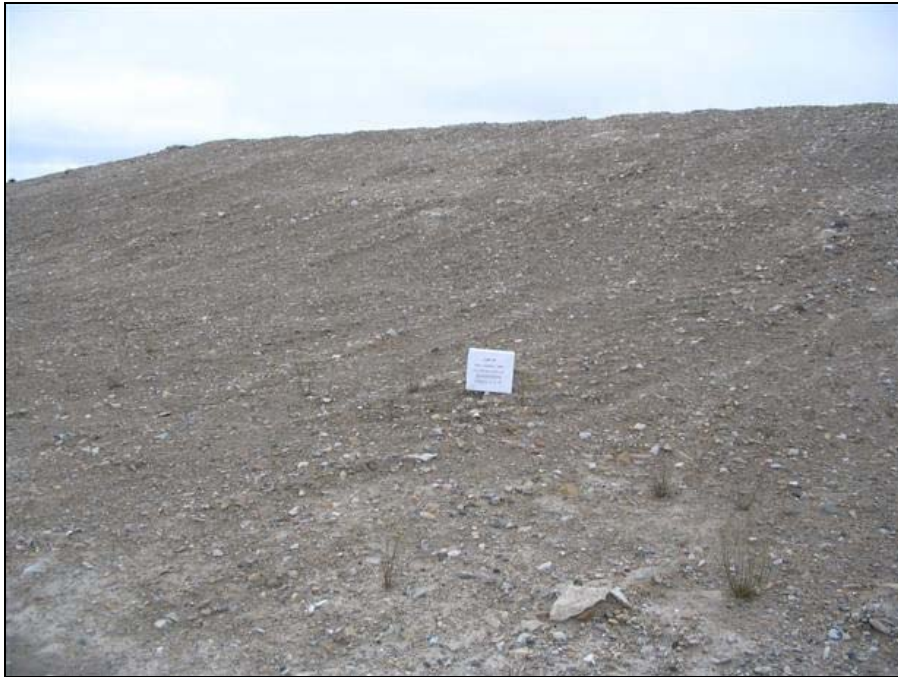
D.C.C. Tier II Soil Disposal Area; view facing south along west slope  
Scale: photo placard dimensions are 29.4 cm wide by 27.5 cm in height

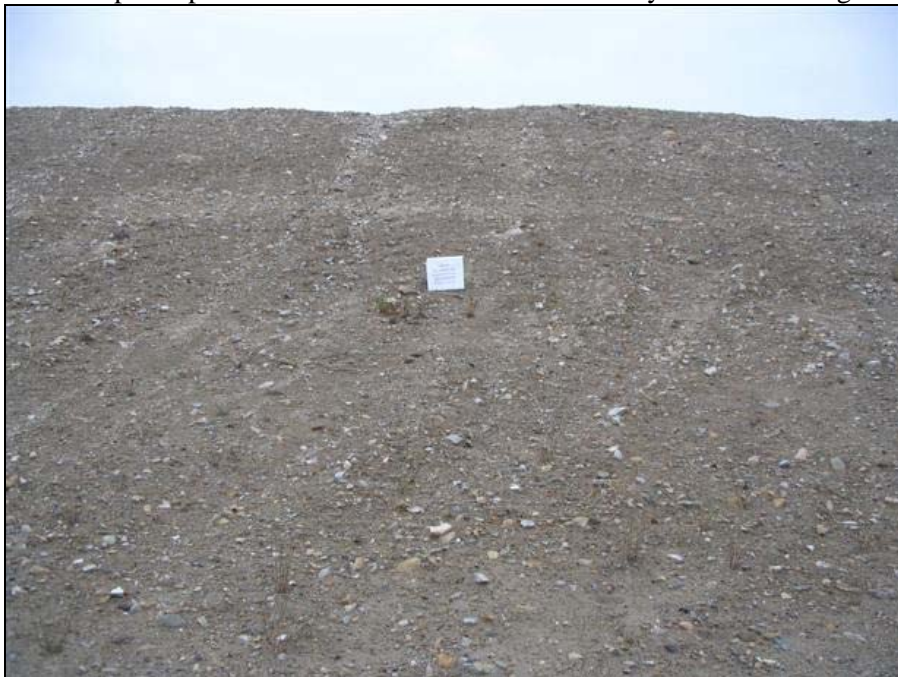
Photo SDA-11A, Easting: 494300, Northing: 7669297, Direction: 60°  
D.C.C. Tier II Soil Disposal Area; view facing northeast  
Scale: photo placard dimensions are 29.4 cm wide by 27.5 cm in height

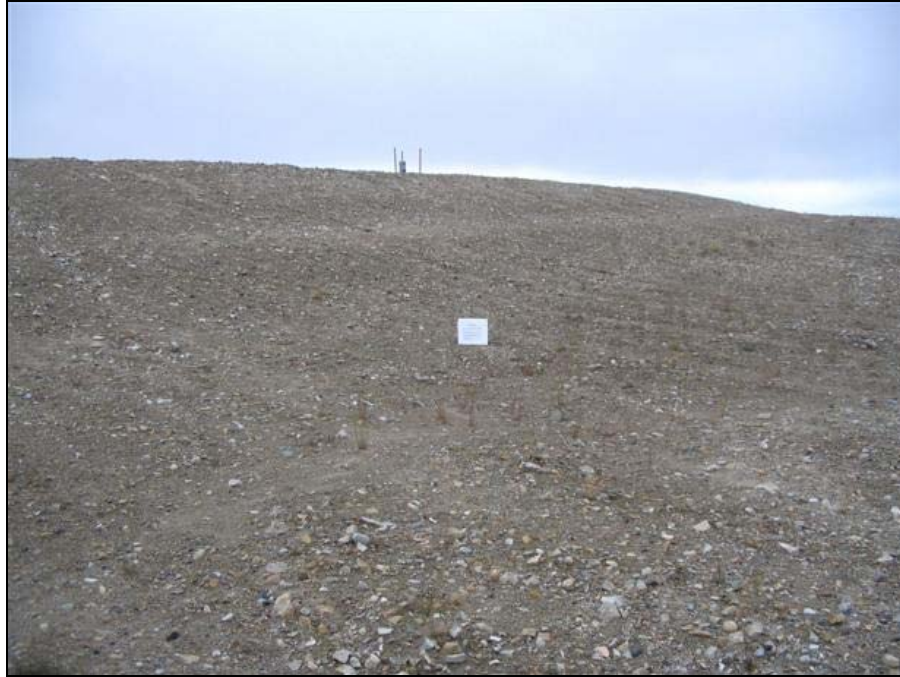
Photo SDA-11B, Easting: 494300, Northing: 7669297, Direction: 110°  
D.C.C. Tier II Soil Disposal Area; view facing east, minor erosion rills  
Scale: photo placard dimensions are 29.4 cm wide by 27.5 cm in height

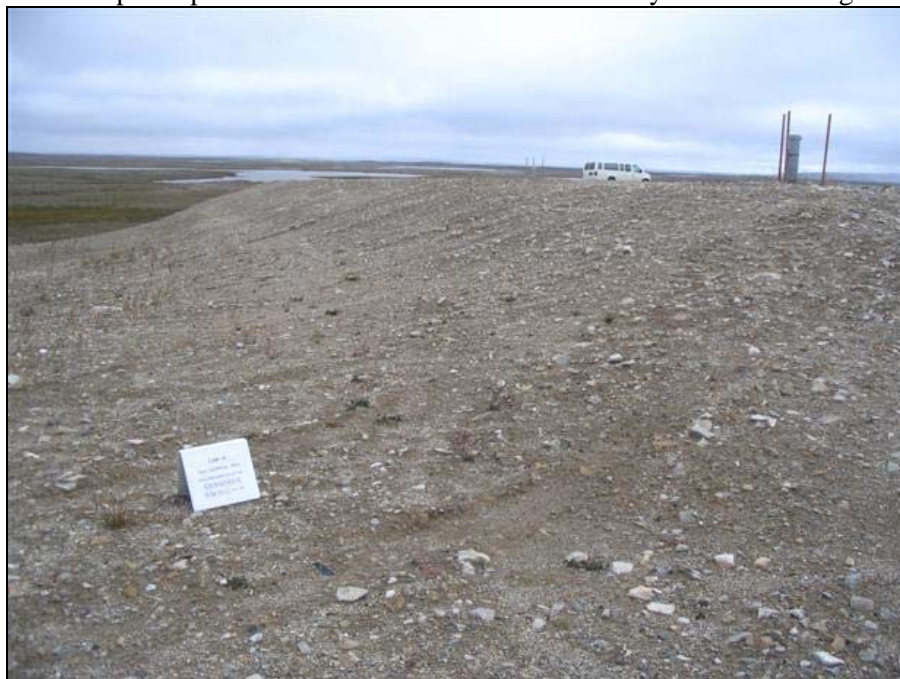
Photo SDA-11C, Easting: 494300, Northing: 7669297, Direction: 160°  
D.C.C. Tier II Soil Disposal Area; view facing southeast  
Scale: photo placard dimensions are 29.4 cm wide by 27.5 cm in height

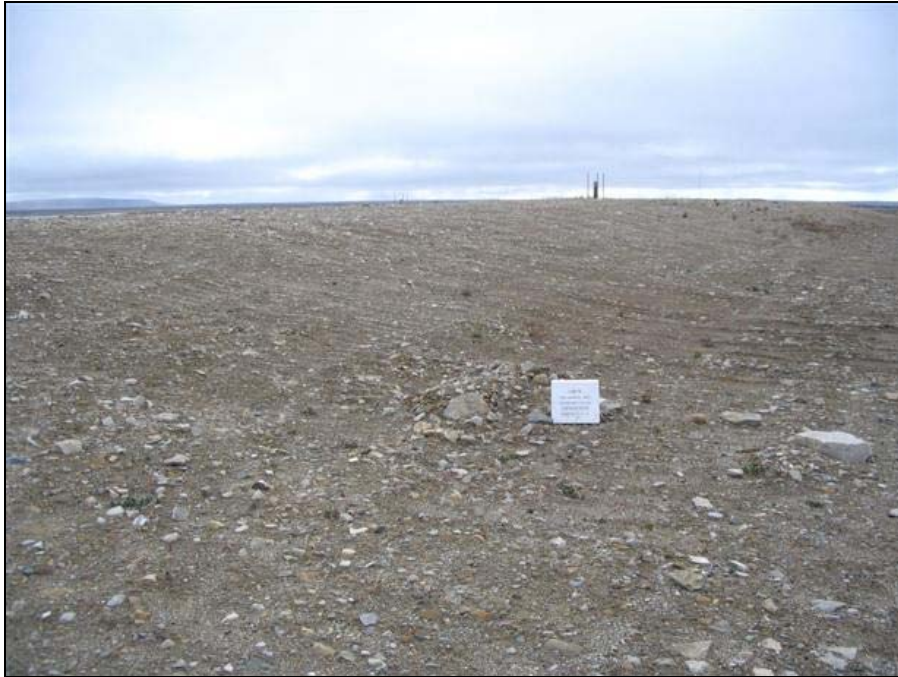
Photo SDA-12A, Easting: 494294, Northing: 7669271, Direction: 315°  
D.C.C. Tier II Soil Disposal Area; view facing northwest along west slope  
Scale: photo placard dimensions are 29.4 cm wide by 27.5 cm in height

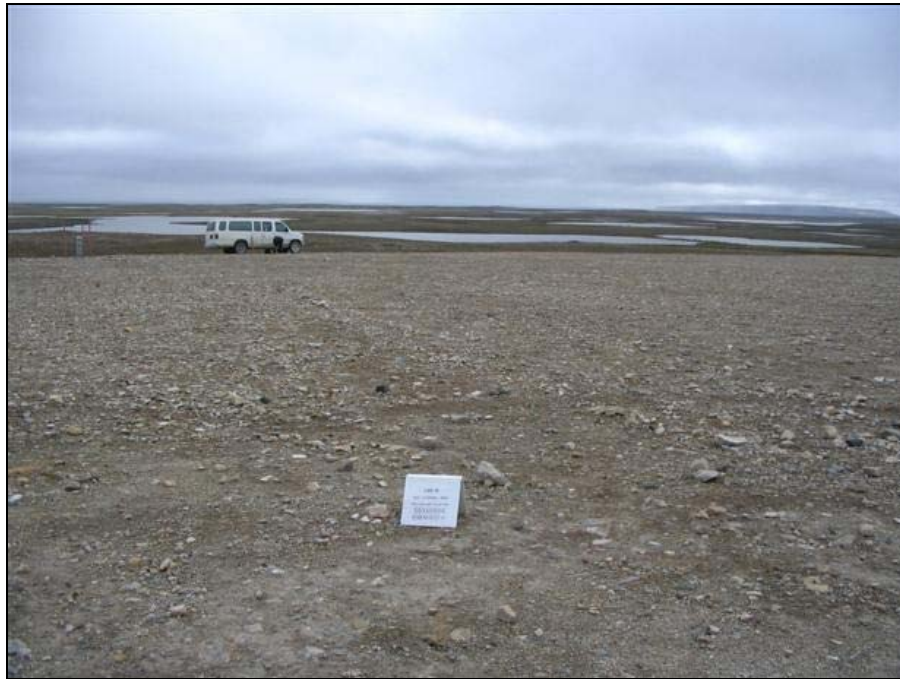
Photo SDA-12B, Easting: 494294, Northing: 7669271, Direction: 70°  
D.C.C. Tier II Soil Disposal Area; view facing northeast along south slope  
Scale: photo placard dimensions are 29.4 cm wide by 27.5 cm in height

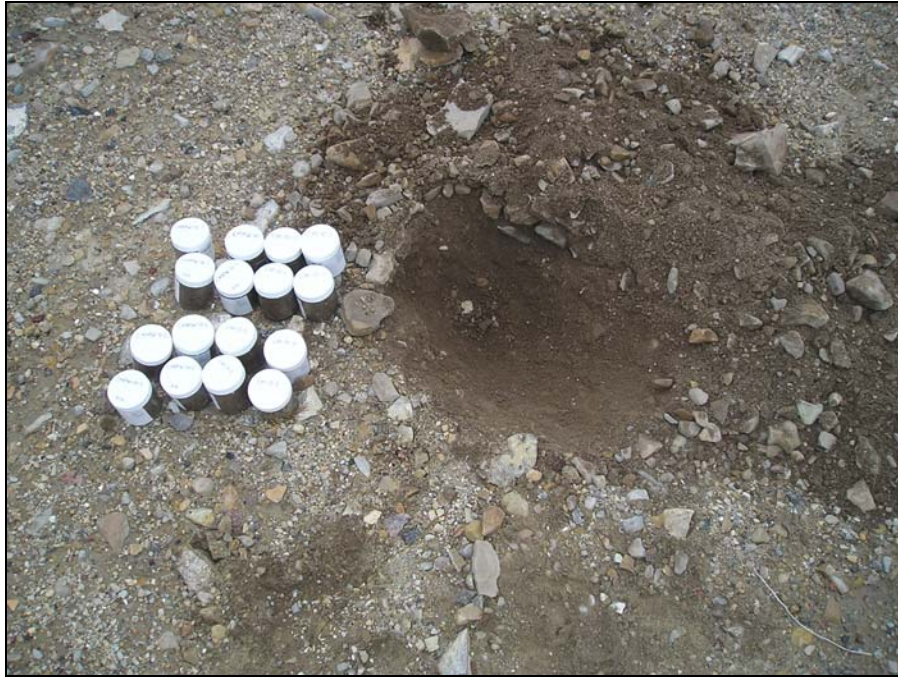
Test pit CM-MW-10. Samples CM-MW-10-1, CM-MW-10-2, CM-15-1 (Duplicate of CM-MW-10-1) and CM-15-2 (Duplicate of CM-MW-10-2) collected. Samples with identification numbers ending in “1” (ex. CM-MW-10-1) collected at 0-10cm and samples with identification numbers ending in “2” collected at 40-50cm.

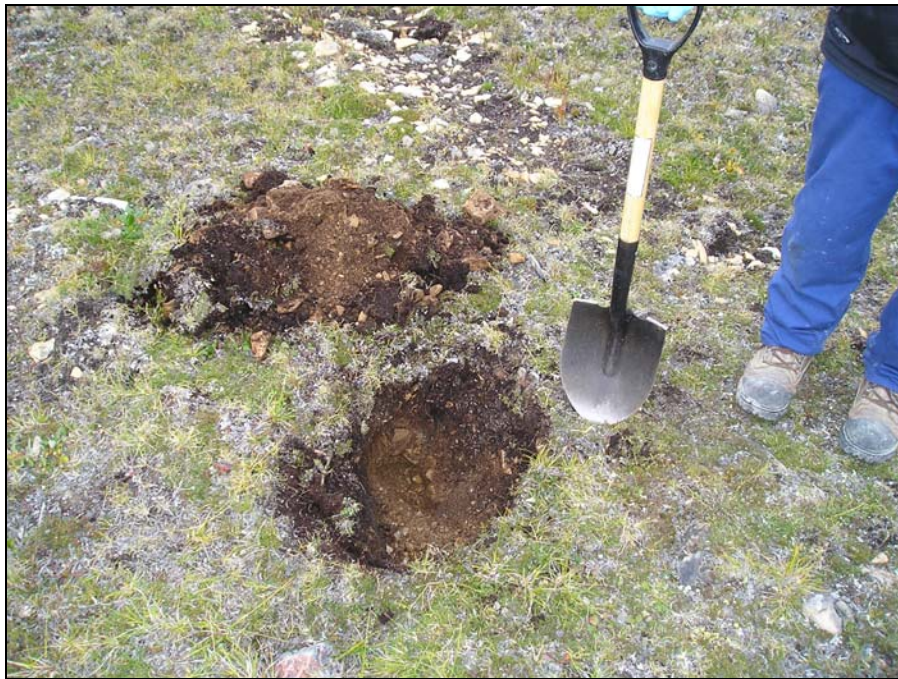
Test Pit CM-MW-11. Samples CM-MW-11-1 and CM-MW-11-2 collected.

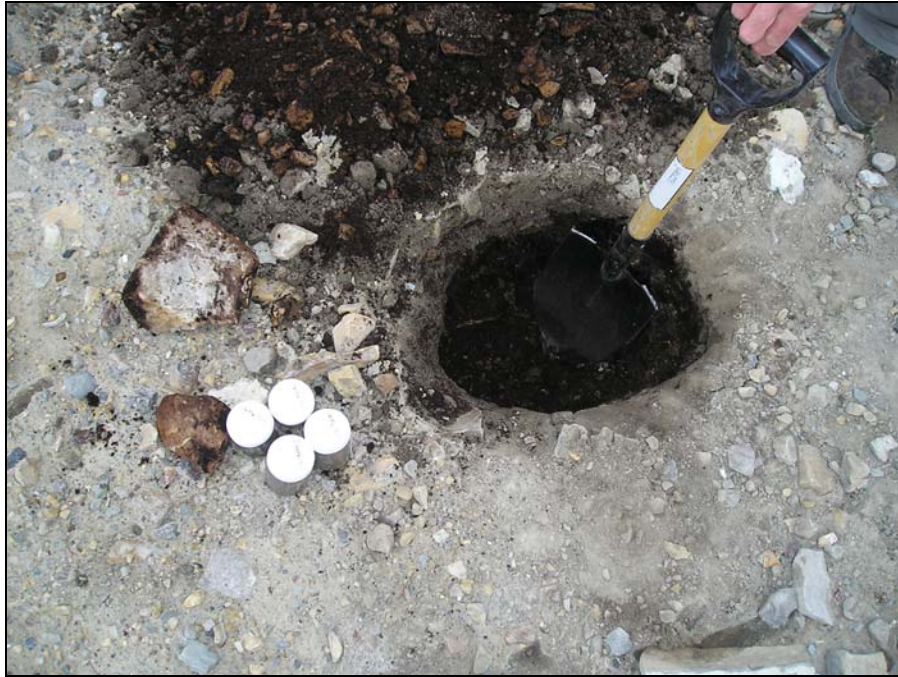
Test pit CM-MW-12. Samples CM-MW-12-1 and CM-MW-12-2 collected.

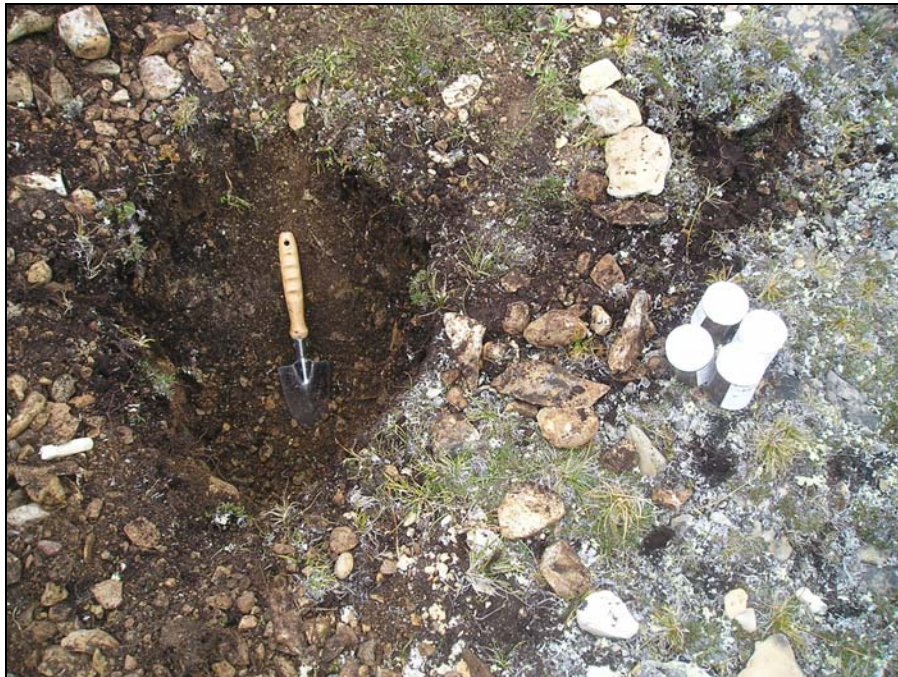
Test Pit CM-MW-13. Samples CM-MW-13-1 and CM-MW-13-2 collected.

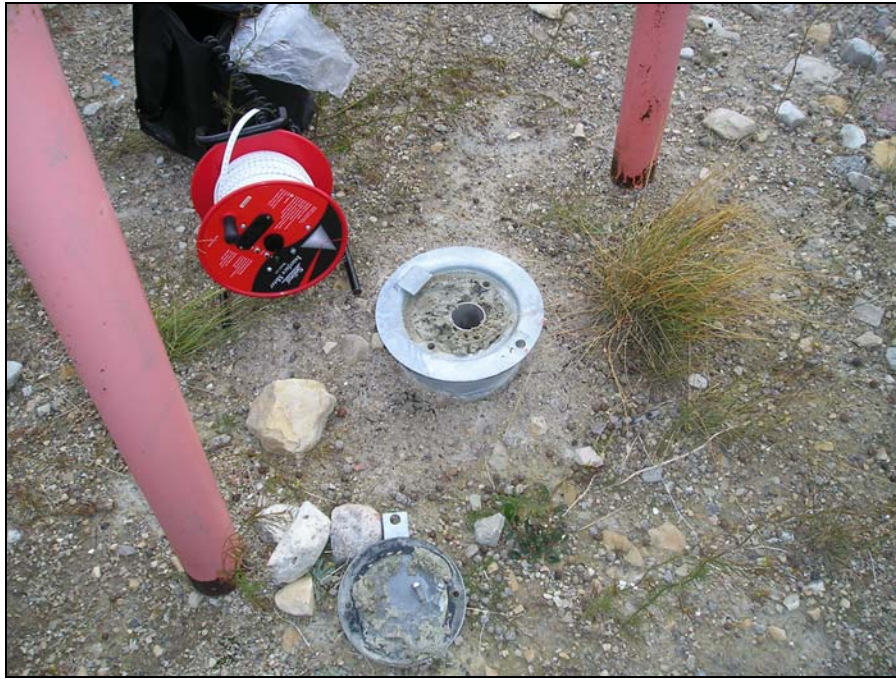
Monitoring well MW-10 (Upgradient). Sample CM-MW-10.

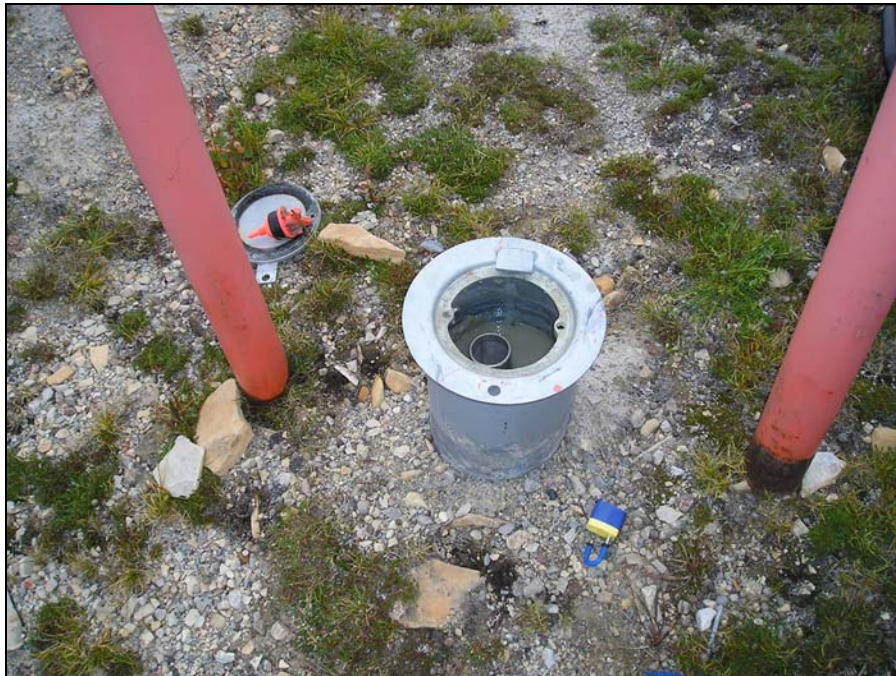
Monitoring well MW-11. Sample CM-MW-11 collected.

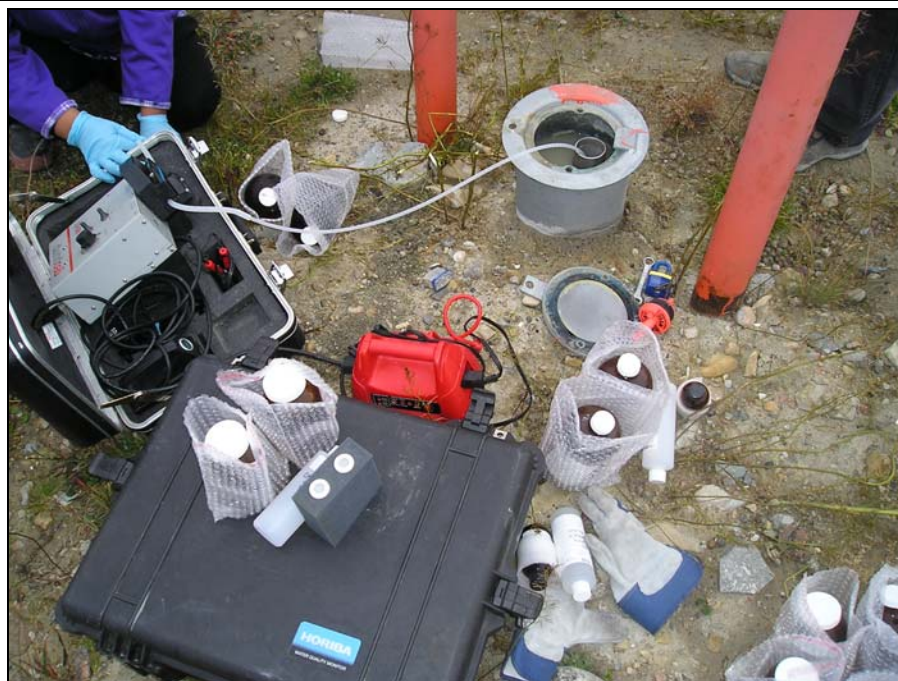
The groundwater samples collected at MW-12 contained concentrations that exceed the site condition standards in a potable groundwater source in Ontario for both Chromium and Nickel, however these values should be evaluated in the context of the DEW Line Monitoring Project. The average concentrations for Chromium and Nickel in the MW-12 samples were 0.184 and 0.174mg/L respectively compared to Ontario standards of 0.05 and 0.1mg/L for Chromium and Nickel respectively.

Monitoring well MW-12. Samples CM-MW-12 and CM-MW-15 (Duplicate) collected.

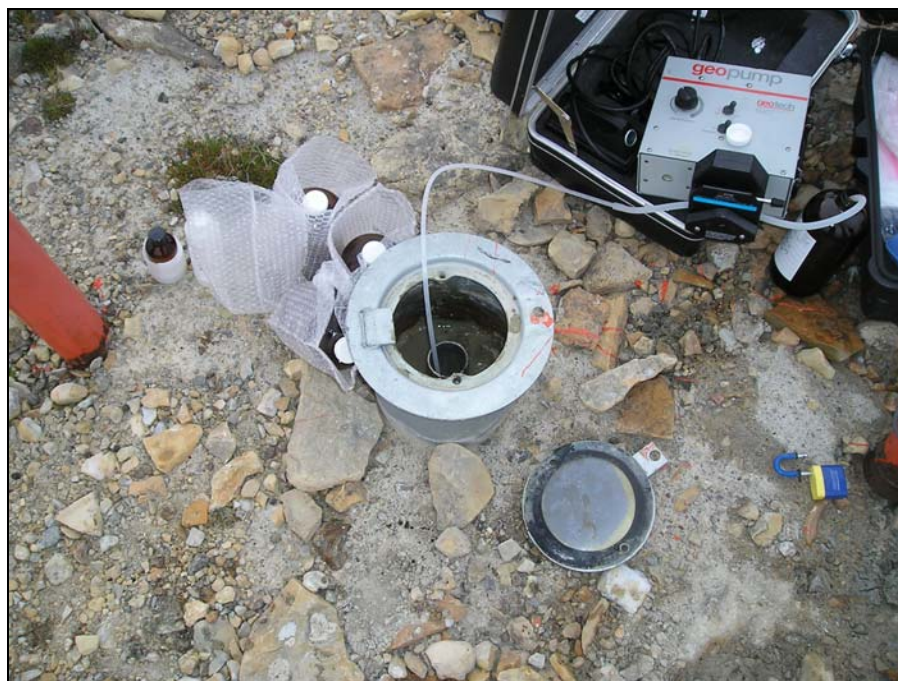
Monitoring well MW-13. Sample CM-MW-13 collected.
