Defence Construction Canada

PIN-2 Cape Young Baseline Landfill Monitoring

January 14, 2013

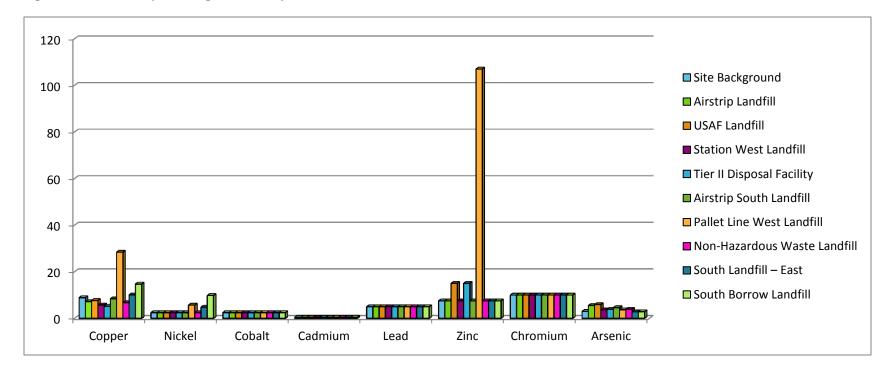
Figure 1.1: PIN-2 Cape Young - Summary of Arithmetic Mean - Soil Baseline Data

To provide a basis for evaluation with subsequent monitoring analytical results, simple statistical analyses were carried out to determine the arithmetic mean, standard deviation, and 95% confidence interval for each inorganic parameter analyzed. In general, for samples in which the concentration was less than the MDL, one-half of the MDL was used in the statistical analyses. However, in cases where the majority of the analytical results fell below the MDL, the arithmetic mean is represented as less than the MDL. It should be noted that MDLs for analyses completed under previous years' landfill assessment programs may not be the same as those specified in Table 1.8, particularly for PCBs. In cases where the contaminant was not detected, the chemical baseline is typically represented as a range over the different MDLs. Summaries of the arithmetic mean of the concentration of inorganic elements in soil are presented in Table 1.6. Additional statistical data is presented under the discussion for each landfill.

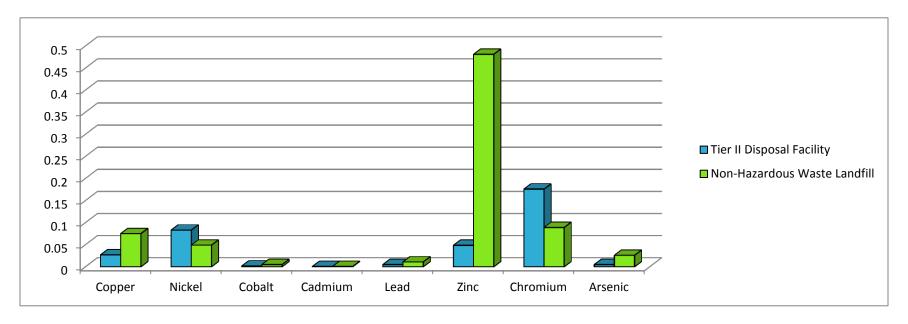
Figure 1.2: PIN-2 Cape Young – Summary of Arithmetic Mean – Groundwater Baseline Data

Area				Arithmetic Me	an (in mg/kg)			
	Copper	Nickel	Cobalt	Cadmium	Lead	Zinc	Chromium	Arsenic
Tier II Disposal Facility	0.027	0.083	<0.0030	<0.0010	<0.010	0.0486	0.1758	0.0050
Non-Hazardous Waste Landfill	0.075	0.049	0.005	<0.0010	0.011	0.481	0.089	0.026

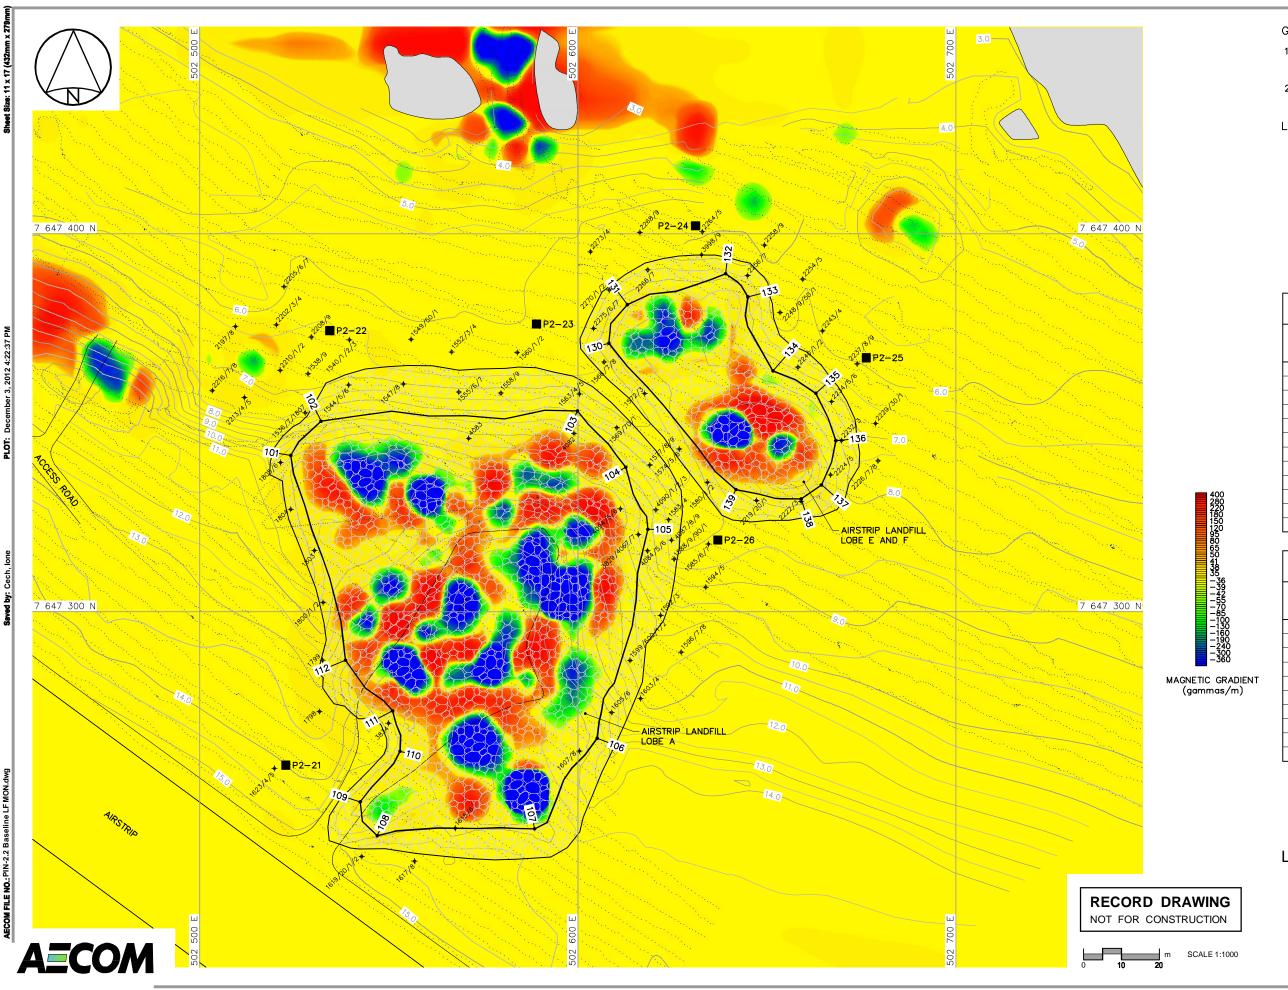
Sample locations for soil baseline data are shown in Figure PIN-2.2. A summary of the baseline soil analytical data is provided in Table 2.1. Baseline data is comprised of site investigation information collected up and down-gradient of the landfill in 2004 and samples collected at permanent monitoring locations up and down-gradient of the landfill in 2011. Mean soil baseline concentrations of inorganic elements are consistent with or lower than site background levels, with the exception of arsenic and PCB concentrations which are slightly higher than background levels. Low levels of TPH were detected at both the up-gradient and down-gradient sample locations. Concentrations of TPH ranged between <10 milligrams per kilogram (mg/kg) and 14,000 mg/kg.

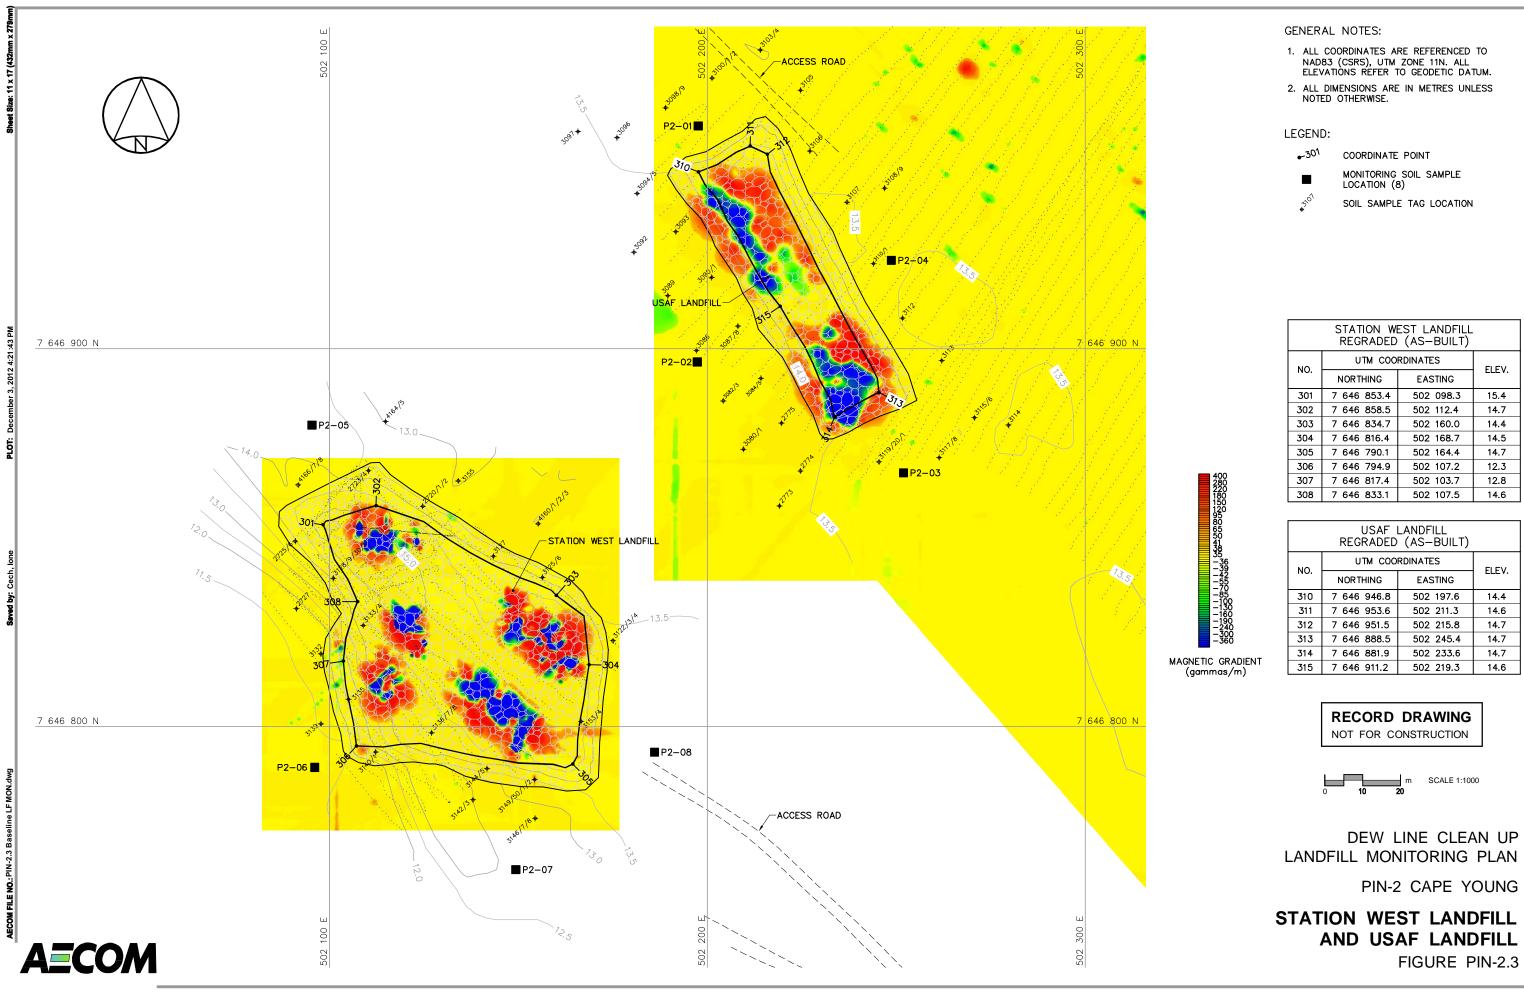
Sample locations for soil baseline data are shown in Figure PIN-2.3. A summary of the baseline soil analytical data is provided in Table 3.1. Baseline data is comprised of site investigation information collected up and down-gradient of the landfill in 2004 and samples collected at permanent monitoring locations up and down-gradient of the landfill in 2011. Mean soil baseline concentrations of inorganic elements are consistent with or lower than site background levels, with the exception of zinc and arsenic concentrations which are slightly higher than background levels. All PCB results were non-detect. Low levels of TPH were detected at down-gradient sample locations. Concentrations of TPH ranged between <10 mg/kg and 15 mg/kg.

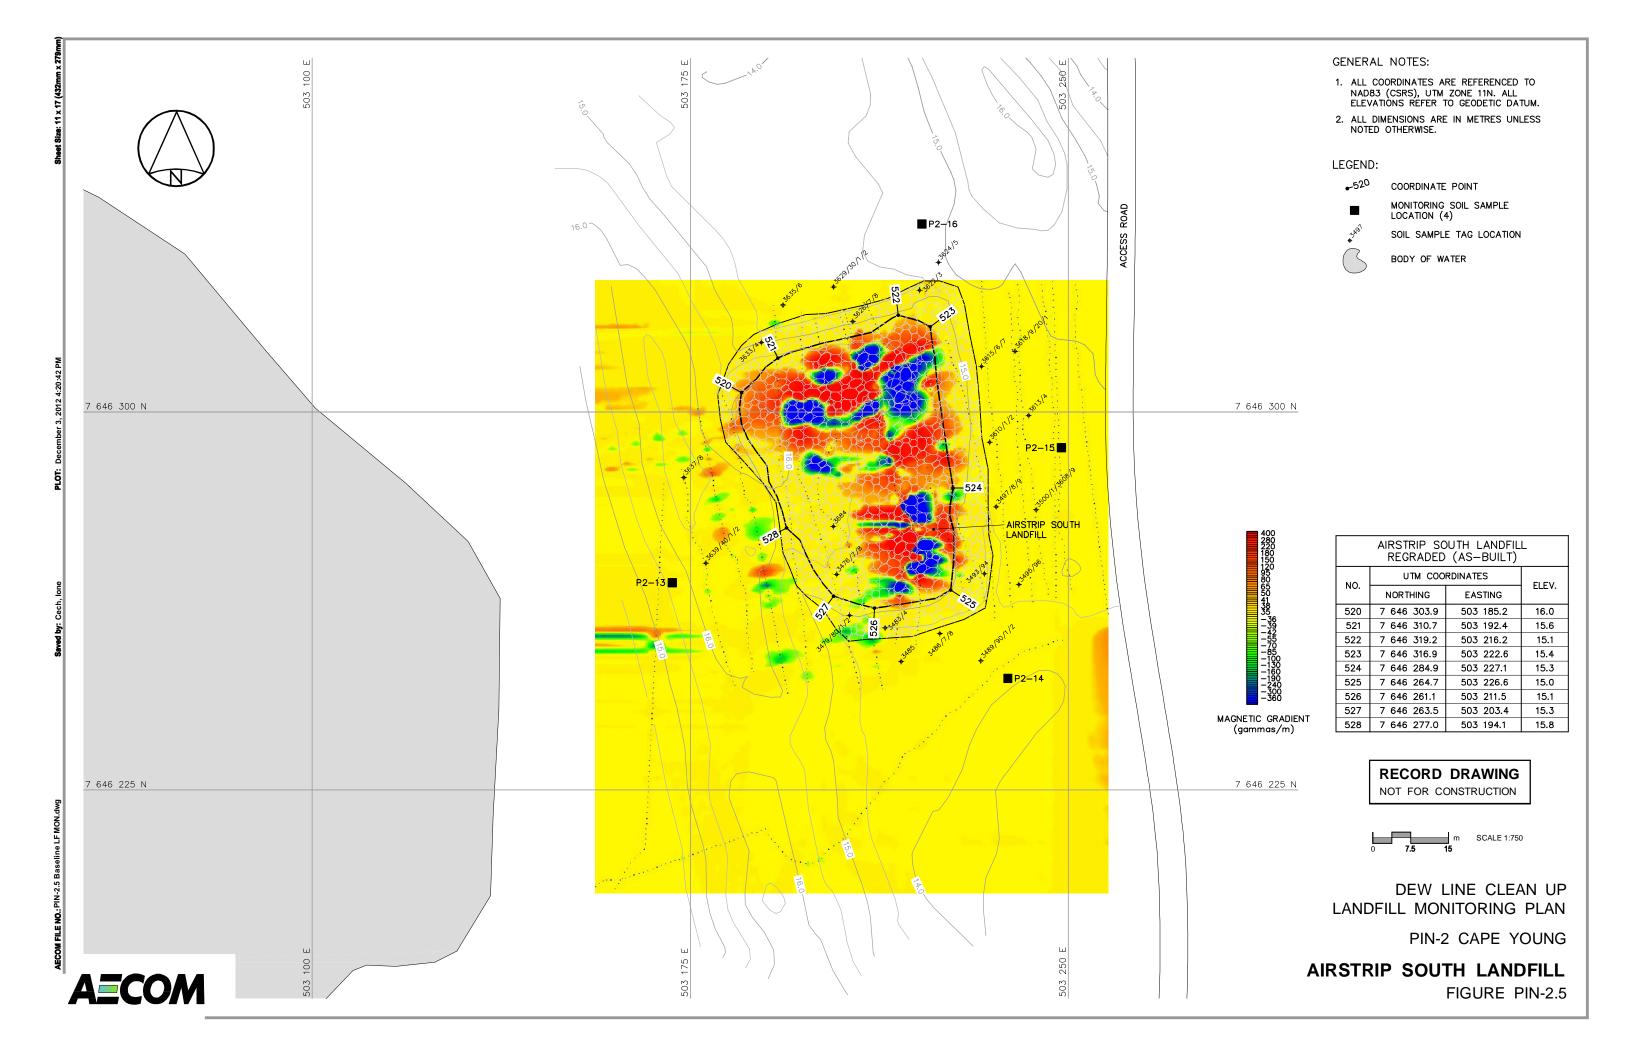
Sample locations for soil baseline data are shown in Figure PIN-2.5. A summary of the baseline soil analytical data is provided in Table 6.1. Baseline data is comprised of site investigation information collected up and down-gradient of the landfill in 2004 and samples collected at permanent monitoring locations up and down-gradient of the landfill in 2011. Mean soil baseline concentrations of inorganic elements are consistent with or lower than site background levels, with the exception of arsenic concentrations which are slightly higher than background levels. All PCB results were not detectable. Low level TPH concentrations (F2 and F3 fractions) were detected at several of the sample locations. Hydrocarbon concentrations ranged between <10 mg/kg to 730 mg/kg.

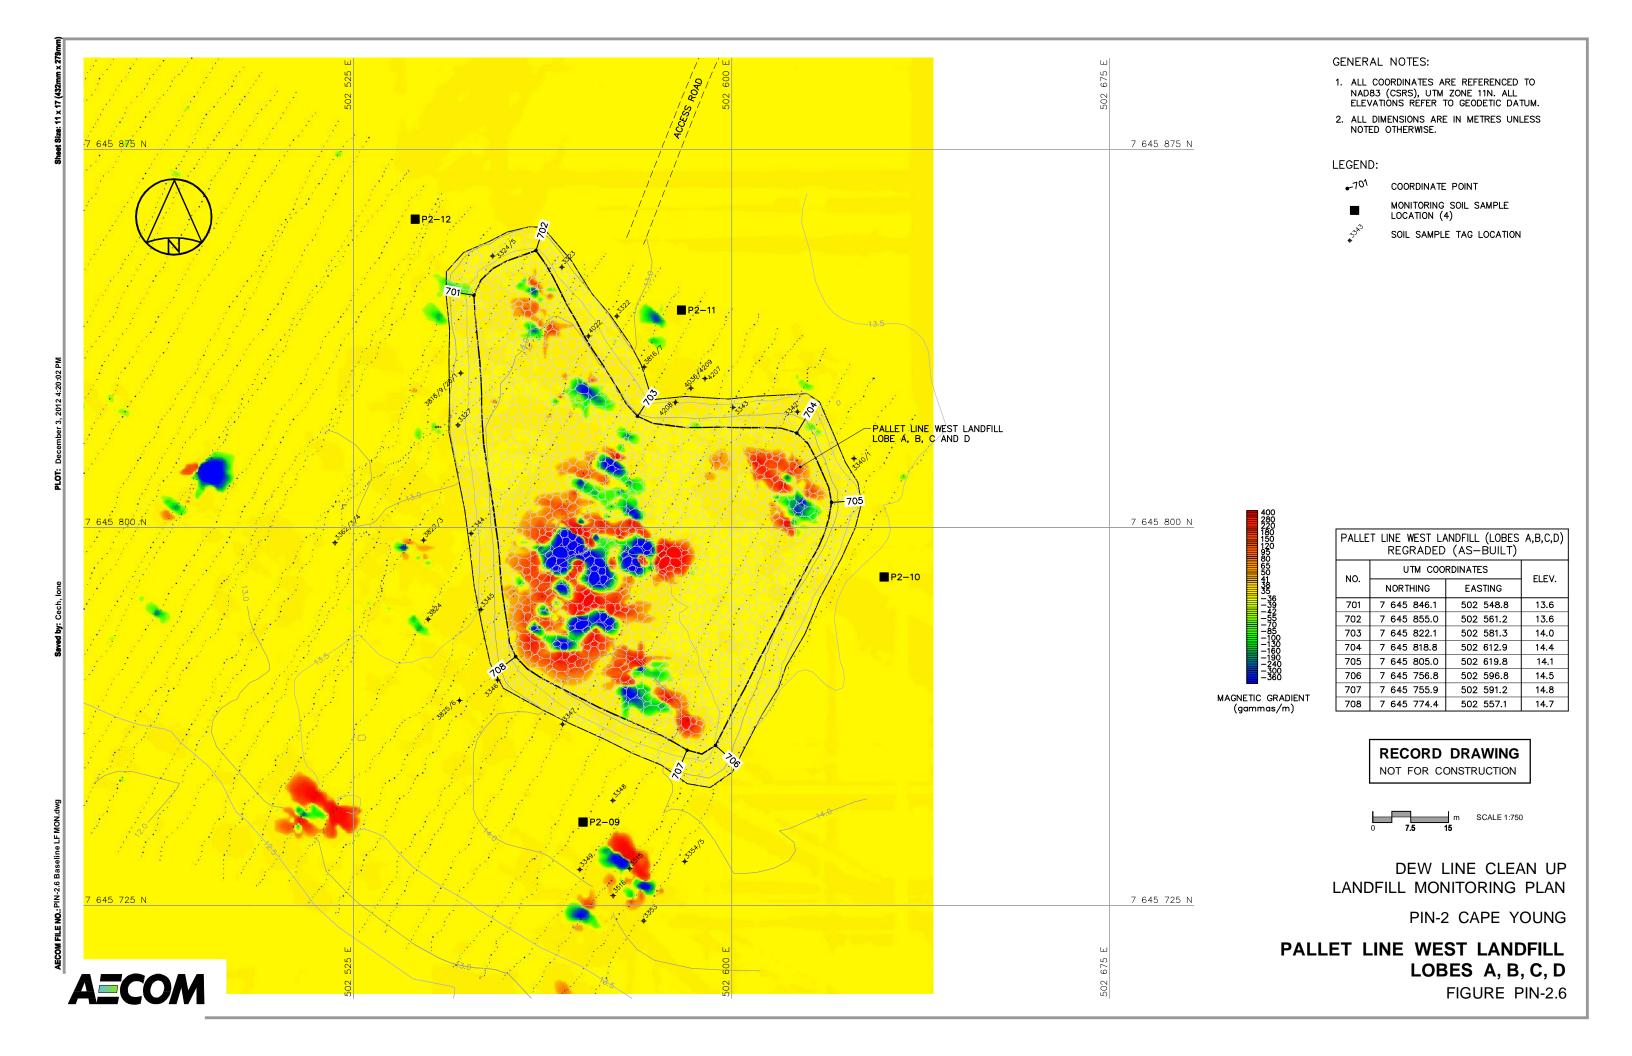
Sample locations for soil baseline data are shown in Figure PIN-2.6. A summary of the baseline soil analytical data is provided in Table 7.1. Baseline data is comprised of site investigation information collected up and down-gradient of the landfill in 2004 and samples collected at permanent monitoring locations up and down-gradient of the landfill in 2011. Mean soil baseline concentrations of inorganic elements are consistent with or lower than site background levels, with the exception of copper, zinc, and arsenic concentrations which are higher than background levels. All PCB results were not detectable. TPH concentrations (F2 and F3 fractions) were detected at several of the sample locations. Hydrocarbon concentrations ranged between 17 mg/kg to 580 mg/kg.

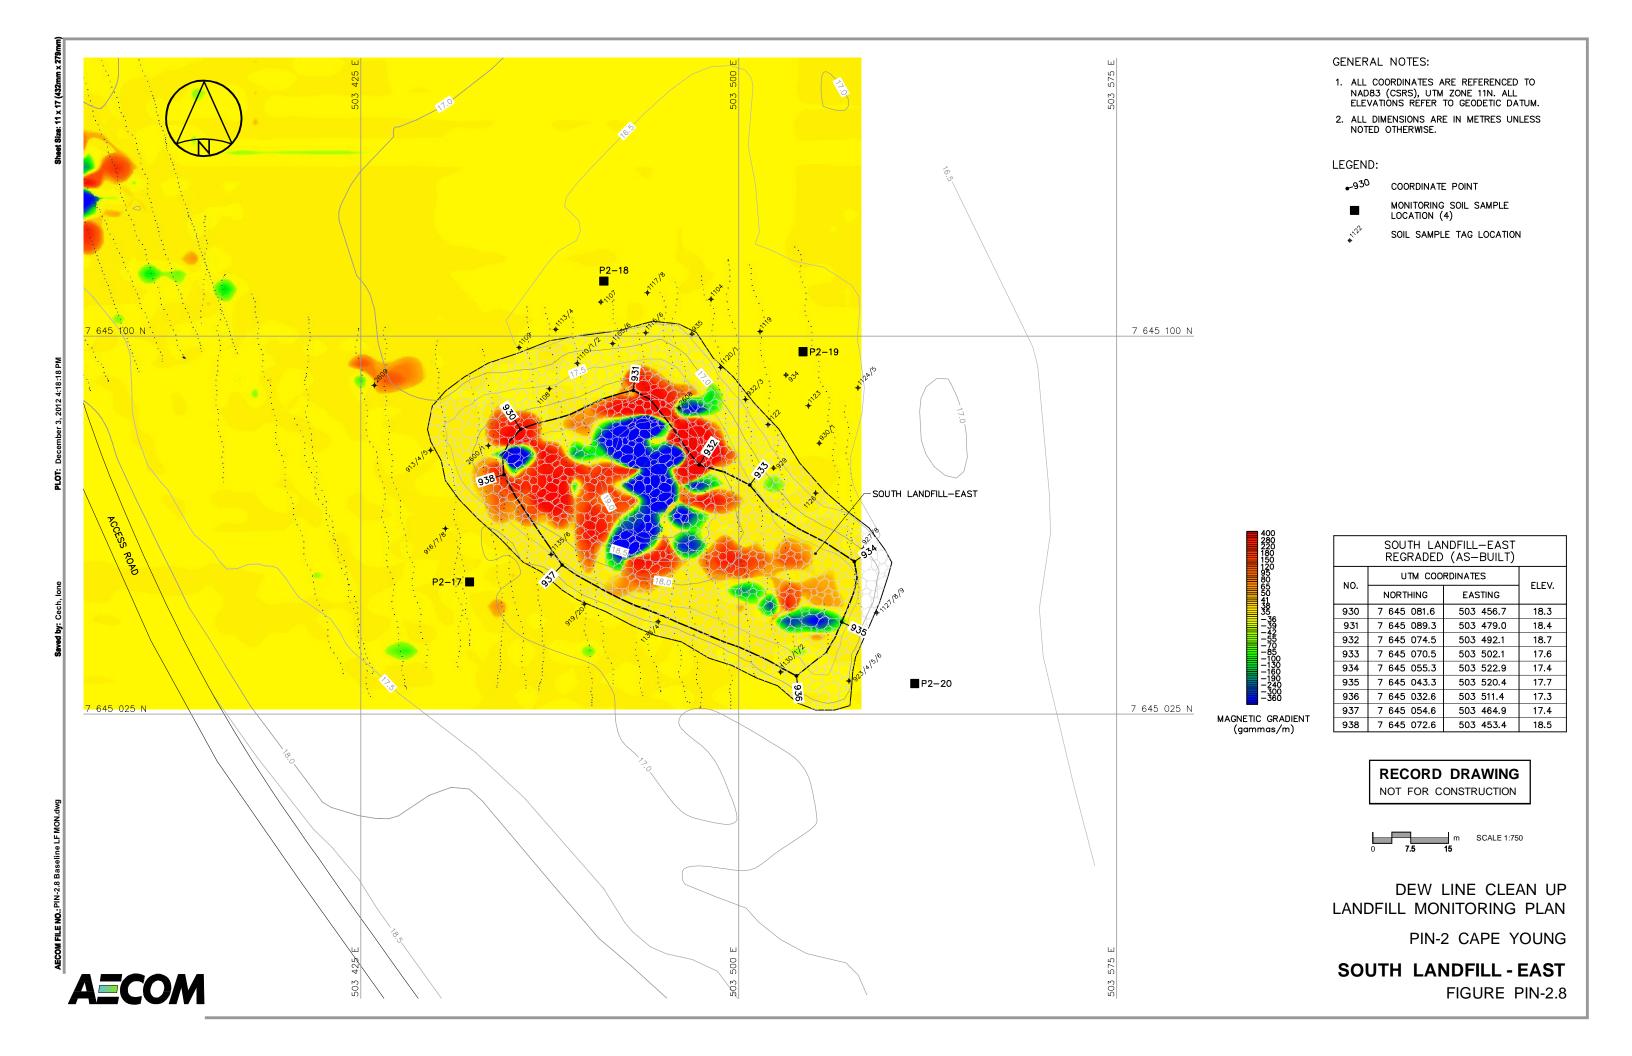
Sample locations for soil baseline data are shown in Figure PIN-2.8. A summary of the baseline soil analytical data is provided in Table 9.1. Baseline data is comprised of site investigation information collected up and down-gradient of the landfill in 2004 and samples collected at permanent monitoring locations up and down-gradient of the landfill in 2011. Mean soil baseline concentrations of inorganic elements are consistent with or lower than site background levels, with the exception of copper and zinc, concentrations which are higher than background levels. All PCB results were below detection limits. TPH concentrations (F2 and F3 fractions) were detected at several of the sample locations. Hydrocarbon concentrations ranged between 10 mg/kg to 170 mg/kg.

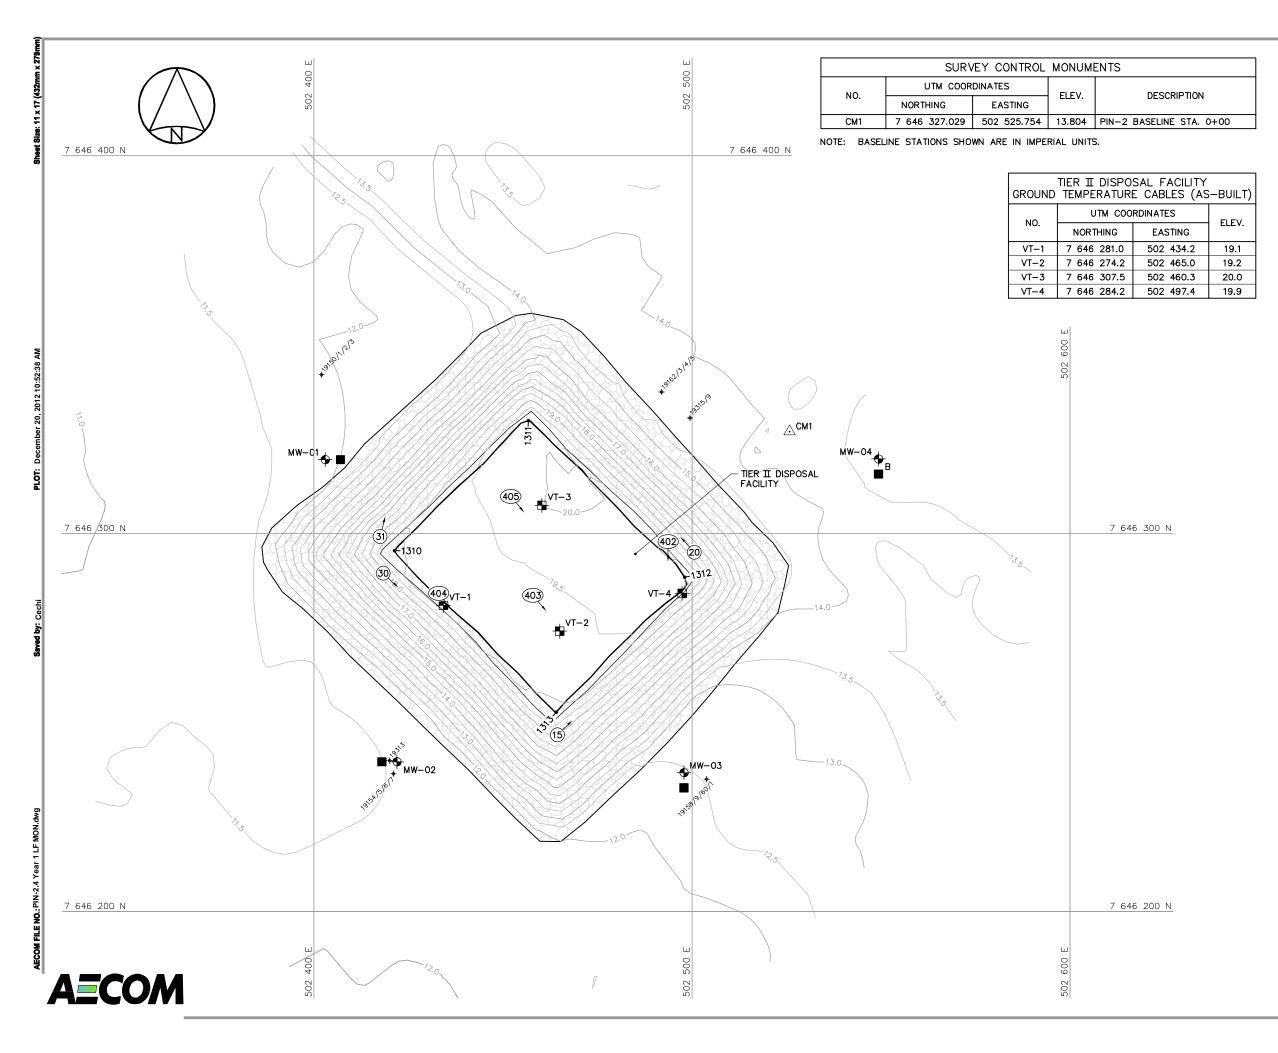
TIER II DISPOSAL FACILITY FIGURE PIN-2.4

The average active layer depth of 2.5 m was less than the design active layer (4.0 m) (EBA 2012). The ground temperatures are expected to cool in subsequent years, and the active layer is expected to reach the design active layer.

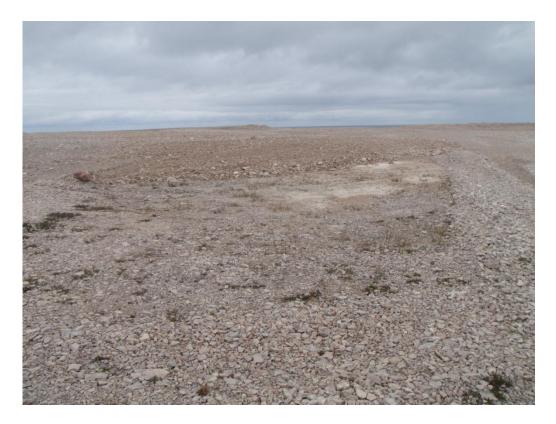
Photograph 41. Area showing signs of minor ponding in the past (Photo 484). ↑
