Indian and Northern
Affairs Canada

PIN-B (Clifton Point) **Long Term Monitoring Plan**

April 15, 2011

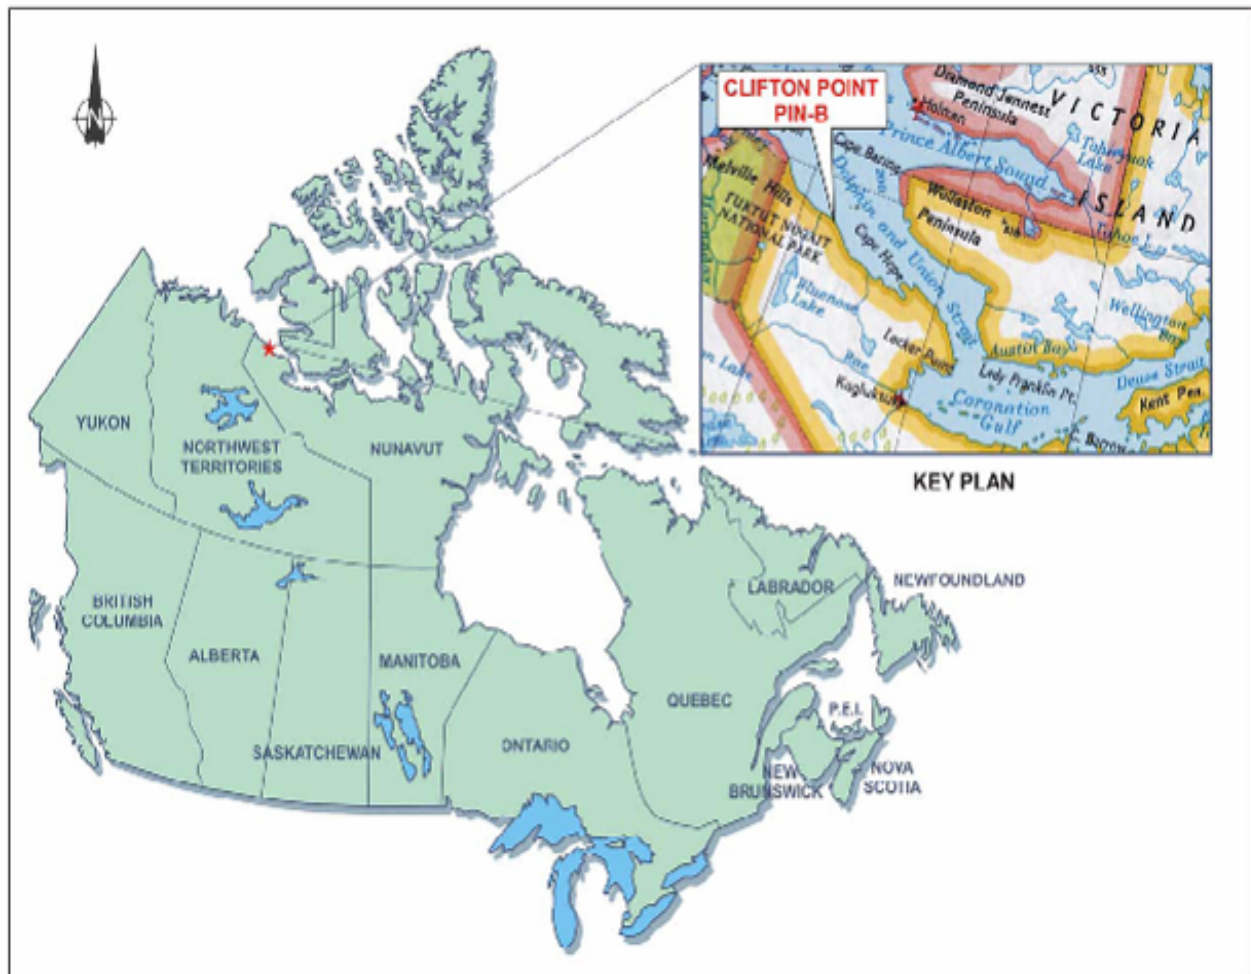
Figure 1: PIN-B (Clifton Point) site location

Clifton Point is located on the coast of Amundsen Gulf (Beaufort Sea) in Nunavut. The nearest communities are Paulatuk, NWT, about 220 km to the northwest, and Kugluktuk, Nunavut about 220 km to the southeast. The site is situated about 1 km inland from the coast (see Figure 1 and Appendix A).

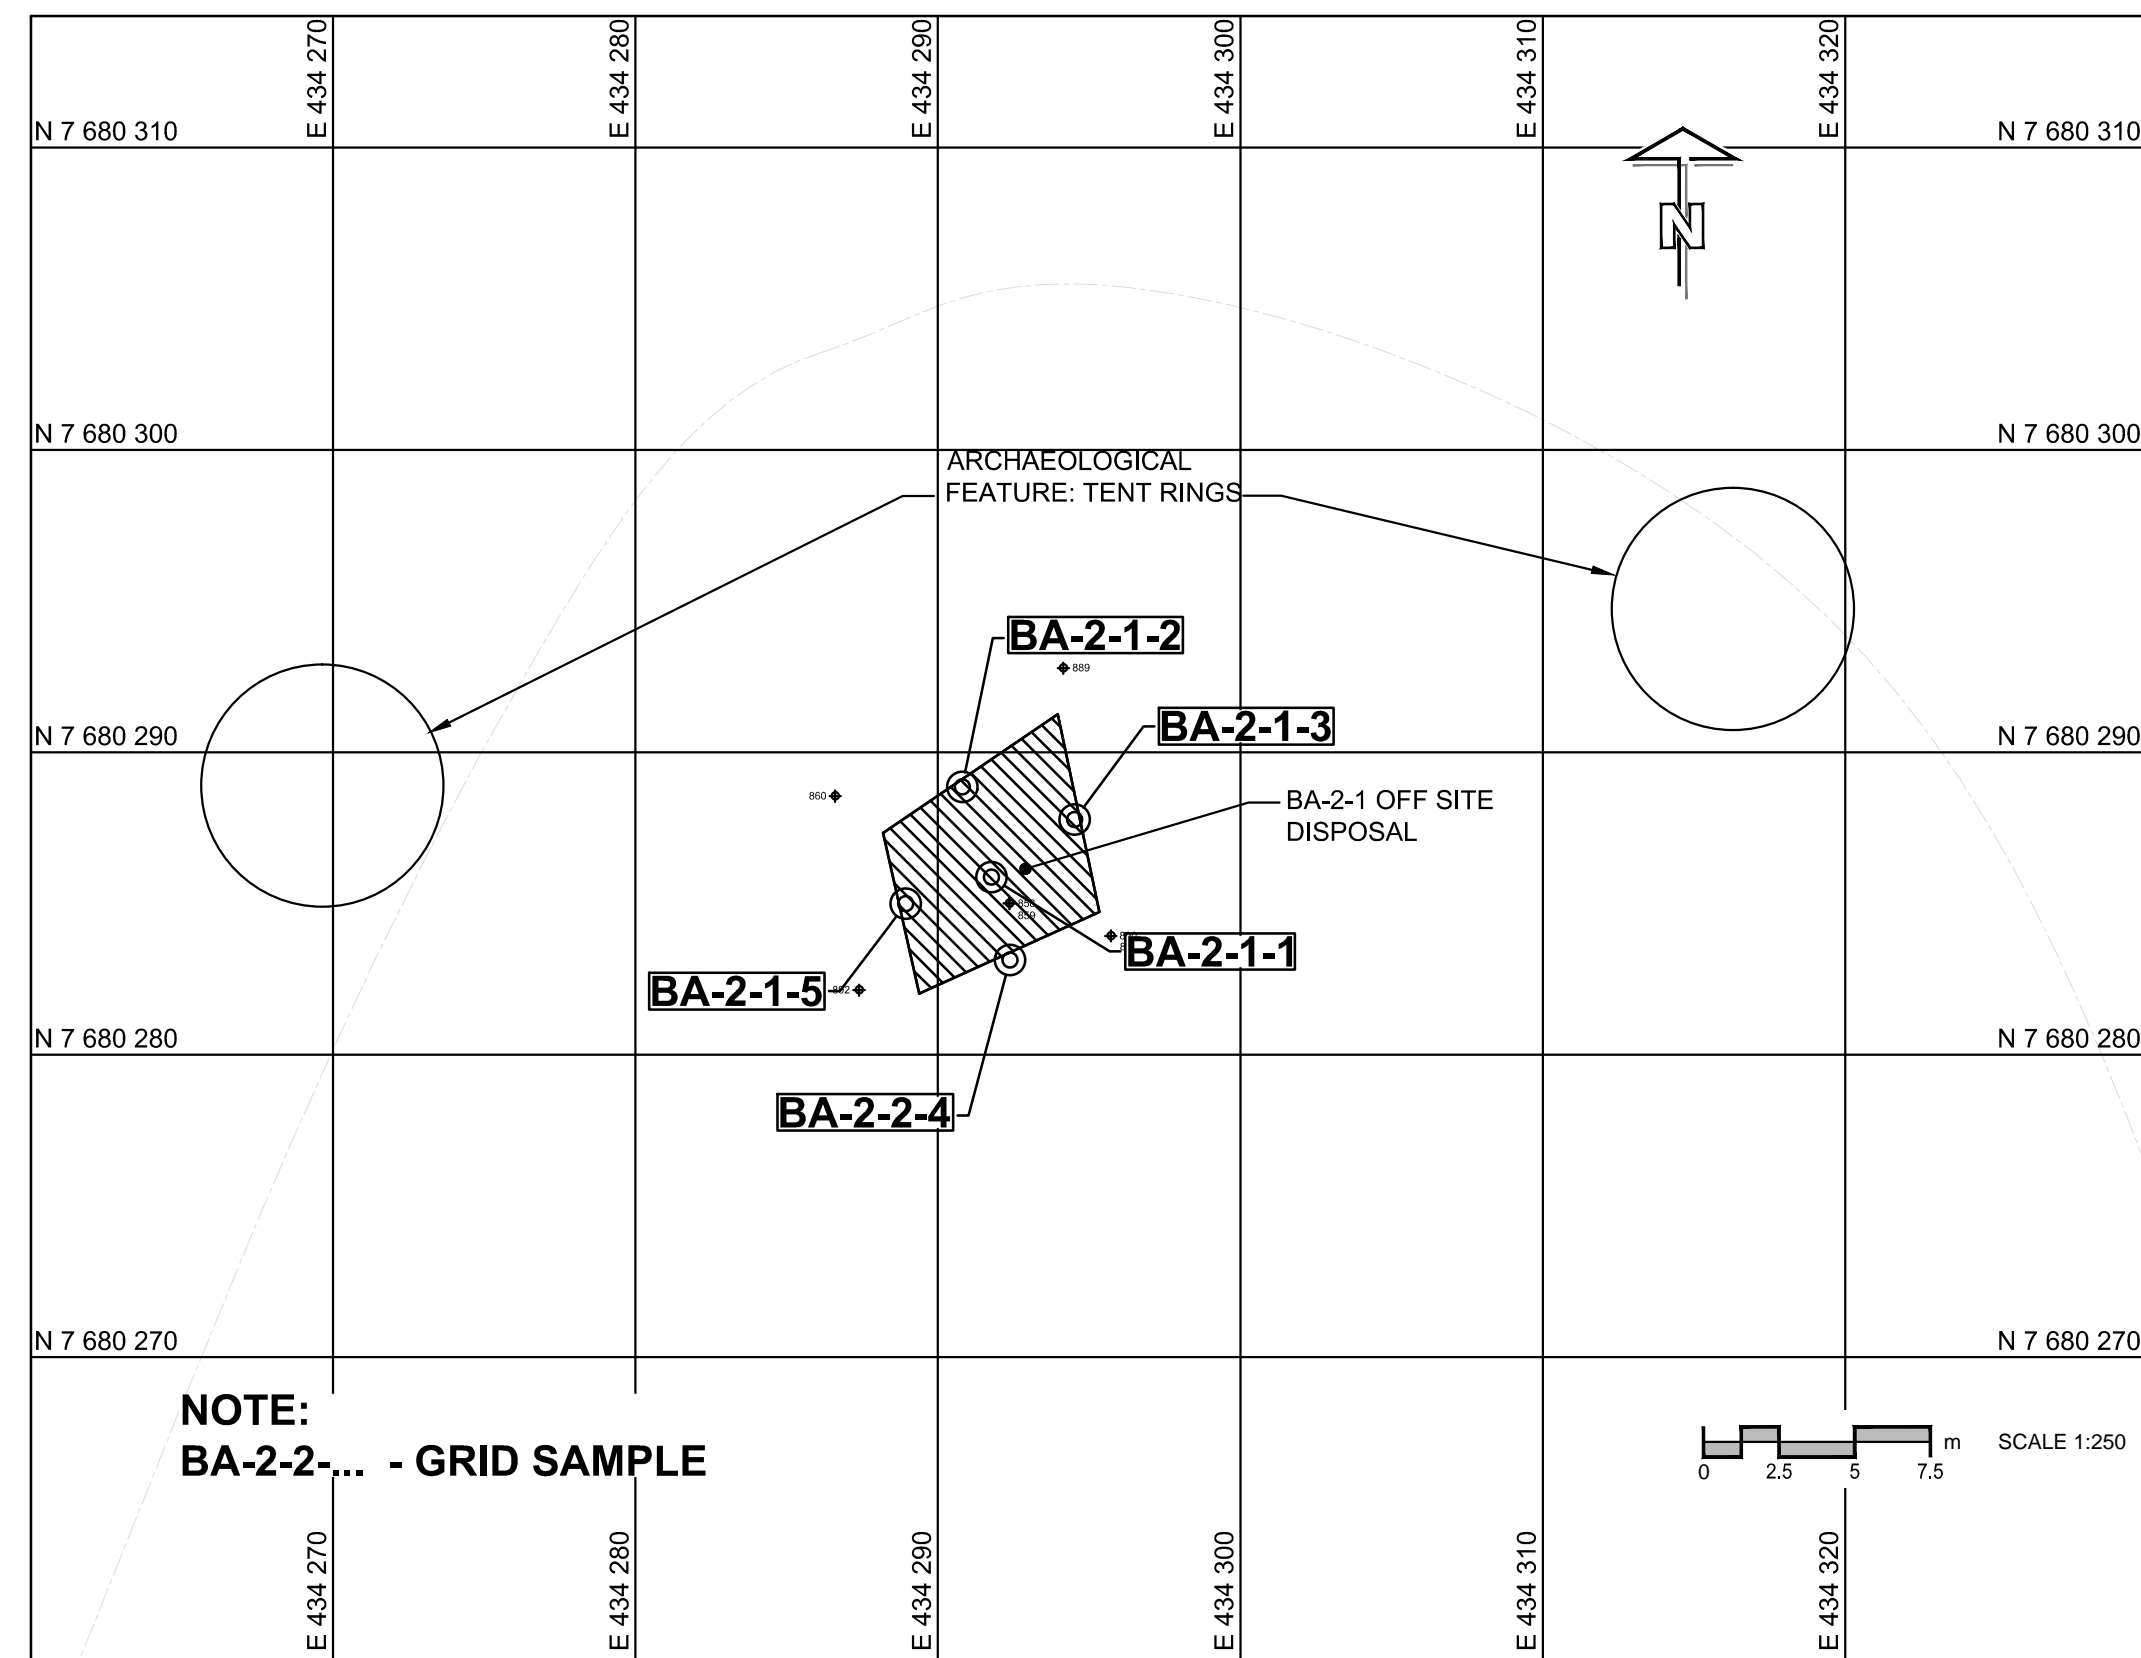
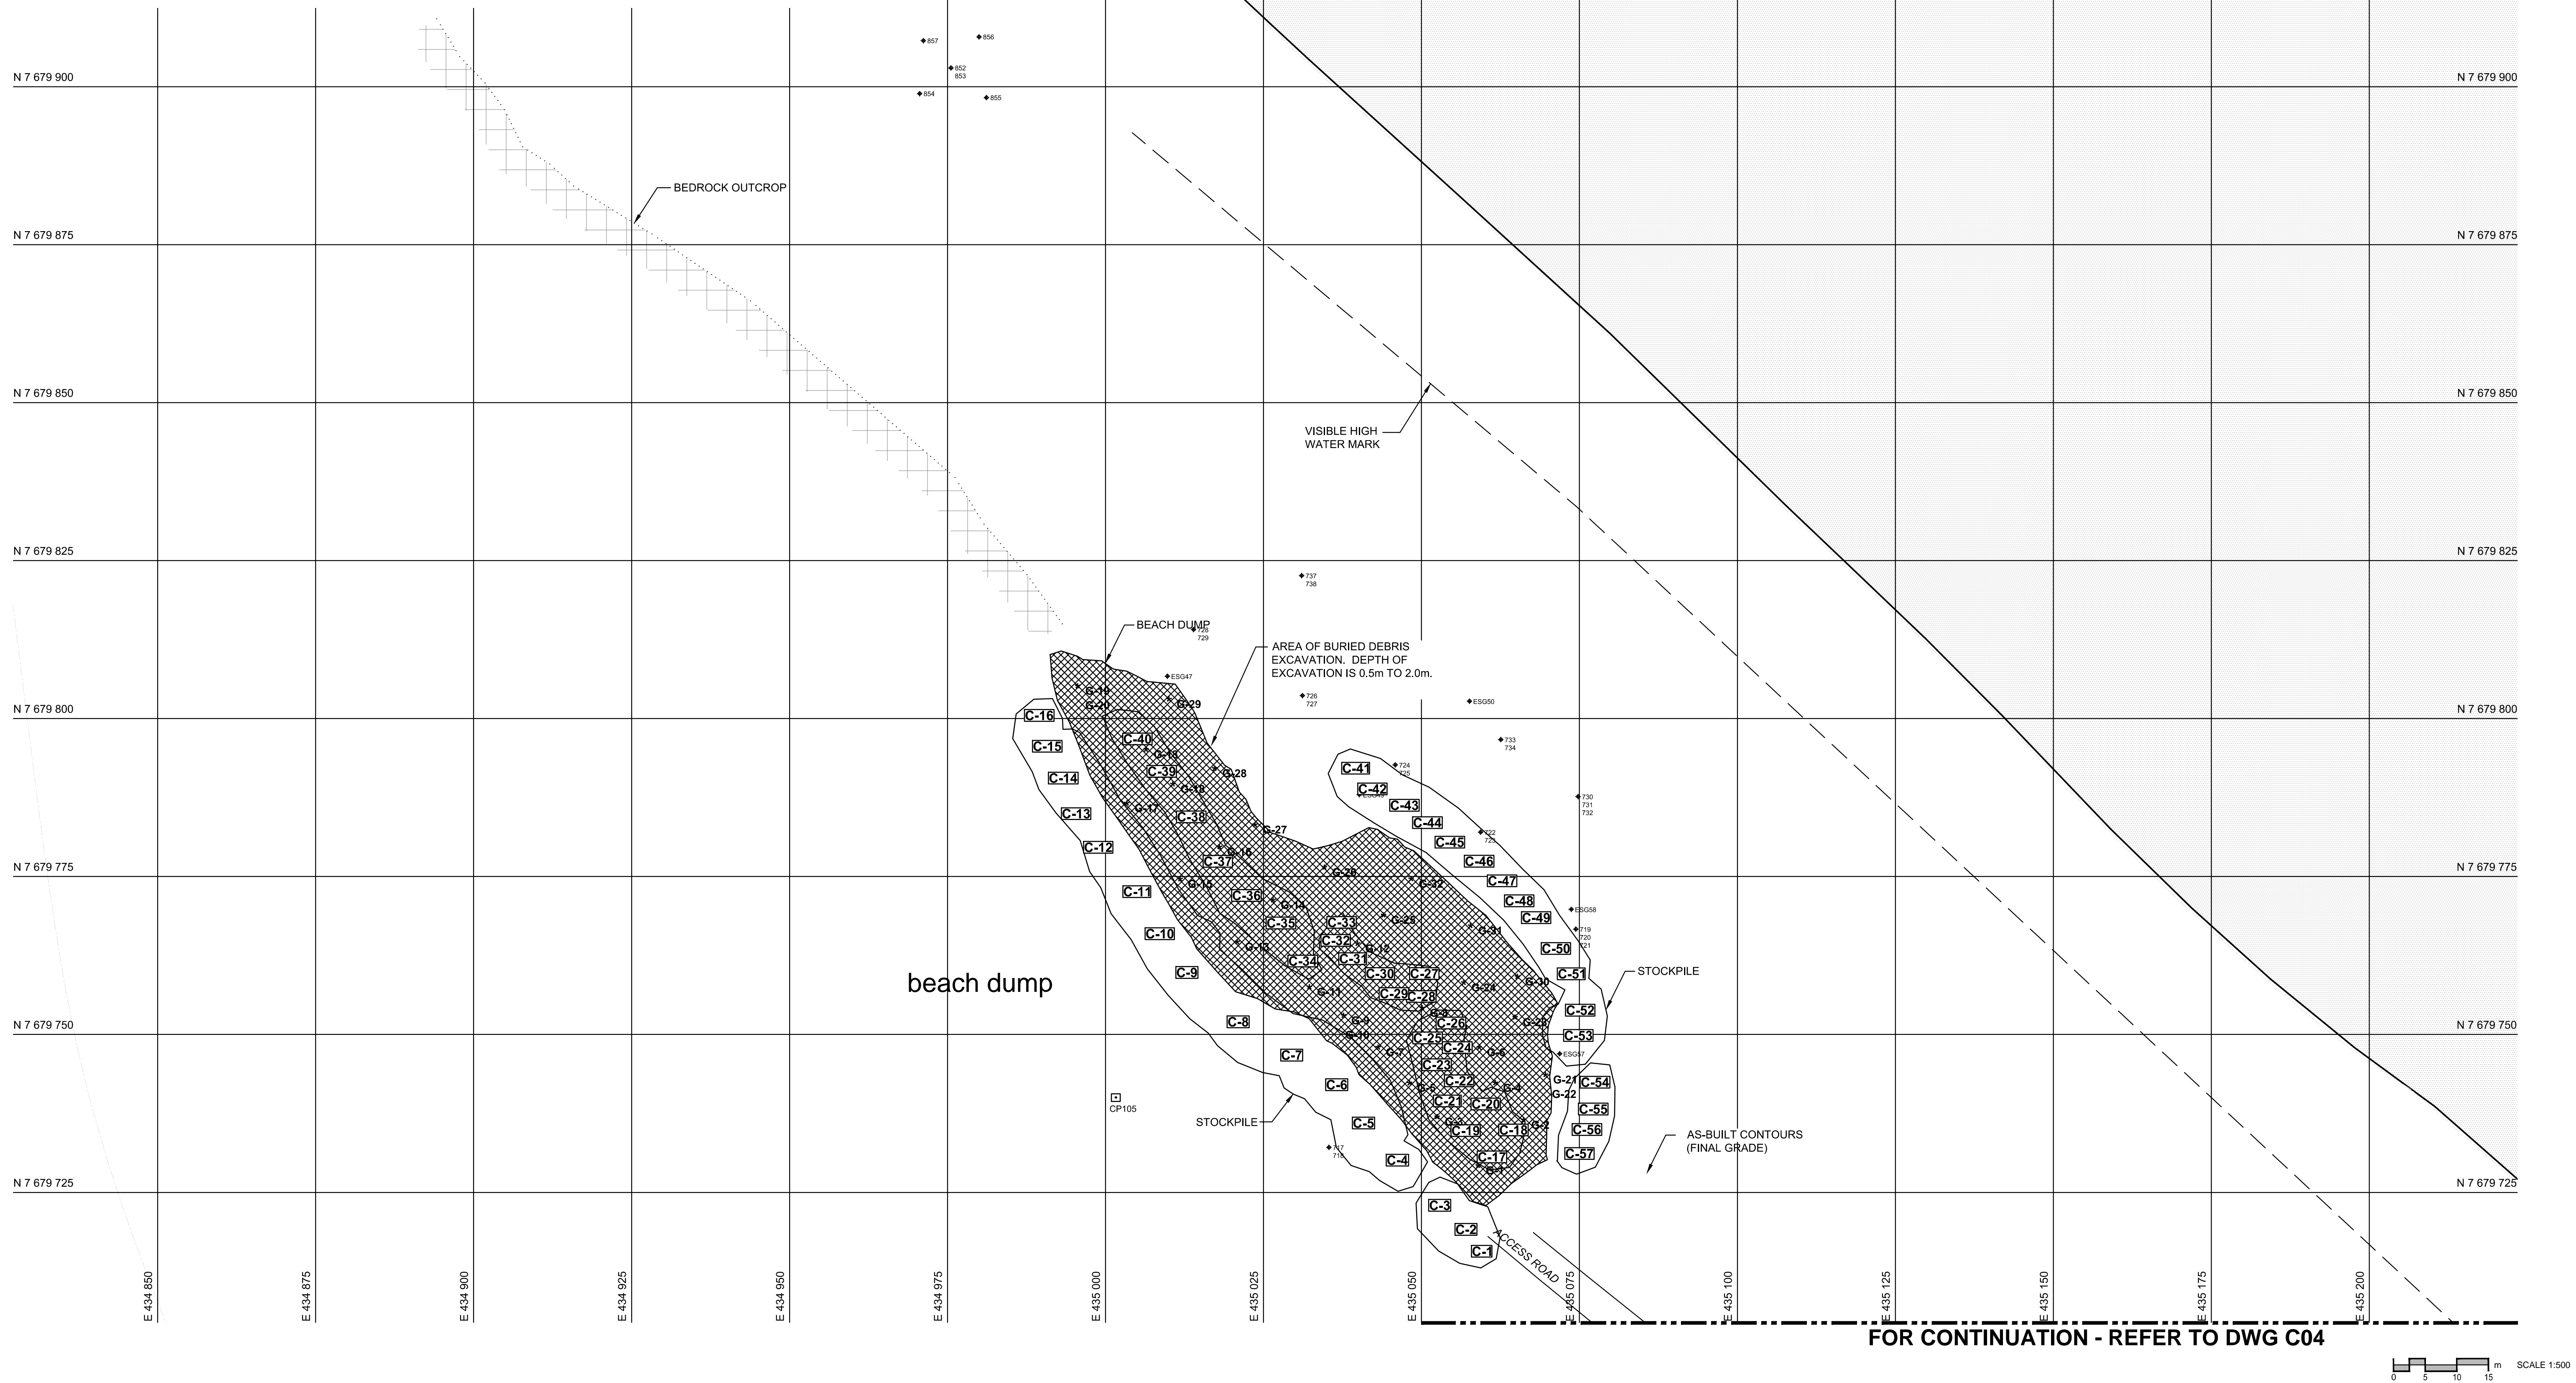
FIGURE 3
AREA 1 AND 2
BEACH DUMP AREA

1. ALL DIMENSIONS ARE IN METRES UNLESS NOTED OTHERWISE.
2. ALL COORDINATES ARE REFERENCED TO NAD83(CSRS). ELEVATIONS ARE REFERENCED TO MEAN SEA LEVEL, RELATIVE TO GEOID MODEL CANADIAN HT2_0.
3. G - # - GRID SAMPLE FROM BASE OF EXCAVATION.
4. C - # - COMPOSITE SAMPLE TAKEN FROM STOCKPILE OF THE SAME #.
5. DISCRETE SAMPLES (NOT SHOWN) WERE TAKEN FROM STOCKPILES

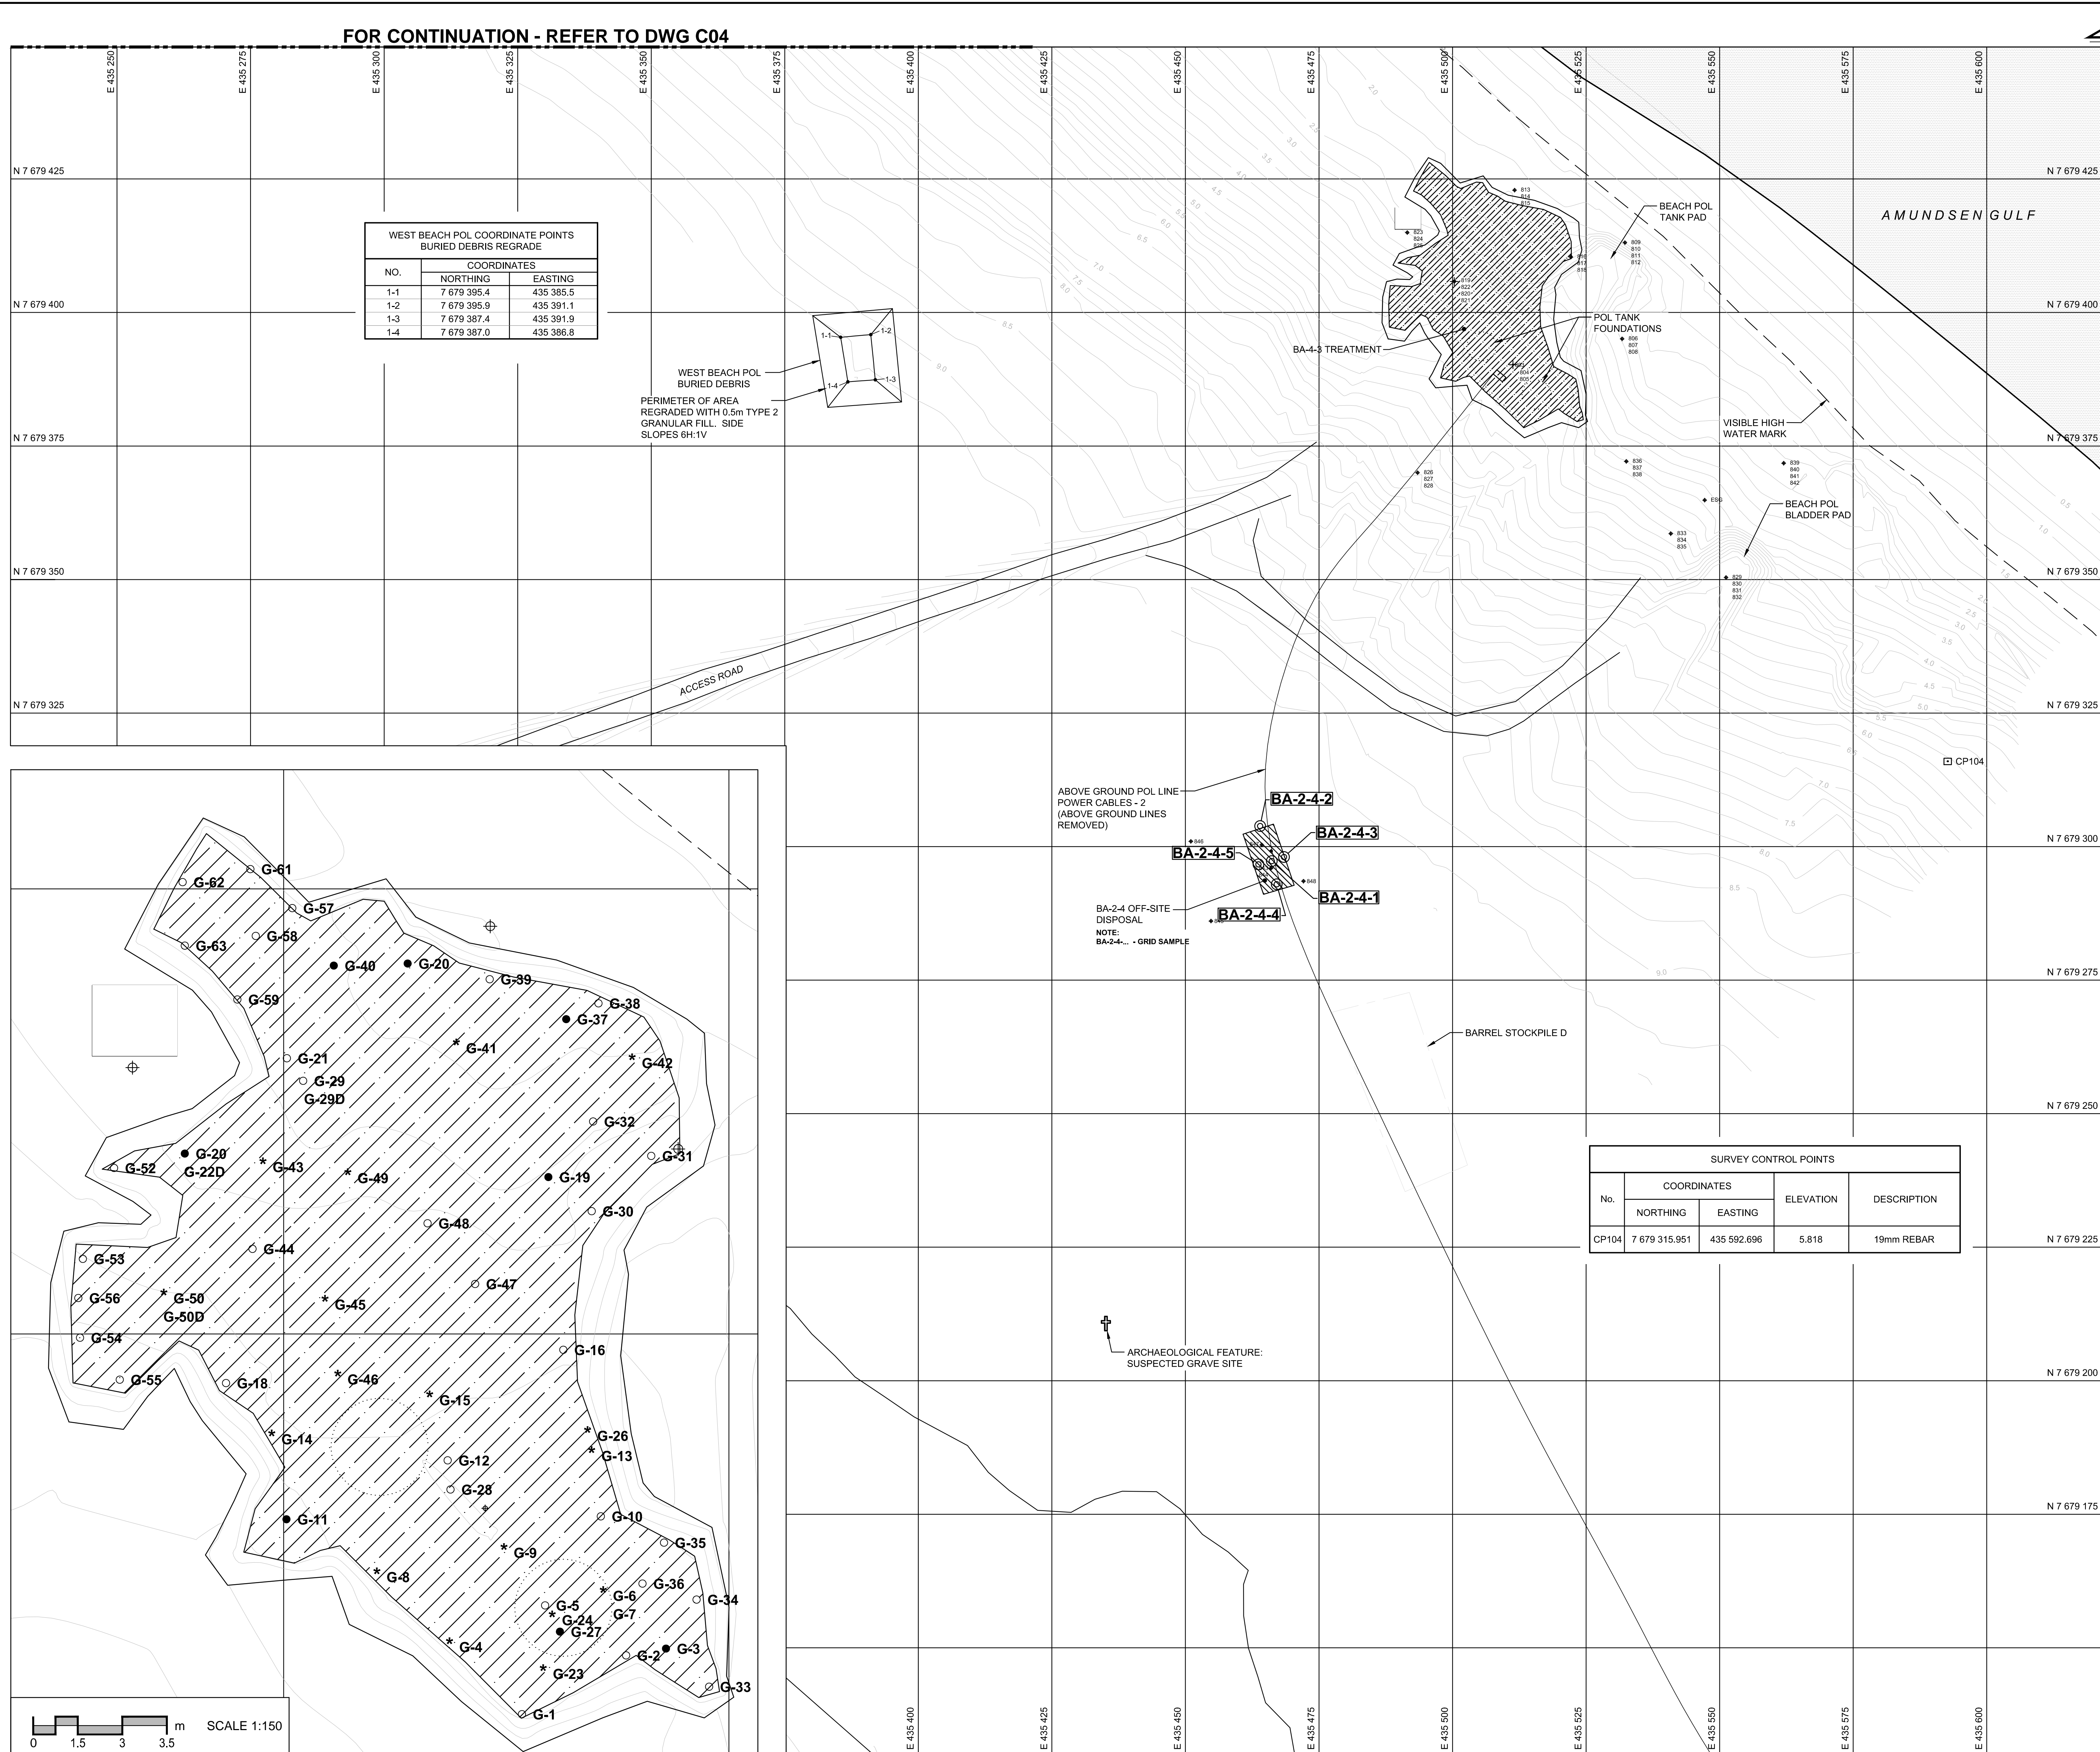
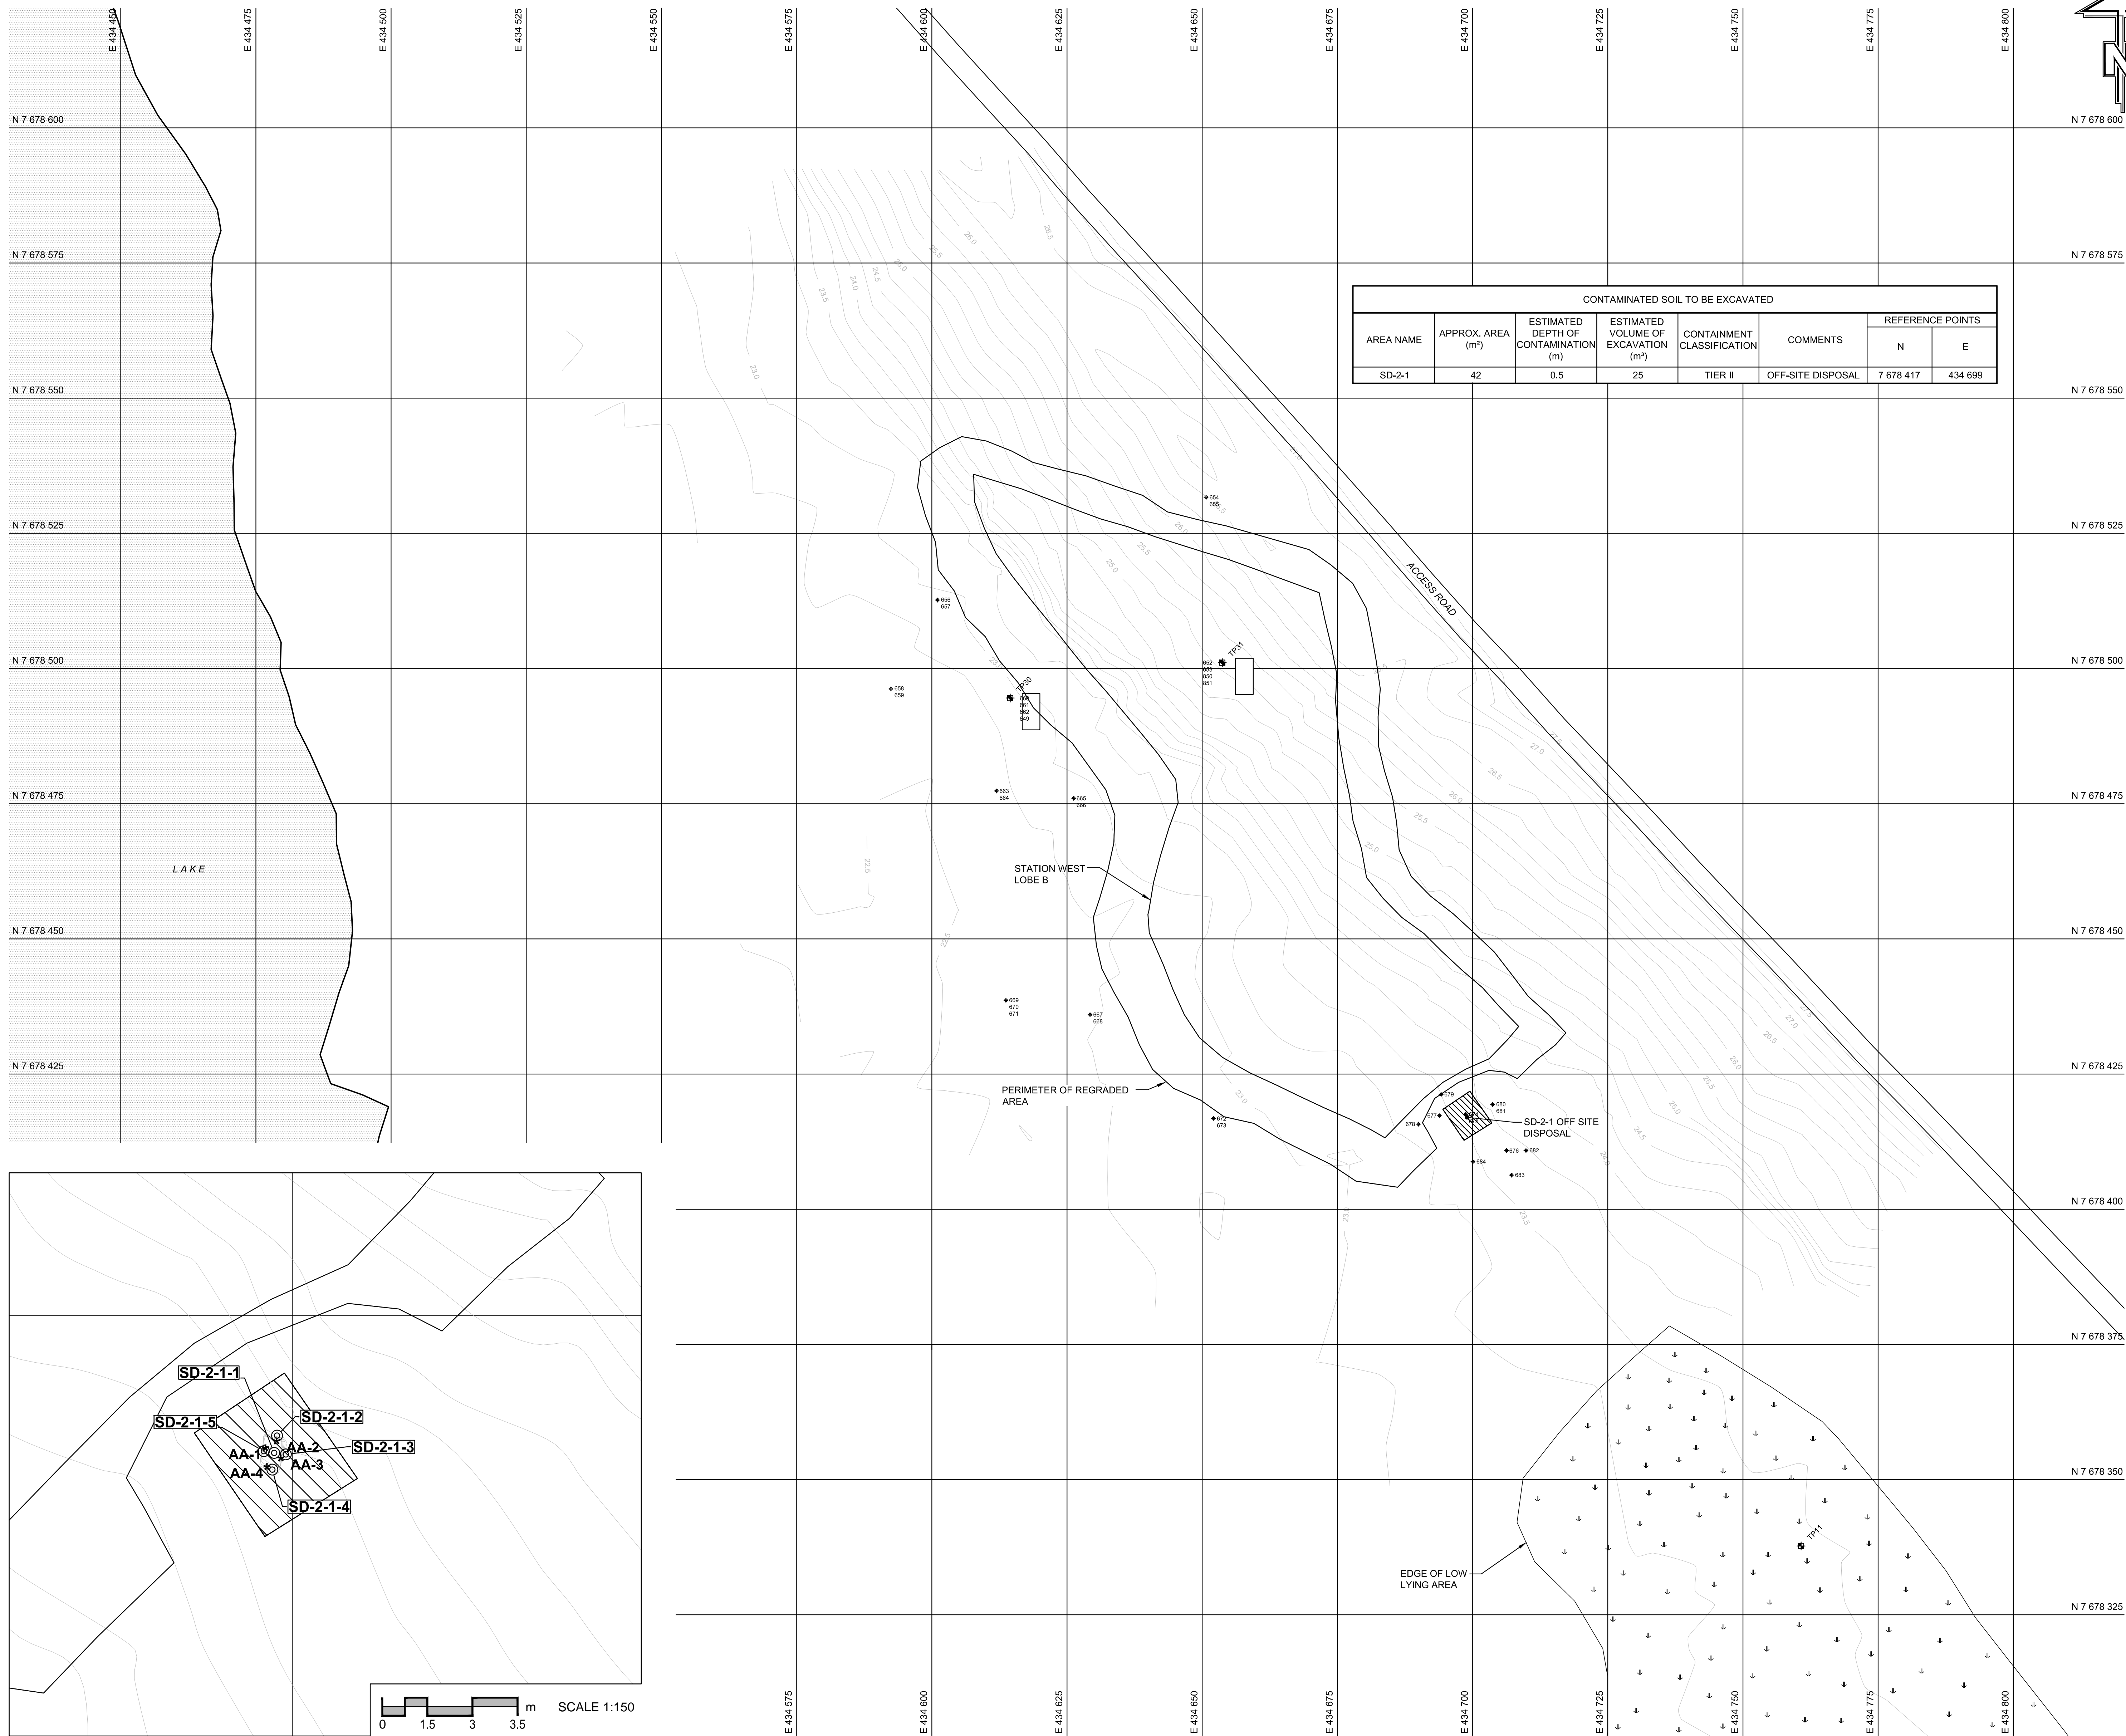
FIGURE 6
AREA 5
STATION WEST DUMP AREA

1. ALL DIMENSIONS ARE IN METRES UNLESS NOTED OTHERWISE.
2. ALL COORDINATES ARE REFERENCED TO NAD83(CRSR). ELEVATIONS ARE REFERENCED TO MEAN SEA LEVEL, RELATIVE TO GEOID MODEL CANADIAN HT2_0.
3. SD - # - GRID SAMPLE FROM BASE OF EXCAVATION.
4. AA - # - COMPOSITE SAMPLE
