CONTWOYTO LAKE REMEDICATION PROJECT

REMEDIAL ACTION PLAN (RAP)

CONTWOYTO LAKE FORMER WEATHER STATION REMEDIAL ACTION PLAN

March 2013
(Revised 15 October 2013)

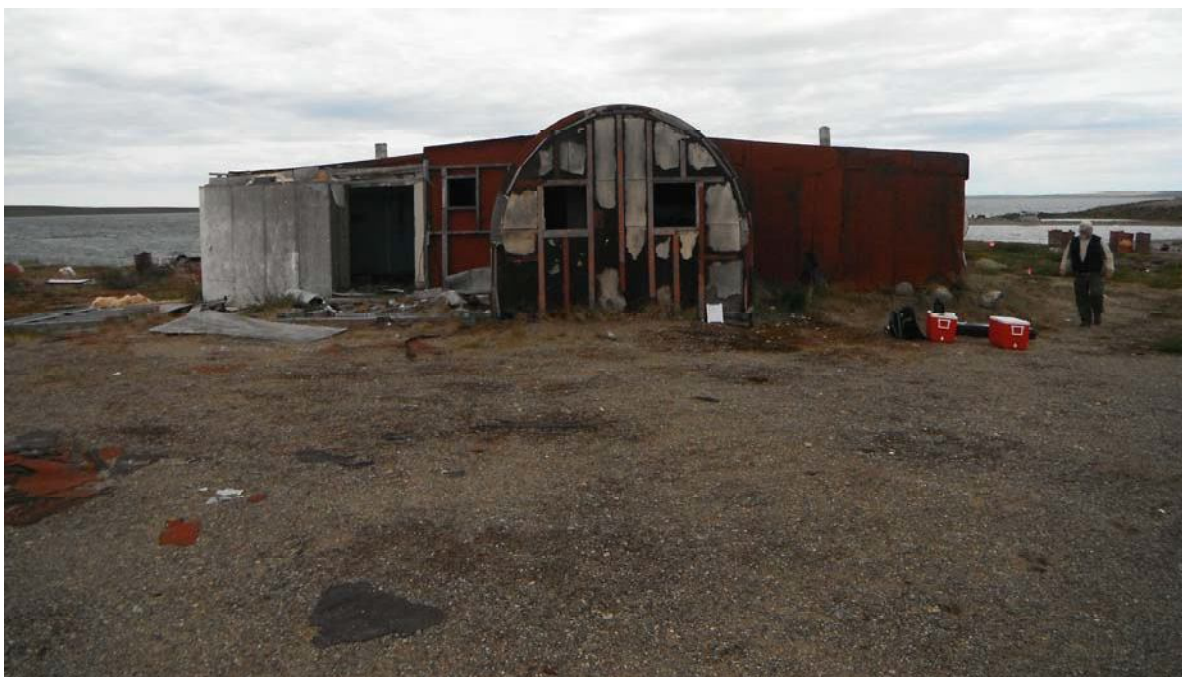
Plate 3.1-1 Structure 02 (Camp Building) at Camp Looking West

- 1) Main Camp Building (Structure 02) – The structure is comprised of a series of wood framed structures added to the original Quonset style structure. The windows are removed and the building is open to the environment. The walls and roof are in reasonable condition, however, are showing signs of deterioration. The structure did house a furnace and generator with a fuel oil tank. Residual debris related to the operation of the station remains within the structure.

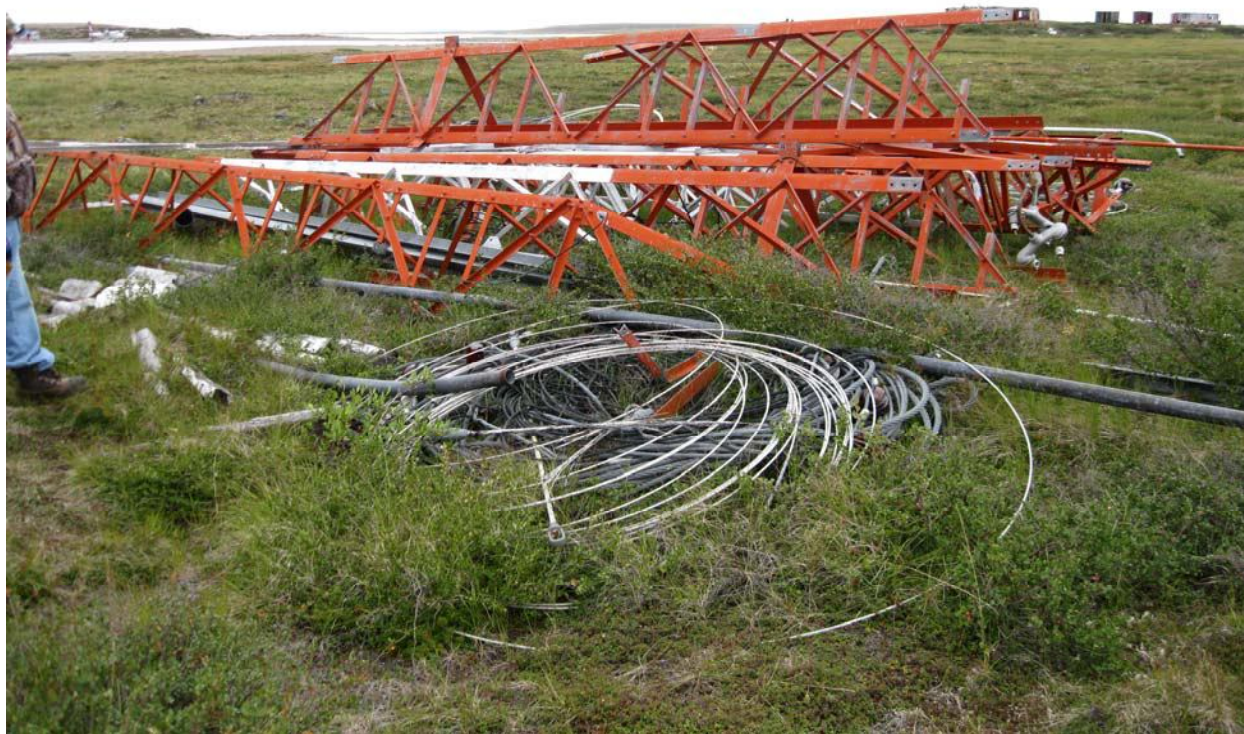
Plate 3.1-13 Radio Tower Sections Looking North

- 7) Equipment and Debris – Miscellaneous equipment (e.g., skidoos parts, radio antenna, radio tower sections), scrap metal (e.g., grounding wire, steel pipes and rails) drums and four above-ground storage tanks are distributed throughout the site beyond the two debris areas noted above.

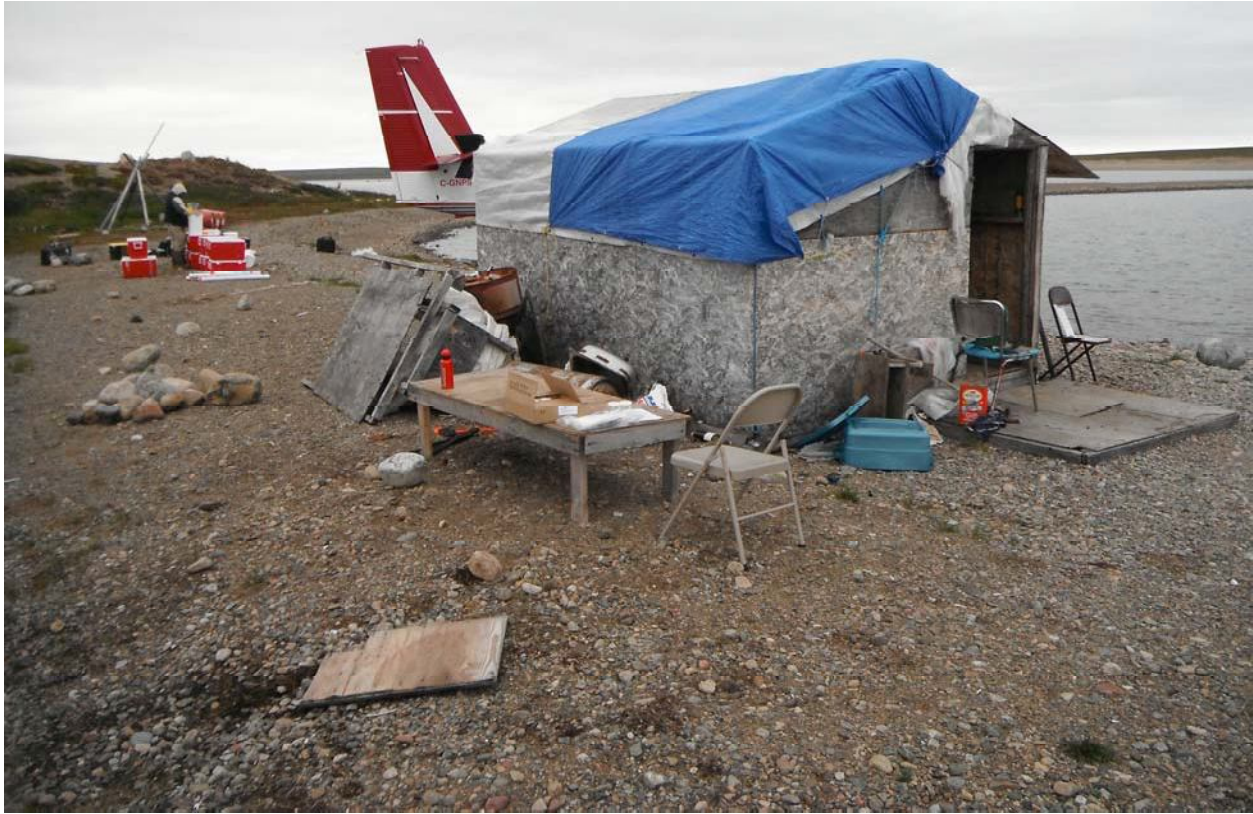
Plate 3.1-15 Existing Inuit Hunting Camp Shed and Surround Looking North

On the peninsula, due west of the former weather station, there exists a small wood frame with a tarped roof. Surrounding this structure are multiple drums of fuel, empty drums full of domestic and camp debris, wood frames used for drying fish and/or meat and remnants of two fire pits. The active drum cache (Drum Cache 01) contains five drums of unopened fuel while the inactive drum cache (Drum Cache 02) has 13 drums of which four were reported to contain water. Figure 3.1-6 provides a plan view of the major features present at the campsite. Selected photographs of the features are presented in Plates 3.1-15 to 3.1-20.

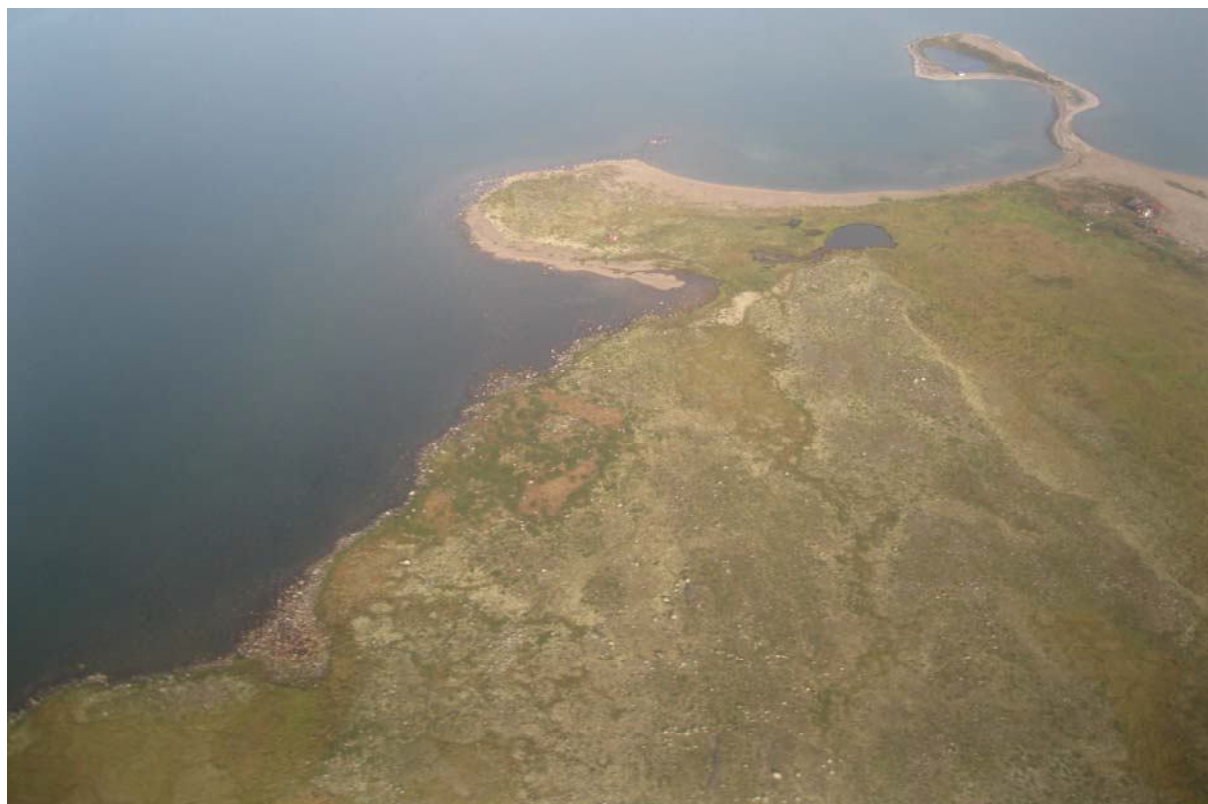
Plate 3.1-21 Aerial Overview of Former Inuit Camp

Figure 3.1-5 provides a plan view of the major features present at the campsite. Selected photographs of the features are presented in Plates 3.1-21 and 3.1-22.

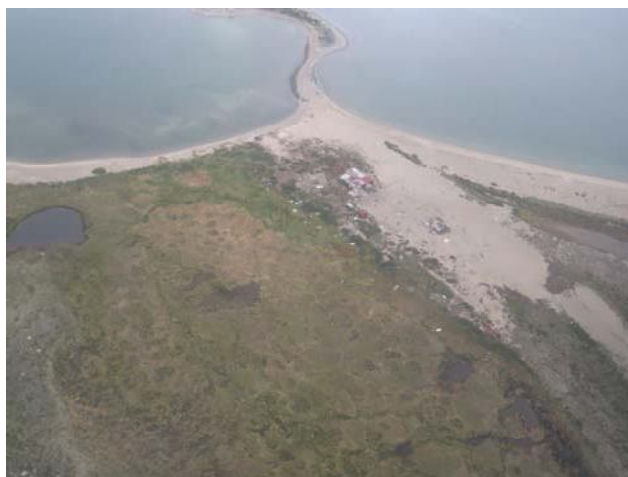
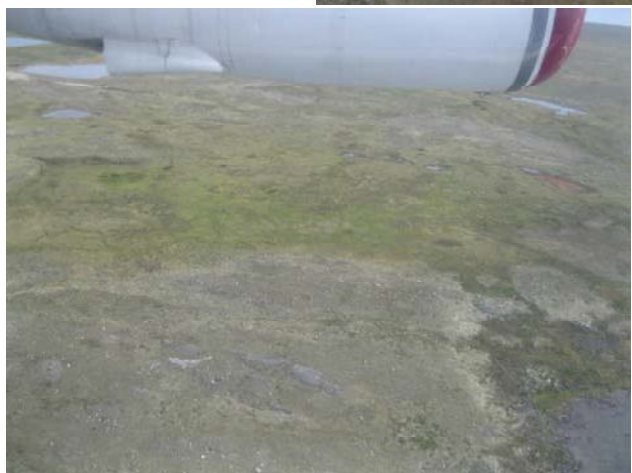
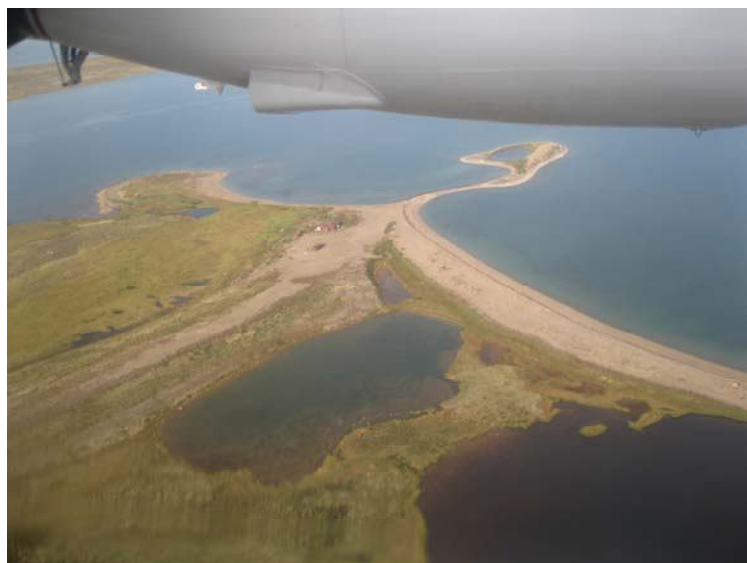
Plate 4.4-1 Photographs of the Lowlying Areas Around the Site

The Department of Fisheries and Oceans (DFO) reports that Contwoyto Lake supports populations of the following fish species: lake trout, Arctic char, round whitefish, lake cisco, Arctic grayling and burbot (DFO 1986). Observations at the weather station indicate that the small inland waters are devoid of aquatic life.

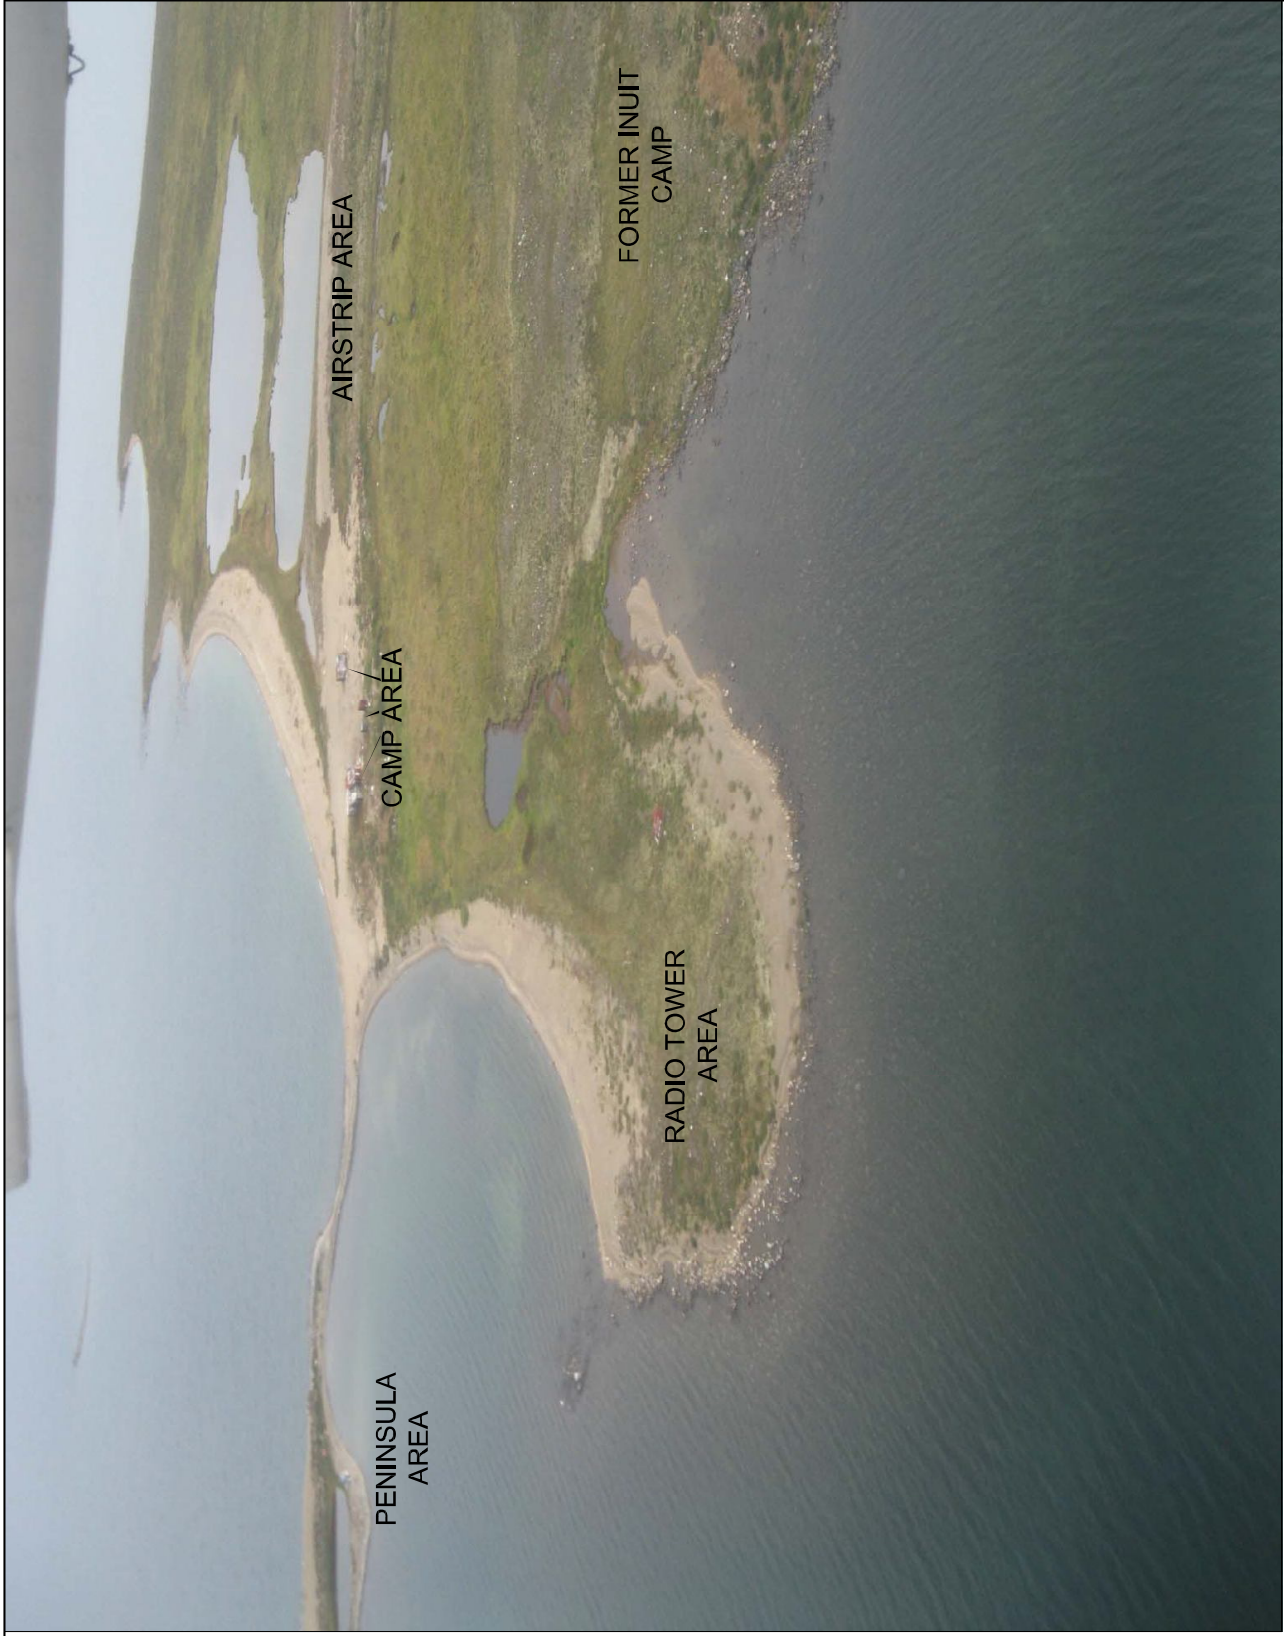
Drawn By: J.B.S.	Reviewed By: C.F.G.	Project No: 3500047-508
Date: MARCH 2013	Scale: NOT TO SCALE	Figure: 3-1-2

REMEDIAL ACTION PLAN
CONTOUYTO REMEDIATION PROJECT
FORMER WEATHER STATION
AERIAL PHOTOGRAPH (2012)
