Coral Harbour Former Military Site Remediation Project, Project Proposal Report

Submission to the Nunavut Impact Review Board for Screening

Final Report

Stantec Consulting Ltd. Yellowknife, NT

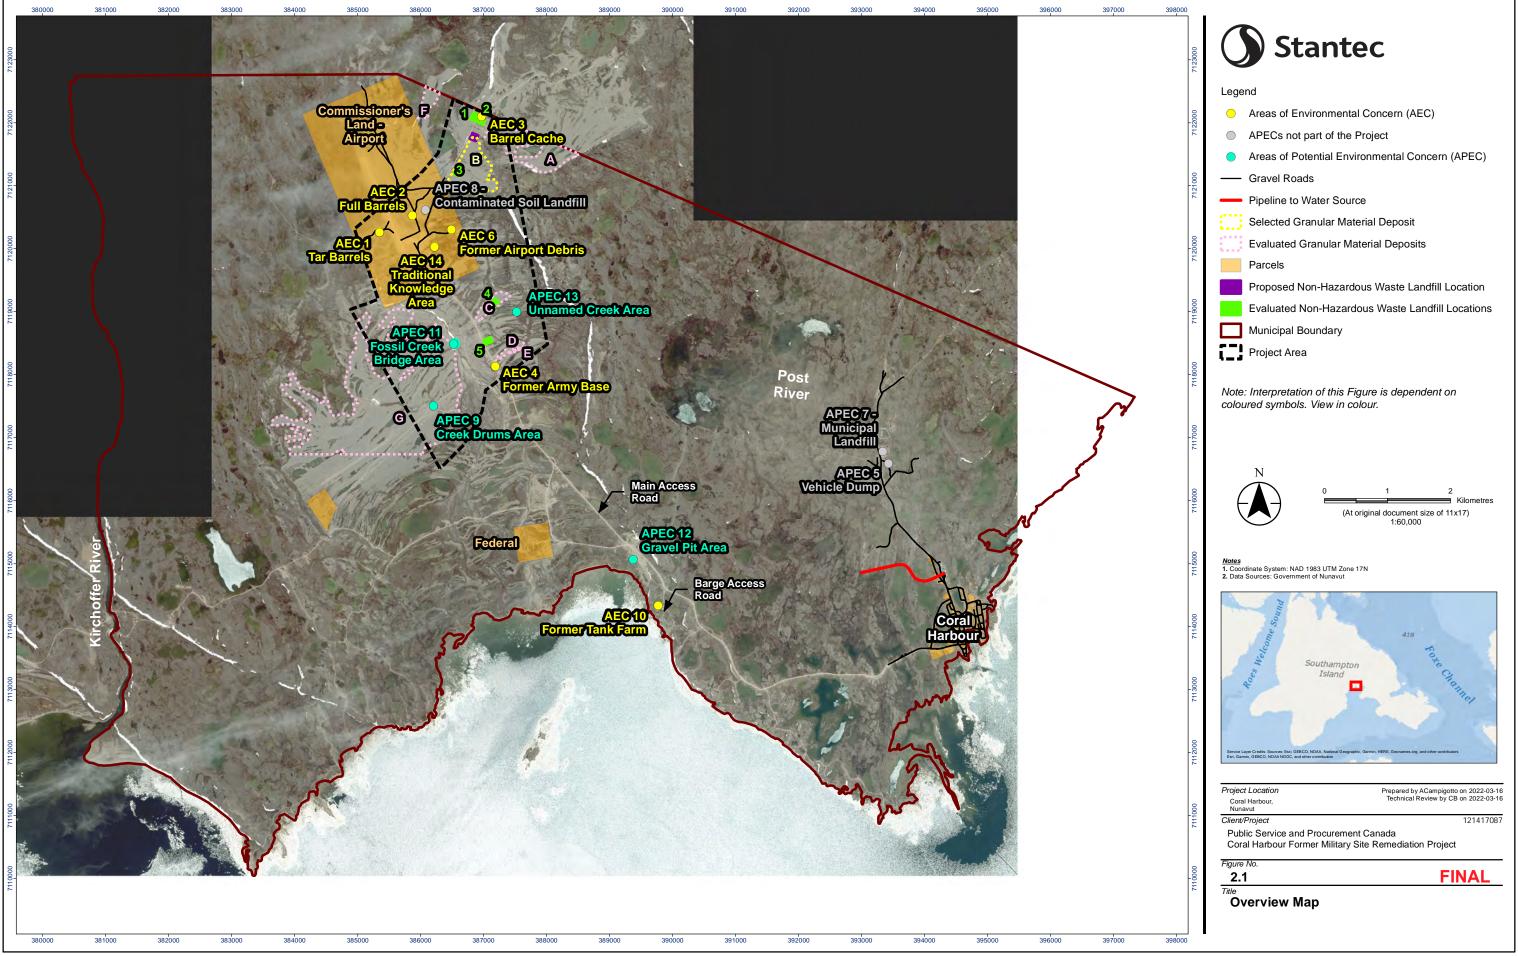
As an outcome of the previous environmental site assessments identified in Section 2.3, 5 of the 16 identified AECs/APECs on Site are proposed for remediation as part of the Project. During the 2020 Site visit, Stantec personnel confirmed through observations and communication with members of the community that APEC 5 (Vehicle Dump, used for large item disposal), APEC 7 (Municipal Landfill, used for municipal landfill material) and APEC 8 (Contaminated Soils Landfill, used to dispose of petroleum impacted soil), were actively being used by the community; as such, CIRNAC determined that the assessment of these APECs would not be included in this Project; therefore, APEC 5, 7 and 8 are not included in the scope of the Project (see Figure 2.1).

Access to AEC 1 currently requires crossing the active airstrip, which may pose a risk to personnel and aircraft safety and may damage the airstrip. It is expected that the Contractor will construct an access road around the airstrip to reduce personnel, vehicle and equipment traveling over the runway during the pre-remedial and remedial program. Current access roads are illustrated on Figure 2.1.

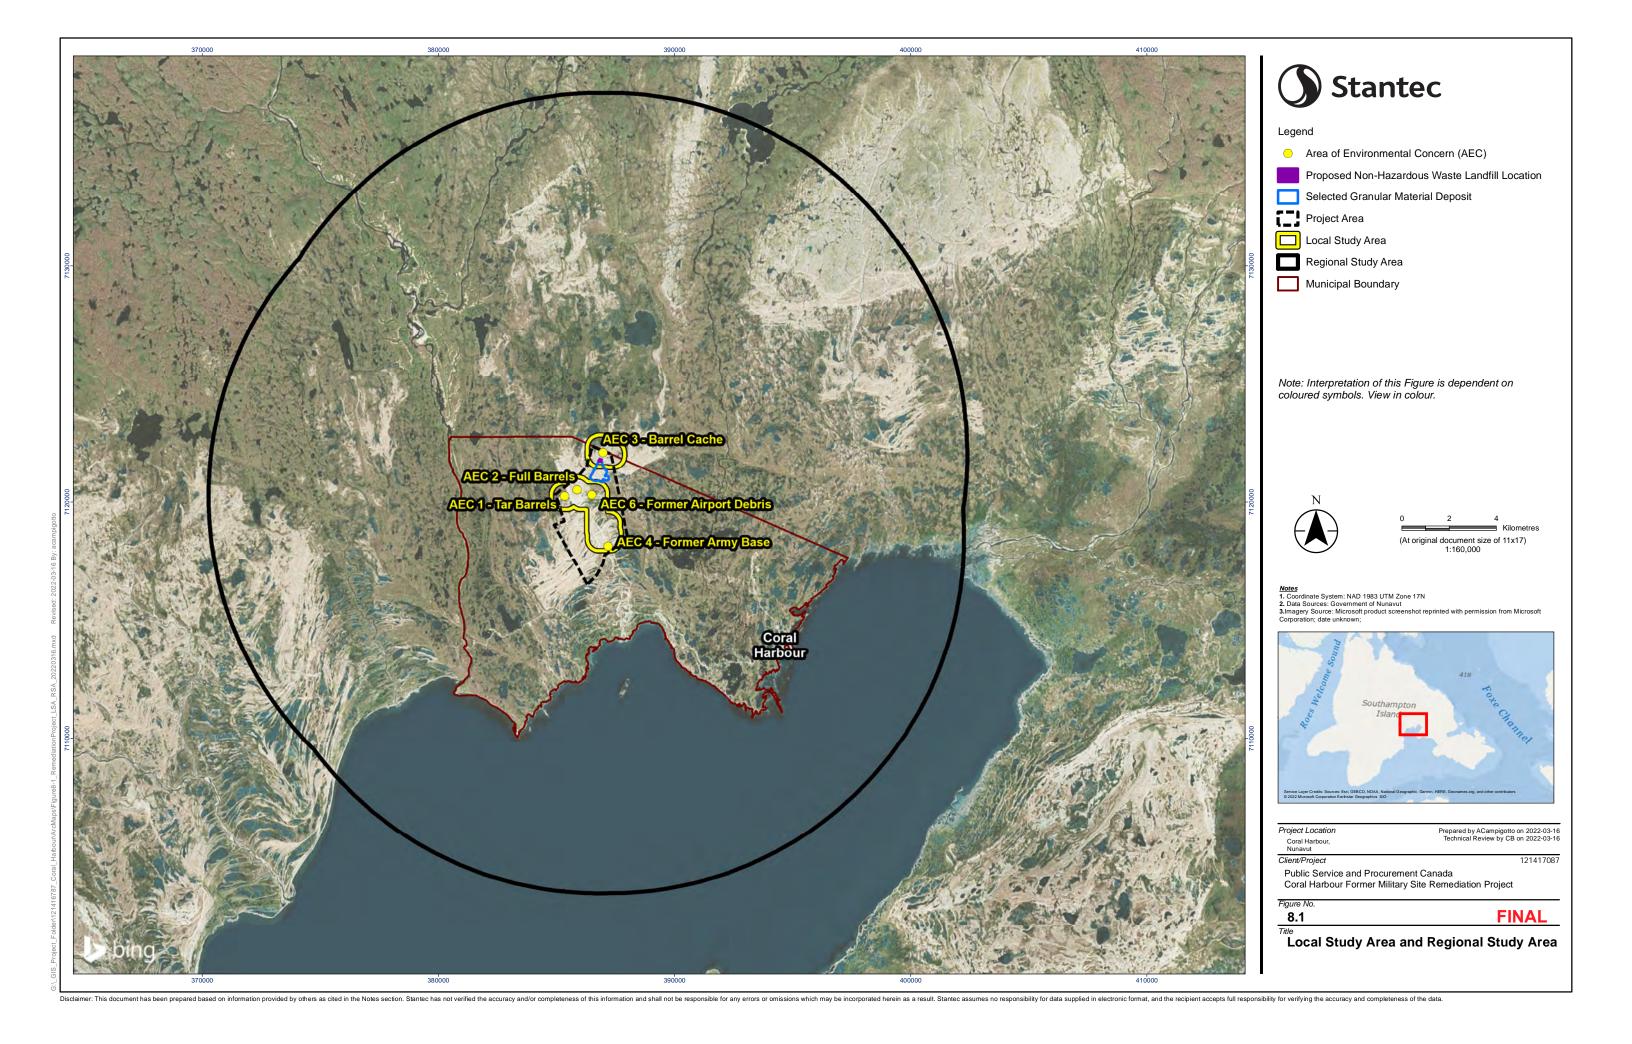
The Project Area is shown in Figure 2.1. The LSA and RSA are shown in Figure 8.1.
