Cambridge Bay Soil and Water Treatment Facility

2017 Annual Report

Nunavut Water Board Licence 1BR-CST1723

Cambridge Bay SWTF 2017 Annual Report
V. 1
16-025

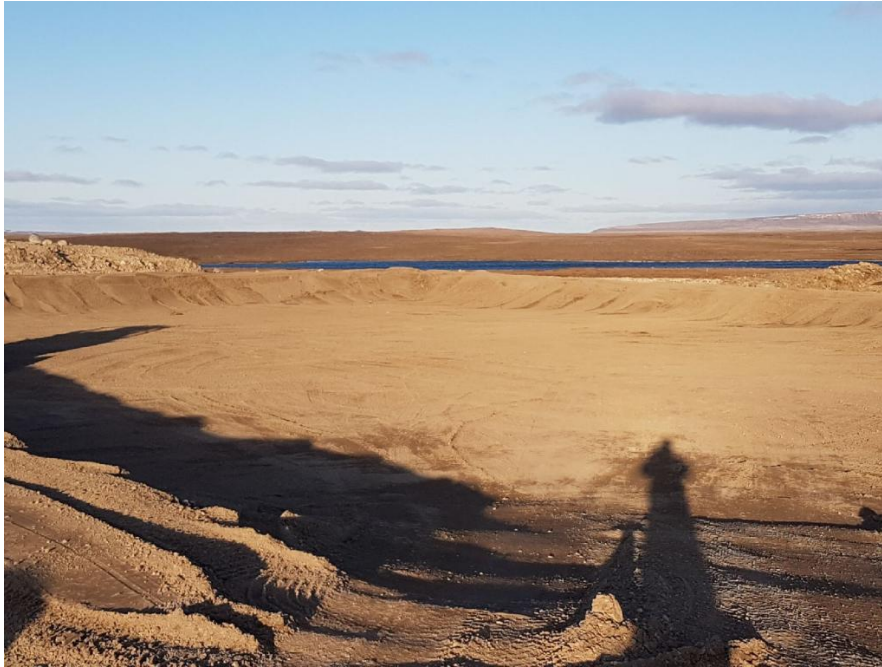
Photo 1: Pad and berm construction August 2017

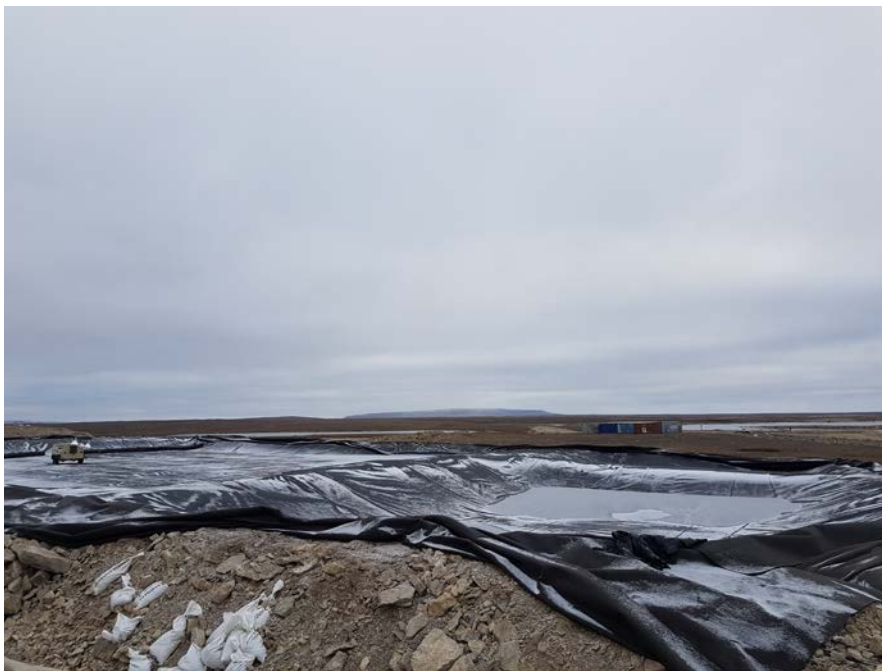
Photo 2: Synthetic liner installation September 21, 2017

The facility was constructed in 2017. A copy of the HDPE liner installation report can be found in Appendix B. As built drawings were submitted to the NWB on December 29, 2017.

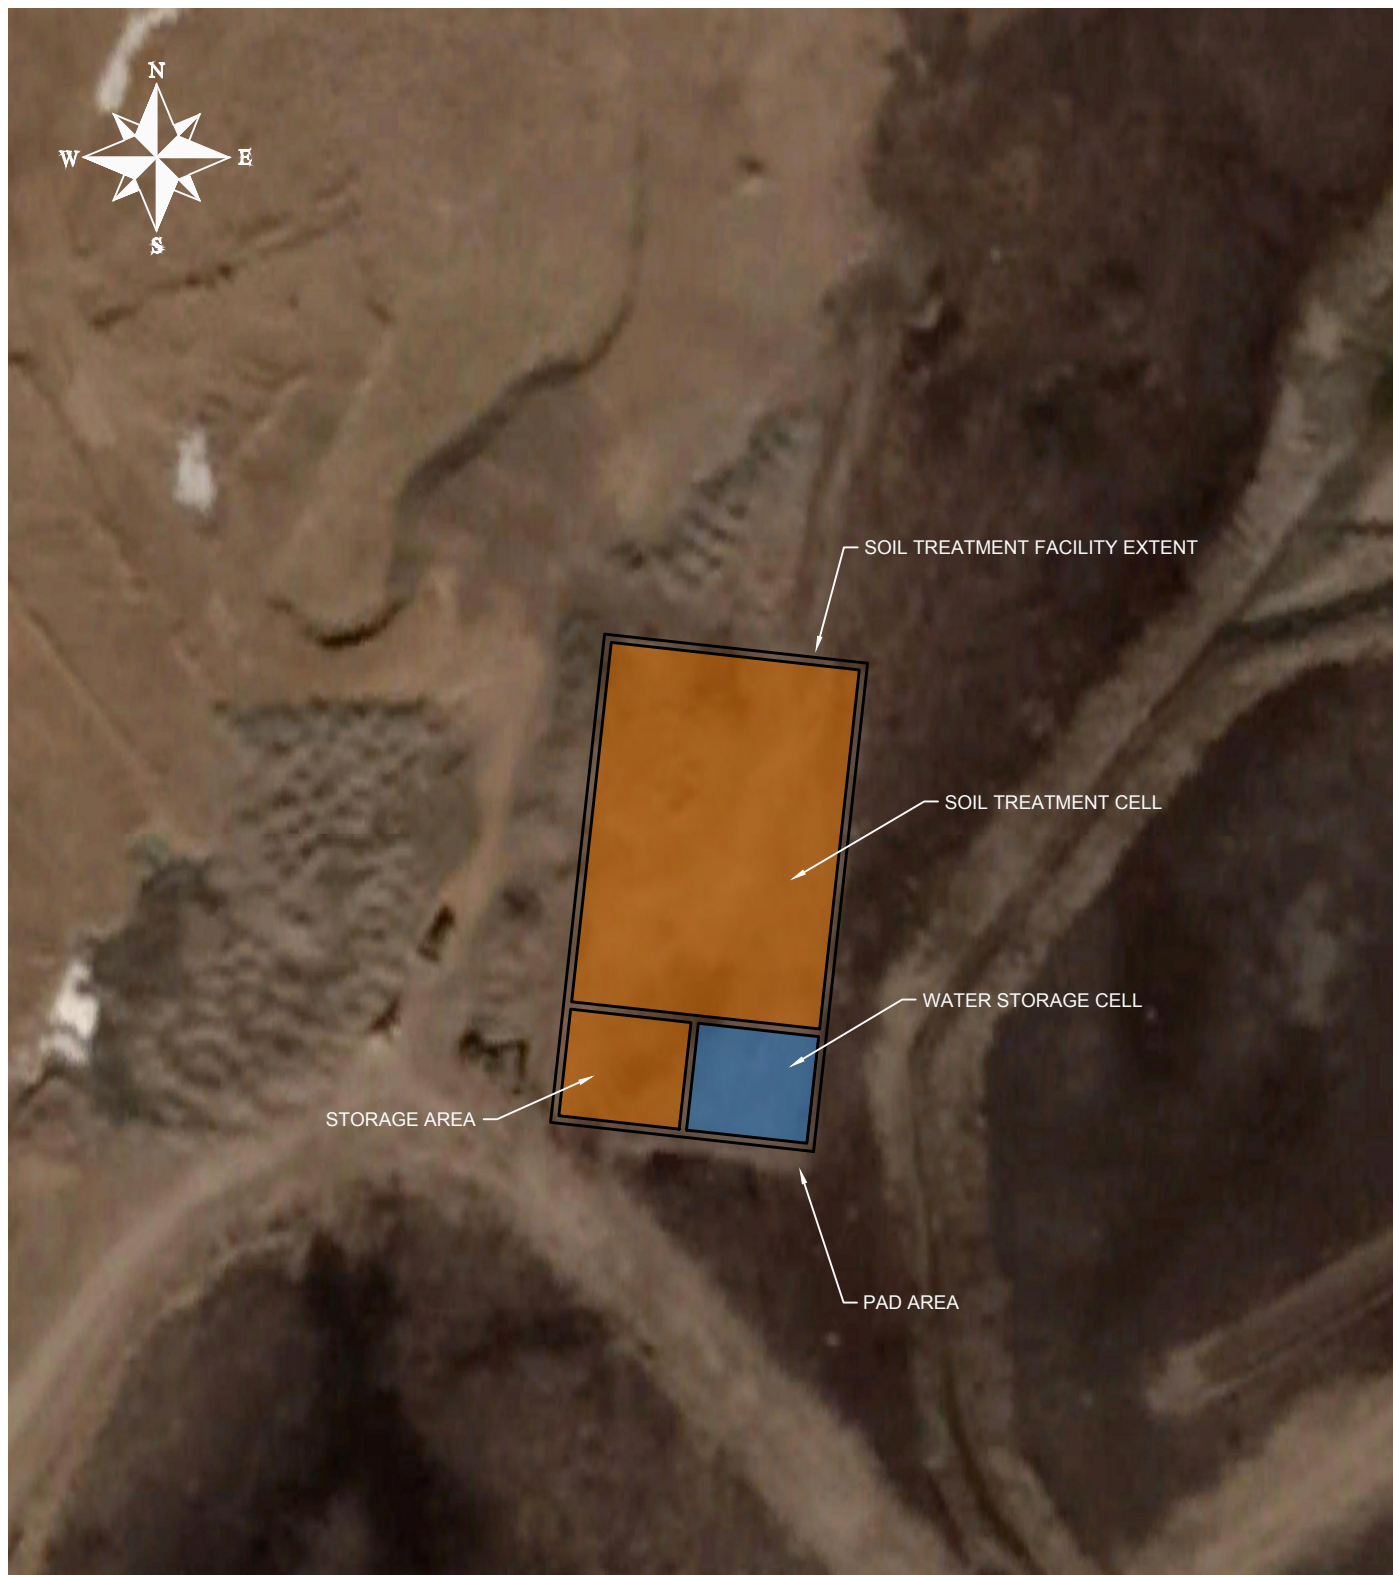
SITE OVERVIEW SHOWING FACILITY DESIGN

The facility consists of one large soil treatment cell for the receipt of soil contaminated with petroleum hydrocarbons, one cell for the receipt of contaminated snow and water along with one cell for the storage of containerized hazardous waste material. The soil treatment cell dimension are approximately 35 meters by 49 meters. The water cell and hazardous waste storage cell dimensions are both approximately 14 meters by 16 meters. The water cell is designed to contain approximately 170 cubic meters. A site diagram is shown on Figure 2.

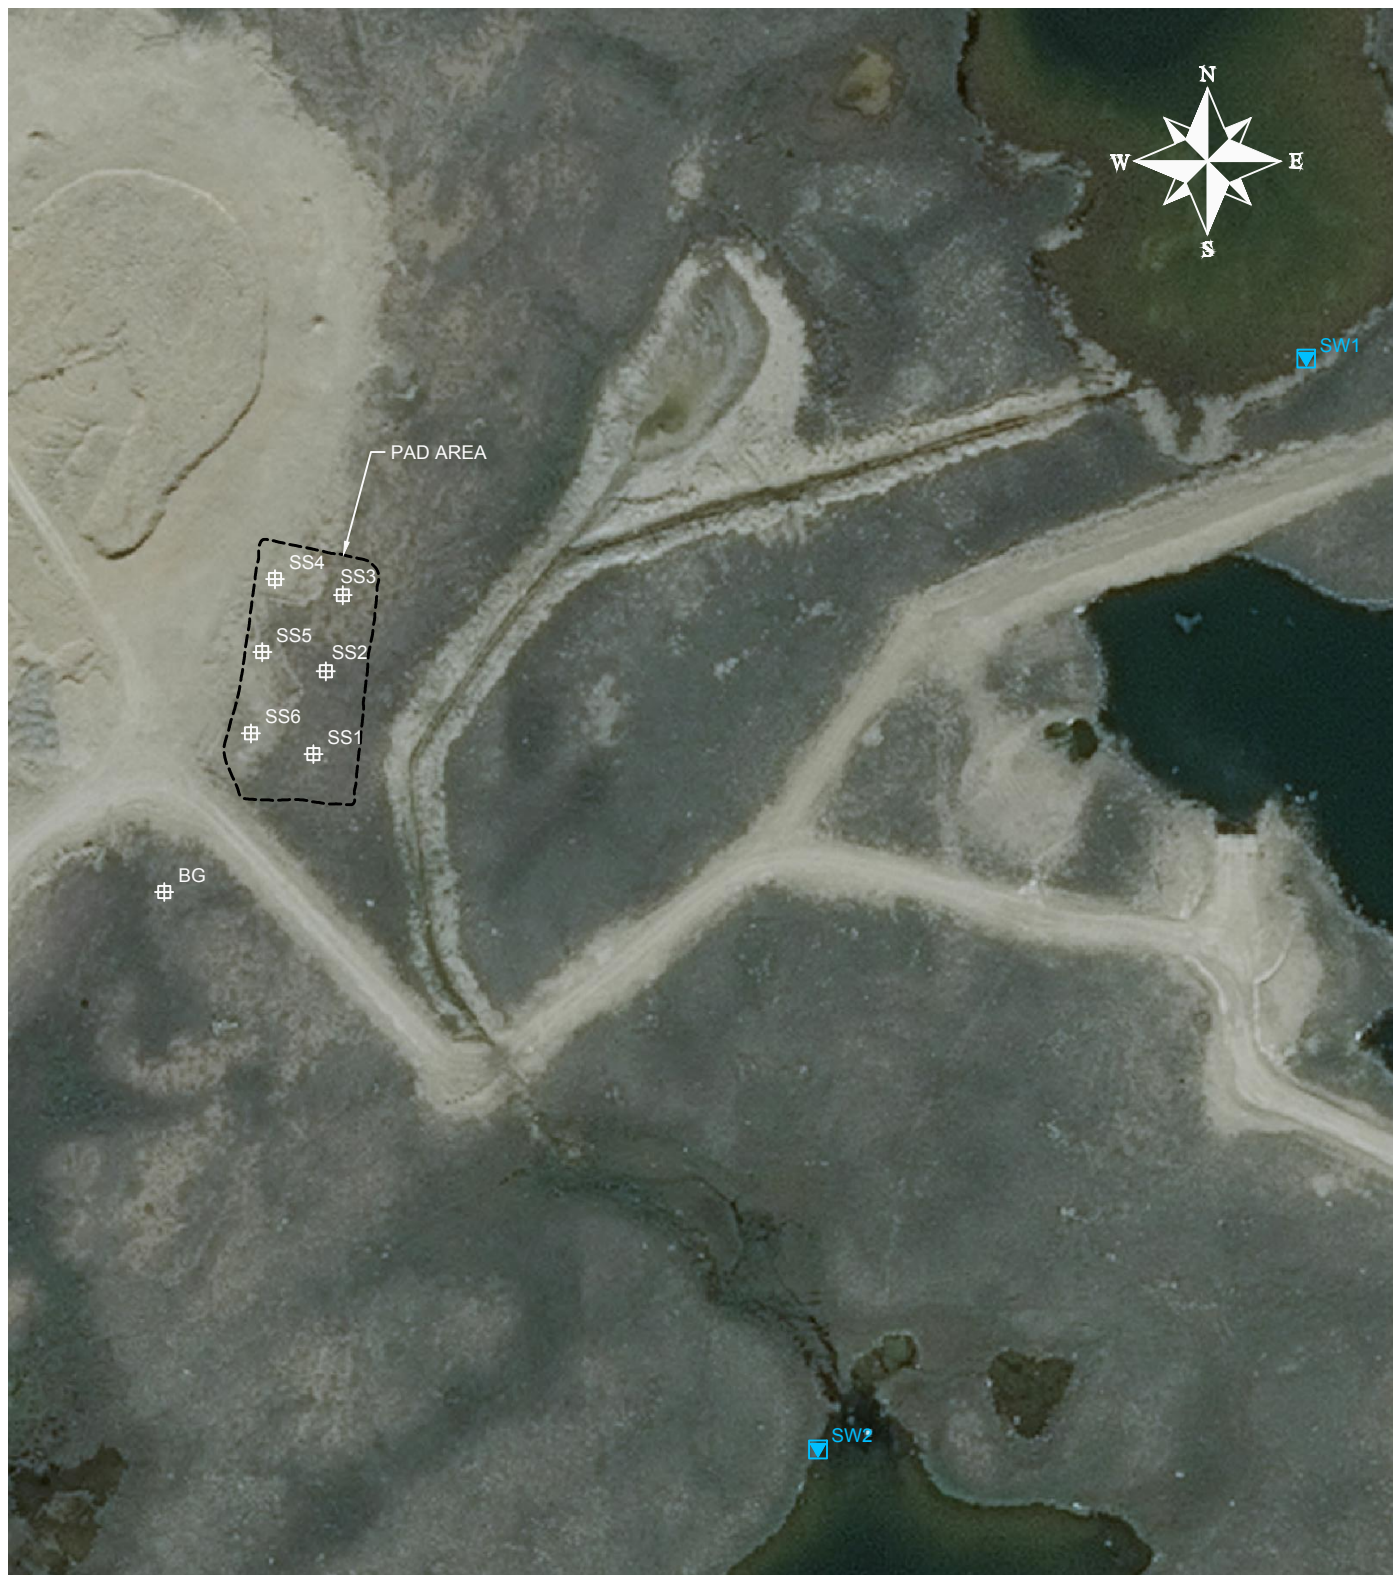
SAMPLE LOCATION DIAGRAM

Baseline soil samples were collected from the footprint of the facility prior to construction along with a background location. Samples were collected from surface to approximately 0.2 meters below surface. Locations of baseline samples are shown on Figure 3.

Baseline surface water sampling was completed prior to construction at two nearby water bodies to confirm representative conditions. Sample locations are shown on Figure 3.
