### August 26, 2001 Water Licence Inspection - Report

INDUSTRIAL WATER USE INSPECTION REPORT

Date: 2001/08/26      Company Rep. (Name/Title): Bill Millward / Project Manager  
Licensee: Homestake Canada Inc., Cullaton Lake      Licence No.: NWB1CUL9902

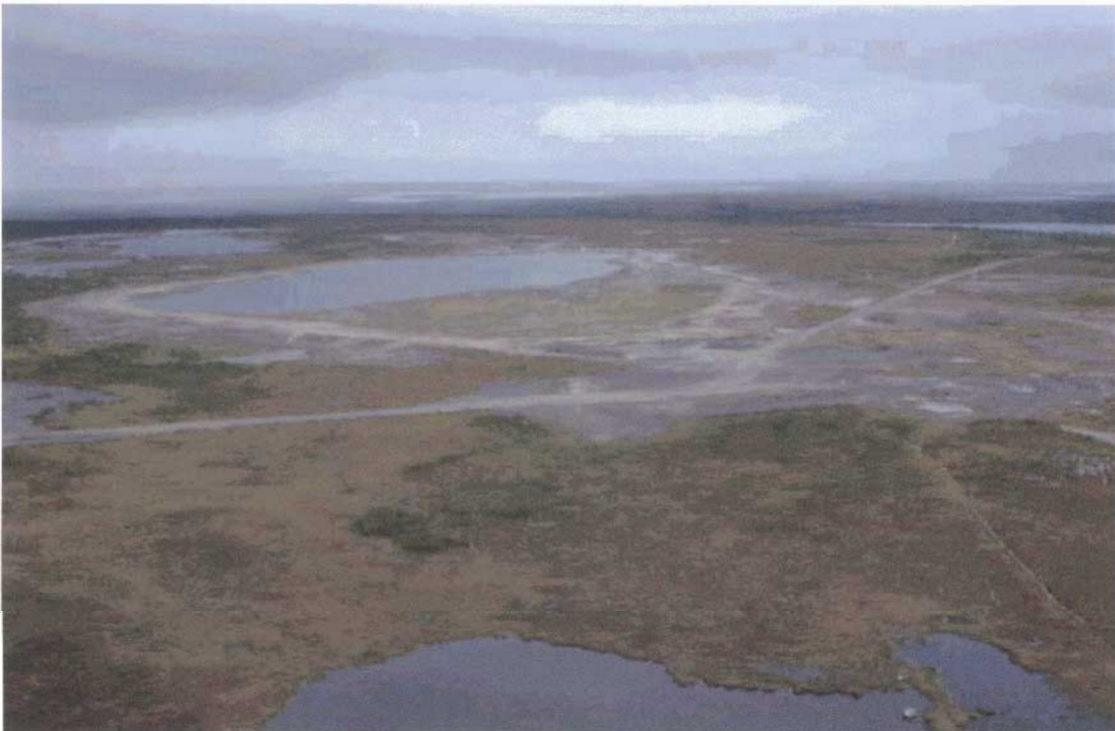
**figure 1.** Aerial view of the Tailings Containment Area (TCA); 2001/08/26.

- **Tailings disposal:** Despite the minor slumping of some sections of its impoundment structures, the overall integrity of the TCA (figure 1) appears unlikely to constitute a cause for concern. Further, the attached analytical results relating to samples collected at the discharge points from Tailings Pond 1 (figure 2) and Tailings Pond 2 (figure 3) indicate that all tested parameters meet both licenced requirements (part C, item 2) and the *Canadian Water Quality Guidelines for the Protection of Freshwater Aquatic Life*. In addition, the same can be said for the area of seepage at Surveillance Network Program (SNP) station 940-22, in the northeastern corner of Tailings Pond 1. Likewise, the respective Microtox samples, which constitute reliable toxicity indicators (IC<sub>50</sub>), did not attribute toxicity to any of the above effluents.

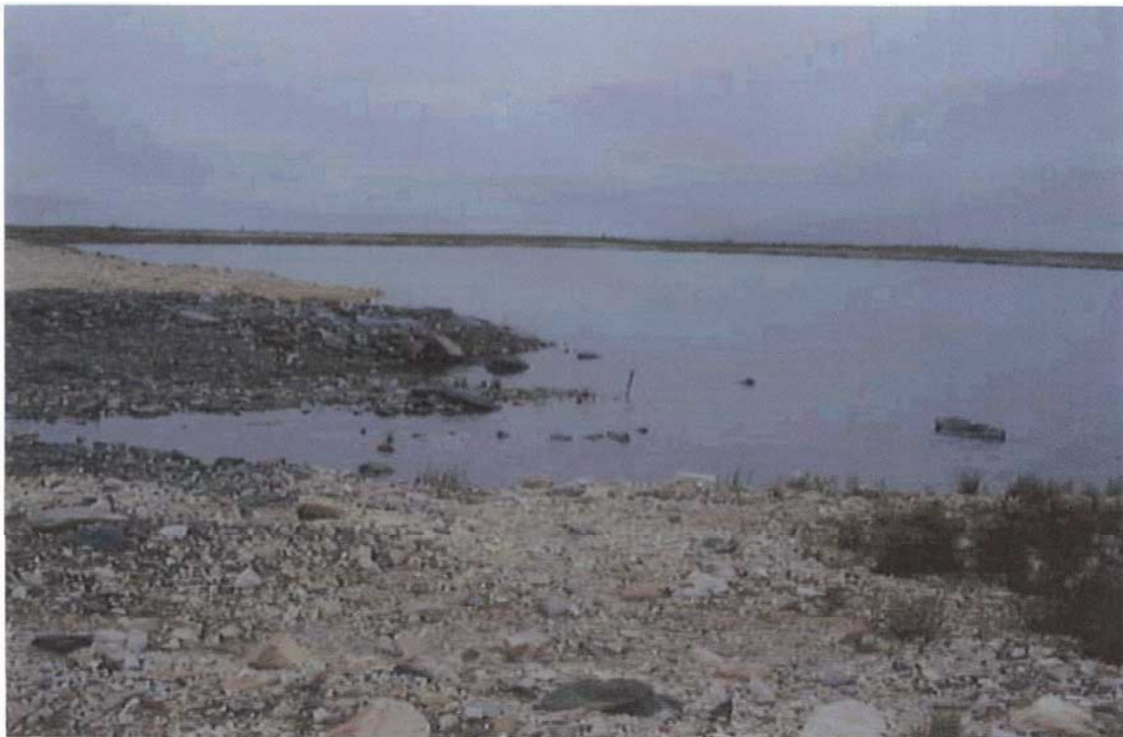
**figure 2.** Discharge from Tailings Pond 1 spillway, SNP station 940-18; 2001/08/26.

RESULTS: NON TOXIC at 45% concentration

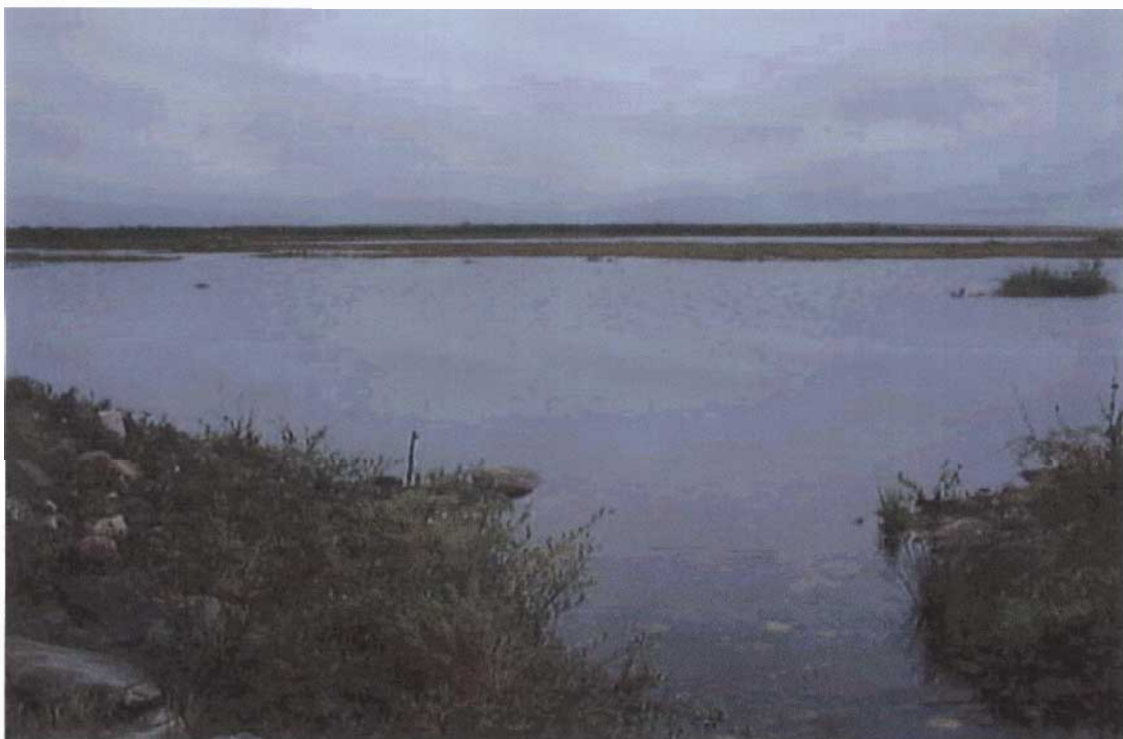
**figure 3.** Final discharge from Tailings Pond 2, SNP station 940-3; 2001/08/26.

RESULTS: NON TOXIC at 45% concentration

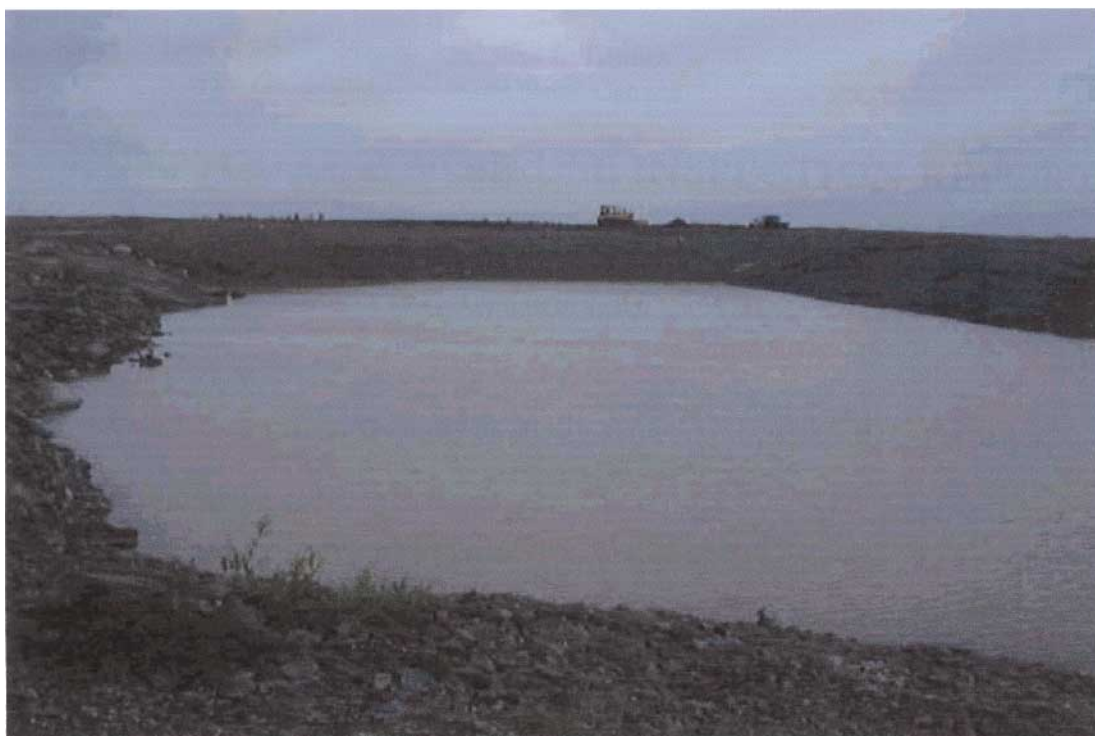
**figure 4.** Quarry pit in vicinity of Tailings Pond 1, SNP station 940-23; 2001/08/26.

- **Solid waste disposal:** Although a significant proportion of the material on-site was buried in the quarry, there nonetheless remains a noteworthy open pit which was at the time of the inspection nearly filled with recent rainwater (figure 4). In this regards, the attached analytical results relating to a sample taken from SNP station 940-23, while complying with the licenced thresholds, exceed the *Canadian Water Quality Guidelines for the Protection of Freshwater Aquatic Life* for arsenic (arsenic (5.6 µg/L vs 5 µg/L), copper (6 µg/L vs 4 µg/L), iron (2.48 mg/L vs 0.3 mg/L), and zinc (70 µg/L vs 30 µg/L). However, the associated Microtox sample did not denote toxicity. In light of this and the presumable amount of bulky metal wastes buried at the quarry, the site ought to be monitored to ensure that the drainage indeed leads towards Tailings Pond 1 as intended, thus providing additional retention and treatment time to the runoff from the pit.

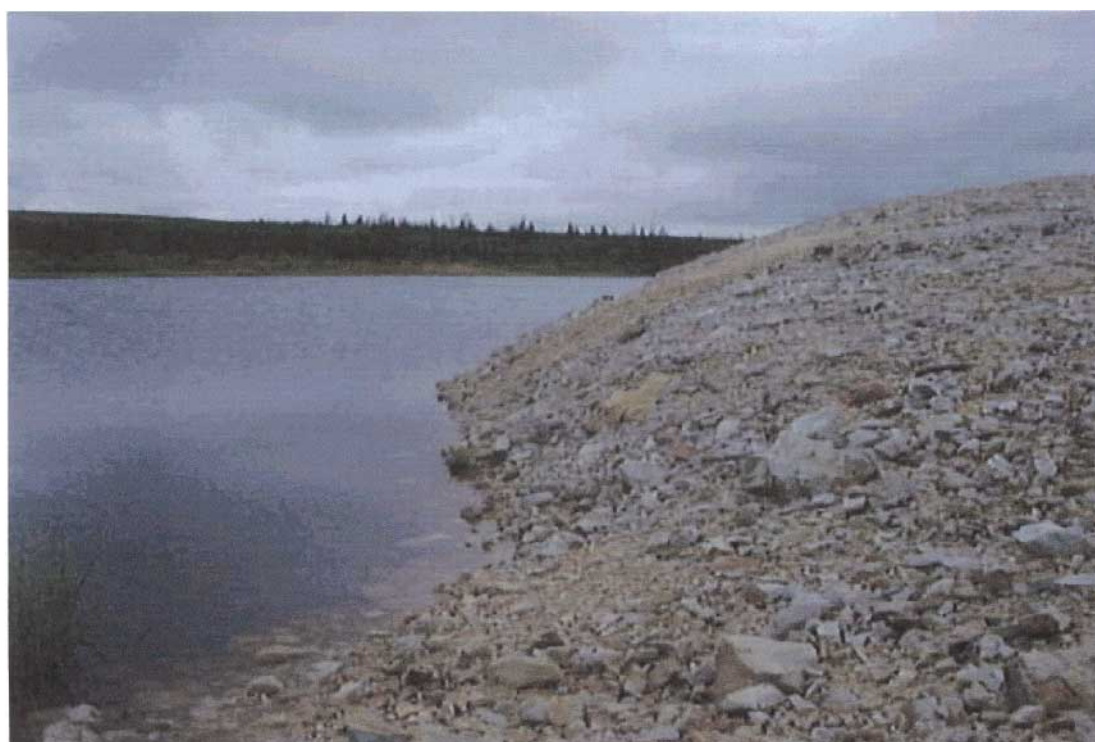
**figure 5.** Waste rock piled along the shoreline of Shear Lake; 2001/08/26.

- **Ore and waste rock stockpiles:** While it encroaches on the shoreline of Shear Lake, the waste rock piled in the area does not appear to significantly impact the water body. Indeed, the attached analytical results relating to a sample collected at the toe of the waste rock pile (figure 5) indicate that all tested parameters meet the *Canadian Water Quality Guidelines for the Protection of Freshwater Aquatic Life*, save for copper (5 µg/L) and iron (756 µg/L). Also, the related Microtox sample did not denote toxicity.

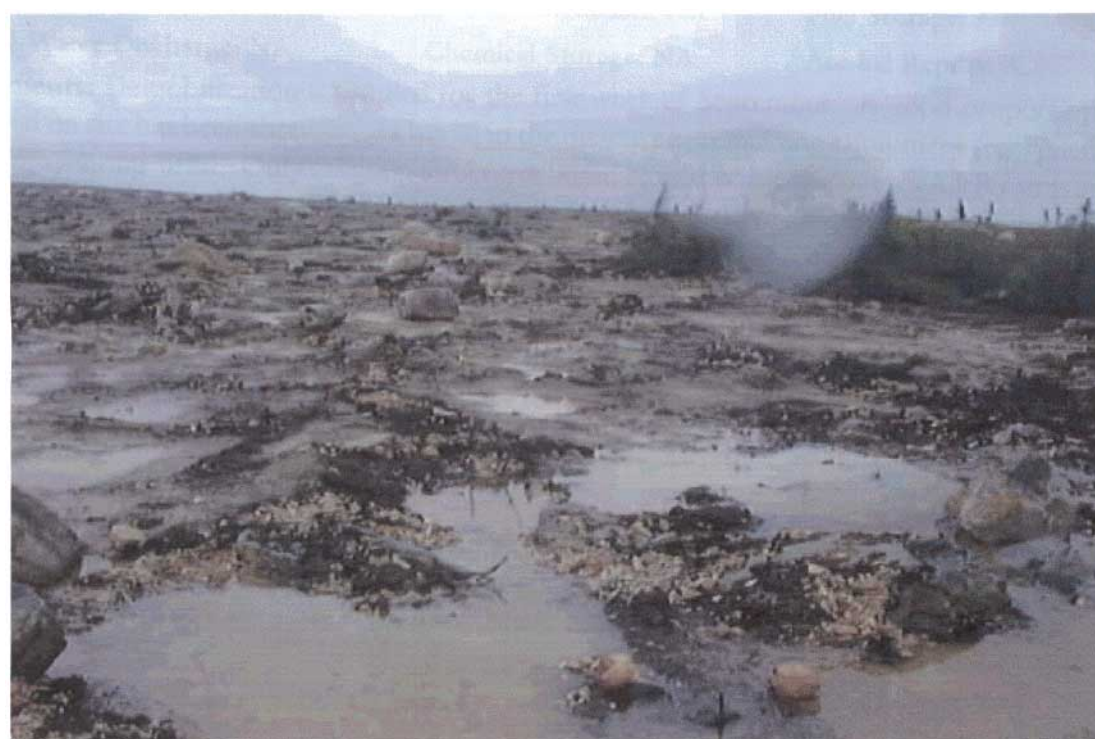
**figure 6.** Location of the higher grade waste rock dump prior to its burial; 2001/08/26.

However, dead vegetation was noted in the location the higher grade waste rock dump occupied prior to its burial. Accordingly, the attached analytical results relating to a sample collected from pooled water in the area (figure 6) reveal that the field pH (3.2 vs 6.0-9.5) breaches the effluent quality requirements set under Water licence NWB1CUL9902. Furthermore, concentrations of cadmium (4.5 µg/L vs 0.017 µg/L), copper (210 µg/L), iron (3.14 mg/L), nickel (268 µg/L vs 150 µg/L), and zinc (420 µg/L) exceed the *Canadian Water Quality Guidelines for the Protection of Freshwater Aquatic Life*. Moreover, the relevant Microtox sample shows that half of light-producing bacteria were inhibited by a sample concentration of 5.0%, whereas 50% and over is considered non-toxic.

Violations of Act or Licence: Effluent quality requirements (part C, item 2) set under Water licence NWB1CUL9902 breached in regards to the Shear Lake higher grade waste rock dump.

RESULTS: TOXIC - IC<sub>50</sub> Concentration: 5.0% (Toxic 0 to 50%)

This being said, especially considering the fact that drainage from the surroundings flows towards Shear creek and/or lake, it is the Inspector's belief that the reclamation of the area cannot be deemed complete before further monitoring assesses that runoff from the site no longer implies potential for the deposit of waste into waters. In addition, the burial site of the high grade waste rock relocated from the above area ought to be equally monitored in order to ensure that sufficient cover material has been applied to effectively seal in the underlying waste rock. Lastly, since the burial of the waste rock did not constitute the Licensee's preferred disposal option and was consequently not fully developed in submitted A&R documents, more details regarding the work would be welcomed in follow-up abandonment documentation.
