Public Works and Government Services Canada

Phase III Environmental Site Assessment Padloping Island Former US Coast Guard Weather Station

AECOM

December 14, 2010

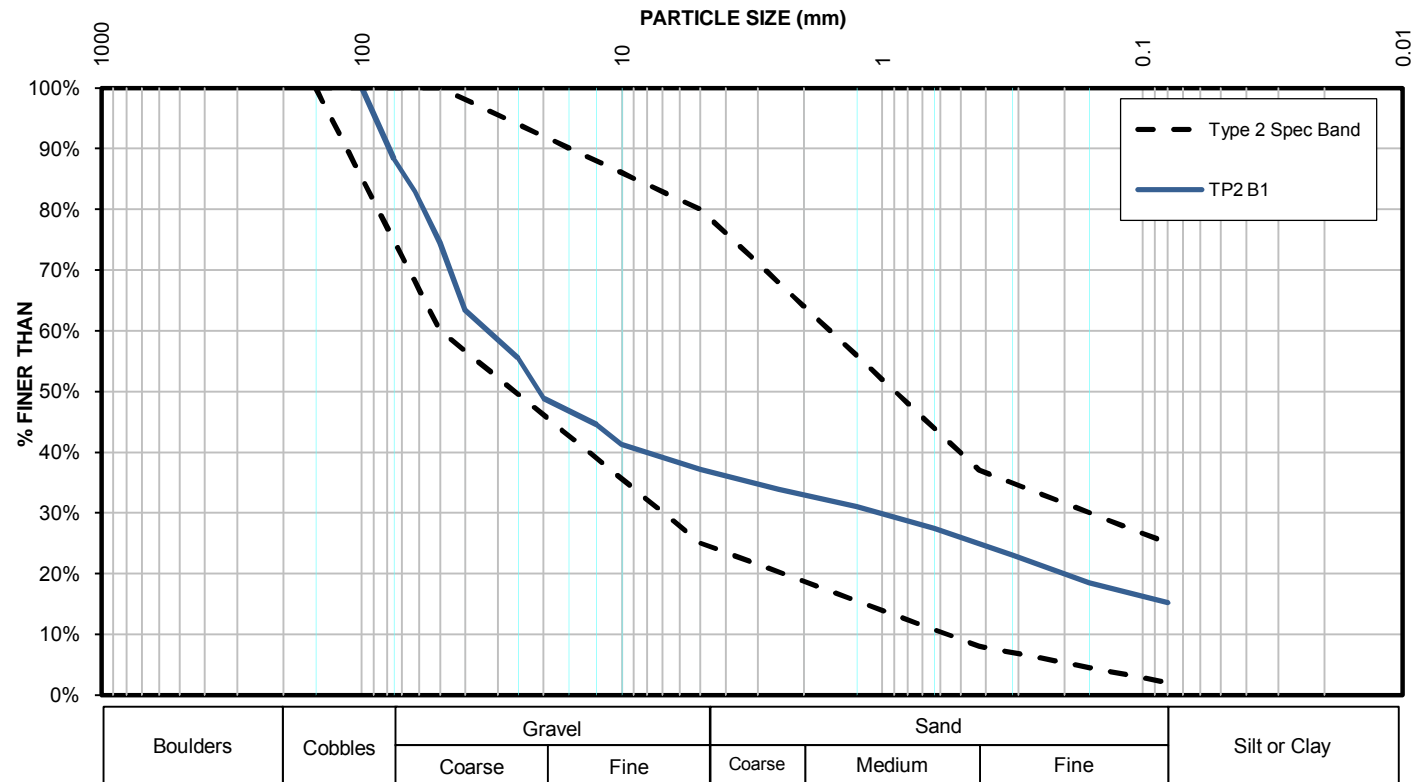
Figure 10

PADLOPING ISLAND - FORMER US COAST GUARD WEATHER STATION
GRAIN SIZE DISTRIBUTION CURVES - BORROW AREA 1 (TYPE 2 MATERIAL)

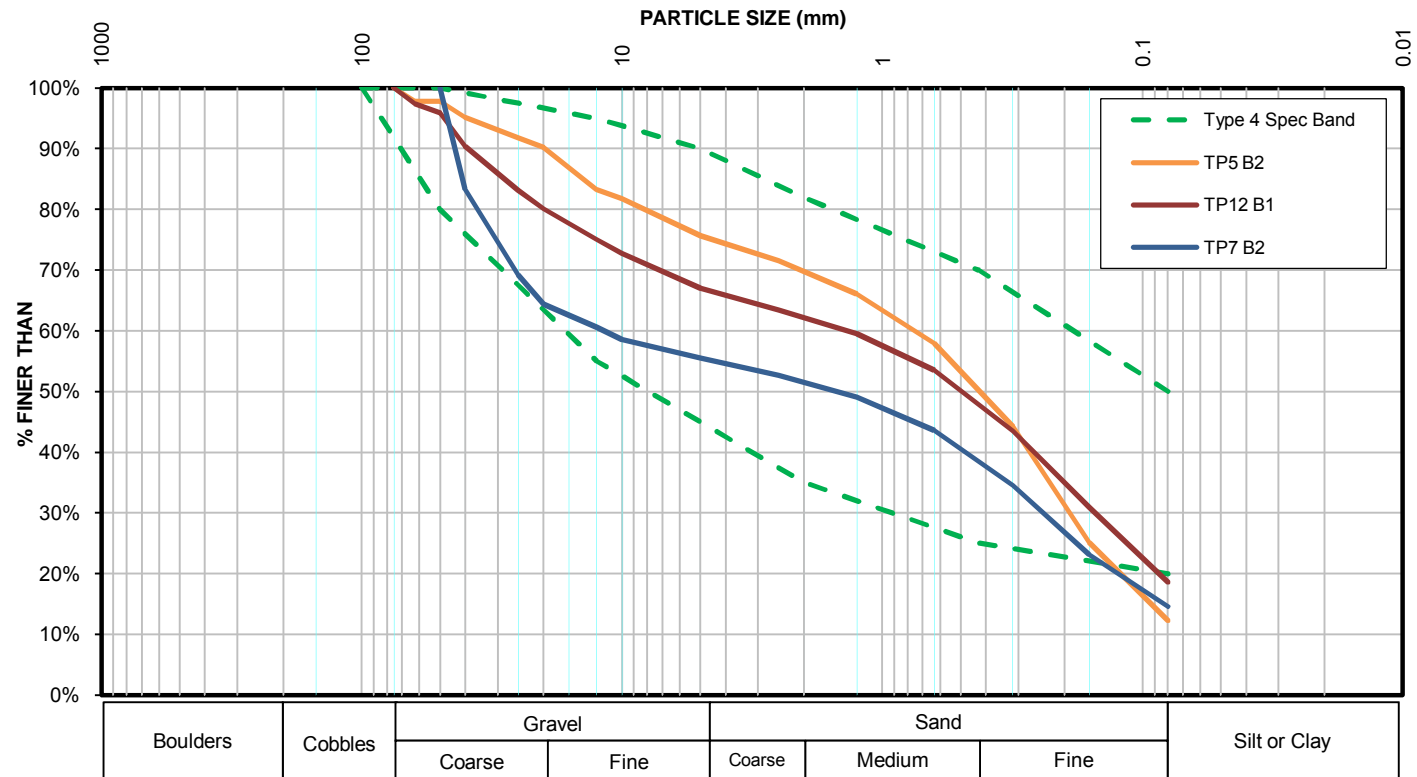
Figure 11

PADLOPING ISLAND - FORMER US COAST GUARD WEATHER STATION
GRAIN SIZE DISTRIBUTION CURVES - BORROW AREA 2 (TYPE 4 MATERIAL)

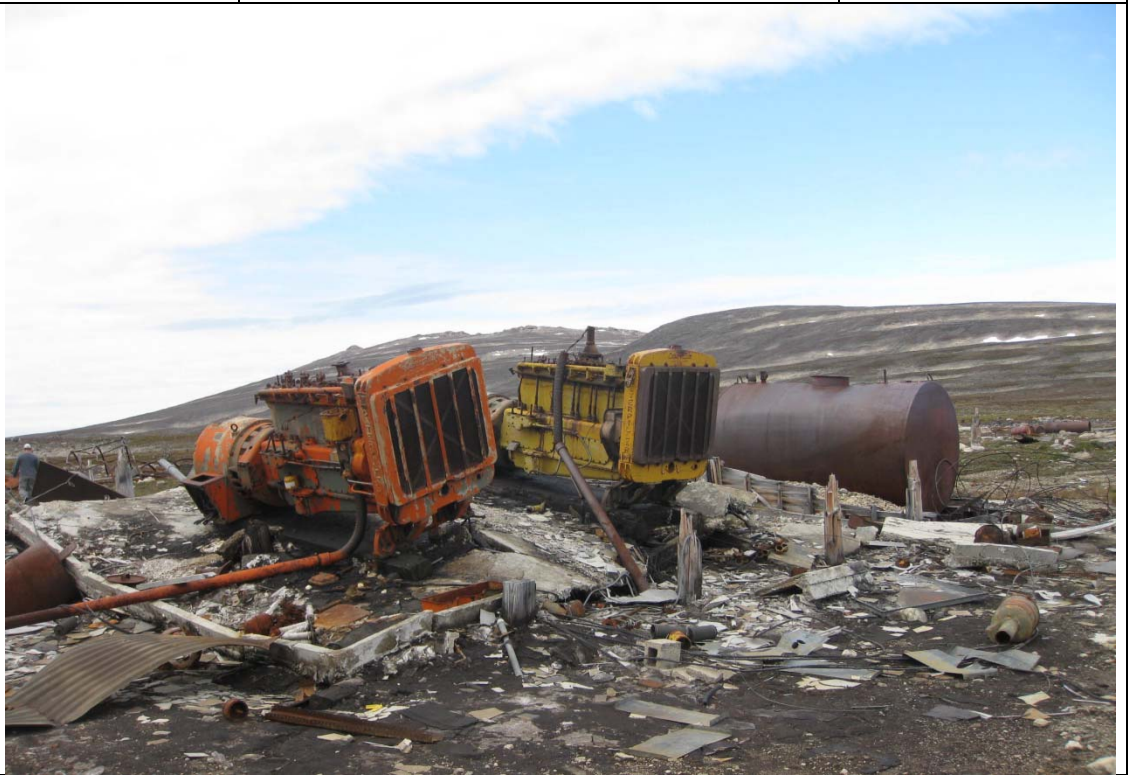
Photo No.
IMG_3548

Generator Building
Foundation and Debris
Areas: Type A TPH stain
in forefront

The extent of PHC impact is limited to the visibly stained areas (Appendix C, IMG_3481). The areas identified by sample tags 10-0047 and 10-0053 have estimated impact areas of 8 and 14 m², respectively to a depth of 0.3 m. The area defined by sample tags 10-0049 to 10-0052 should be combined into one area of approximately 74 m² to a depth of 0.3 m.

ESG-7519 (tag 19) was found in its correct location according to ESG report figures and was not confirmed because the concentration detected in 1996 was well above the Tier II criterion of 500 mg/kg at 1,200 mg/kg. In total, 15 samples were collected to delineate the previously identified areas of impact with five being analyzed for metals and one analyzed for PHCs (Appendix A, Figure 2.1). All results were below the applicable criteria with detectable Type B PHC in sample 10-0068 at 76 mg/kg. PCBs were not investigated at this location since no impacts were previously identified by ESG or Earth Tech. No evidence of PCB contamination was observed in 2010 (Appendix C, IMG_3548).

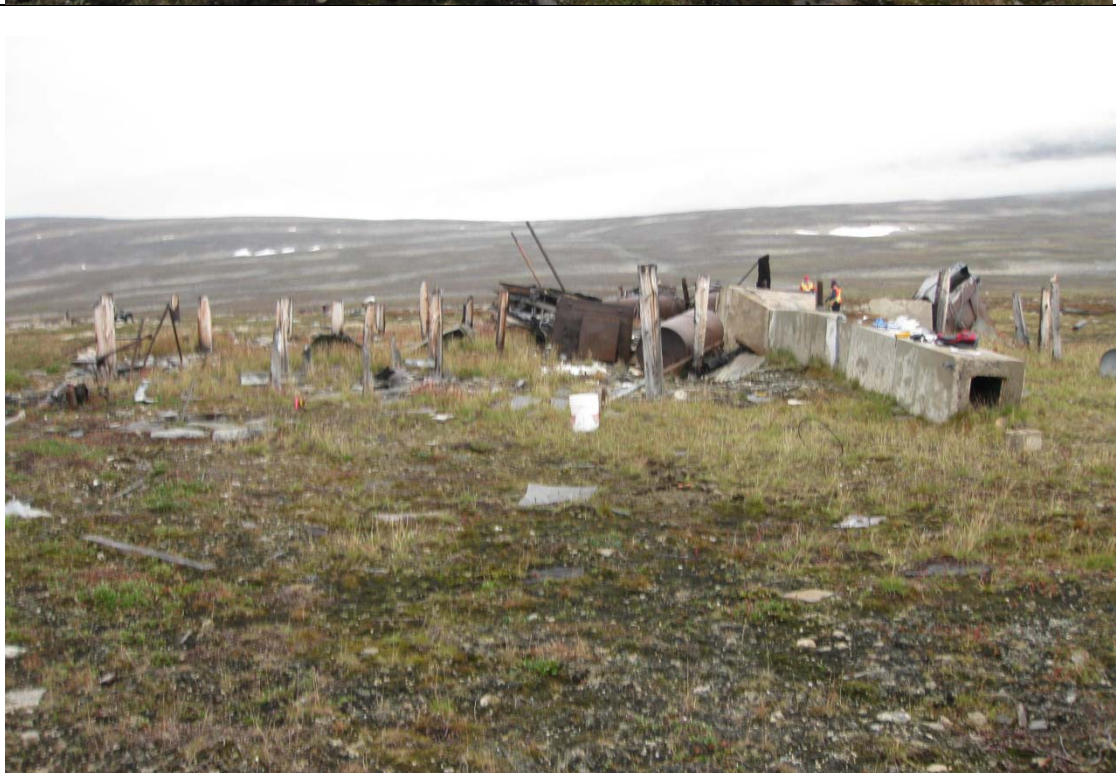
Description: Kitchen/Mess Hall Foundation and Debris Area: fallen concrete chimney limited delineation sampling on southeast corner

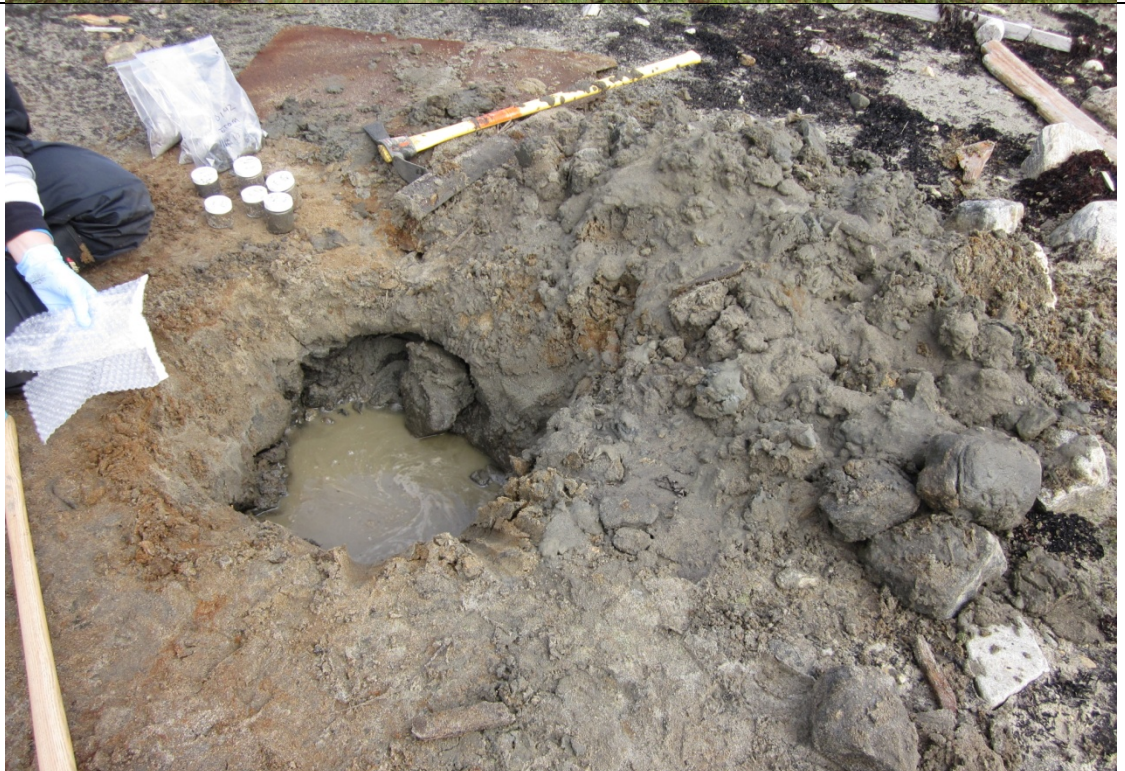
Test Pit South of West Barrel Cache, soil is stained and water has a sheen

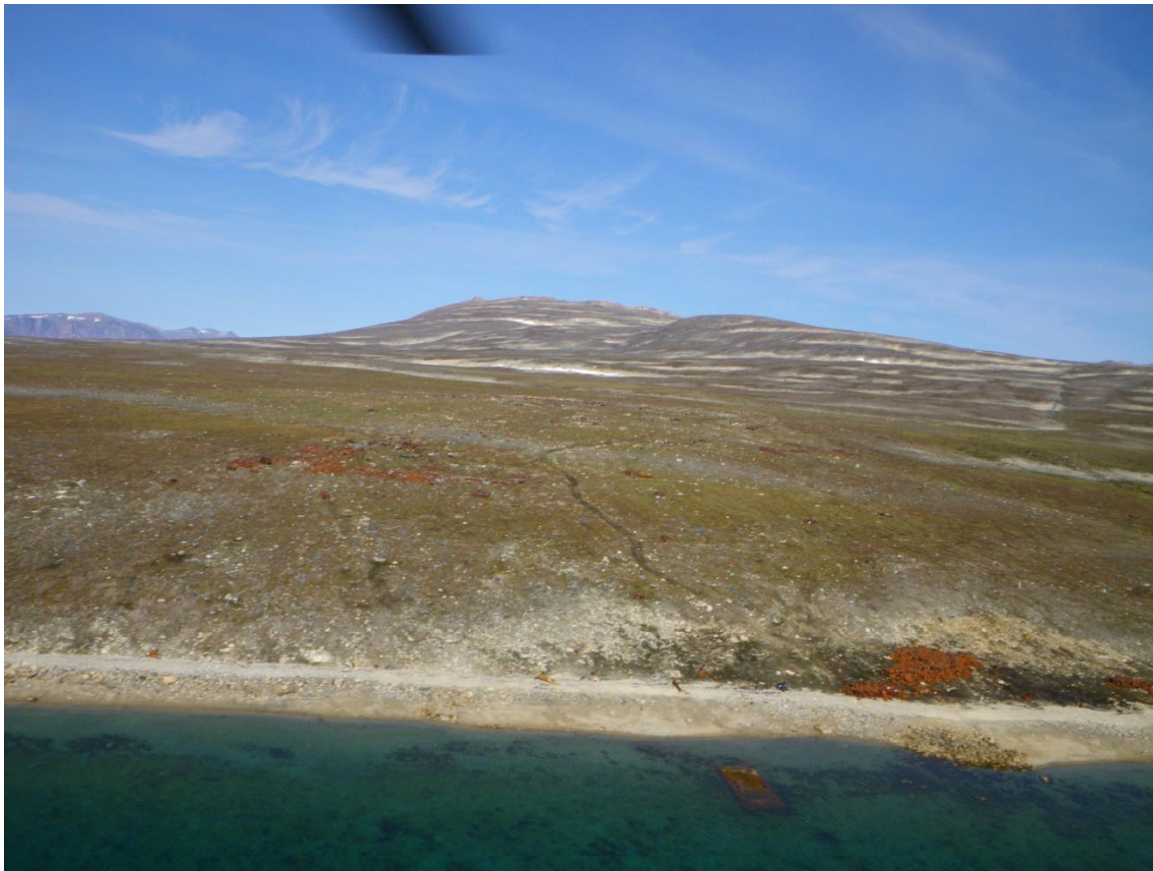
Plate 2 Aerial photo of the beach landing area with main site in the background. Barrel dumps can be seen on shore and a sunken barge is seen off the beach.

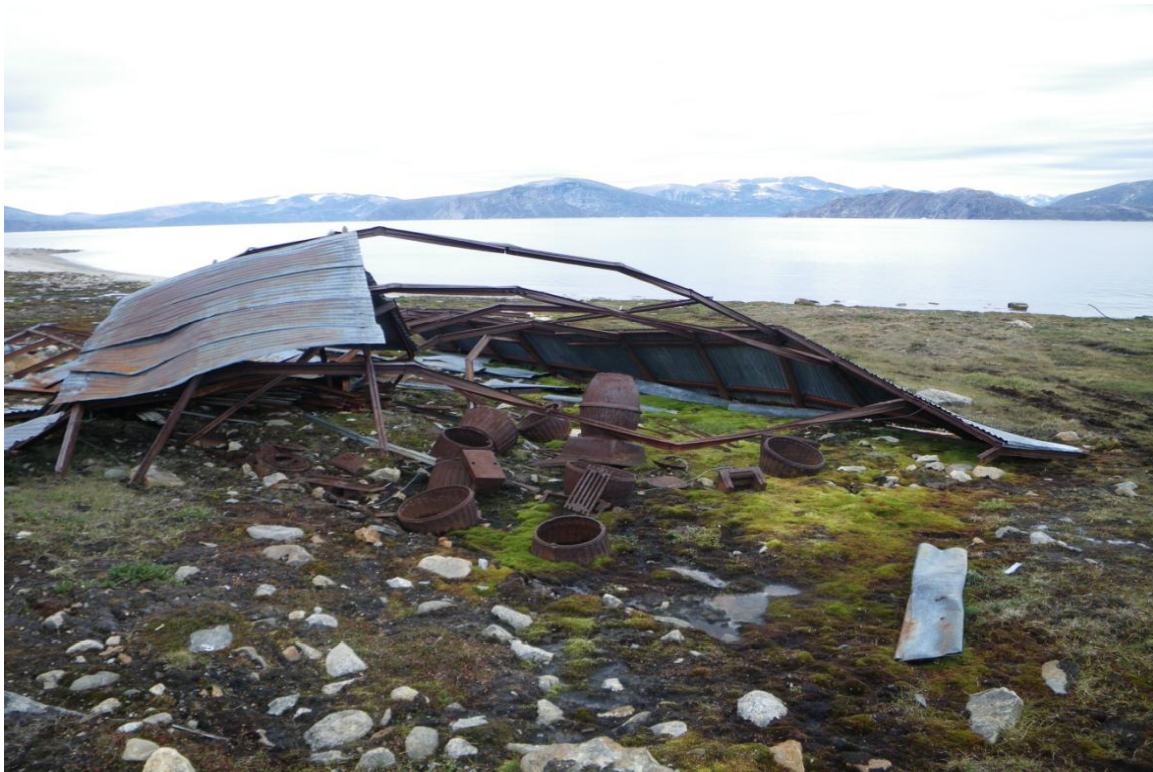
Plate 12 View east of warehouse #2 showing structural remains and US Army canon heaters.
