NWB Annual Report

Project Name: FOX-C Ekalugad Fjord Remediation Project

DIESEL FUEL SPILL AT EKALUGAD FIORD / FOX-C SPILL CLEAN-UP REPORT WITH CONFIRMATORY SAMPLING RESULTS

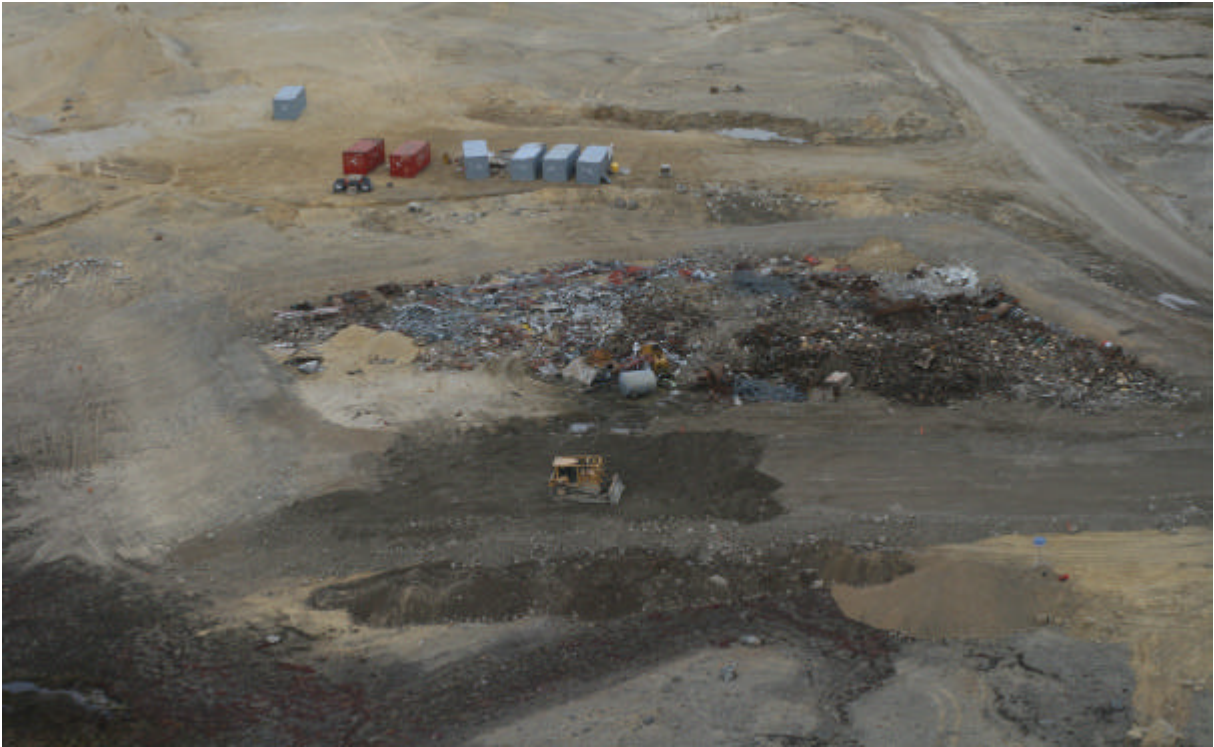
As built drawings are not being submitted because the Non-Hazardous Waste Landfill is not complete. Please see the pictures below:

Lower Site Non-Hazardous Waste Landfill

- Landfarm construction & operation
 - Completed and ongoing
- Installation of monitoring wells at lower site
 - Completed
- Non hazardous waste landfill
 - Berm construction 3 of 4 completed

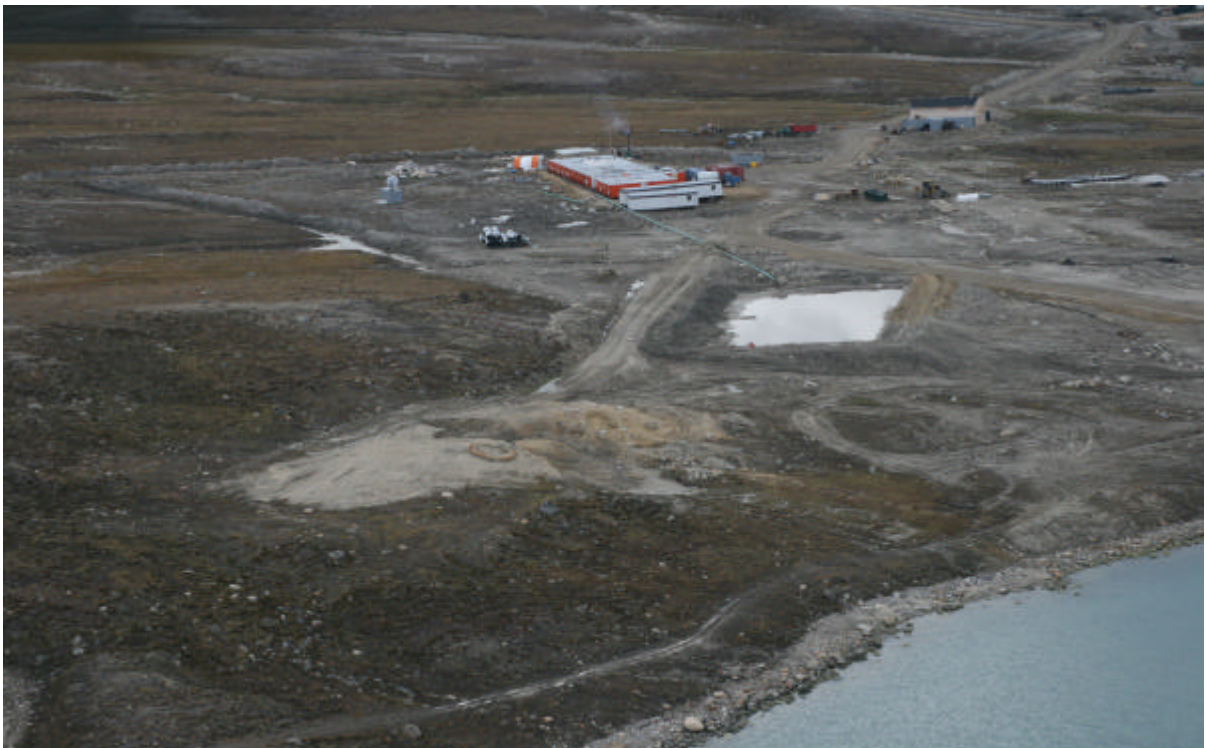
Camp and Sewage Lagoon

- Sewage lagoon construction & operation
 - complete
- Lower site hazardous waste processing area
 - Completed
- Beach tank demolition and land filling
 - Completed

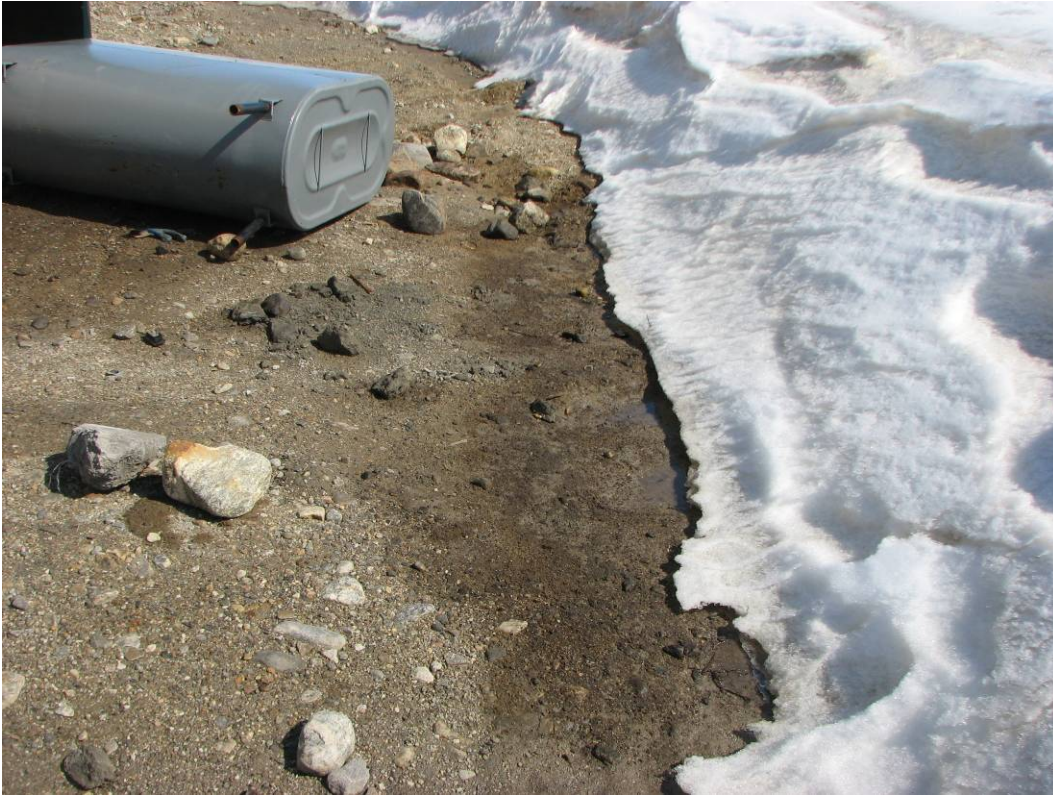
The fuel tank had detached from the garage building and was lying on its side. Approximately 5 gallons of diesel remained in the tank.

Figure 1 : Fuel tank on its side and visible diesel fuel contaminated soil

Upon arrival, the spill source was stopped by securing the tank in upright position. The work crew then shovelled the diesel contaminated soil by hand into 45 gallon overpack drums. Three (3) overpack drums were filled with soil. The depth of the excavation was limited to 6 – 10 inches deep due to encounter of large boulders (used for the foundation of the garage building). Sorbent pads were place at the bottom of the excavation and sorbent booms around its perimeter to absorb any remaining diesel fuel.

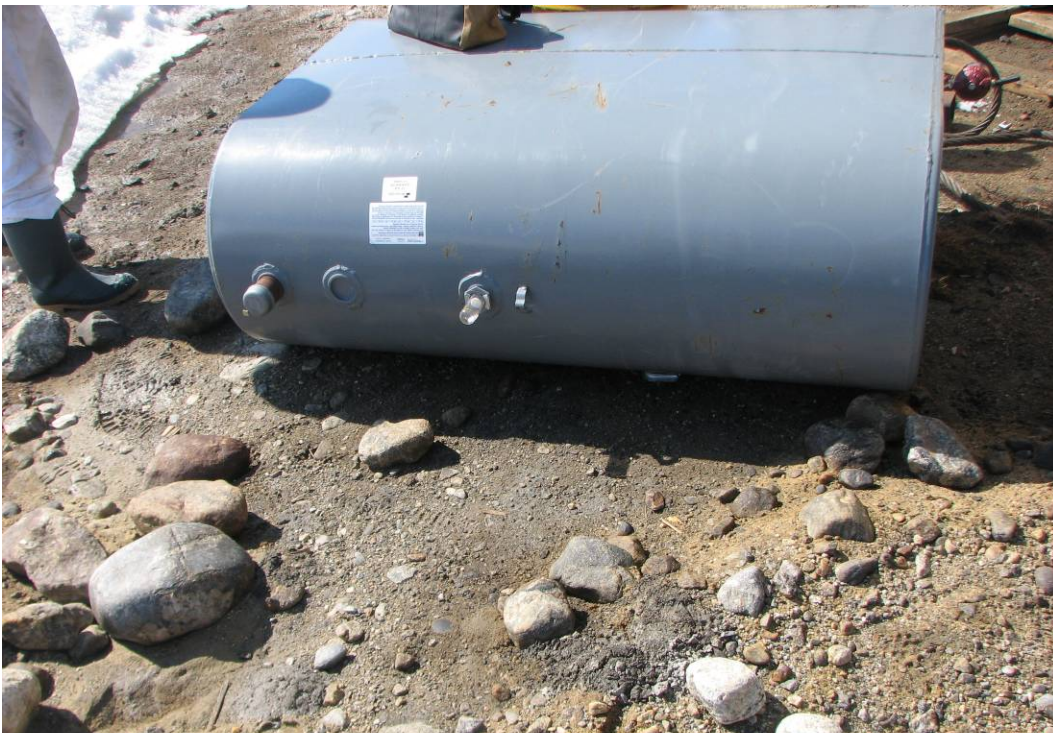
Figure 2 : Fuel tank on its side (view of the top of the tank)

In July 2007, the fuel tank was braced directly to the garage building, in order to further minimise the risk of tipping during high winds in the off-season months.

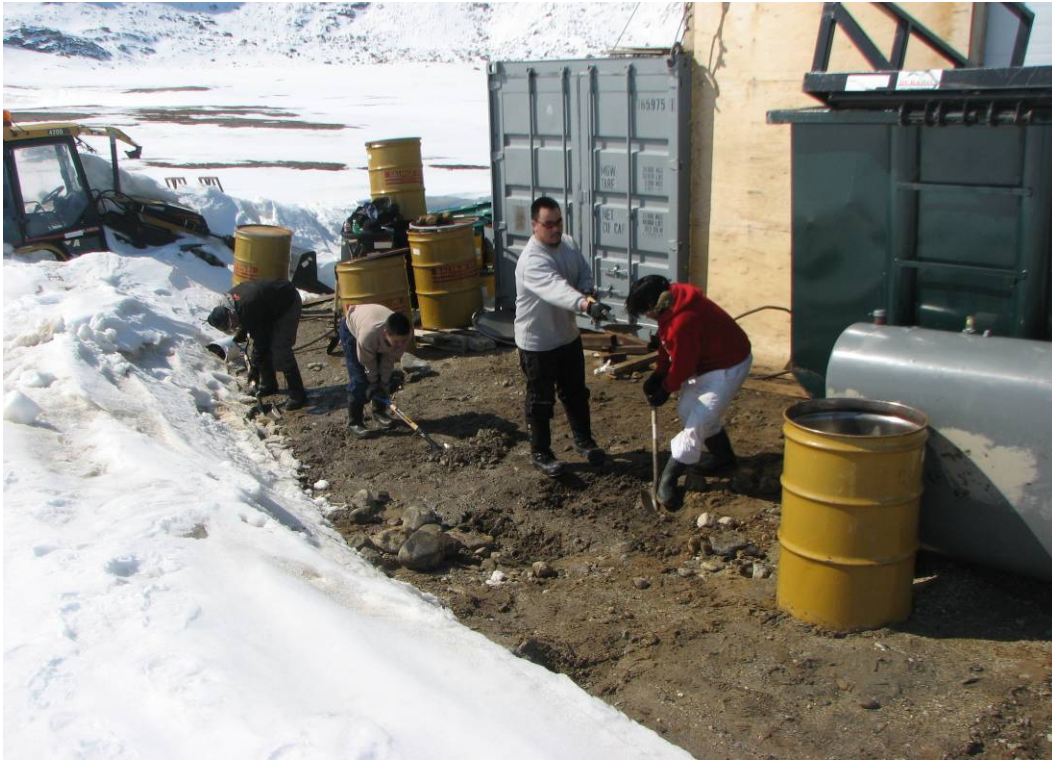
Figure 3 : Shovelling of contaminated soil into yellow Overpack Drums

The excavated contaminated soil will be shipped south for disposal at the end of the FOX-C Remediation Project. The used sorbent pads and booms will also be disposed of accordingly off-site.

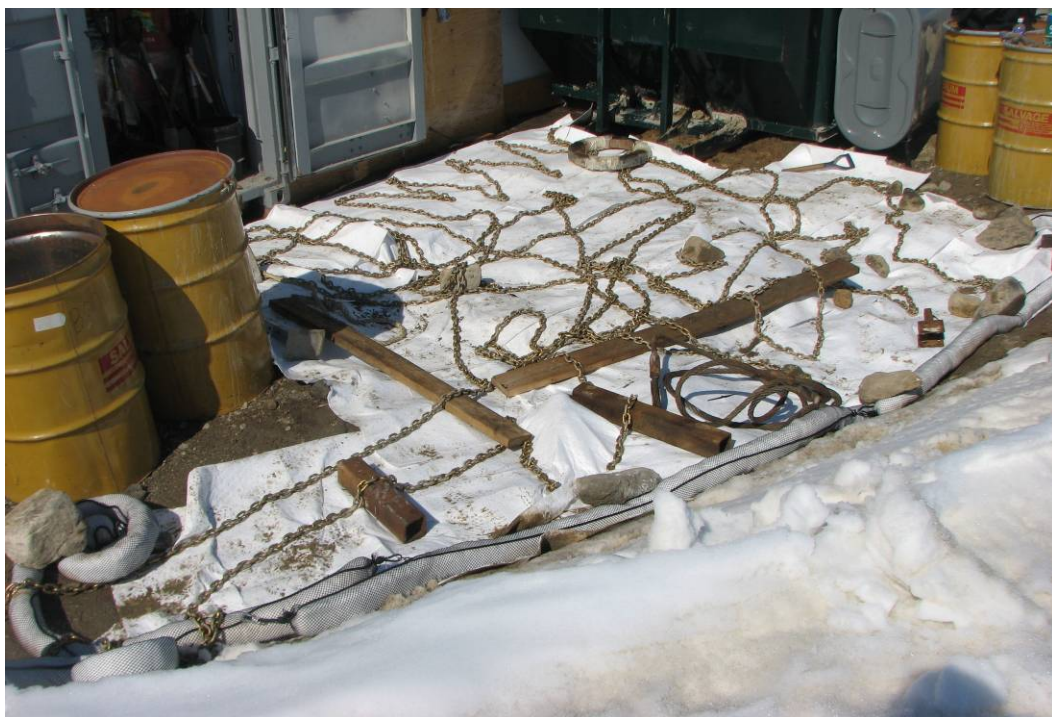
Figure 4 : Sorbent pads and booms around decontaminated area

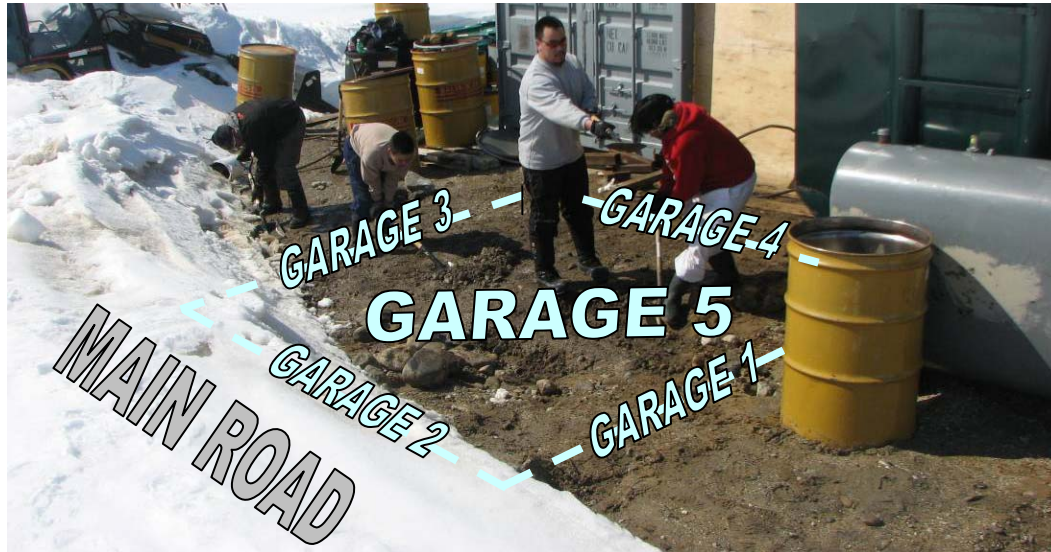
Confirmatory testing was conducted in July 2007 by Cathy Baptista, P. Eng. Composite samples were taken on the perimeter (samples *GARAGE 1* to *GARAGE 4*) and the bottom (sample *GARAGE 5*) of the excavation. The samples were sent to CAEAL accredited Bodycote Laboratory for analysis. A sketch of the soil samples locations is provided below.

Figure 5: Layout of confirmatory sampling locations

As seen in Table 1, all confirmatory test results are well below the applicable hydrocarbon criteria except for the F3 fraction of the *GARAGE 2* composite sample. The side of the excavation corresponding to the *GARAGE 2* composite sample is on the limit of the main road, as such, the excavation could not be extended during the current working season without affecting the road.

Prior to the end of the FOX-C Remediation Project, the side of the excavation along the main road, corresponding to sample GARAGE 2, will be retested. If it remains above criteria, the excavation will be extended into the main road until confirmatory testing demonstrates that all the diesel contaminated soil has been adequately removed.
