Public Works and Government Services Canada

FOX-C Ekalugad Fiord
2008 Construction Clean-Up Summary

Project Number: 2977-328-04
Date: April 28, 2009

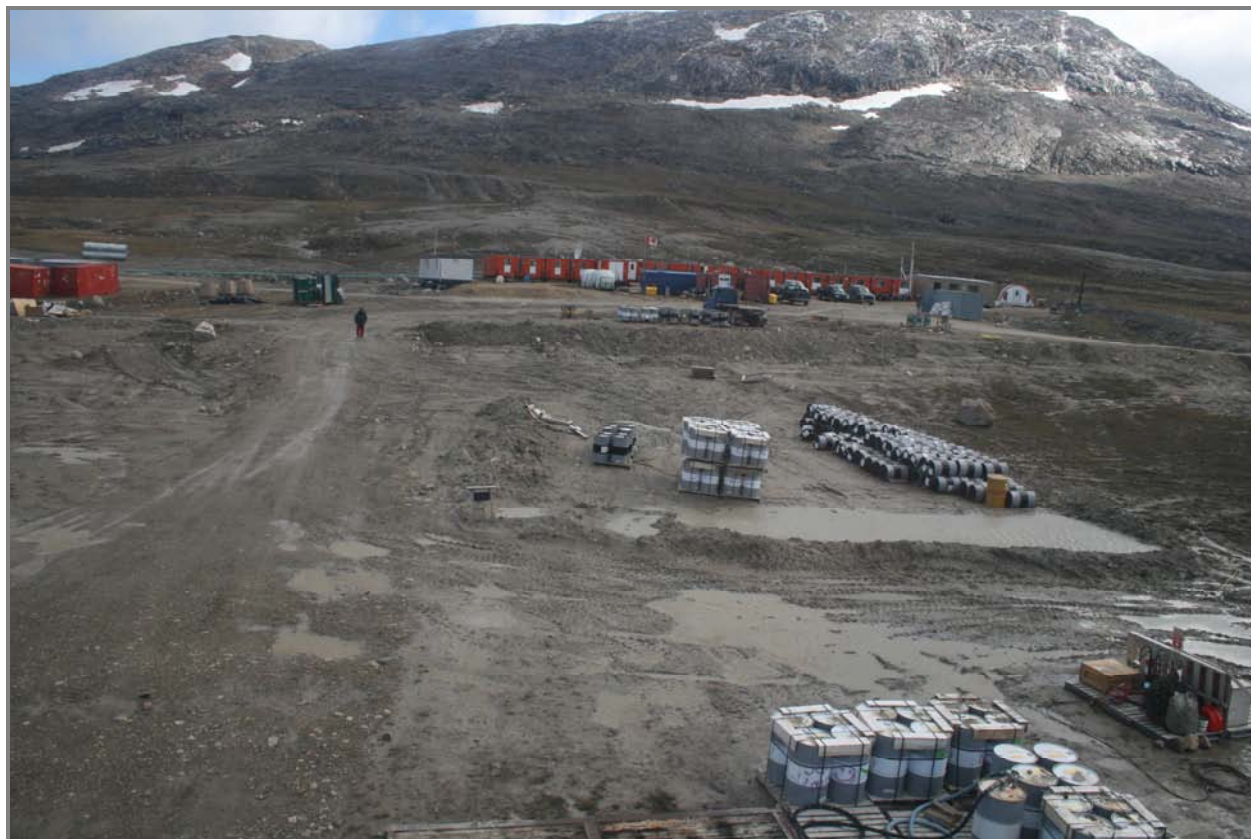
Camp

The camp at FOX-C consisted of 18 modular trailers with living, eating and sleeping quarters, one mechanical / water storage trailer, one recreation room and two gensets. The maximum occupancy of camp during the field season was 48.

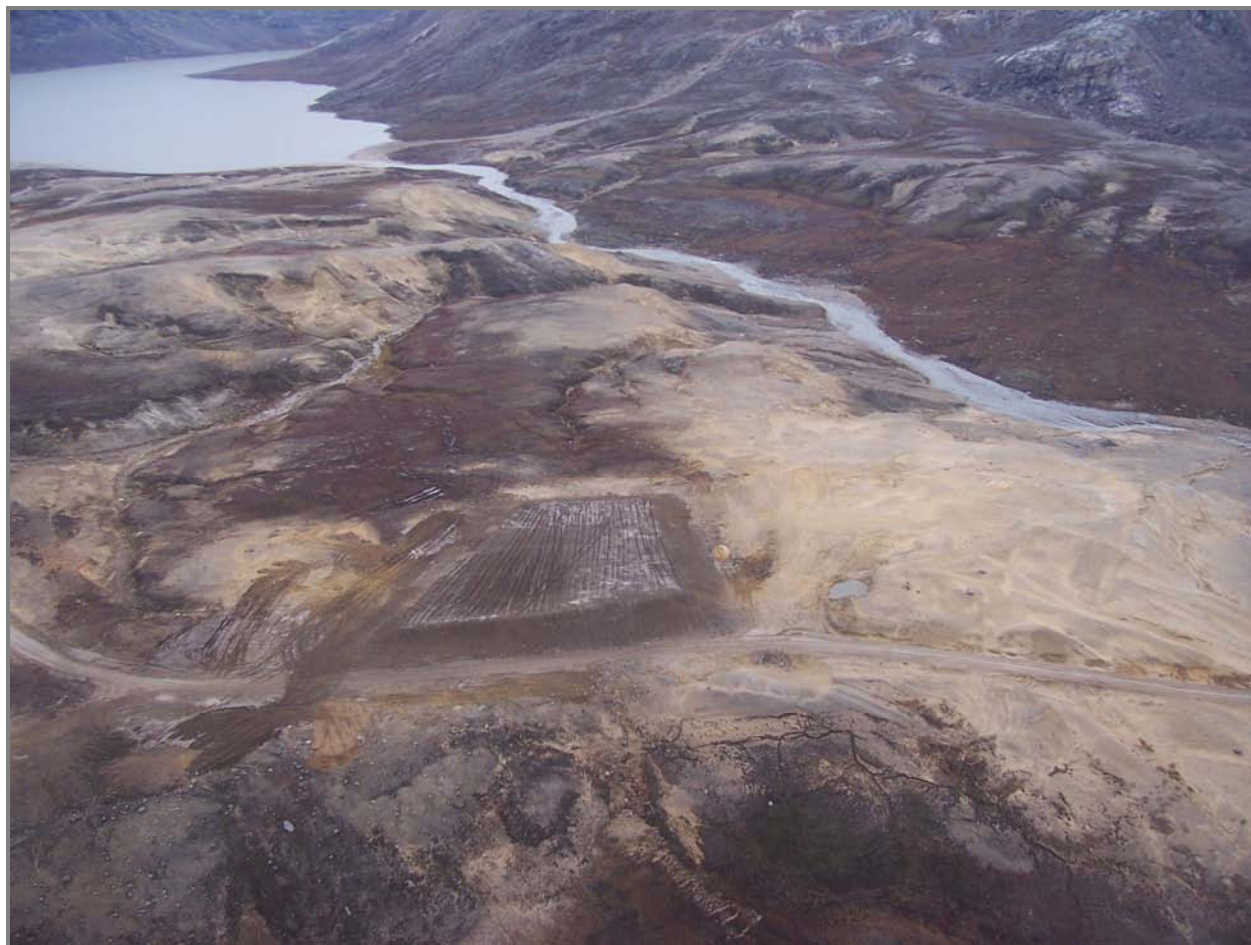
3.4.2 Non-Hazardous Waste Landfill

Berm construction began June 29, 2008 at the NHWL and was completed August 28, 2008. Debris placement in the NHWL began the week of July 6 - 12, 2008.

A survey of the east berm following construction indicated that it was not constructed according to design - the inside slope was too steep and the outside slope was too flat. The inside slope was field fit to a revised 1.5H:1V and the outside slope although flatter than the designed 3H:1V, met the design intent and was left as-is. The west berm was under built; fill was added to meet the 3H:1V design. The final 1.0 m thick cap was placed on the landfill in sections covering approximately one-third of the surface area. Type 2 fill was placed by a bulldozer and compacted in lifts using a smooth drum vibratory compactor.
