**FOX-C Ekalugad Fjord Long Term Monitoring Event  
Qikiqtaaluk Region, Nunavut**

**2018 Long Term Monitoring Report**

**CROWN-INDIGENOUS RELATIONS AND NORTHERN AFFAIRS CANADA  
NUNAVUT REGIONAL OFFICE**

**December 2018  
SLR Project No. 209.40585.00000**

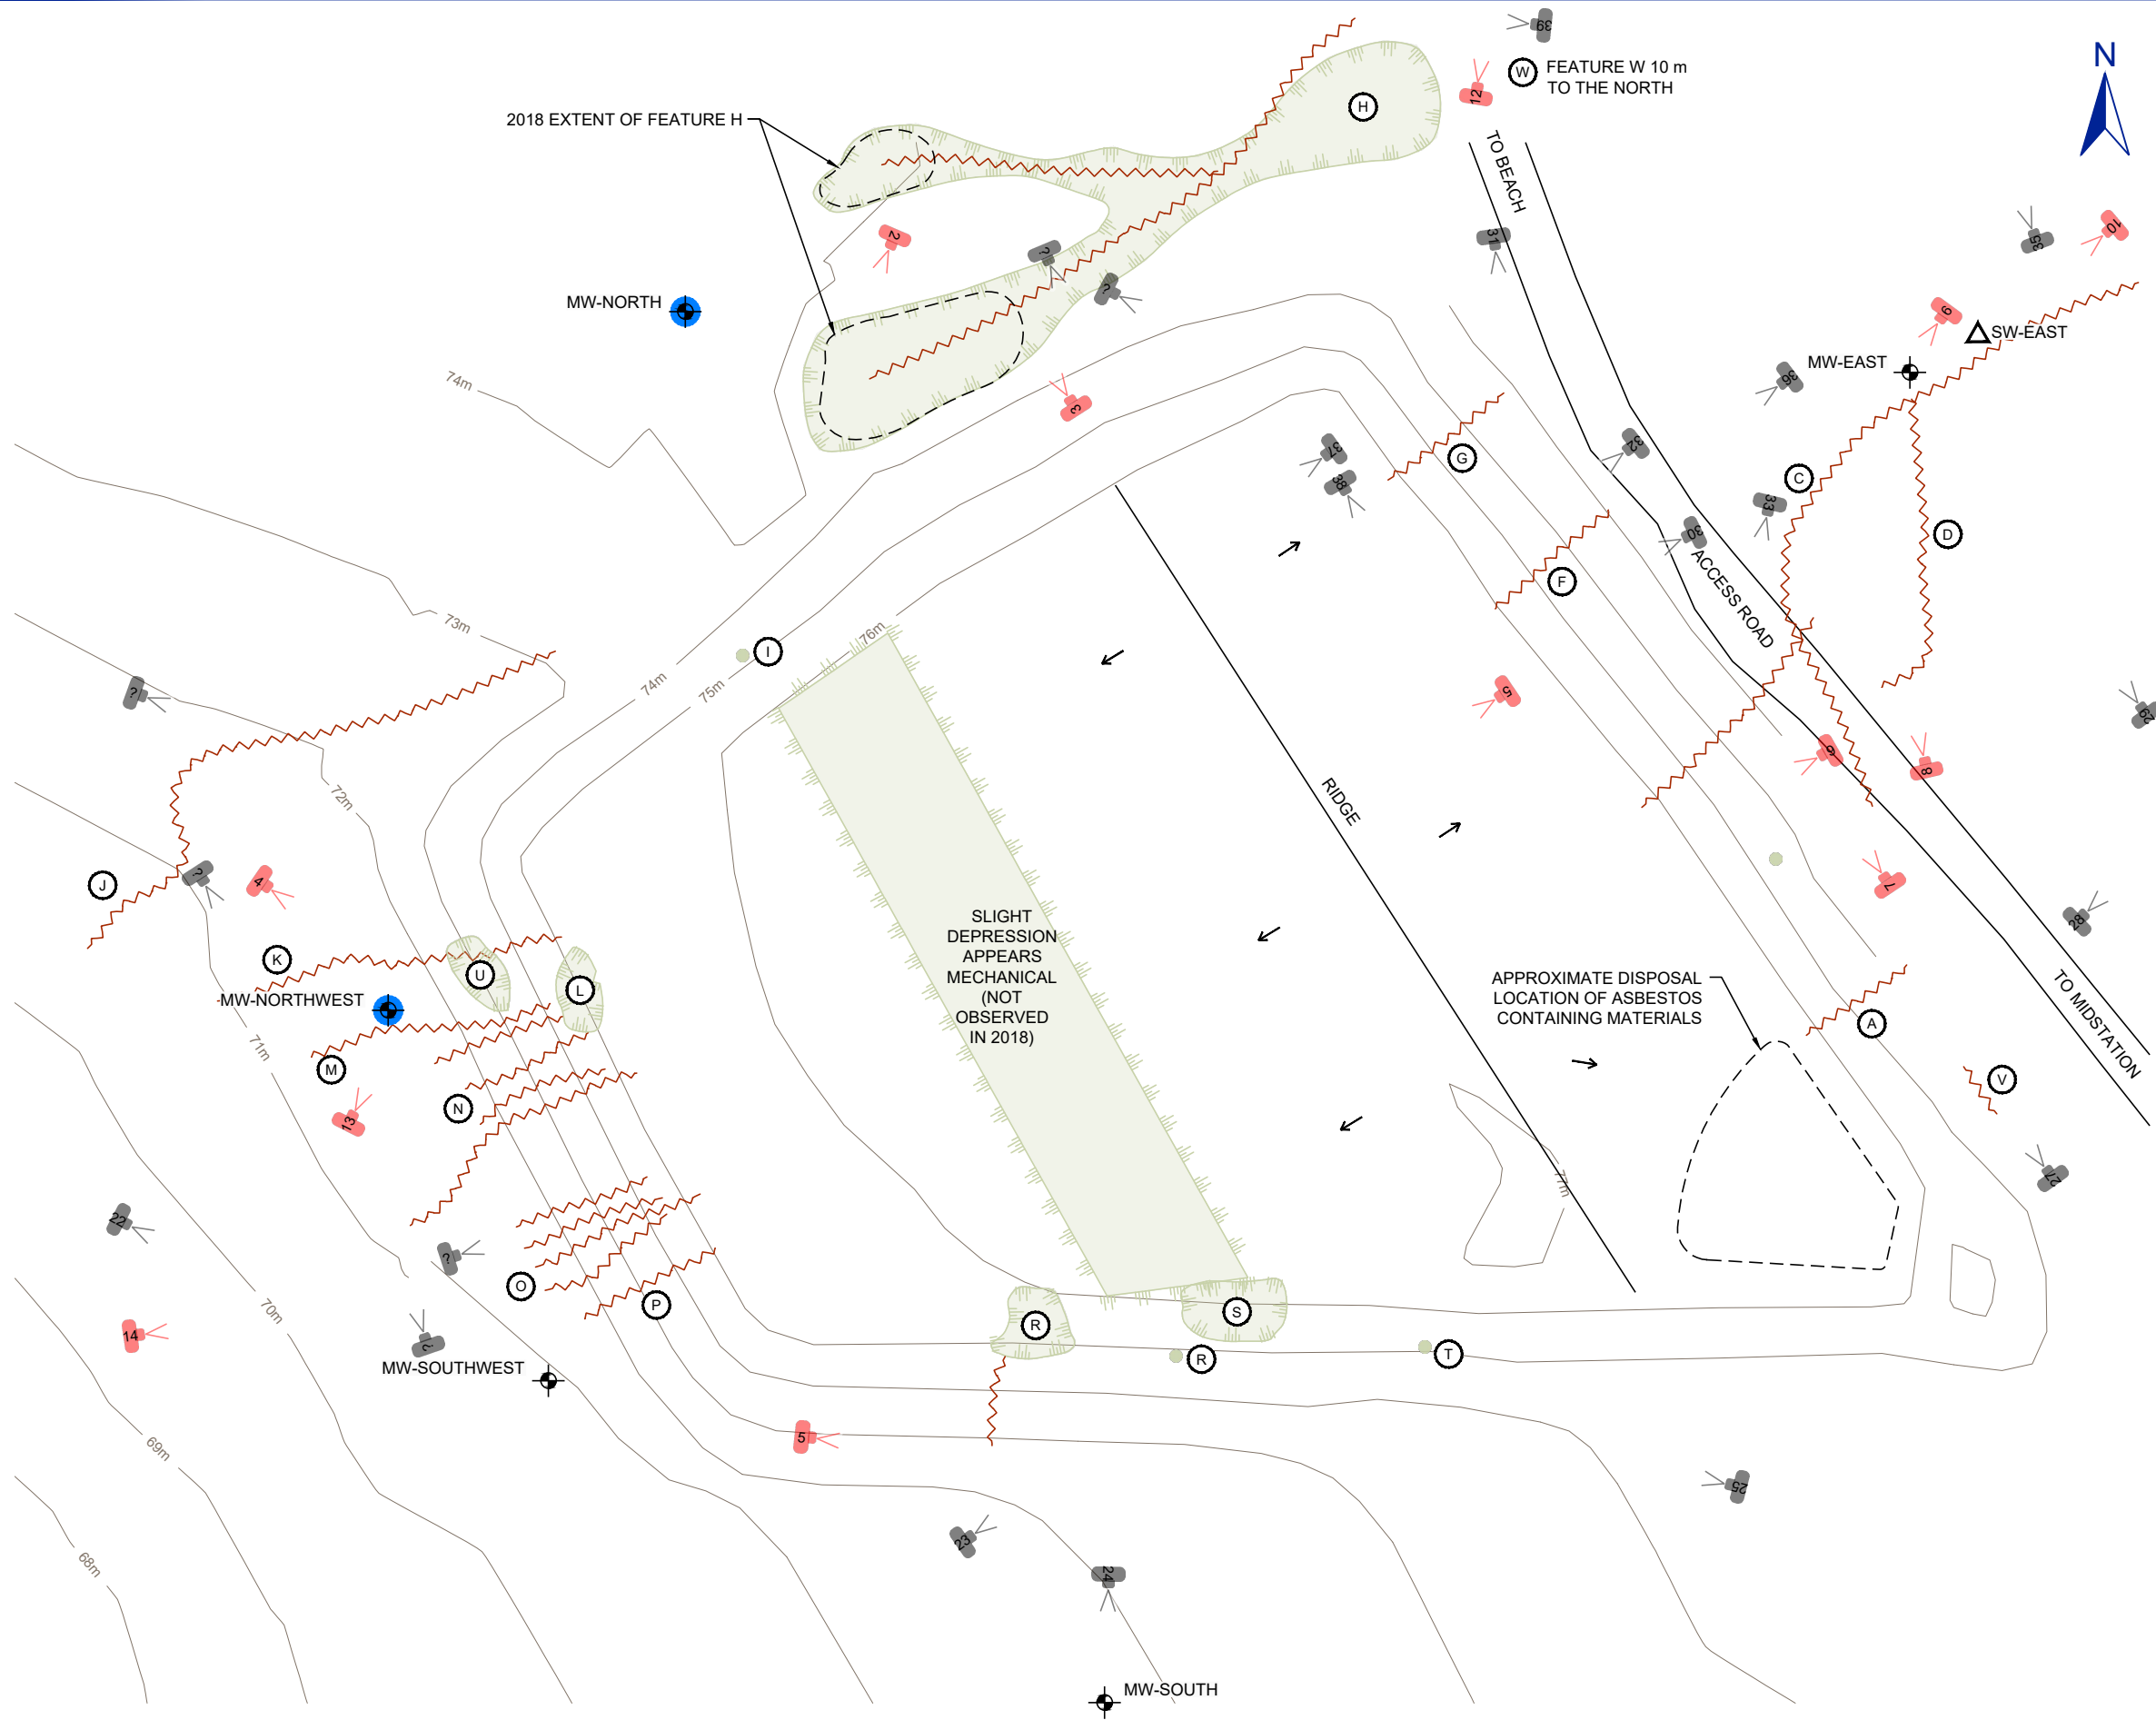
The physical integrity of the NHWL was assessed by collecting visual evidence staining, seepage, erosion, frost action, settlement, and lateral movement. Features identified in previous monitoring programs were assessed during the 2018 site visit for condition and stability. Additionally, any new features were noted for size and extent. The locations historic features referred to in the sections below are available on **Drawing 2** at the end of this report. The following table provides a summary of the NHWL features.

Feature H has been historically noted as a large depression where ponded water accumulates. This feature was observed to be present in 2018, however the size and extent of the ponded water accumulation has decreased (Photos 2 and 3, **Appendix A**). The new approximate size and extent of feature H has been noted on **Drawing 2**.

The large rectangular depression noted to be located on the landfill cap in 2016 (see **Drawing 2**, no reference letter), was not observed in 2018. The landfill cap appears to be in excellent condition with no signs of settlement, ponded water, or erosion.

A new area of settlement and ponded water was observed north of the northeast corner of the NHWL (Photo 12, **Appendix A**). Location is noted on **Drawing 2** and is referenced as Feature W.

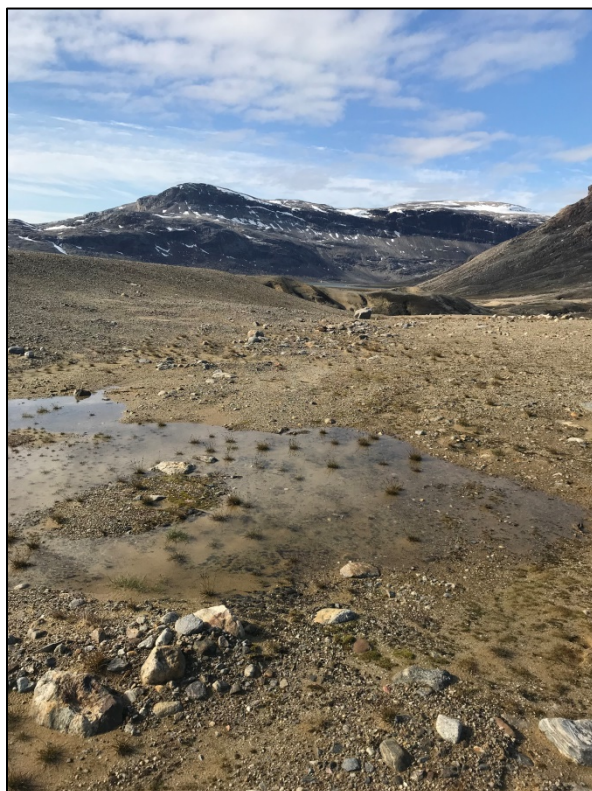
**Photograph 2.** Historic Feature H – Ponding observed to a lesser extent in 2018. Facing southwest

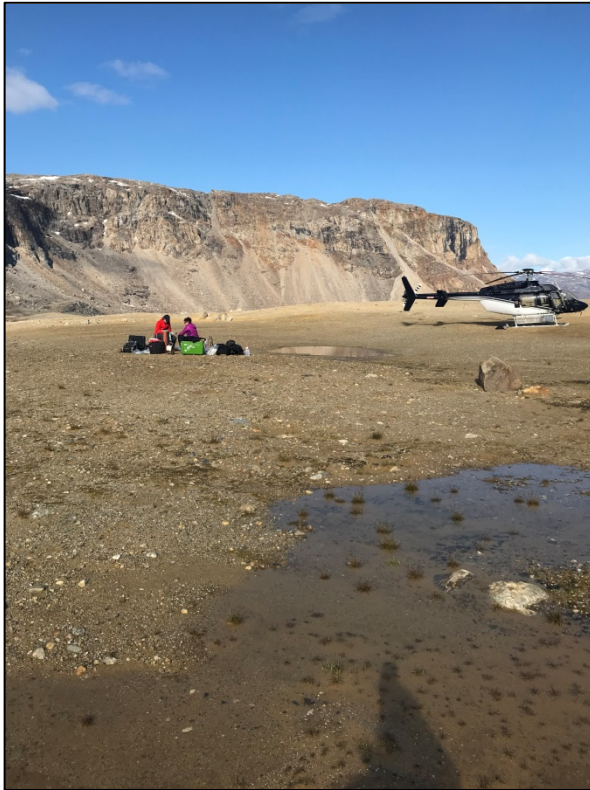
**Photograph 3.** Sampling at MW-North, Historic Feature H – Ponding observed to a lesser extent in 2018. Facing northwest

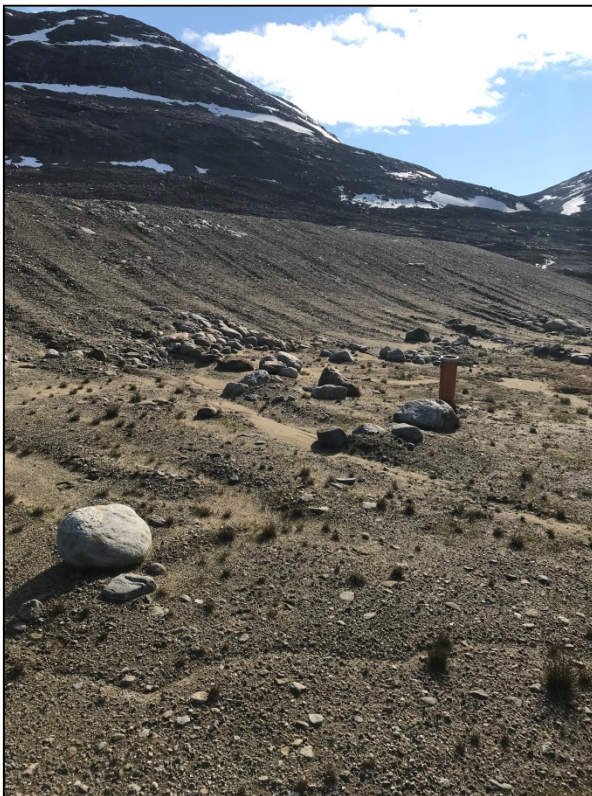
Features Q, R, and T have been historically observed as areas of settlement along the southern edge of the NHWL. These features were not identified during the 2018 site visit. Features U and L, located along the western edge of the NHWL were identified as depressions in 2018, however no ponded water was present (Photo 4, **Appendix A**).

Erosion channels have been historically observed running down the eastern and western side of the Landfill (Features, A, E, F, G, K, M, N, O, and P, see Photos 4, 6, and 9 in **Appendix A**). All of these features were identified in 2018 but appear to be of similar size and extent to that observed previously. Channels along the southwest edge of the NHL appear to be the largest, approximately 20 cm deep at the toe. There is an accumulation of fine grained sediment along the invert of each of these channels.

**Photograph 4.** Runnelling along western edge of NHL, facing southeast. MW-Northwest in view.

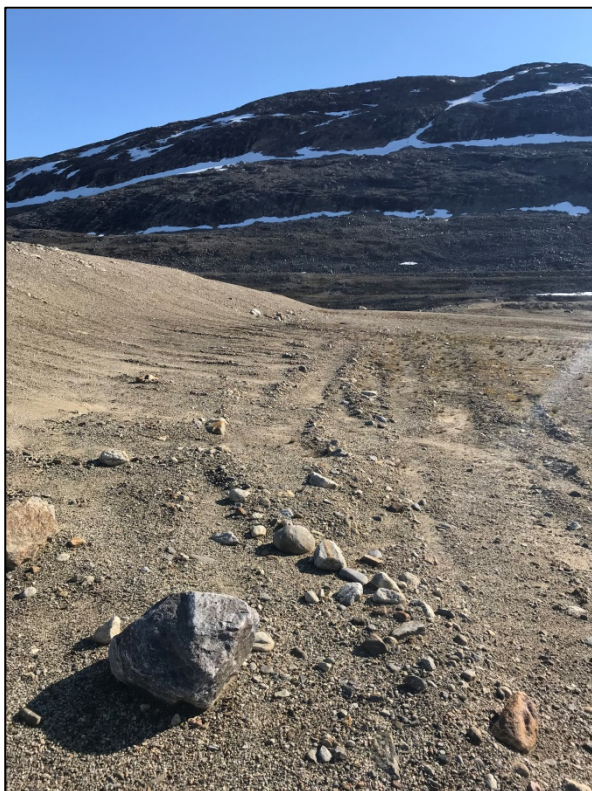
Feature S, a historic erosional feature consisting of exposed cobbles along the southern berm of the NHL, was not observed in 2018 (Photo 5, **Appendix A**).

**Photograph 5.** Southern edge of NHL, facing east. Light runneling along slope.

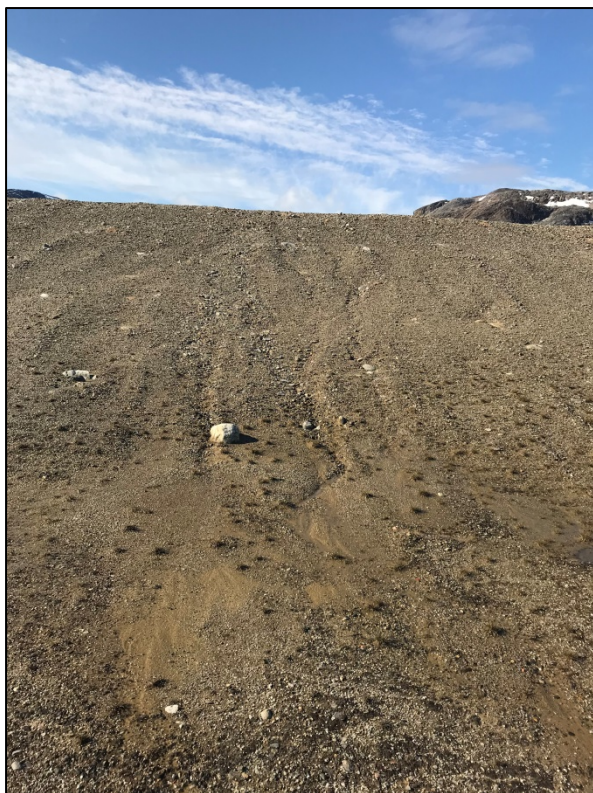
**Photograph 6.** Erosion along eastern edge of NHL. Noted during previous monitoring programs. Similar extent. Facing West.

### Discussion

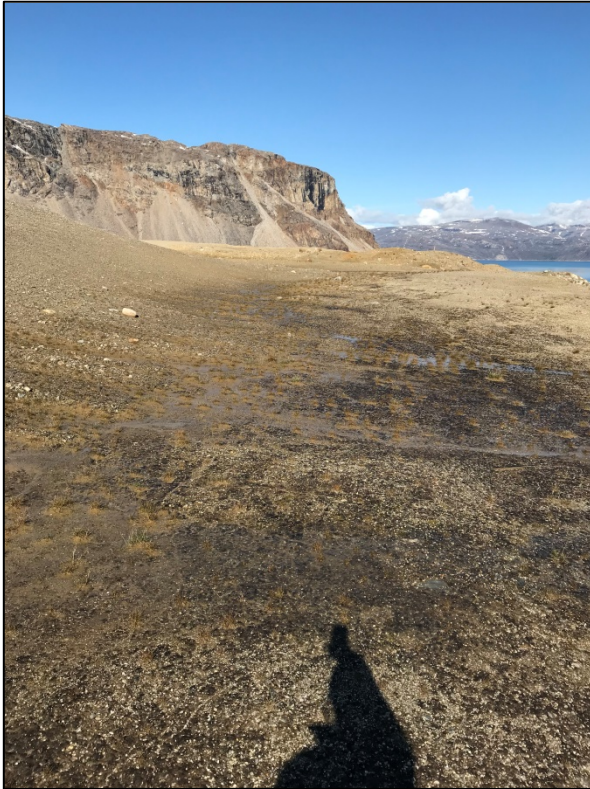
**Photograph 7.** Ponded water at base of eastern slope of NHWL. Facing north

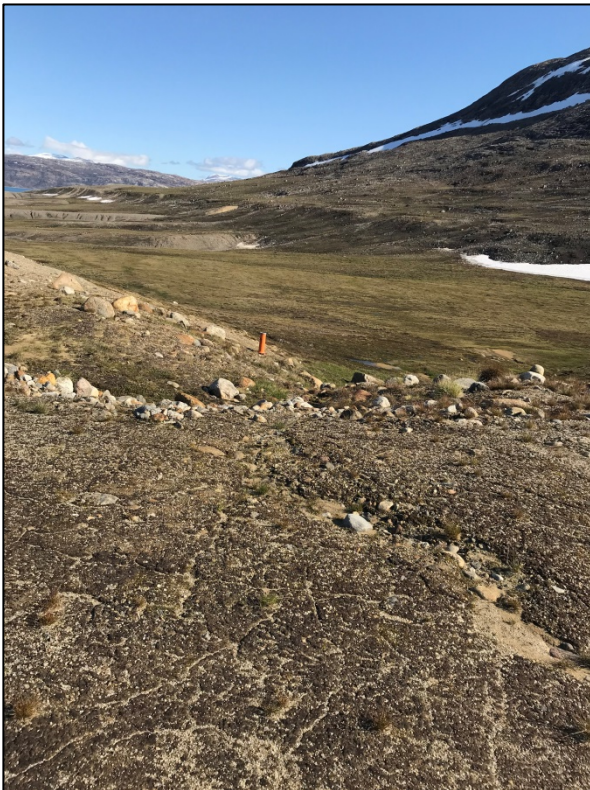
Feature D and Feature C have been historically observed as seepage points and have been growing in size and extent since 2011. The two channels begin at the toe of the eastern edge of the NHWL and converge to form a large ditch that runs to the northeast adjacent to MW-East (Photos 8 and 10, **Appendix A**). This was the site of the surface water sample that was collected in 2018 (see **Drawing 2** for surface water sampling location). Future programs should closely monitor this feature for growth and continue to collect surface water samples at this point. No other areas of seepage were observed during the 2018 site visit.

**Photograph 8.** Channelized water flowing from NHWL downslope to the east. MW-East in view. Facing northeast

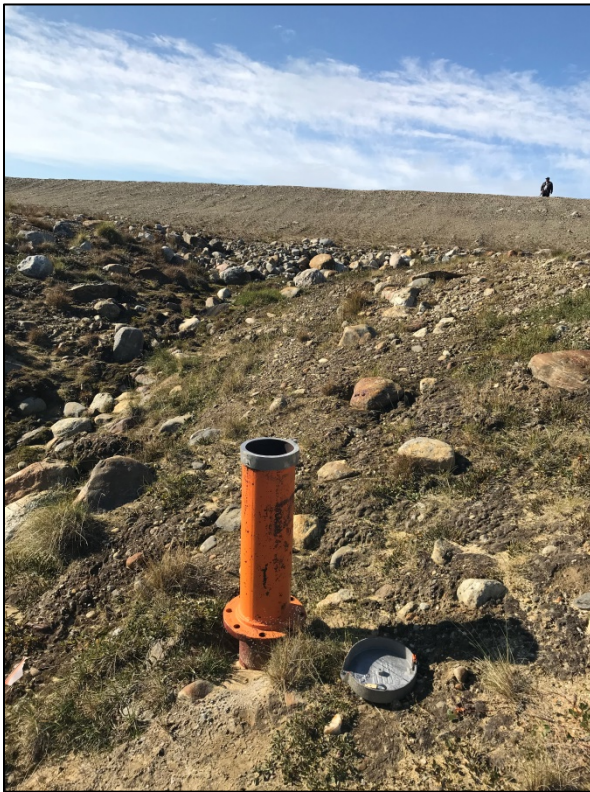
MW-East to the east of the NHWL showed signs of frost jacking and should be monitored during future monitoring programs as repair may be required. No damage to the interior well casing

MW-East, located to the east of the FOX-C NHWL is showed signs of potential frost jacking as the well monument appeared to have risen above the ground surface (Photo 9, **Appendix A**). This may be associated with the erosion occurring to the south and east of MW-East.

**Photograph 9.** MW-East showing signs of jacking. Facing west.

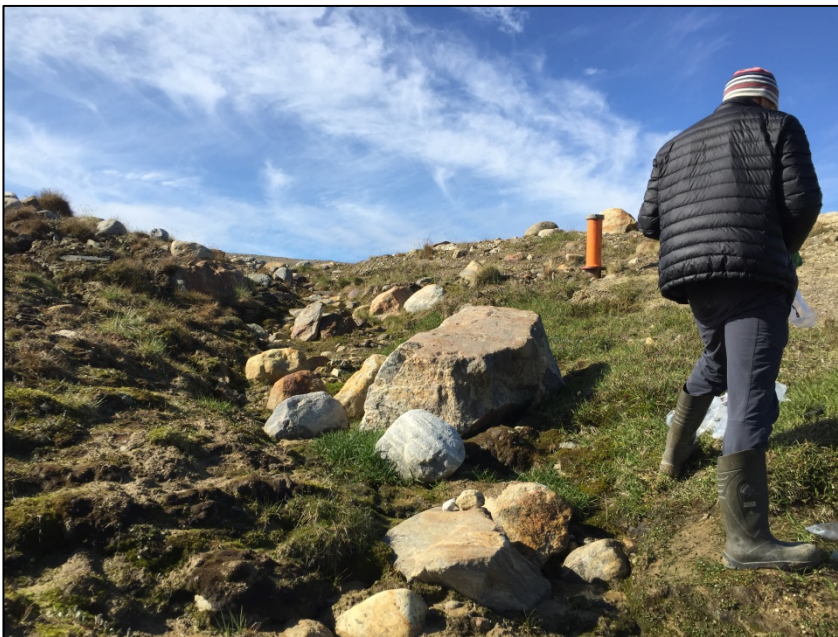
Soil samples were not collected during the 2018 site visit due to no new areas of staining or other anomalies being observed. A surface water sample was collected from the location where Features C and D (seepage points) converge on the eastern side of the NHWL. While this feature does not currently appear to affect the stability or integrity of the NHWL, it should be closely monitored during future site visits and surface water samples should be continued to be collected.

**Photograph 10.** Location of surface water sampling, east of MW-East. Facing West.

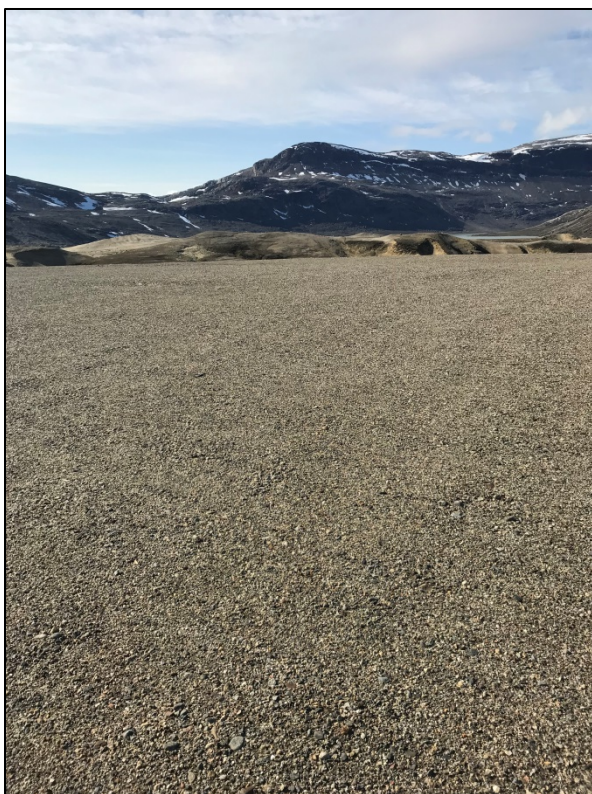
**Photograph 11.** Top of NHWL, facing west. Cap appears to be very flat with no obvious signs of settlement or depression. No ponded water present.

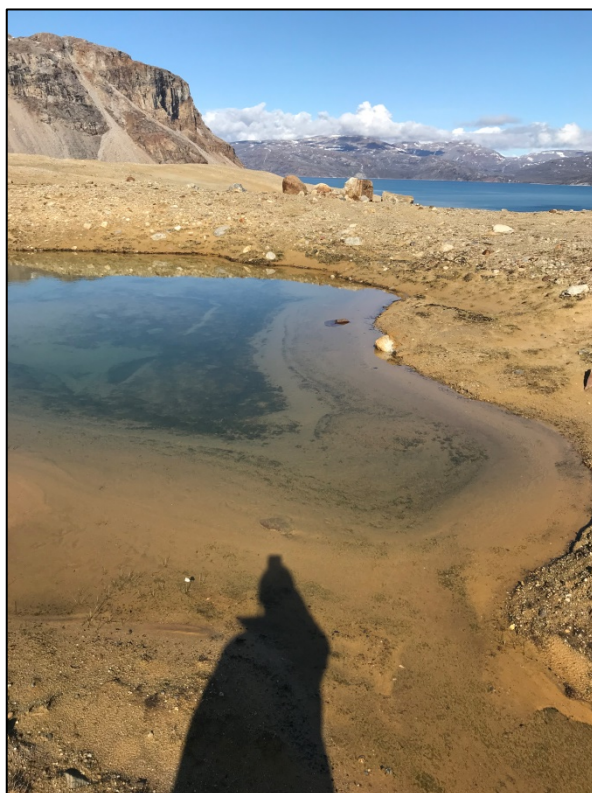
**Photograph 12.** New area of ponding observed to the north of the northeast corner of the NHWL. Facing north.

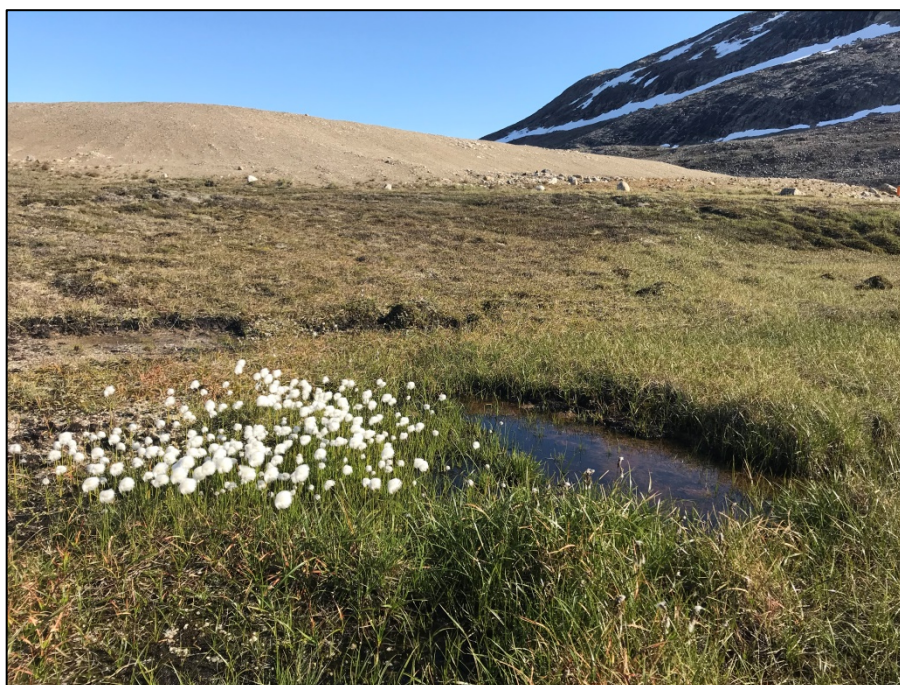
Re-establishment of vegetation is likely to take a significant amount of time due to the coarse materials used to construct the landfill (i.e. coarse gravel) and due to the fact that the growing season is short in northern regions. Very little vegetation was observed on the NHL. Vegetation including grasses, lichen, Arctic poppy (*Papaver radicum*), and Arctic cotton (*Eriophorum callitrix*) growth begins anywhere from 2 – 10 m from the toe of each side of the NHL (Photo 14, **Appendix A**).

**Photograph 14.** Vegetation south of the NHWL including grasses and arctic cotton. Vegetation was not present on the NHWL but began 2 – 10 m from the base of the NHWL slope on all sides.
