## LONG TERM MONITORING, 2016

Ennadai Lake Former Weather Station, Nunavut

February 3, 2017

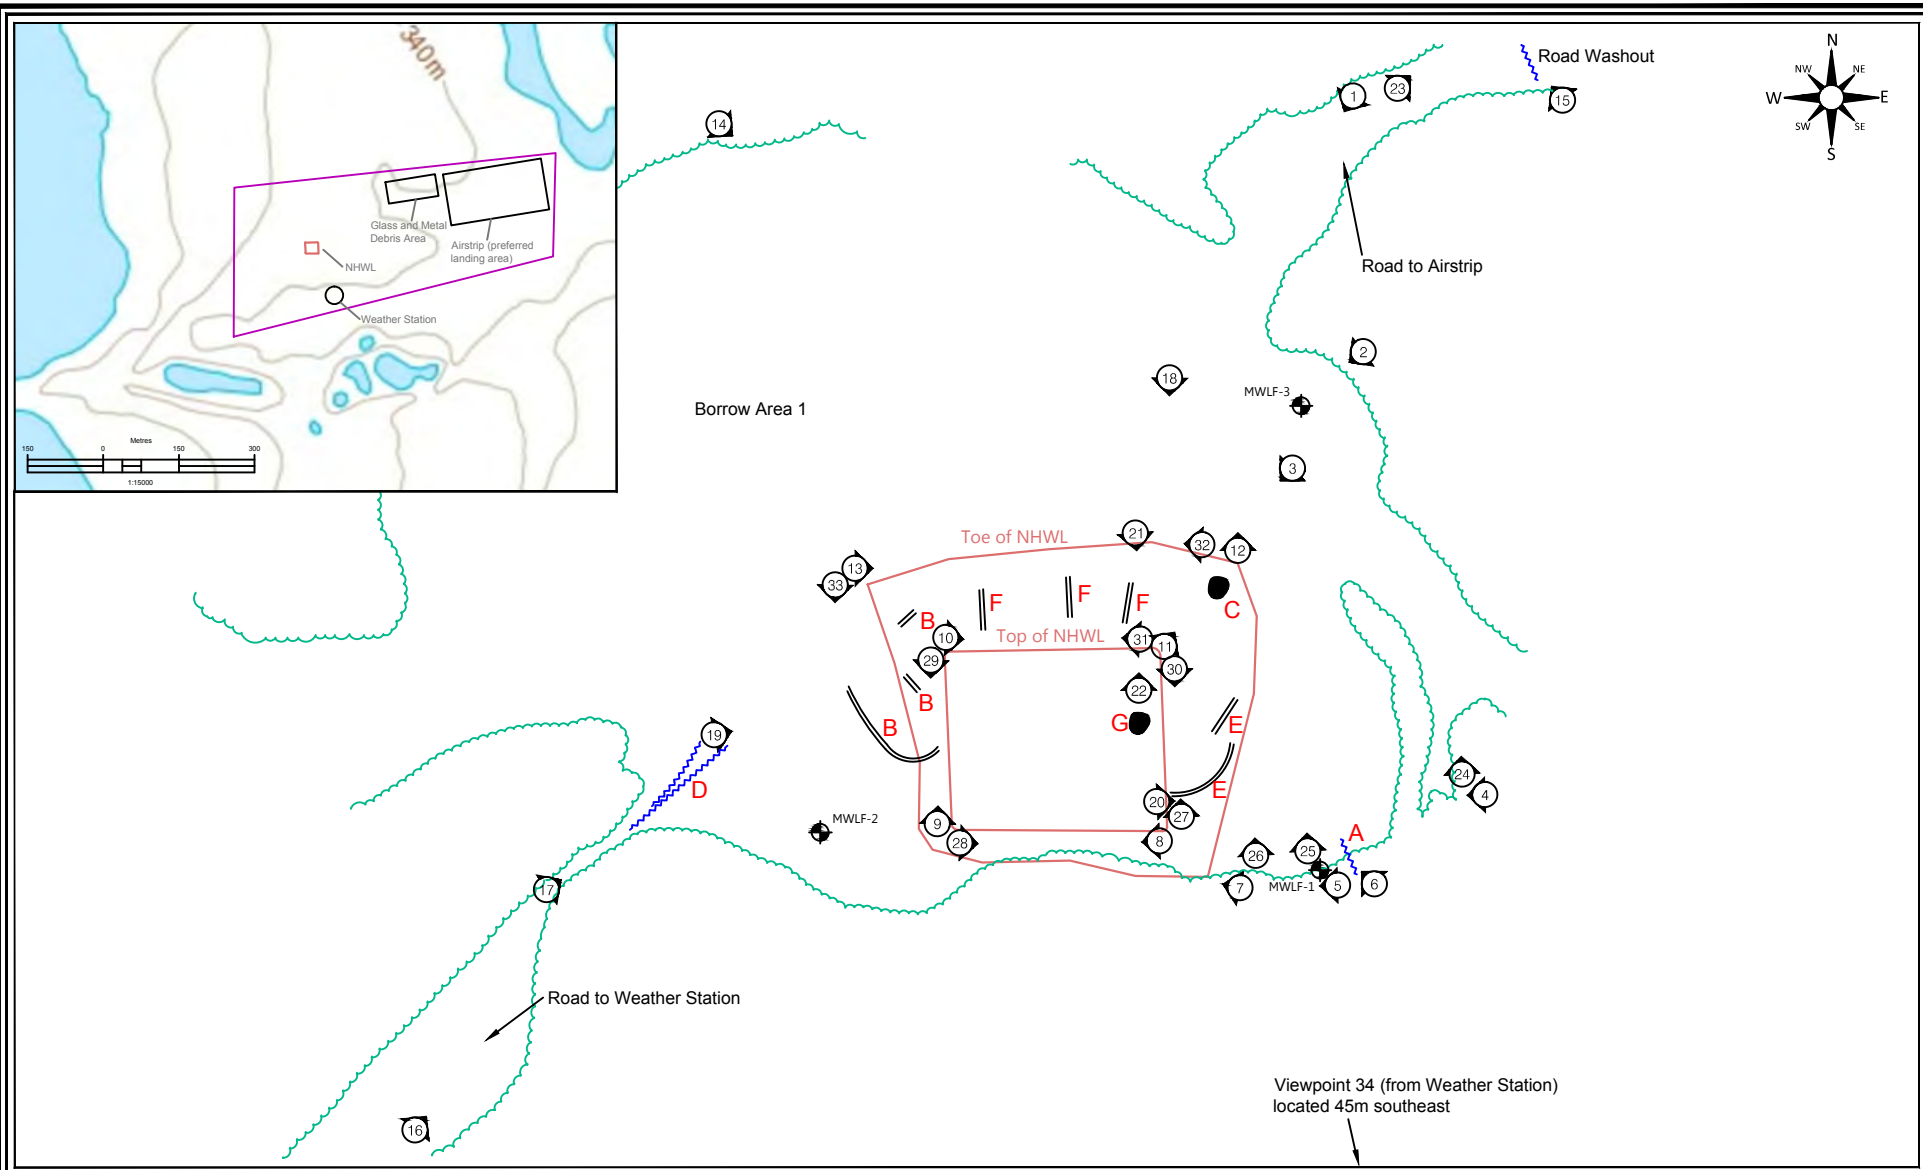
- Approximate Site Boundary
- Non Hazardous Waste Landfill (NHWL)
- Viewpoint Location
- Edge of Brush
- ATV Tracks
- Area of Settlement/Pothole
- Erosion Channel
- Monitoring Well

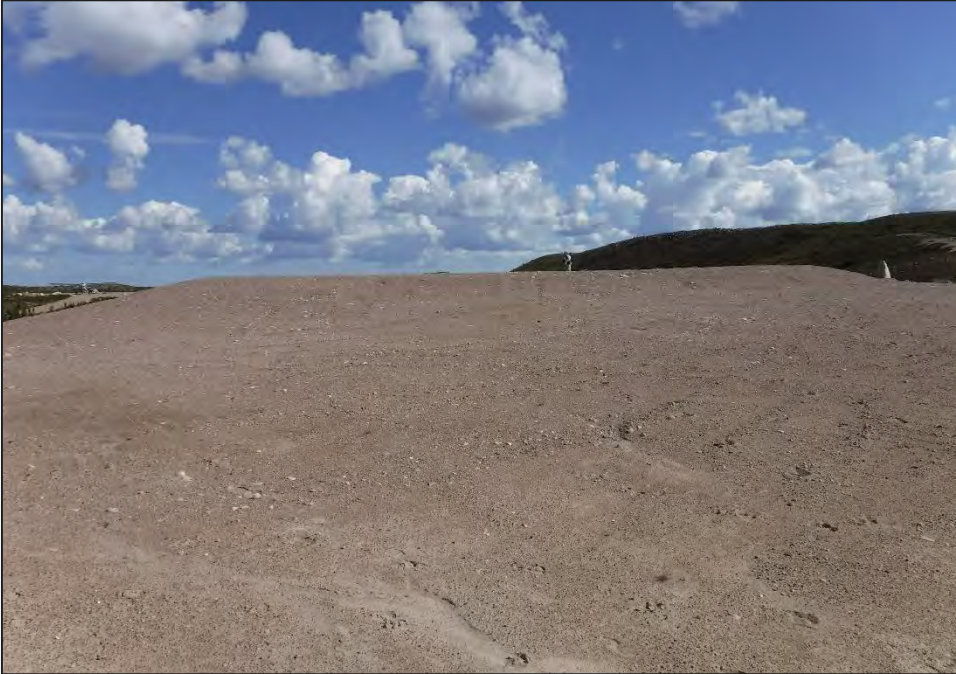
**Photo:** 5

Numerous ATV tracks were observed on and around the NHWL. Those noted as Features (Features B, E and F, Viewpoints 19, 33, 20 and 21) were located on the slopes of the berms and could develop into drainage/erosion channels. They should be monitoring during future LTM events.

Viewpoint 19

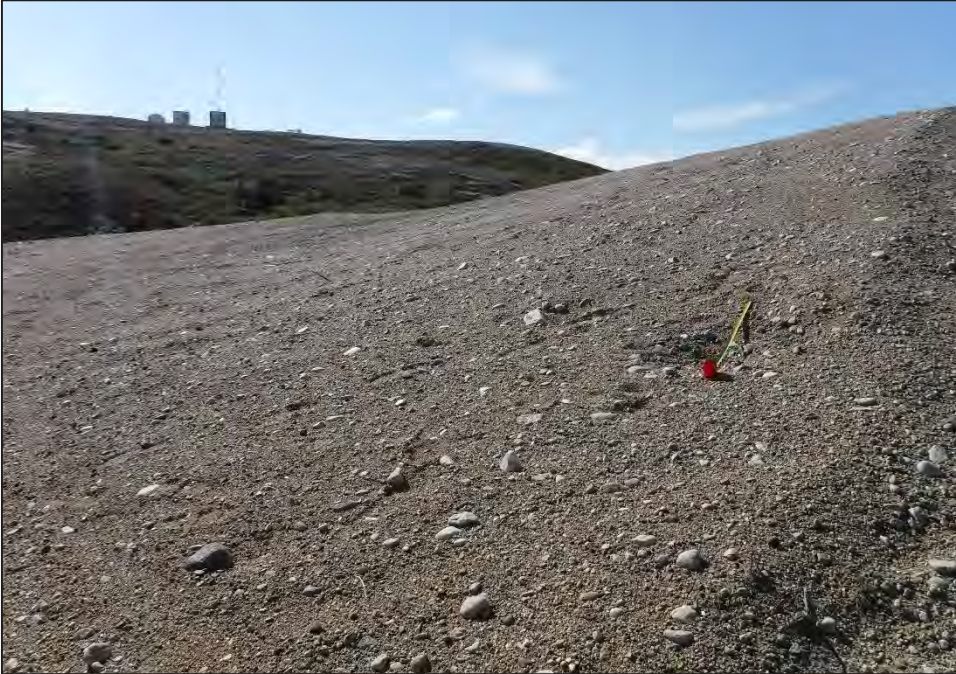
**Photo:** 7

Two areas of settlement were observed. Two small potholes were observed in the northeast corner of the NHWL, one on the cap (Feature G, Viewpoint 22) and one near the toe of the berm (Feature C, Viewpoint 12). These potholes are considered small in nature ( $\leq 0.5$  m across) and do not appear to impact the integrity of the landfill.

Viewpoint 12

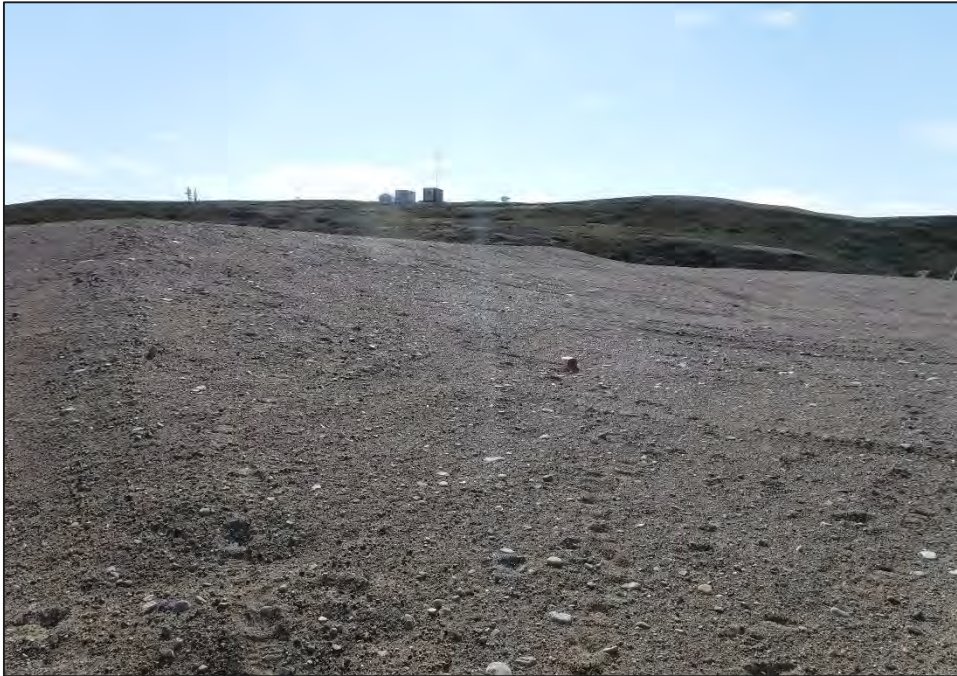
**Photo:** 9

Viewpoint 33

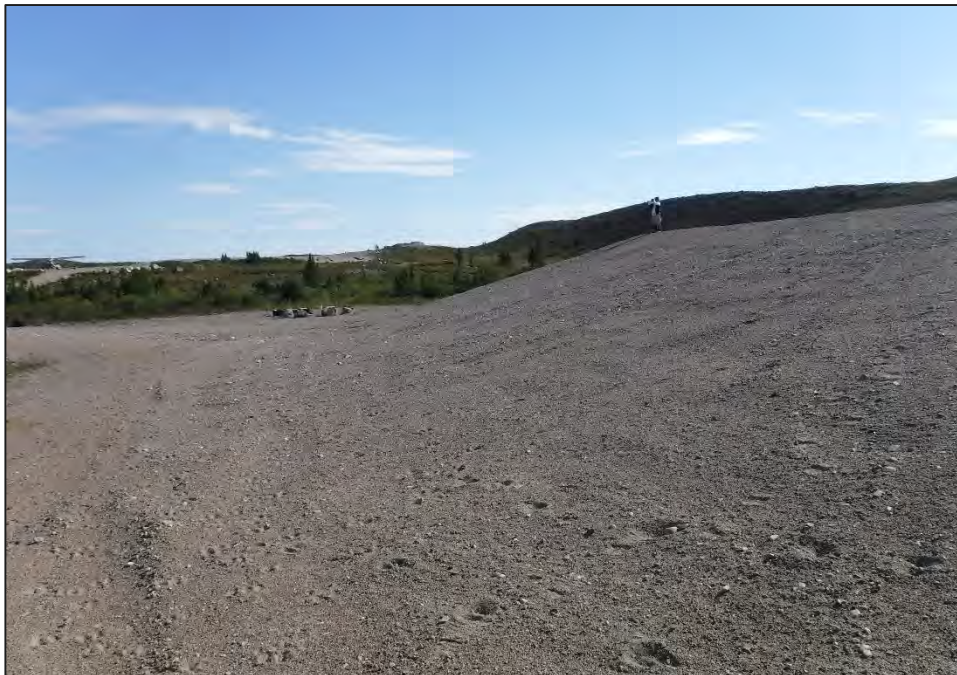
**Photo:** 10

Other	F	Descending north berm, near middle	10	0.2	0.03	<1%	ATV tracks	Observed in 2016; located on slope of berm and may develop into erosion channel	VP 18, Photo 10
Settlement	G	On cap of NHWL, near NE corner	0.5	0.3	0.09		Pothole; minor depression on cap	Observed in 2016	Photo 13

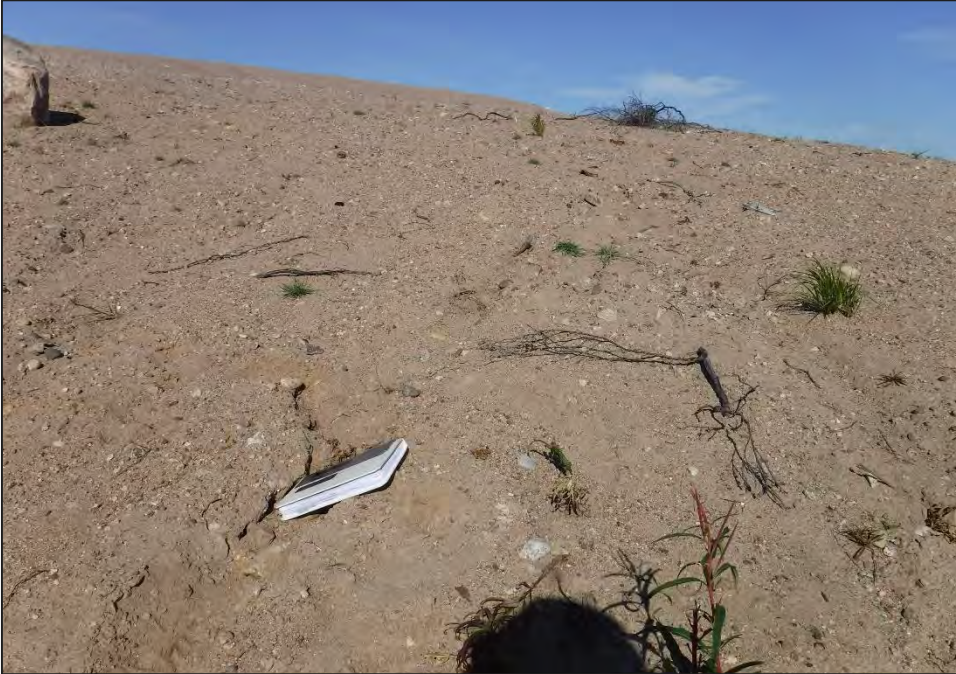
**Photo: 11**

Two erosion channels were observed near the NHWL. The first, Feature A, is located near the southeast corner, at the base of the NHWL (Viewpoint 6). It is not considered to impact landfill integrity. The second area of erosion, Feature D, is approximately 30 m from the NHWL, along the road to the Weather Station. Although it doesn't affect NHWL integrity, the road could washout and affect access to the Weather Station.

Viewpoint 6

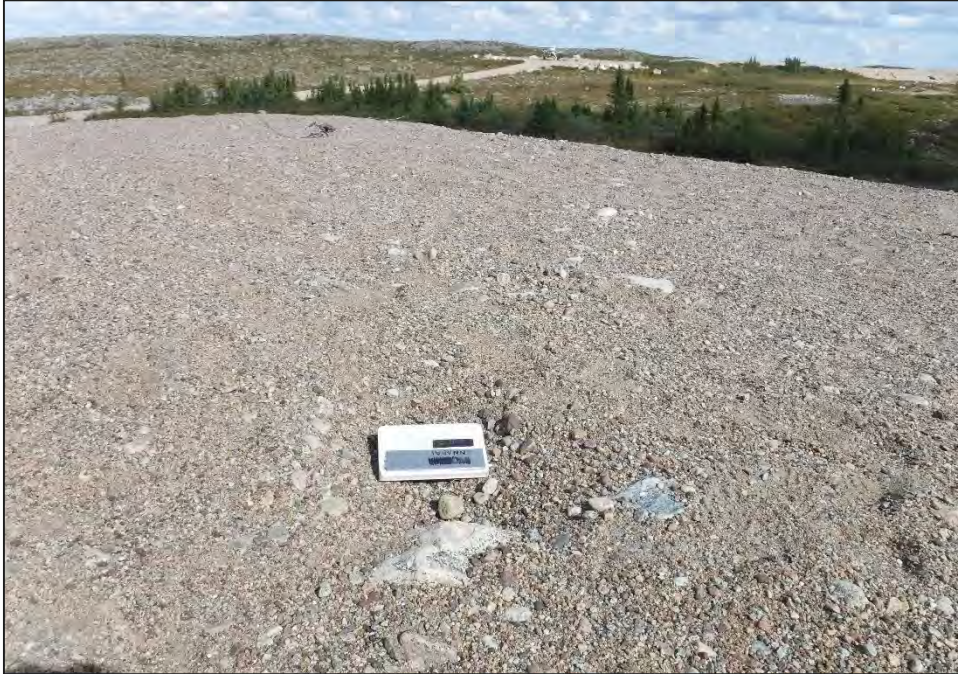
**Photo:** 13

Viewpoint 22

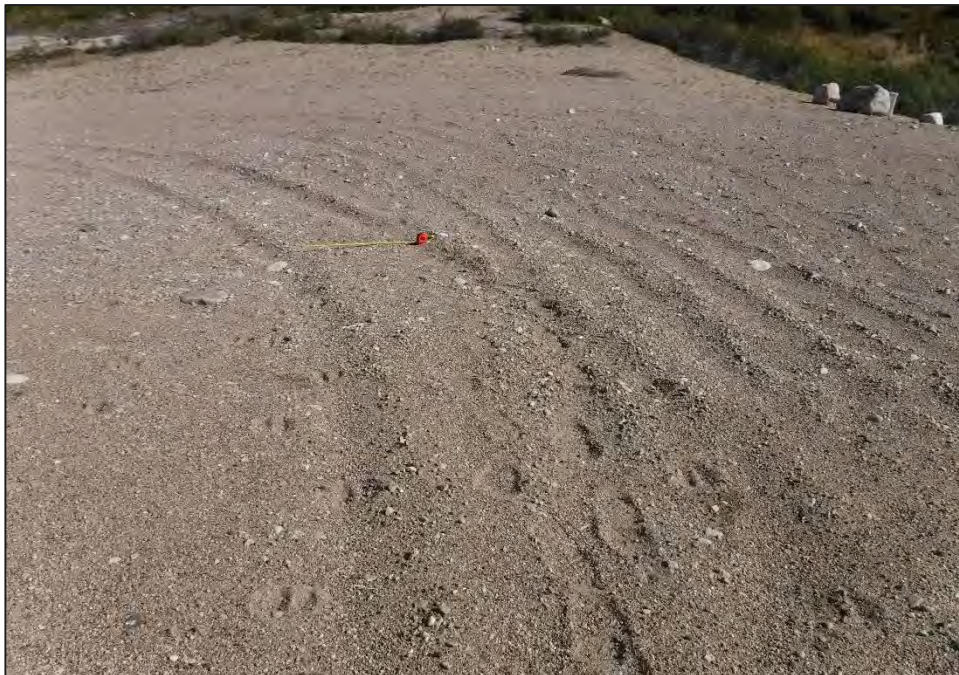
**Photo:** 14

Checklist Item	Feature Letter	Relative Location	Length (m)	Width (m)	Depth (m)	Extent	Description (Change)	Additional Comments	Photo Reference
Erosion	A	Southeast corner of NHWL, at toe of berm	4.0	0.1	0.05	<1%	Minor erosion channel	Observed in 2016	VPs 6A and 6B, Photo 11
Other	B	Descending west berm	10	0.1	0.03	<1%	ATV tracks	Observed in 2016; located on slope of berm and may develop into erosion channel	VPs 29 and 33, Photo 9
Settlement	C	Northeast corner of NHWL, near toe of berm	0.3	0.45	0.08	<1%	Pothole on slope of berm	Observed in 2016	VP 3, Photo 7
Erosion	D	Access road between NHWL and weather station	15 m and 10 m	0.15	0.05	NA	Two parallel erosion channels, could restrict access to weather station in future	Observed in 2016	VP 17
Other	E	Descending east berm, near SE corner	20	0.2	0.04	<1%	ATV tracks	Observed in 2016; located on slope of berm and may develop into erosion channel	VP 26, Photo 14
