**Ennadai Lake Long Term Monitoring Event
Kivalliq Region, Nunavut**

2018 Long Term Monitoring Report

**CROWN-INDIGENOUS RELATIONS AND NORTHERN AFFAIRS CANADA
NUNAVUT REGIONAL OFFICE**

**December 2018
SLR Project No. 209.40585.00000**

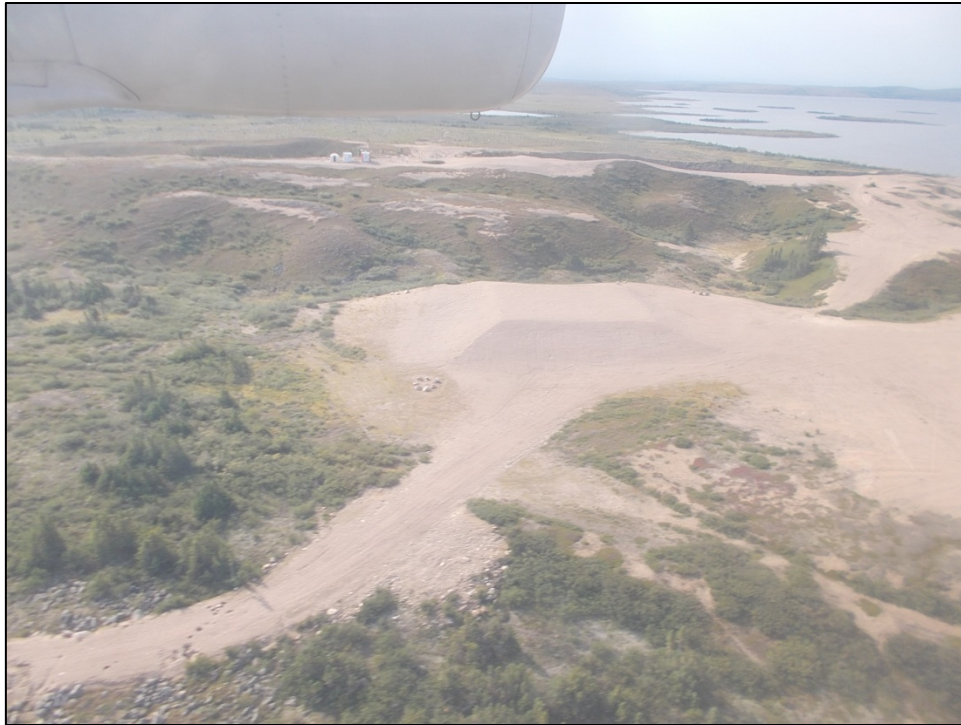
Photograph 1. View of NHWL from Plane

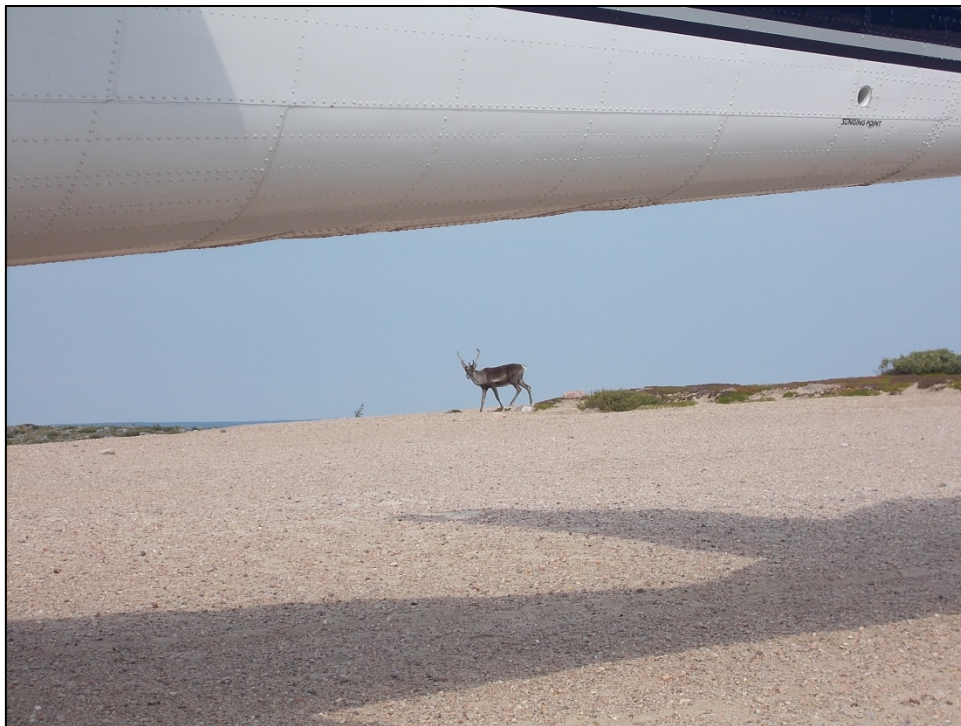
Prior to landing, eight caribou were identified south of the airstrip that ran off during the flyover. Numerous caribou tracks and scat were observed around the airstrip and NHWL, and the pilots identified bear scat west of the NHWL. Several siksik burrows were observed in the road between the NHWL and airstrip. Very minimal vegetation was present on the NHWL flanks and surrounding area. Prior to leaving site, four bull caribou and one cow caribou were spotted north of the airstrip (**Photo 2, Appendix A**).

Photograph 2. Caribou near plane

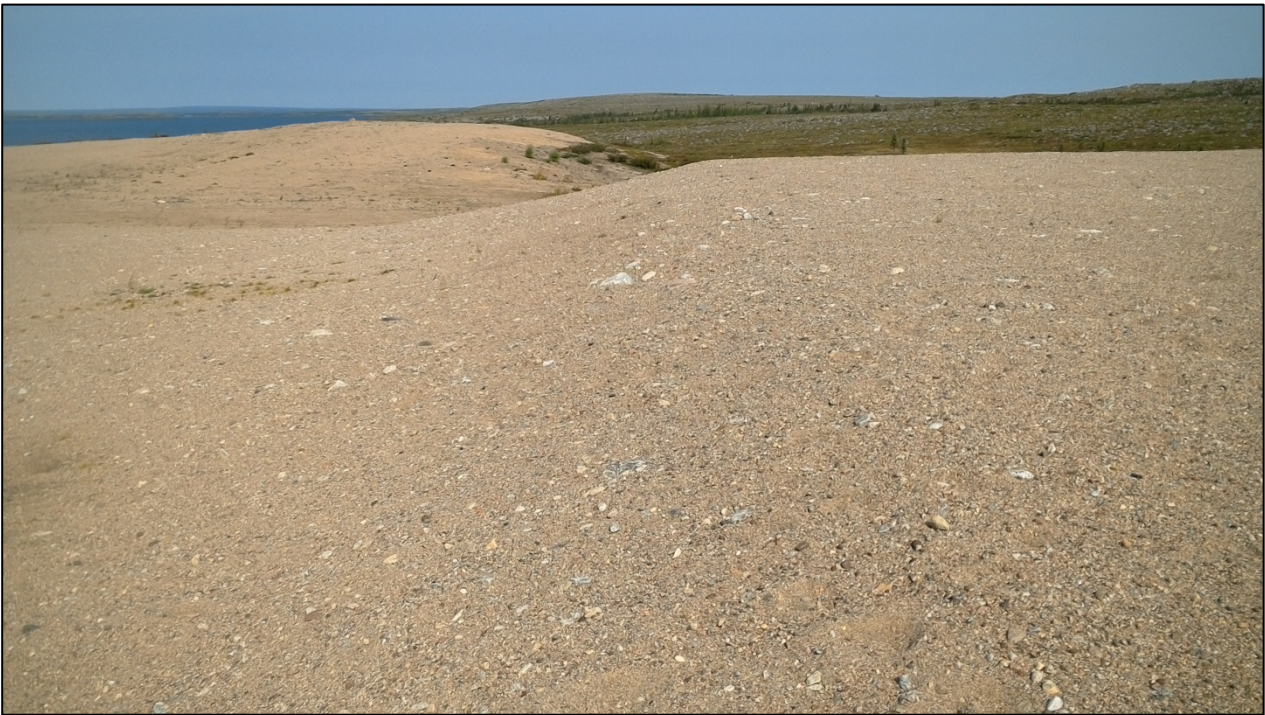
Historically, two areas of settlement were observed in the northeast corner of the NHWL (**Photo 43, Appendix A**). One was located on the cap (Feature G), and one was located at the toe of the berm (Feature C). The potholes were small in nature (< 0.5 m) and were not considered to impact the integrity of the landfill. These features were observed in 2018 but appear to be of similar size and extent as observed previously. These features should be monitored during future site visits but are not considered to be of concern at this time. No other areas of settlement were observed on the NHWL.

Photograph 9. Depression in Cap, Facing SW

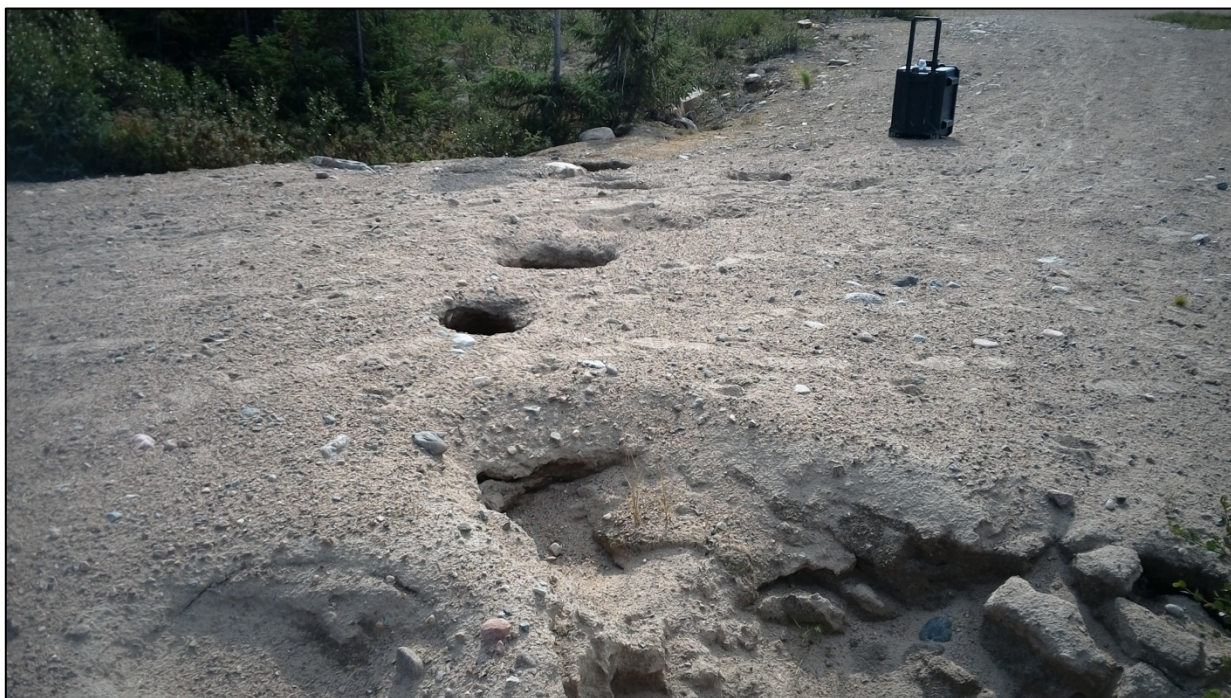
Several siksik burrows were observed on the access road to the NHWL at Ennadai Lake (**Photo 17, Appendix A**). No evidence of animal burrows was observed on the NHWL itself.

Photograph 17. Siksik burrows on access road, facing S

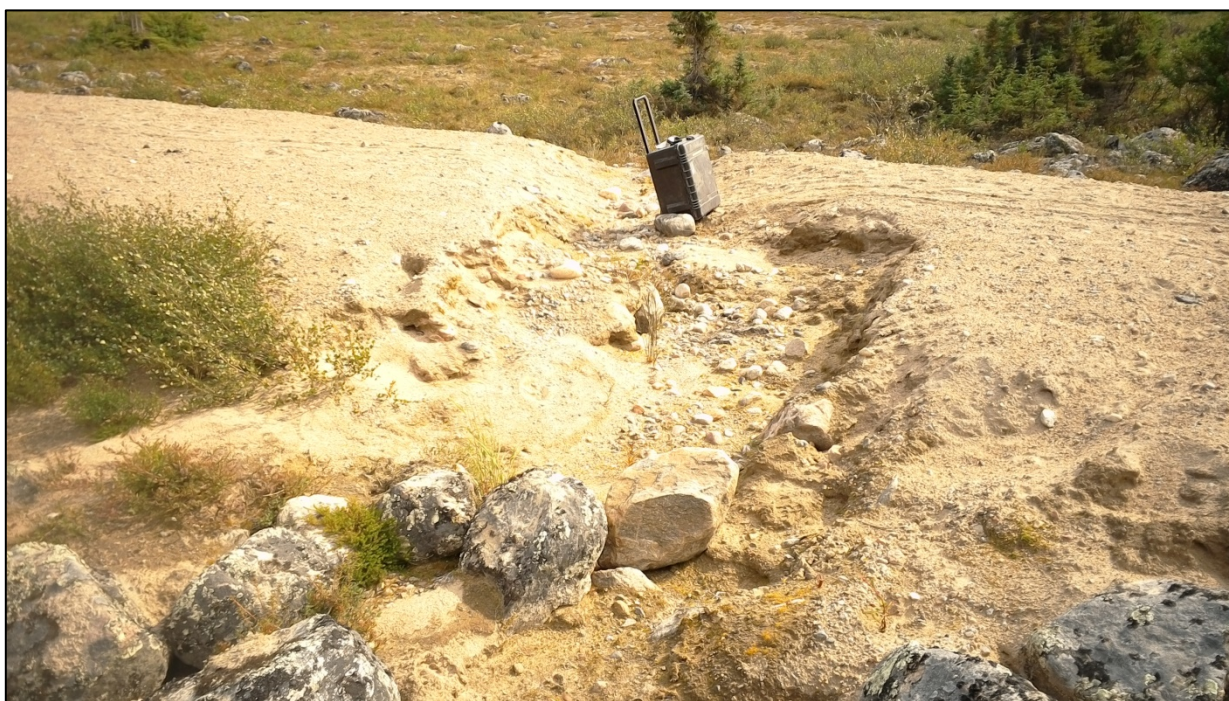
Erosion was observed along the access road to the airstrip in 2018 (**Photo 18, Appendix A**). The road appears significantly washed out. This area of erosion does not appear to impact the integrity of the NHWL but could impact access to both the NHWL and the weather station.

An area of significant erosion was noted on the access road from the airstrip to the NHWL (**Photo 18, Appendix A**). This feature was noted during the previous monitoring event. This erosion should be continually monitored as it may affect access to the NHWL and the weather station. All other areas surrounding the NHWL appear to be in stable and good condition.

Photograph 18. Erosion along access road, facing S

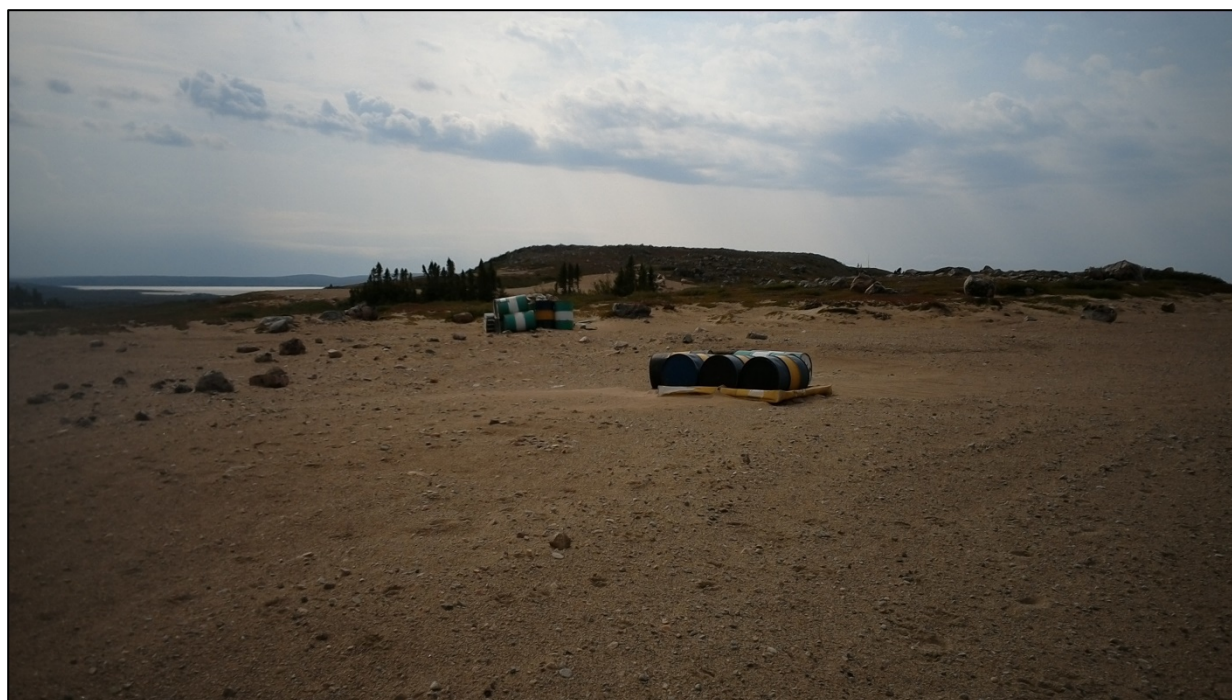
Photograph 20. Drums on airstrip, facing SW
