Regarding: 2011 Annual Report: FOX-4, Cape Hooper DEW Line Site

NWB Annual	Report			Year being re	eported:	2012
License No:	1BR-FOX071	3		Issued Date: Expiry Date:		, 2013
	Project Nam	e: F	OX-4, CApe	Hooper DEW	/ Line Site Clean Up	
	Licensee:	Defence	e Construction	on Canada		
	Mailing Add	ress:	DGME 101 Colone	onstruction Ca el By Drive, tario, Canada		
	Name of Correlationship be AECOM Design Engir	tween the	two entities, if	applicable):	erent from Name of Lic	ensee please clarify
General Back	kground Info	rmation	on the Proj	ect (*optional):		
with A summary r	Part B	▼ Ite	m 1 ▼	sposal activit	owing information i ies, including, but i gement; drill waste	not limited to:
solid and haz						_
	Water Source Water Quant	` '	Water Supp 18 per day 809	Actual C	4-1) Allowable Domestic tuantity Used Domes Allowable Drilling (clantity Used Drilling	stic (cu.m) cu.m)
	Sewa Drill V Greyv Hazar Other Additional De	Waste Disp ge Vaste vater dous :	osal	728.1 cu.m of to sewage lag	f sewage and greyw goon I in the application s

Re: 2012 Report for Water Use License Number: IBR-FOX1118

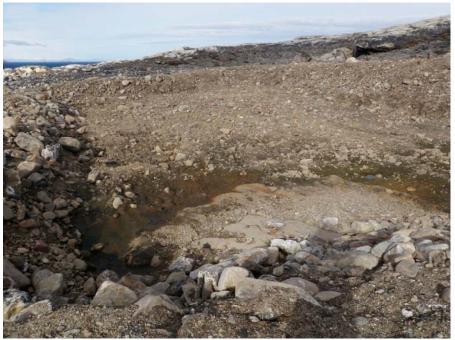
Photograph 1 (09-12-2012): FOX-4 west sewage lagoon, facing west.

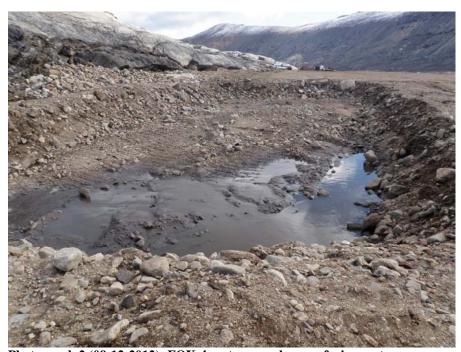
Photograph 2 (09-12-2012): FOX-4 east sewage lagoon, facing east.

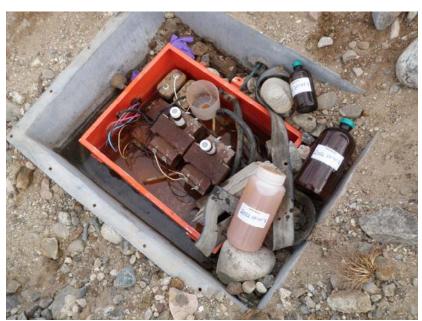
Photograph 1 (07-28-2012): Sample 12-15457- collected from the aviation lighting box at the northwest corner of the airstrip.

Wastewater sample 12-15457 did not comply with the discharge criteria and therefore was not discharged to land.

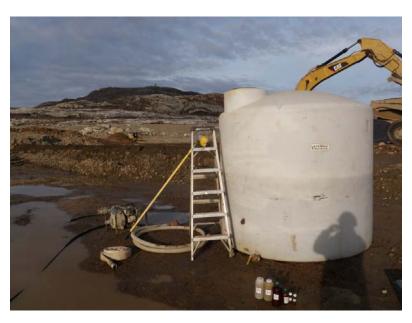
Photograph 1 (08-19-2012): Sample 12-15473 collected from the poly tank on the east side of the Tier II Disposal Facility.

Wastewater from the poly tank was discharged to the ground on September 9, 2012. The water was discharged on the east side of the Tier II (588507, 7595961).

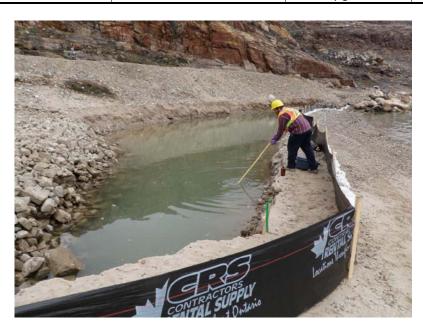
Photograph 1 (08-22-2012): Sample 12-15474 collected from pooled water in the BP-08048 excavation.

Wastewater sample 12-15474 did not comply with the discharge criteria and therefore was not discharged to land.

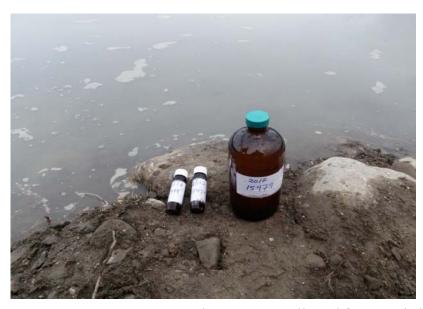
Photograph 1 (08-22-2012): Sample 12-15479 collected from pooled water in the Landfarm.

Wastewater from the Landfarm was discharged to the ground on August 23, 2012. The water was discharged on the southwest side of the Landfarm (588080, 7595873 and 588089, 7595868).

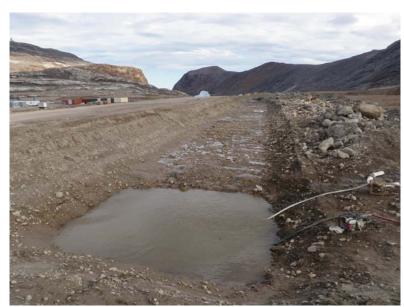
Photograph 1 (08-31-2012): Sample 12-15486 collected from pooled water in the Landfarm.

Wastewater from the Landfarm was discharged to the ground on September 8, 2012. The water was discharged on the southwest side of the Landfarm (588080, 7595873 and 588089, 7595868).

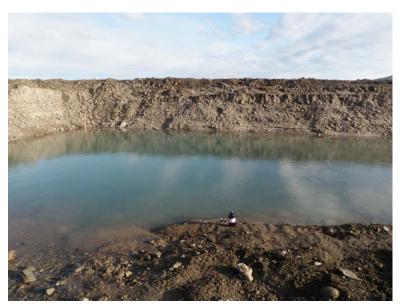
Photograph 1 (09-04-2012): Sample 12-15499 collected from pooled water in the northwest corner of the Landfarm.

Wastewater from the Landfarm was discharged to the ground on September 8, 2012. The water was discharged on the southwest side of the Landfarm (588080, 7595873 and 588089, 7595868).

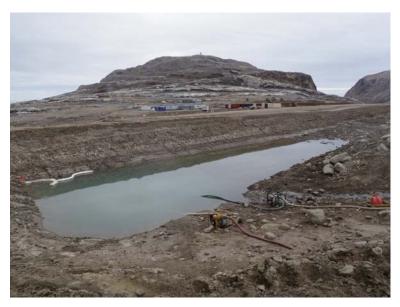
Photograph 2 (09-09-2012): Sample 12-15506 collected from pooled water in the northwest corner of the Landfarm.

Wastewater from the Landfarm was discharged to the ground on September 14, 2012. The water was discharged on the southwest side of the Landfarm (588080, 7595873 and 588089, 7595868).

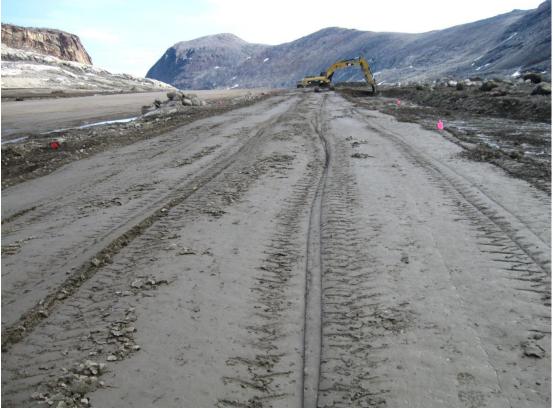
Landfarm containment berm.

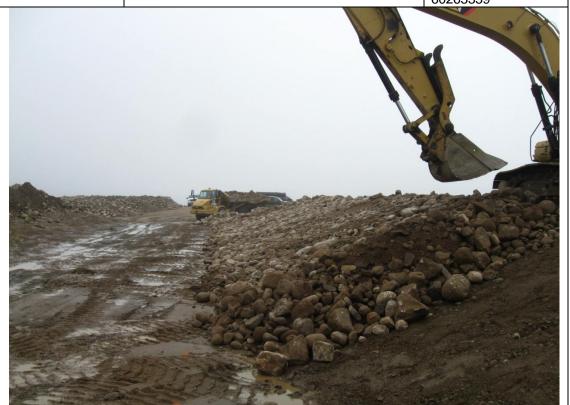
Arming Non-Hazardous Waste Landfill with Type 1 Granular Fill

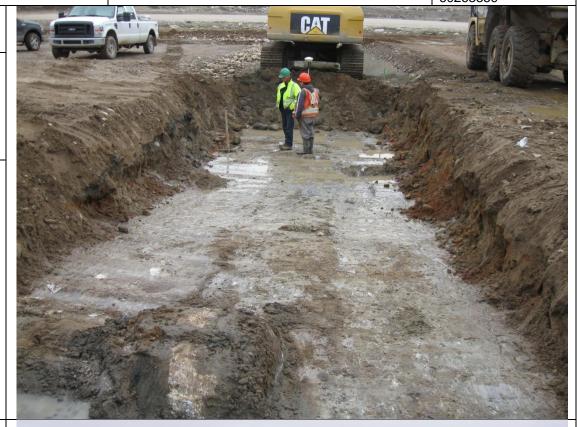
Key trench at Tier II Disposal Facility, north portion of west trench

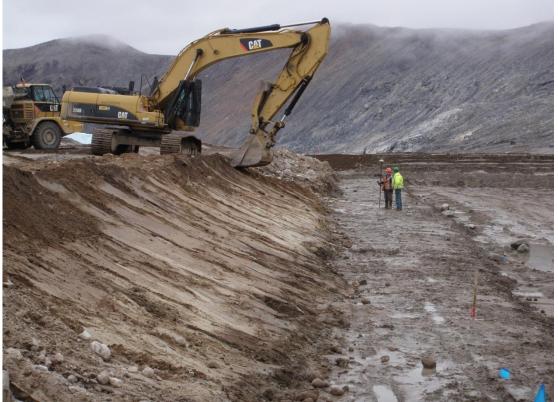
Photo No. 16 **Date:** Aug 22, 2012

Trimming of Existing Tier II Disposal Facility berm to tie into Tier II Disposal Facility

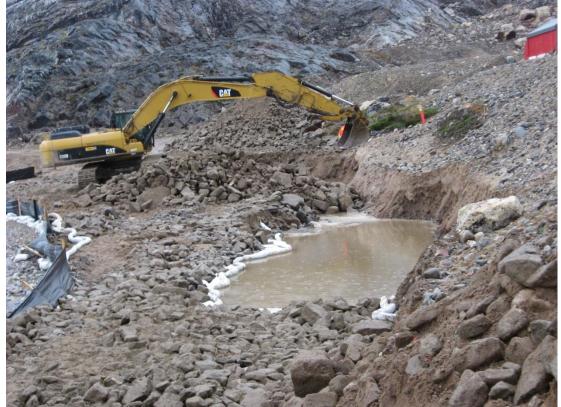
Photo No. 18 **Date:** Aug 24, 2012

Beach POL excavation

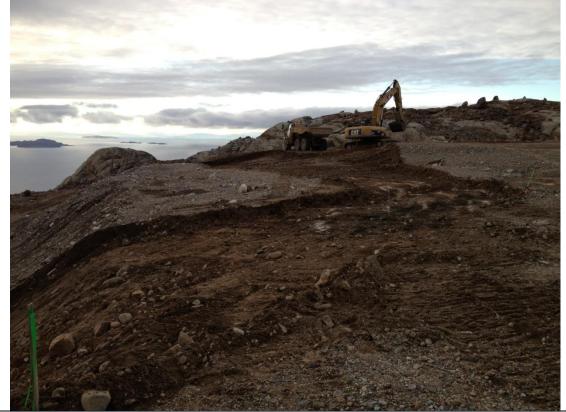
Upper site contaminated soil excavation
