Project No: Water Use License 1BR-FOX1118

Regarding: 2013 Annual Report: FOX-4, Cape Hooper DEW Line Site

Project Name: FOX-4, Cape Hooper DEW Line Site Clean Up

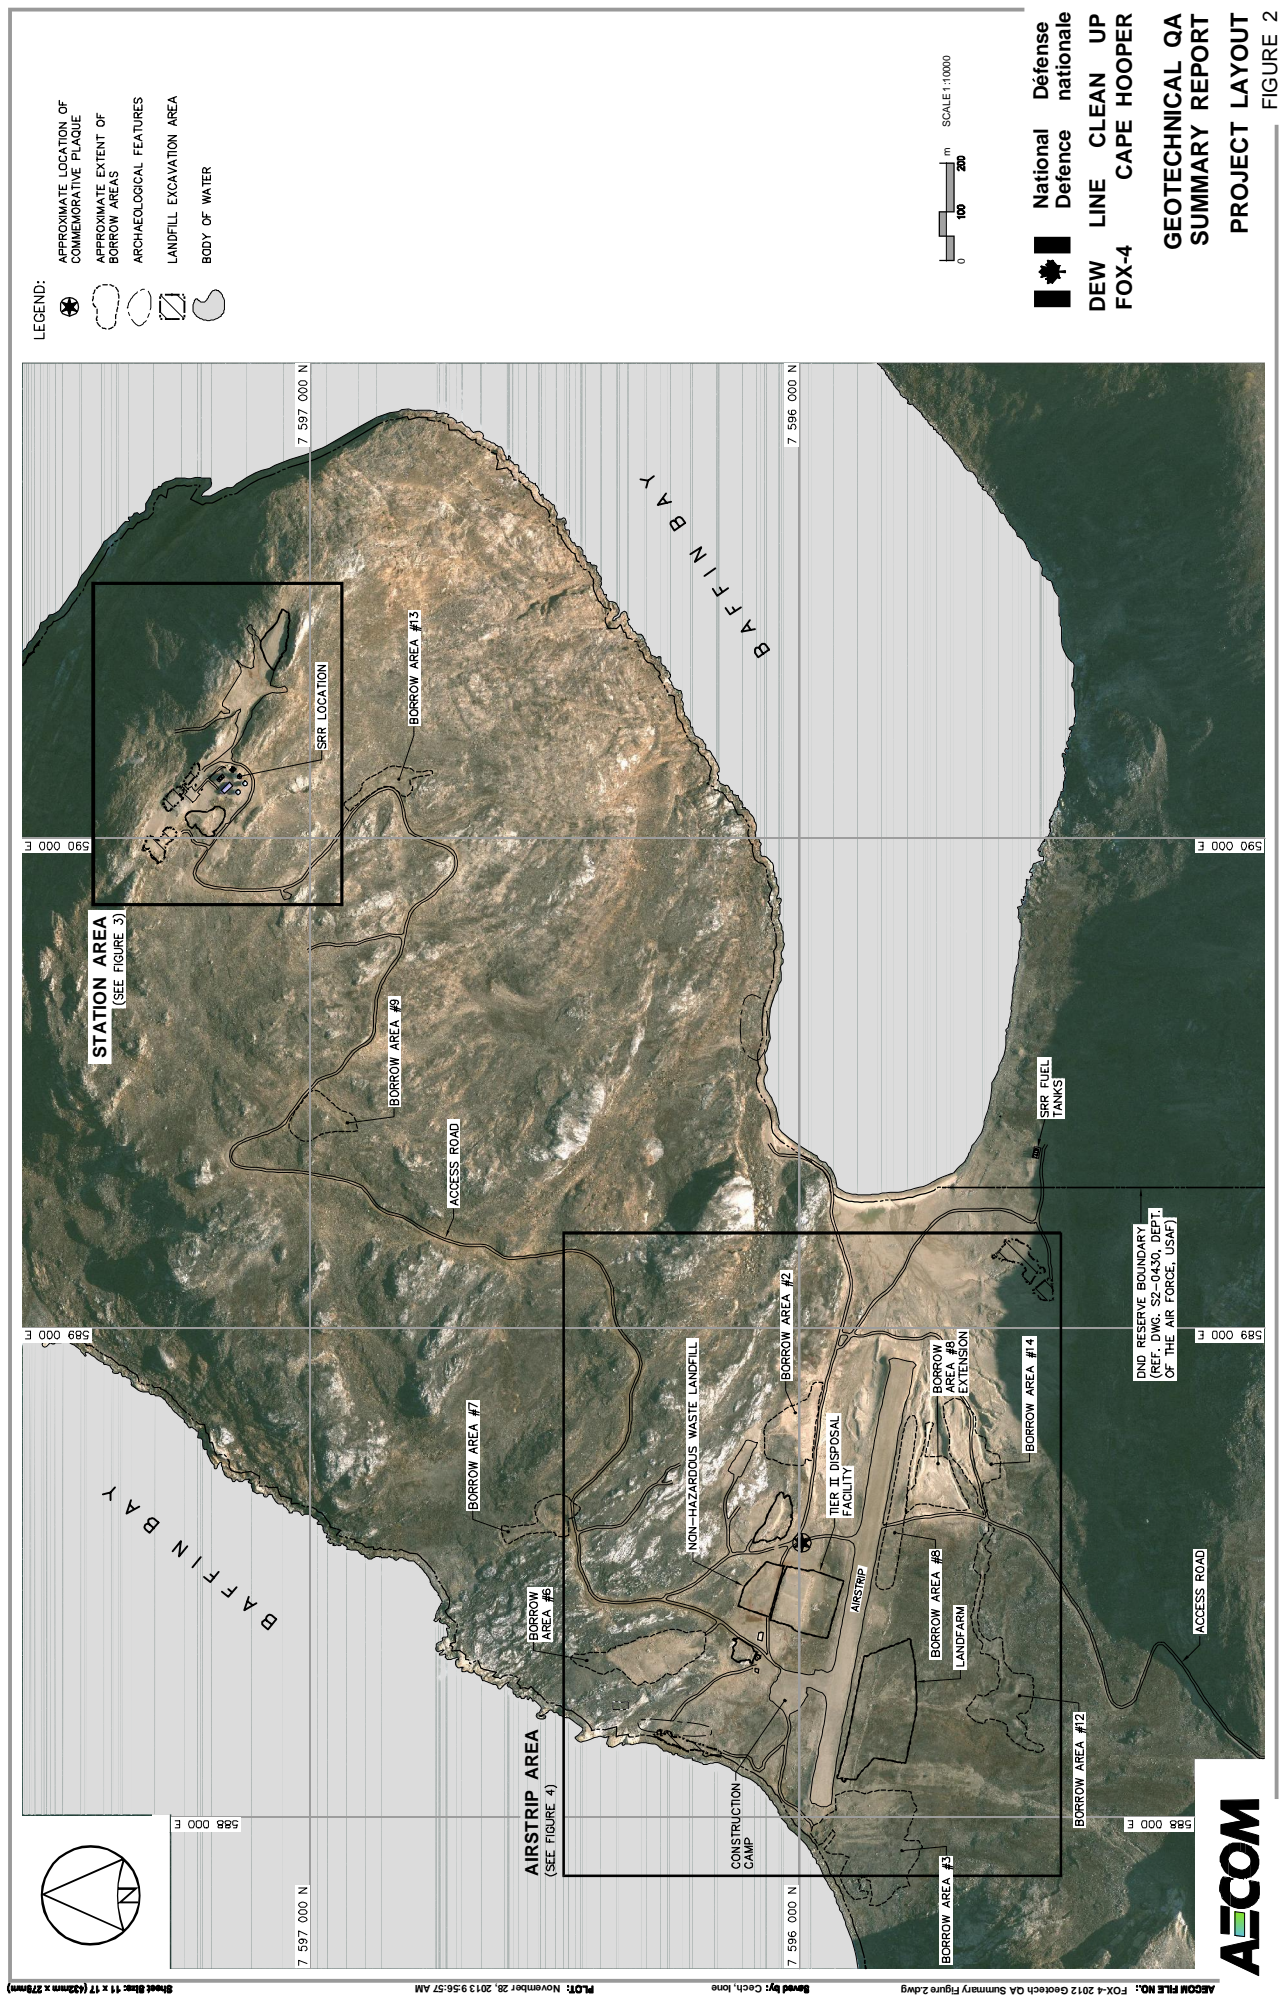
FIGURE 1

OVERALL SITE PLAN

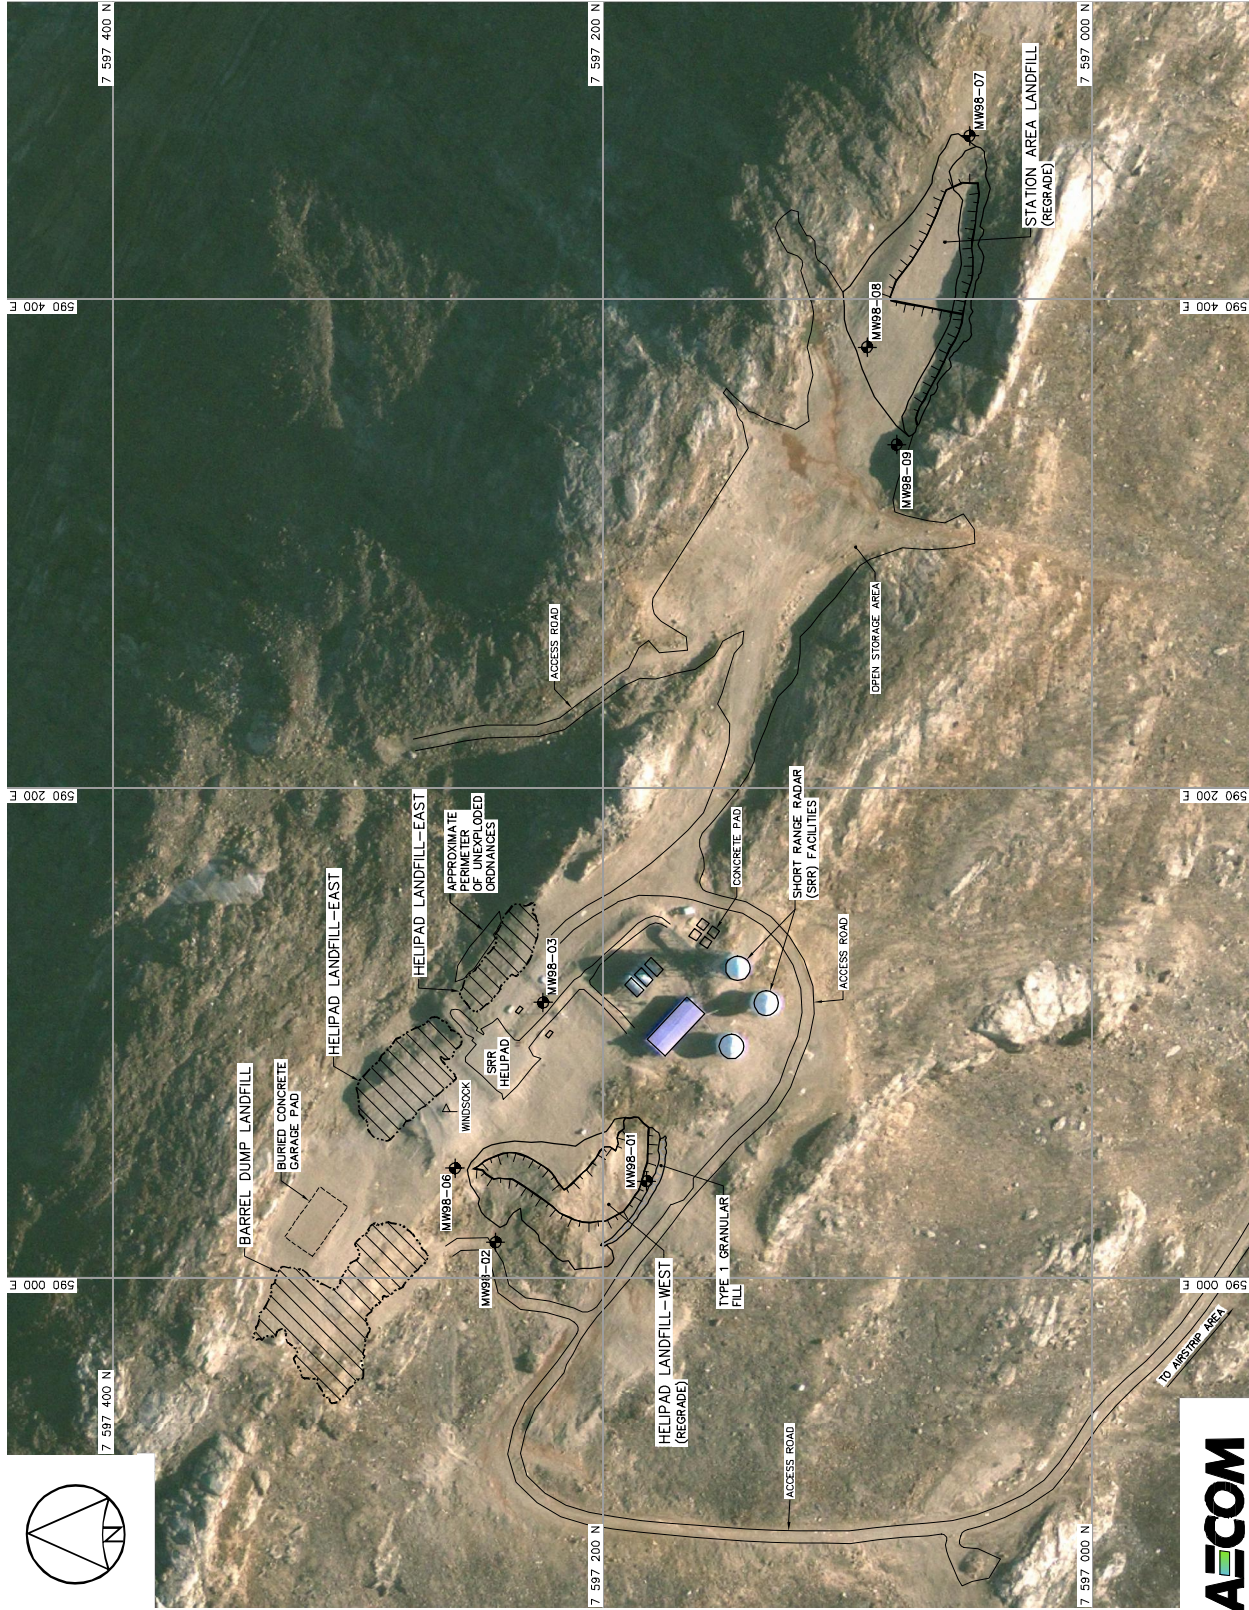
FIGURE 3

GEOTECHNICAL QA
SUMMARY REPORT
STATION AREA

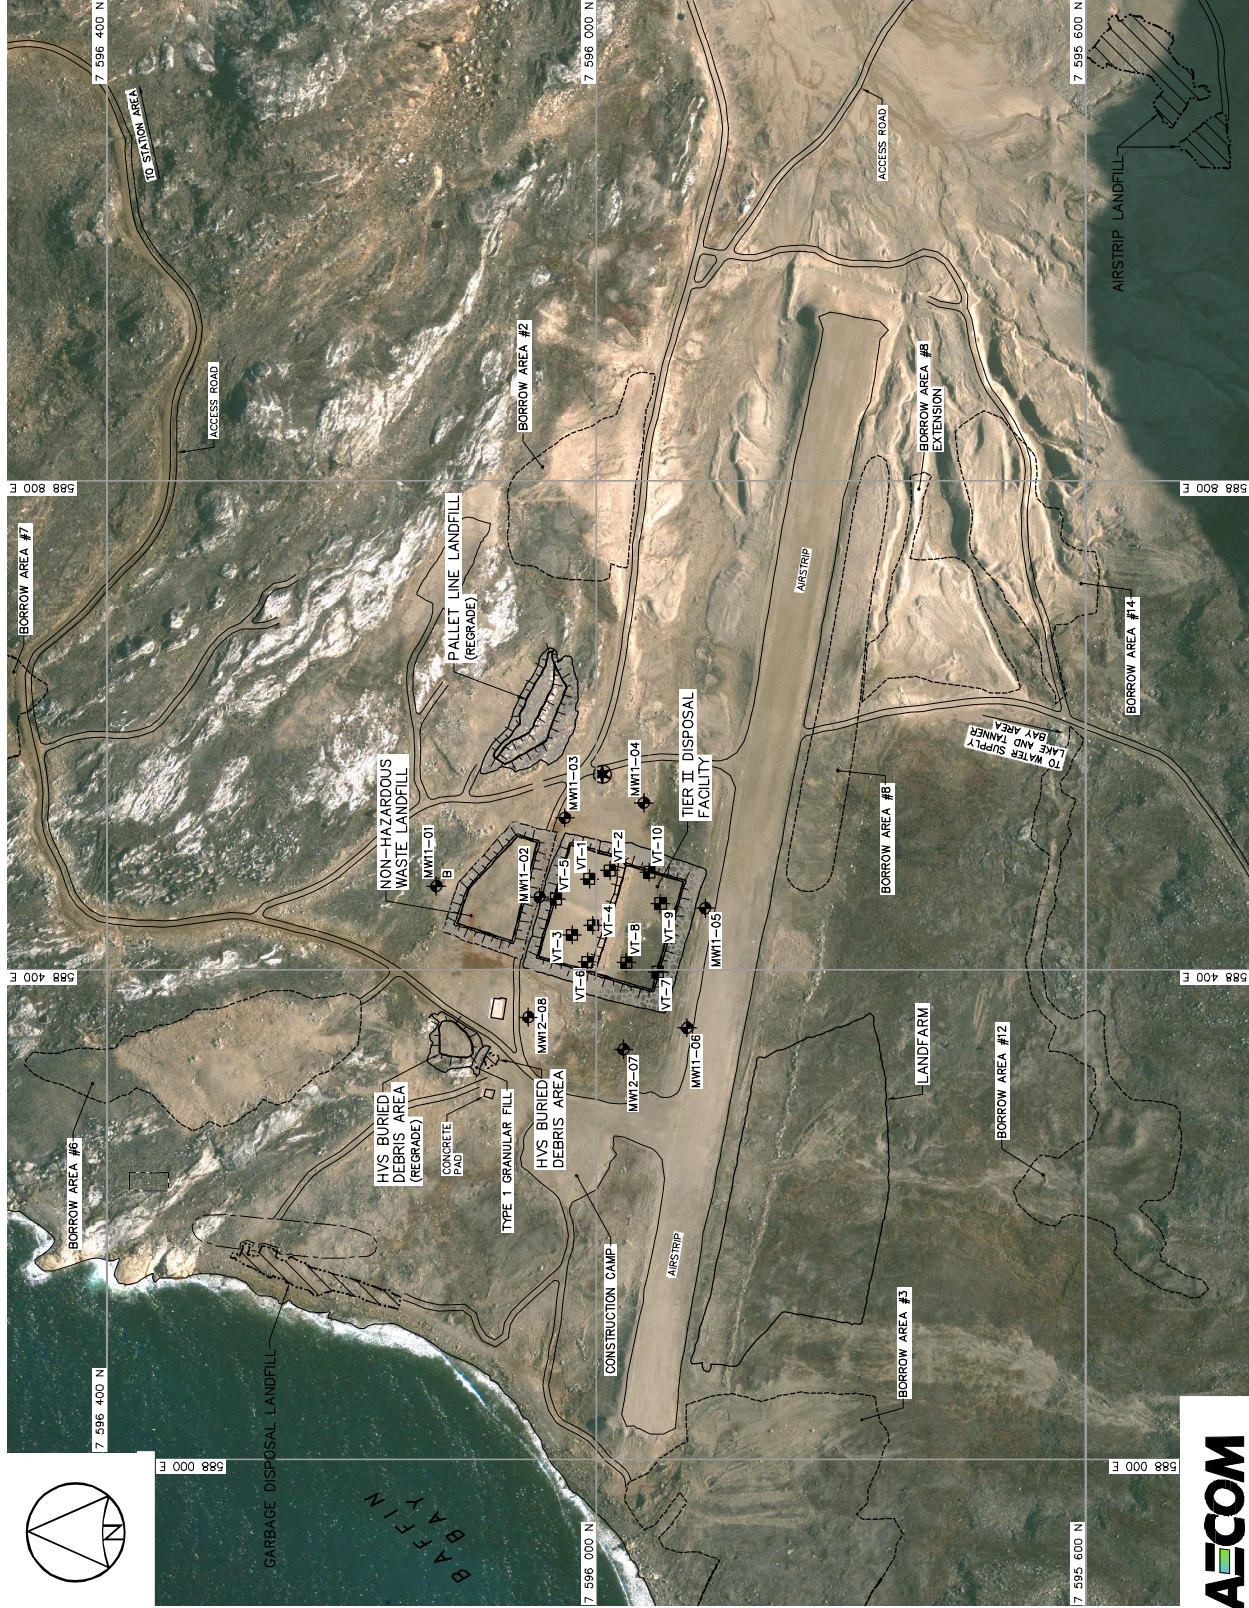
FIGURE 4

GEOTECHNICAL QA
SUMMARY REPORT
AIRSTRIIP AREA

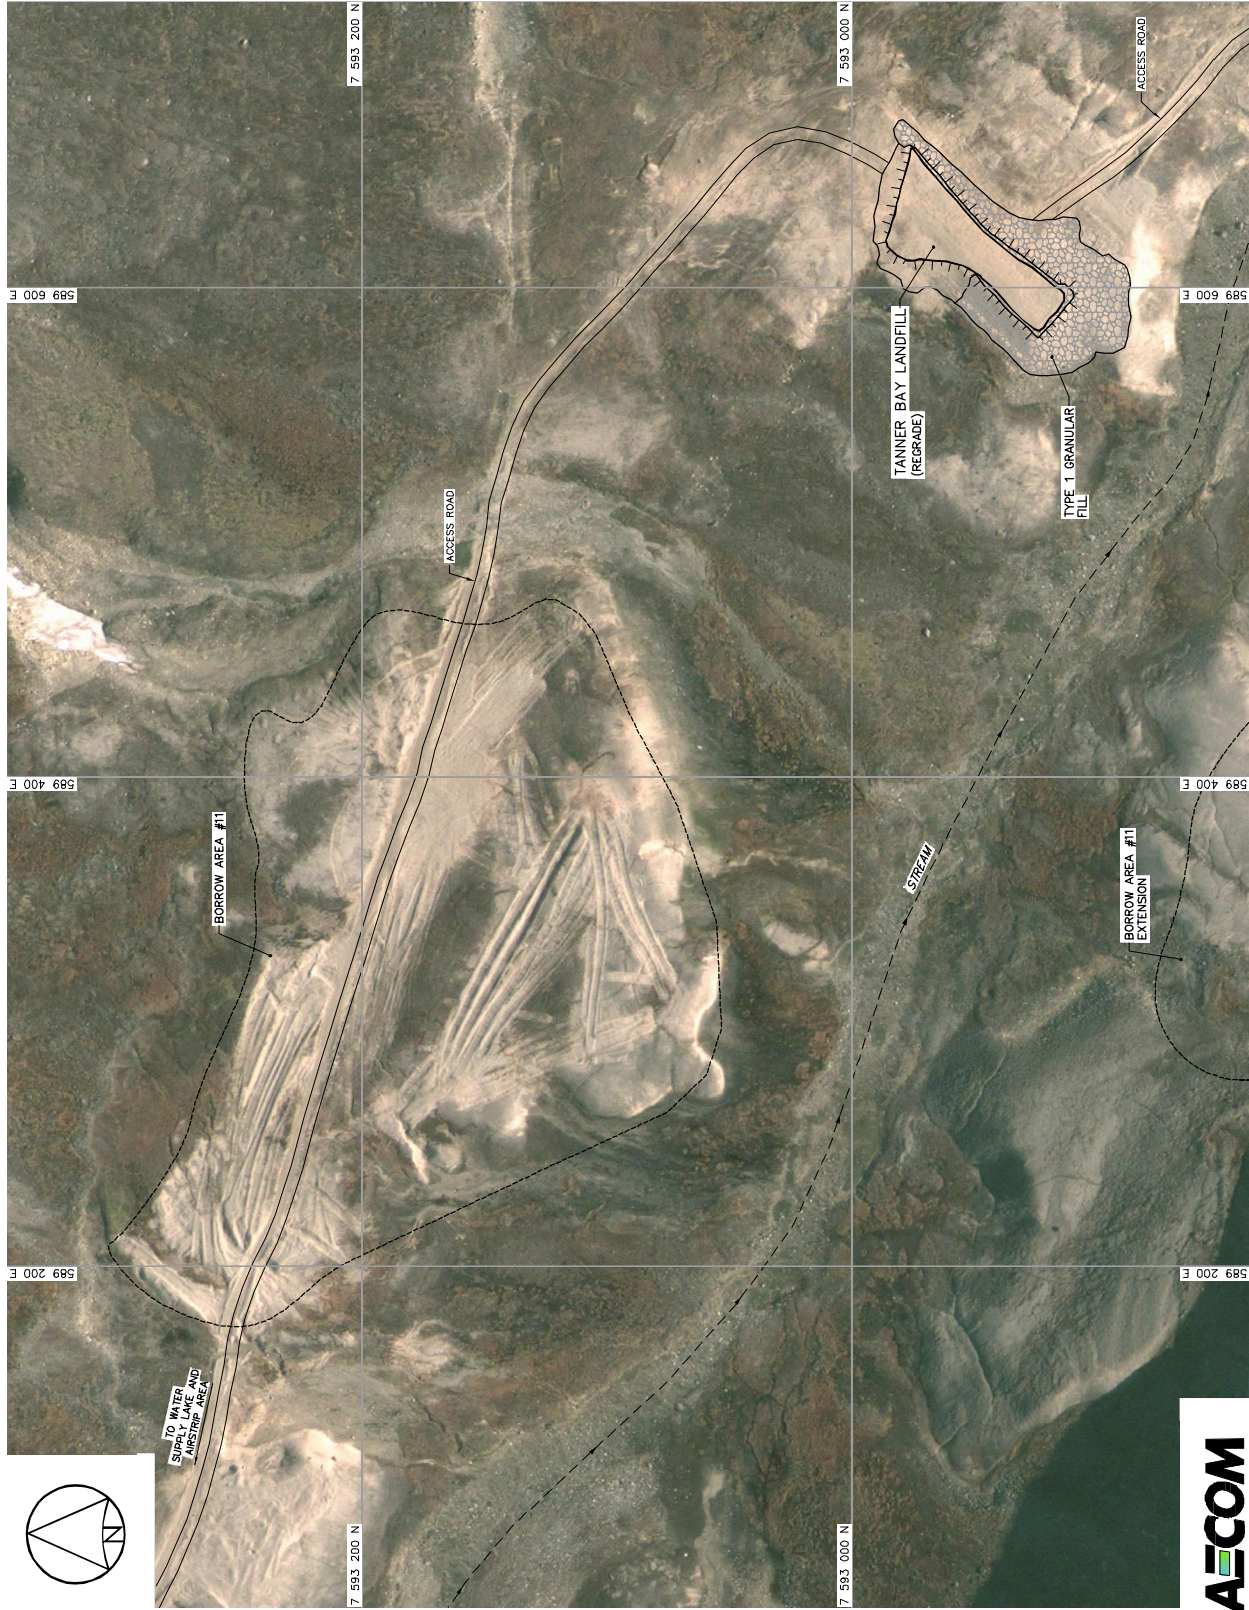
FIGURE 5

GEOTECHNICAL QA
SUMMARY REPORT
TANNER BAY AREA

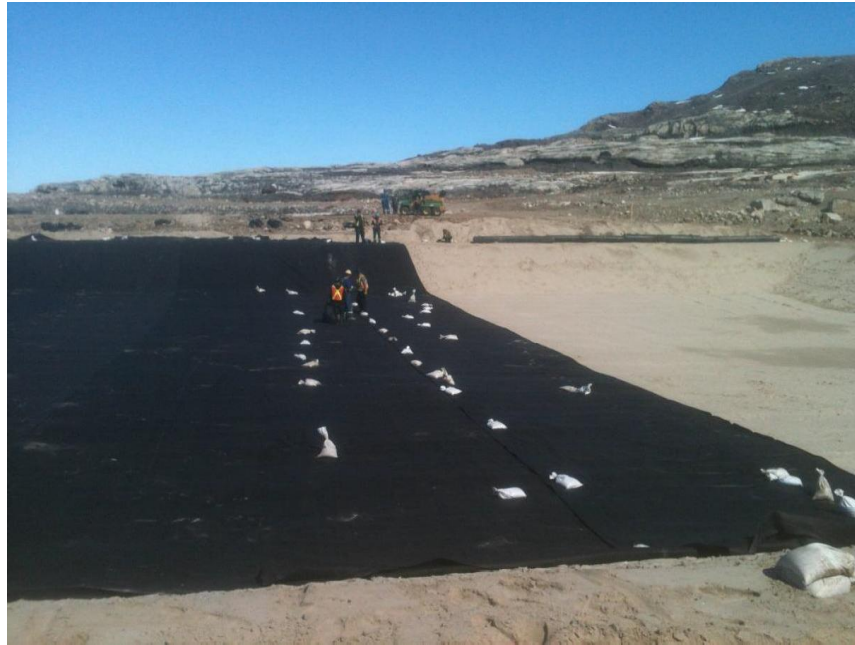
Photograph 1. First Layer of Geotextile at the Tier II Facility

- Thermistors were extended to account for the additional cap thickness
- Expanded Tier II Disposal Facility construction activity:
 - The bottom liner system, with Type 5 embedment materials, was installed at the beginning of the 2013 construction season and the facility was ready to accept contaminated soils by July 17, 2013

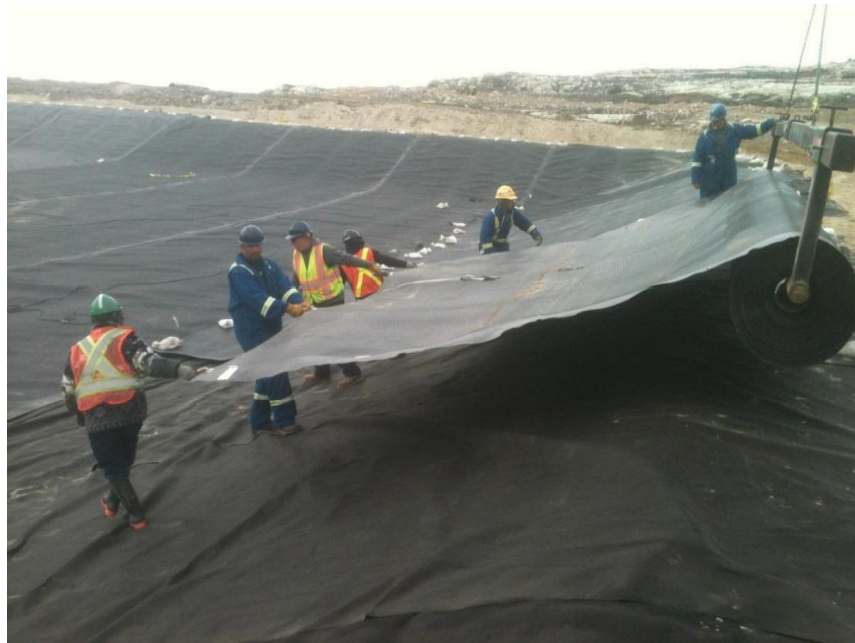
Photograph 2. Placement of HDPE Liner (Geomembrane) at the Tier II Facility

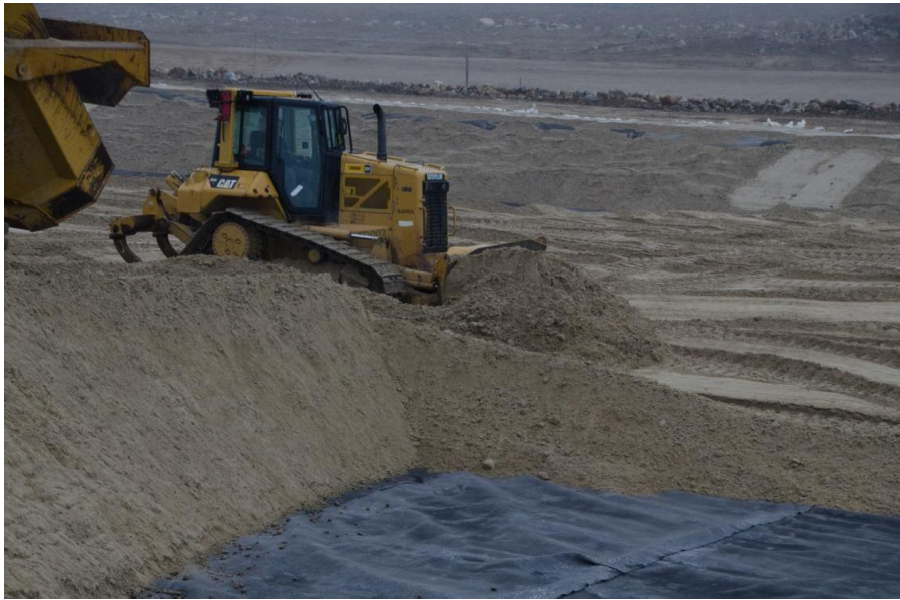
Photograph 3. Placement of Type 5 Granular Fill Above Liner

- Tier II contaminated material was brought to this facility from all of the landfill excavations. The final load occurred on August 23, 2013
 - Capping involved 0.3m Type 2 Granular Fill, liner, Type 5 Granular Fill and a thermal cover of 2.35m Type 2 Granular Fill

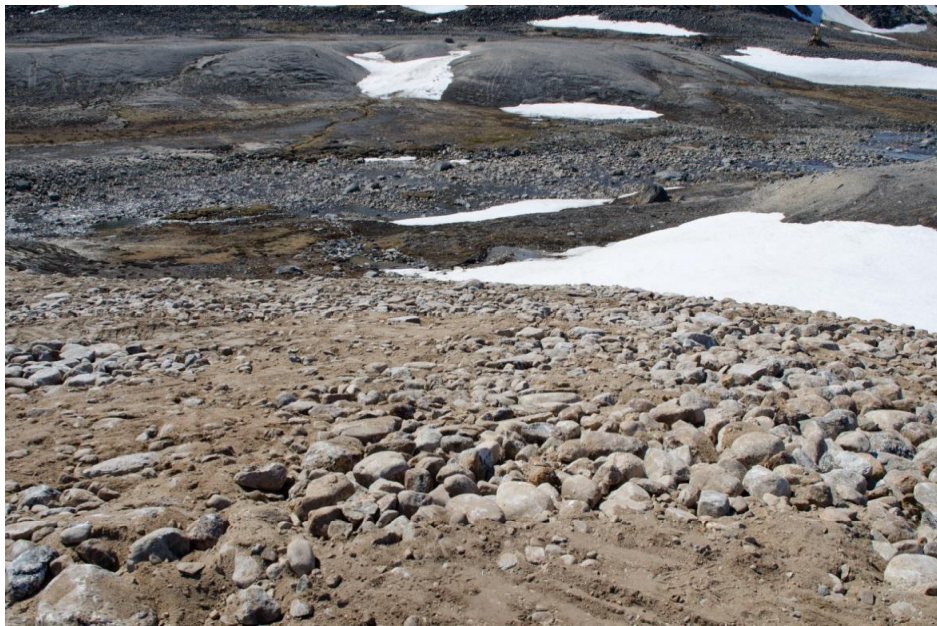
Photograph 4. Type1 Granular Fill at on Tanner Bay Regrade Slopes

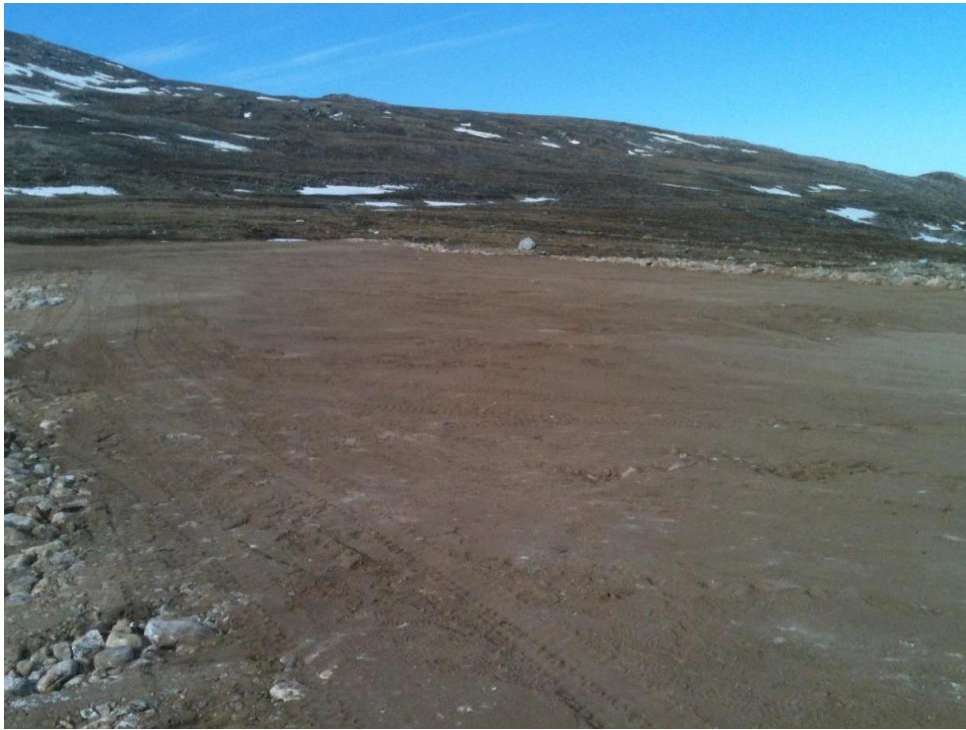
Photograph 5. Final Type 2 Granular Fill Surface at Tanner Bay Regrade

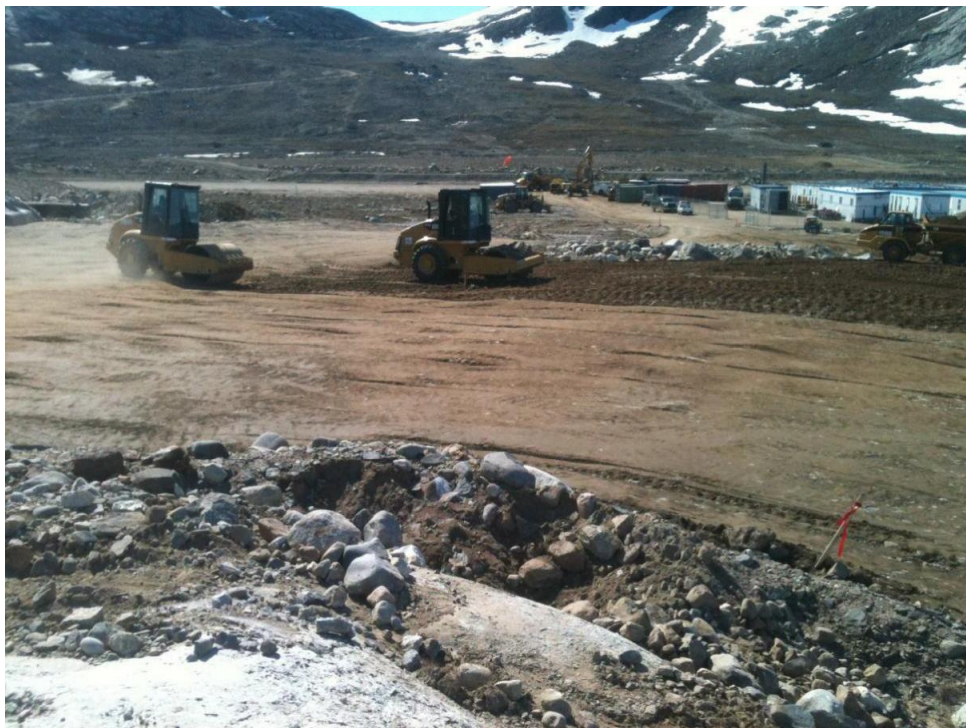
Photograph 6. HVS Buried Debris Area Regrade Type 2 Granular Fill Compaction

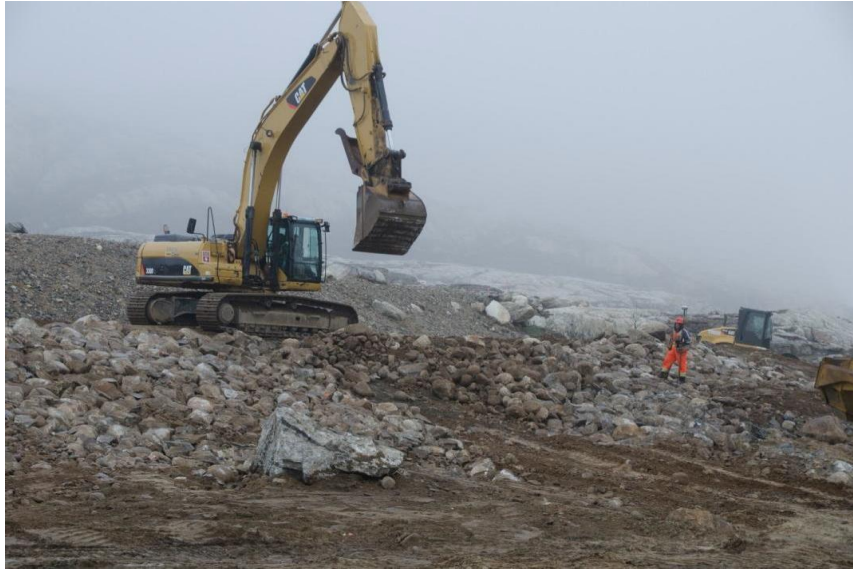
Photograph 7. Type 1 Granular Fill Placement at Pallet Line Landfill Regrade

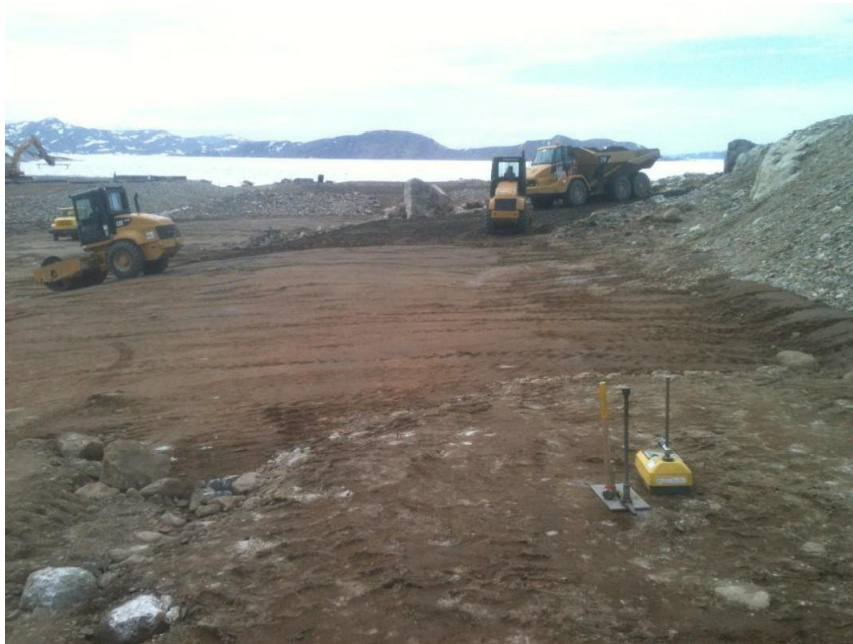
Photograph 8. Type 2 Granular Fill Compaction at Pallet Line Landfill Regrade

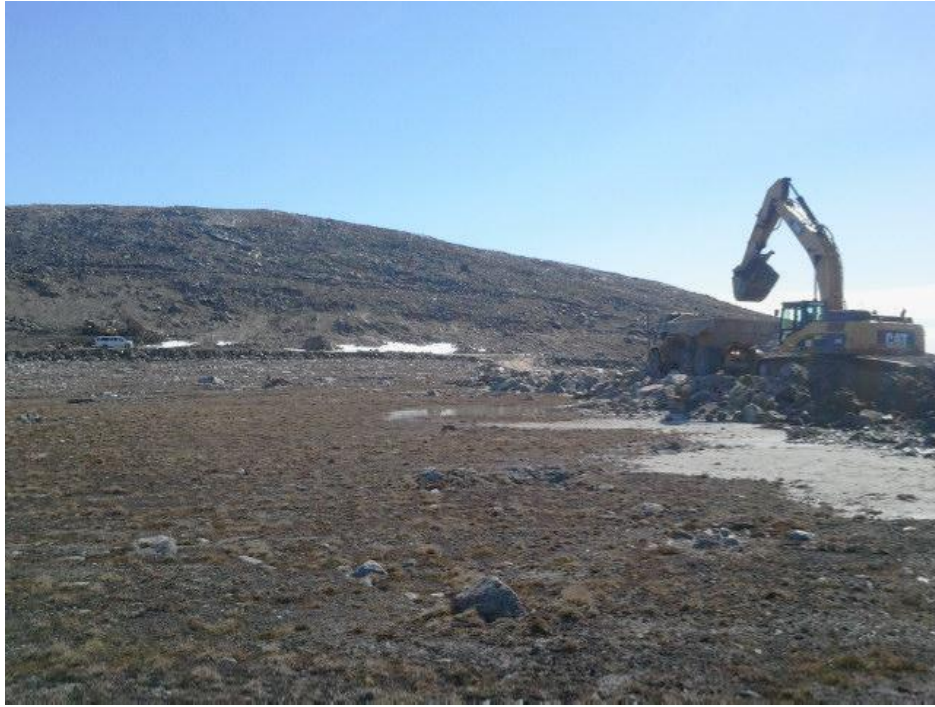
Photograph 9. Borrow 10 – Haul road removal and Borrow 10 Extension reclamation

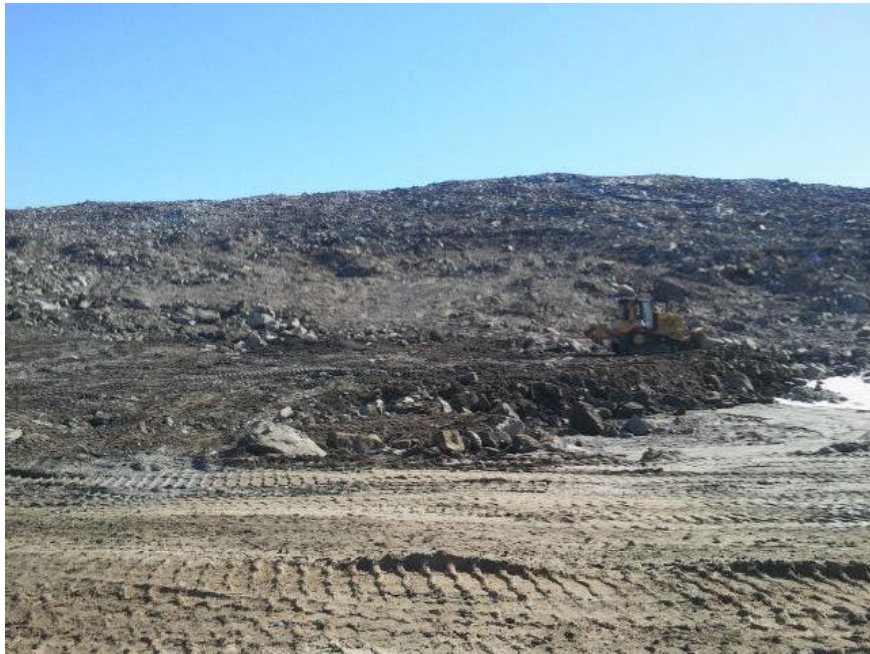
Photograph 10. Borrow 10 Extension - Reclamation

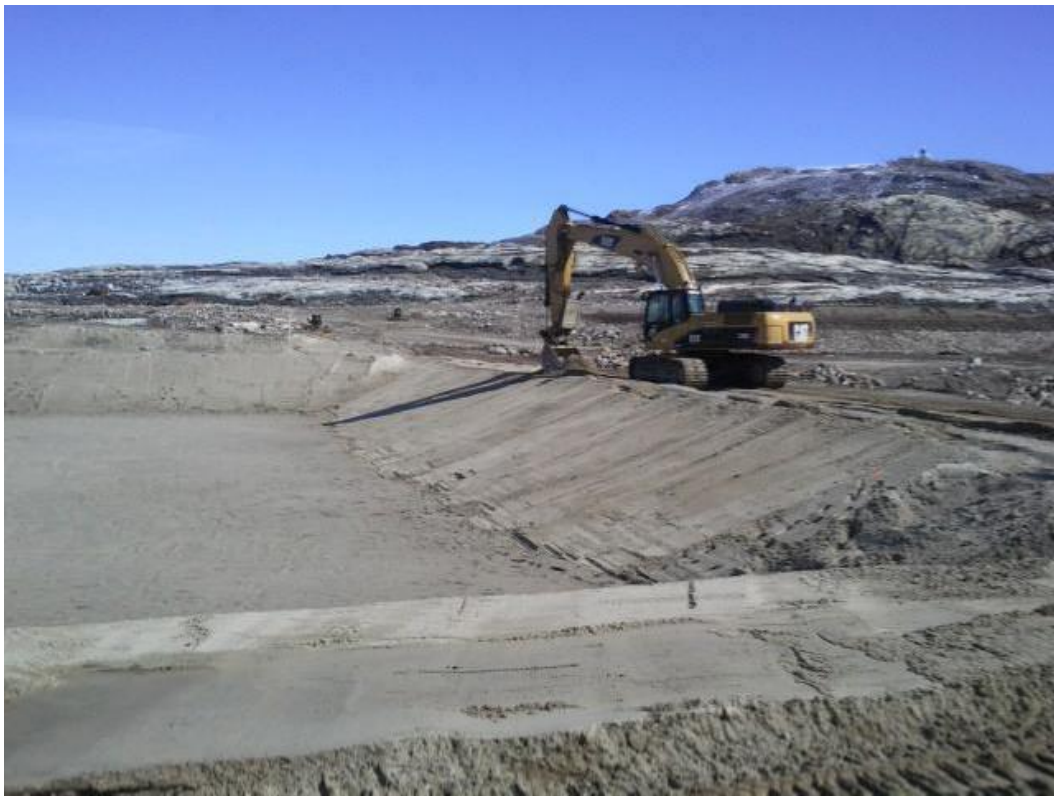
**Photograph 11.**

Tier 2 Facility – East berm being trimmed

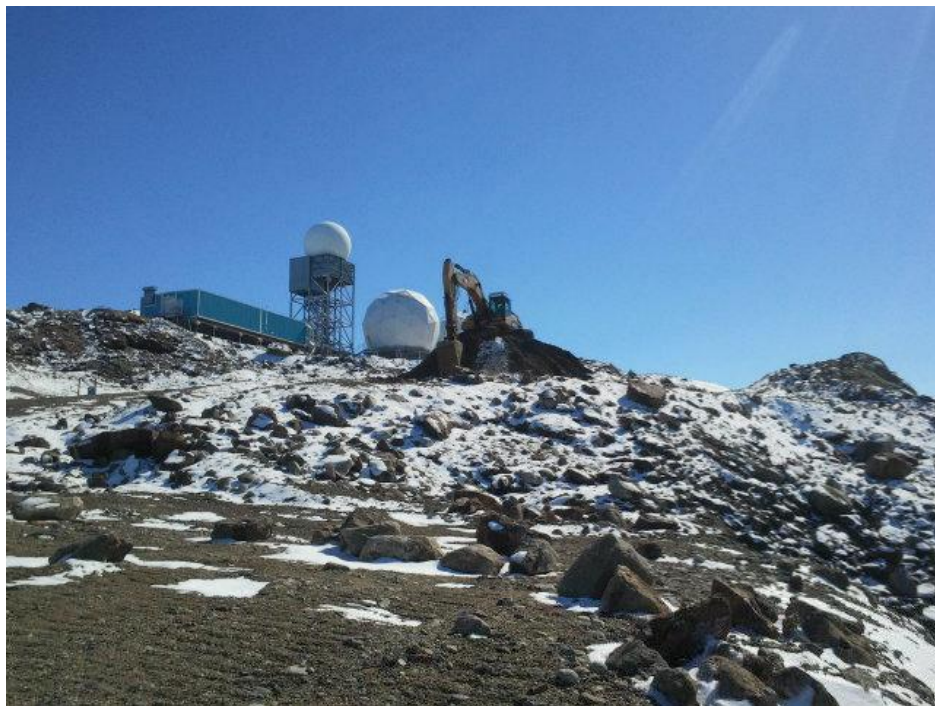
**Photograph 12.**

Type 2 Granular Fill from Borrow 13 stockpiled at Station

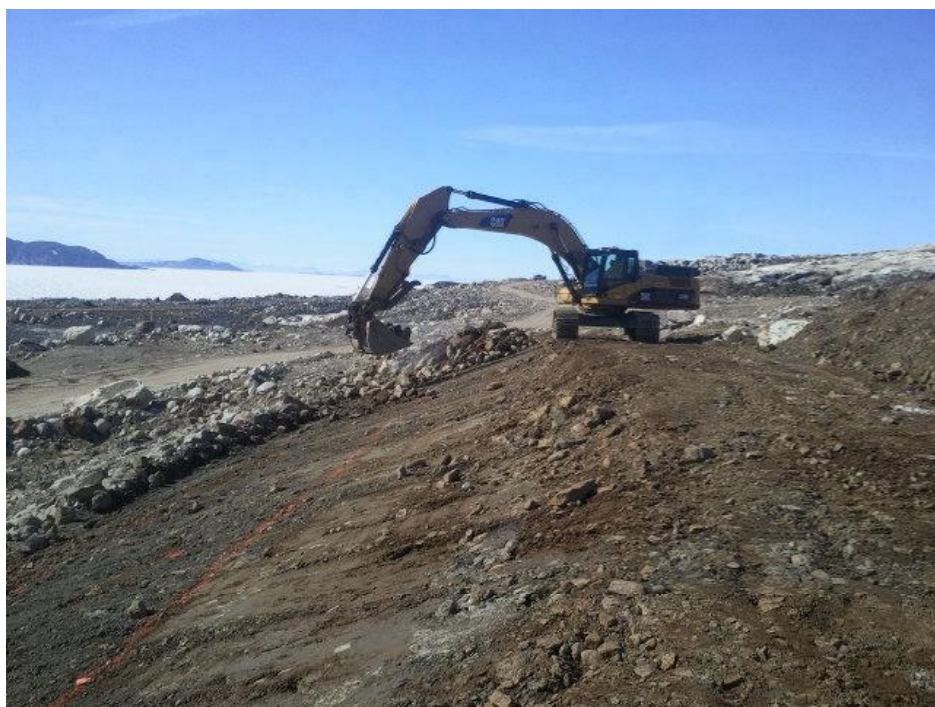
Photograph 13. Pallet Line Landfill Regrade – Placing Type 1 Fill material

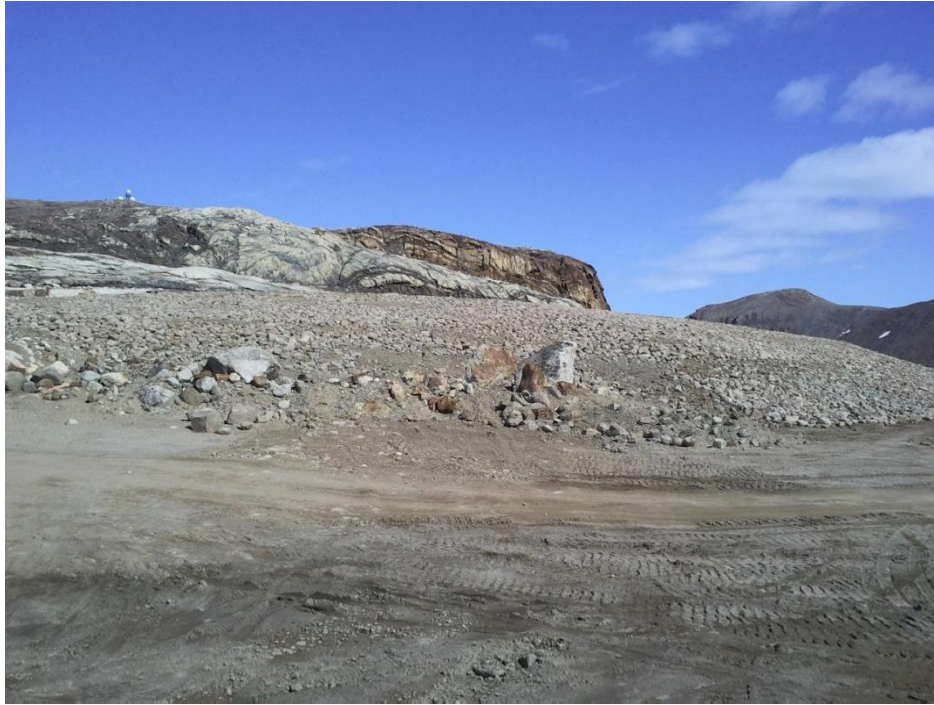
Photograph 14. Pallet Line Landfill Regrade - Completed

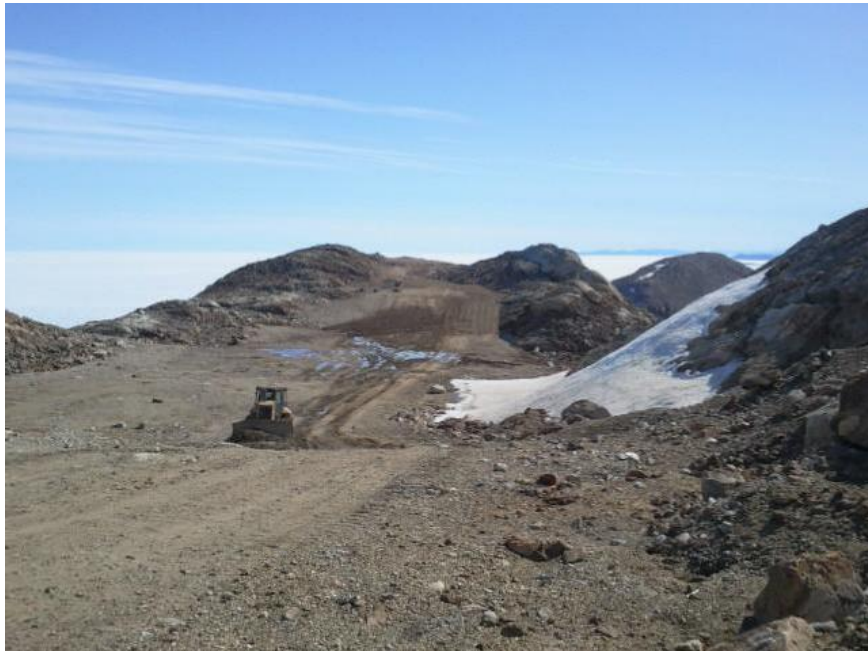
Photograph 15. Station Area Ridge Regrade - Completed

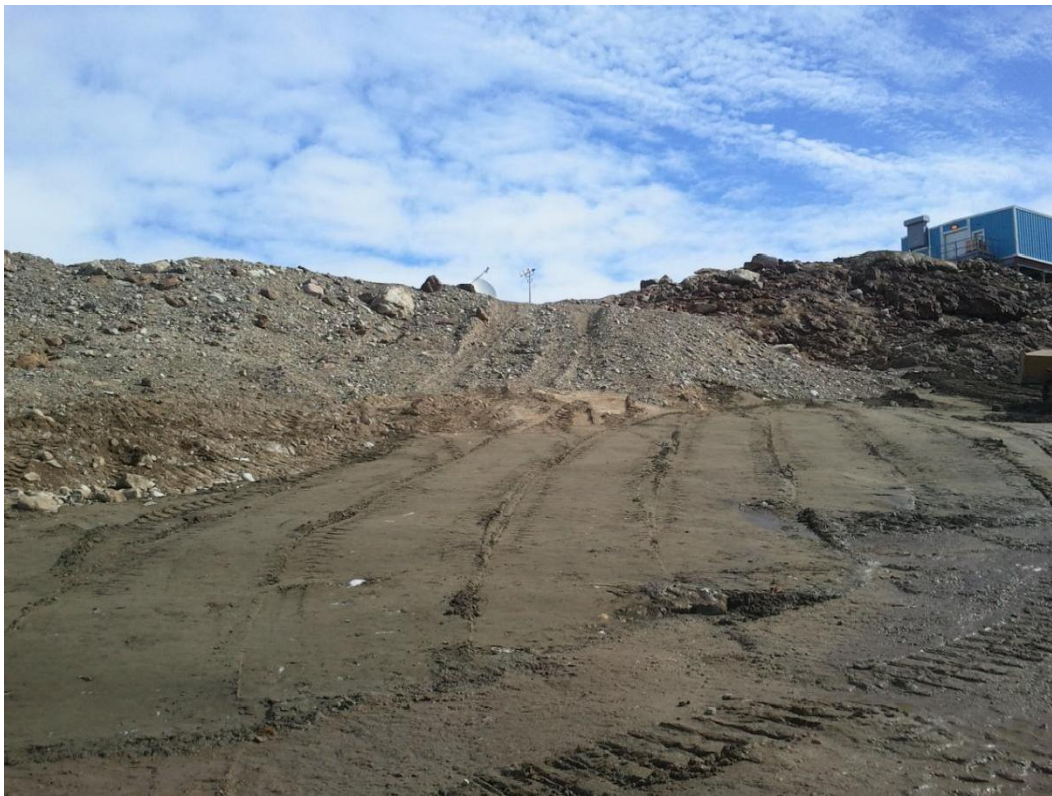
Photograph 16.

Helipad Landfill - West

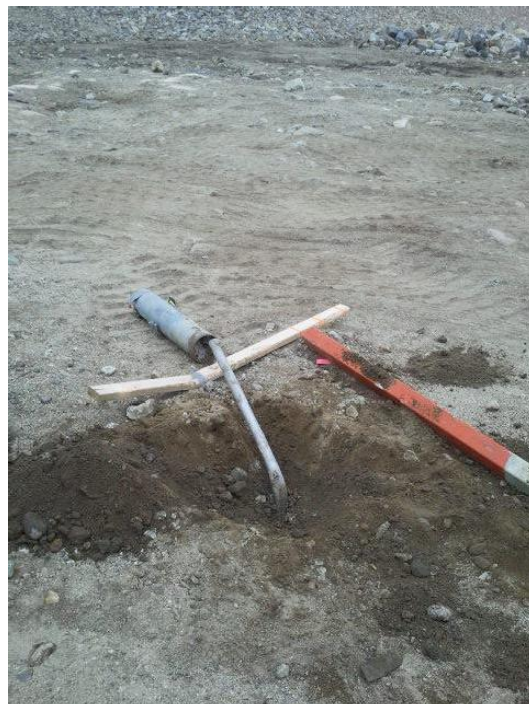
Photograph 17.

Damaged Monitoring Well

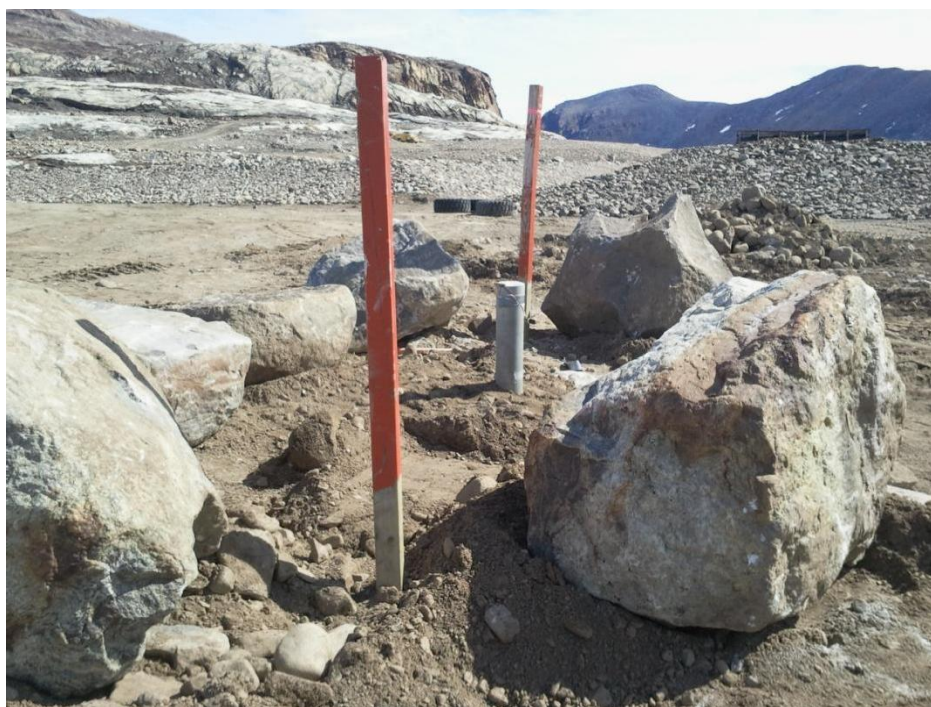
Photograph 18.

Repaired Monitoring Well

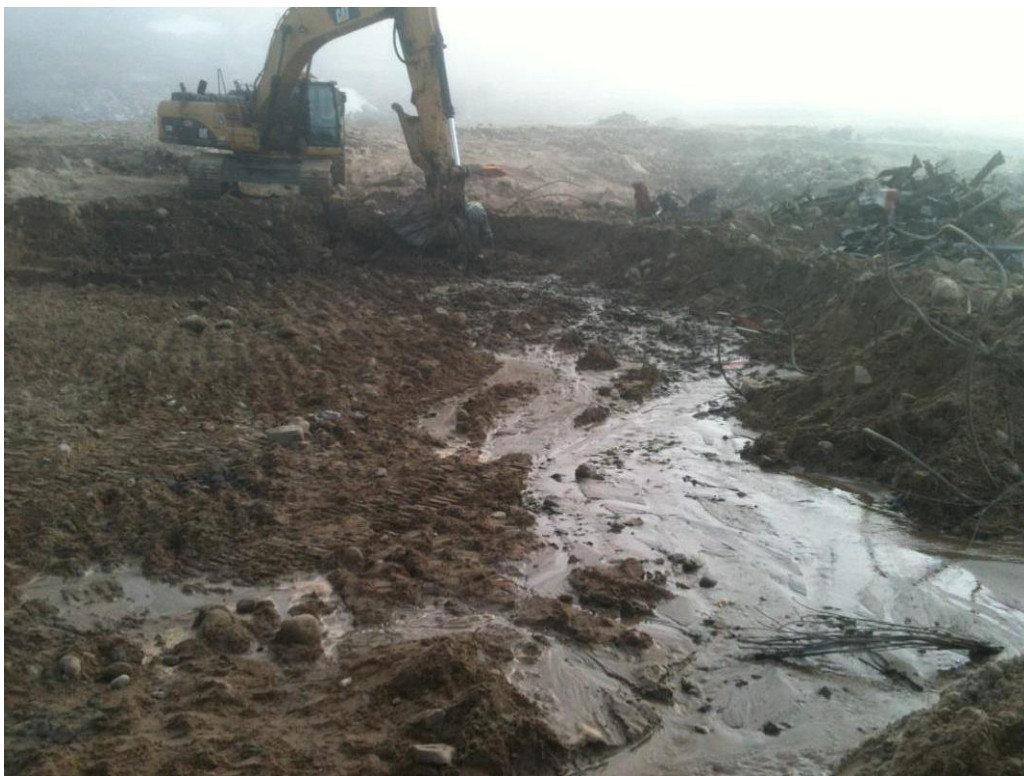
Photograph 19. Airstrip Landfill Excavation

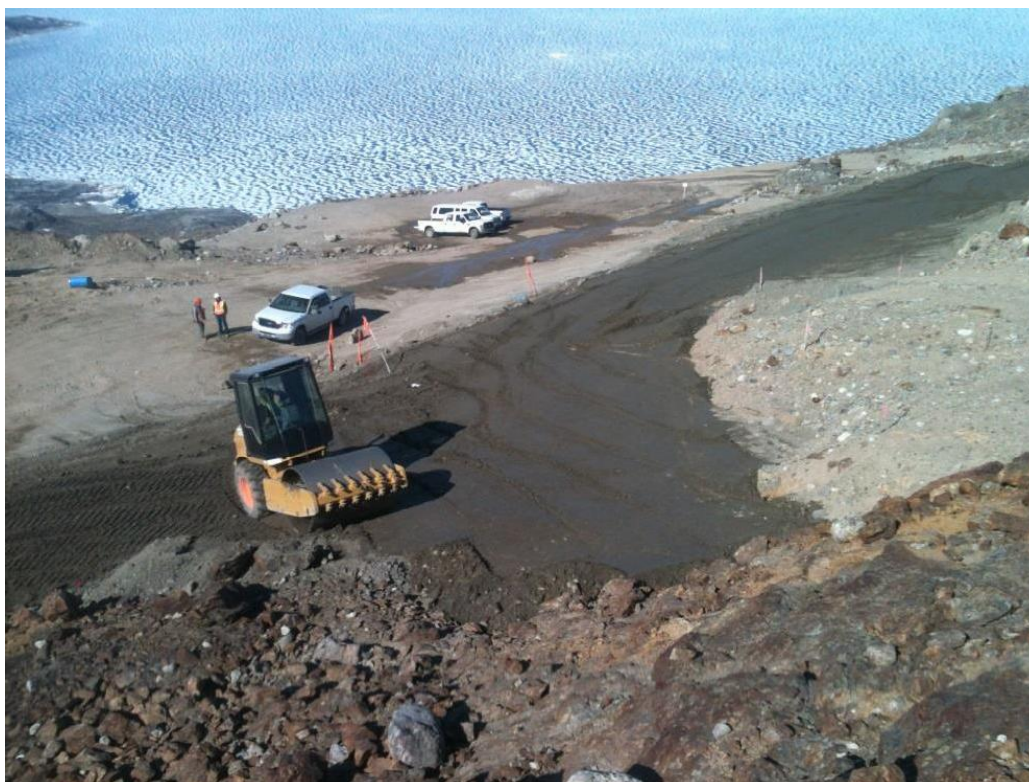
Photograph 20. Helipad West Landfill Regrade

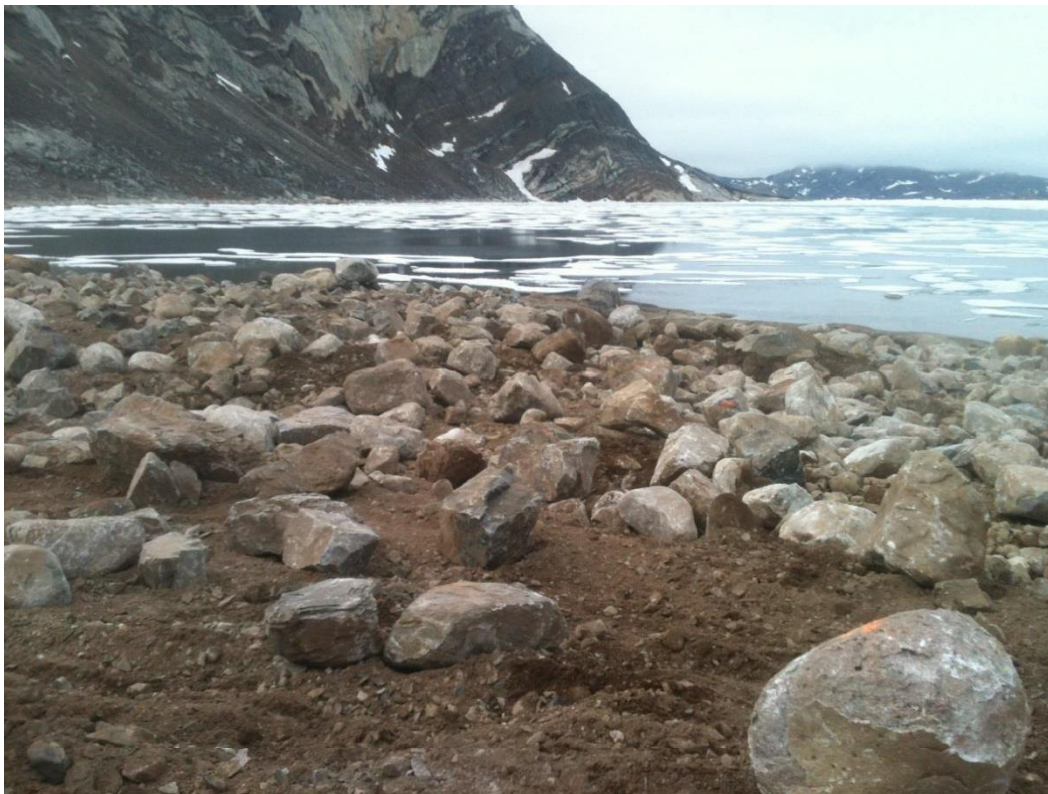
Photograph 21. Garbage Disposal Landfill Backfilled and Graded
