Project No: Water Use License 1BR-FOX1118

Regarding: 2013 Annual Report: FOX-4, Cape Hooper DEW Line Site

Project Name: FOX-4, Cape Hooper DEW Line Site Clean Up

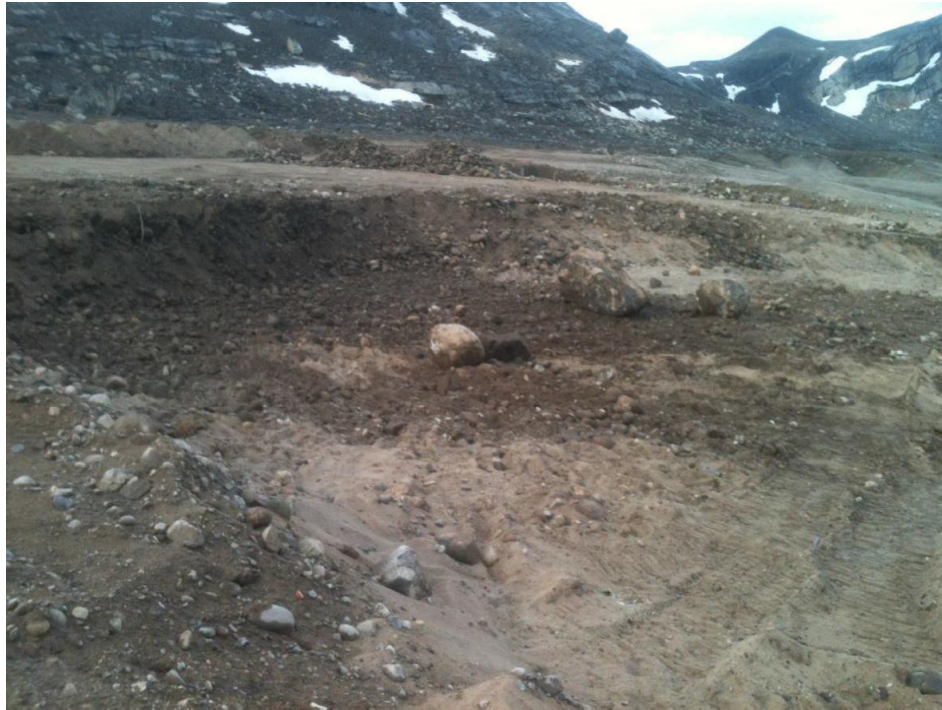
Photograph 22. Airstrip Landfill Excavation

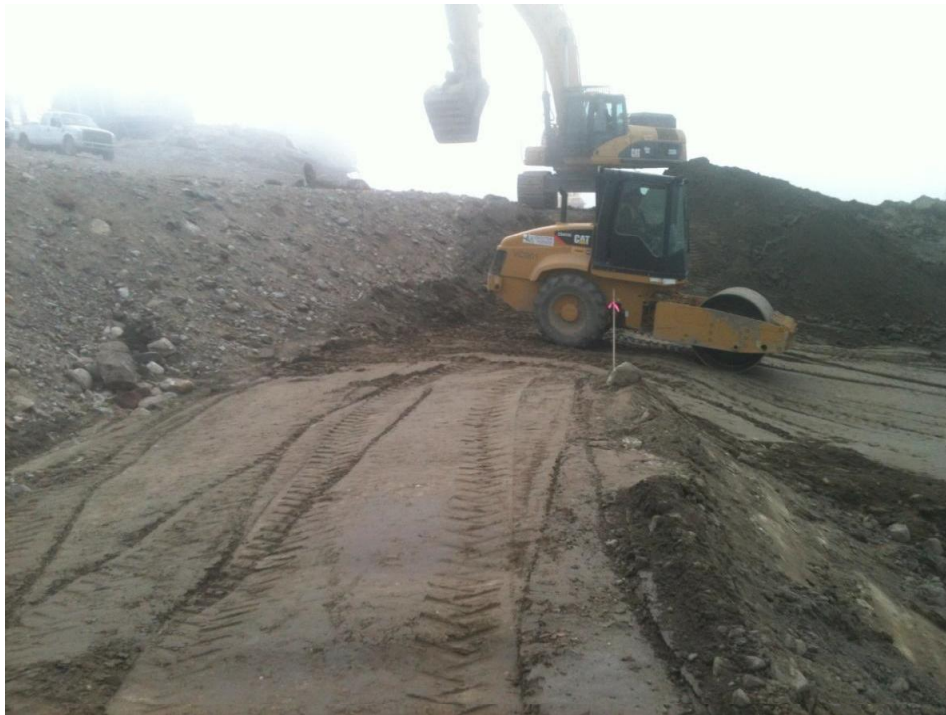
Photograph 23. Helipad West Landfill Regrade

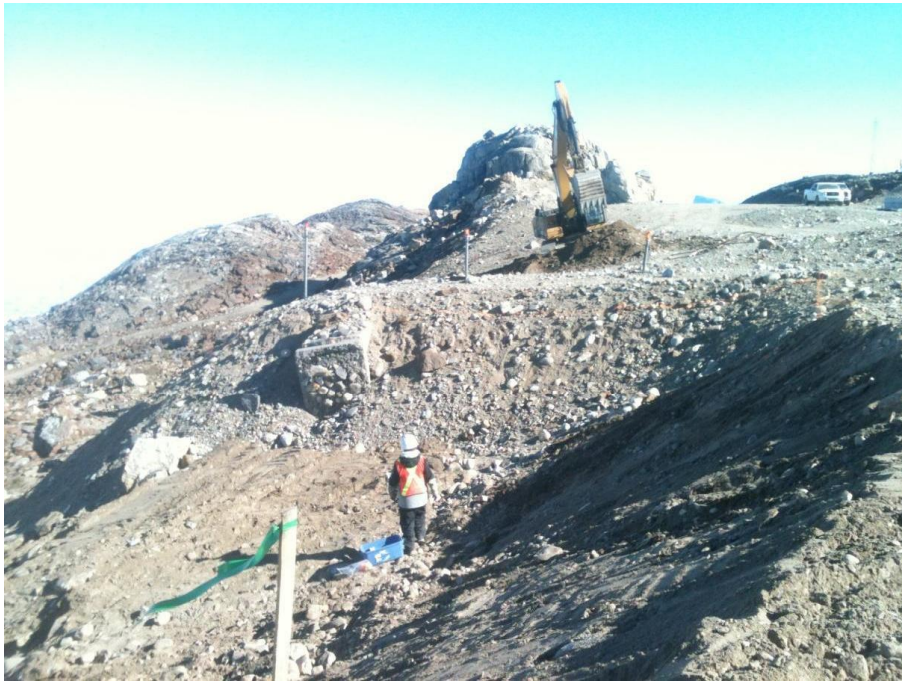
Photograph 24. Helipad East Landfill Excavation

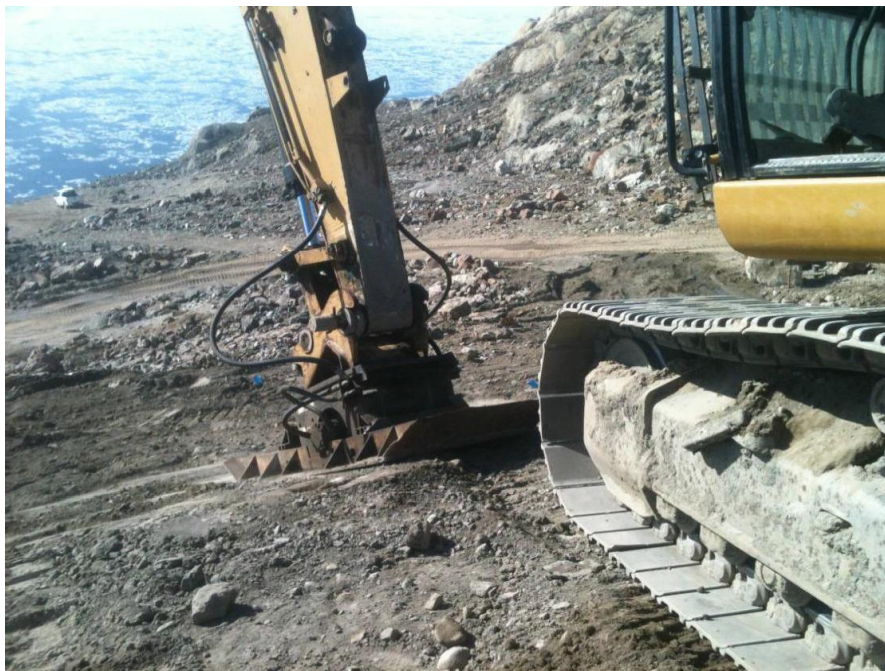
Photograph 25. Compaction Attachment for Excavator at Helipad-West Regrade

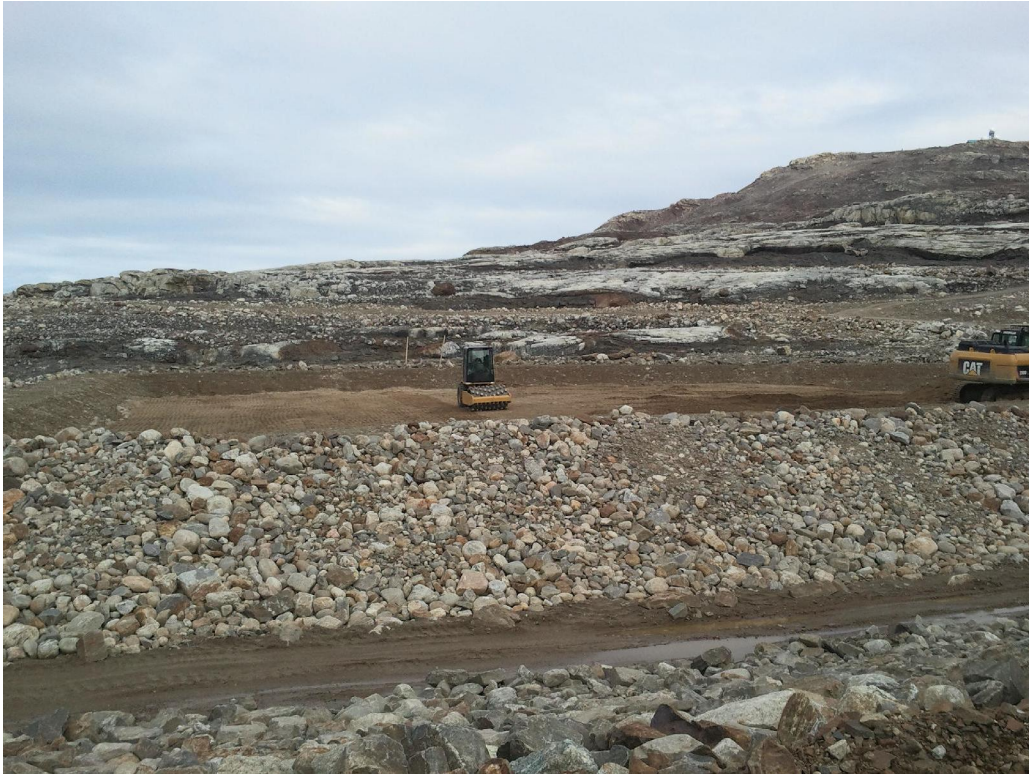
Photograph 26. Non-Hazardous Waste Landfill – Compacting Type 6 Granular Fill over Debris

- Type 6 Granular Fill was added as specified
 - The landfill was capped with a 1 metre thick cap of Type 2 Granular Fill.
- Landfarm construction activity:

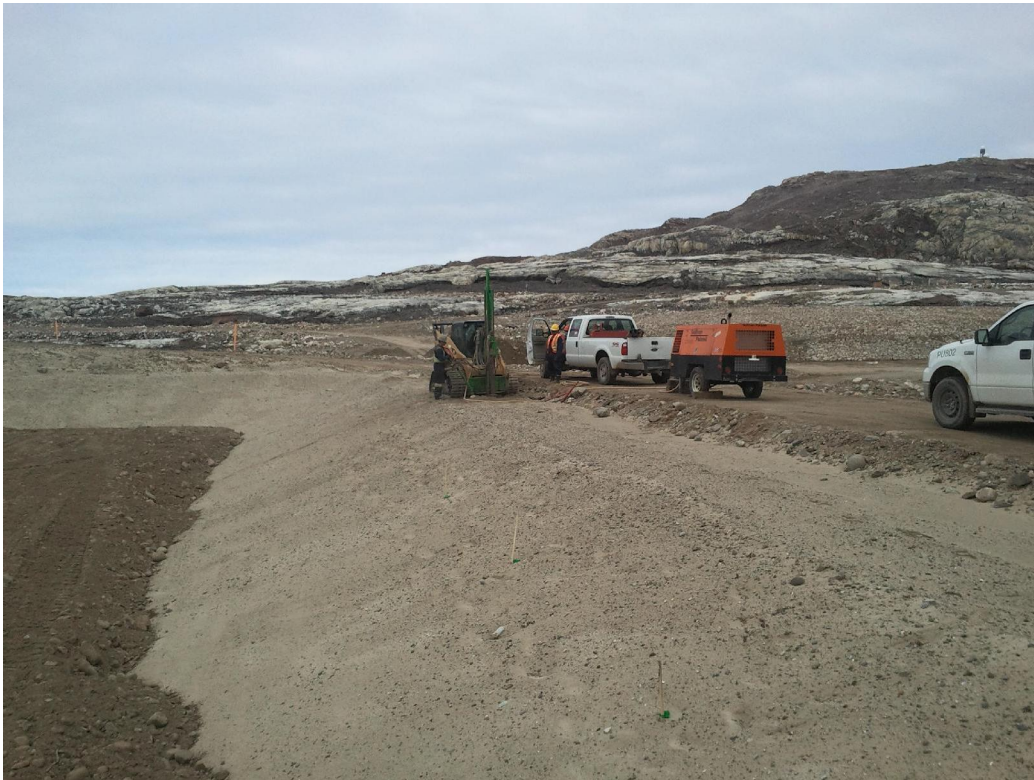
Photograph 27. Tier II Facility – Drilling VT-10 on Western Berm

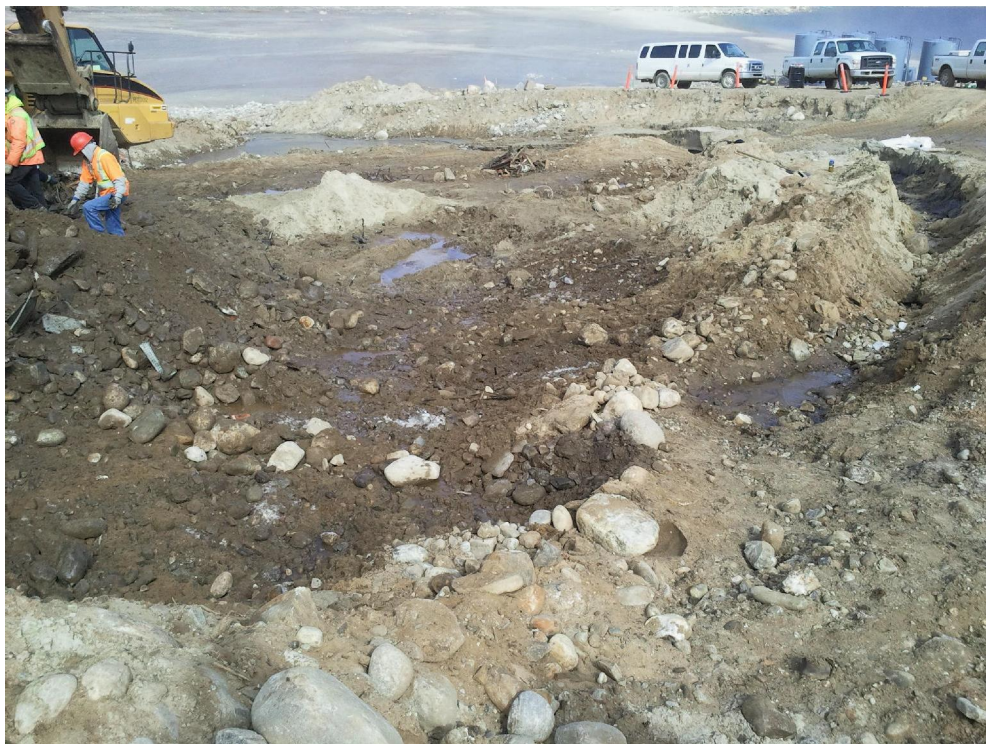
Photograph 28. Airstrip Landfill West – Groundwater Seepage

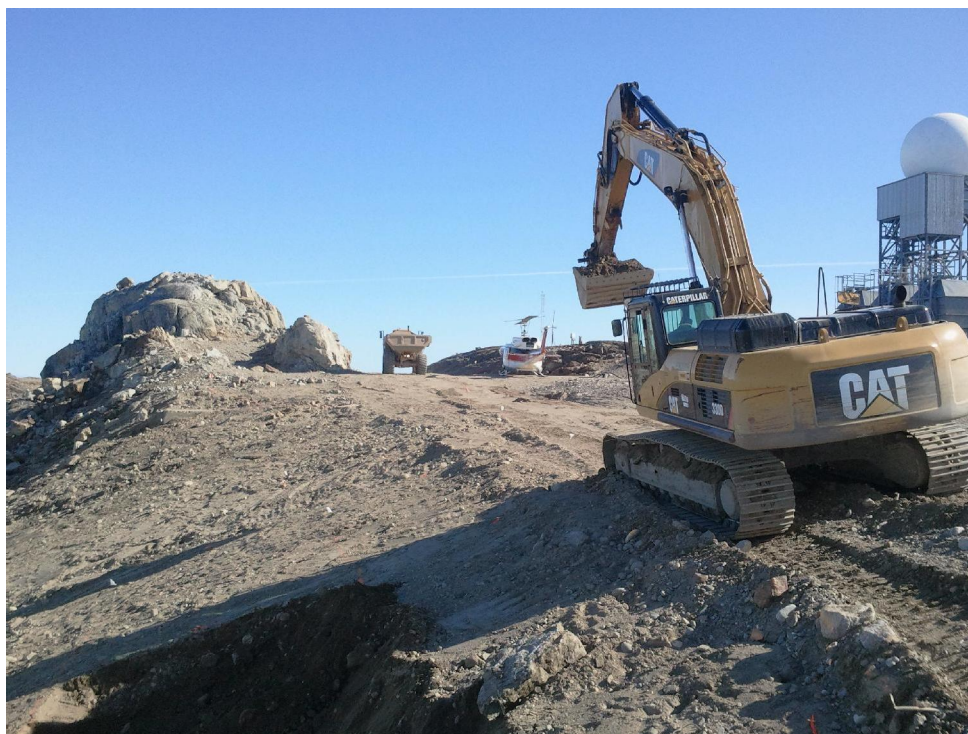
Photograph 29. Helipad Landfill East - Excavation

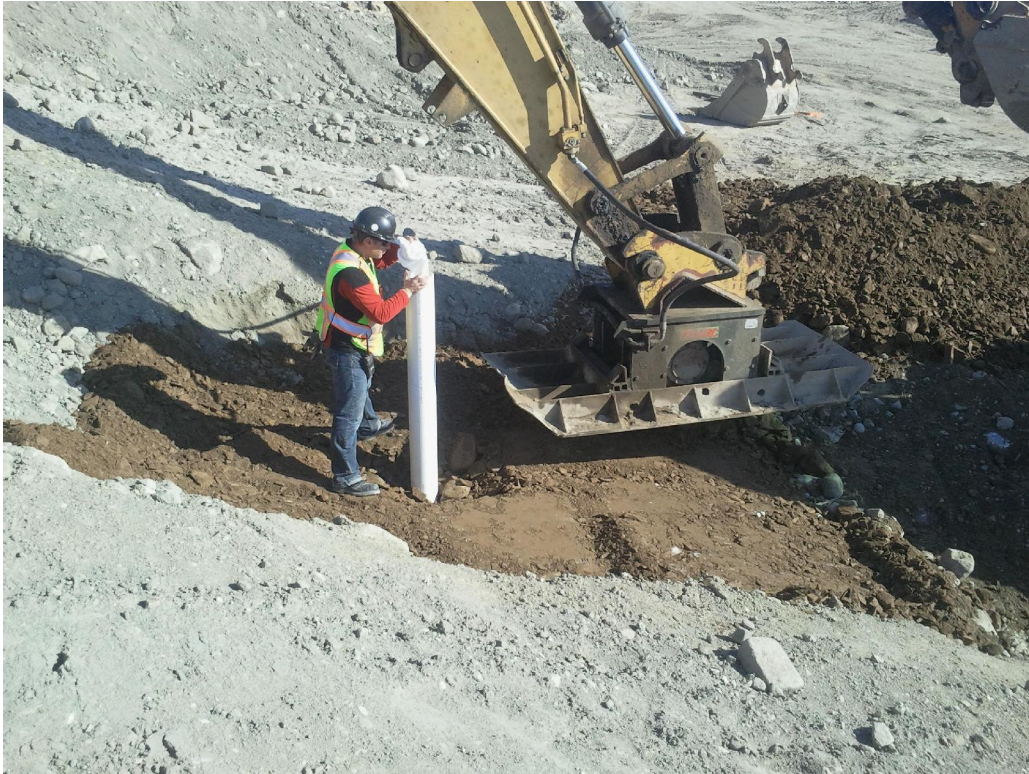
Photograph 30. Helipad West Regrade – Compacting Type 2 Granular Fill around MW-01

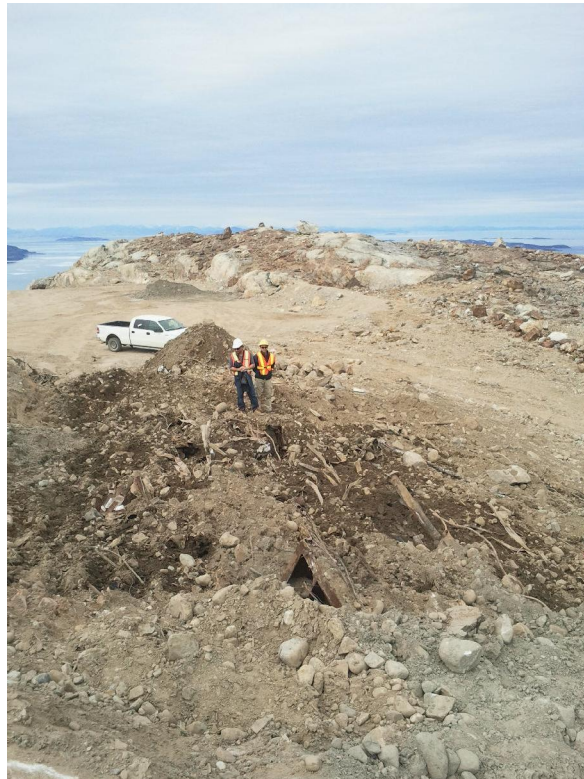
Photograph 31. Helipad East Landfill – Remaining Debris (August 7)

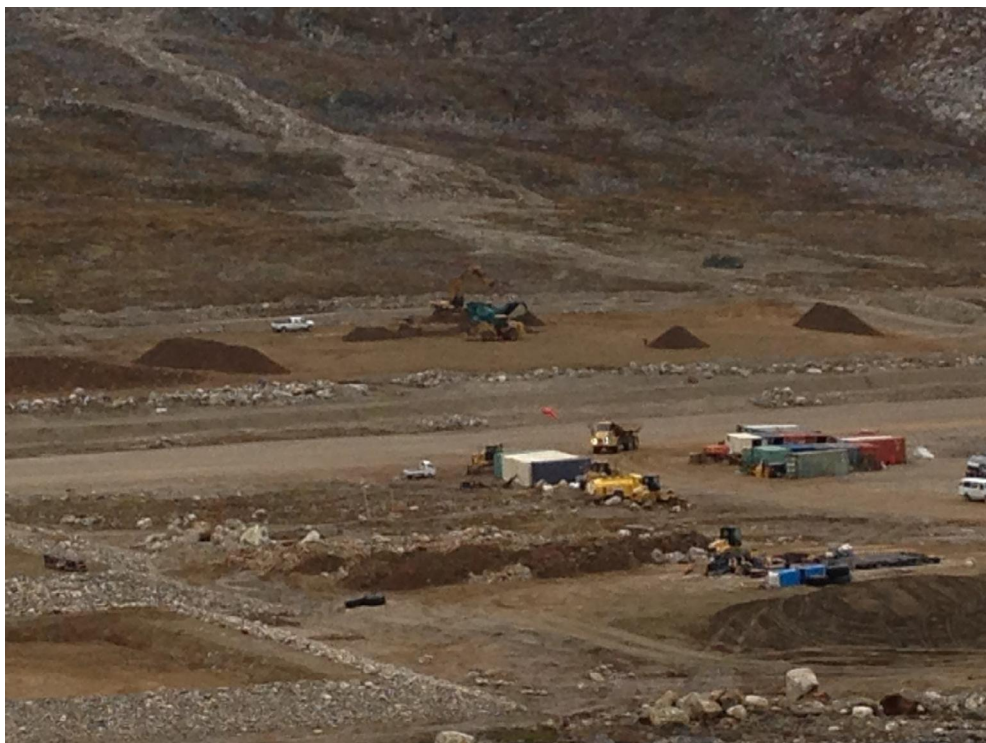
Photograph 32. Landfarm – Before spreading the three separate areas of material: 2,500 – 5,000 ppm (not screened), +10,000 ppm (screened), and 5,000 – 7,500 ppm (screened) from right to left.

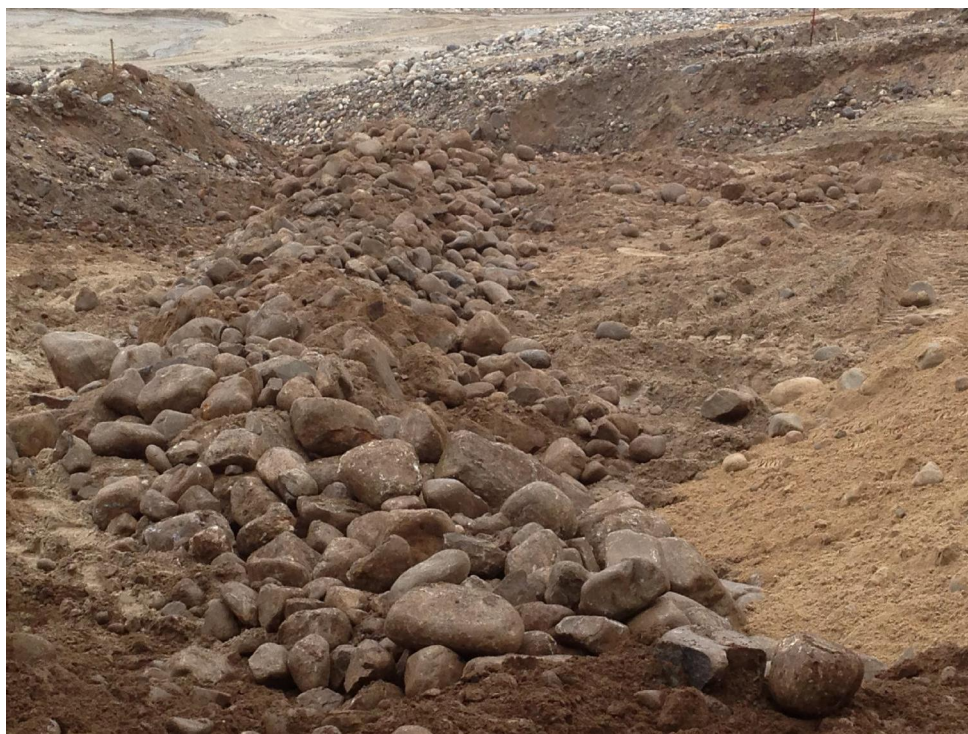
Photograph 33. Airstrip Landfill East – French Drain System

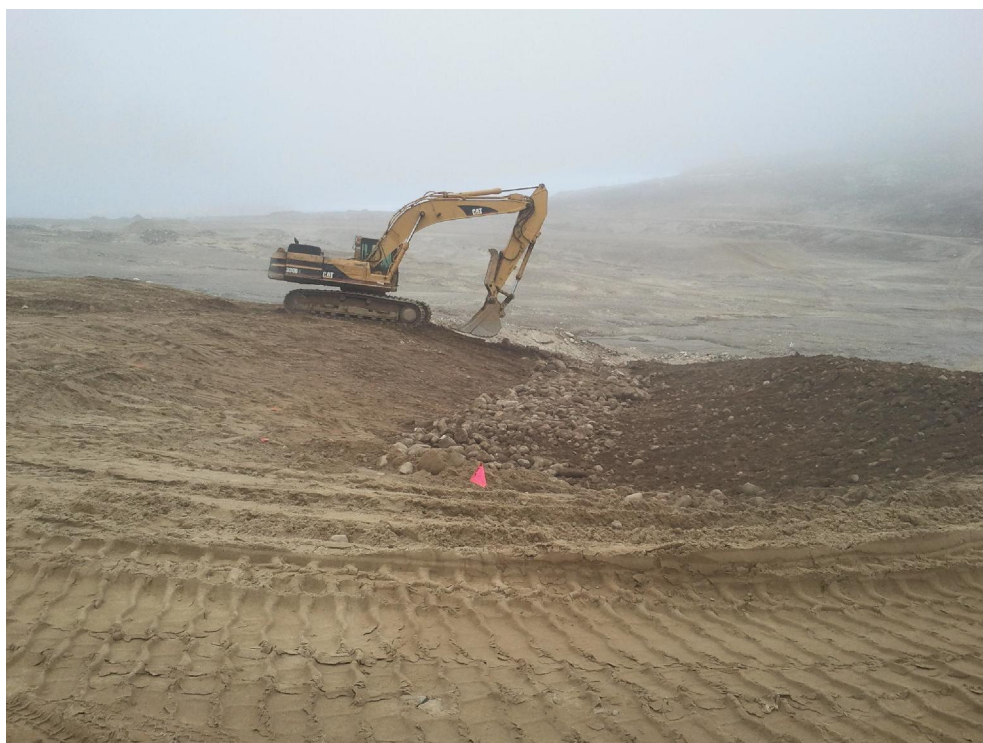
Photograph 34. Airstrip Landfill East – Drainage Swale

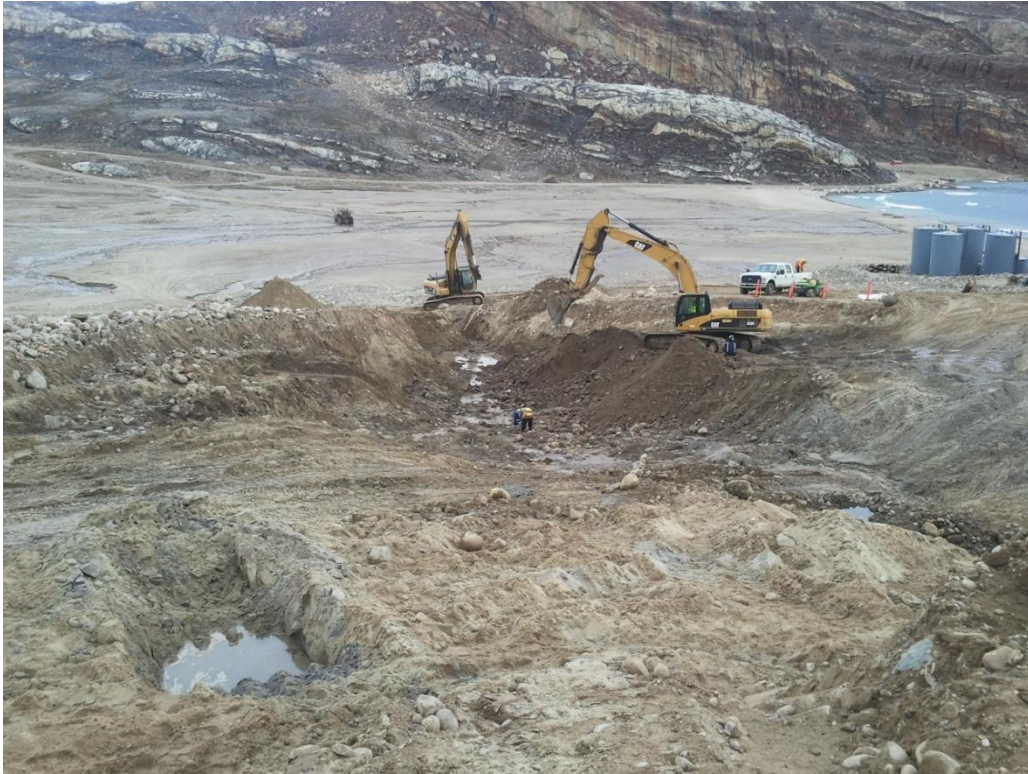
Photograph 35. Airstrip Landfill East Lobe – North Eastern Extent Debris Excavation Nearing Completion

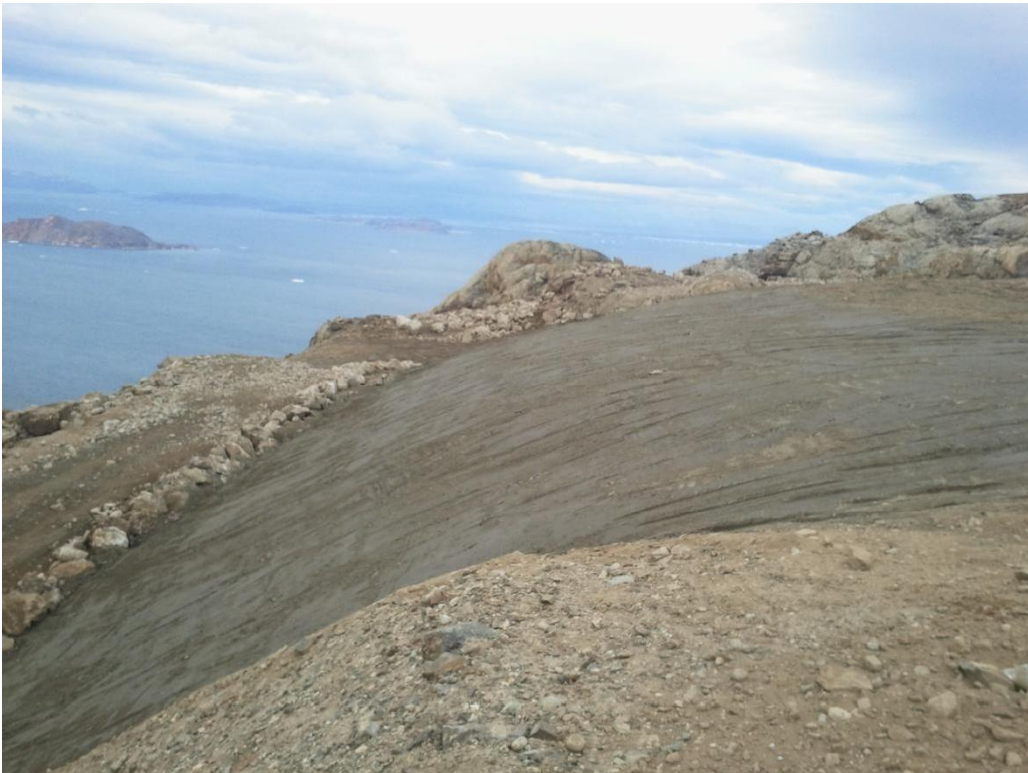
Photograph 36. Barrel Dump Landfill – Type 2 Granular Fill Material Cap Complete

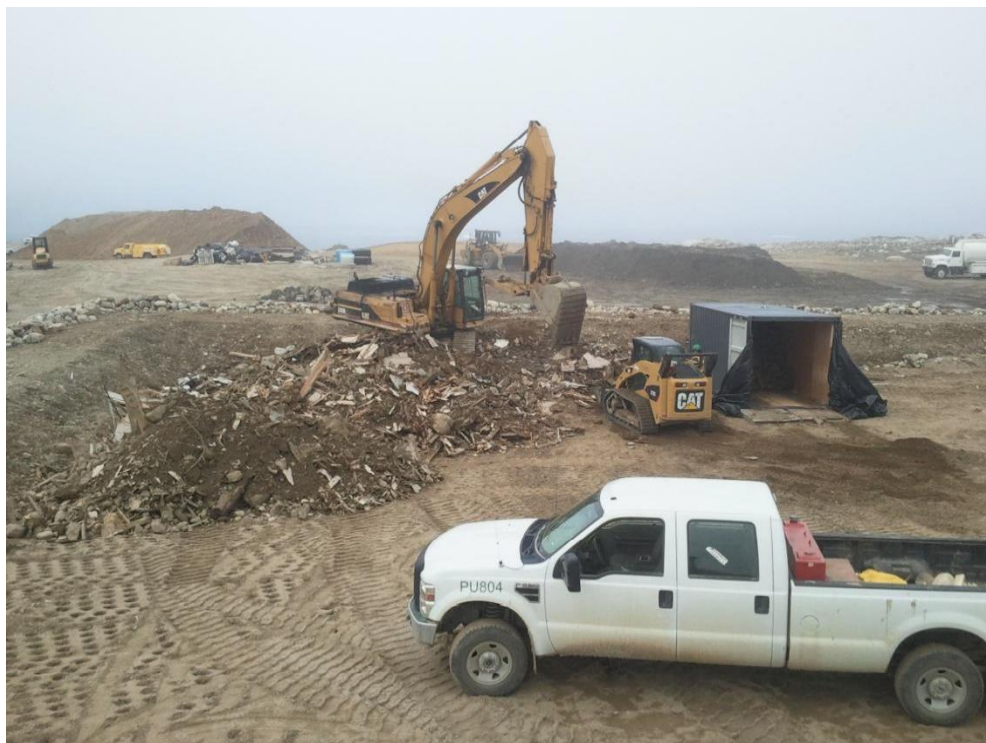
Photograph 37. Non-Hazardous Waste Facility – Using a Modified Barge Container QM is Preparing Wood PCB Paint for Transport Off Site

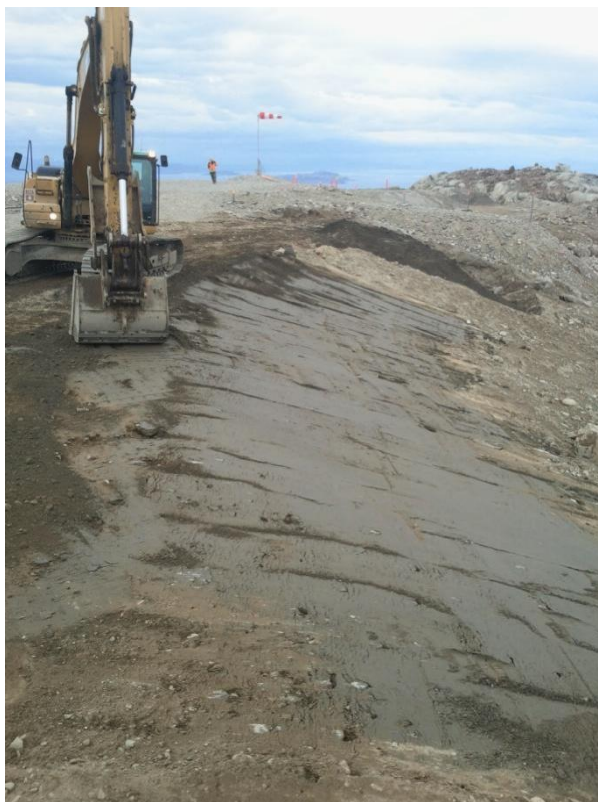
Photograph 38. Helipad East – East Lobe – Backfilling Complete

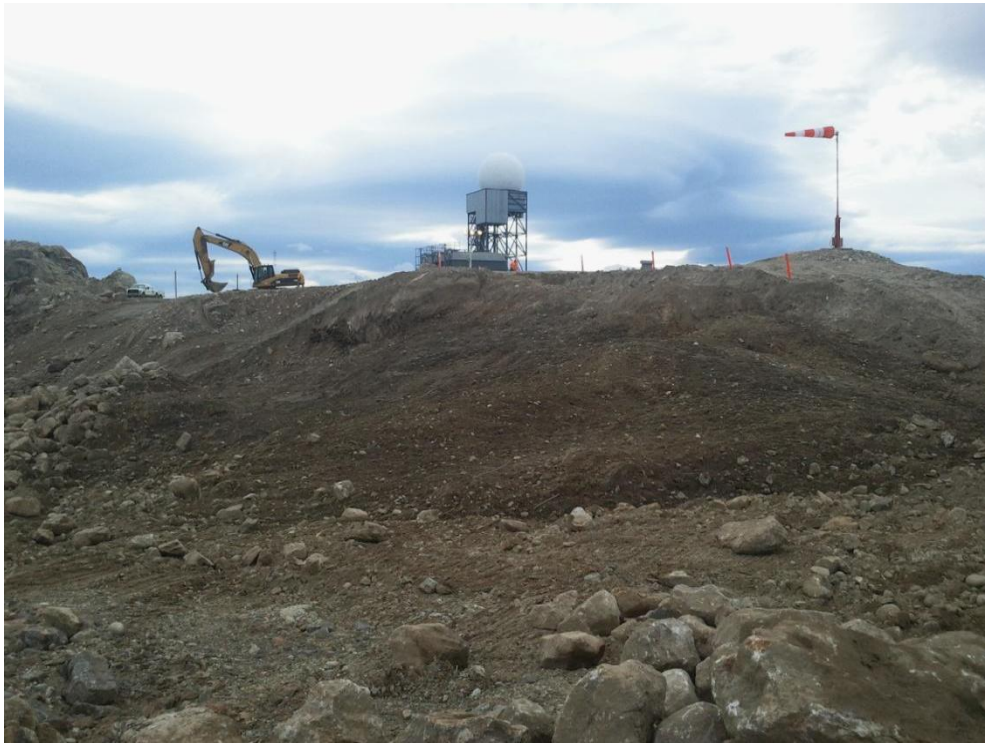
Photograph 39. Helipad East – West Lobe – Completed Excavation

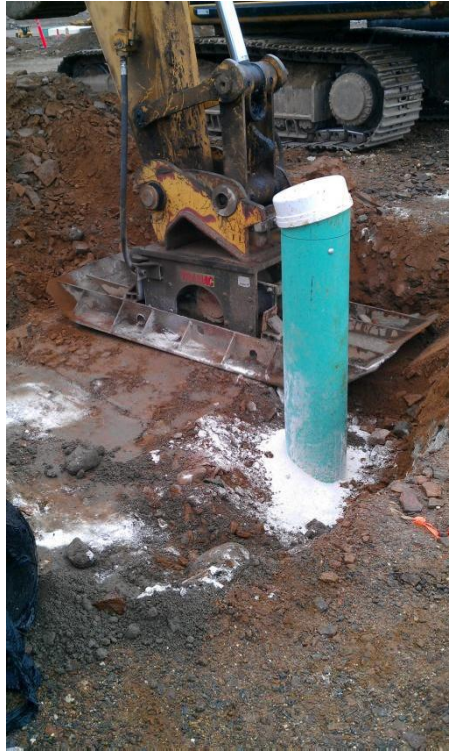
Photograph 40. Existing Tier II Facility - Backfilling Ground Temperature Monitoring Excavation

- Thermistors were extended to account for the additional cap thickness
- Expanded Tier II Disposal Facility construction activity:
 - The bottom liner system, with Type 5 embedment materials, was installed at the beginning of the 2013 construction season and the facility was ready to accept contaminated soils by July 17, 2013

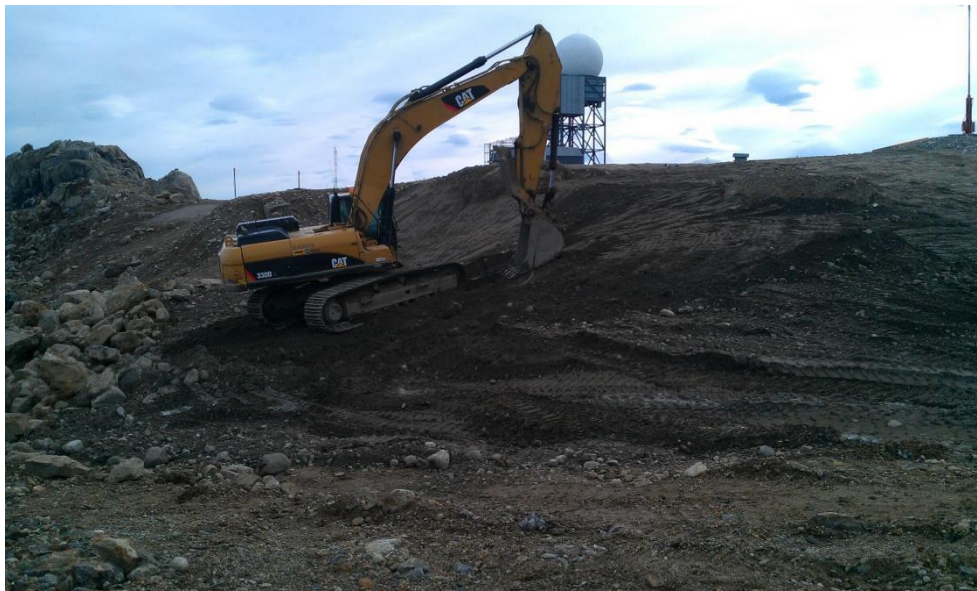
Photograph 41. Helipad East Regrade

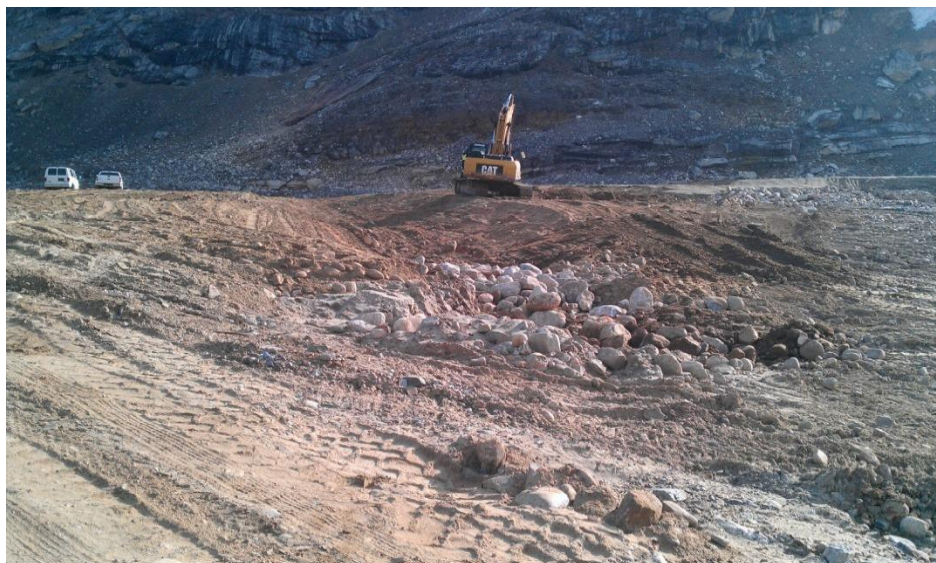
Photograph 42. Airstrip Landfill – Backfill of the large lobe complete.

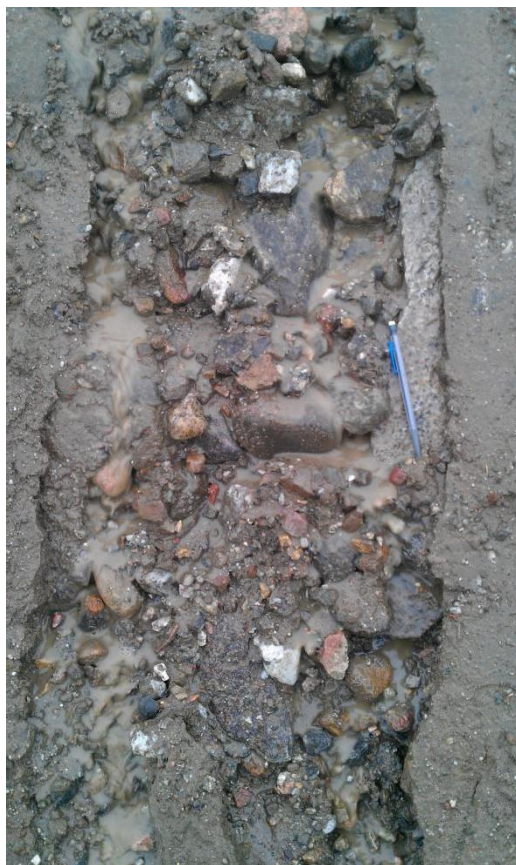
Photograph 44. Helipad West – Self Armouring of Material
at Helipad-Landfill West

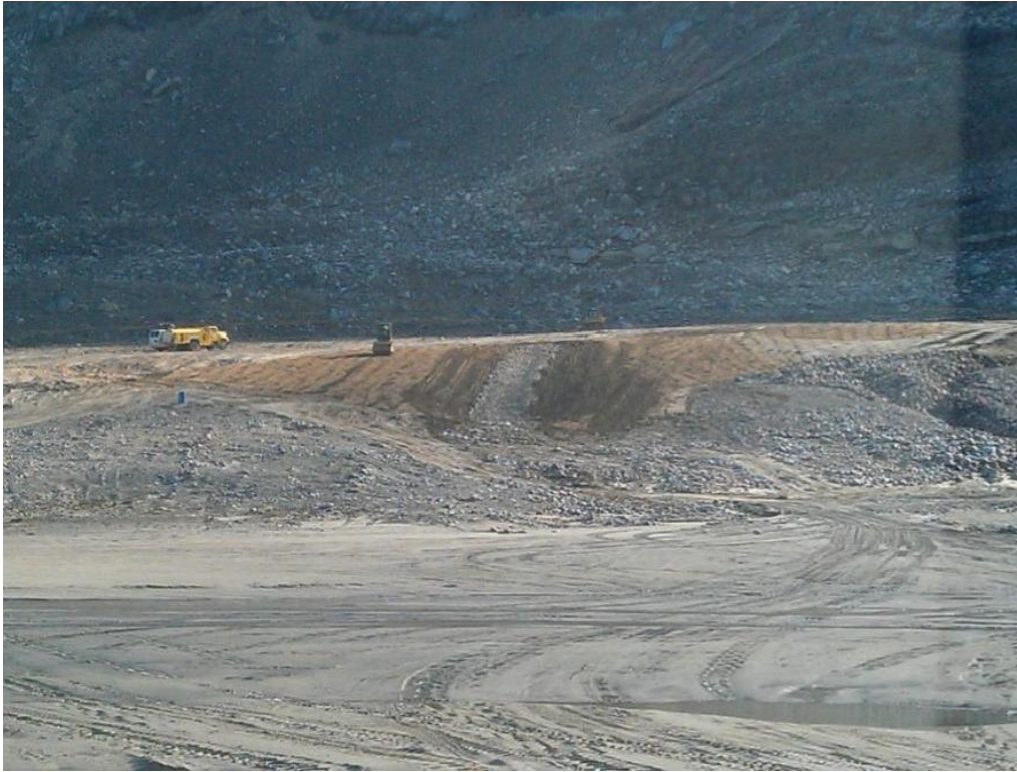
Photograph 45. Airstrip Landfill – Completed Swale and Type 2 Granular Fill Cap

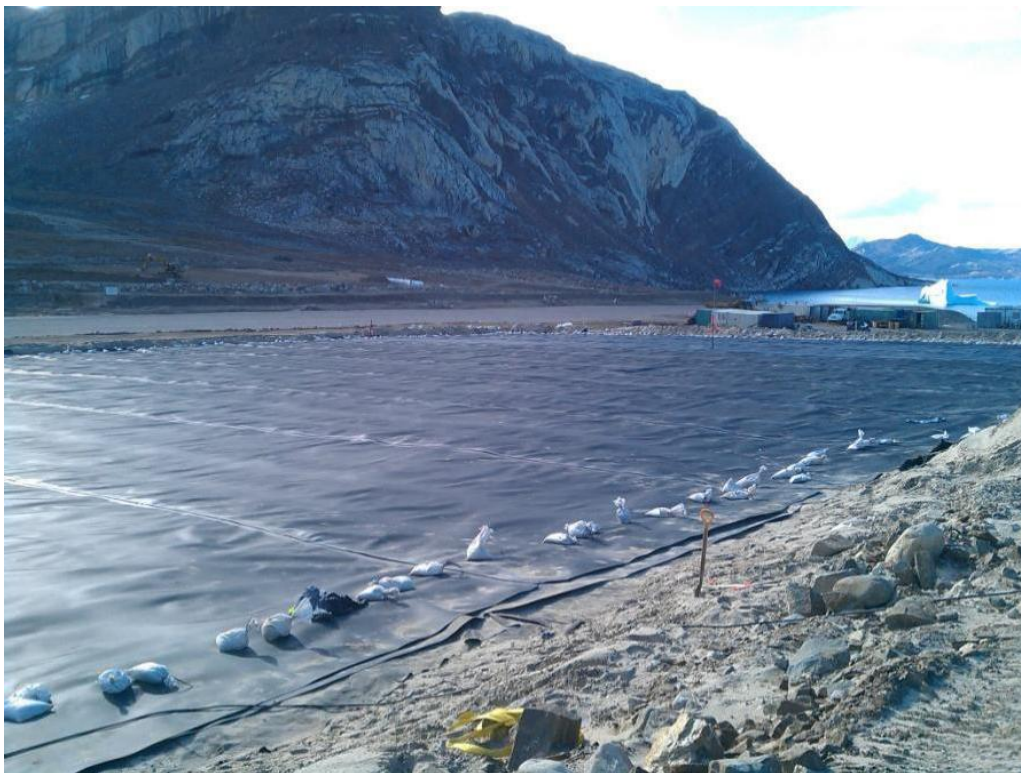
Photograph 46. Tier II Facility – Geomembrane Laid Out

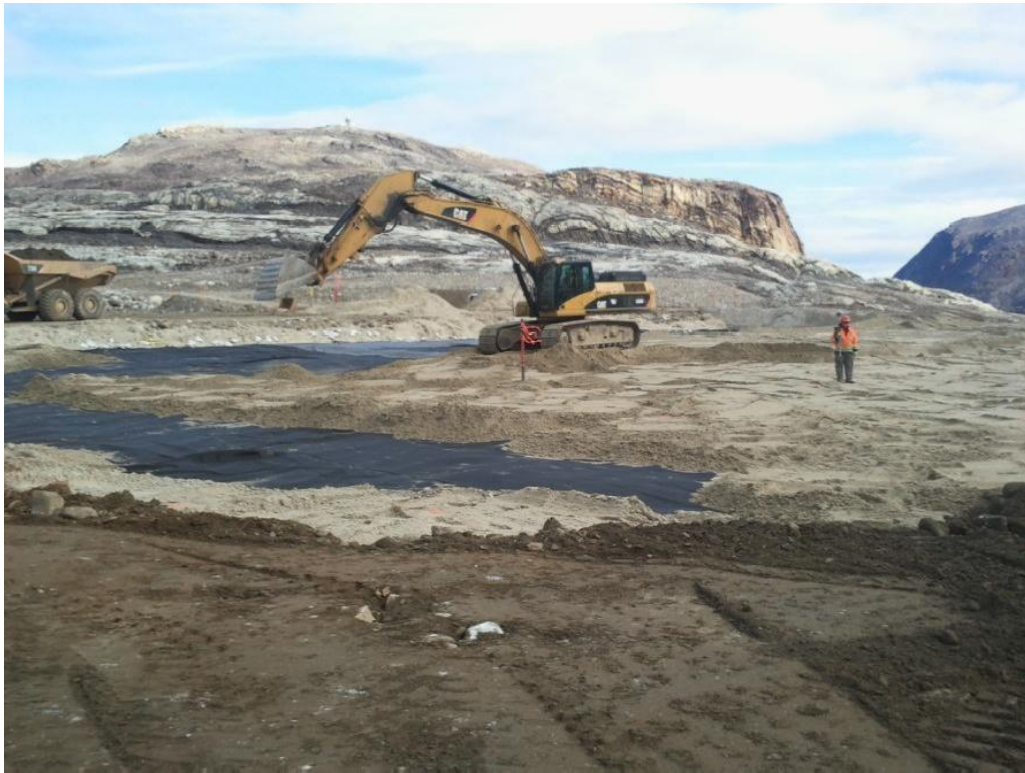
Photograph 47. Tier II Facility – Placing Type 5 Granular Fill over Synthetic Liner

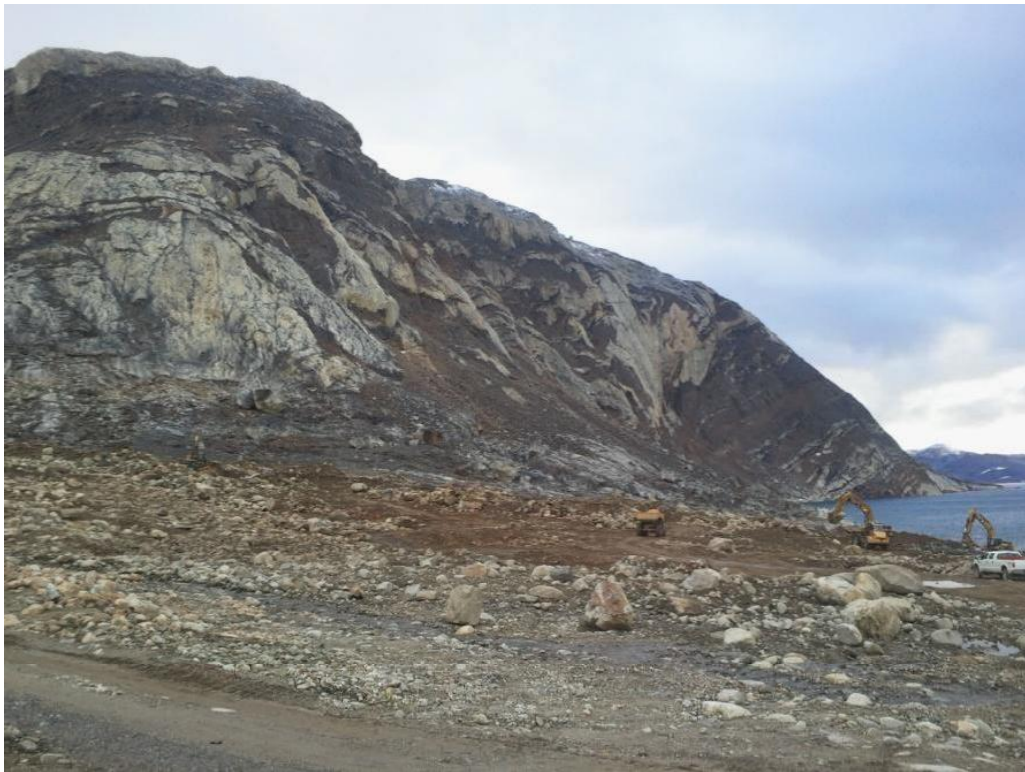
Photograph 48. Borrow Area 3 – Mining Activities

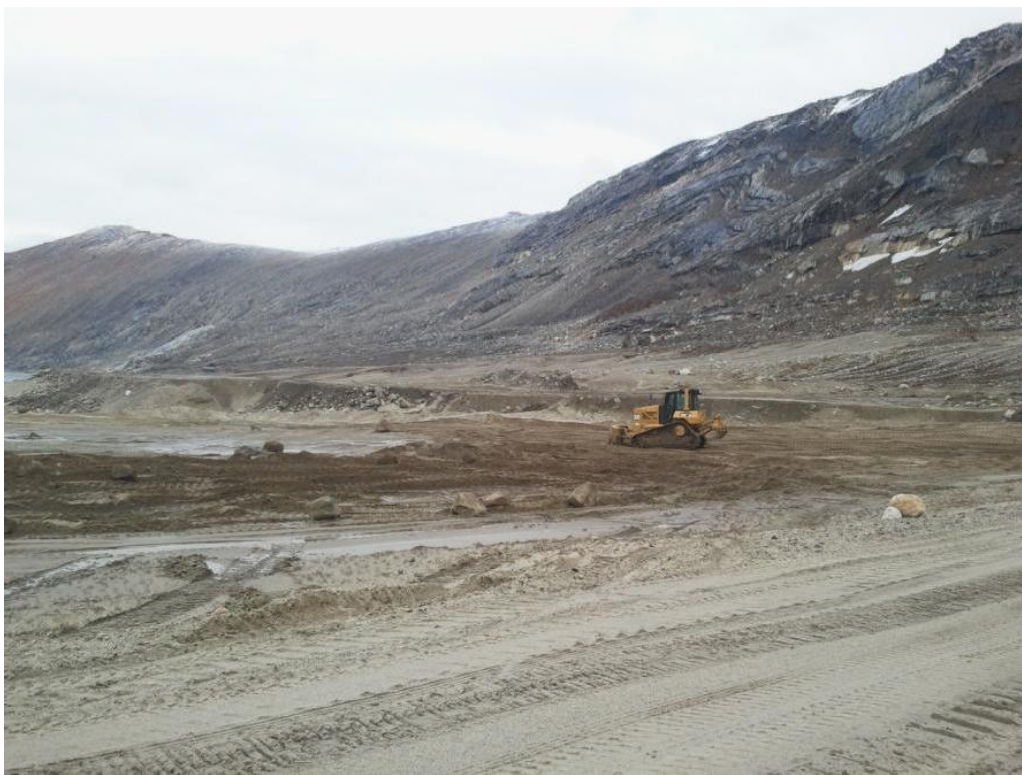
Photograph 49. Borrow Area 14 – Reclamation Work in Progress

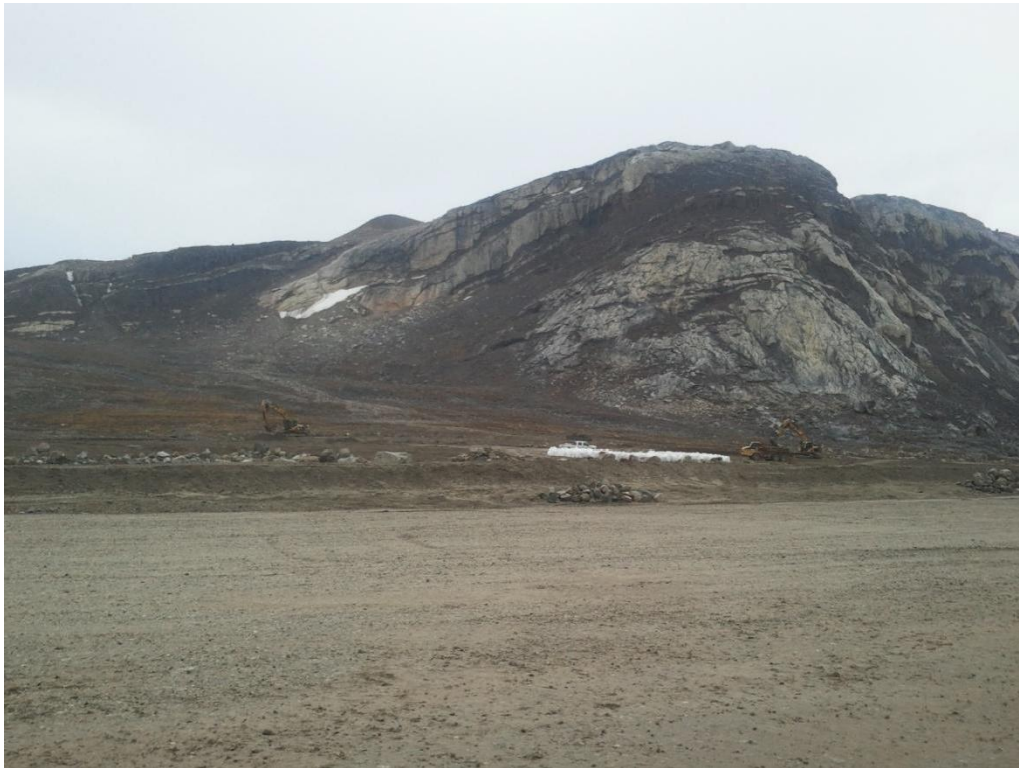
Photograph 50. Landfarm – Berms being removed

- Type B contaminated soils were placed and type 1 Granular Fill was used from the treatment soils
 - Decommissioning of the Landfarm involved using the Type 2 Granular Fill to from the construction of the berms for grading the Landfarm

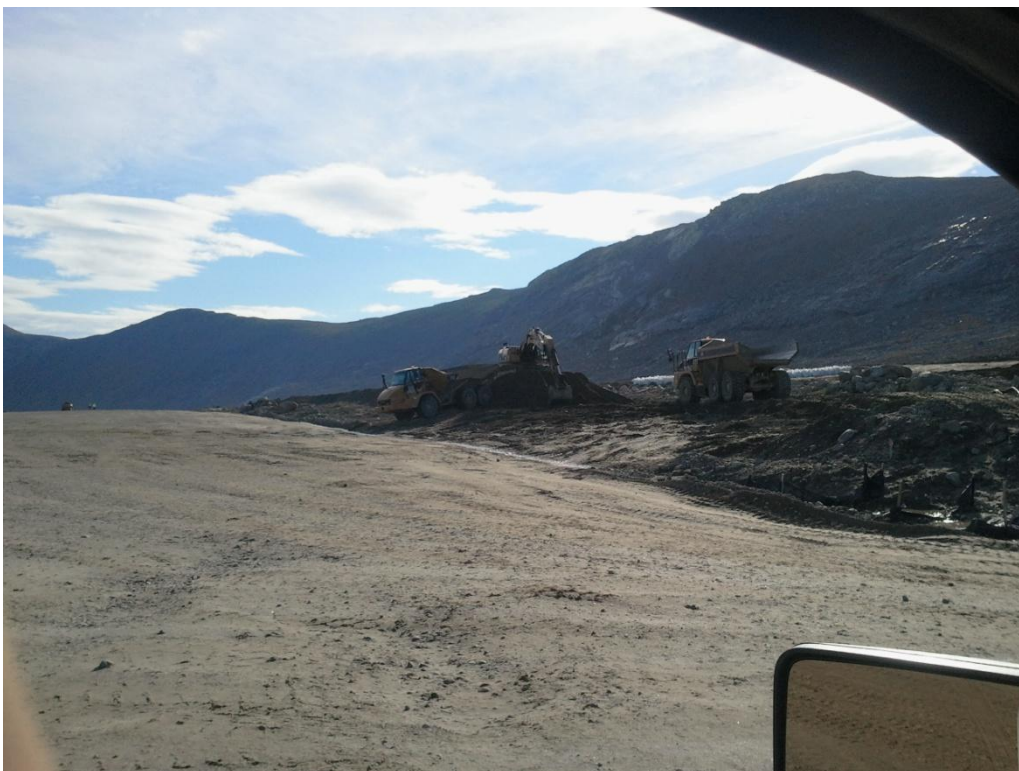
Photograph 51. Landfarm – North Berm being removed

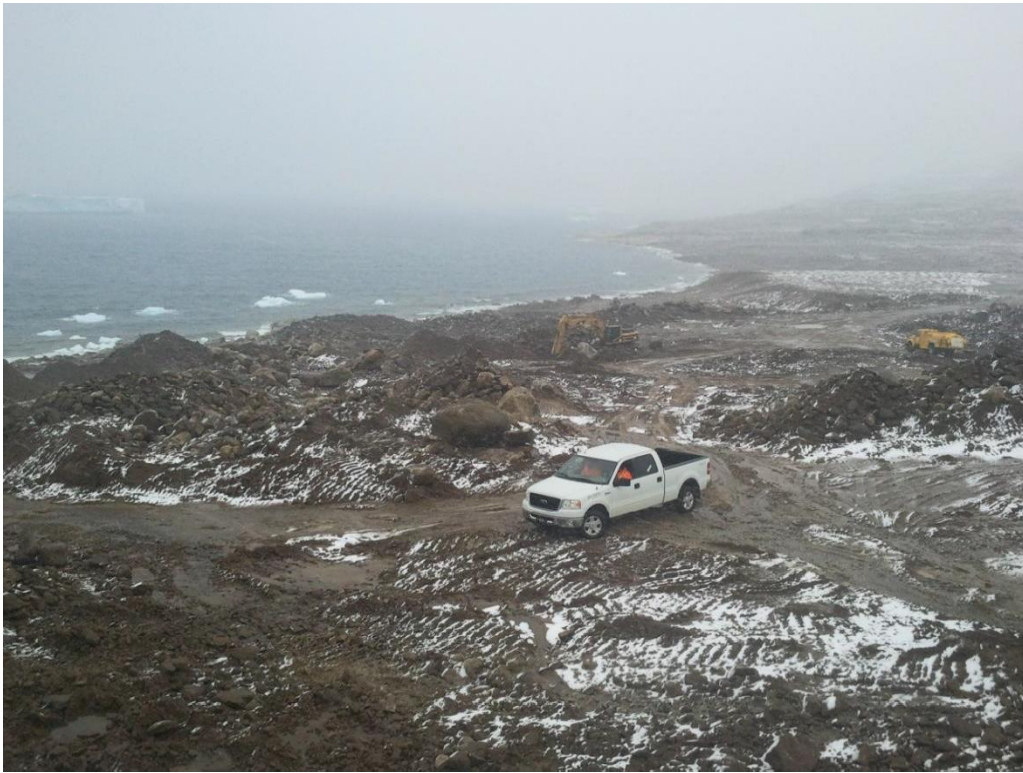
Photograph 52. Borrow Area 3 – Type 2 Granular Fill Mining Activities

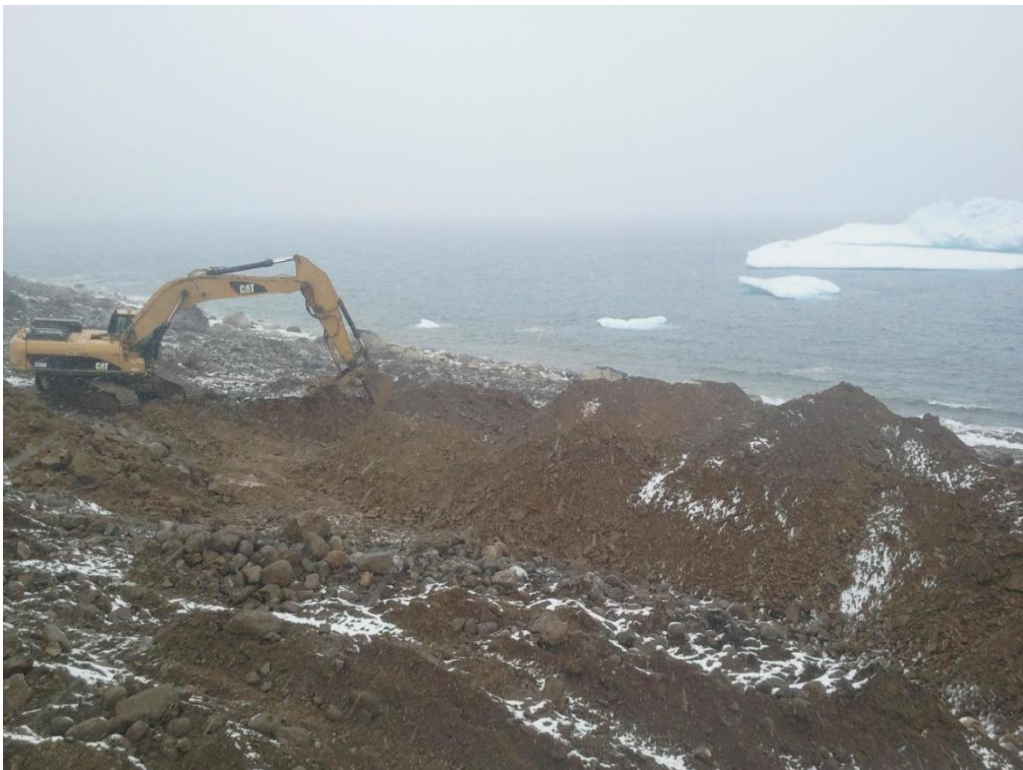
Photograph 53. Borrow Area 3 – Type 2 Granular Fill Mining Activities

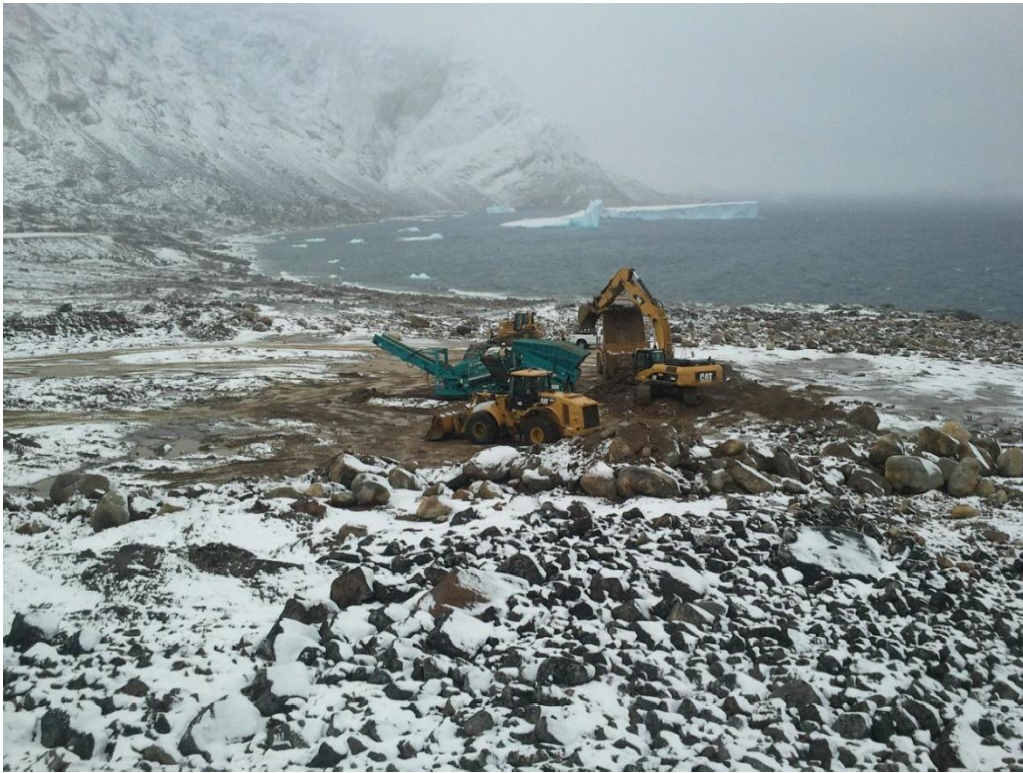
Photograph 54. Borrow Area 6 – Screening Material for Airstrip Improvement Project

- Airstrip Landfill
- General site grading included:
 - The airstrip was repaired and depressions were filled using screened granular fill from Borrow Area 6
