Project No: Water Use License 1BR-FOX1118

Regarding: 2013 Annual Report: FOX-4, Cape Hooper DEW Line Site

Project Name: FOX-4, Cape Hooper DEW Line Site Clean Up

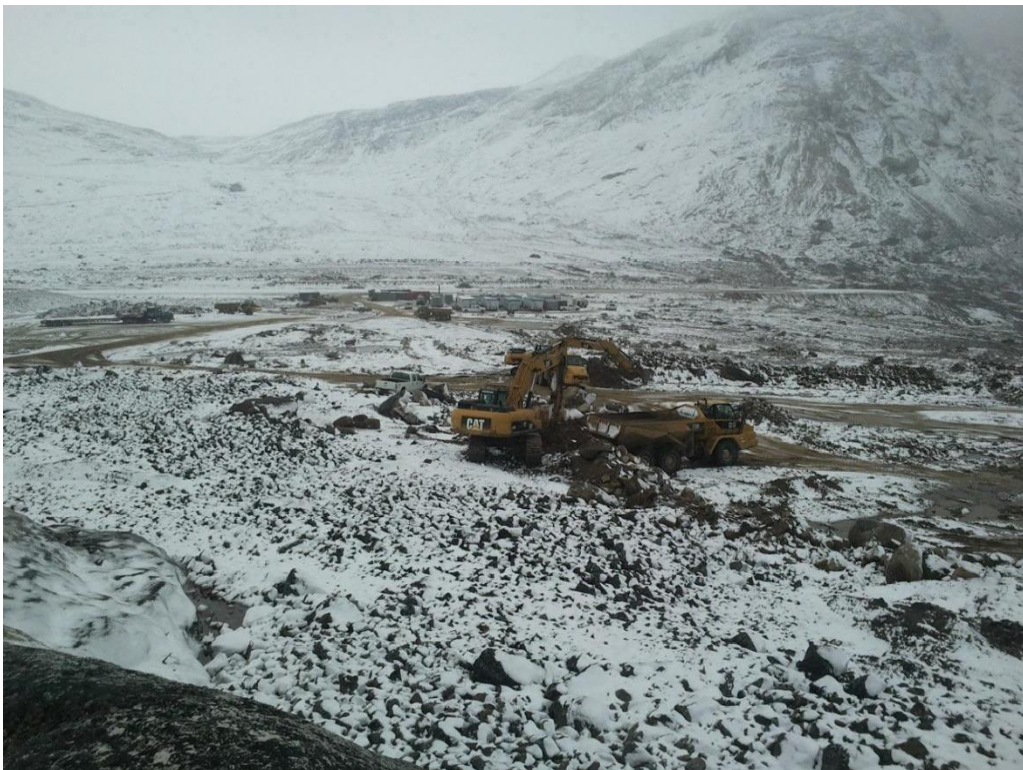
Photograph 55. Borrow Area 6 – Mining Material to be Screened for Airstrip Improvement Project

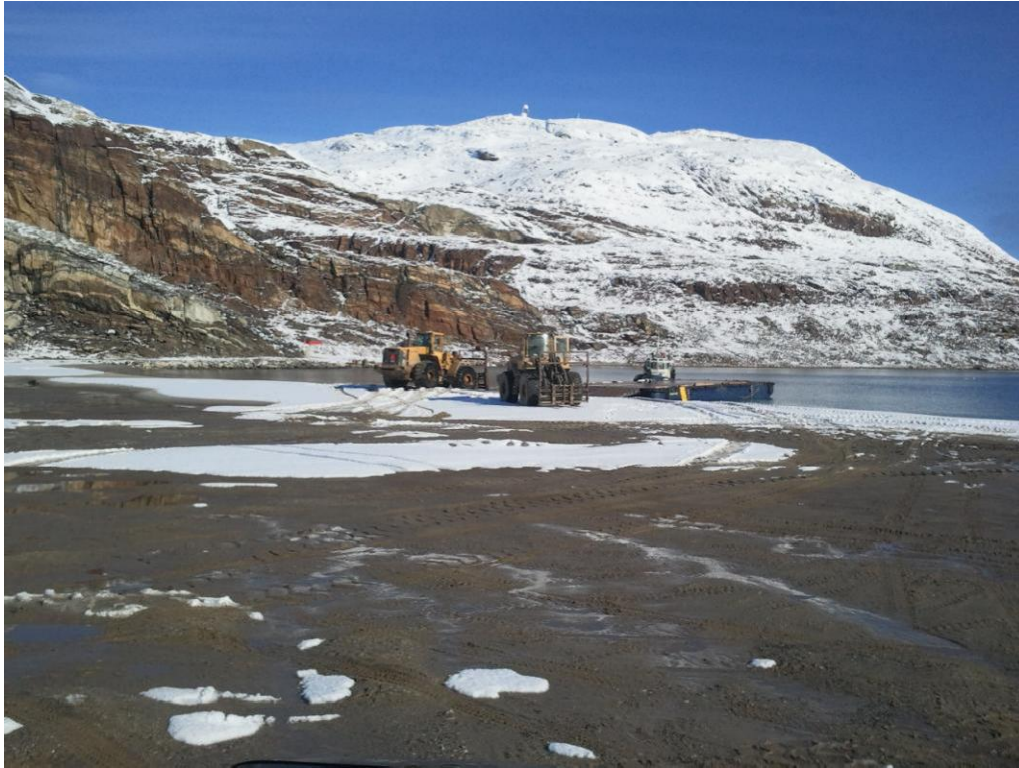
Photograph 56. Hooper Bay – Loading Soil Bags onto Barge

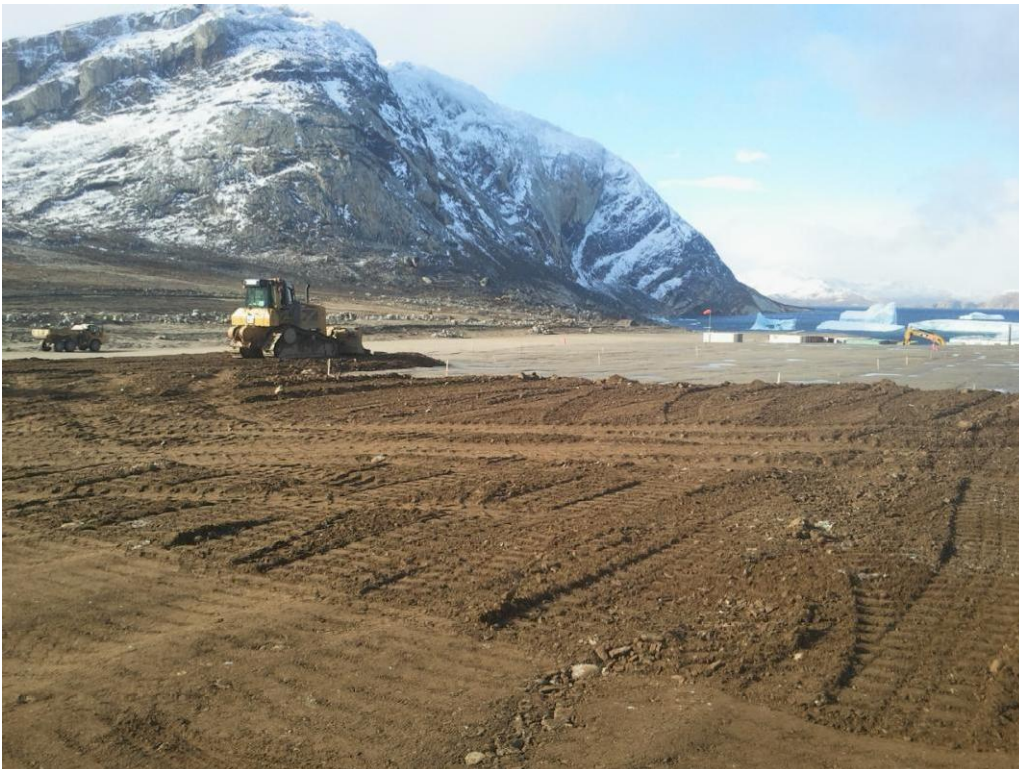
Photograph 57. Tier II Facility – Spreading Final Lift

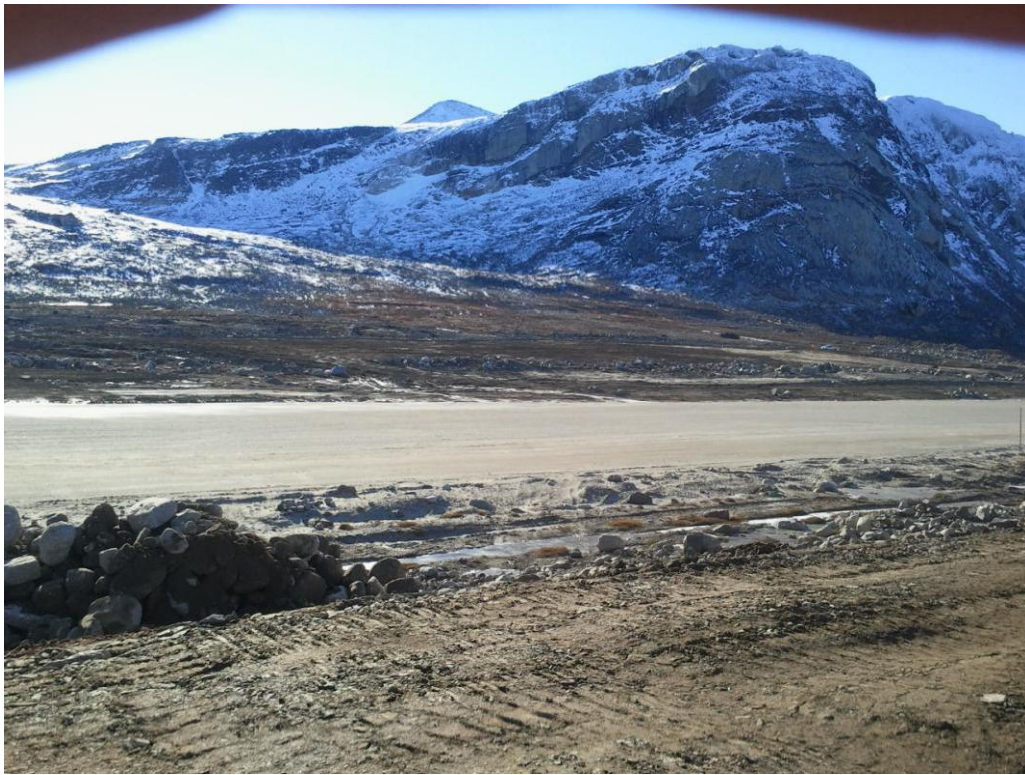
Photograph 58. Landfarm – Decommissioning Complete

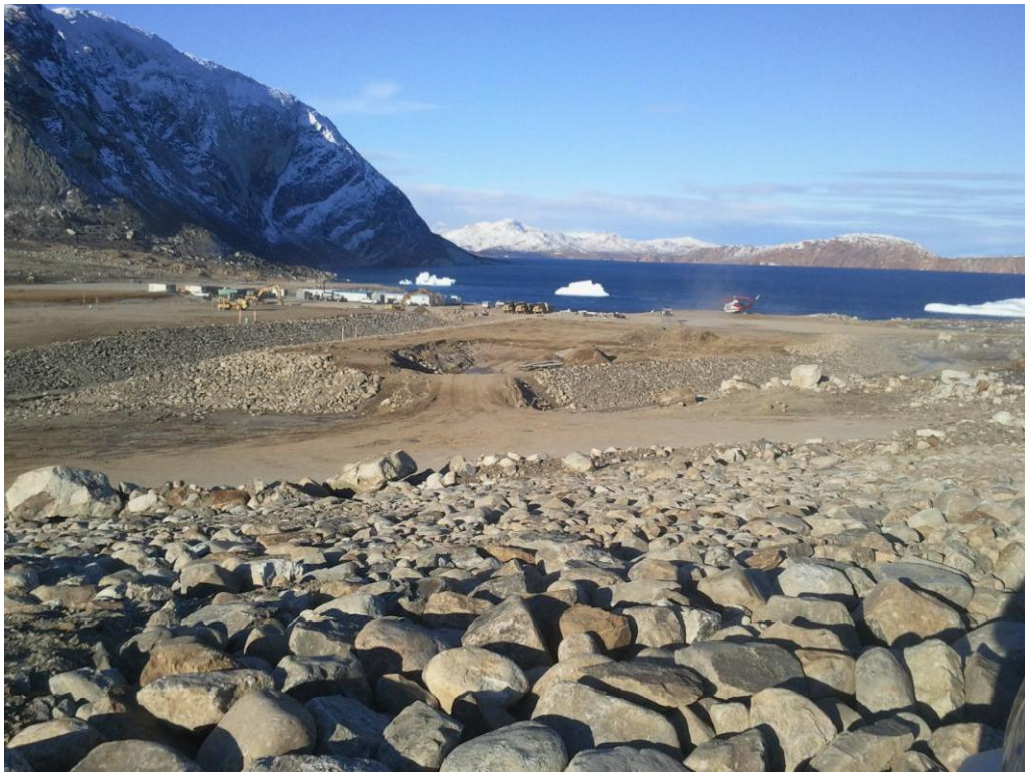
Photograph 59. Non-Hazardous Waste Landfill – Complete Except for Final Placing Area for Camp Disassembly Waste.

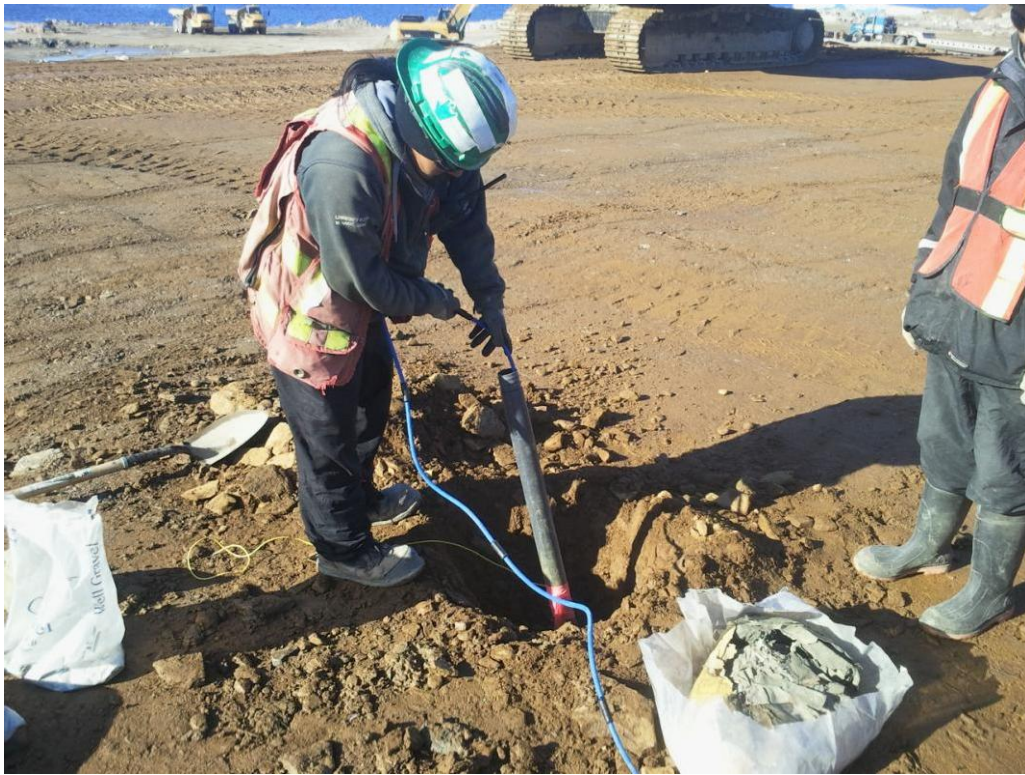
Photograph 60. Tier II Facility – Installing Thermistors

- Four thermistors were installed within this facility
- Non-Hazardous Waste Landfill construction activity:
 - Debris was placed within the Landfill during the 2013 Construction season

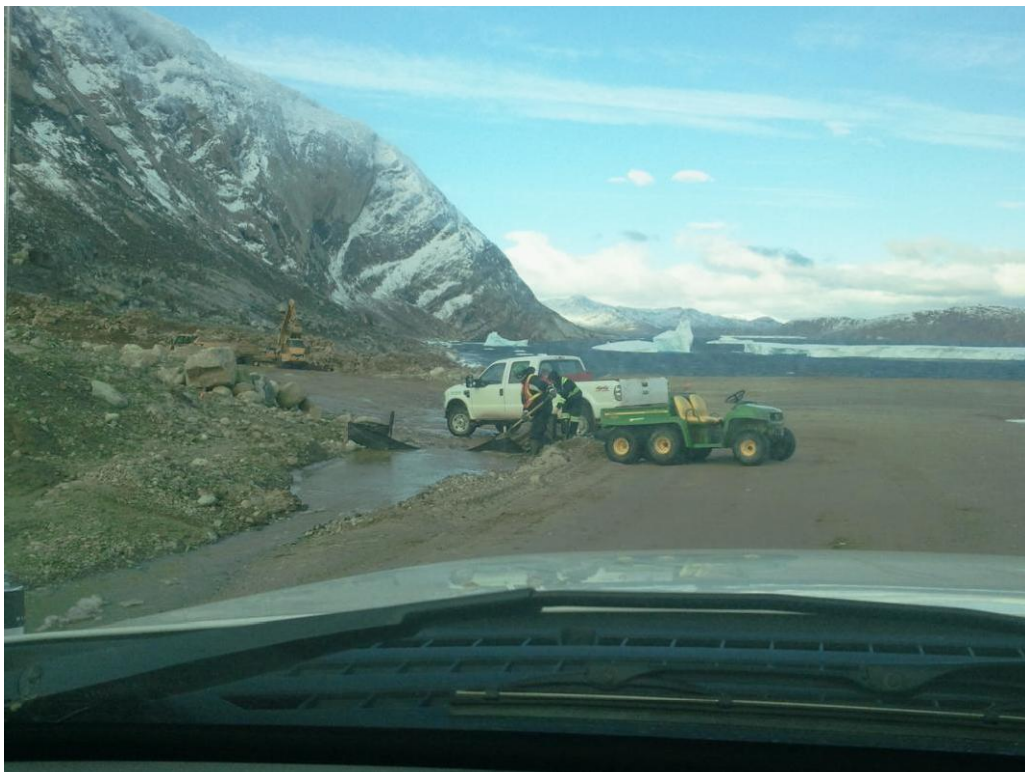
Photograph 61. Site Clean Up – Removing Silt Fences

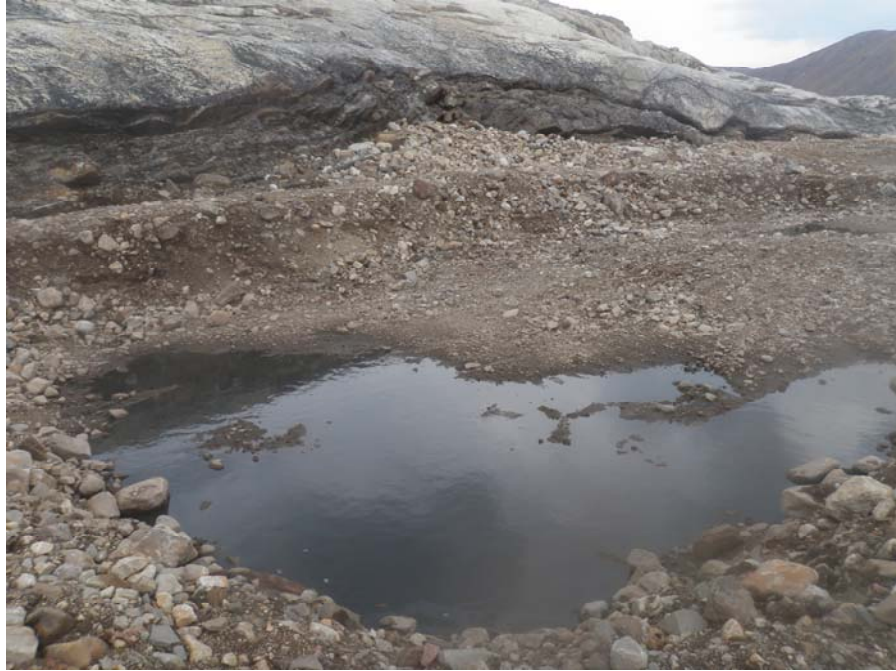
Photograph 1 (07-27-2013): FOX-4 east sewage lagoon, facing northeast.

Two sewage lagoons were constructed at FOX-4 in September 2011 and July 2012. The lagoons were constructed a minimum of 100 m from drainage courses and water bodies. Both lagoons were decommissioned in 2013 by flattening the berms and reshaping the area.

Sampling was not completed at the FOX-4 sewage lagoons during the 2013 field season. The level of liquid in the lagoons remained low and discharge was not required.

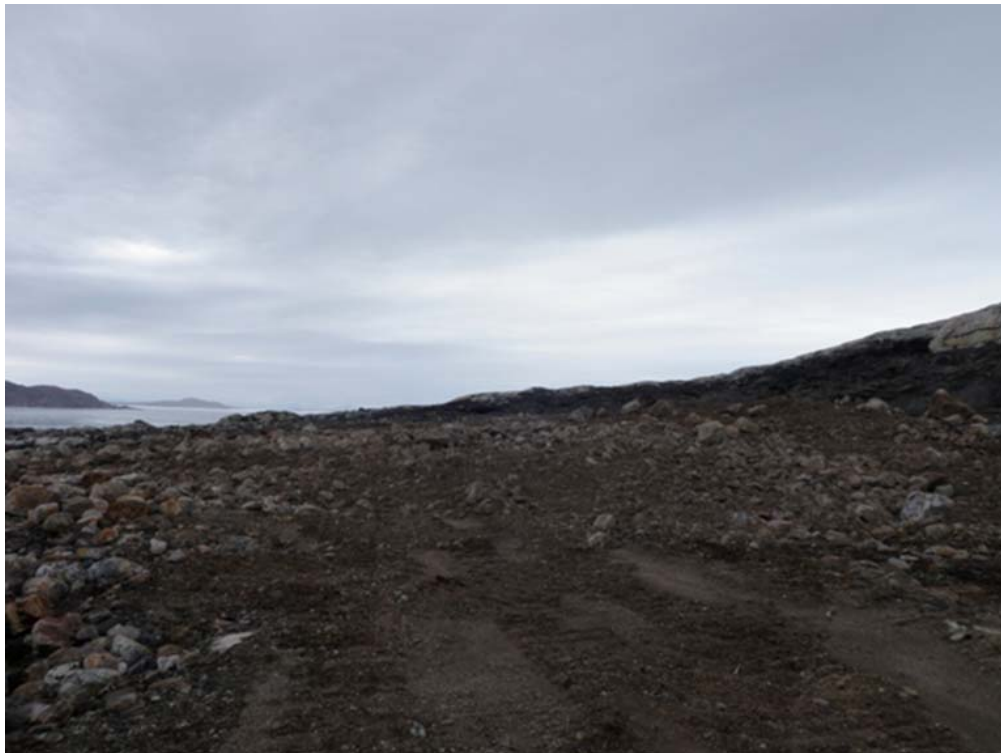
Photograph 2 (07-28-2013): FOX-4 west sewage lagoon after decommissioning, facing west.

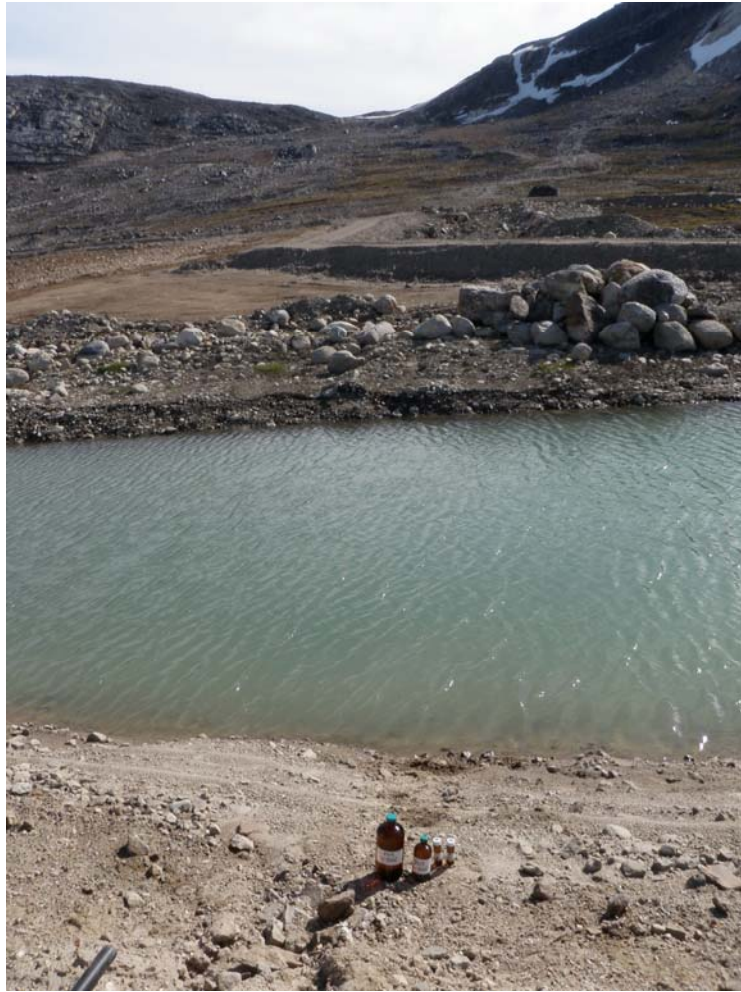
Photograph 1 (07-22-2013): Sample 13-15862 collected from pooled water in the Landfarm.

Wastewater from the Landfarm was discharged to the ground on July 31, 2013. The water was discharged on the west side of the Landfarm (588080, 7595901).

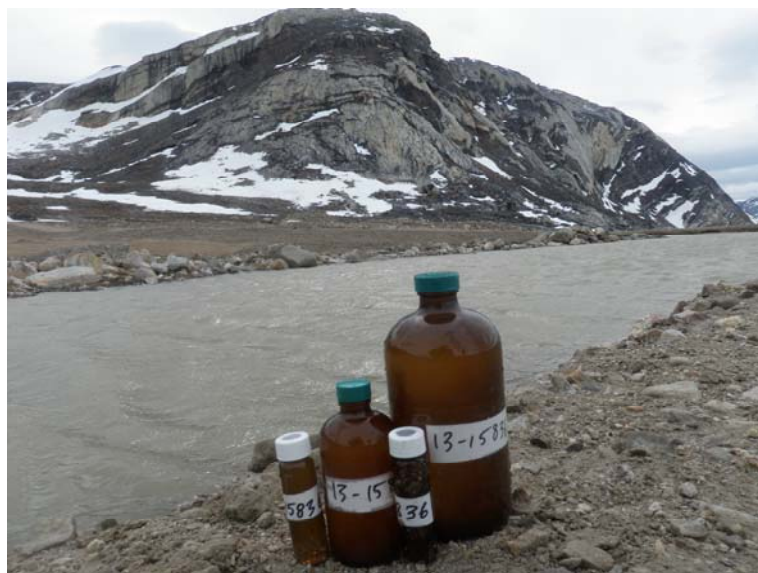
Photograph 1 (06-18-2013): Sample 13-15836 collected from pooled water in the Landfarm.

Wastewater from the Landfarm was discharged to the ground on June 27, 2013. The water was discharged on the west side of the Landfarm (588080, 7595901).
