**Nunavut Baffin Region
2014 DEW Line Landfill Monitoring Program
FOX-4 Cape Hooper
Final Monitoring Report**

350600-515-002

**RE: Final Monitoring Report
Baffin Region Nunavut DEW LINE Landfill Monitoring Program
Fox-4 Cape Hooper, NU
DND Project #: DLCLFMP2 (QIKIQ14)**

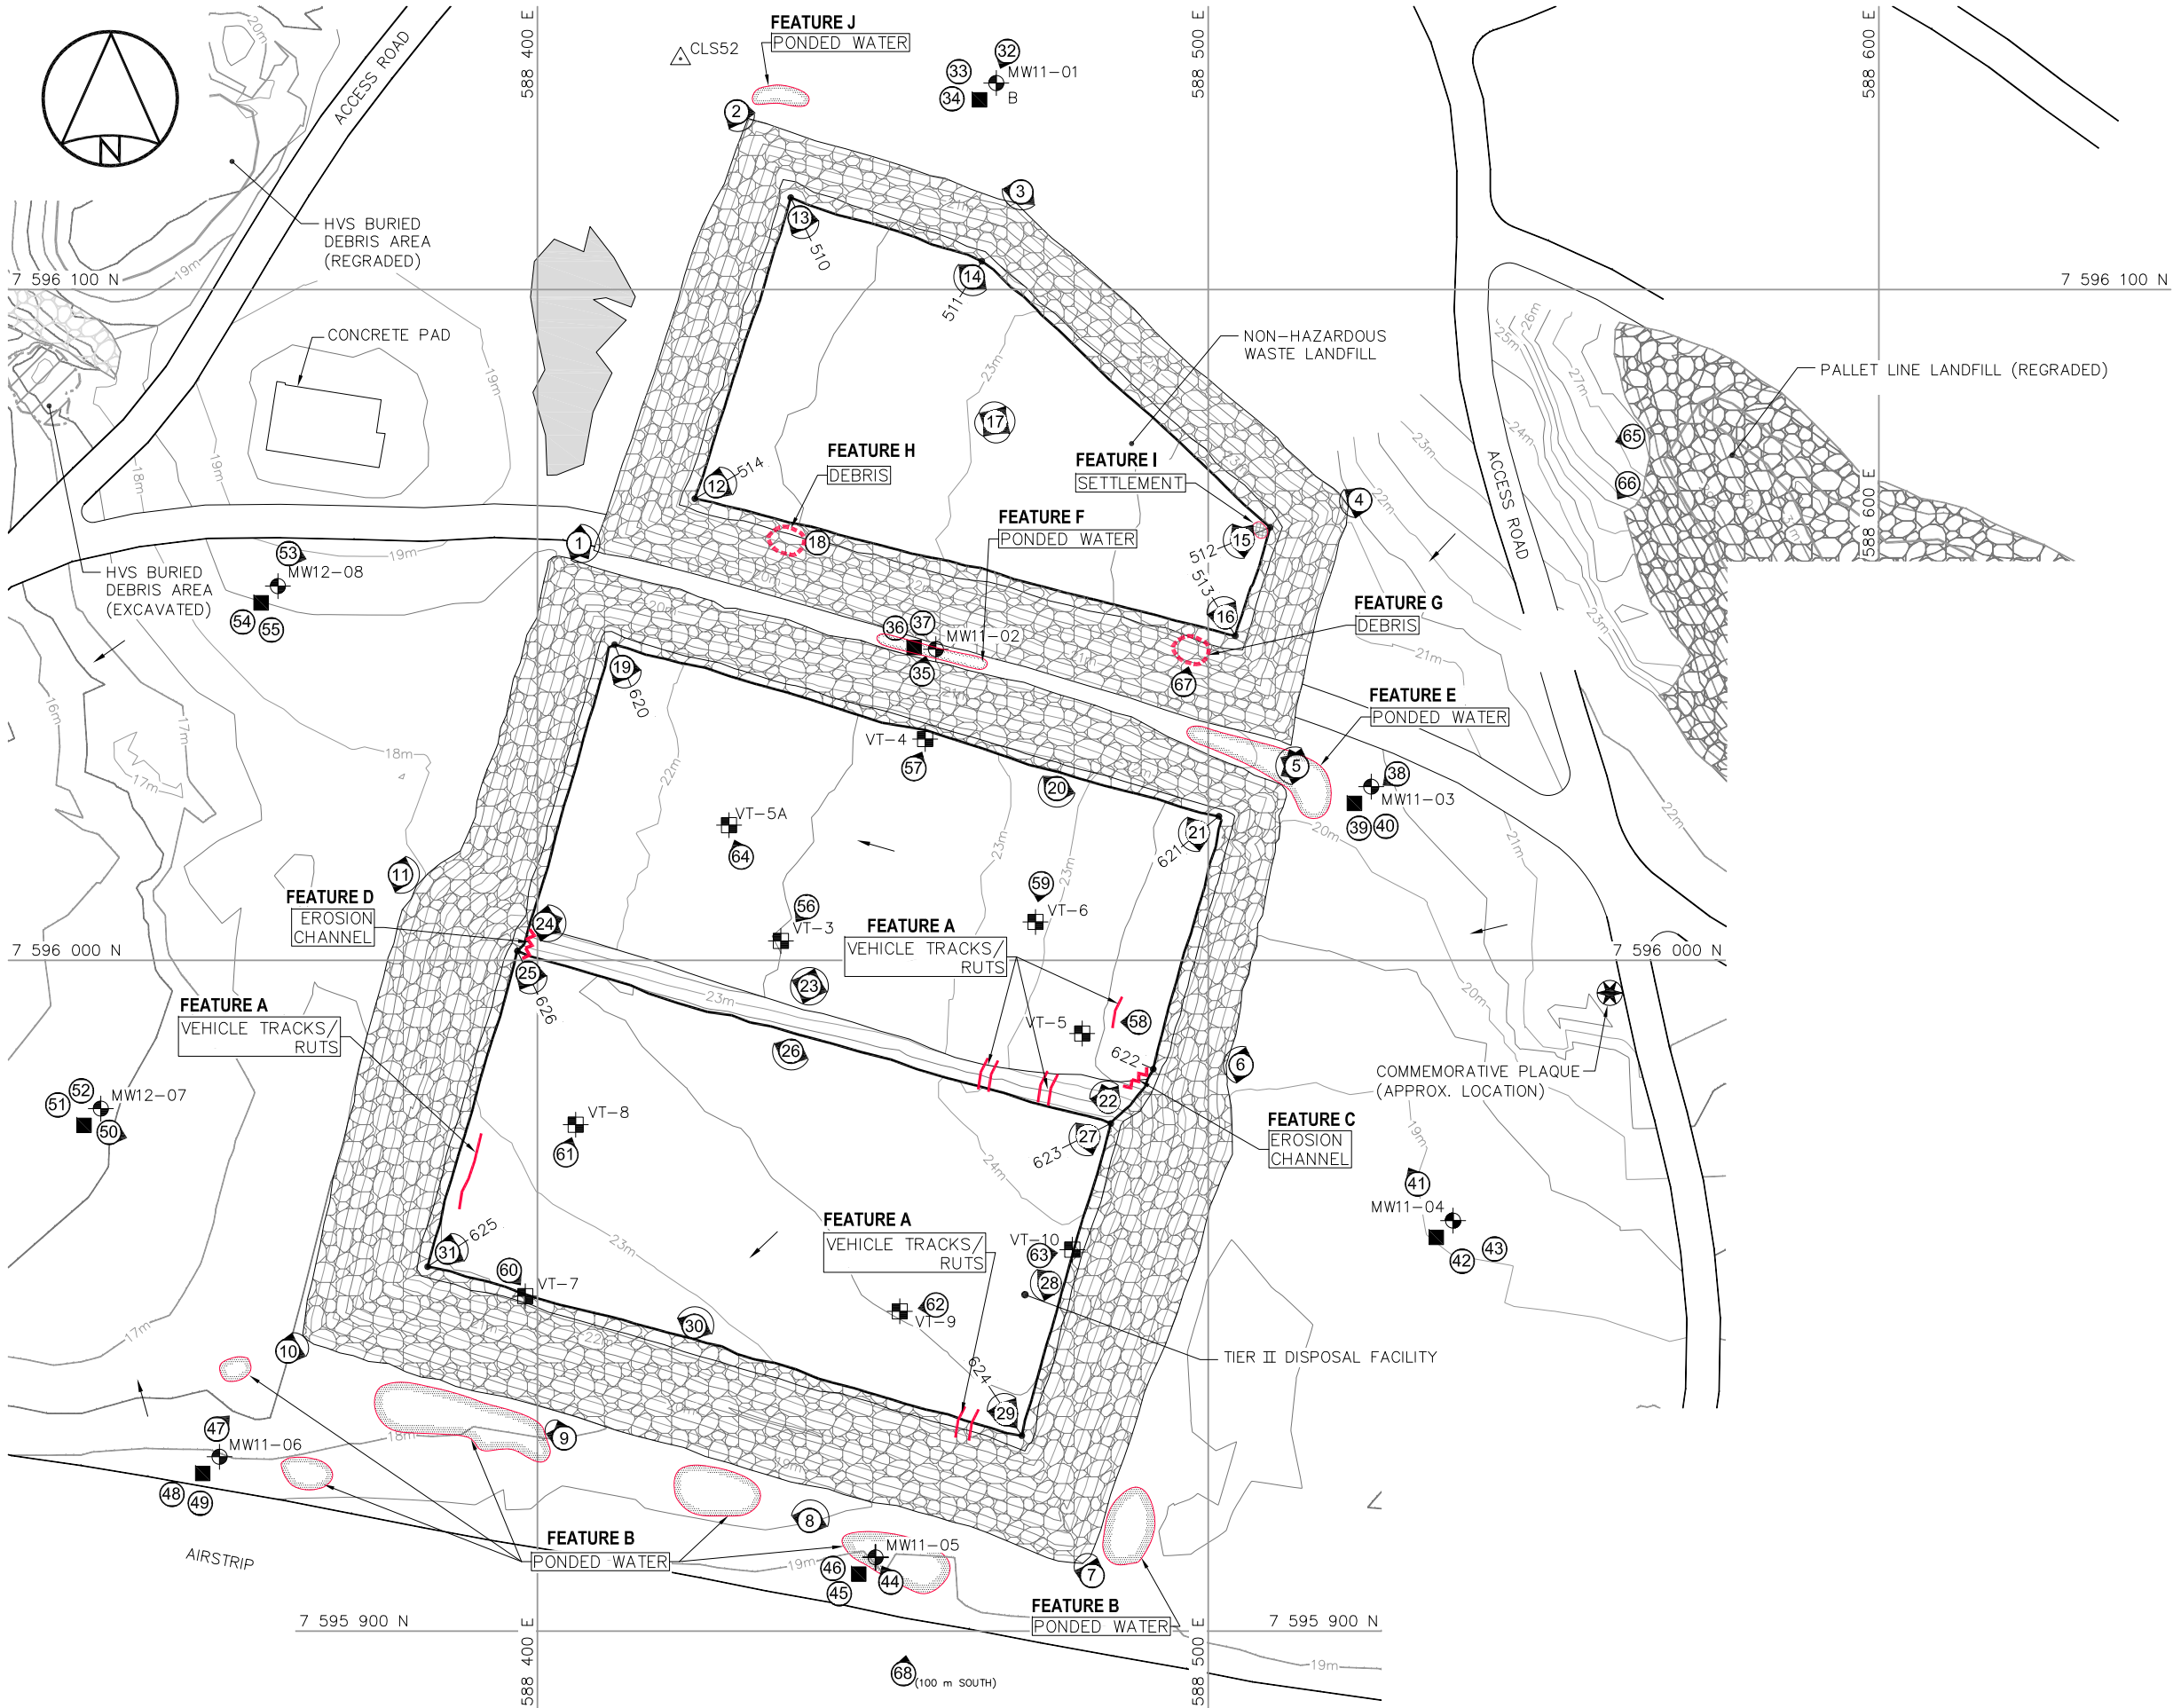
Drawn By: I.S.Z.	Approved By: C.F.G.	Project No: 350600-515-2
Date: FEB. 2015	Scale: 1:1000	Drawing No: FIGURE 2

PUBLIC WORKS AND GOVERNMENT SERVICES CANADA
2014 DEW LINE MONITORING PROGRAM
FOX-4 CAPE HOOPER, NUNAVUT
AIRSTRIP AREA
NON-HAZARDOUS WASTE LANDFILL AND
TIER II DISPOSAL FACILITY

Item	Description
Settlement	Minor settlement in the form of a small depression was observed on the northeast corner of the Non-Hazardous Waste Landfill (Feature I).
Erosion	Small erosion channels were noted on the west and east sides of the Tier II Disposal Facility, on the small slope between the north and south cells (Feature C, D).
Frost Action	None observed.
Sloughing and Cracking	None observed.
Animal Burrows	None observed.
Vegetation	None observed.
Staining	Natural red staining was observed on ponded water located between the Non-Hazardous Waste Landfill and the Tier II Disposal Facility (Feature F).
Vegetation Stress	None observed.
Seepage Points	No active seepage points were observed.
Debris Exposed	Two instances of small metal debris were noted on the south side of the Non-Hazardous Waste Landfill. These pieces of debris did not originate within the landfill (Feature G, H).
Presence/Condition of Monitoring Instruments	Nine vertical thermistor installations and eight monitoring well installations were observed at the landfill. These monitoring installations were found to be in good condition.

Other Features of Note	Vehicle tracks/ruts were observed on the west and east sides of the Tier II Disposal Facility (Feature A). Ponded water was located around and in between the landfill cells (Feature B, E, F, J).

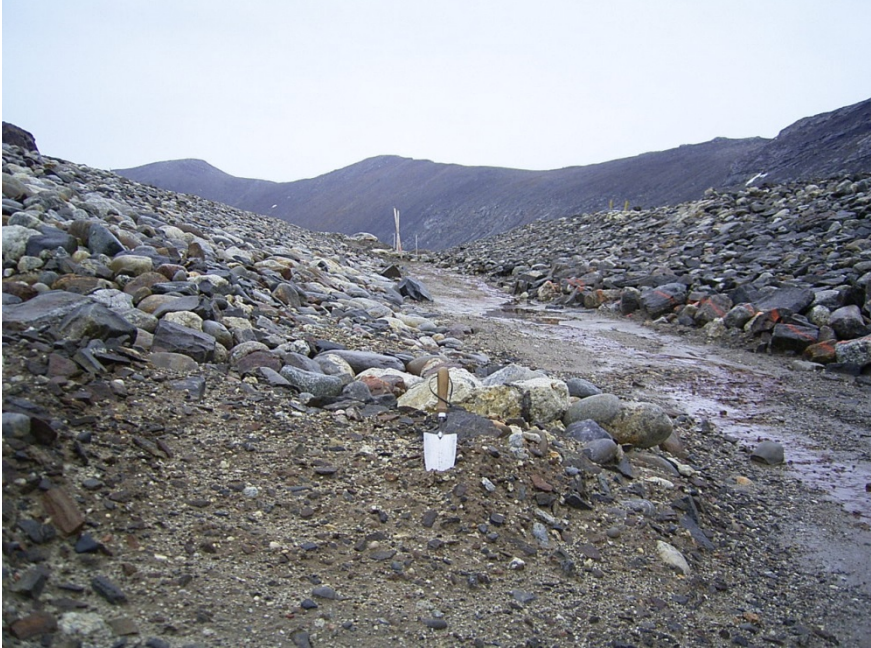
Photo 1.1 (FOX-4 NHT2 P-1 east.jpg)	Photo 1.2 (FOX-4 NHT2 P-1 north.jpg)
Description: View east looking down corridor between the Non-Hazardous Landfill on the left and the Tier II Disposal Facility on the right.	Description: View north along western slope of the Non-Hazardous Waste Facility.

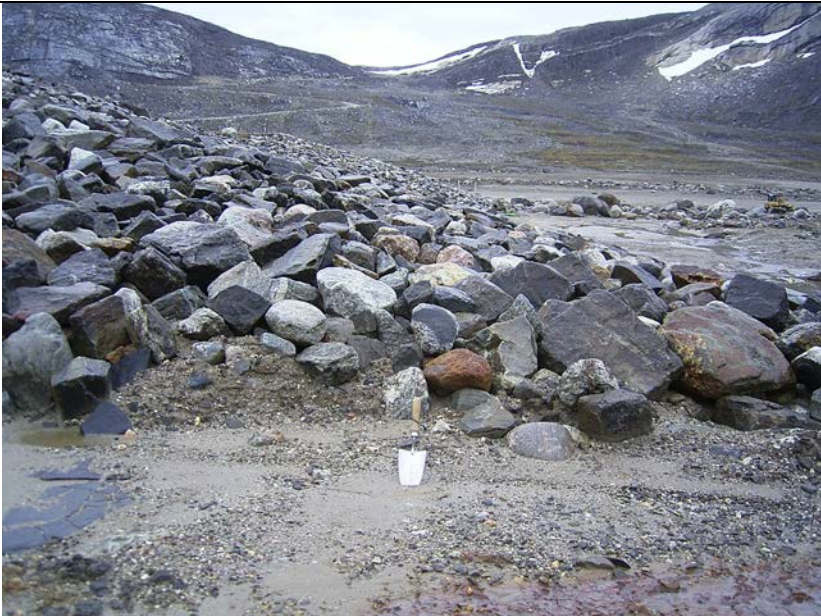
Photo 1.3 (FOX-4 NHT2 P-1 south.jpg)	Photo 2.1 (FOX-4 NHT2 P-2 east.jpg)
Description: View south along western slope of Tier II Disposal Facility.	Description: View east along northern slope of the Non-Hazardous Waste Landfill.

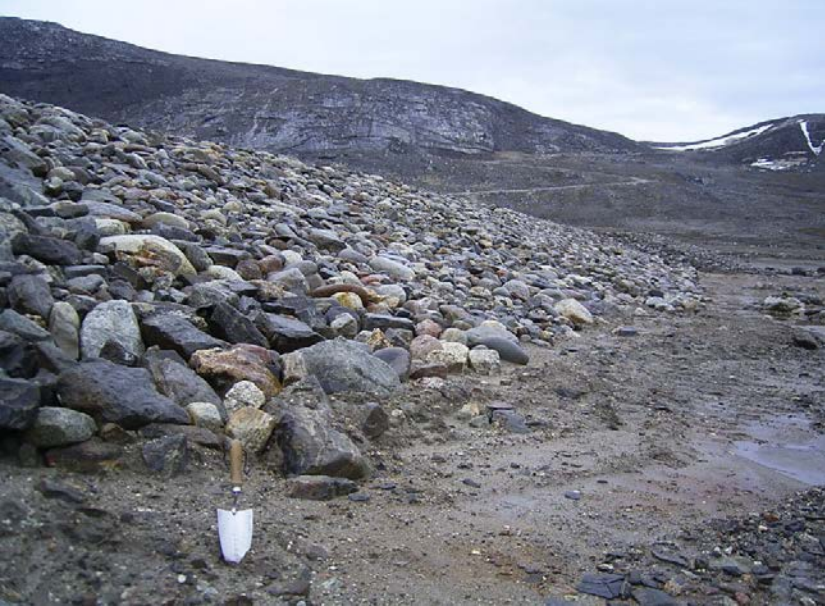
Photo 2.2 (FOX-4 NHT2 P-2 south.jpg)	Photo 3.1 (FOX-4 NHT2 P-3 se.jpg)
Description: View south along western slope of the Non-Hazardous Waste Landfill.	Description: View southeast along the northeastern slope of the Non-Hazardous Waste Landfill.

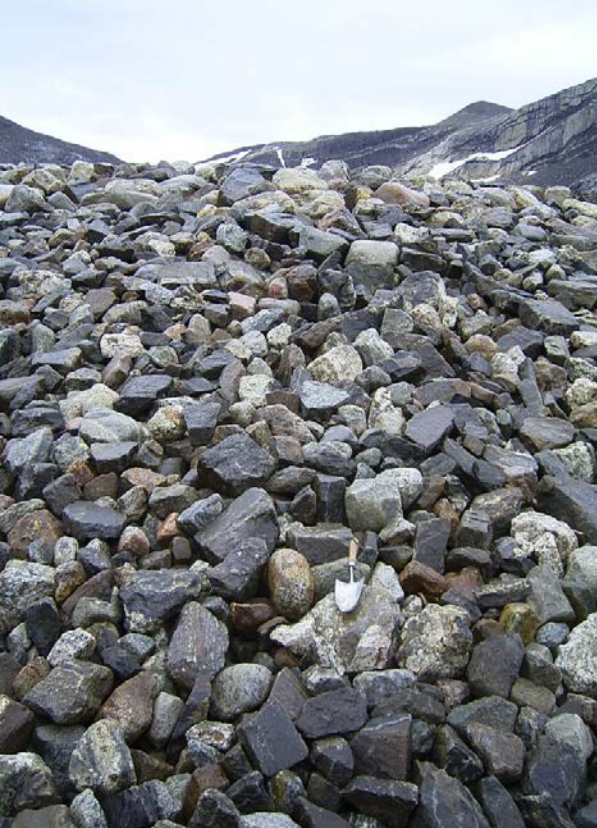
Photo 3.2 (FOX-4 NHT2 P-3 south.jpg)	Photo 3.3 (FOX-4 NHT2 P-3 west.jpg)
Description: View of the northern slope of the Non-Hazardous Waste Landfill	Description: View west along the northern slope of the Non-Hazardous Waste Landfill.

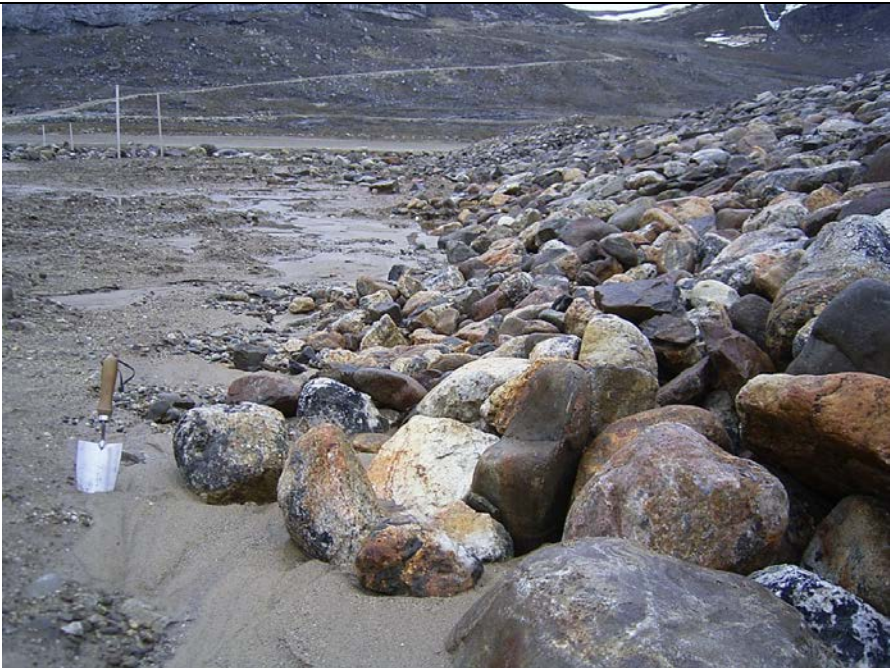
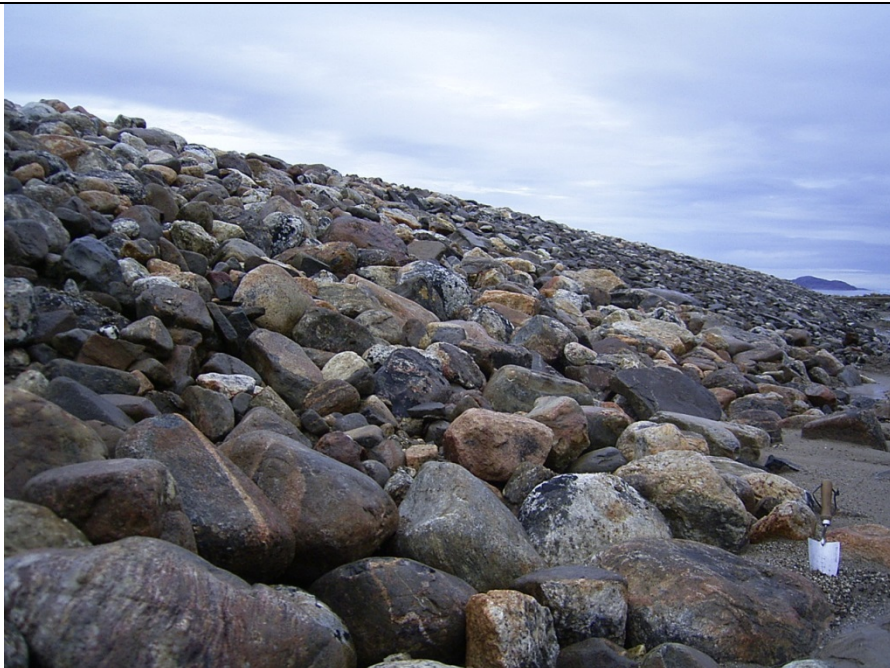
Photo 4.1 (FOX-4 NHT2 P-4 south.jpg)	Photo 4.2 (FOX-4 NHT2 P-4 west.jpg)
Description: View south along eastern slope of the Non-Hazardous Waste Landfill.	Description: View west of the northeastern slope of the Non-Hazardous Waste Landfill.

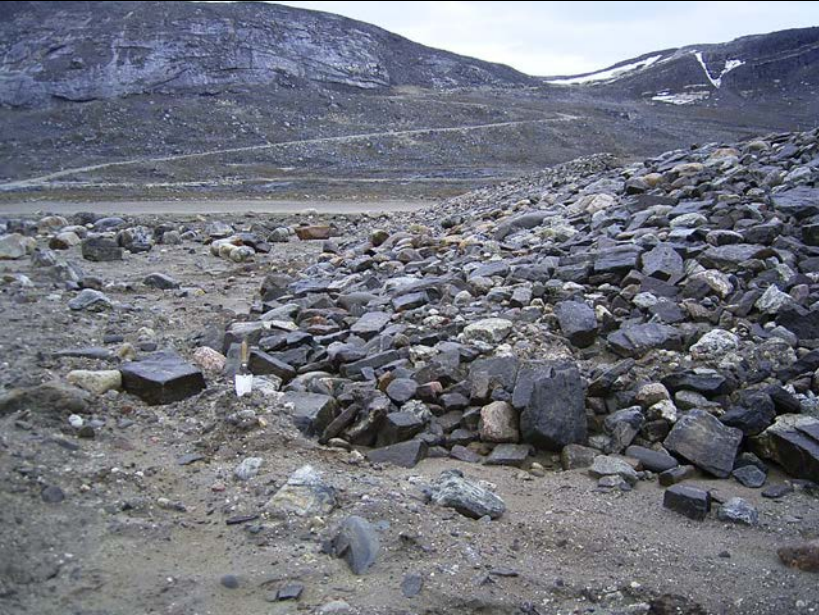
Photo 5.3 (FOX-4 NHT2 P-5 south.jpg)	Photo 5.4 (FOX-4 NHT2 P-5 sw.jpg)
Description: View south of the eastern slope of the Tier II Disposal Facility.	Description: View of northern slope of Tier II Disposal Facility.

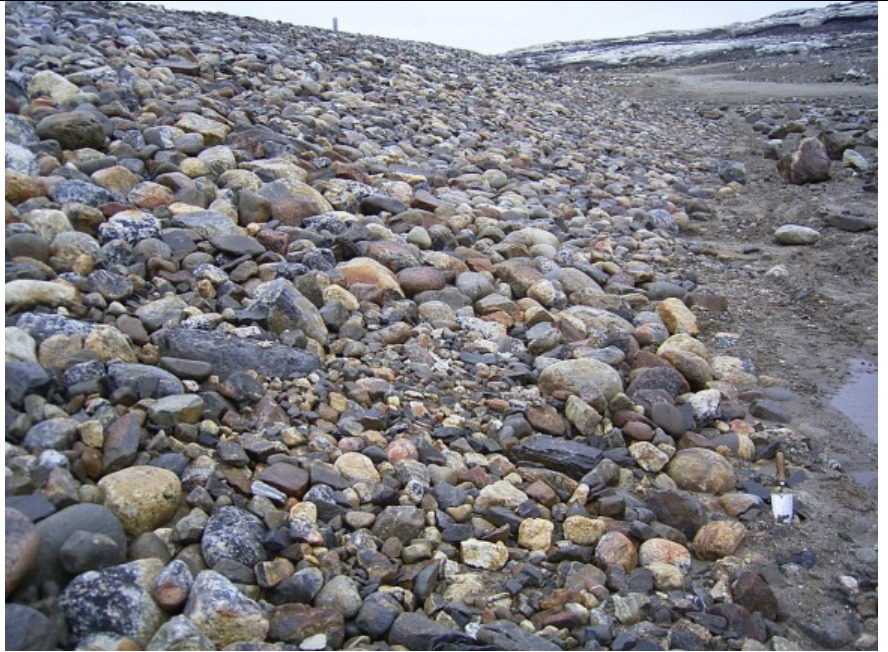
Photo 6.2 (FOX-4 NHT2 P-6 south.jpg)	Photo 7.1 (FOX-4 NHT2 P-7 north.jpg)
Description: View south of the eastern slope of the Tier II Disposal Facility	Description: The eastern slope of the Tier II Disposal Facility. VT-10 seen at top of slope.

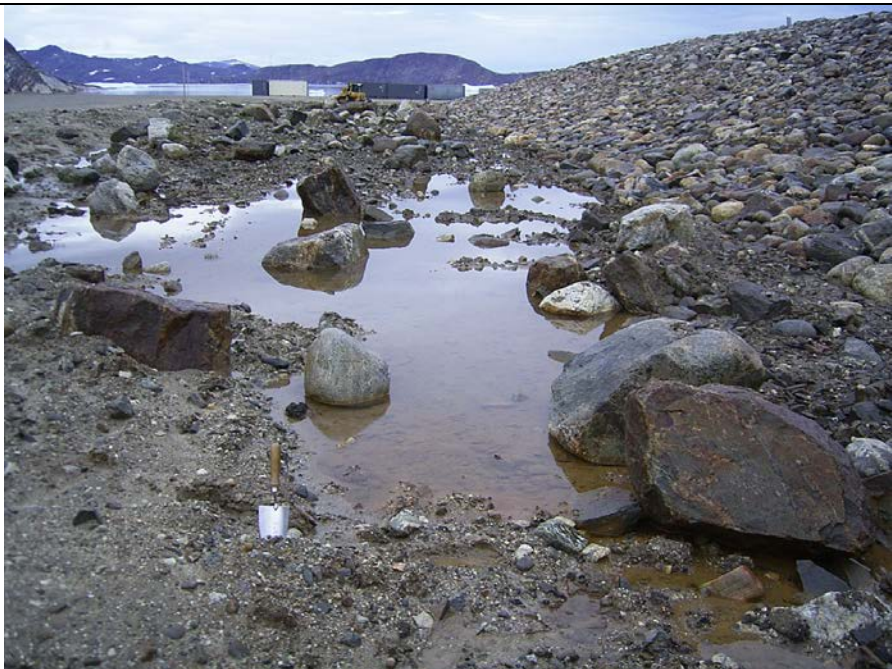
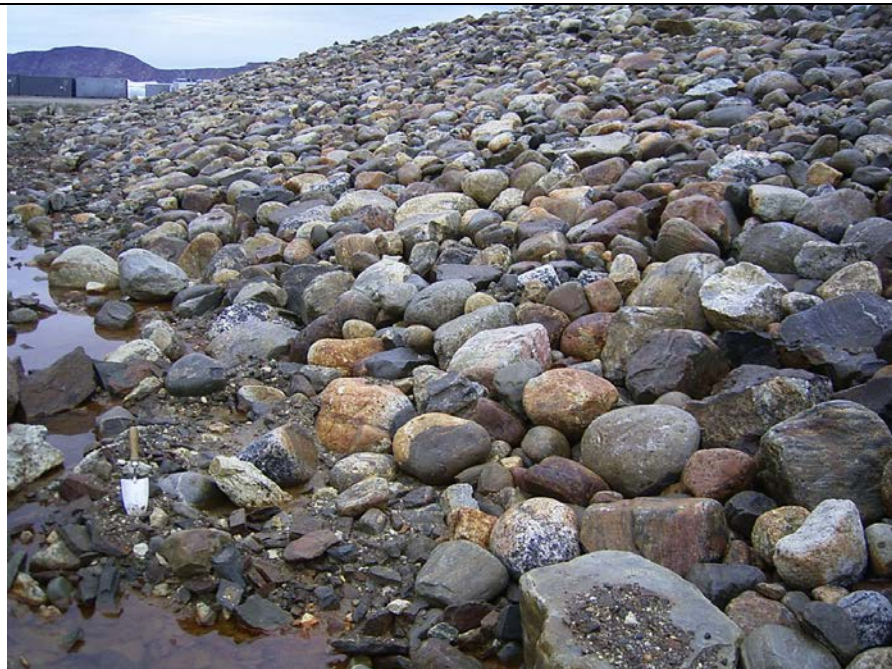
Photo 8.3 (FOX-4 NHT2 P-8 west.jpg)	Photo 9.1 (FOX-4 NHT2 P-9 nw.jpg)
Description: View east over ponded water at the toe of the southern slope of the Tier II Disposal Facility. (FEATURE B)	Description: View of the western part of the southern slope of the Tier II Disposal Facility. Ponded water observed at toe. (FEATURE B)

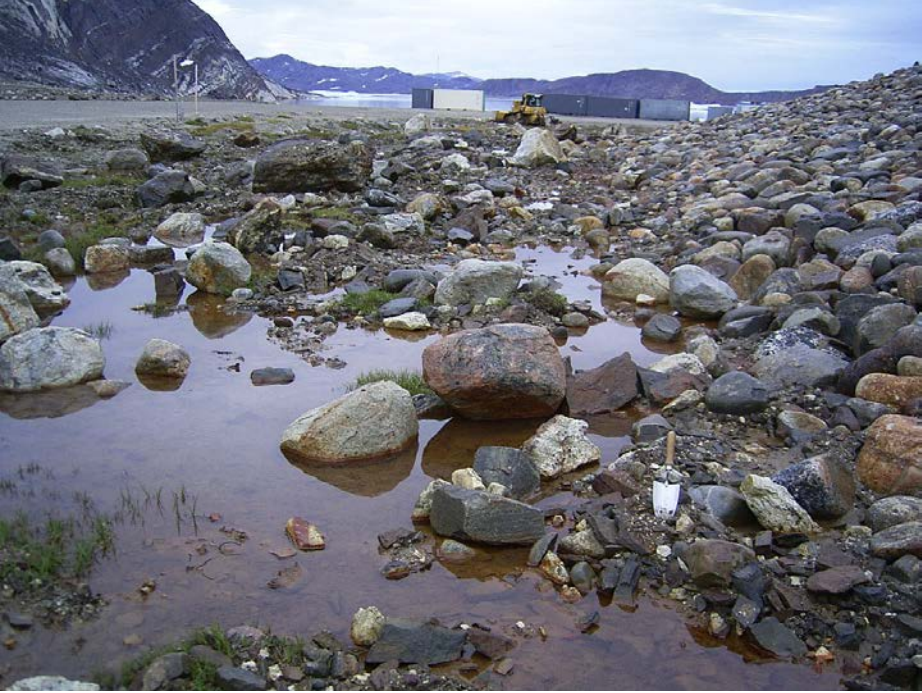
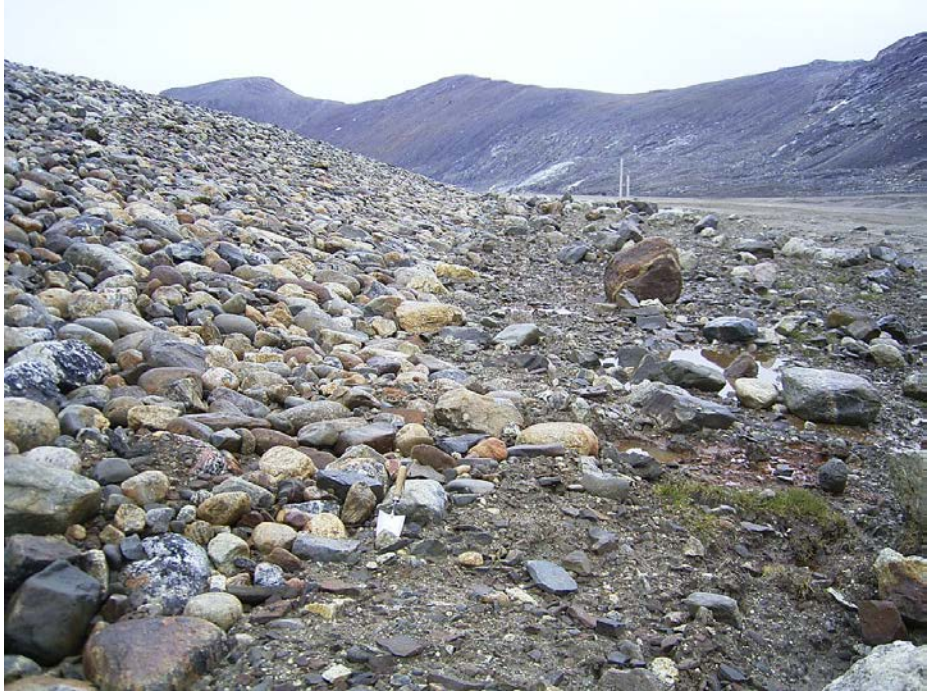
Photo 9.2 (FOX-4 NHT2 P-9 west.jpg)	Photo 10.1 (FOX-4 NHT2 P-10 east.jpg)
Description: Ponded water at the toe of the southern slope of the Tier II Disposal Facility. (FEATURE B)	Description: View east from southwestern corner of the Tier II Disposal Facility.

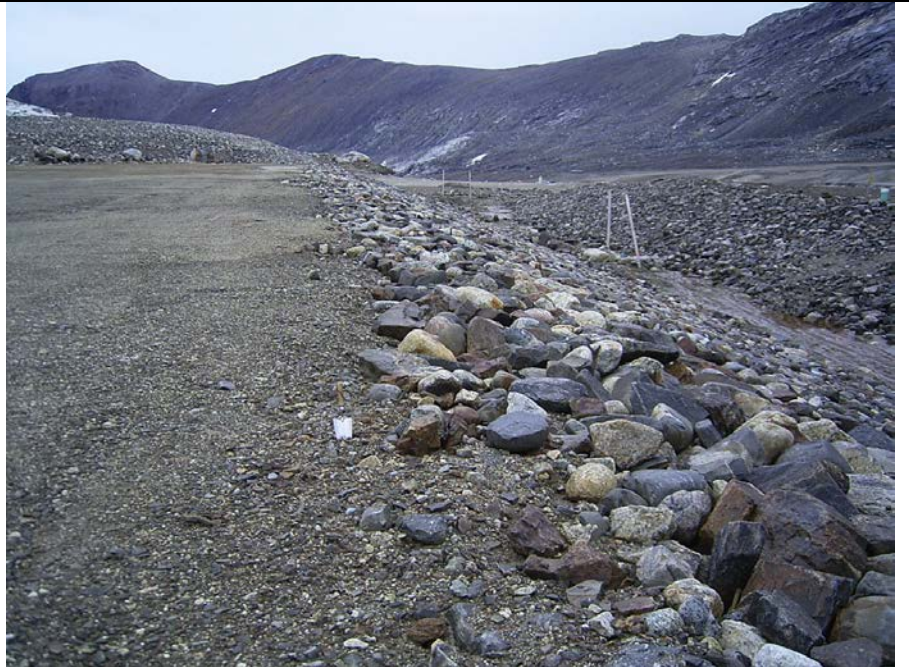
Photo 11.3 (FOX-4 NHT2 P-11 south.jpg)	Photo 12.1 (FOX-4 NHT2 P-12 east.jpg)
Description: View south of the western slope of the Tier II Disposal Facility.	Description: View east along Non-Hazardous Waste Landfill cap. Corridor adjacent to the Tier II Disposal Facility is seen on the left hand side. The stakes in the corridor demarcate the MW11-02 location.

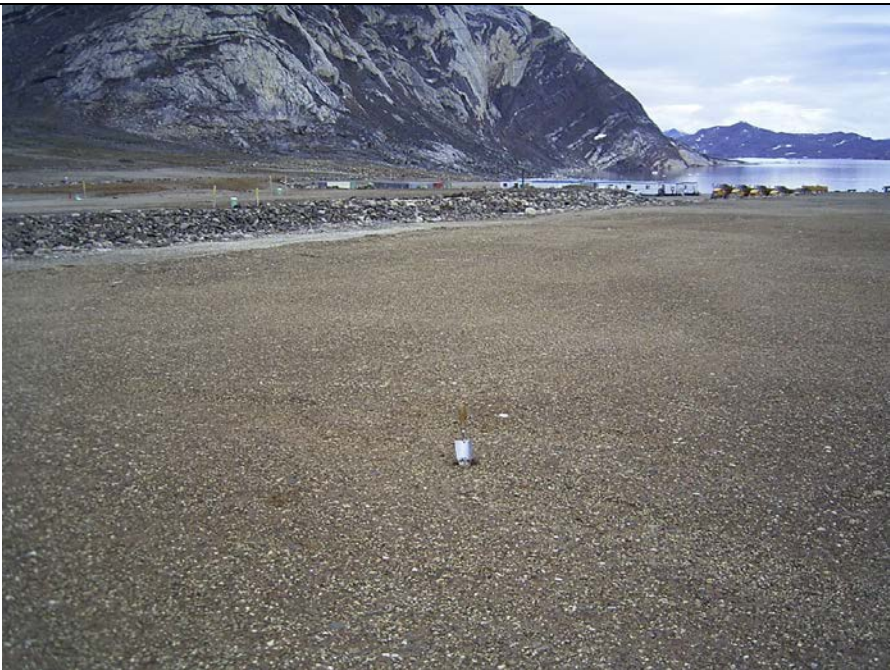
Photo 15.3 (FOX-4 NHT2 P-15 sw.jpg)	Photo 15.4 (FOX-4 NHT2 P-15 north.jpg)
Description: The Non-Hazardous Waste Landfill cap from the northeast corner.	Description: Small area of settlement at northeast corner of Non-Hazardous Waste Landfill. (FEATURE I)

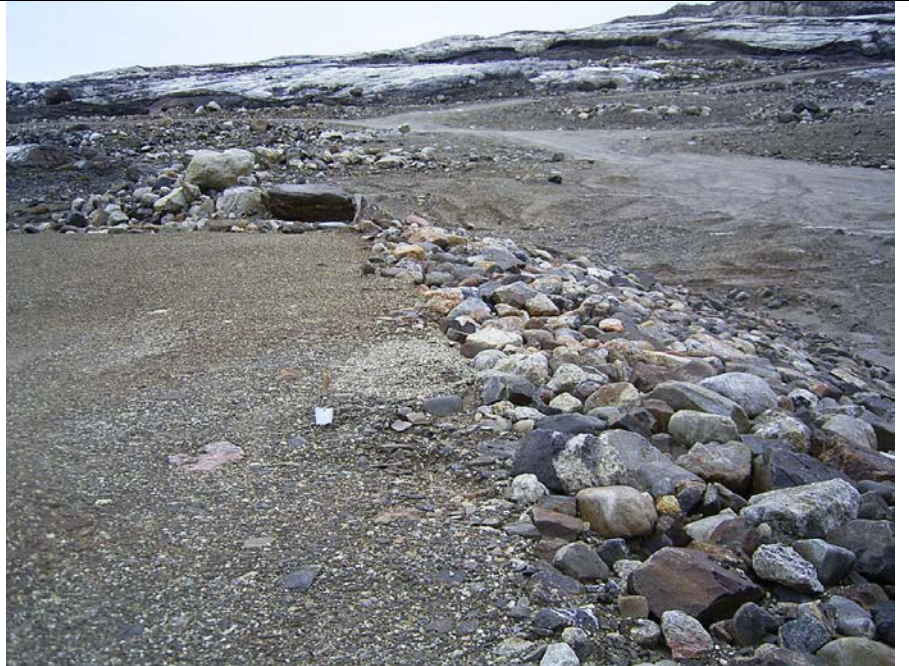
Photo 15.5 (FOX-4 NHT2 P-15 closeup.jpg)	Photo 16.1 (FOX-4 NHT2 P-16 north.jpg)
Description: Minor settlement at northeast corner of Non-Hazardous Waste Landfill. (FEATURE I)	Description: The eastern top of slope of the Non-Hazardous Waste Landfill.

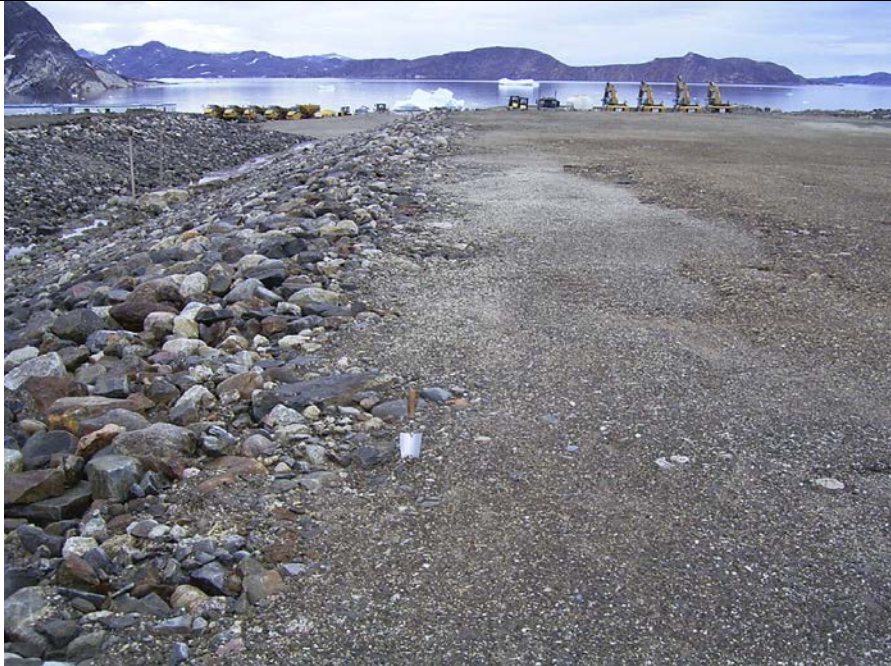
Photo 16.2 (FOX-4 NHT2 P-16 nw.jpg)	Photo 16.3 (FOX-4 NHT2 P-16 west.jpg)
Description: The Non-Hazardous Waste Landfill from the southeastern corner of the cap.	Description: The southern top of slope of the Non-Hazardous Waste Landfill. Northern slope of the Tier II Disposal Facility can be seen on the left.

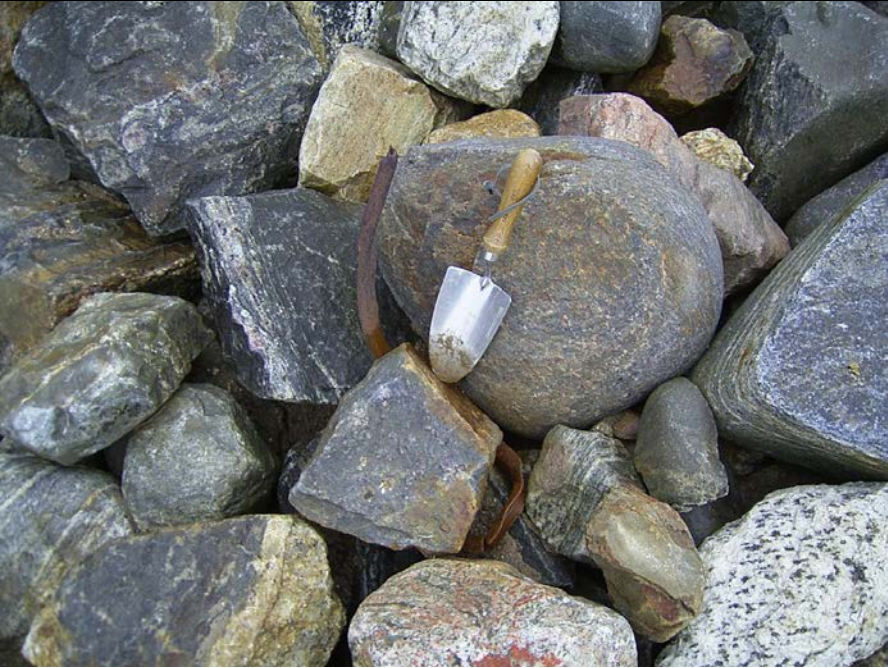
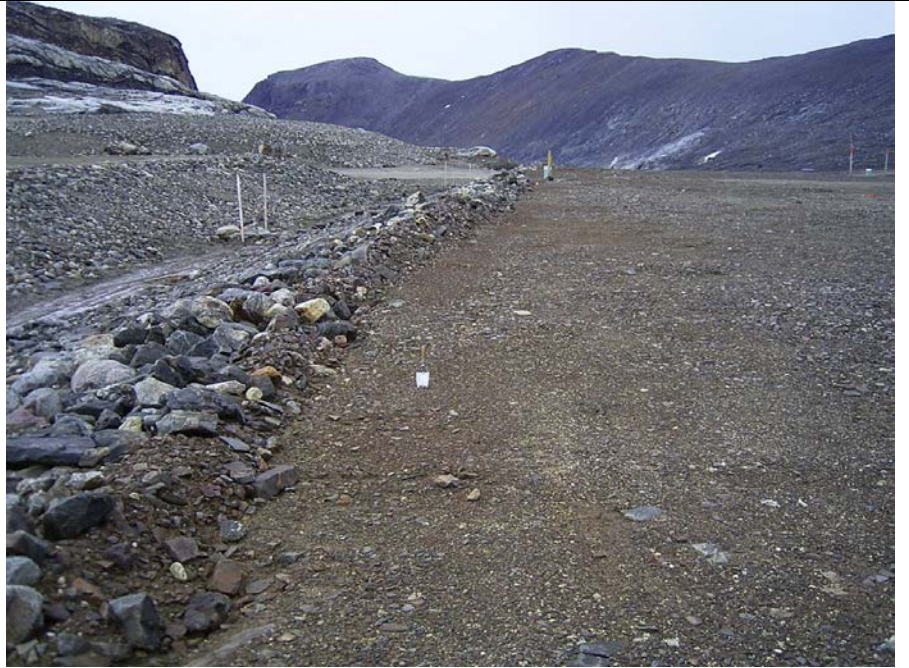
Photo 18.1 (FOX-4 NHT2 P-18.jpg)	Photo 19.1 (FOX-4 NHT2 P-19 east.jpg)
Description: Minor debris (metal strapping) observed on the southern slope of the Non-Hazardous Waste Landfill. (FEATURE H)	Description: The top of the northern slope of the Tier II Disposal Facility.

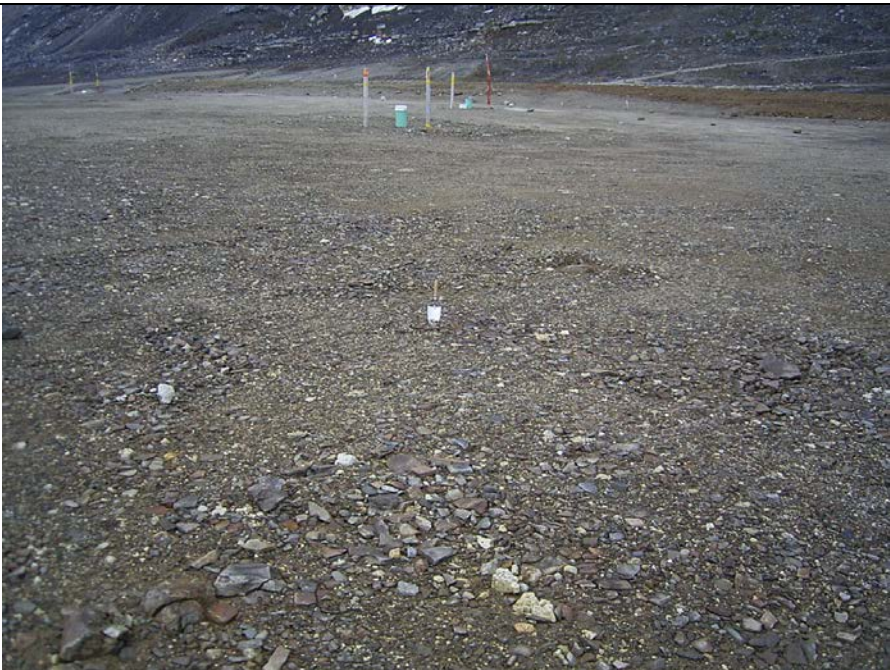
Photo 19.2 (FOX-4 NHT2 P-19 se.jpg)	Photo 19.3 (FOX-4 NHT2 P-19 south.jpg)
Description: View southeast from the northwest corner of the Tier II Disposal Facility cap. VT-5A (foreground) and VT-3 (background) can be seen.	Description: The western top of slope of the Tier II Disposal Facility..

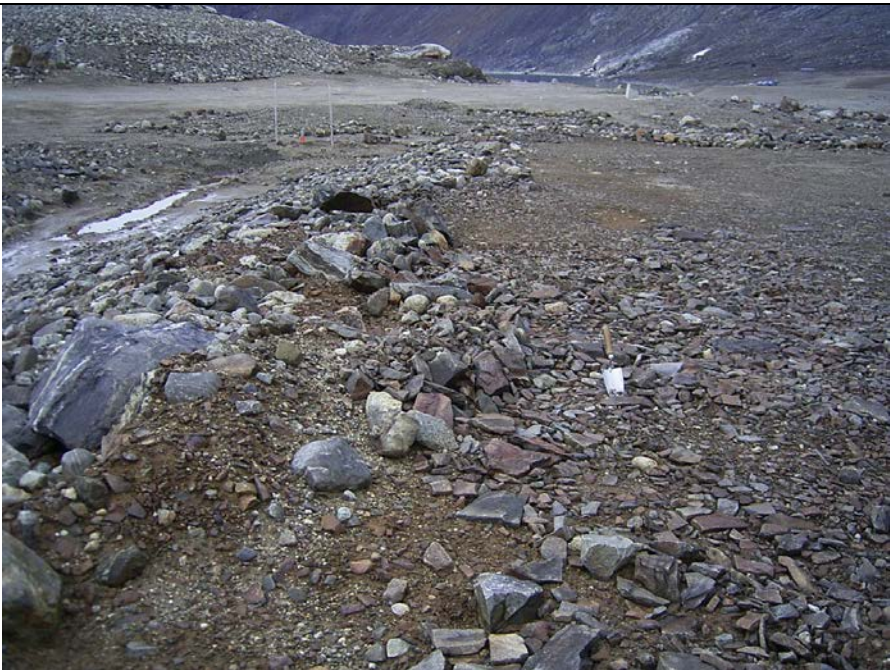
Photo 20.1 (FOX-4 NHT2 P-20 east.jpg)	Photo 20.2 (FOX-4 NHT2 P-20 south.jpg)
Description: View east toward northeastern corner of the Tier II Disposal Facility.	Description: View south over the Tier II Disposal Facility cap.

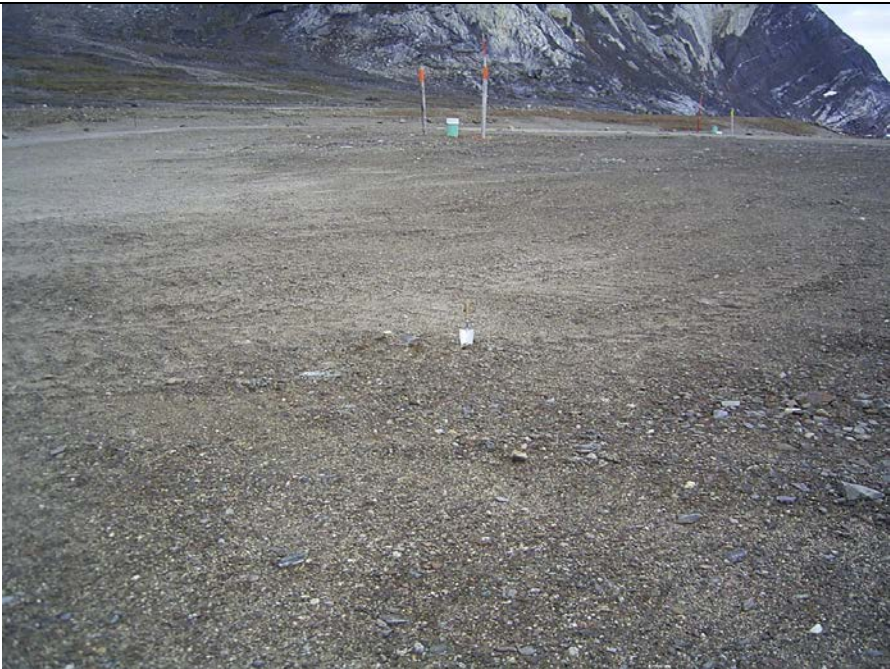
Photo 20.3 (FOX-4 NHT2 P-20 sw.jpg)	Photo 20.4 (FOX-4 NHT2 P-20 west.jpg)
Description: View southwest across Tier II Disposal Facility cap.	Description: The northern slope of the Tier II Disposal Facility. View west, toward VT-4.

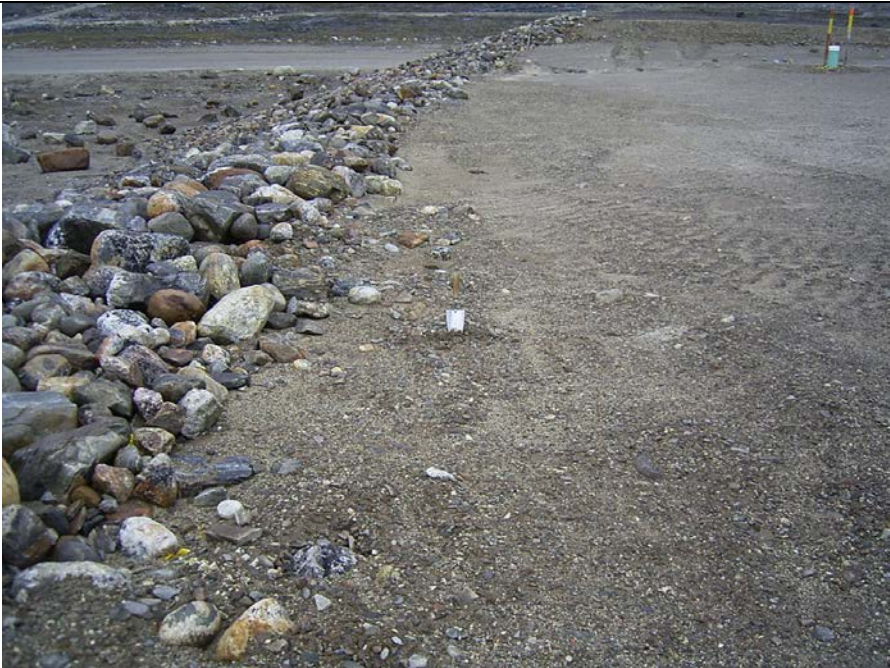
Photo 21.1 (FOX-4 NHT2 P-21 south.jpg)	Photo 21.2 (FOX-4 NHT2 P-21 sw.jpg)
Description: The eastern top of slope of the Tier II Disposal Facility.	Description: The Tier II Disposal Facility cap from the northeastern corner.

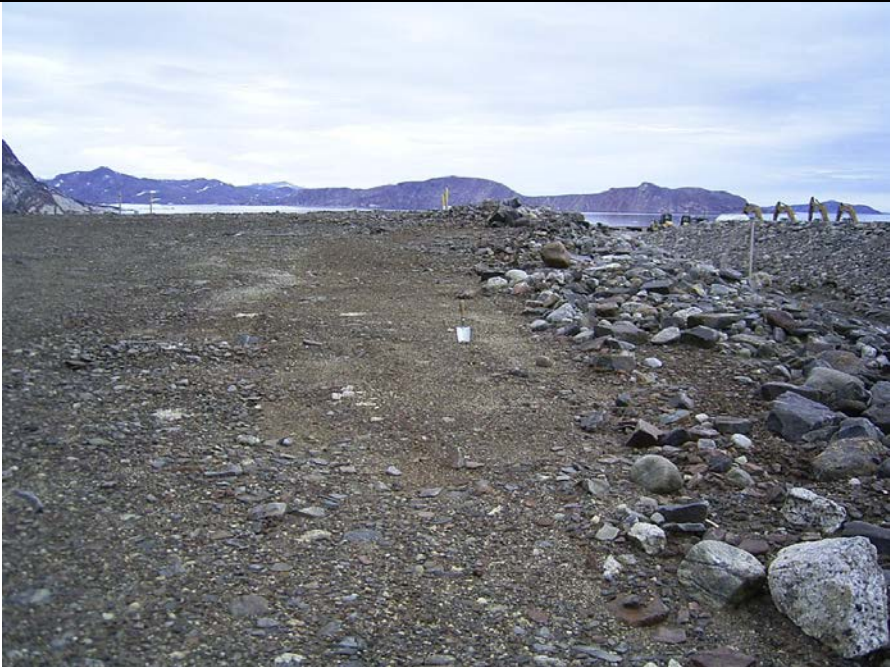
Photo 21.3 (FOX-4 NHT2 P-21 west.jpg)	Photo 22.1 (FOX-4 NHT2 P-22 north.jpg)
Description: The northern top of slope of the Tier II Disposal Facility.	Description: The eastern top of slope of the Tier II Disposal Facility.

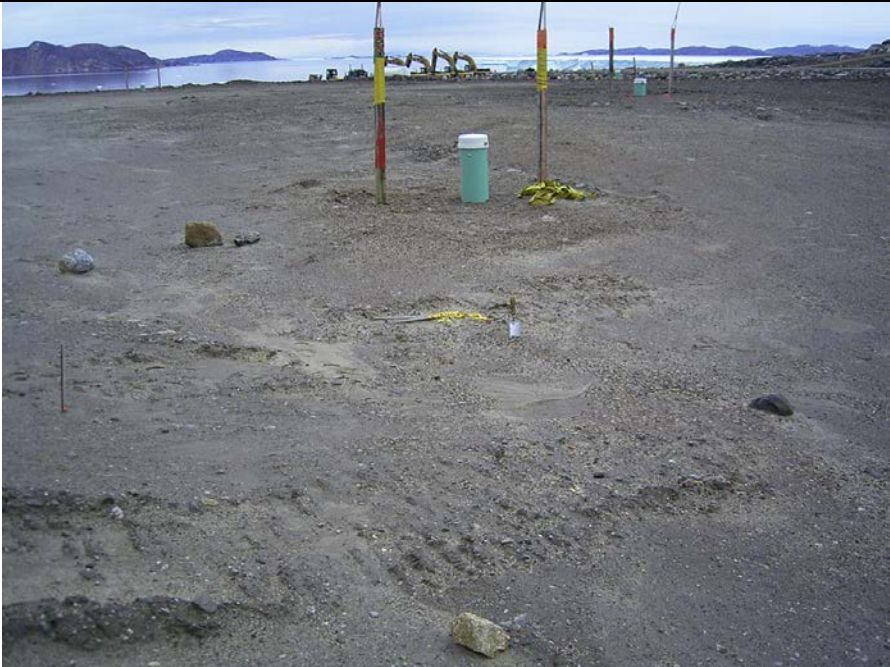
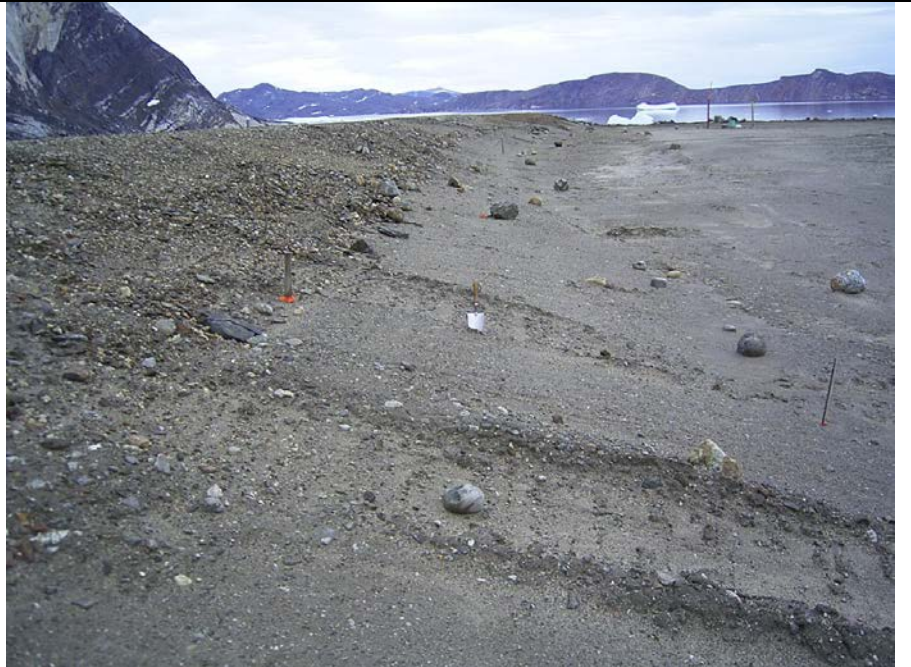
Photo 22.2 (FOX-4 NHT2 P-22 nw.jpg)	Photo 22.3 (FOX-4 NHT2 P-22 west.jpg)
Description: Vehicle tracks/ruts near VT-5. (FEATURE A)	Description: Vehicle tracks/ruts near VT-5. View west along middle slope of the Tier II Disposal Facility. (FEATURE A)

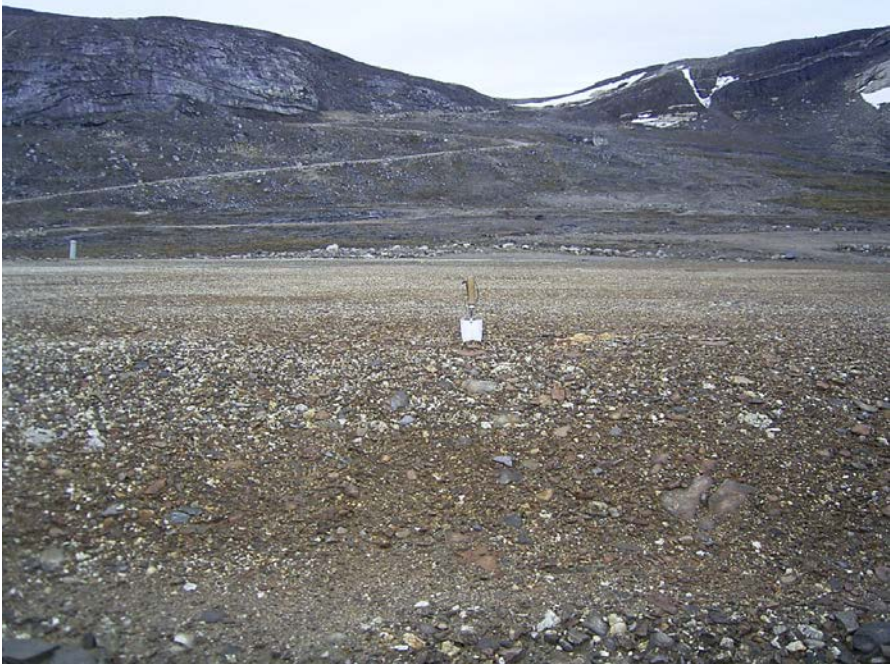
Photo 23.3 (FOX-4 NHT2 P-23 south.jpg)	Photo 23.4 (FOX-4 NHT2 P-23 west.jpg)
Description: The southern cap of the Tier II Disposal Facility.	Description: View west along middle slope of the Tier II Disposal Facility.

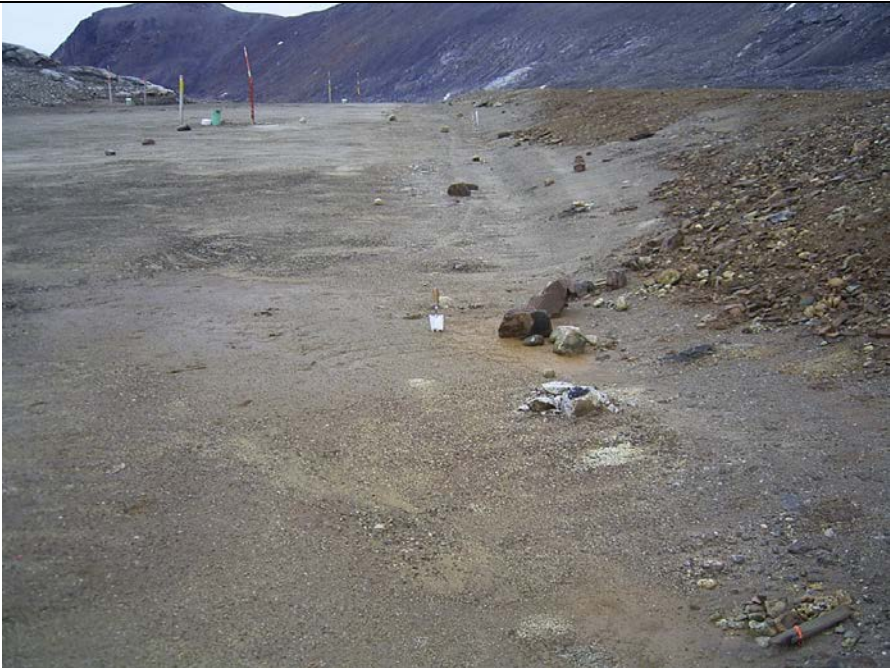
Photo 24.1 (FOX-4 NHT2 P-24 east.jpg)	Photo 24.2 (FOX-4 NHT2 P-24 ne.jpg)
Description: View east along middle slope of the Tier II Disposal Facility.	Description: View northeast across the northern cap of the Tier II Disposal Facility.

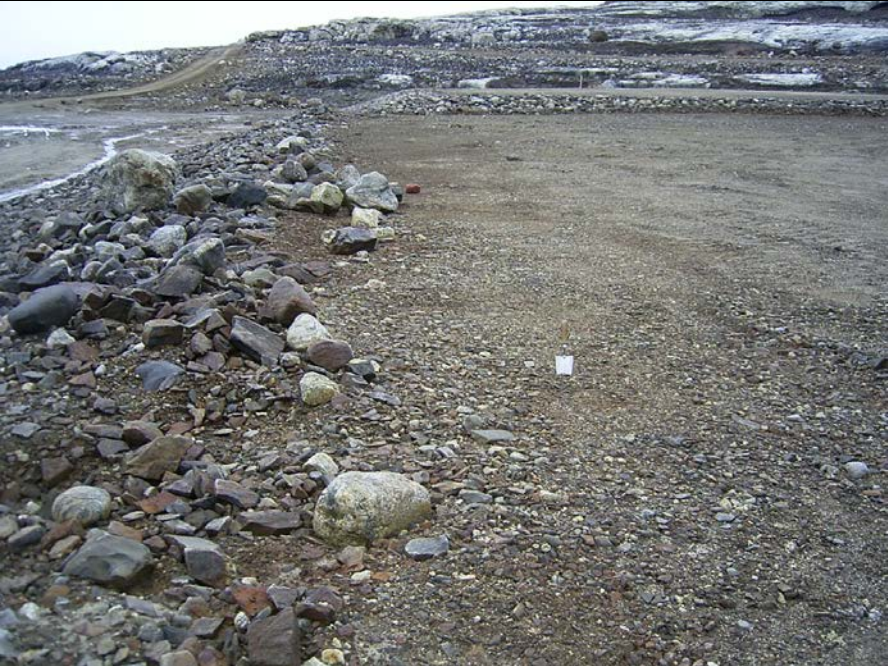
Photo 24.3 (FOX-4 NHT2 P-24 north.jpg)	Photo 25.1 (FOX-4 NHT2 P-25 east.jpg)
Description: The western top of slope of the northern half of the Tier II Disposal Facility.	Description: View east along top of middle slope of the Tier II Disposal Facility cap.

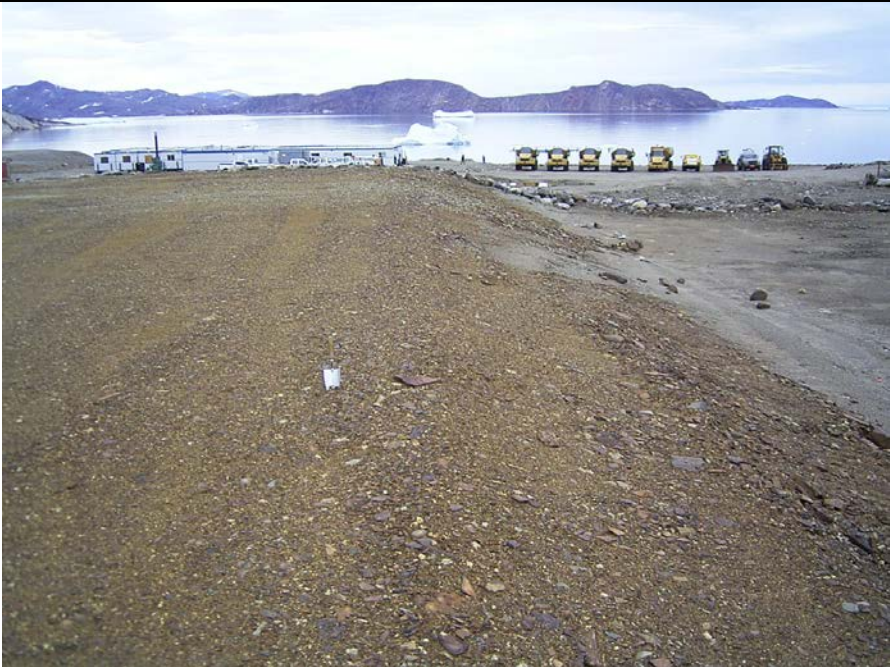
Photo 26.3 (FOX-4 NHT2 P-26 west.jpg)	Photo 27.1 (FOX-4 NHT2 P-27 south.jpg)
Description: View west along the middle slope of the Tier II Disposal Facility cap.	Description: The eastern top of slope of the Tier II Disposal Facility cap. VT-10 can be seen.
