**Nunavut Baffin Region
2014 DEW Line Landfill Monitoring Program
FOX-4 Cape Hooper
Final Monitoring Report**

350600-515-002

**RE: Final Monitoring Report
Baffin Region Nunavut DEW LINE Landfill Monitoring Program
Fox-4 Cape Hooper, NU
DND Project #: DLCLFMP2 (QIKIQ14)**

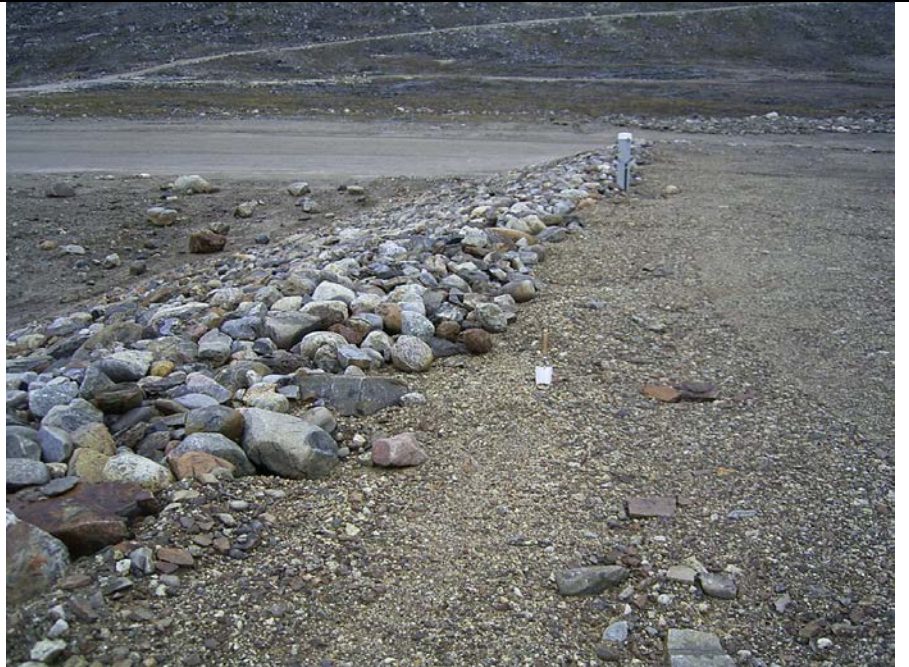
Photo 26.3 (FOX-4 NHT2 P-26 west.jpg)	Photo 27.1 (FOX-4 NHT2 P-27 south.jpg)
Description: View west along the middle slope of the Tier II Disposal Facility cap.	Description: The eastern top of slope of the Tier II Disposal Facility cap. VT-10 can be seen.

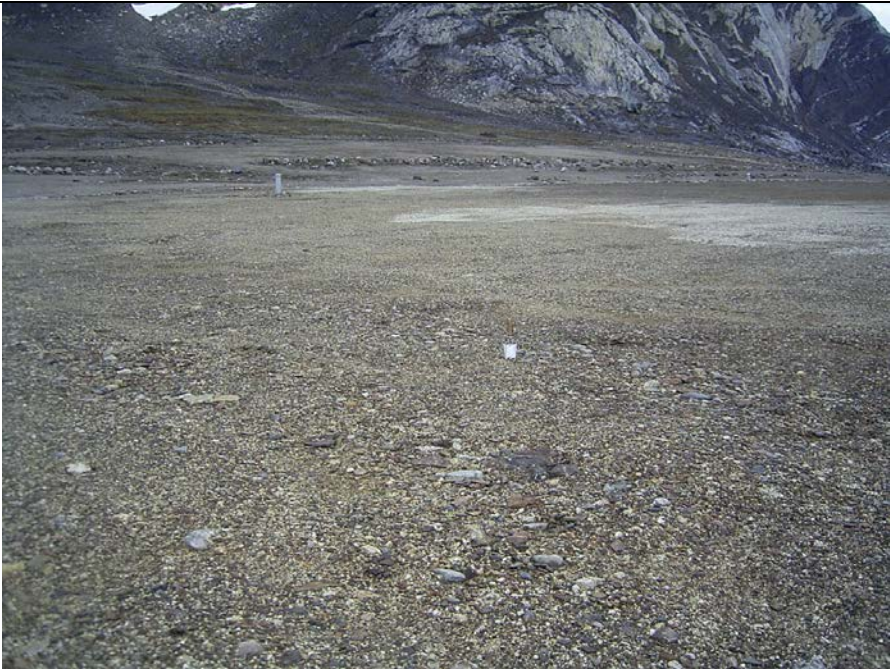
Photo 27.2 (FOX-4 NHT2 P-27 sw.jpg)	Photo 27.3 (FOX-4 NHT2 P-27 west.jpg)
Description: The southern half of the Tier II Disposal Facility cap.	Description: View west along middle slope of the Tier II Disposal Facility cap.

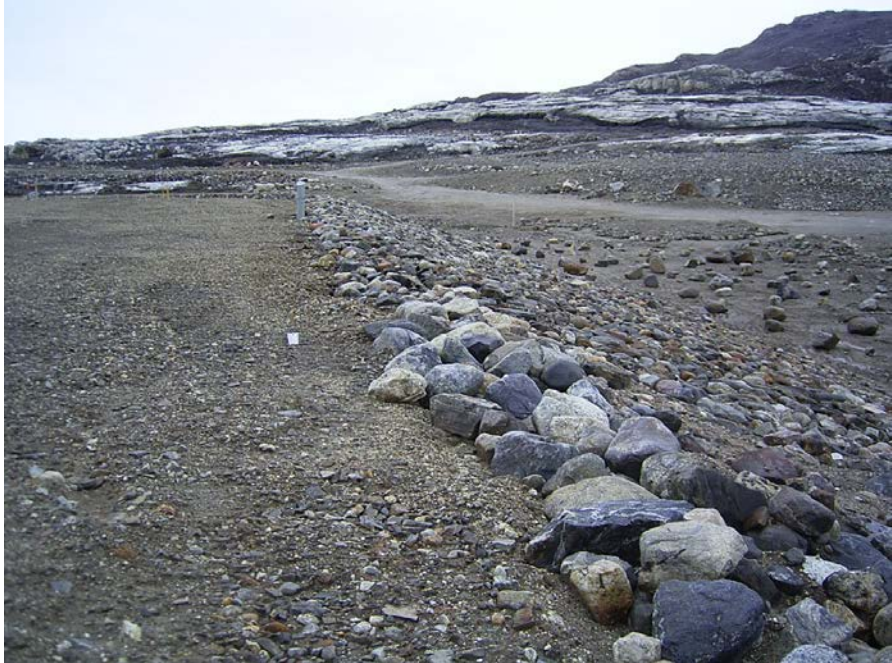
Photo 29.1 (FOX-4 NHT2 P-29 north.jpg)	Photo 29.2 (FOX-4 NHT2 P-29 nw.jpg)
Description: The eastern top of slope of the Tier II Disposal Facility.	Description: The southern half of the Tier II Disposal Facility cap. Photo taken from southeastern corner.

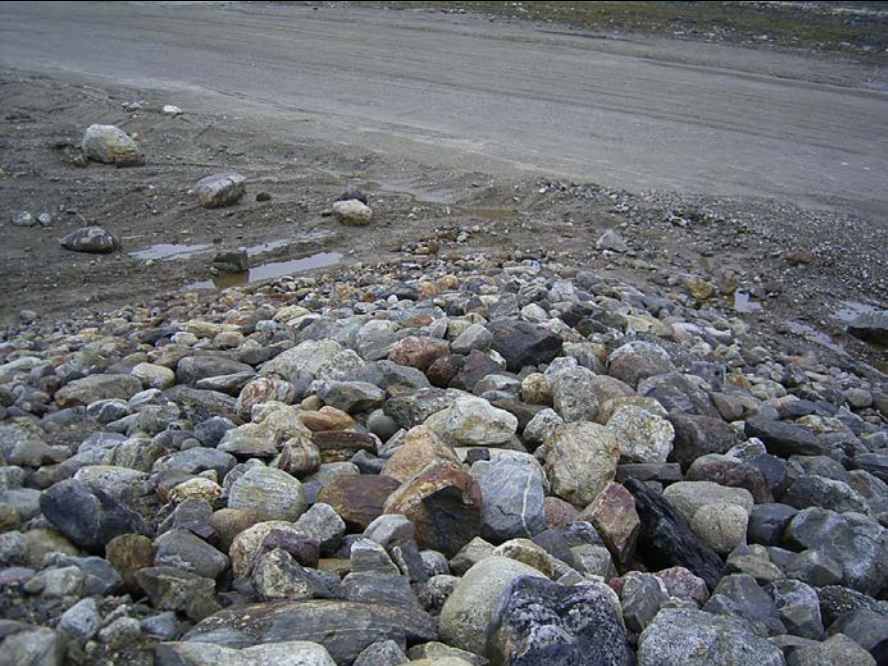
Photo 29.3 (FOX-4 NHT2 P-29 se.jpg)	Photo 29.4 (FOX-4 NHT2 P-29 west.jpg)
Description: View downslope of the southeastern corner of the Tier II Disposal Facility.	Description: The southern top of slope of the Tier II Disposal Facility.

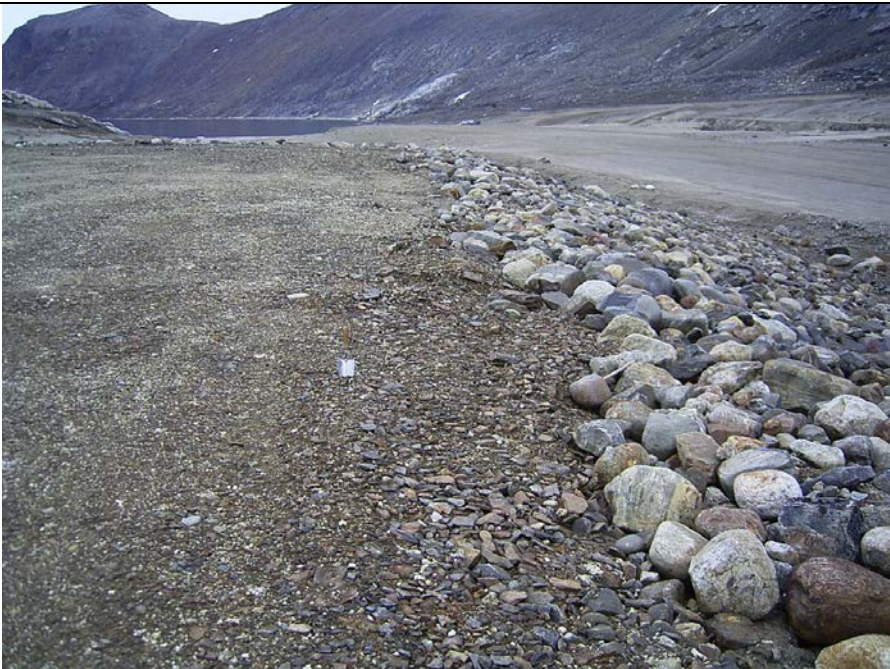
Photo 30.1 (FOX-4 NHT2 P-30 east.jpg)	Photo 30.2 (FOX-4 NHT2 P-30 north.jpg)
Description: The southern top of slope of the Tier II Disposal Facility.	Description: The southern half of the Tier II Disposal Facility cap. Photo taken from the southern top of slope.

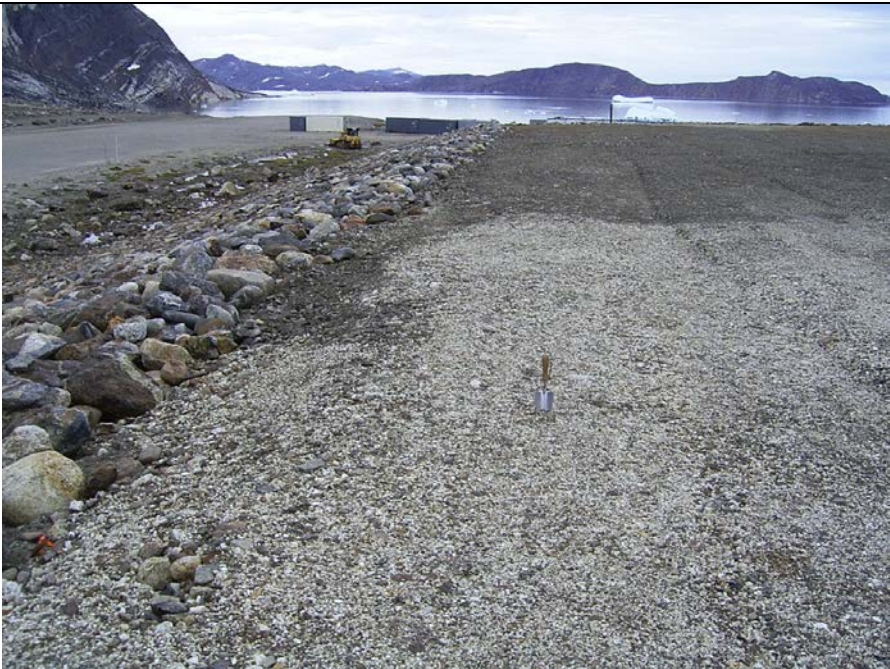
Photo 30.3 (FOX-4 NHT2 P-30 west.jpg)	Photo 31.1 (FOX-4 NHT2 P-31 east.jpg)
Description: The western top of slope of the Tier II Disposal Facility.	Description: View toward VT-7 along the southern top of slope of the Tier II Disposal Facility.

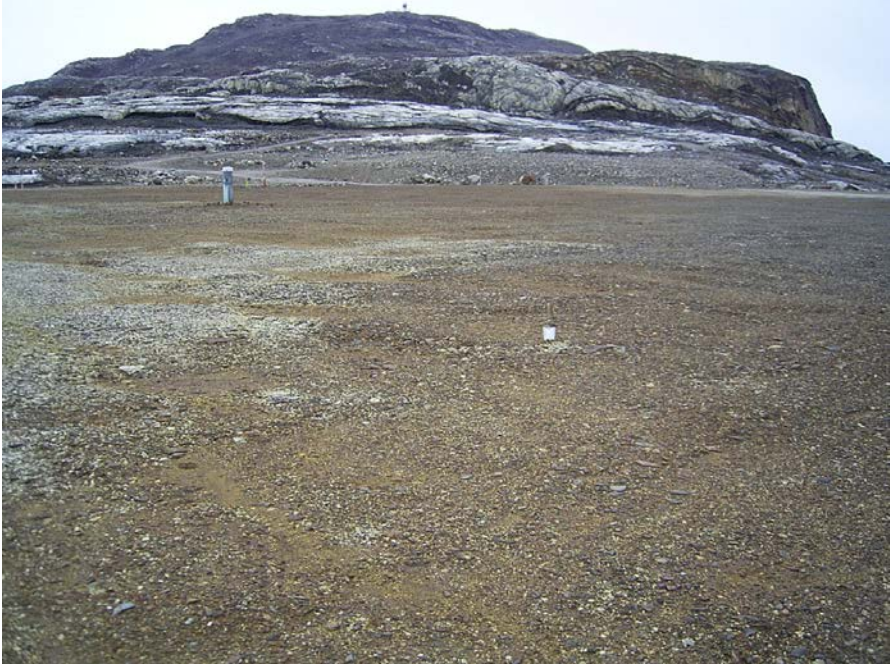
Photo 31.2 (FOX-4 NHT2 P-31 ne.jpg)	Photo 31.3 (FOX-4 NHT2 P-31 north.jpg)
Description: View across the southern half of the Tier II Disposal Facility from the southwestern corner.	Description: The western top of slope of the Tier II Disposal Facility.

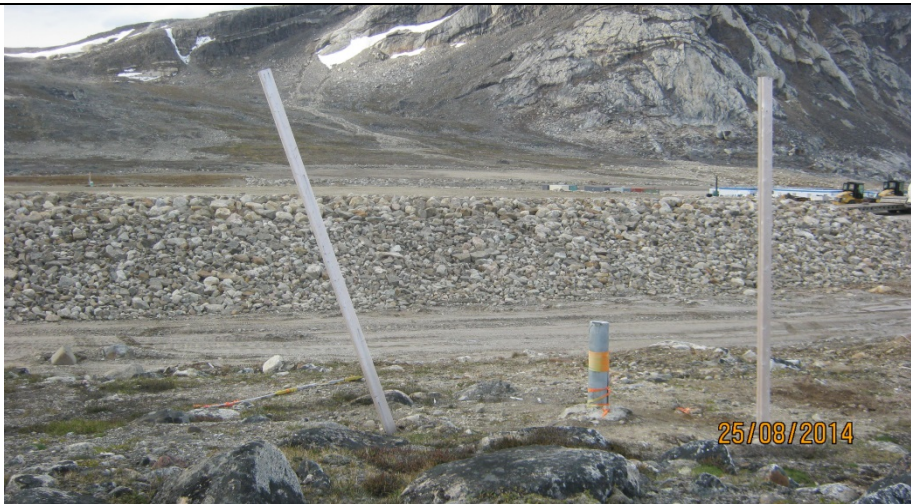
Photo 32.1 (FOX-4 NHT2 P-32 south.jpg)	Photo 33.1 (FOX-4 NHT2 P-33.jpg)
Description: View south toward MW11-01 and the Non-Hazardous Waste Landfill.	Description: Soil sample collection of F4-NH-MW11-01.

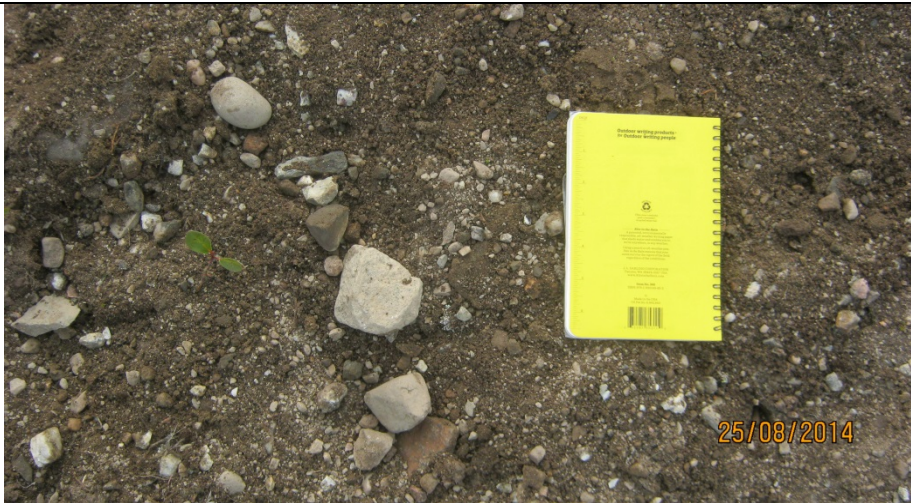
Photo 34.1 (FOX-4 NHT2 P-34.jpg)	Photo 35.1 (FOX-4 NHT2 P-35.jpg)
Description: After sample collection and backfill of F4-NH-MW11-01.	Description: Poned water at MW11-02. (FEATURE F)

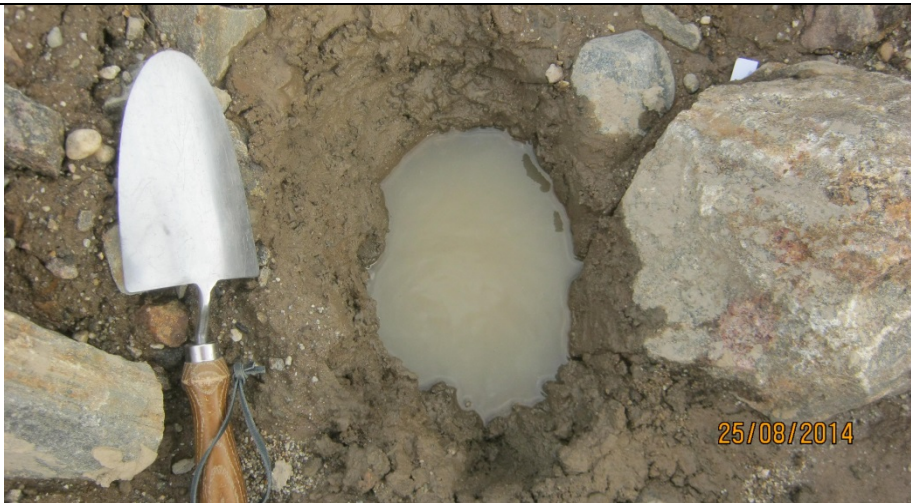
Photo 36.1 (FOX-4 NHT2 P-36.jpg)	Photo 37.1 (FOX-4 NHT2 P-37.jpg)
Description: Sample collection of F4-NH-MW11-02.	Description: After collection and backfill of F4-NH-MW11-02..

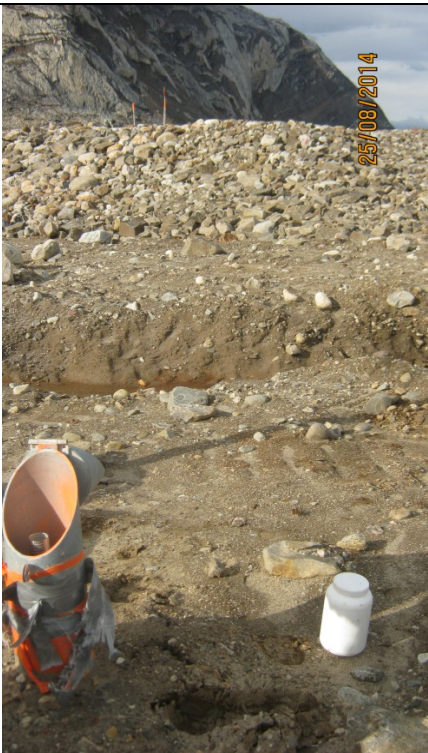
Photo 38.1 (FOX-4 NHT2 P-38 sw.jpg)	Photo 39.1 (FOX-4 NHT2 P-39.jpg)
Description: View toward MW11-03 and the Tier II Disposal Facility.	Description: Sample collection of F4-NH-MW11-03.

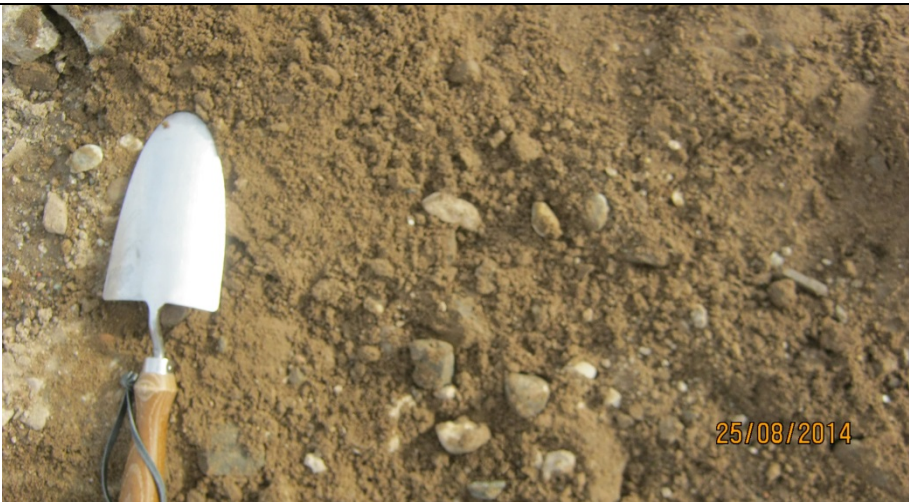
Photo 40.1 (FOX-4 NHT2 P-40.jpg)	Photo 41.1 (FOX-4 NHT2 P-41.jpg)
Description: After collection and backfill of F4-NH-MW11-03.	Description: View from MW11-04 toward the Tier II Disposal Facility.

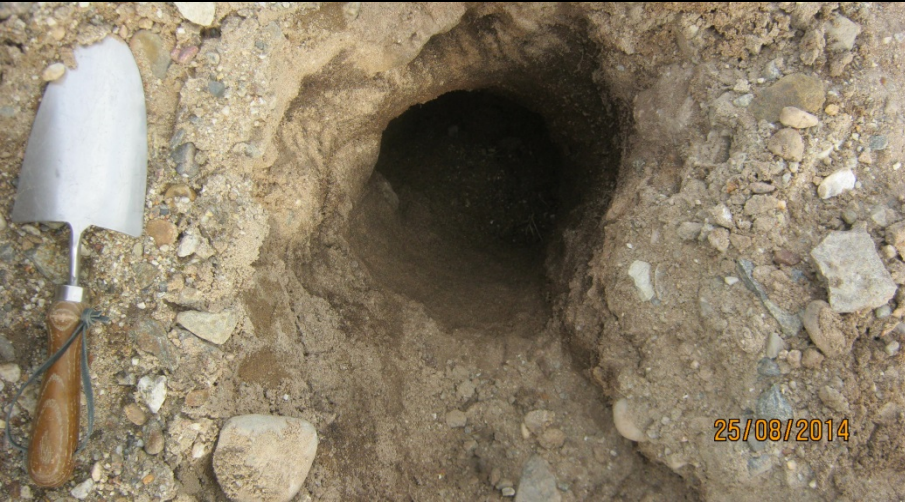
Photo 42.1 (FOX-4 NHT2 P-42.jpg)	Photo 43.1 (FOX-4 NHT2 P-43.jpg)
Description: F4-NH-MW11-04 during soil sample collection.	Description: After collection and backfill of F4-NH-MW11-04.

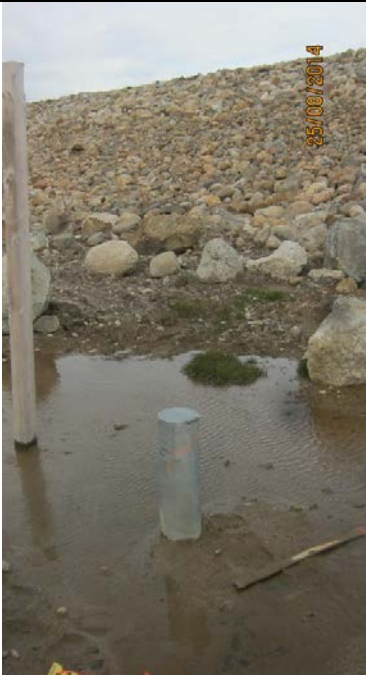
Photo 44.1 (FOX-4 NHT2 P-44 north.jpg)	Photo 45.1 (FOX-4 NHT2 P-45.jpg)
Description: Pounded water at MW11-05. View looking toward southern slope of the Tier II Disposal Facility. (FEATURE B)	Description: F4-NH-MW11-05 during soil sample collection..

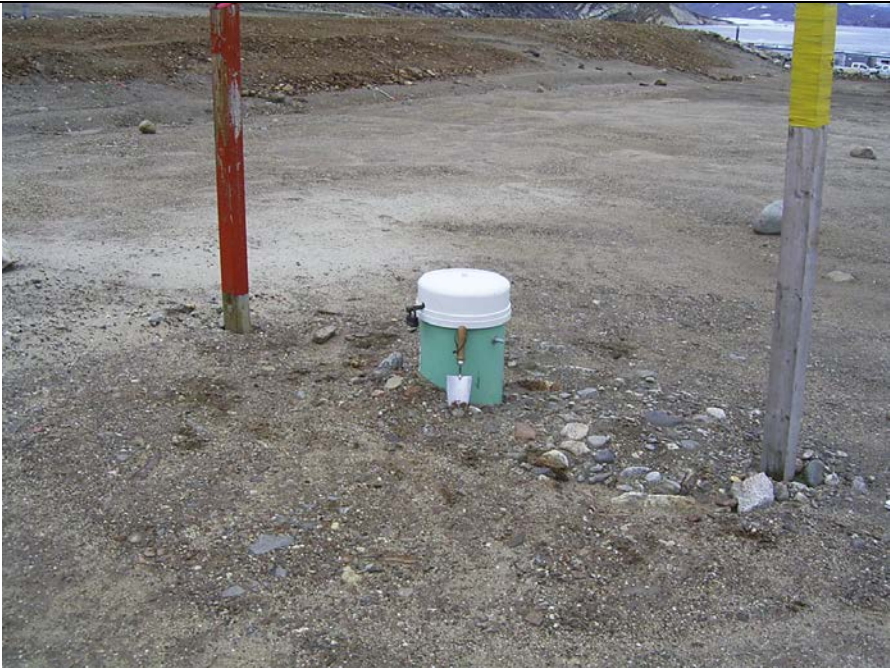
Photo 56.1 (FOX-4 NHT2 P-56 se.jpg)	Photo 57.1 (FOX-4 NHT2 P-57 north.jpg)
Description: Vertical thermistor VT-3.	Description: Vertical thermistor VT-4.

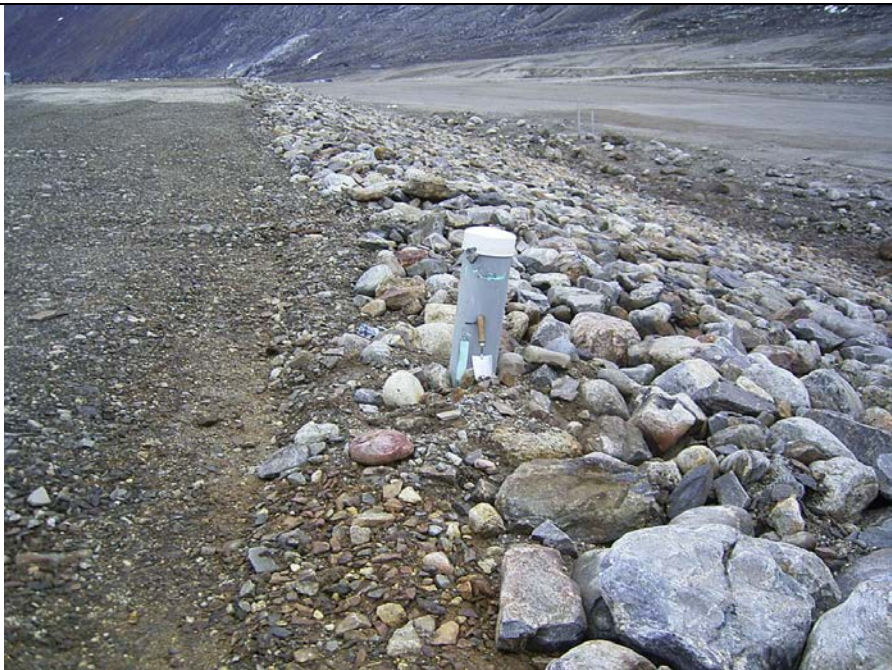
Photo 60.1 (FOX-4 NHT2 P-60 east.jpg)	Photo 61.1 (FOX-4 NHT2 P-61 north.jpg)
Description: Vertical thermistor VT-7.	Description: Vertical thermistor VT-8.

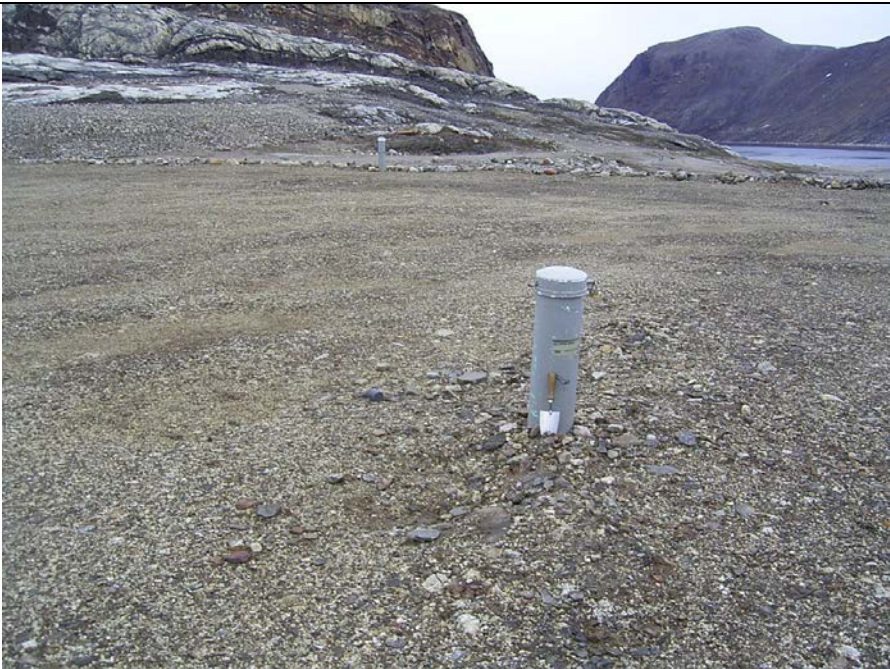
Photo 62.1 (FOX-4 NHT2 P-62 west.jpg)	Photo 63.1 (FOX-4 NHT2 P-63 east.jpg)
Description: Vertical thermistor VT-9.	Description: Vertical thermistor VT-10.

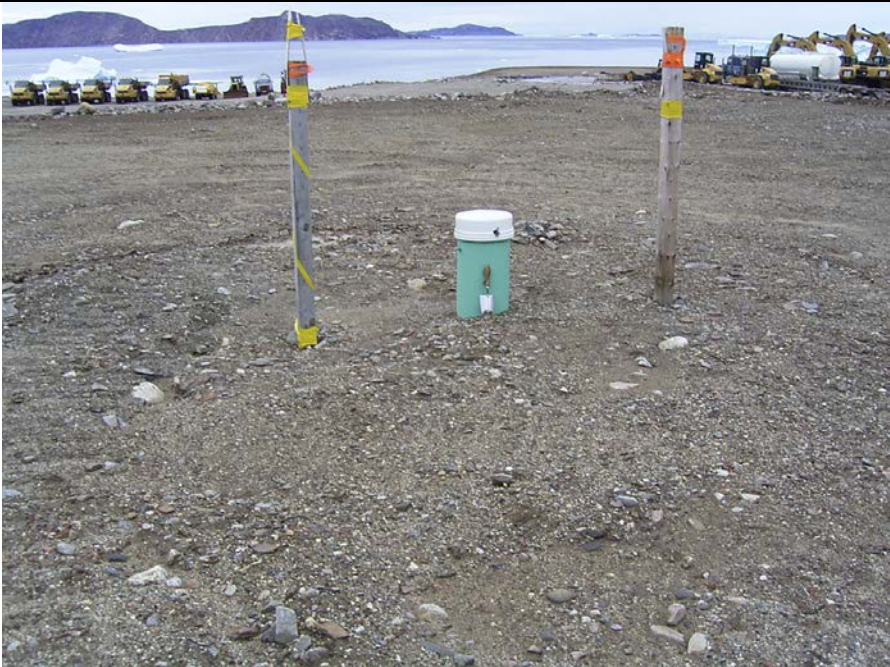
Photo 64.1 (FOX-4 NHT2 P-64 nw.jpg)	Photo 65.1 (FOX-4 NHT2 P-65 west.jpg)
Description: Vertical thermistor VT-5A.	Description: The Non-Hazardous Waste Landfill. View looking west from the Pallet Line Landfill.

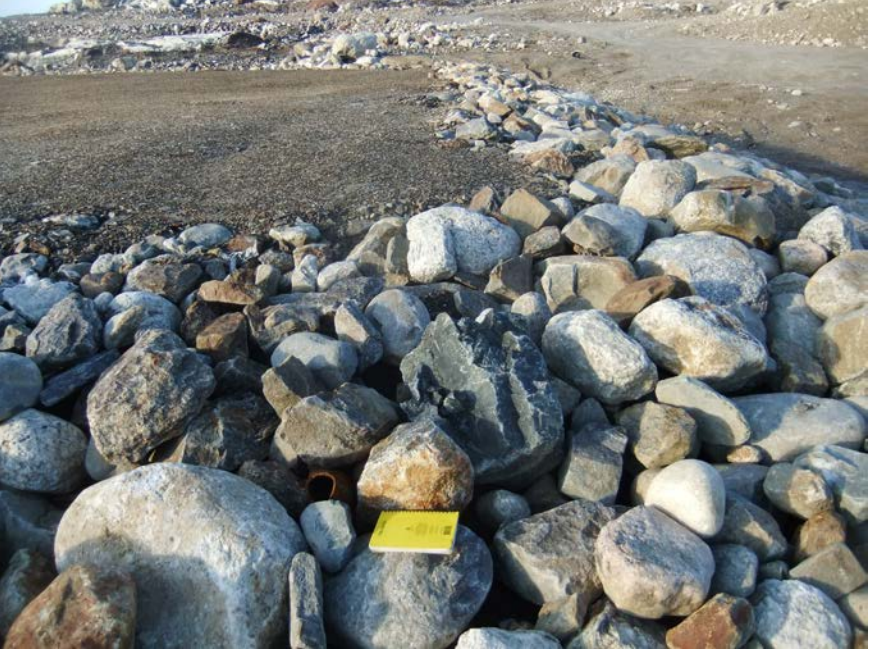
Photo 66.1 (FOX-4 NHT2 P-66 south.jpg)	Photo 67.1 (FOX-4 NHT2 P-67 north.jpg)
Description: The Tier II Disposal Facility. View south from the Pallet Line Landfill.	Description: Metal debris at southeast corner of Non-Hazardous Waste Landfill. (FEATURE G)

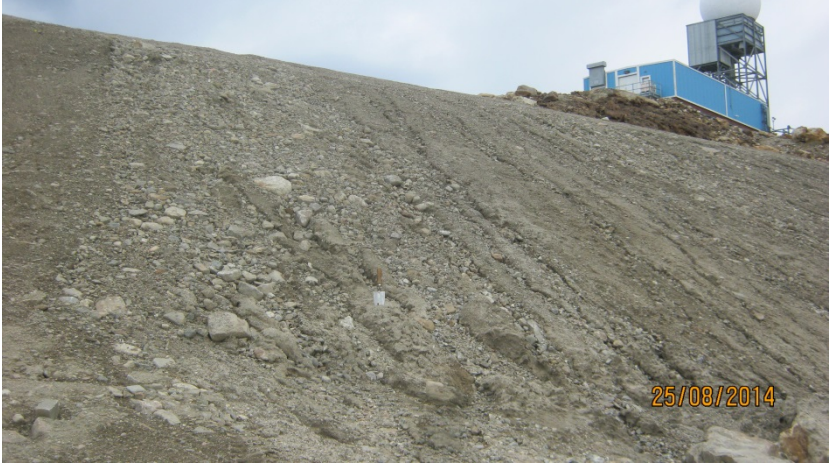
Photo 1.3 (FOX-4 HEL P-1 nw.jpg)	Photo 2.1 (FOX-4 HEL P-2 east.jpg)
Description: View northwest from access road near MW98-01.	Description: View east looking up slope toward erosion channels. (FEATURE C)

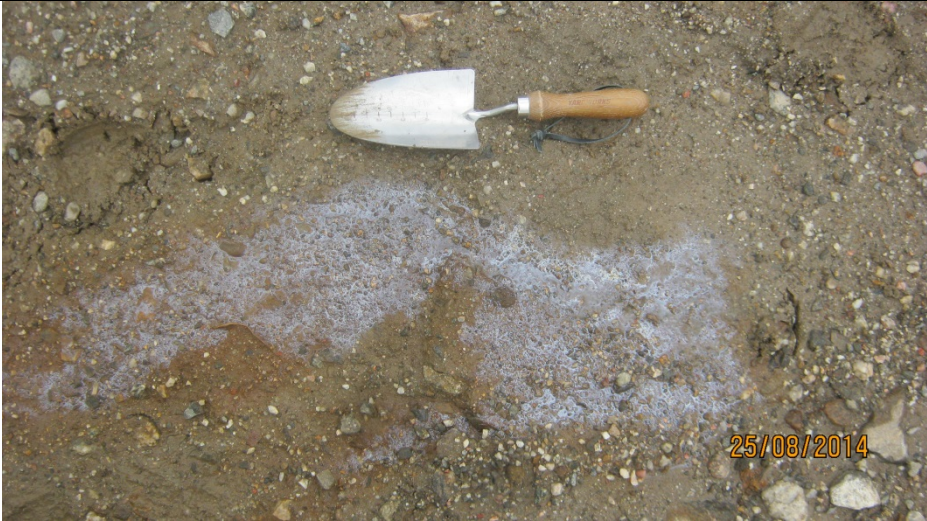
Photo 4.1 (FOX-4 HEL P-4.jpg)	Photo 5.1 (FOX-4 HEL P-5.jpg)
Description: View of stain southeast of MW98-02. (FEATURE J)	Description: Stain south of MW98-02. (FEATURE J)

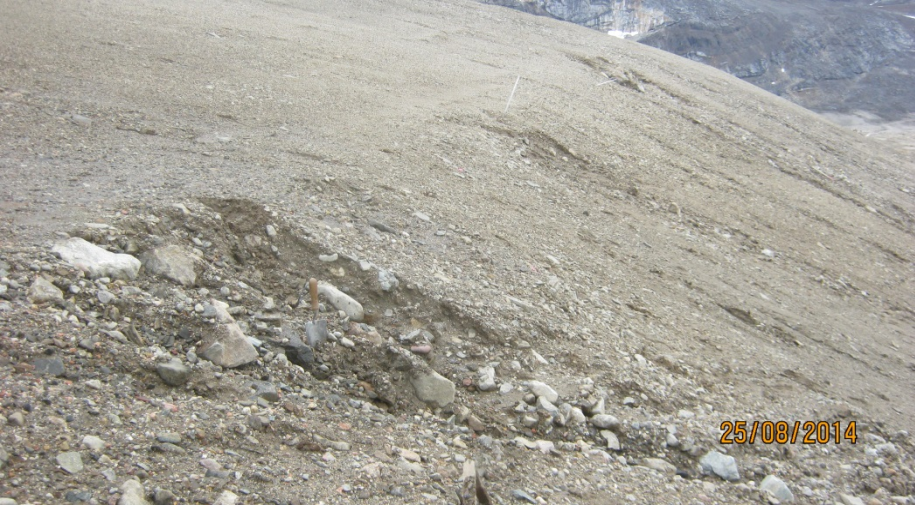
Photo 6.1 (FOX-4 HEL P-6 south.jpg)	Photo 7.1 (FOX-4 HEL P-7 nw.jpg)
Description: Erosion channel east of MW98-02. (FEATURE D)	Description: View looking down slope toward MW98-02.

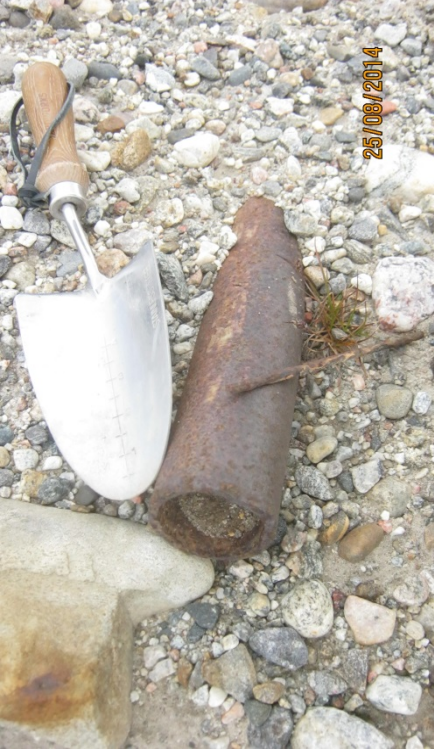
Photo 10.1 (FOX-4 HEL P-10.jpg)	Photo 11.1 (FOX-4 HEL P-11 se.jpg)
Description: Exposed old pipe east of MW98-06. (FEATURE L)	Description: View southeast across helipad from windsock.

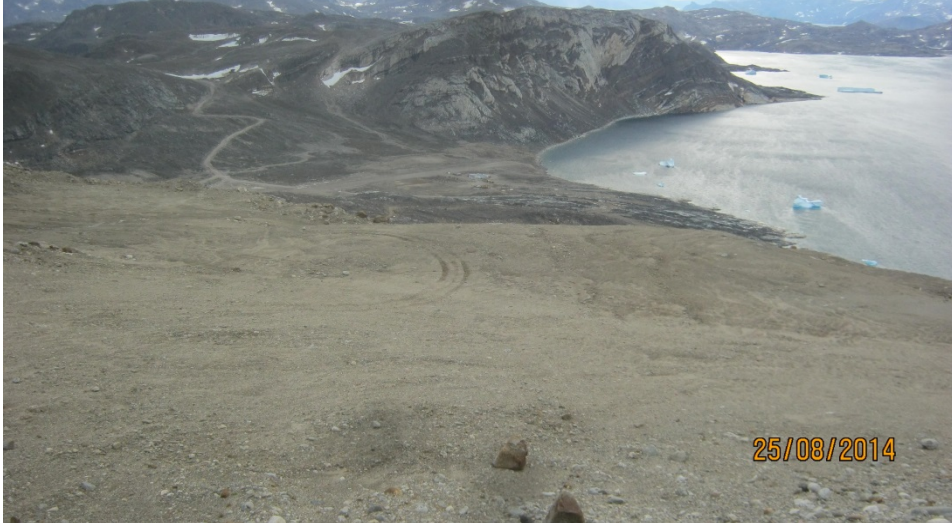
Photo 14.1 (FOX-4 HEL P-14 nw.jpg)	Photo 15.1 (FOX-4 HEL P-15 west.jpg)
Description: View northwest from windsock.	Description: View downslope from helipad. Vehicle tracks/ruts can be seen on the flatter part of the slope (centre of photo). (FEATURE A)

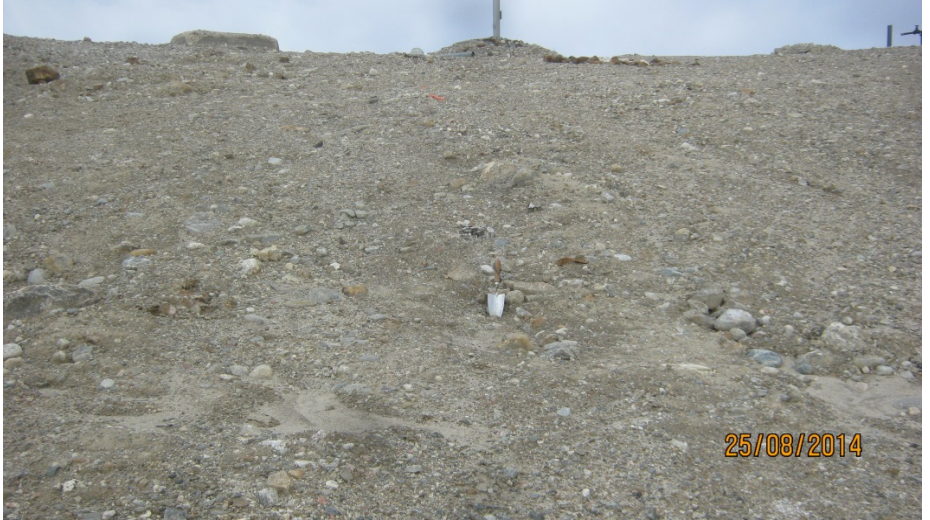
Photo 16.1 (FOX-4 HEL P-16 west.jpg)	Photo 17.1 (FOX-4 HEL P-17 east.jpg)
Description: View west looking downslope.	Description: View east looking upslope toward helipad access road.

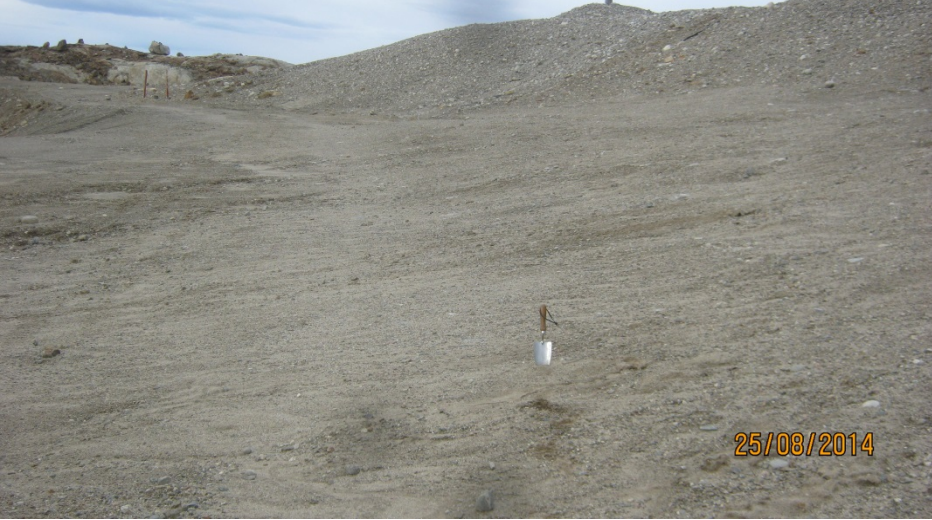
Photo 18.1 (FOX-4 HEL P-18 north.jpg)	Photo 19.1 (FOX-4 HEL P-19 sw.jpg)
Description: View north of flatter section of helipad landfill west.	Description: View downhill towards MW98-01 location (not seen in photo). Minor settlement located at trowel. (FEATURE E)

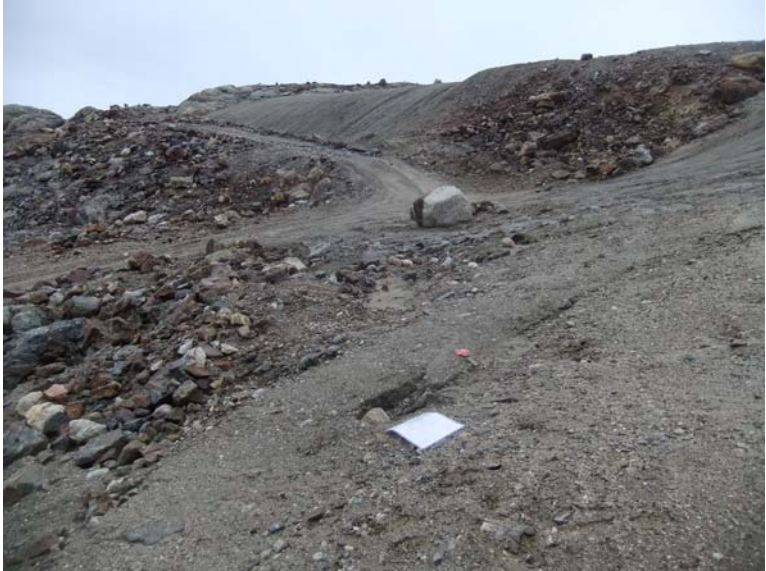
Photo 32.1 (FOX-4 HEL P-32.jpg)	Photo 33.1 (FOX-4 HEL P-33.jpg)
Description: After collection and backfill of F4-HEL-MW98-06.	Description: Settlement on landfill slope. (FEATURE G)

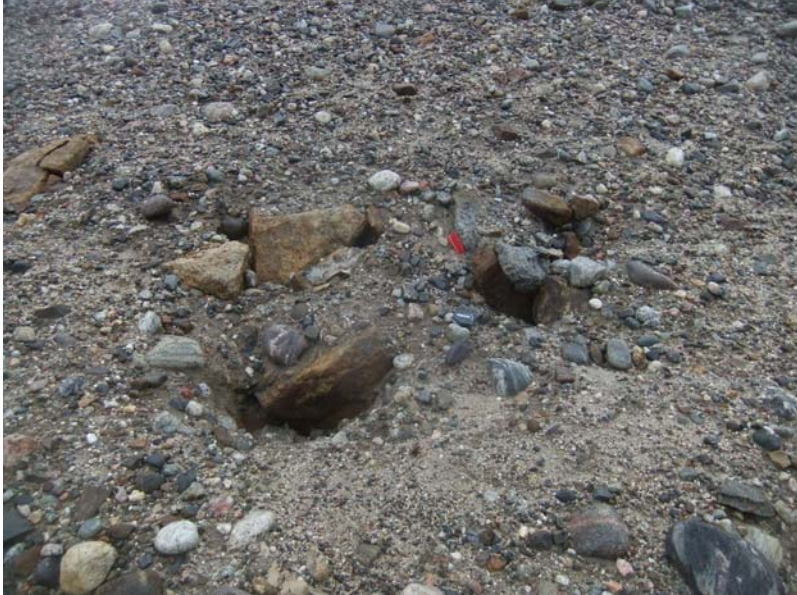
Photo 34.1 (FOX-4 HEL P-34.jpg)	Photo 35.1 (FOX-4 HEL P-35.jpg)
Description: Debris (wires) within landfill slope. (FEATURE K)	Description: Sinkholes in landfill slope. (FEATURE H)

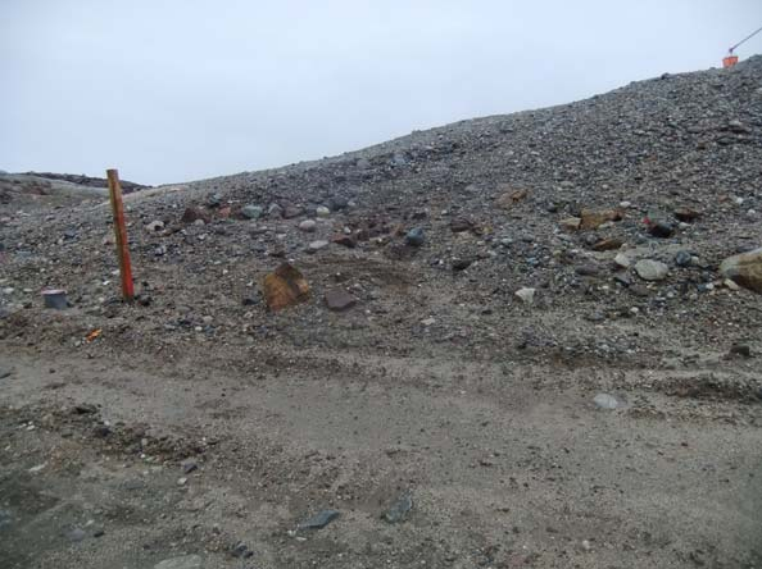
Photo 35.2 (FOX-4 HEL P-35 n.jpg)	Photo 36.1 (FOX-4 HEL P-36.jpg)
Description: Location of sinkholes east of MW98-06 near red mark on right side of picture. (FEATURE H)	Description: Sinkholes above boulders at base of slope. (FEATURE I)

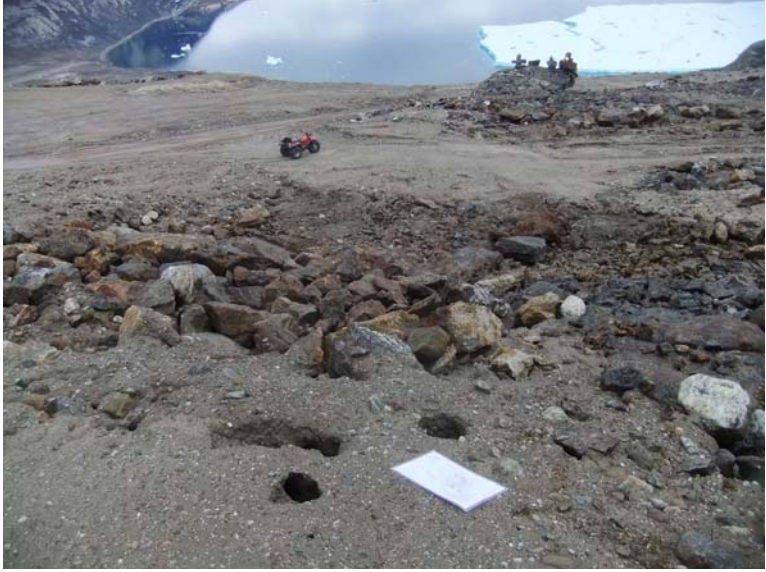
Large boulders have been placed at the bottom of some of the slopes at this landfill. Some sinkholes have been noted above these large boulders. This is likely a result of infilling of void spaces around these large boulders with fine material from above, resulting in sinkholes due to loss of material. These areas should be closely monitored to ensure that large sinkholes are not developing that could result in failures of the slopes above these areas.

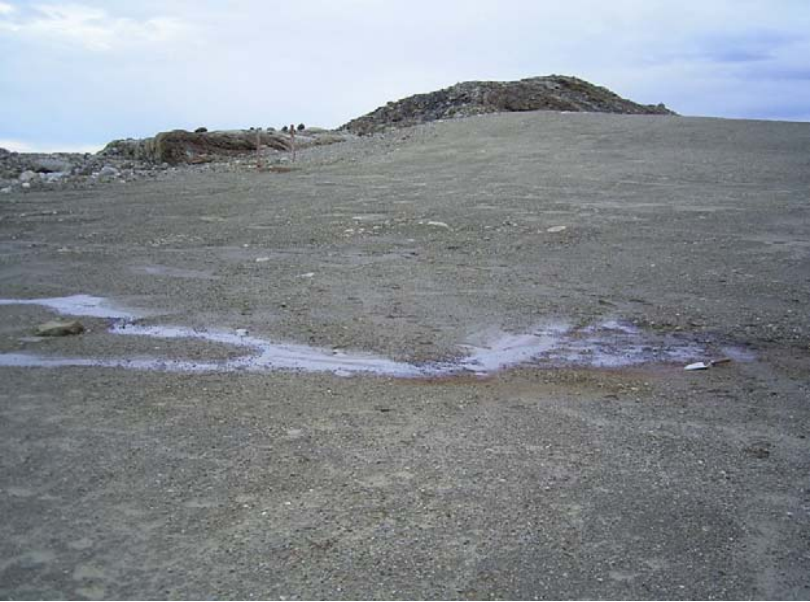
Photo 1.1 (FOX-4 STA P-1 east.jpg)	Photo 2.1 (FOX-4 STA P-2 east.jpg)
Description: View looking east from east of MW98-09. Staining observed at standing water near trowel. (FEATURE B, L)	Description: View looking east toward MW98-08 over standing water, oxidation staining visible in water. (FEATURE B, L)

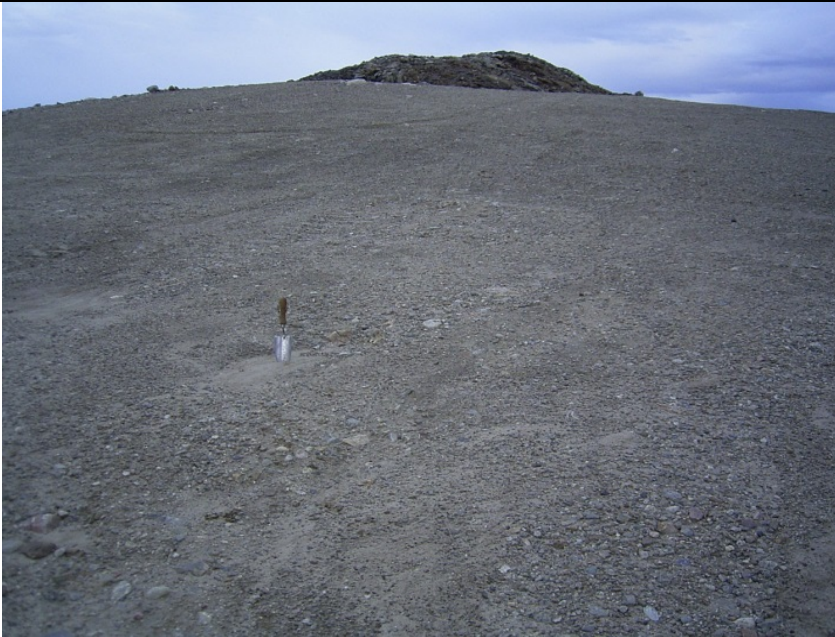
Photo 3.1 (FOX-4 STA P-3 east.jpg)	Photo 4.1 (FOX-4 STA P-4 east.jpg)
Description: View east looking up the slope of the Station Area Non-hazardous landfill. Minor settlement observed at trowel location. (FEATURE H)	Description: View west looking downslope along erosion channel. (FEATURE D)

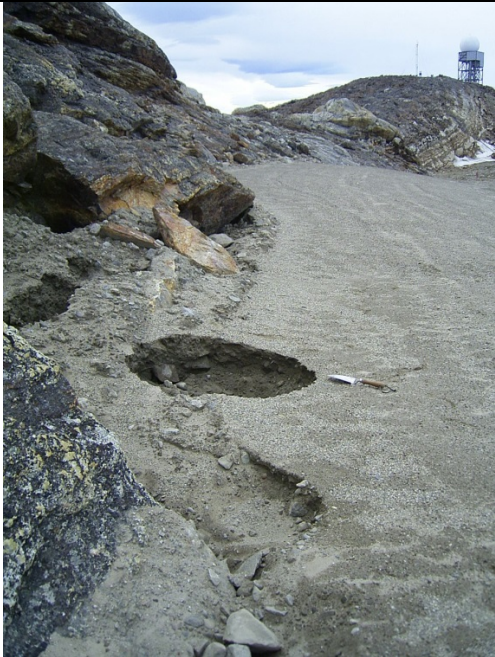
Photo 7.2 (FOX-4 STA P-7 north.jpg)	Photo 8.1 (FOX-4 STA P-8 nw.jpg)
Description: View looking north, upslope, in the vicinity of MW98-07.	Description: View looking west, toward station, of sink hole. The sink hole measured approximately 1 m in diameter. (FEATURE D)

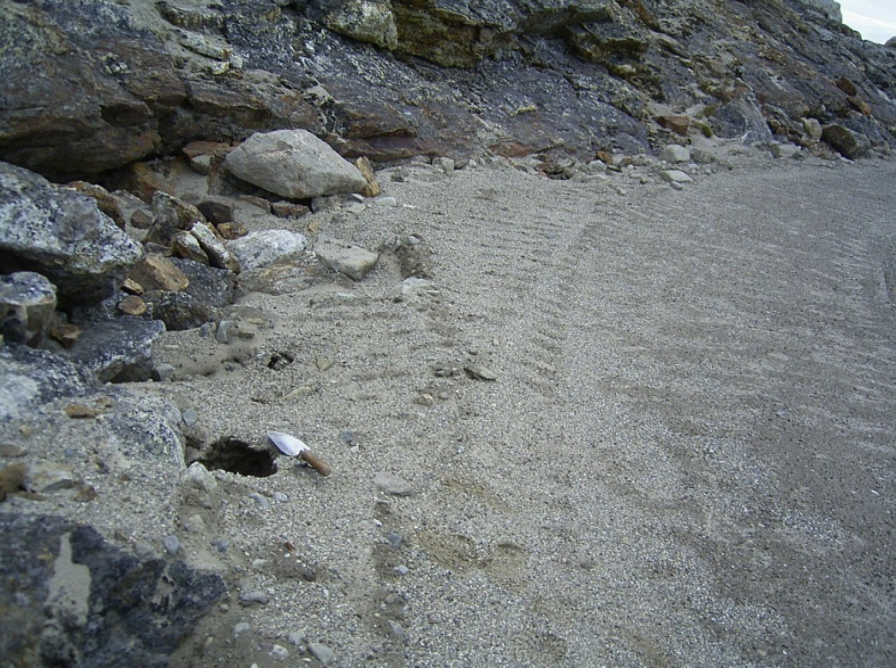
Photo 9.1 (FOX-4 STA P-9 west.jpg)	Photo 10.1 (FOX-4 STA P-10 east.jpg)
Description: View of small sinkhole, measuring approximately 0.3 m diameter, on southern edge of landfill. (FEATURE E)	Description: View of minor settlement, measuring 0.3 m x 0.2 m, at trowel. MW98-07 is in the distance. (FEATURE G)

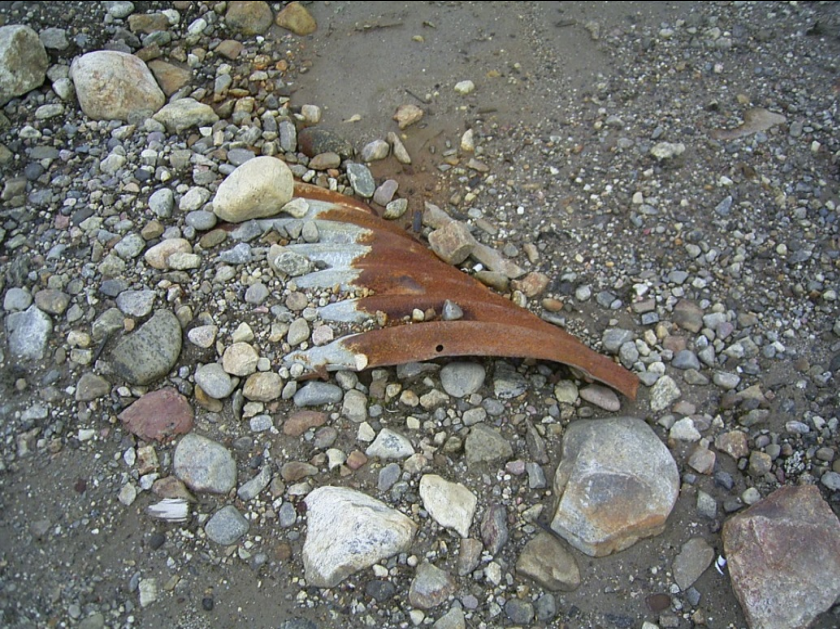
Photo 13.1 (FOX-4 STA P-13.jpg)	Photo 14.1 (FOX-4 STA P-14.jpg)
Description: Old culvert west of the landfill. (FEATURE K)	Description: Minor debris such as plastic and scrap wood observed west of landfill. (FEATURE J)

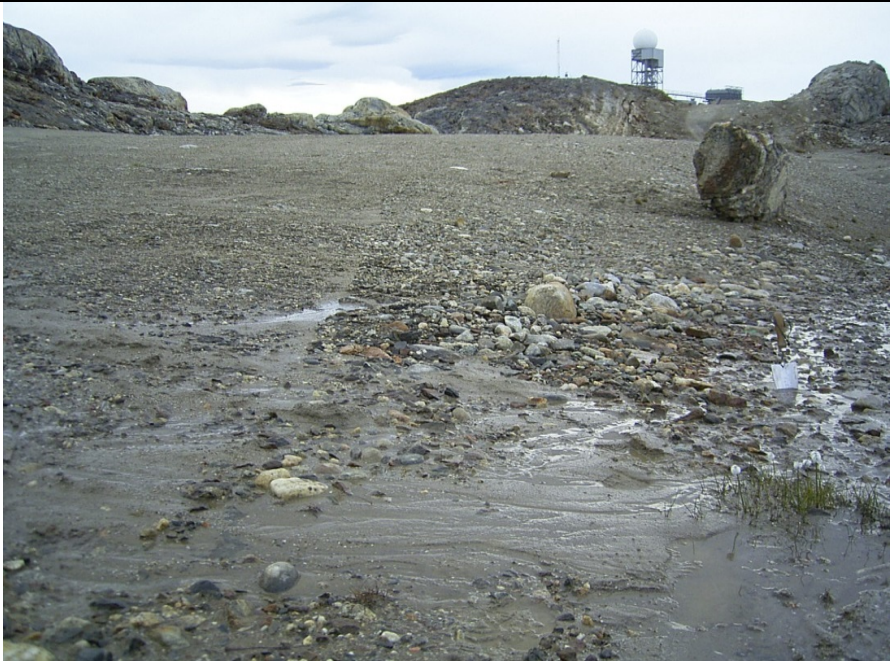
Photo 15.1 (FOX-4 STA P-15 west.jpg)	Photo 16.1 (FOX-4 STA P-16 west.jpg)
Description: View of southern edge of landfill, looking west toward station.	Description: View of ponded water at eastern end of landfill, west of MW98-07. (FEATURE A)

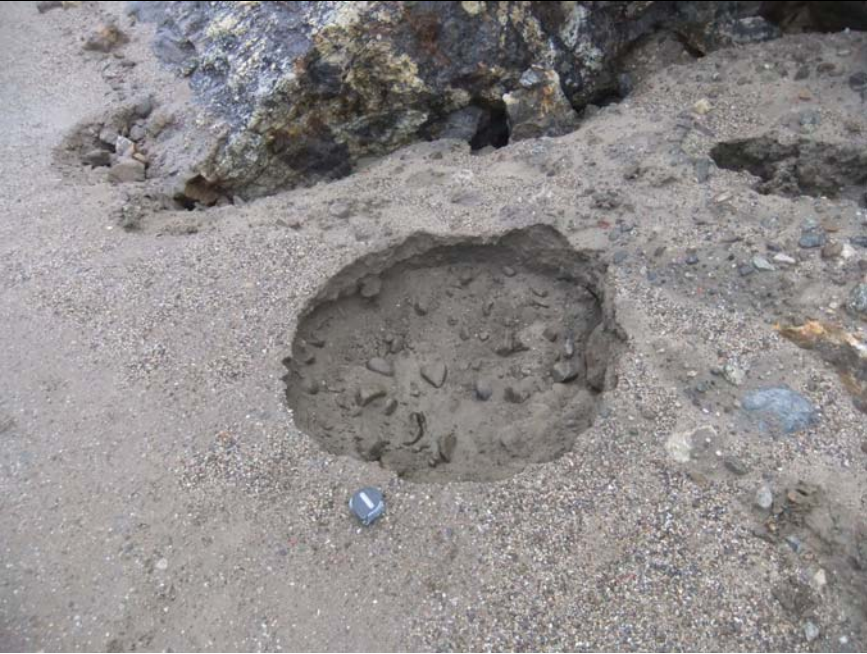
Photo 27.1 (FOX-4 STA P-27.jpg)	
Description: Closeup of sinkhole. (FEATURE D)

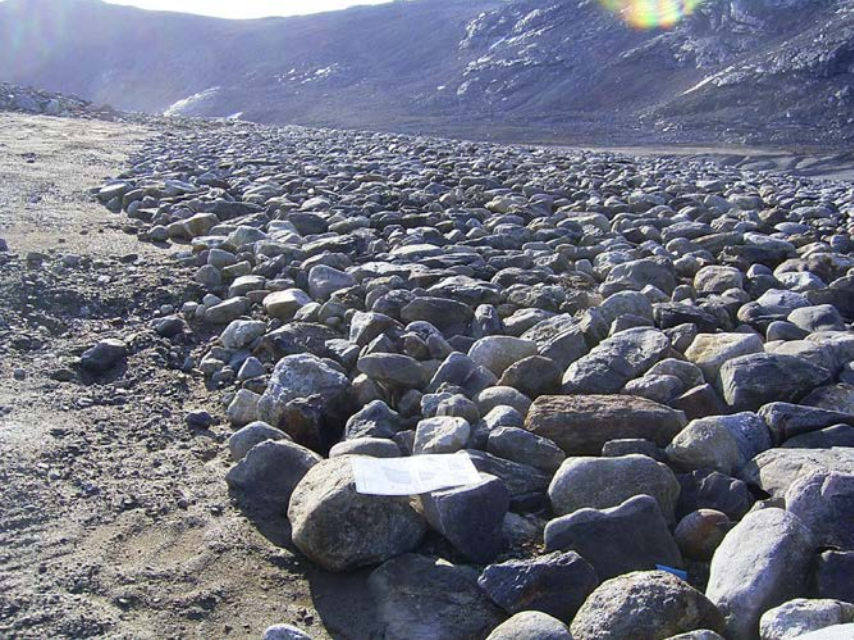
Photo 2.1 (FOX-4 PAL P-2 east.jpg)	Photo 2.2 (FOX-4 PAL P-2 south.jpg)
Description: View east along northern limit of Pallet Line Landfill.	Description: View south across landfill.

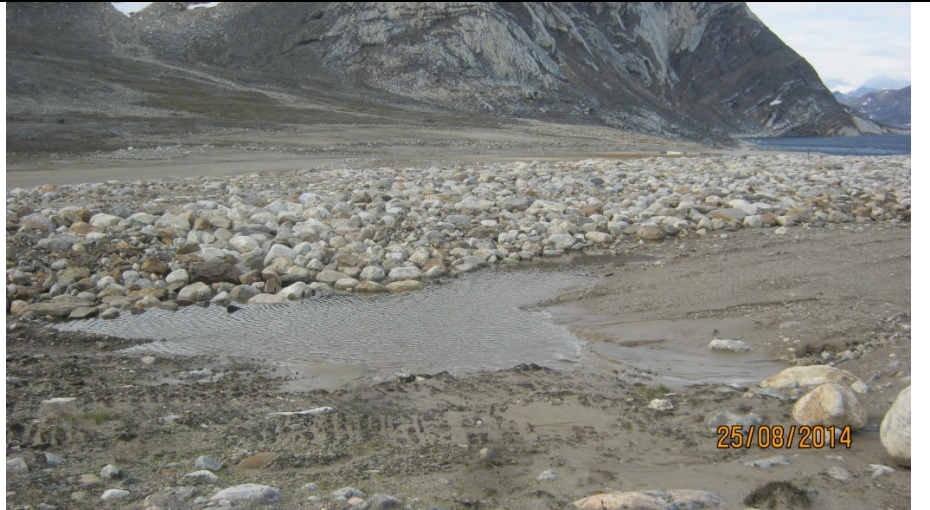
Photo 16.1 (FOX-4 PAL P-16.jpg)	Photo 17.1 (FOX-4 PAL P-17 sw.jpg)
Description: F4-PAL-25 after sample collection and backfill.	Description: Ponded water at the northeast corner of the landfill. View from F4-PAL-26. (FEATURE A)

The 2014 visual inspection of the Pallet Line Landfill did not identify any items of concern. Ponded water was noted northeast of the landfill however this is not expected to represent an issue at the present time.

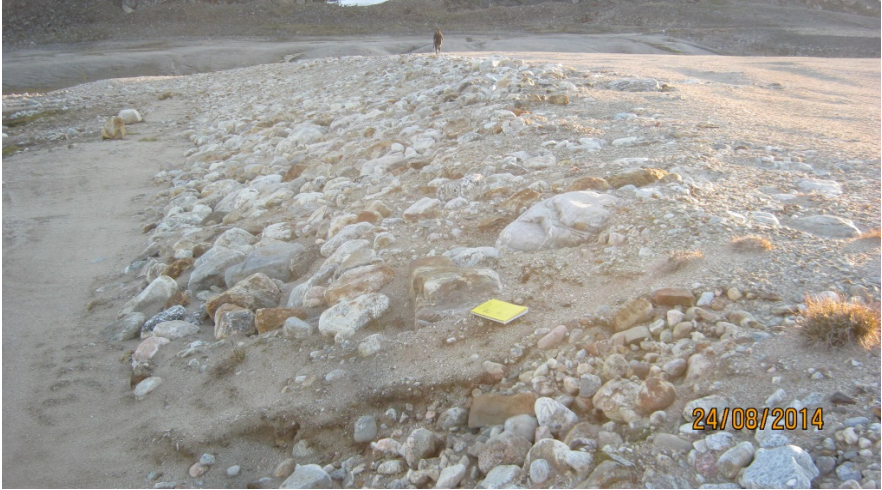
Photo 1.1 (FOX-4 TAN P-1 sw.jpg)	Photo 2.1 (FOX-4 TAN P-2 south.jpg)
Description: View from the northeastern corner of the Tanner Bay Landfill. View looking southwest along the slope. Erosion channel at field book location. (FEATURE B)	Description: View of erosion channel on slope near northeastern corner of landfill. (FEATURE B)

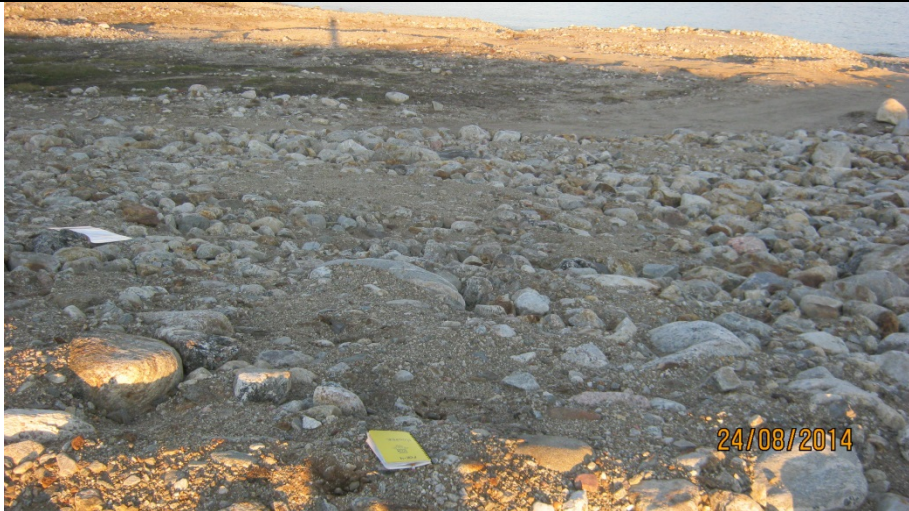
Photo 4.2 (FOX-4 TAN P-4 se.jpg)	Photo 4.3 (FOX-4 TAN P-4 sw.jpg)
Description: View looking downhill of the eastern slope of the Tanner Bay Landfill.	Description: The top of the slope along southeast portion of the Tanner Bay Landfill.
