**Nunavut Baffin Region
2014 DEW Line Landfill Monitoring Program
FOX-4 Cape Hooper
Final Monitoring Report**

350600-515-002

**RE: Final Monitoring Report
Baffin Region Nunavut DEW LINE Landfill Monitoring Program
Fox-4 Cape Hooper, NU
DND Project #: DLCLFMP2 (QIKIQ14)**

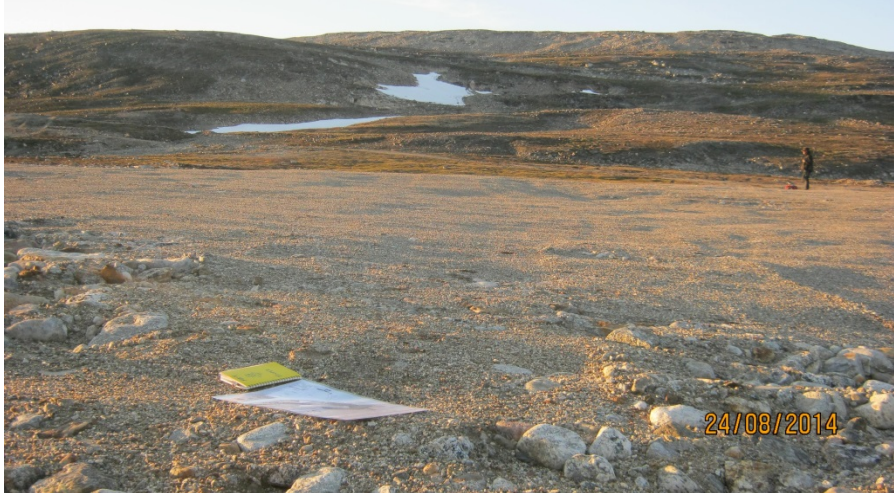
Photo 5.1 (FOX-4 TAN P-5 north.jpg)	Photo 5.2 (FOX-4 TAN P-5 ne.jpg)
Description: View across the landfill cap from the southeastern corner of the landfill.	Description: View of the top of the eastern slope of the landfill.

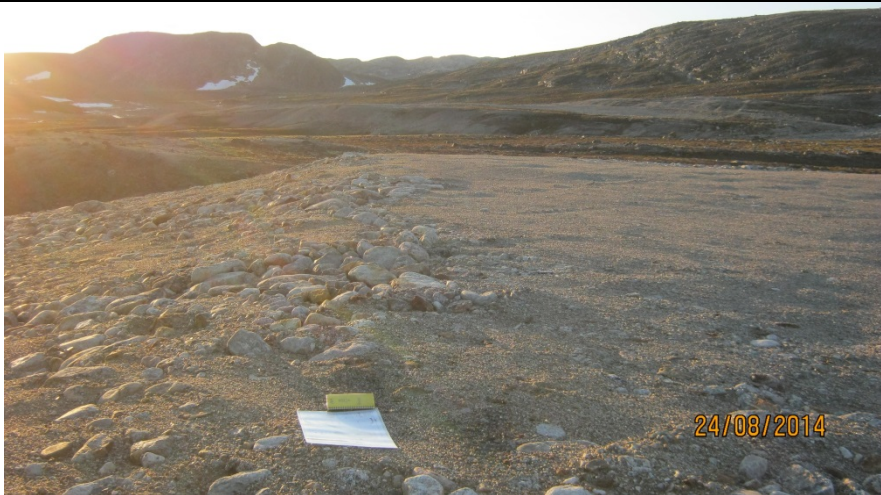
Photo 5.3 (FOX-4 TAN P-5 nw.jpg)	Photo 5.4 (FOX-4 TAN P-5 south.jpg)
Description: View from the southeastern corner toward the southwestern corner. View along the top of the slope.	Description: View downhill of landfill slope from southeastern corner of cap.

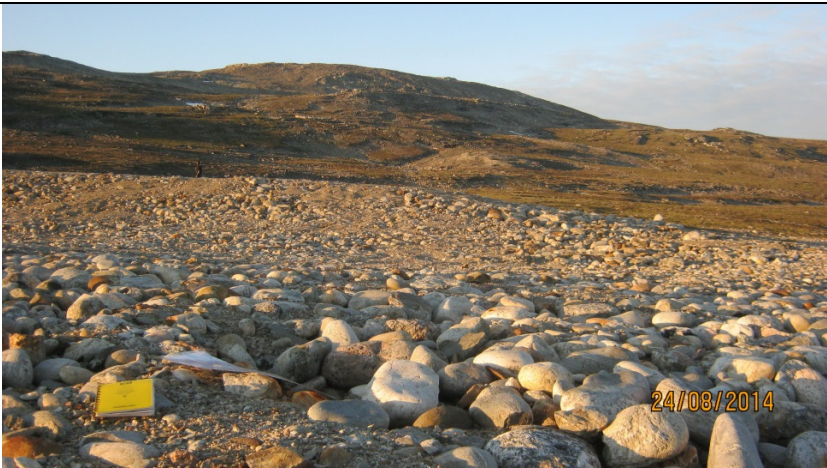
Photo 6.1 (FOX-4 TAN P-6 north.jpg)	Photo 6.2 (FOX-4 TAN P-6 south.jpg)
Description: View looking uphill from toe of Tanner Bay Landfill.	Description: View looking downhill from toe of the landfill.

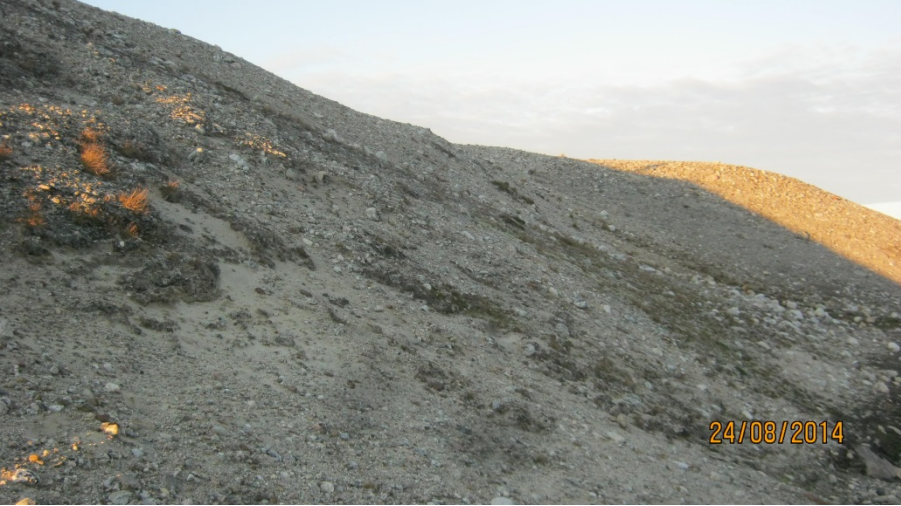
Photo 7.1 (FOX-4 TAN P-7 east.jpg)	Photo 7.2 (FOX-4 TAN P-7 north.jpg)
Description: The sloped terrain downhill of the Tanner Bay Landfill.	Description: The sloped terrain downhill of the Tanner Bay Landfill. Wildlife monitor seen on the landfill.

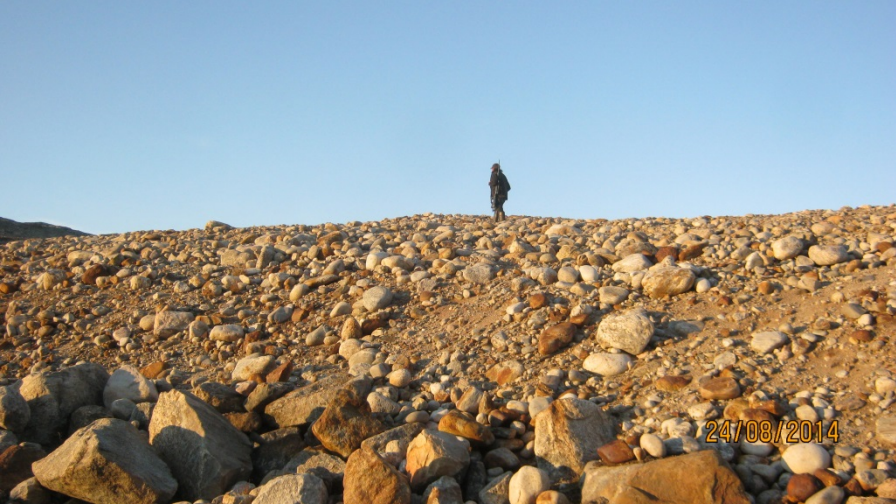
Photo 8.1 (FOX-4 TAN P-8 ne.jpg)	Photo 9.1 (FOX-4 TAN P-9 ne.jpg)
Description: View toward the Tanner Bay Landfill from adjacent to the southwestern toe.	Description: View along western slope of the Tanner Bay Landfill.

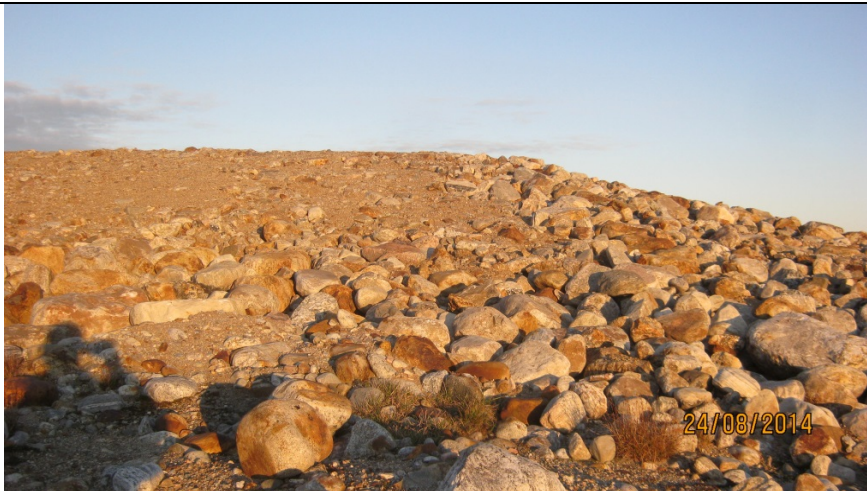
Photo 9.2 (FOX-4 TAN P-9 se.jpg)	Photo 10.1 (FOX-4 TAN P-10 ne.jpg)
Description: The southern portion of the landfill cap.	Description: The western slope of the Tanner Bay Landfill. View from the southwestern corner of the cap.

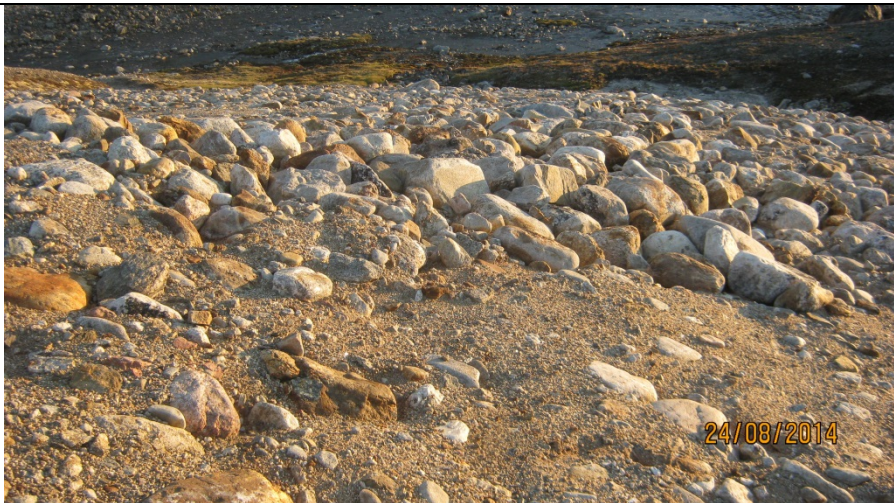
Photo 10.2 (FOX-4 TAN P-10 south.jpg)	Photo 11.1 (FOX-4 TAN P-11 ne.jpg)
Description: View looking downhill from the southwestern corner of the landfill cap.	Description: The Tanner Bay Landfill cap. Tire ruts visible north of field book.

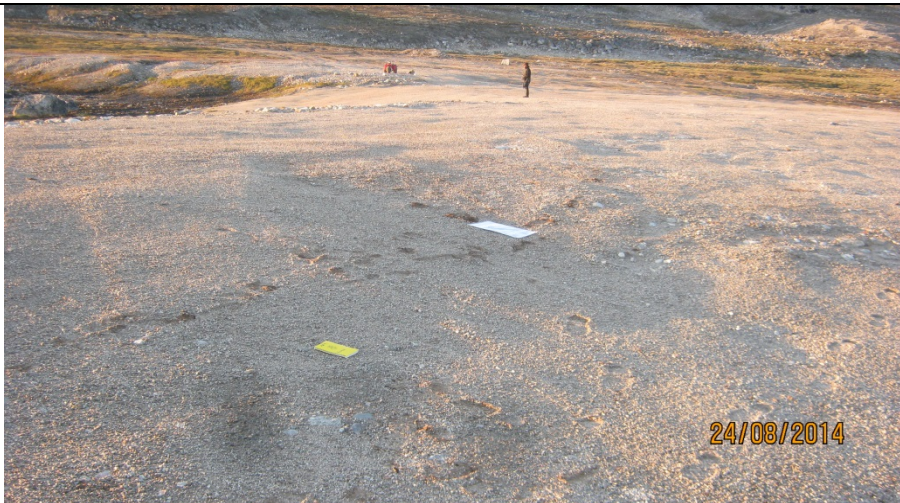
Photo 11.2 (FOX-4 TAN P-11 north.jpg)	Photo 11.3 (FOX-4 TAN P-11 se.jpg)
Description: Minor settlement observed on landfill cap measured 1.5 m x 1.0 m x 0.05 m. Minor settlement located in photo at white paper on ground. (FEATURE A)	Description: The southern portion of the landfill cap and the southern slope toward Tanner Bay.

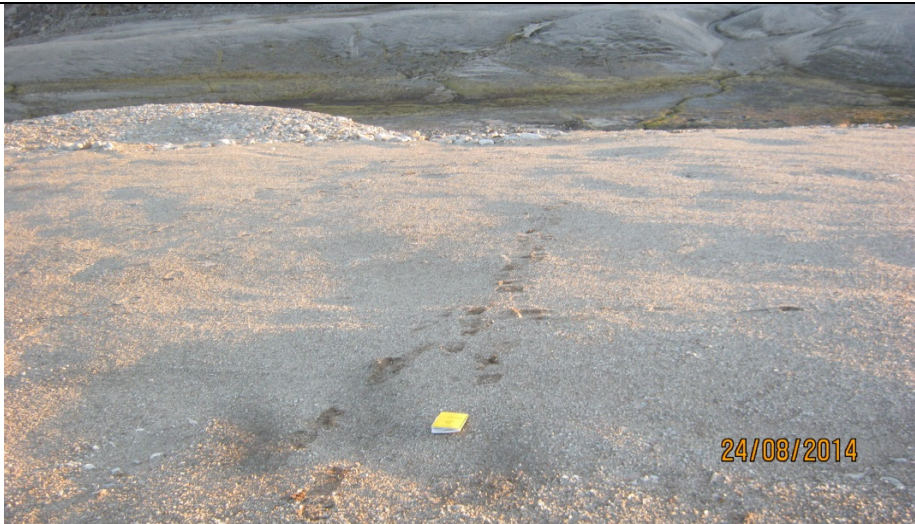
Photo 11.4 (FOX-4 TAN P-11 sw.jpg)	Photo 12.1 (FOX-4 TAN P-12 se.jpg)
Description: The southern portion of the cap.	Description: The northern portion of the cap, looking toward Tanner Bay. Area of former ponded water in foreground.

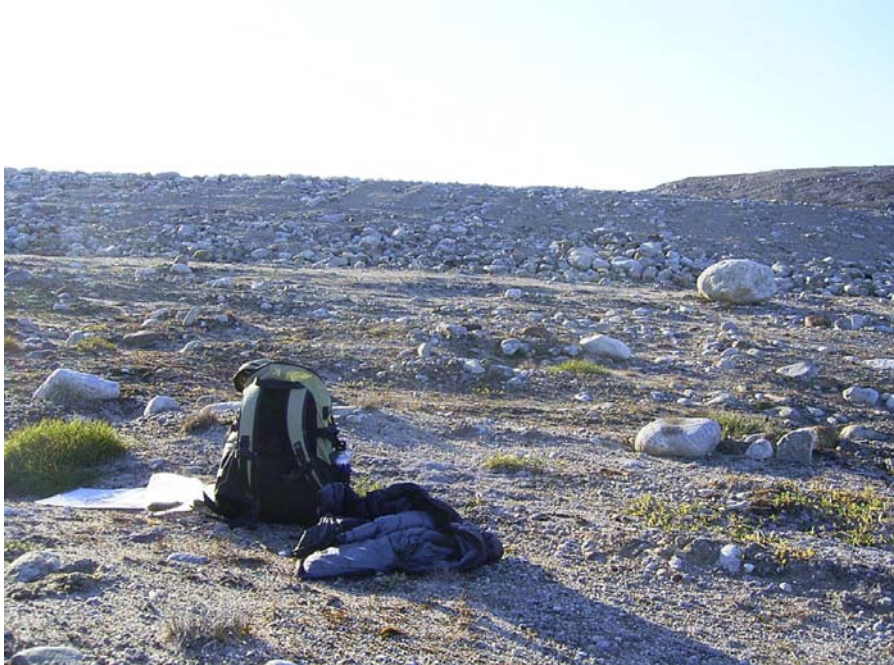
Photo 13.1 (FOX-4 TAN P-13 nw.jpg)	Photo 14.1 (FOX-4 TAN P-14.jpg)
Description: The eastern slope of the Tanner Bay Landfill from F4-TAN-11.	Description: Sample collection at F4-TAN-11.

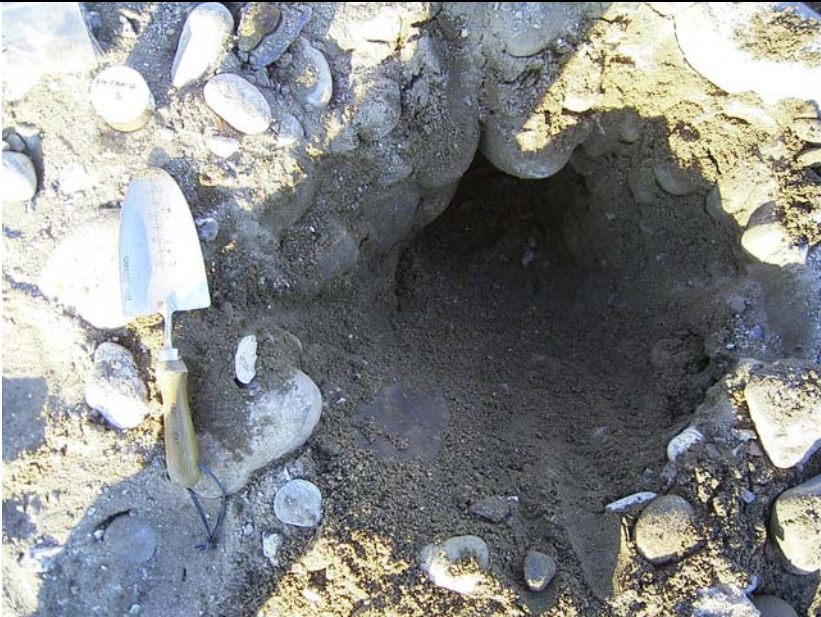
Photo 17.1 (FOX-4 TAN P-17.jpg)	Photo 18.1 (FOX-4 TAN P-18.jpg)
Description: Sample collection of F4-TAN-12	Description: After sample collection and backfill of F4-TAN-12.

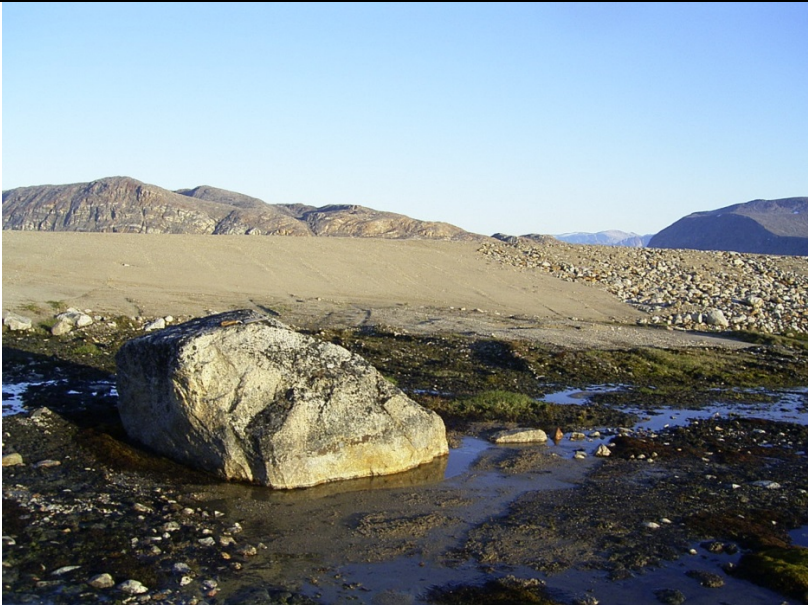
Photo 19.1 (FOX-4 TAN P-19 se.jpg)	Photo 20.1 (FOX-4 TAN P-20.jpg)
Description: The Tanner Bay Landfill view from F4-TAN-13.	Description: Sample collection of F4-TAN-13.

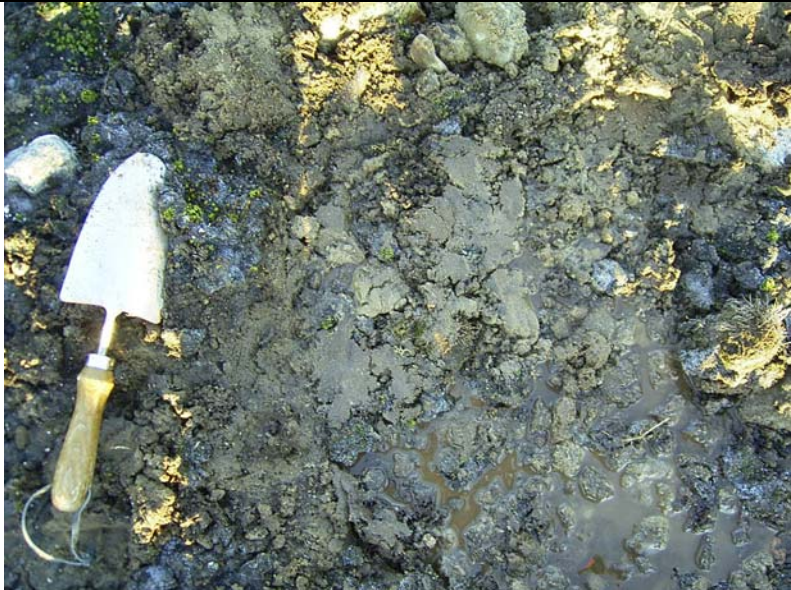
Photo 21.1 (FOX-4 TAN P-21.jpg)	Photo 22.1 (FOX-4 TAN P-22 se.jpg)
Description: After sample collection and backfill of F4-TAN-13.	Description: View looking toward the Tanner Bay Landfill from the access road.
