## **QIKIQ15 BAFFIN REGION DEW LINE SITE MONITORING**

# **2016 FOX-4 Monitoring Report**

**Report Number:** 1530908-2000-R6-V3

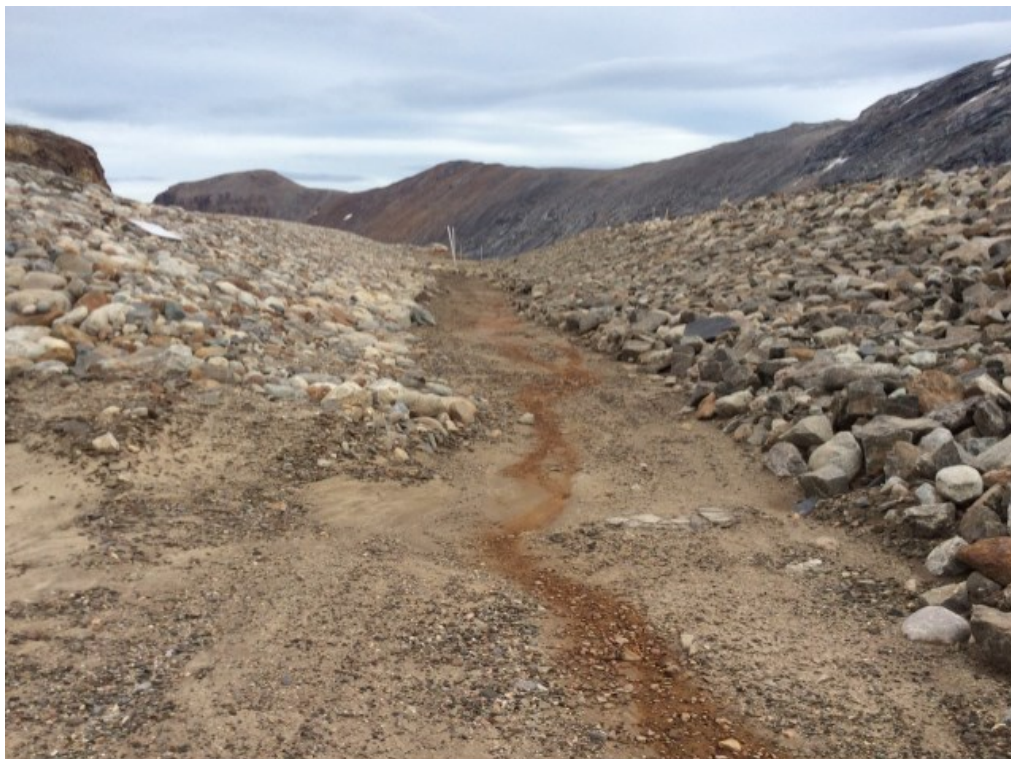
Photo 7: FOX-4 – NHWL/Tier II DF – Ditch between landfills facing east – Feature L – Orange staining (Acceptable) (ATT16\_Photo16.jpg)

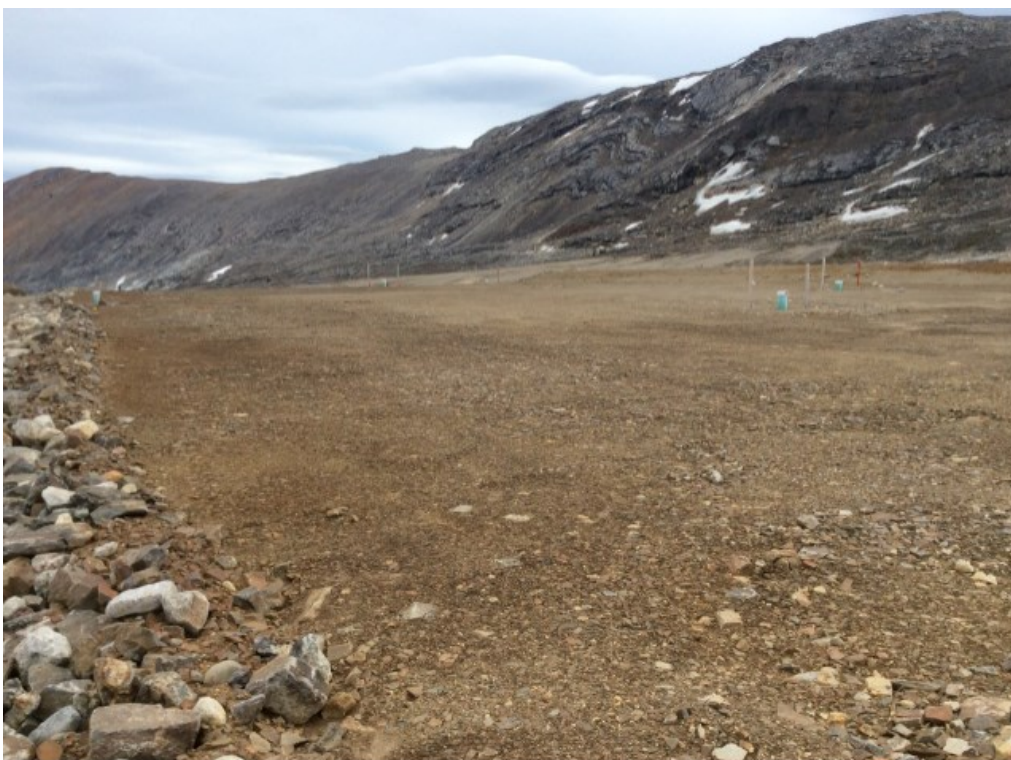
Photo 8: FOX-4 – NHWL/Tier II DF – Crest surface facing southeast (ATT17\_Photo17.jpg)

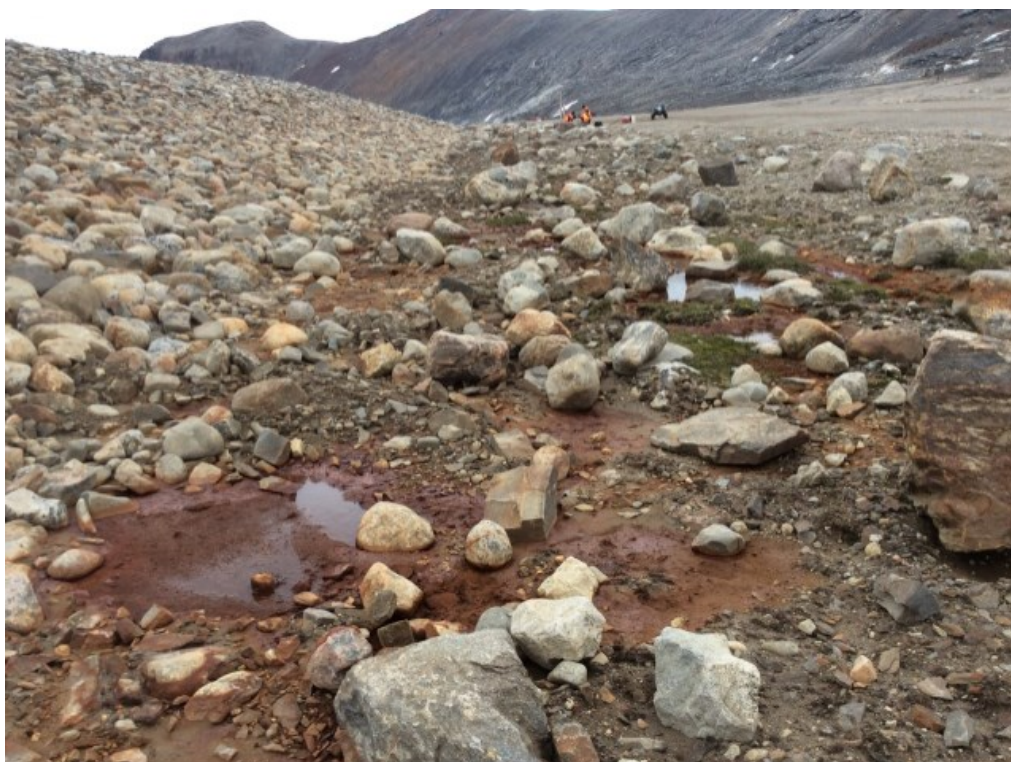
Photo 17: FOX-4 – NHWL/Tier II DF – South toe facing east – Feature B – Ponded water with orange staining (Acceptable) (ATT96\_Photo96.jpg)

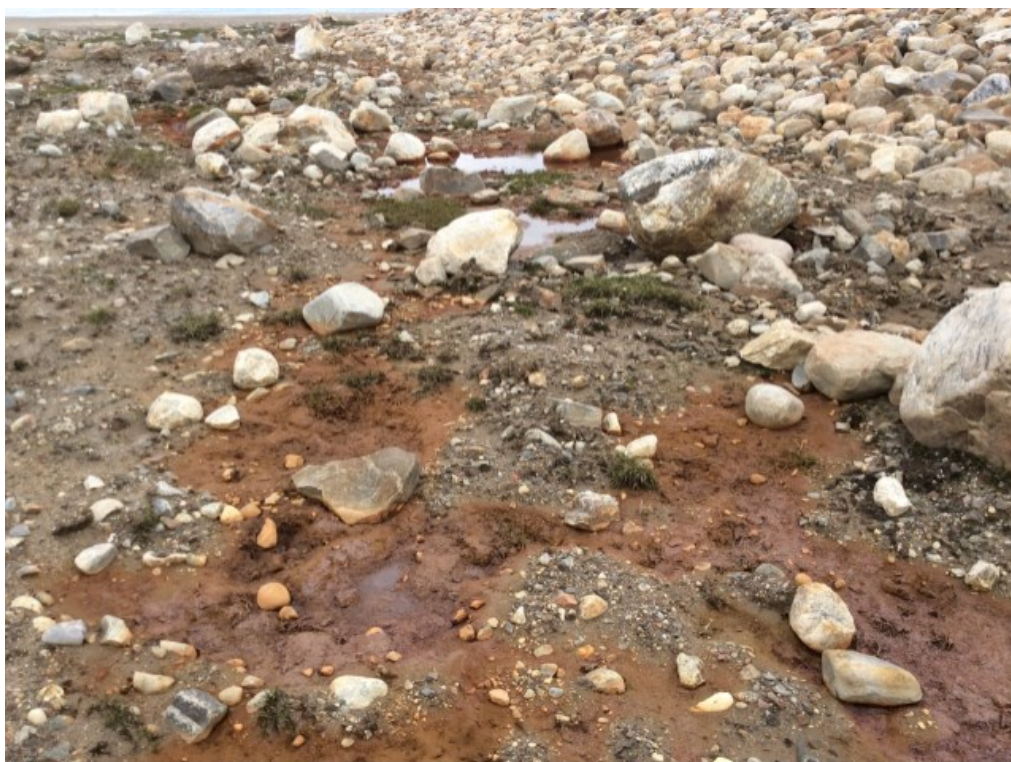
Photo 18: FOX-4 – NHWL/Tier II DF – South toe facing west – Feature B – Ponded water with some orange staining (Acceptable) (ATT97\_Photo97.jpg)

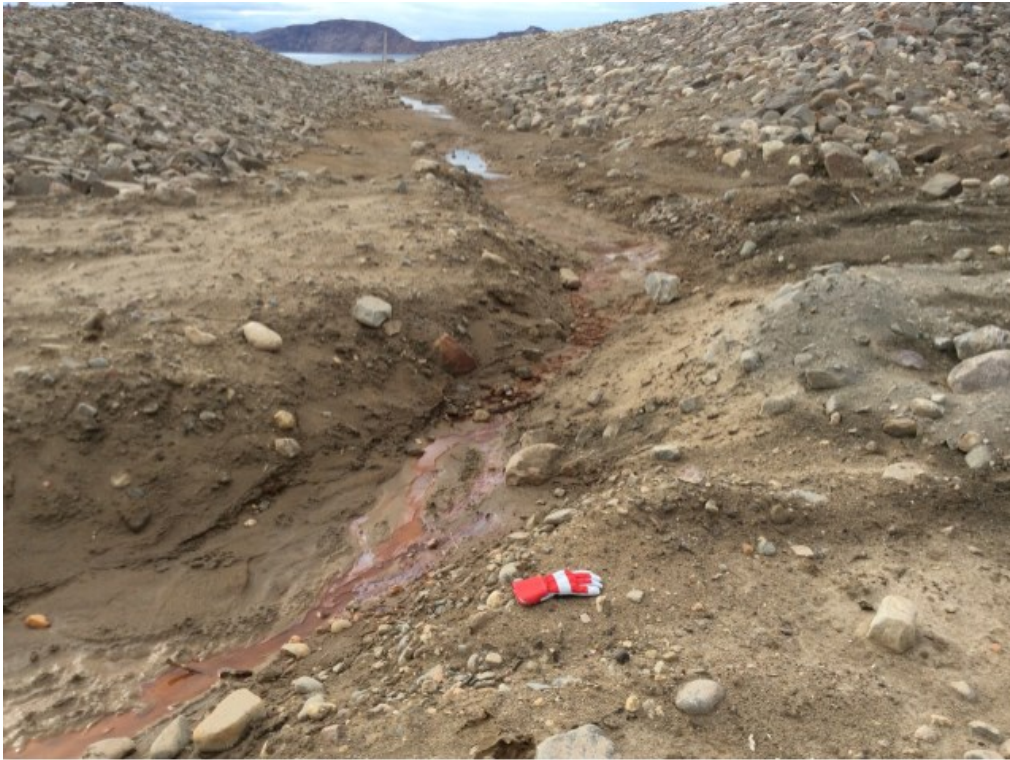
Photo 21: FOX-4 – NHWL/Tier II DF – Ditch between landfills facing west – Feature E – Orange staining and seepage (Acceptable) (ATT117\_Photo117.jpg)

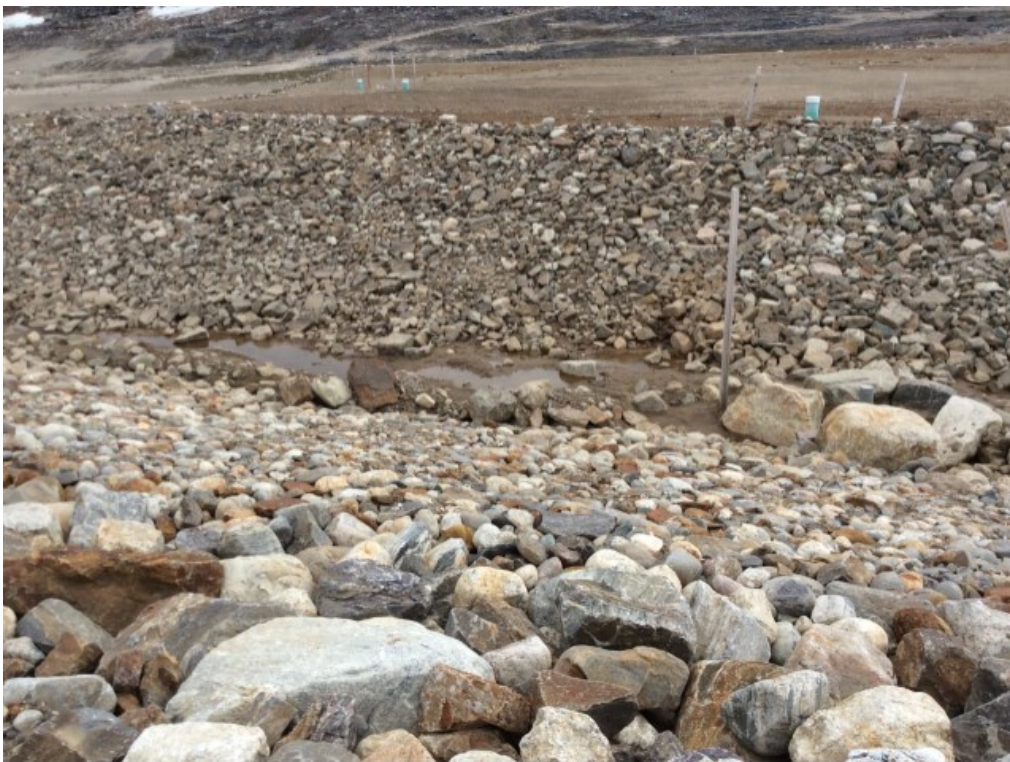
Photo 22: FOX-4 – NHWL/Tier II DF – Feature F – Ponded water near MW11-02 (Acceptable), facing south (ATT105\_Photo105.jpg)

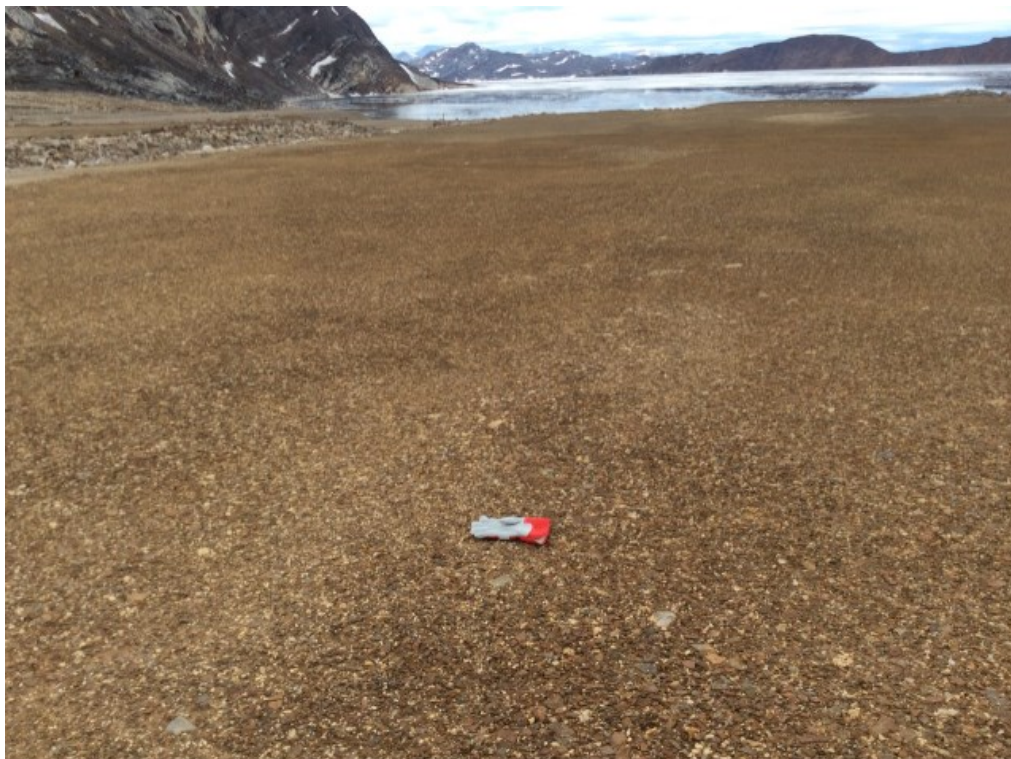
Photo 25: FOX-4 – NHWL/Tier II DF – Crest surface facing west – Previously observed minor settlement (Feature I) considered as-built undulations (Acceptable) (ATT102\_Photo102.jpg)

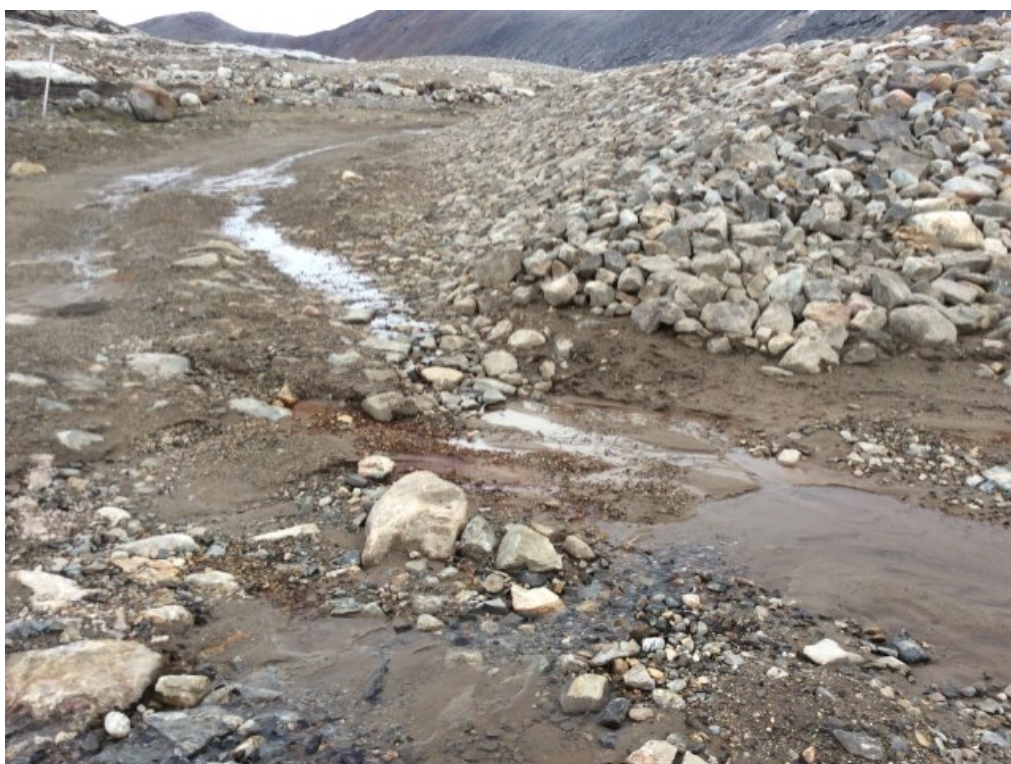
Photo 26: FOX-4 – NHWL/Tier II DF – Northwest toe facing east – Feature J – Ponded water (Acceptable) (ATT101\_Photo101.jpg)

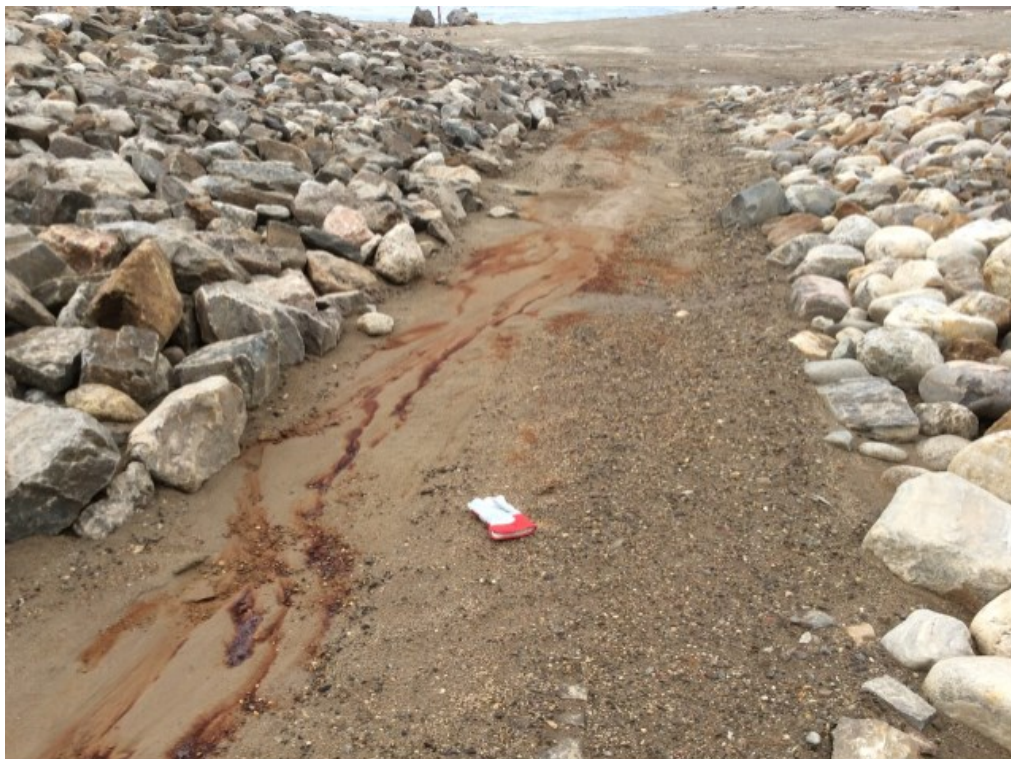
Photo 29: FOX-4 – NHWL/Tier II DF – Feature L – Orange staining between landfills, facing west (Acceptable) (ATT107\_Photo107.jpg)

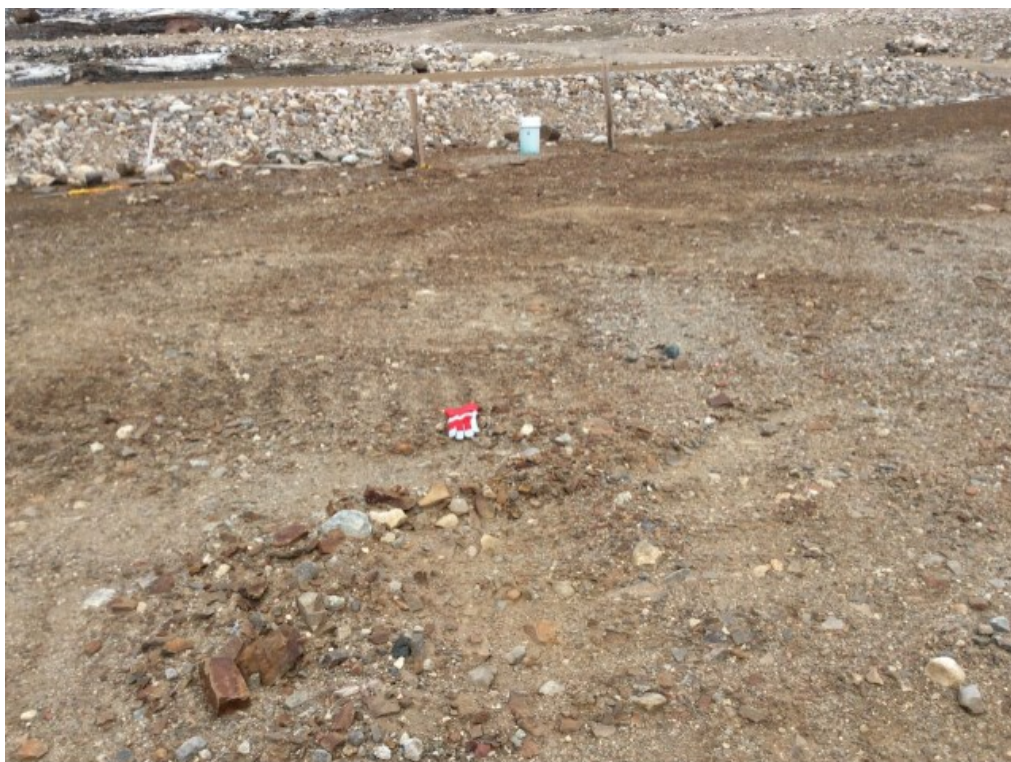
Photo 30: FOX-4 – NHWL/Tier II DF – Crest surface facing north – Feature M – Rough grading (Acceptable) (ATT110\_Photo110.jpg)

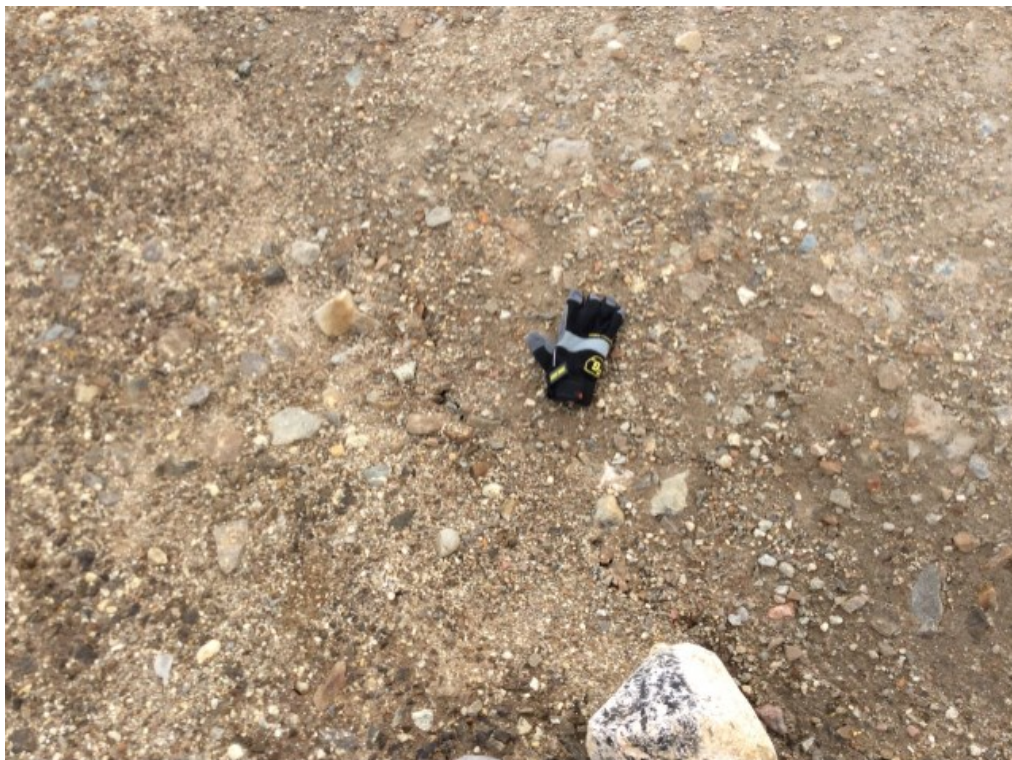
Photo 32: FOX-4 – NHWL/Tier II DF – Feature O – Cracking at bottom of crest surface change (Acceptable), facing south (ATT128\_Photo128.jpg)

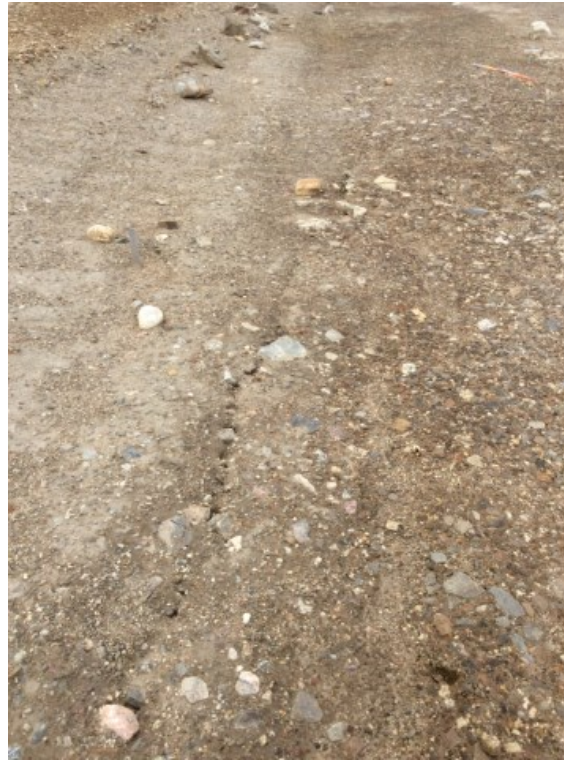
Photo 33: FOX-4 – NHWL/Tier II DF – Feature O – East end of cracking at toe of crest surface grade change (Acceptable), facing south (ATT129\_Photo129.jpg)

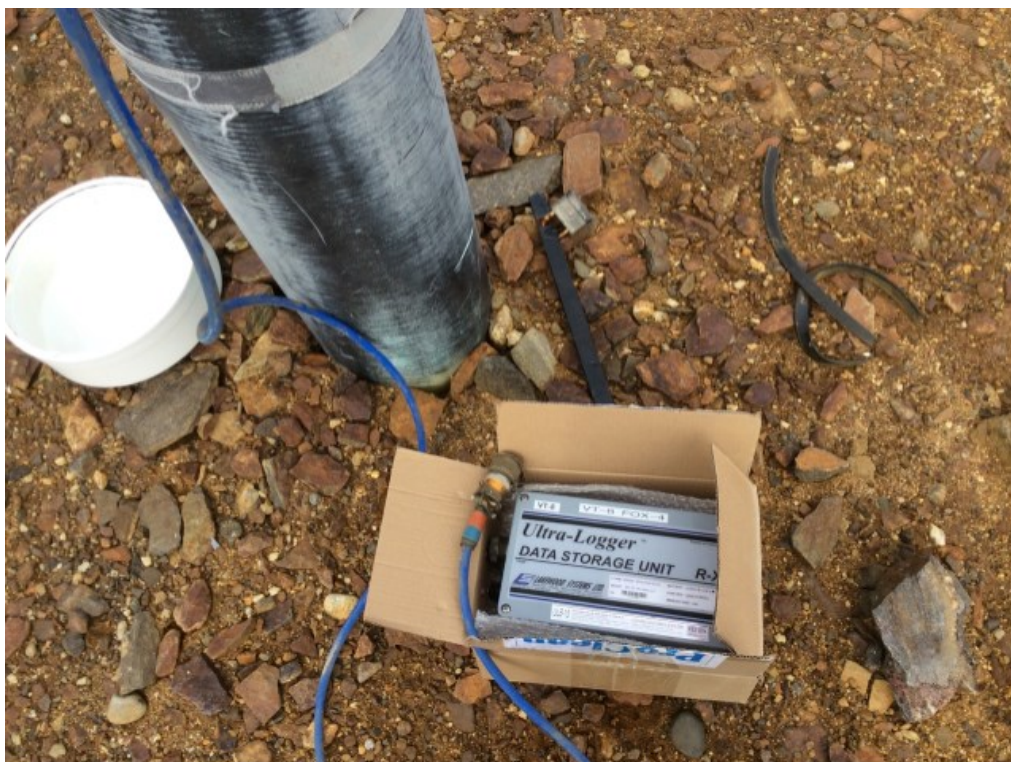
Photo 34: FOX-4 – NHWL/Tier II DF – Thermistor VT-8 (replaced repaired datalogger) (ATT120\_Photo120.jpg)

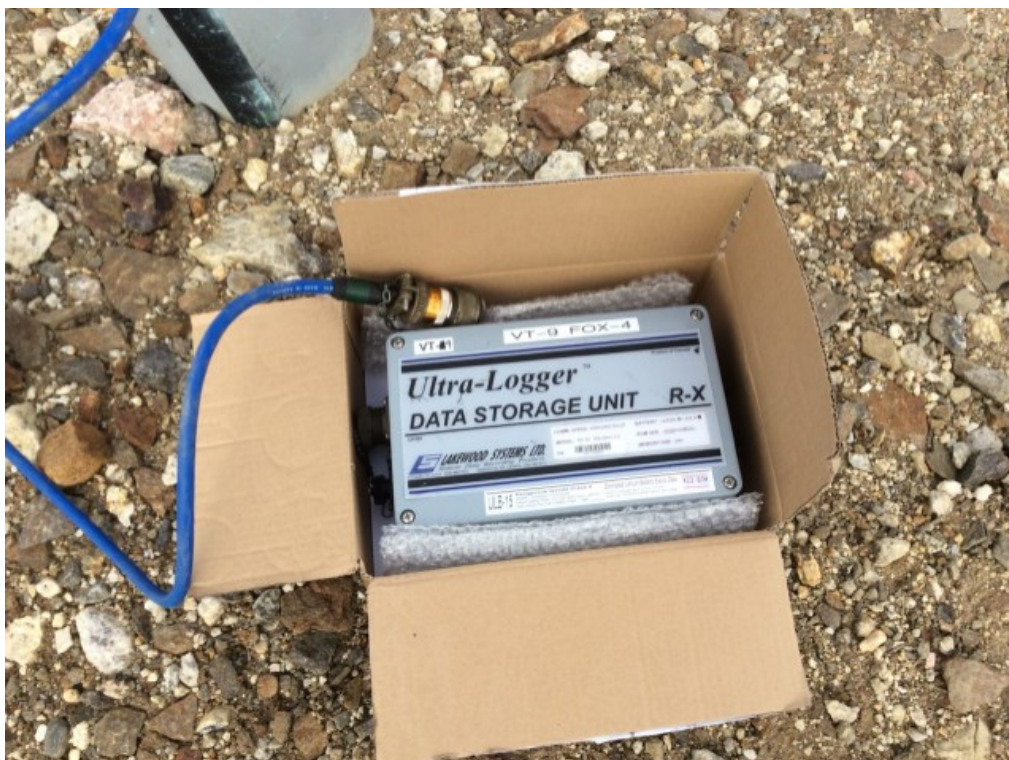
Photo 42: FOX-4 – NHWL/Tier II DF – Thermistor VT-9 (replaced repaired datalogger) (ATT119\_Photo119.jpg)

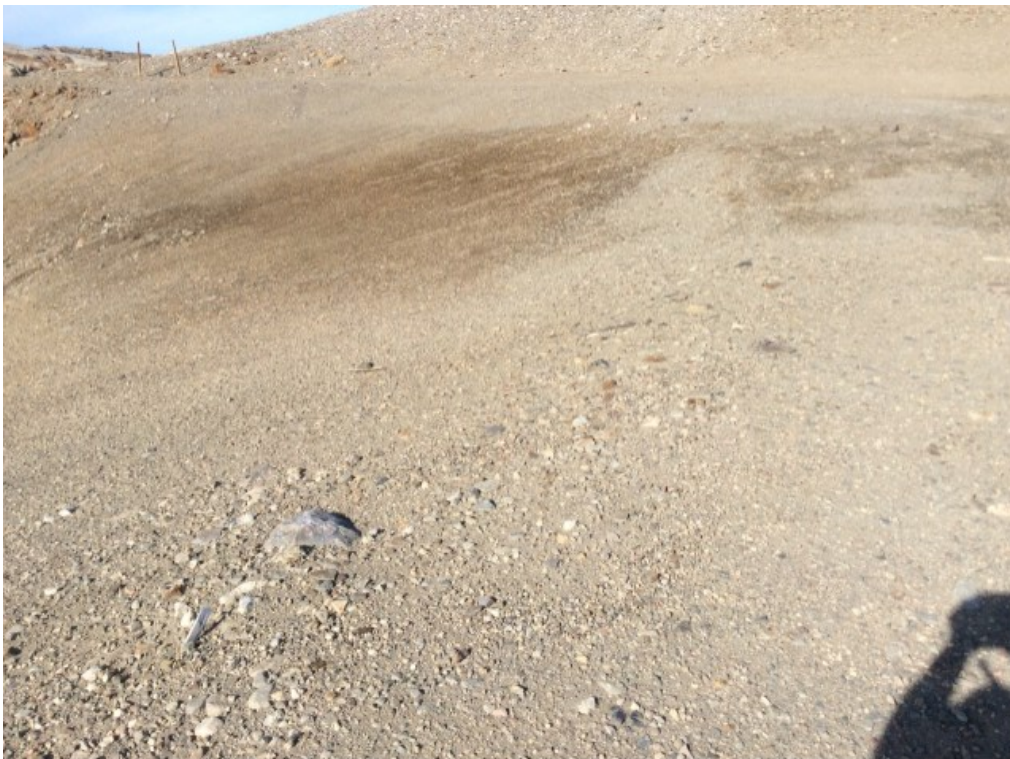
Photo 86: FOX-4 – Helipad West Landfill – Crest facing north in area of previously observed vehicle tracks (Feature A not observed in 2016) (ATT29\_Photo29.jpg)

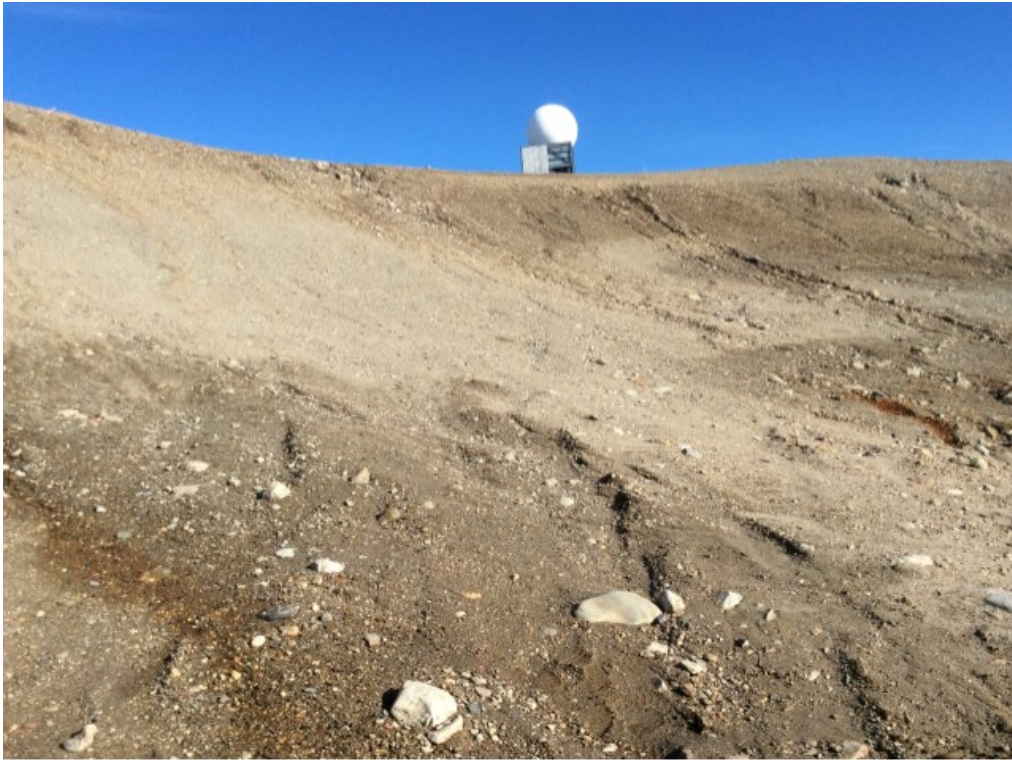
*Photo 87: FOX-4 – Helipad West Landfill – NW toe facing southeast upslope – Previously observed settlement (Feature G) is uneven ground at centre and previously observed staining (Feature J) at right (ATT30\_Photo30.jpg)*

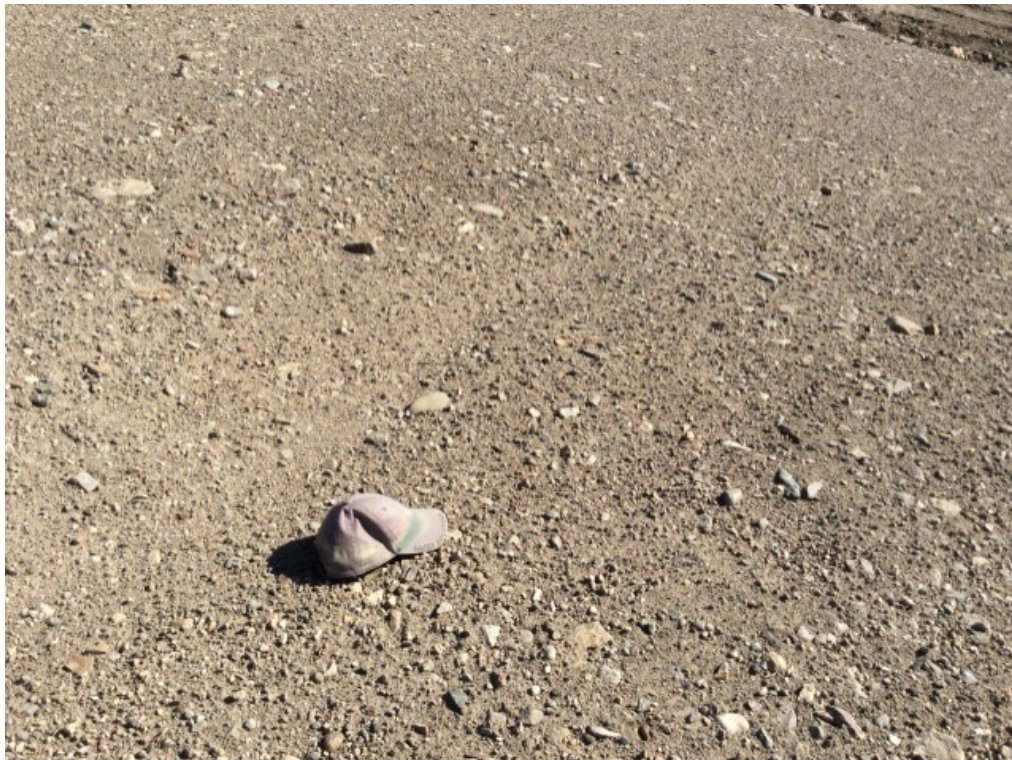
Photo 93: FOX-4 – Helipad West Landfill – Previously observed vehicle tracks (Feature A) not considered noteworthy in 2016, facing southwest downslope (ATT148\_Photo148.jpg)

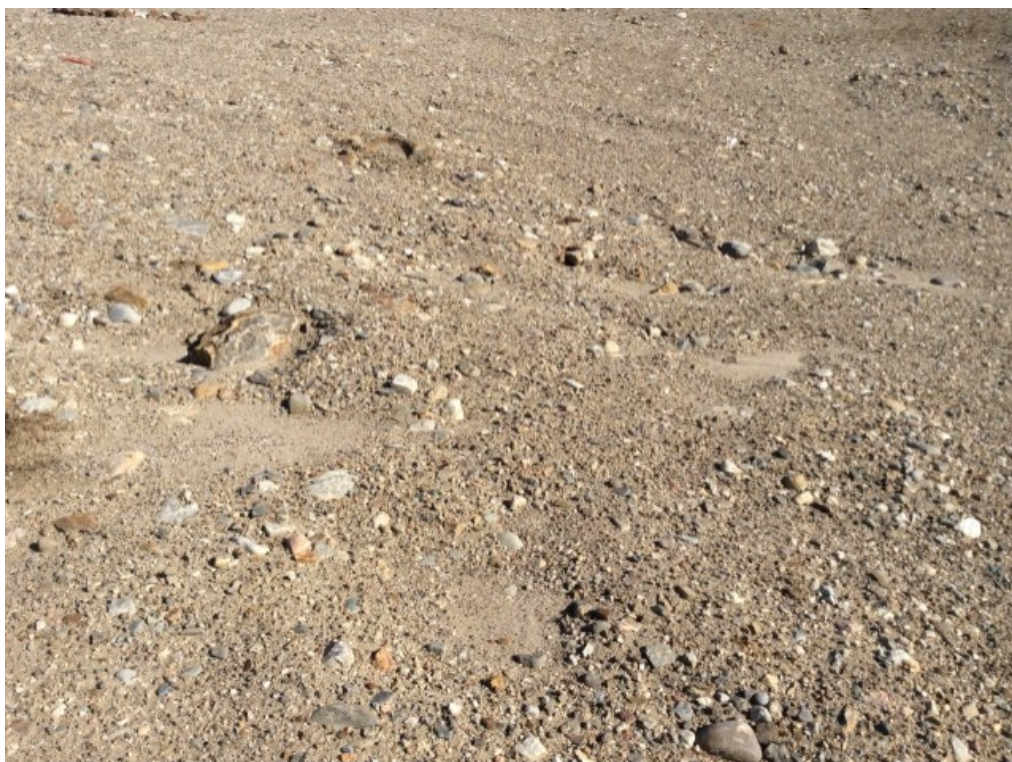
Photo 94: FOX-4 – Helipad West Landfill – Feature F – Minor settlement or uneven ground (Acceptable), facing south (ATT146\_Photo146.jpg)

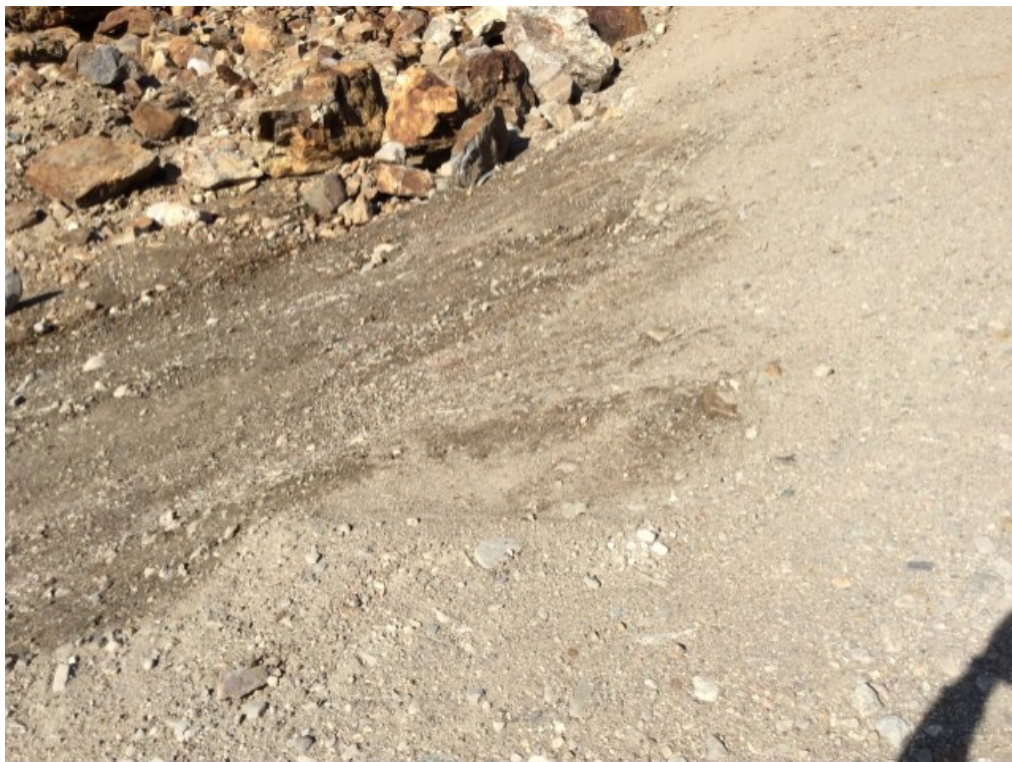
*Photo 96: FOX-4 – Helipad West Landfill – NW toe facing northwest – Previously observed settlement (Feature G) appears to be area of uneven ground and not considered noteworthy in 2016 (ATT157\_Photo157.jpg)*

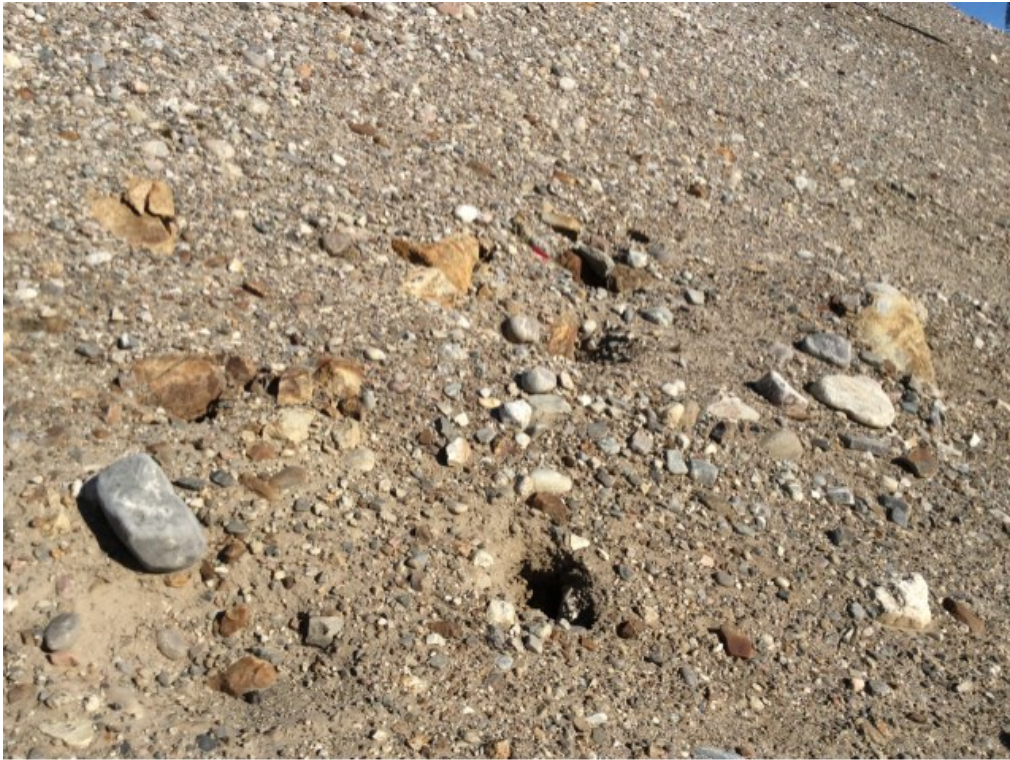
Photo 97: FOX-4 – Helipad West Landfill – Slope above landfill facing south – Feature H – Previously observed settlement area with small sinkholes (Acceptable) (ATT141\_Photo141.jpg)

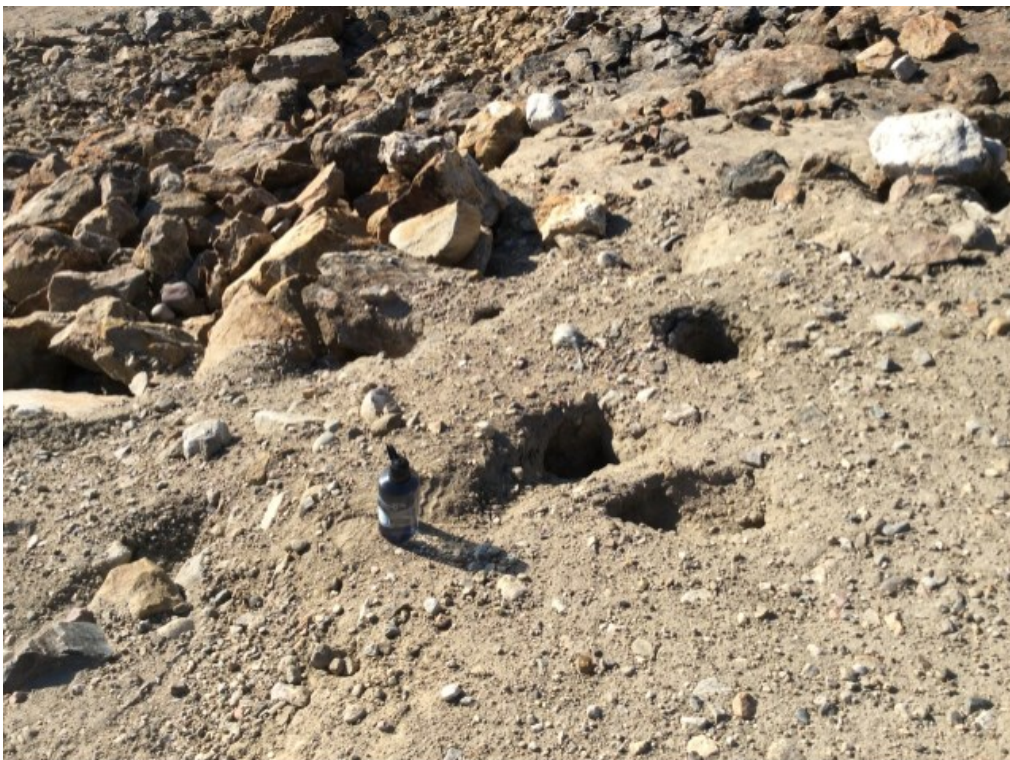
Photo 98: FOX-4 – Helipad West Landfill – West toe facing north – Feature I – Minor sink holes at edge of coarse rock fill (Acceptable) (ATT154\_Photo154.jpg)

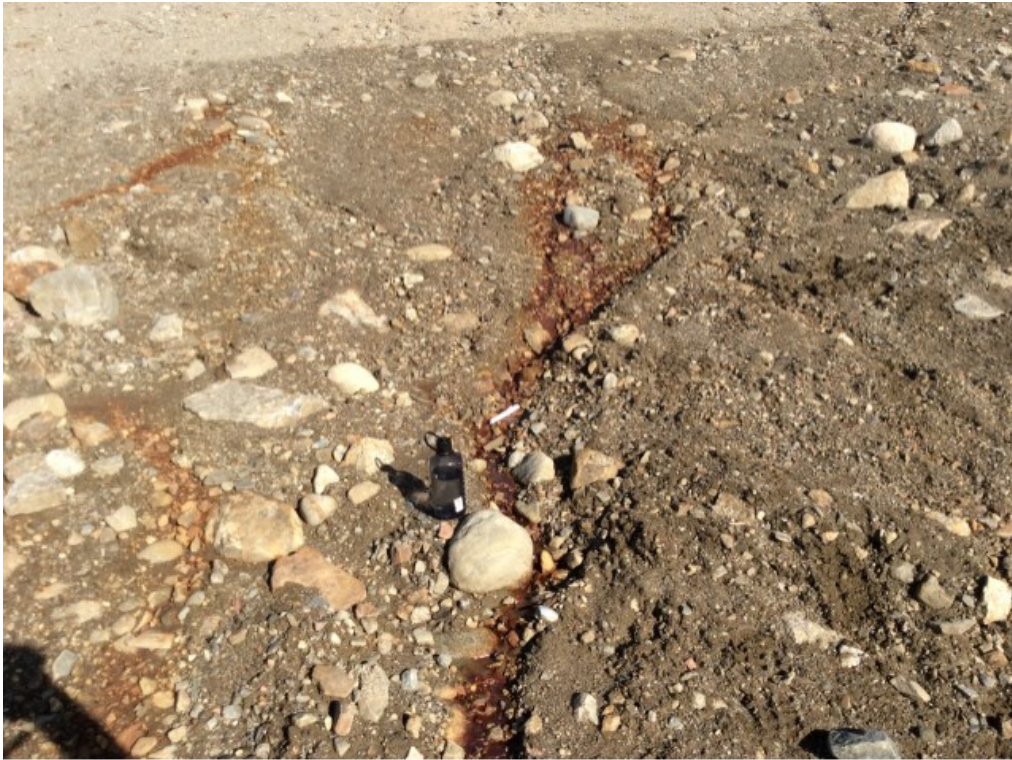
Photo 99: FOX-4 – Helipad West Landfill – Feature J – Orange staining and seepage with sheen, soft saturated ground – West toe facing east (Acceptable) (ATT155\_Photo155.jpg)

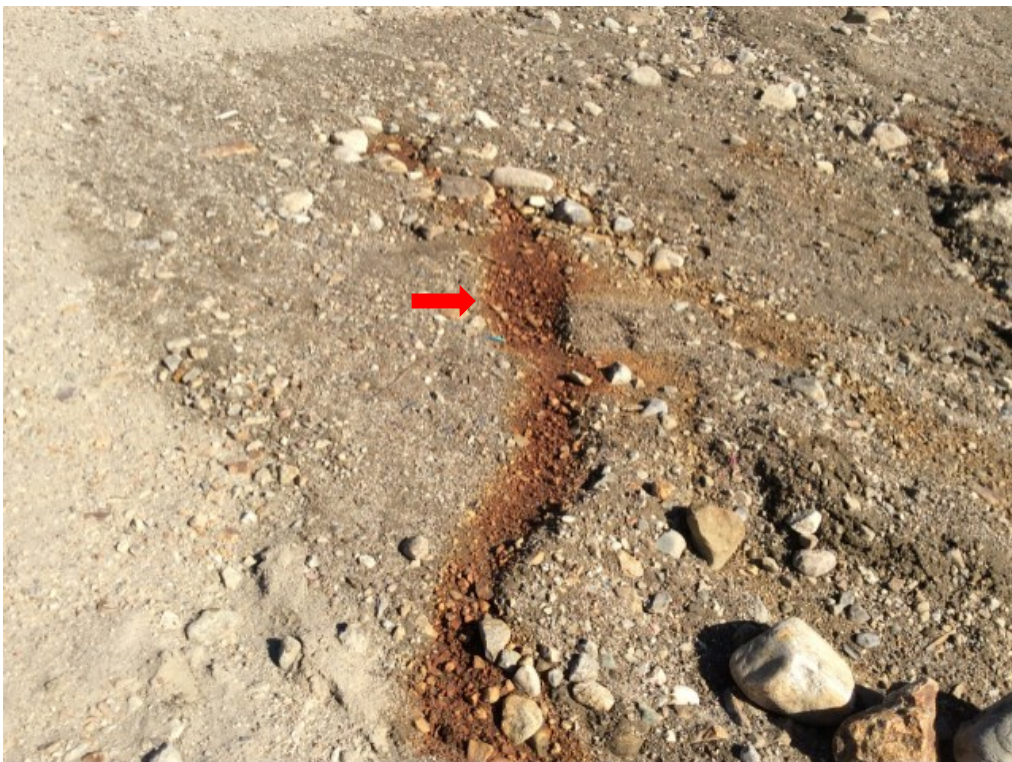
Photo 100: FOX-4 – Helipad West Landfill – Feature J – Orange staining with no seepage at time of 2016 inspection – West toe facing southeast (ATT156\_Photo156.jpg)

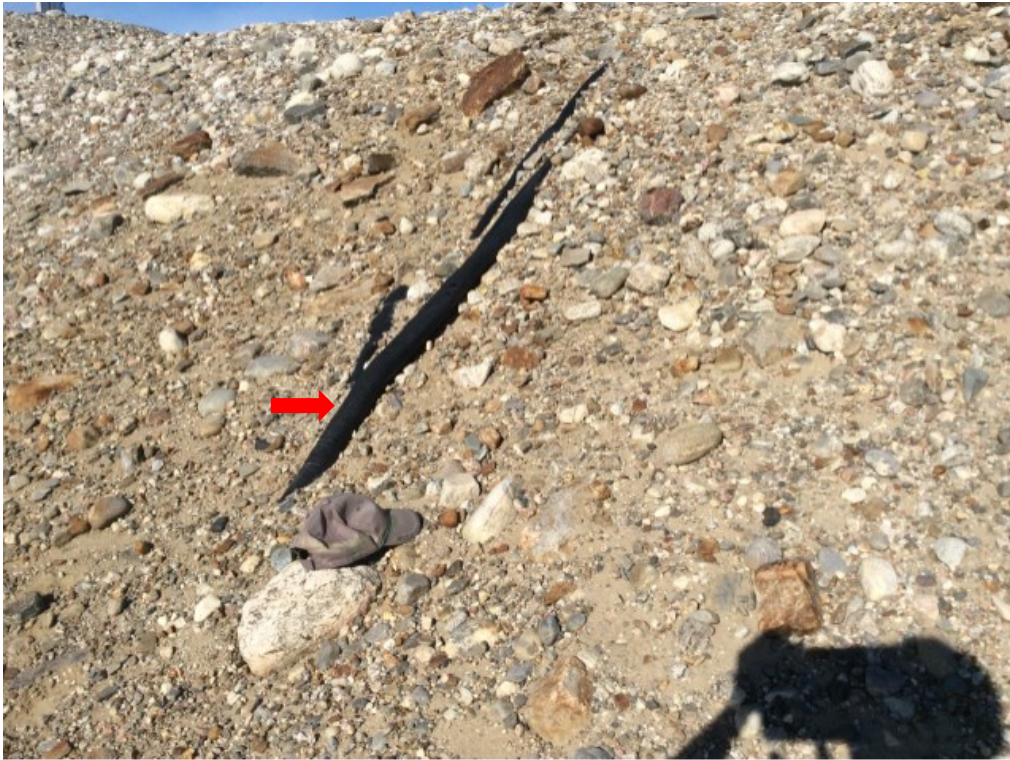
Photo 101: FOX-4 – Helipad West Landfill – Slope above landfill and below helipad facing west– Feature K – previously observed exposed wires (Acceptable) (ATT145\_Photo145.jpg)

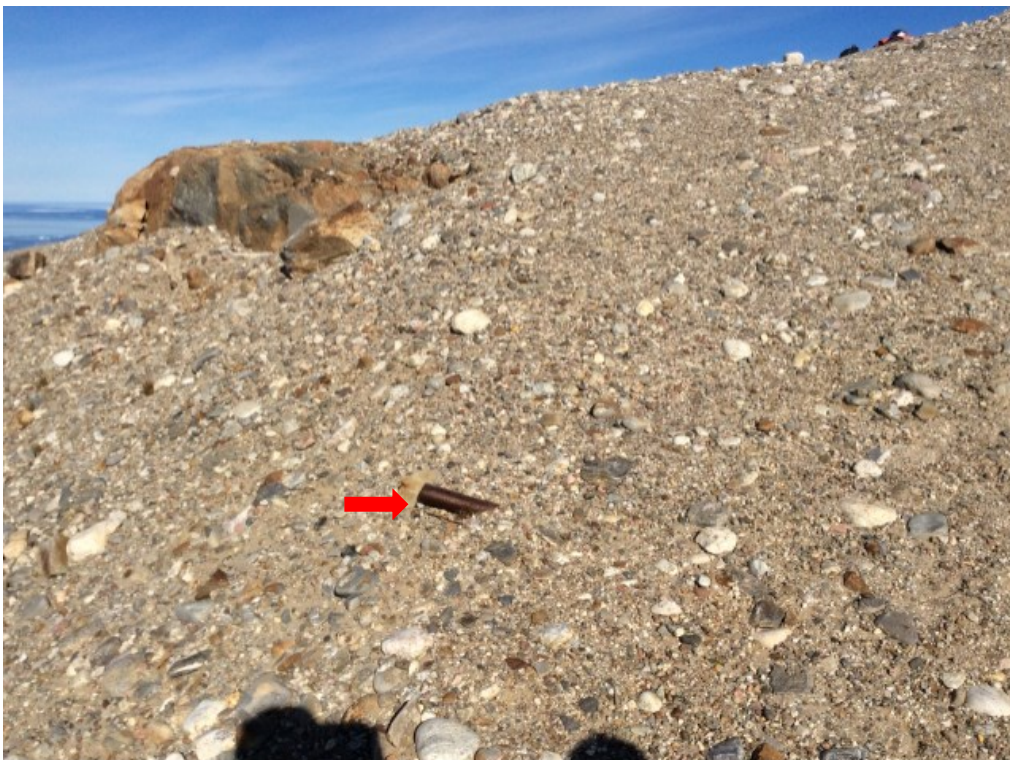
Photo 102: FOX-4 – Helipad West Landfill – Slope east of MW98-06 facing south – Feature L – Exposed steel pipe (Acceptable) (ATT142\_Photo142.jpg)

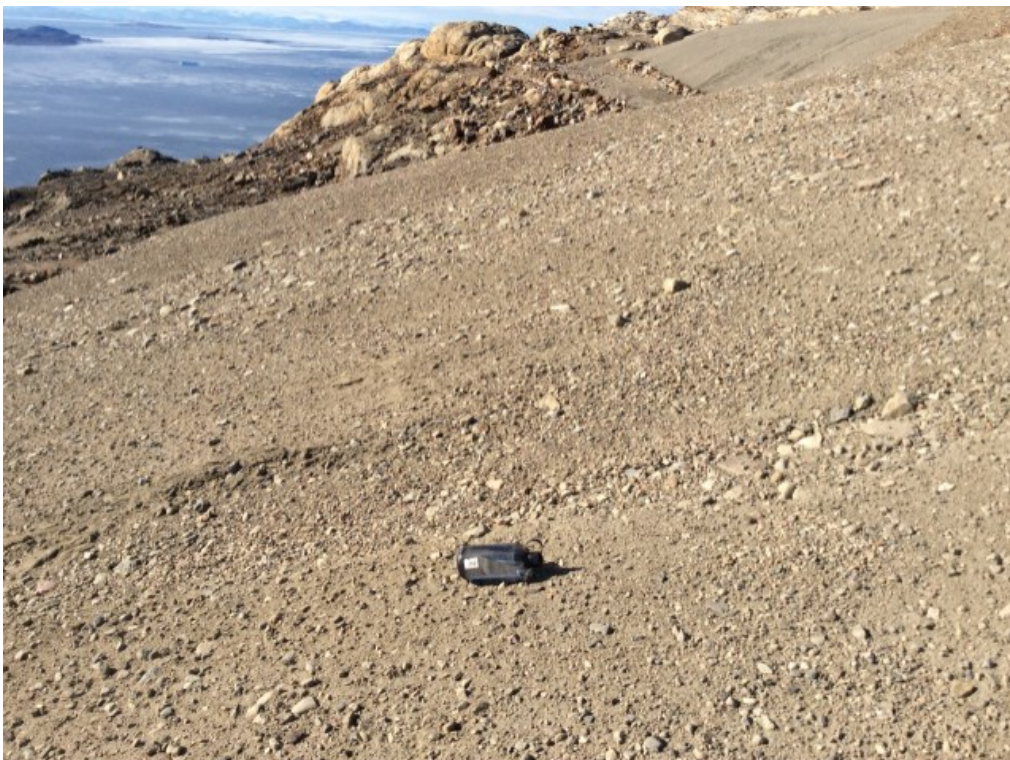
Photo 106: FOX-4 – Helipad West Landfill – West slope west – Feature C – Self-armouring erosion (Acceptable) (ATT152\_Photo152.jpg)

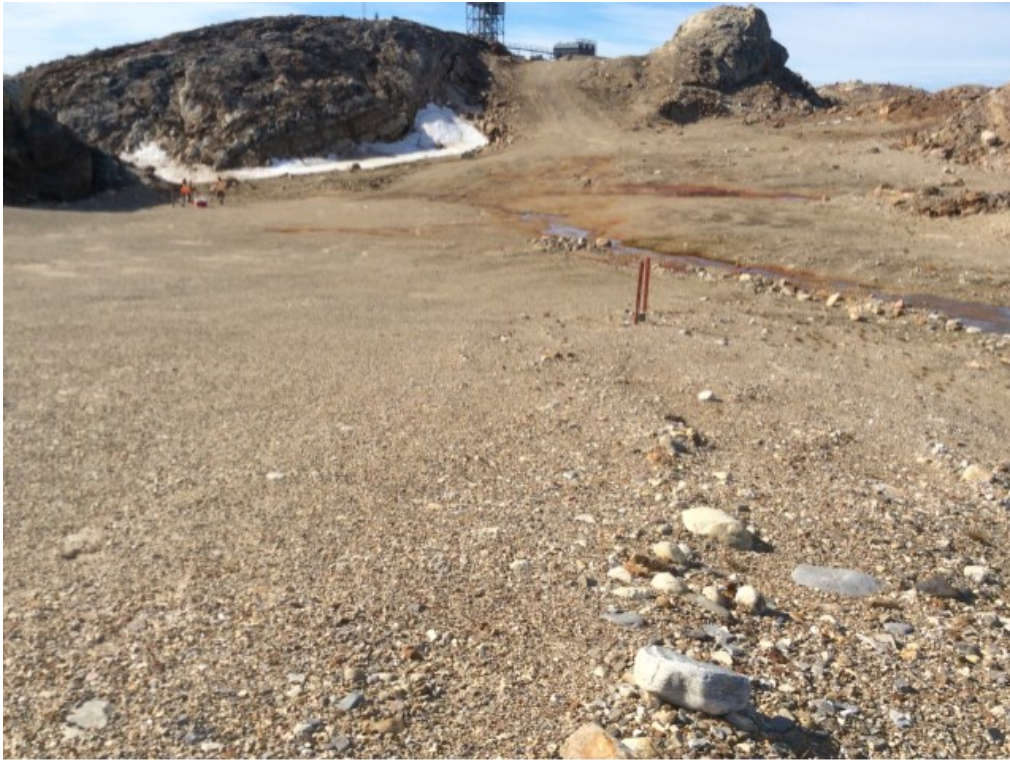
Photo 125: FOX-4 – Station Area Landfill – North side facing west and MW98-08 – Feature L (staining) and Feature B (ponded water) in background (Acceptable) (ATT24\_Photo24.jpg)

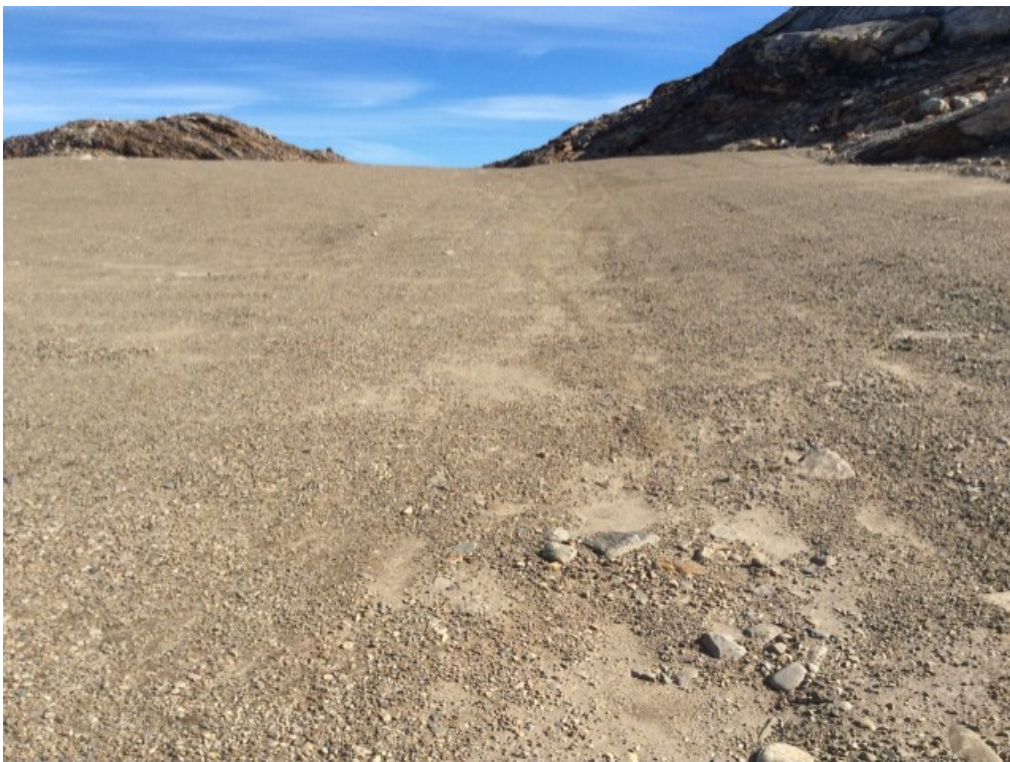
Photo 126: FOX-4 – Station Area Landfill – West end facing east – Previously observed minor settlement (Feature H) is just rough grading and not considered noteworthy (ATT25\_Photo25.jpg)

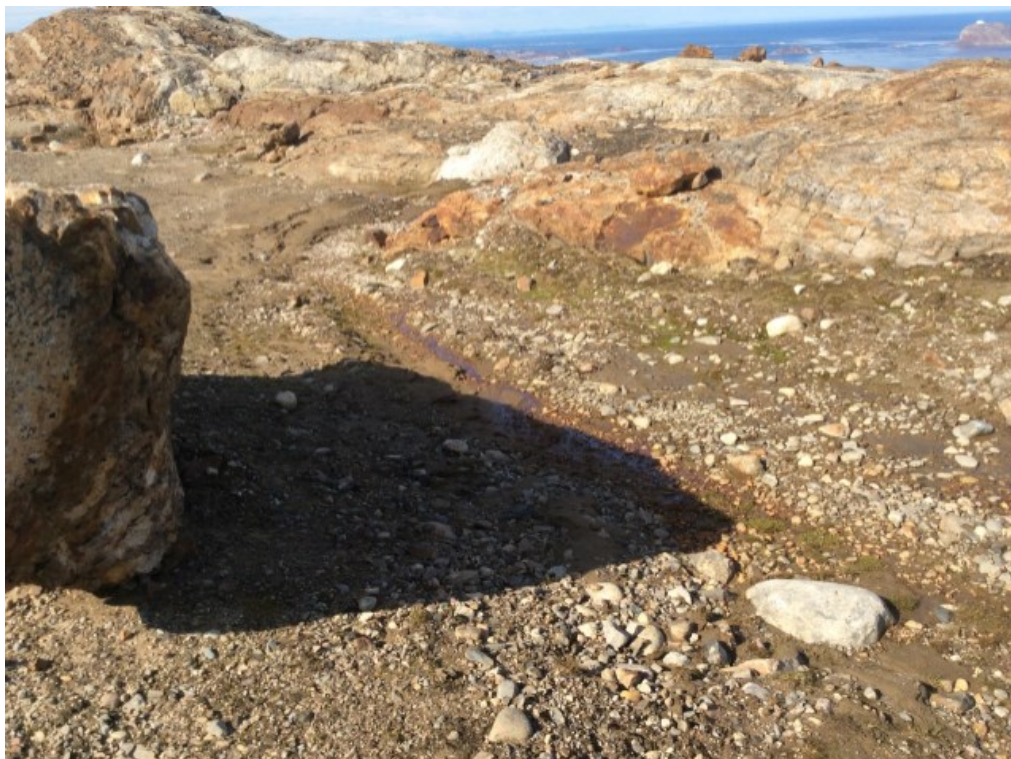
Photo 127: FOX-4 – Station Area Landfill – East end toe facing northwest – Previously observed Feature A - Seepage with orange staining (Acceptable) (ATT134\_Photo134.jpg)
